**ANNUAL REPORT
JULY 2014 THROUGH JUNE 2015
CALLE DEL BARCO
LANDSLIDE ASSESSMENT DISTRICT
MALIBU, CALIFORNIA**

Prepared for:
CITY OF MALIBU

November 2015
Fugro Project No. 04.62140605

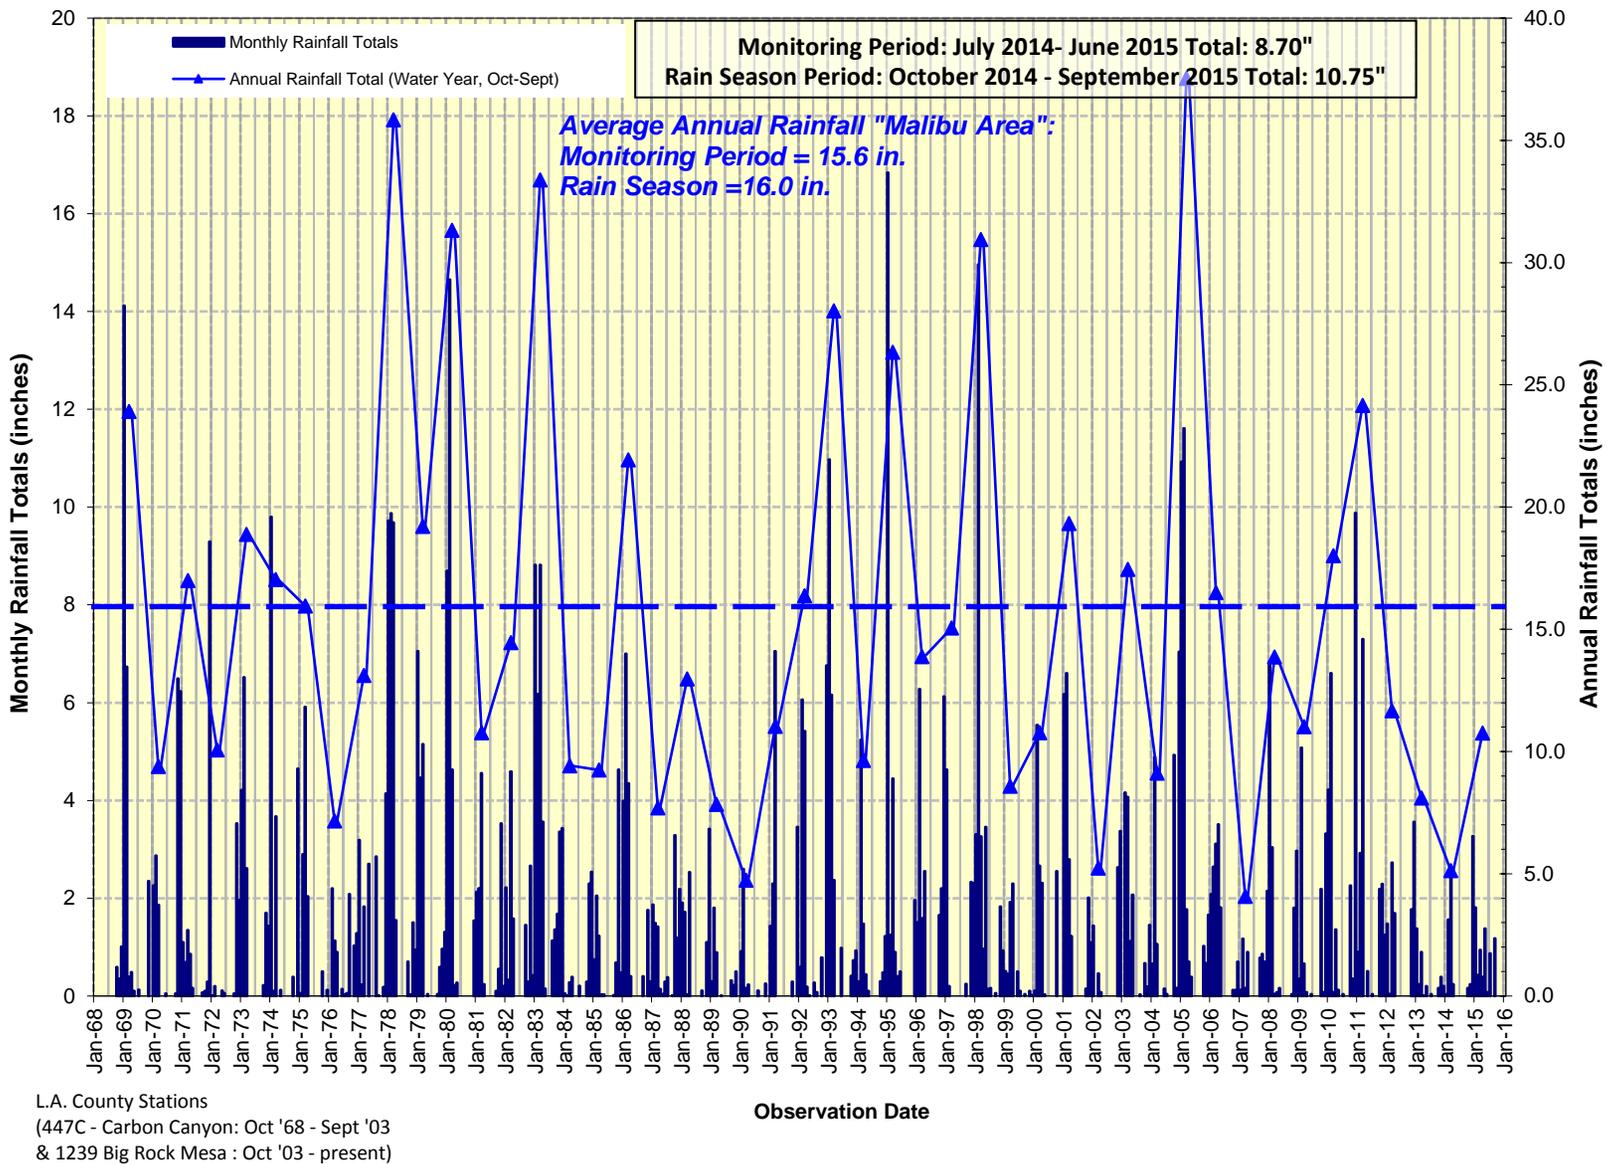
RAINFALL GRAPH
 Calle del Barco Landslide Assessment District
 Malibu, California

Rainfall data indicate that approximately 8.70 inches of precipitation fell during the monitoring period from July 1, 2014, through June 30, 2015. The average annual rainfall from 1968 to 2015 in the "Malibu Area" for the monitoring period is approximately 15.6 inches.

Rainfall data are usually analyzed in terms of the annual "rain season" that covers the time period October 1 through September 30. Rainfall for October 1, 2014, through September 30, 2015, was approximately 10.75 inches. This is approximately 33 percent of the average annual rainfall of 16.0 inches for the "rain seasons" between 1968 and 2015.

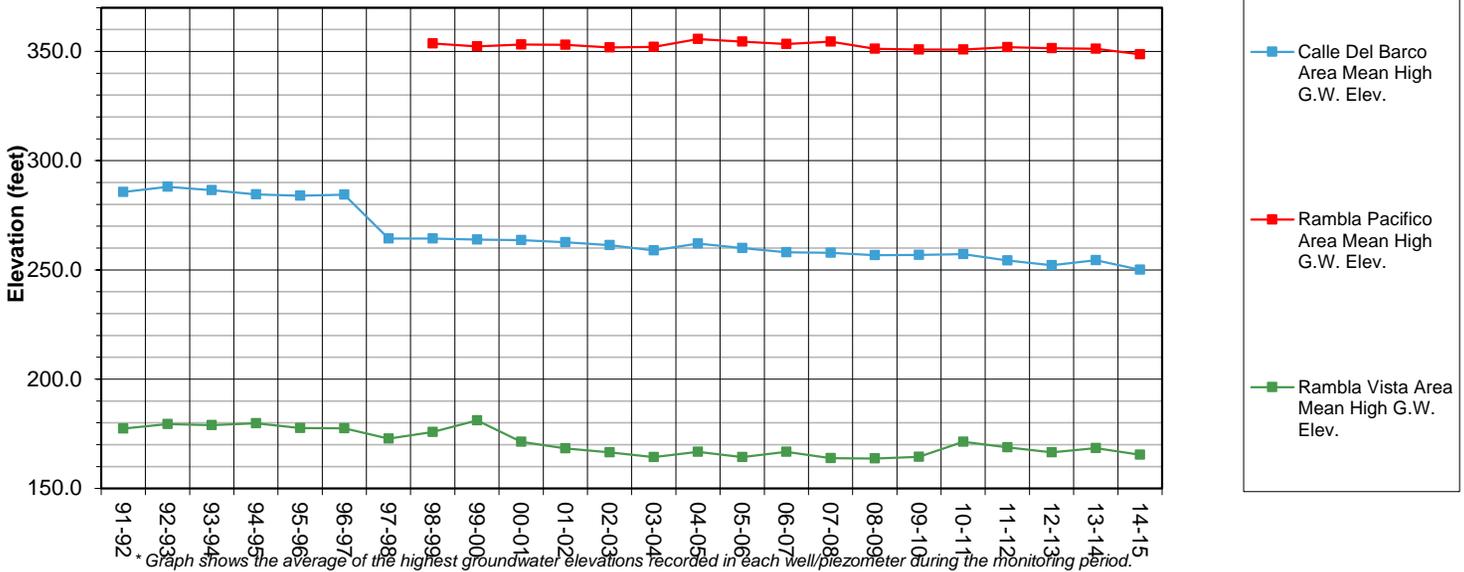
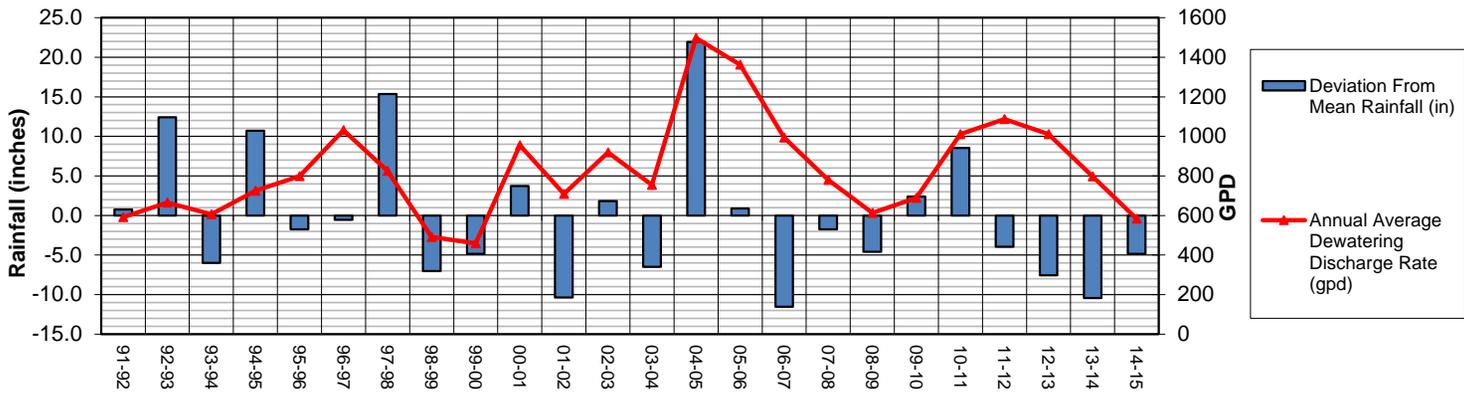
GROUNDWATER LEVELS, DEWATERING AND RAINFALL
 Calle del Barco Landslide Assessment District
 Malibu, California

A summary graph of mean high groundwater elevations for the Assessment District is presented on Plate 5. Plate 5 also shows the average dewatering output (gallons per day, gpd) and the yearly magnitude of deviation from the mean annual rainfall. The average annual rainfall used for the chart was computed using data from 1988 through the present. That graph illustrates that since 2010-2011, annual rainfall has been generally decreasing. During the same period, the average dewatering output has been decreasing.

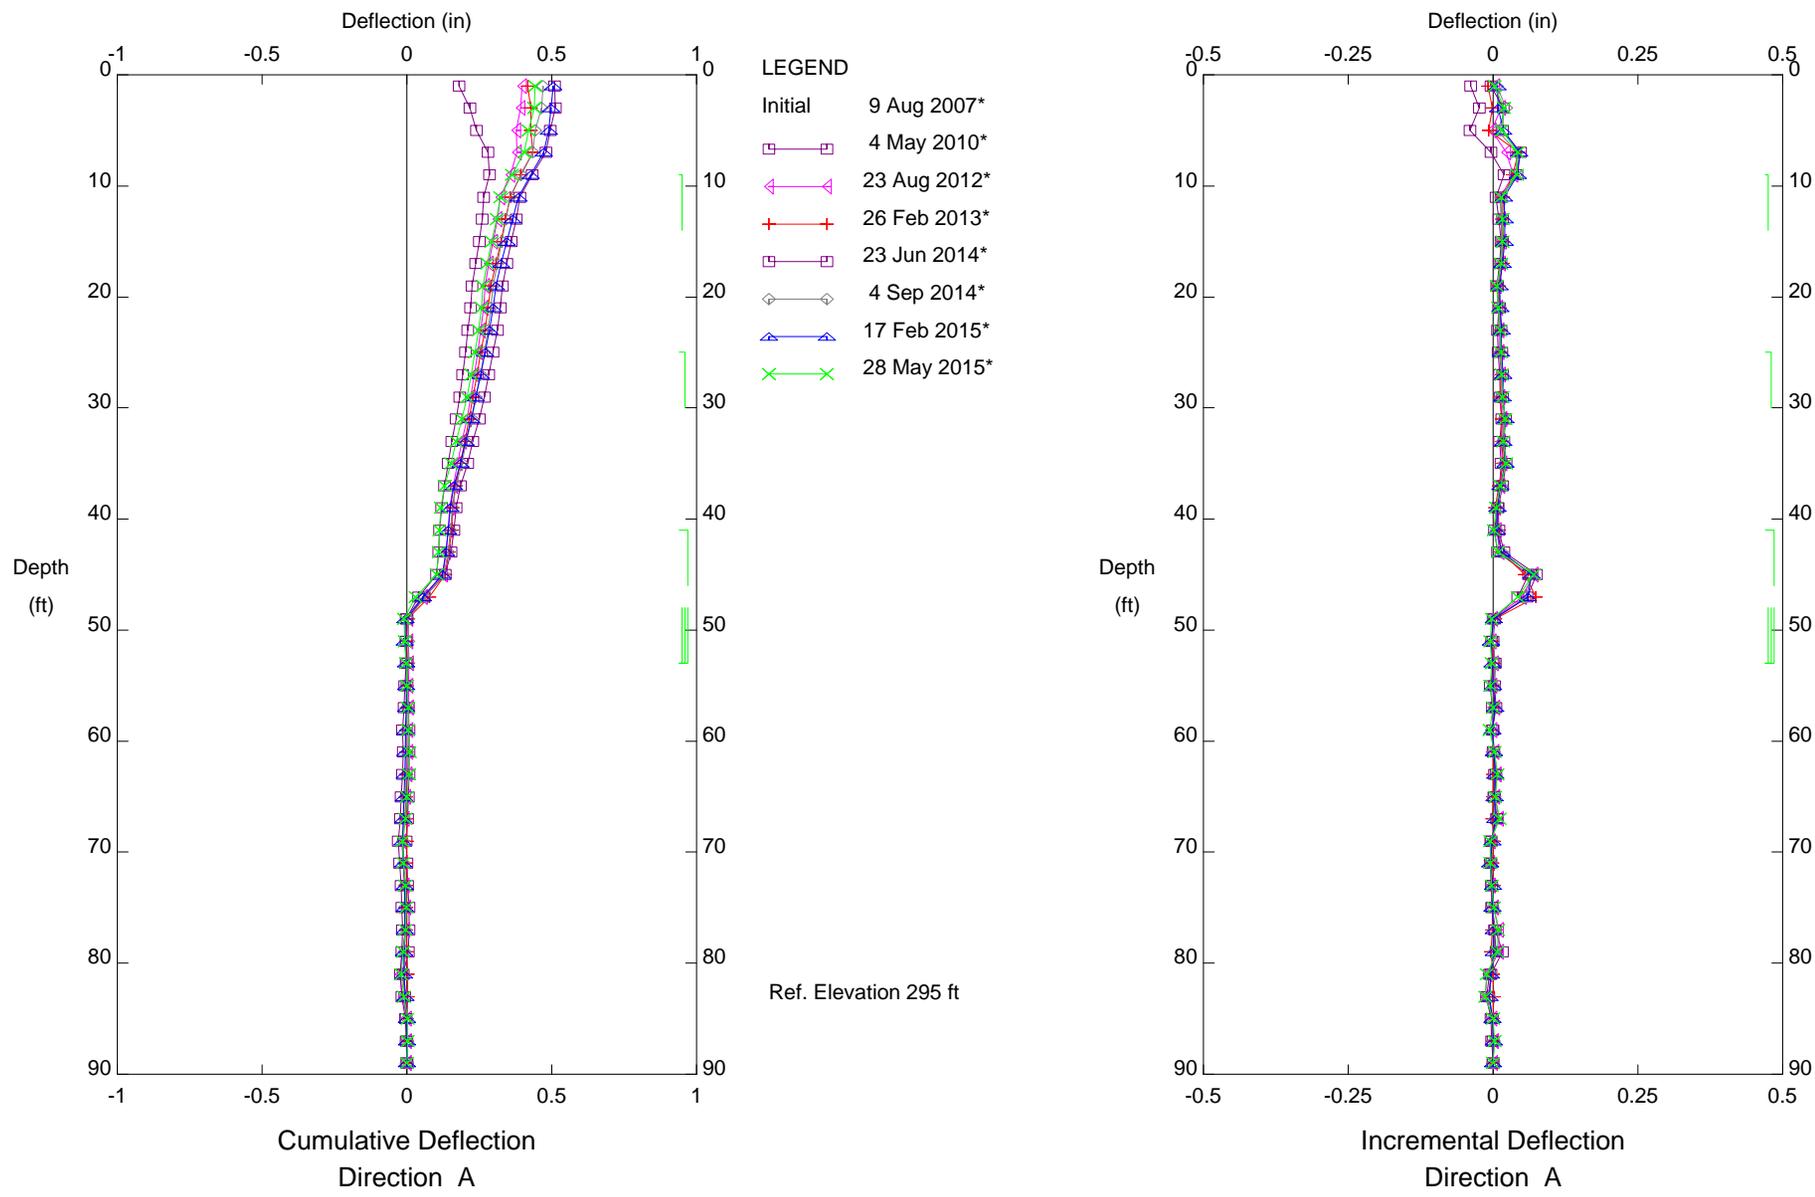
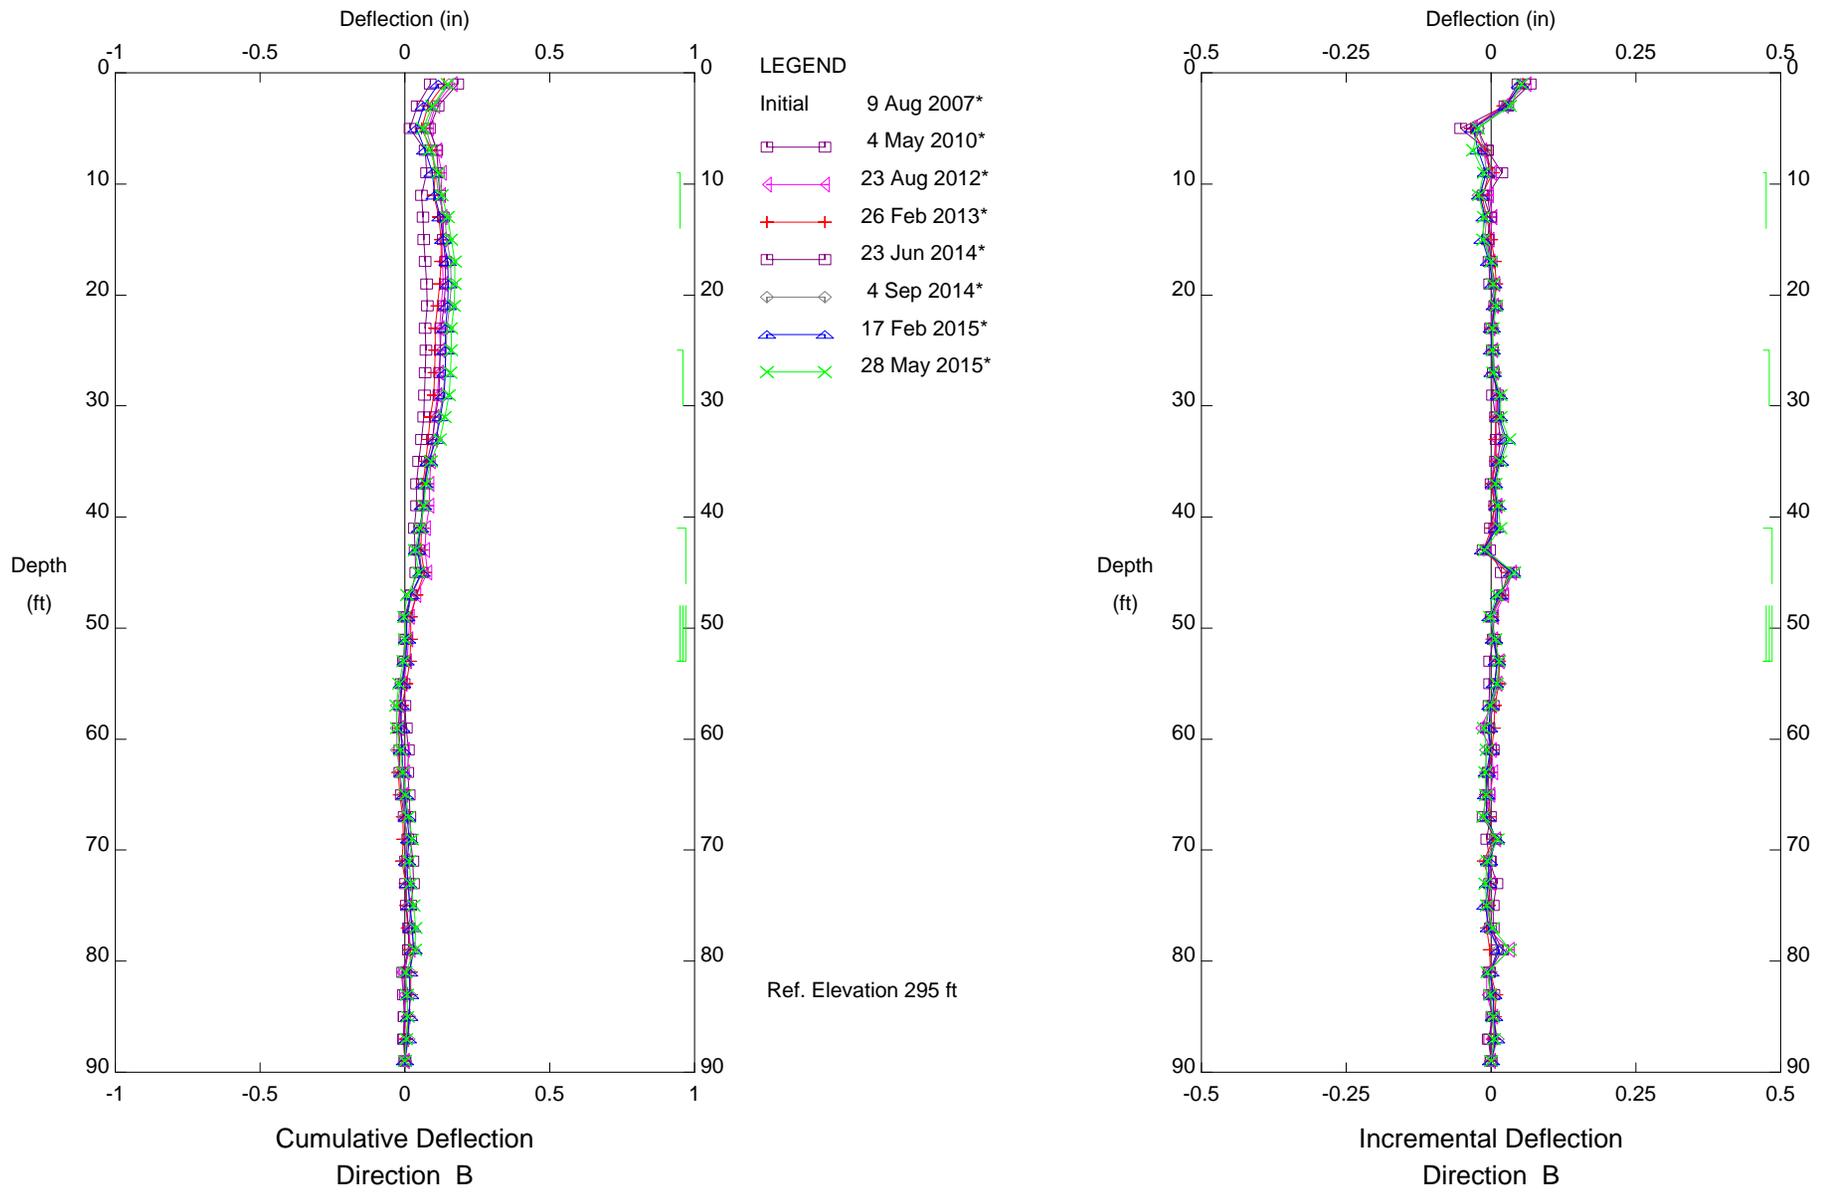
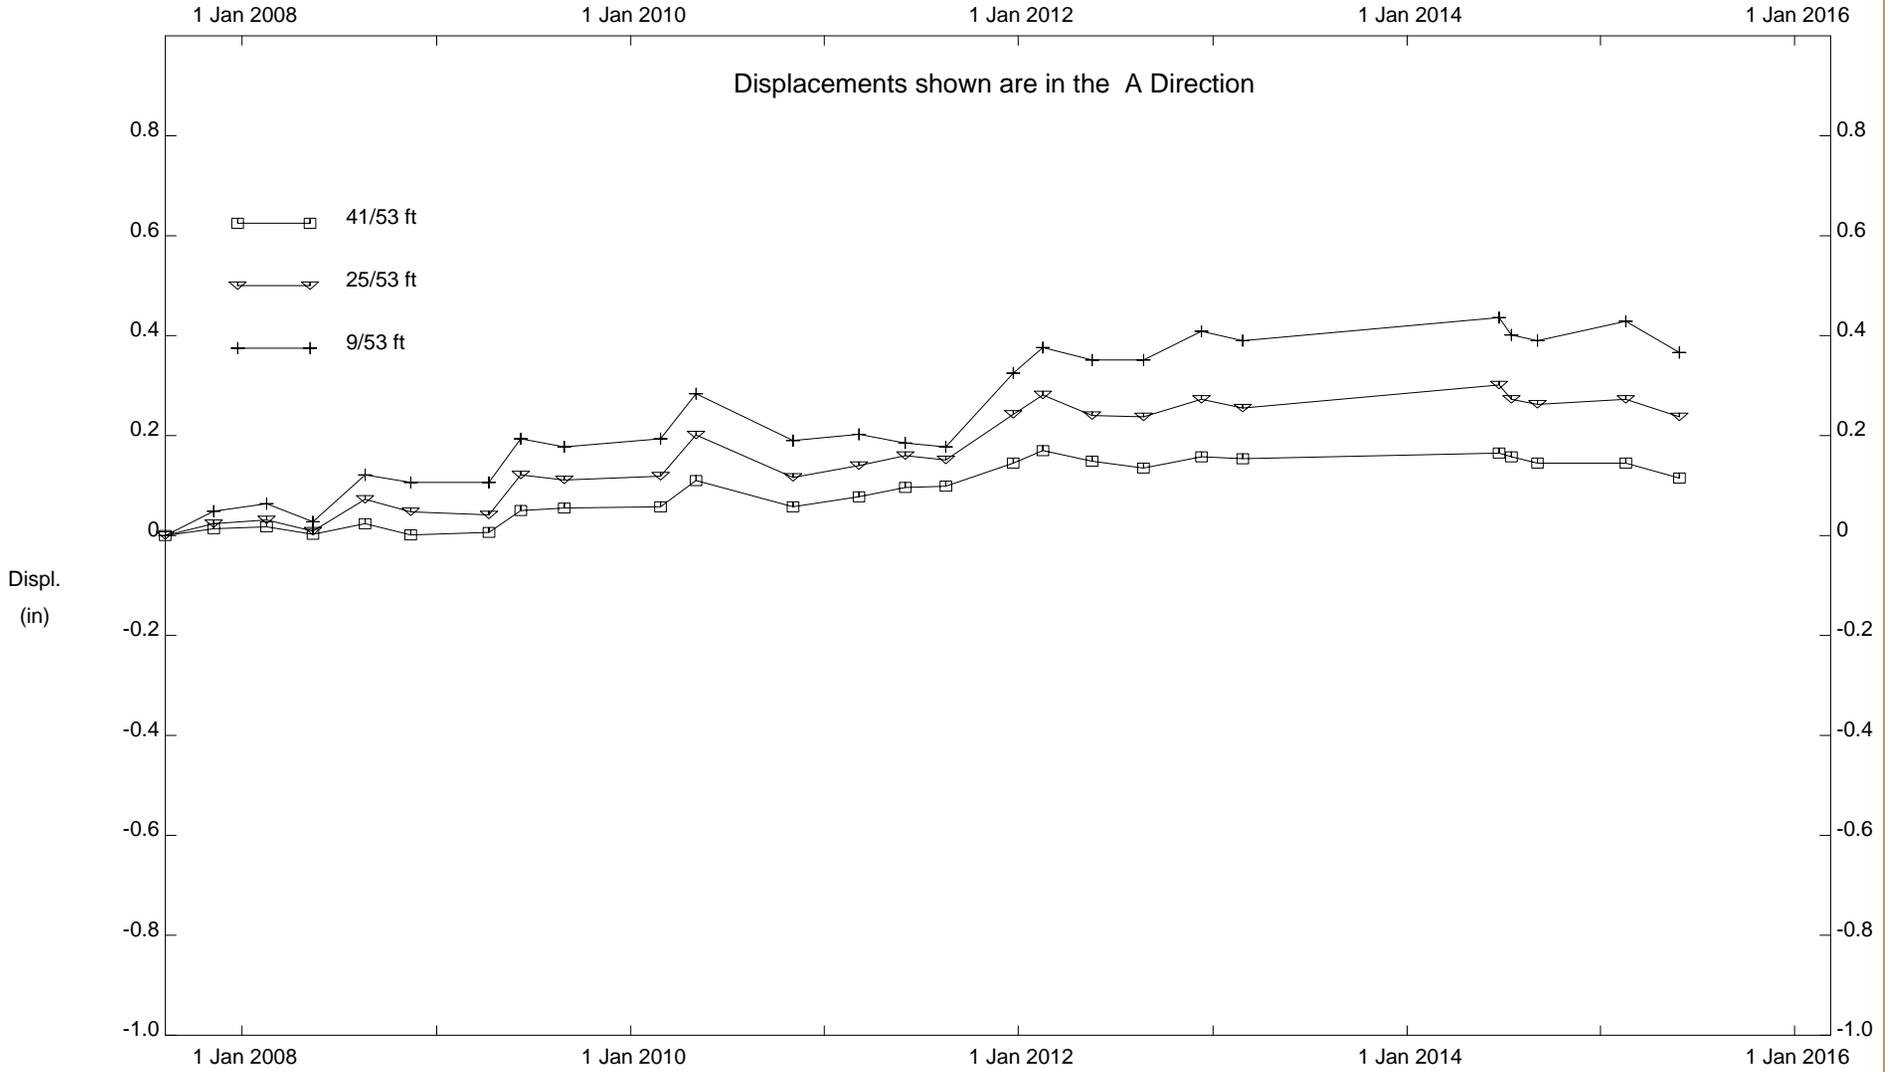
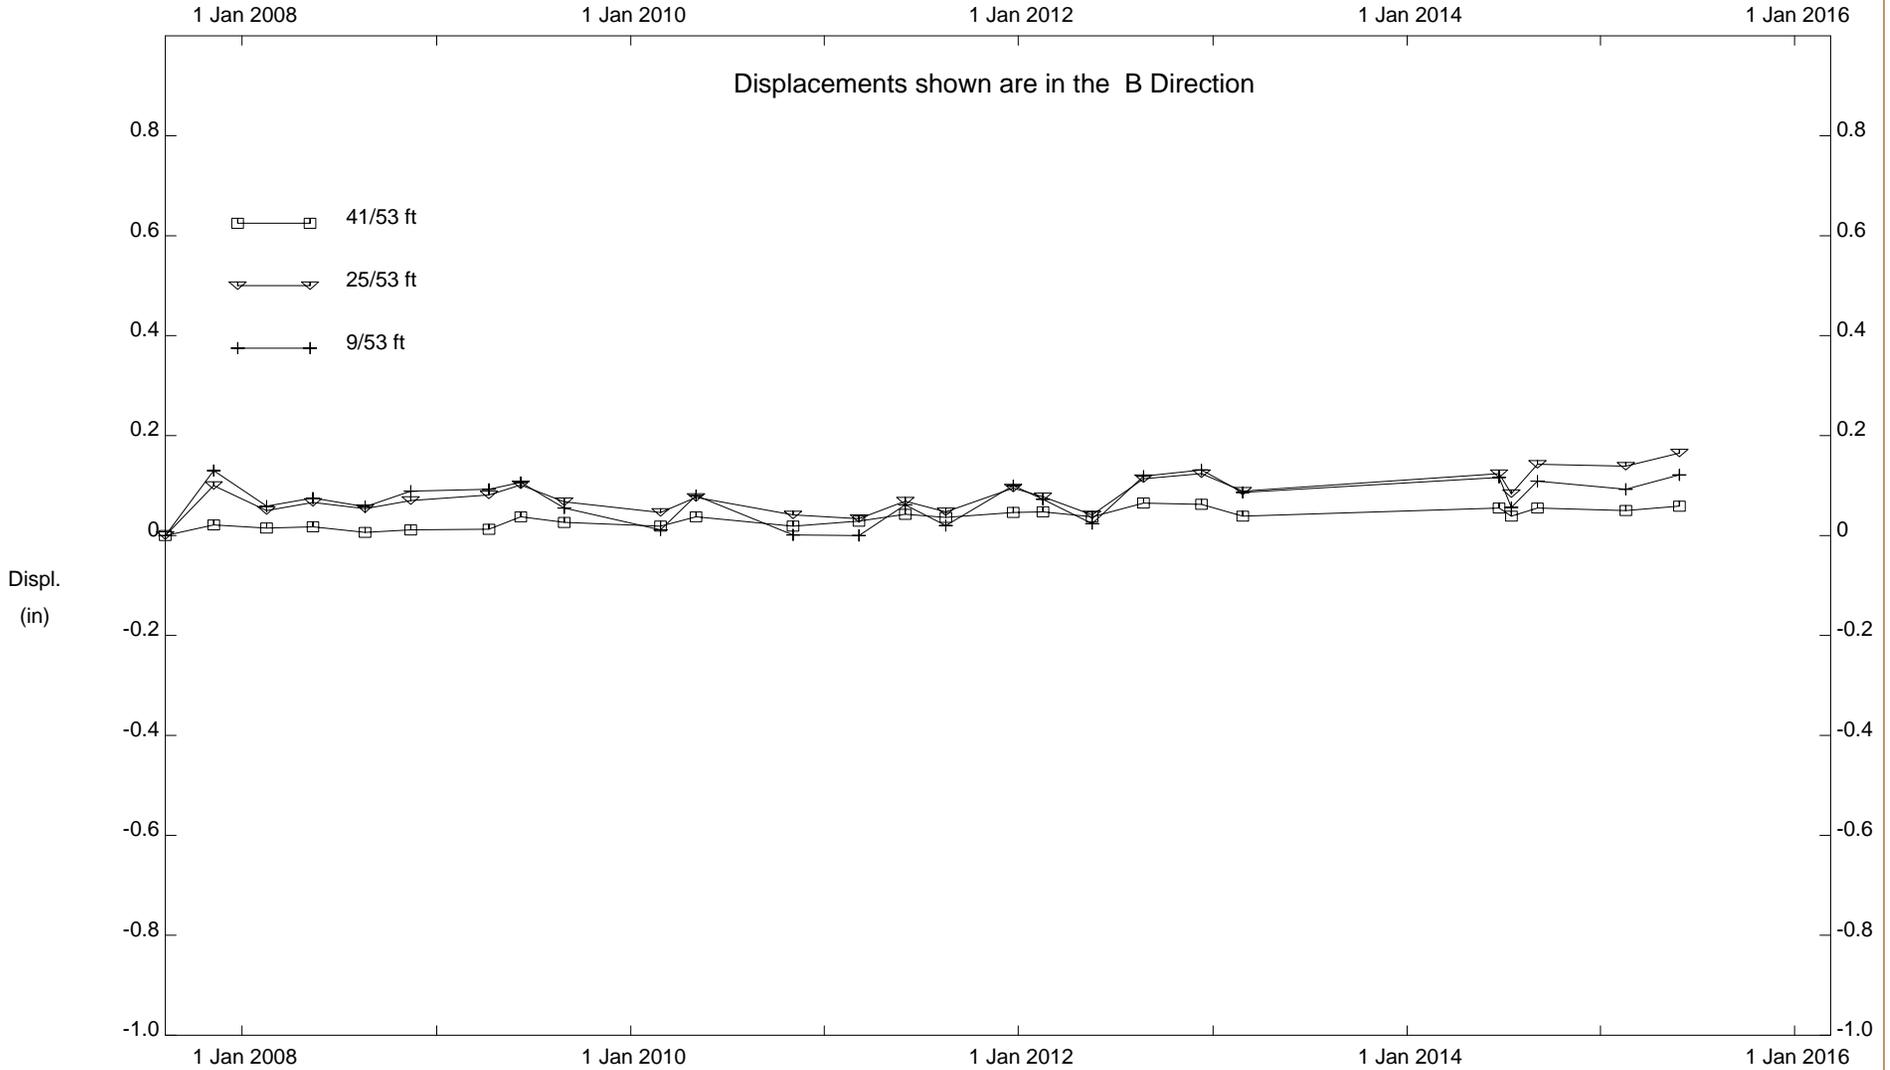
Assessment District 98-2, Inclinometer SI-16
 City of Malibu

Inclinometer SI-16 exhibits a pattern of movement measured at the ground surface at an average rate of up about 0.08 inches/year since 2005, resulting in approximately 0.5 inches of cumulative displacement at the ground surface since the 2004-05 monitoring period. Movement of the inclinometer appears to be both translational at specific depths between 0 to 10 feet and between 40 and 50 feet and rotational about a hinge point at about 50 feet below the ground surface. This is similar to the movement observed in inclinometer SI-9 located in close proximity to SI-16.

Although the movement observed in inclinometers SI-9 and SI-16 has not produced observed distress in pavements or other development of which Fugro is aware, the movement is nevertheless quantifiable and can be defined by a clear trend.
