**ANNUAL REPORT
JULY 2017 THROUGH JUNE 2018
BIG ROCK MESA LANDSLIDE
ASSESSMENT DISTRICT
City of Malibu, California**

March 2019
Fugro Project No. 04.62160606
Document No. 04.62160606-PR-005(Rev.00)

Annual Report of Maintenance and Monitoring, July 2017 through June 2018, Big Rock Mesa Landslide Assessment District, City of Malibu, California

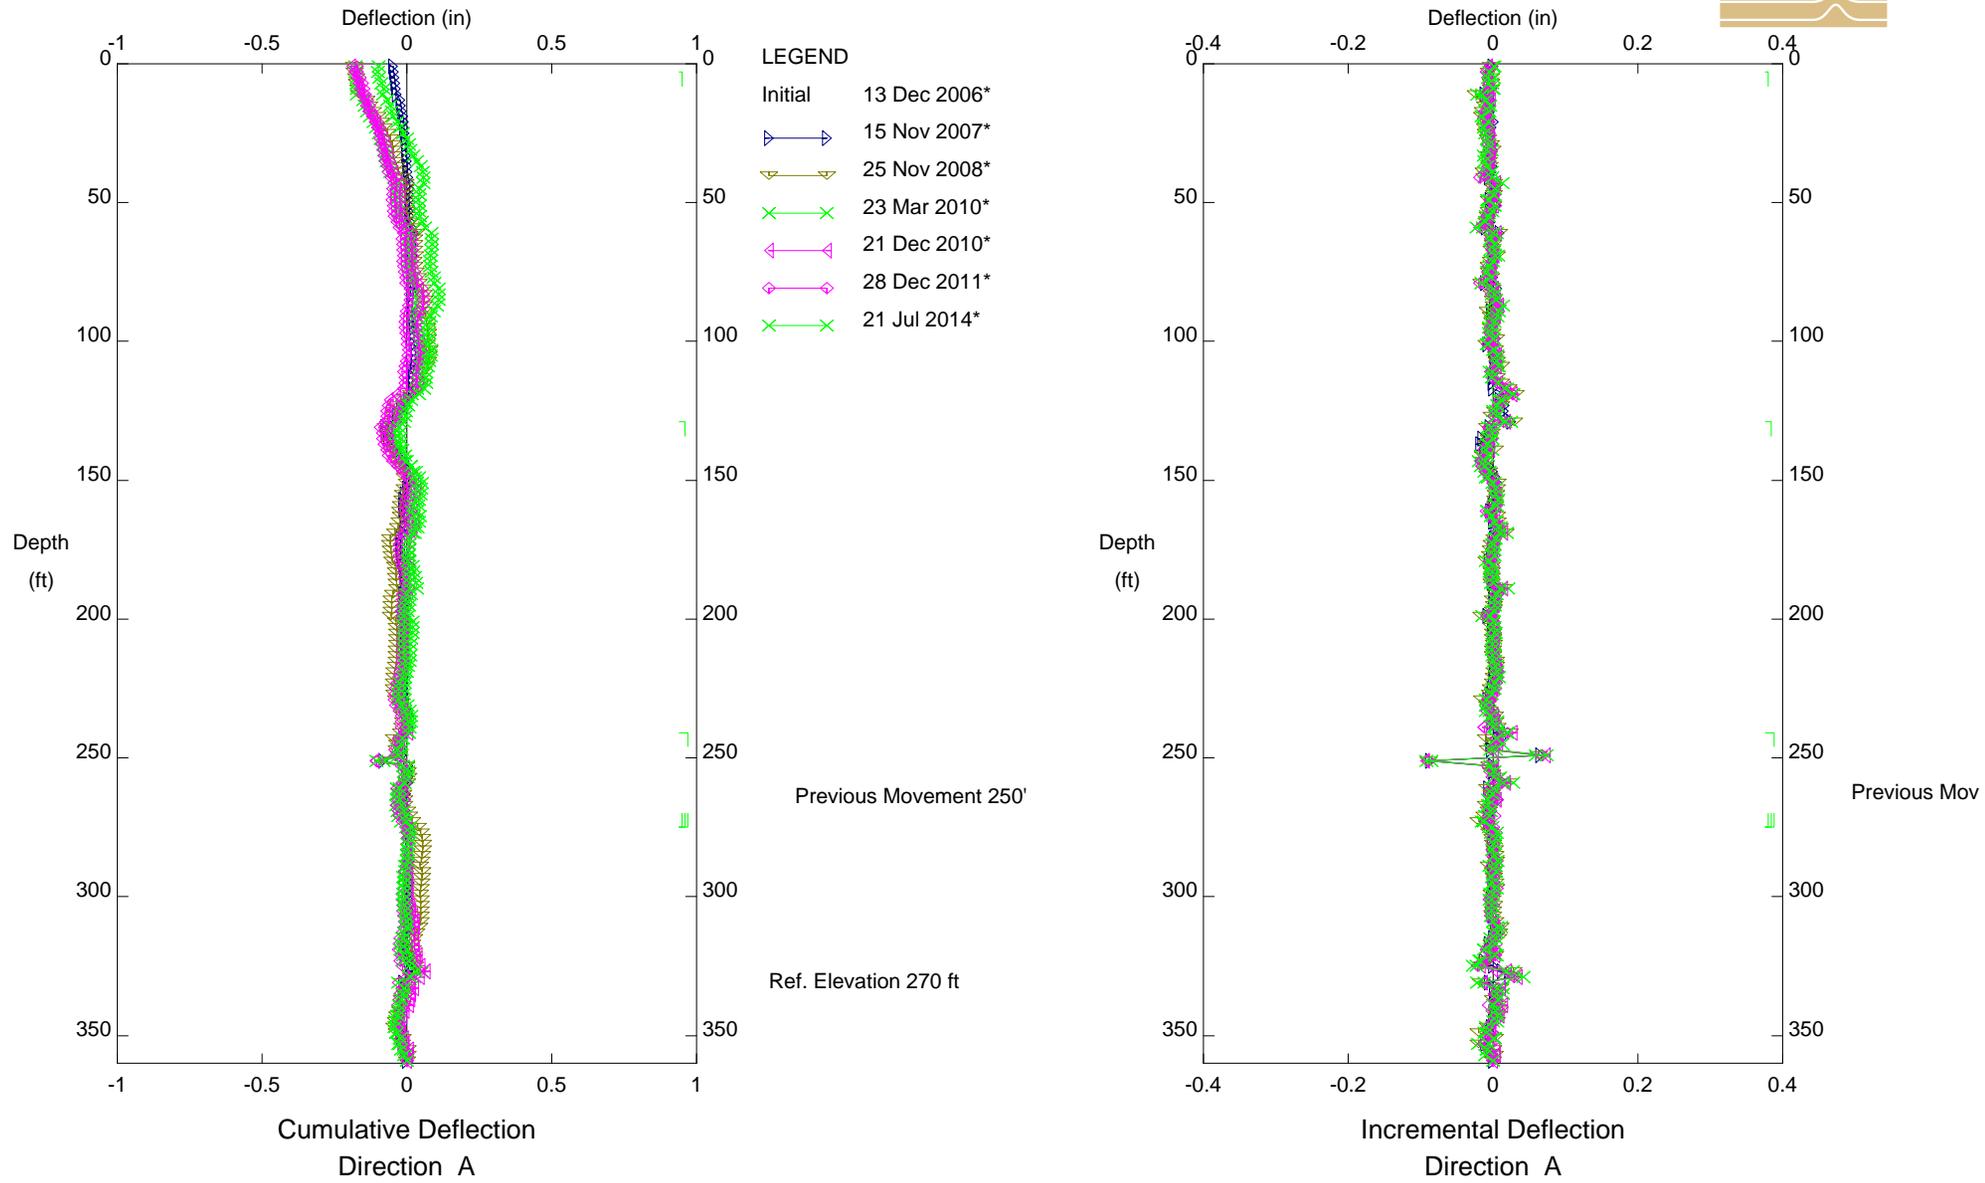
**BIG ROCK MESA, Inclinometer SP-28
 BLUFF REGION**

past movement at 245 feet
