### Annual Report July 2017 Through June 2018 Calle Del Barco Landslide Assessment District Malibu, California

March 2019  
Fugro Project No. 04.62160605  
Document No. 04.62160605-PR-002(Rev.00)

City of Malibu

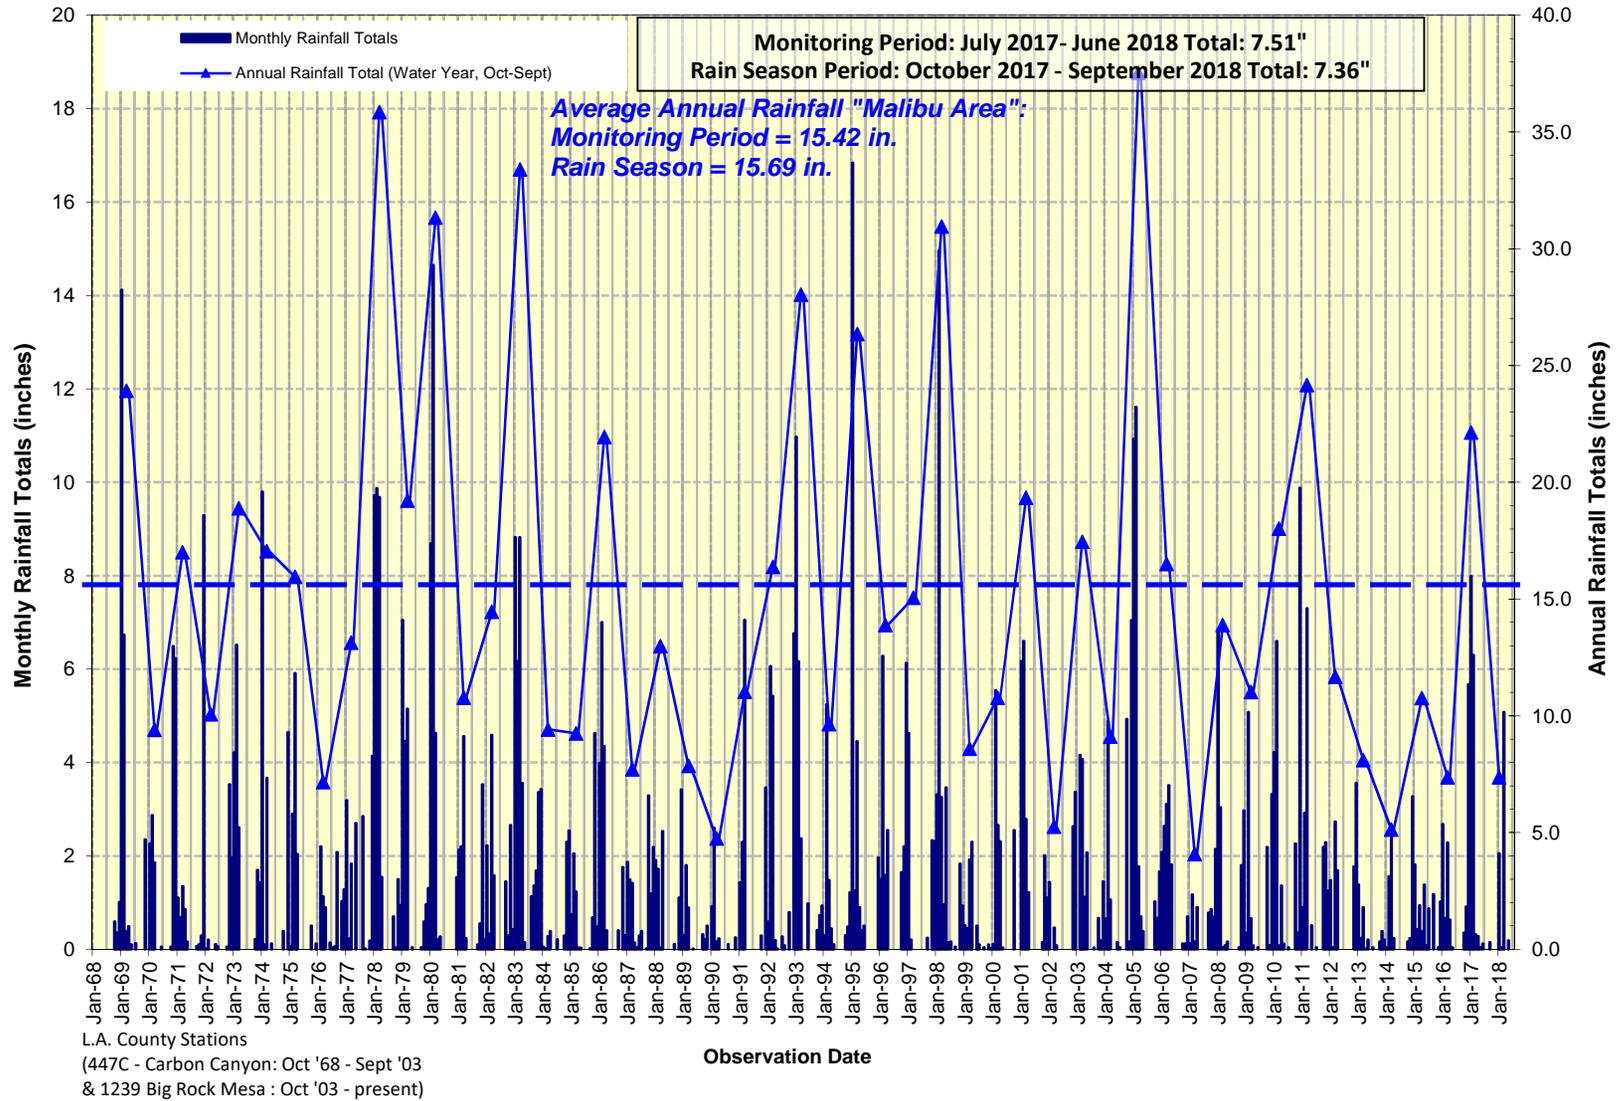
**RAINFALL GRAPH**  
 Calle Del Barco Landslide Assessment District  
 Malibu, California

A graph of historical monthly rainfall and average annual rainfall from October 1968 through September 30, 2018, is shown on Plate 3 - Rainfall Graph. Monthly rainfall totals from 1968 through 2004 were obtained from County of Los Angeles Department of Public Works (LADPW) Carbon Canyon Rain Station 447C and monthly rainfall totals from 2004 to the present were obtained from LADPW Big Rock Mesa Rain Gauge 1239.

Rainfall data indicate that approximately 7.36 inches of precipitation fell during the monitoring period from July 1, 2017, through June 30, 2018. The average annual rainfall from 1968 to 2018 in the "Malibu Area" for the same months is approximately 15.4 inches.

However, rainfall data are usually analyzed in terms of the annual "rain season" that covers the time period between October 1 through September 30. Rainfall for October 1, 2017 through September 30, 2018, was approximately 7.36 inches. That is approximately 47 percent of the average annual rainfall of 15.69 inches for the "rain seasons" between 1968 and 2018.

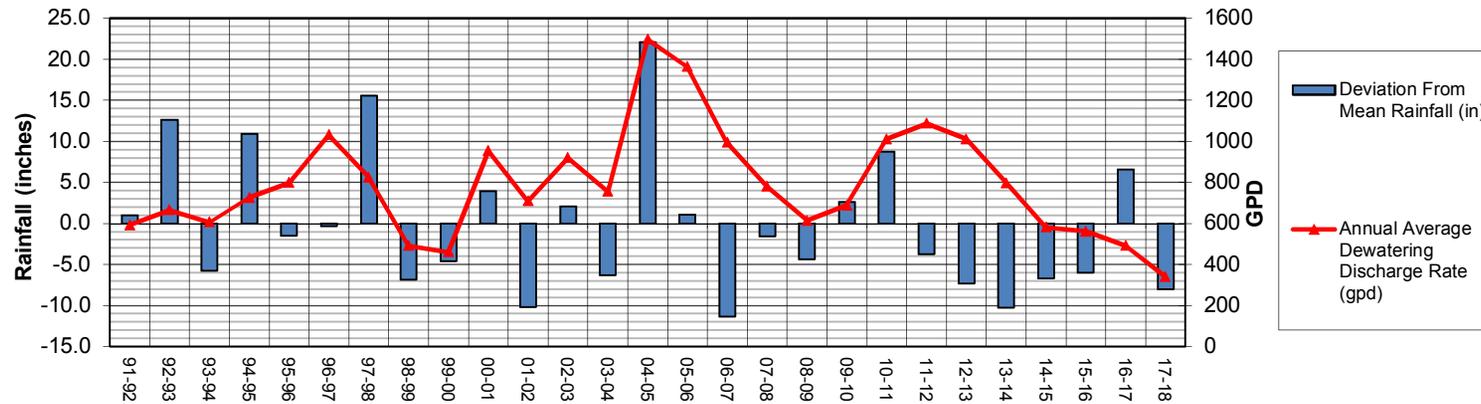
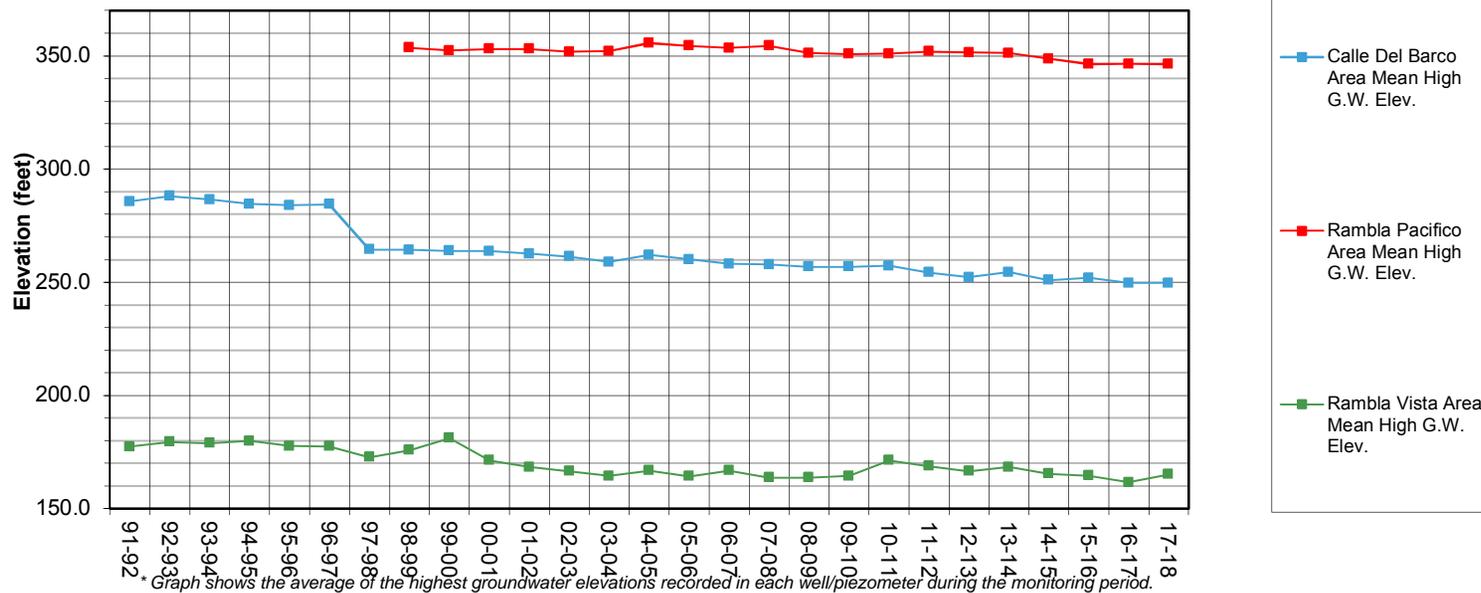
**GROUNDWATER LEVELS, DEWATERING AND RAINFALL**  
 Calle del Barco Landslide Assessment District  
 Malibu, California

Plate 5 – Groundwater Levels, Dewatering, and Rainfall shows the yearly magnitude of deviation of each years' rainfall relative to the mean annual rainfall. The graphic also shows the average annual dewatering output in gallons per day (gpd). The data illustrate that the average annual dewatering output is generally consistent with average rainfall.

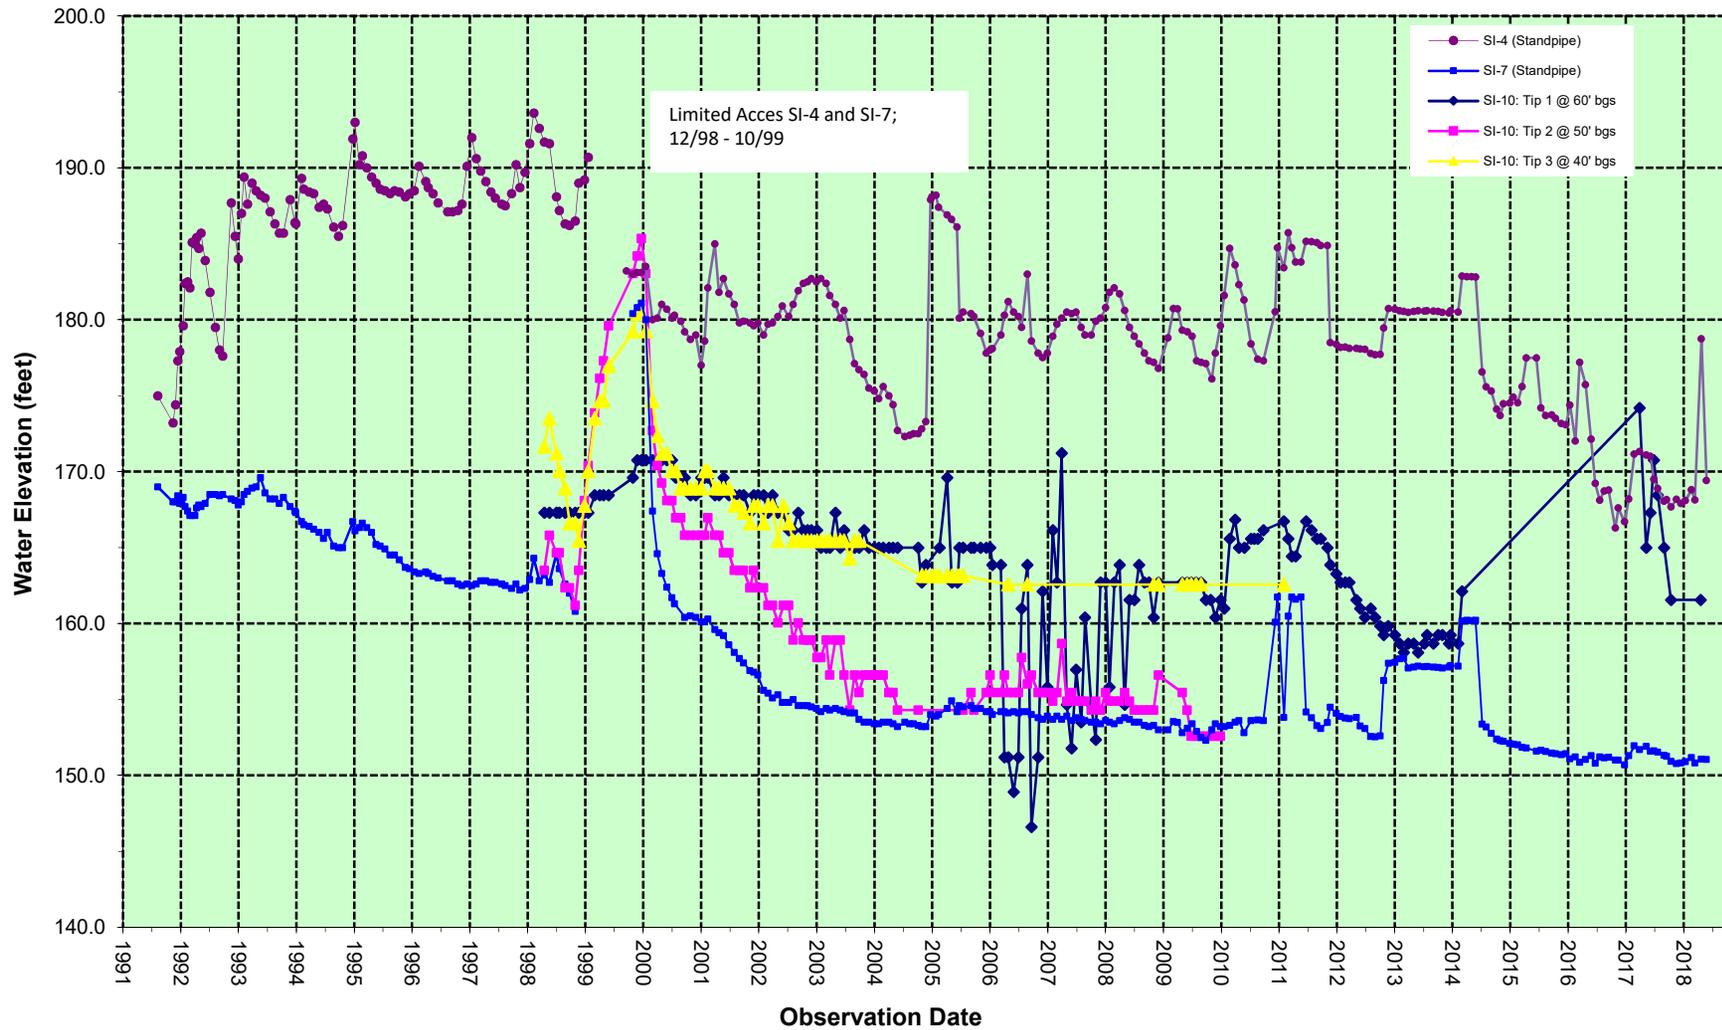
**GROUNDWATER HYDROGRAPH**  
**Rambla Vista**  
Calle delBarco Landslide Assessment District  
Malibu, California

**Rambla Vista.** Groundwater elevation data for the Rambla Vista Area are presented in Plate A-3. Groundwater levels for this area are monitored using standpipes SI-4 and SI-7 and the pneumatic piezometers attached to Inclinator SI-10. In general, groundwater elevations in the Rambla Vista Area remained relatively constant during the 2017-2018 monitoring period. The calculated area average (160.2 ft) was equal to the area average for the 2016-2017 monitoring period and is about 7.5 feet lower than the mean water level elevation for this area for the period of record (1991-2018).

Groundwater levels measured in standpipe SI-4 remained relatively stable throughout the monitoring year with the exception of an anomalous reading in May 2018 that was approximately nine feet higher than the average elevation for the monitoring period. Groundwater elevations in SI-7 remained relatively constant. Pore pressure readings in pneumatic piezometer SI-10 Tip 3 and Tip 4 measured 0 PSI. Pneumatic piezometer SI-10 Tip 3 has read 0 PSI since September 2006 and Tip 4 has read 0 PSI since installation. It is believed that Tip 3 and Tip 4 are functioning, but are reading zero due to the groundwater elevation being lower than the piezometer tip elevation. SI-10 Tip 2 is clogged and non-functional and was last readable in January 2010. SI-10 Tip 1 decreased throughout the monitoring year.

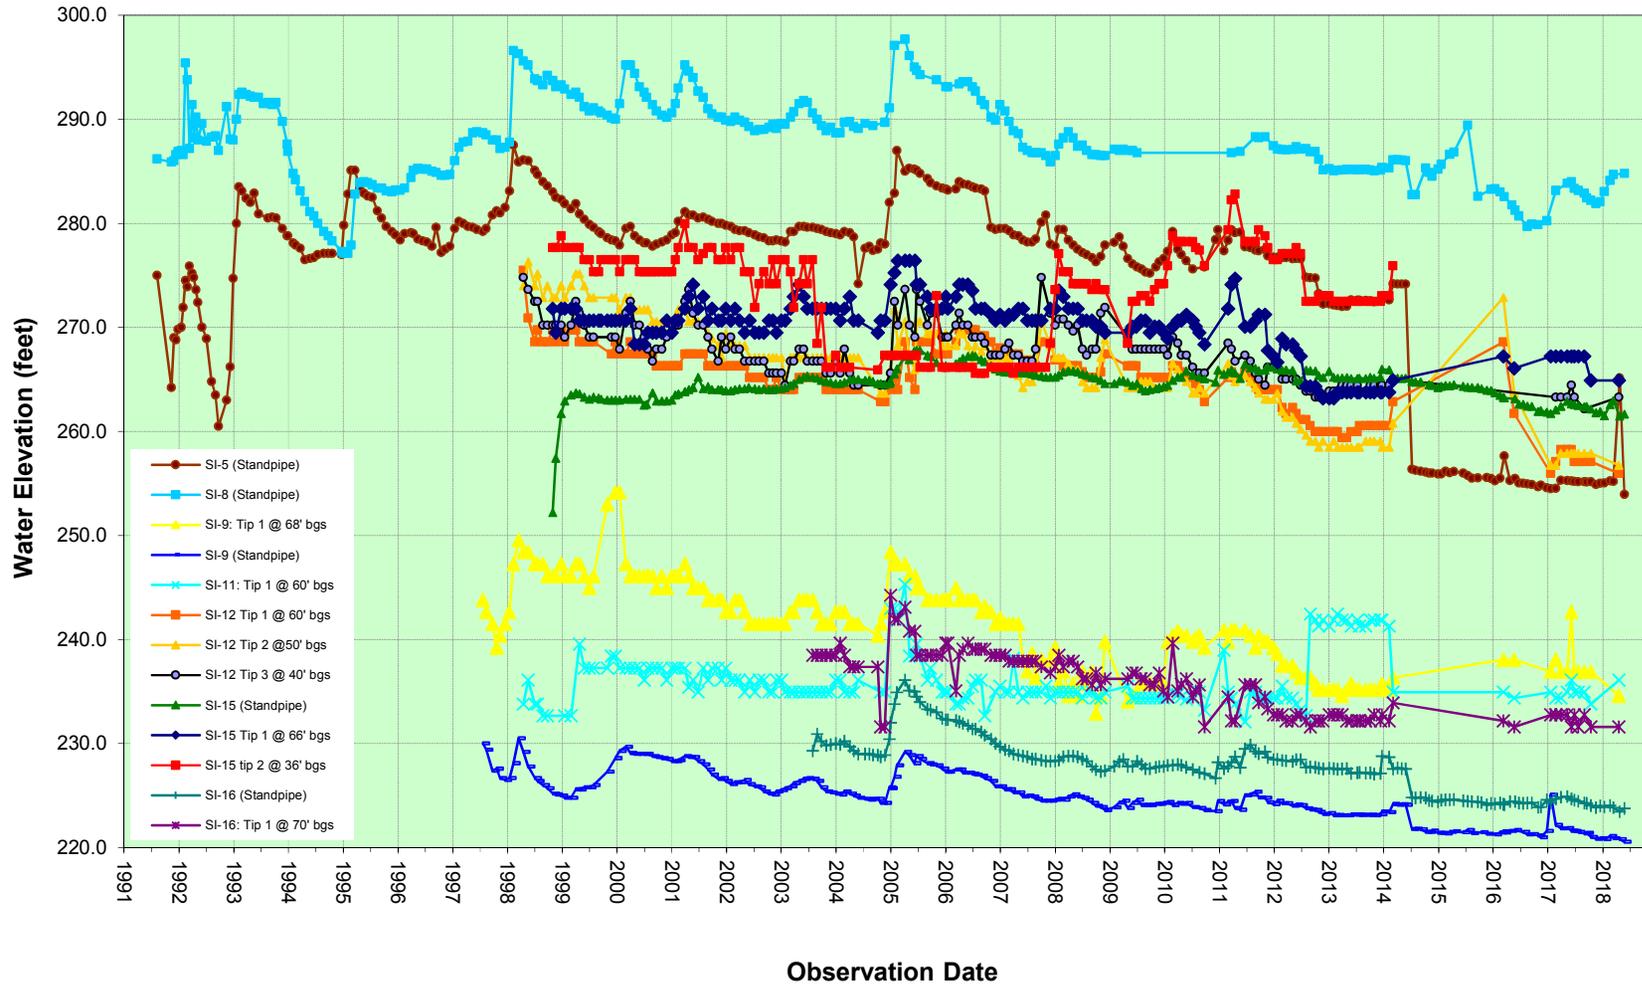
**GROUNDWATER HYDROGRAPH**  
**Calle del Barco**  
 Calle del Barco Landslide Assessment District  
 Malibu, California

**Calle Del Barco.** Groundwater data for the Calle del Barco Area is presented on Plate A-4. Groundwater levels for this area are monitored using standpipe piezometers SI-5, SI-8, SI-9, SI-15, and SI-16 and pneumatic piezometers attached to inclinometers SI-9, SI-11, SI-12, SI-15, and SI-16. In general, groundwater elevations in the Calle del Barco Area for the 2017-2017 monitoring period decreased approximately 0.2 feet from the 2016-2017 monitoring period. The Calle del Barco area remains approximately 13.5 feet below the mean water level elevation for this area over the period of record.

Water levels in all of the individual standpipe piezometers remained relatively constant throughout the monitoring year with the exception of an anomalous reading in SI-5 in May 2018 that was approximately ten feet higher than the average elevation for the monitoring period. Pneumatic piezometers remained relatively constant throughout the monitoring year.
