Project Update and Facility Status

City of Malibu Landslide Assessment District 98-1 Big Rock Mesa

October 6, 2020

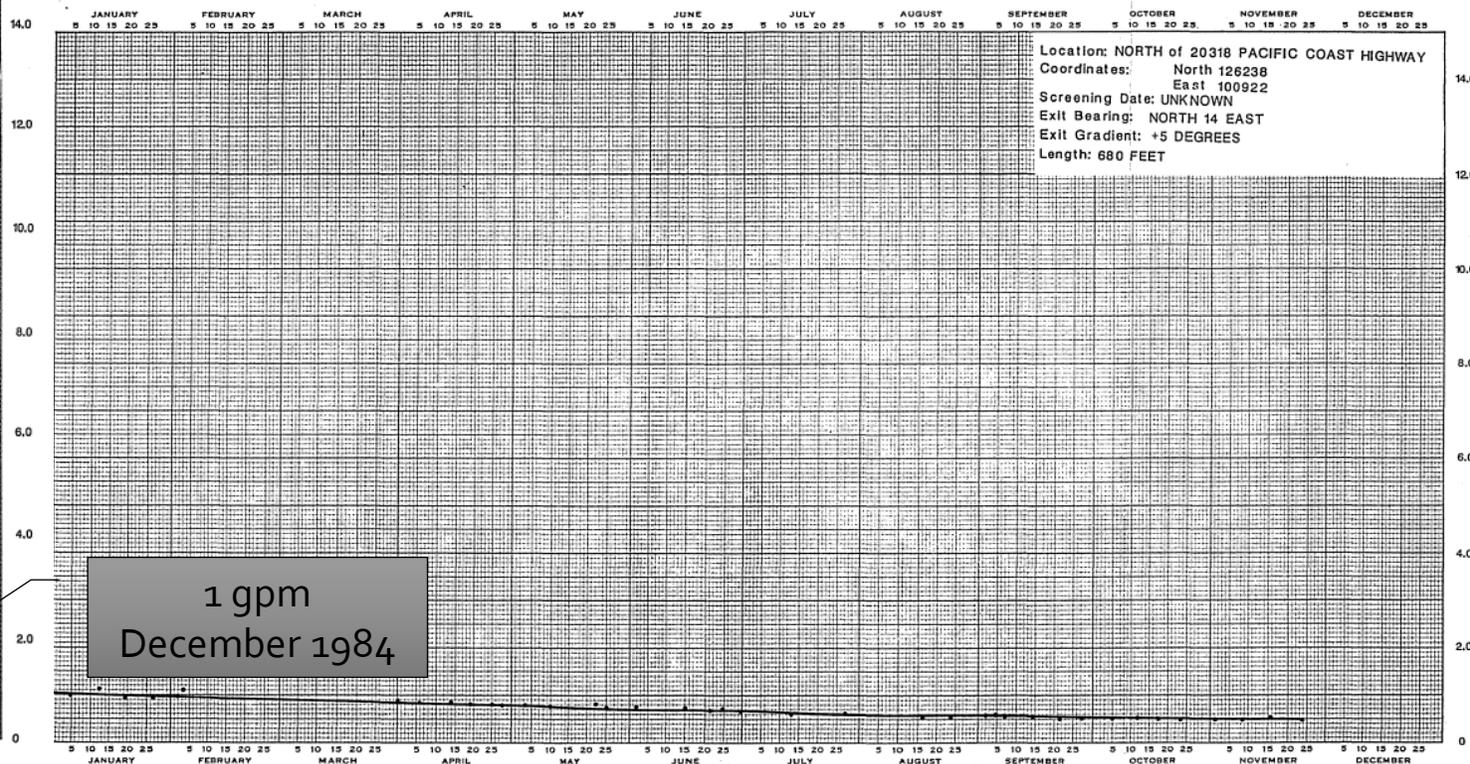
PRODUCTION YEAR - 1985

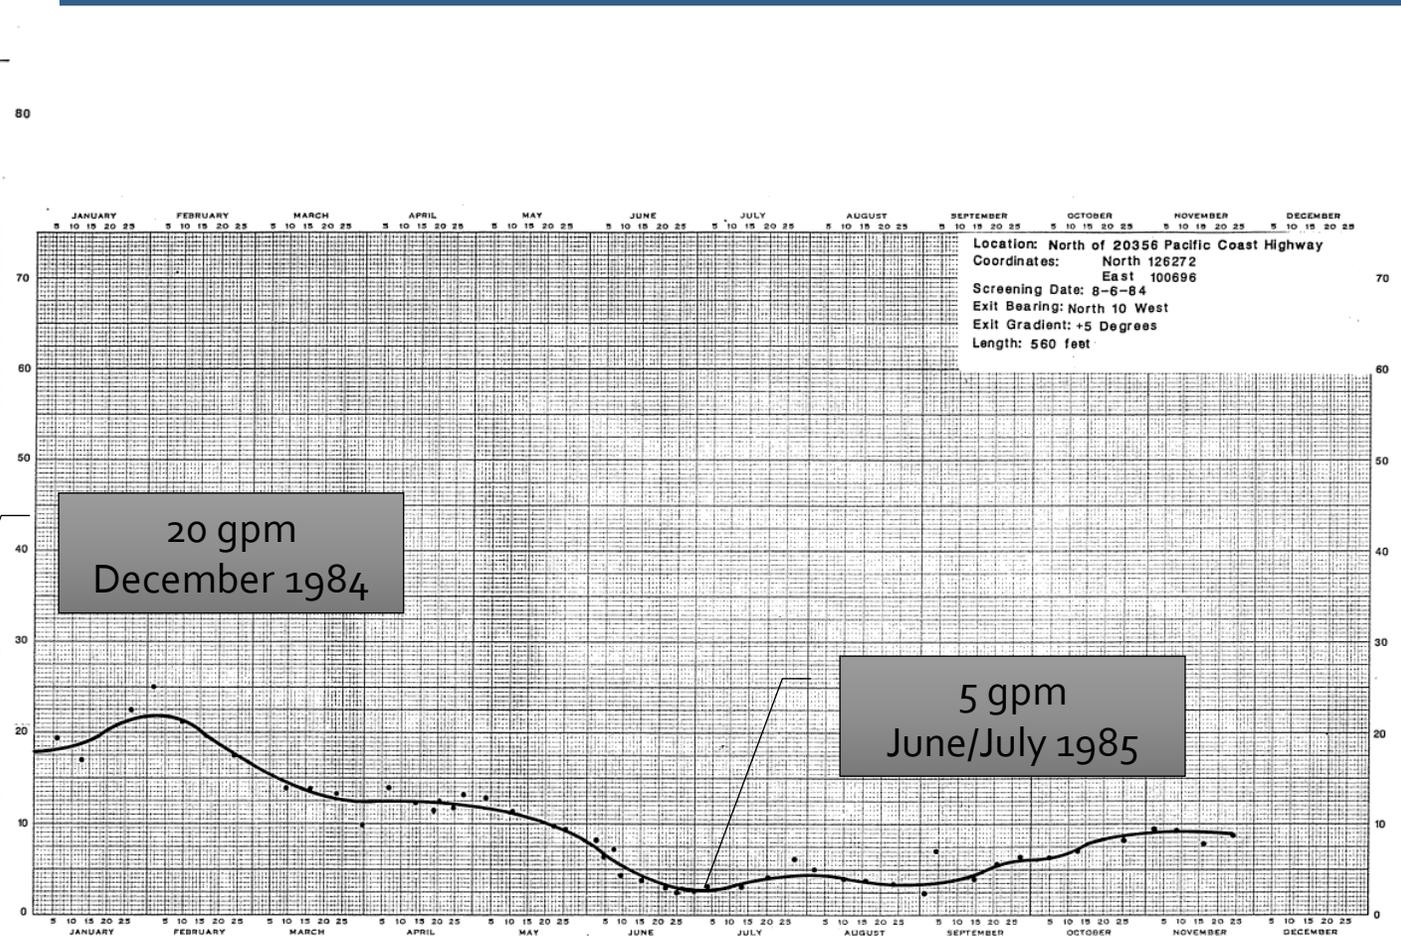
PRODUCTION YEAR - 1985
