Project Update and Facility Status

City of Malibu Landslide Assessment District 98-1 Big Rock Mesa

November 9, 2020

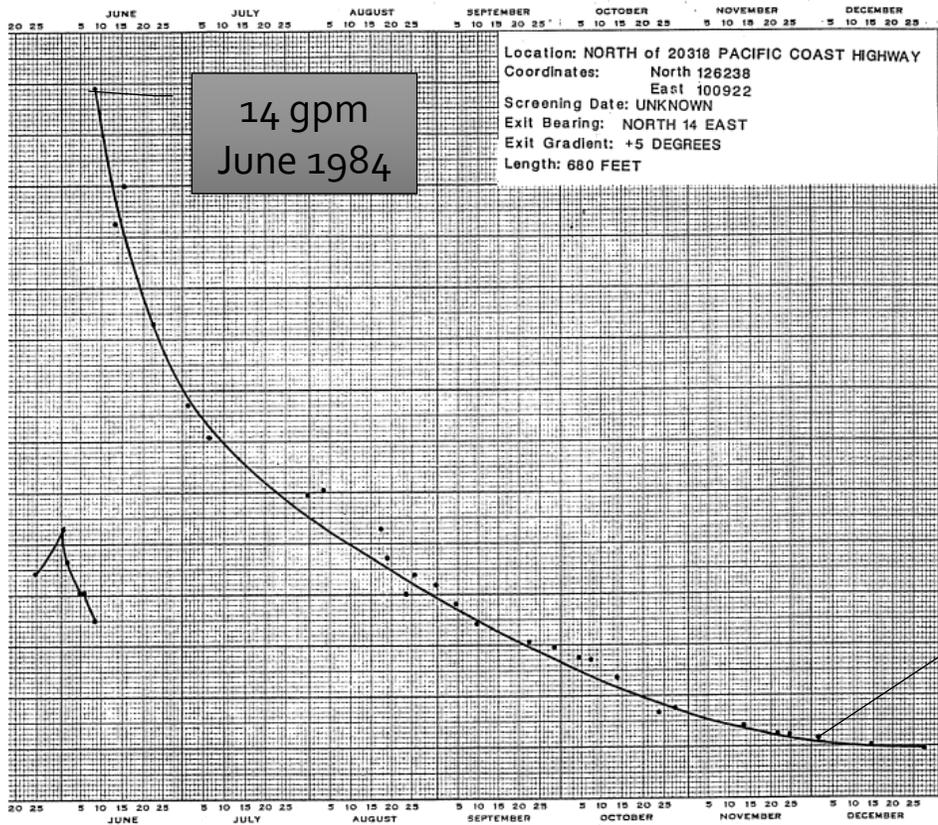
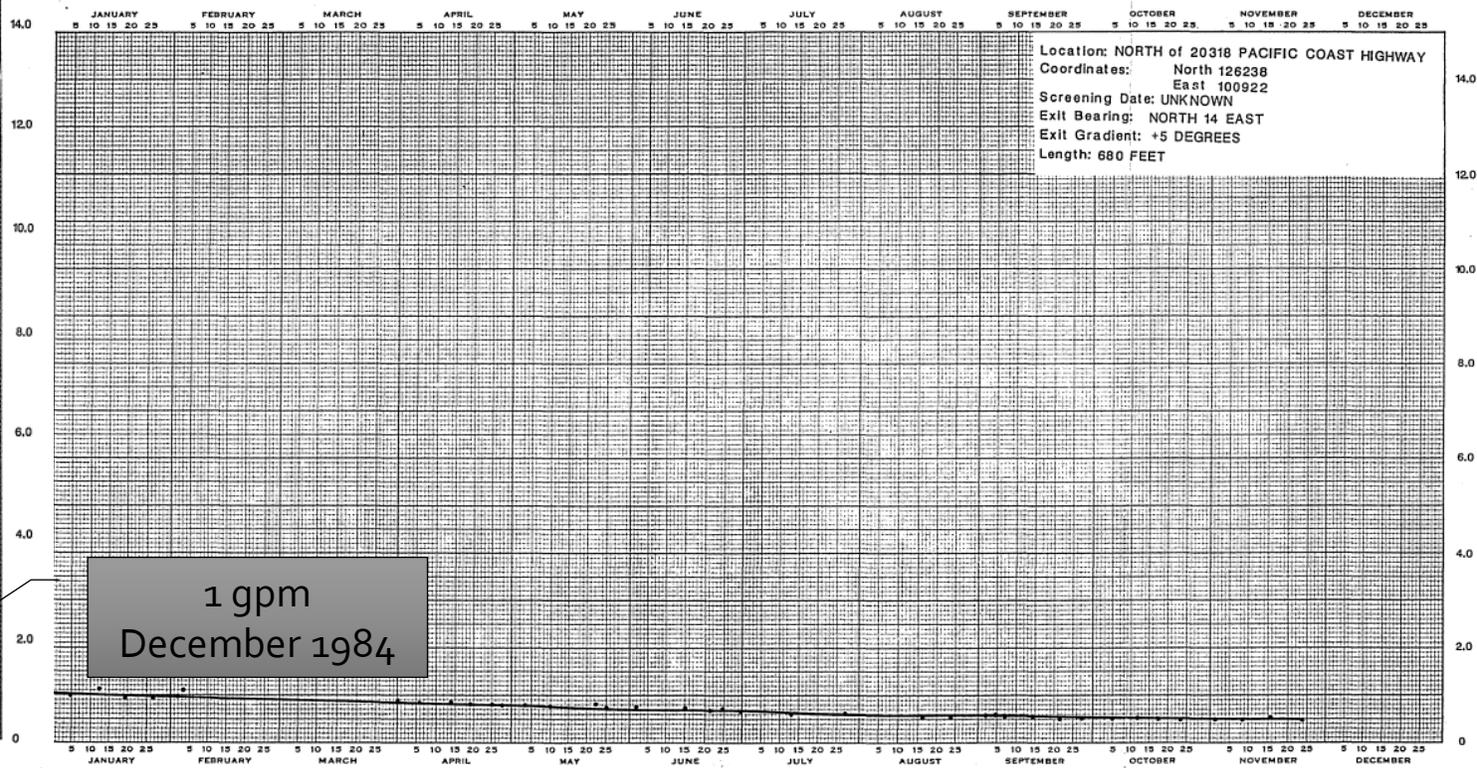
H-4

PRODUCTION YEAR - 1984

PRODUCTION YEAR - 1985

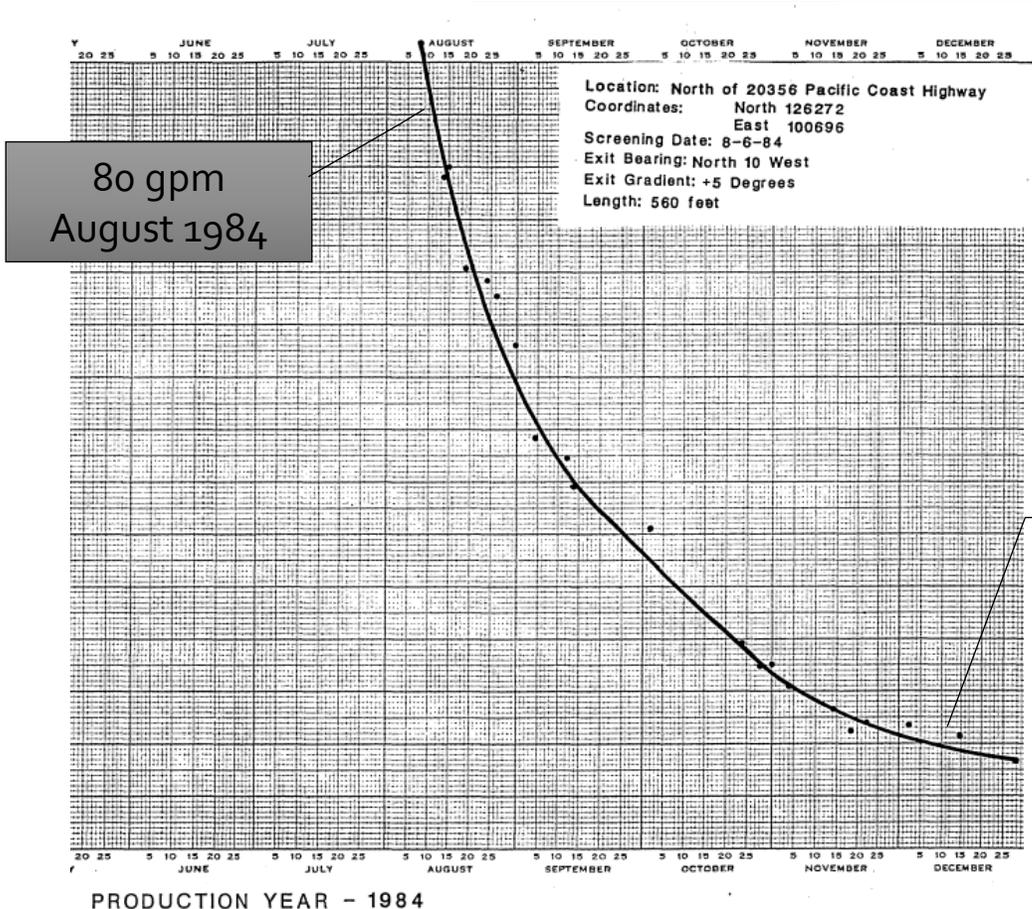
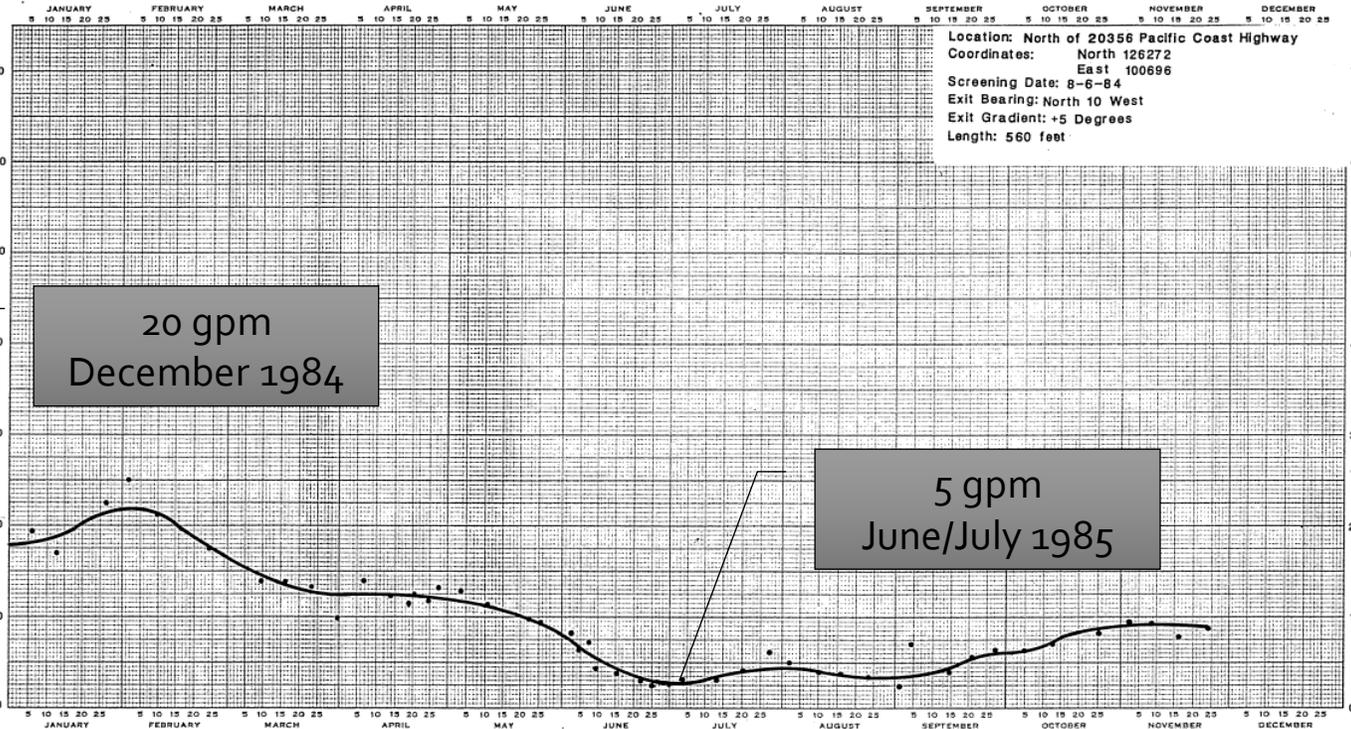
HD-3

PRODUCTION YEAR - 1984

PRODUCTION YEAR - 1985

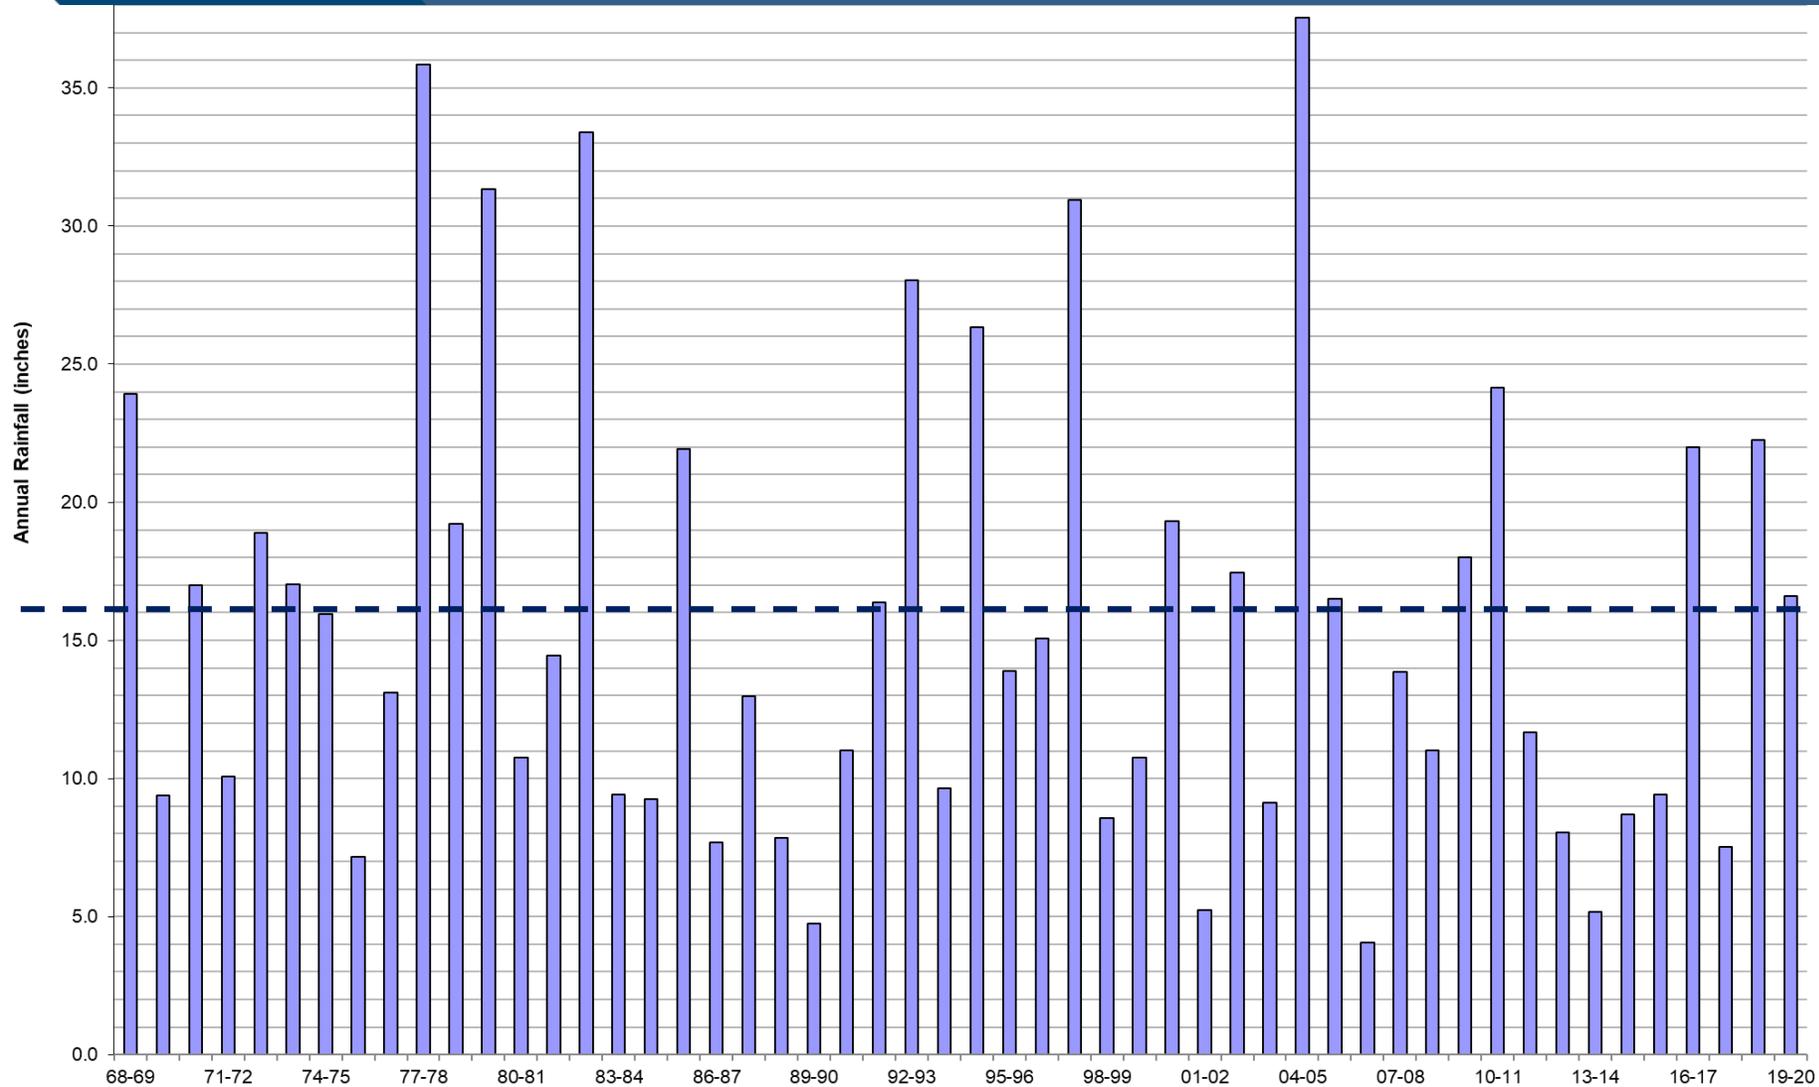
Ave: 15.4"
(1968-2020)

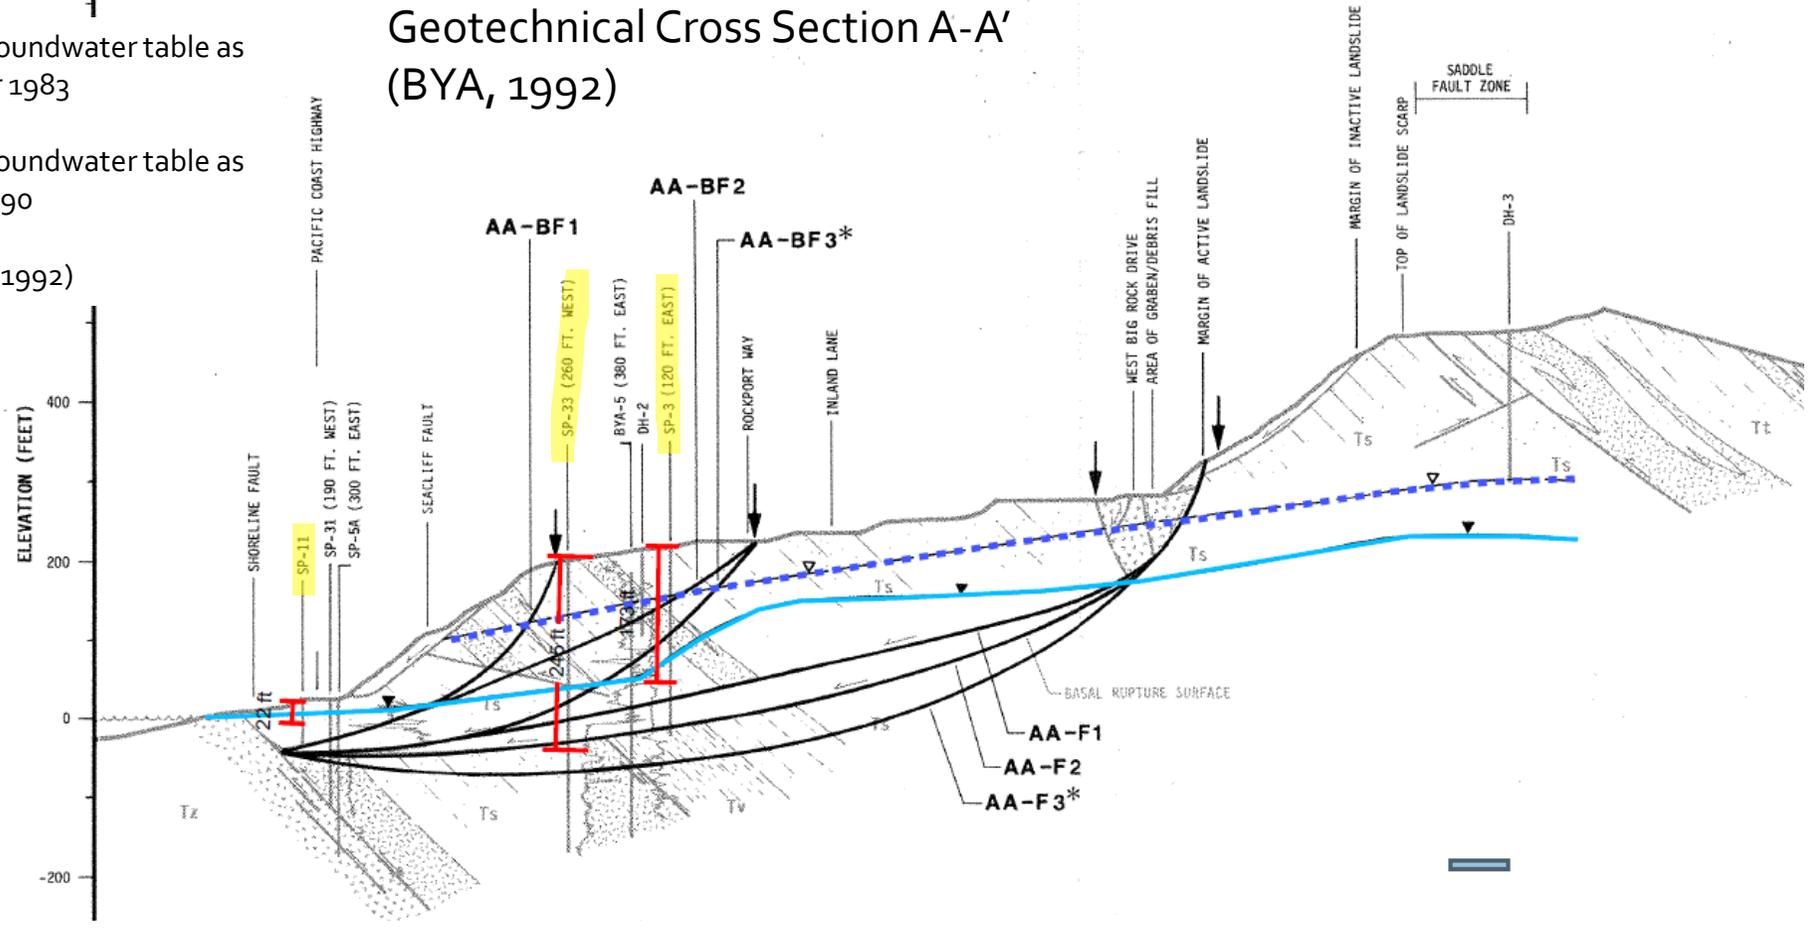
Geotechnical Cross Section A-A'
(BYA, 1992)

Estimated Groundwater table as of September 1983

Estimated Groundwater table as of October 1990

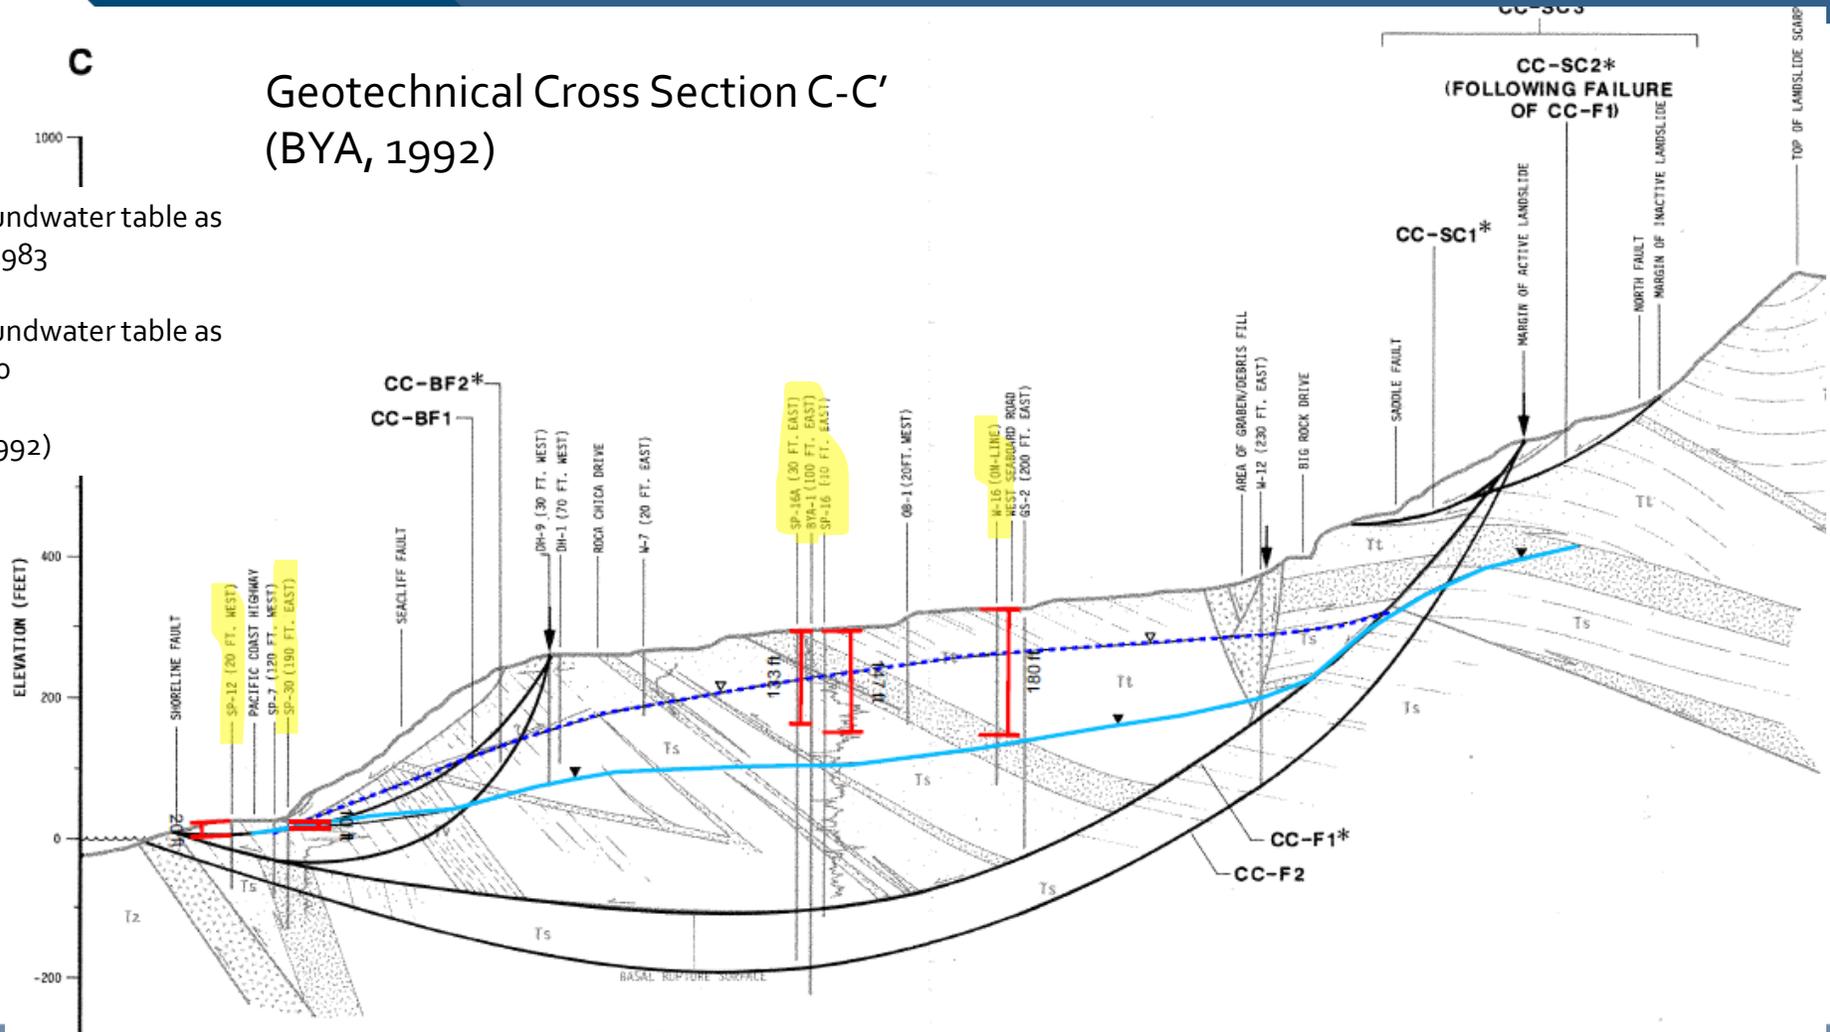
Geotechnical Cross Section C-C'
(BYA, 1992)

Estimated Groundwater table as of September 1983

Estimated Groundwater table as of October 1990

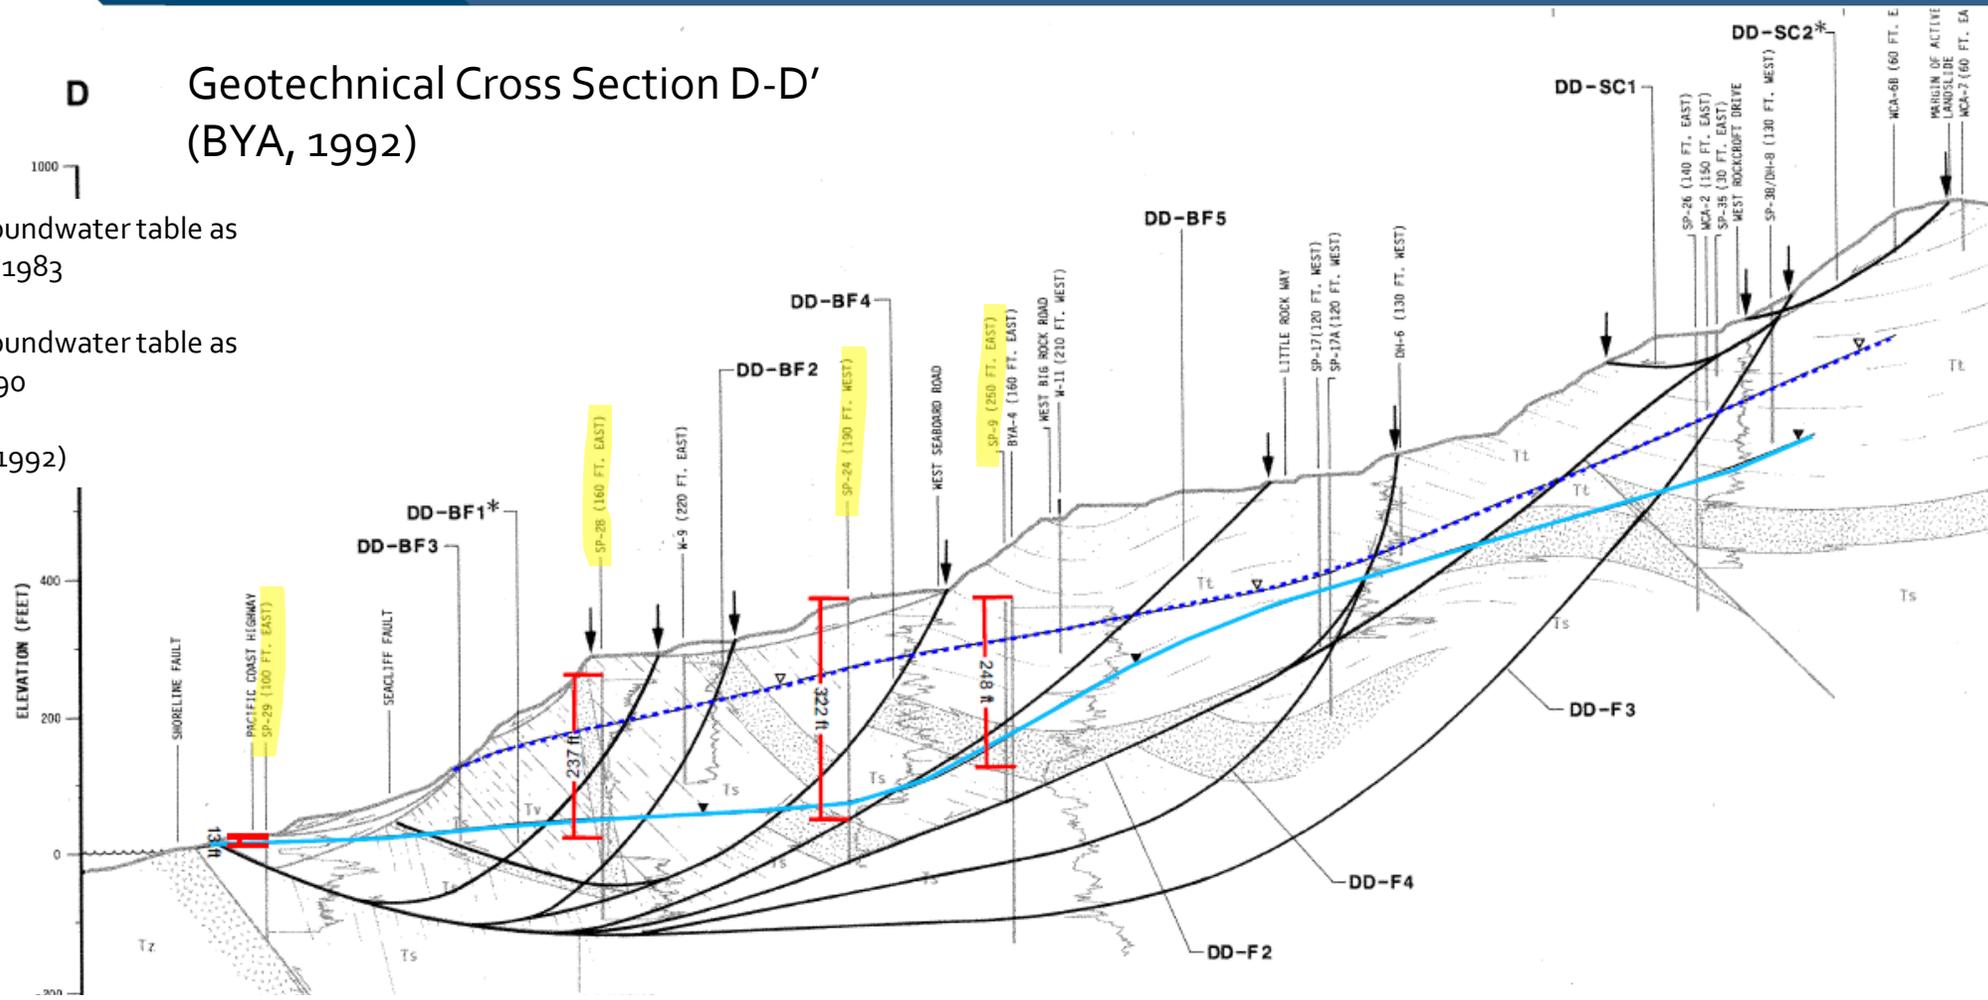
D Geotechnical Cross Section D-D'
(BYA, 1992)

Estimated Groundwater table as of September 1983

Estimated Groundwater table as of October 1990

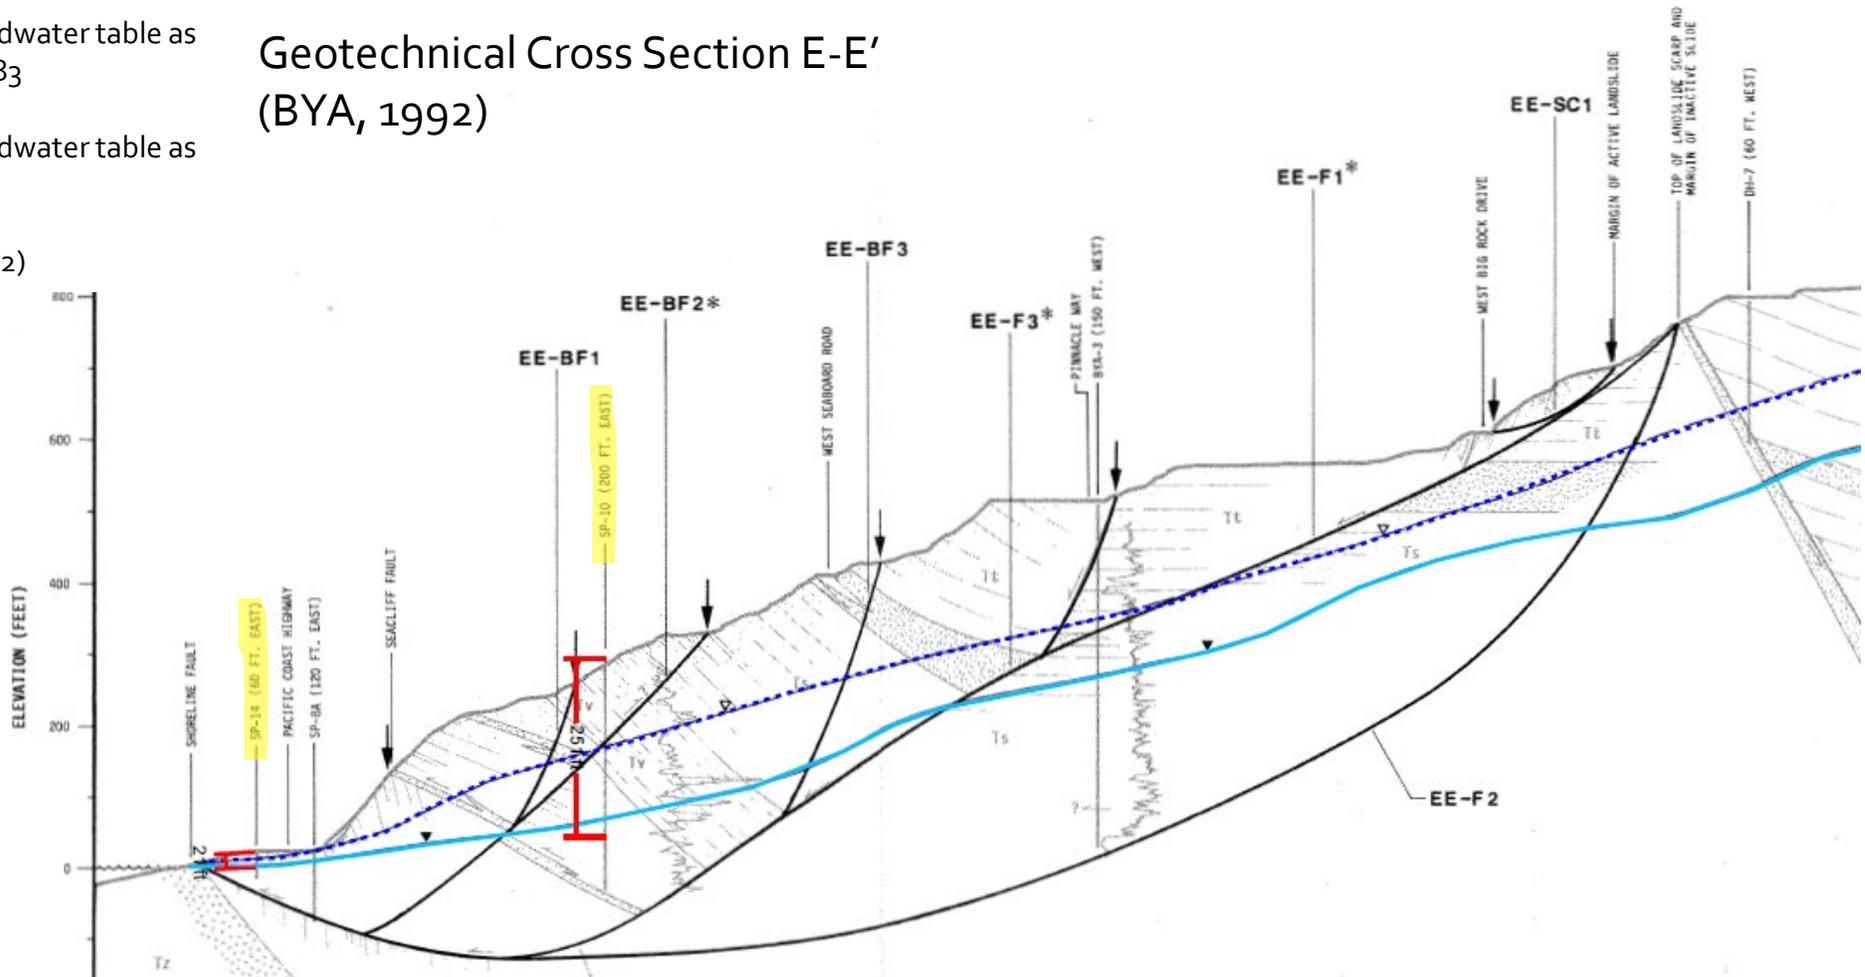
Geotechnical Cross Section E-E' (BYA, 1992)

Estimated Groundwater table as of September 1983

Estimated Groundwater table as of October 1990
