FY20/21 Maintenance and Monitoring

AD98-1, Big Rock Mesa

City of Malibu, California

Subject: Annual Monitoring and Maintenance Report FY20/21, City of Malibu Assessment District 98-1, Big Rock Mesa, Malibu, CA

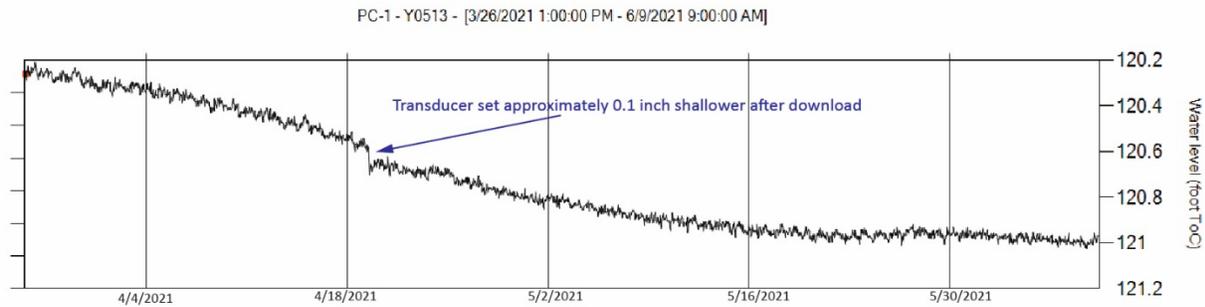
Figure 3: Hydrograph of standpipe, PC-1 with 1-hour recorded intervals, March 26 to June 9, 2021

Average groundwater levels within the Eastern Region decreased by 5.1 feet since the prior monitoring year. Groundwater levels within individual standpipes located in the Eastern Region remained essentially unchanged with some temporal responses to isolated rainfall events. Water levels were recorded at PC-1 between March 26, 2021 and June 9, 2021 by a pressure transducer

programmed to record data every hour. Figure 3 is the resulting groundwater hydrograph from PC-1. Monthly water level data from the remaining standpipes that are within the Eastern Region are presented in Appendix A.

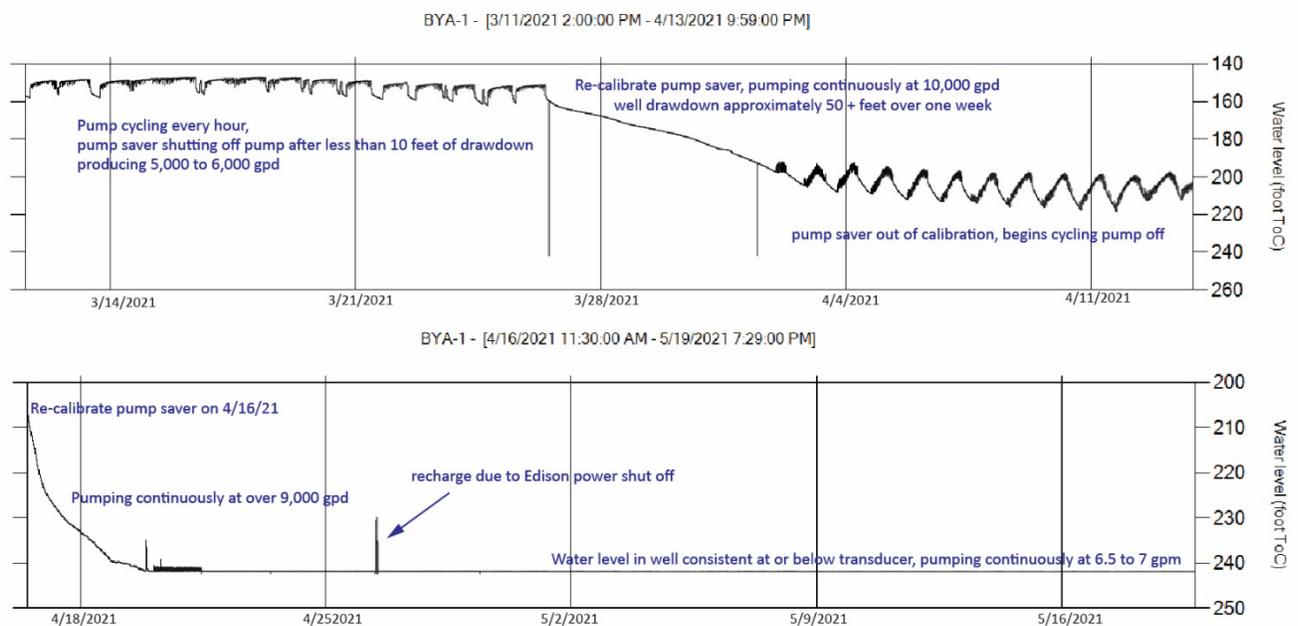
Figure 4: BYA-1 transducer data; 1- minute readings; water level response to pump control adjustments March 11 to May 19, 2021

During the 2020-2021 monitoring year, the average total well production was 50,519 gpd which is 19.8 % higher than last year’s average production of 42,155 gpd and 2.1% less than the historical production average of 51,611 gpd calculated from 1993 to present and 27.5% less than the maximum production of 69,741 gpd recorded during the 2004-2005 monitoring year.

Well production typically varies in response to rainfall totals. The production increase over this monitoring year despite historically low rainfall totals is due to maintenance efforts as well as changes to well pump controls. Yeh introduced the use of pressure transducers within producing wells to observe the well pump cycle and the reaction of water level to changes throughout the pump cycle and as a result of outside events. Figure 4 is an example of how pressure transducer data was observed, tracked, and used to adjust pump controls to maximize the dewatering capacity of BYA-1.

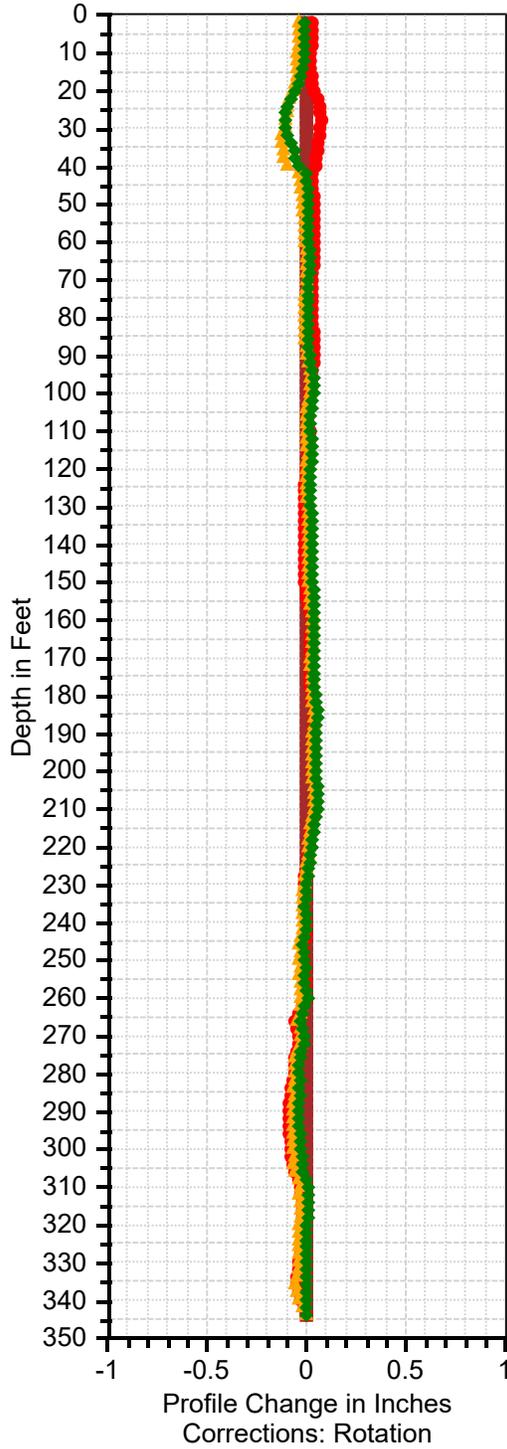
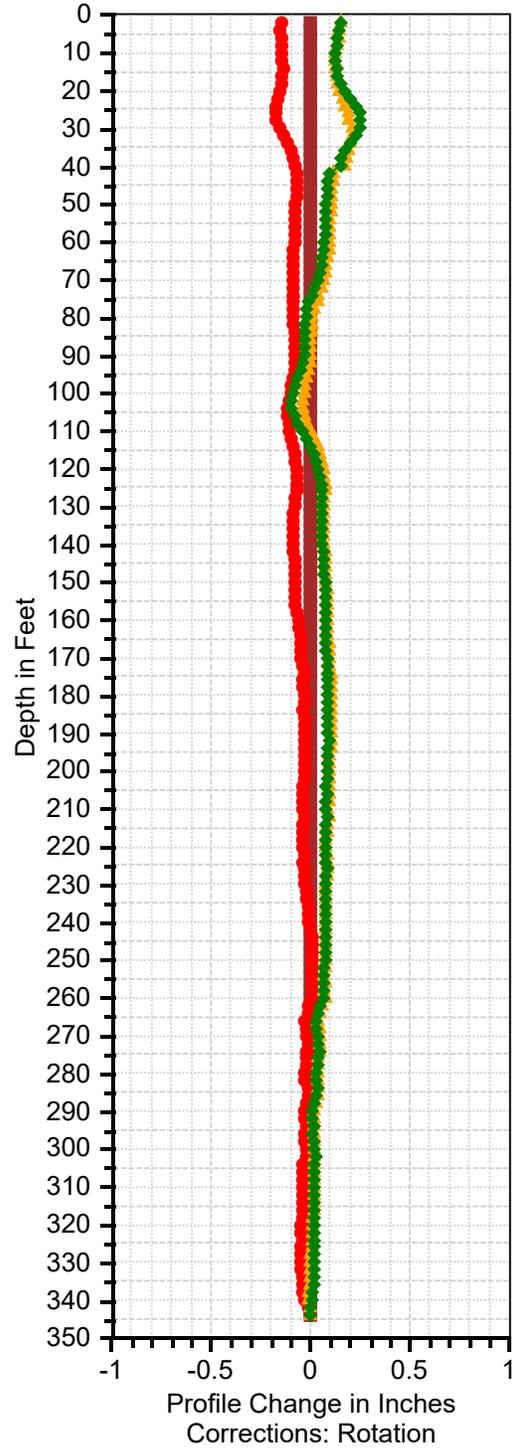
BRM SP-26 A

The Headscarp Region consists of the steep slopes at the northern boundary of the mapped landslide. SP-26 is the only usable inclinometer in the Headscarp Region. During the monitoring year, SP-26 continues to display inconsistent readings in the upper 40 feet that is interpreted to be associated with casing deformity and probe stabilization errors. BYA (1996) reported that SP-26 was sheared off in 1983-1984 slope movement and the upper approximately 40 feet of casing was replaced and possibly backfilled with a foam product.
