FY21/22 Maintenance and Monitoring

AD98-1, Big Rock Mesa

Yeh Project No.: 220-276

Subject: Annual Monitoring and Maintenance Report FY21/22, City of Malibu Assessment District 98-1, Big Rock Mesa, Malibu, CA

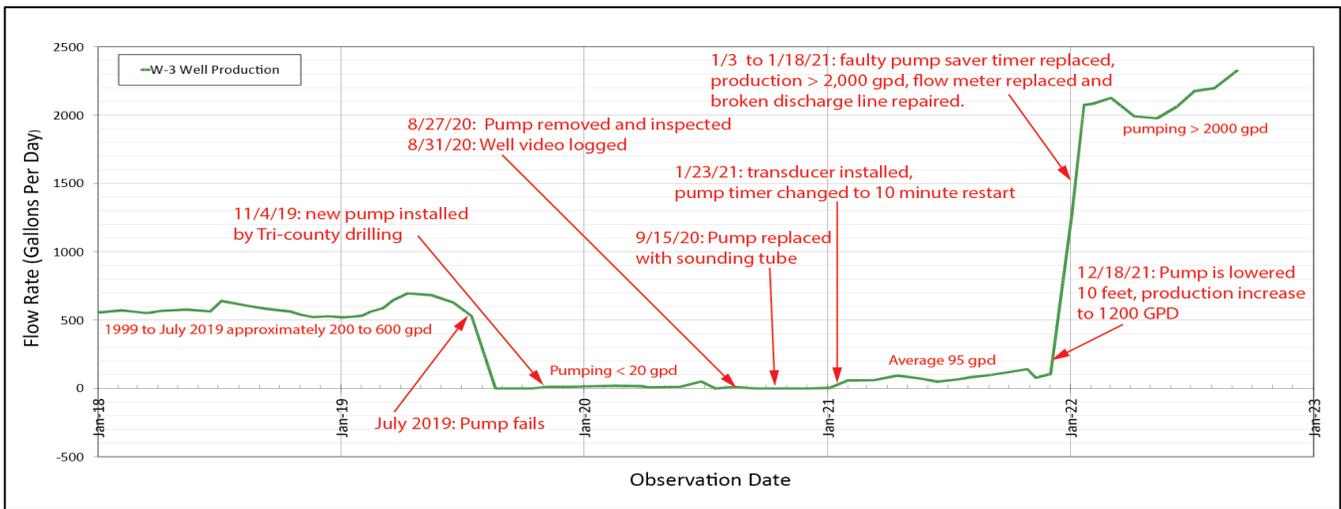
Figure 3: W-3 production data from 1/2019 to 9/2022

Yeh personnel measure flow from the dewatering wells and also tracks their performance and maintains and troubleshoots equipment for maximize performance. Figure 3 presents a plot of measured flow from dewatering well W-3 between January 2018 to present. The plot is annotated with the dates of maintenance and repair that was performed that resulted in improvement to the well's dewatering performance. This is an example of how the use of well video logging and pressure

transducer data was used to make repairs and adjustments to maximize the existing dewatering capacity.

1/5/22: Yeh noted leaking into the well vault, probably from a broken discharge line (new task added 1/5/22 Row ID 14)
				After lowering pump 10 feet average production increased from 95 gpd to 1200 gpd. Pump saver with defective timer was replaced on 1/18/22 and production increased from 95 gpd to approximately 2,000 gpd for February through the end of June .
2	Jul-20	BYA-1	known casing damage at 250 feet	1/27/22: WRS attempted to clear previously identified possible obstruction at 250 feet. Attempt to clear obstruction was unsuccessful, during airlifting and in post-attempt video log well appears filled in with formation rock below approximately 250 feet.
3	Jul-20	BYA-1	electrical box is damaged, and decomposed, bottom of box is corroded away, door falling off, this item is to replace the electrical box	Consulted, visited site and obtained quotes from Taft, Harts, Layne and Quest. Visited site with Edison. Received final estimate from Quest to perform work beginning of 2022-2023 FY.

13	Jan-22	W-3	when checking pump electronics, CP noted flow meter not working, pump had been lowered 10 feet on 12/17/21 likely sediment or debris has clogged meter.	1/6/22: CP replaces flow meter, flow meter operating normally as of 1/17/22, repair complete.
14	Jan-22	W-3	Yeh downloading transducer to asses pump saver timer noted that water was leaking into well vault, suspect that clogged flow meter had increased back pressure in aging galvanized discharge line	1/6/22: CP area north of vault excavated to expose and locate a leak approximately 6 inches outside the well vault, turned off pump to prevent flooding residents yard
				1/8/22: Yeh attempted to apply temporary clamp, but noted the leak extended into the concrete of the well vault, will require Burns pacific to repair
				1/11/22: Assessed by BP
1/12/22: BP excavated and replaced approximately 4 feet of discharge line, reconnected it to the pump drop pipe, and patched the vault wall with concrete, well was returned to service.

- Dewatering wells BYA-1 and W-3 should be replaced to original depth as part of long-term capital improvement planning.

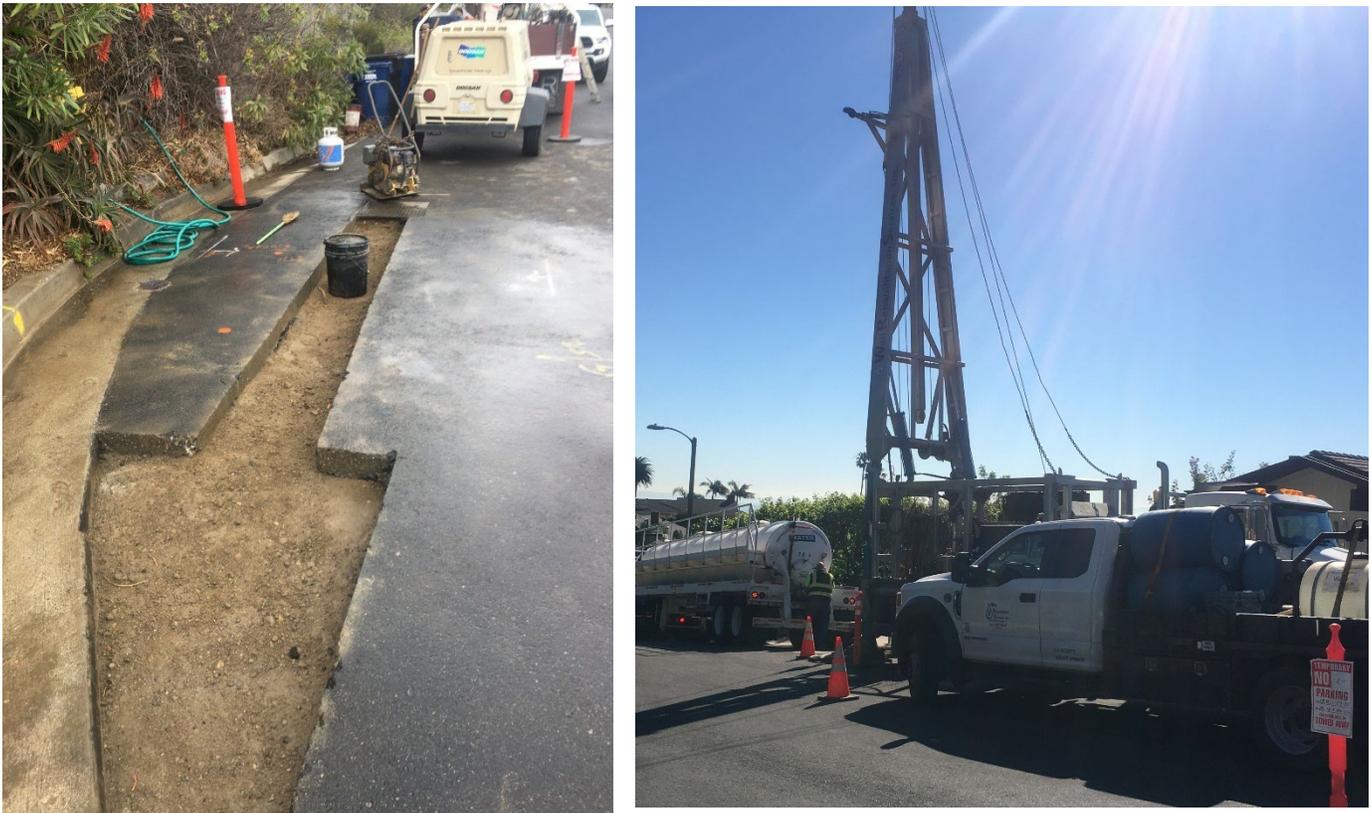
Figure 4: Photo Left - 12/8/21 discharge line repair in Inland Lane; Photo Right - 2/11/22 airlifting equipment operation at BYA-1

Larger maintenance projects for the 2021-2022 monitoring year included replacement of leaking well discharge lines beneath paved streets in Inland Lane and Seamoor Drive and rehabilitation to dewatering wells BYA-1 and W-2. Well rehabilitation included chemical treatment, casing scrubbing and airlifting of sediment and debris from the bottom of the wells. Effluent produced during the scrubbing and airlift process was directly contained in a 2,000-gallon tanker truck and disposed offsite.

2/11/22: WRS and Burns Pacific performed one day of airlift with water added from water truck and discharge collected in 2,000 gallon tanker for offsite disposal.
				2/15/22: WRS performed post rehab video.
2/17/22: CP installs new pump and motor with same drop pipe and sounding tube as prior at 240' depth.				
2/18/22: Yeh installs pressure transducer and assess well, well operating normally				
11	Nov-21	Discharge line on Inland lane	Reported by residents that parent is intermittently wet on north side of Inland Lane Cule De Sac. 11/12/21 assessed by Yeh, water was observed seeping through pavement near W-1, W-2, BYA-13 discharge line junction box, assess for broken or clogged buried discharge line.	11/12/21 Yeh Assess water levels in the vicinity, turned off W-1, W-2, BYA-13. Install transducers in W-1, W-2 and SP-33.
				1/12/21: Yeh assess for leak and to determine cause of leak, was able to determine that wet condition is related to wells W-1, W-2 and BYA-13 which flow into common discharge line at north side of Inland lane. Require access to storm drain but manhole bolts are frozen.
