## **FY22/23 Maintenance and Monitoring**

**AD98-1, Big Rock Mesa**

**City of Malibu, California**

**Subject: Annual Monitoring and Maintenance Report FY22/23, City of Malibu Assessment District 98-1, Big Rock Mesa, Malibu, CA**

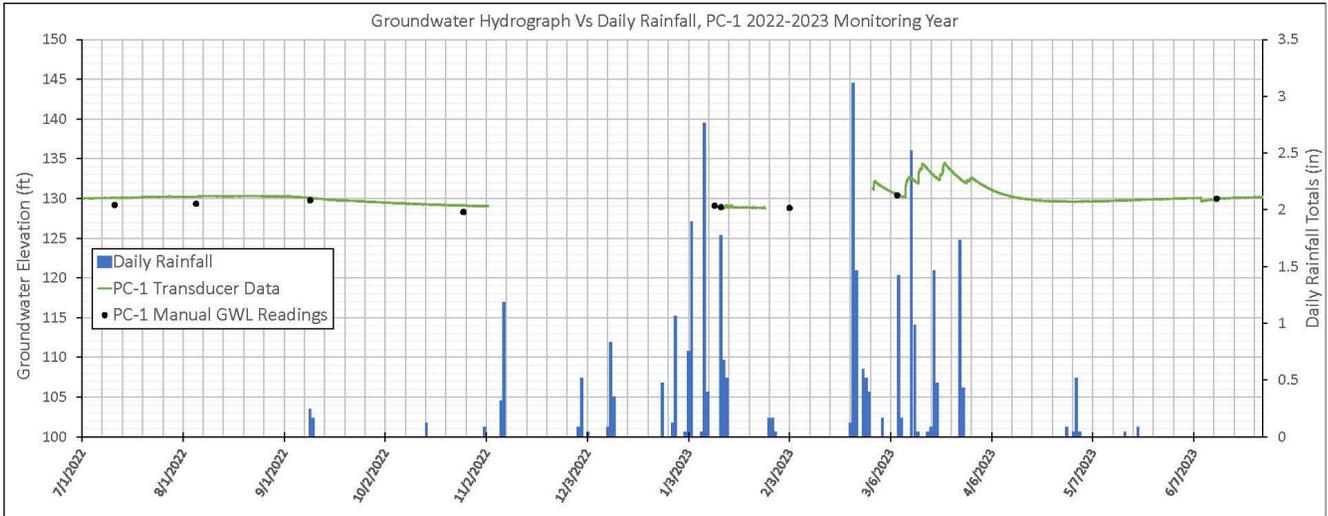
- PC-1 water levels increased by less than 5 feet, relatively quickly in response to individual rain events and then dissipated over a day to a few days.
- Water levels in SP-3A appeared to rise nearly immediately in response to rainfall and lower quickly to close to previous levels. It is noted that the water level within the well casing rose on the order of up to 60 feet over a few minutes. This is thought to be a result of the surface runoff directly entering the casing. Water levels recorded in SP-3A may not represent the true water levels until surface water that entered the casing has dissipated. A transducer is currently installed in SP-3A and is logging at 1-minute intervals to continue evaluations of water levels responses.

**Figure 3: PC-1 transducer hydrograph vs daily rainfall, programmed to 1-hour**

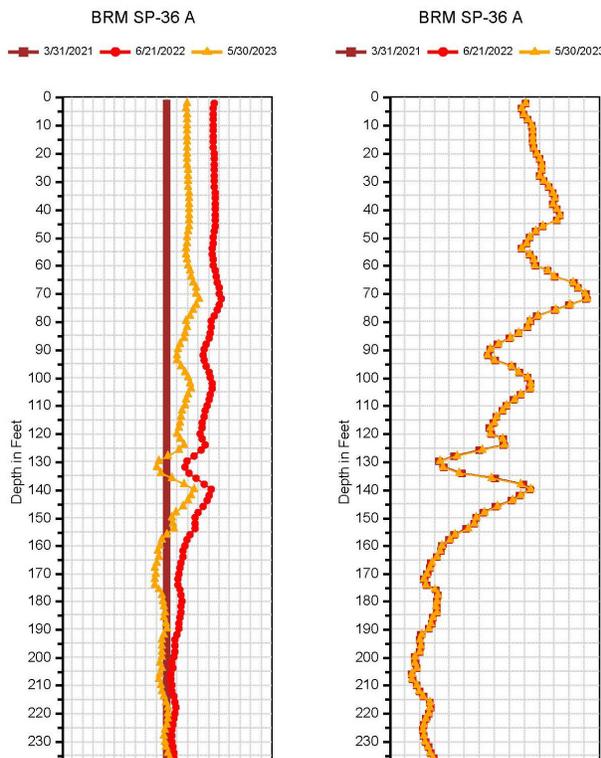
inclinometers have tilted and curved casing at the depth of suspected error. Research indicates that highly tilted casing introduces error in inclinometer surveys due to accelerometer sensor properties (Mikkelson, 2003) (Ru Et Al., 2022) and that curvature affects the repeatability of probe placement. Analysis of the data plots indicate that the largest source of error is likely depth positioning error (DPE). Small changes in probe depth placement along highly curved casing may result in false movement displayed on the profile change plots. The inclinometers reviewed each present with a geometric-congruence between graphical cumulative displacement and tilt magnitude plots which is highly suggestive of DPE (Mikkelson, 2015). An example of geometric-congruence is shown in Figure 5 for SP-36.

Figure 5: SP-36, Geometric “Mirror” Congruence Between Cumulative Change vs Tilt Magnitude Plots

Inclinometers SP-34, -35 and -36 were installed during the 1998-1999 monitoring year, by the same contractor and are all highly tilted throughout the casing. The casing issues appear to be the result of vertical buckling during the counter-buoyancy techniques used for initial grouting. SP-11 and -26 displayed high tilt in the areas where they were extensively sheared during the 1983 landslide and they have therefore been prone to error at those depths since that time. The use of the AT system inclinometer probe has minimized inconsistent placement and the most likely cause for the DPE is minute changes to the cable length between surveys.

Inclinometers SP-11, -26, -34, -35 and -36 will continue to be surveyed and will be processed and interpreted with additional consideration of the casing conditions. SP-11 and -26 have previously reported possible creep type movement that appears to have continued for some time after major movements ceased. The locations are currently used exclusively to monitor for very small incipient or creep movements but are likely too deformed at the identified shear depths for the traversing probe to reliably measure at the required precision. Future improvements should include fitting these inclinometer casings with non-traversing, in-place sensors across the identified shear zone to confirm the presence or absence of ongoing creep.

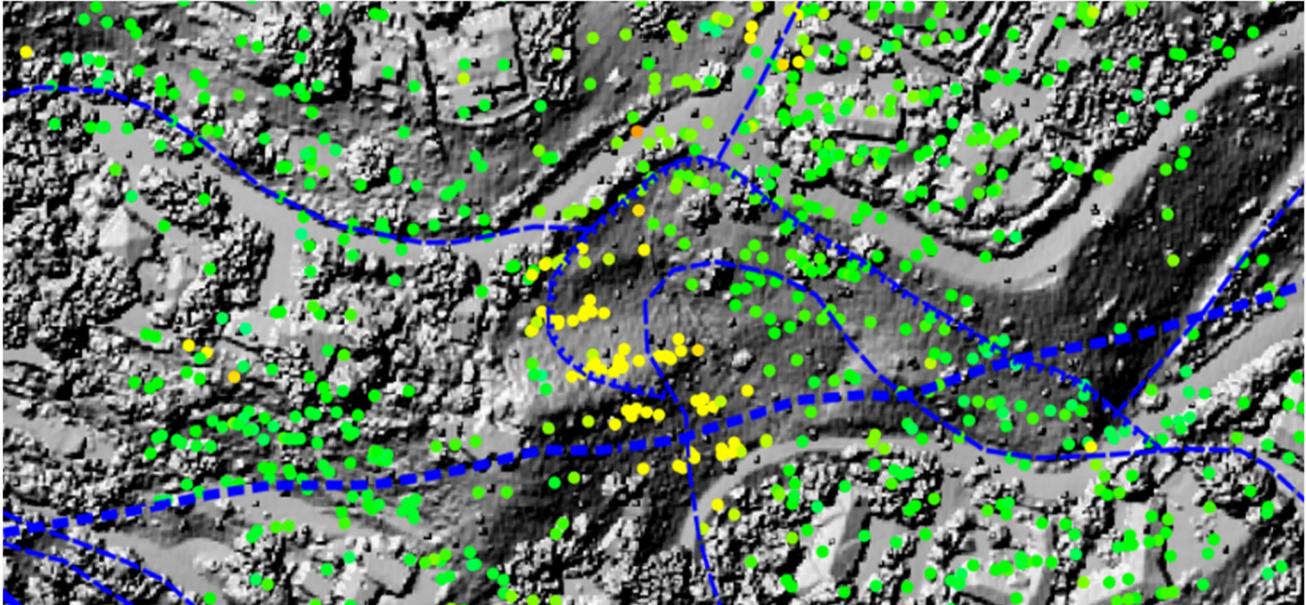
**Figure 11: Area 4, slope below Pinnacle Way at Big Rock Drive with Geologic map (BYA 1992); Highest Quality all points area of displacement +/-5mm per year**

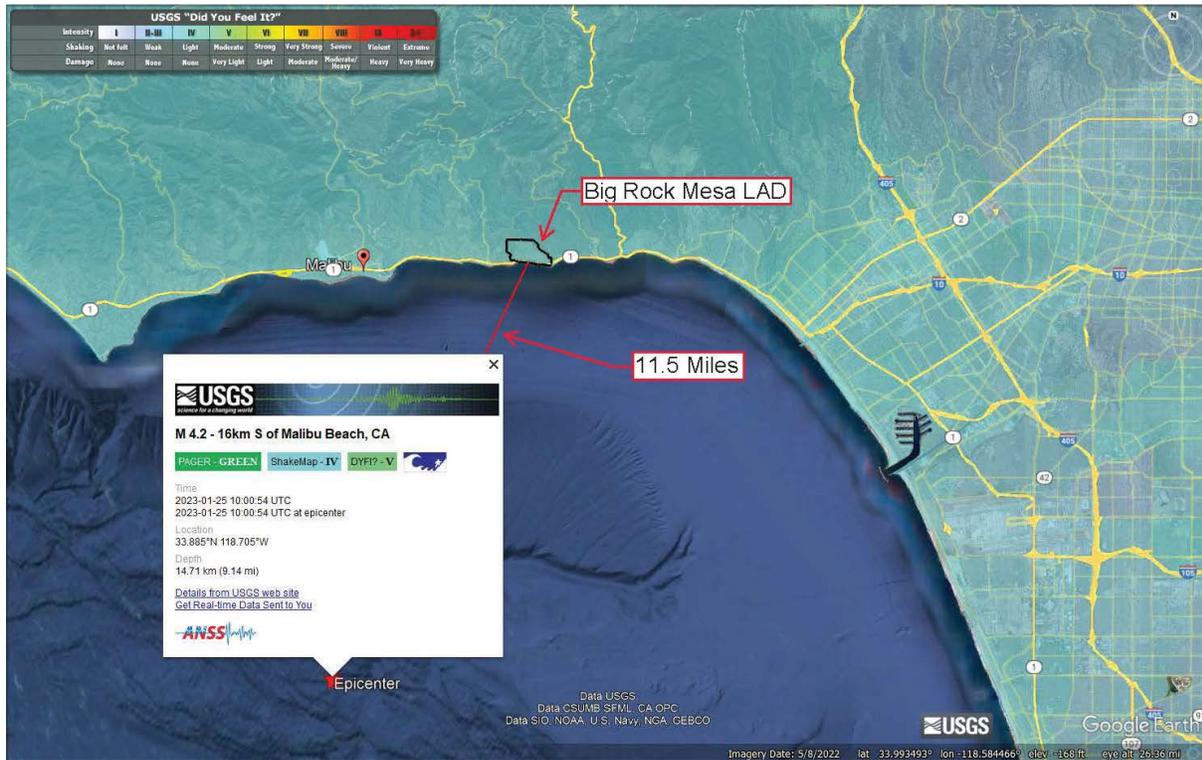
One earthquake with a magnitude of 4.0 or greater was recorded within a 100-mile radius of the project area. On January 25, 2023, a M 4.2 event occurred approximately 16 kilometers south of Malibu Beach, a M 3.6 aftershock occurred approximately 3 minutes later. The epicenters were located approximately 11.5 miles southwest from the Big Rock Mesa LAD boundary.

**Figure 12: Epicenter of January 25, 2023 M4.2 EQ relative to Big Rock LAD**

Yeh personnel performed post-earthquake observations and measurements that included surveying of key inclinometers and/or field observations of the ground surface made during scheduled monitoring and maintenance before and after the earthquake event. No movement secondary to the earthquake was interpreted on the inclinometers surveyed. Yeh staff did not observe surface displacements related to the earthquake and is unaware of any reports of damage local to the Big Rock Mesa Landslide AD resulting from the earthquake.
