FY23/24 Maintenance and Monitoring

AD98-1, Big Rock Mesa

Yeh Project No.: 220-276

Subject: Annual Monitoring and Maintenance Report FY23/24, City of Malibu Assessment District 98-1, Big Rock Mesa, Malibu, CA

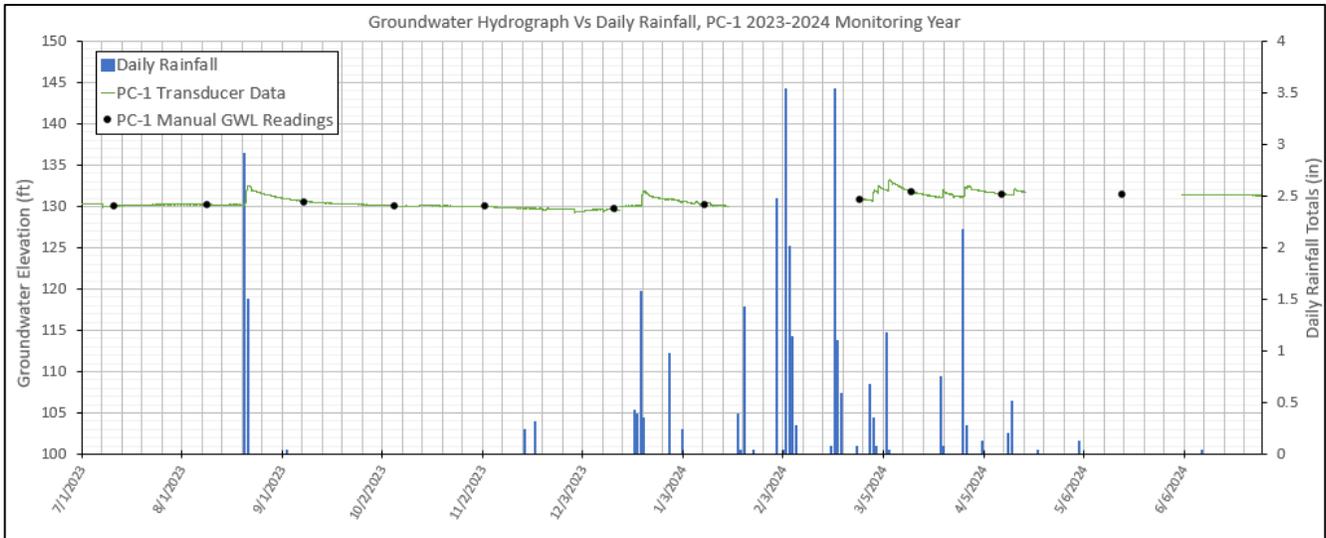
- PC-1 water levels increased by less than 2 feet, in response to individual rain events and then dissipated over a day to a few days.
- Water levels in SP-3A appeared to rise nearly immediately in response to rainfall and then lower over the several days to a level close to the pre-storm level. It is noted that the water level within the well casing rose on the order of up to 150 feet over a few minutes with rainfall. This may be a result of surface runoff directly entering the casing. Water levels recorded in SP-3A may not represent the true water levels until surface water that entered the casing has dissipated. A transducer is currently installed in SP-3A and is logging at 1-minute intervals to continue evaluations of water levels responses.

Figure 3: PC-1 transducer hydrograph vs daily rainfall, programmed to 1-hour and 1-minute

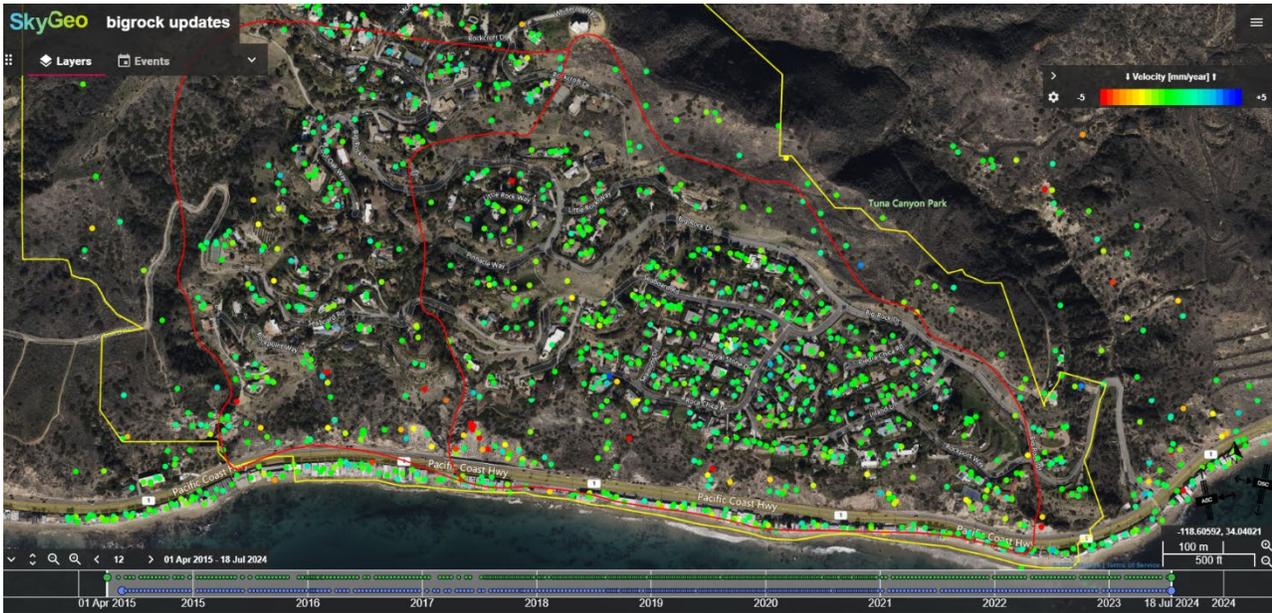
roads. Both plots indicate below threshold movement rates for all areas not on a steep slope. Areas of shallow slope failures such as rockfall, debris flow and shallow slumps that occurred during heavy rain were filtered out by manual point quality selection or algorithm due to either lost coherence as a detectable DS pixel or lost phase tracking.

Figure 5: Highest Quality PS Pixels Only, Displacement Rate $\pm 5\text{mm/year}$

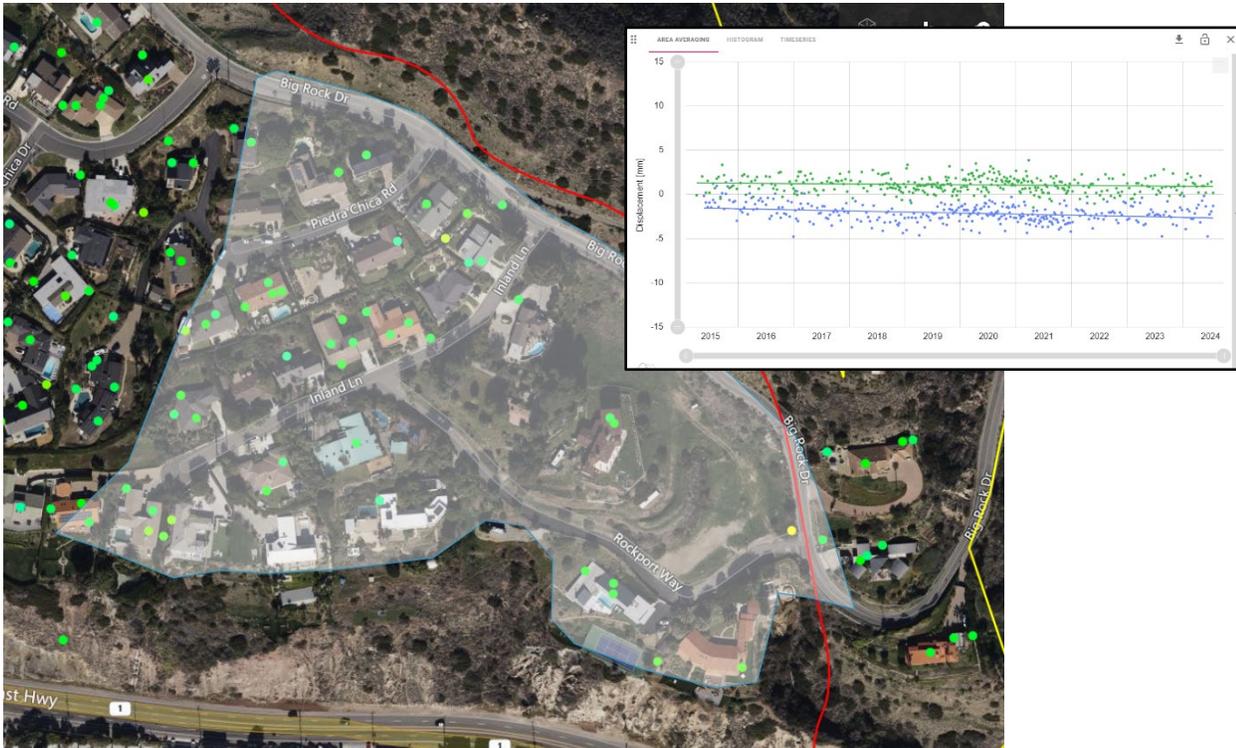
Figure 7 shows the results of grouping and statistics interface tool to assess PS pixels for the non-slope areas of the Eastern Region. The calculated average displacement for the area is -0.1mm/year

with no obvious trend of displacement over time and no distinct displacements at a given point. This calculated rate is below the margin of error. This process was performed for each project subregion and yielded similar results.

Figure 7: Eastern Region, Non-slope Area Averaging, Highest Quality PS Pixels Only area averages = -0.1 mm/year are within margin of error
