# **FY23/24 Maintenance and Monitoring**

**AD98-3, Malibu Road**

**City of Malibu, California**

**Subject: Annual Monitoring and Maintenance Report FY23/24, City of Malibu Assessment District 98-3, Malibu Road, Malibu, CA**

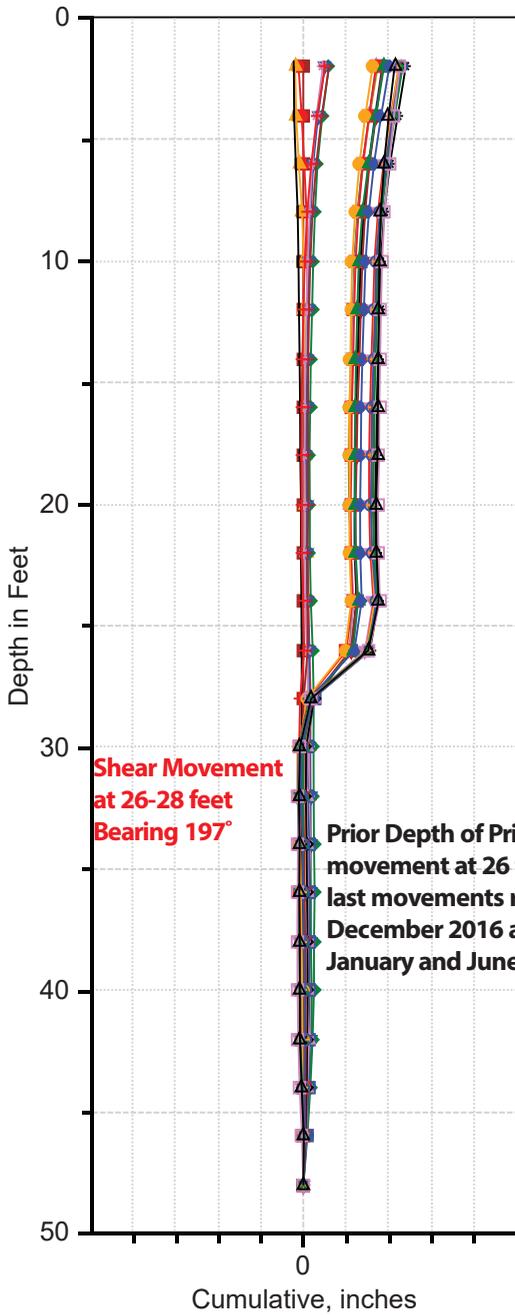
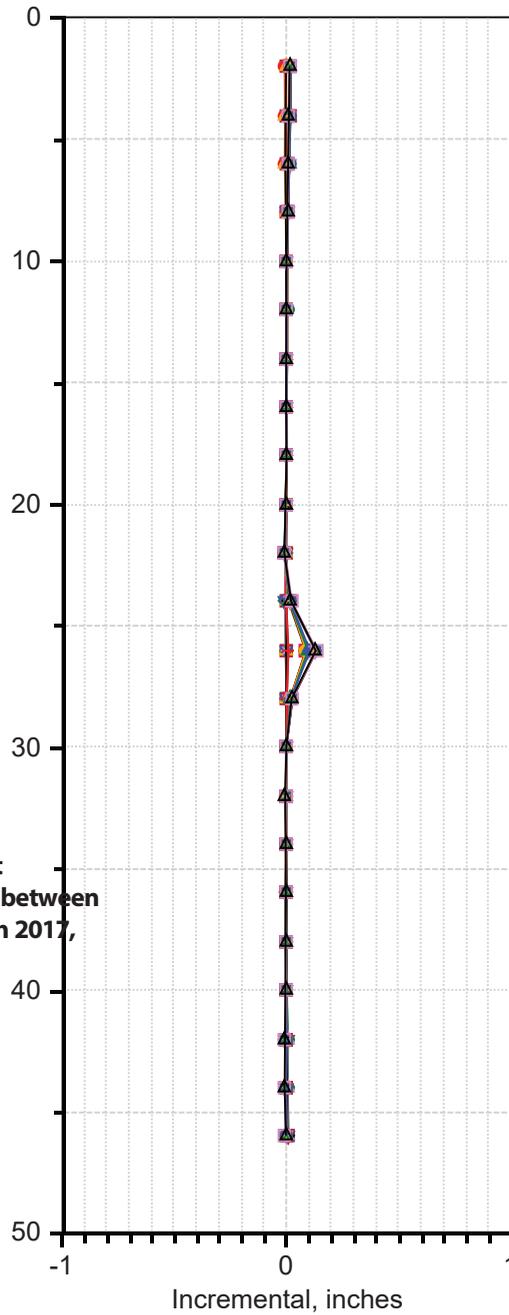
Plot Type: Cumulative and Incremental		Plot Direction: A-Direction	
Depth of Survey (ft): 46		Baseline Date: 5/04/2021	
Install Date: 8/2006		Interpreted Movement Since Baseline (in): 0.14	
Installed Depth (ft): 50		Interpreted Movement Monitoring Year (in): 0.02	
Corrections: None

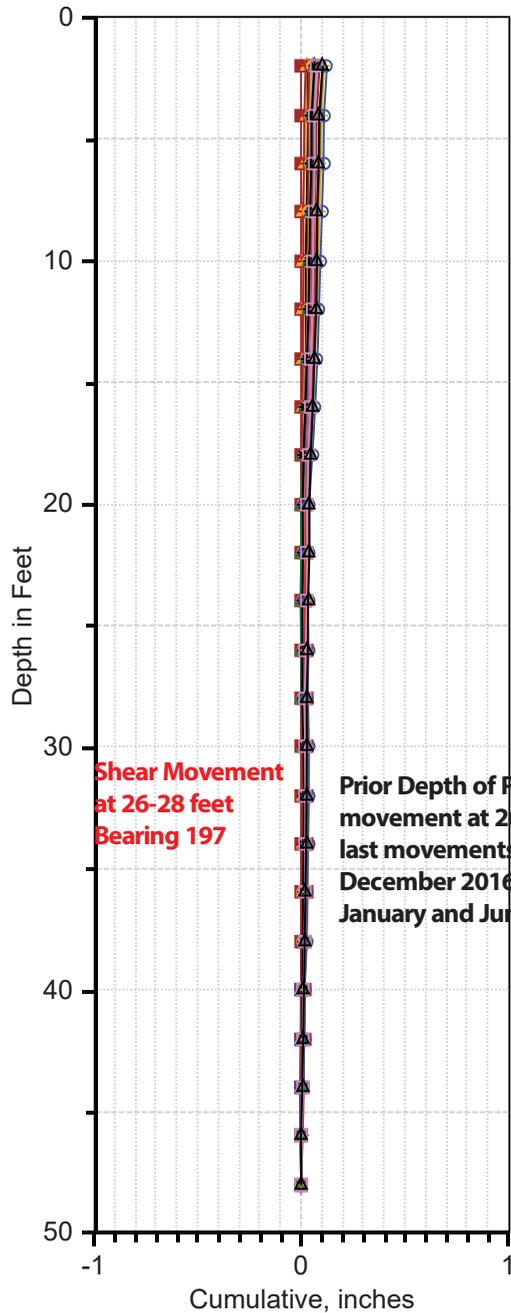
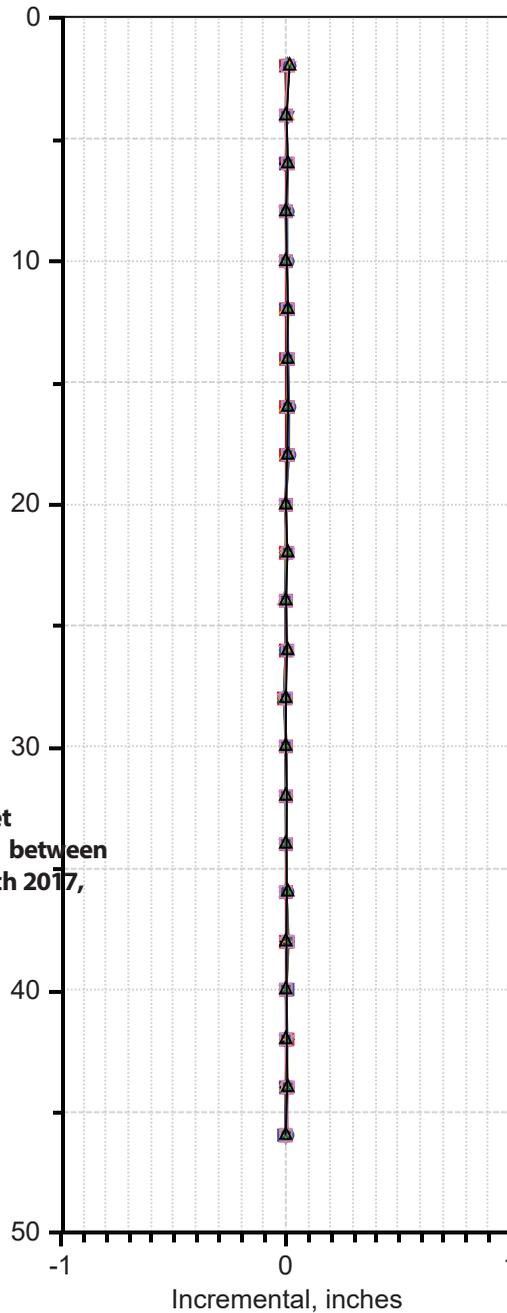
Shear Movement  
at 26-28 feet  
Bearing 197

Prior Depth of Primary  
movement at 26 to 30 feet  
last movements reported between  
December 2016 and March 2017,  
January and June 2023

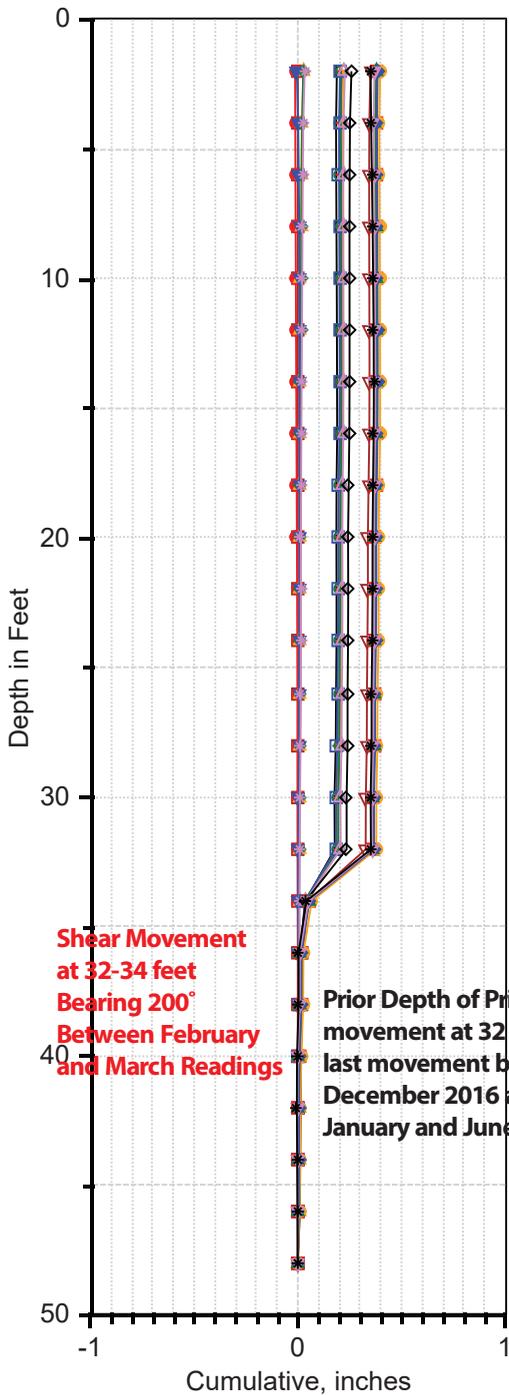
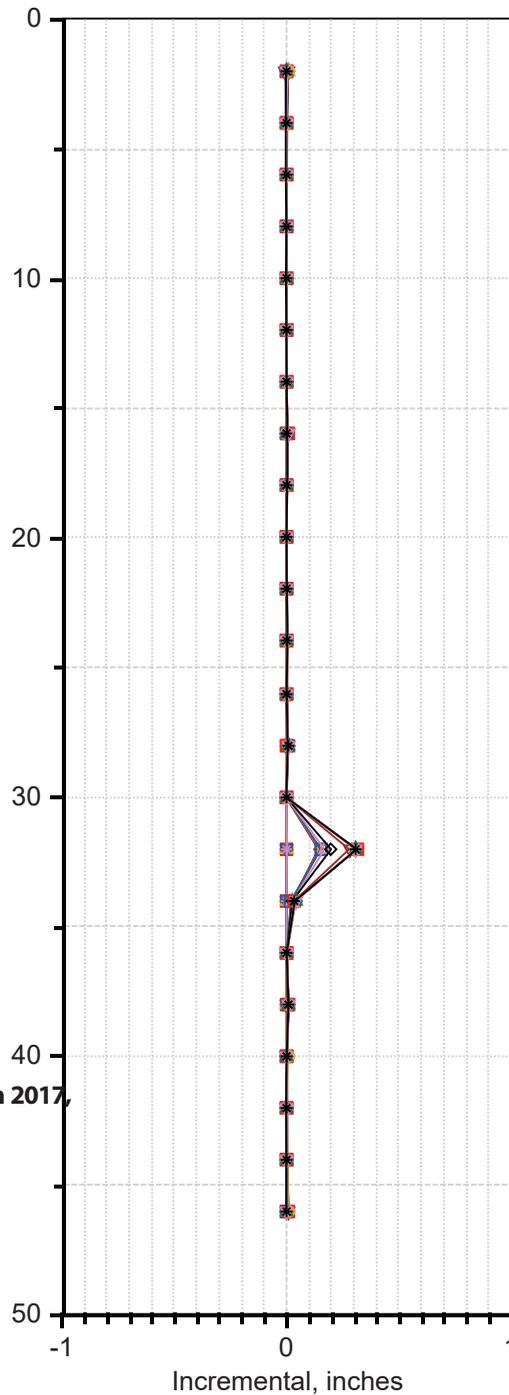
Shear Movement at 32-34 feet Bearing 200° Between February and March Readings

Prior Depth of Primary movement at 32 to 34 feet last movement between December 2016 and March 2017, January and June 2023

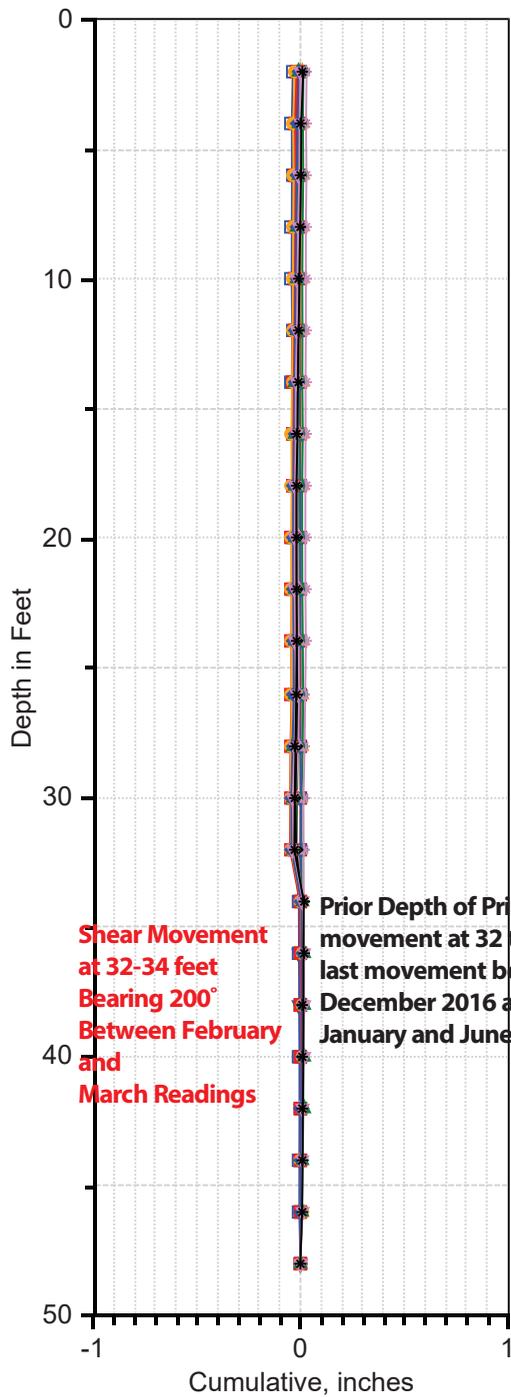
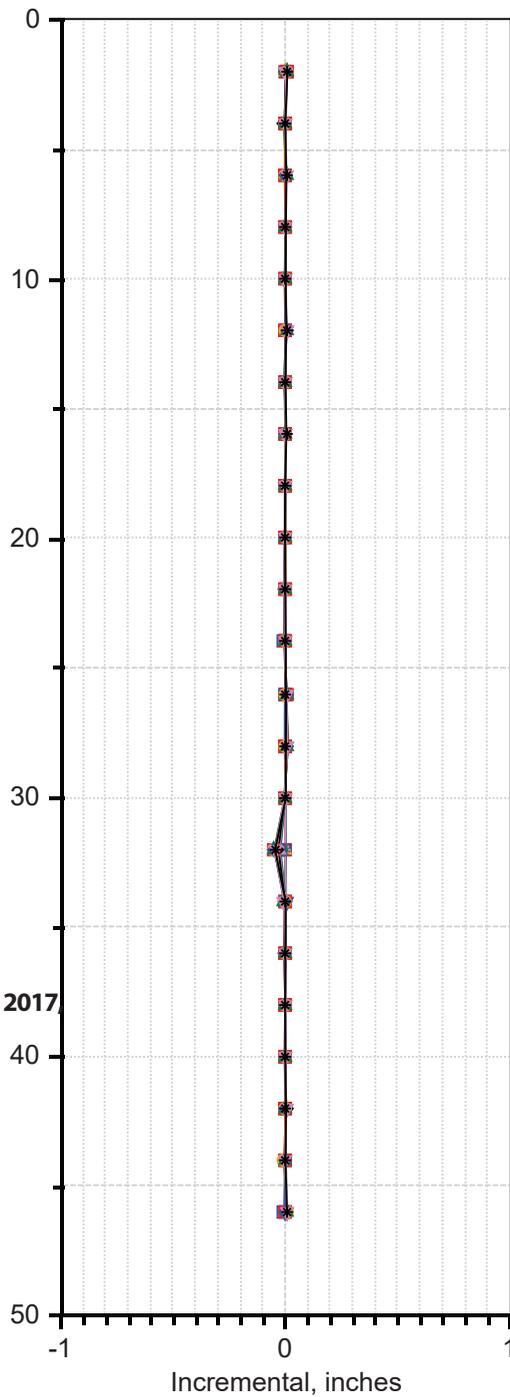
Shear Movement  
at 32-34 feet  
Bearing 200°  
Between February  
and  
March Readings

Prior Depth of Primary  
movement at 32 to 34 feet  
last movement between  
December 2016 and March 2017,  
January and June 2023

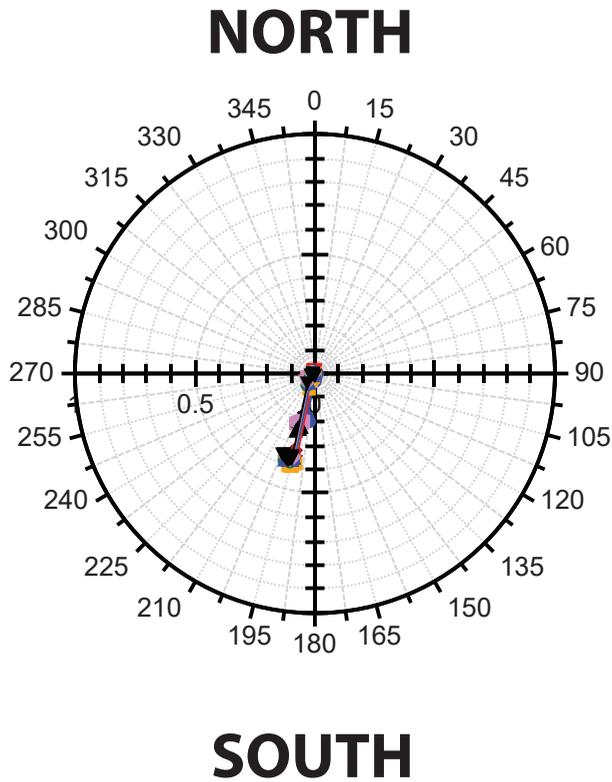
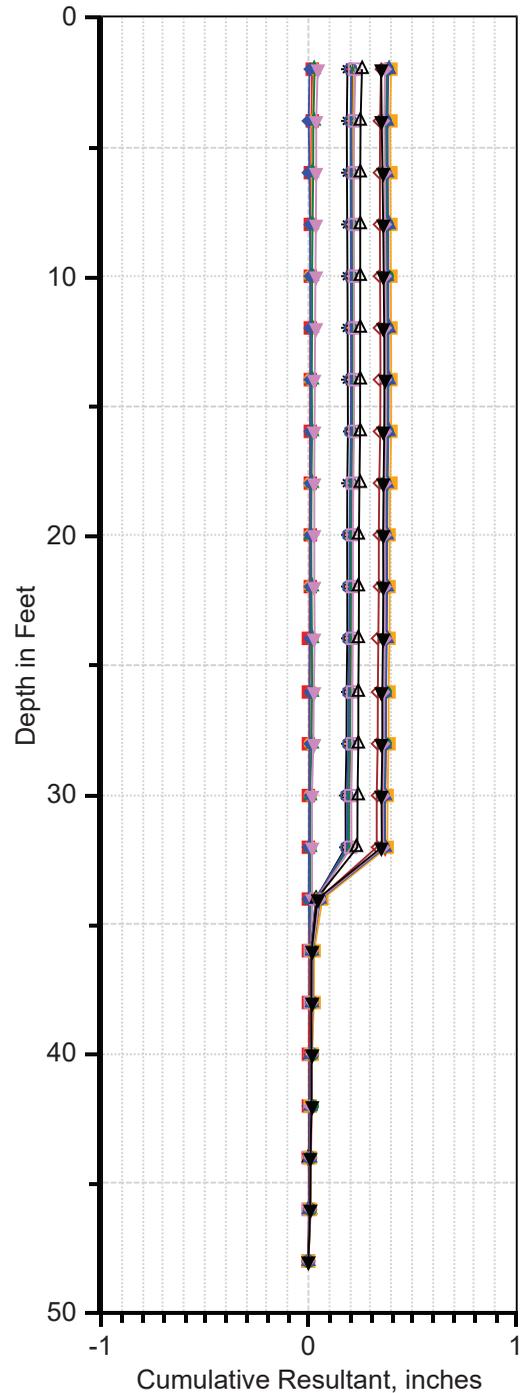
<b>Plot of Slope Inclinometer</b>  <b>SI-2A</b>	Plot Type: Cumulative Resultant, Polar and Profile Views		Plot Direction: Resultant
	Depth of Survey (ft): 48	Baseline Date: 12/15/2021	
	Install Date: 9/2010	Installed Depth (ft): 64	Interpreted Movement Since Baseline (in): 0.36
		Interpreted Movement Monitoring Year (in): 0.16

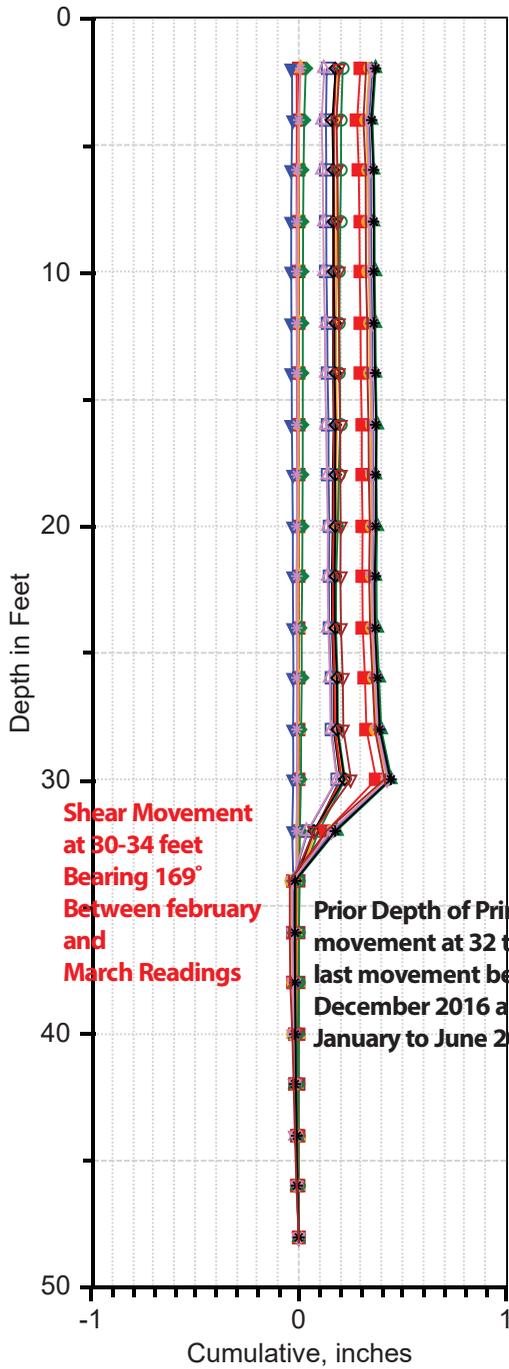
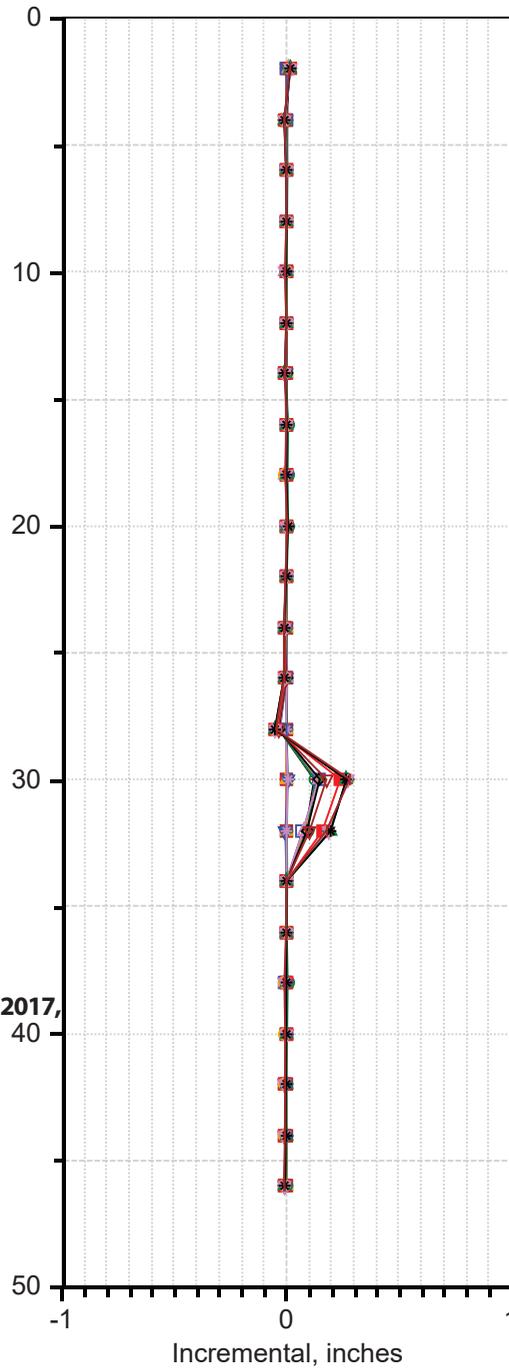
Plot of Slope Inclinometer  
SI-4A

Shear Movement at 30-34 feet Bearing 169° Between february and March Readings

Prior Depth of Primary movement at 32 to 34 feet last movement between December 2016 and March 2017, January to June 2023

Plot Type: Cumulative and Incremental		Plot Direction: A-Direction	
Depth of Survey (ft): 48		Baseline Date: 8/06/2021	
Install Date: 8/2012		Interpreted Movement Since Baseline (in): 0.48	
Installed Depth (ft): 50		Interpreted Movement Monitoring Year (in): 0.20	
		Corrections: None

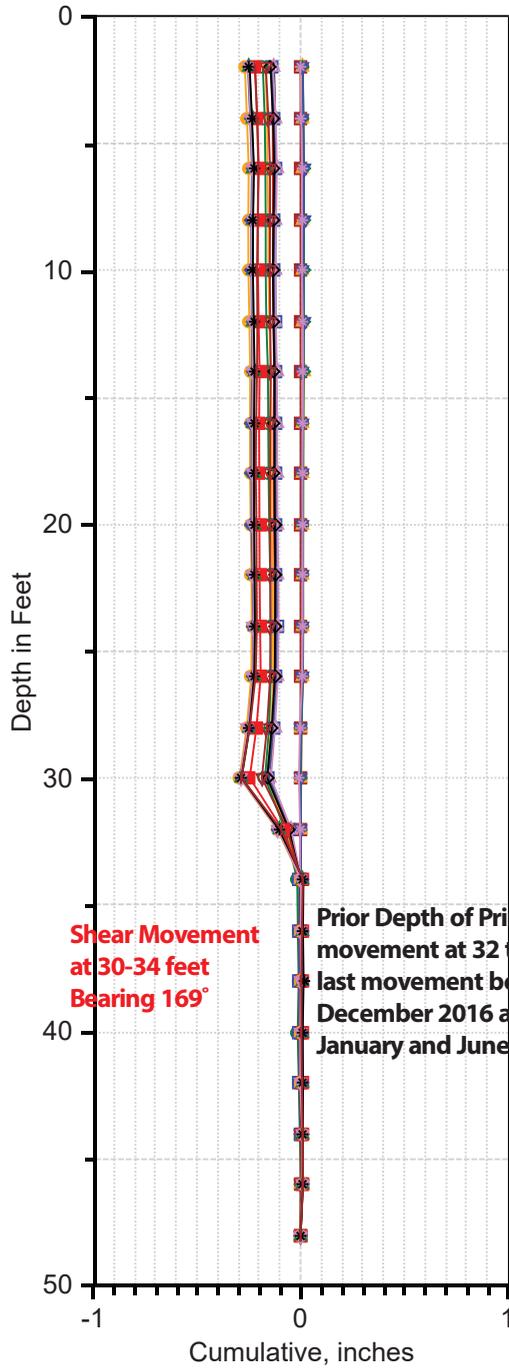
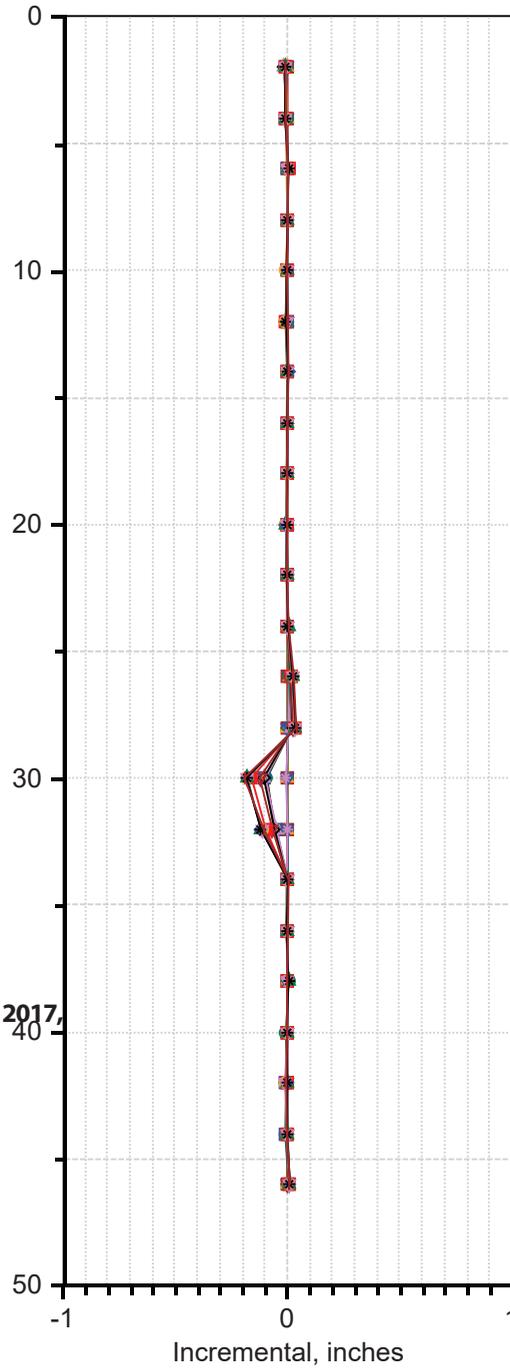
Plot of Slope Inclinometer  
SI-4A

Shear Movement at 30-34 feet Bearing 169°

Prior Depth of Primary movement at 32 to 34 feet last movement between December 2016 and March 2017, January and June 2023

Plot Type: Cumulative and Incremental		Plot Direction: B-Direction	
Depth of Survey (ft): 48		Baseline Date: 8/6/2021	
Install Date: 8/2012		Interpreted Movement Since Baseline (in): 0.48	
Installed Depth (ft): 50		Interpreted Movement Monitoring Year (in): 0.20	
Install Date: 8/2012		Interpreted Movement Monitoring Year (in): 0.20

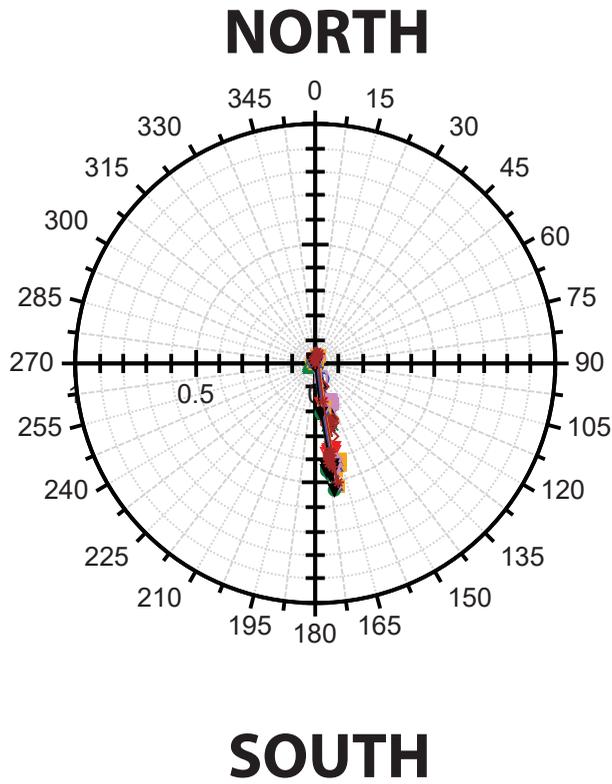
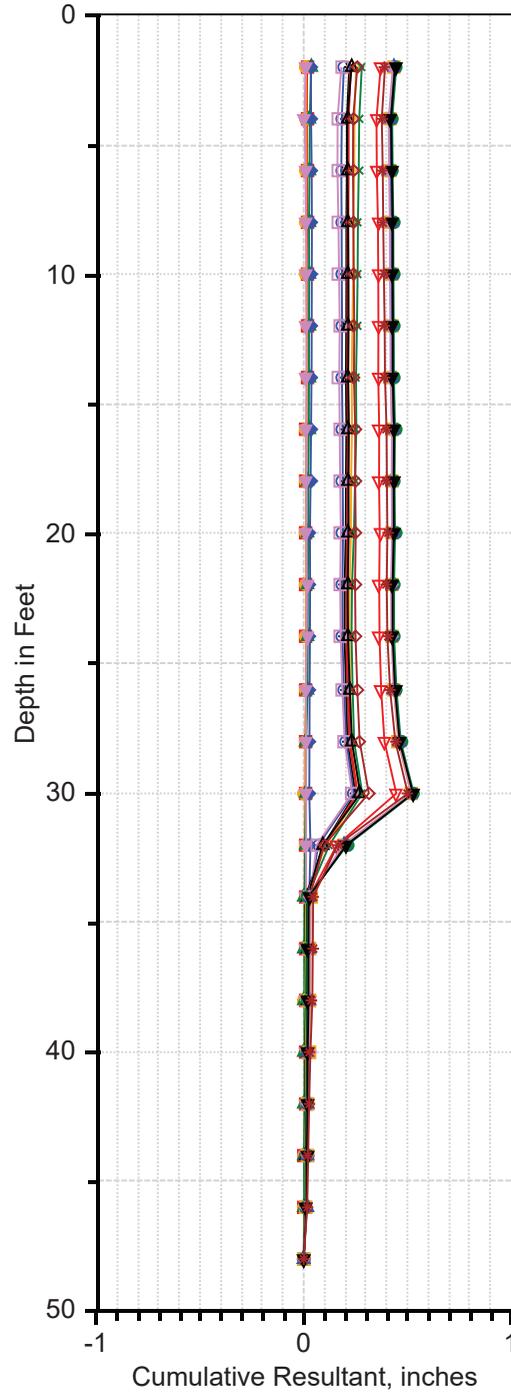
**Plot of Slope Inclinometer**  
**SI-4A**

Plot Type: Cumulative Resultant, Polar and Profile Views		Plot Direction: Resultant	
Depth of Survey (ft): 48		Baseline Date: 12/15/2021	
Install Date: 8/2012		Interpreted Movement Since Baseline (in): 0.48	
Installed Depth (ft): 50		Interpreted Movement Monitoring Year (in): 0.20
