**ANNUAL REPORT
JULY 2011 THROUGH JUNE 2012
CALLE DEL BARCO
LANDSLIDE ASSESSMENT DISTRICT
MALIBU, CALIFORNIA**

Prepared for:
CITY OF MALIBU

September 2012
Fugro Job No. 04.B3399005

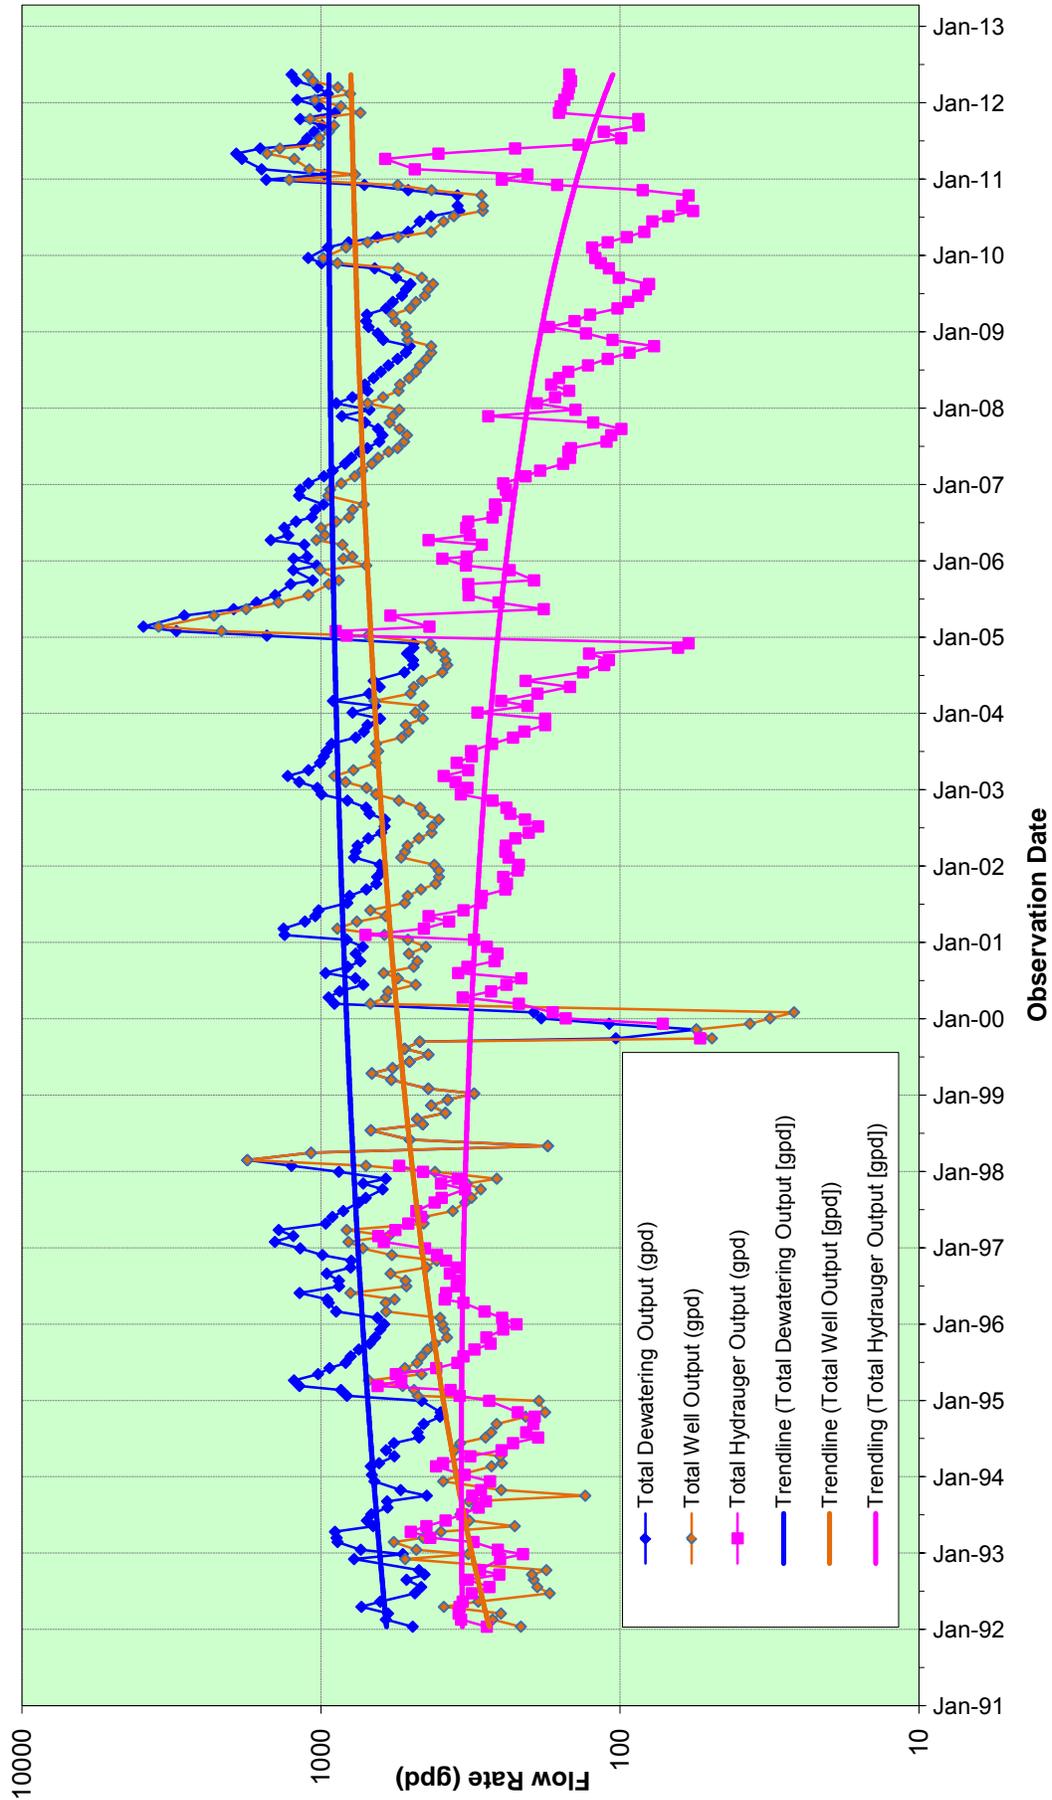
DEWATERING GRAPH
Total Output - All Wells & Hydraugers
Calle del Barco Landslide Assessment District
Malibu, California

The total production rate for all hydraugers from August 1991 through June 2012 is depicted on Plate 4. Hydrauger production rates for individual hydraugers are presented on Plate B-4 (Appendix B). Additional data regarding hydraugers and production rates are included in Appendix B.

The average hydrauger production rate for all hydraugers over the monitoring period was approximately 183 gpd. This represents approximately 82 percent of last year's hydrauger production rate of 223 gpd.

- Slope inclinometer readings indicate no significant ground movement.
- Additional dewatering facilities are recommended in order to increase the dewatering capacity of the landslide stabilization system. Plate 4 indicates decreased production from hydraugers. Over time, hydraugers become clogged and less efficient at removal of water by gravity. Replacement hydraugers should be considered for Rambla Orienta.

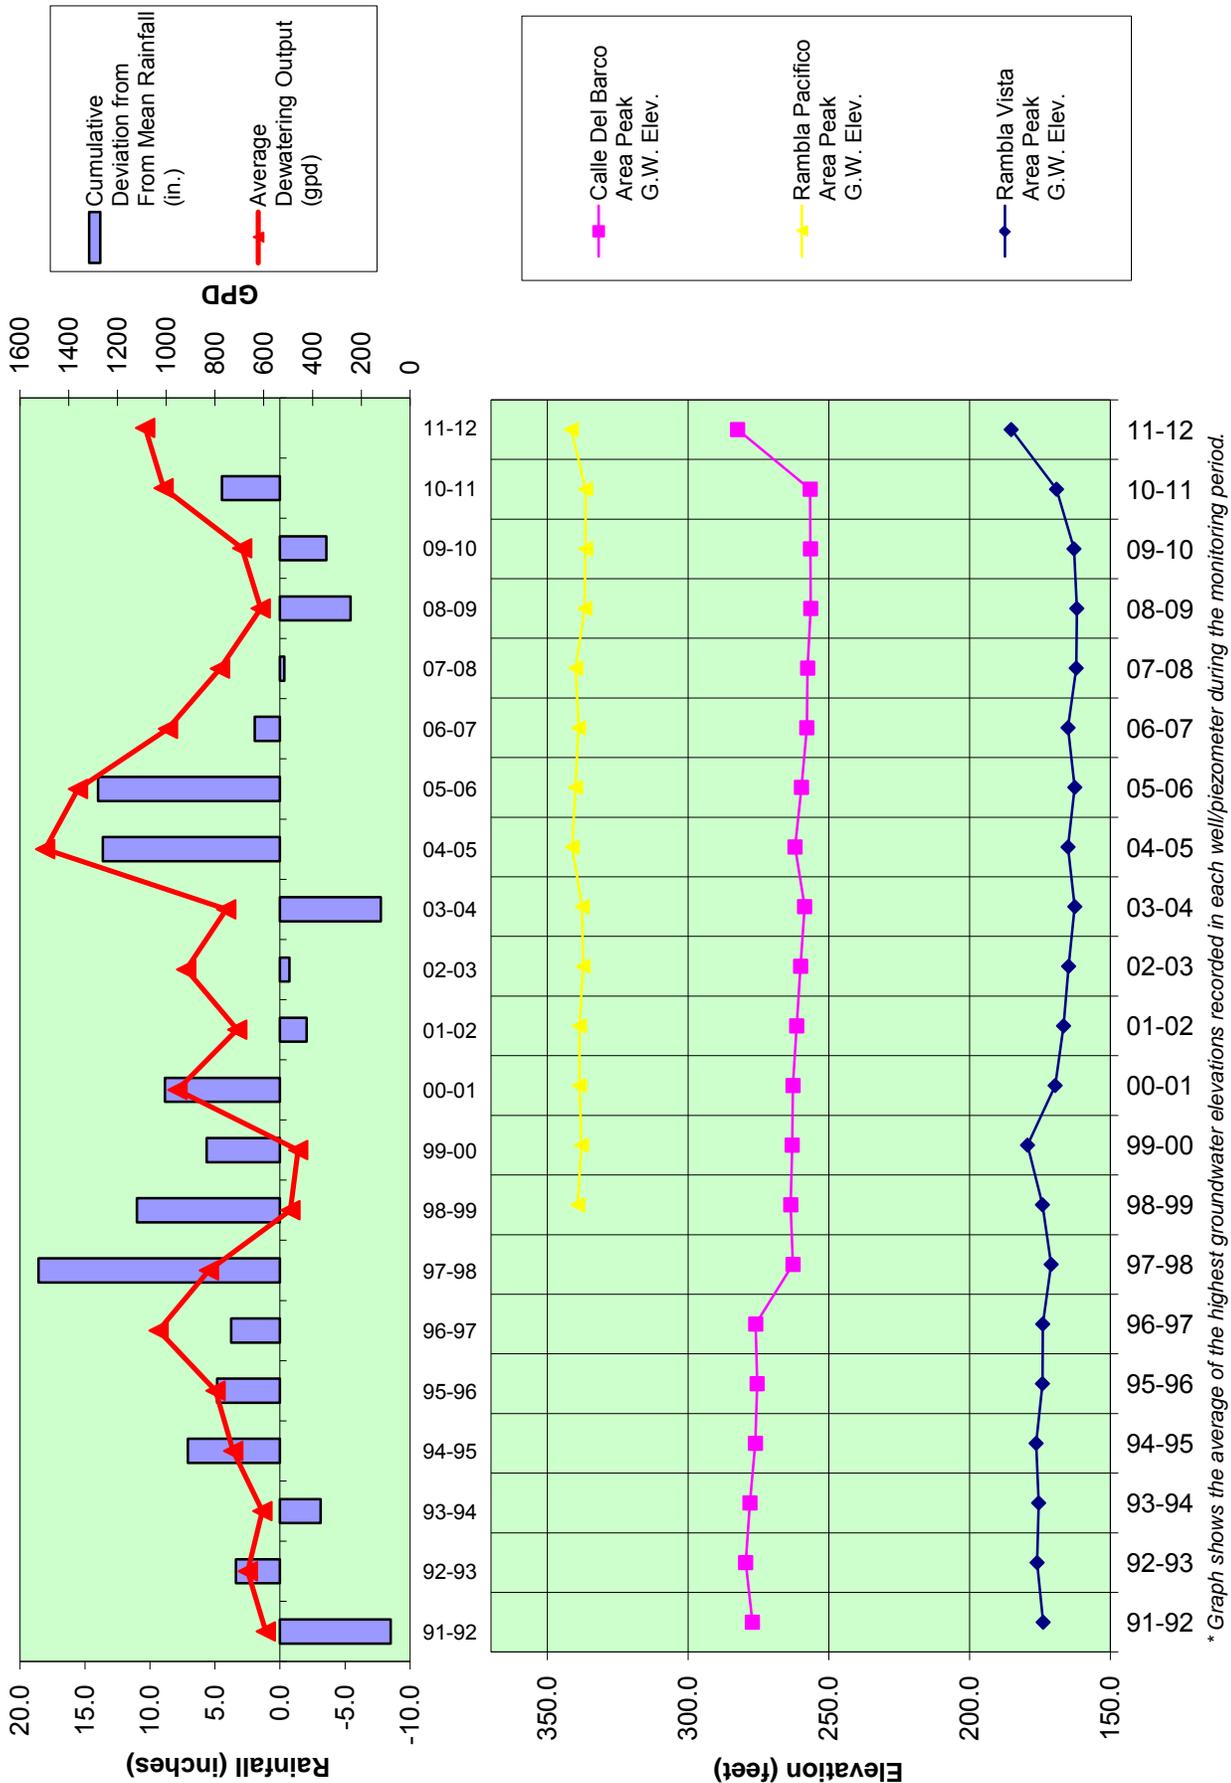
SUMMARY GRAPH
Groundwater Levels, Dewatering, & Rainfall
 Calle del Barco Landslide Assessment District
 Malibu, California

A summary graph of normalized peak groundwater elevations for Calle del Barco is presented on the bottom graph of Plate 5. The top graph on Plate 5 shows the average dewatering output (gpd) and the cumulative departure from the mean rainfall. The average annual rainfall used for the chart was computed using all of the data from 1988 through the present. This graph illustrates that although annual rainfall has been generally increasing since 2008, the average dewatering output has been decreasing.

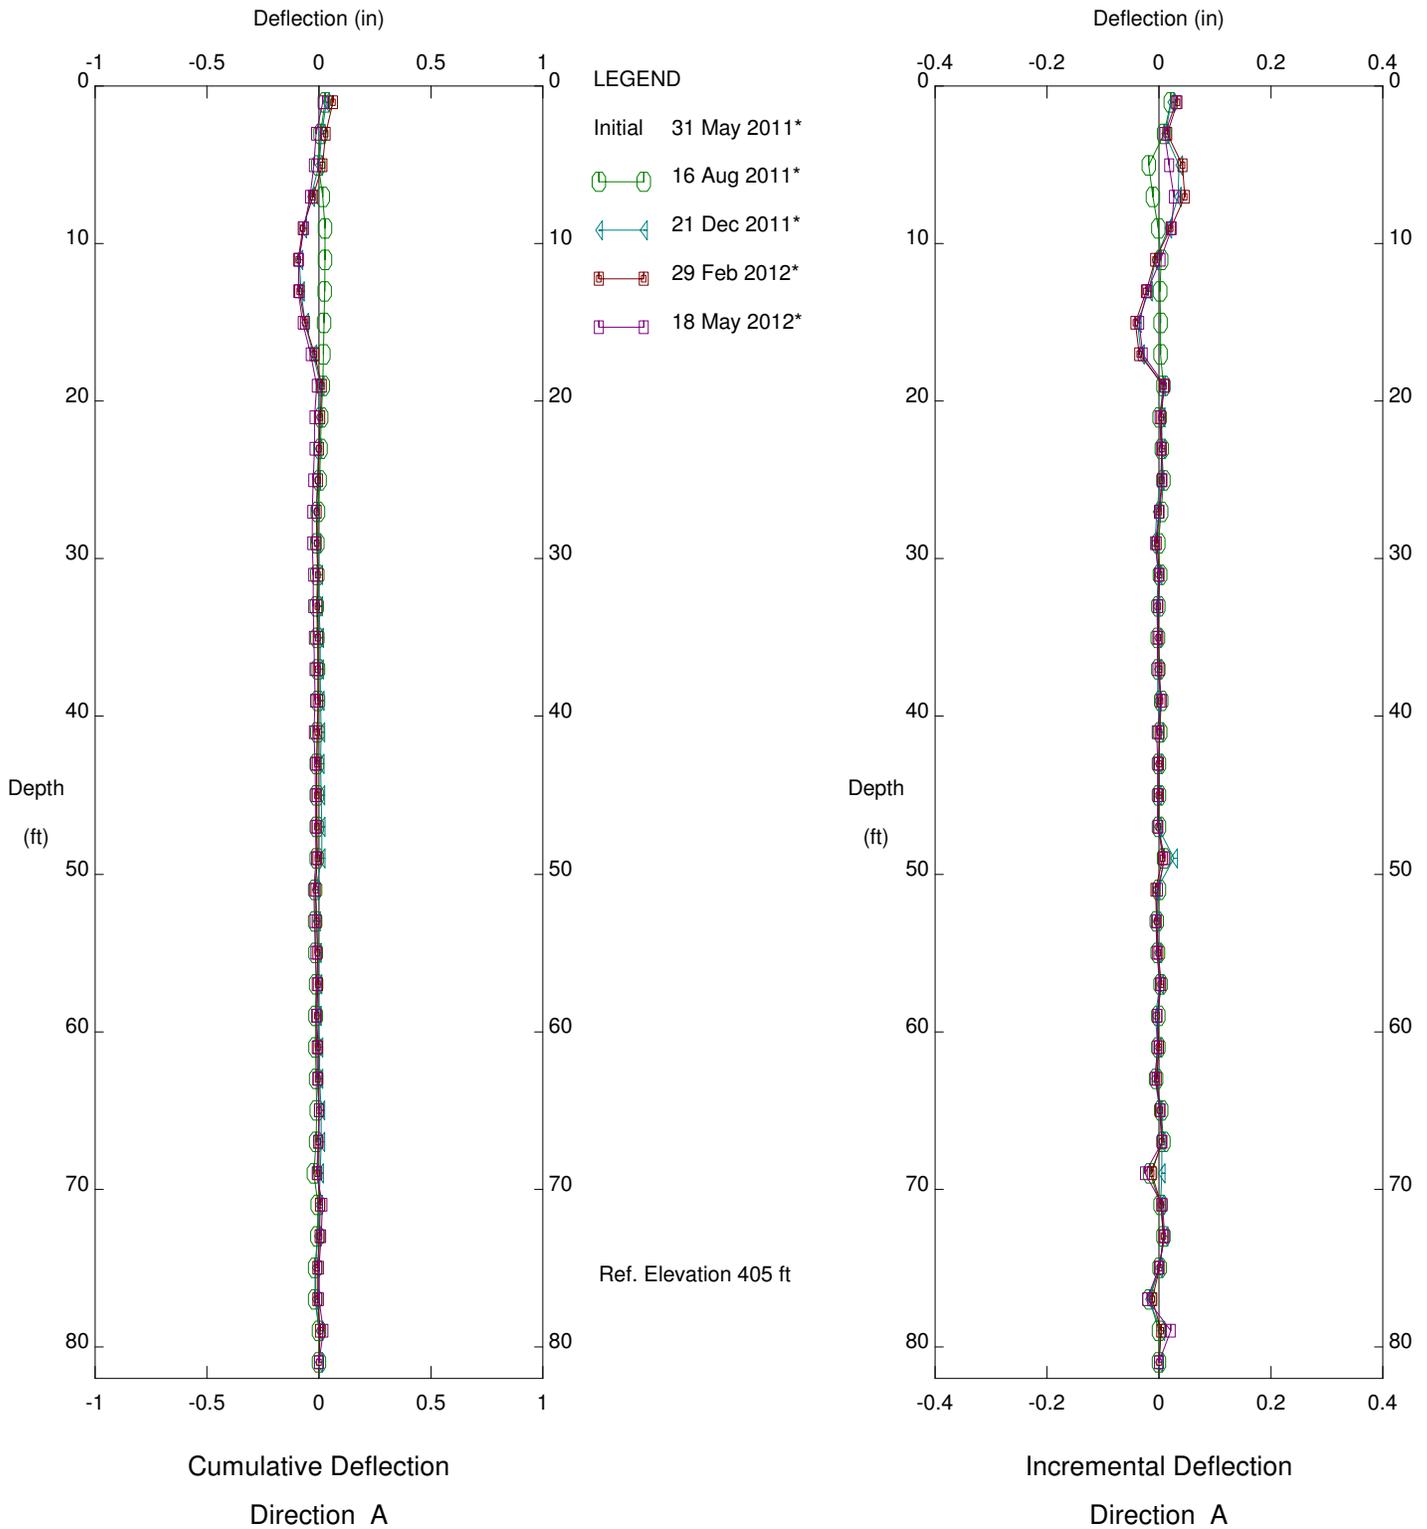
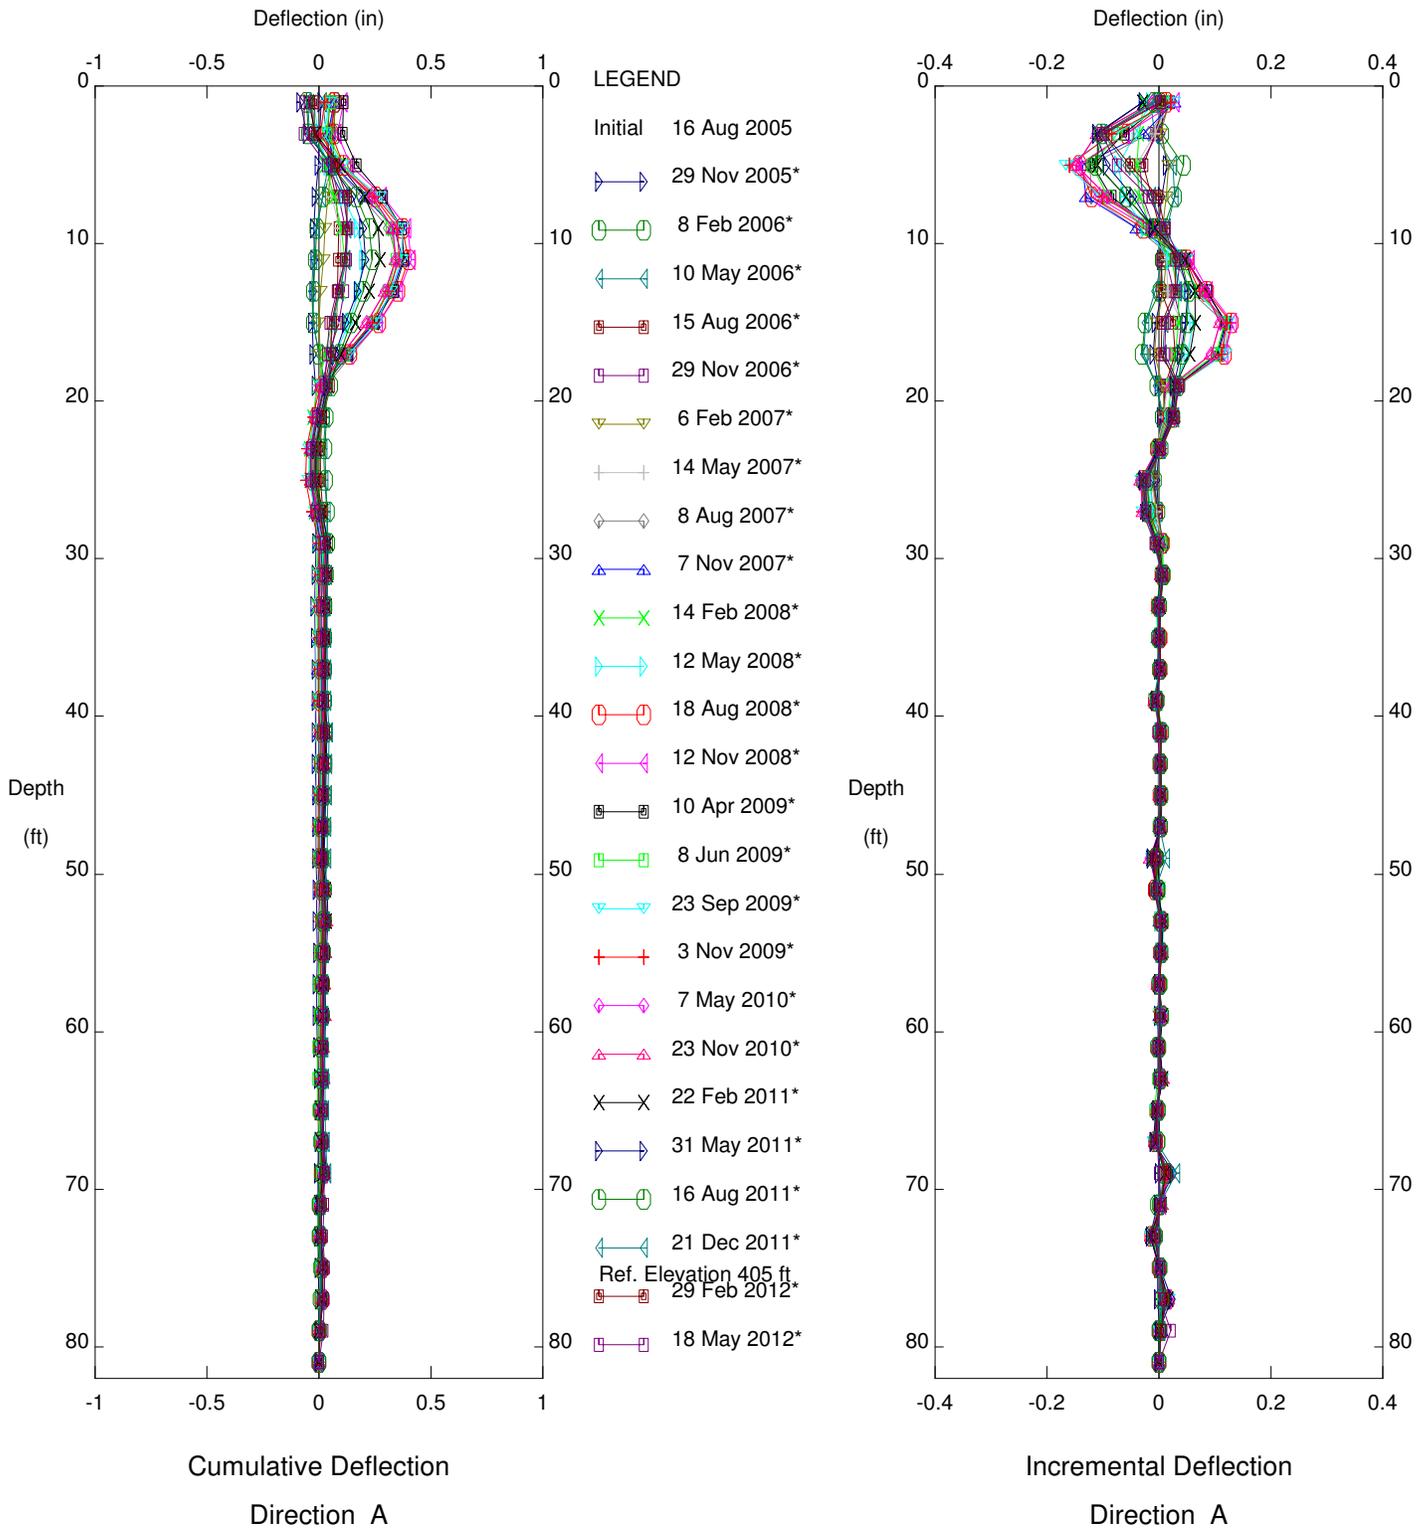
CALLE DEL BARCO, Inclinometer SI-13

SI-13 (located on Rambla Pacifico above and outside the deep landslide) continues to show a variable pattern of compression in the upper 30 feet. However, no significant observable lateral displacement has been associated with this compression. If it appears that lateral movement is occurring, or distress is observed outside the current defined limits of the deep slide, the City may wish to consider replacing the inclinometer or adding other types of monitoring observations in order to monitor or characterize conditions in that area.
