Subject: Phase I Environmental Site Assessment, 24200 Pacific Coast Highway,  
Malibu, Los Angeles County, California

PHASE I ENVIRONMENTAL SITE ASSESSMENT  
24200 PACIFIC COAST HIGHWAY  
MALIBU  
LOS ANGELES COUNTY, CALIFORNIA

Project No. 031793-017

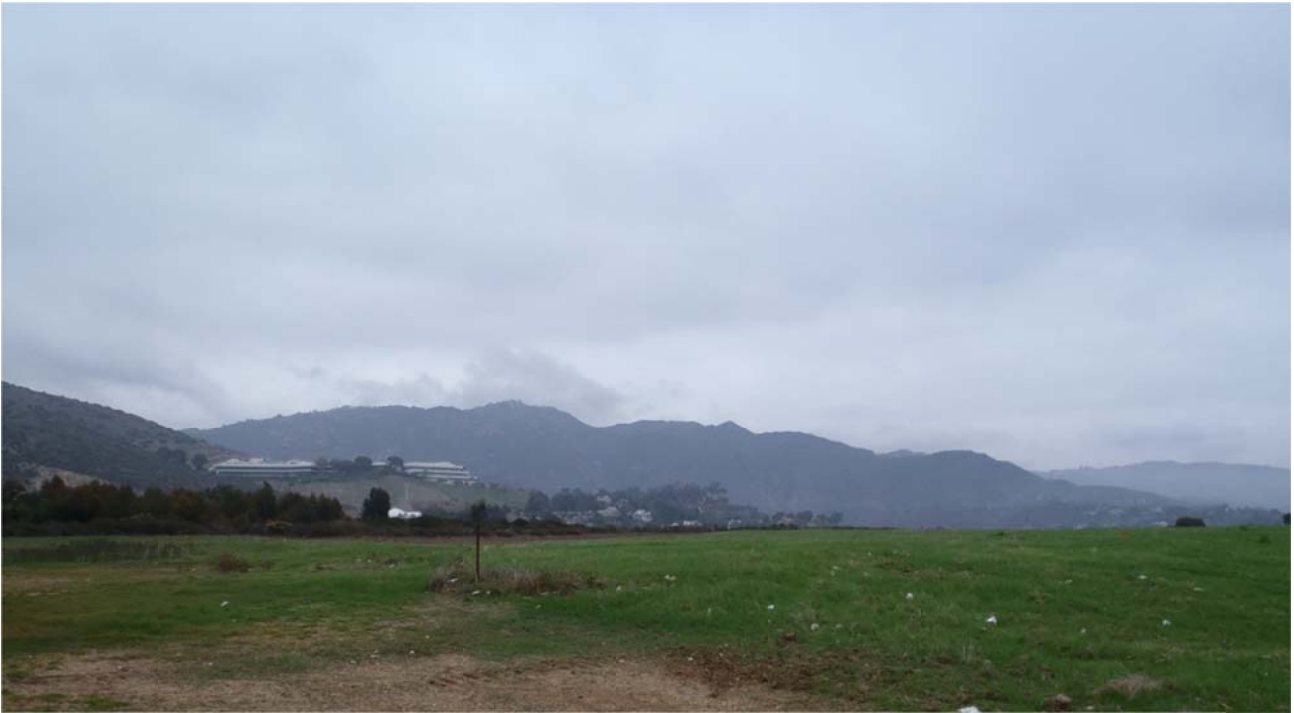
### **PHOTO NO. 1:**

The subject site is currently 24.31 acres of vacant, undeveloped land (Photos 1 through 4, Appendix B).

*East facing view from subject site entrance.*

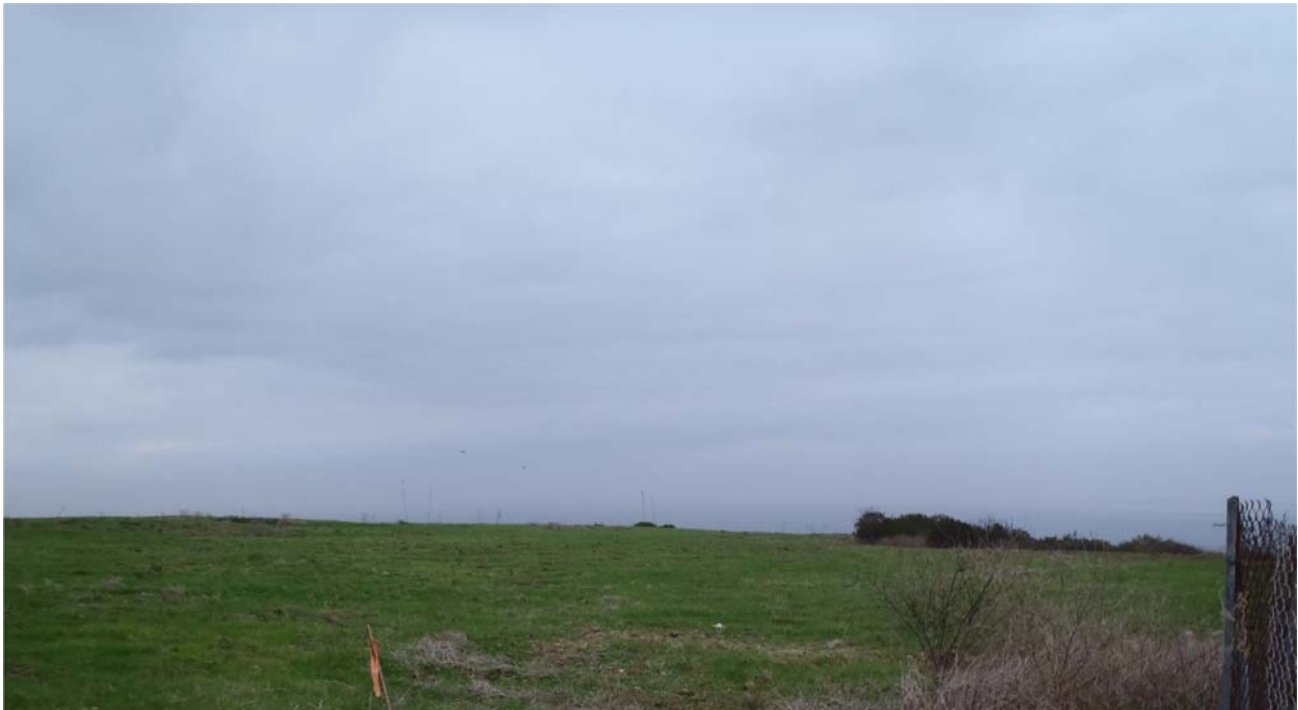
### **PHOTO NO. 2:**

*South facing view from subject site entrance.*

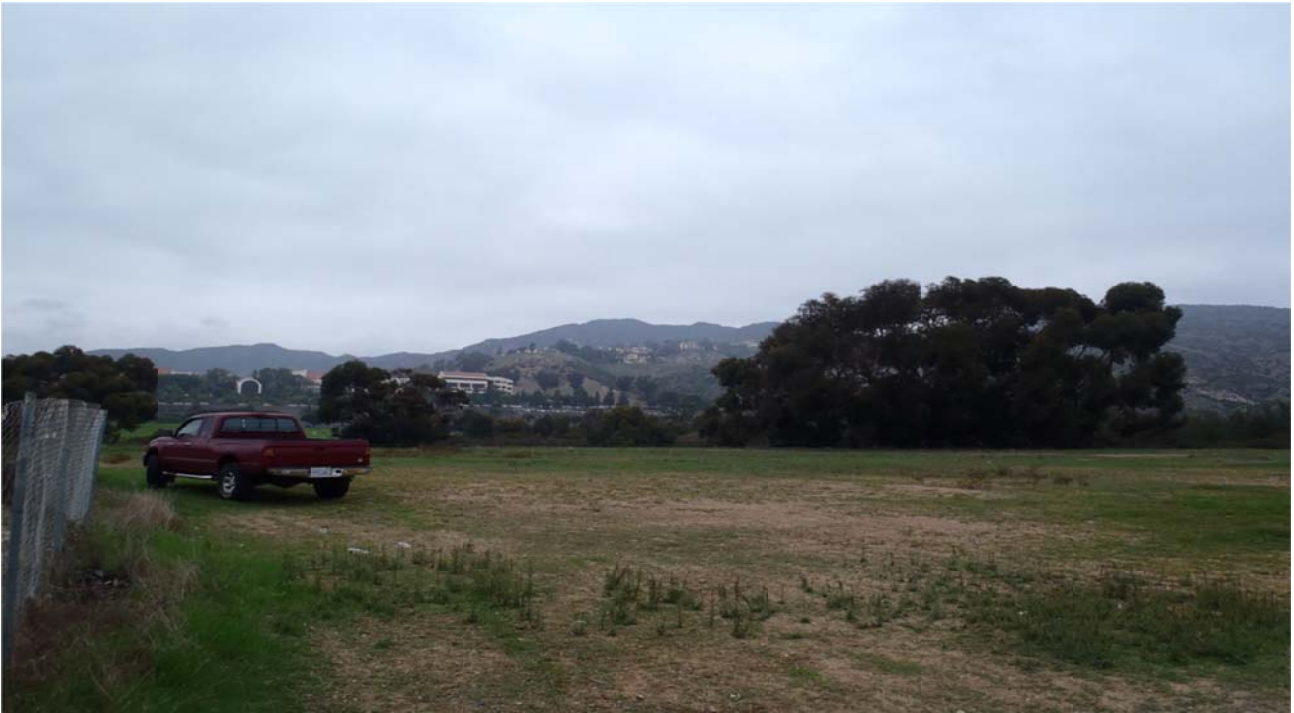
### **PHOTO NO. 3:**

*North facing view from subject site entrance.*

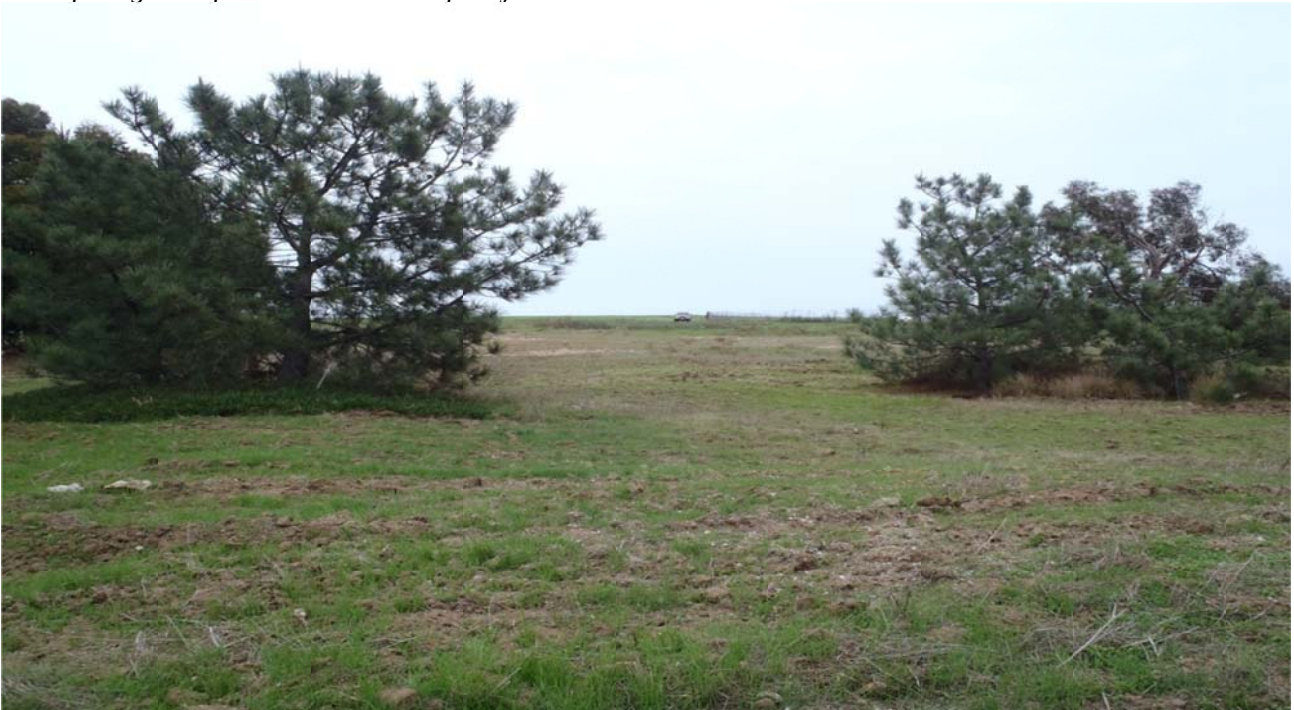
### **PHOTO NO. 4:**

*South facing view from north corner of subject site.*

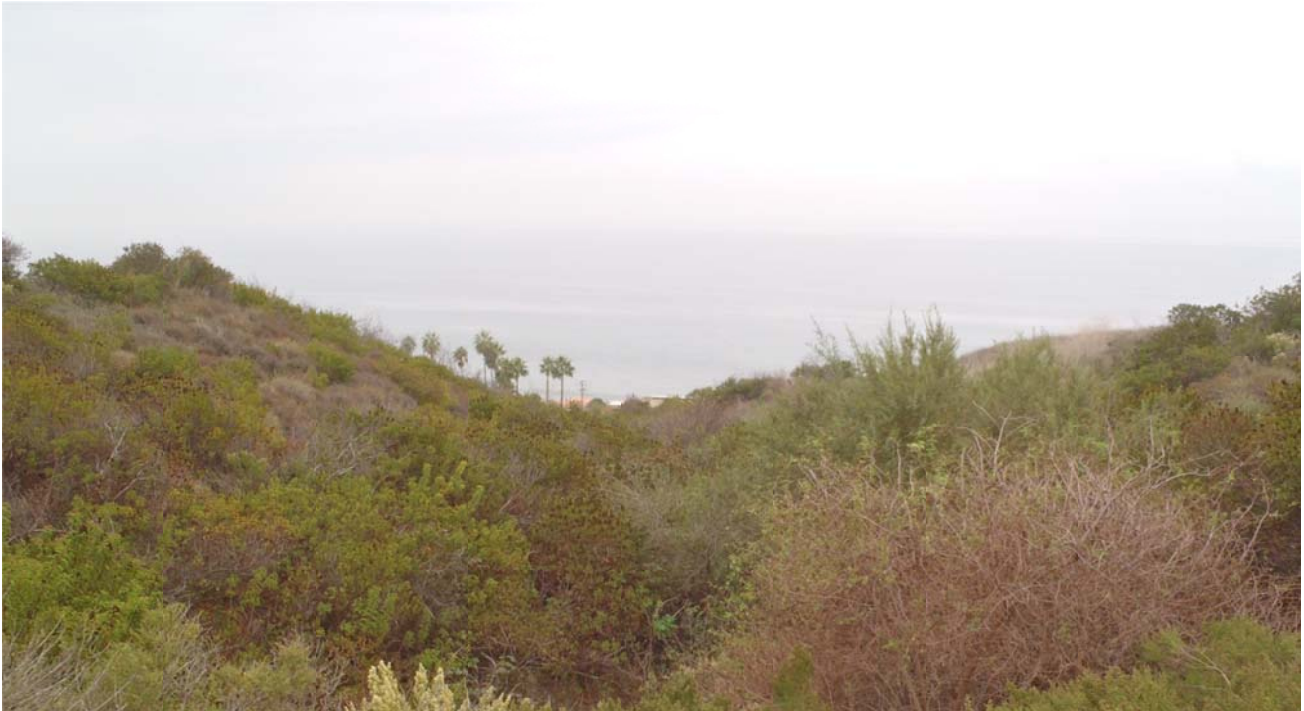
### PHOTO NO. 5:

There are currently no structures or roads on the subject site. A small dirt path follows the perimeter of the subject site. The subject site has been cleared of most vegetation, although the slopes to the north, east, and south remain heavily vegetated with thick brush (Photos 5 and 6, Appendix B). A low lying area extends from the center of the site to the southern boundary (Photo 7, Appendix B) and is also heavily vegetated with low-lying brush and trees.

*South facing view down slope from southern boundary*

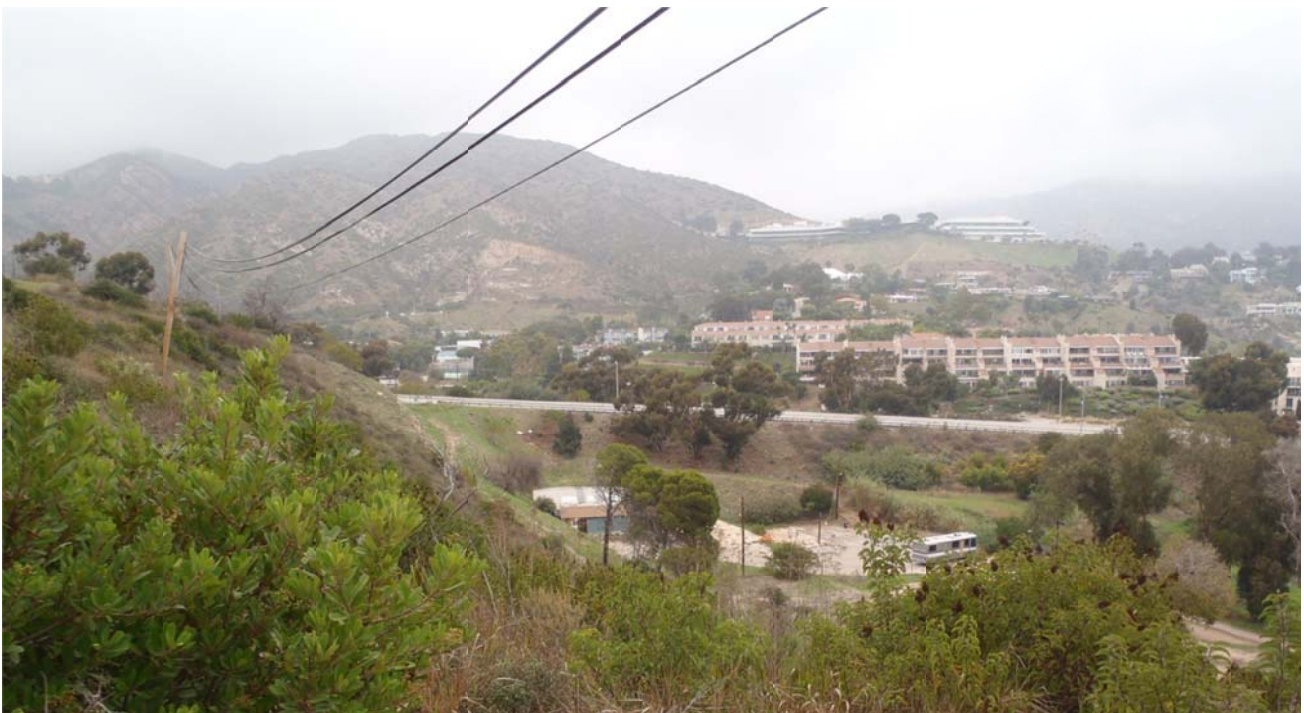
### PHOTO NO. 6:

Residential single-family use properties were observed to the south of the subject site along Malibu Road. An abandoned residence was observed to the east of the subject site (Photo 6, Appendix B). Malibu Bluffs Park borders the subject site to the west (Photo 8, Appendix B). The Pacific Coast Highway is located to the north, followed by Pepperdine University.

*North-east facing view of eastern site boundary and abandoned adjoining property (23913 ½ Malibu Road).*

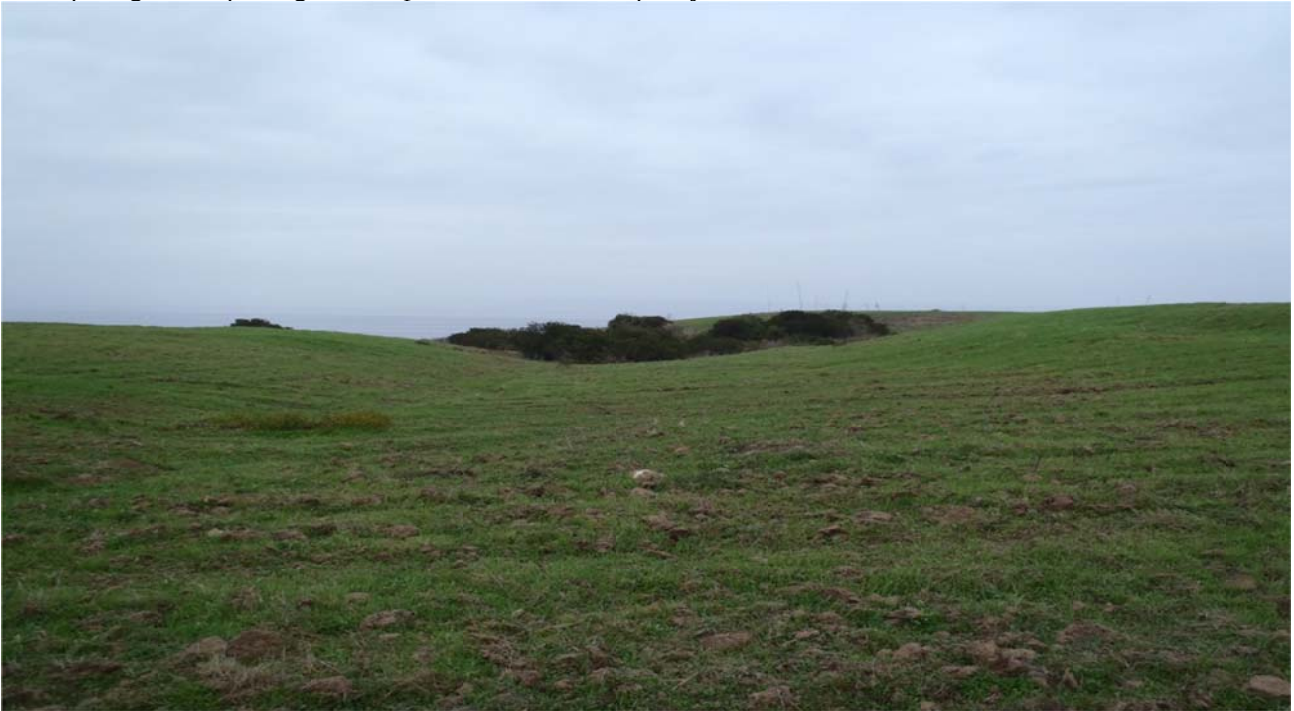
### **PHOTO NO. 7:**

Historically, the subject site has been vacant, undeveloped land. In a 1994 aerial photograph, a baseball diamond was observed in the northwestern portion of the subject site. Currently, the subject site is currently 24.31 acres of vacant, undeveloped land (Photos 1 through 4, Appendix B). There are currently no structures or roads on the subject site. A small dirt path follows the perimeter of the subject site. The subject site has been cleared of most vegetation, although the slopes to the north, east, and south remain heavily vegetated with thick brush (Photos 5 and 6, Appendix B). A low lying area extends from the center of the site to the southern boundary (Photo 7, Appendix B) and is also heavily vegetated with low-lying brush and trees.

*South facing view of overgrown depression in center of subject site.*

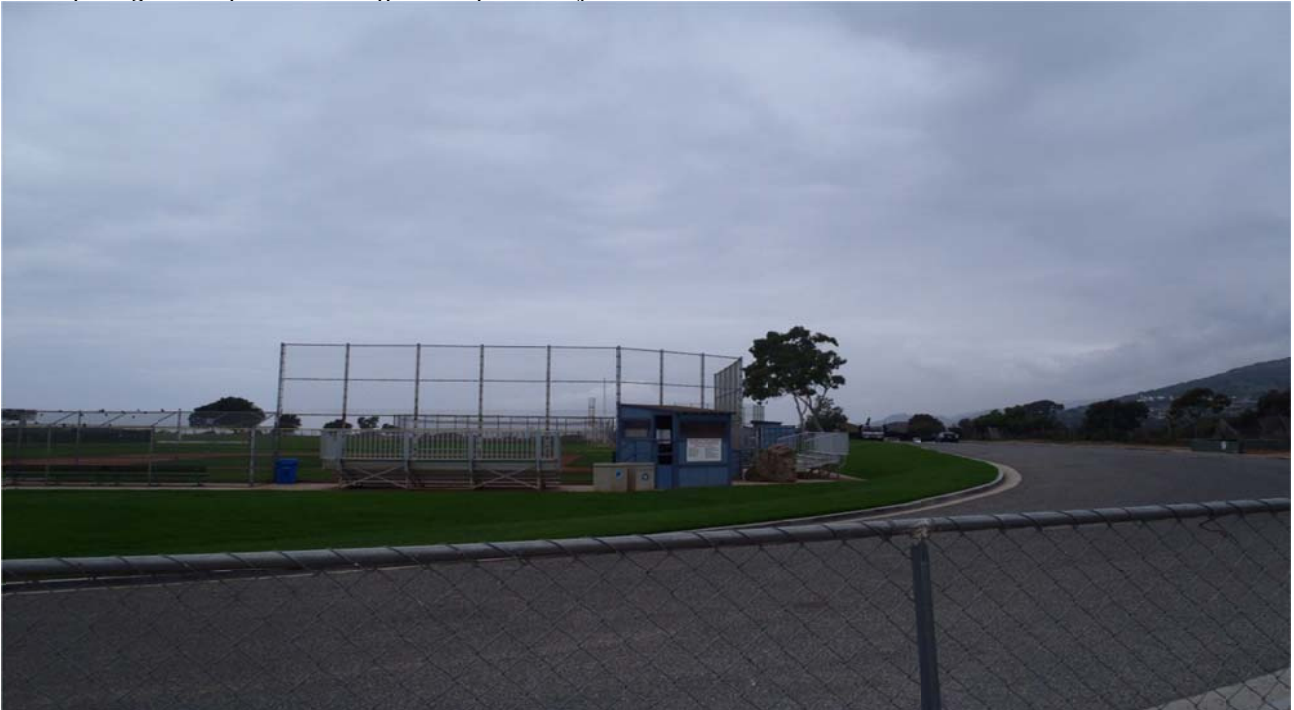
### **PHOTO NO. 8:**

*North facing view of Malibu Bluffs Park from subject site entrance.*

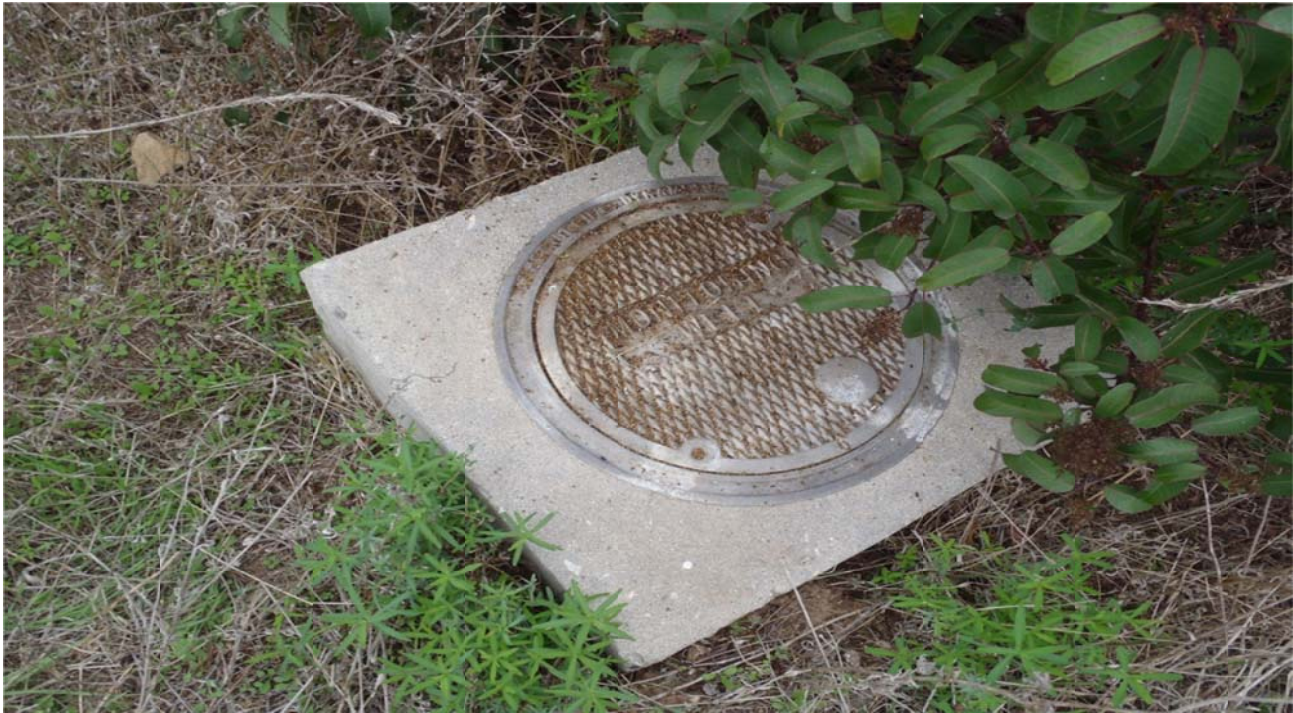
### PHOTO NO. 9:

Several monitoring wells were observed on the subject site (Photos 9 and 10, Appendix B). These monitoring wells were installed to assist in the geotechnical evaluation of the proposed onsite wastewater treatment system (Leighton, 2009a).

*Unmarked monitoring well near southern boundary of subject site.*

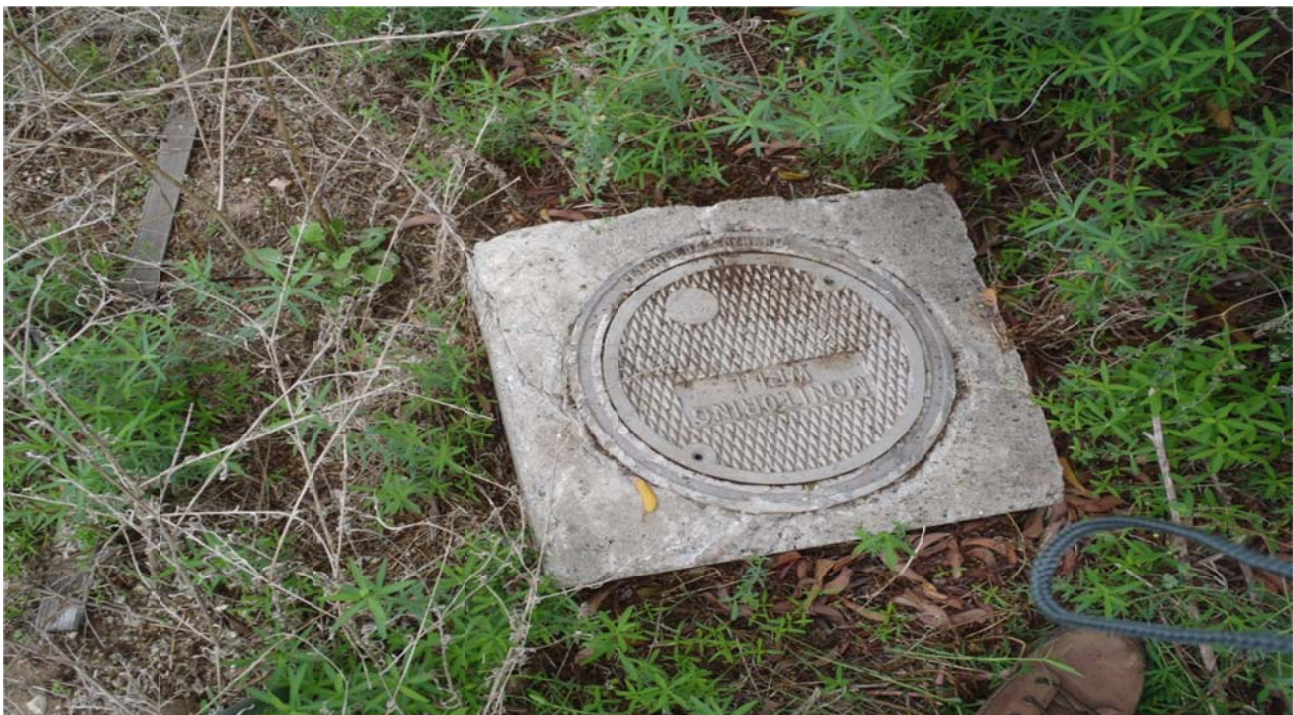
### PHOTO NO. 10:

*Unmarked monitoring well near southeastern boundary of subject site.*

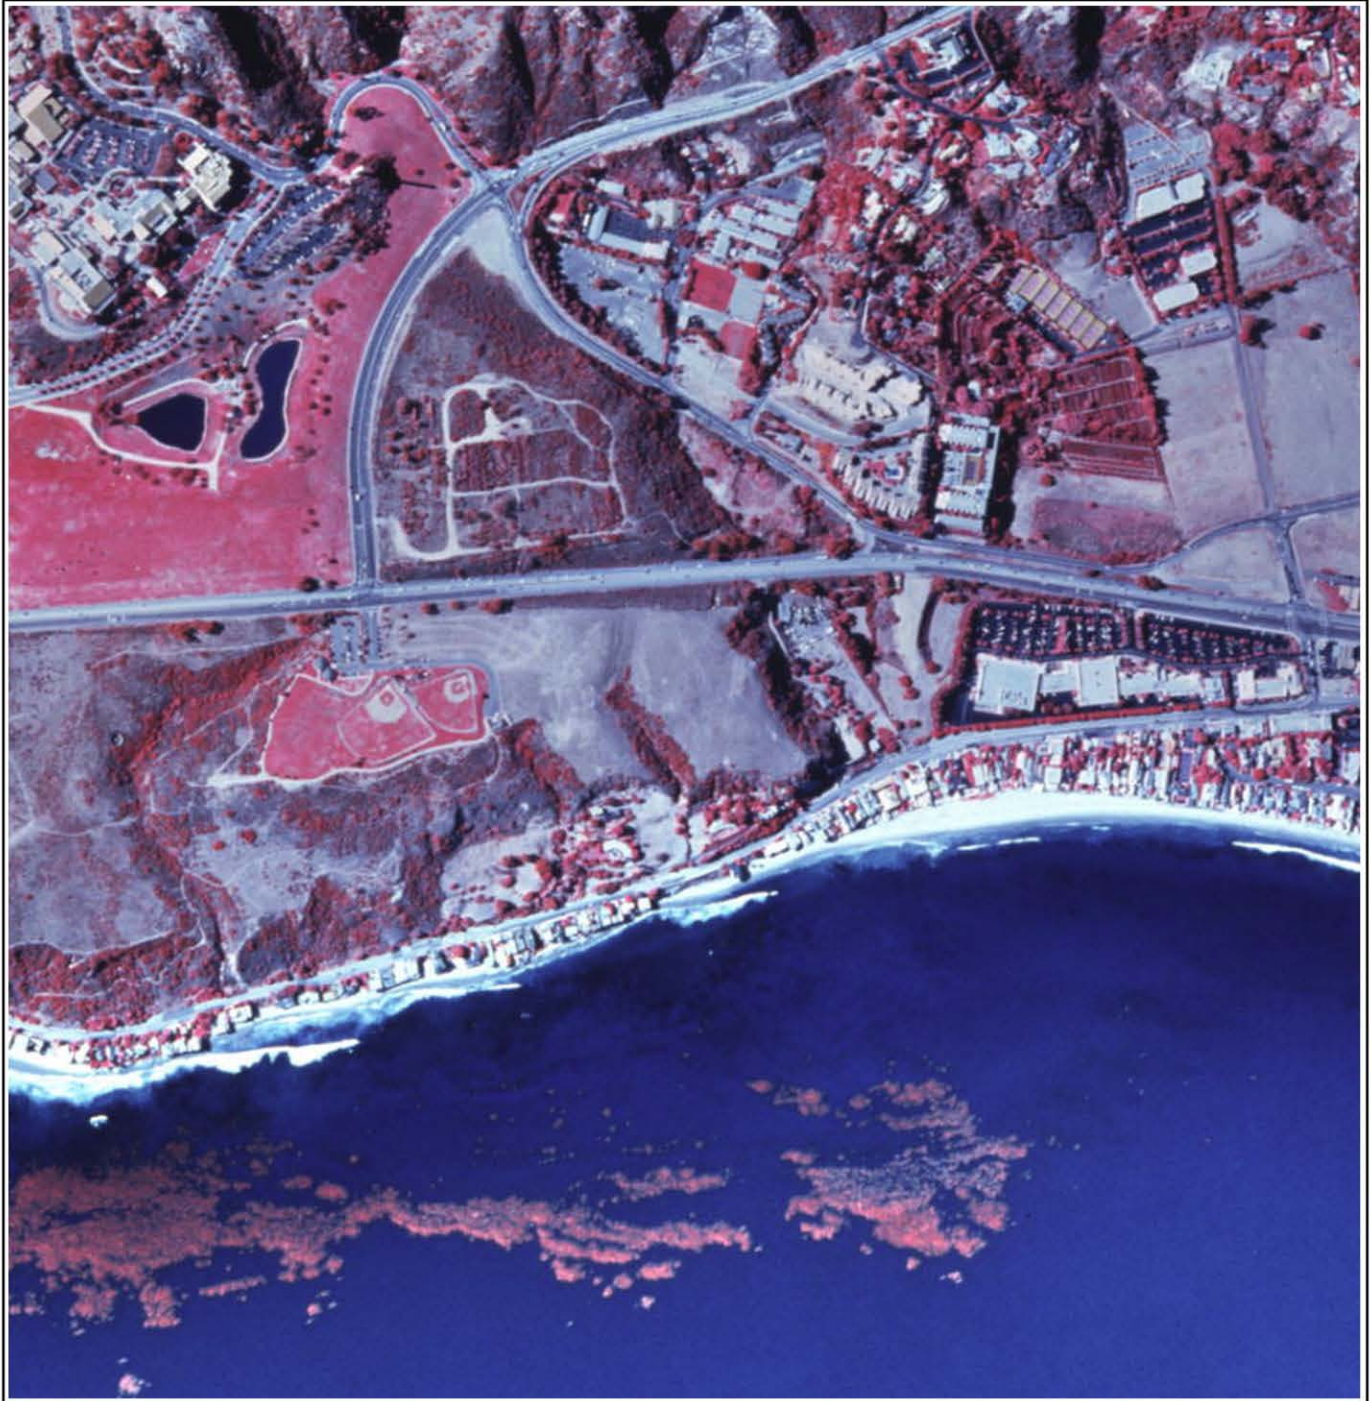
2002

In the **2002** aerial photograph, two significant changes were observed. The baseball diamond was no longer visible on the subject site and additional structures have been constructed to the east of the subject site.

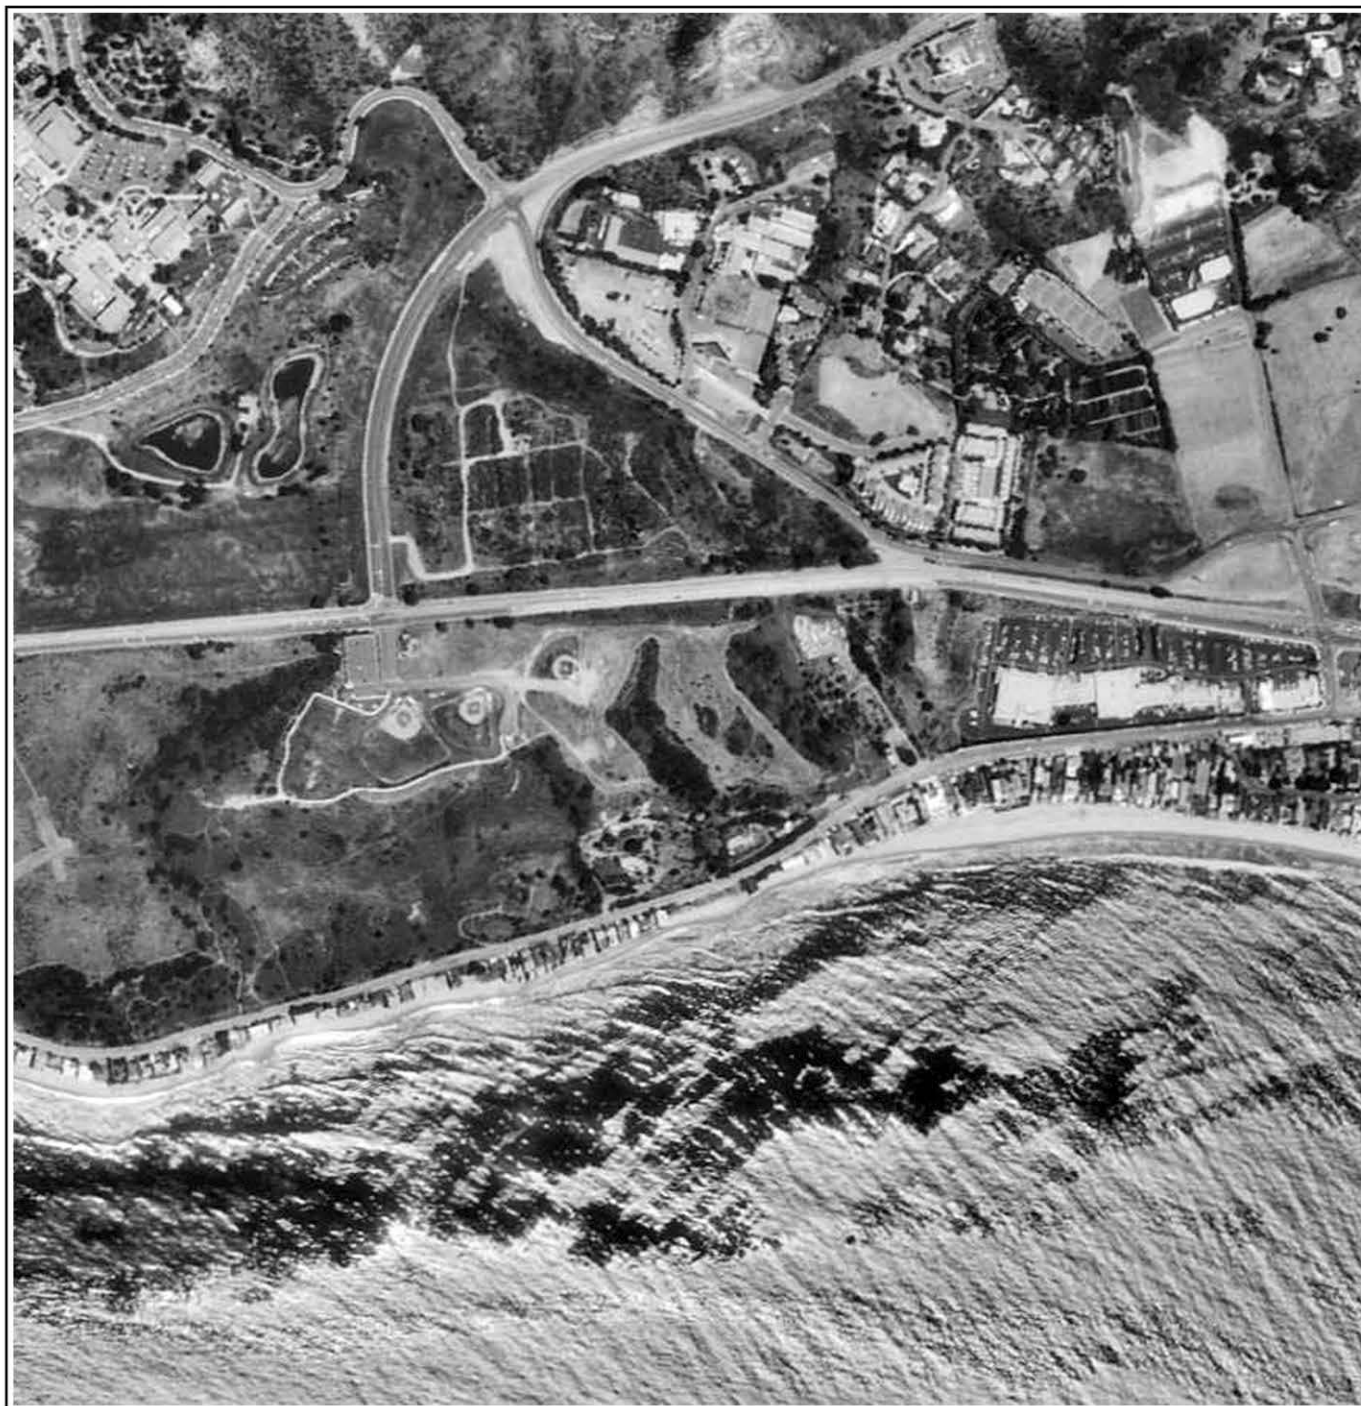
1994

In the **1994** aerial photograph, a baseball diamond is observed on the northwest portion of the subject site. The reminder of the subject site is observed to be vacant land. Additional baseball diamonds and vacant land are observed to the west of the subject site. The adjacent property to the north (north of Pacific Coast Highway) was observed to be parceled into square parcels (as observed in the 1968 aerial photograph) by dirt roads; however was still vacant land. Adjacent to the south are residential structures and Malibu Road. Residential structures and vacant land were observed to the east of the subject site.

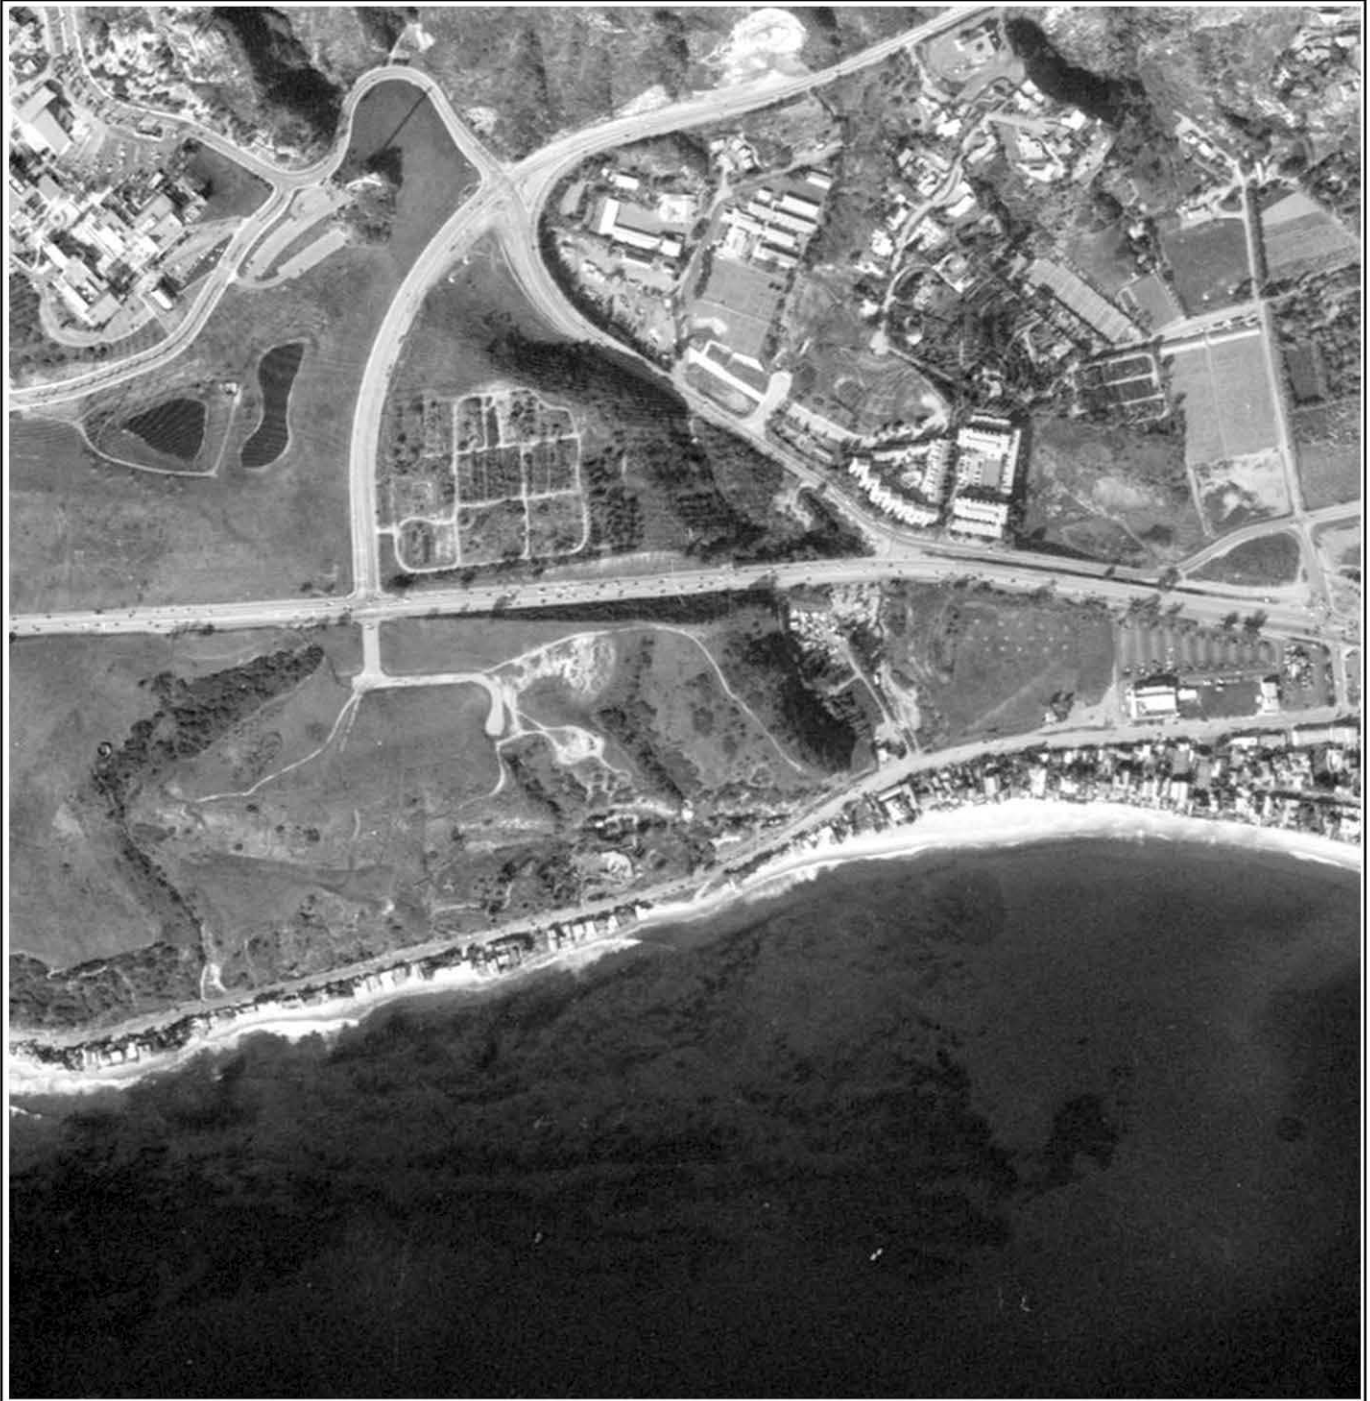
1982

In the **1982** aerial photograph, no significant changes were observed the subject site or adjacent properties.

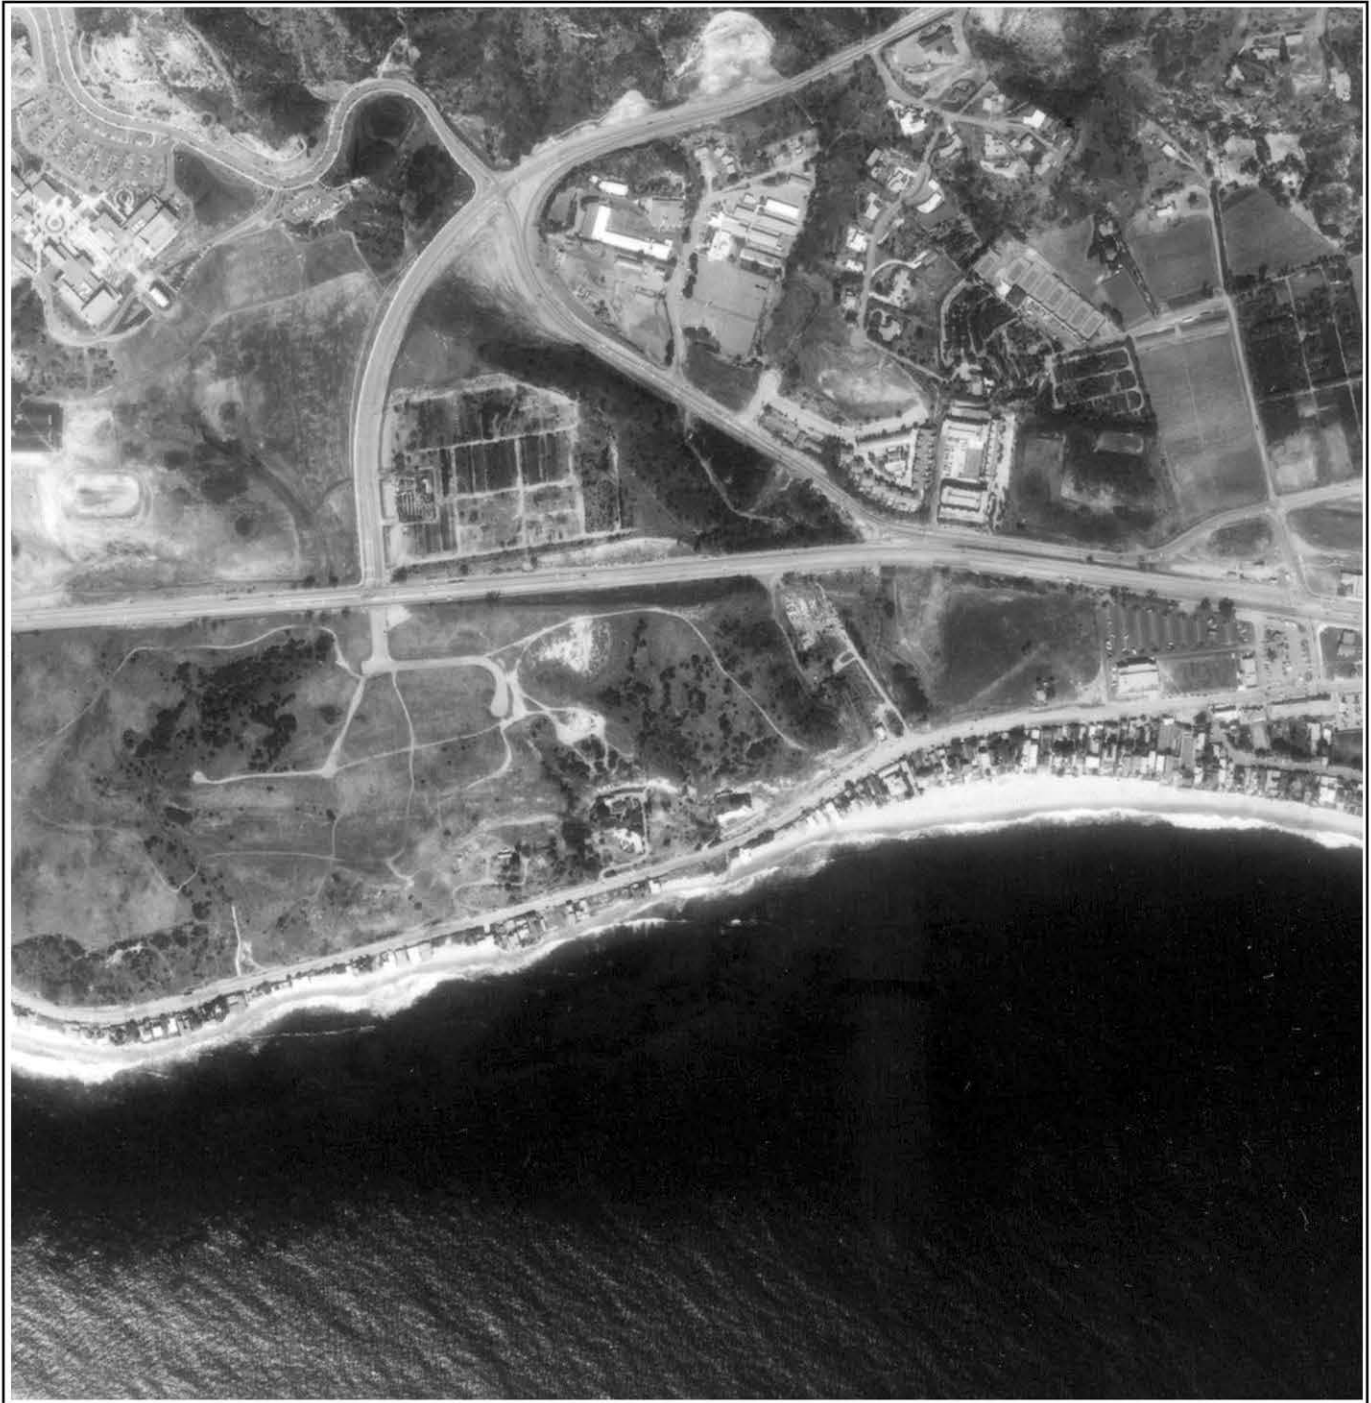
1976

In the **1976** aerial photograph, two significant changes are observed on the subject site. The orchards are no longer observed to the east of the subject site and Malibu Canyon Road has now been constructed to the northeast of the subject site.

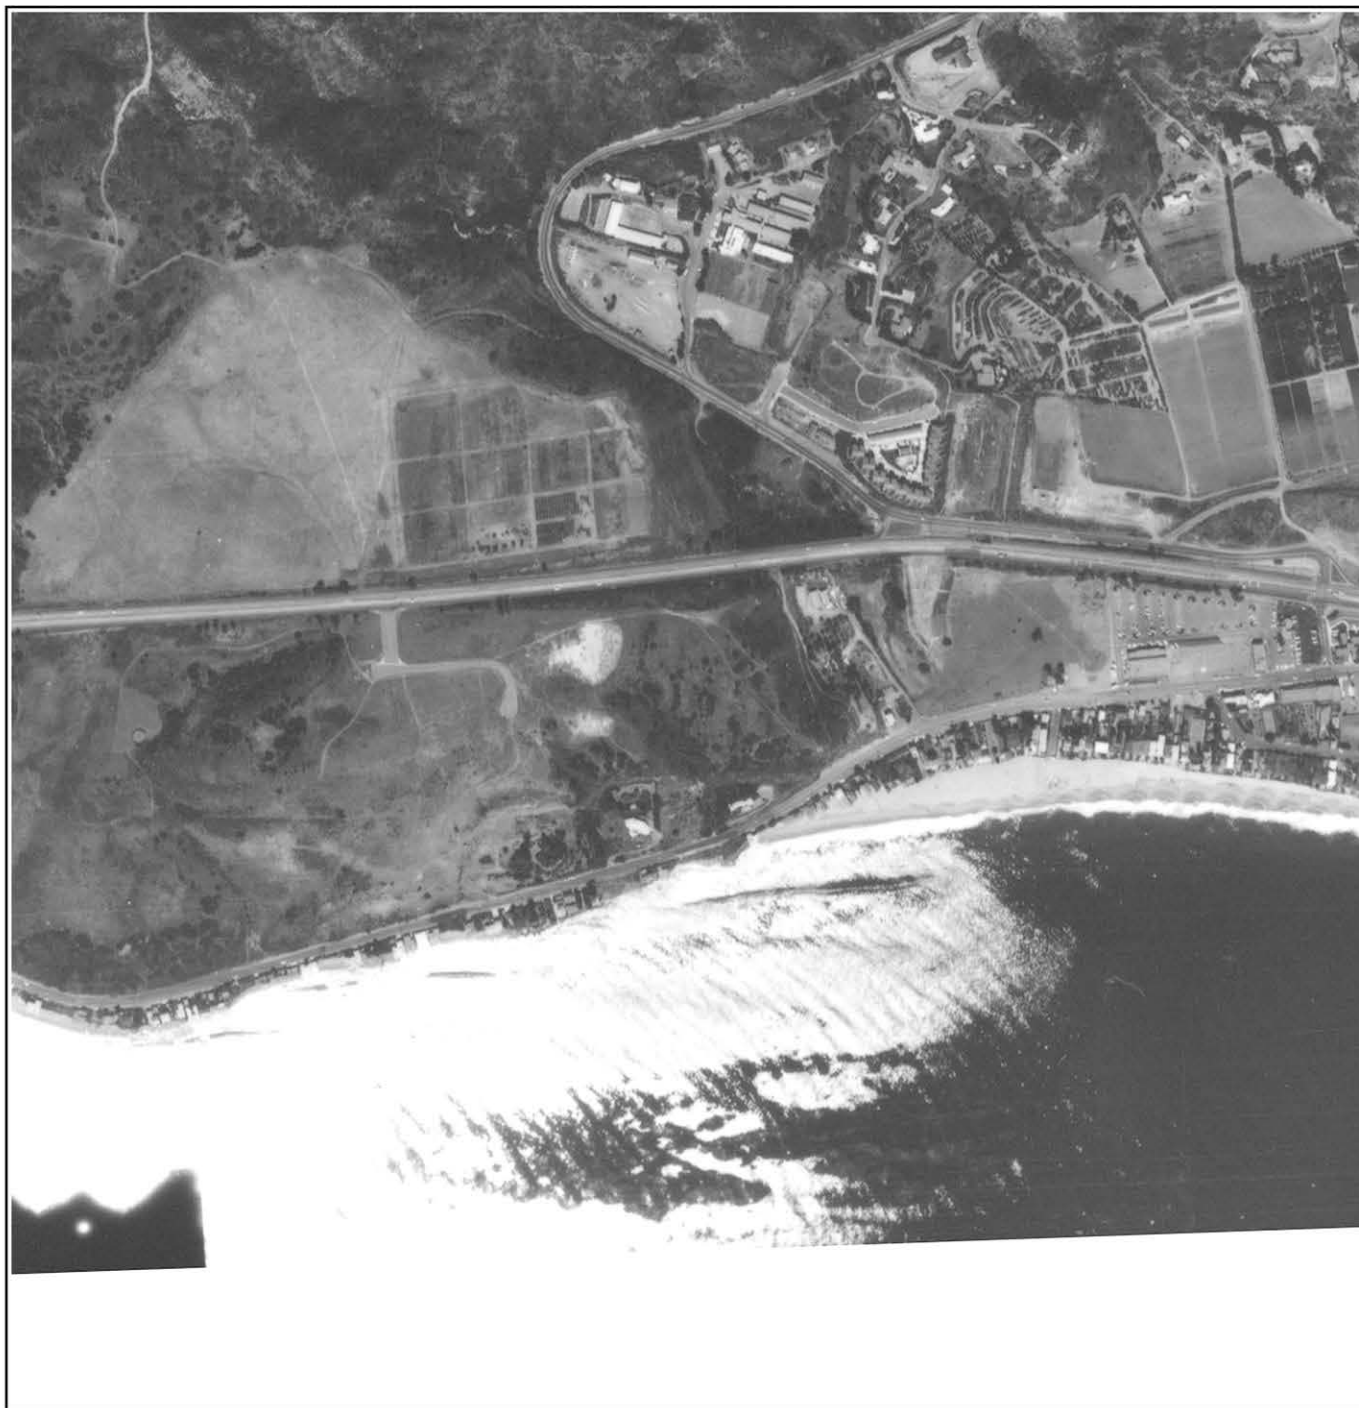
1968

In the **1968** aerial photograph, two significant changes are observed. The adjacent property to the north (north of Pacific Coast Highway) was observed to be parceled into square parcels by dirt roads and Winter Mesa Drive has been constructed to the west of the subject site.

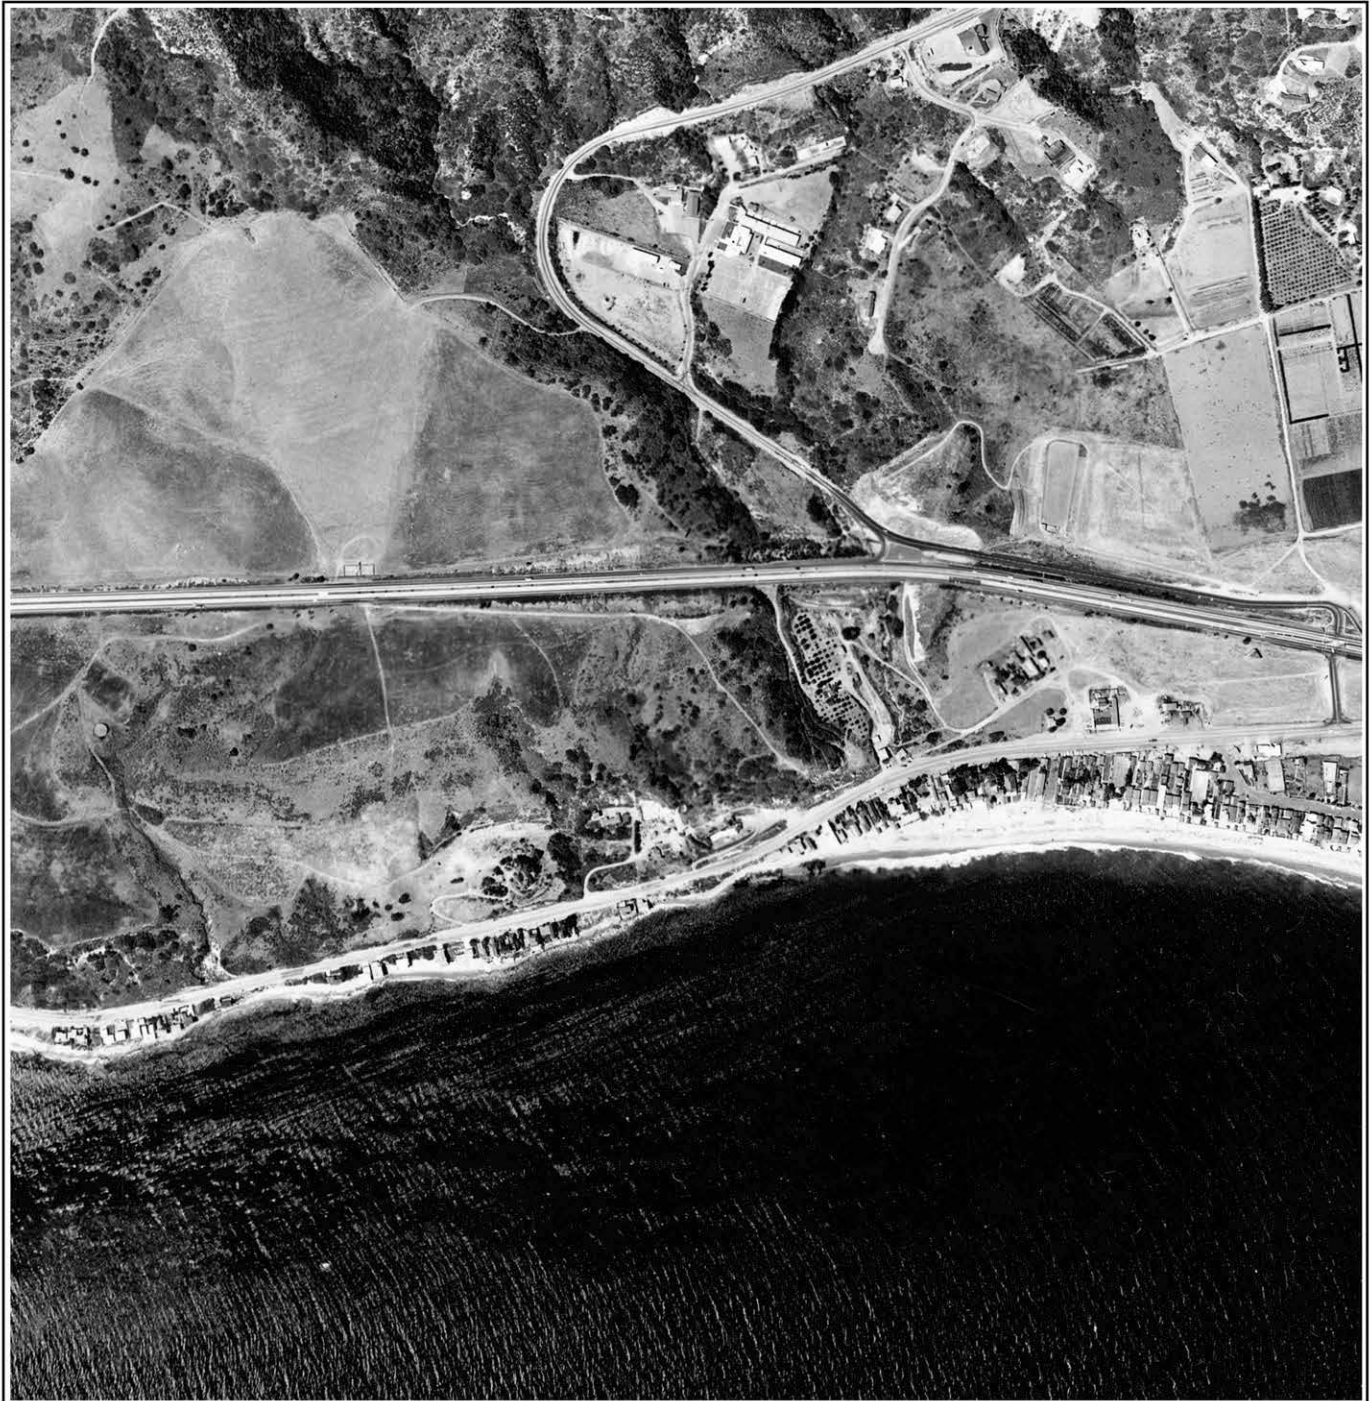
1956

In the **1956** aerial photograph, the subject site and adjacent properties to the north and west are observed to be vacant undeveloped land. Pacific Coast Highway is observed to the north of the subject site. Remnants of an orchard and small residential structures are observed to the east of the subject site. Residential structures and a road are observed to the south of the subject site.
