Subject: Phase I Environmental Site Assessment, 24200 Pacific Coast Highway,  
Malibu, Los Angeles County, California

PHASE I ENVIRONMENTAL SITE ASSESSMENT  
24200 PACIFIC COAST HIGHWAY  
MALIBU  
LOS ANGELES COUNTY, CALIFORNIA

Project No. 031793-017

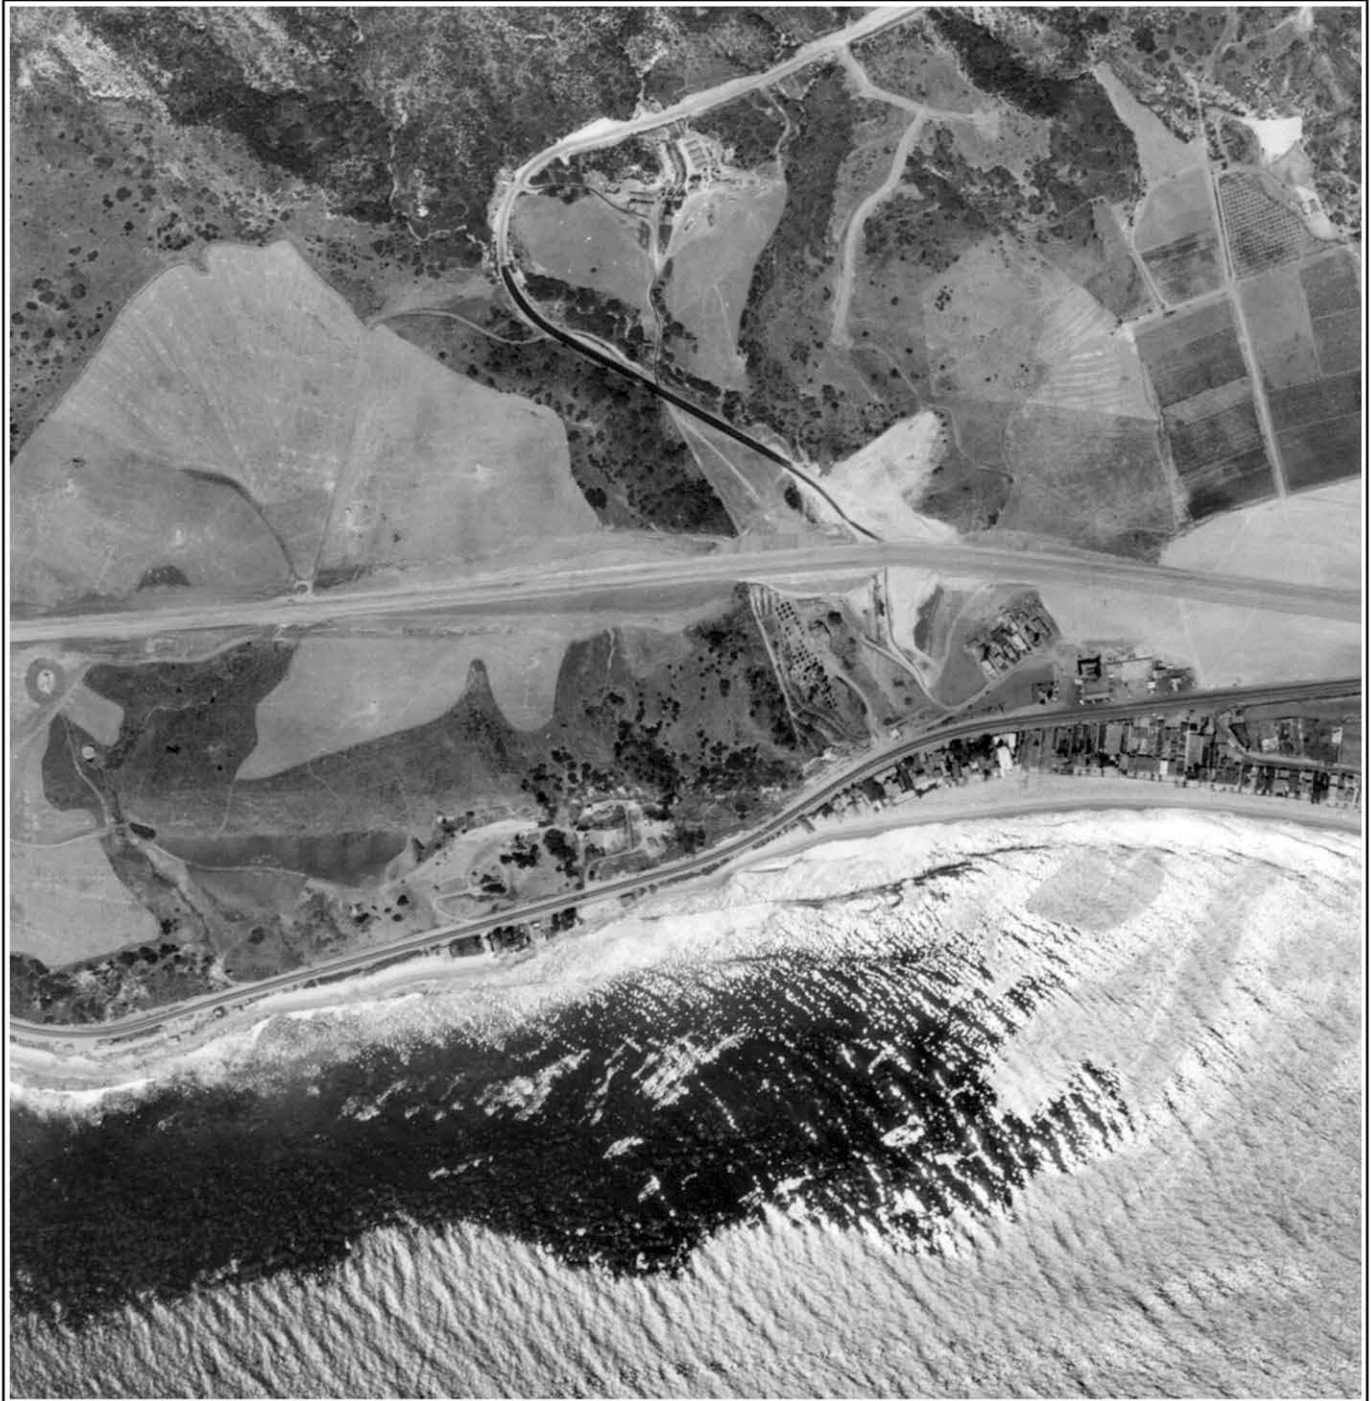
1947

In the **1947** aerial photograph, the subject site and adjacent properties to the north and west are observed to be vacant undeveloped land. The northern portion of the site is observed to have been cleared of vegetation. Pacific Coast Highway is observed in development to the north of the subject site. Remnants of an orchard are observed to the east of the subject site. Residential structures and a road are observed to the south of the subject site.

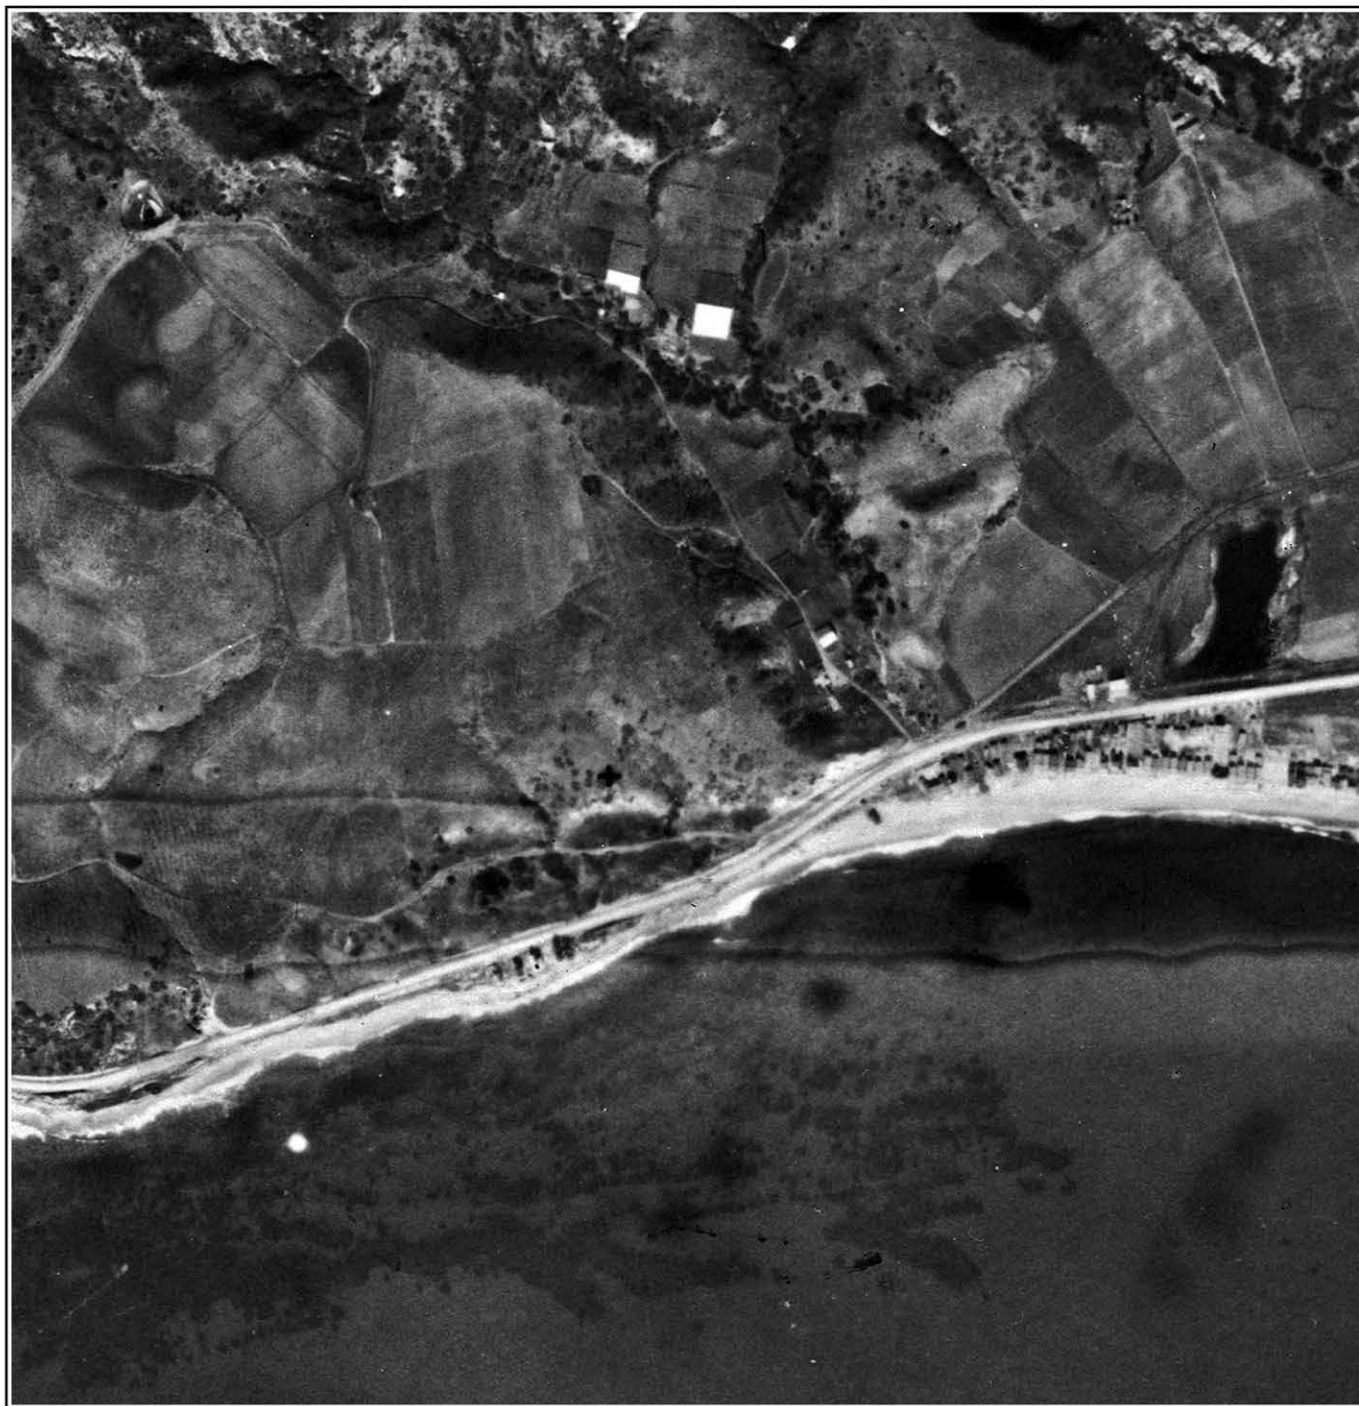
1928

In the **1928** aerial photograph, the subject site and adjacent properties to the north and west are observed to be vacant undeveloped land. Vacant land and small residential structures are observed to the west of the subject site. Vacant land and a road are observed to the south of the subject site. Pacific Coast Highway has not been developed to north of the subject site.
