**ANNUAL REPORT
JULY 2014 THROUGH JUNE 2015
CALLE DEL BARCO
LANDSLIDE ASSESSMENT DISTRICT
MALIBU, CALIFORNIA**

Prepared for:
CITY OF MALIBU

November 2015
Fugro Project No. 04.62140605

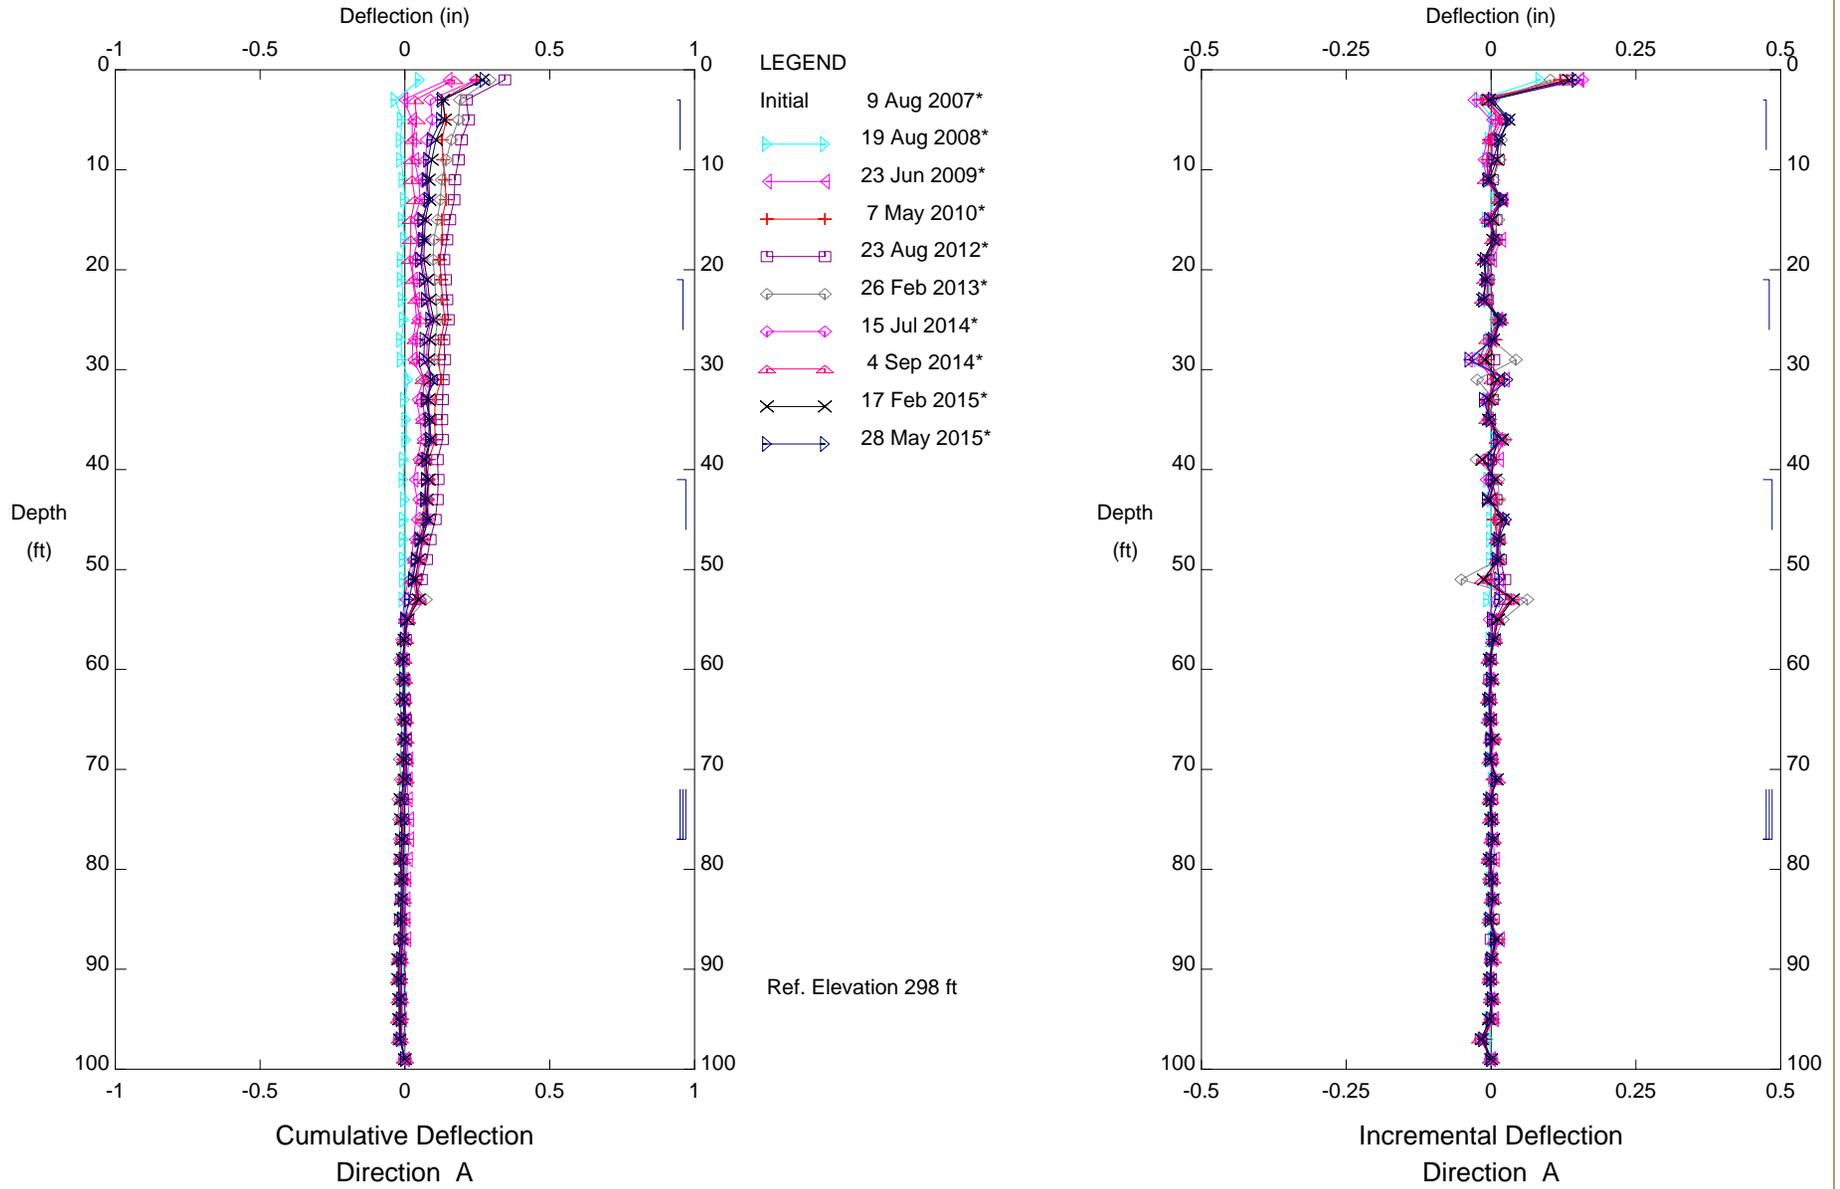
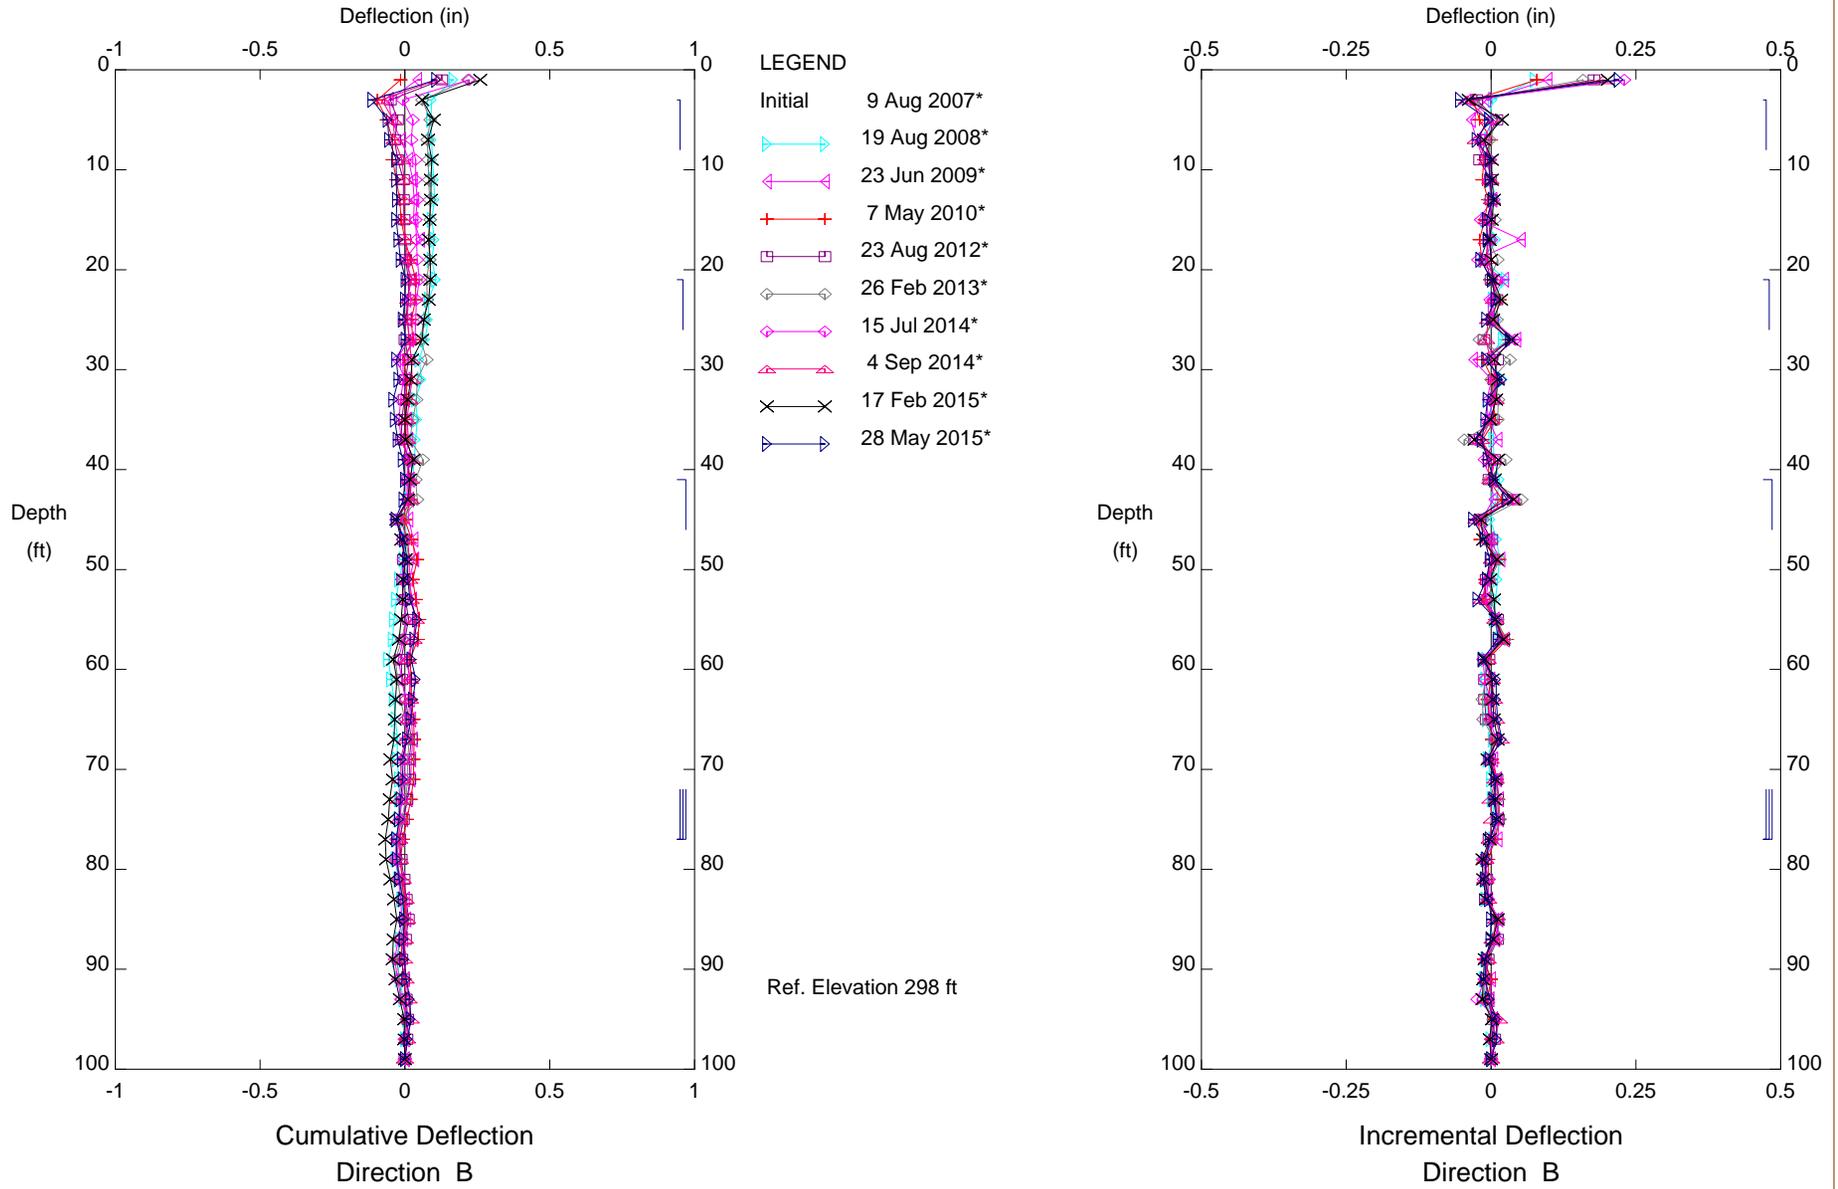
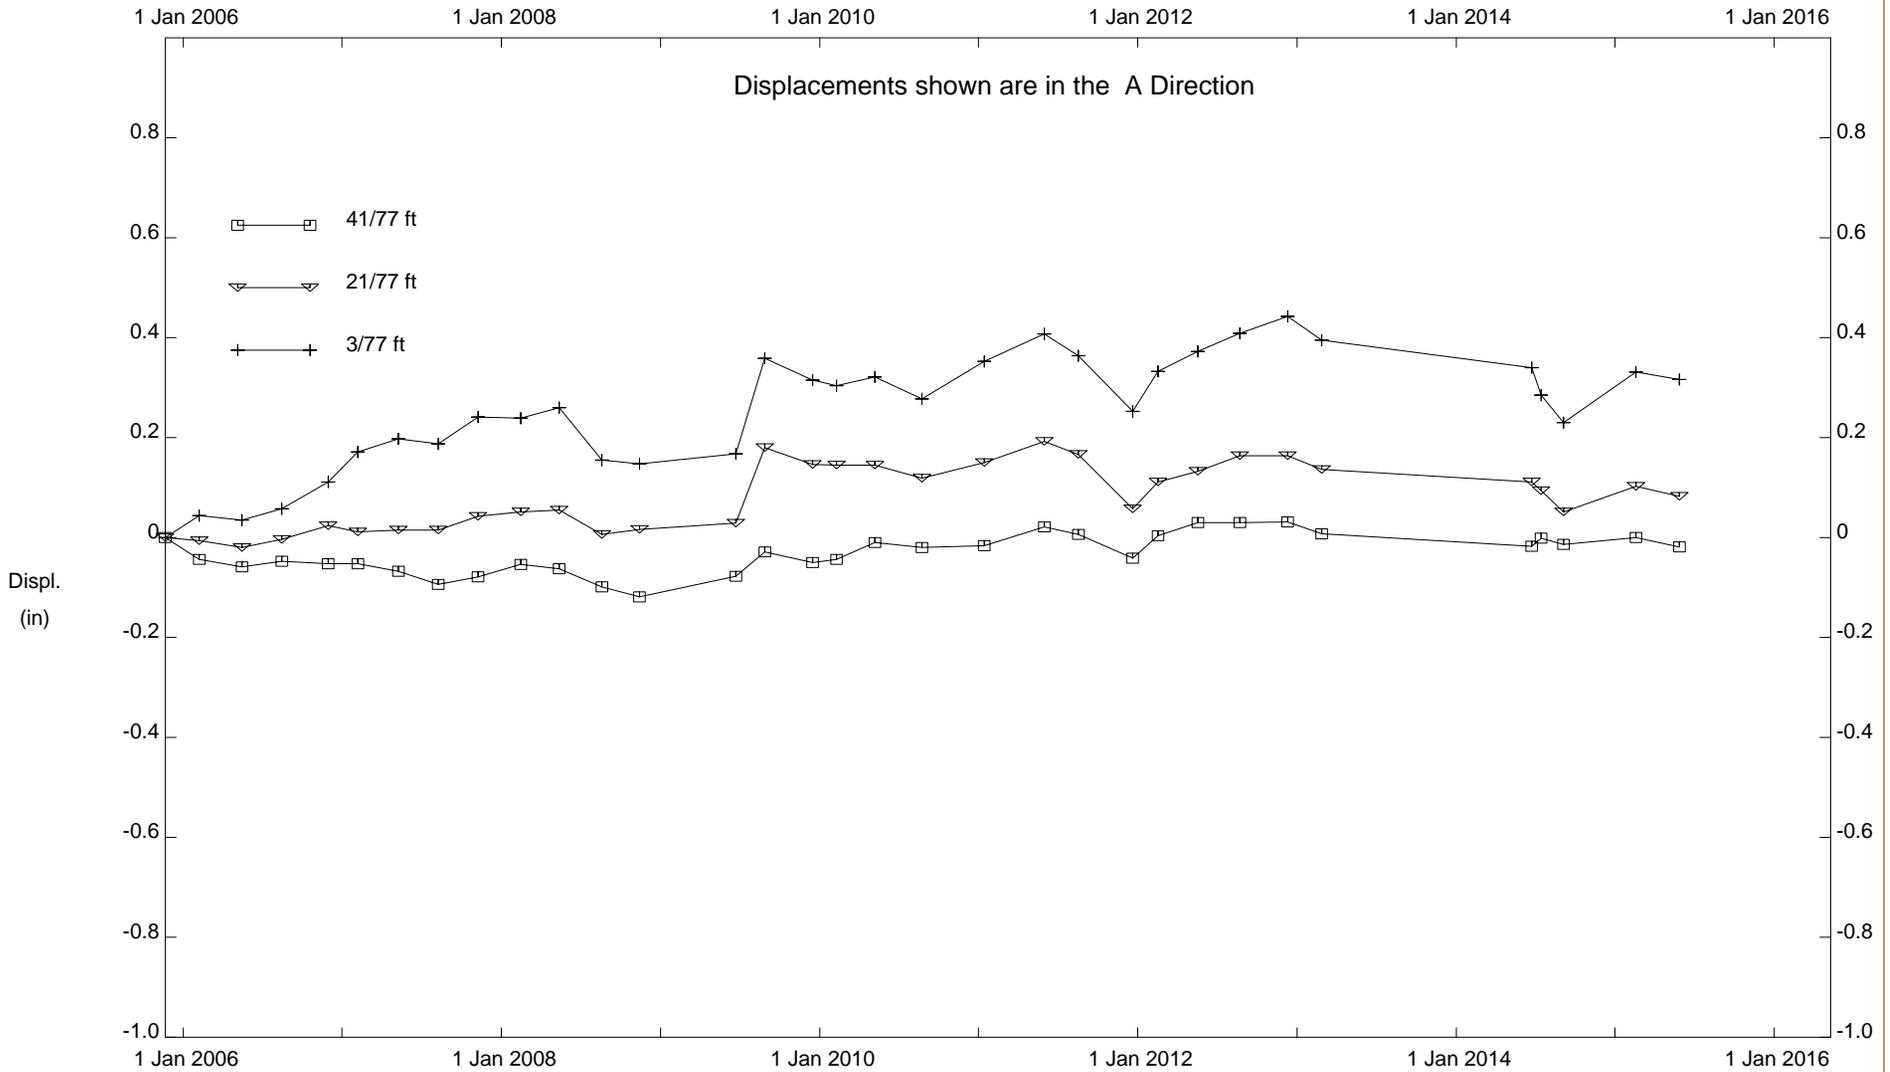
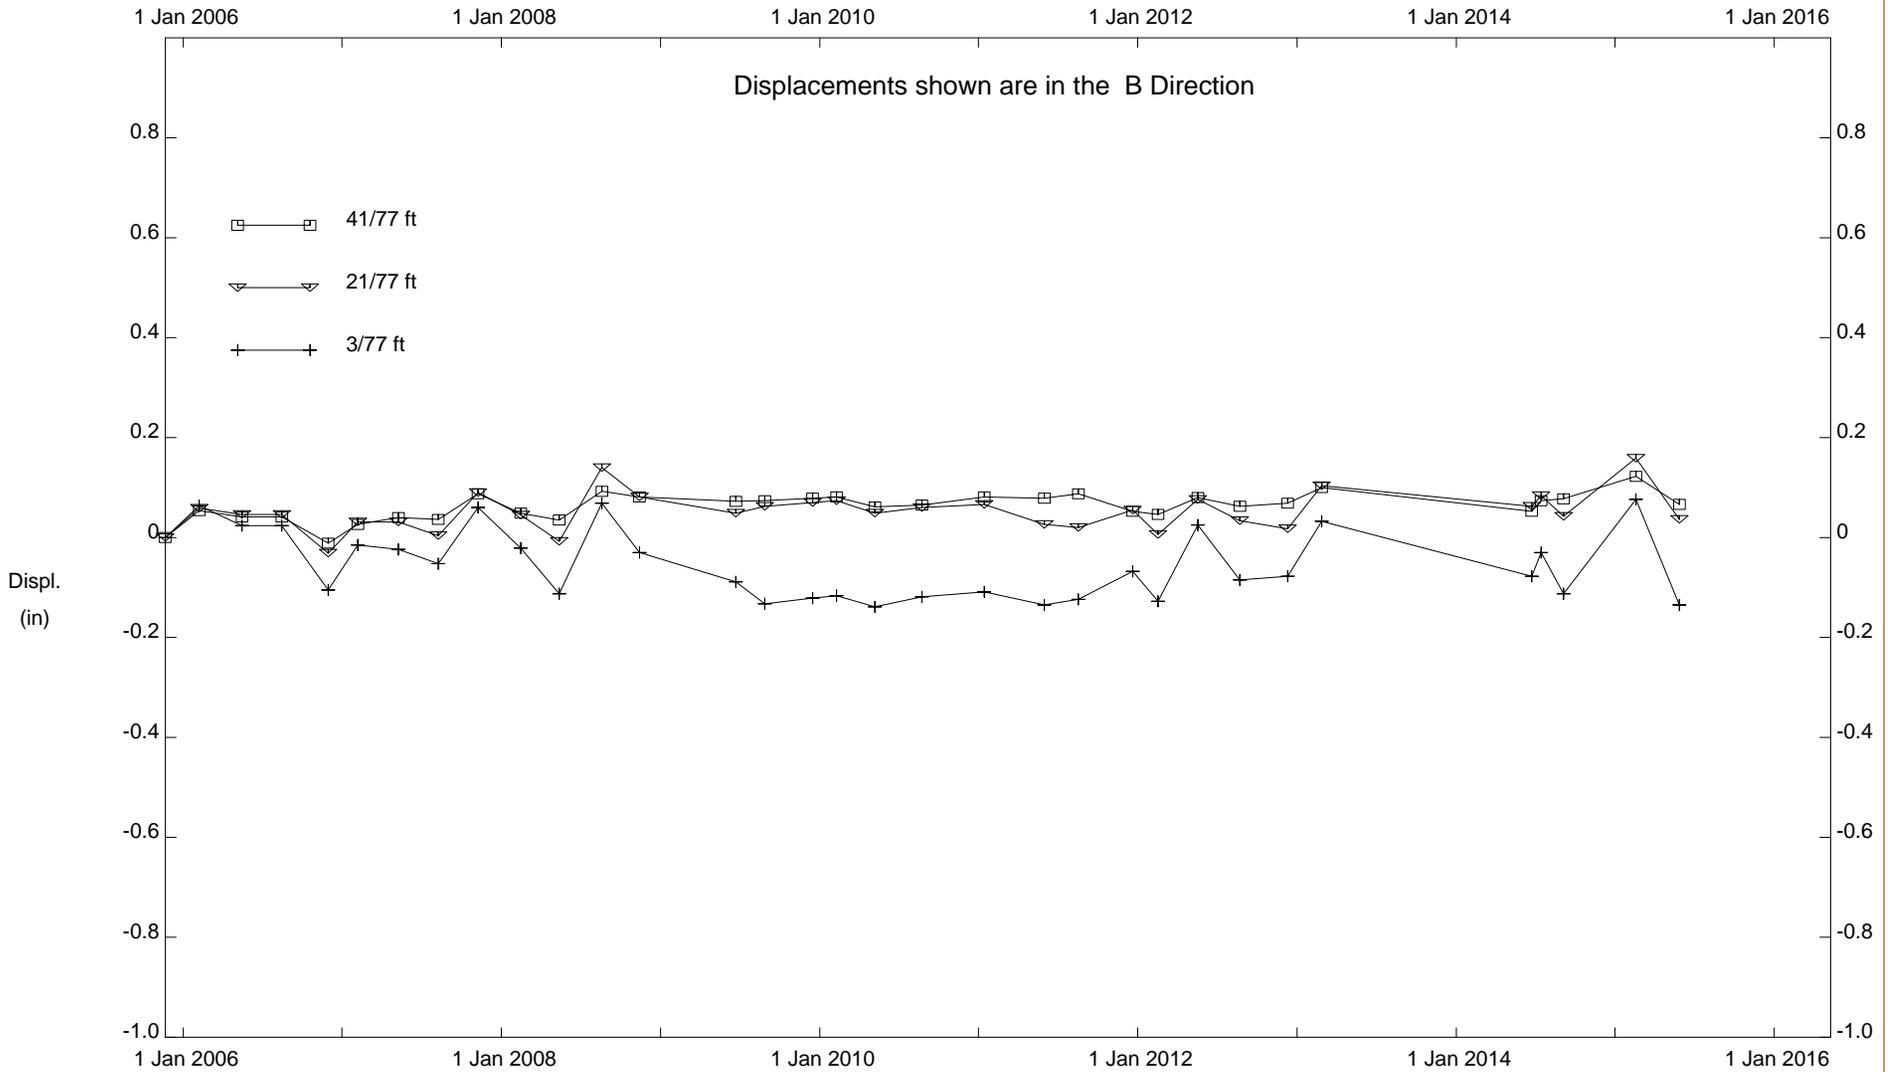
Calle del Barco, Inclinometer SI-9
 City of Malibu

Inclinometer SI-16 exhibits a pattern of movement measured at the ground surface at an average rate of up about 0.08 inches/year since 2005, resulting in approximately 0.5 inches of cumulative displacement at the ground surface since the 2004-05 monitoring period. Movement of the inclinometer appears to be both translational at specific depths between 0 to 10 feet and between 40 and 50 feet and rotational about a hinge point at about 50 feet below the ground surface. This is similar to the movement observed in inclinometer SI-9 located in close proximity to SI-16.

Although the movement observed in inclinometers SI-9 and SI-16 has not produced observed distress in pavements or other development of which Fugro is aware, the movement is nevertheless quantifiable and can be defined by a clear trend.
