## **FY22/23 Maintenance and Monitoring**

**AD98-1, Big Rock Mesa**

**City of Malibu, California**

**Subject: Annual Monitoring and Maintenance Report FY22/23, City of Malibu Assessment District 98-1, Big Rock Mesa, Malibu, CA**

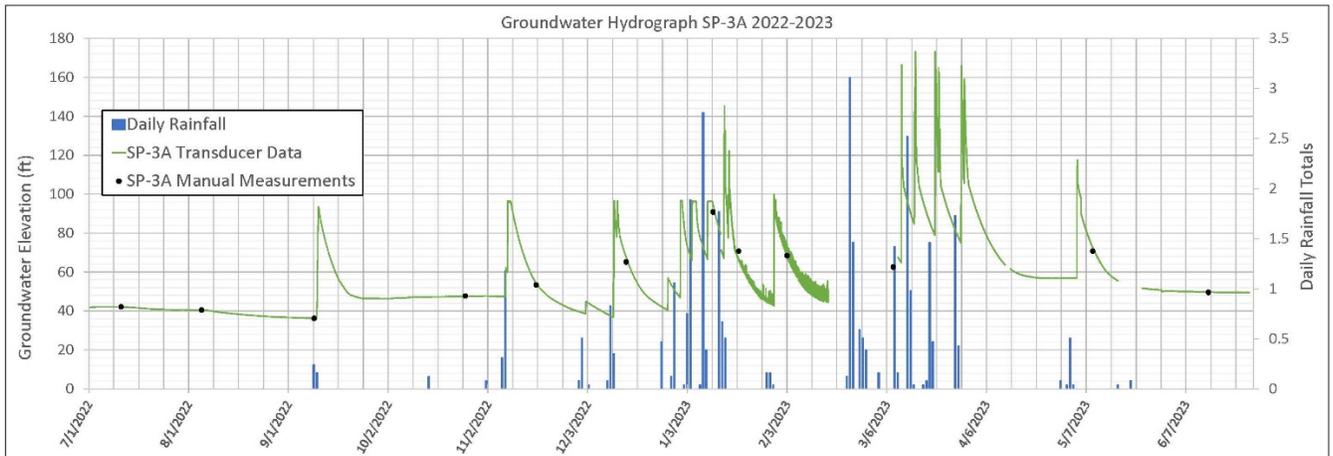
**Figure 4: SP-3A transducer hydrograph vs daily rainfall, programmed to 24, 12, 1-hour and 1-minute**

- PC-1 water levels increased by less than 5 feet, relatively quickly in response to individual rain events and then dissipated over a day to a few days.
- Water levels in SP-3A appeared to rise nearly immediately in response to rainfall and lower quickly to close to previous levels. It is noted that the water level within the well casing rose on the order of up to 60 feet over a few minutes. This is thought to be a result of the surface runoff directly entering the casing. Water levels recorded in SP-3A may not represent the true water levels until surface water that entered the casing has dissipated. A transducer is currently installed in SP-3A and is logging at 1-minute intervals to continue evaluations of water levels responses.

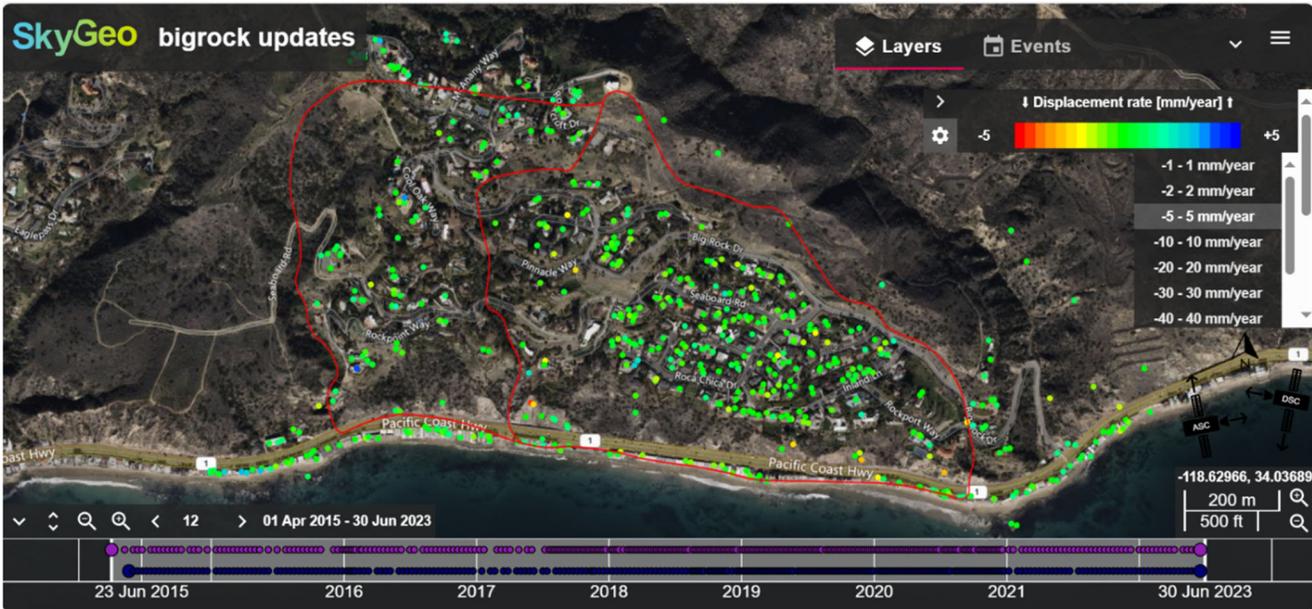
Figure 6: Highest Quality PS Pixels Only, Displacement Rate  $\pm 5$ mm/year

- There has been no reportable substantial gross, vertical displacement estimated within the body of the Big Rock Mesa Landslide or its subregions between April 2015 and the end of the current monitoring year.
- There has been no substantial movement estimated along the toe of the landslide. Therefore, we can infer that there is no substantial thrust or uplift along the toe of the landslide.
- Downslope movement estimates that occur on the faces of steep slopes are likely the result of shallow soil movement and can be tracked by DS pixels.

Figure 6 shows the entire Big Rock area with only high-quality PS pixels, which cover most of the developed residential areas. In Figure 7, DS pixels of the same quality are added to the PS pixel map and can be seen covering most of the undeveloped areas, slopes, landscaped areas, sidewalks and roads. Both plots indicate below threshold movement rates for all areas not on a steep slope. Areas of shallow slope failures such as rockfall, debris flow and shallow slumps that occurred during heavy rain were filtered out by algorithm due to either lost coherence as a detectable DS pixel or lost phase tracking.

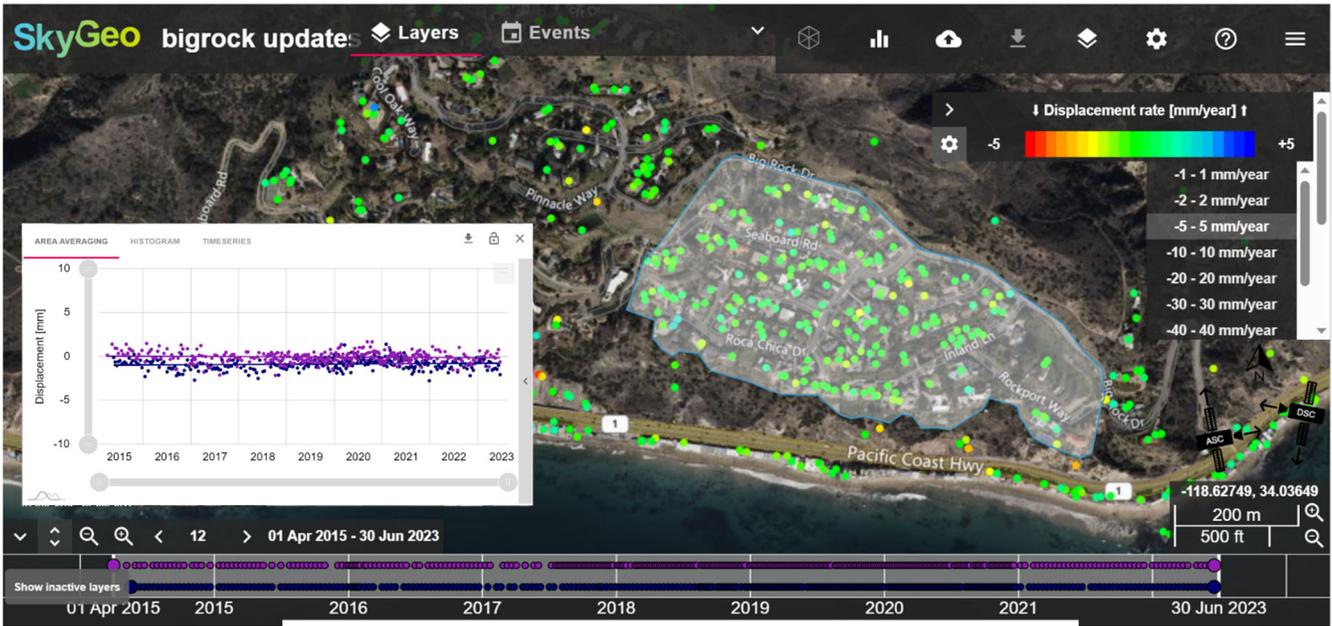
Figure 8: Eastern Region and Lower Central Region, Non-slope Area Averaging, Highest Quality PS Pixels Only

Figure 8 shows an example of results of using the grouping and statistics interface tool to assess PS pixels for the non-slope areas of the Eastern Region and Lower Central Region. The average displacement interpreted for the area is less than  $\pm 2$ mm/year with no trend of displacement over time and no distinct displacements at a given point. This process was performed for each project subregion and yielded similar results.

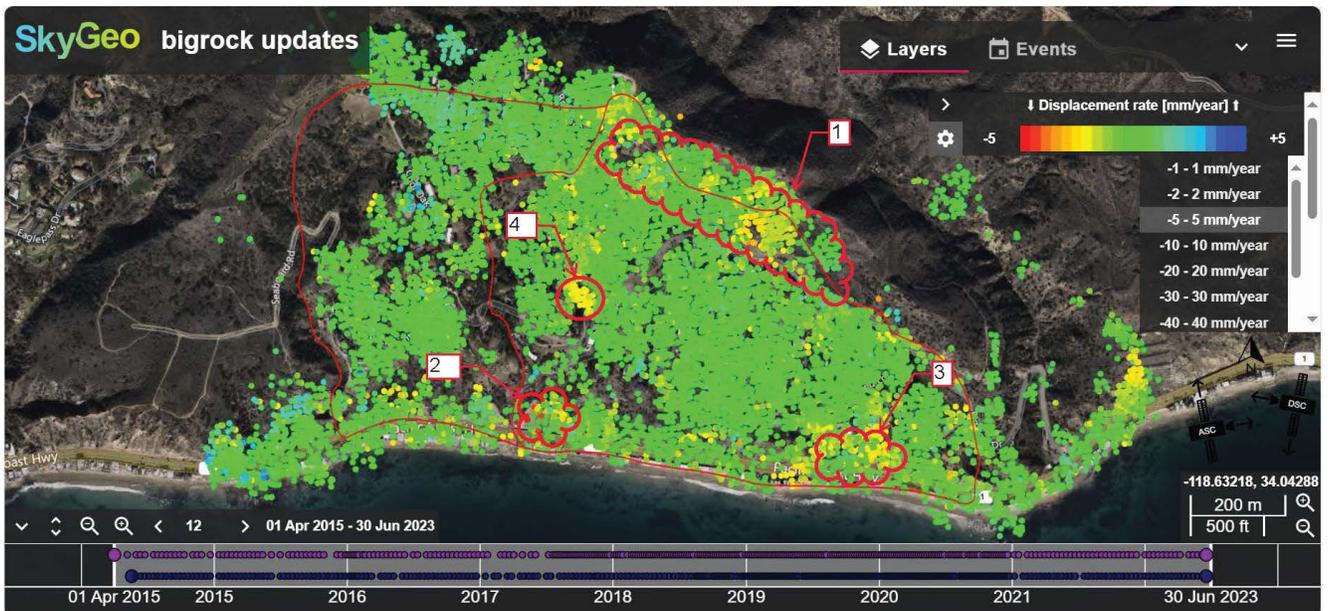
Figure 9: Four localized areas of further investigation

Yeh identified four localized areas where clusters of pixels presented with intermittent to consistent downward displacement estimates. Each of the locations are on steep terrain and the amount of interpreted movement is on the order of 2 to 4 mm per year. These movements are interpreted to be localized and shallow and not related to displacement of the greater Big Rock Mesa Landslide.

1. One area is throughout the steep faces of the East Ridge and North Peak and the movement is identified as shallow soil creeping or raveling downhill.

2. One area is on the PCH Bluff where soil, rock and a failing anchored mesh are sliding down the slope. The movement is interpreted to be downhill movement of surficial material.

3. One area is located on the Bluff along PCH below Rockport Way and within and near the headscarp of a previously mapped subslide. Portions of this area had been identified as an active shallow slide since at least 1972 (Merrill, 1972) and was subsequently mapped by DA Evans (DA Evans, 1986) as one slide area and later by BYA (BYA, 1992) as two separate smaller areas (BYA, 1992). The sub-slides consist of shallow slide debris within well-defined scarps. Material at the top of the headscarps consist of artificial fill placed over native soils (Merrill, 1972), (Geoconcepts, 2015). DS pixels associated with undeveloped areas show displacements, PS pixels associated with structures do not indicate displacements. See Figure 9.

4. The fourth area is below the intersection of Pinnacle Way and Big Rock Drive. This area is approximately within the headscarp of a previously mapped prehistoric sub-slide. The DS pixels align consistently with the steep slopes of the subslide headscarp and no other pixels across the body of the sub-slide indicate displacement. The movement is interpreted to be surface material creeping downslope. See Figure 10.

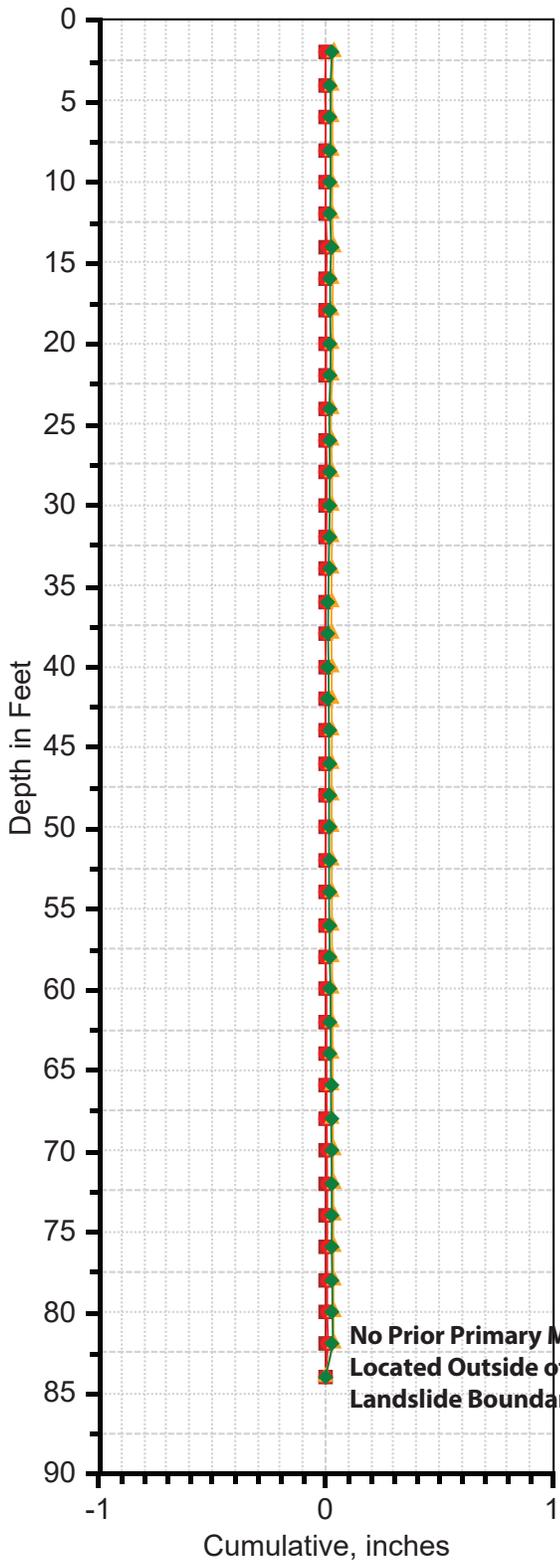
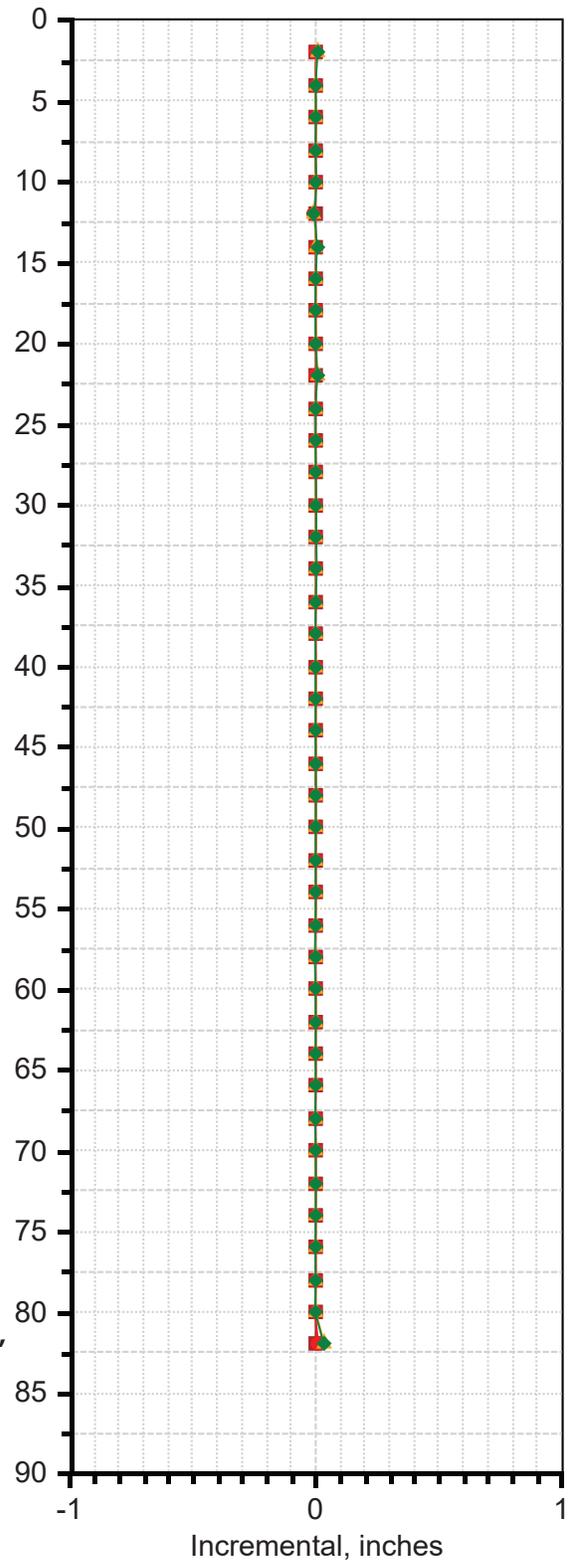
No Prior Primary Movement,  
Located Outside of Mapped  
Landslide Boundary

<b>Plot of Slope Inclinometer</b>  <b>SP-19</b>	Plot Type: Cumulative and Incremental		Plot Direction: A-Direction
	Depth of Survey (ft): 84	Baseline Date: 9/14/2021	Corrections: None
	Install Date: 1/1984	Installed Depth (ft): 95	Interpreted Movement Since Baseline (in): 0
			Interpreted Movement Monitoring Year (in): 0

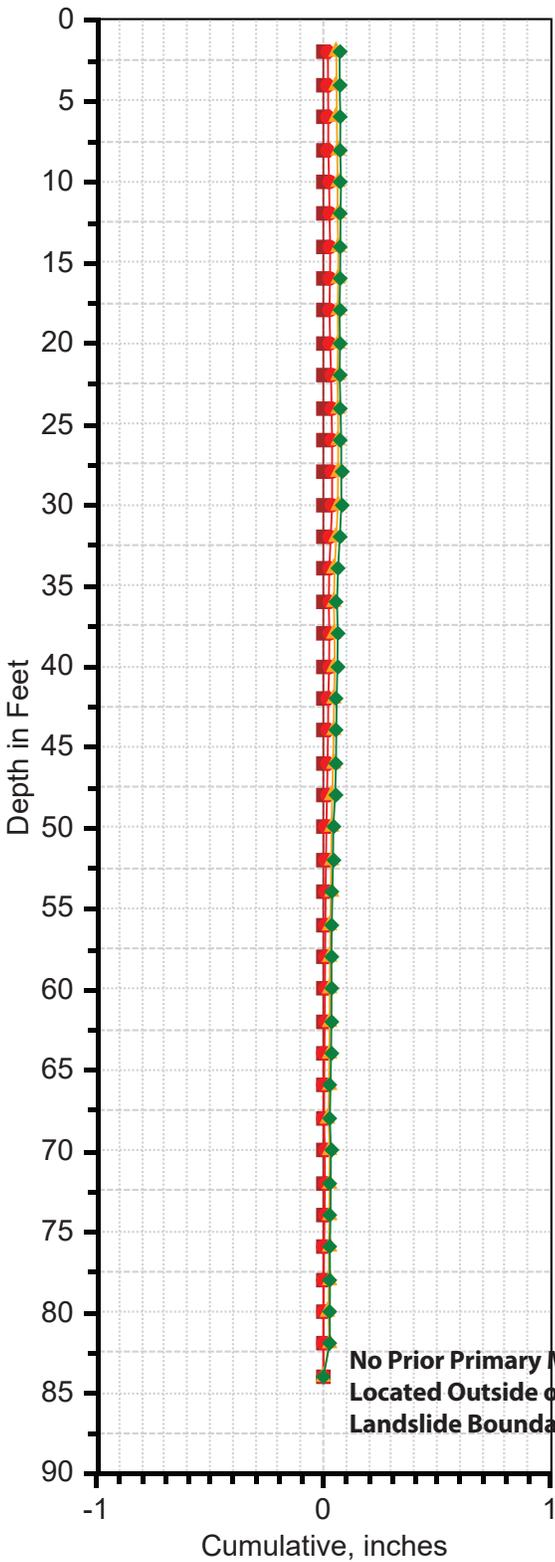
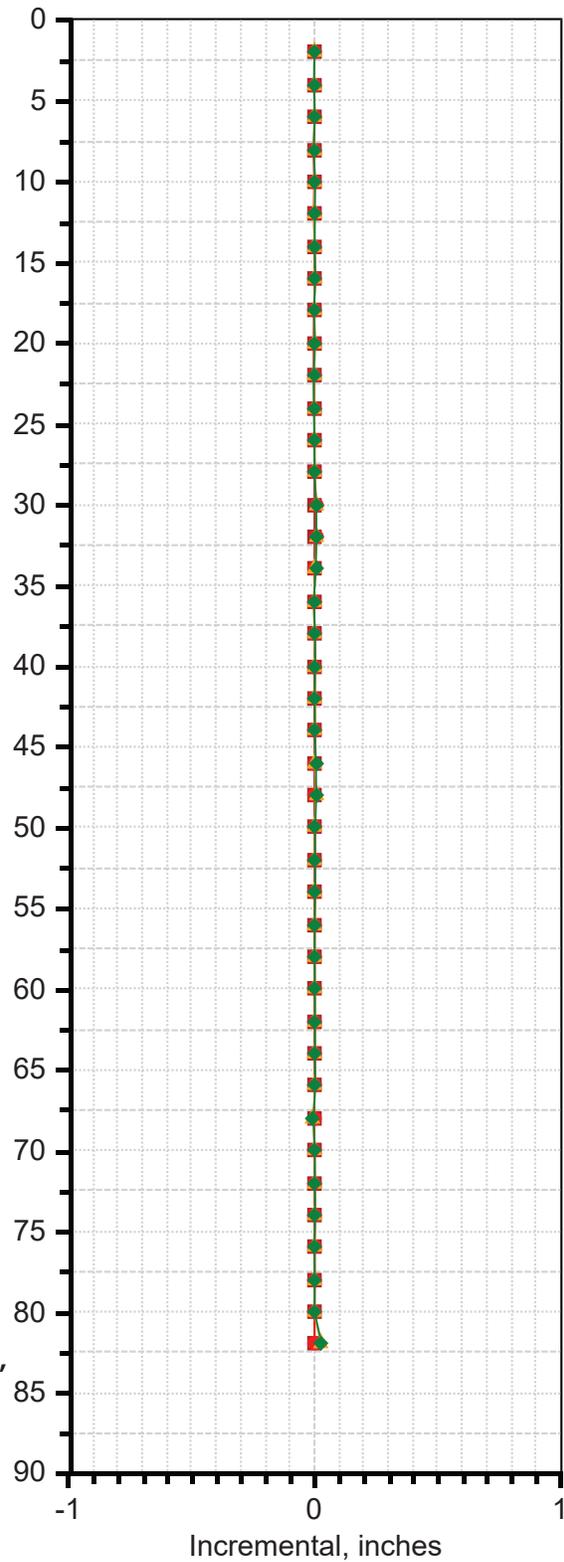
No Prior Primary Movement,  
Located Outside of Mapped  
Landslide Boundary

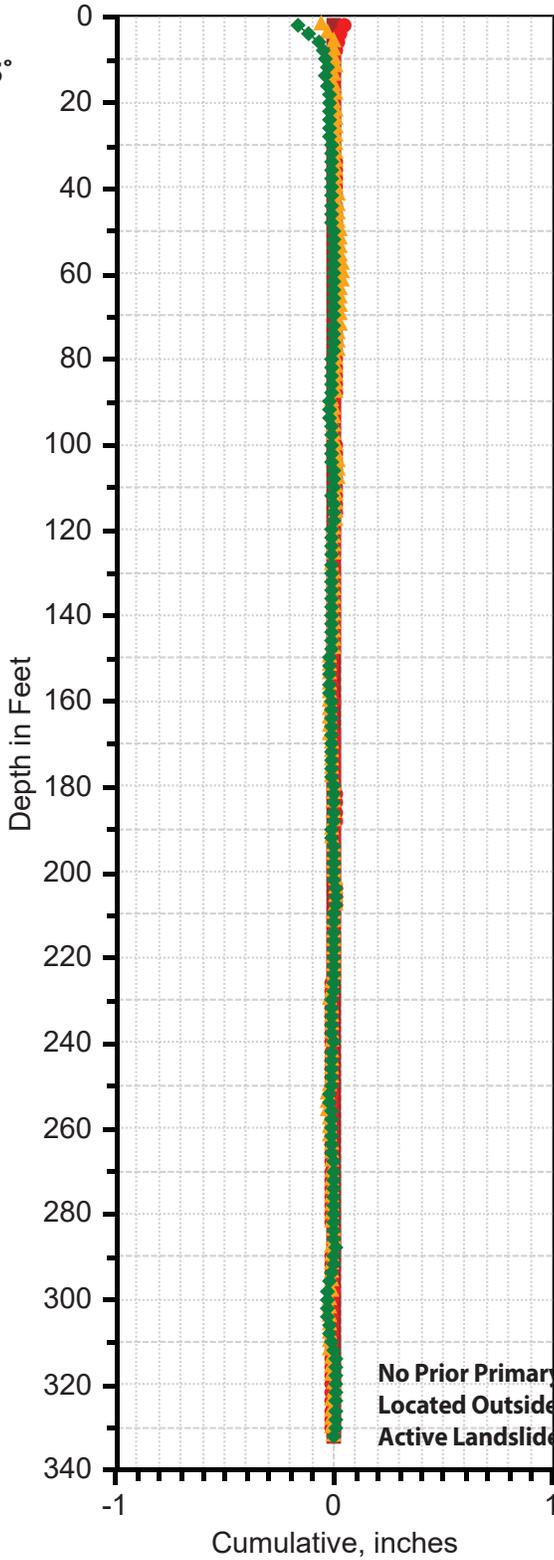
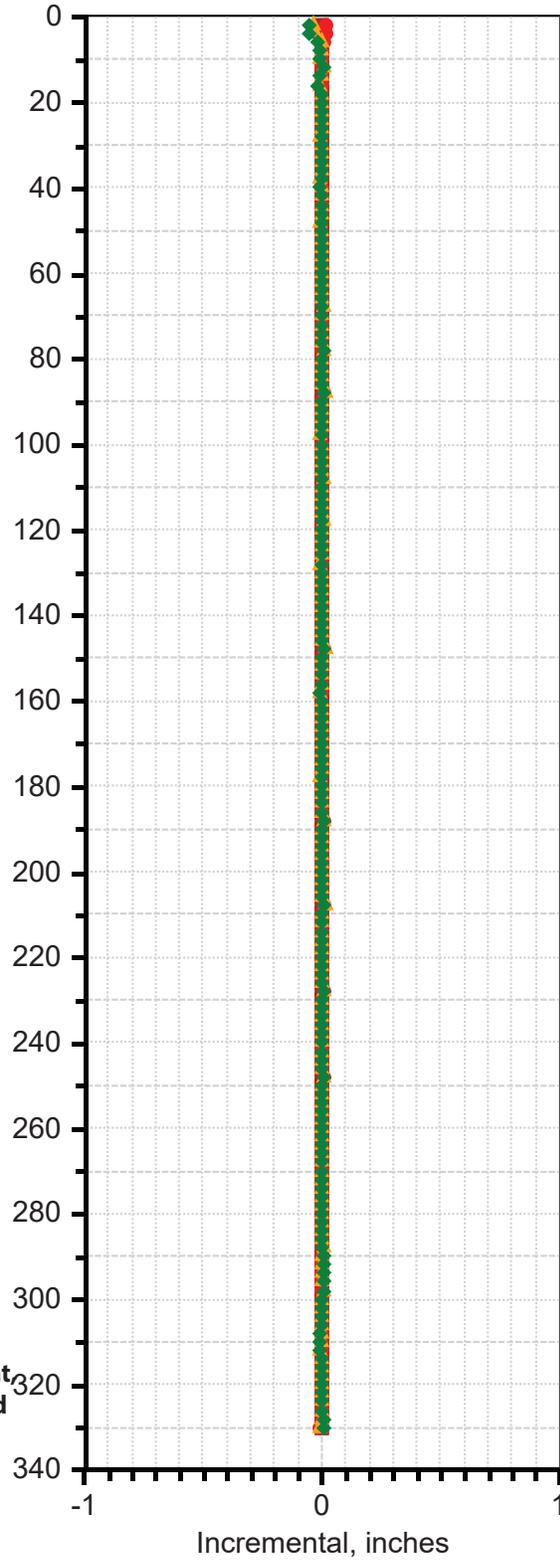
No Prior Primary Movement Located Outside of Mapped Active Landslide Boundary

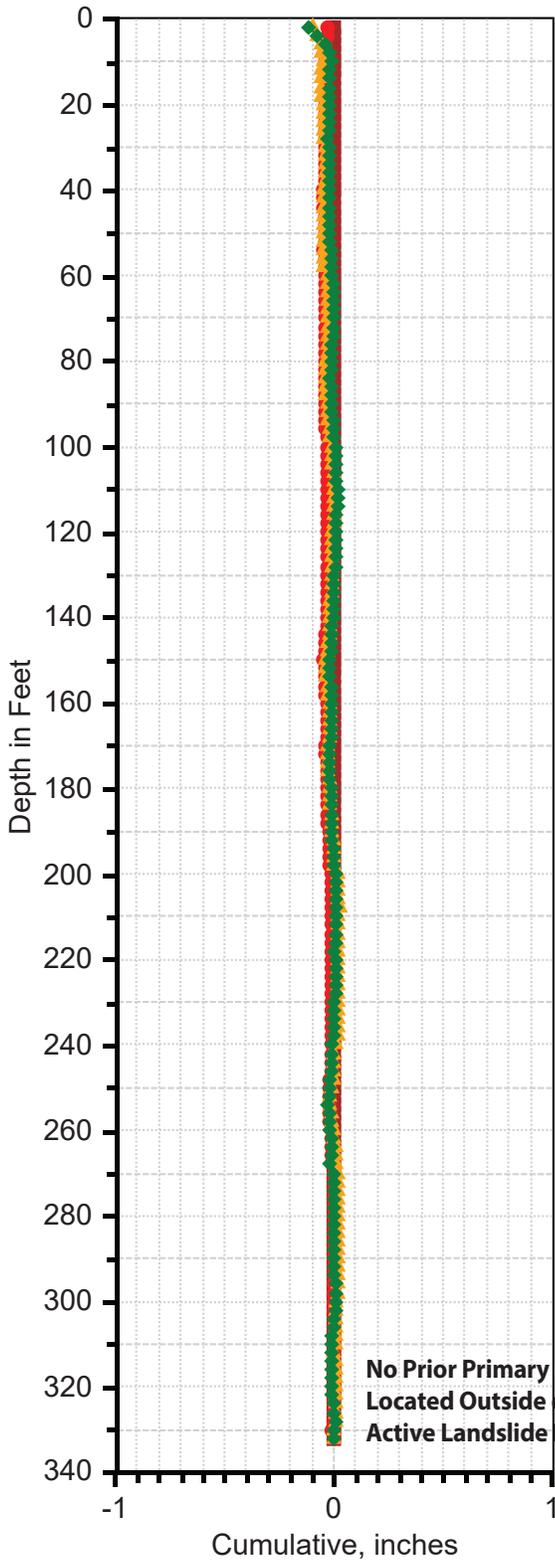
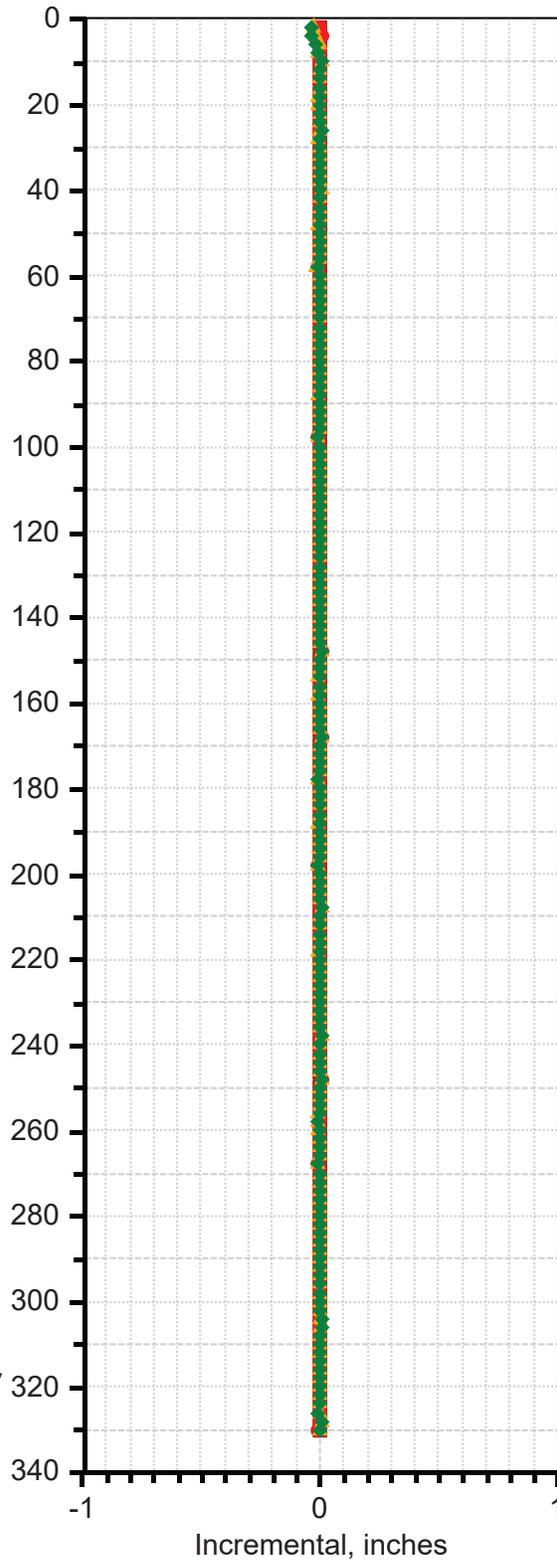
**No Prior Primary Movement,  
Located Outside of Mapped  
Active Landslide Boundary**

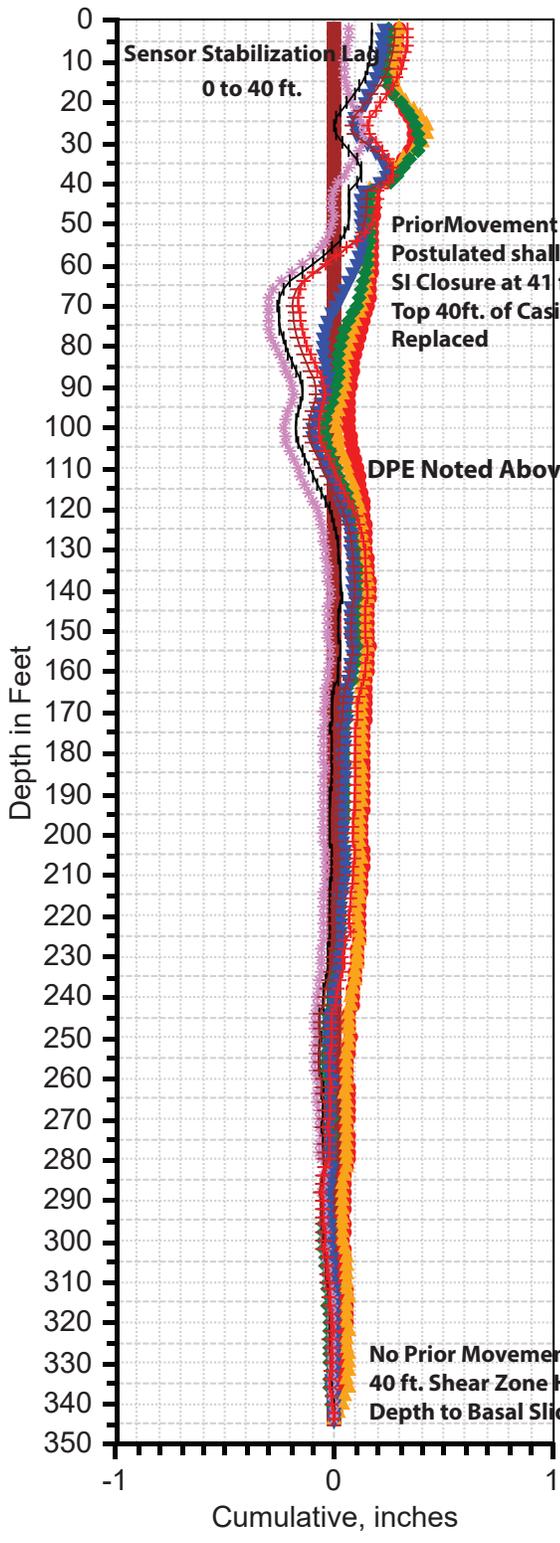
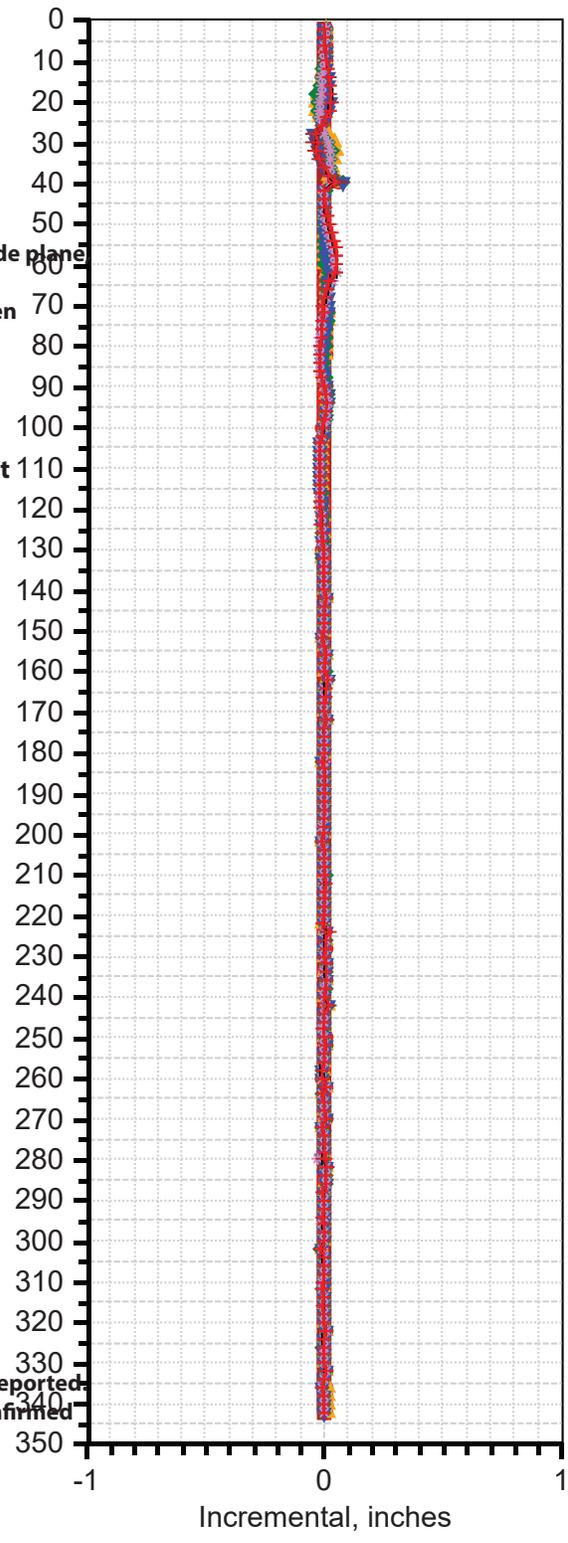
<b>Plot of Slope Inclinometer</b>  <span style="font-size: 2em;">SP-26</span>	Plot Type: Cumulative and Incremental		Plot Direction: B-Direction
	Depth of Survey (ft):	342	Baseline Date: 4/09/2021
	Install Date: 4/1984	Installed Depth (ft): 405	Interpreted Movement Since Baseline (in): 0
		Interpreted Movement Monitoring Year (in): 0

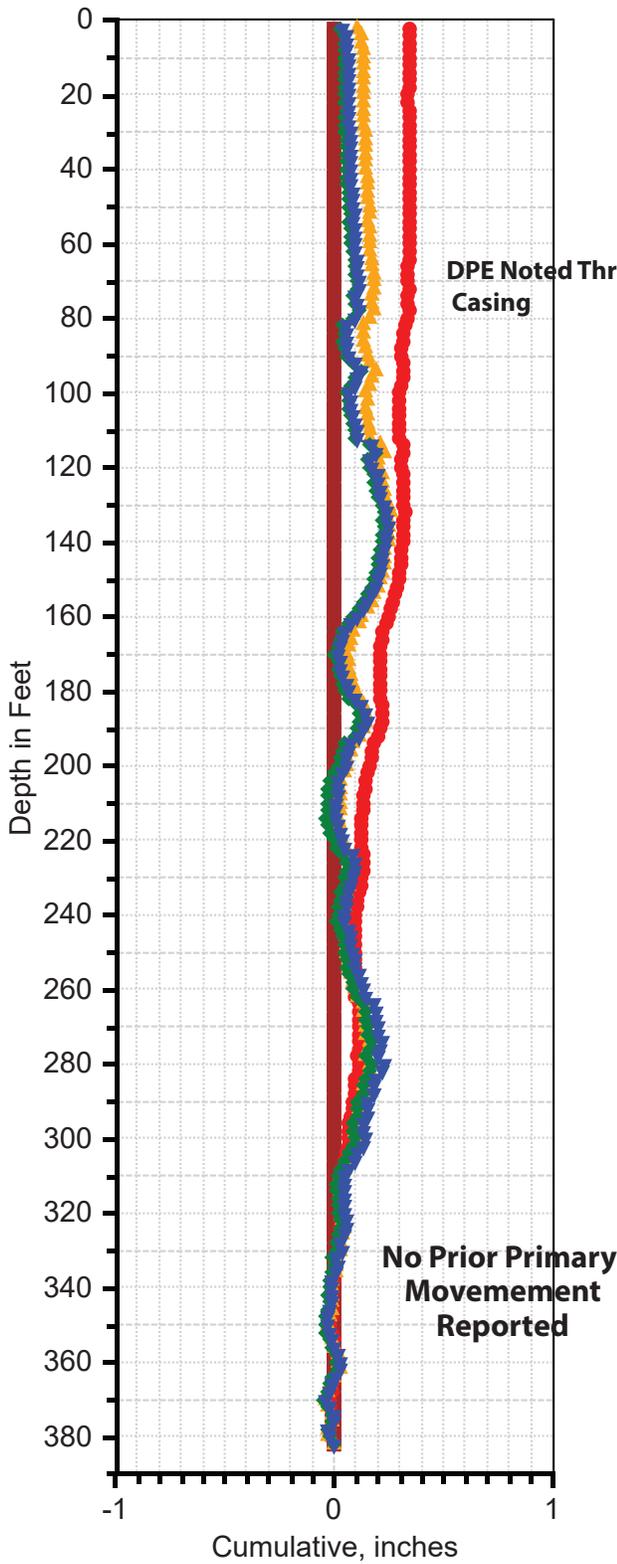
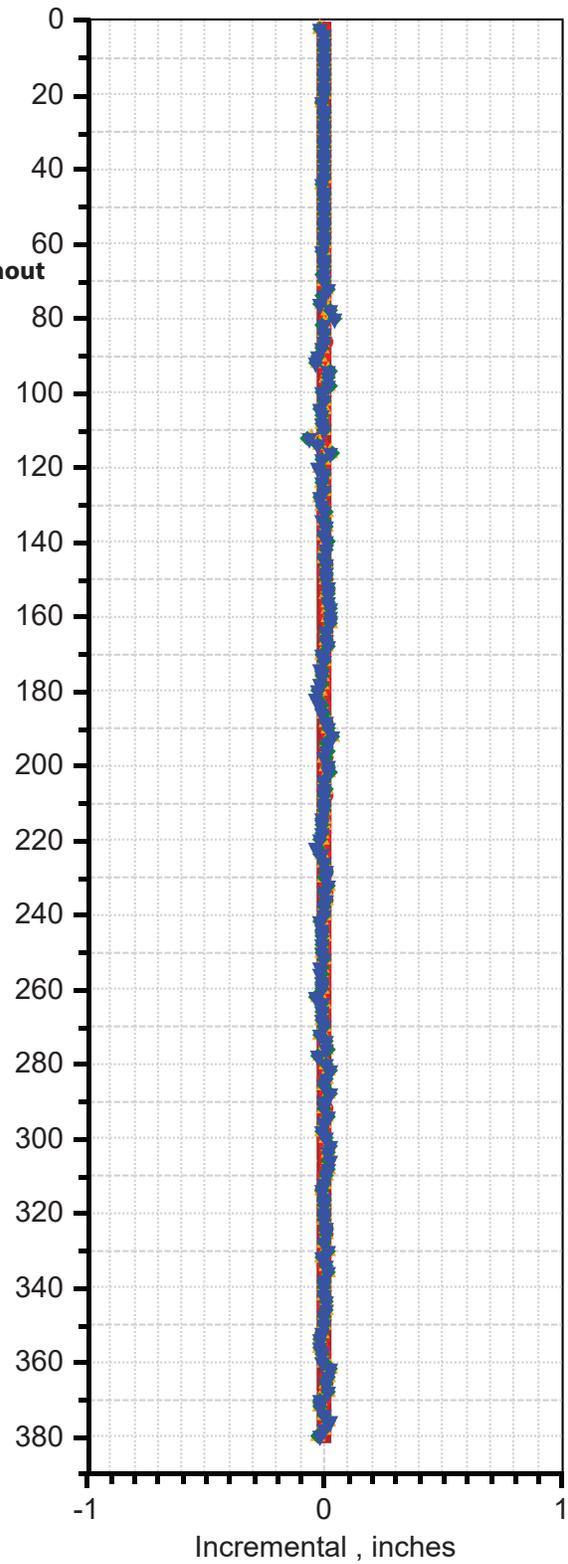
Plot of Slope Inclinometer  <b>SP-34</b>	Plot Type: Cumulative and Incremental		Plot Direction: A-Direction
	Depth of Survey (ft):	380	Baseline Date: 4/01/2021
	Install Date: 2/1999	Installed Depth (ft): 382	Interpreted Movement Since Baseline (in): 0
			Interpreted Movement Monitoring Year (in): 0

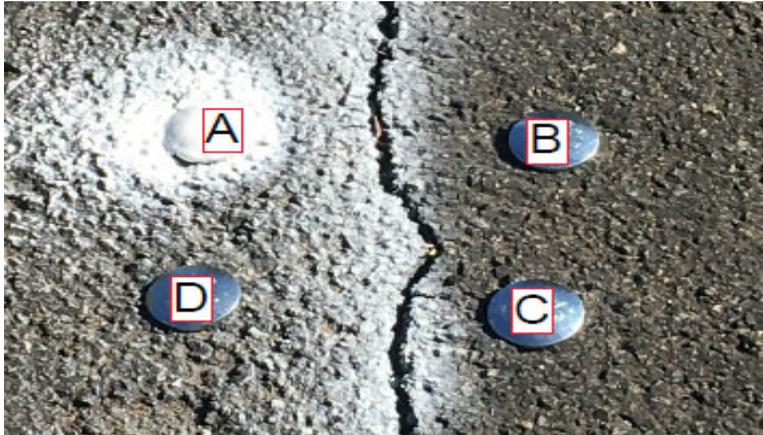
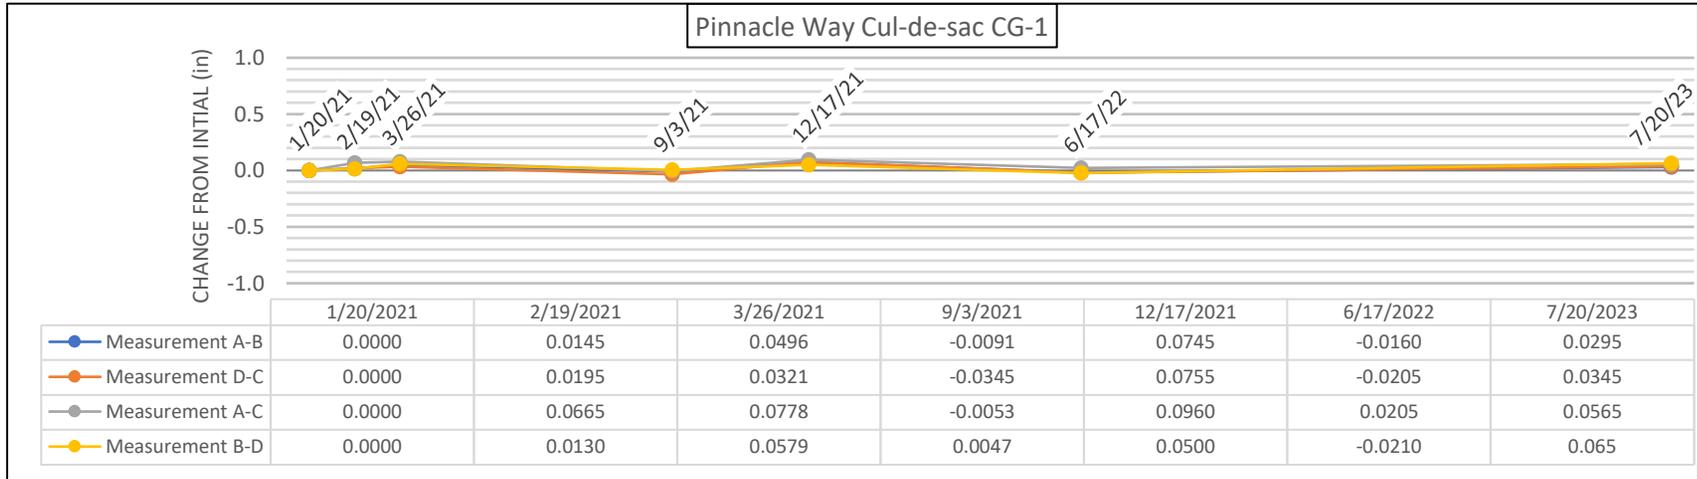
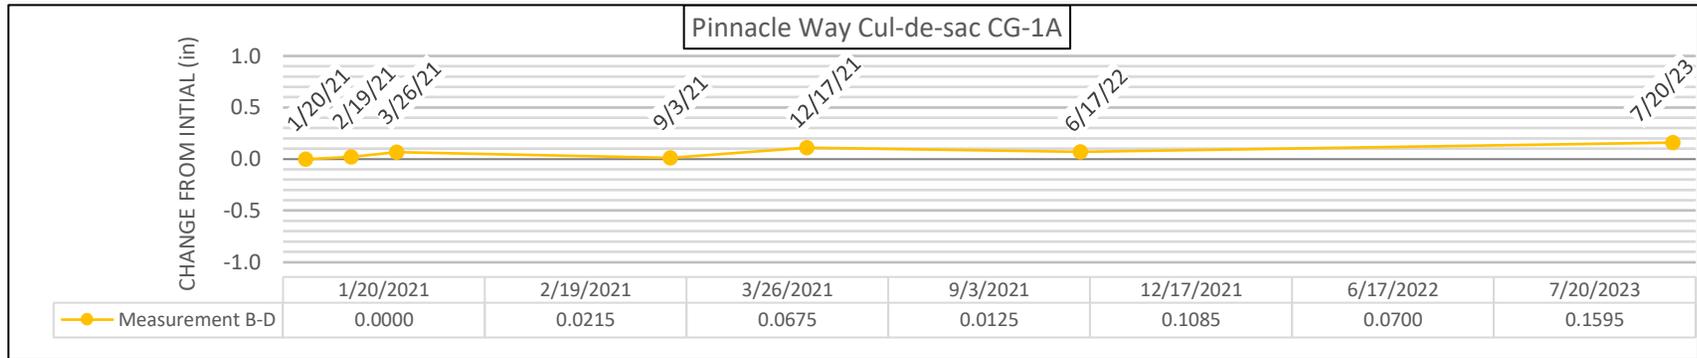
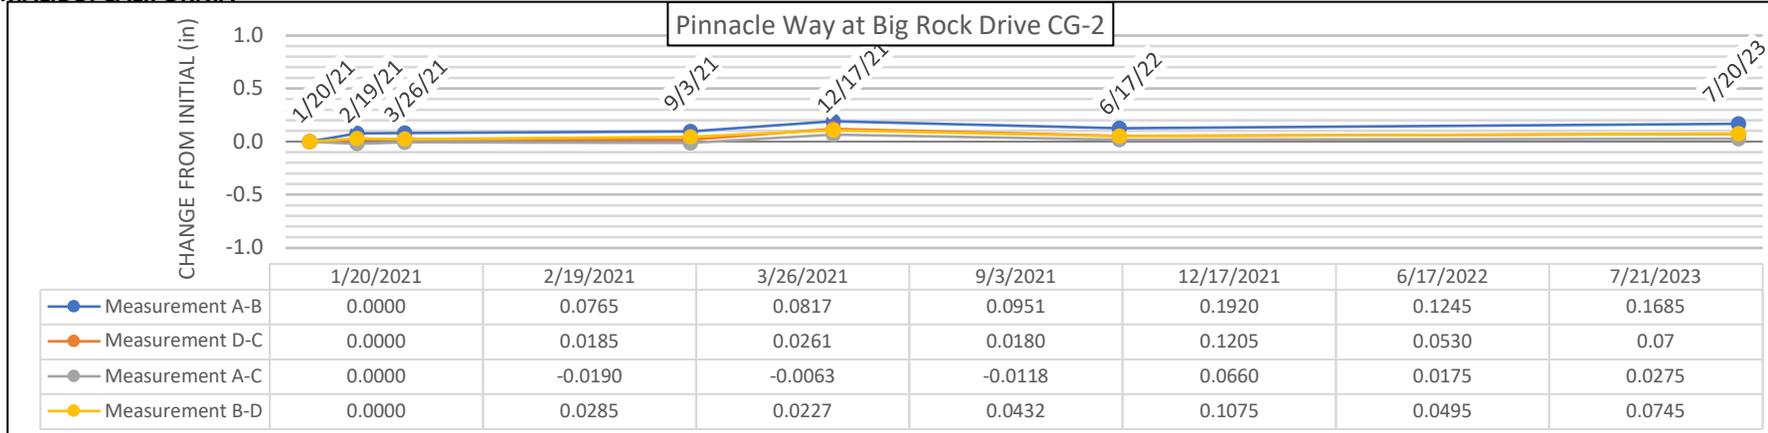
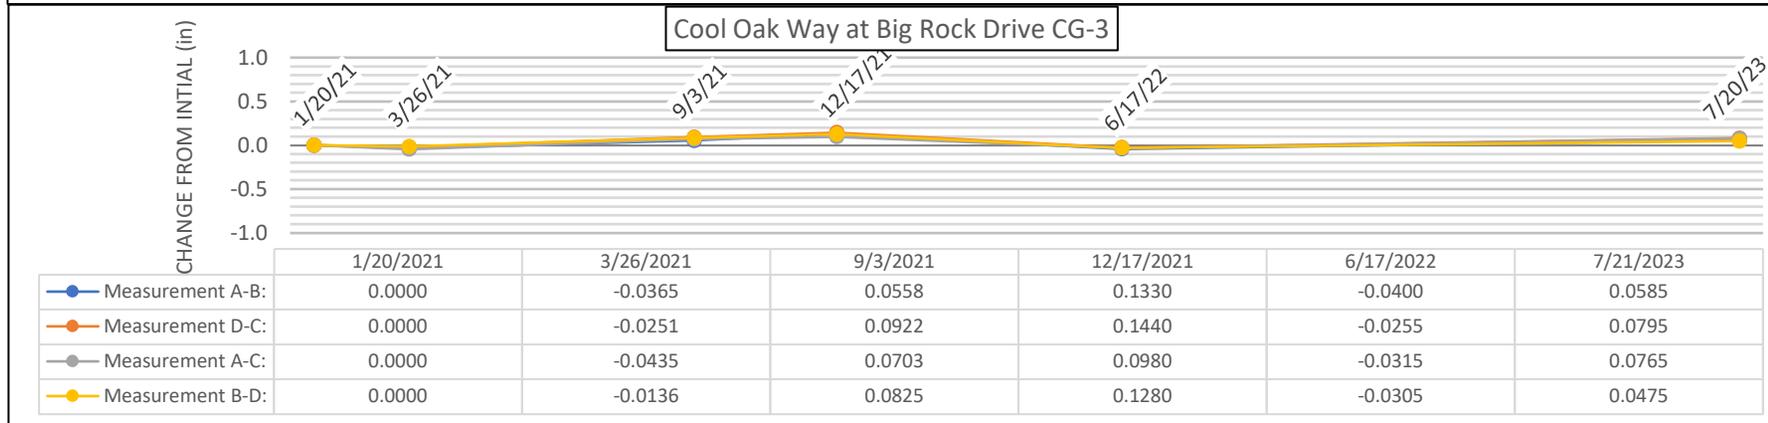
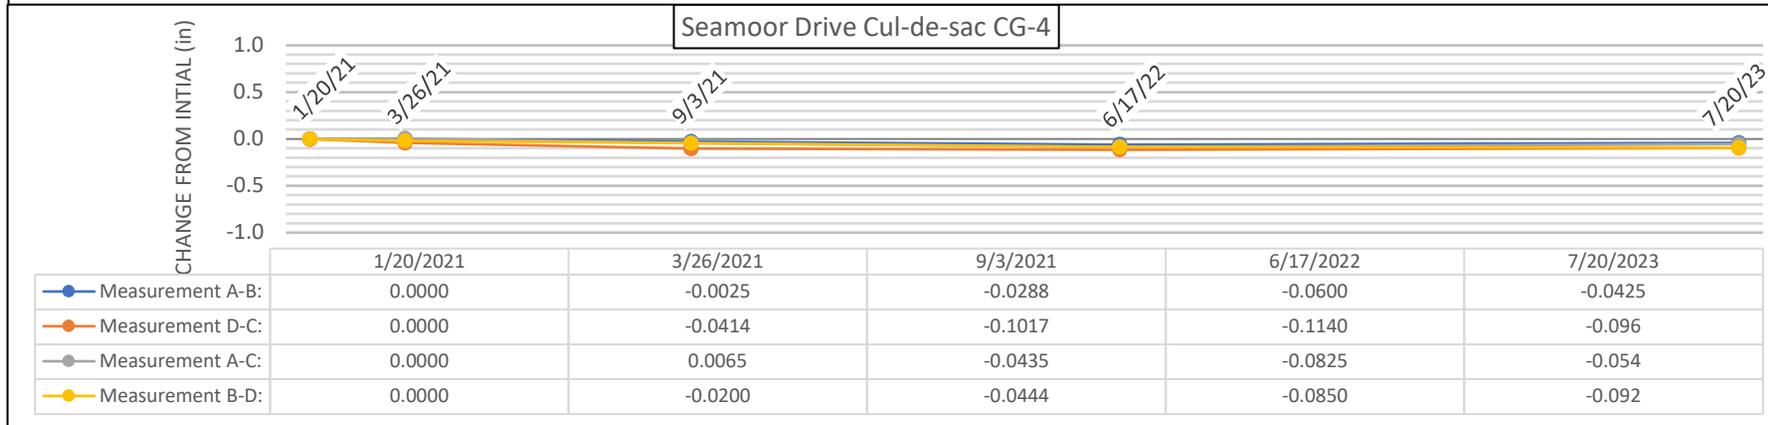
## APPENDIX C – CRACK GAUGE PLOTS

Results for five of the crack gauges are attached in Appendix C. The crack gauge located on Lower Big Rock Drive near Rockport Way was damaged and no results were recorded. No measurable displacement was observed on the crack gauges since the last monitoring year.
