FY23/24 Maintenance and Monitoring

AD98-1, Big Rock Mesa

Yeh Project No.: 220-276

Subject: Annual Monitoring and Maintenance Report FY23/24, City of Malibu Assessment District 98-1, Big Rock Mesa, Malibu, CA

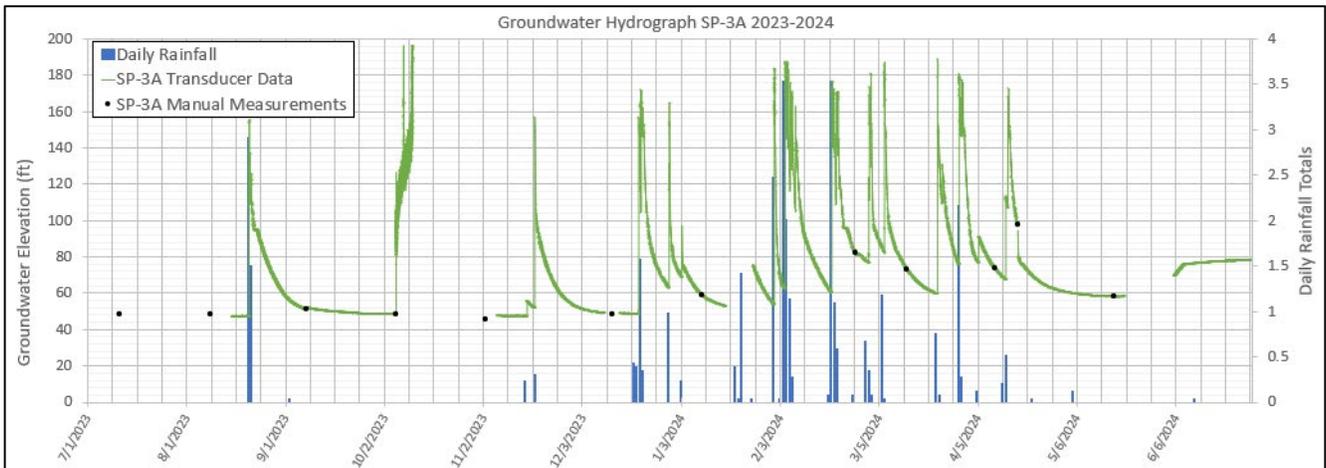
Figure 4: SP-3A transducer hydrograph vs daily rainfall, programmed to 24, 12, 1-hour and 1-minute

- PC-1 water levels increased by less than 2 feet, in response to individual rain events and then dissipated over a day to a few days.
- Water levels in SP-3A appeared to rise nearly immediately in response to rainfall and then lower over the several days to a level close to the pre-storm level. It is noted that the water level within the well casing rose on the order of up to 150 feet over a few minutes with rainfall. This may be a result of surface runoff directly entering the casing. Water levels recorded in SP-3A may not represent the true water levels until surface water that entered the casing has dissipated. A transducer is currently installed in SP-3A and is logging at 1-minute intervals to continue evaluations of water levels responses.

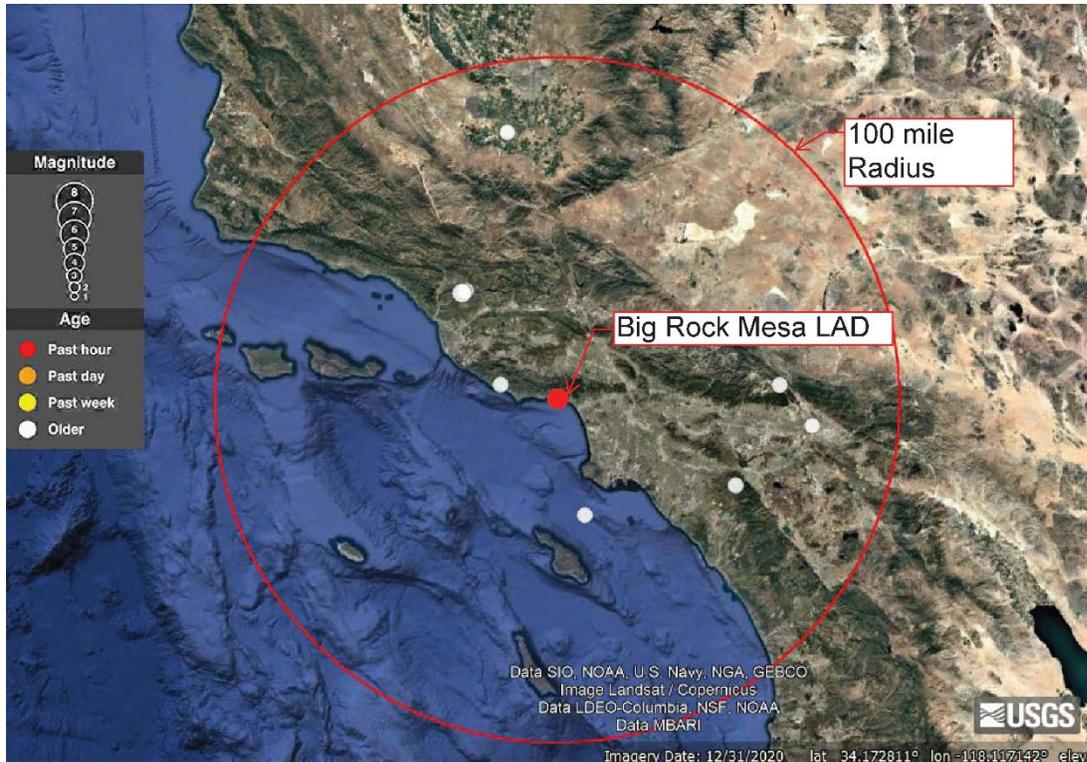
Figure 8: M4.0+ earthquakes within 100-miles of Big Rock Mesa LAD between 7/1/2023 and 6/30/2024

Eight earthquakes with a magnitude of 4.0 or greater were recorded within a 100-mile radius of the project area (See Figure 8). Earthquake magnitudes ranged from M4.09 to M5.08 with epicentral distances ranging from 16.6 to 79 miles. The largest event was reported as M5.08 and located 79 miles to the northwest, near Ojai, CA).

Yeh personnel performed post-earthquake observations and measurements that included surveying of key inclinometers and/or field observations of the ground surface made during scheduled monitoring and maintenance before and after the earthquake events. Small movement measured on inclinometer SP-11 and small possible movement on SP-26 that occurred during Q1 2024 cannot definitively be attributed to seismic activity. Yeh staff did not observe surface displacements related to any of the earthquakes and is unaware of any reports of damage local to the Big Rock Mesa Landslide AD resulting from the earthquake.

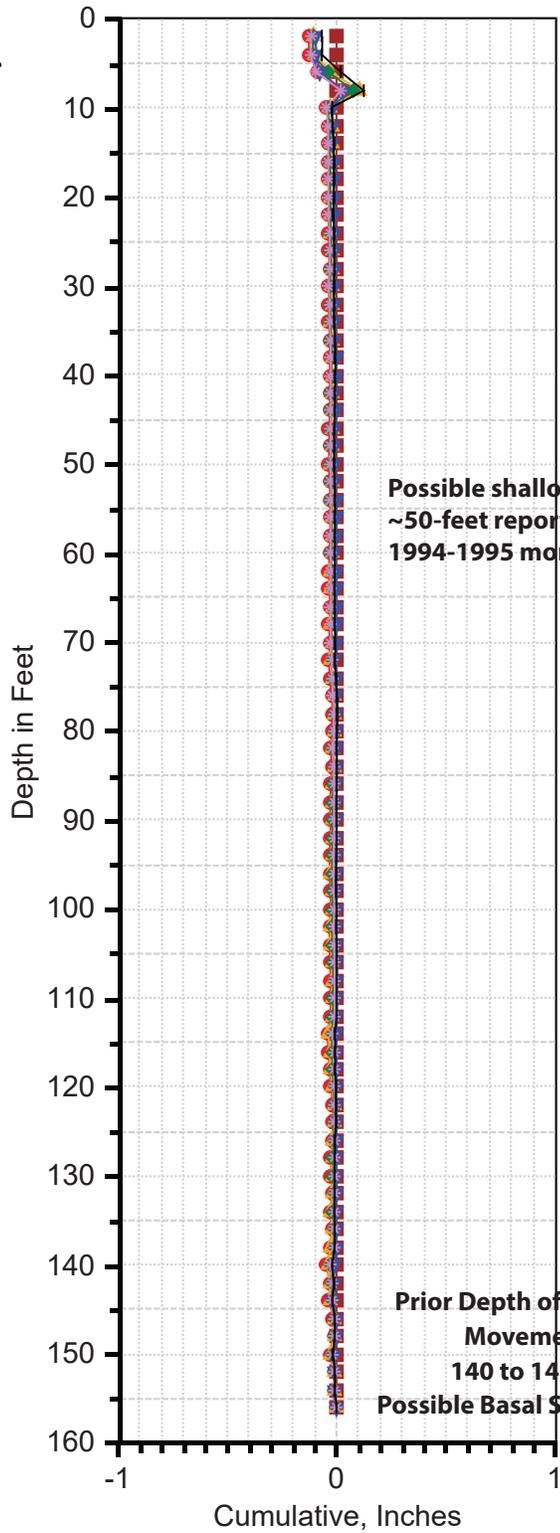
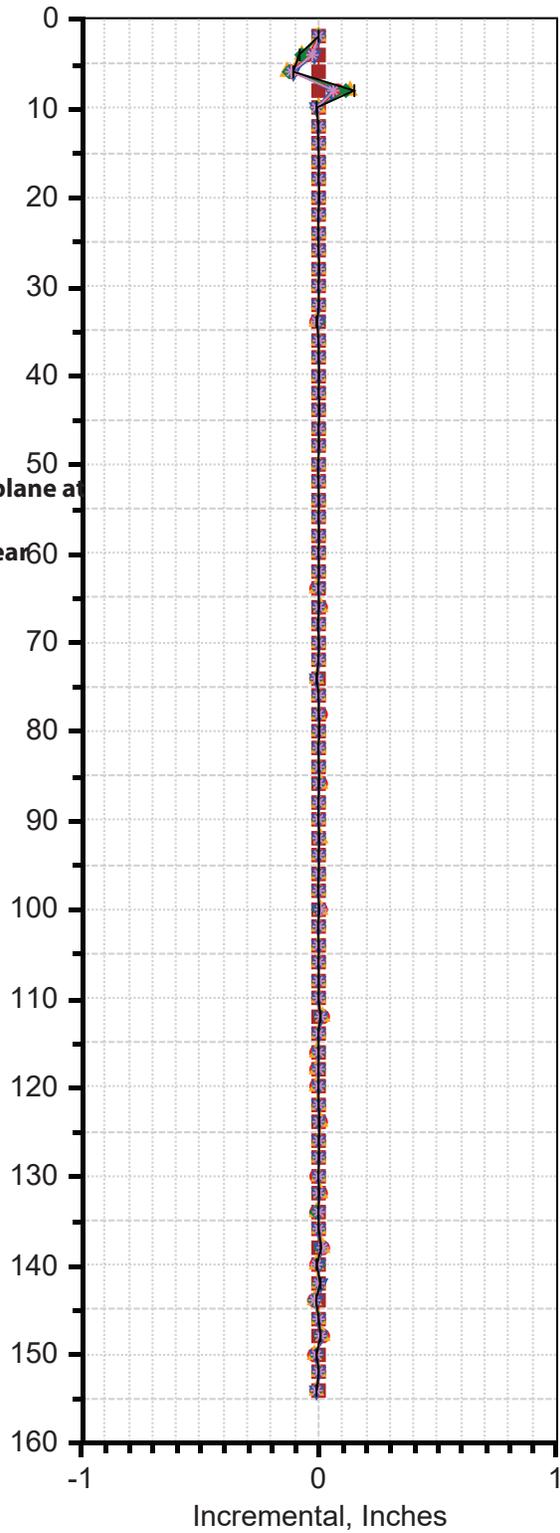
Possible shallower slide plane at
~50-feet reported
1994-1995 monitoring year

Prior Depth of Primary
Movement
140 to 143 ft.
Possible Basal Slide Plane

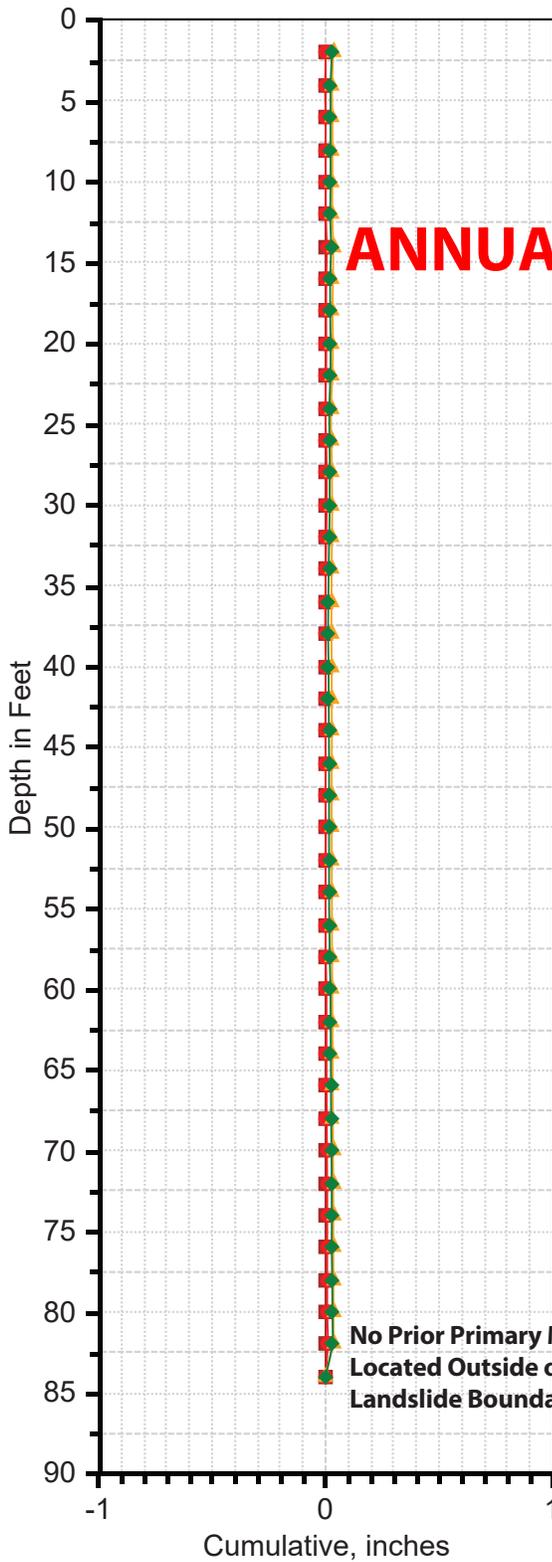
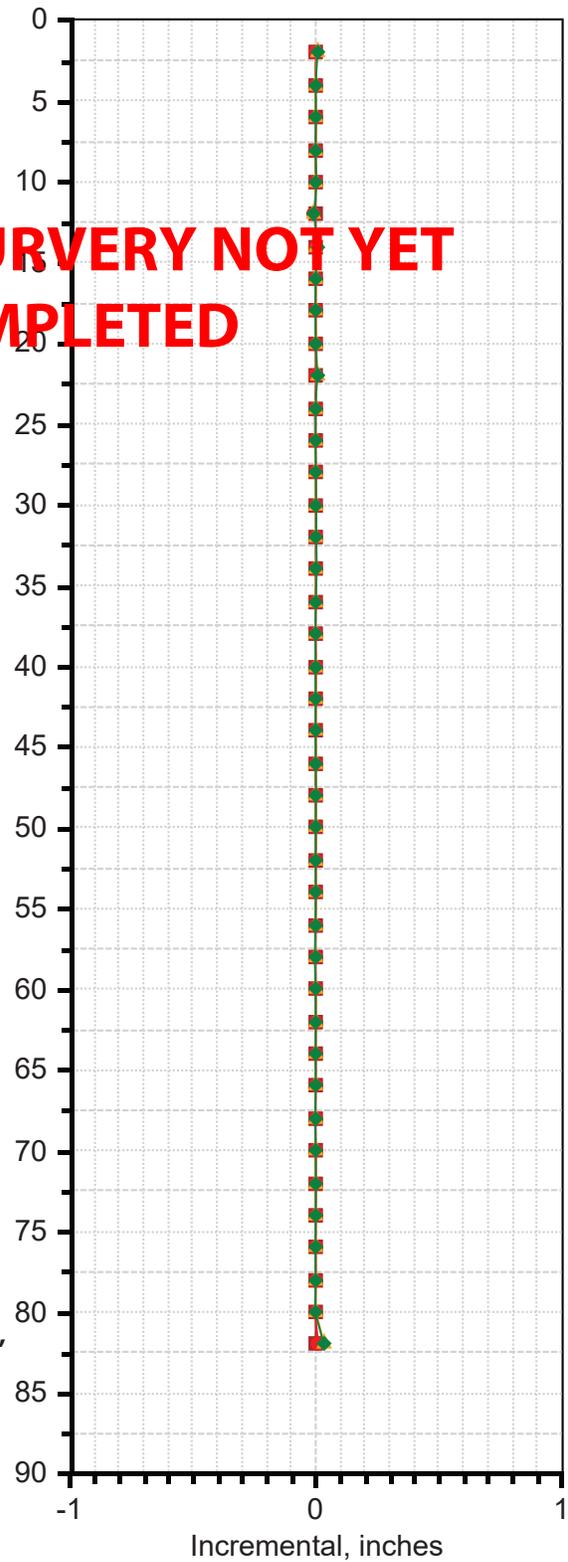
ANNUAL SURVEY NOT YET COMPLETED

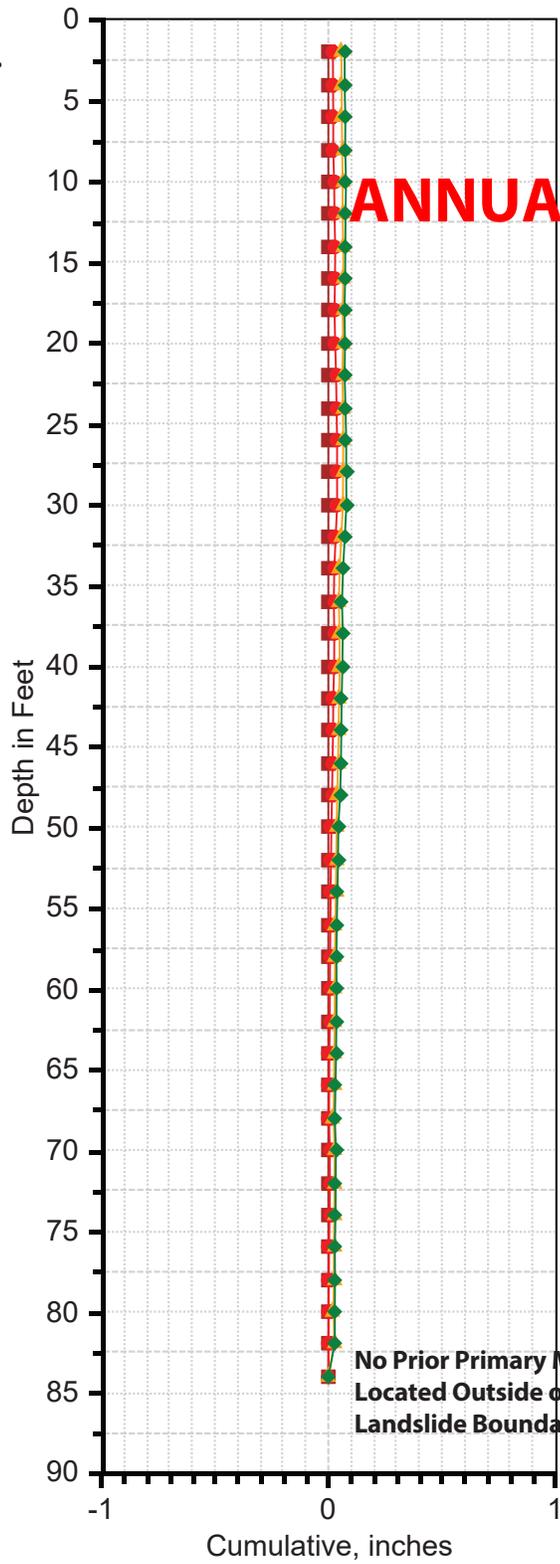
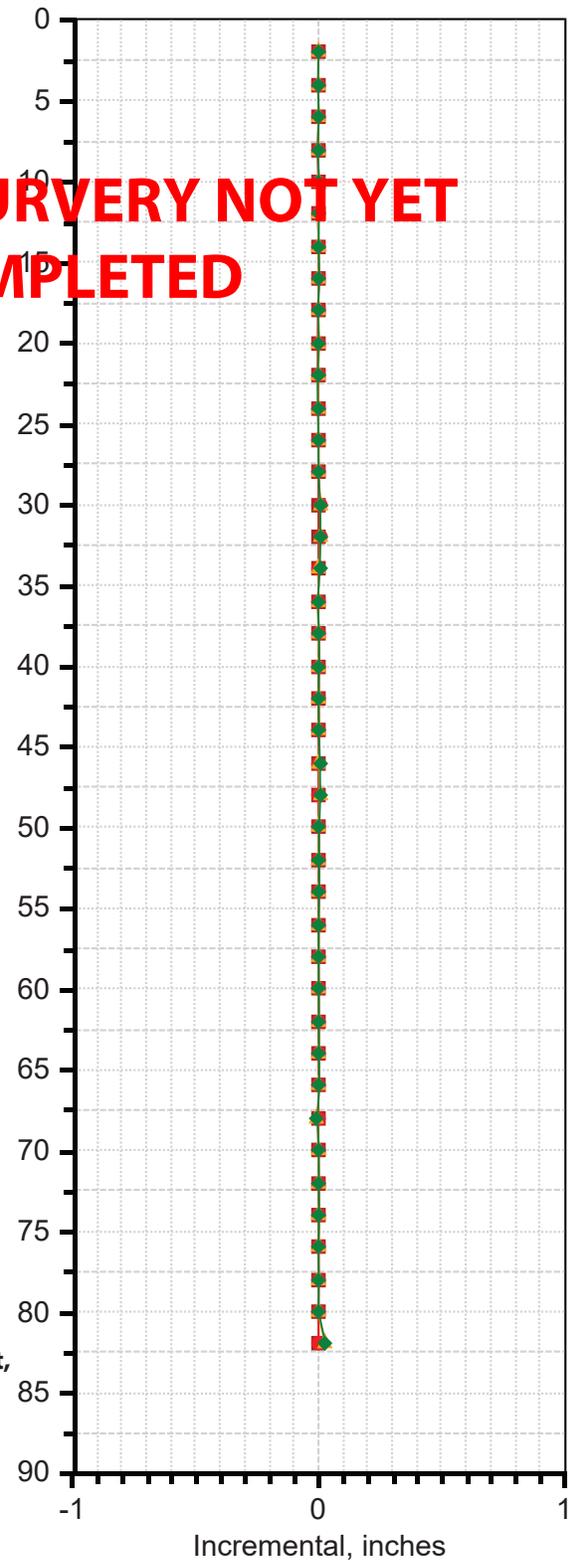
ANNUAL SURVEY NOT YET COMPLETED

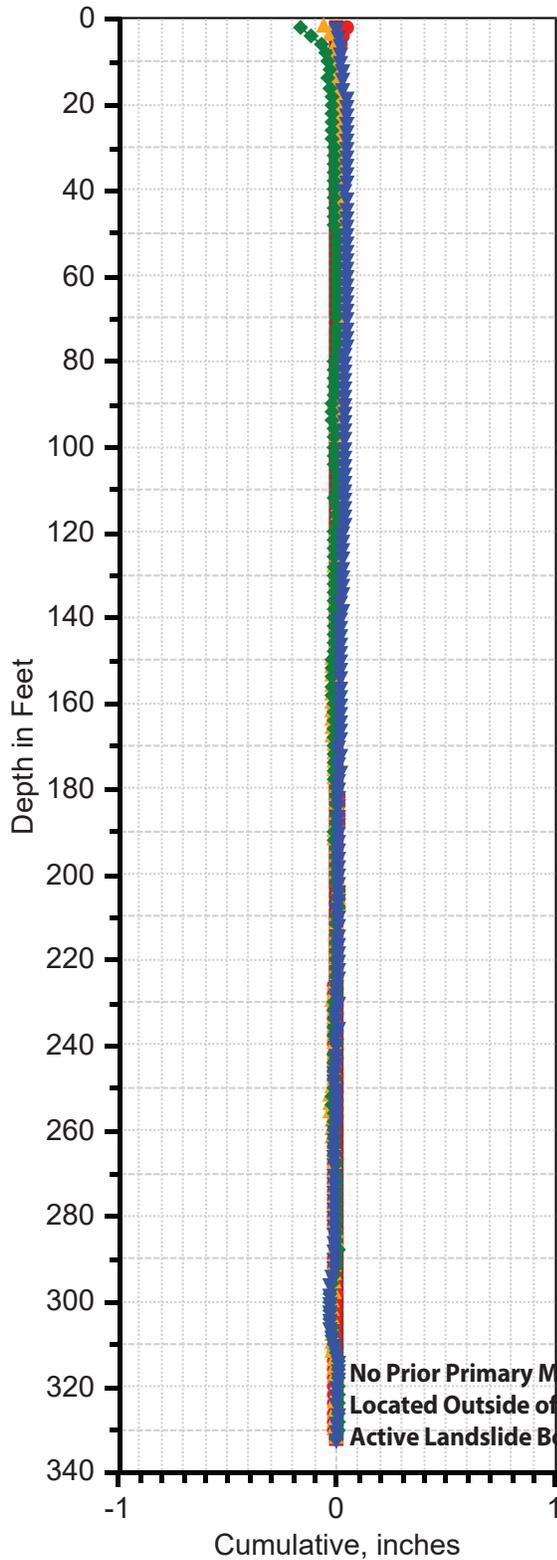
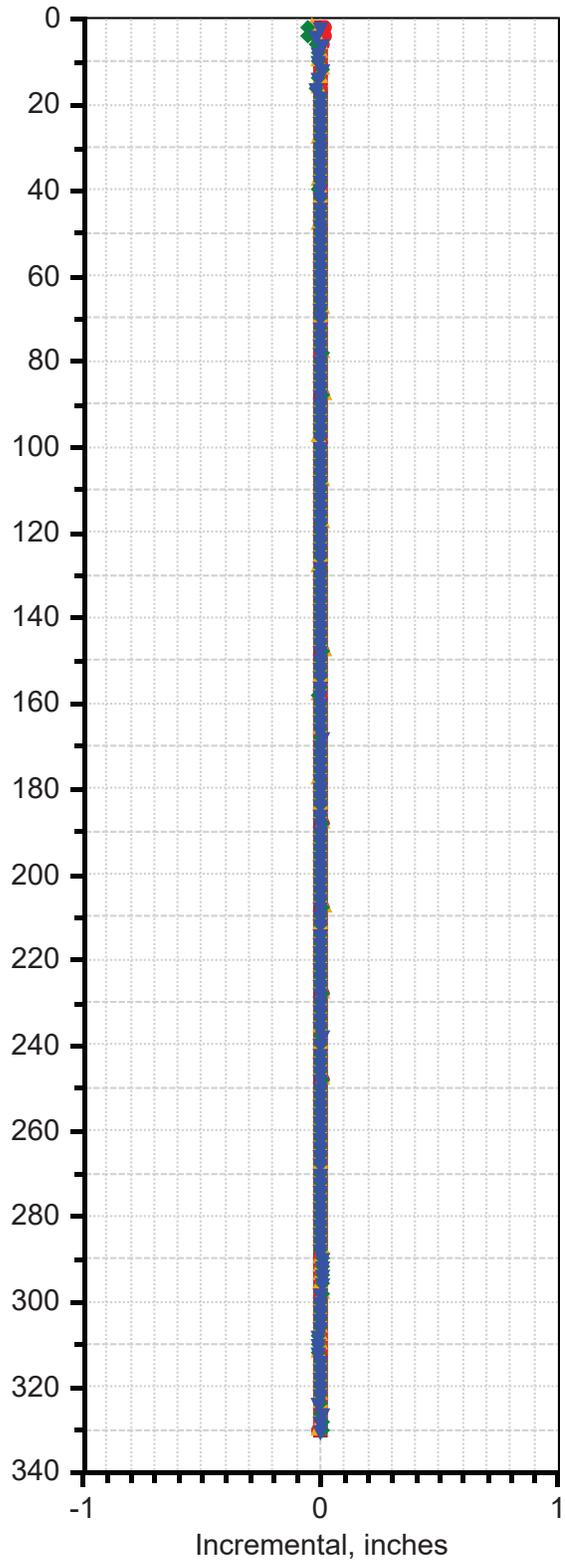
No Prior Primary Movement,
Located Outside of Mapped
Active Landslide Boundary

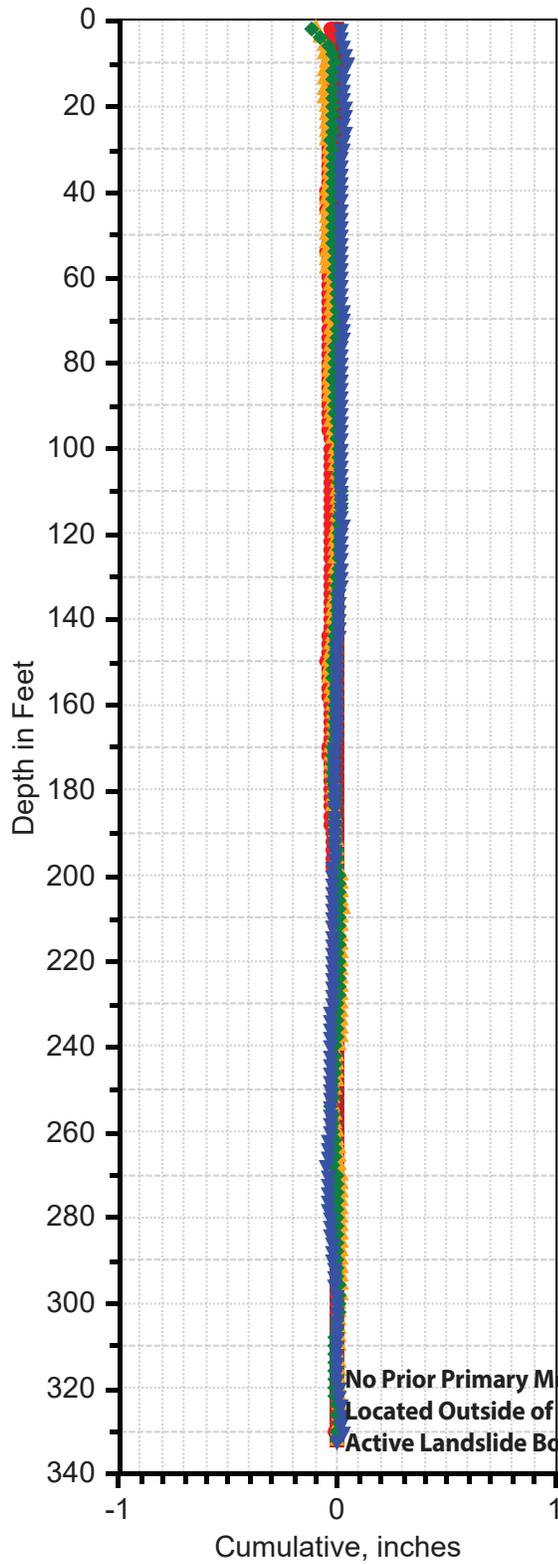
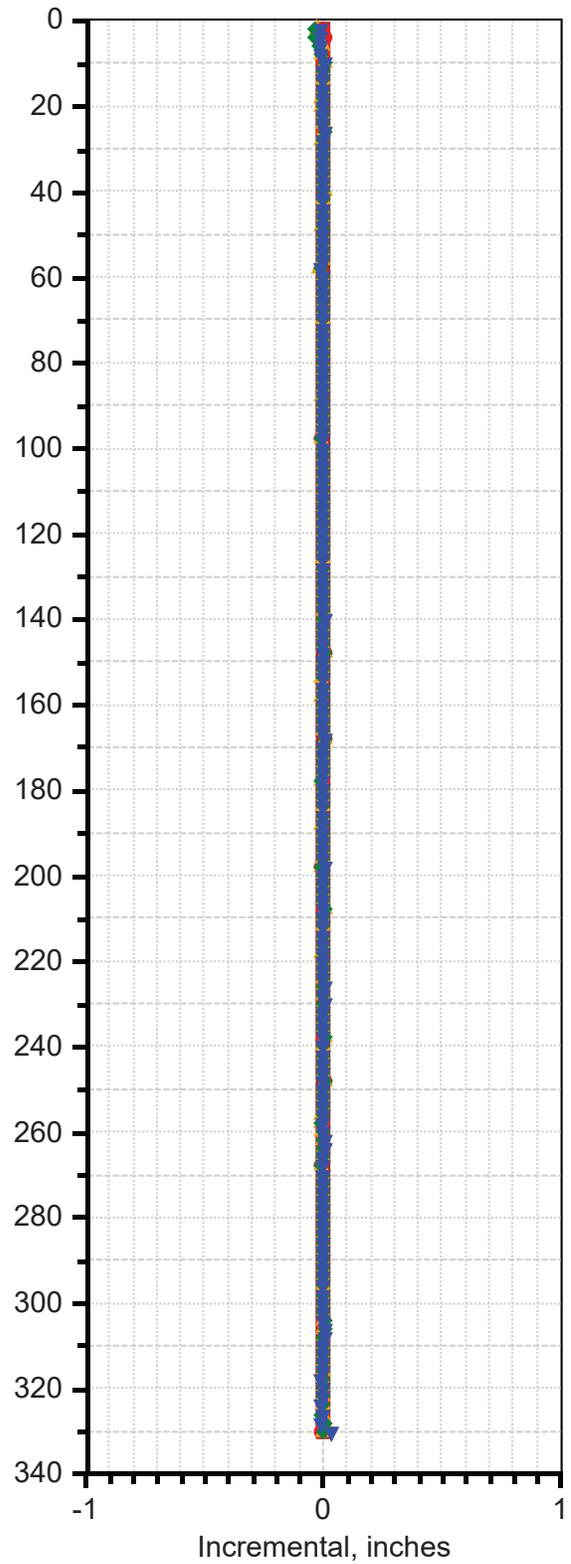
No Prior Primary Movement,
Located Outside of Mapped
Active Landslide Boundary

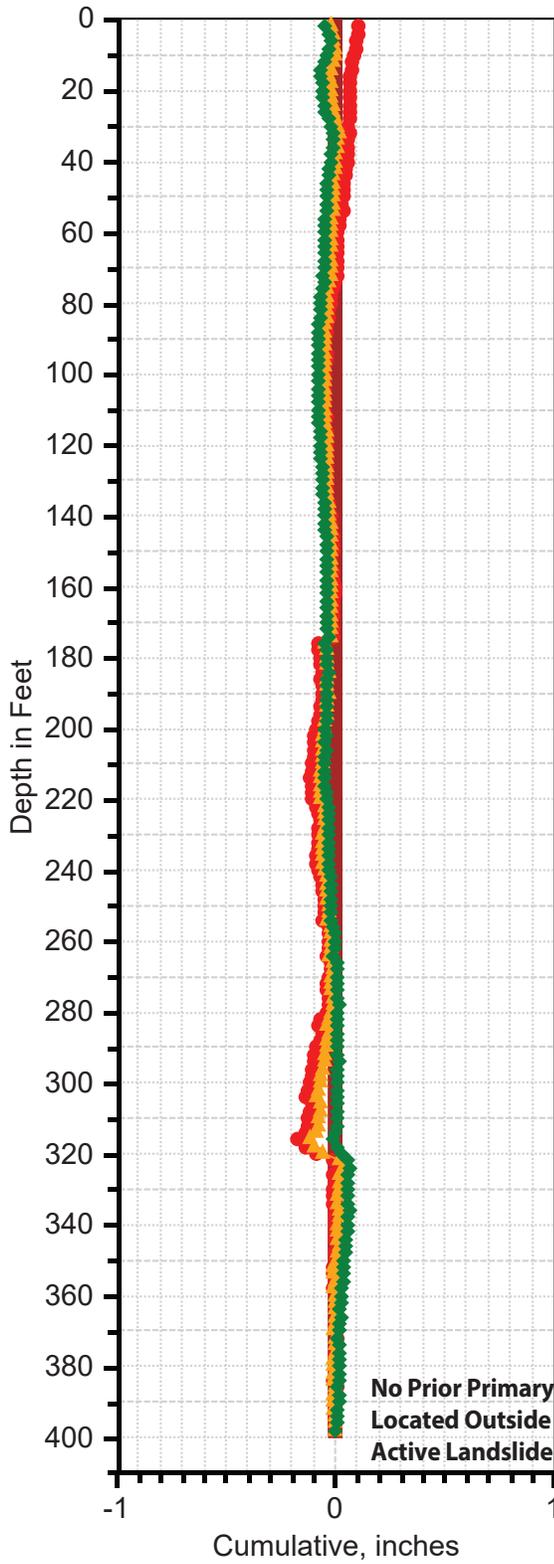
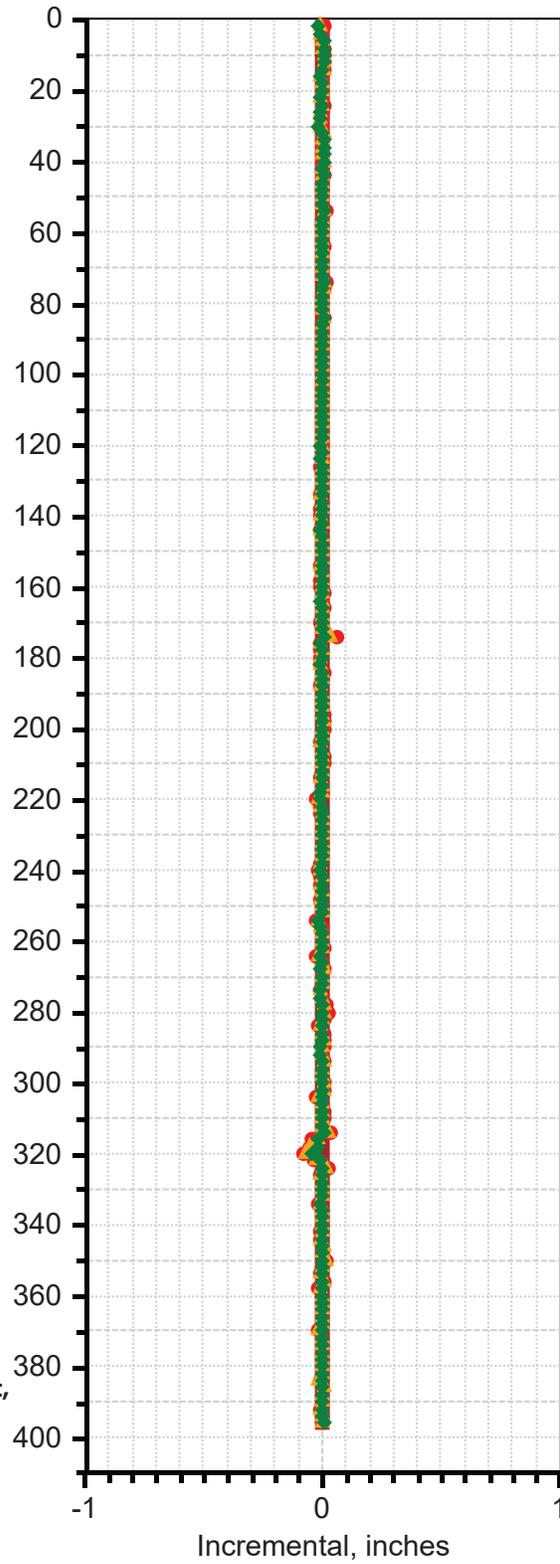
No Prior Primary Movement,
Located Outside of Mapped
Active Landslide Boundary

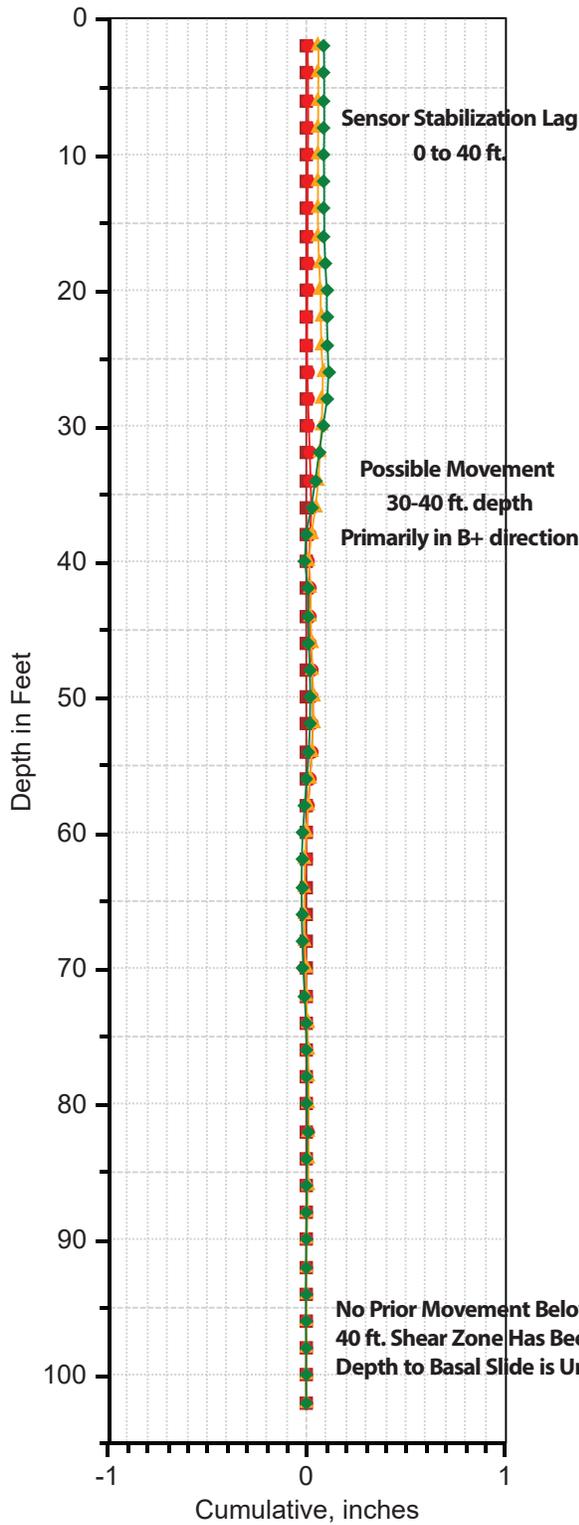
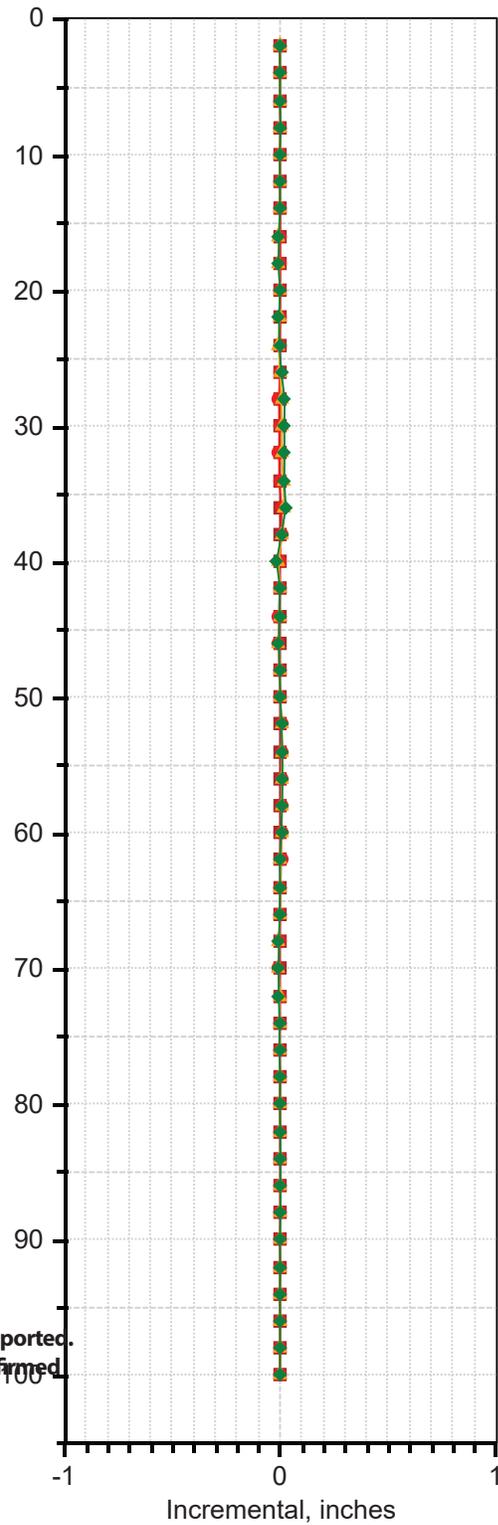
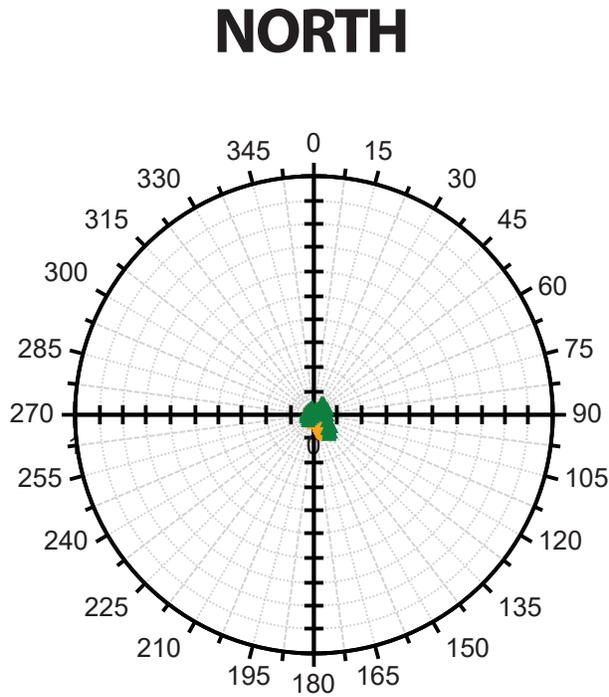
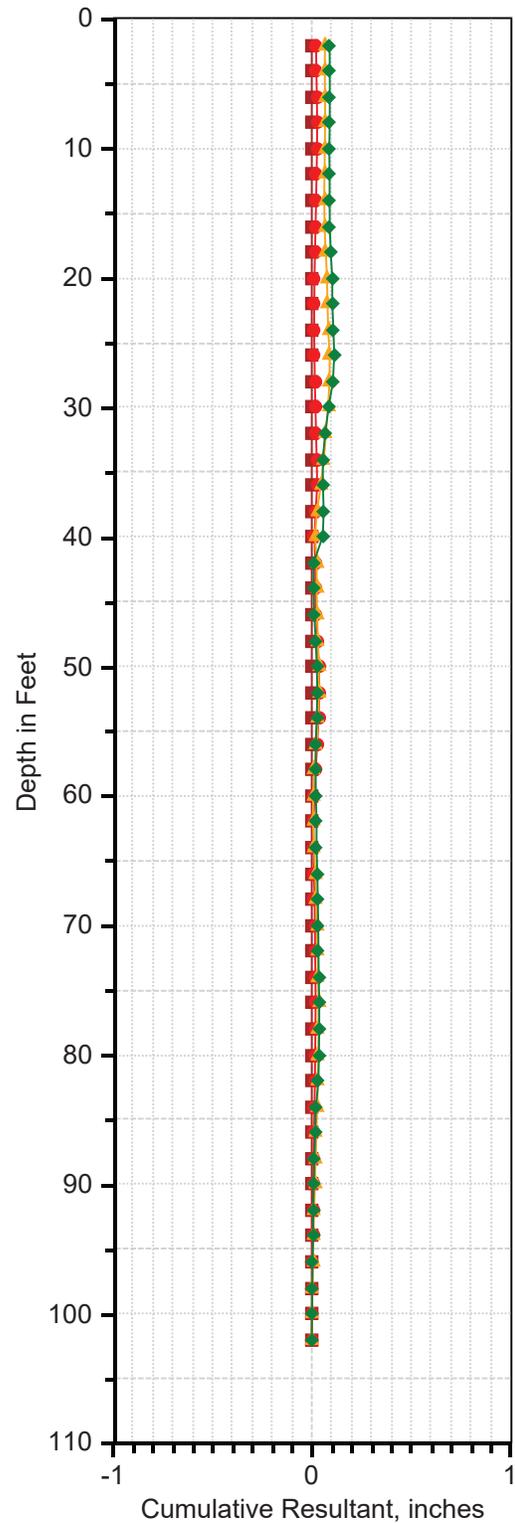
SP-26

Plot Type: Cumulative and Incremental		Plot Direction: B-Direction	
Depth of Survey (ft): 100		Baseline Date: 11/30/2023	
Install Date: 4/1984		Corrections: None	
Installed Depth (ft): 405	Interpreted Movement Since Baseline (in): 0.1 possible	Interpreted Movement Monitoring Year (in): 0.1 possible

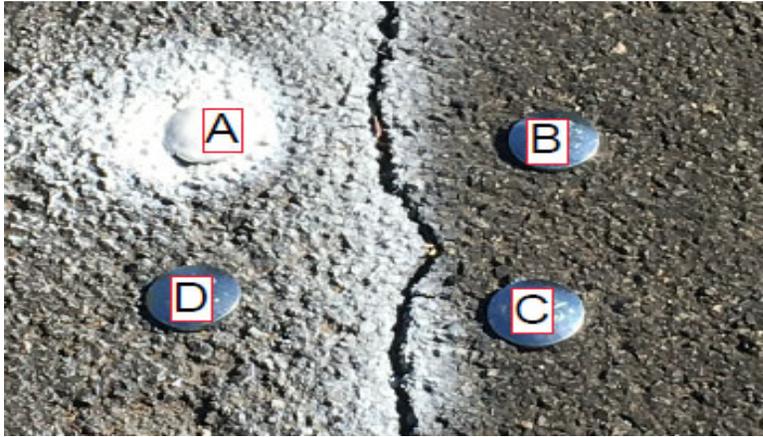
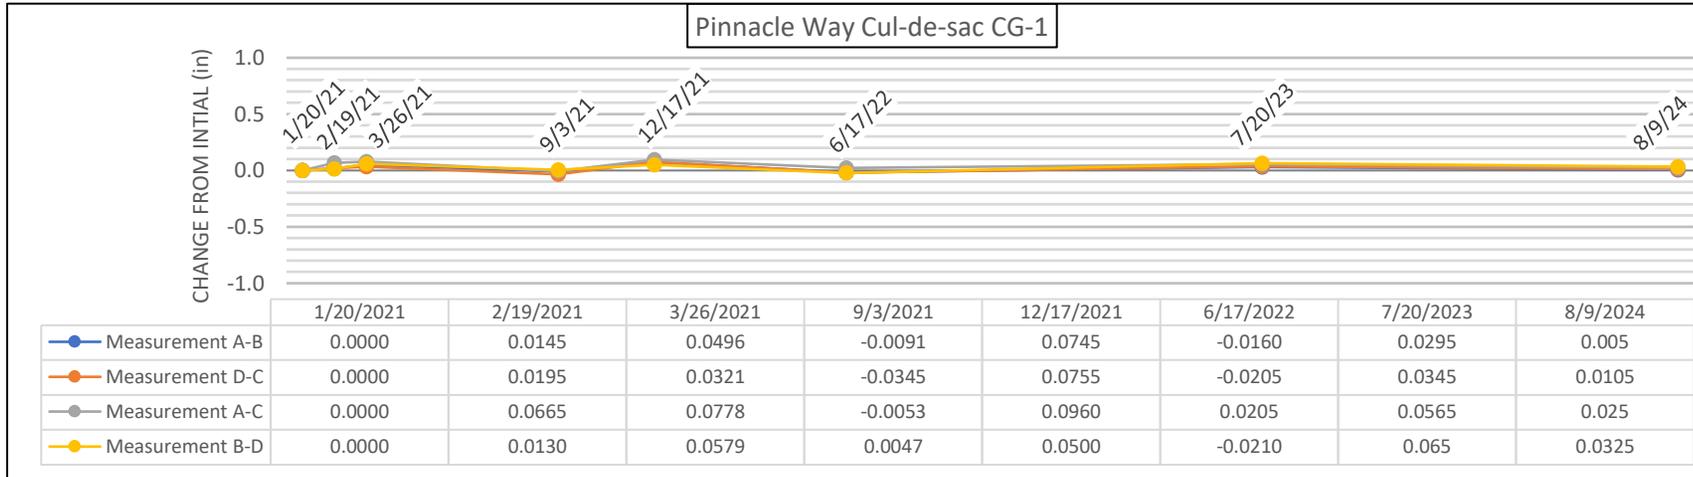
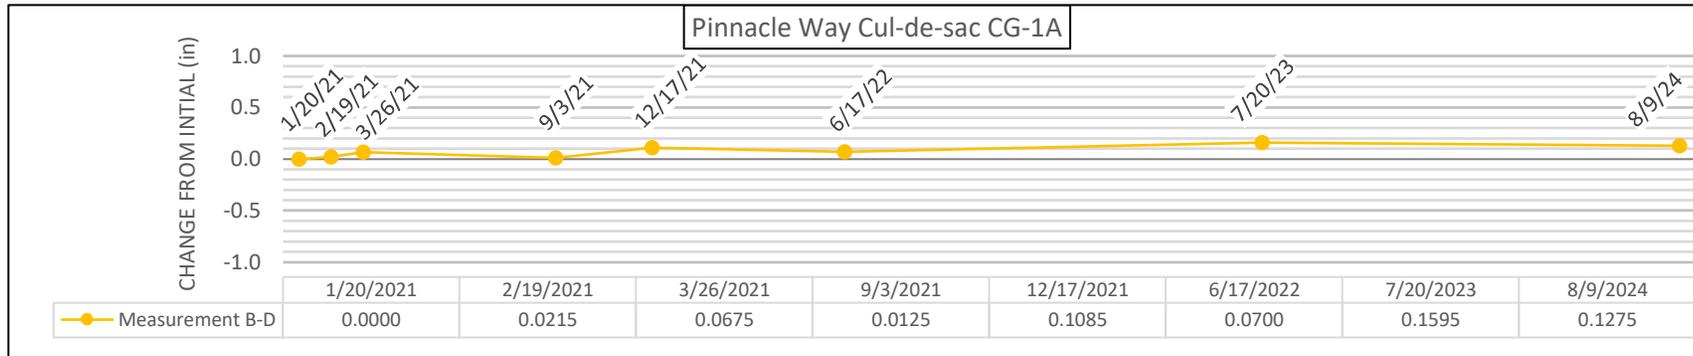
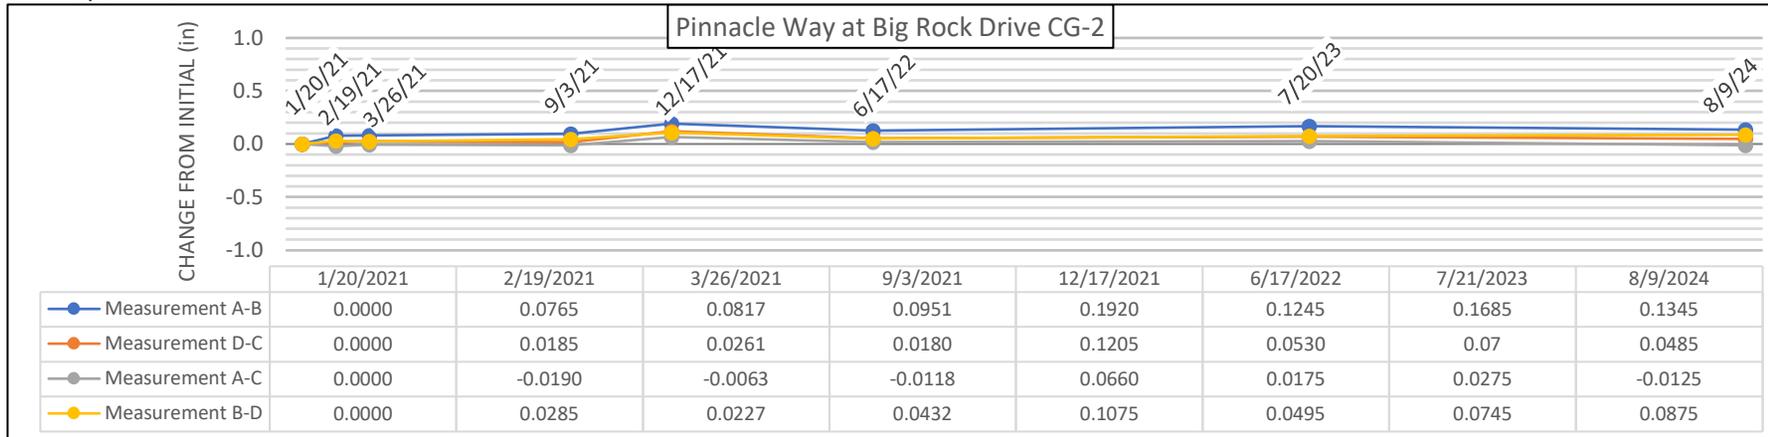
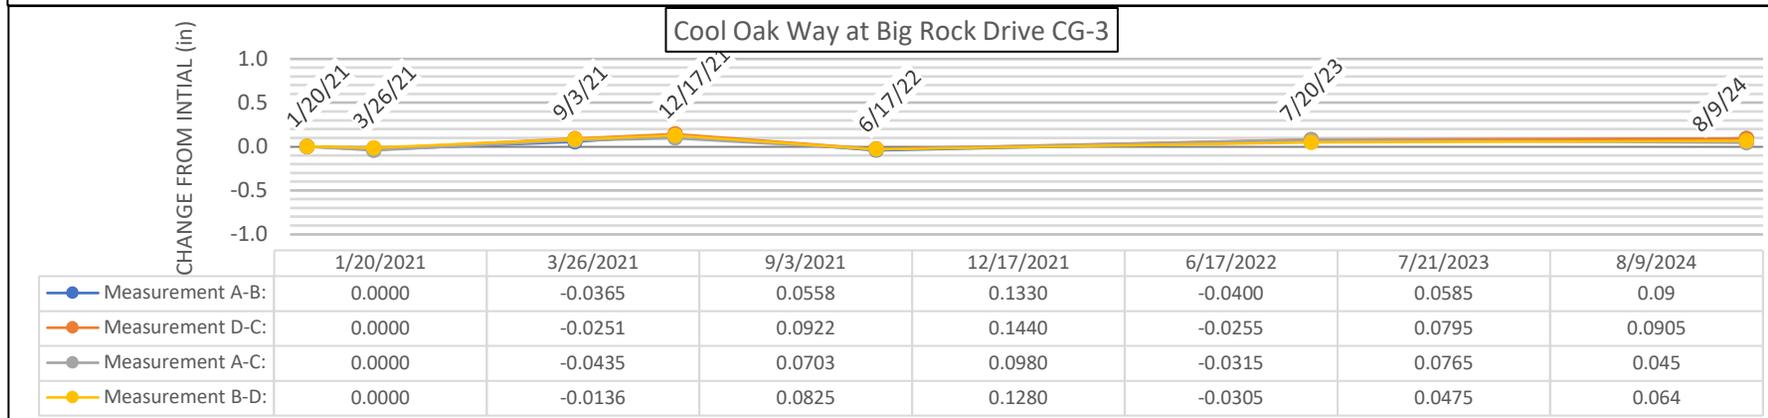
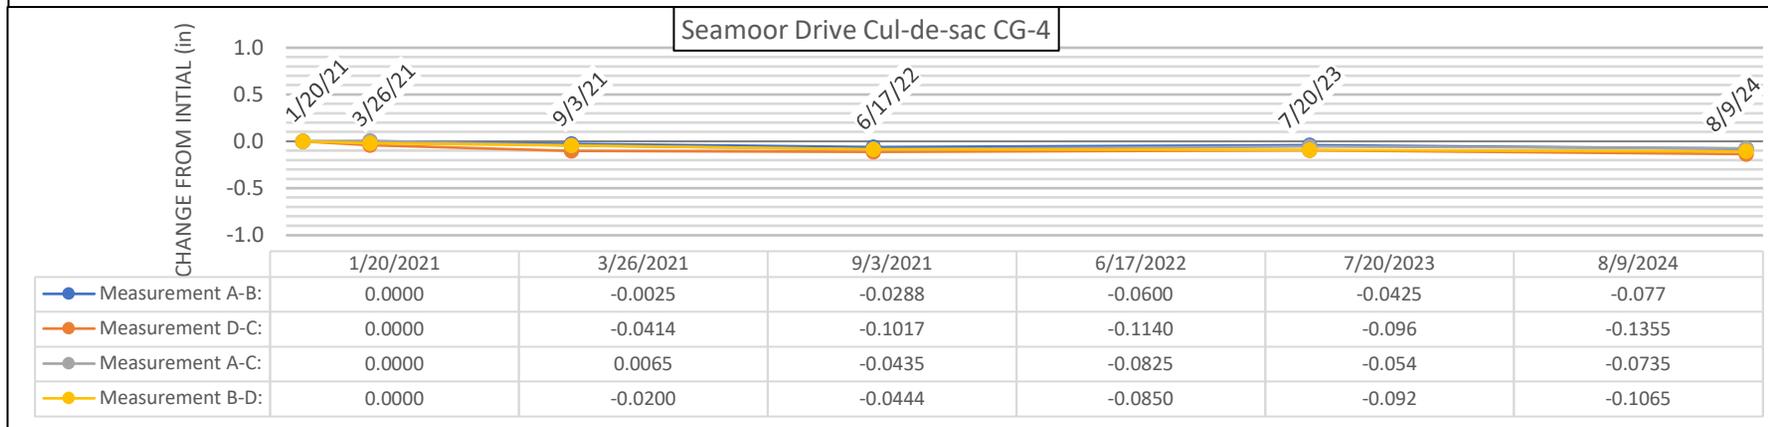
APPENDIX C – CRACK GAUGE PLOTS

Results for the five measured crack gauges are attached in Appendix C. No measurable displacement was observed on the crack gauges since the last monitoring year. No measurable displacement has been recorded on the crack gauges since installation.
