# **FY23/24 Maintenance and Monitoring**

**AD98-3, Malibu Road**

**City of Malibu, California**

**Subject: Annual Monitoring and Maintenance Report FY23/24, City of Malibu Assessment District 98-3, Malibu Road, Malibu, CA**

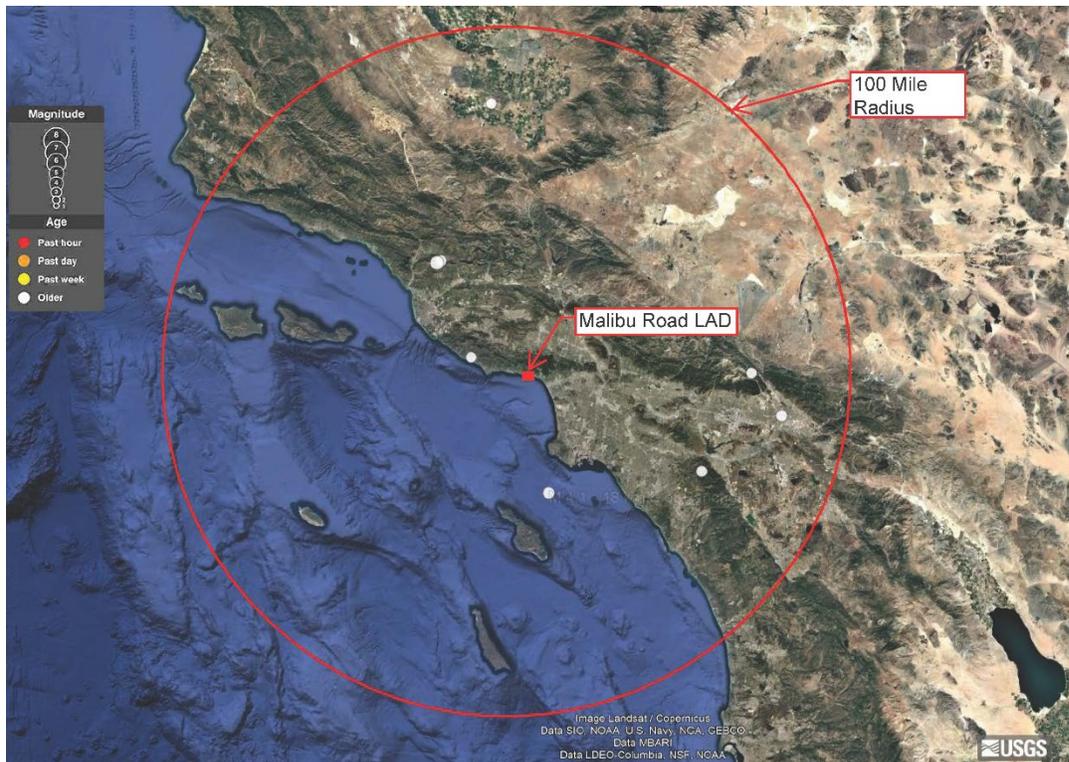
**Figure 2: M4.0+ earthquakes within 100-miles of Malibu Road LAD between 7/1/2023 and 6/30/2024**

Eight earthquakes with a magnitude of 4.0 or greater were recorded within a 100-mile radius of the project area (USGS). Earthquake magnitudes ranged from M4.09 to M5.08 with epicentral distances ranging from 16.6 to 79 miles. The largest event was reported as M5.08 that occurred August 20, 2023, and was located 37 miles to the northwest, near Ojai, CA.

Yeh personnel performed post-earthquake observations and measurements that included survey of key inclinometers and/or field observations of the ground surface made during scheduled monitoring and maintenance before and after the earthquake events. Small movement measured on inclinometers that occurred during the monitoring year cannot definitively be attributed to seismic activity. Yeh staff did not observe surface displacements related specifically to the earthquakes and is unaware of any reports of damage local to the Malibu Road Landslide AD resulting from the earthquakes.

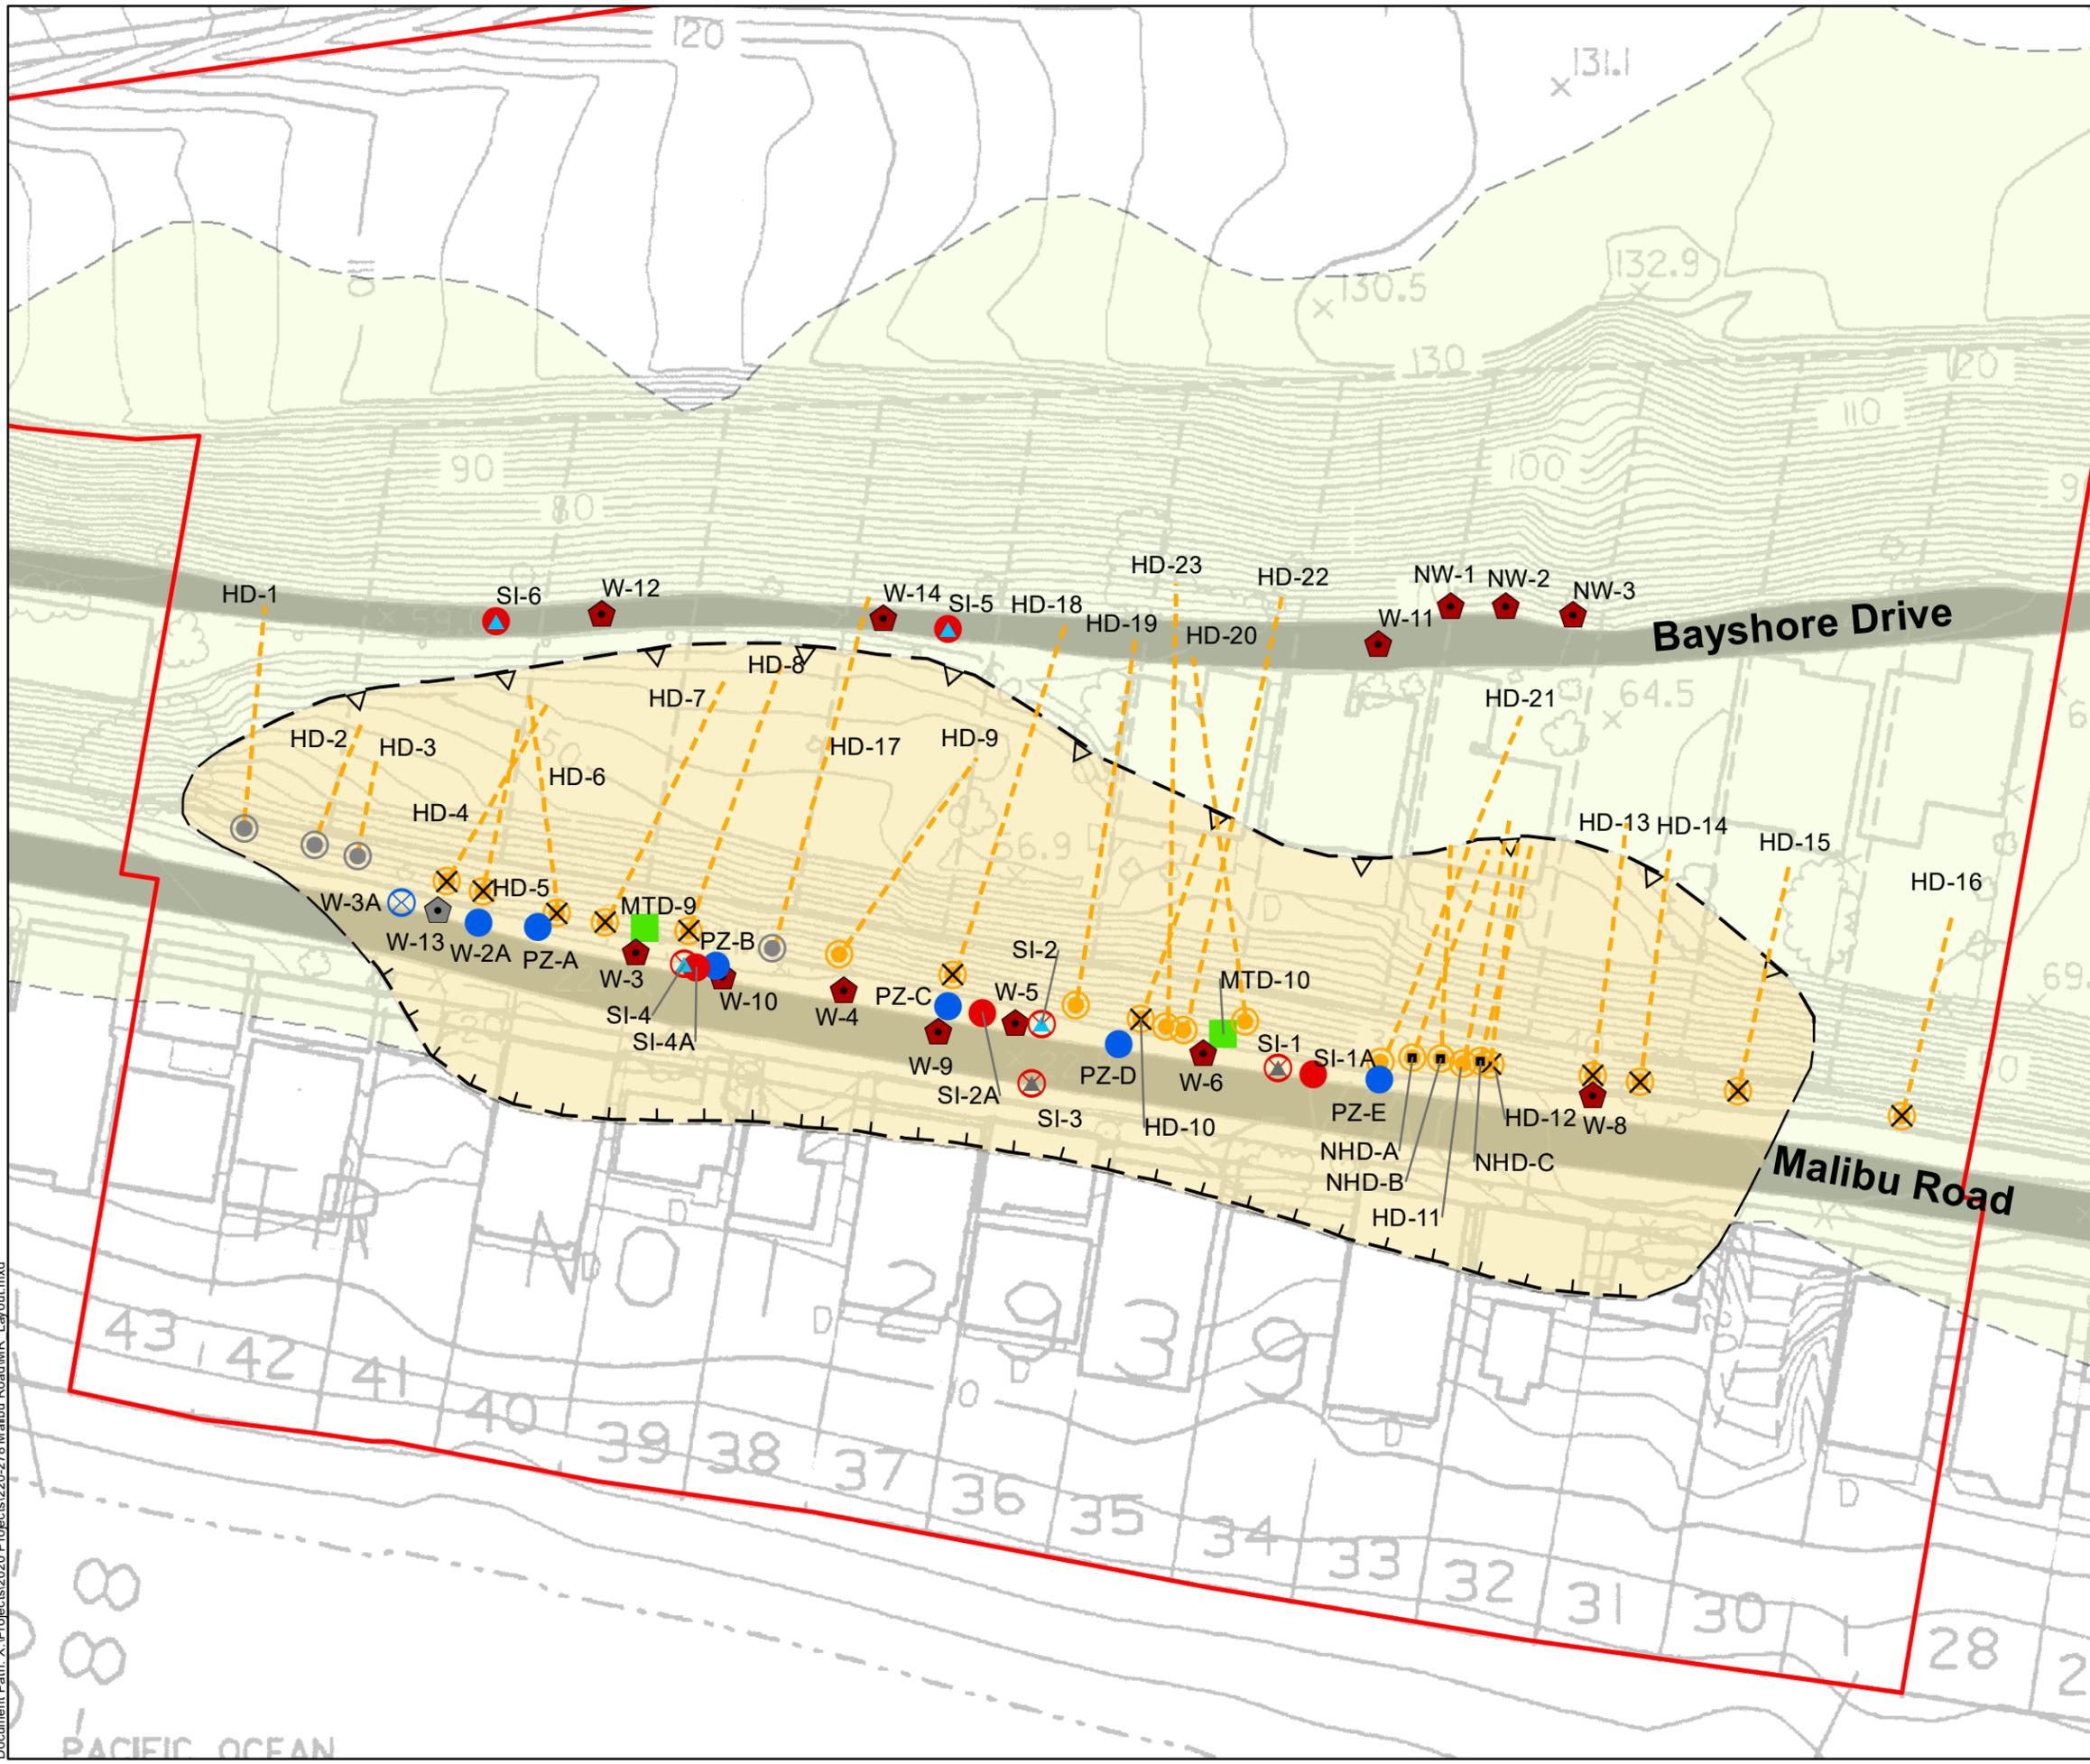
## MONITORING INSTRUMENTATION AND DEWATERING FACILITIES MAP

Groundwater levels were measured approximately monthly in 8 standpipe piezometers shown on Plate 1. Water levels are acquired by lowering an electric probe into the standpipe to contact the groundwater surface and manually recording the depth to water. Groundwater hydrographs for individual standpipes from historic through the end of the current monitoring year are presented in Appendix A.

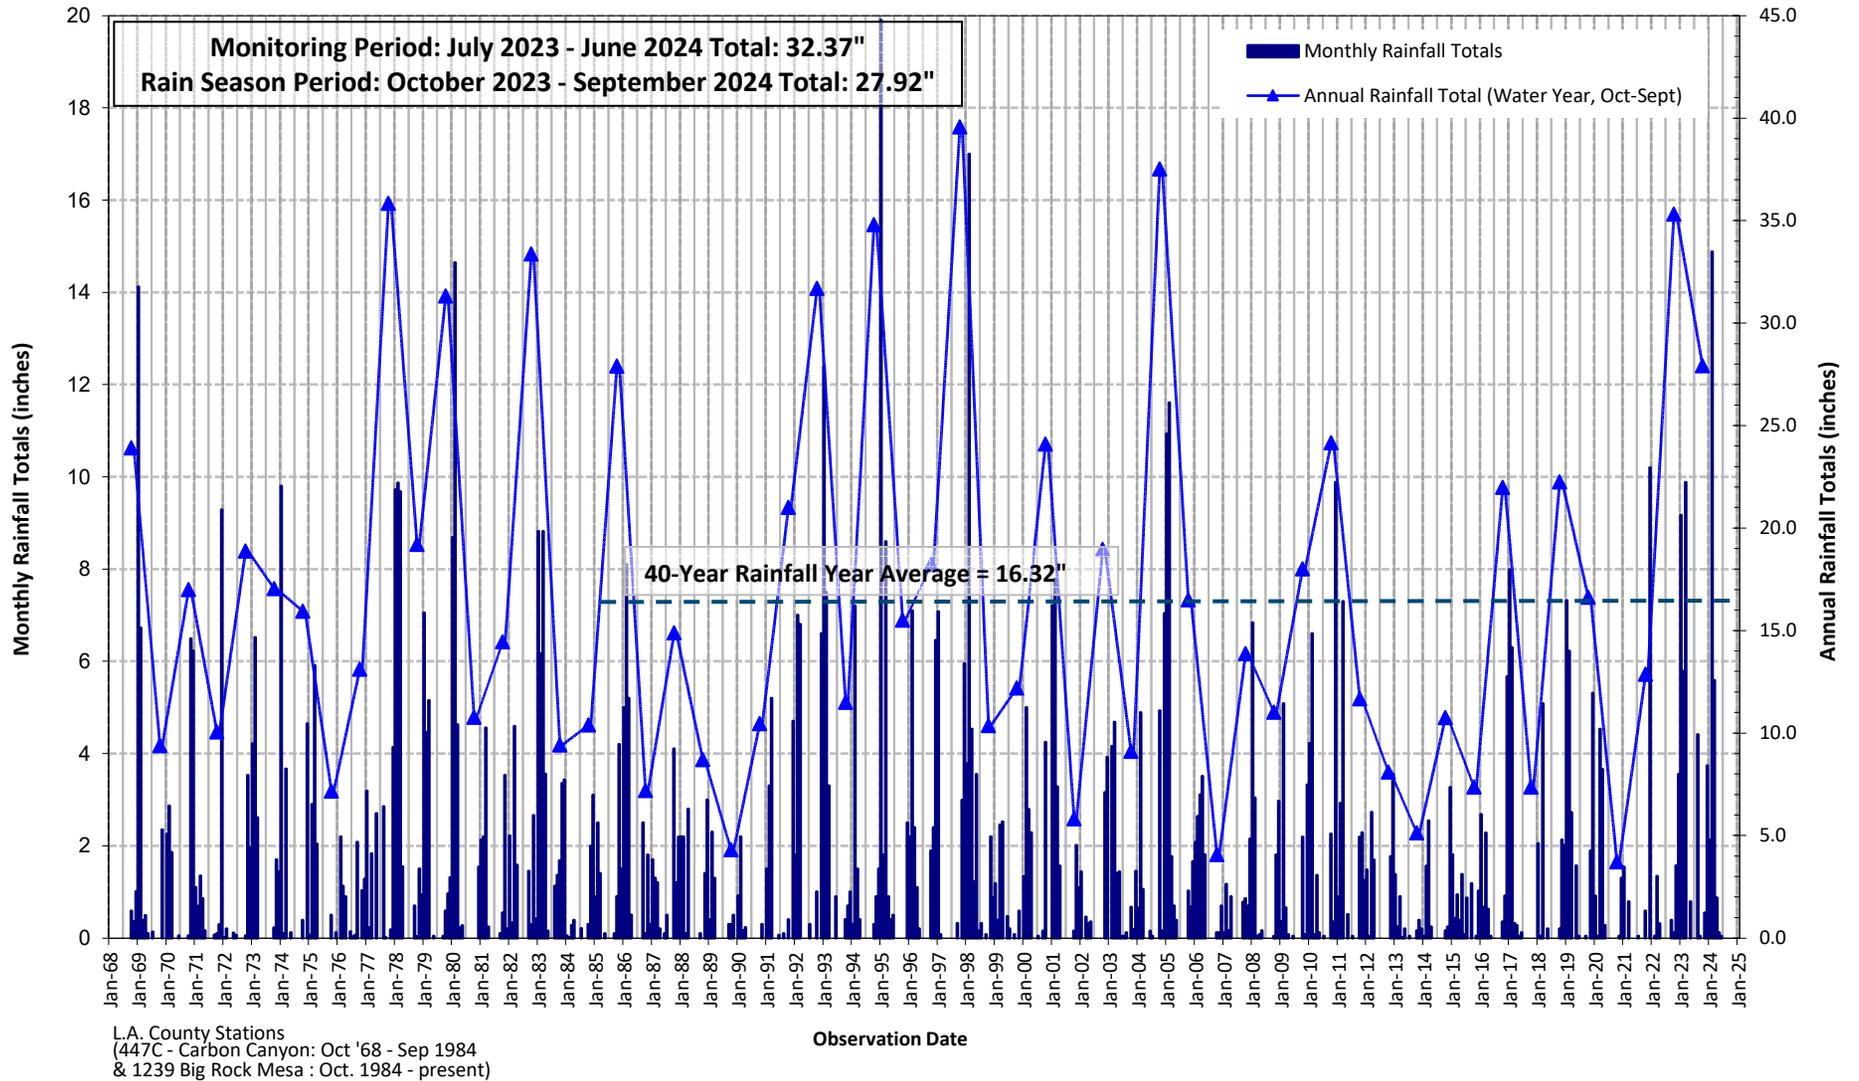
**RAINFALL GRAPH**  
 Landslide Assessment Districts  
 Malibu, California

Plate 2 - Rainfall Graph displays historical monthly and water year annual rainfall from October 1968 through September 2024. Recorded rainfall over the monitoring year from July 1, 2023 to June 30, 2024 totaled 32.37 inches, which is 15.93 inches above the 40-year Big Rock Mesa Rain Gauge running average of 16.44 inches. The recorded rainfall total for the water year from October 1, 2023, to September 30, 2024 totaled 27.92 inches.
