**ANNUAL REPORT
JULY 2011 THROUGH JUNE 2012
CALLE DEL BARCO
LANDSLIDE ASSESSMENT DISTRICT
MALIBU, CALIFORNIA**

Prepared for:
CITY OF MALIBU

September 2012
Fugro Job No. 04.B3399005

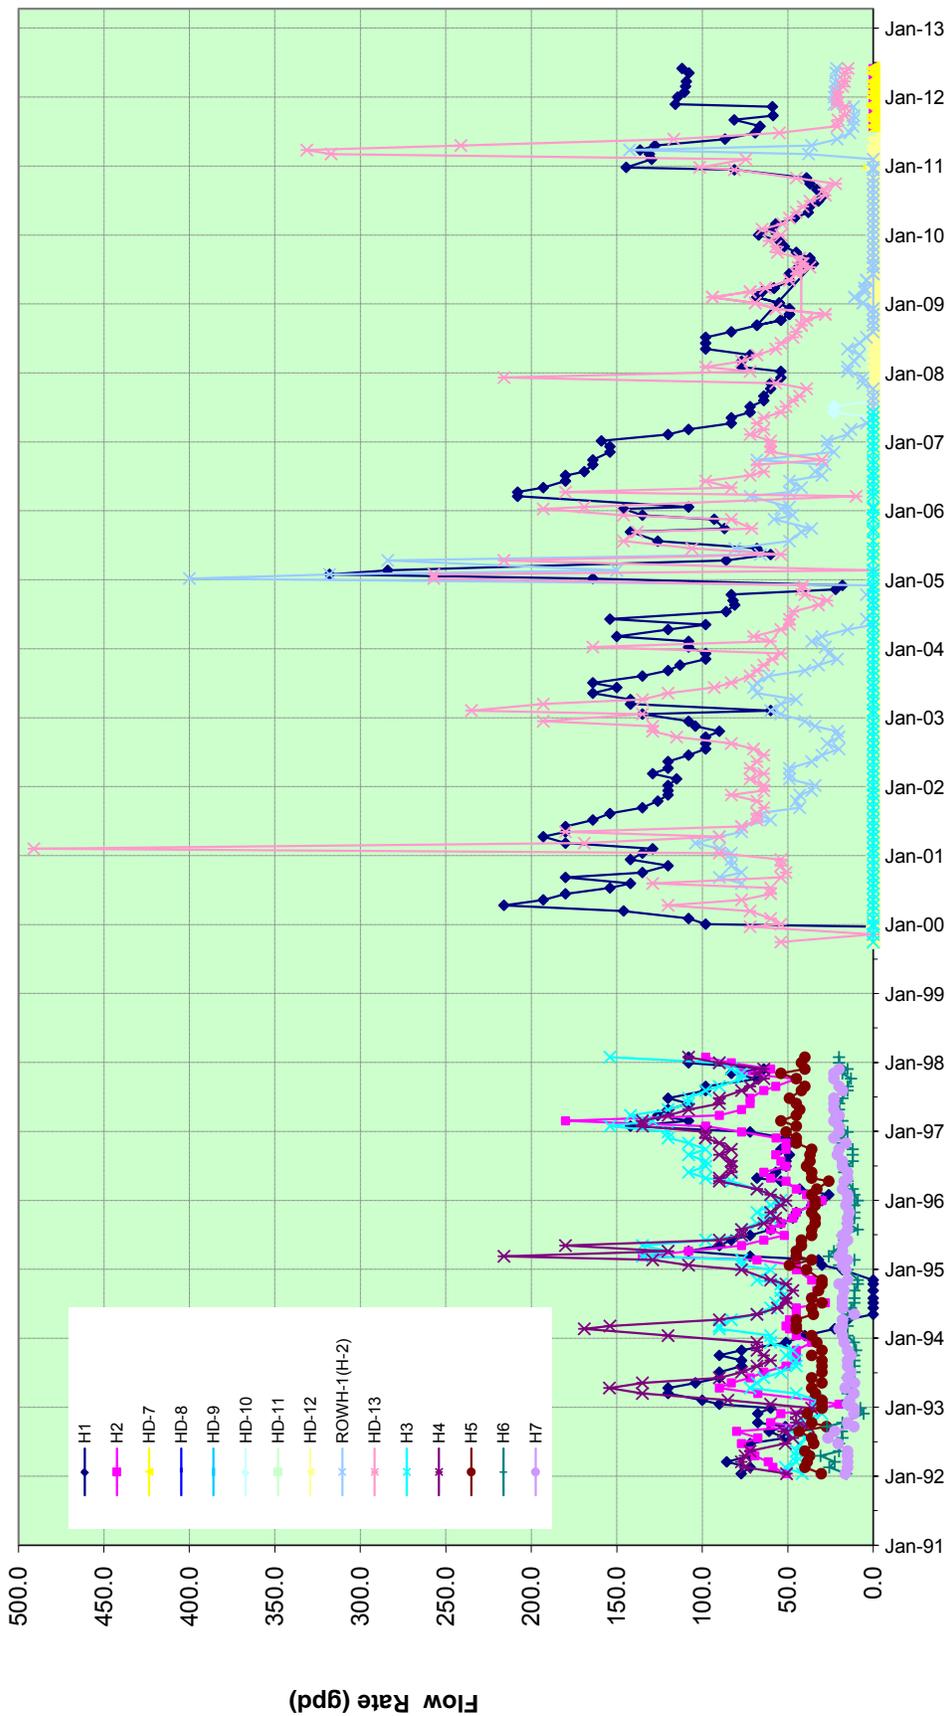
HYDRAUGER GRAPH
Discharge Rates for all Hydraulics
Calle del Barco Landslide Assessment District
Malibu, California

- Slope inclinometer readings indicate no significant ground movement.
- Additional dewatering facilities are recommended in order to increase the dewatering capacity of the landslide stabilization system. Plate 4 indicates decreased production from hydraugers. Over time, hydraugers become clogged and less efficient at removal of water by gravity. Replacement hydraugers should be considered for Rambla Orienta.
