**ANNUAL REPORT
JULY 2016 THROUGH JUNE 2017
BIG ROCK MESA LANDSLIDE
ASSESSMENT DISTRICT
City of Malibu, California**

March 2018
Fugro Project No. 04.62160606
Document No. 04.62160606-PR-004(Rev.00)

**Annual Report of Maintenance and Monitoring, July 2016 through June 2017,
Big Rock Mesa Landslide Assessment District, City of Malibu, California**

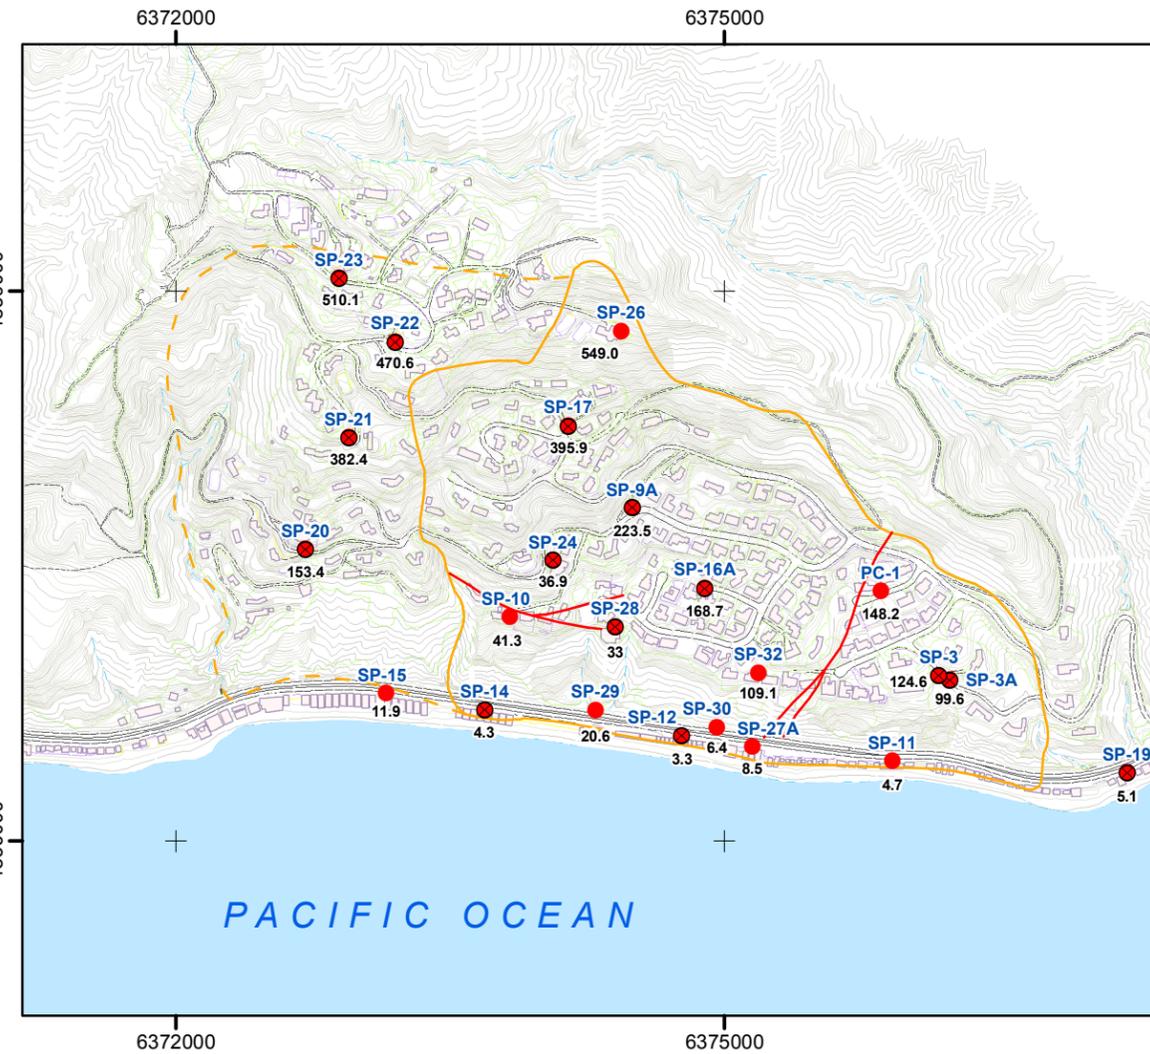
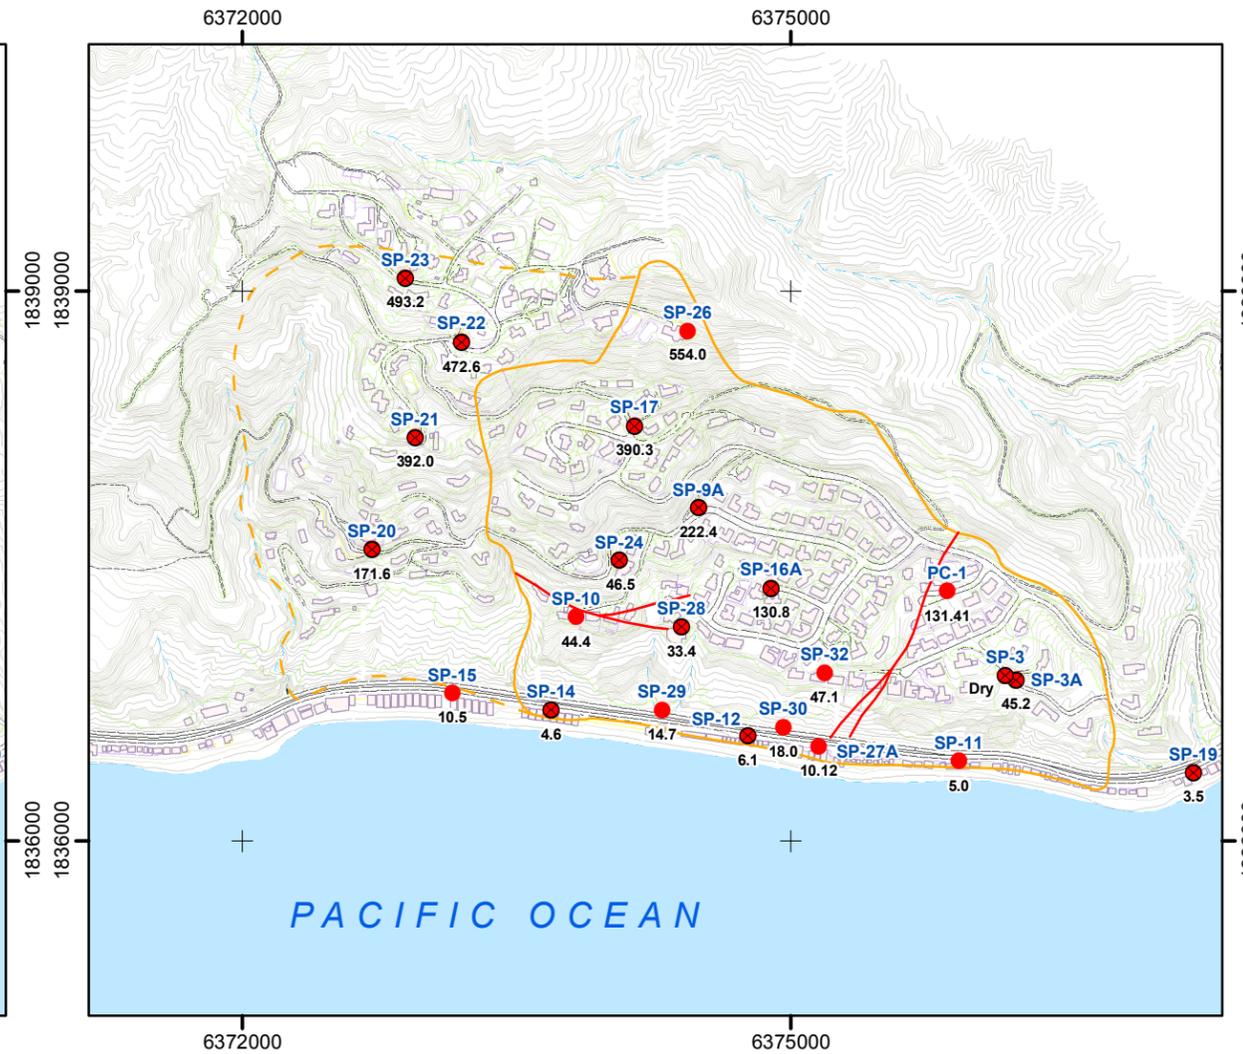
**GROUNDWATER ELEVATION MAP
MAY 1995 AND MAY 2017**
Big Rock Mesa Landslide
Assessment District
Malibu, California

Groundwater Elevation (May 8, 1995)

Groundwater Elevation (May 15, 2017)

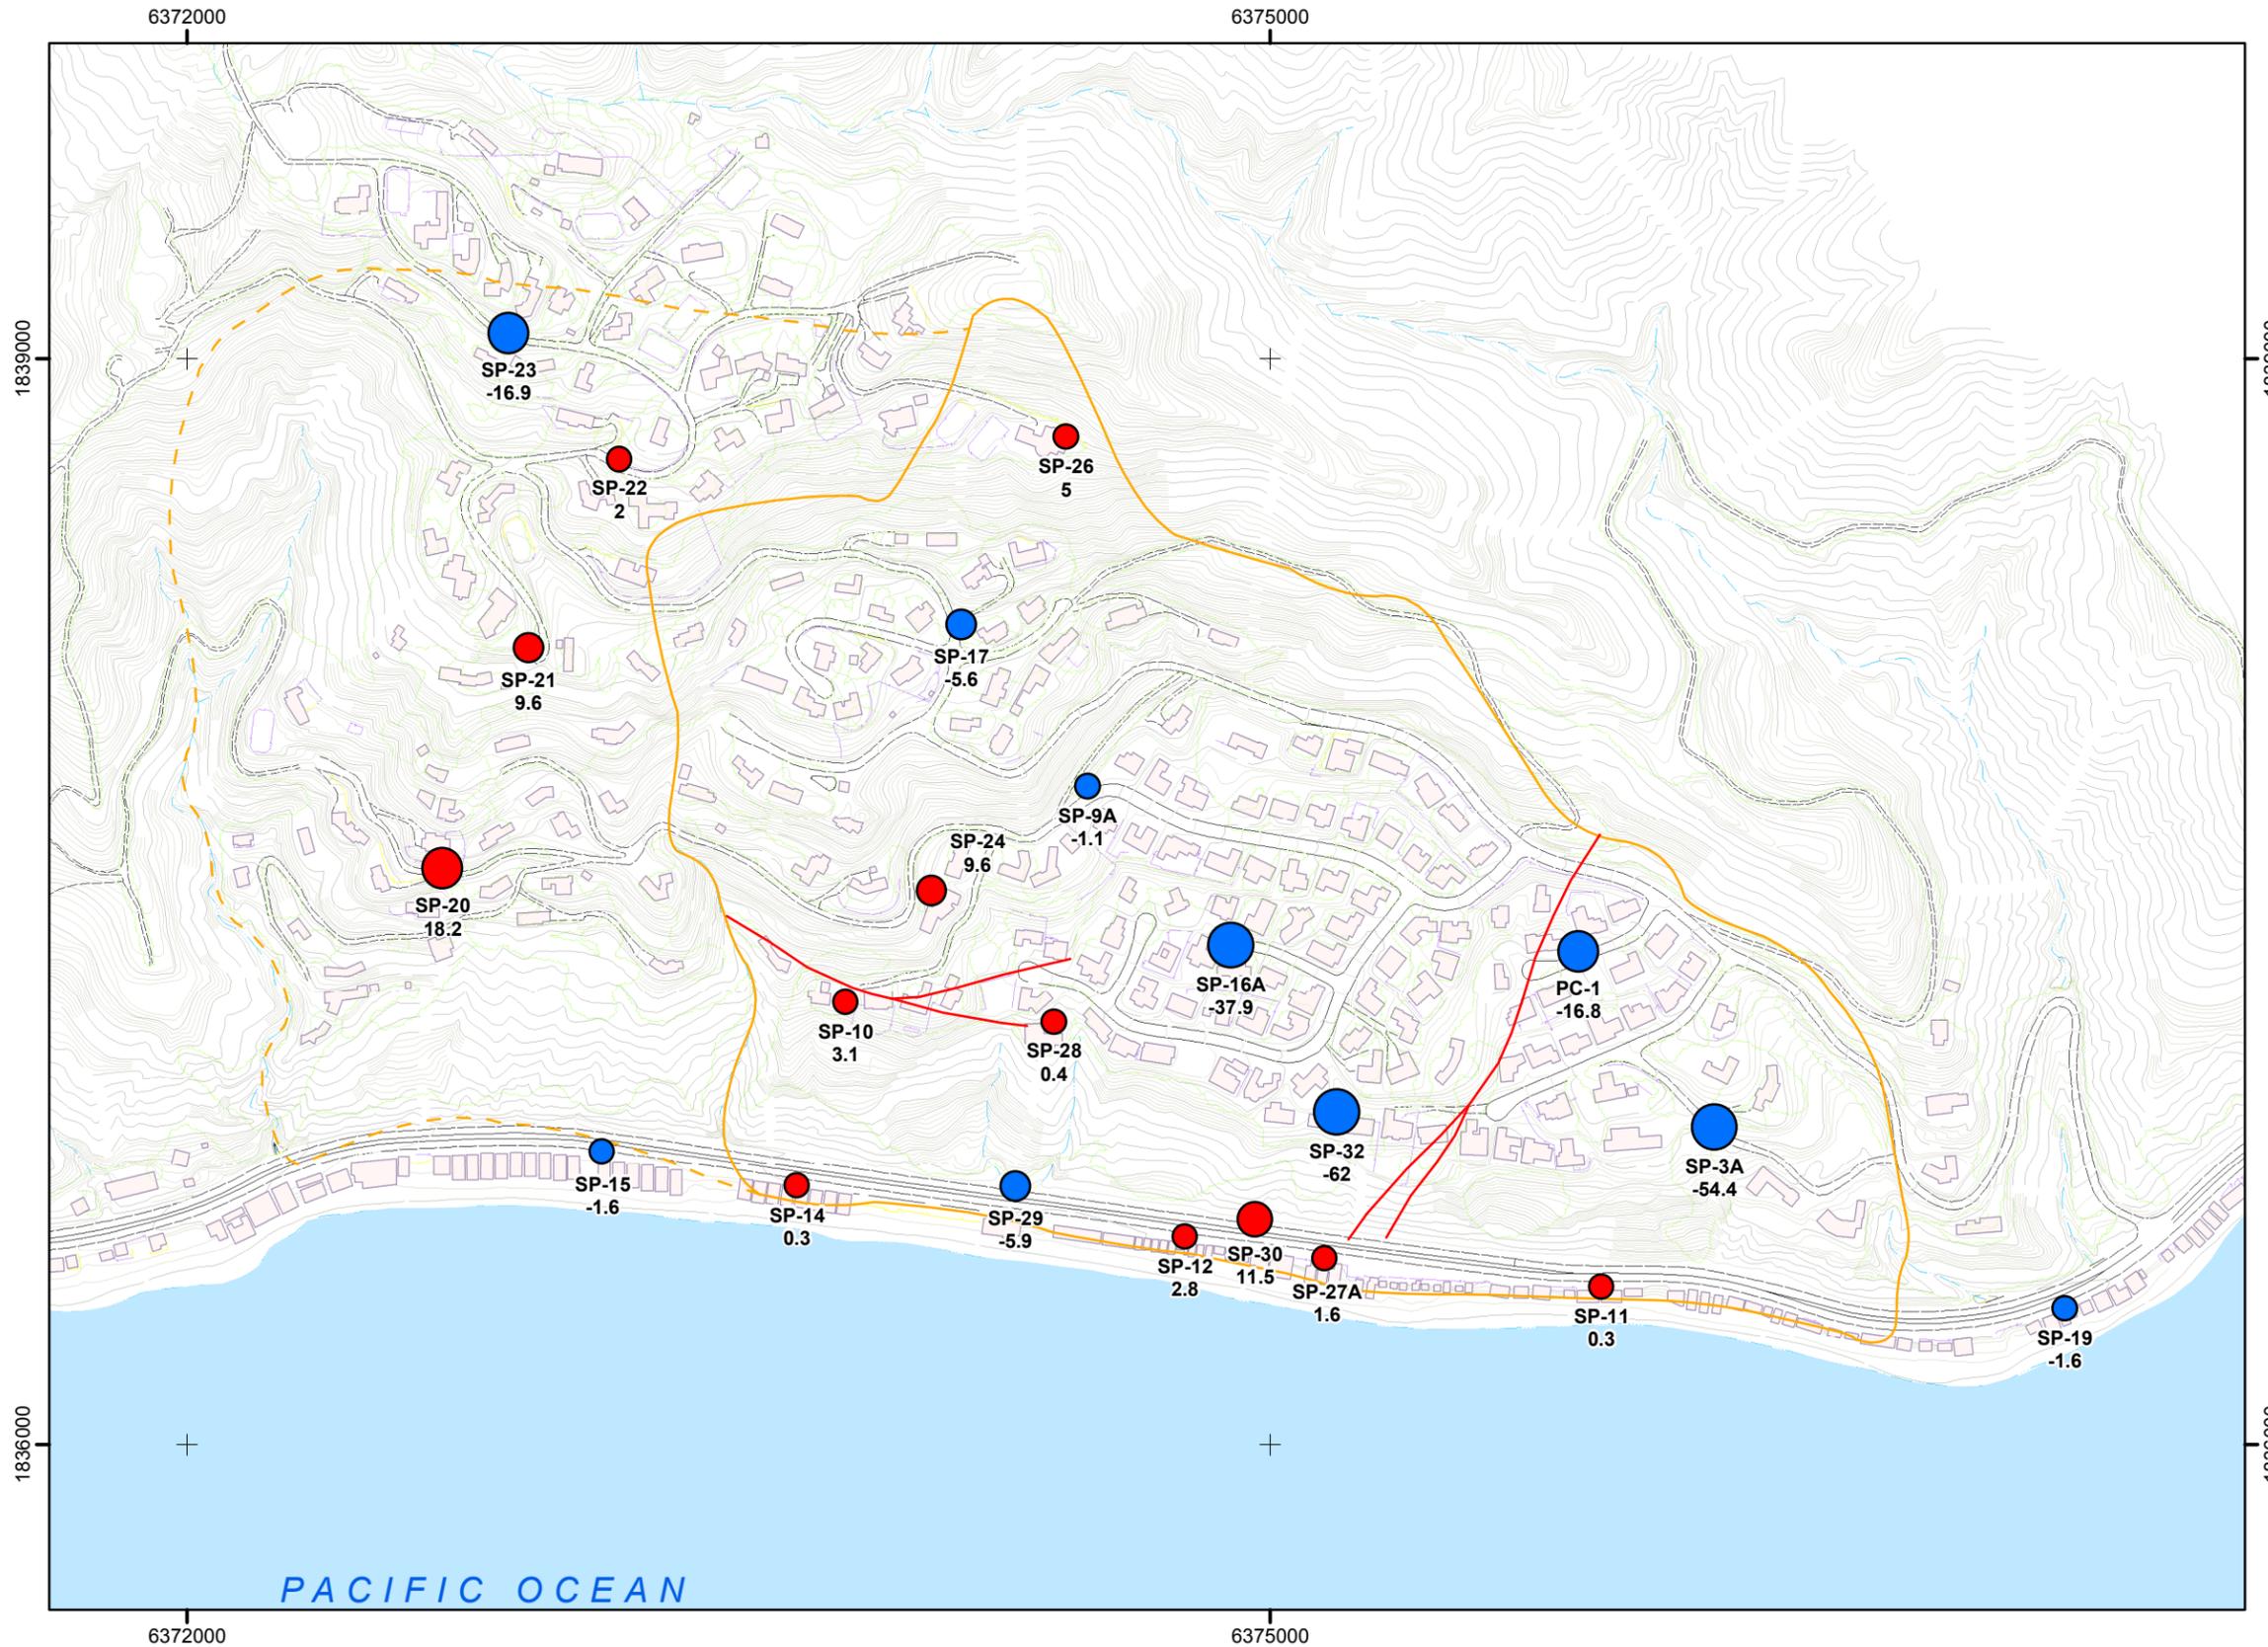
**CHANGE IN GROUNDWATER
ELEVATION MAY 1995 TO MAY 2017**
Big Rock Mesa Landslide
Assessment District
Malibu, California

SP-16
-3.1
Instrument Label and
Ground Water Elevation
Change in feet

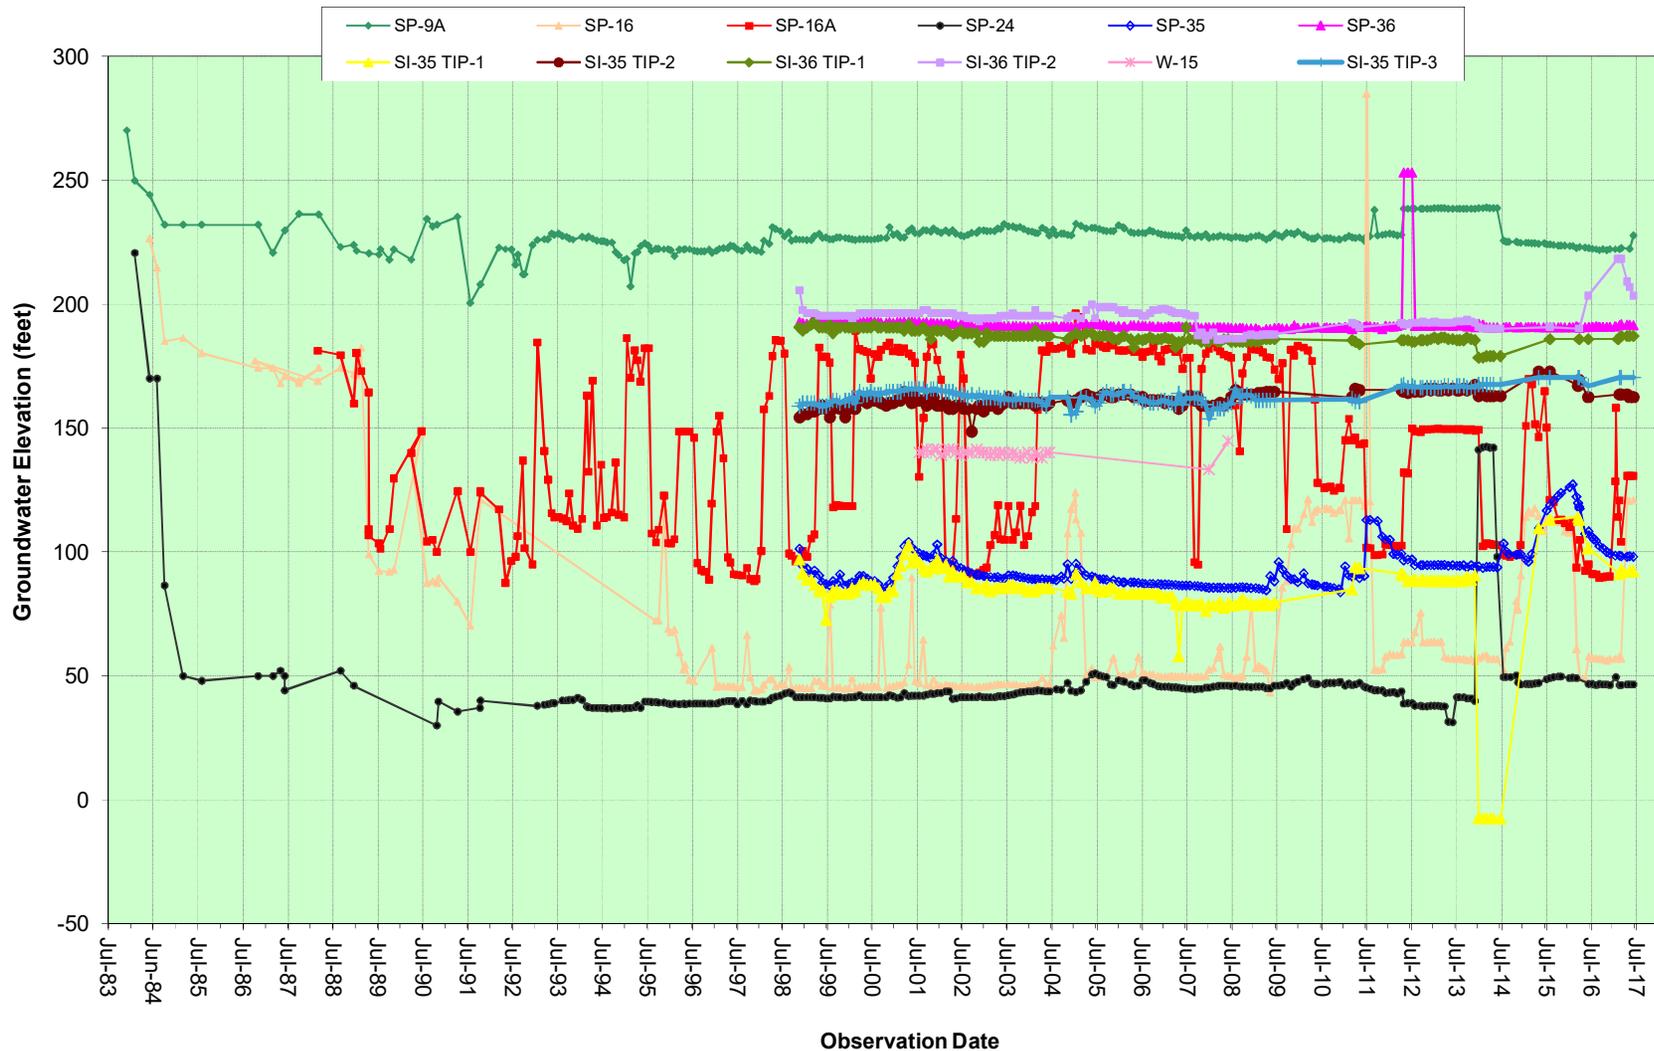
PLATE A-6a

GROUNDWATER ELEVATION DATA

Central Mesa Region

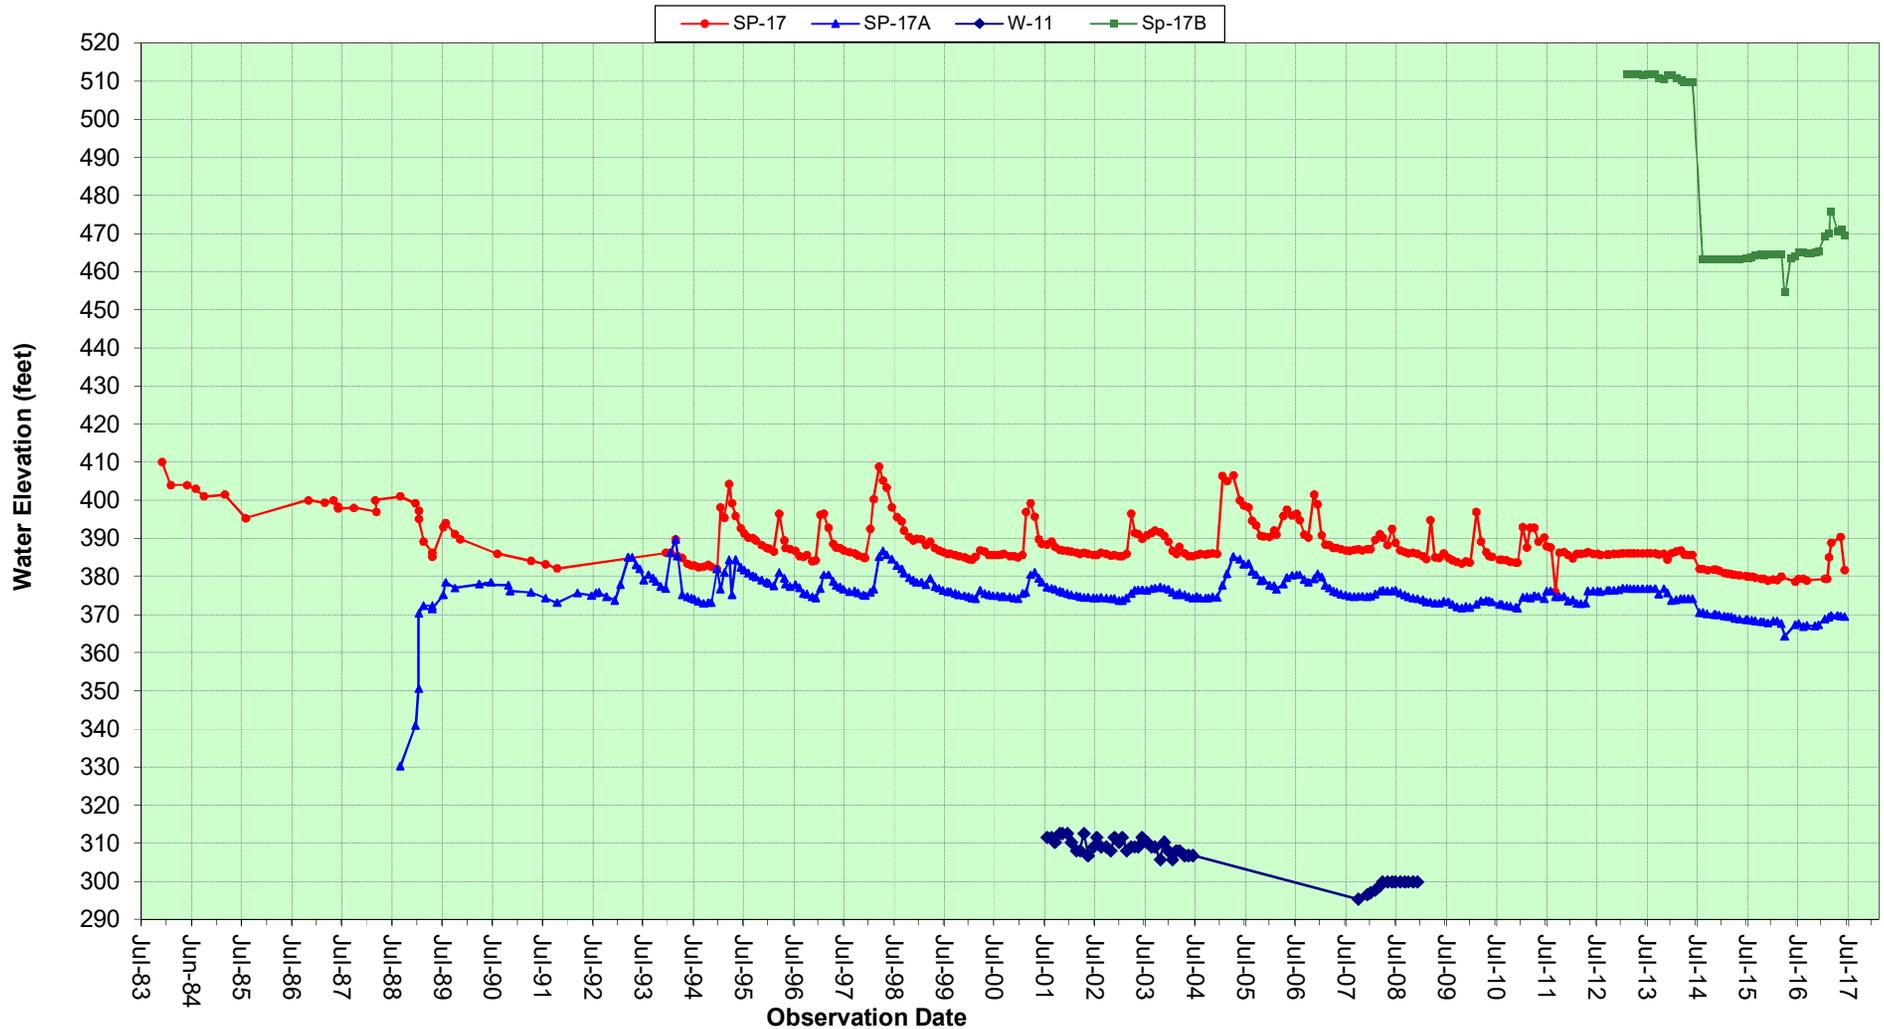
PLATE A-6b

GROUNDWATER ELEVATION DATA

Central Mesa Region

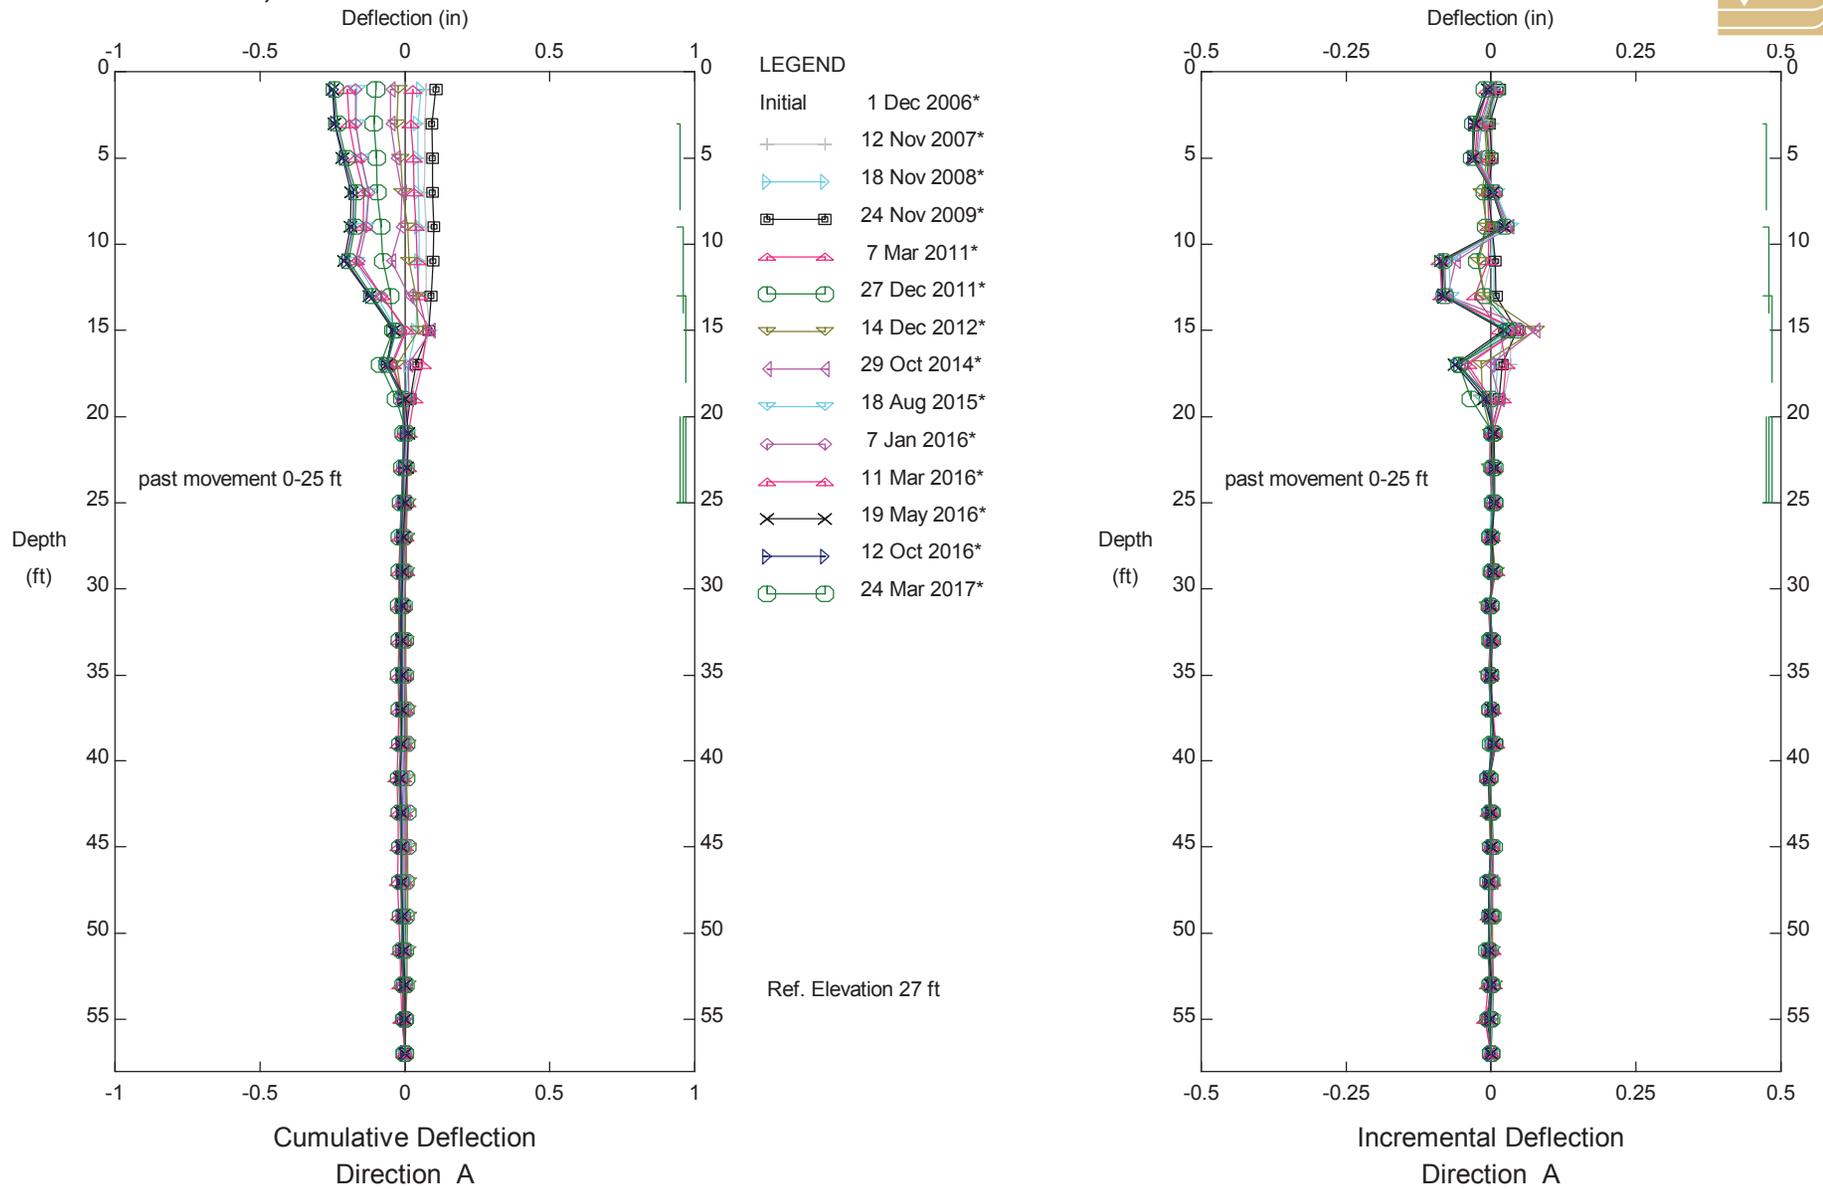
BIG ROCK MESA, Inclinometer SP-11
 PCH REGION

Sets marked * include zero shift and/or rotation corrections.

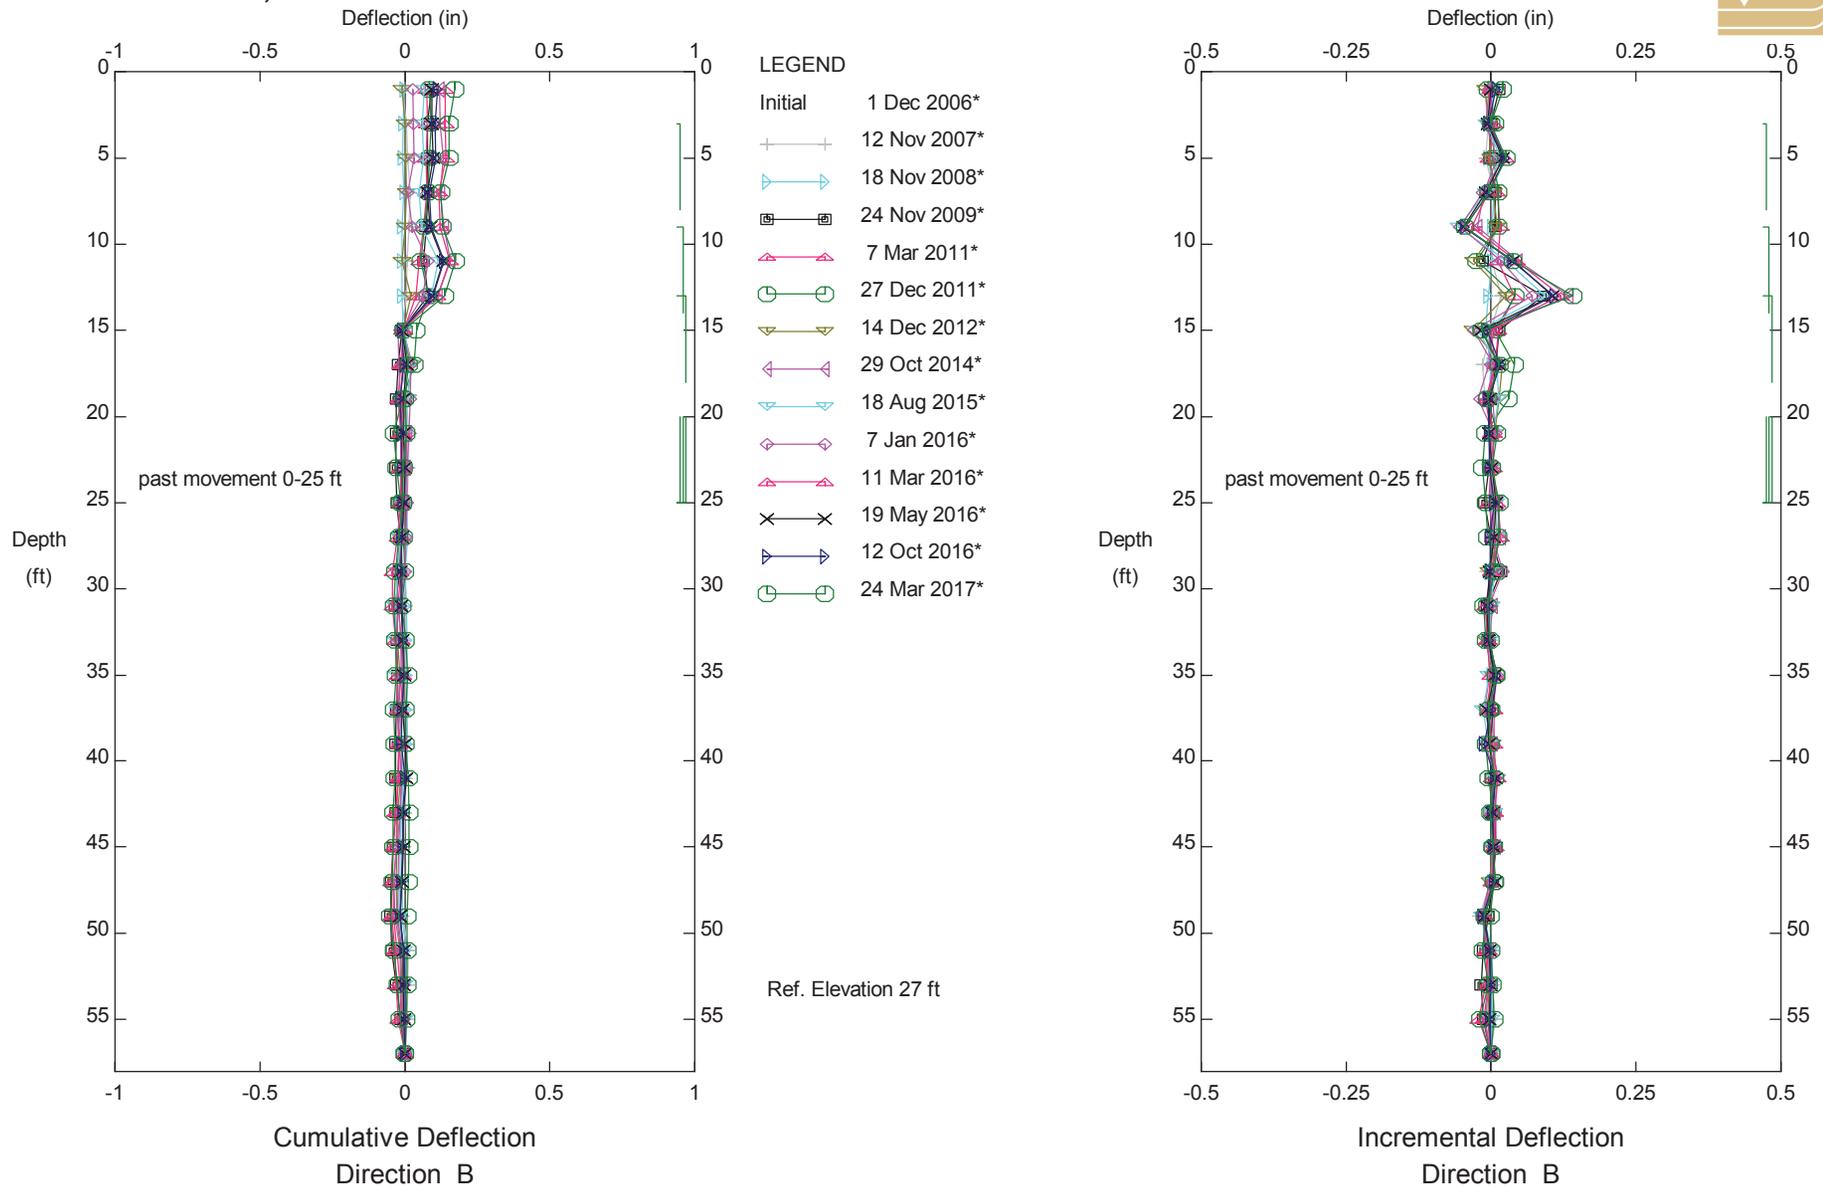
BIG ROCK MESA, Inclinometer SP-11
 PCH REGION

Sets marked * include zero shift and/or rotation corrections.

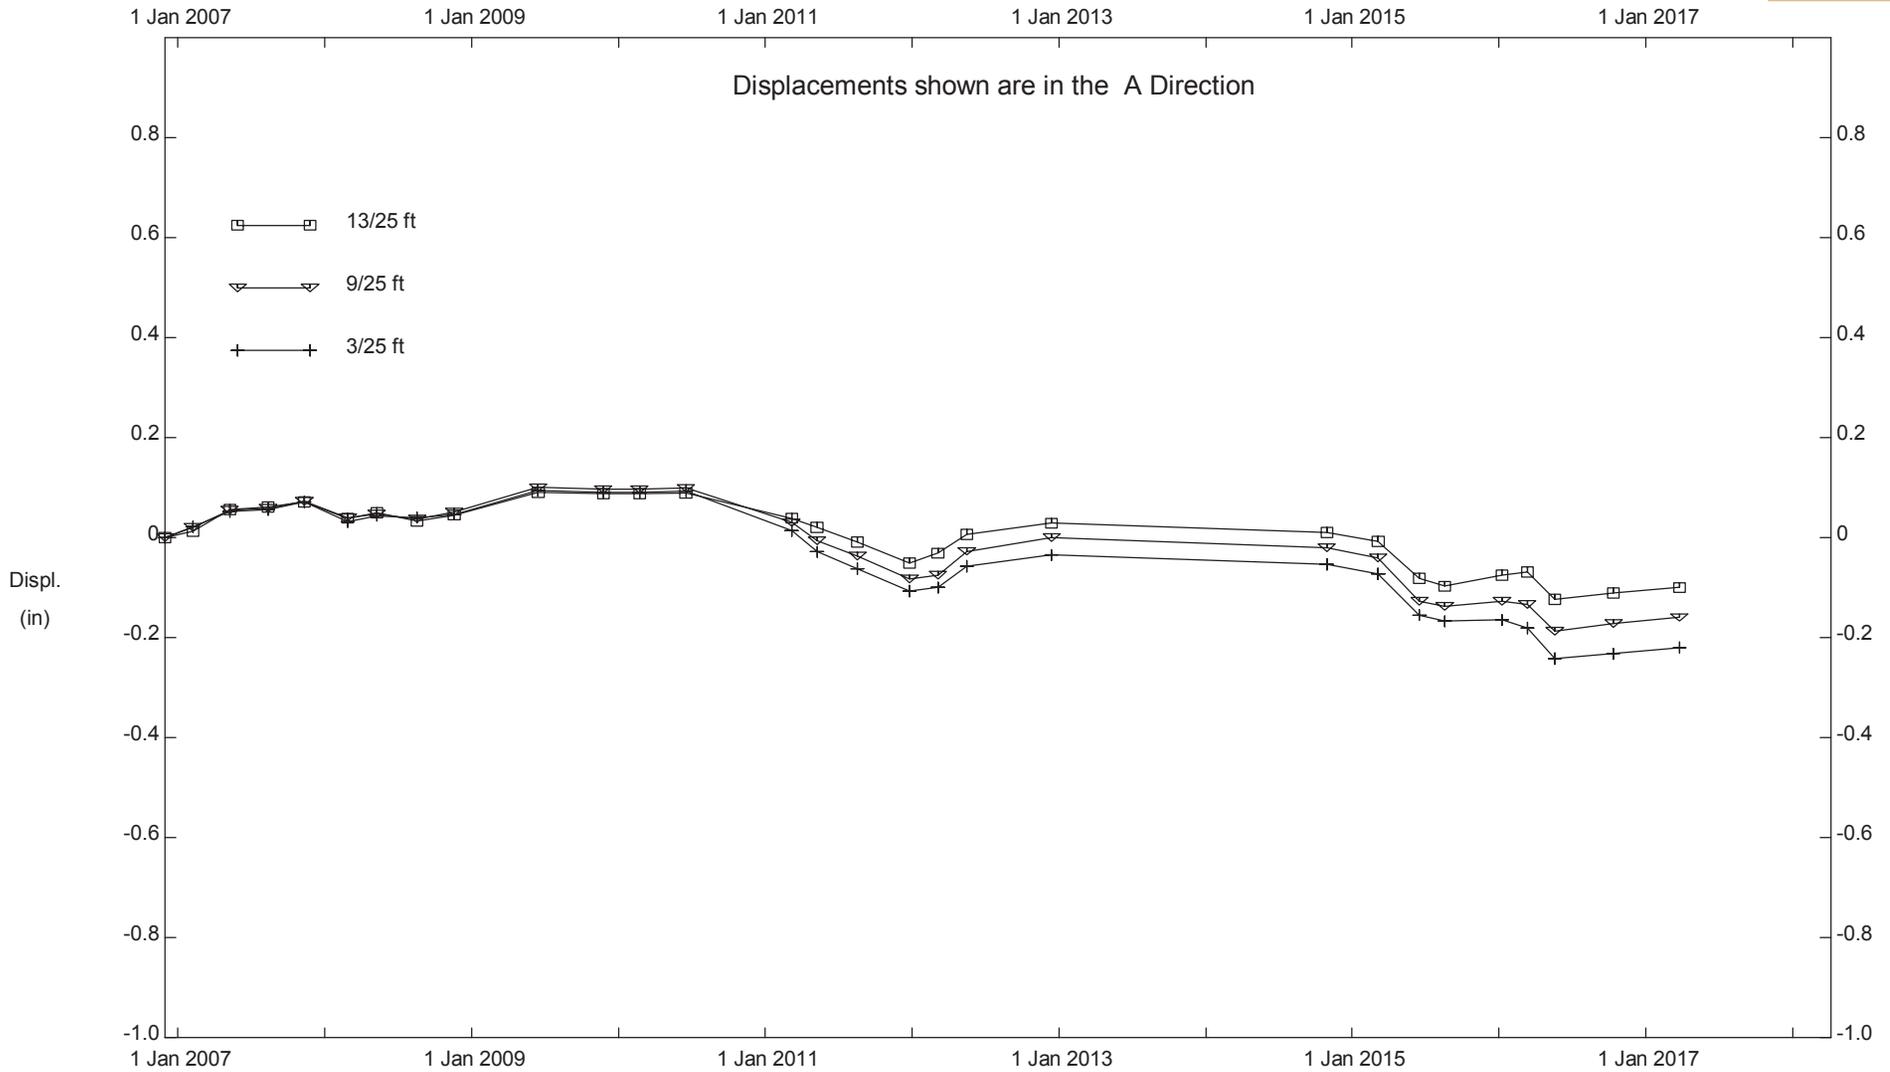
PLATE D2-3

BIG ROCK MESA, Inclinator SP-11

PCH REGION

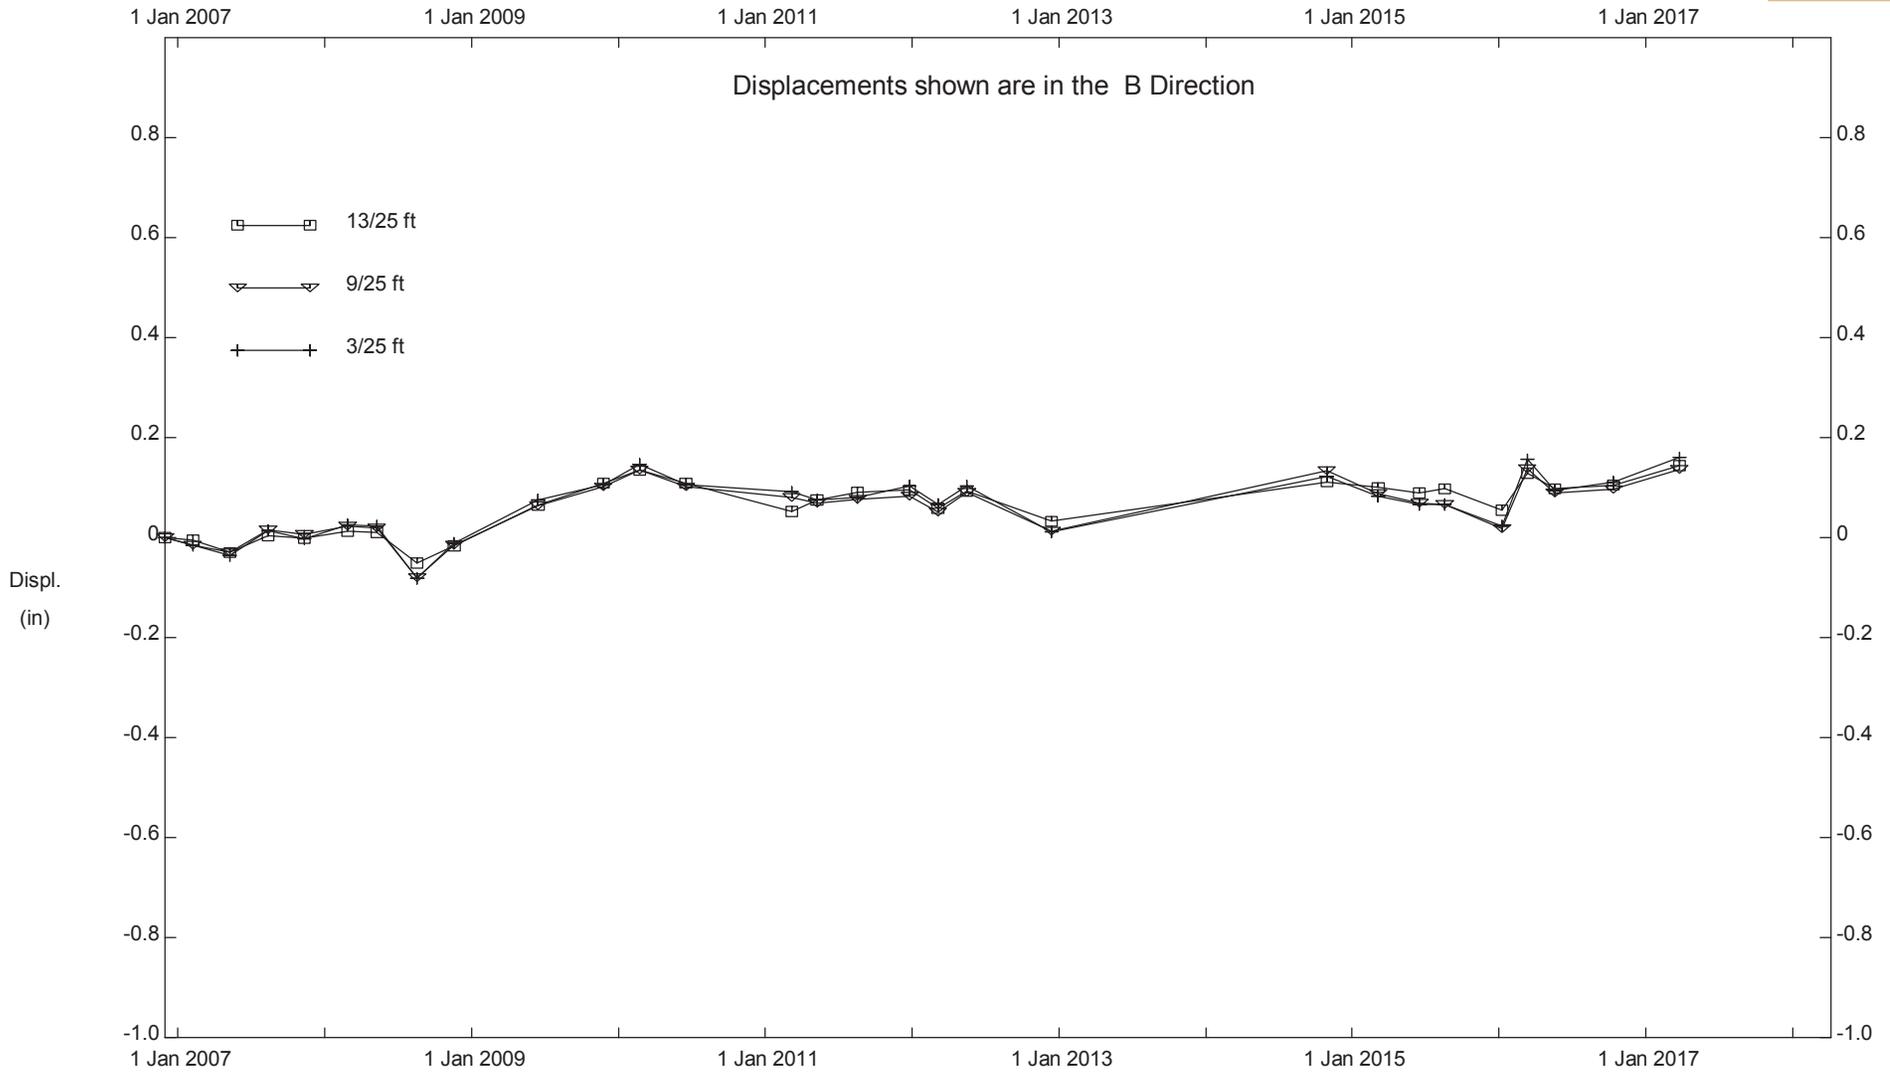
PLATE D2-4

BIG ROCK MESA, Inclinator SP-11

PCH REGION

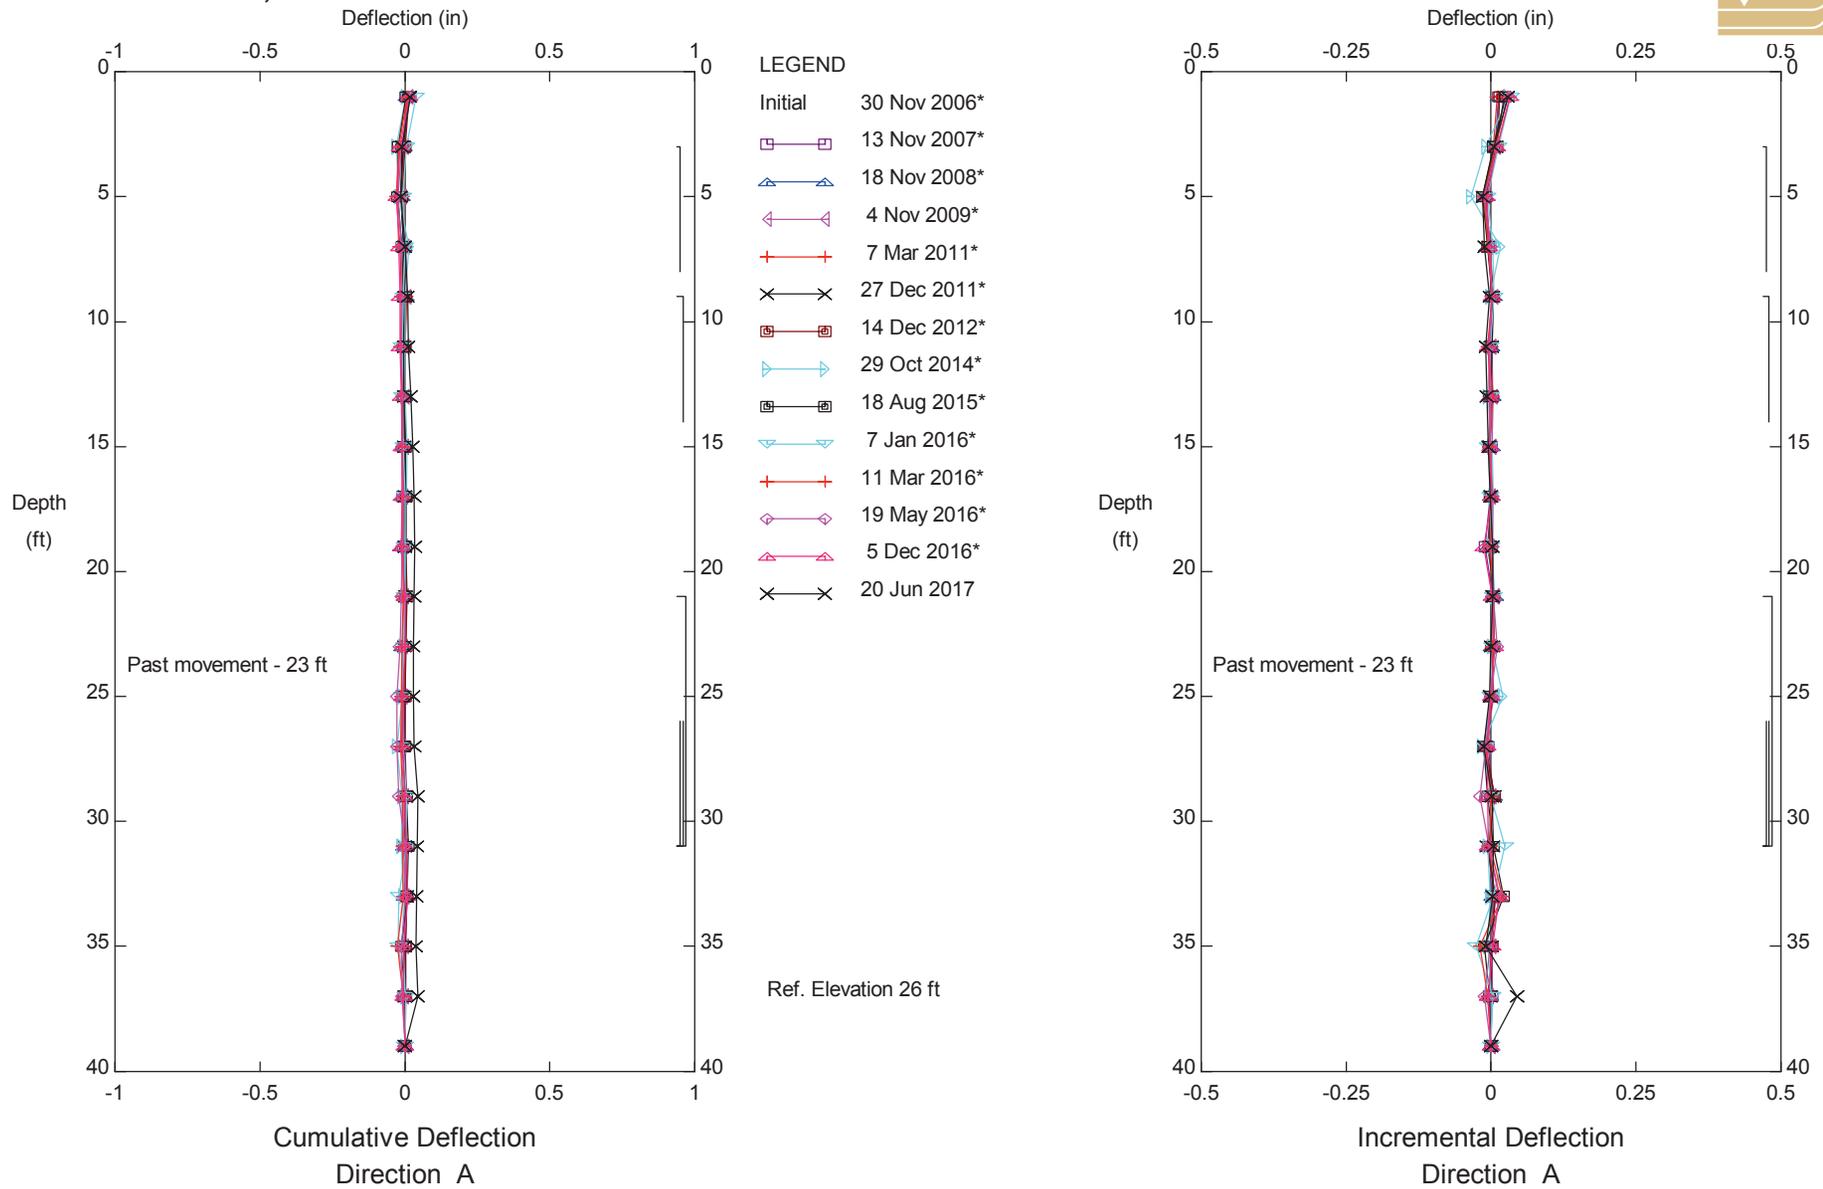
BIG ROCK MESA, Inclinometer SP-12
 PCH REGION

Sets marked * include zero shift and/or rotation corrections.

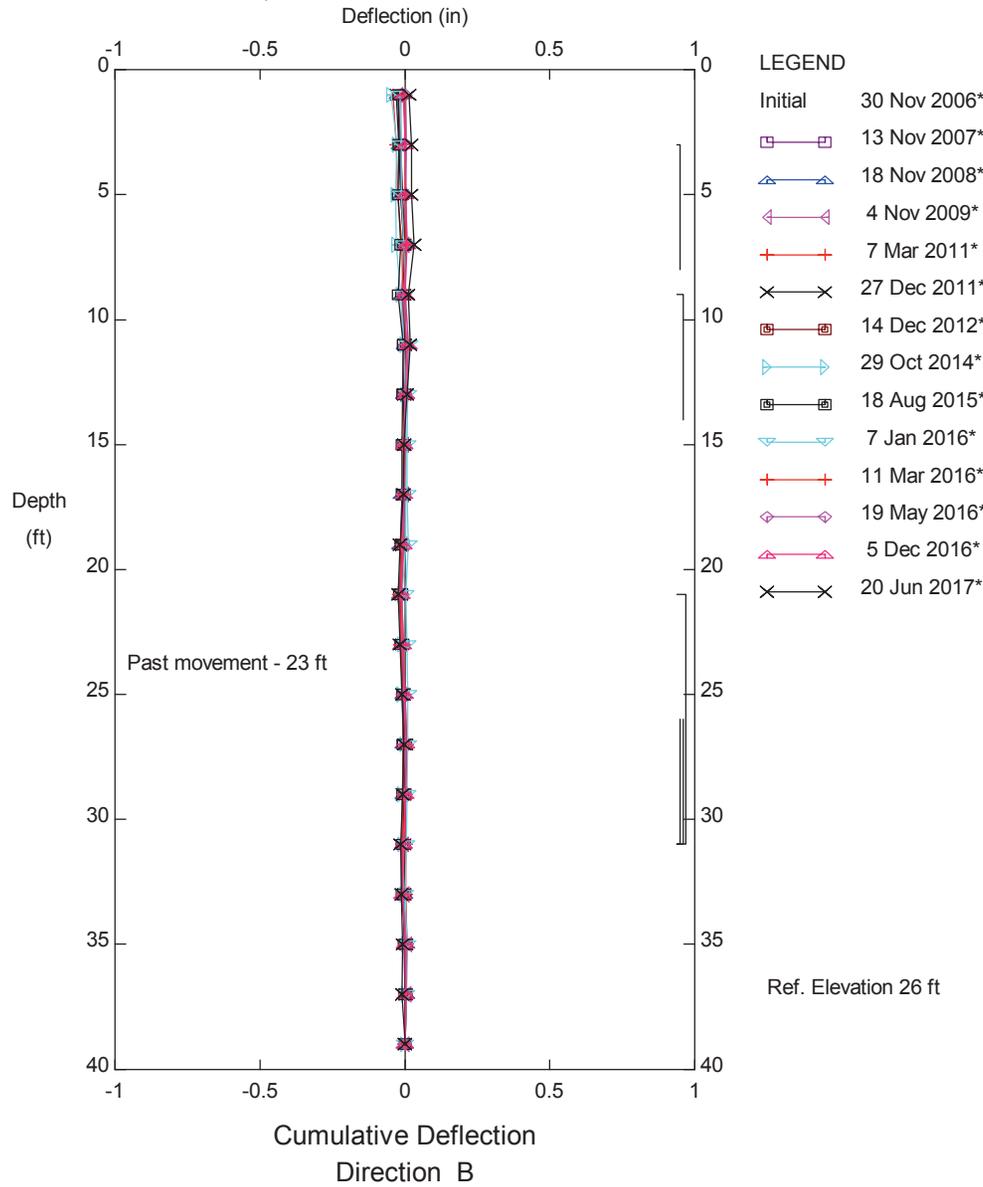
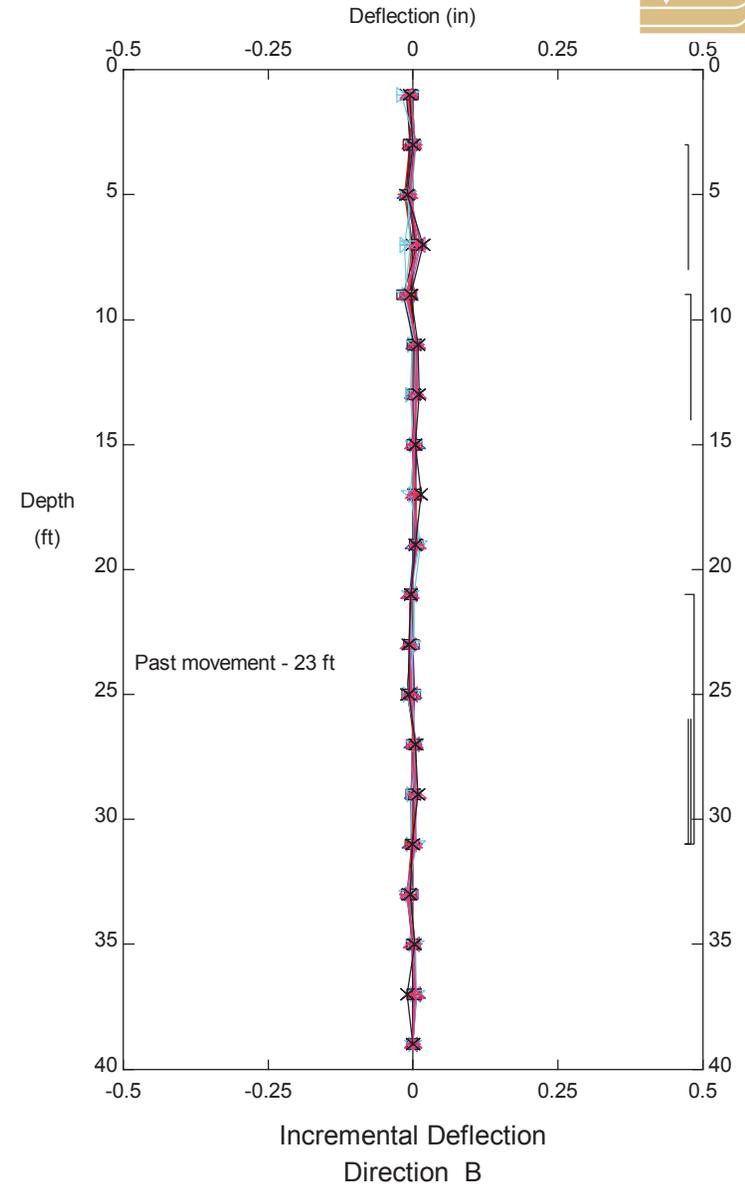
BIG ROCK MESA, Inclinator SP-12
 PCH REGION

Sets marked * include zero shift and/or rotation corrections.
