**ANNUAL REPORT
JULY 2016 THROUGH JUNE 2017
BIG ROCK MESA LANDSLIDE
ASSESSMENT DISTRICT
City of Malibu, California**

March 2018
Fugro Project No. 04.62160606
Document No. 04.62160606-PR-004(Rev.00)

**Annual Report of Maintenance and Monitoring, July 2016 through June 2017,
Big Rock Mesa Landslide Assessment District, City of Malibu, California**

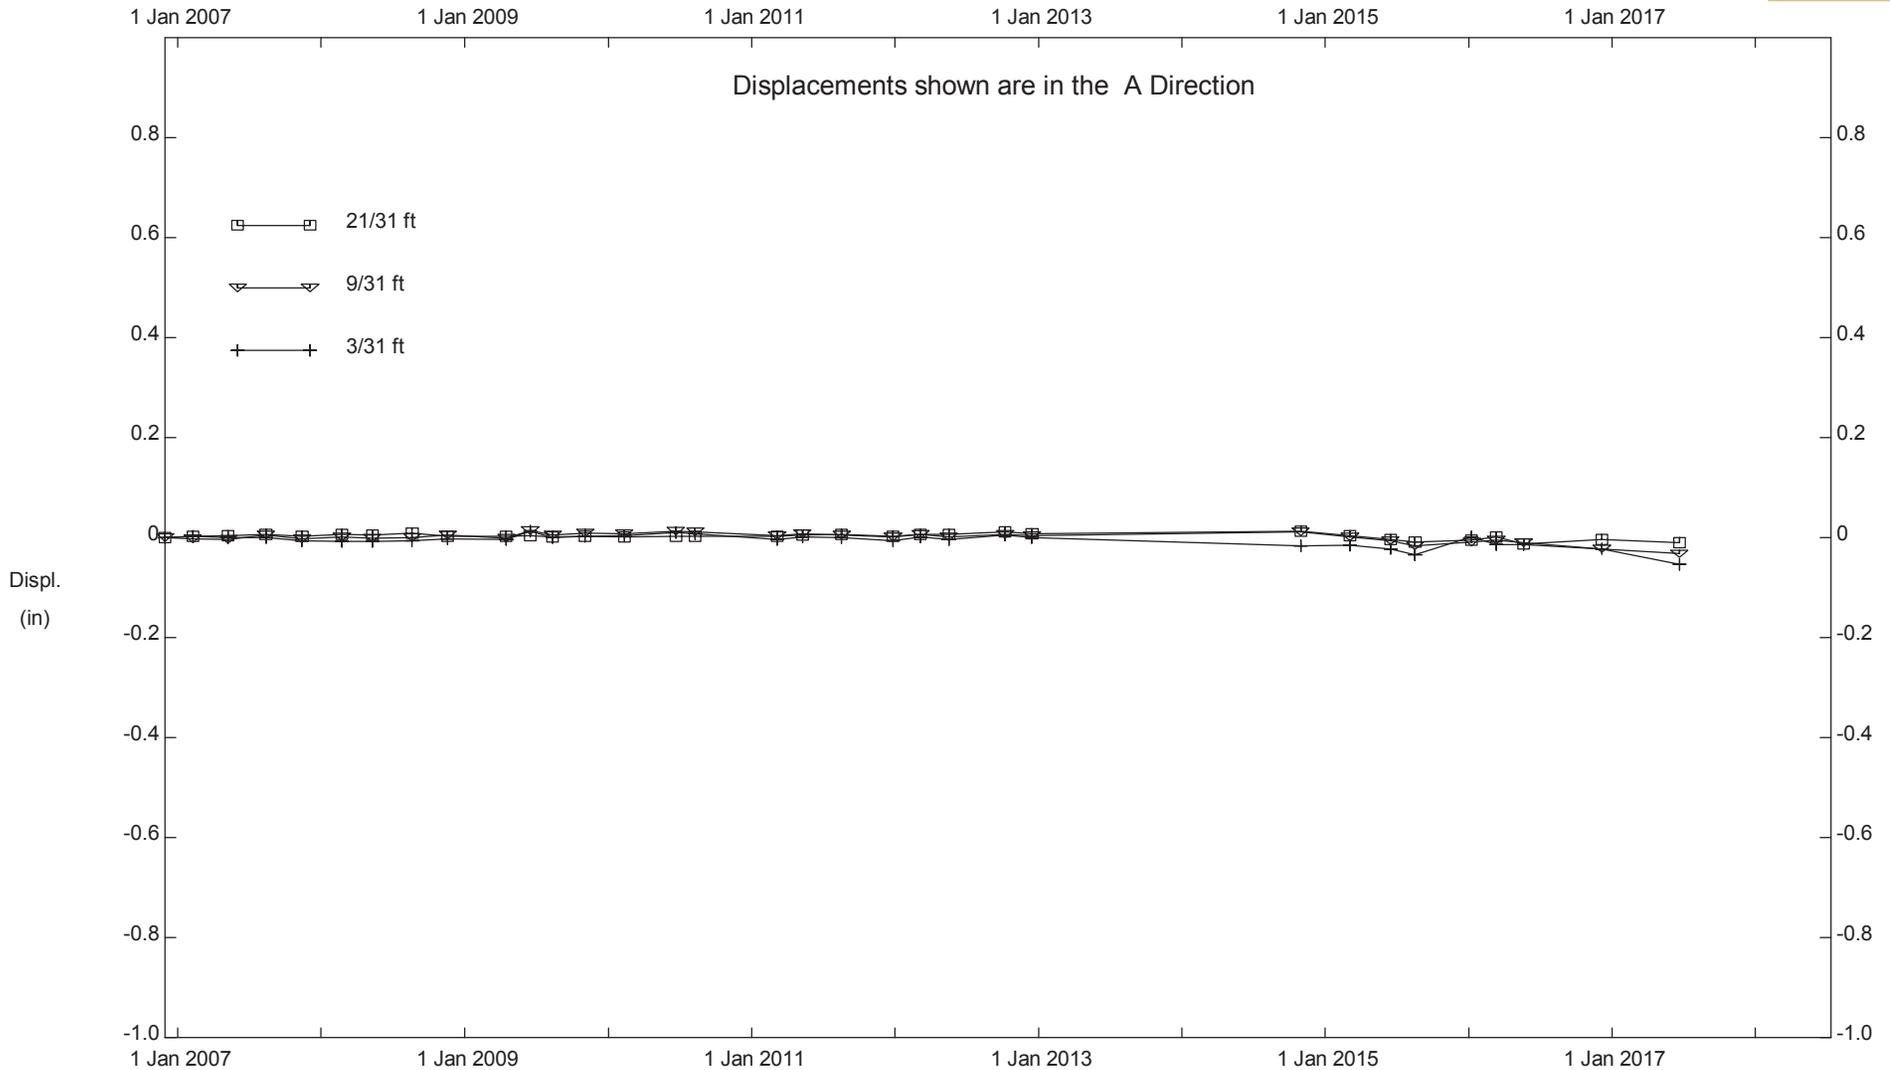
PLATE D3-3

BIG ROCK MESA, Inclinator SP-12

PCH REGION

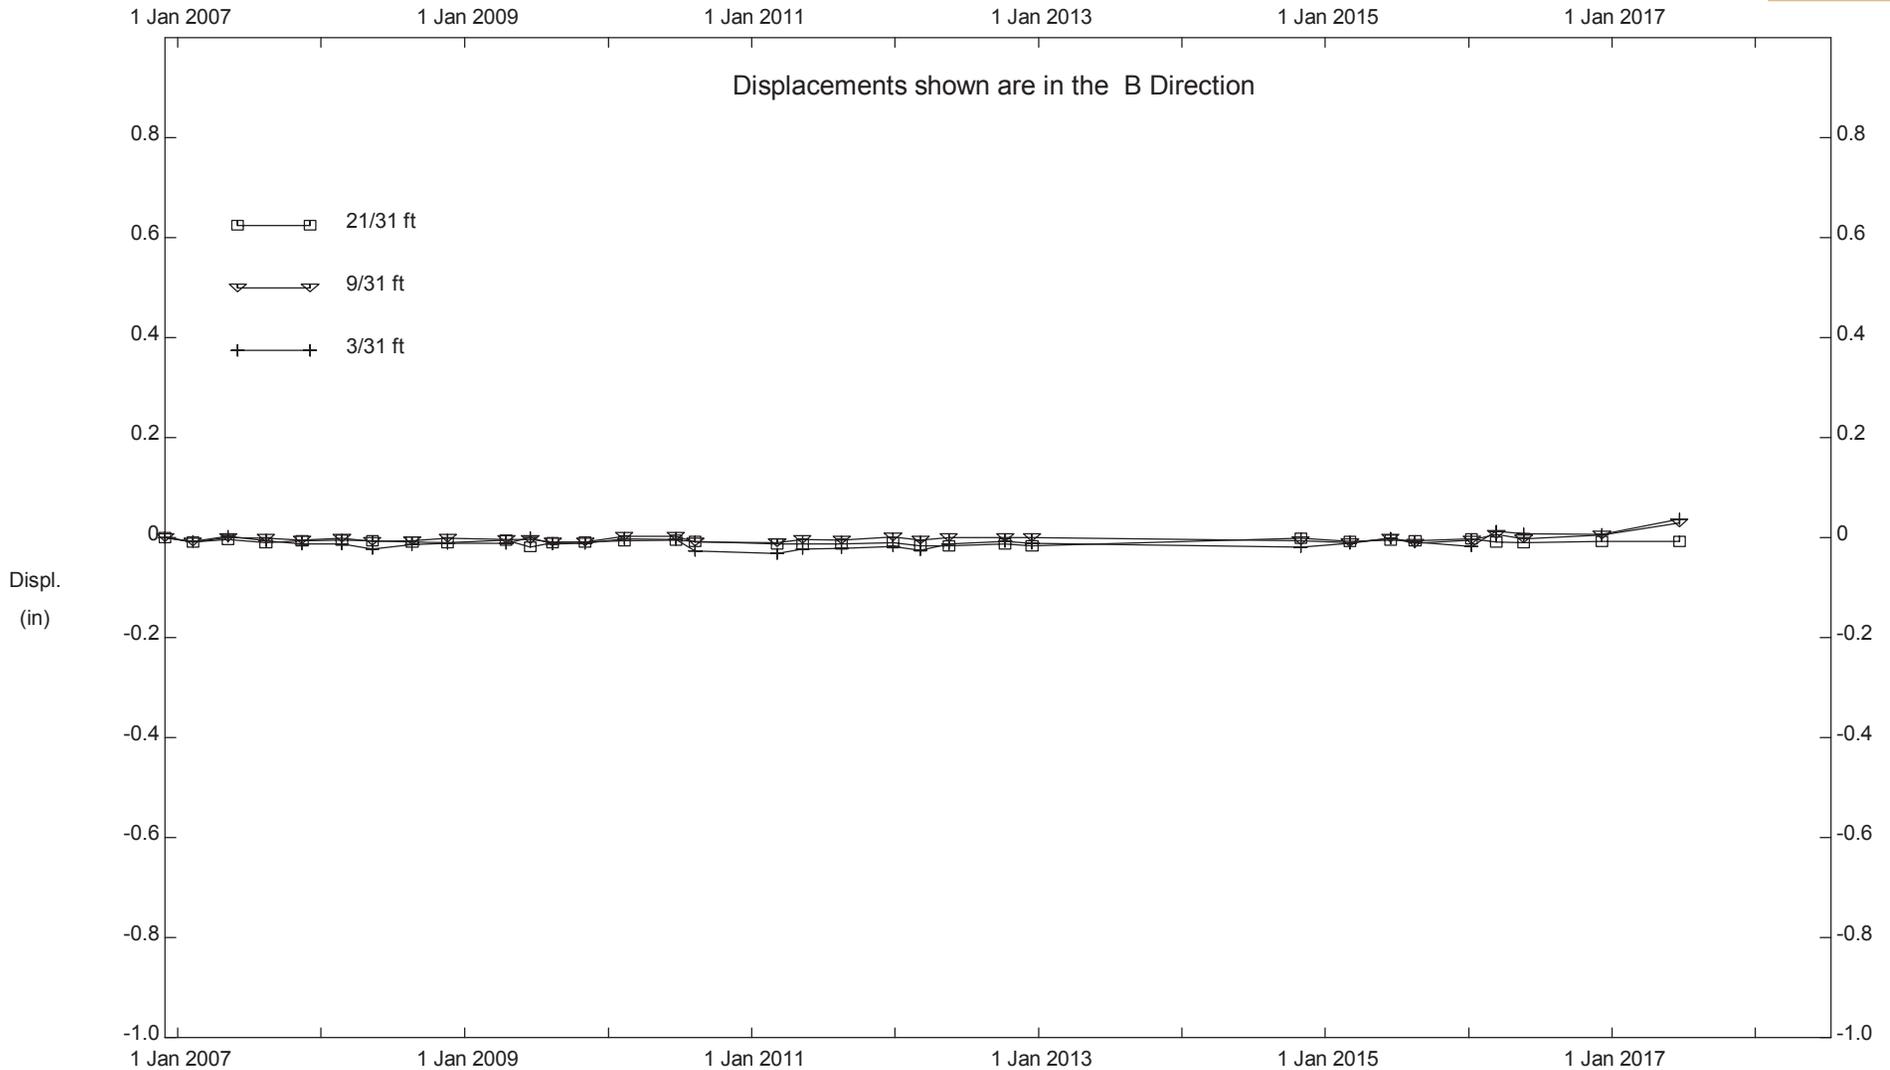
PLATE D3-4

BIG ROCK MESA, Inclinator SP-12

PCH REGION

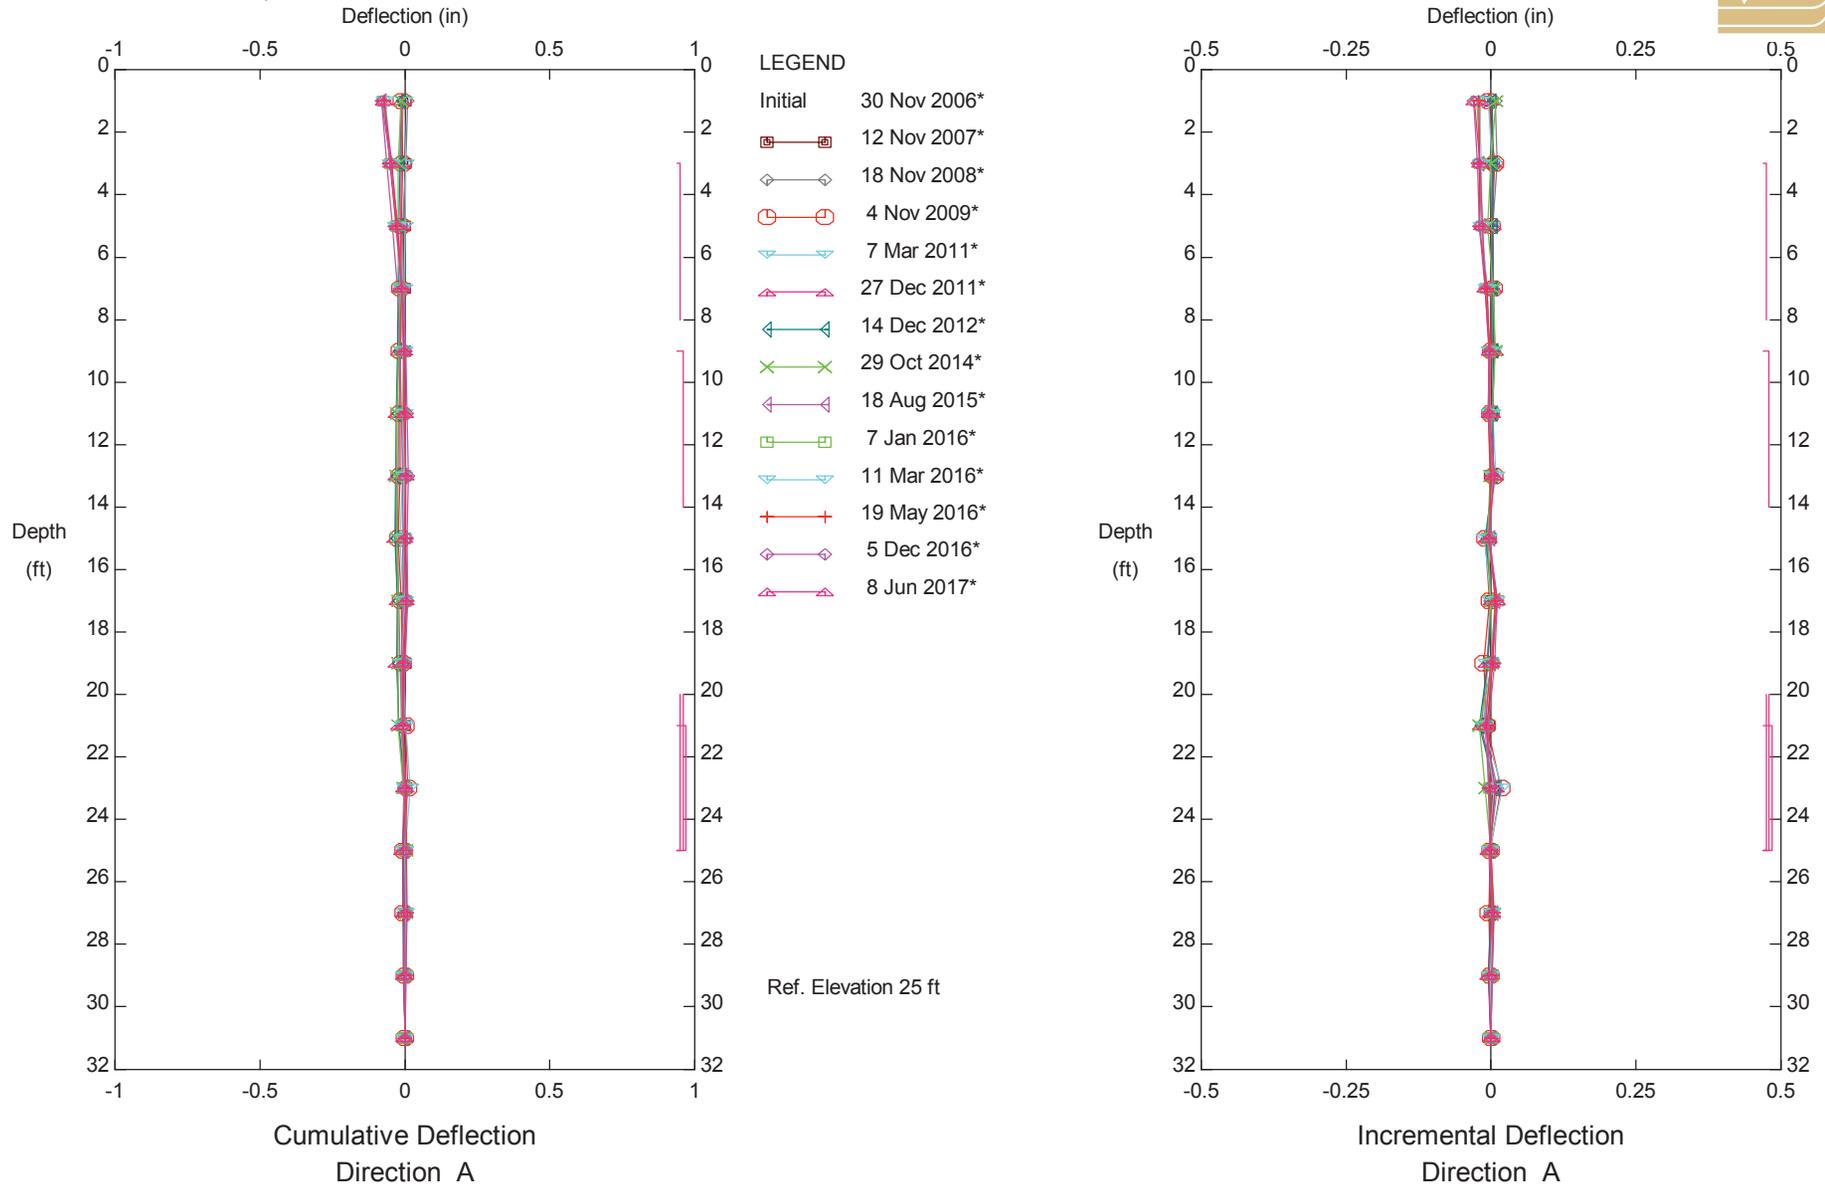
BIG ROCK MESA, Inclinometer SP-14
 PCH REGION

Sets marked * include zero shift and/or rotation corrections.

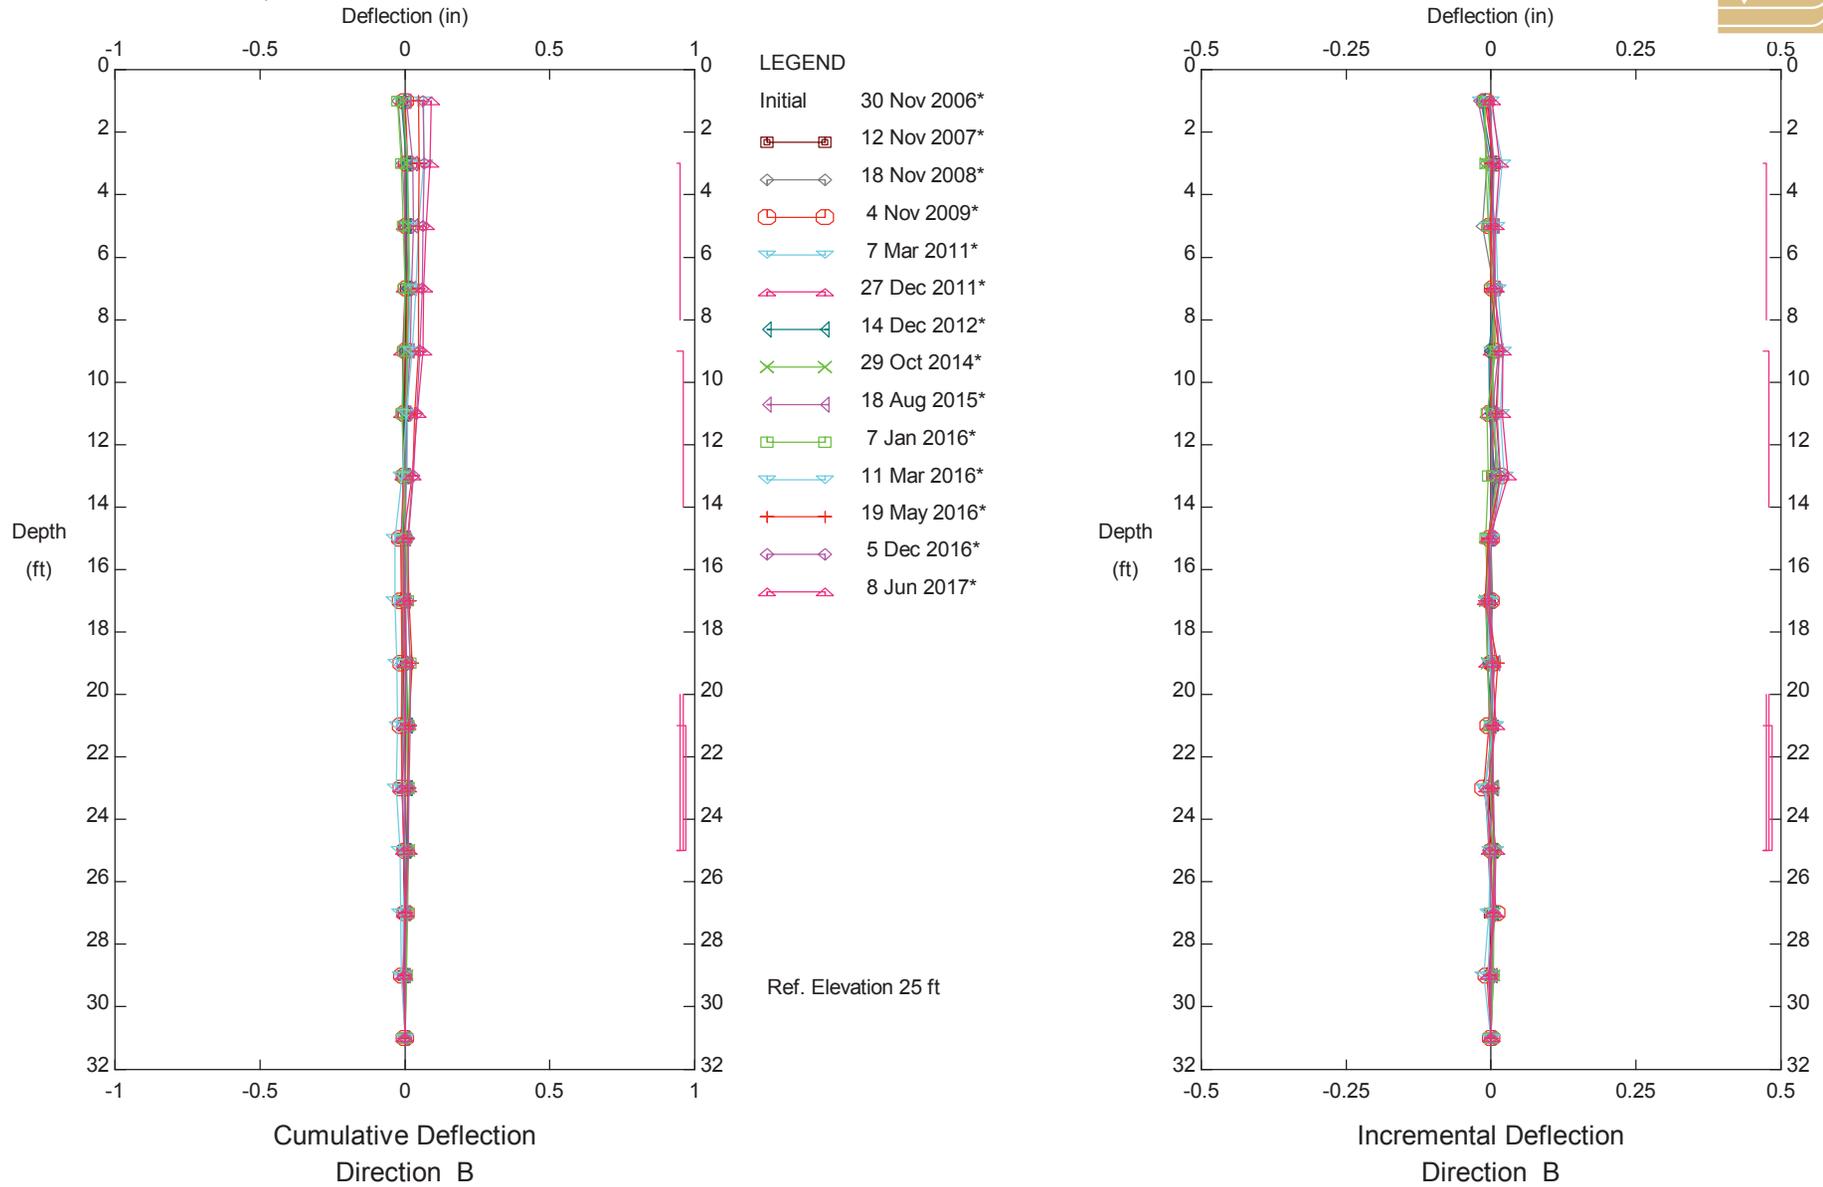
BIG ROCK MESA, Inclinometer SP-14
 PCH REGION

Sets marked * include zero shift and/or rotation corrections.

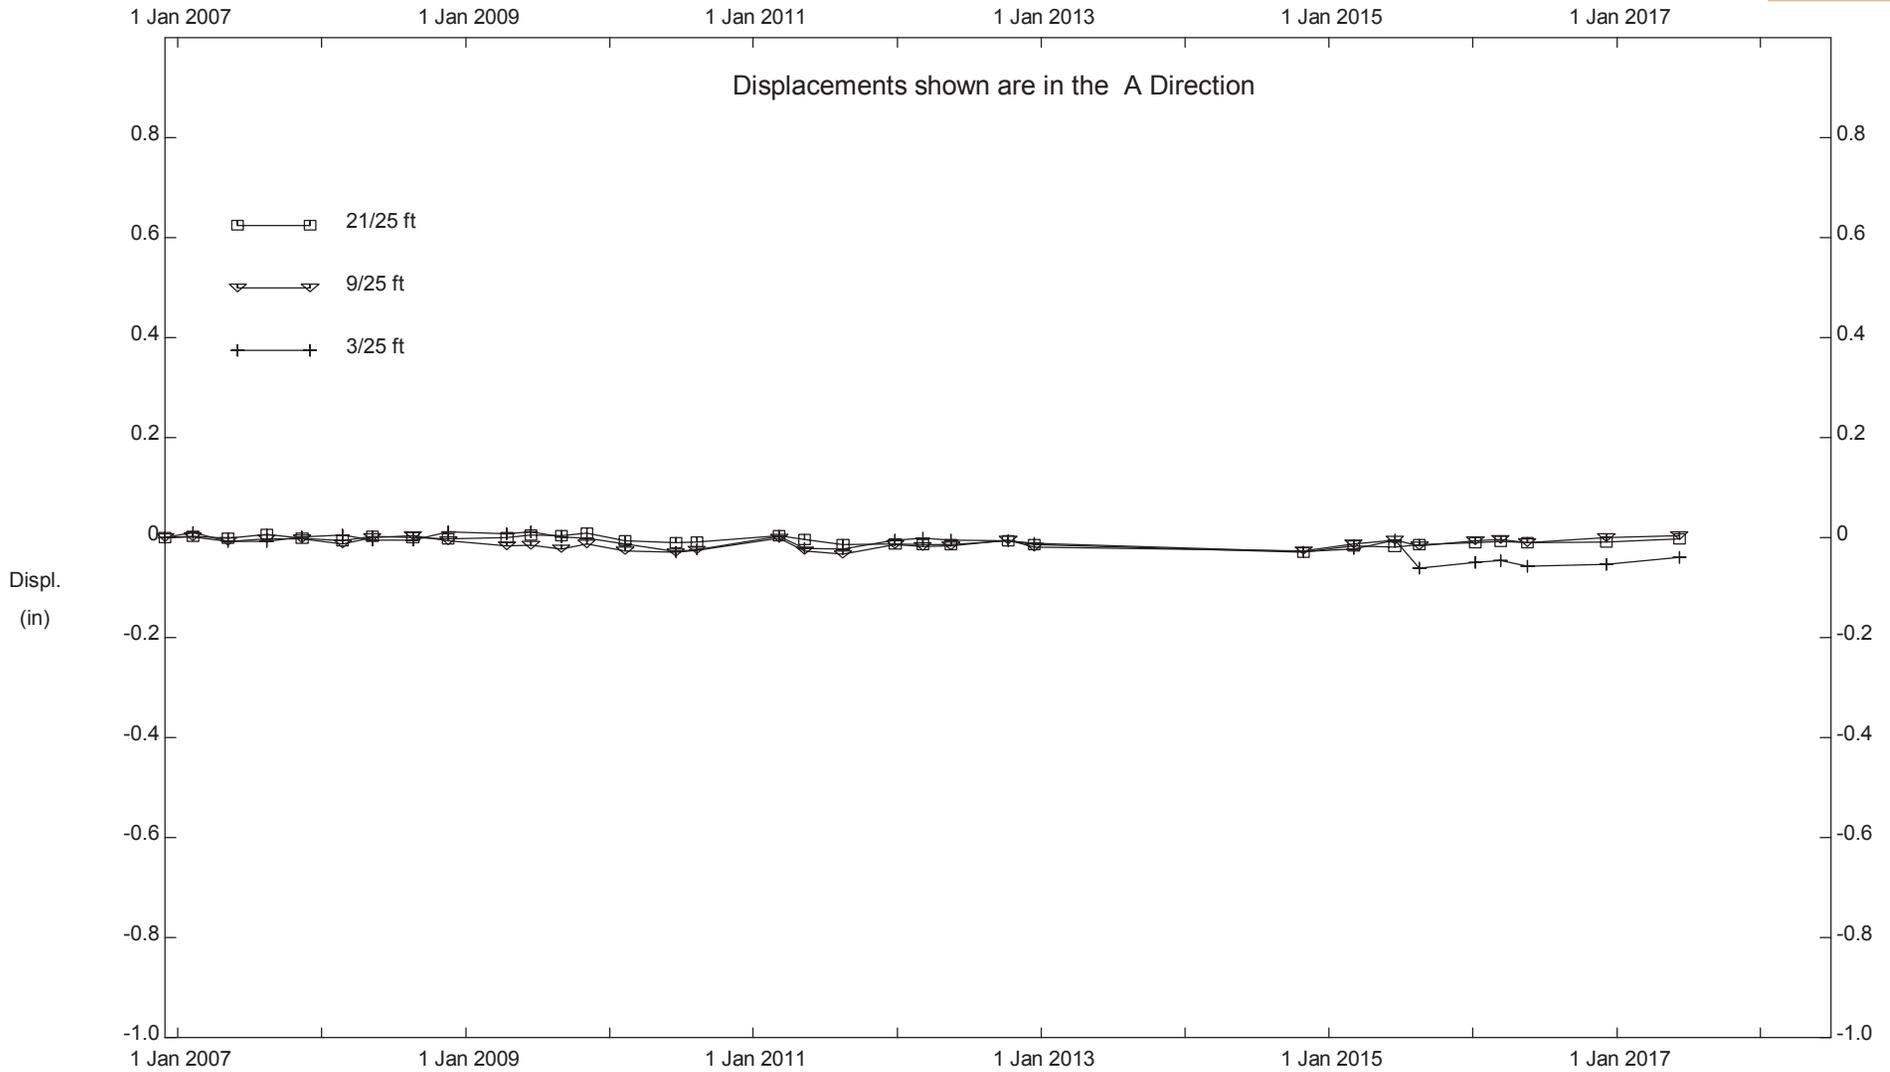
PLATE D4-3

BIG ROCK MESA, Inclinator SP-14

PCH REGION

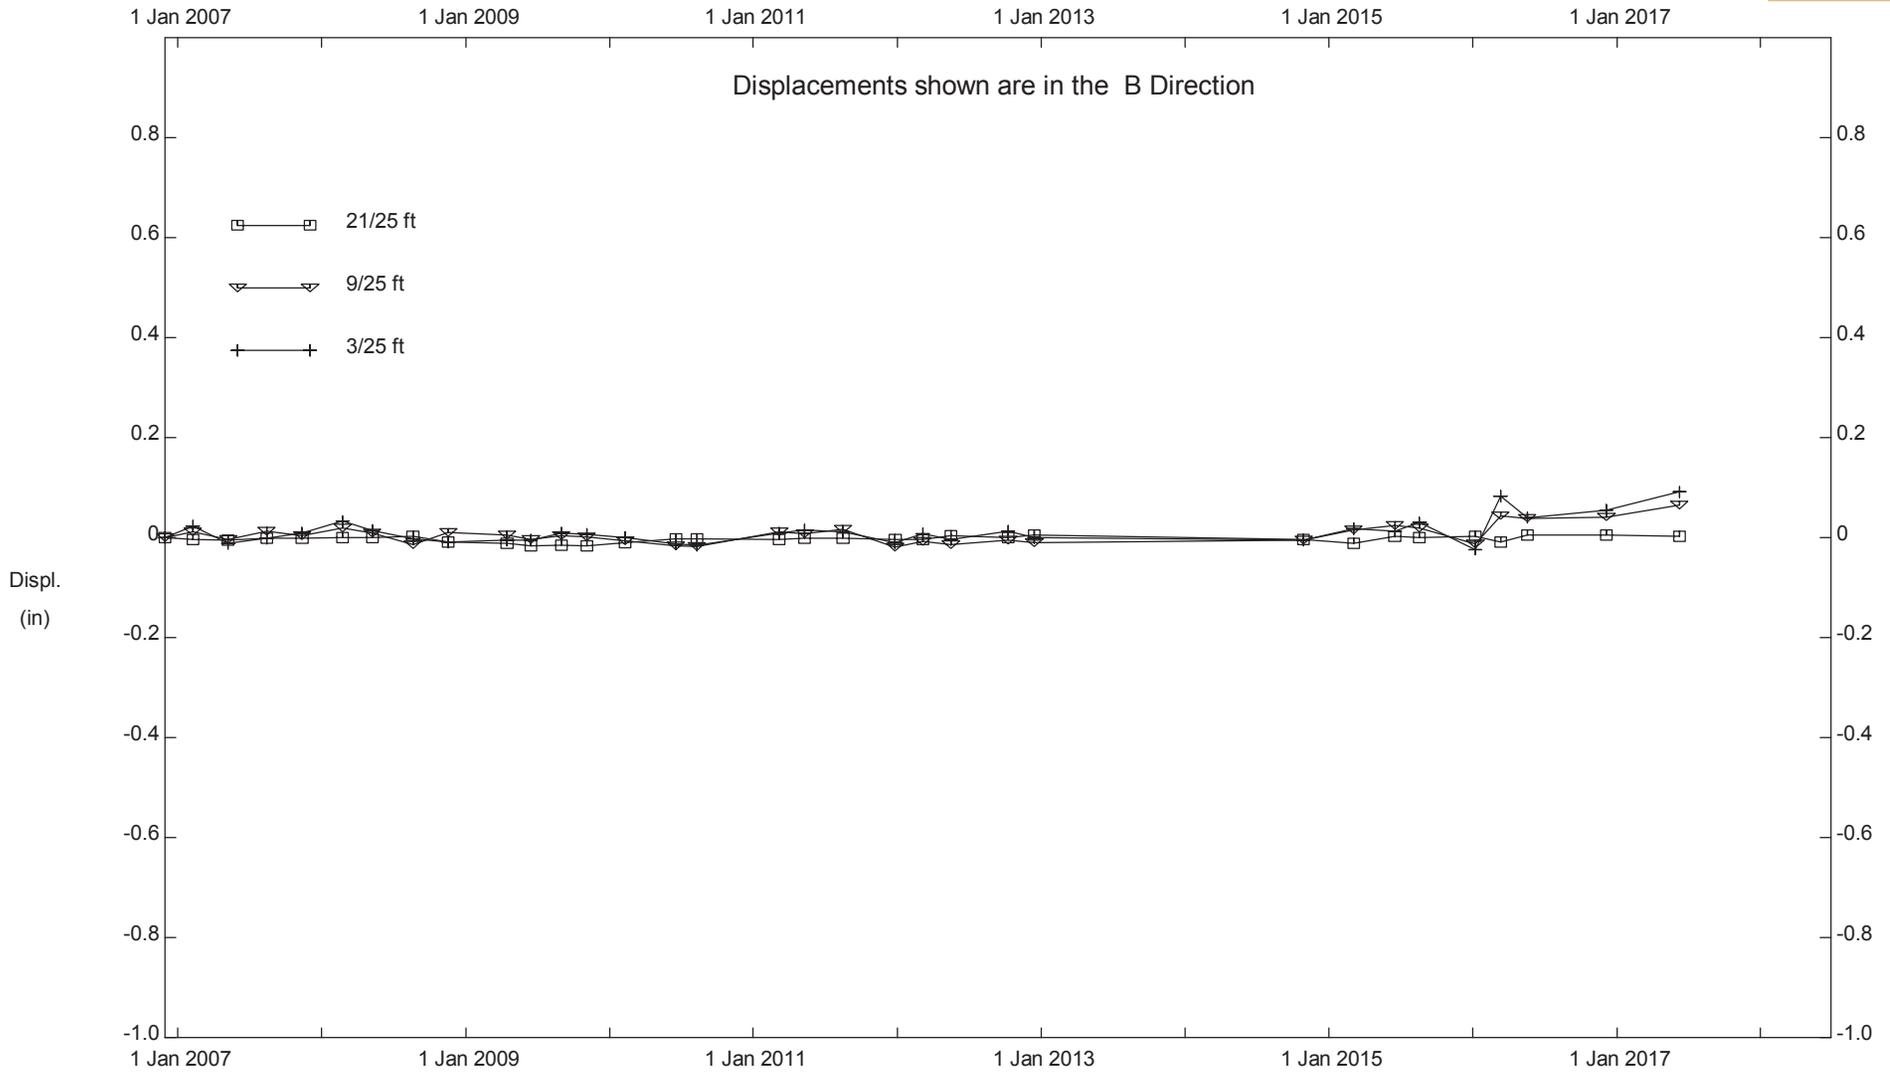
PLATE D4-4

BIG ROCK MESA, Inclinator SP-14

PCH REGION

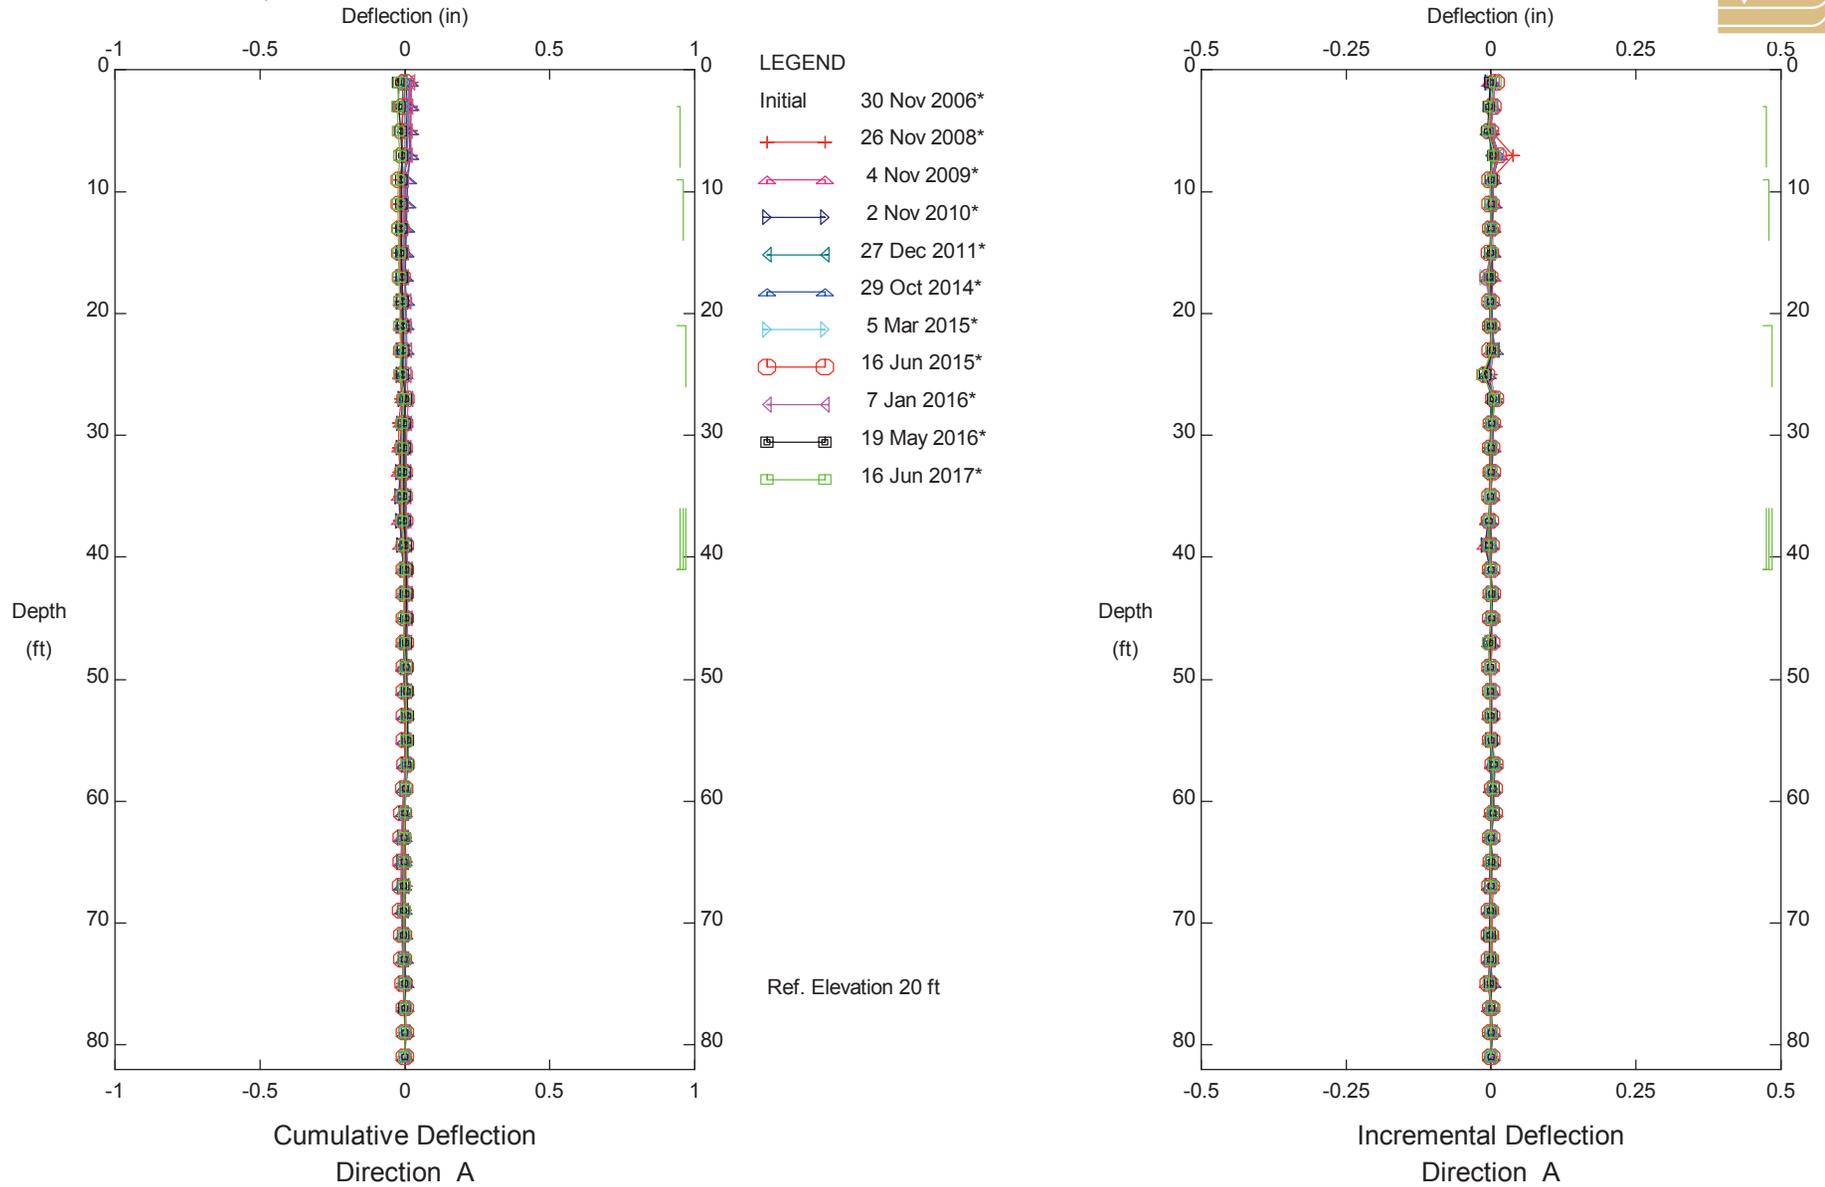
BIG ROCK MESA, Inclinometer SP-15
 PCH REGION

Sets marked * include zero shift and/or rotation corrections.

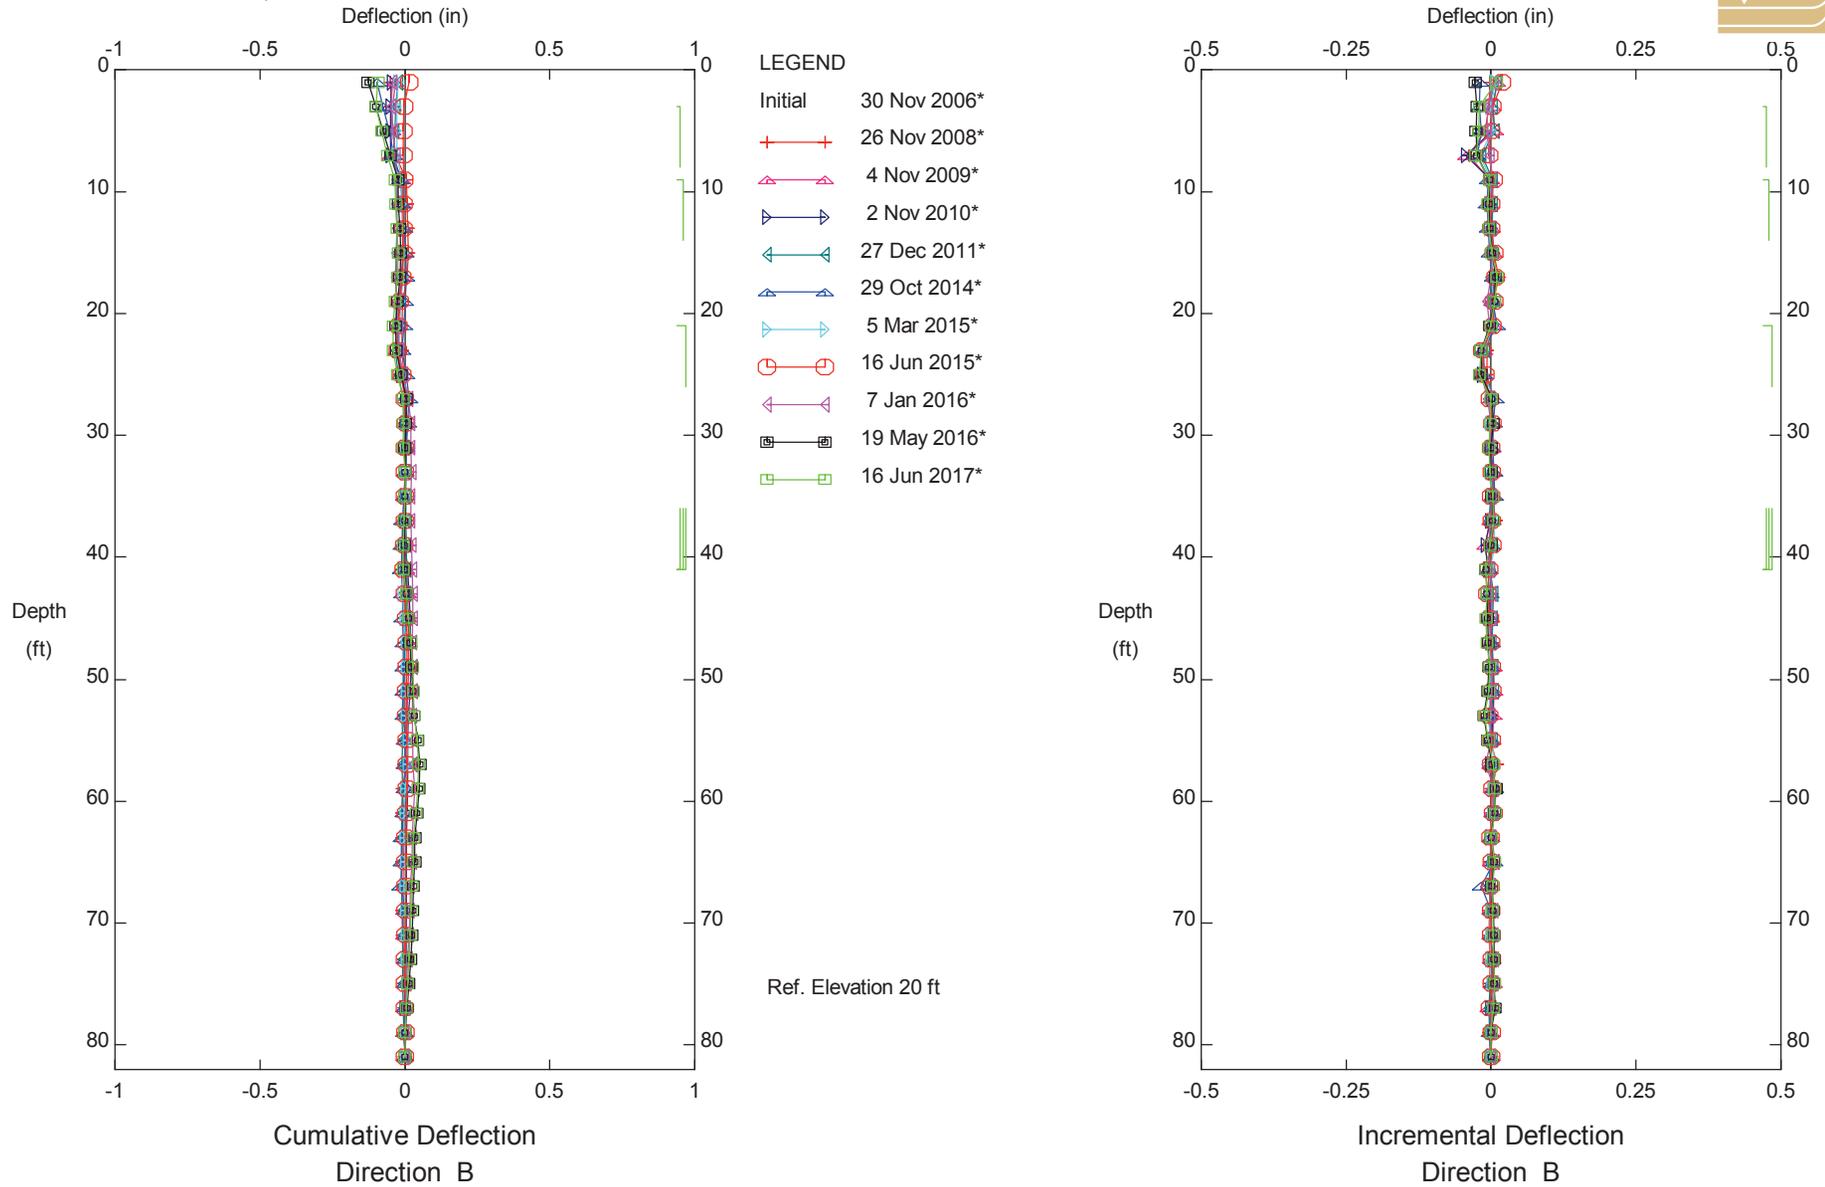
BIG ROCK MESA, Inclinerometer SP-15
 PCH REGION

Sets marked * include zero shift and/or rotation corrections.

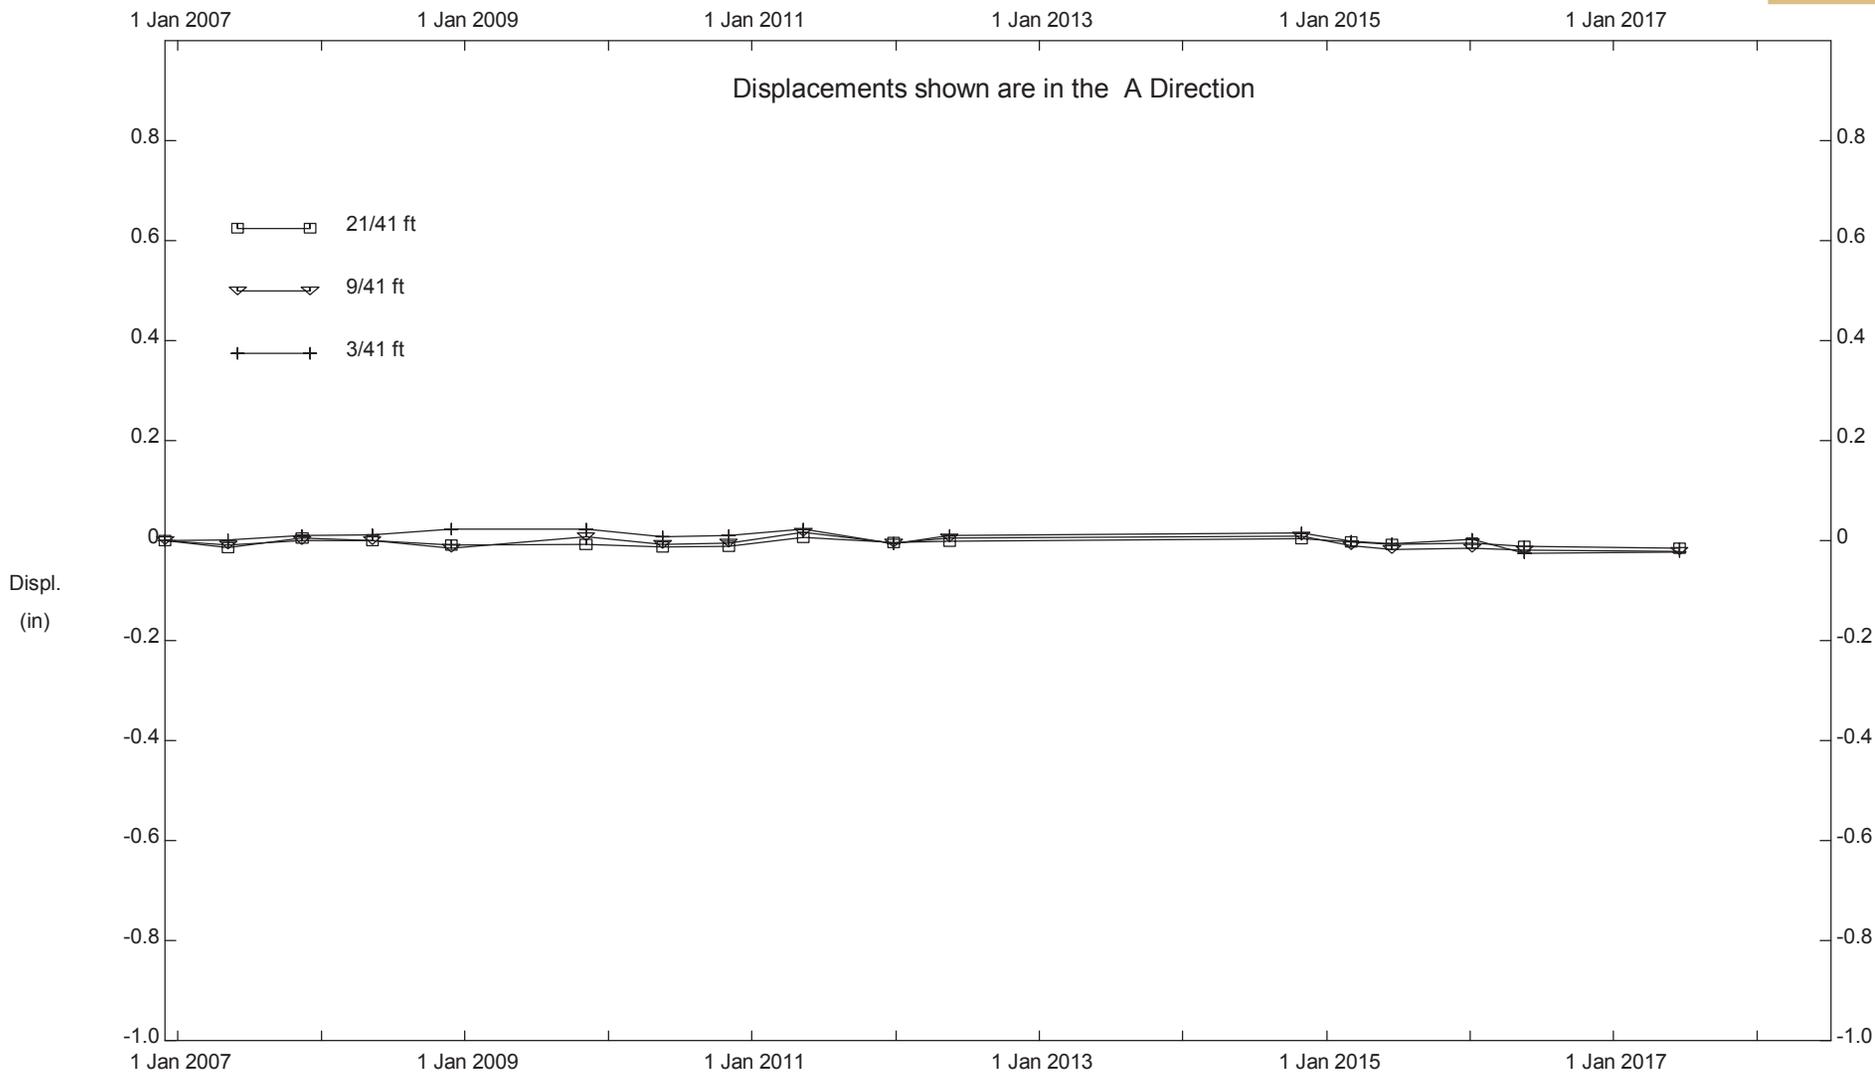
PLATE D5-3

BIG ROCK MESA, Inclinator SP-15

PCH REGION

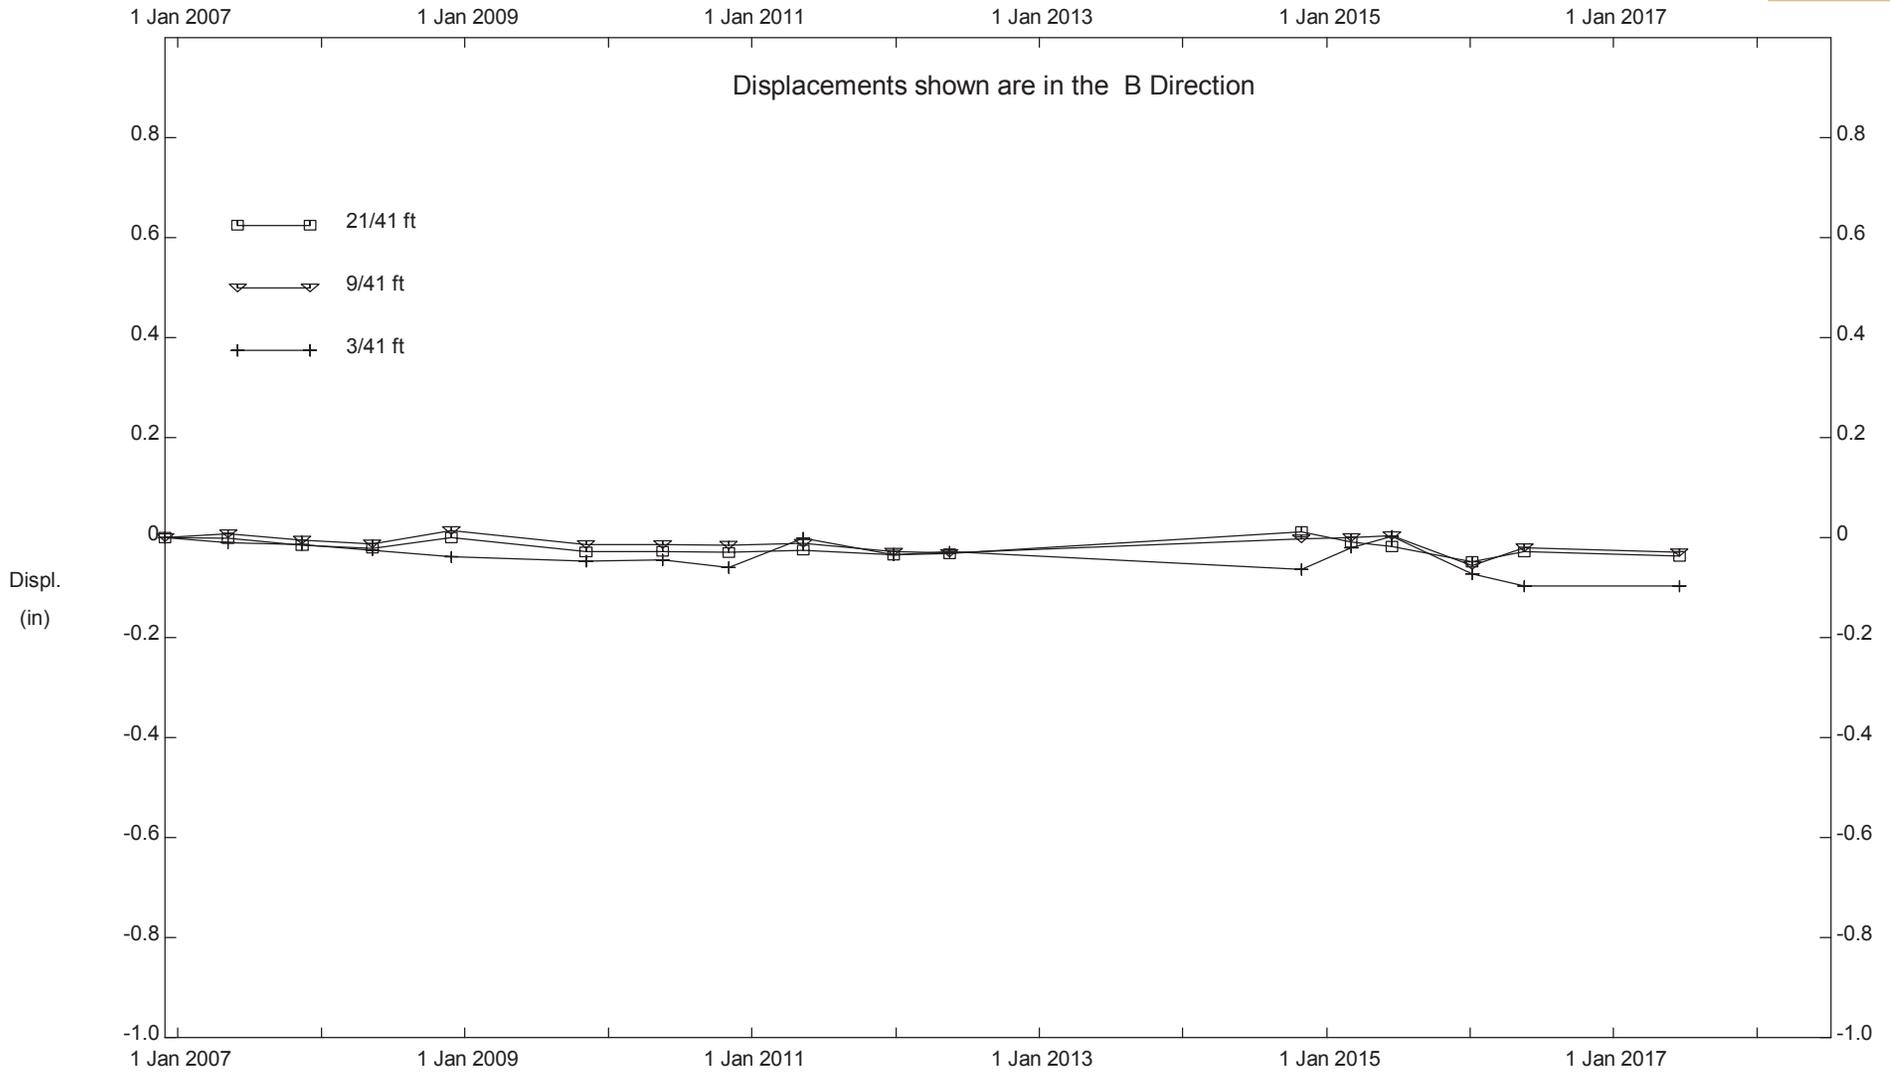
PLATE D5-4

BIG ROCK MESA, Inclinator SP-15

PCH REGION

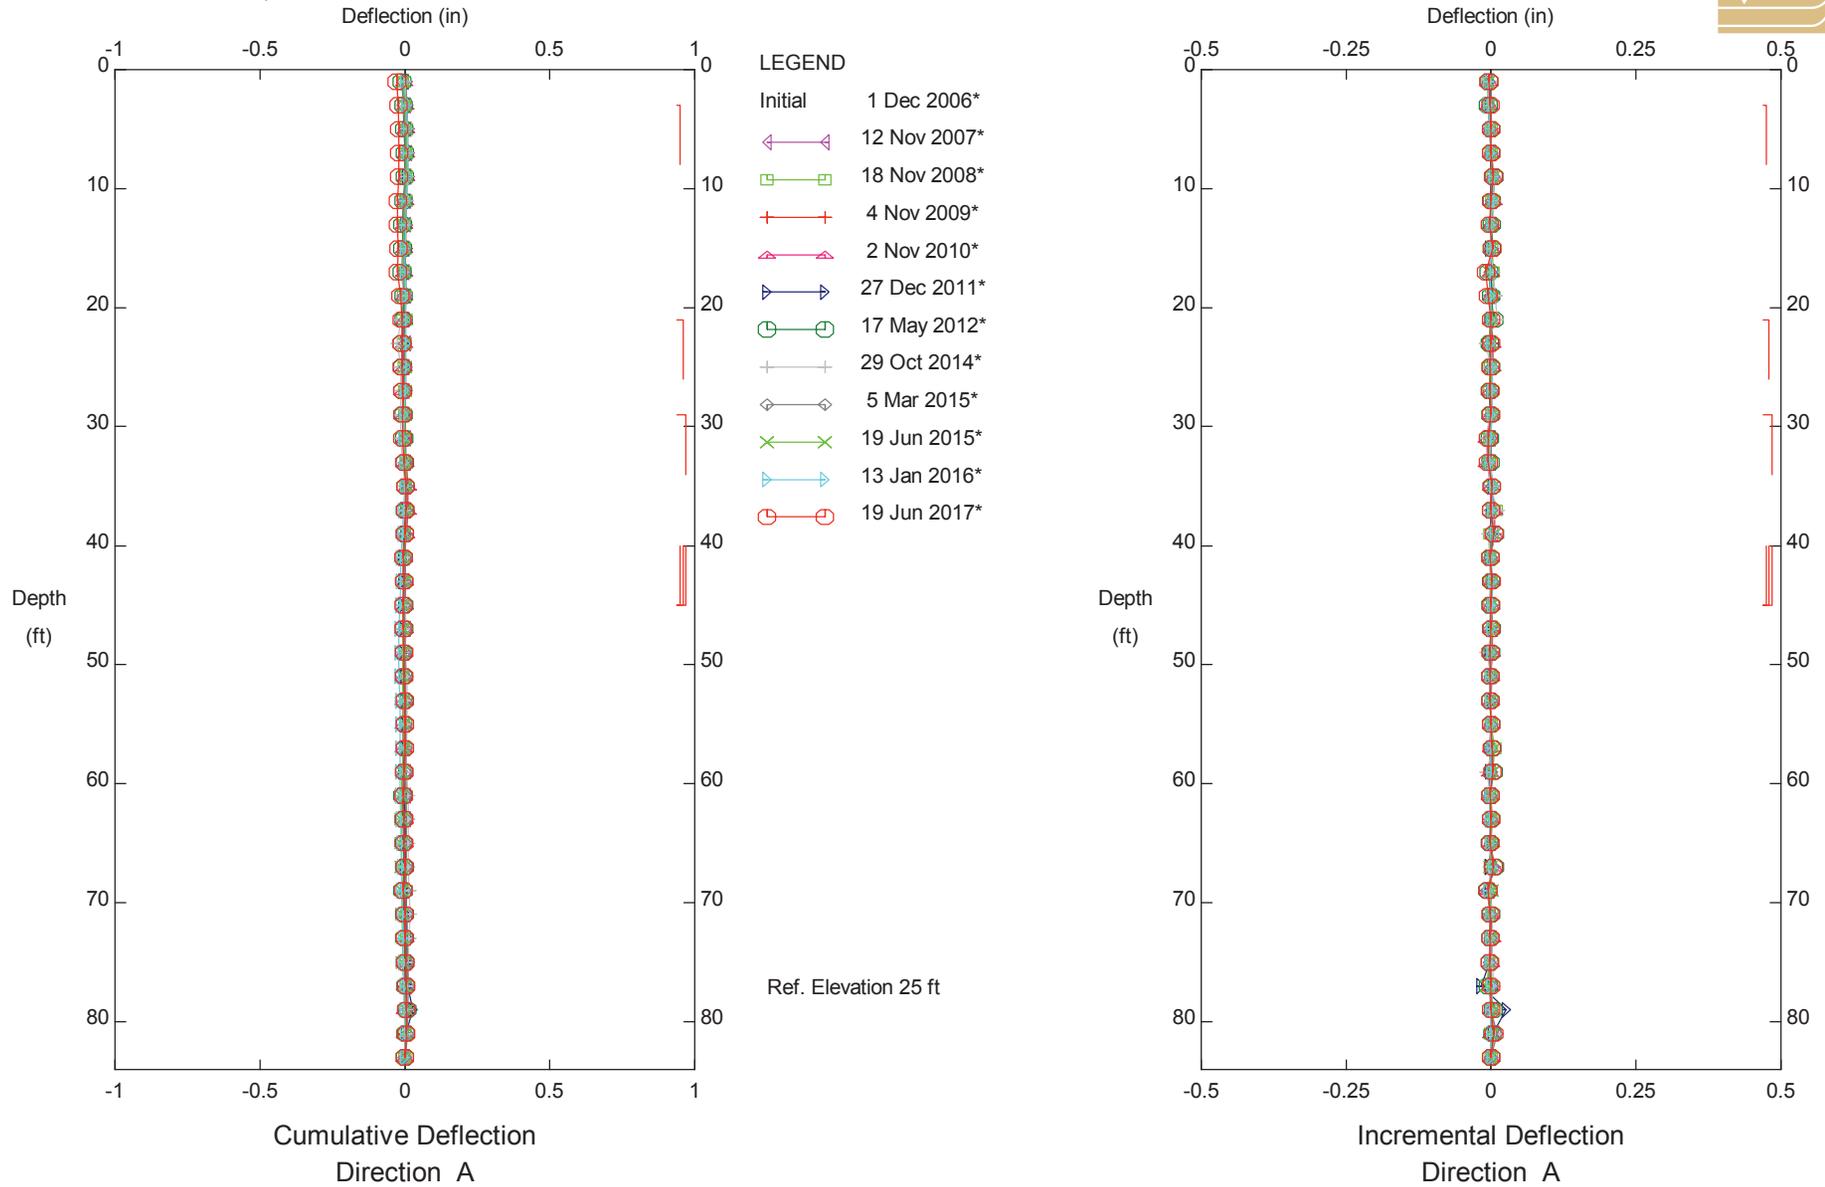
BIG ROCK MESA, Inclinometer SP-19
 PCH REGION

Sets marked * include zero shift and/or rotation corrections.
