**ANNUAL REPORT
JULY 2016 THROUGH JUNE 2017
BIG ROCK MESA LANDSLIDE
ASSESSMENT DISTRICT
City of Malibu, California**

March 2018
Fugro Project No. 04.62160606
Document No. 04.62160606-PR-004(Rev.00)

**Annual Report of Maintenance and Monitoring, July 2016 through June 2017,
Big Rock Mesa Landslide Assessment District, City of Malibu, California**

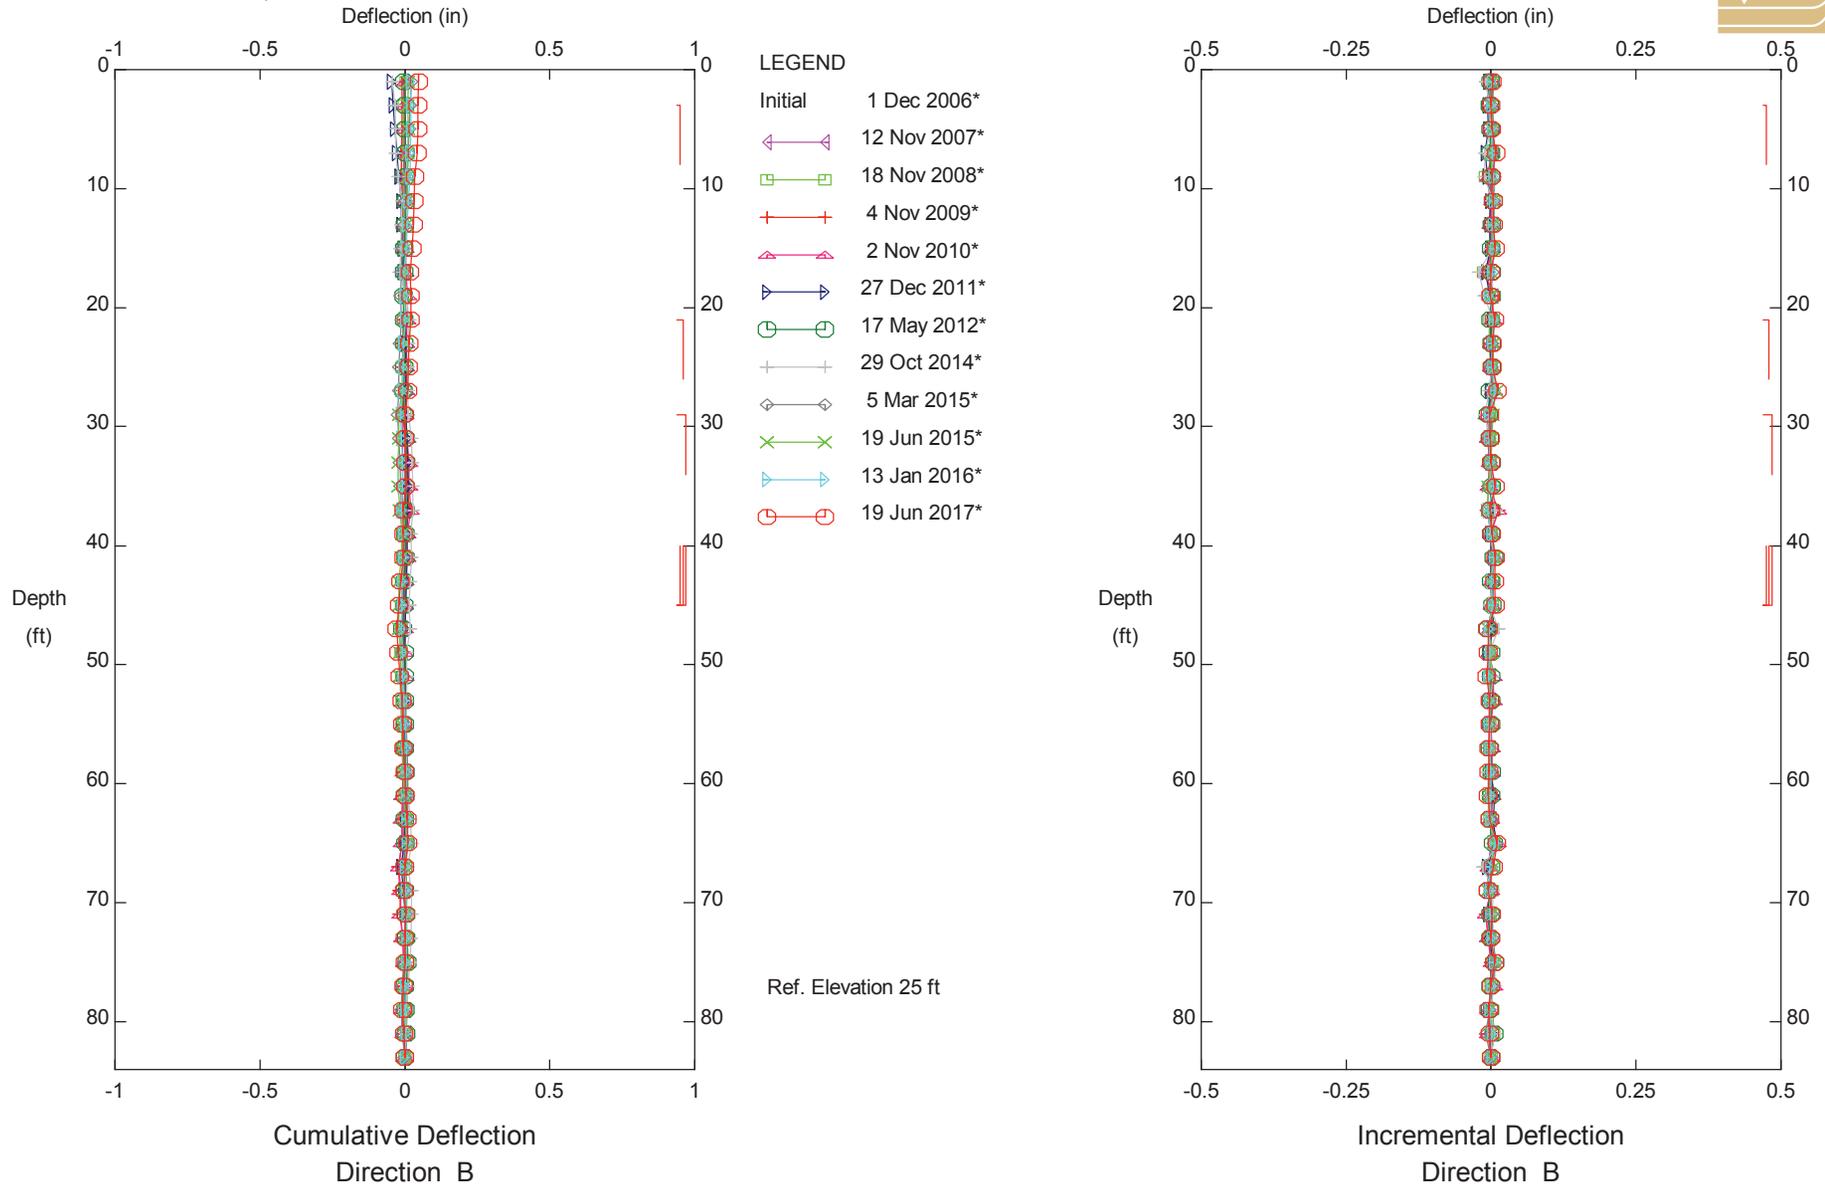
BIG ROCK MESA, Inclinerometer SP-19
 PCH REGION

Sets marked * include zero shift and/or rotation corrections.

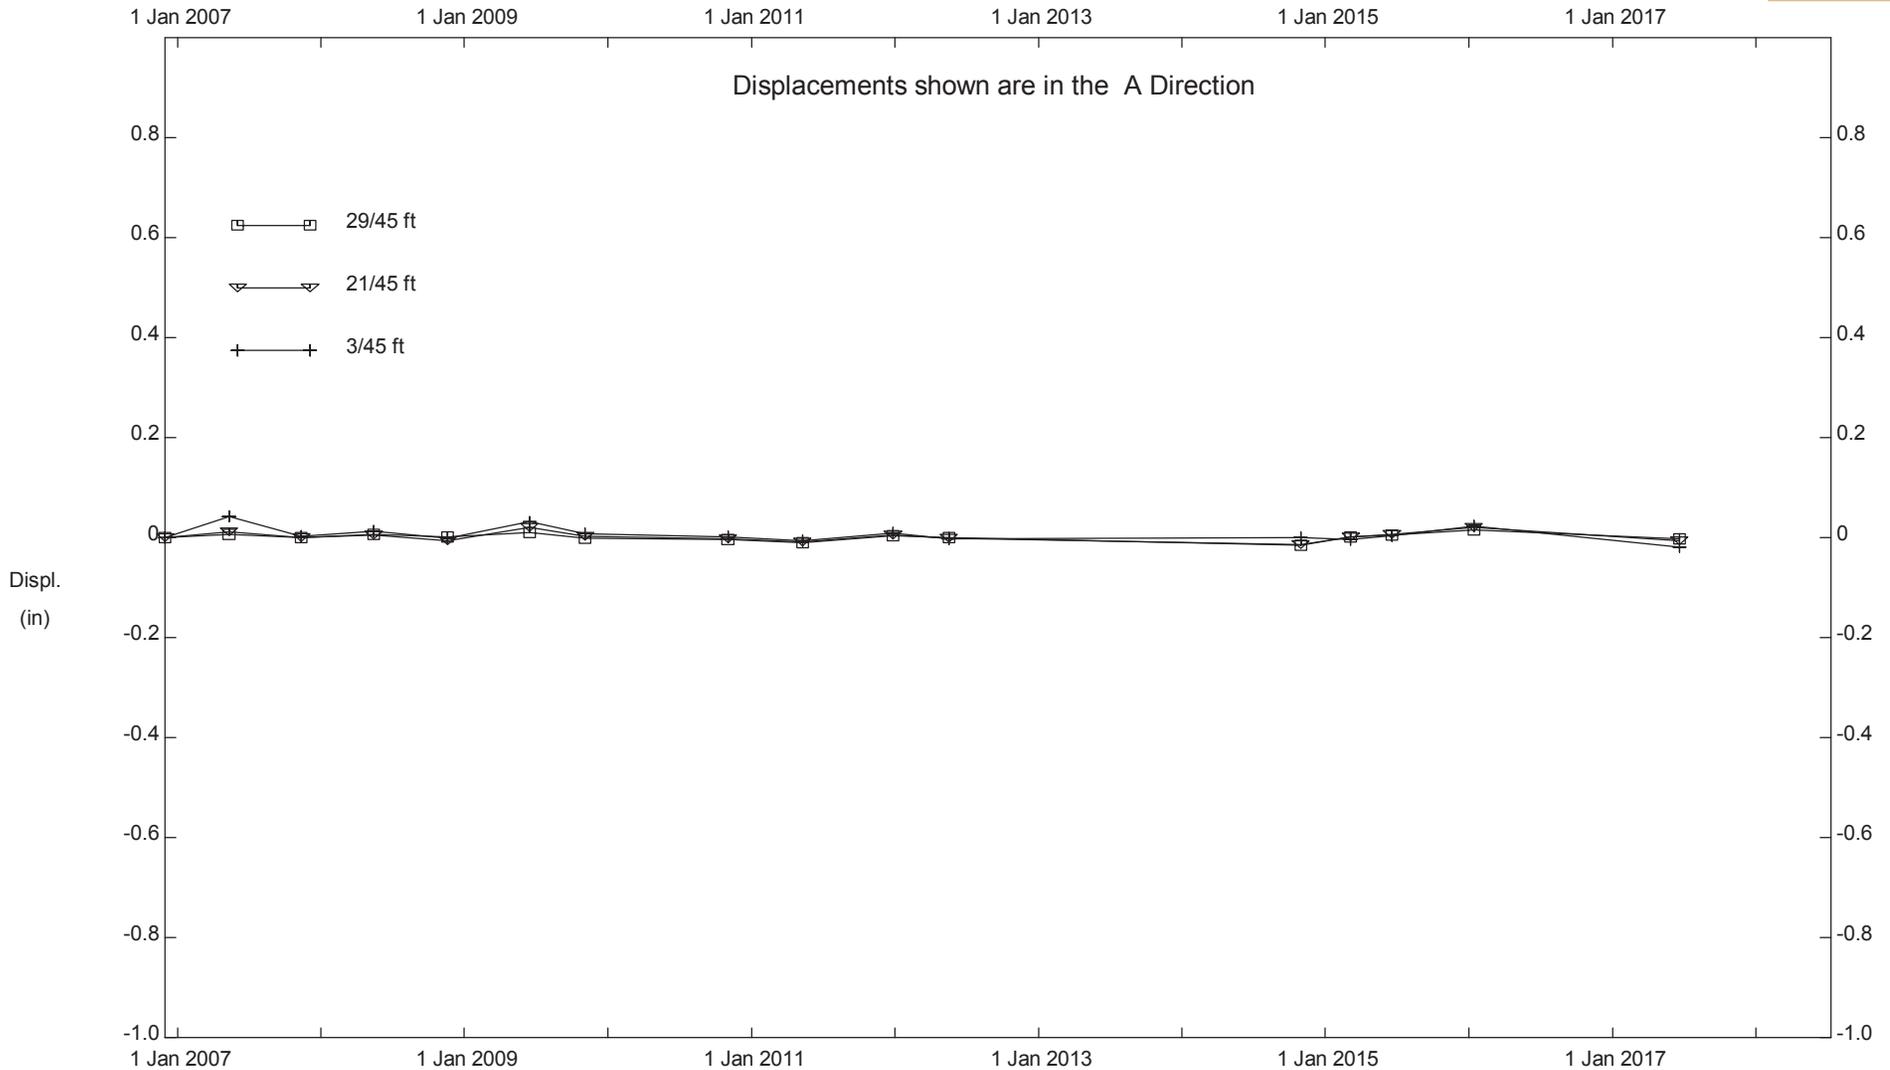
PLATE D6-3

BIG ROCK MESA, Inclinator SP-19

PCH REGION

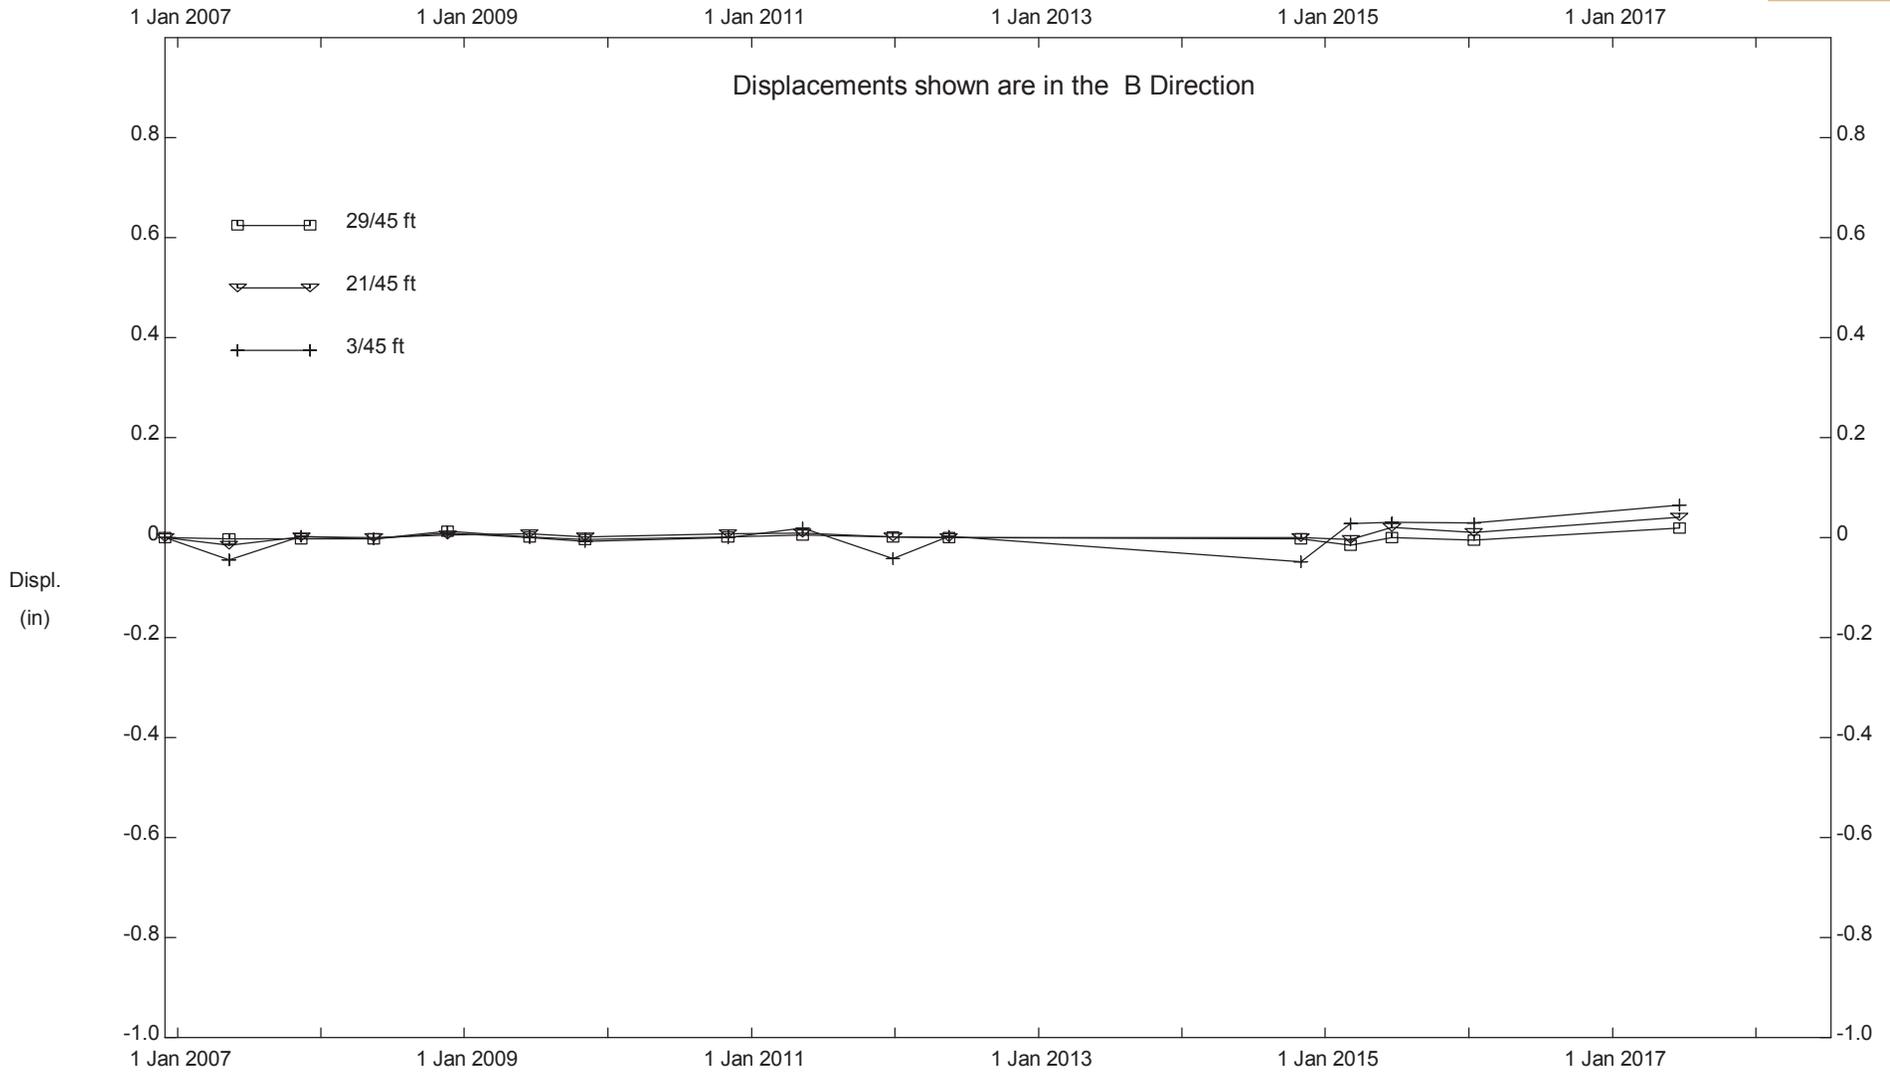
PLATE D6-4

BIG ROCK MESA, Inclinator SP-19

PCH REGION

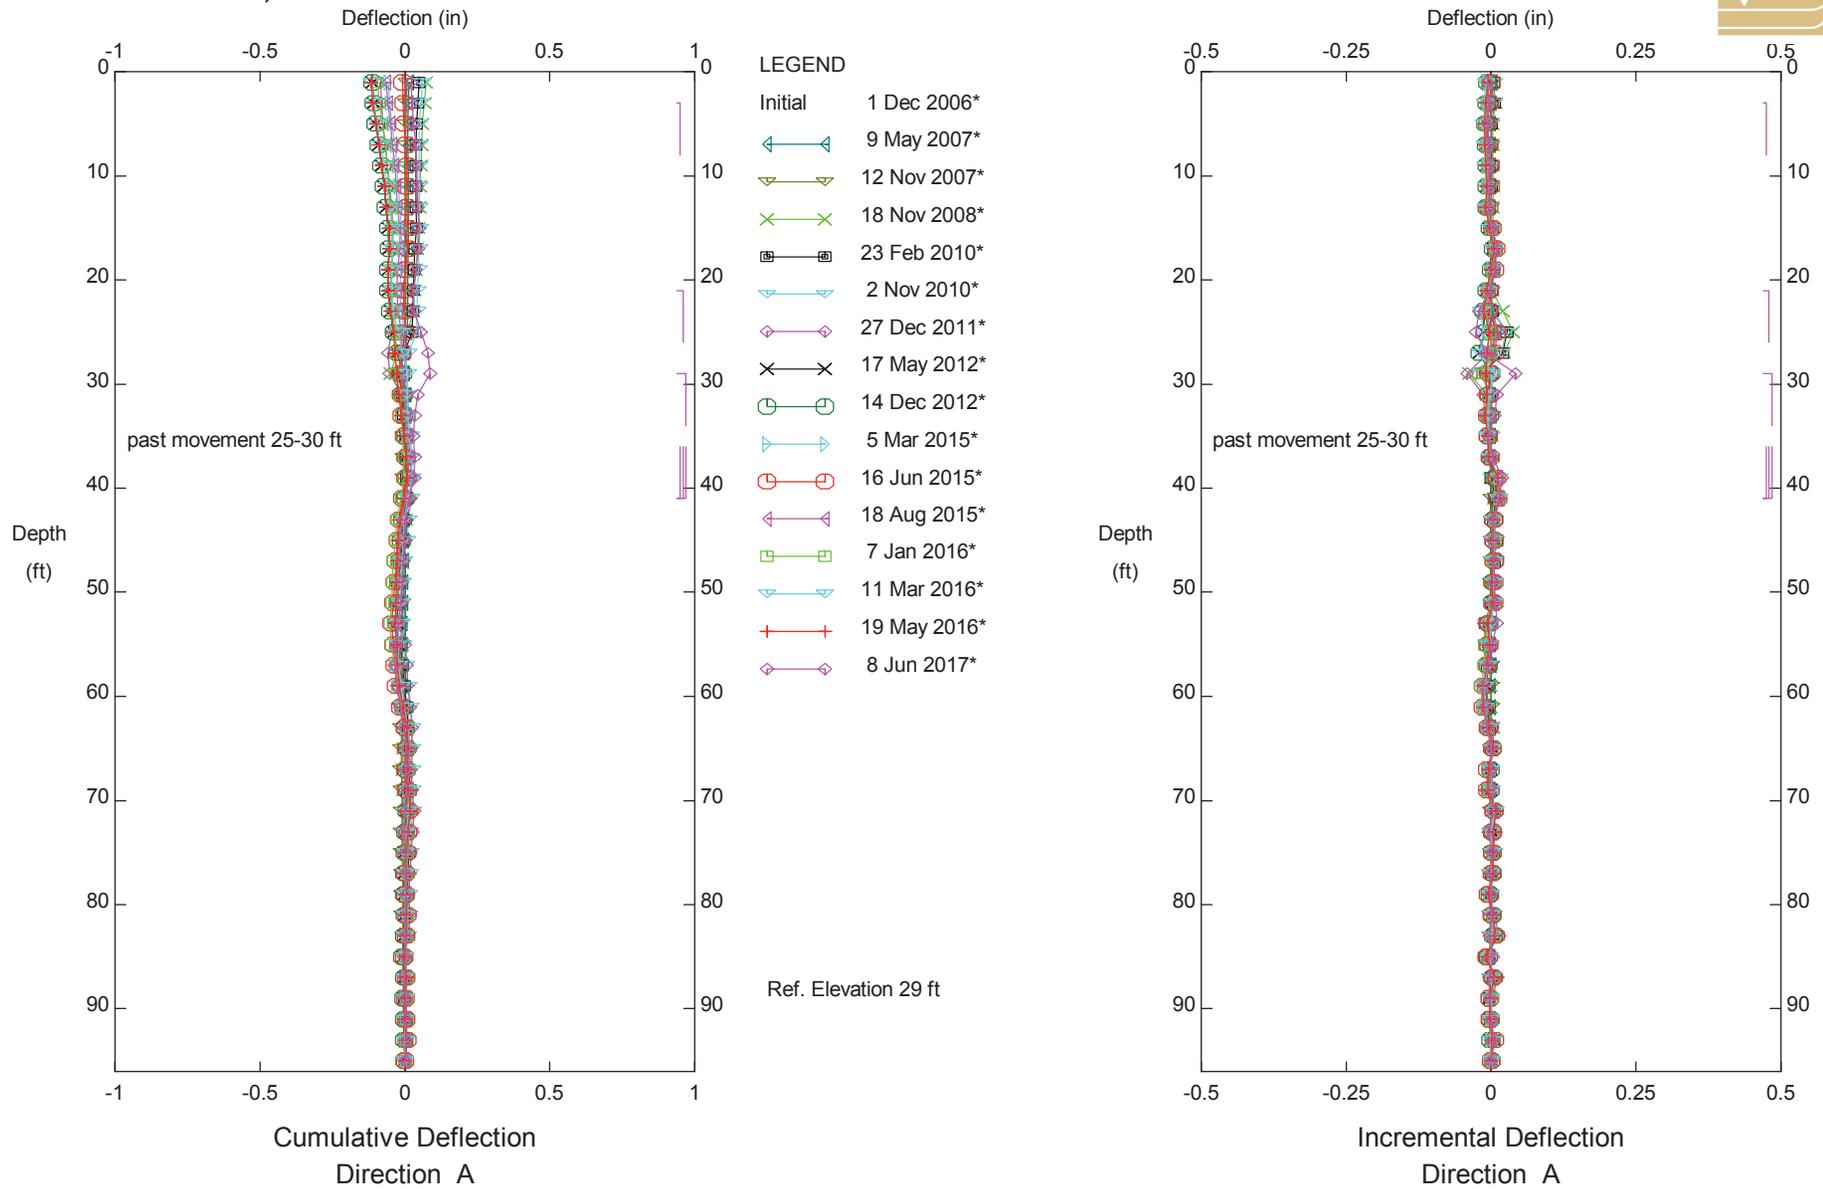
BIG ROCK MESA, Inclinometer SP-27A
 PCH REGION

Sets marked * include zero shift and/or rotation corrections.

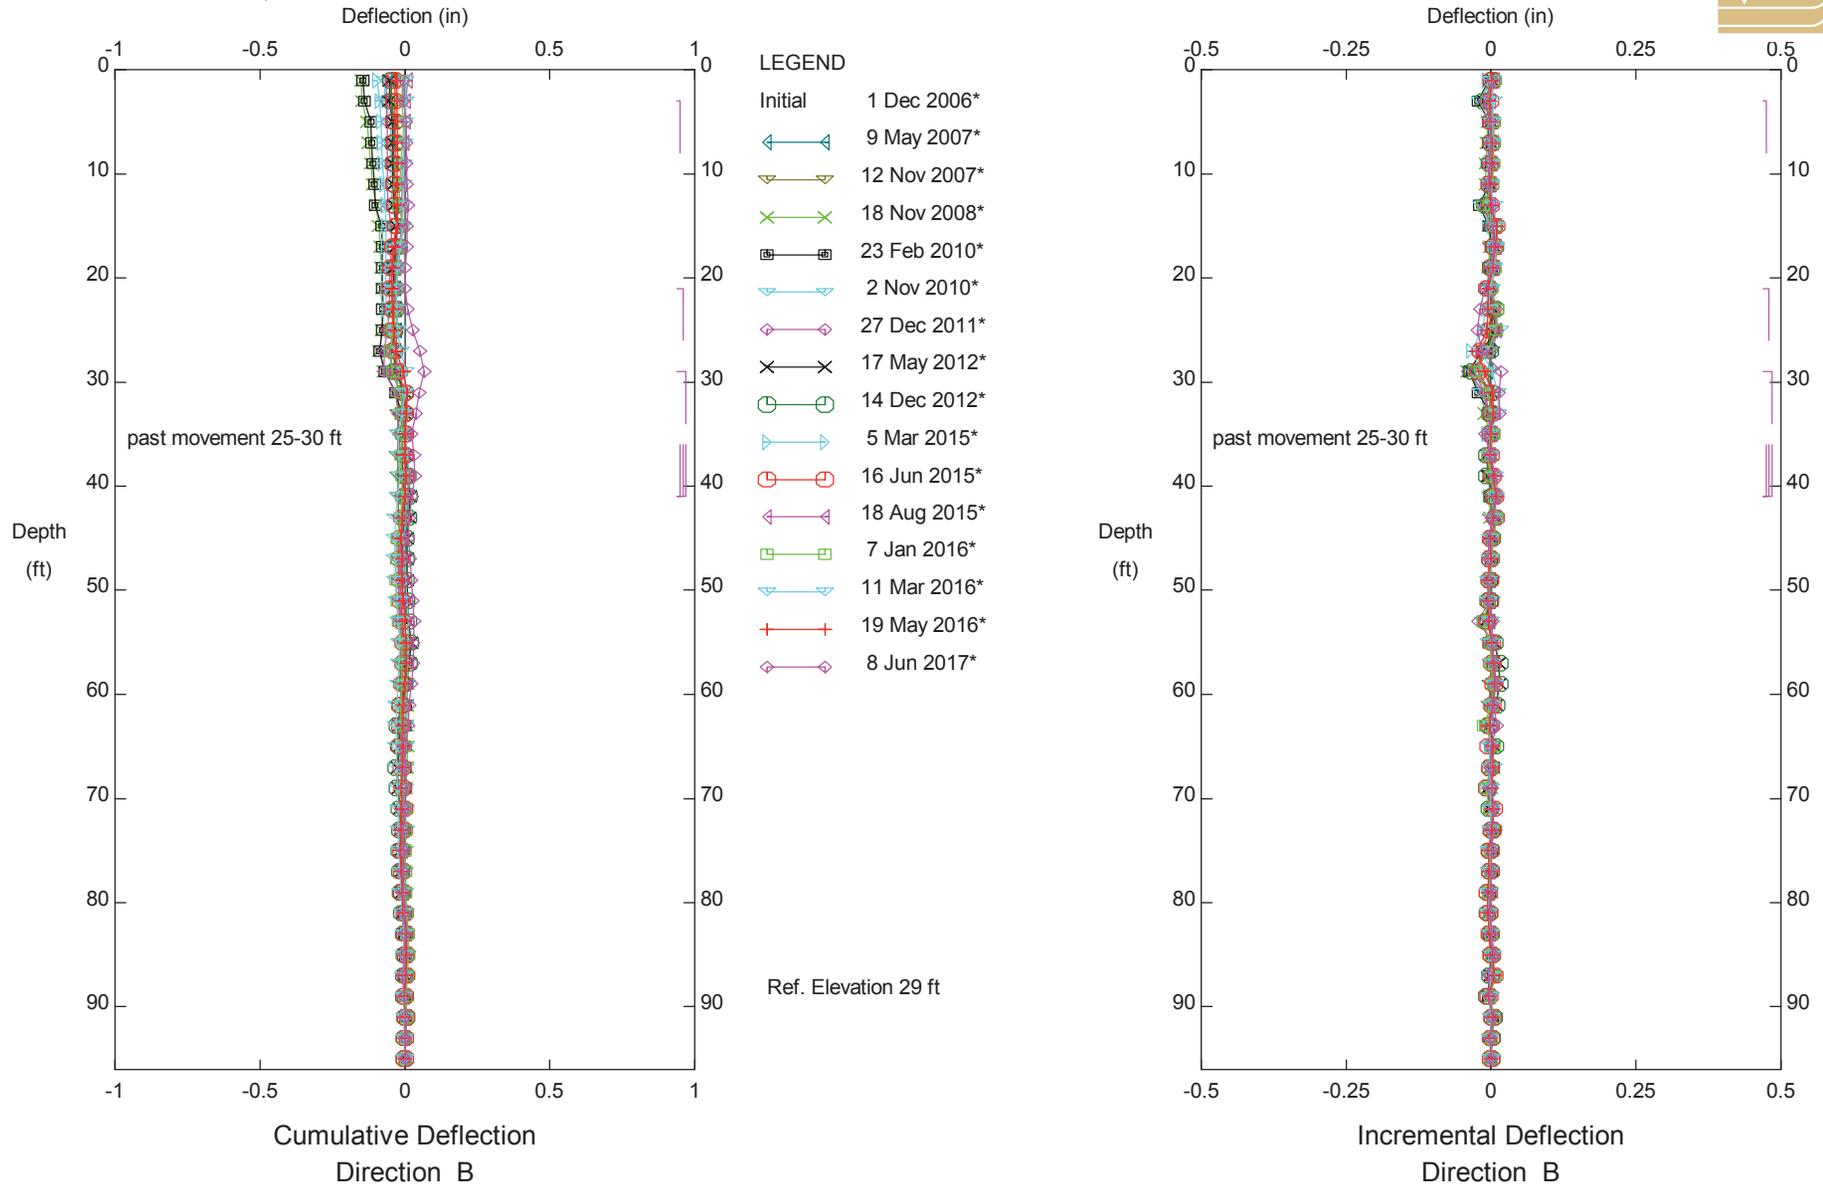
**BIG ROCK MESA, Inclinometer SP-27A
 PCH REGION**

Sets marked * include zero shift and/or rotation corrections.

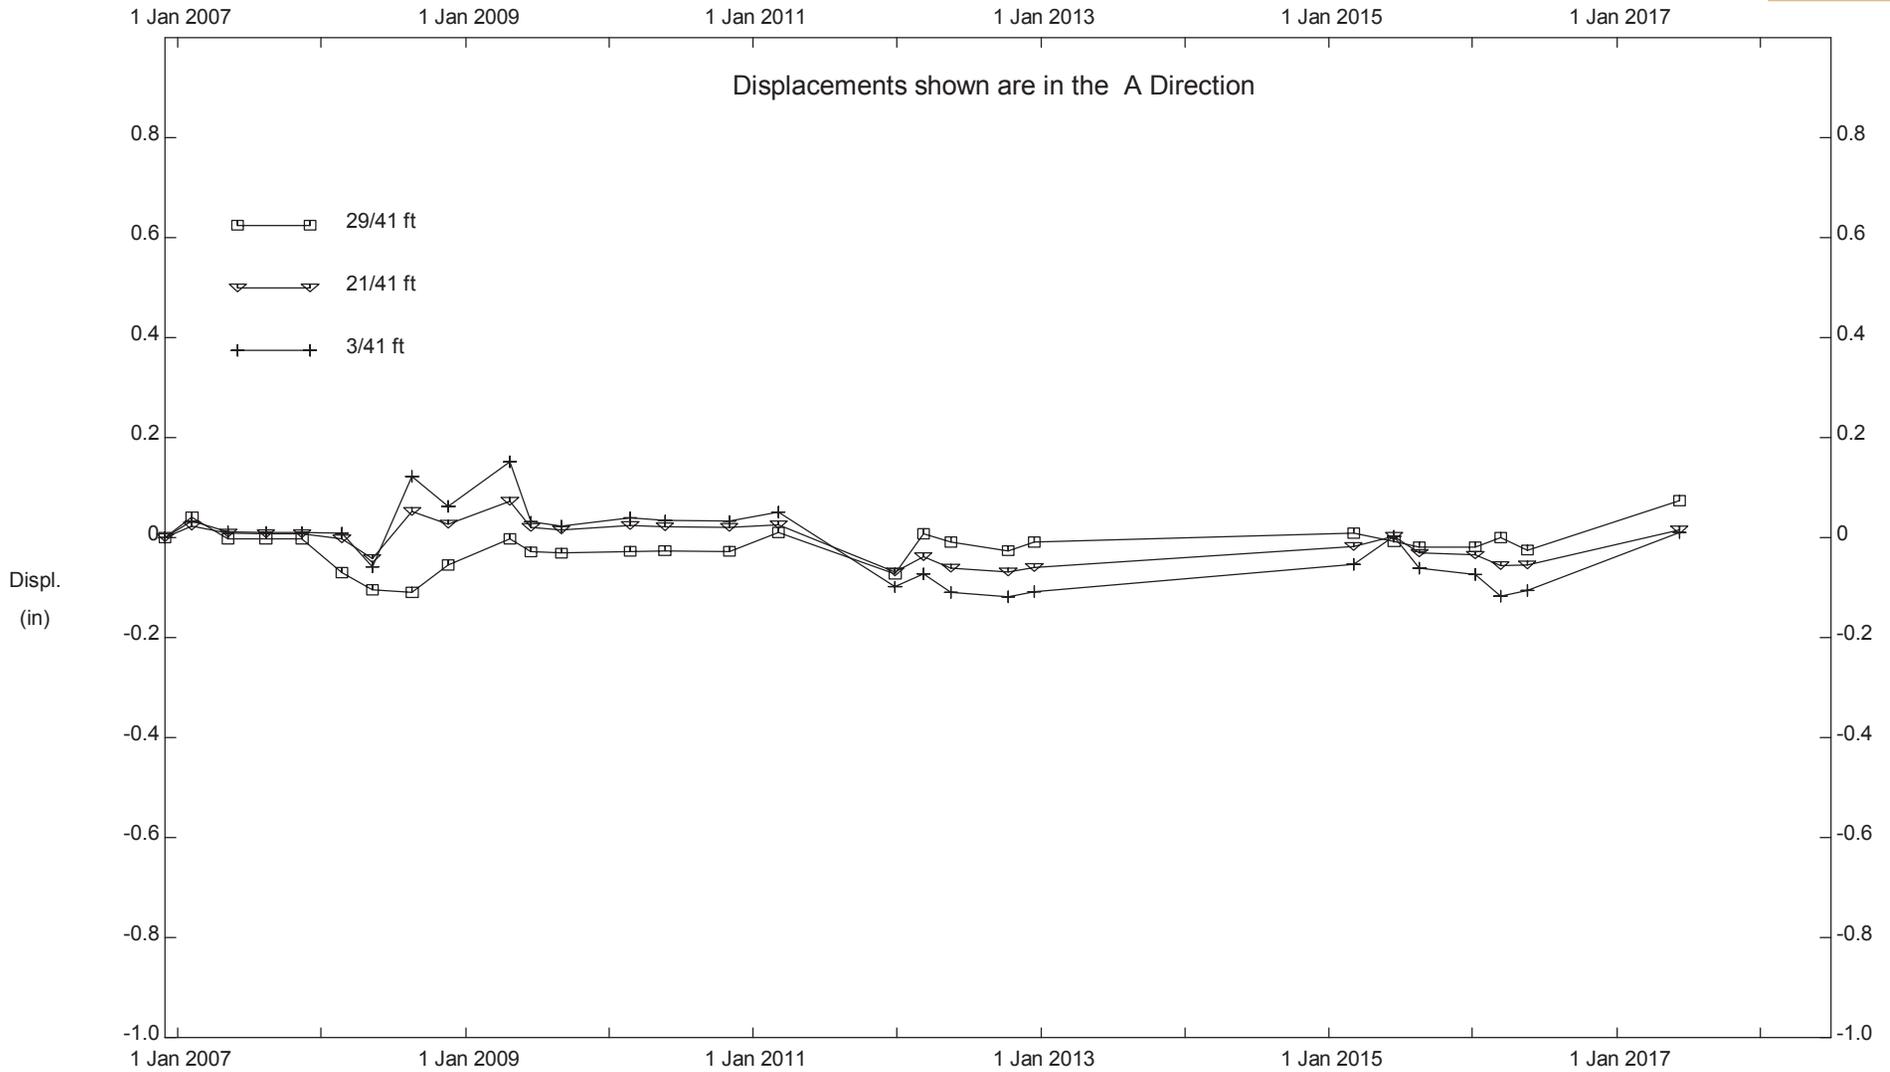
PLATE D7-3

BIG ROCK MESA, Inclinator SP-27A

PCH REGION

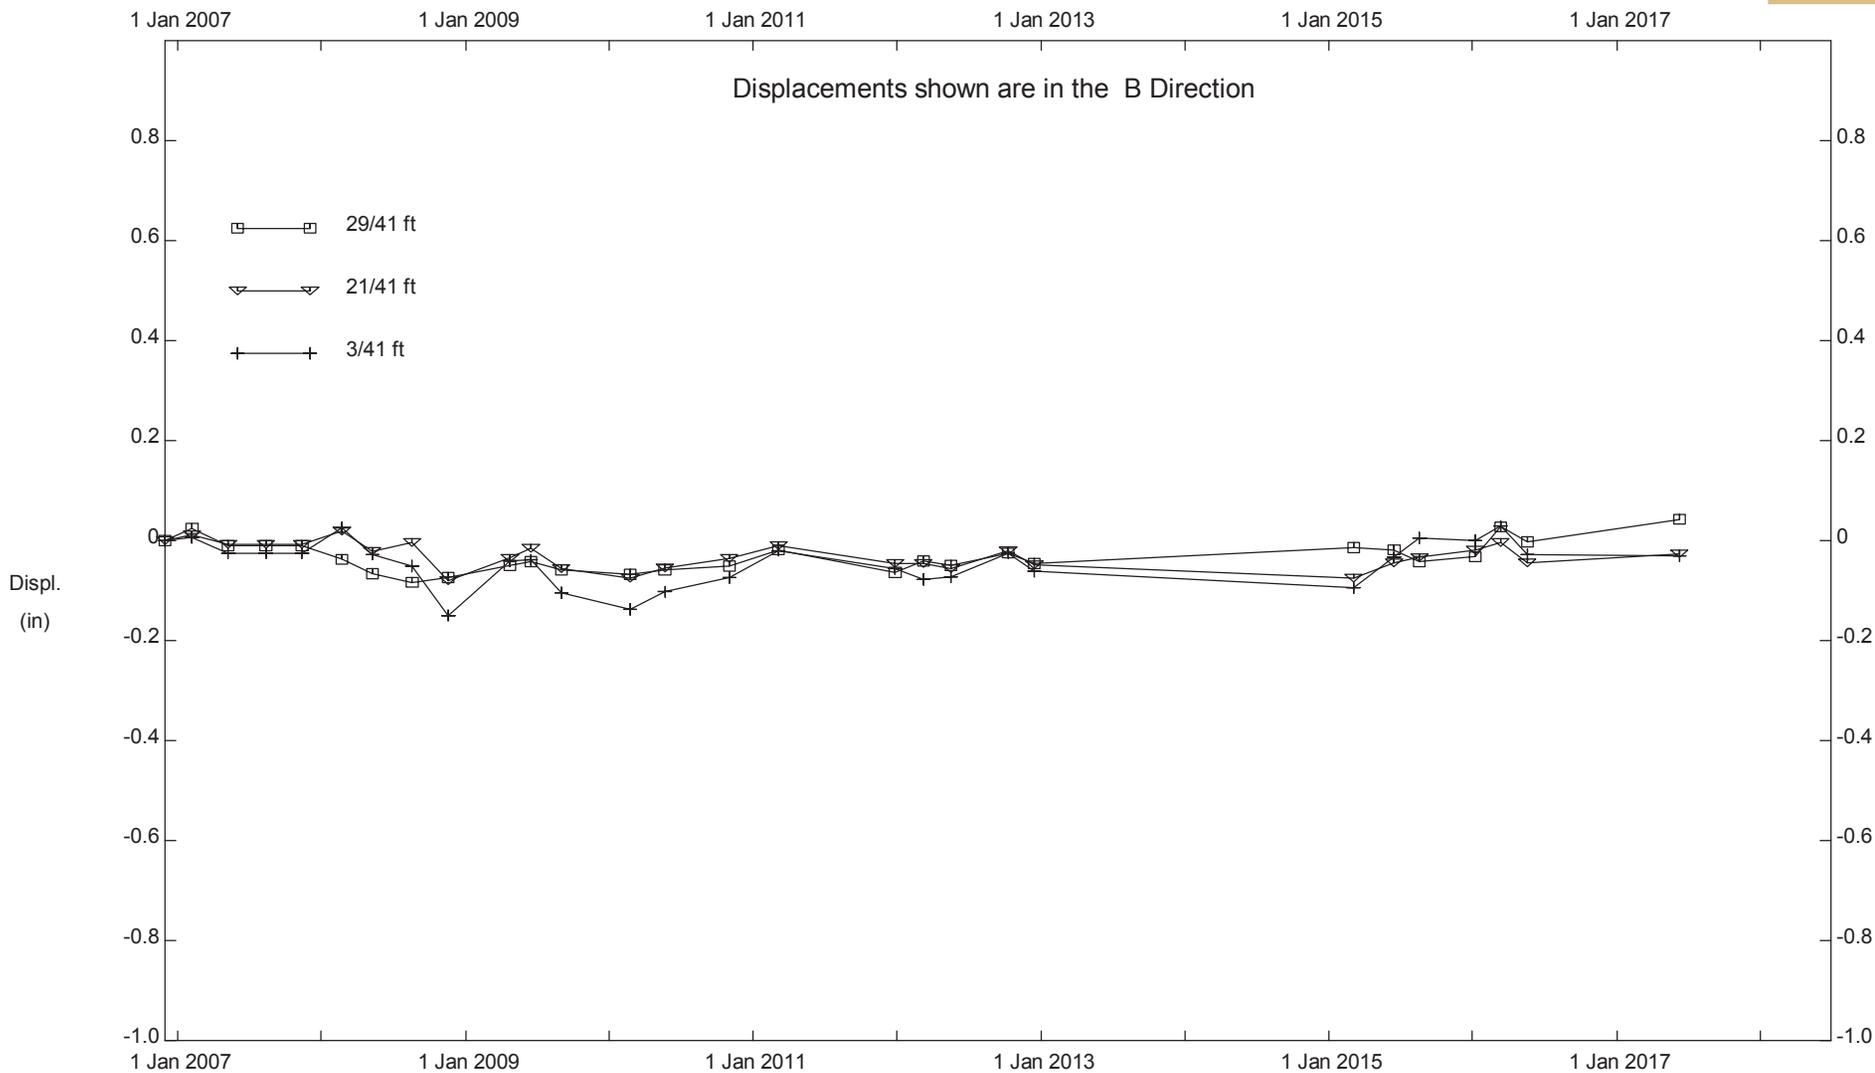
PLATE D7-4

BIG ROCK MESA, Inclinator SP-27A

PCH REGION

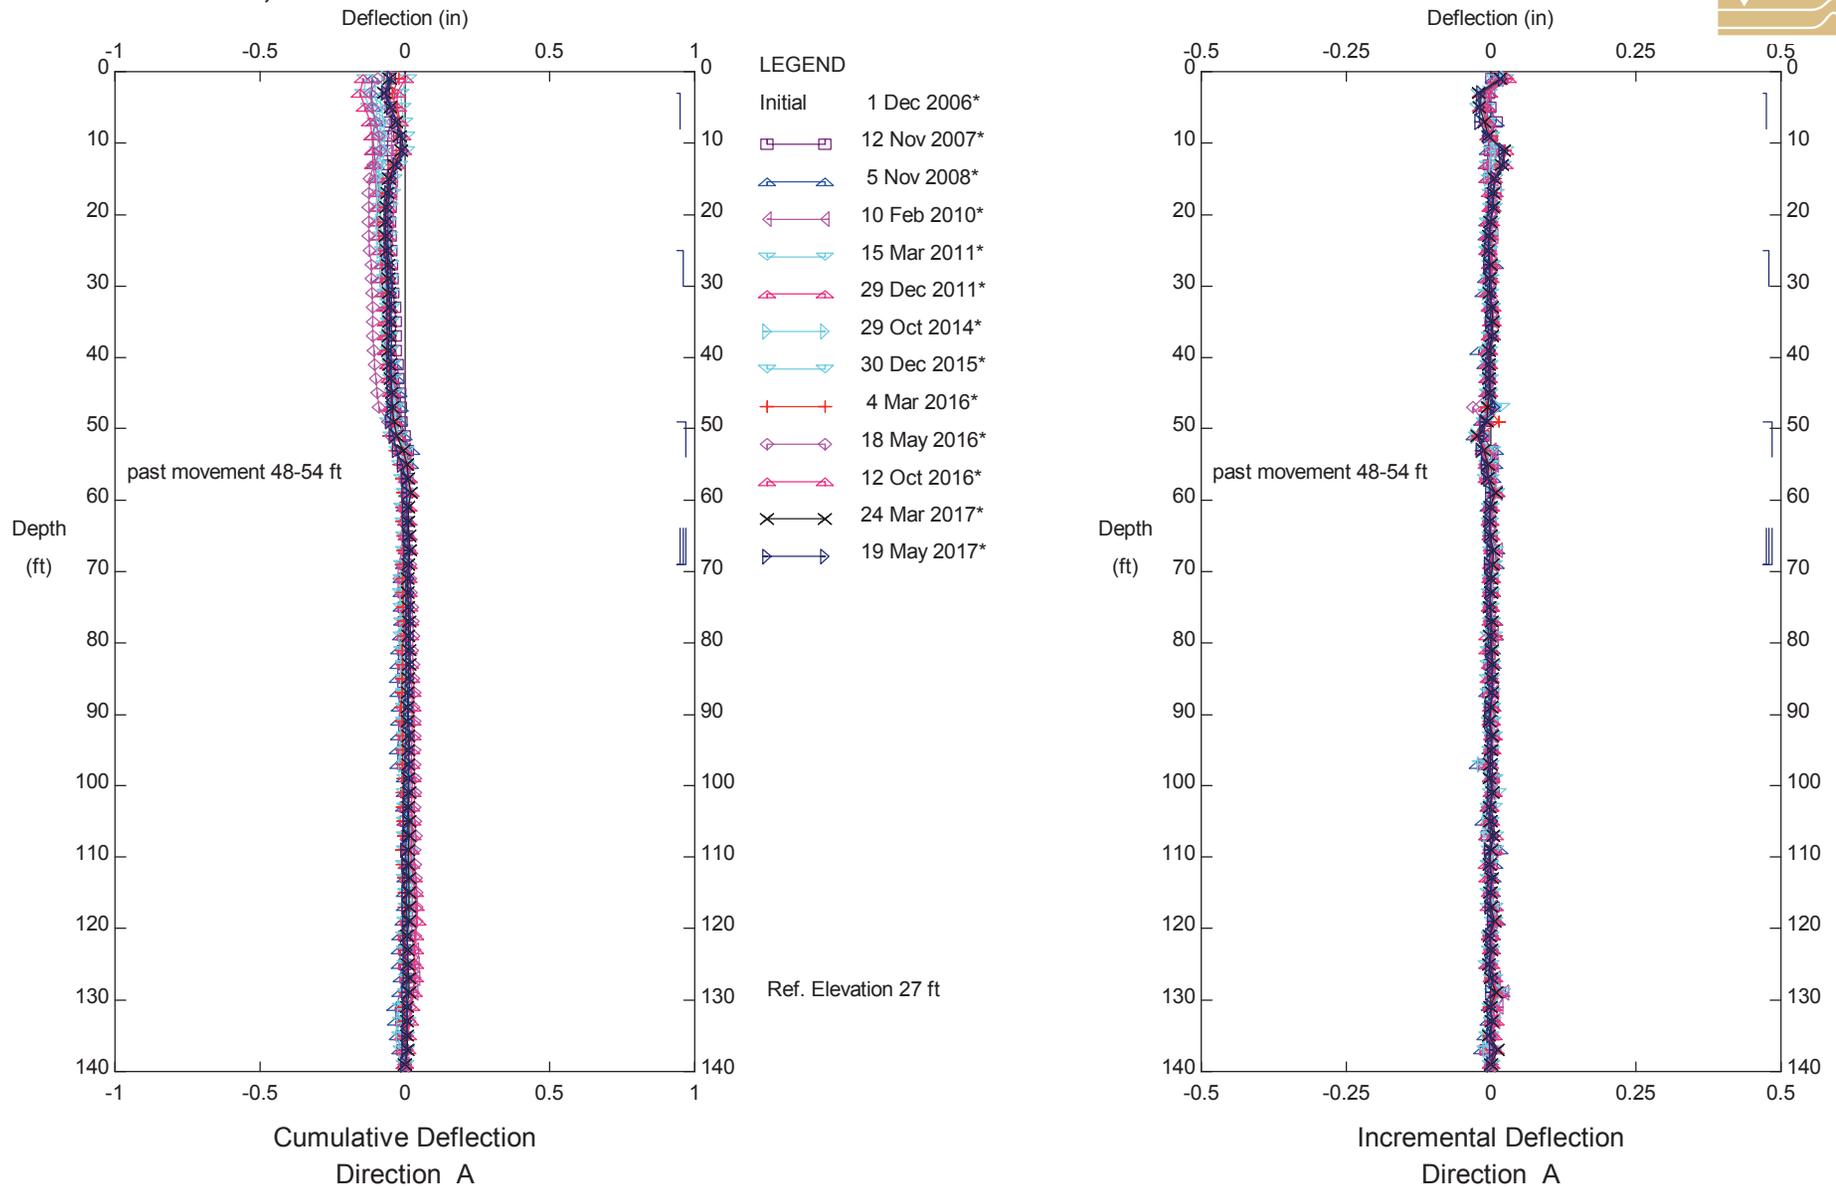
BIG ROCK MESA, Inclinometer SP-29
 PCH REGION

Sets marked * include zero shift and/or rotation corrections.

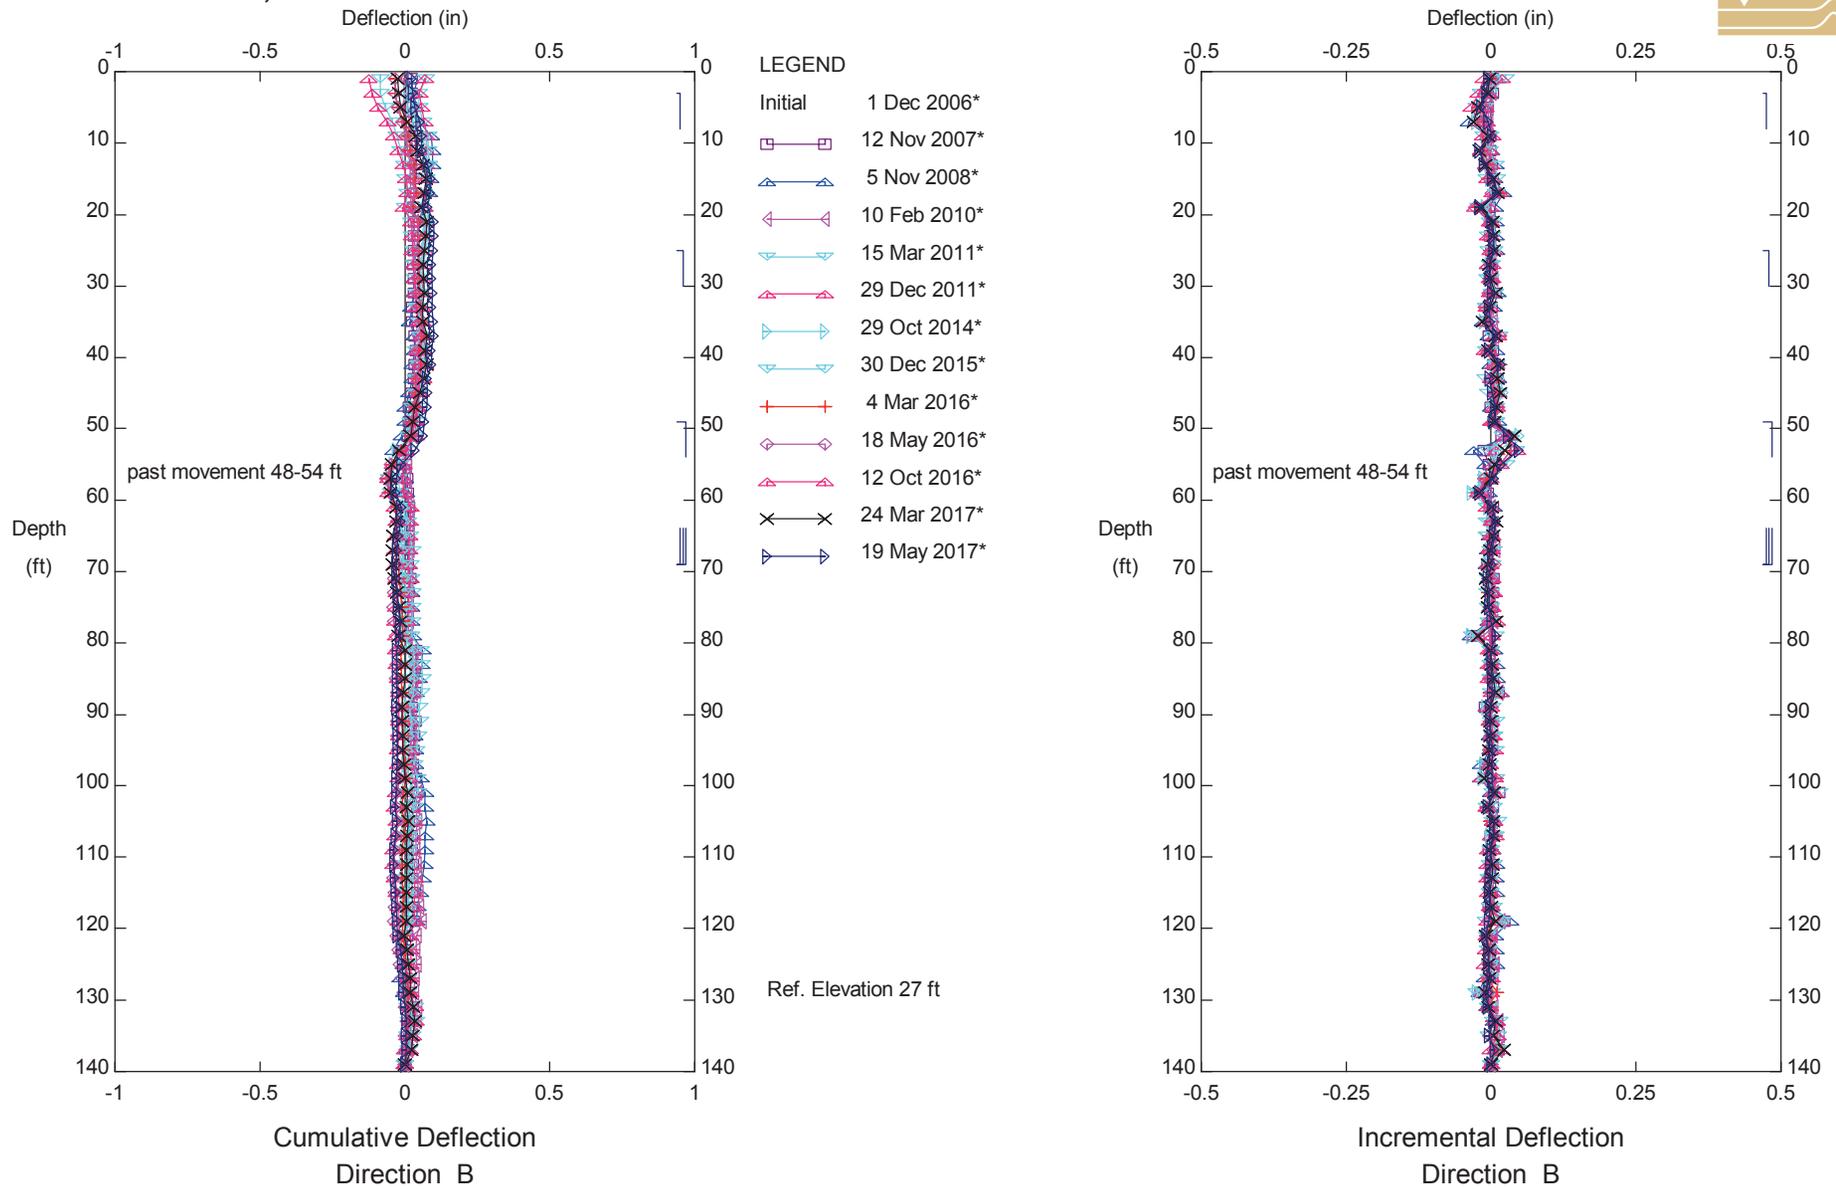
BIG ROCK MESA, Inclinometer SP-29
 PCH REGION

Sets marked * include zero shift and/or rotation corrections.

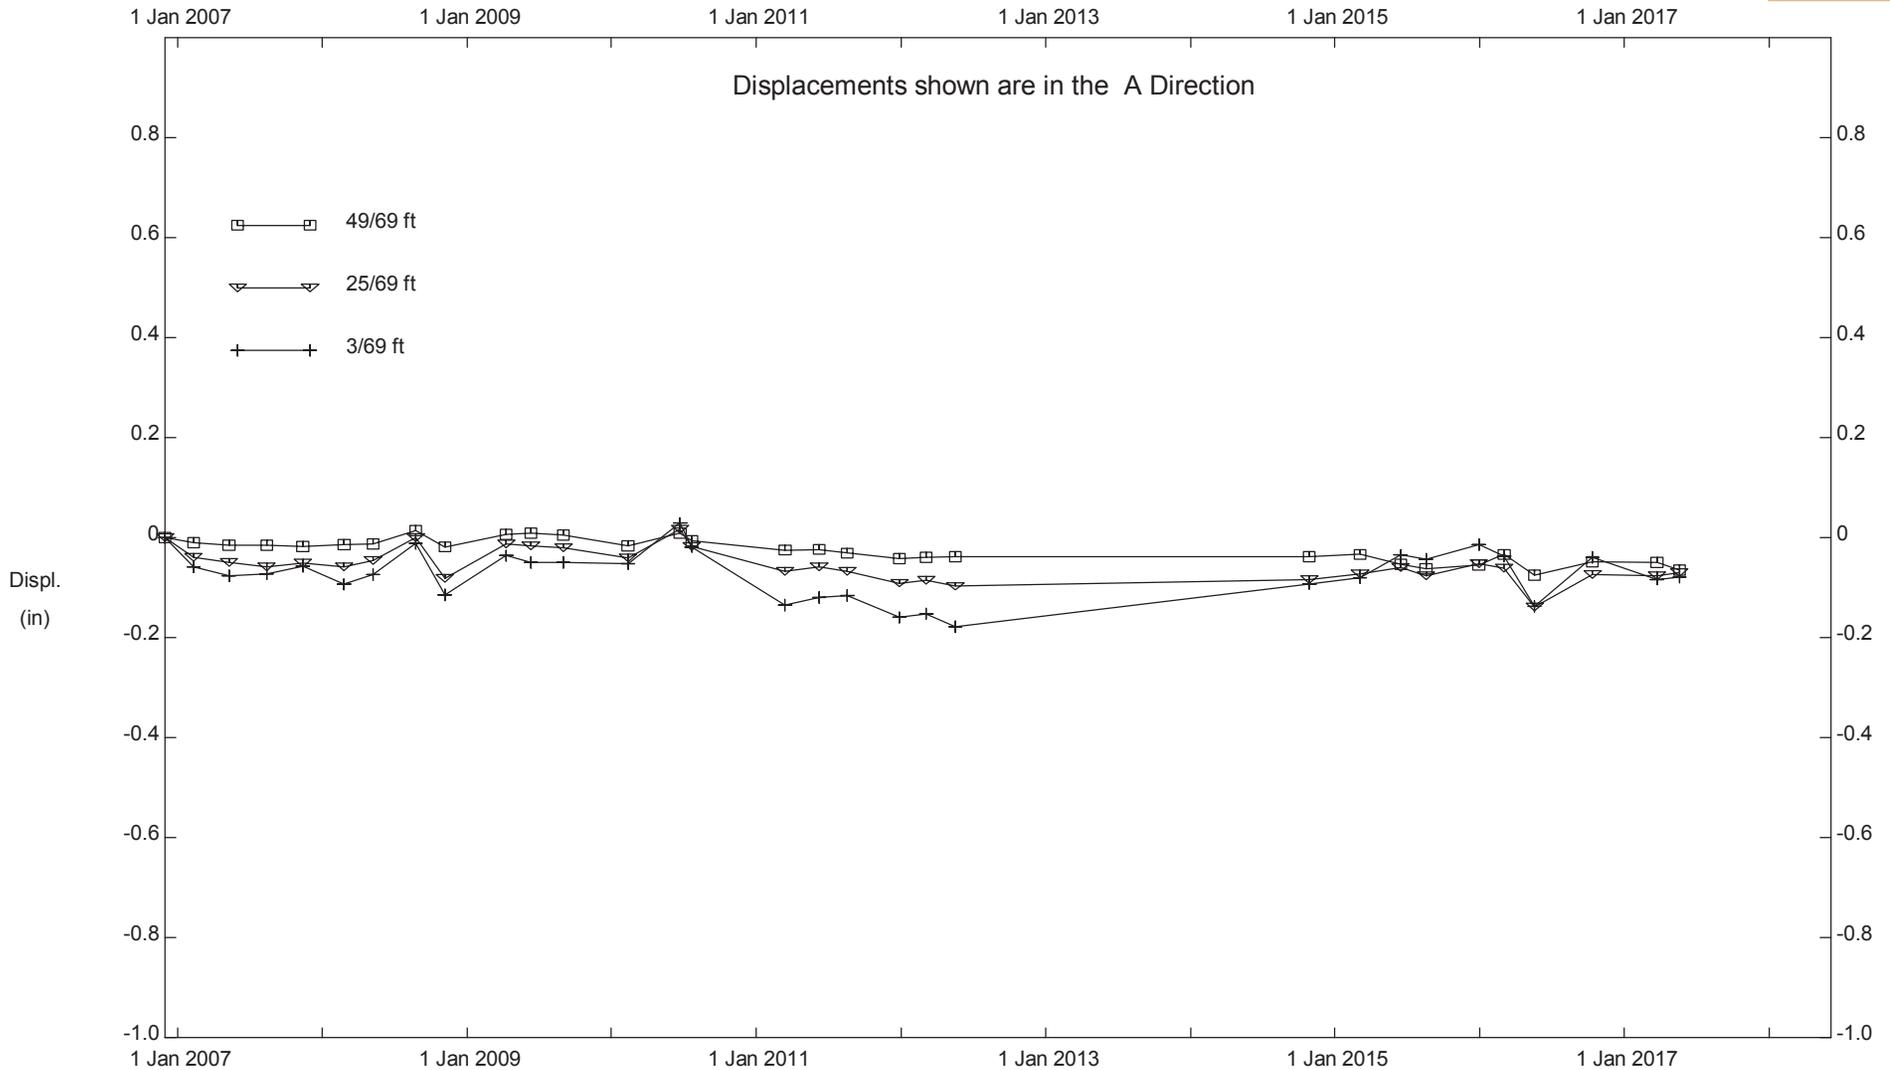
PLATE D8-3

BIG ROCK MESA, Inclinator SP-29

PCH REGION

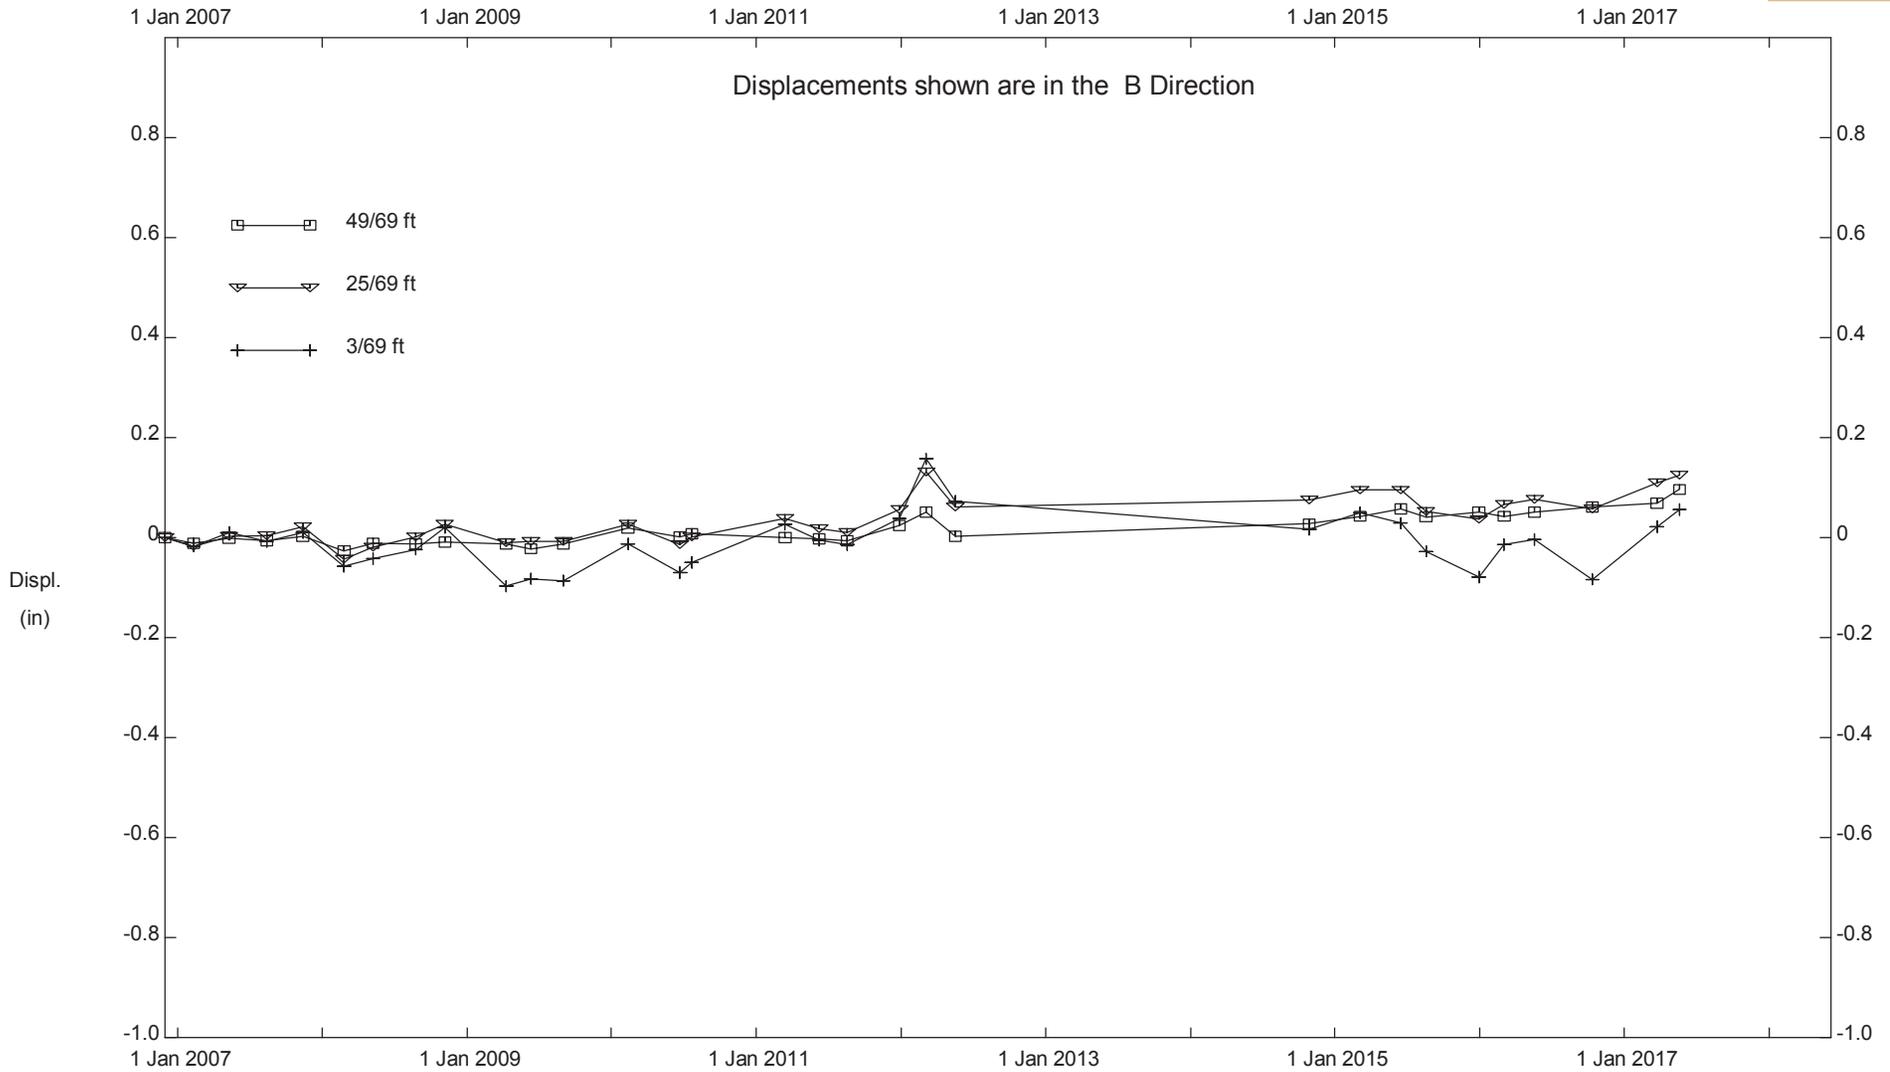
PLATE D8-4

BIG ROCK MESA, Inclinometer SP-29

PCH REGION
