**ANNUAL REPORT
JULY 2016 THROUGH JUNE 2017
BIG ROCK MESA LANDSLIDE
ASSESSMENT DISTRICT
City of Malibu, California**

March 2018
Fugro Project No. 04.62160606
Document No. 04.62160606-PR-004(Rev.00)

**Annual Report of Maintenance and Monitoring, July 2016 through June 2017,
Big Rock Mesa Landslide Assessment District, City of Malibu, California**

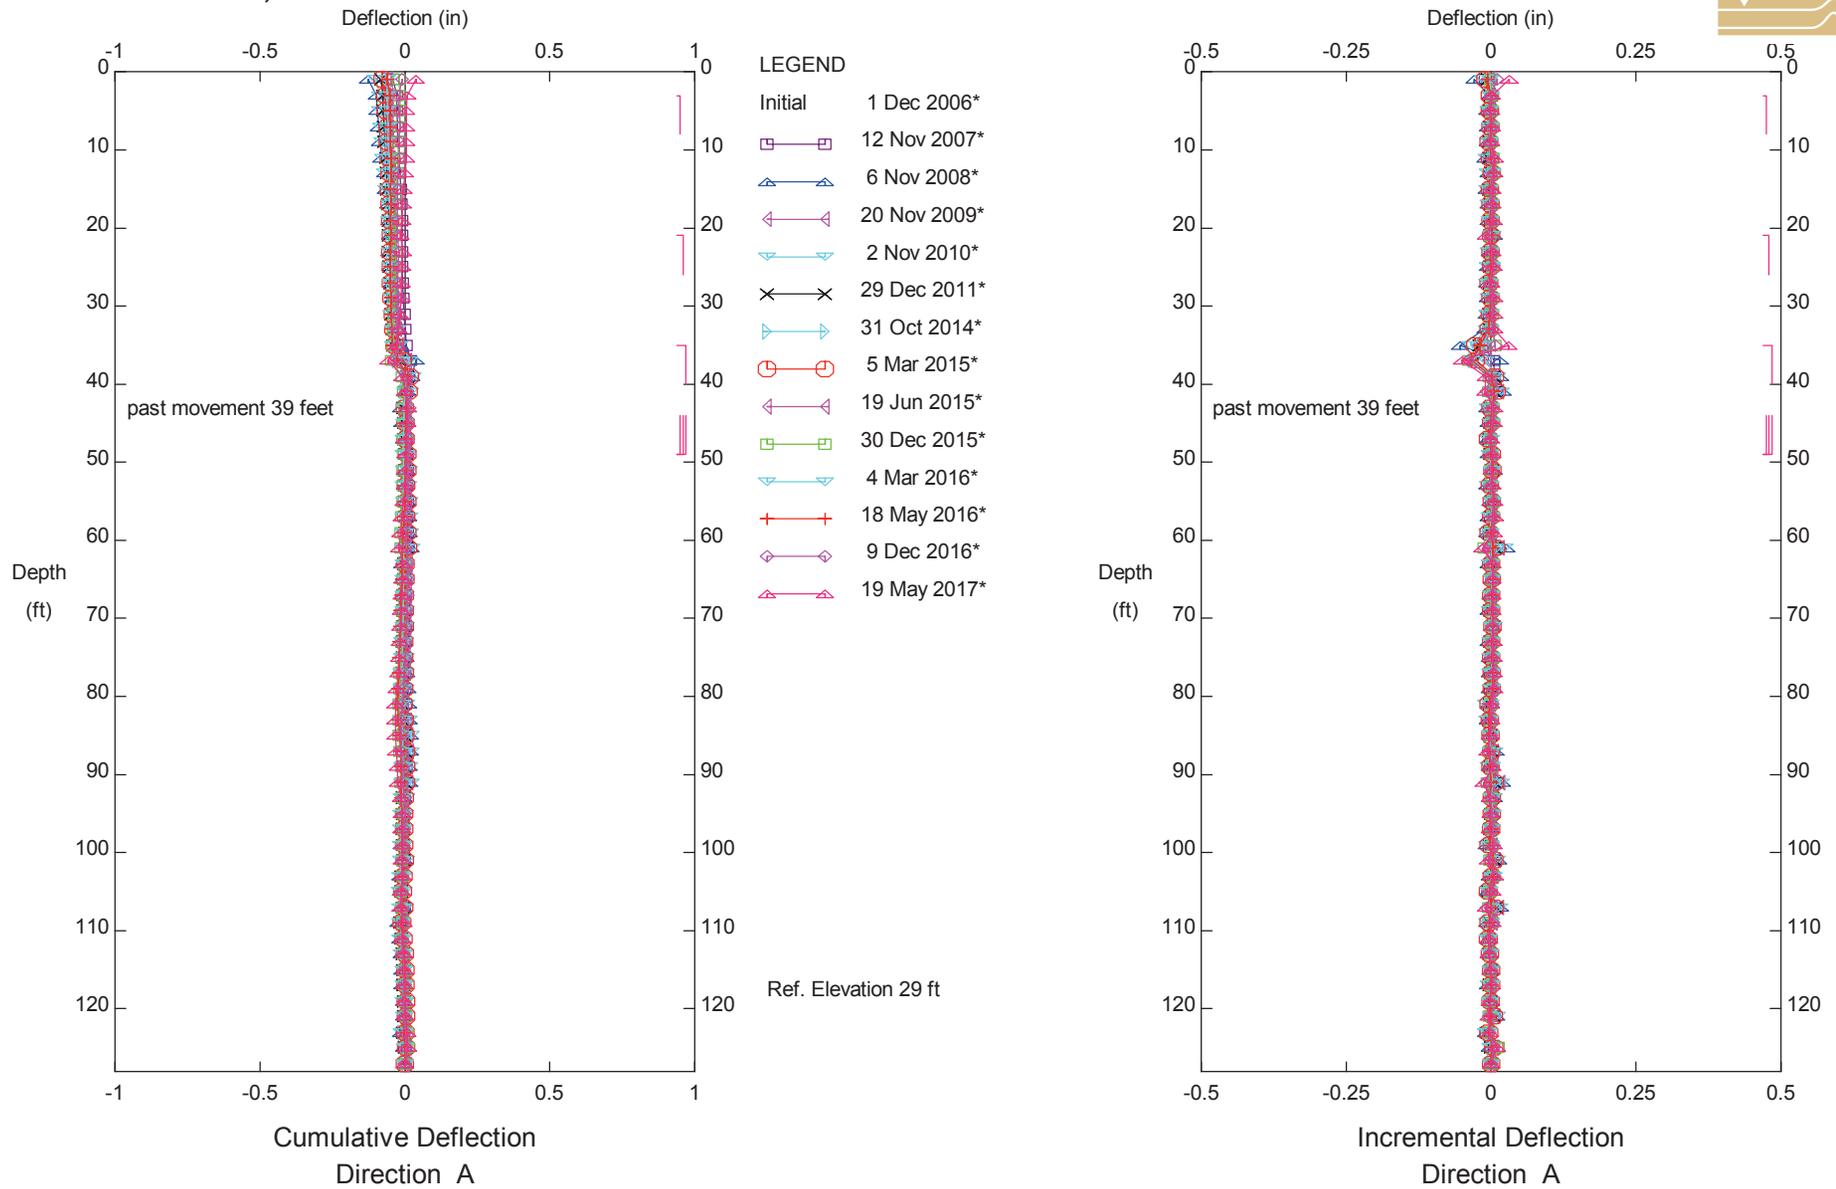
BIG ROCK MESA, Inclinator SP-30
 PCH REGION

Sets marked * include zero shift and/or rotation corrections.

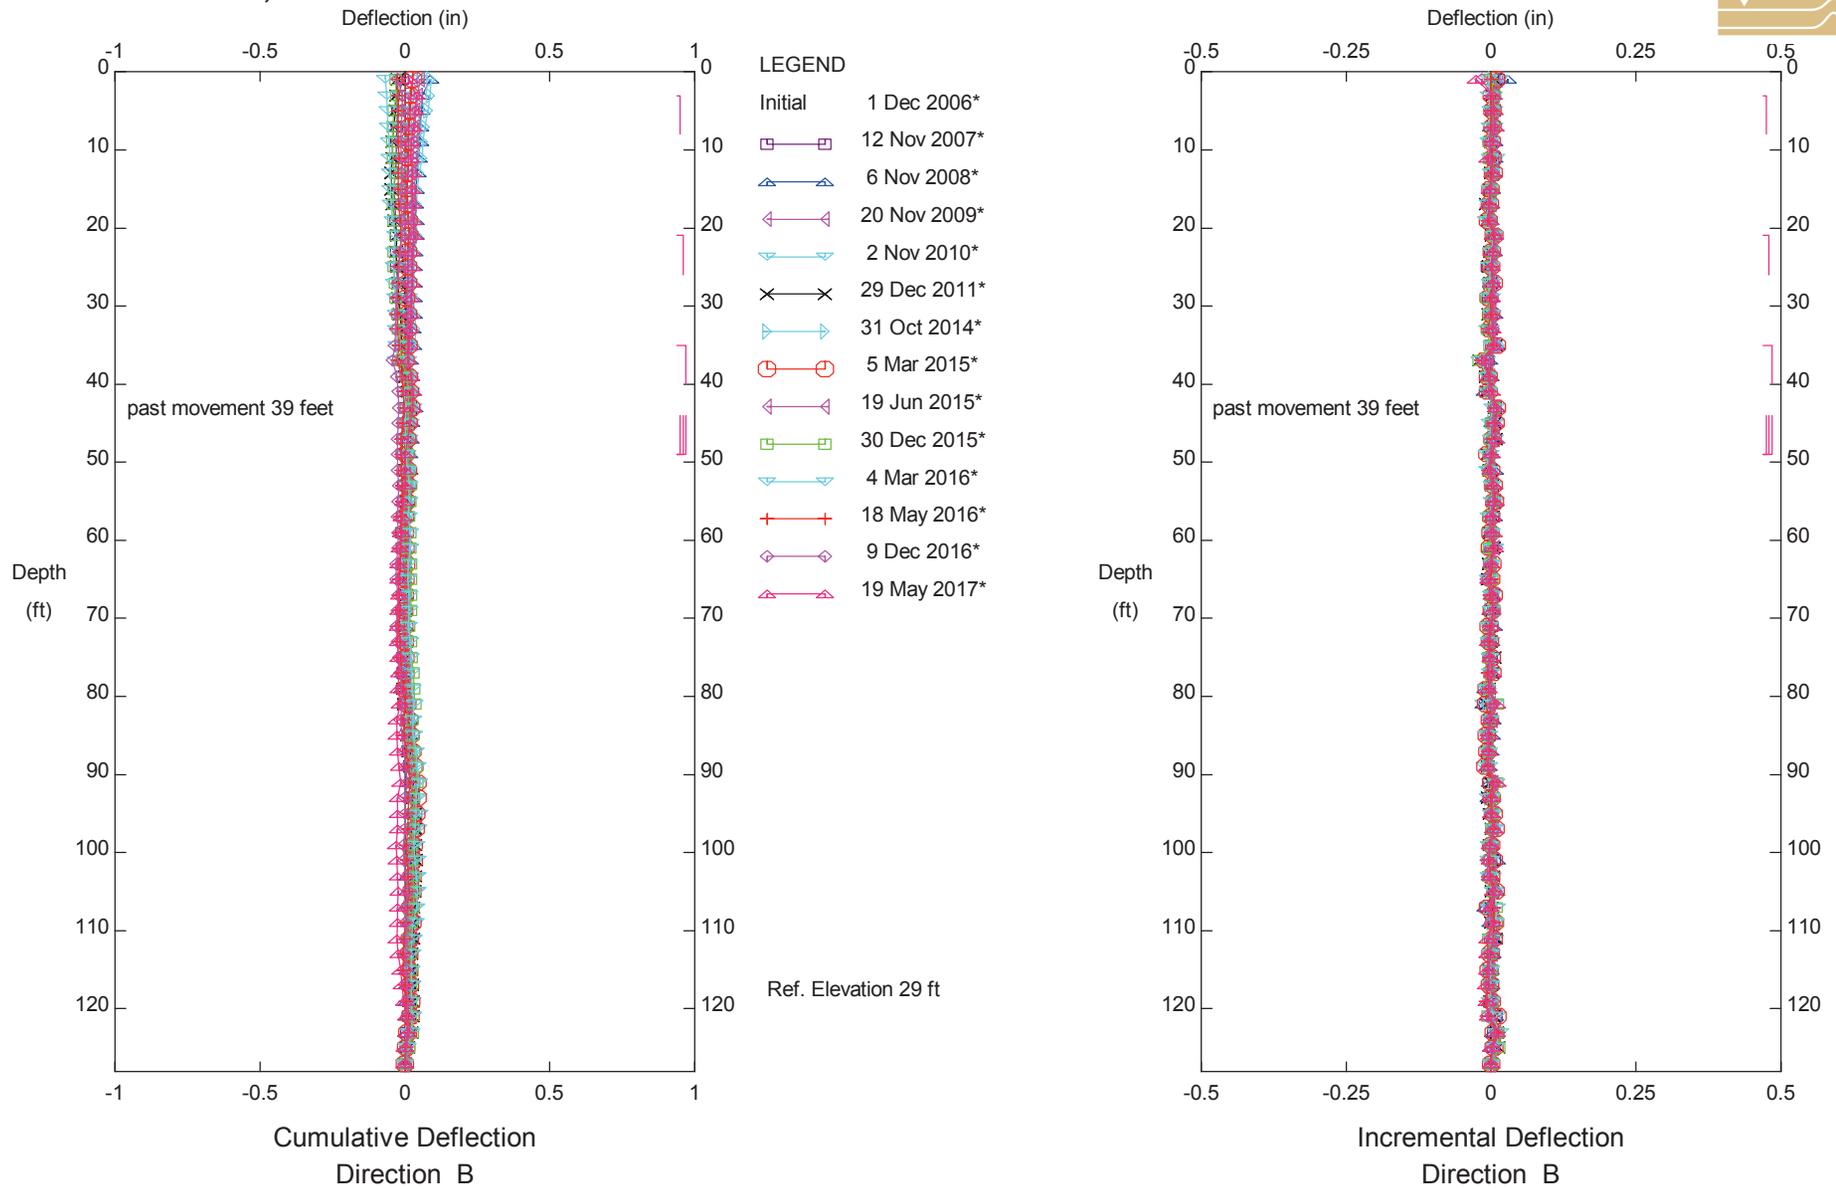
BIG ROCK MESA, Inclinerometer SP-30
 PCH REGION

Sets marked * include zero shift and/or rotation corrections.

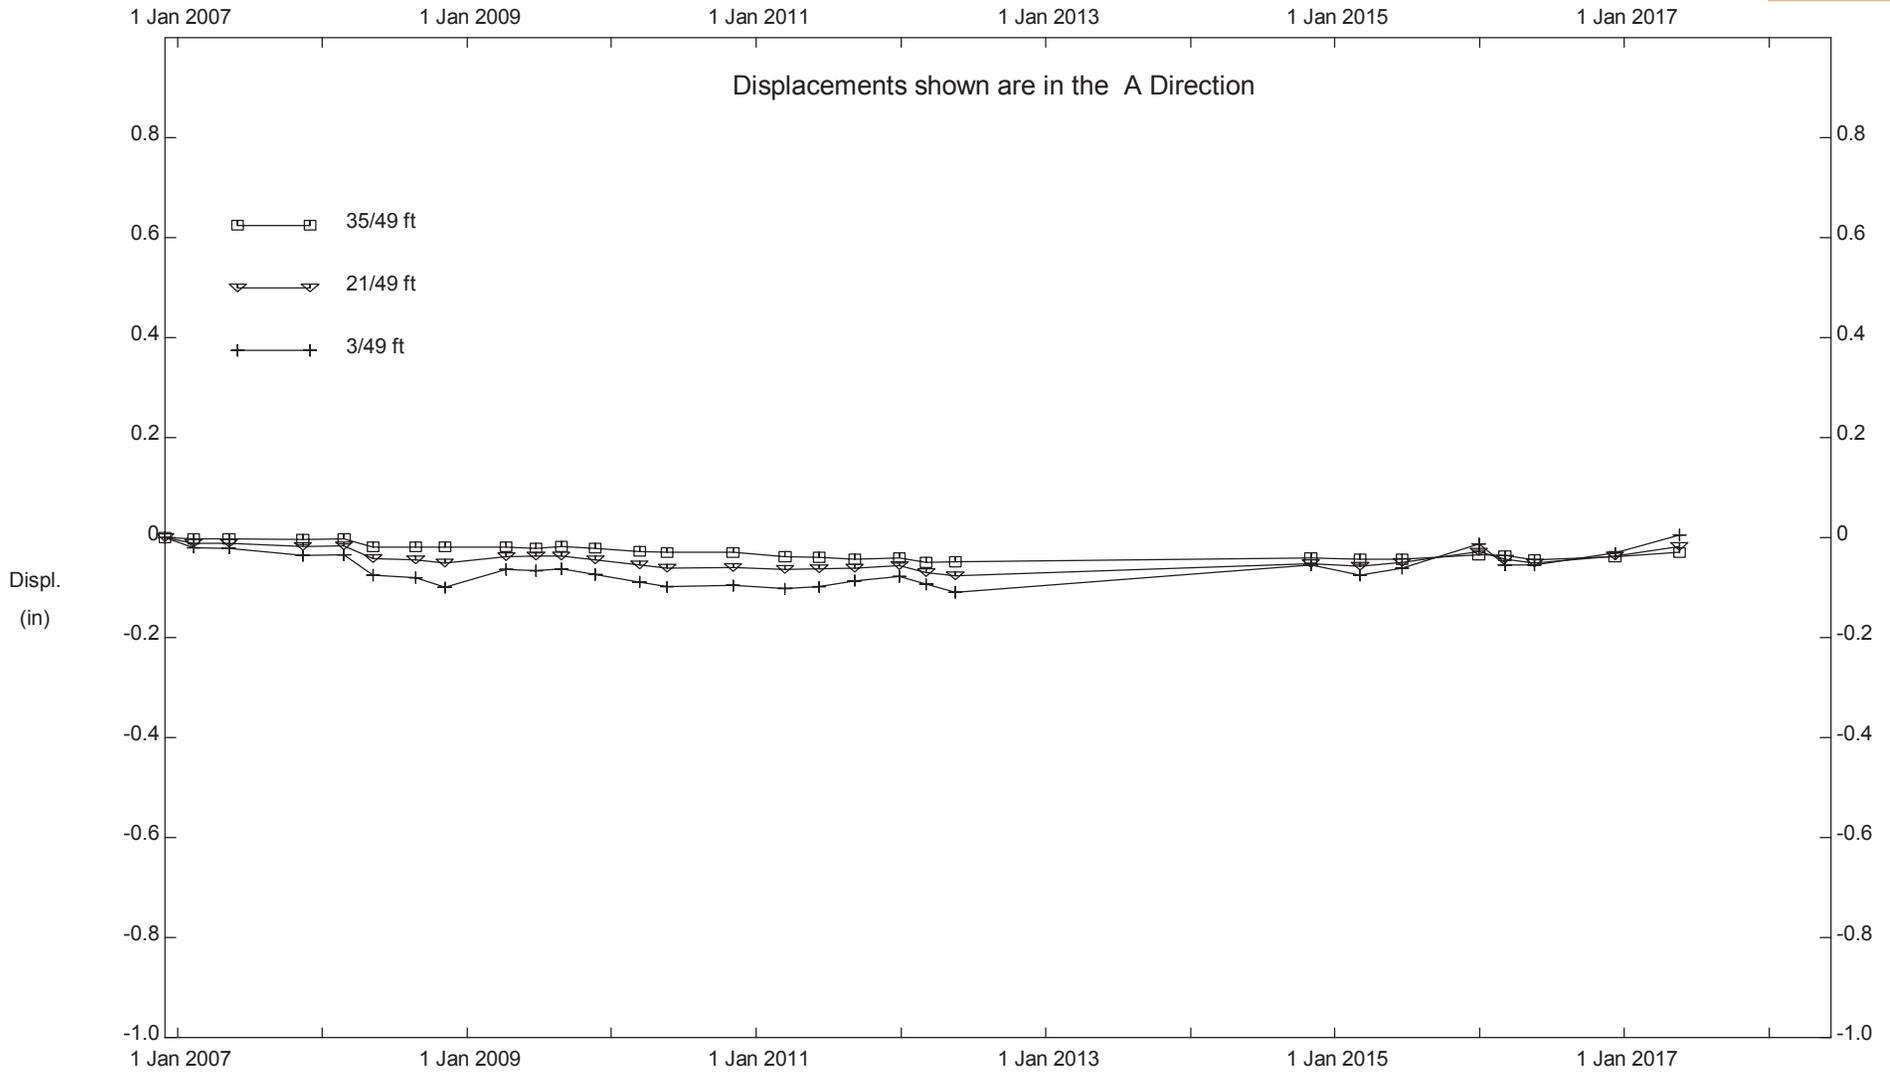
PLATE D9-3

BIG ROCK MESA, Inclinometer SP-30

PCH REGION

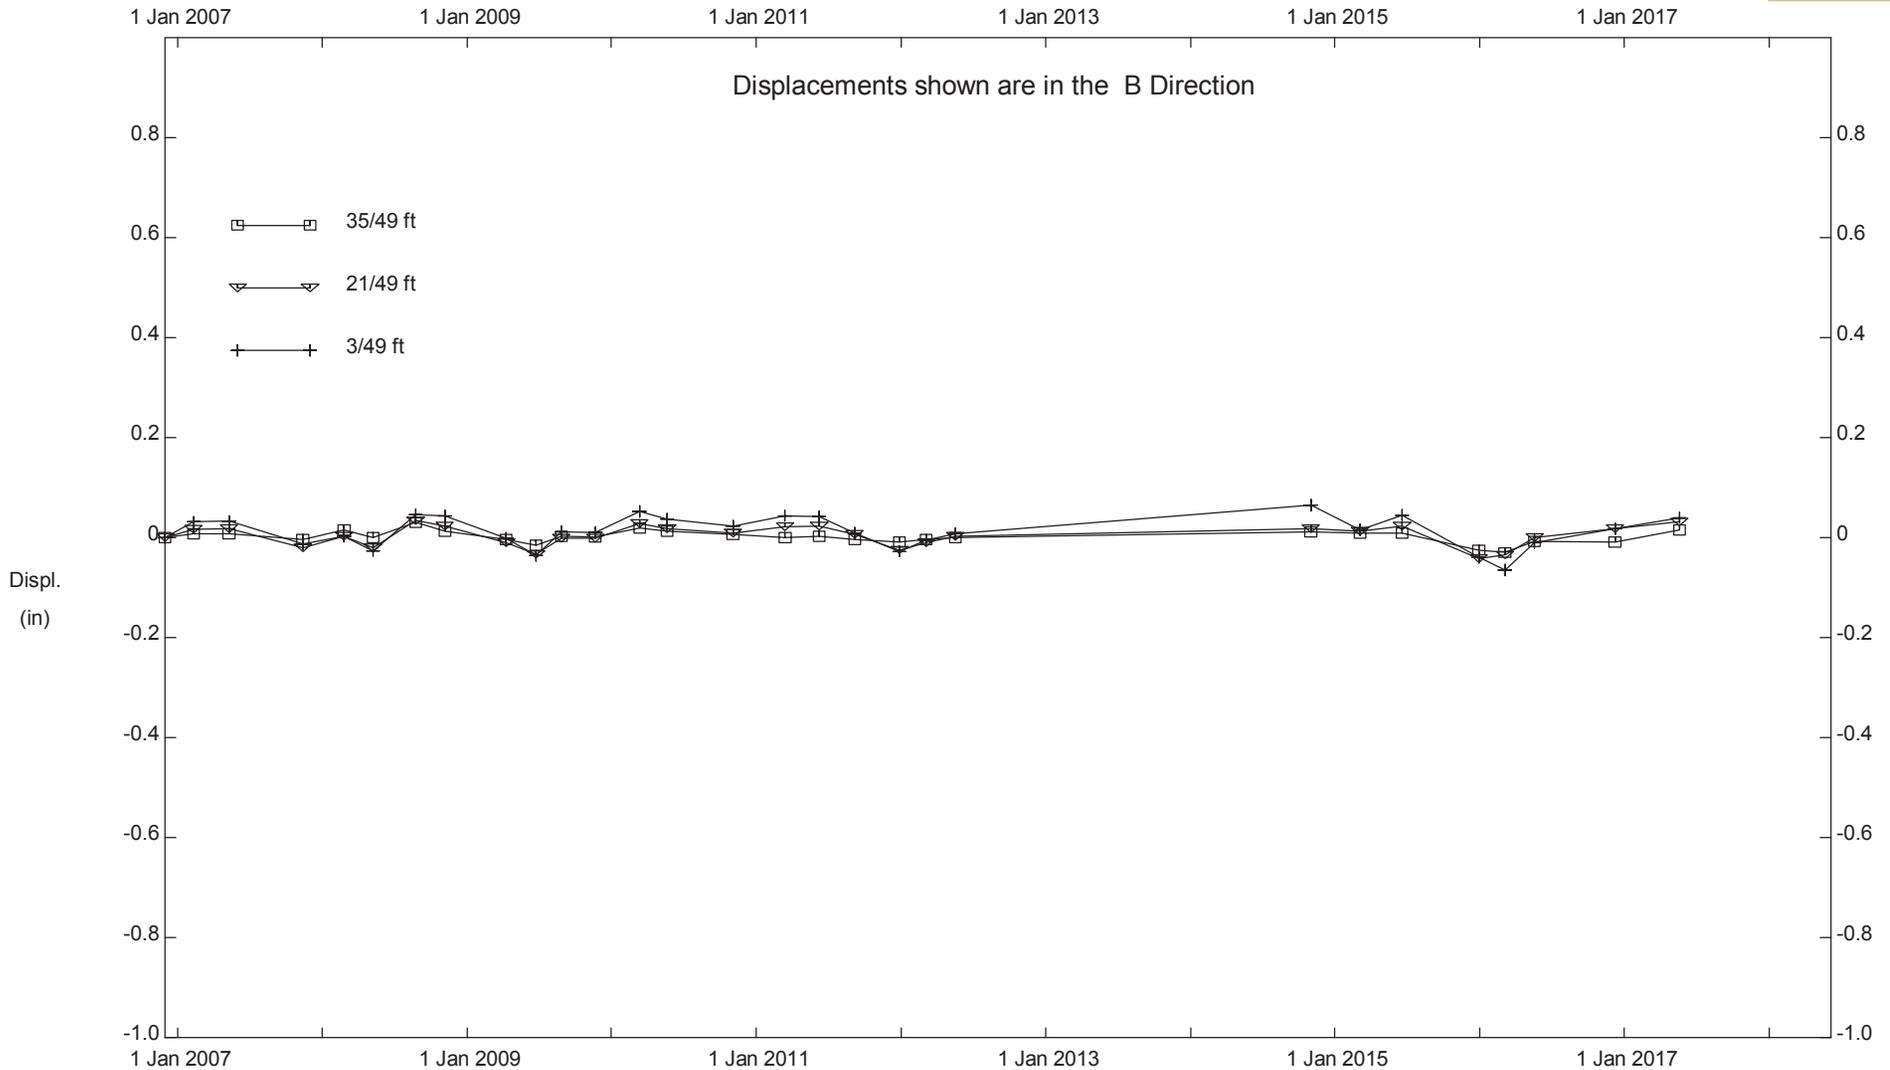
PLATE D9-4

BIG ROCK MESA, Inclinometer SP-30

PCH REGION

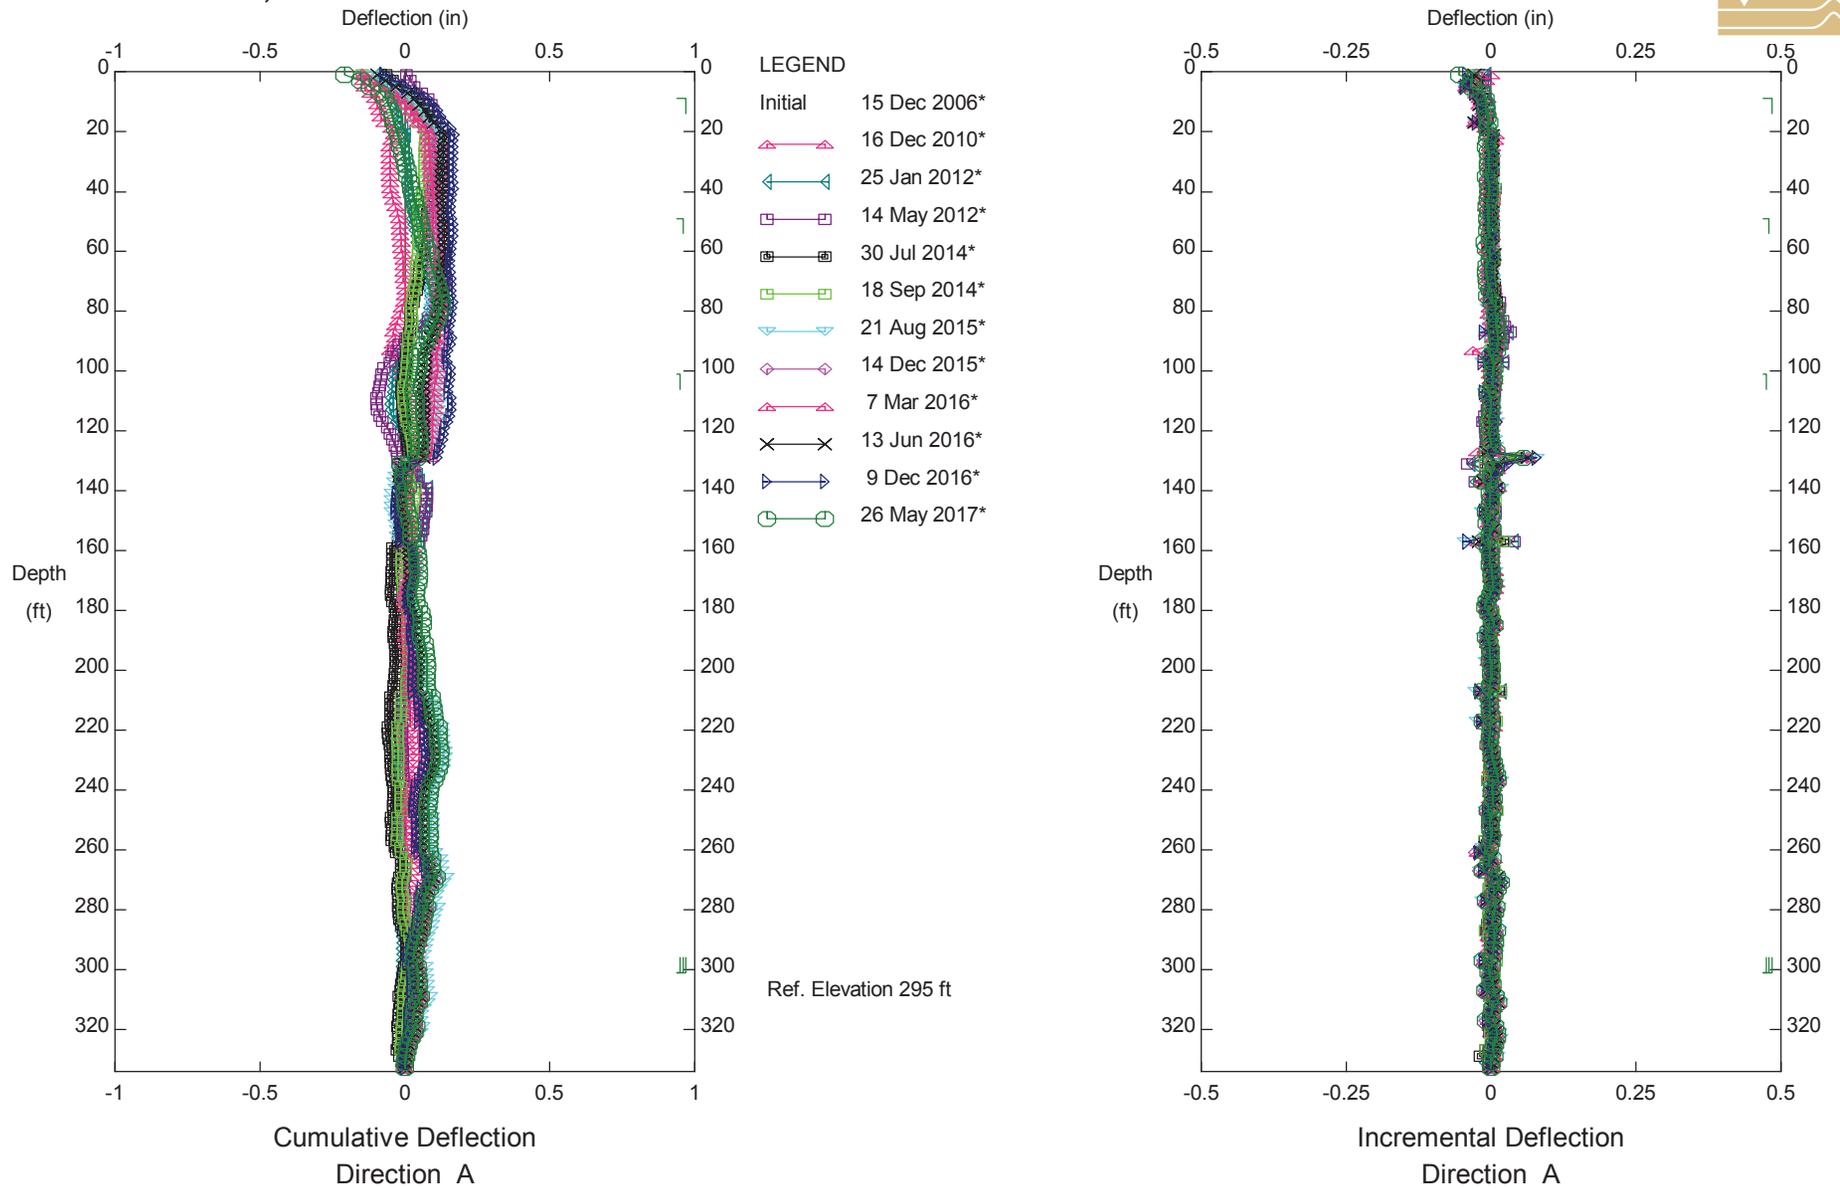
BIG ROCK MESA, Inclinometer SP-10
 BLUFF REGION

Sets marked * include zero shift and/or rotation corrections.

The Bluff Region extends along the top of the slope immediately north of the PCH Region, where intense ground cracking was observed during the 1983 landslide. The inclinometers in that area are deep and show evidence of depth position and rotation errors, associated with cable stretch, casing curvature, and casing deviation from vertical. No quantifiable offsets within the inclinometers of the Bluff Region were measured during this monitoring period.

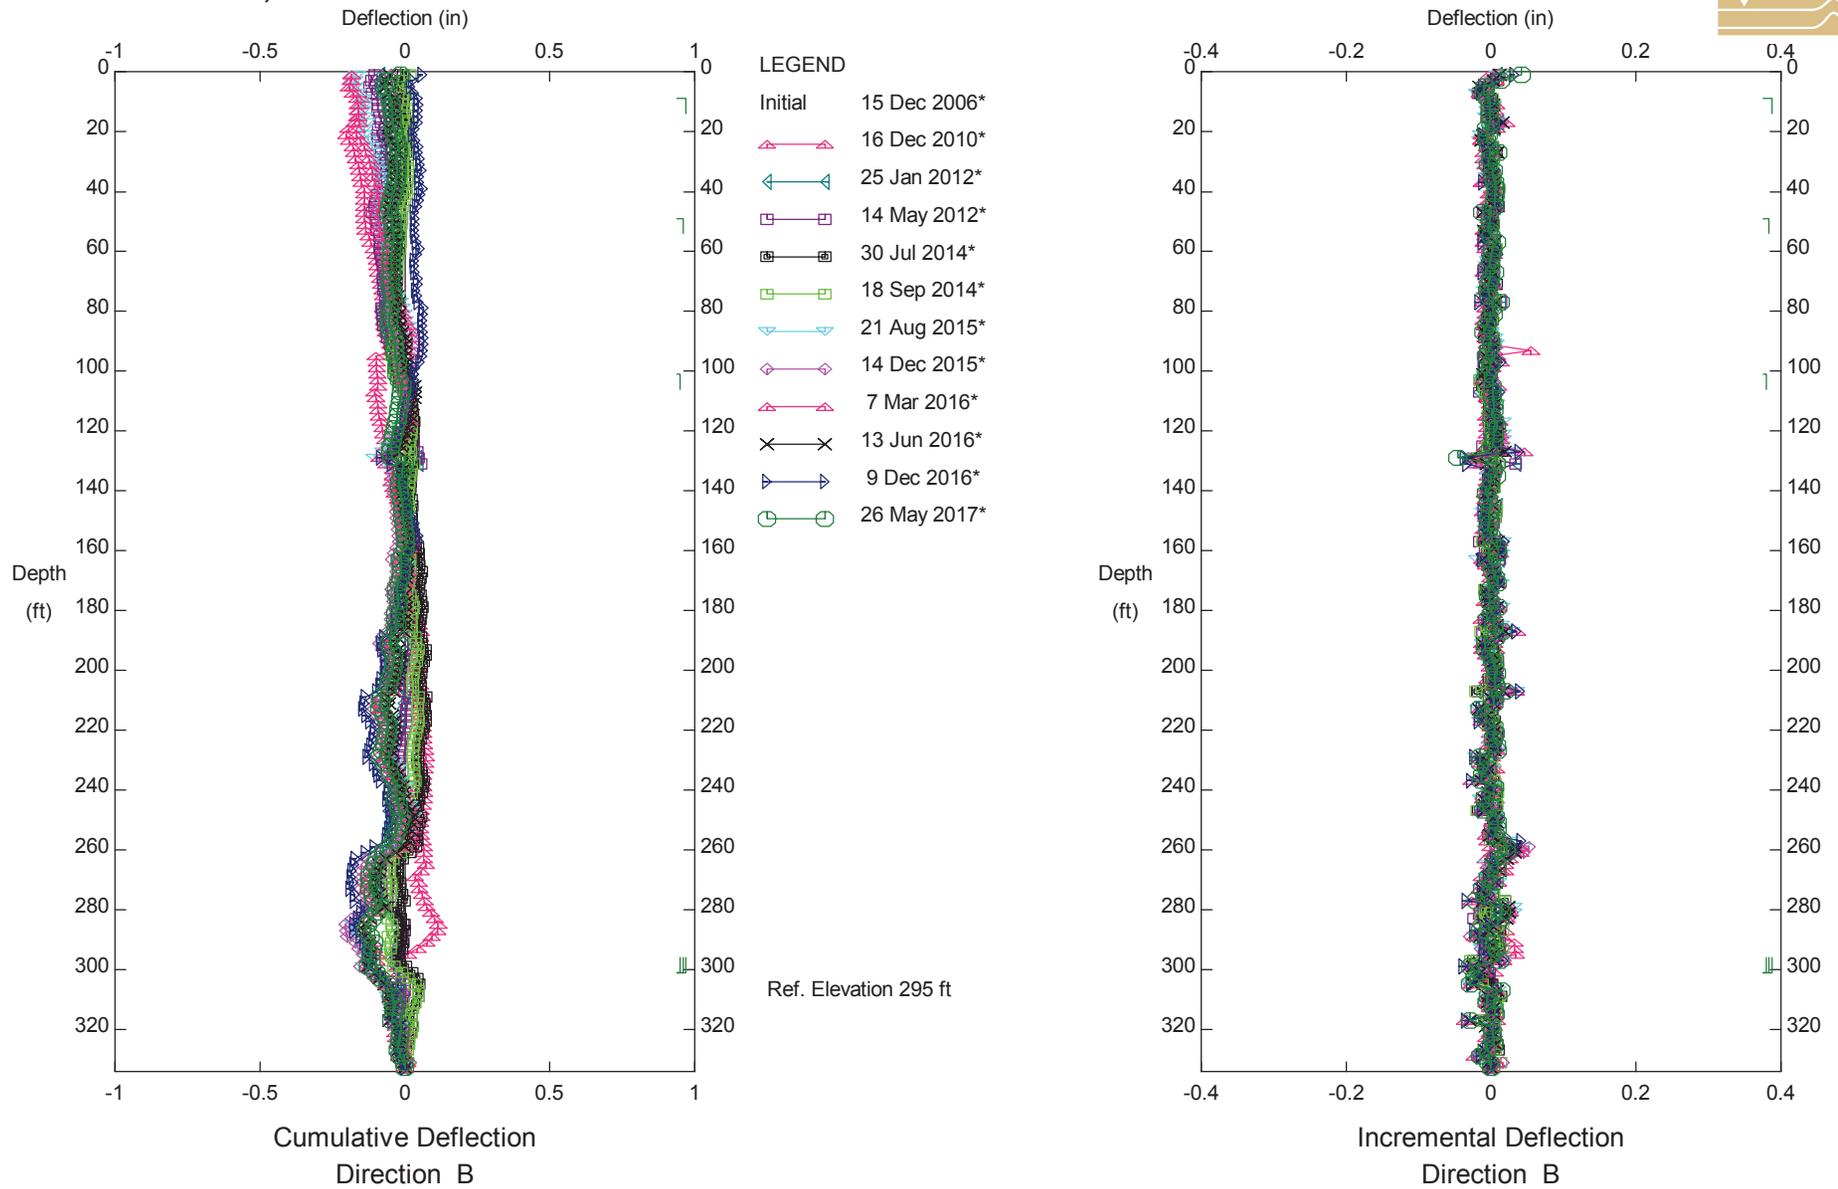
BIG ROCK MESA, Inclinometer SP-10
 BLUFF REGION

Sets marked * include zero shift and/or rotation corrections.

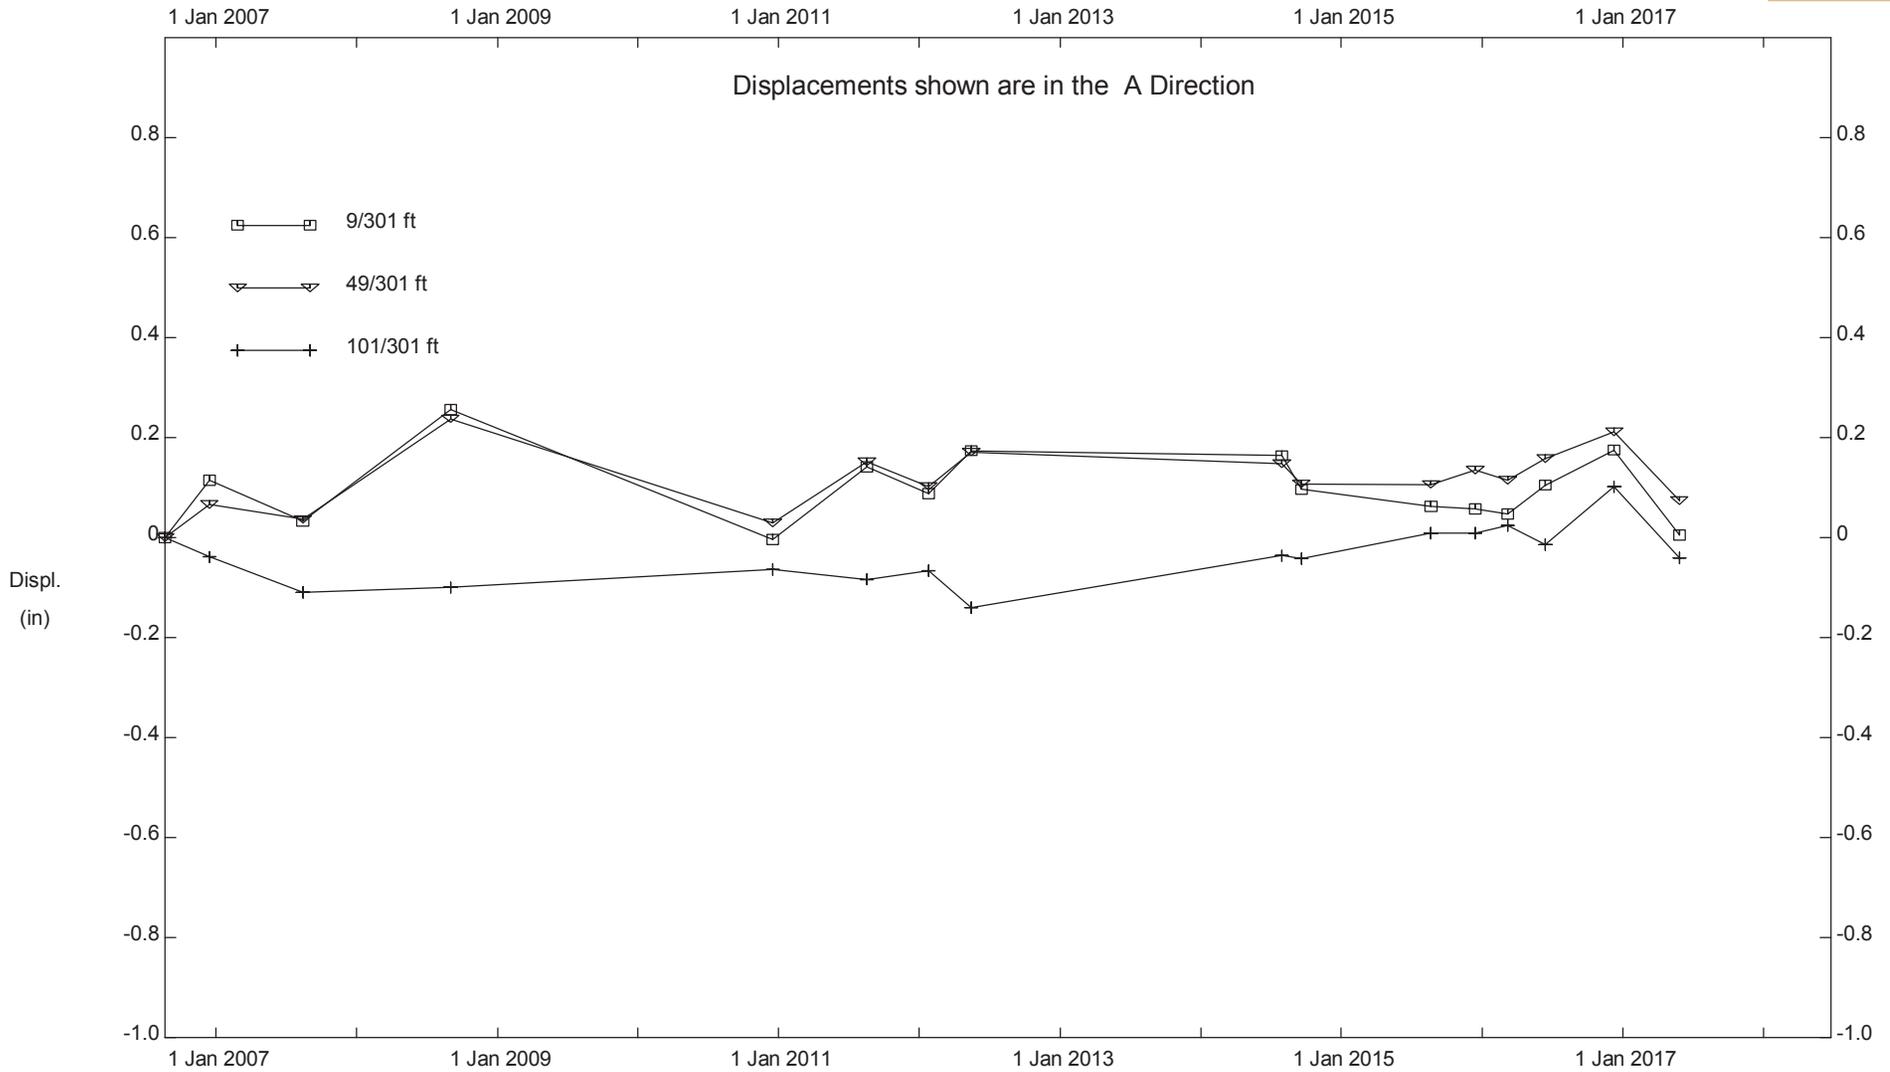
PLATE D10-3

BIG ROCK MESA, Inclinometer SP-10

BLUFF REGION

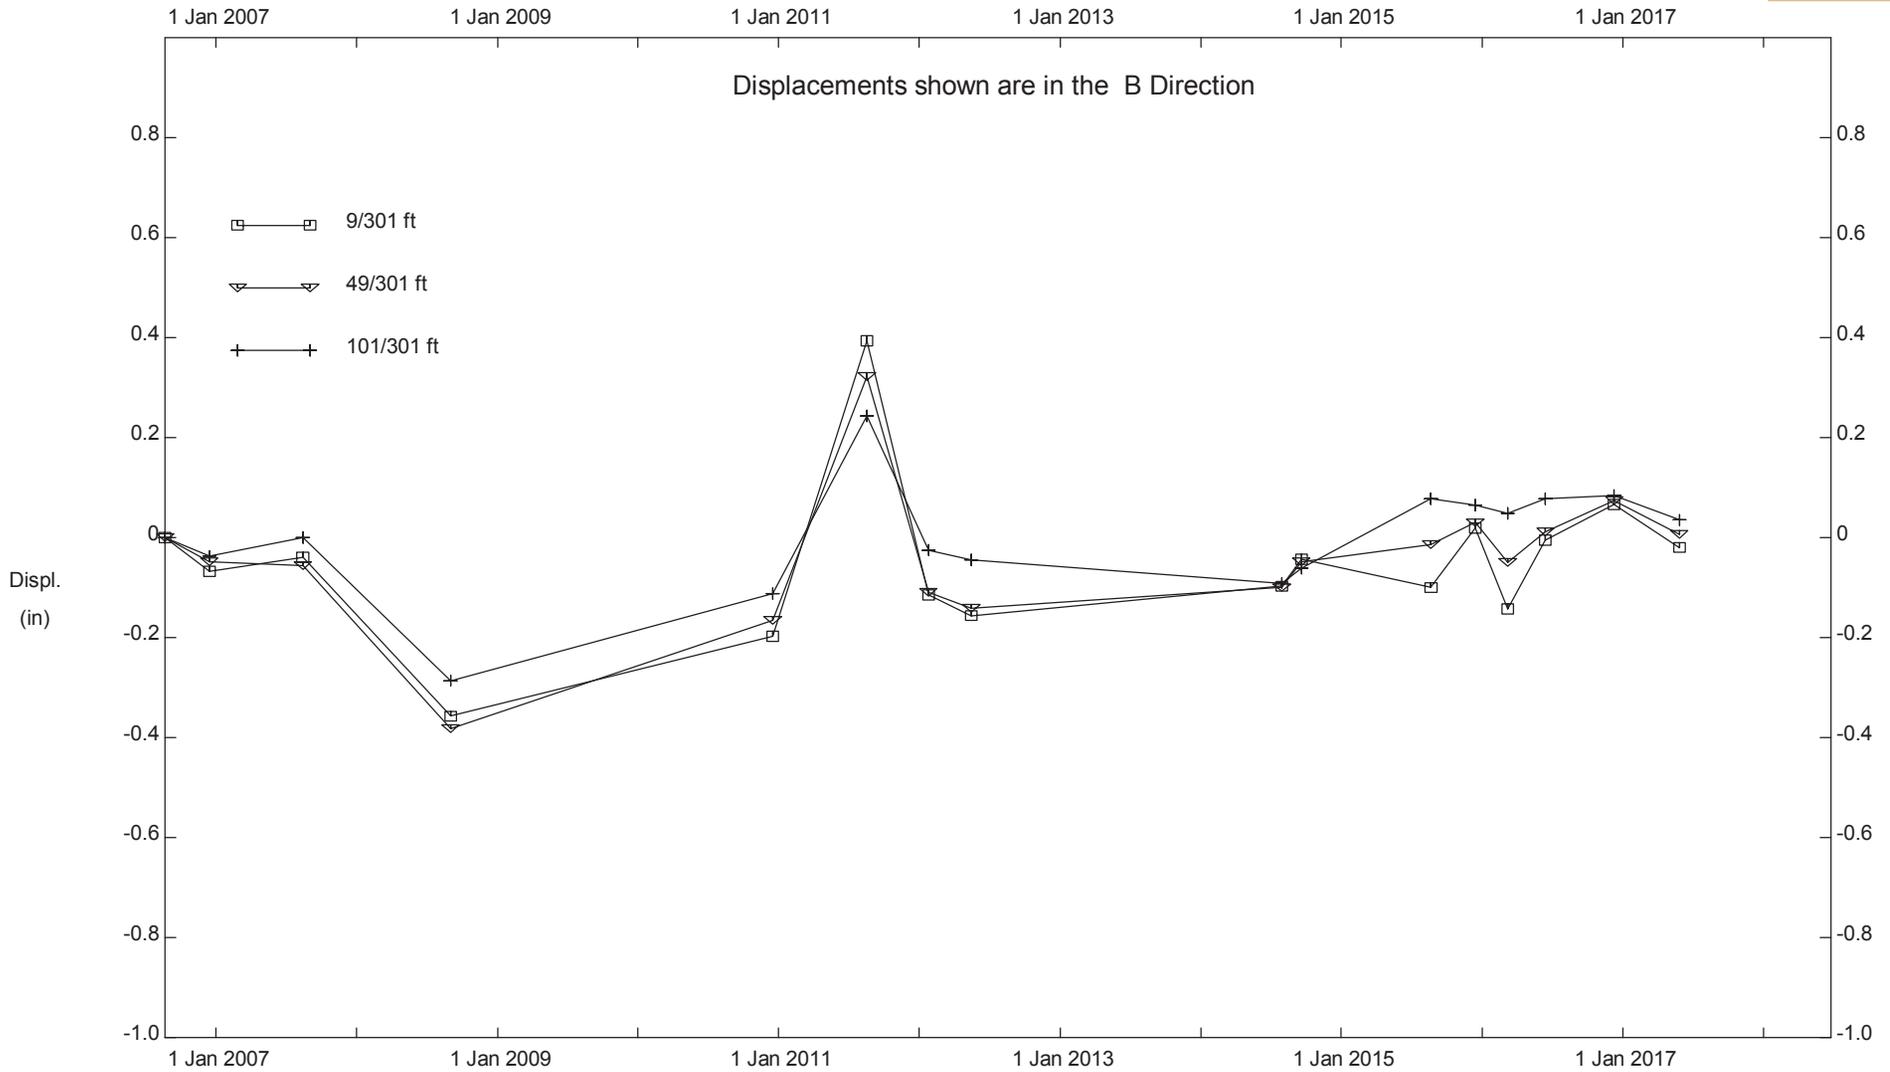
PLATE D10-4

BIG ROCK MESA, Inclinometer SP-10

BLUFF REGION

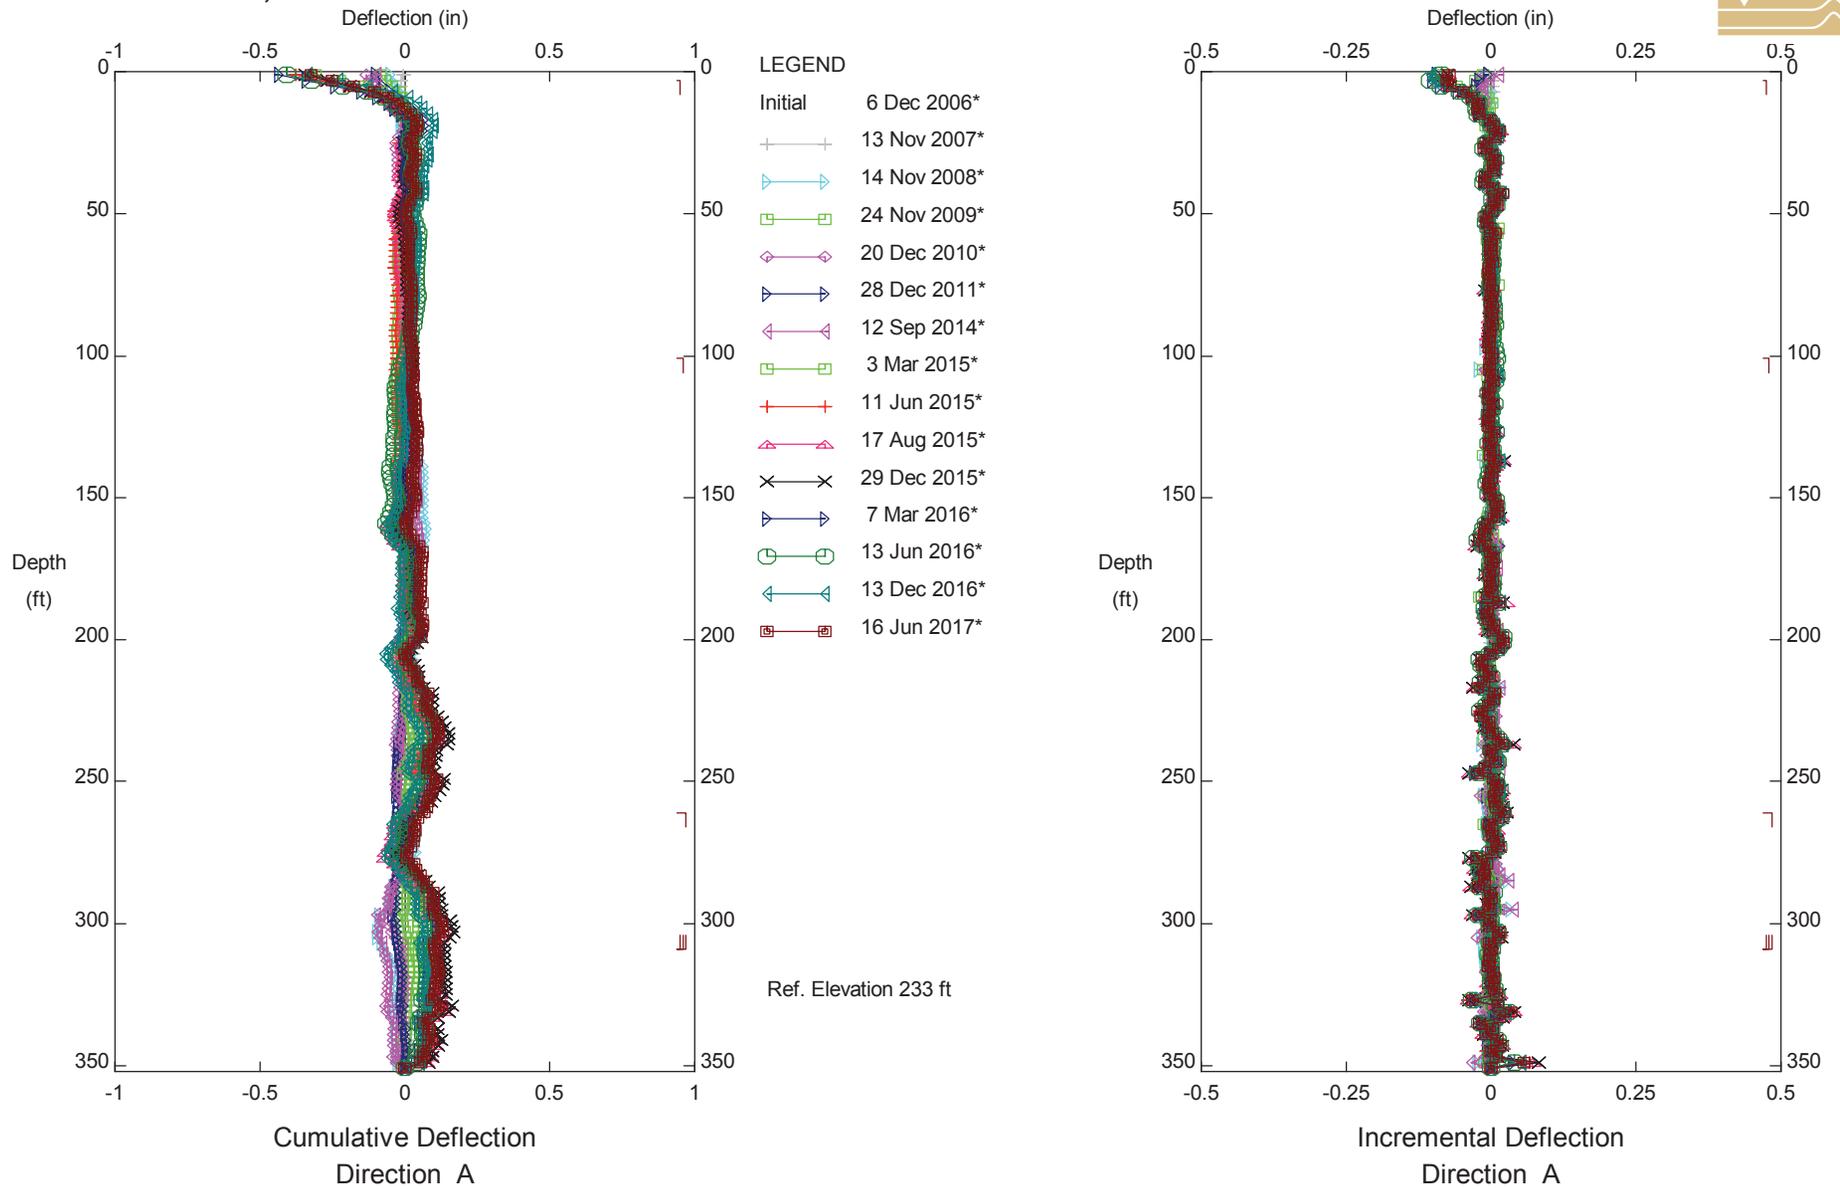
BIG ROCK MESA, Inclinometer SP-32
 BLUFF REGION

Sets marked * include zero shift and/or rotation corrections.

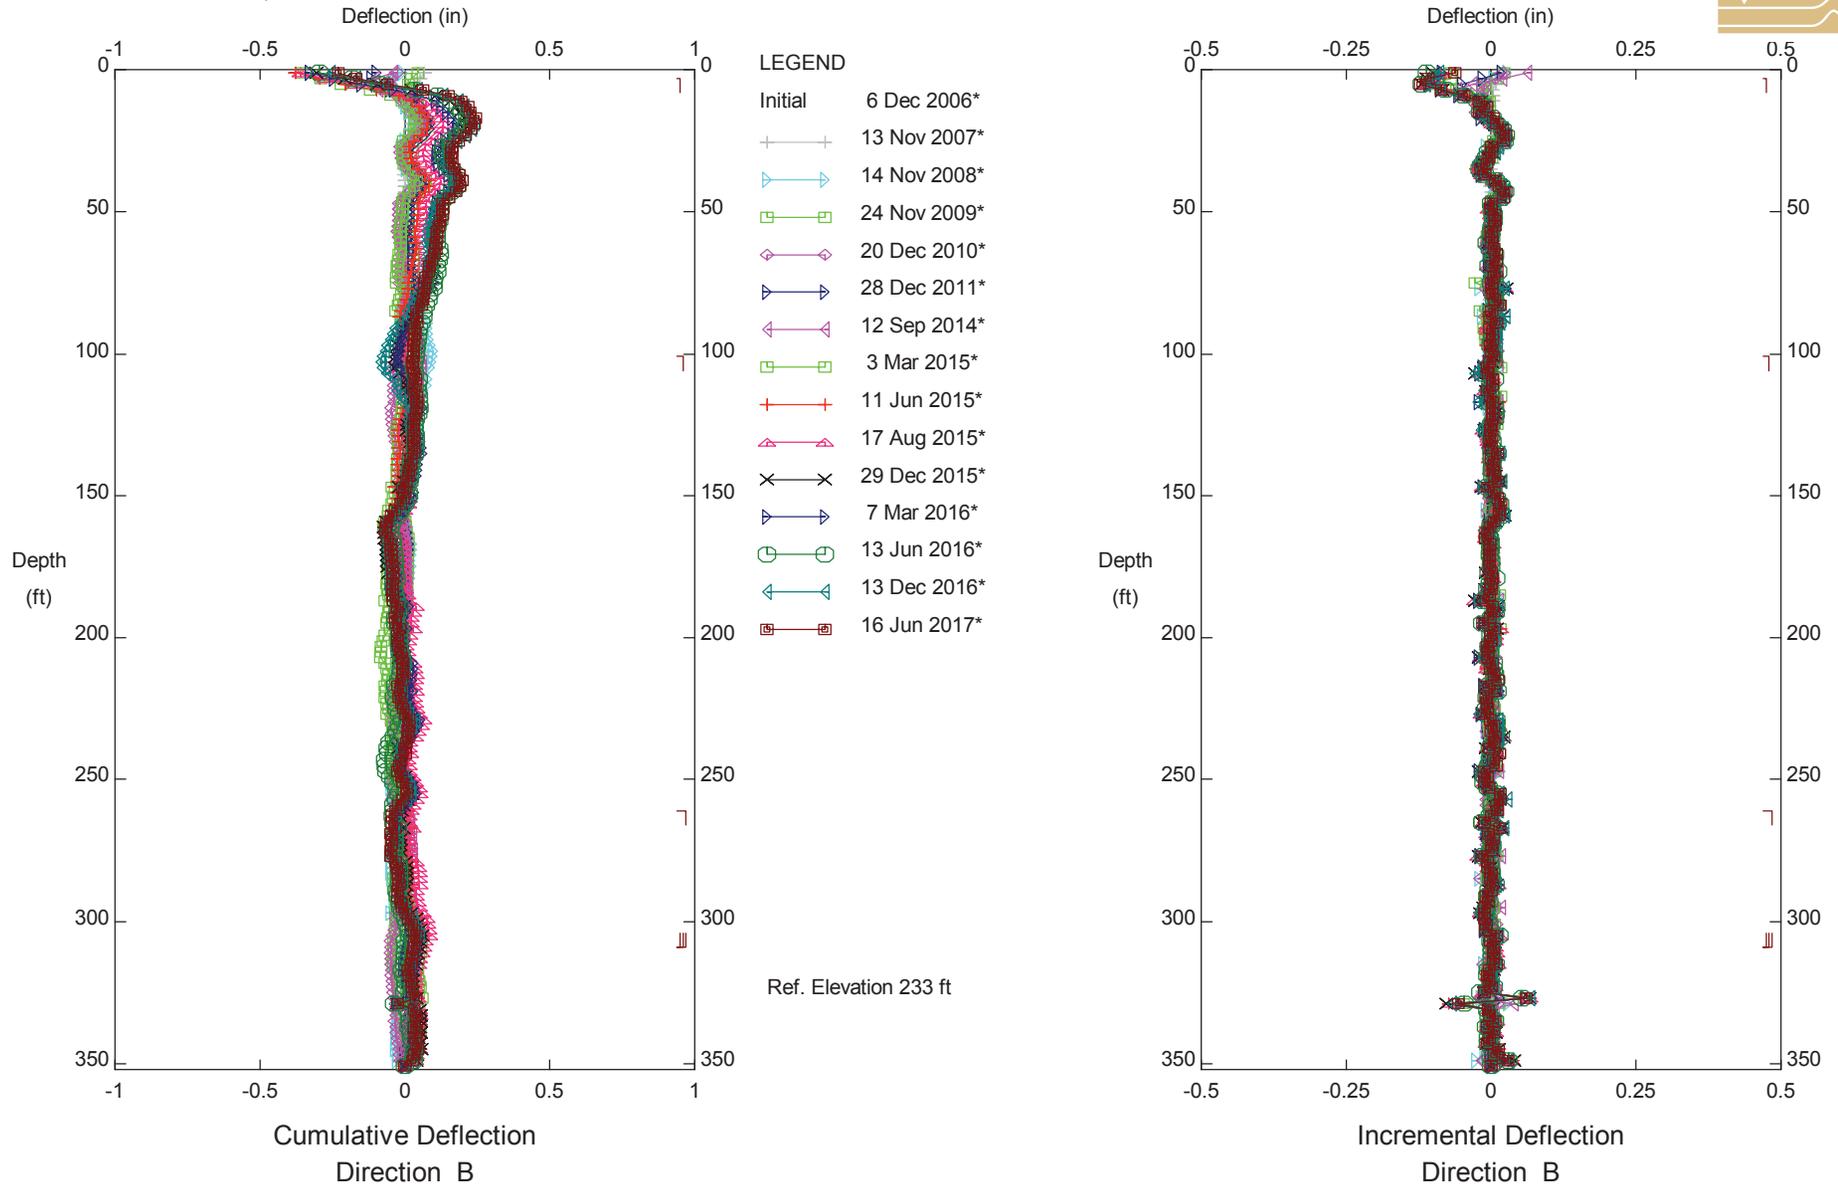
BIG ROCK MESA, Inclinometer SP-32
 BLUFF REGION

Sets marked * include zero shift and/or rotation corrections.
