**ANNUAL REPORT
JULY 2016 THROUGH JUNE 2017
BIG ROCK MESA LANDSLIDE
ASSESSMENT DISTRICT
City of Malibu, California**

March 2018
Fugro Project No. 04.62160606
Document No. 04.62160606-PR-004(Rev.00)

**Annual Report of Maintenance and Monitoring, July 2016 through June 2017,
Big Rock Mesa Landslide Assessment District, City of Malibu, California**

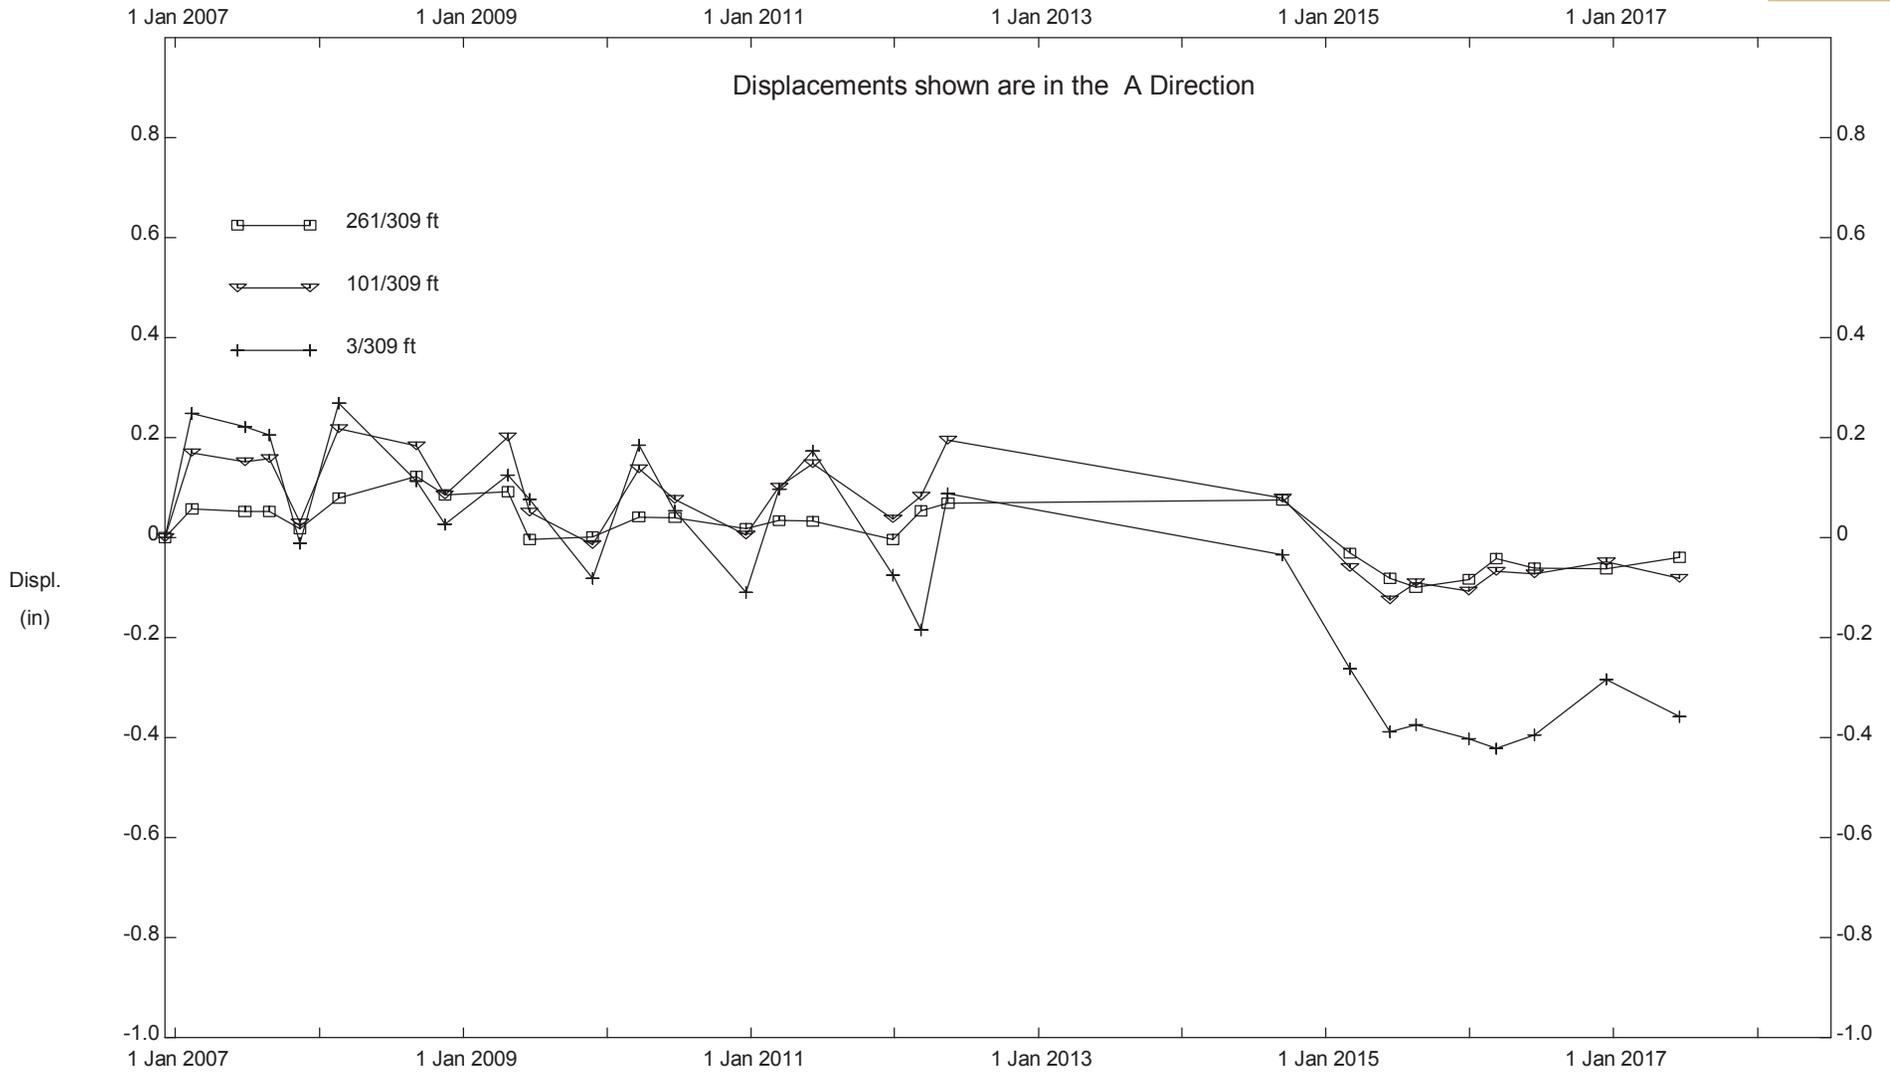
PLATE D12-3

BIG ROCK MESA, Inclinometer SP-32

BLUFF REGION

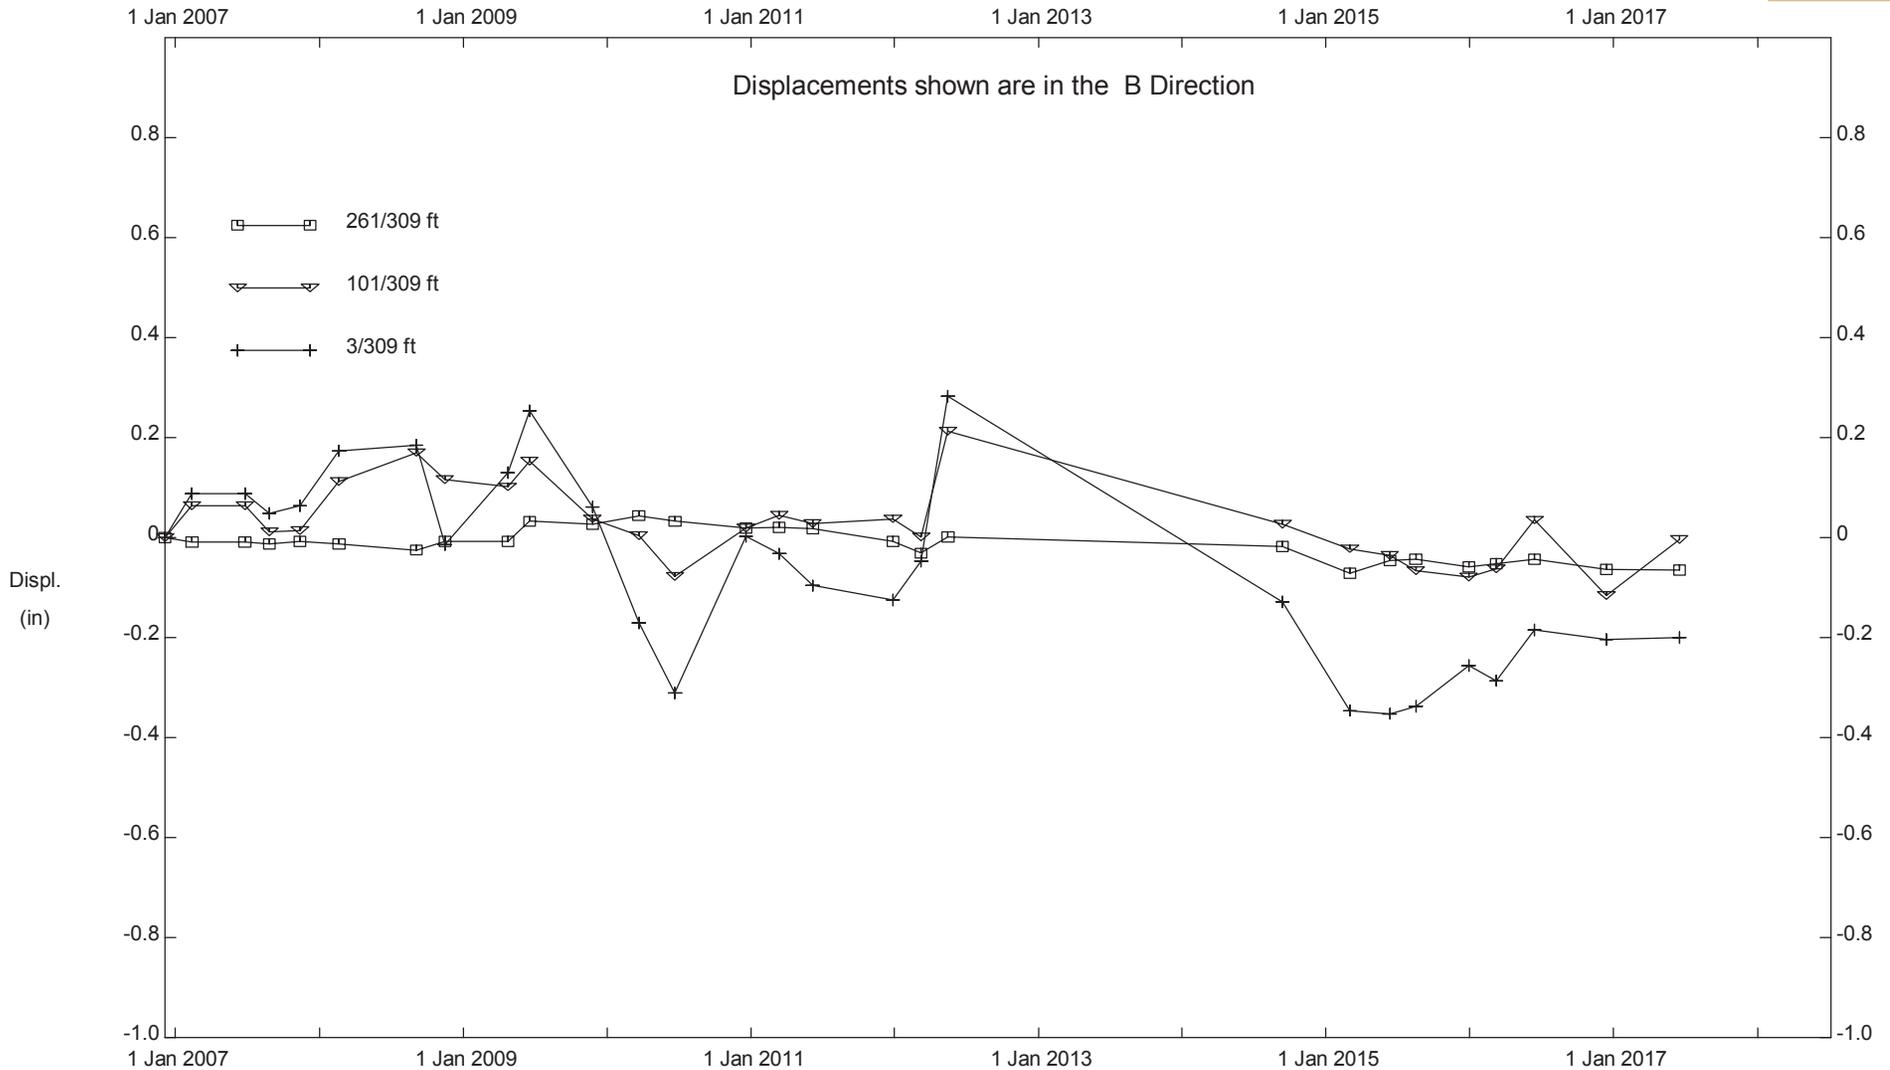
BIG ROCK MESA, Inclinometer SP-32

BLUFF REGION

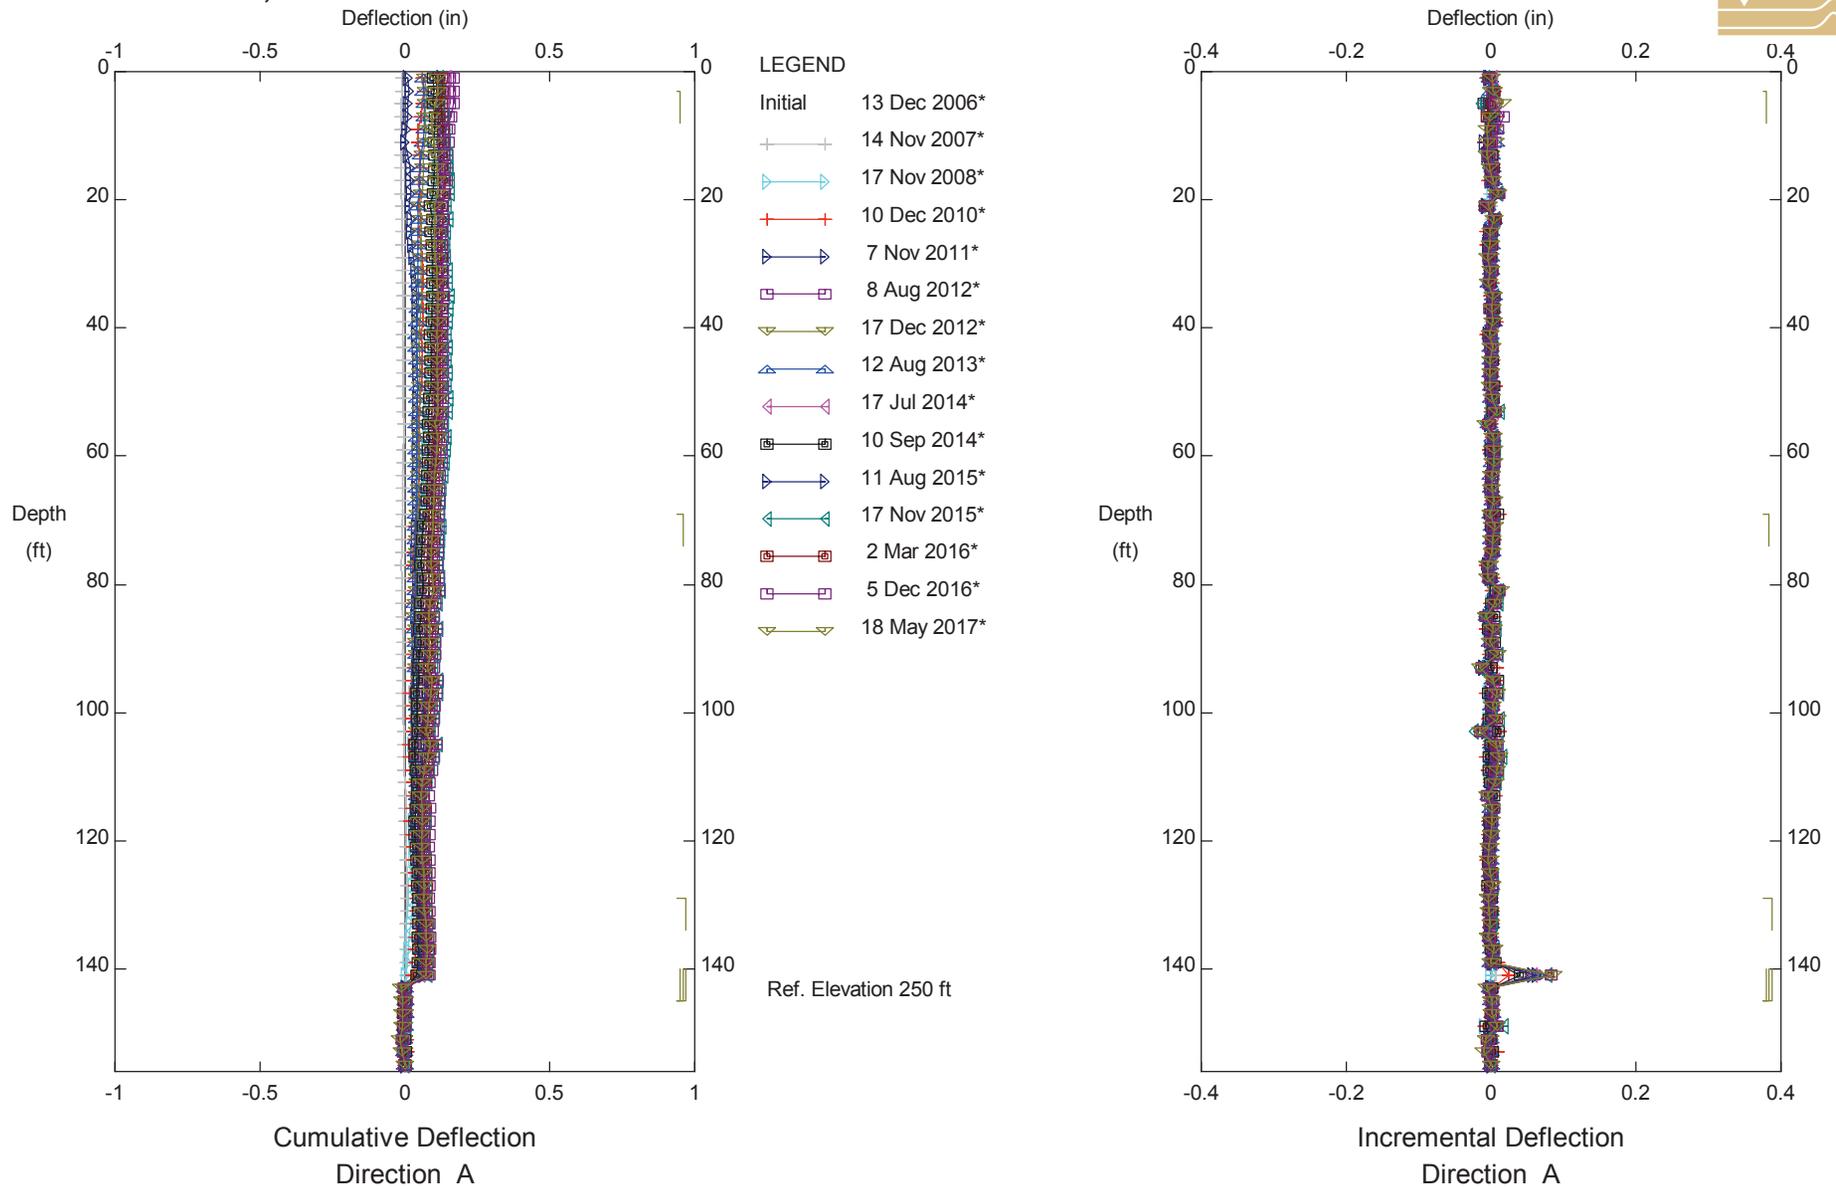
**BIG ROCK MESA, Inclinator PC-1
 EASTERN REGION**

Sets marked * include zero shift and/or rotation corrections.

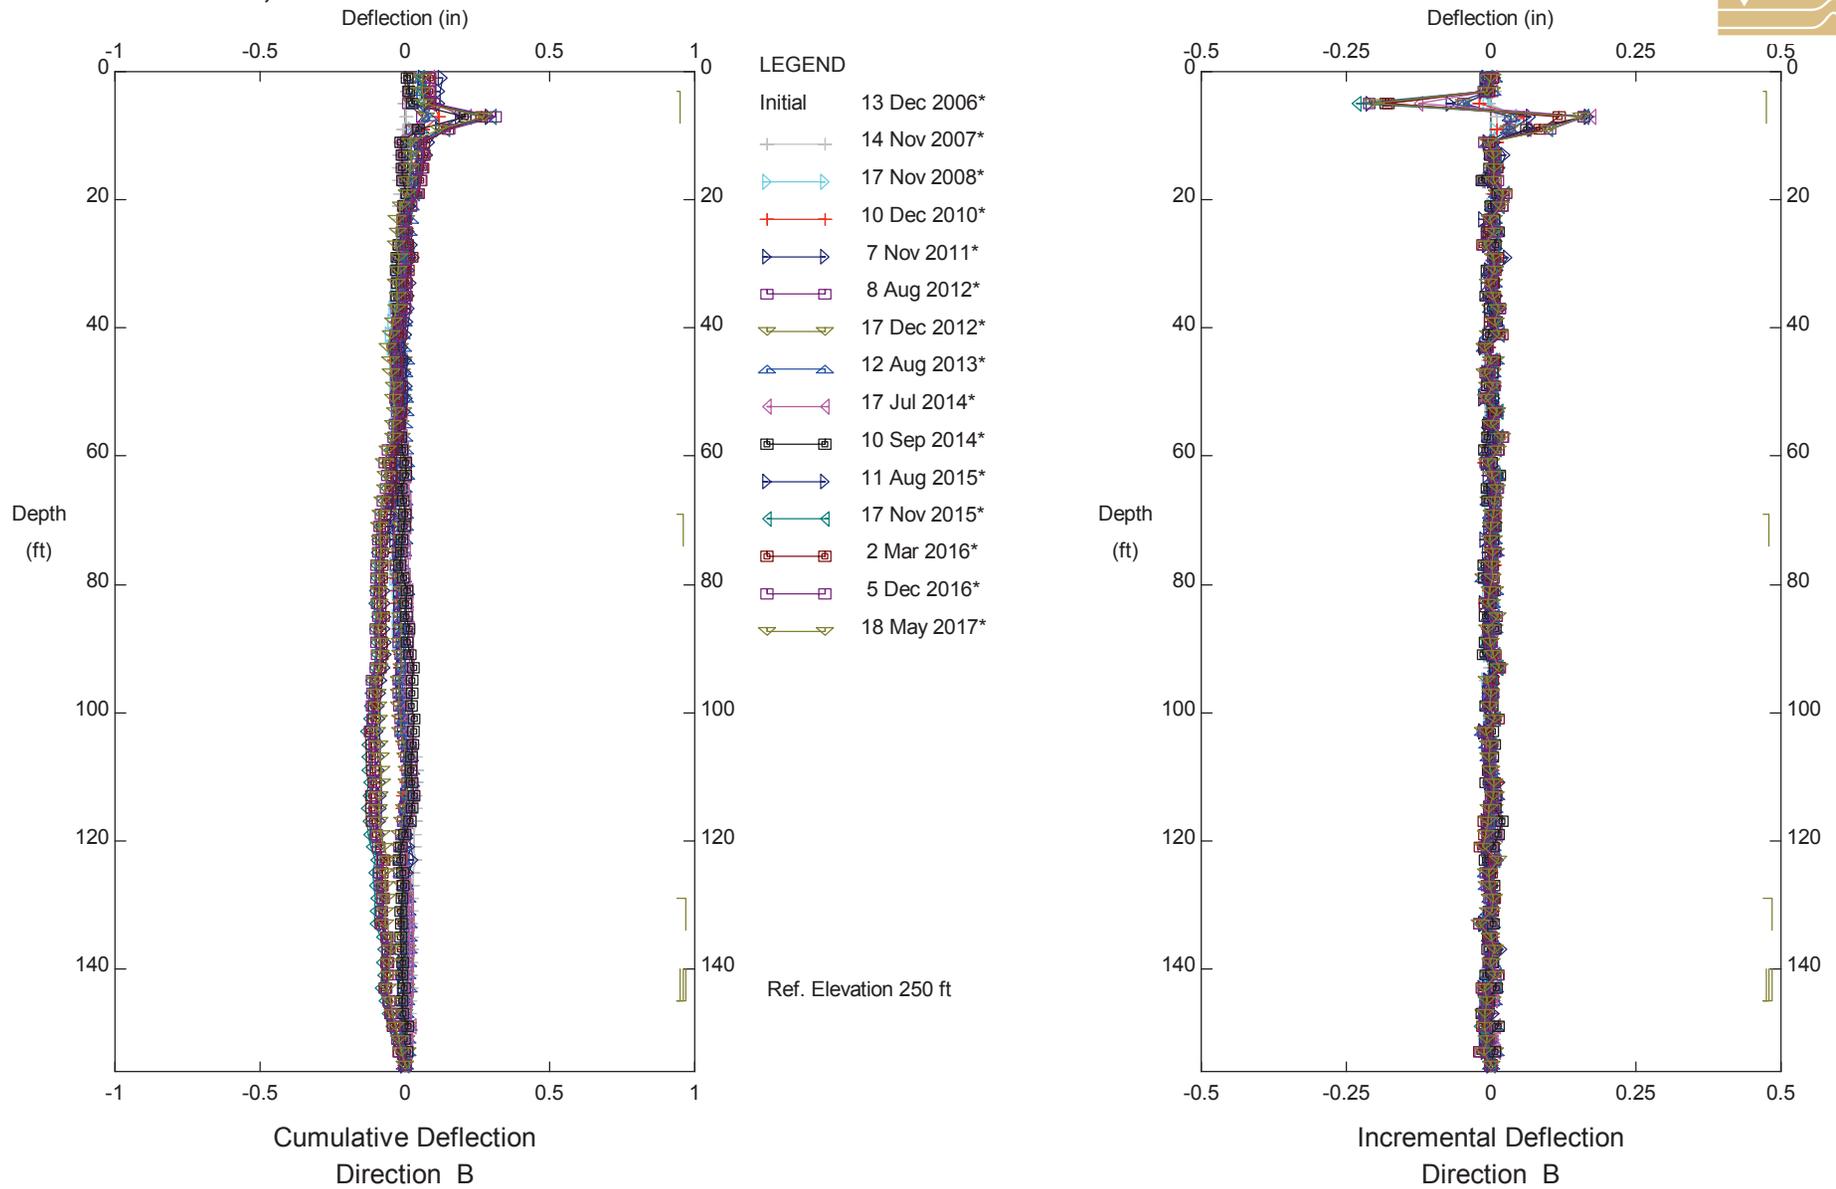
**BIG ROCK MESA, Inclinometer PC-1
 EASTERN REGION**

Sets marked * include zero shift and/or rotation corrections.

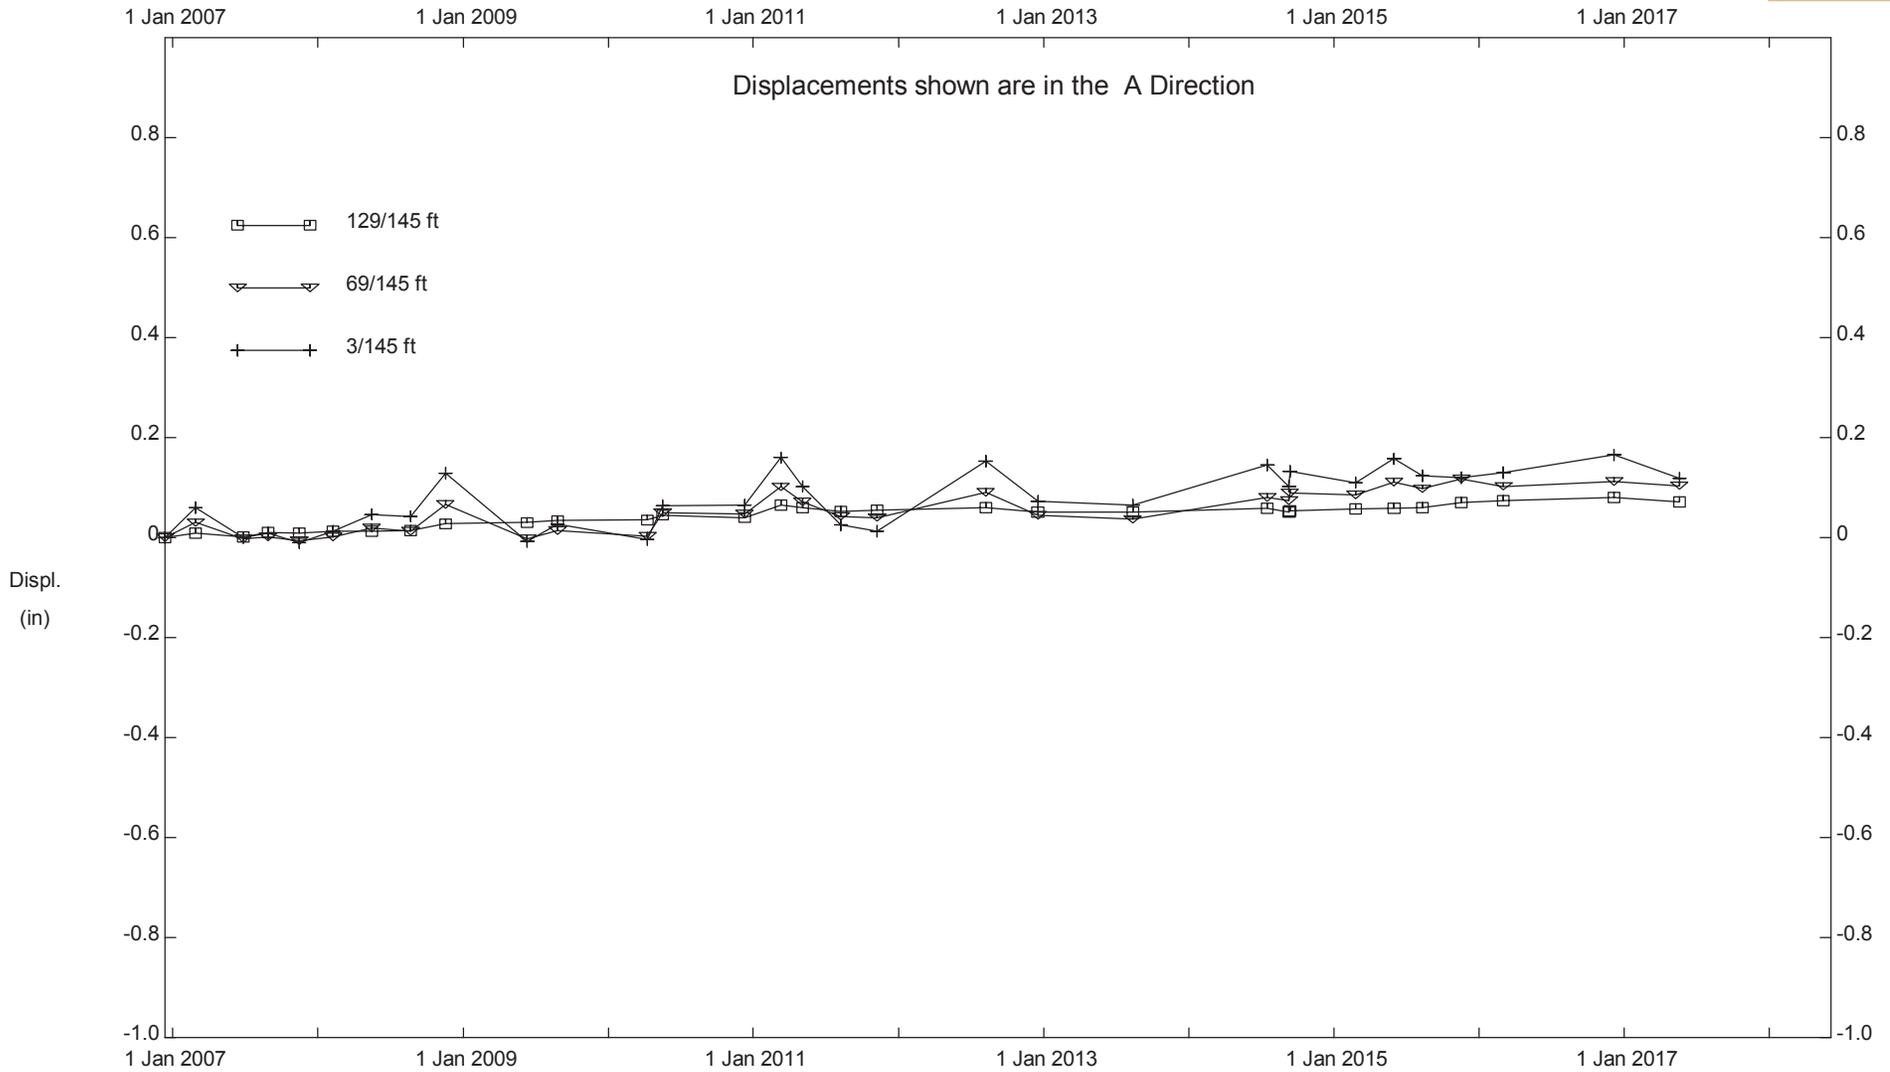
PLATE D13-3

BIG ROCK MESA, Inclinometer PC-1

EASTERN REGION

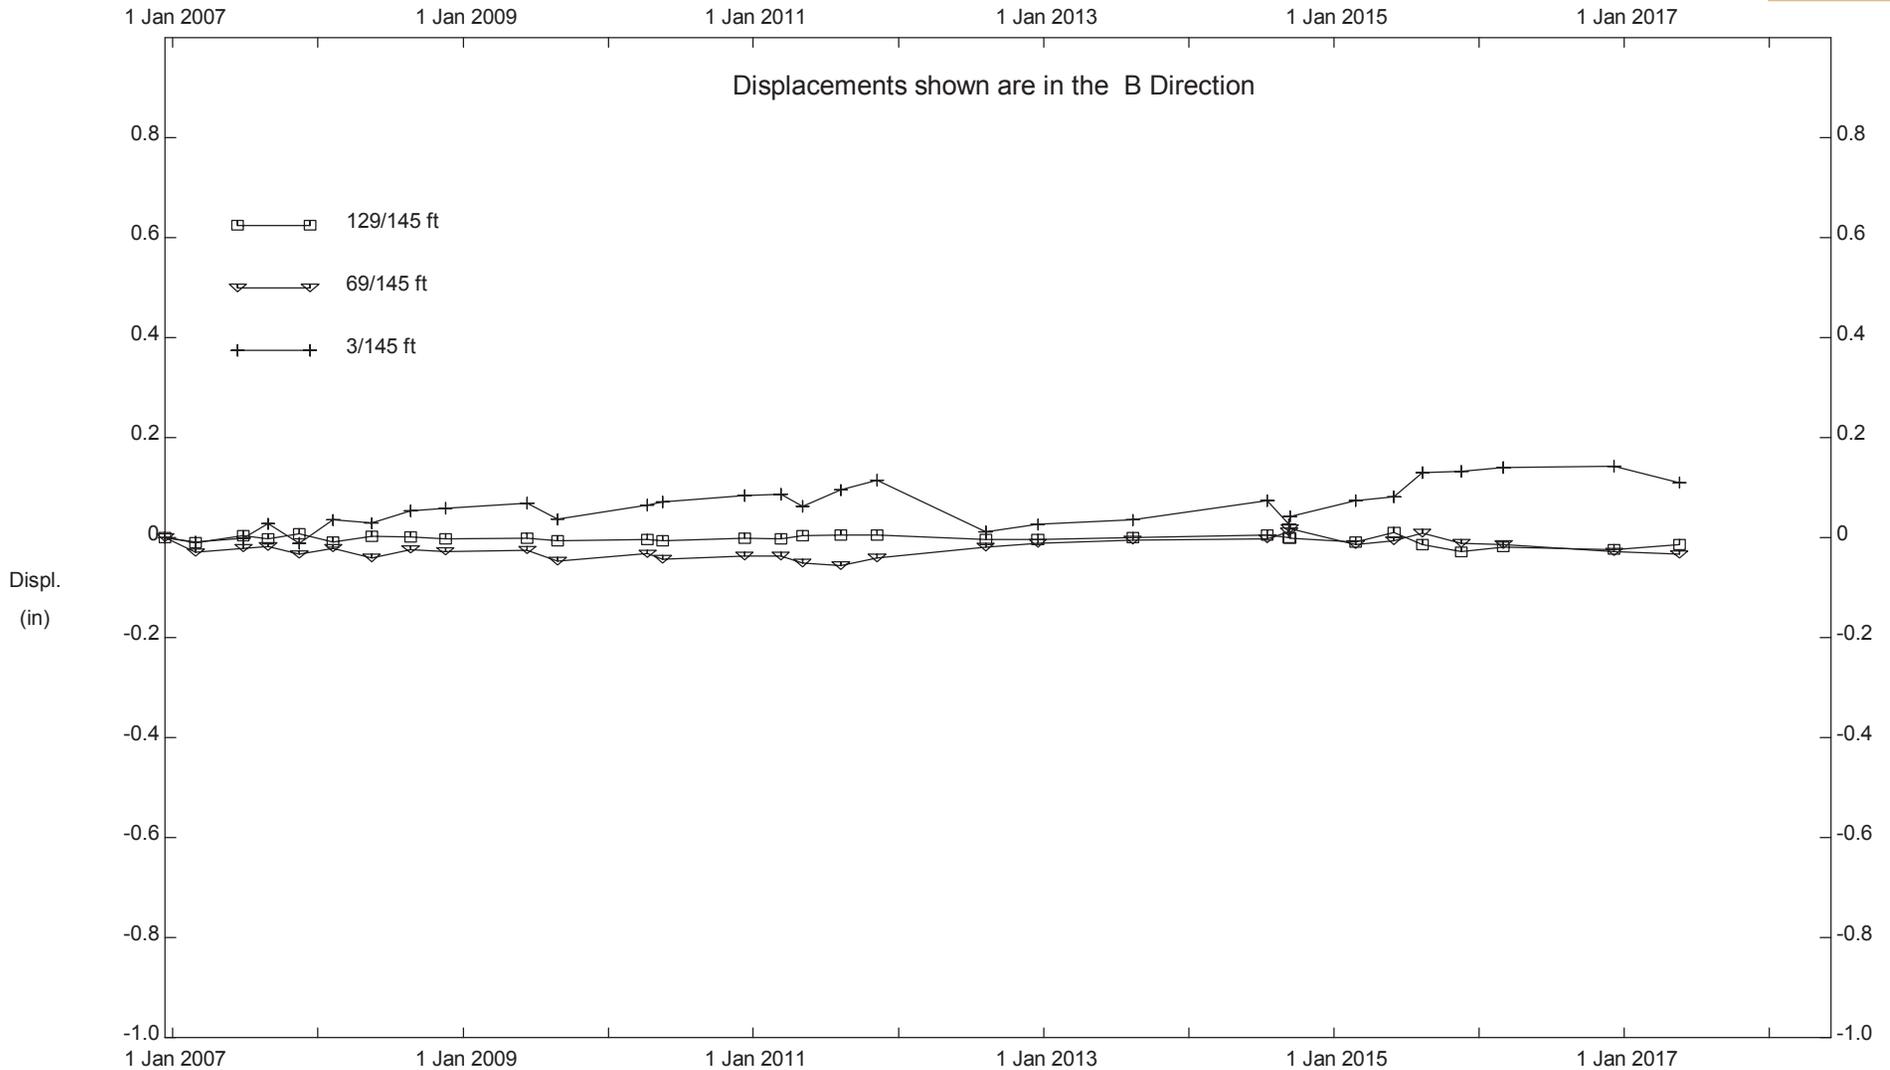
PLATE D13-4

BIG ROCK MESA, Inclinometer PC-1

EASTERN REGION

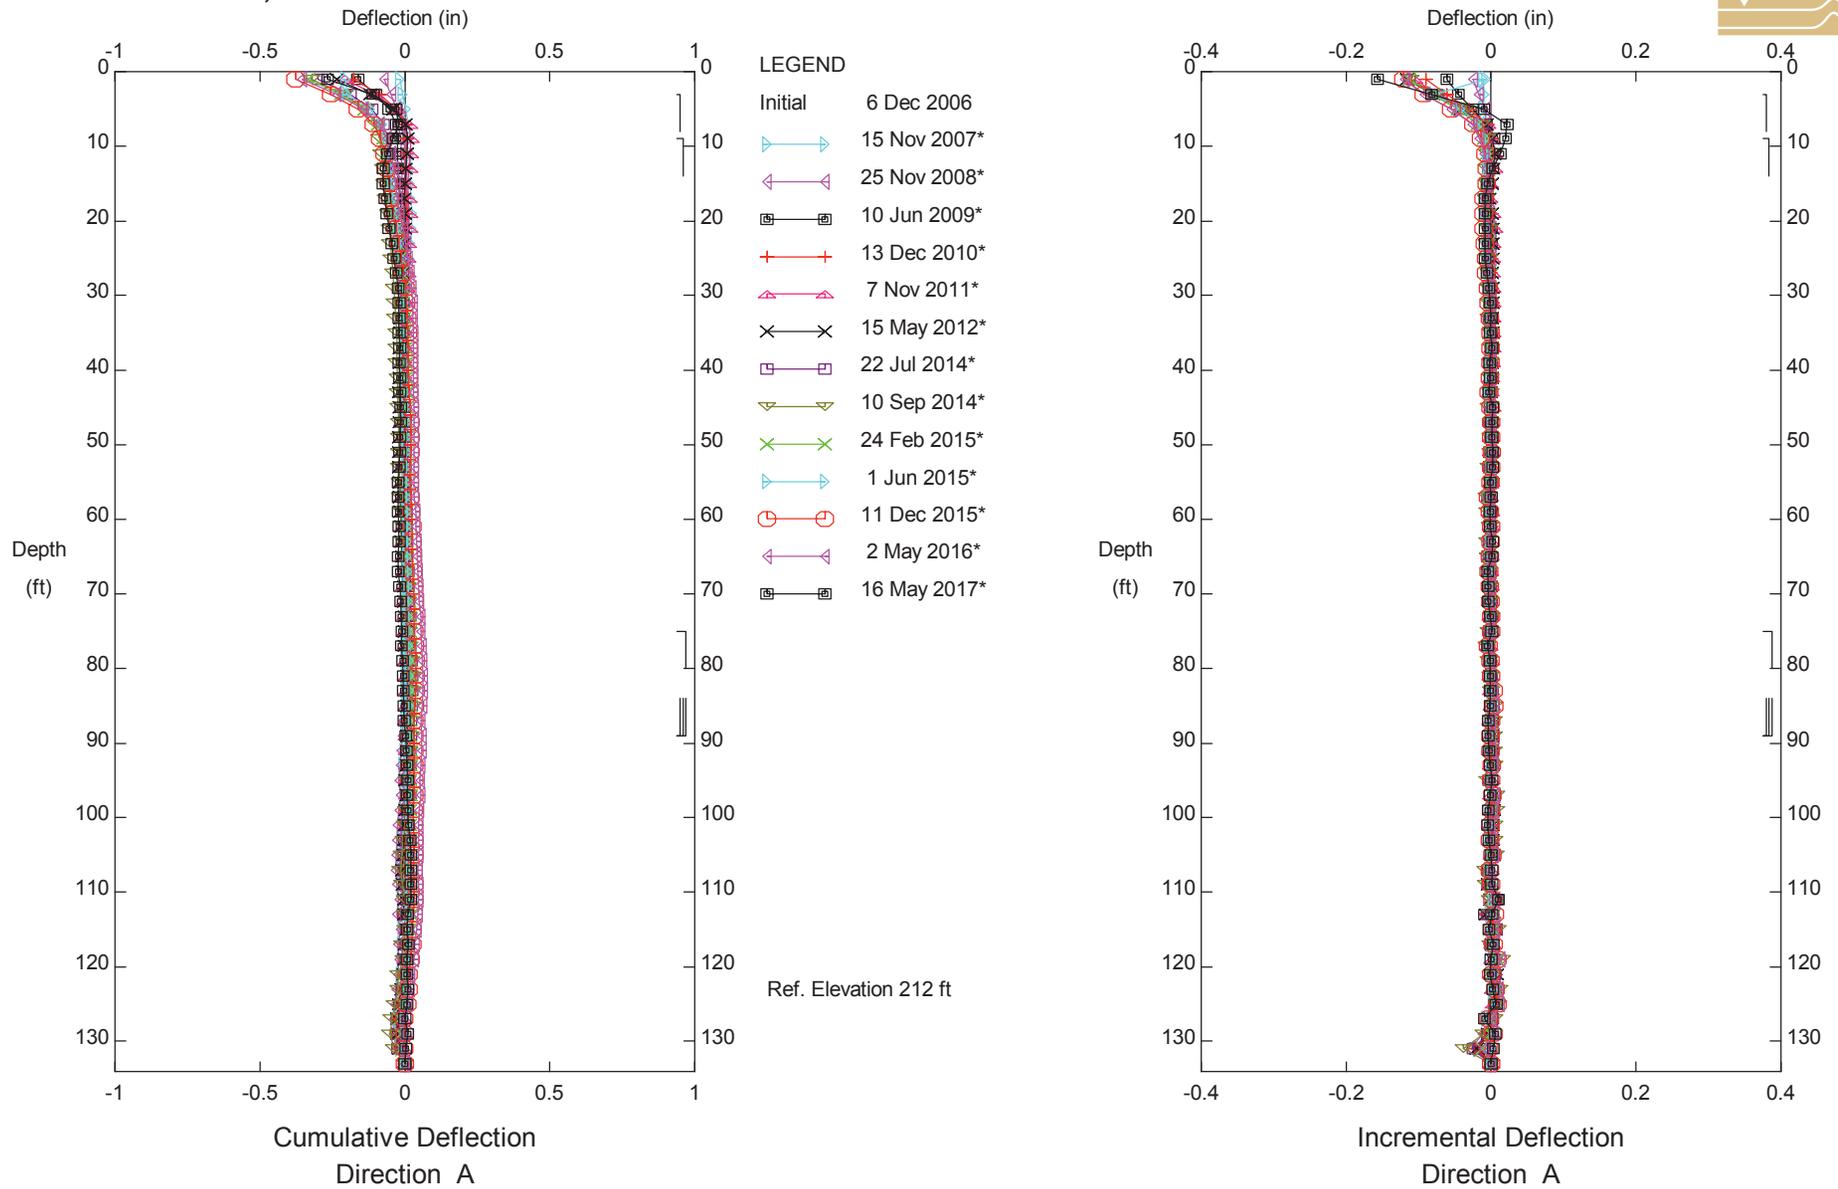
**BIG ROCK MESA, Incliner SP-3
 EASTERN REGION**

Sets marked * include zero shift and/or rotation corrections.

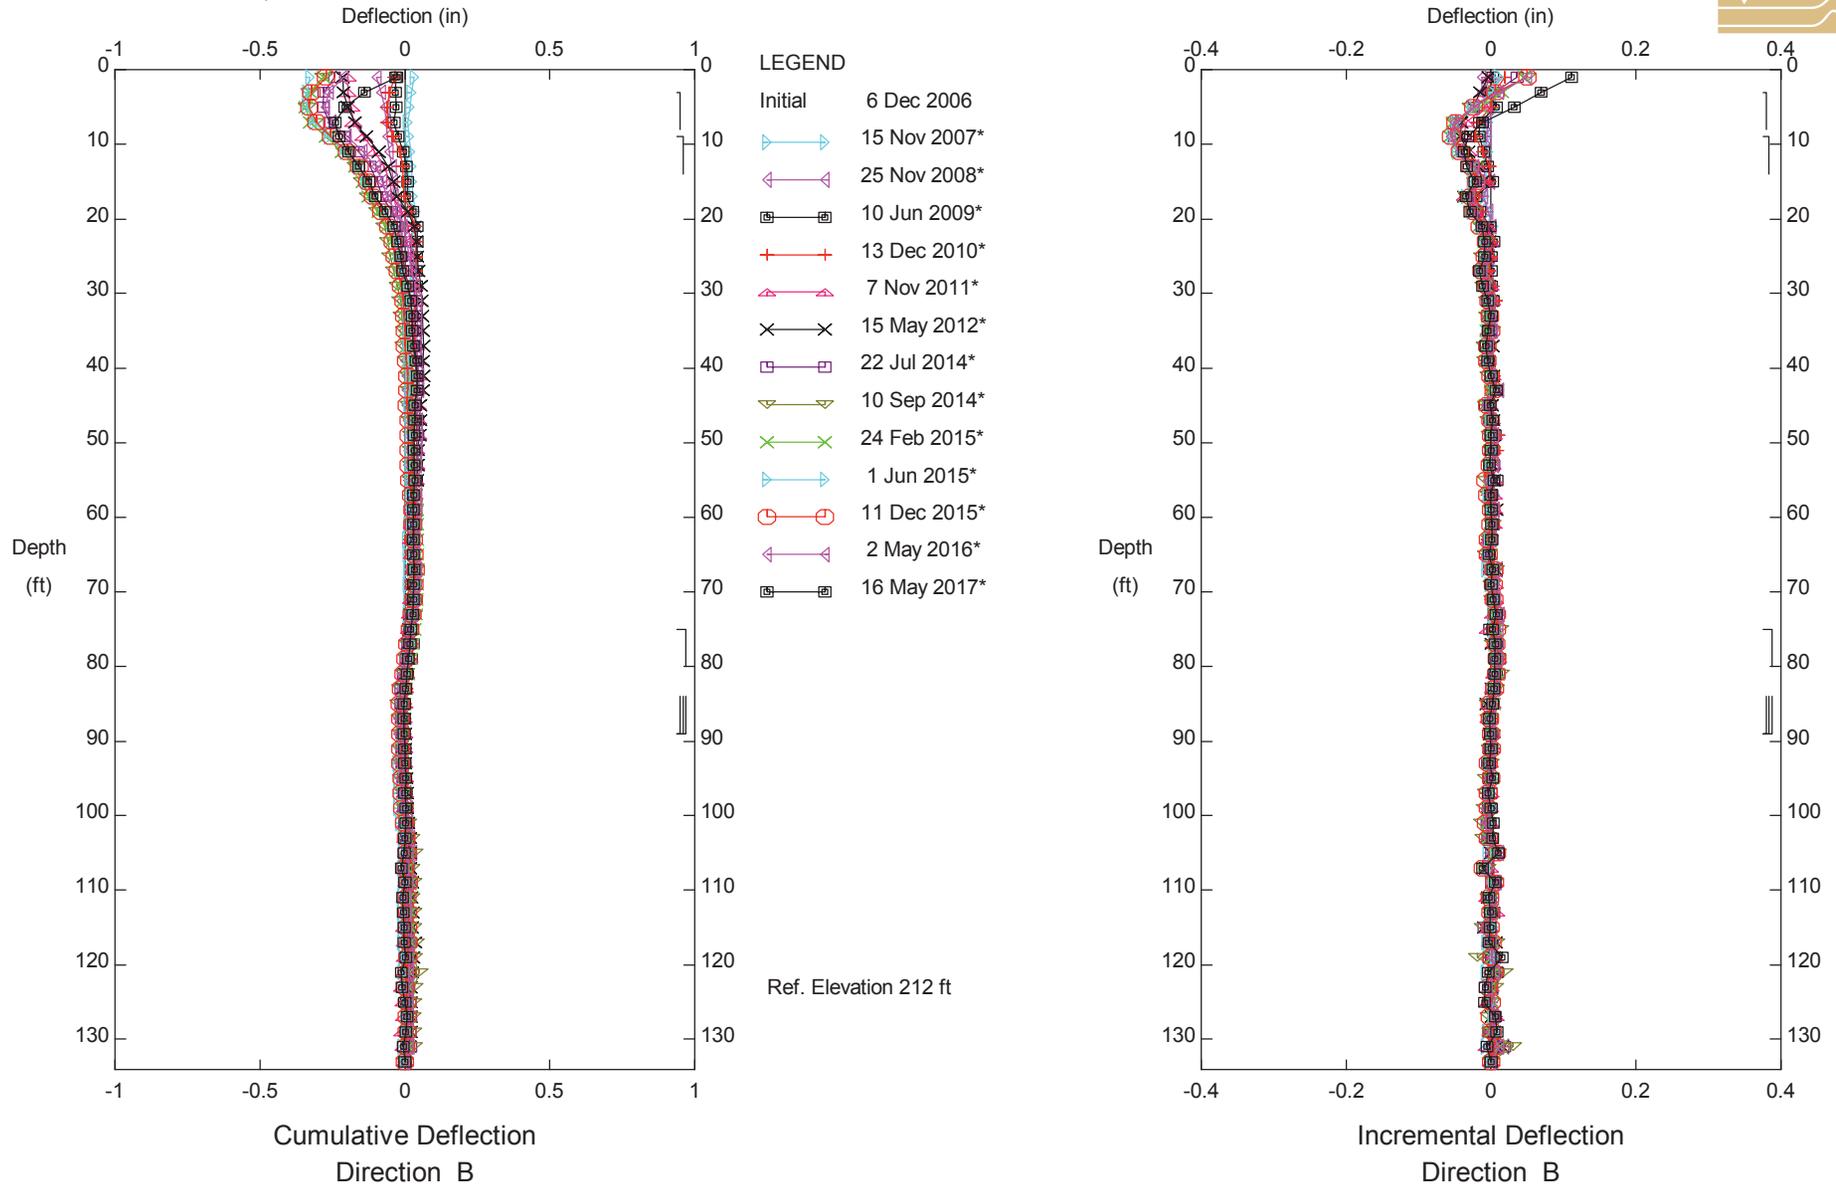
**BIG ROCK MESA, Inclinator SP-3
 EASTERN REGION**

Sets marked * include zero shift and/or rotation corrections.

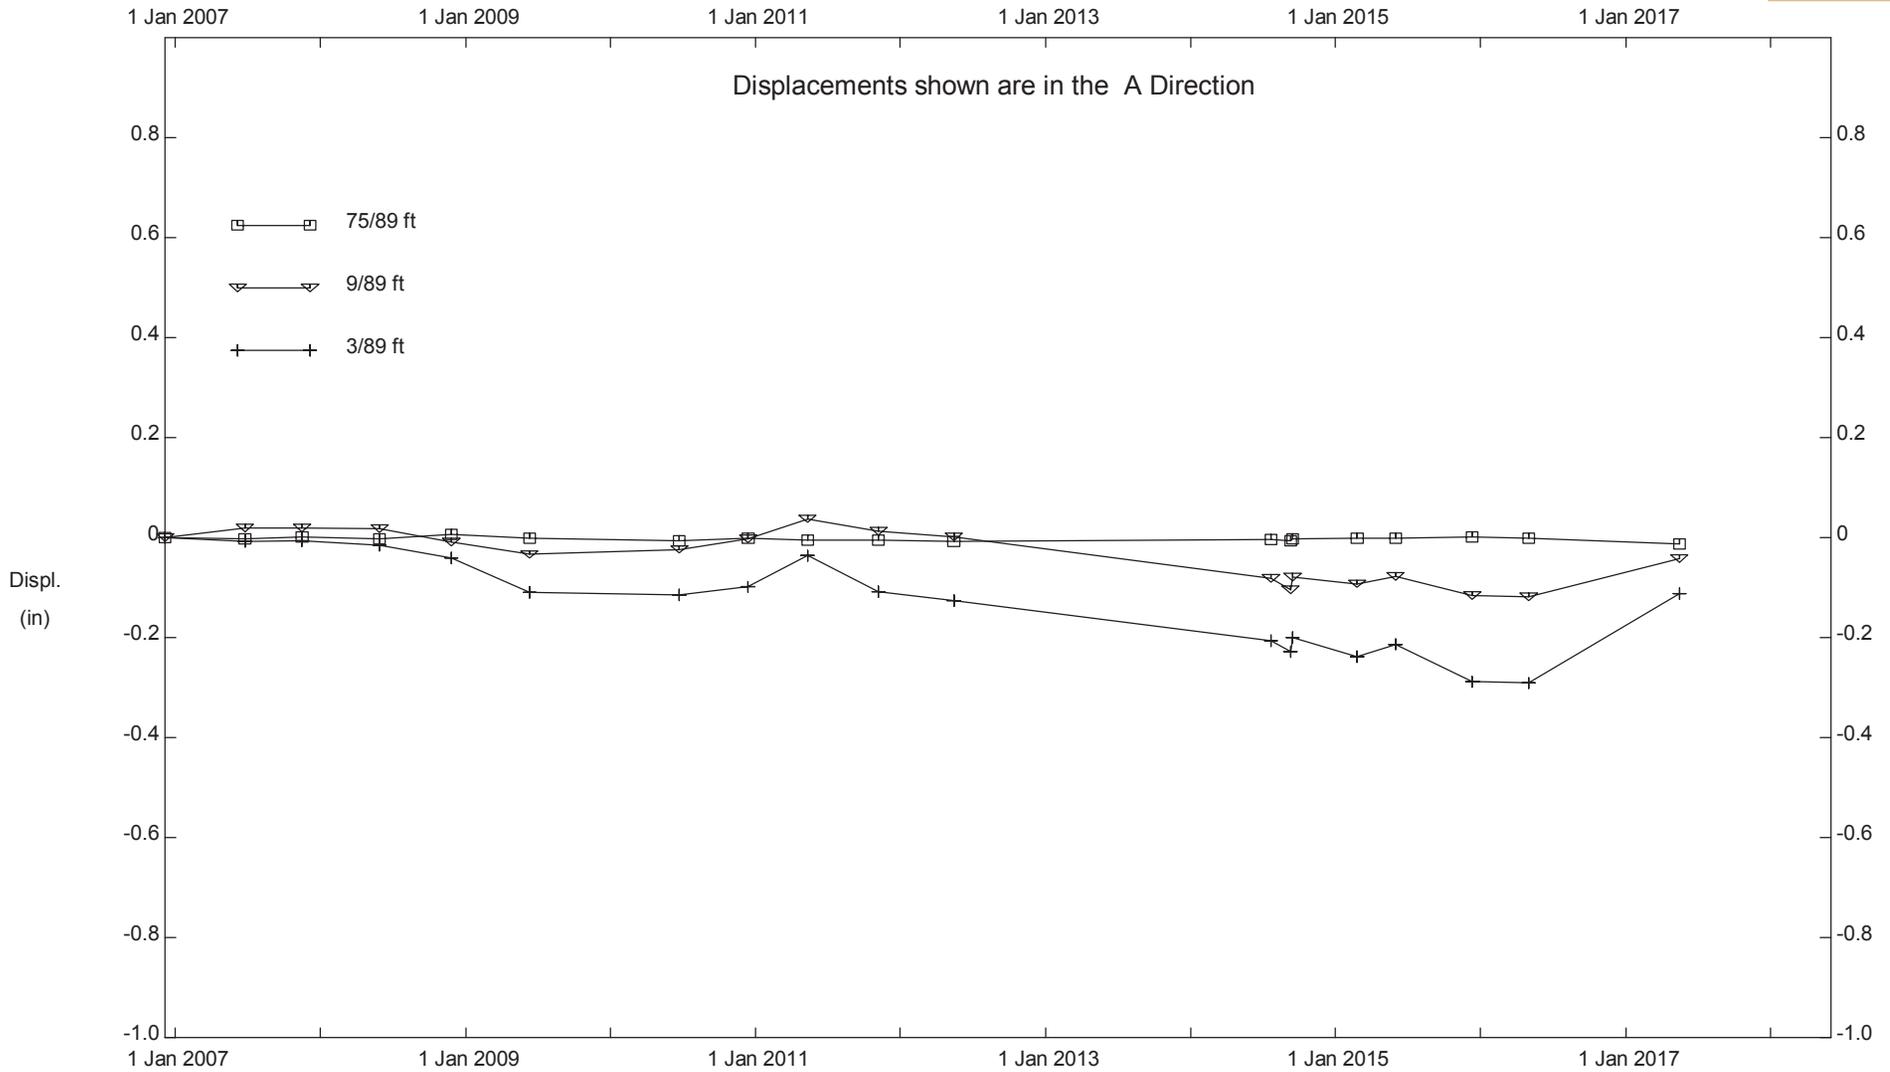
PLATE D14-3

BIG ROCK MESA, Inclinator SP-3

EASTERN REGION

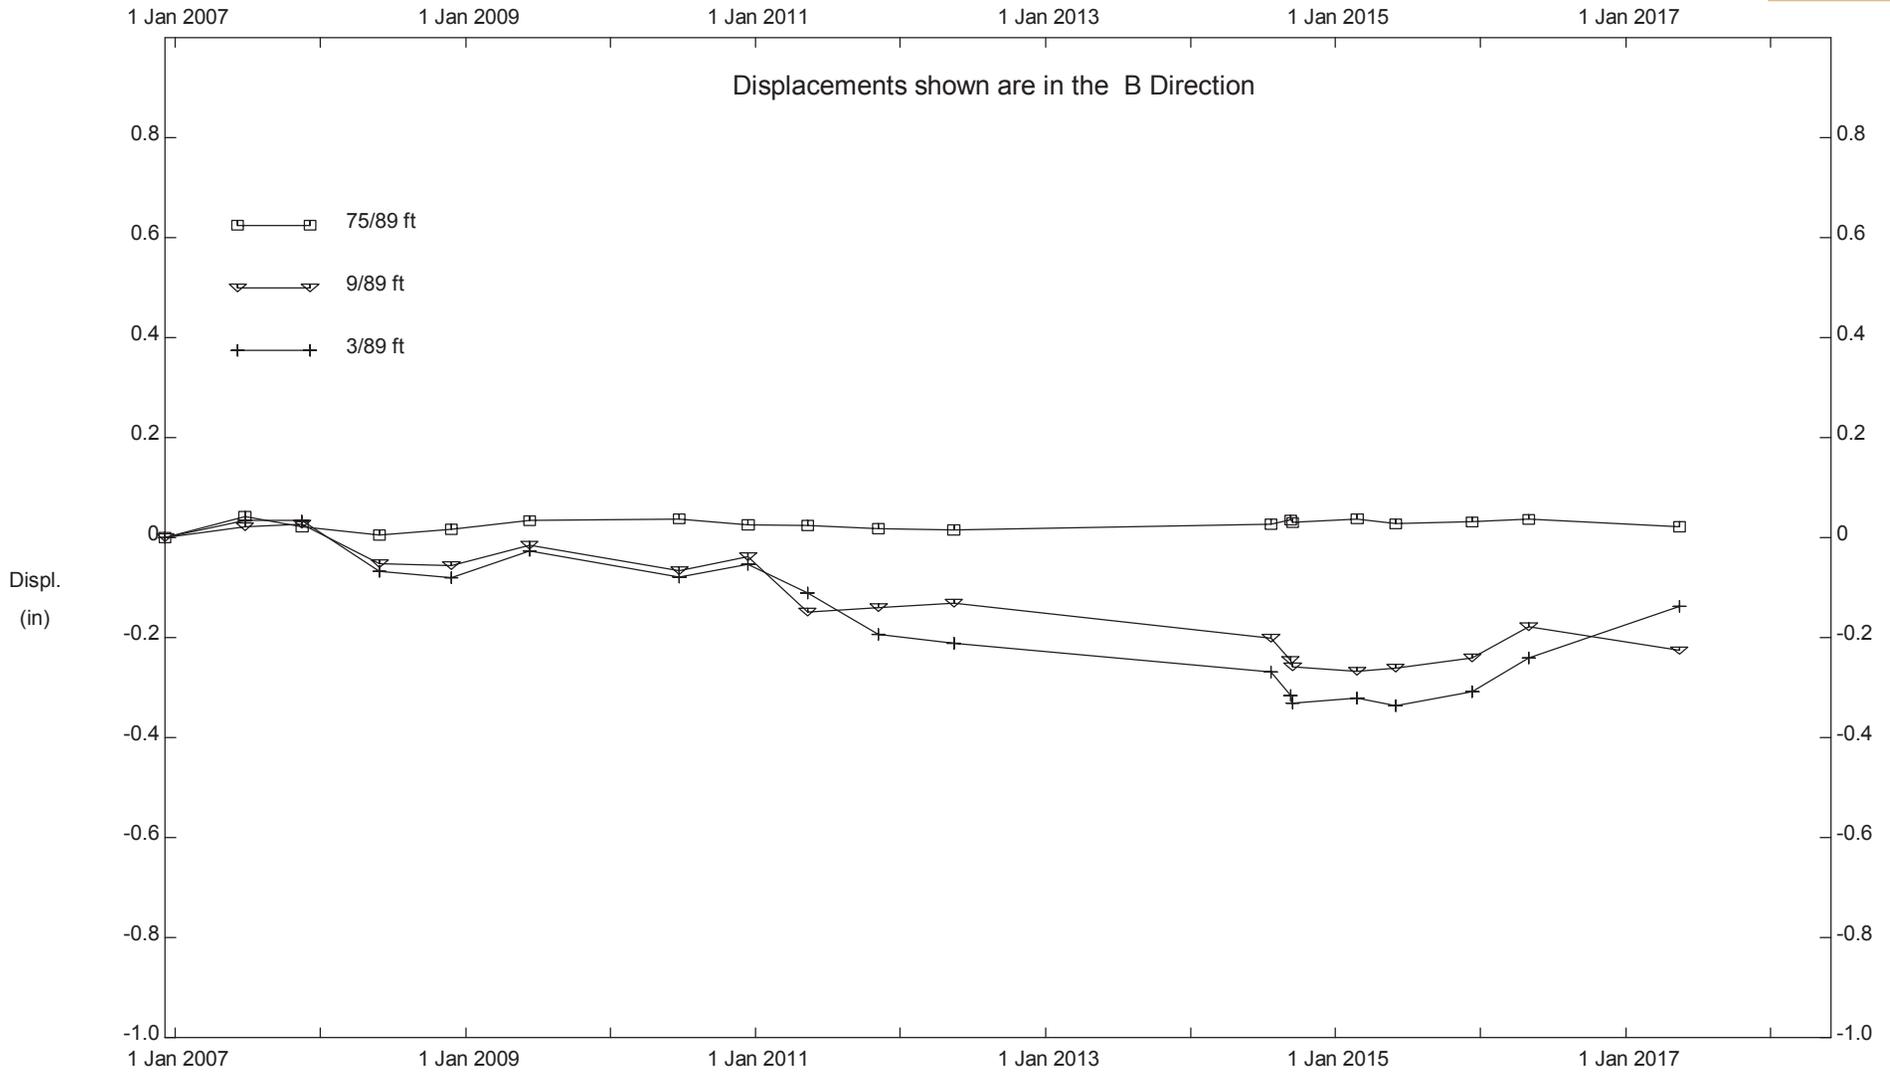
PLATE D14-4

BIG ROCK MESA, Inclinator SP-3

EASTERN REGION

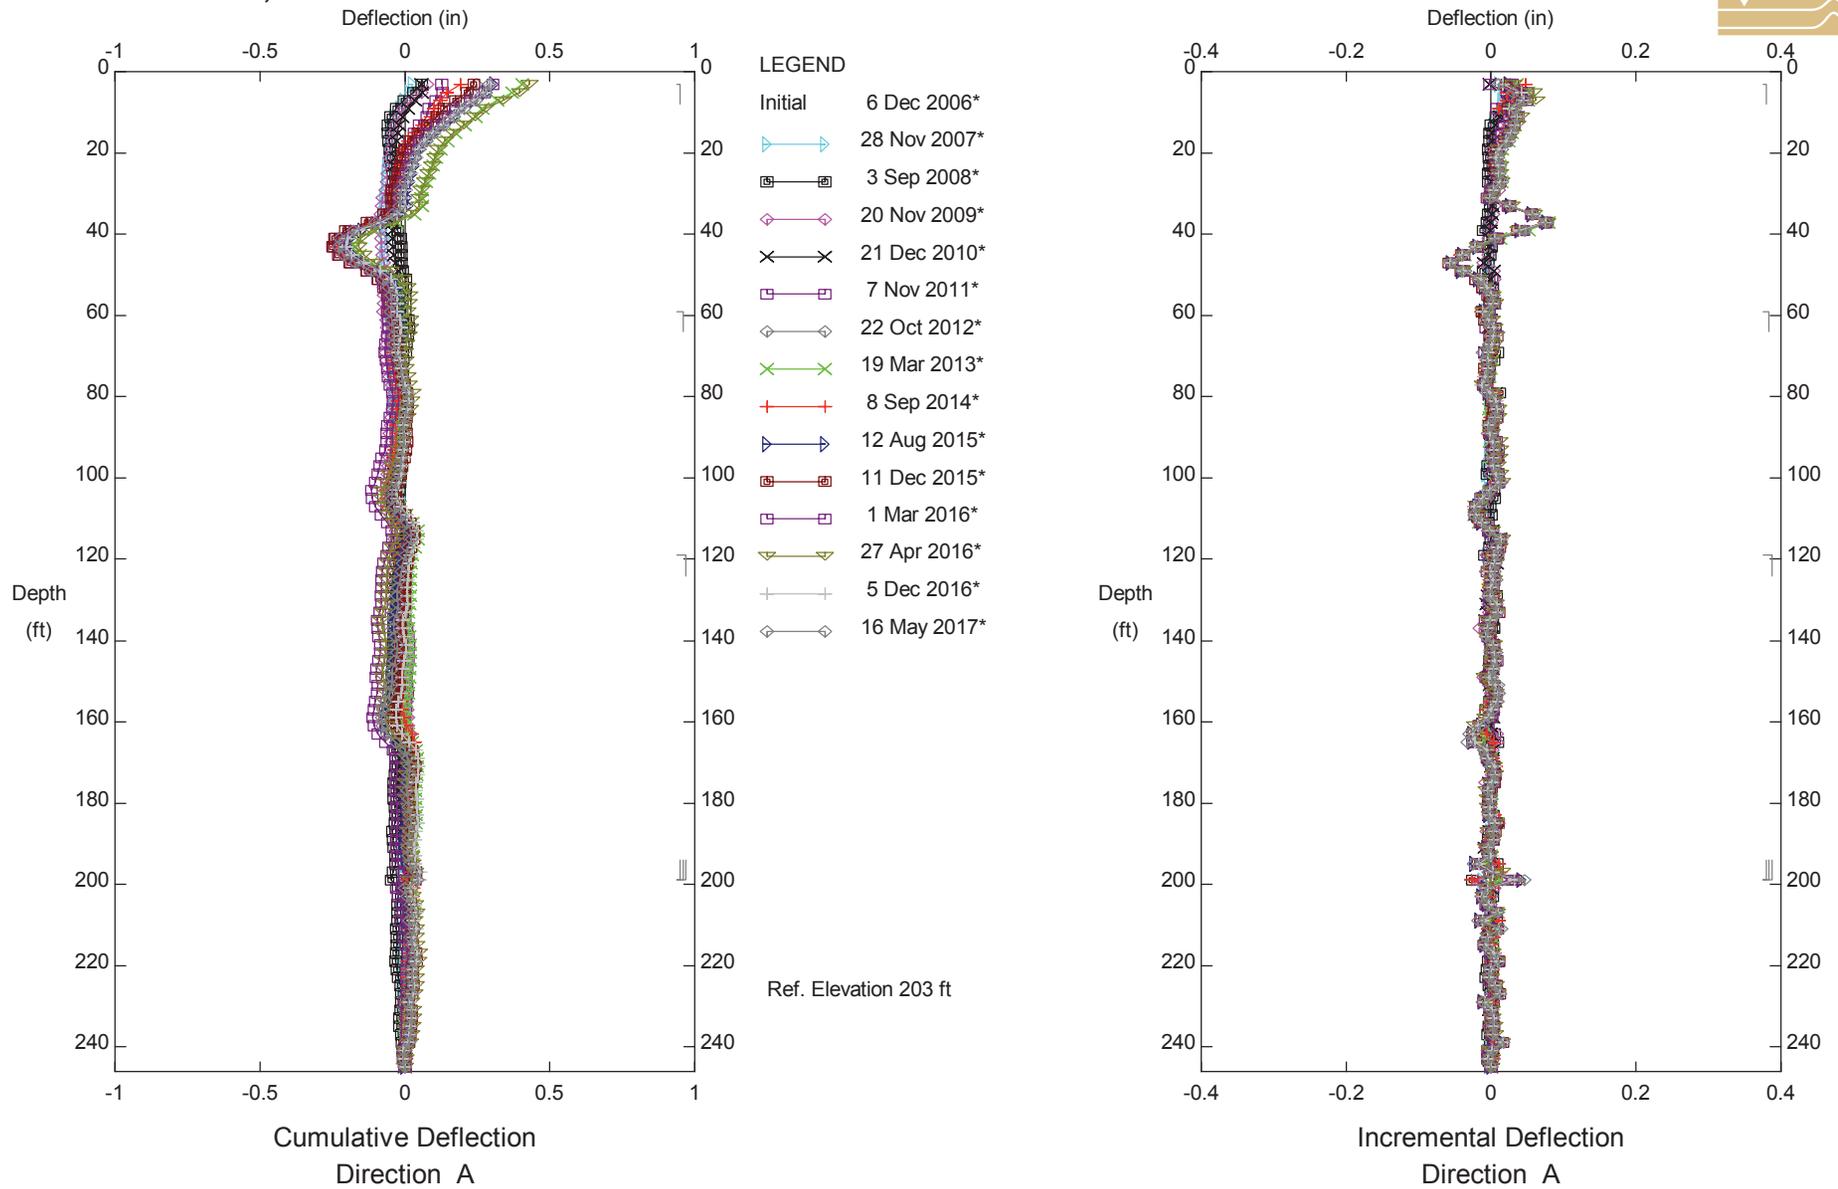
BIG ROCK MESA, Inclinometer SP-3A
 EASTERN REGION

Sets marked * include zero shift and/or rotation corrections.
