**ANNUAL REPORT
JULY 2016 THROUGH JUNE 2017
BIG ROCK MESA LANDSLIDE
ASSESSMENT DISTRICT
City of Malibu, California**

March 2018
Fugro Project No. 04.62160606
Document No. 04.62160606-PR-004(Rev.00)

**Annual Report of Maintenance and Monitoring, July 2016 through June 2017,
Big Rock Mesa Landslide Assessment District, City of Malibu, California**

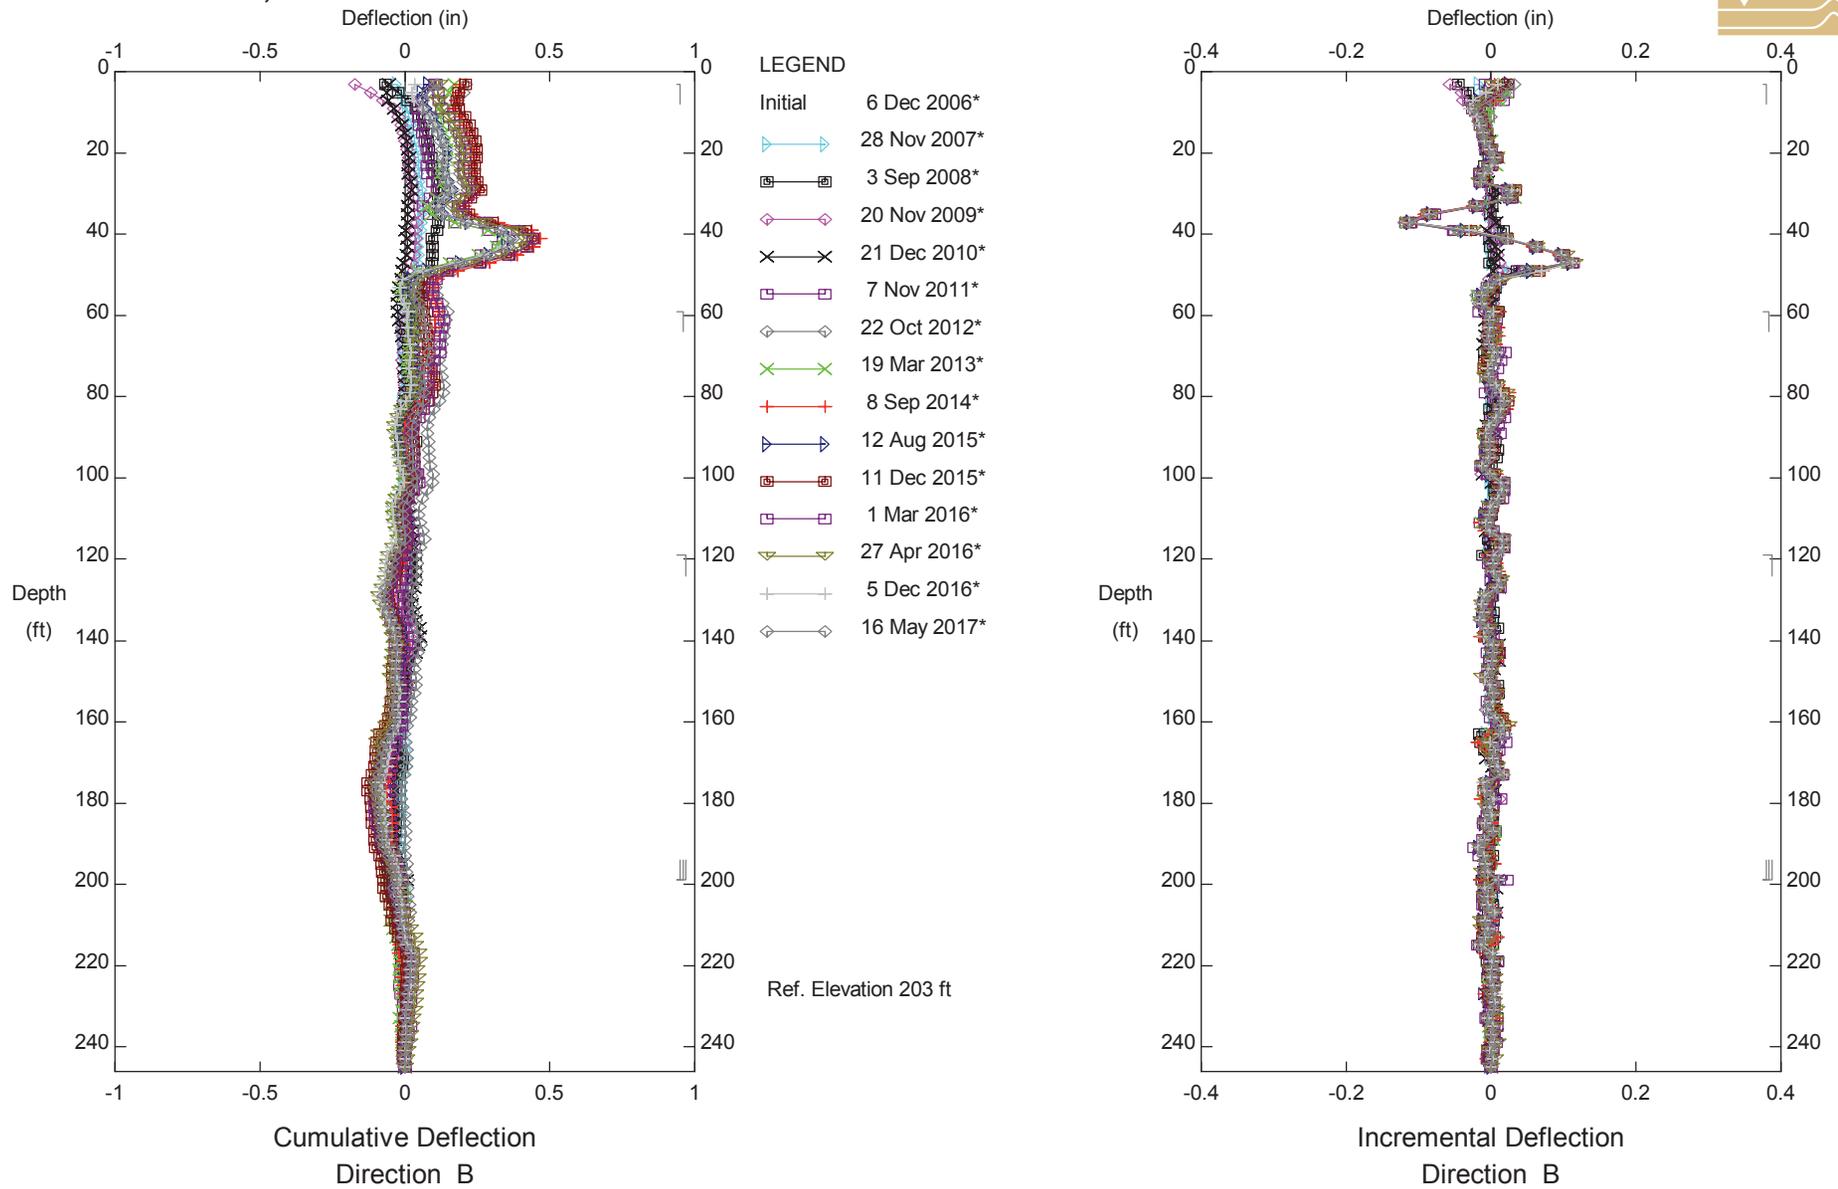
BIG ROCK MESA, Inclinometer SP-3A
 EASTERN REGION

Sets marked * include zero shift and/or rotation corrections.

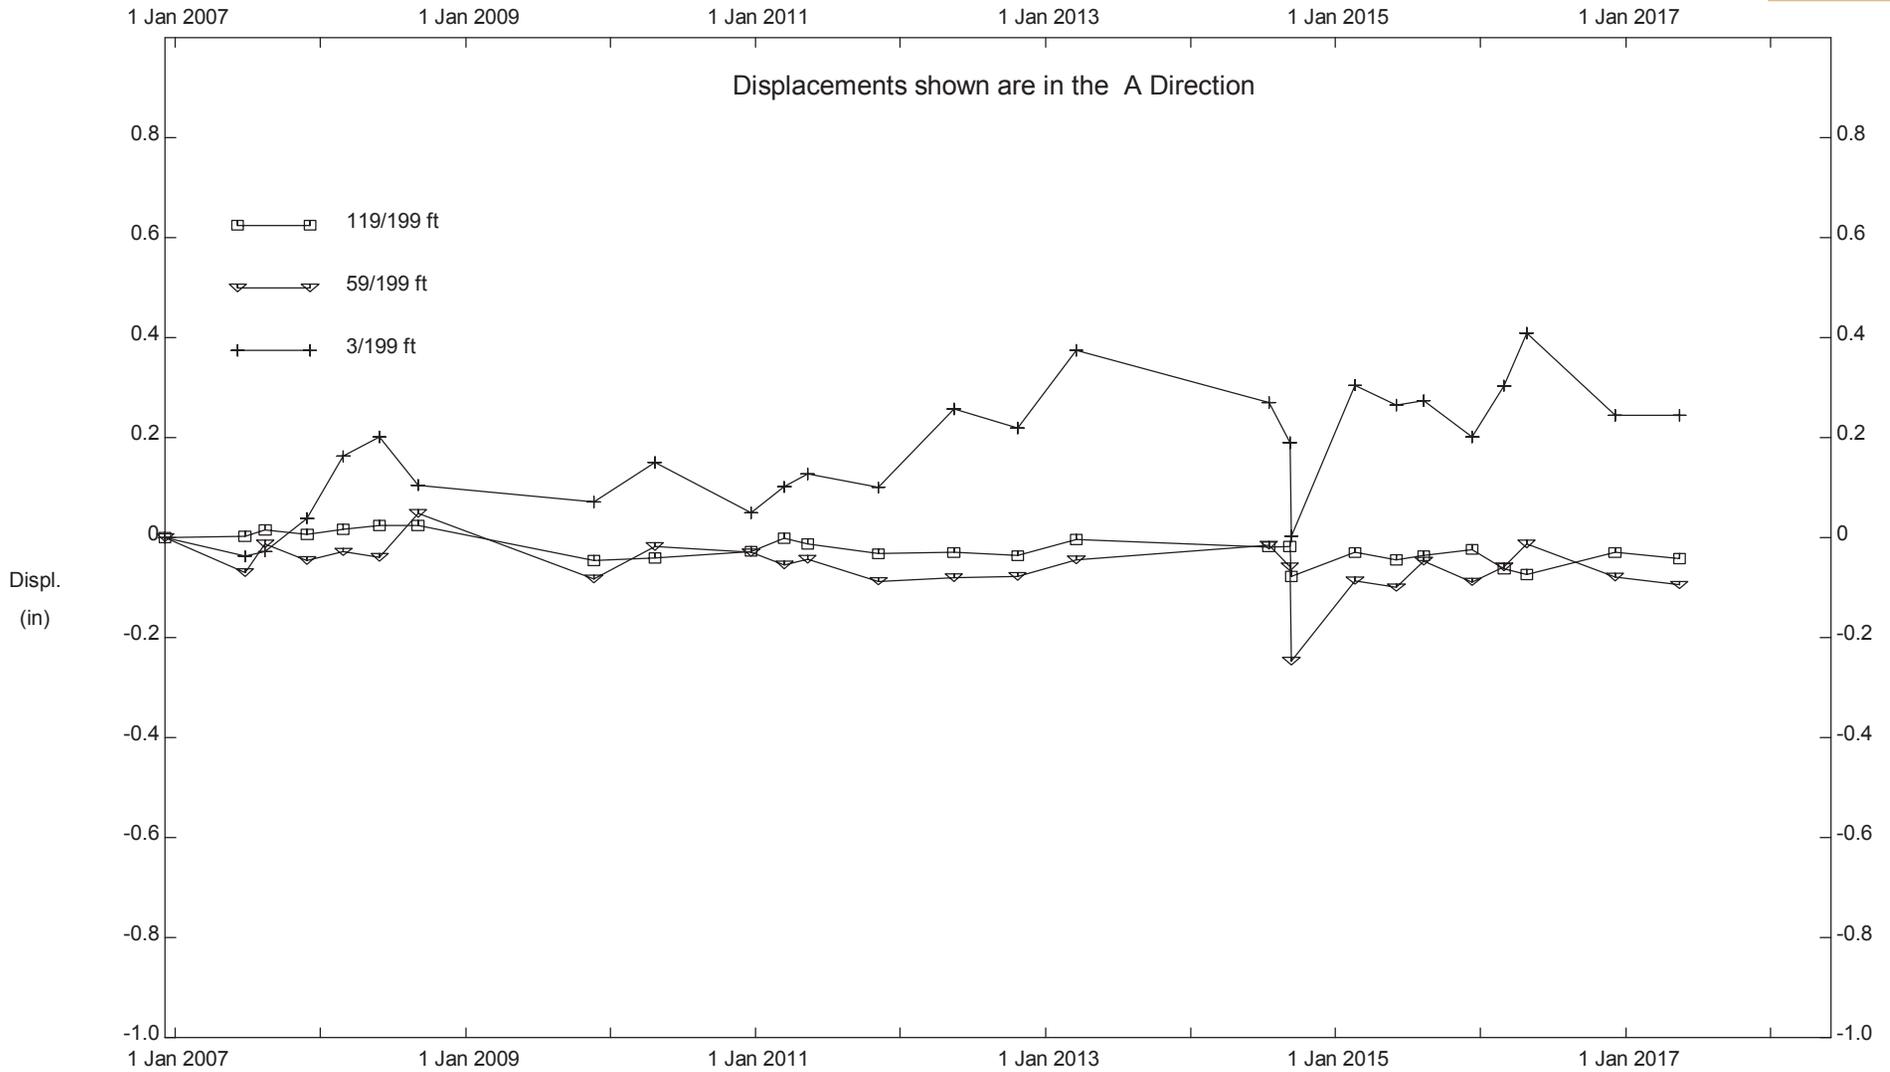
PLATE D15-3

BIG ROCK MESA, Inclinometer SP-3A

EASTERN REGION

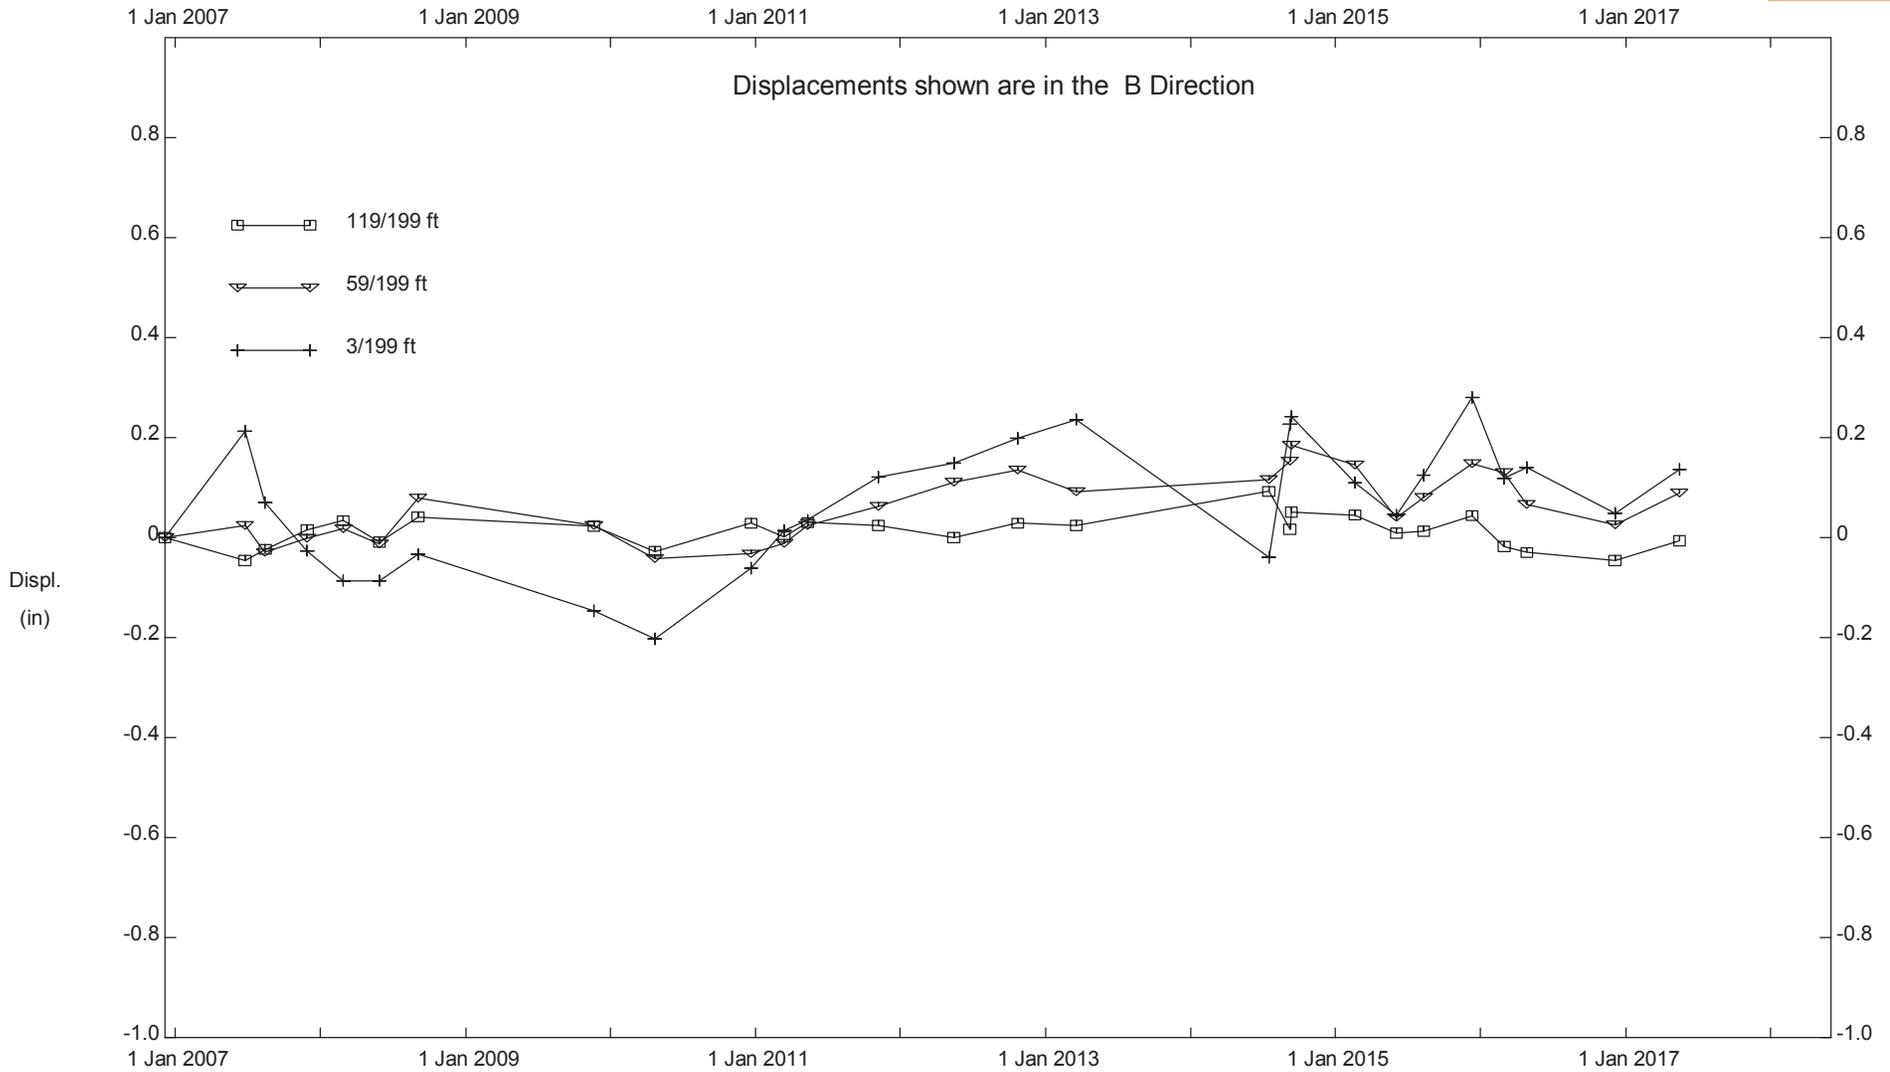
PLATE D15-4

BIG ROCK MESA, Inclinometer SP-3A

EASTERN REGION

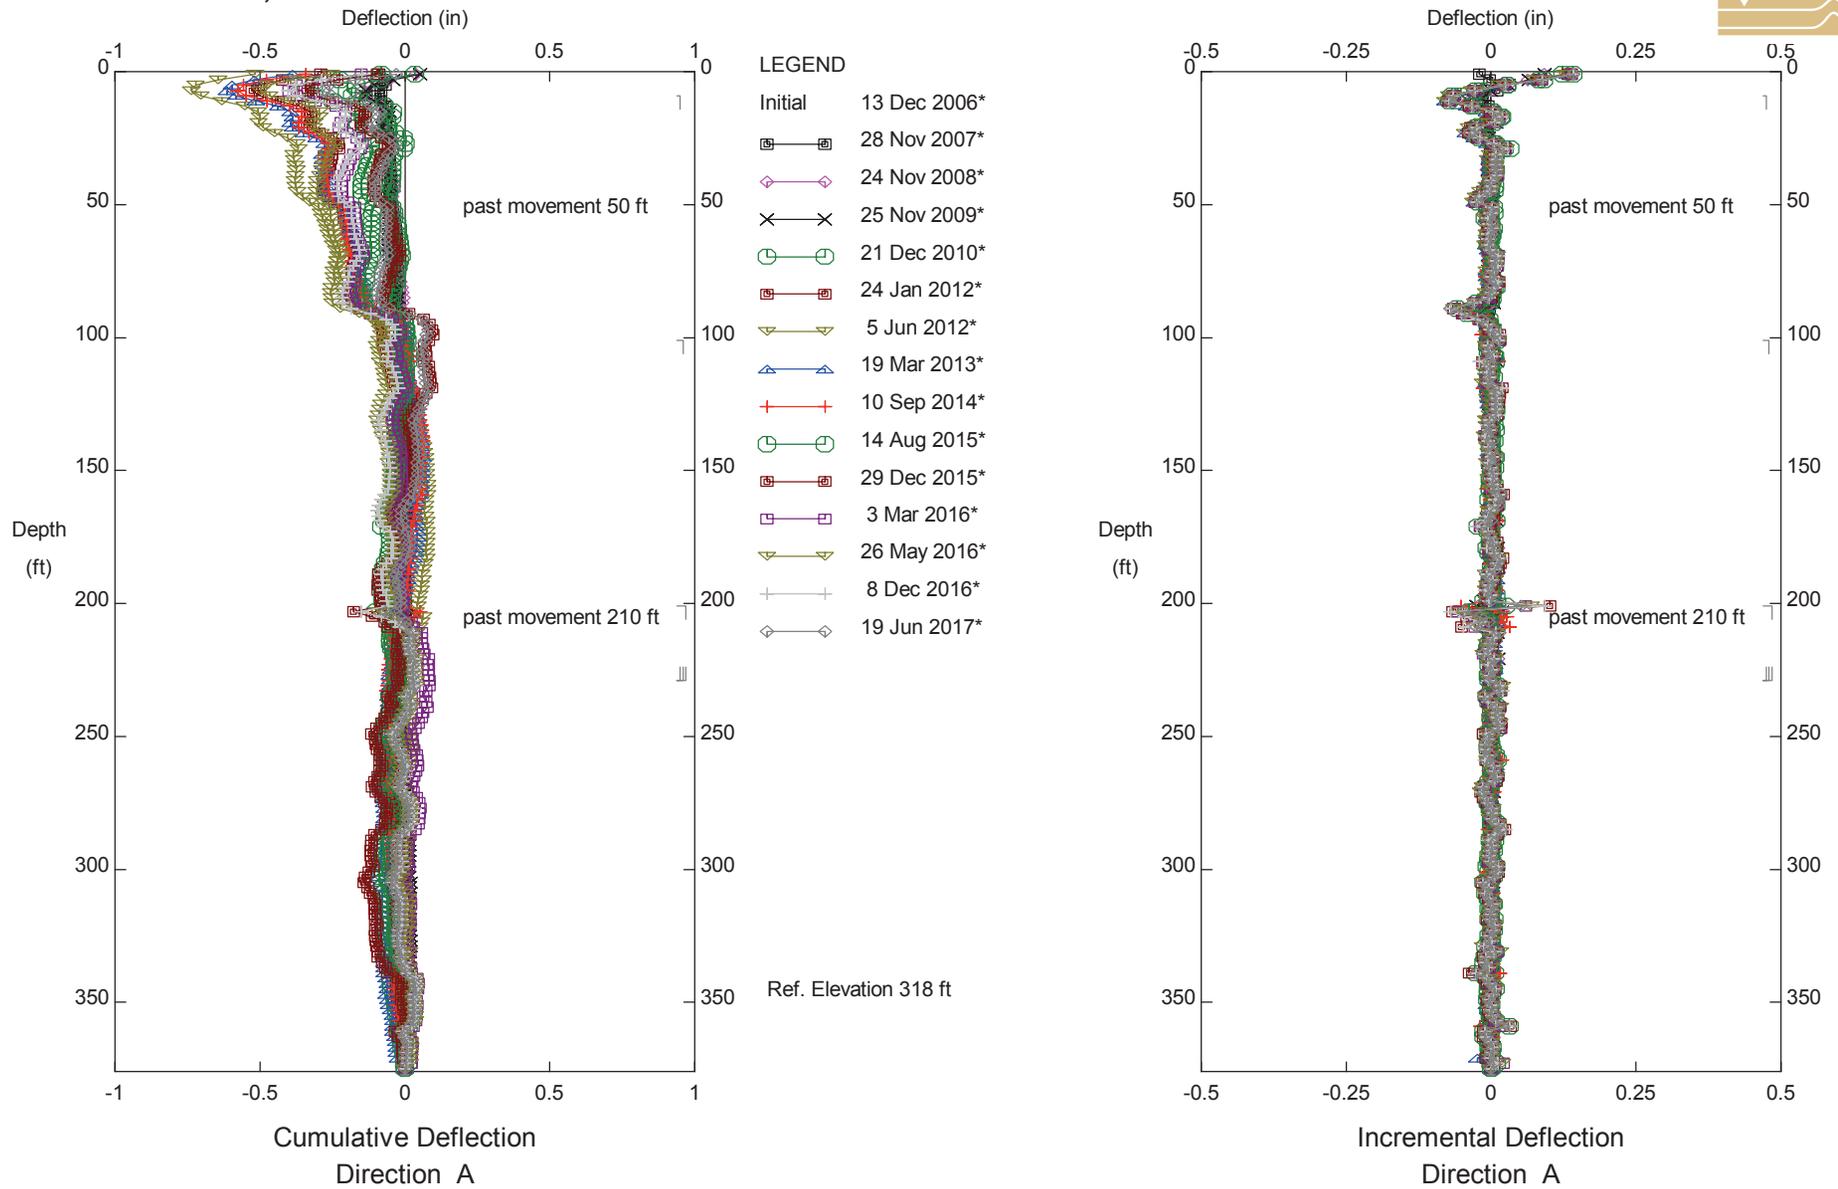
BIG ROCK MESA, Inclinometer SP-33
 EASTERN REGION

Sets marked * include zero shift and/or rotation corrections.

Groundwater levels in SP-33 remained relatively stable over the 2016-2017 monitoring year with the exception of November 2016 and January 2017 in which groundwater elevation was measured approximately 6 to 9 feet higher than preceding or subsequent measurements. It should be noted that this report uses the pre-1999 reference elevation for SP-33 to be consistent with measured field survey data and topographical maps. Groundwater elevation data (including historical data) for SP-33 presented in this report have been adjusted accordingly.

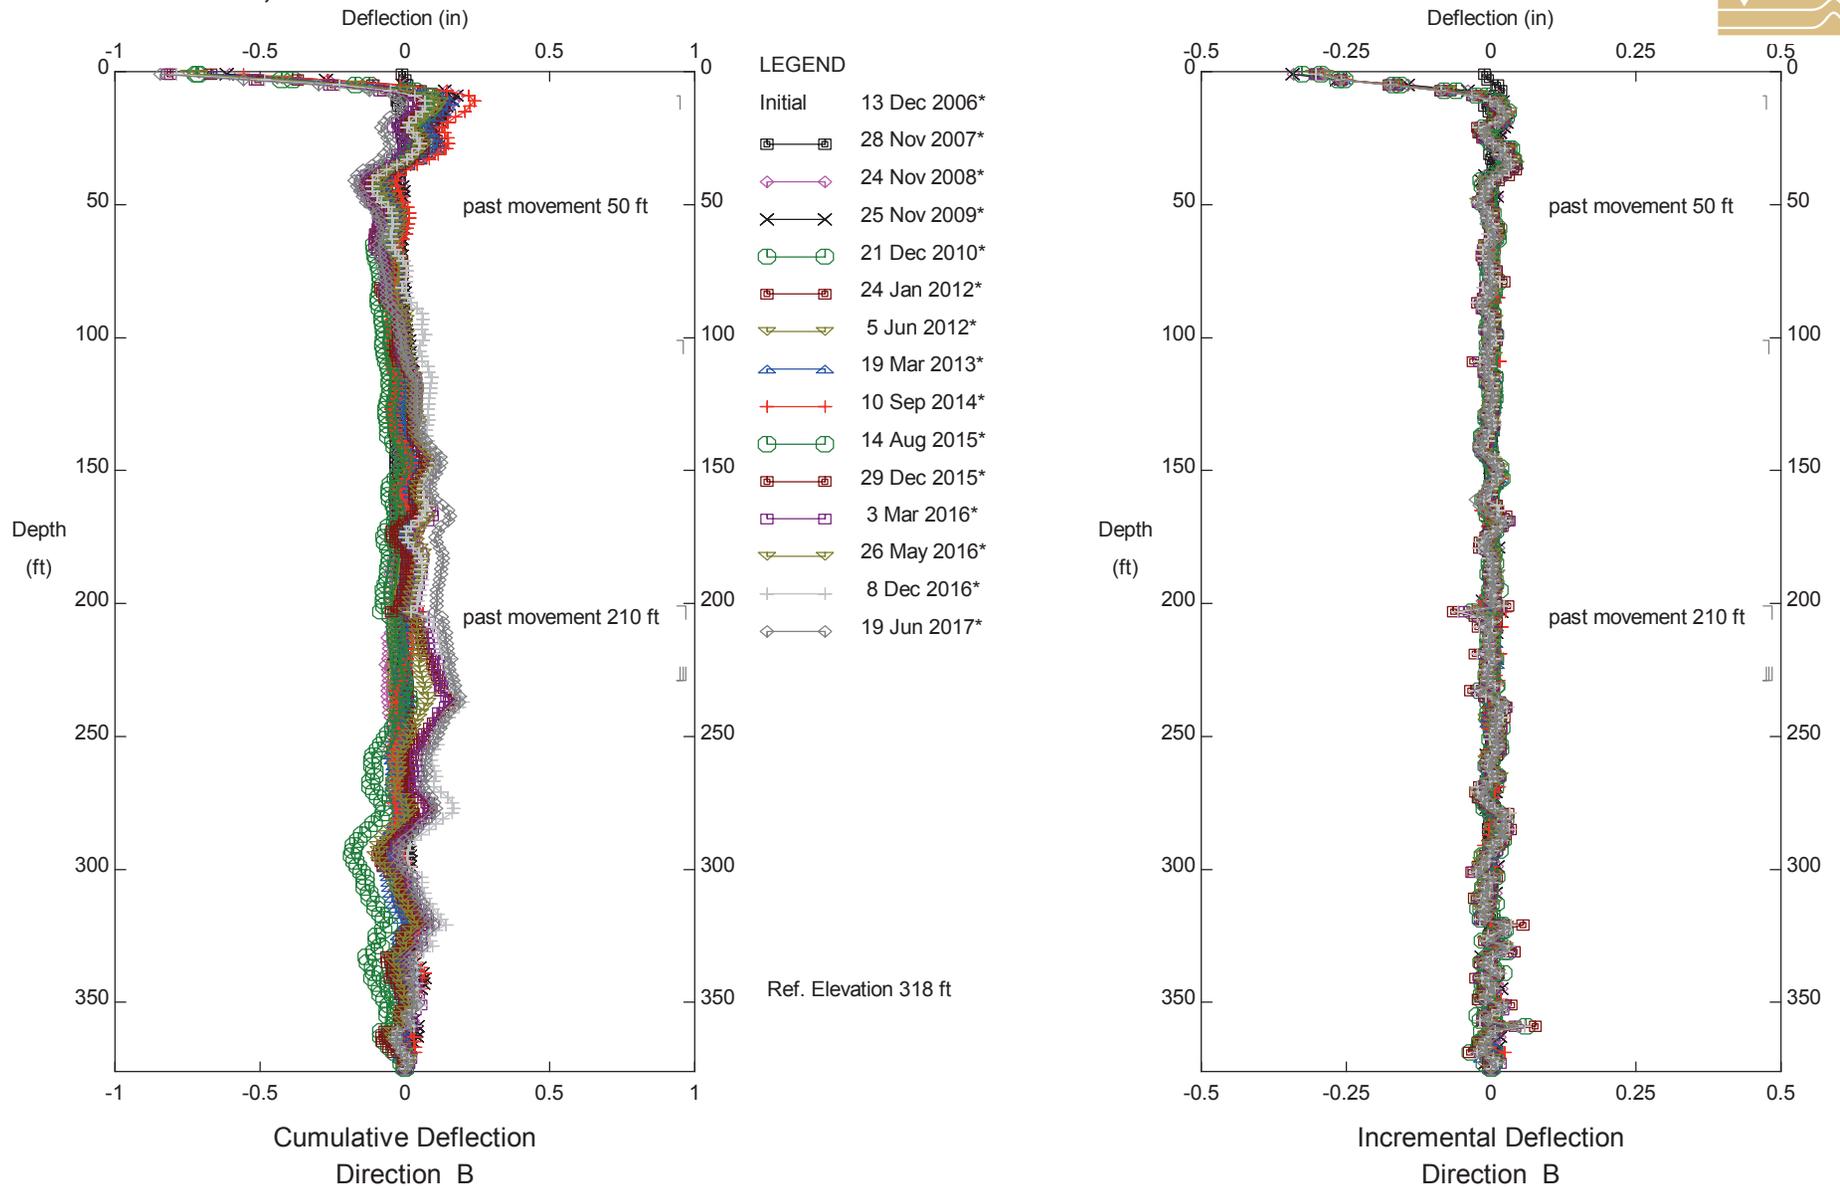
BIG ROCK MESA, Inclinometer SP-33
 EASTERN REGION

Sets marked * include zero shift and/or rotation corrections.

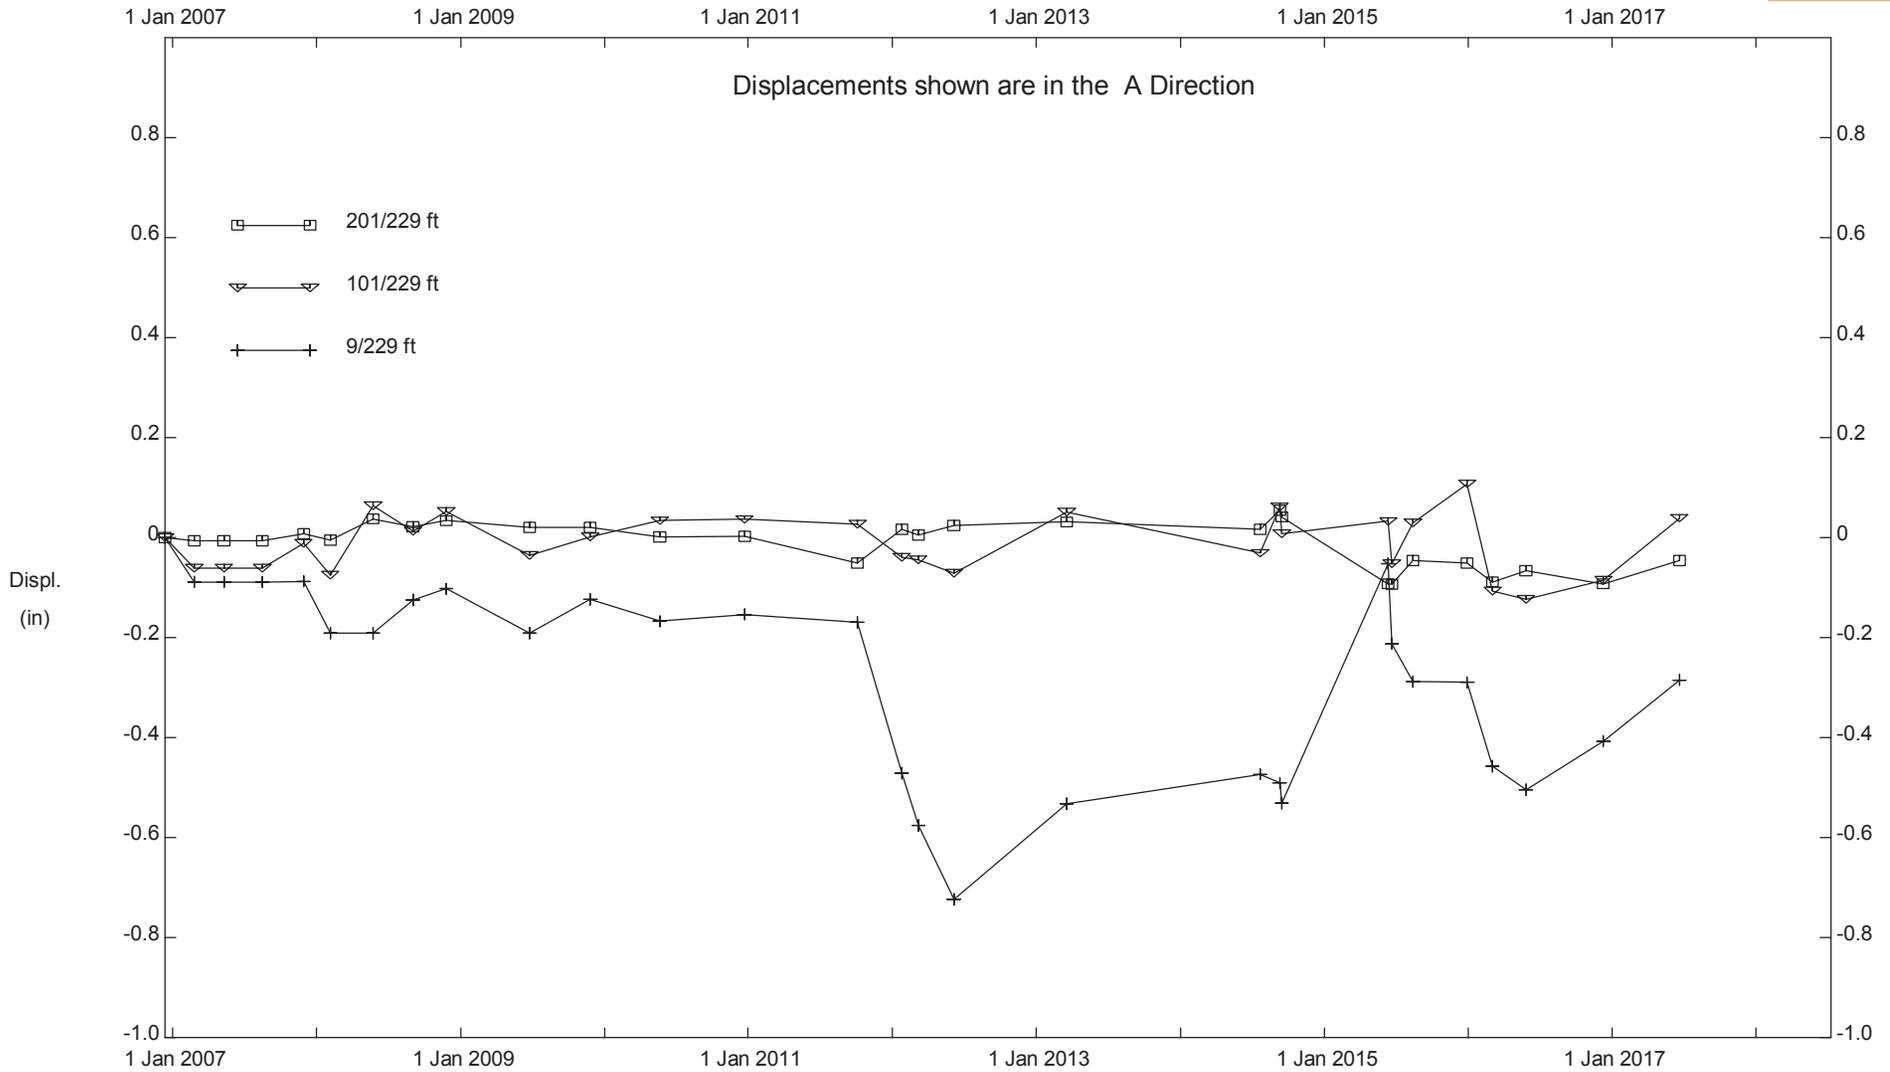
PLATE D16-3

BIG ROCK MESA, Inclinator SP-33

EASTERN REGION

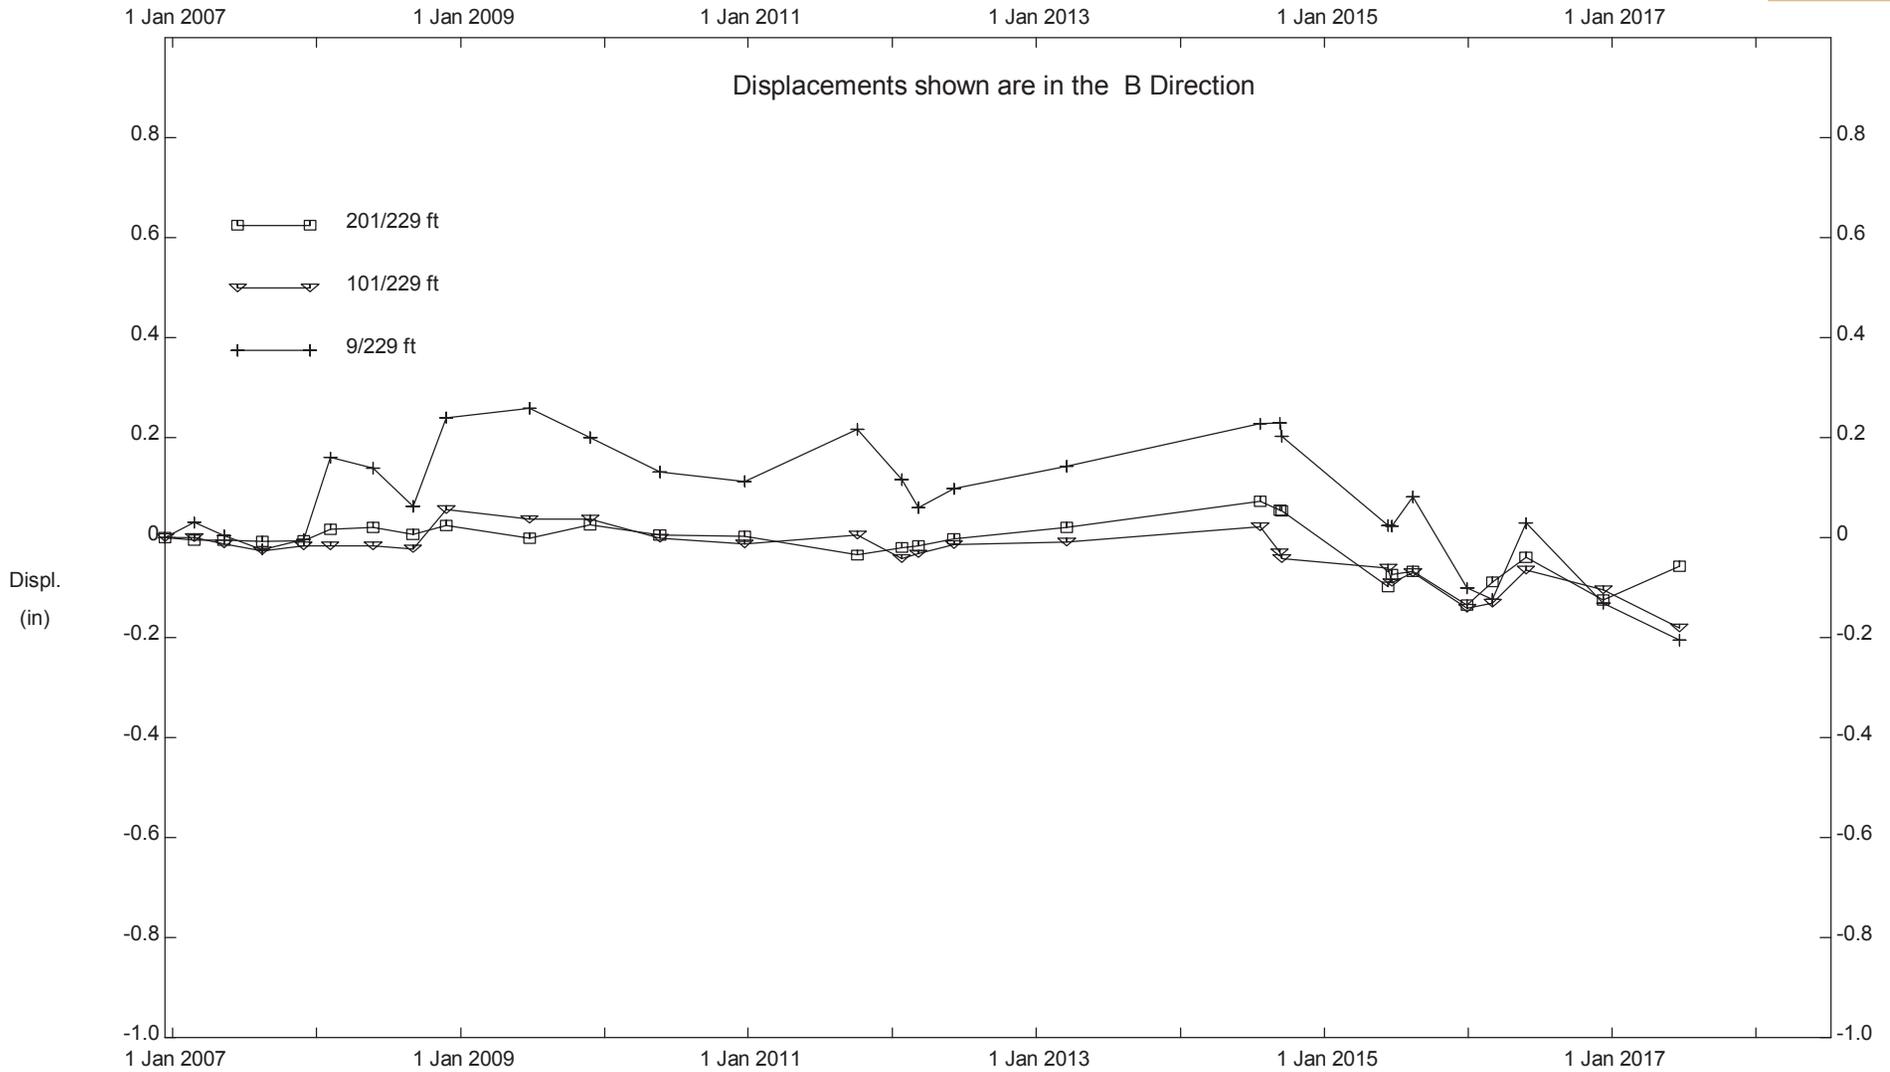
PLATE D16-4

BIG ROCK MESA, Inclinometer SP-33

EASTERN REGION

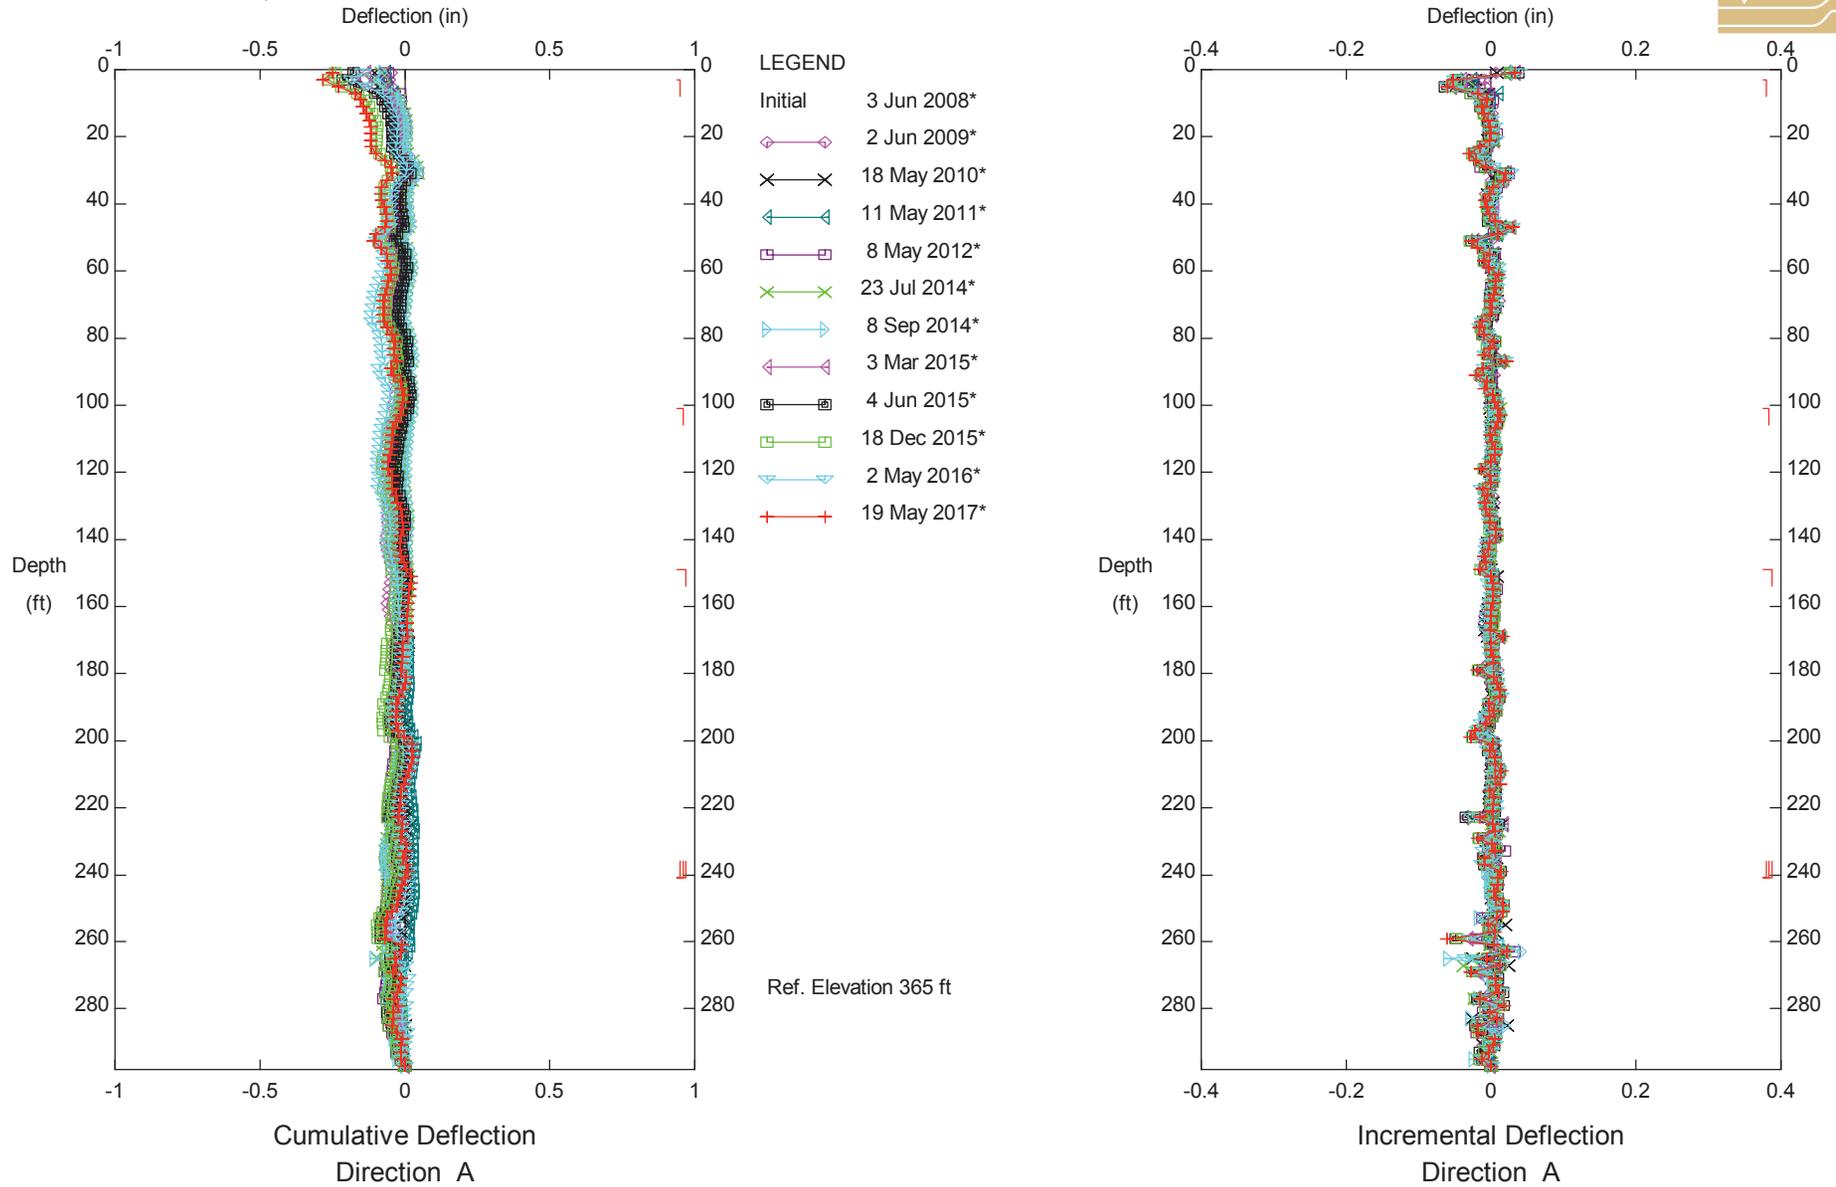
BIG ROCK MESA, Inclinator SP-9A
 CENTRAL REGION

Sets marked * include zero shift and/or rotation corrections.

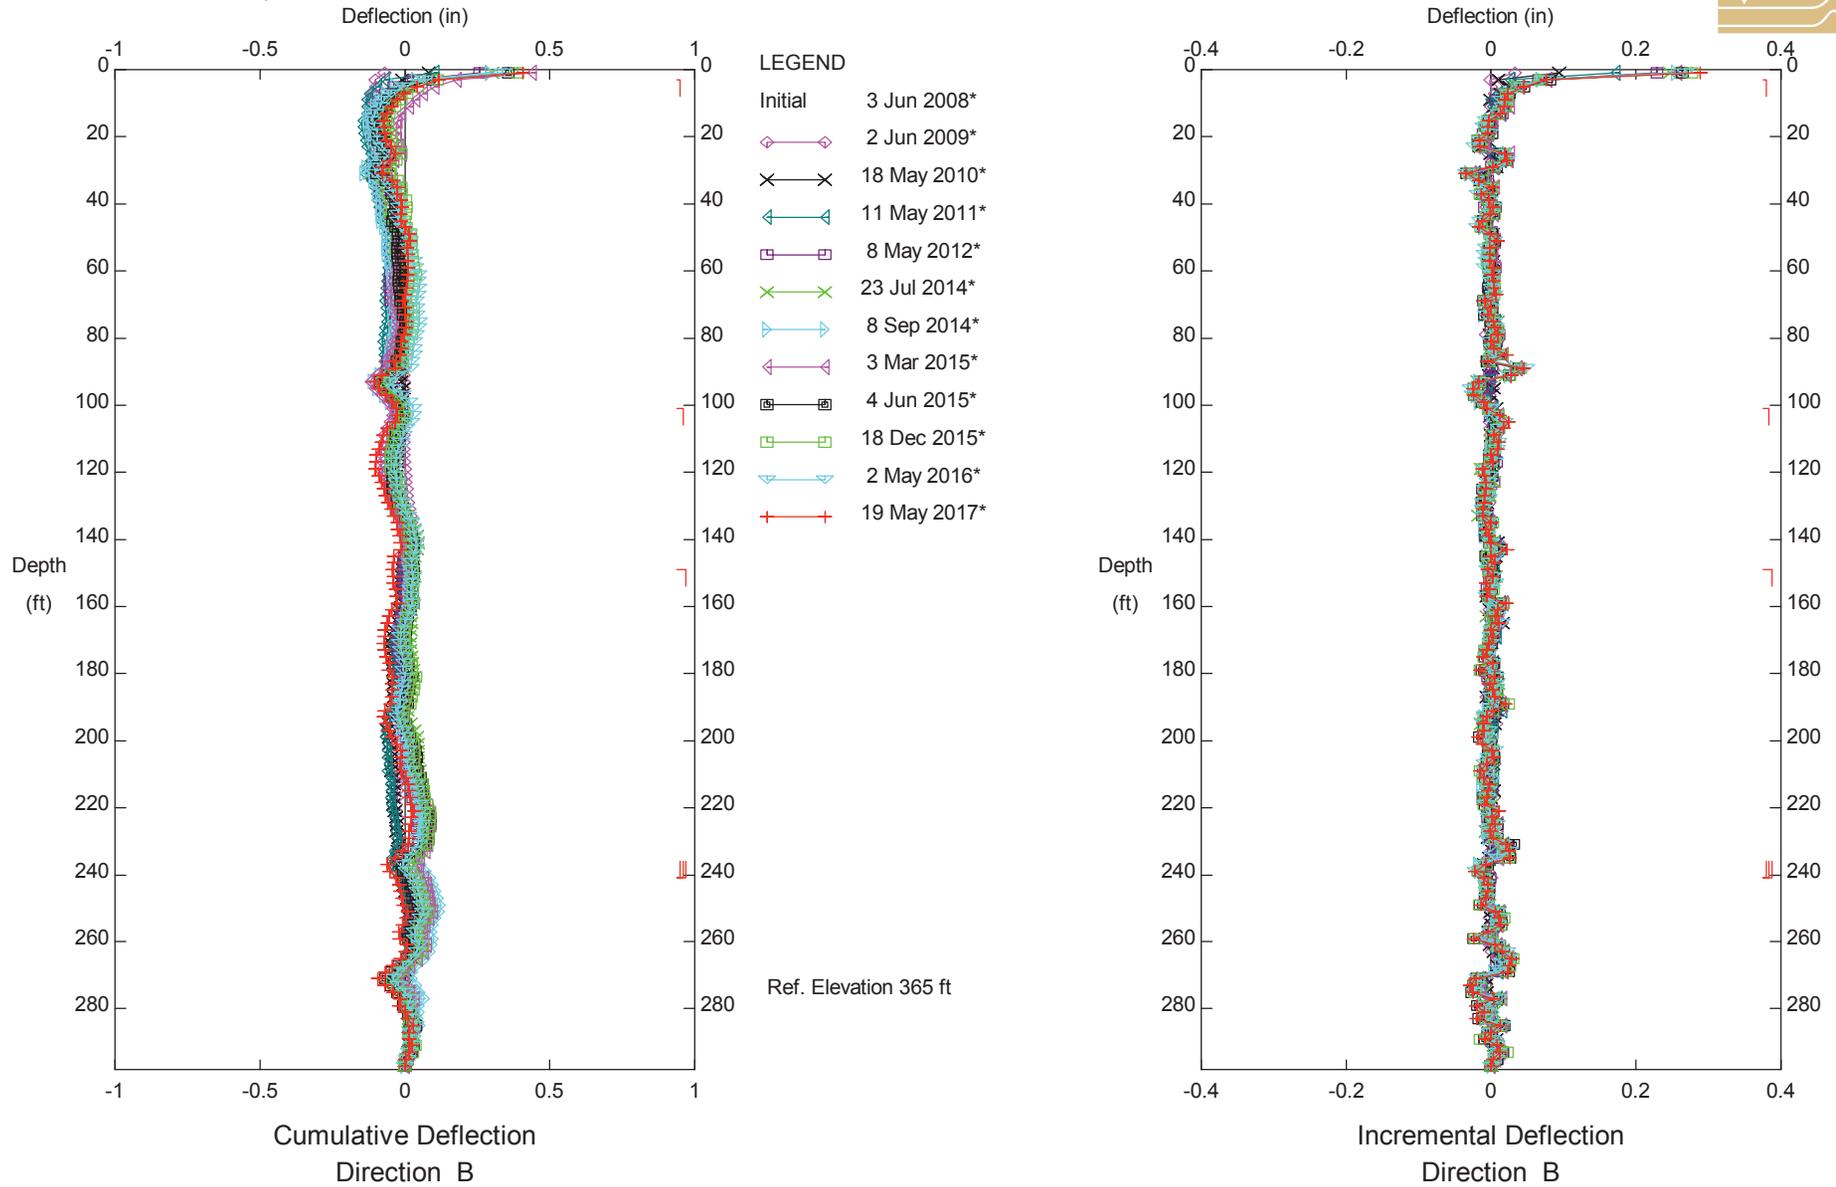
BIG ROCK MESA, Inclinometer SP-9A
 CENTRAL REGION

Sets marked * include zero shift and/or rotation corrections.

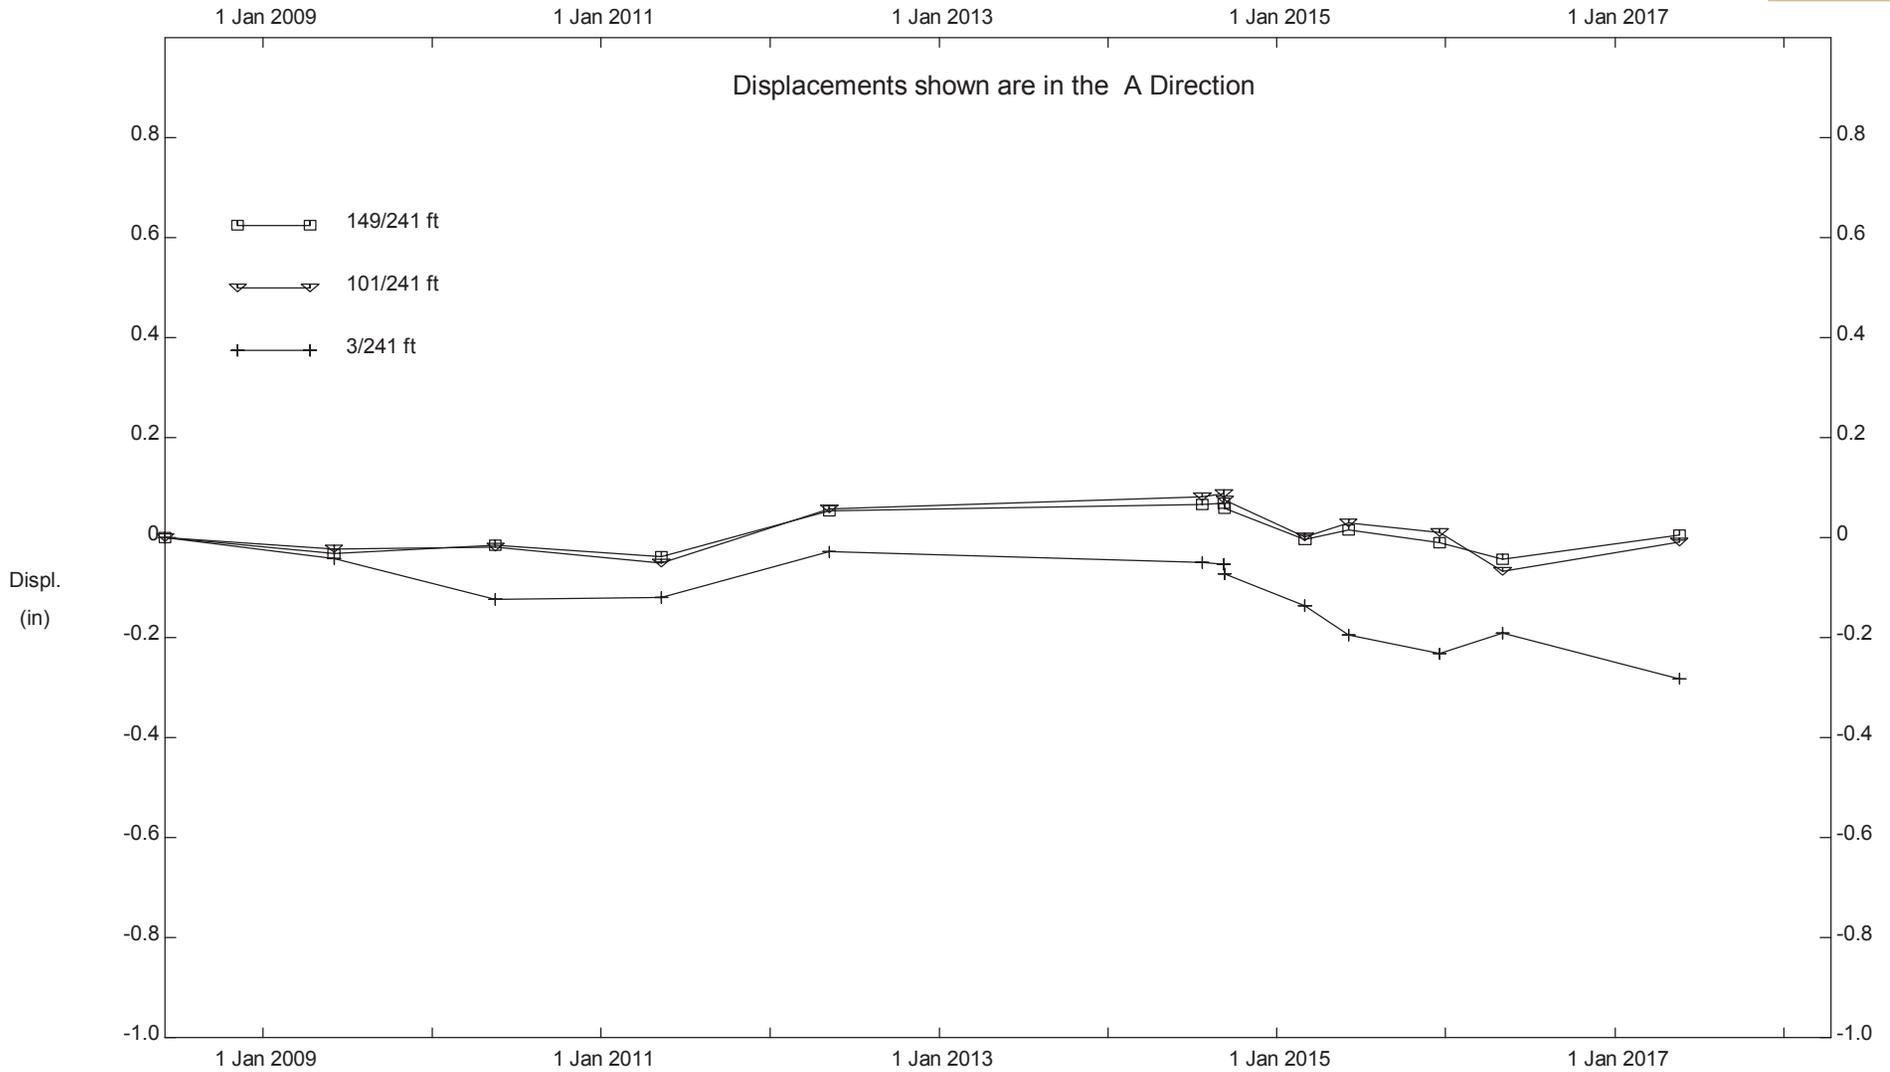
PLATE D17-3

BIG ROCK MESA, Inclinometer SP-9A

CENTRAL REGION
