**ANNUAL REPORT
JULY 2016 THROUGH JUNE 2017
BIG ROCK MESA LANDSLIDE
ASSESSMENT DISTRICT
City of Malibu, California**

March 2018
Fugro Project No. 04.62160606
Document No. 04.62160606-PR-004(Rev.00)

**Annual Report of Maintenance and Monitoring, July 2016 through June 2017,
Big Rock Mesa Landslide Assessment District, City of Malibu, California**

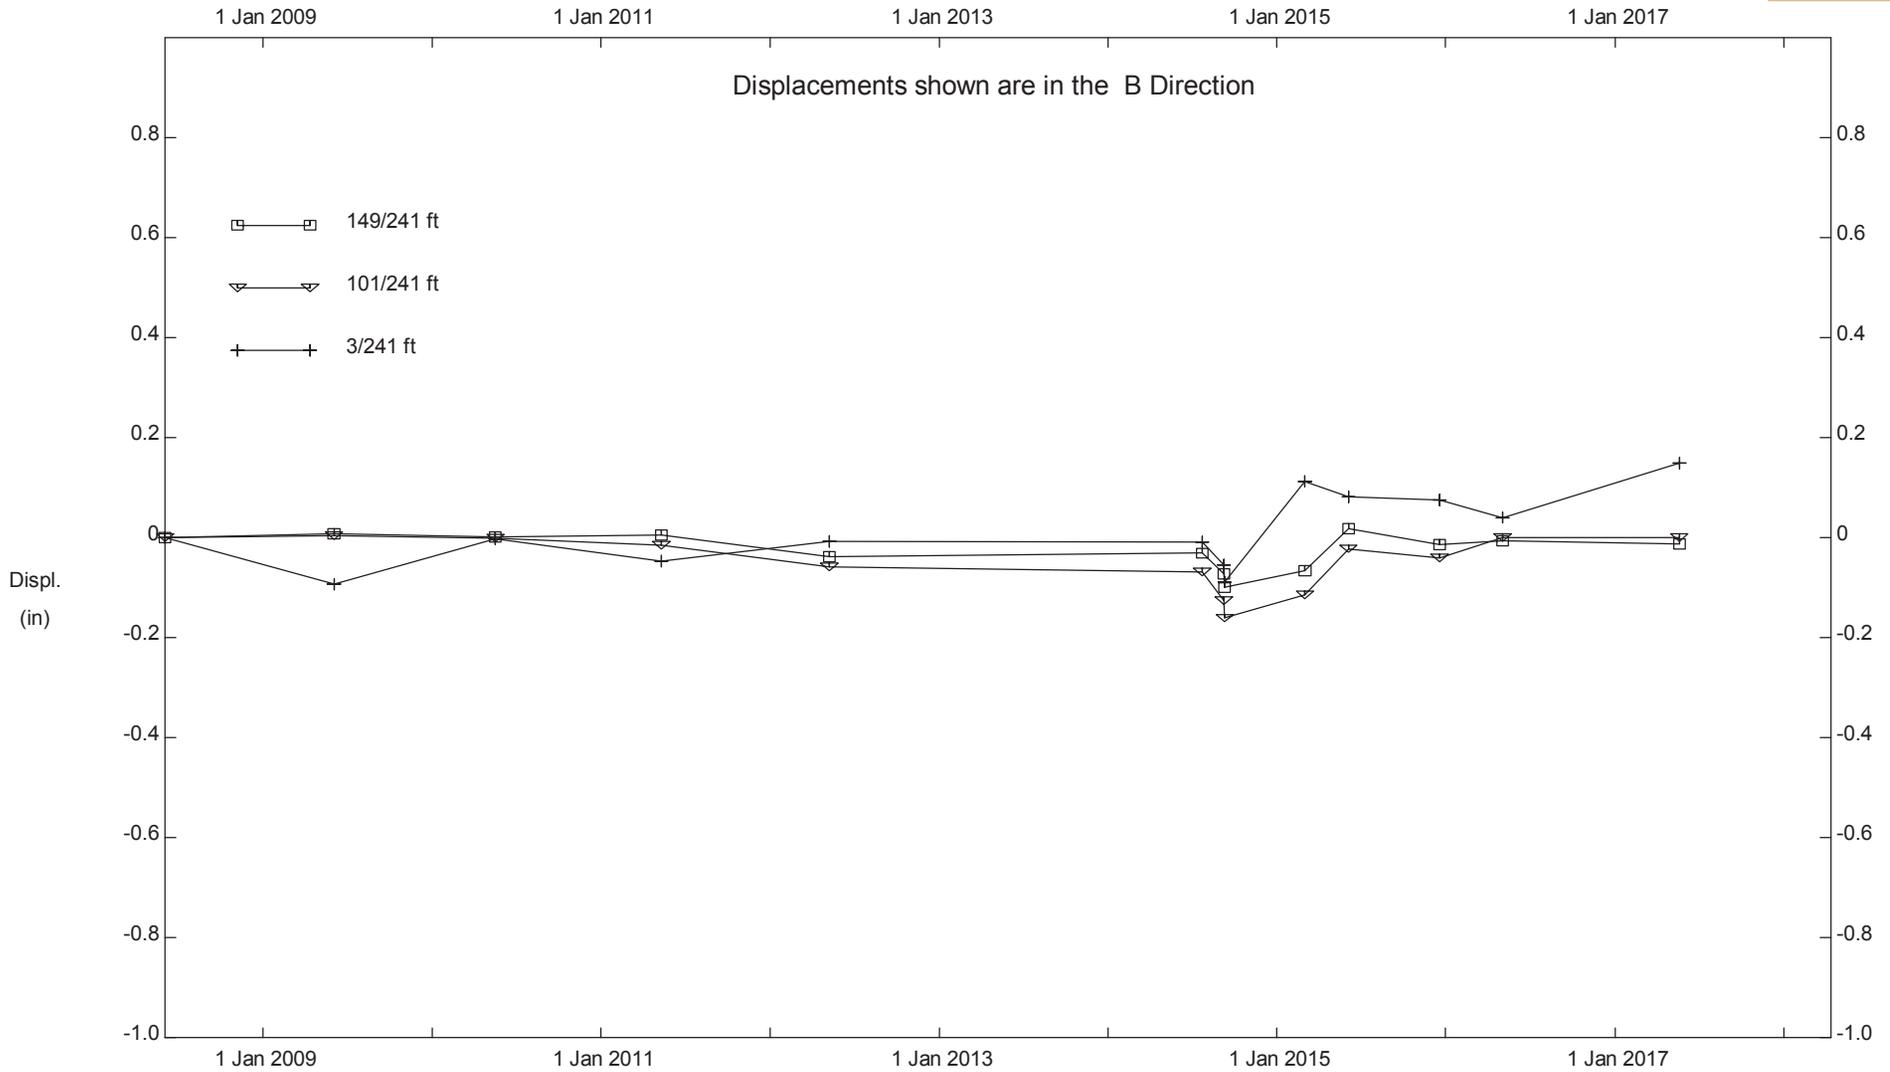
PLATE D17-4

BIG ROCK MESA, Inclinometer SP-9A

CENTRAL REGION

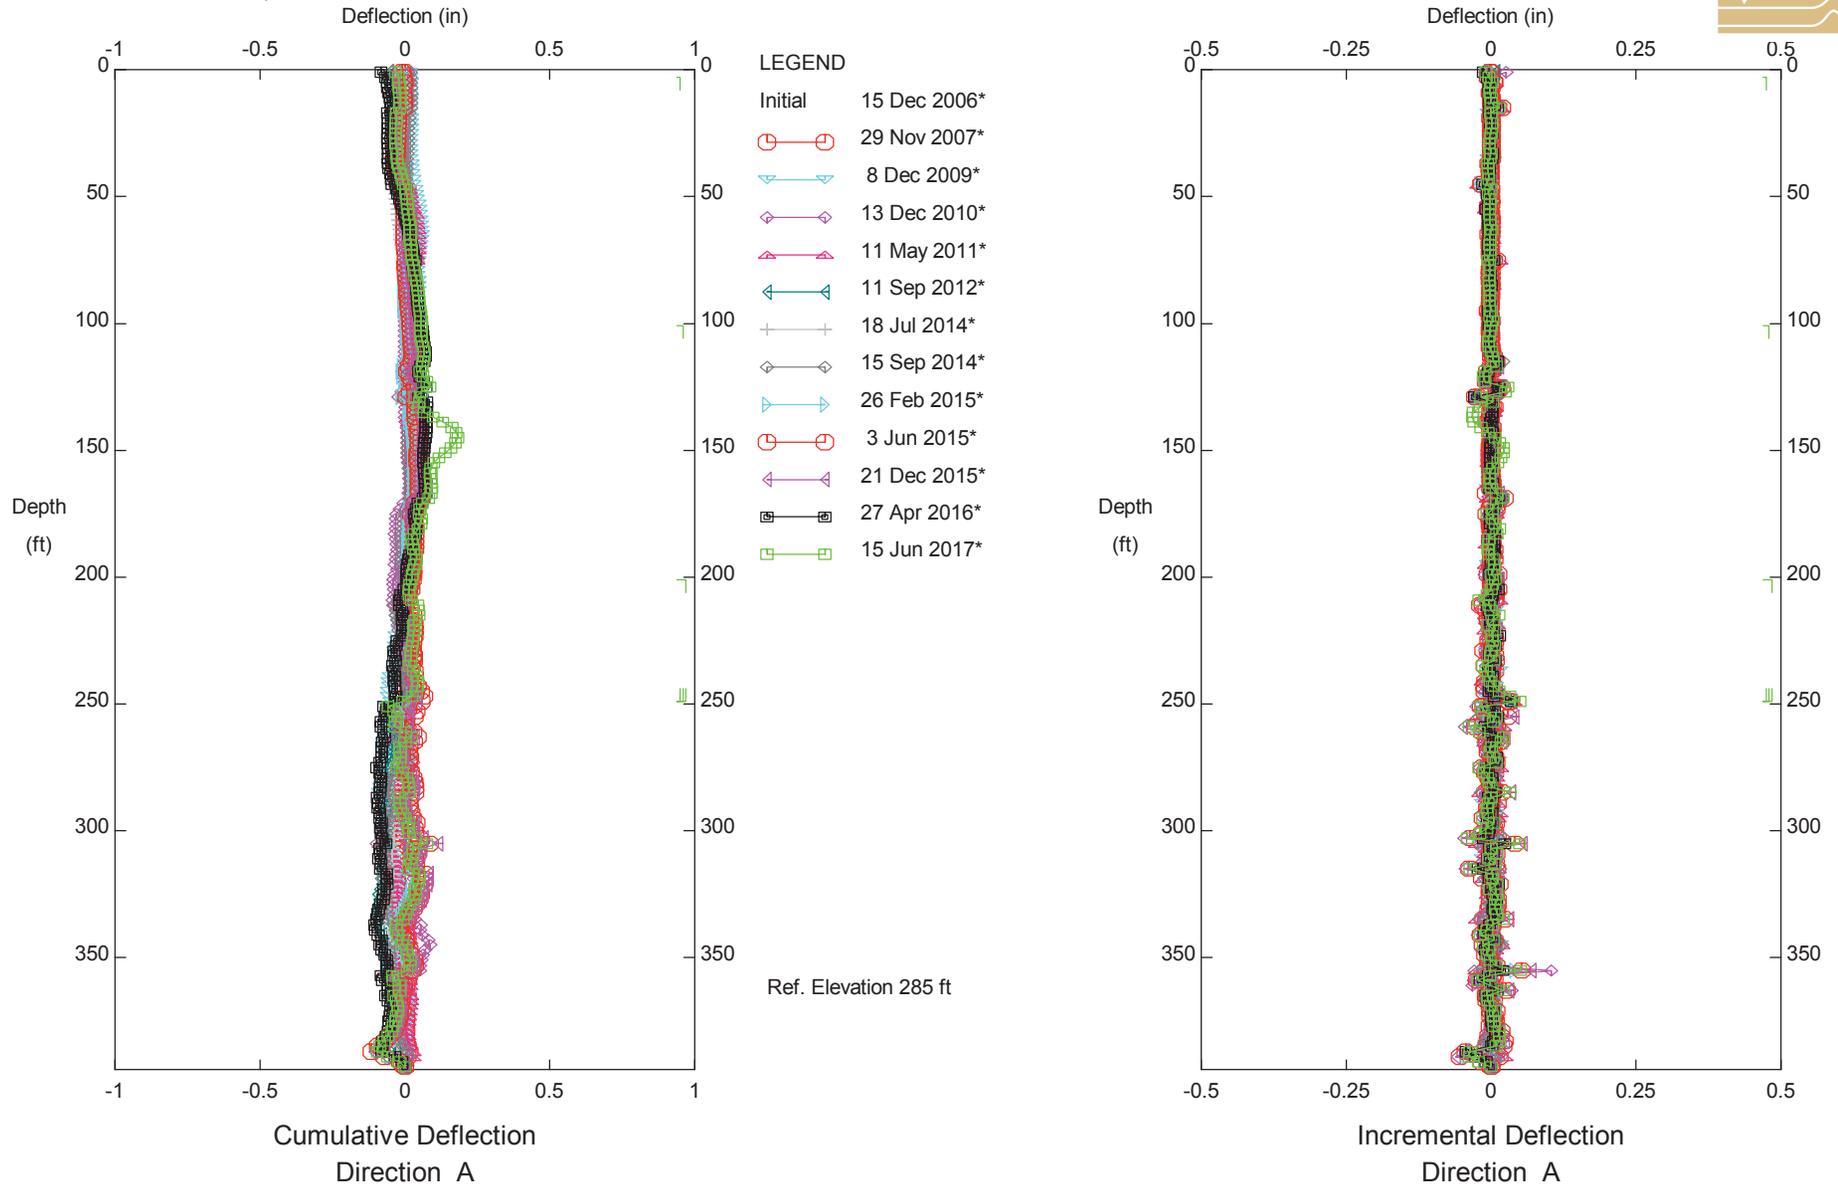
**BIG ROCK MESA, Inclinometer SP-16A
 CENTRAL REGION**

Sets marked * include zero shift and/or rotation corrections.

Groundwater elevations in standpipes SP-16 and -16A recorded sudden increases in April 2016 as the pump in dewatering well BYA-1 began to fail. BYA-1 was replaced on June 26, 2017. It is anticipated that groundwater levels in SP-16 and -16A will decrease as BYA-1 pumps water out of the area.

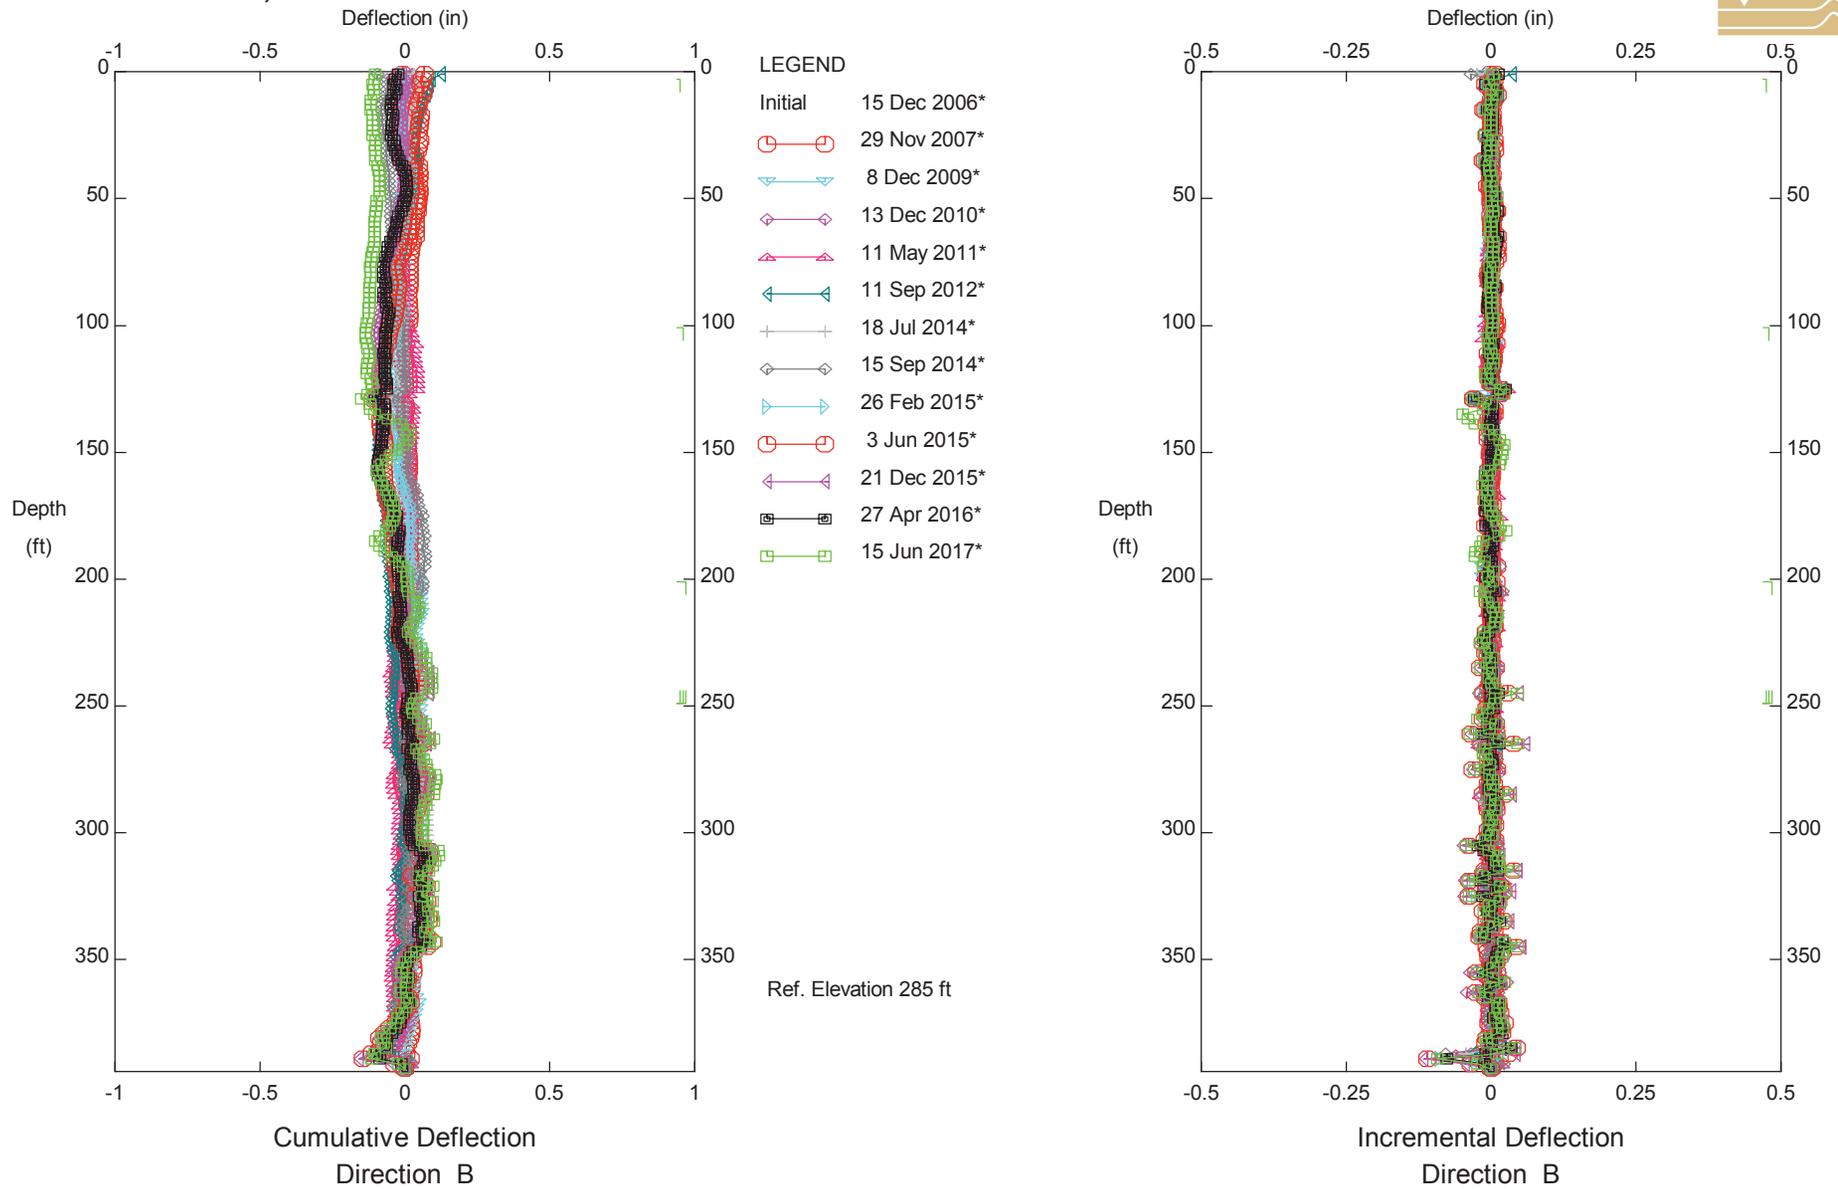
**BIG ROCK MESA, Inclinometer SP-16A
 CENTRAL REGION**

Sets marked * include zero shift and/or rotation corrections.

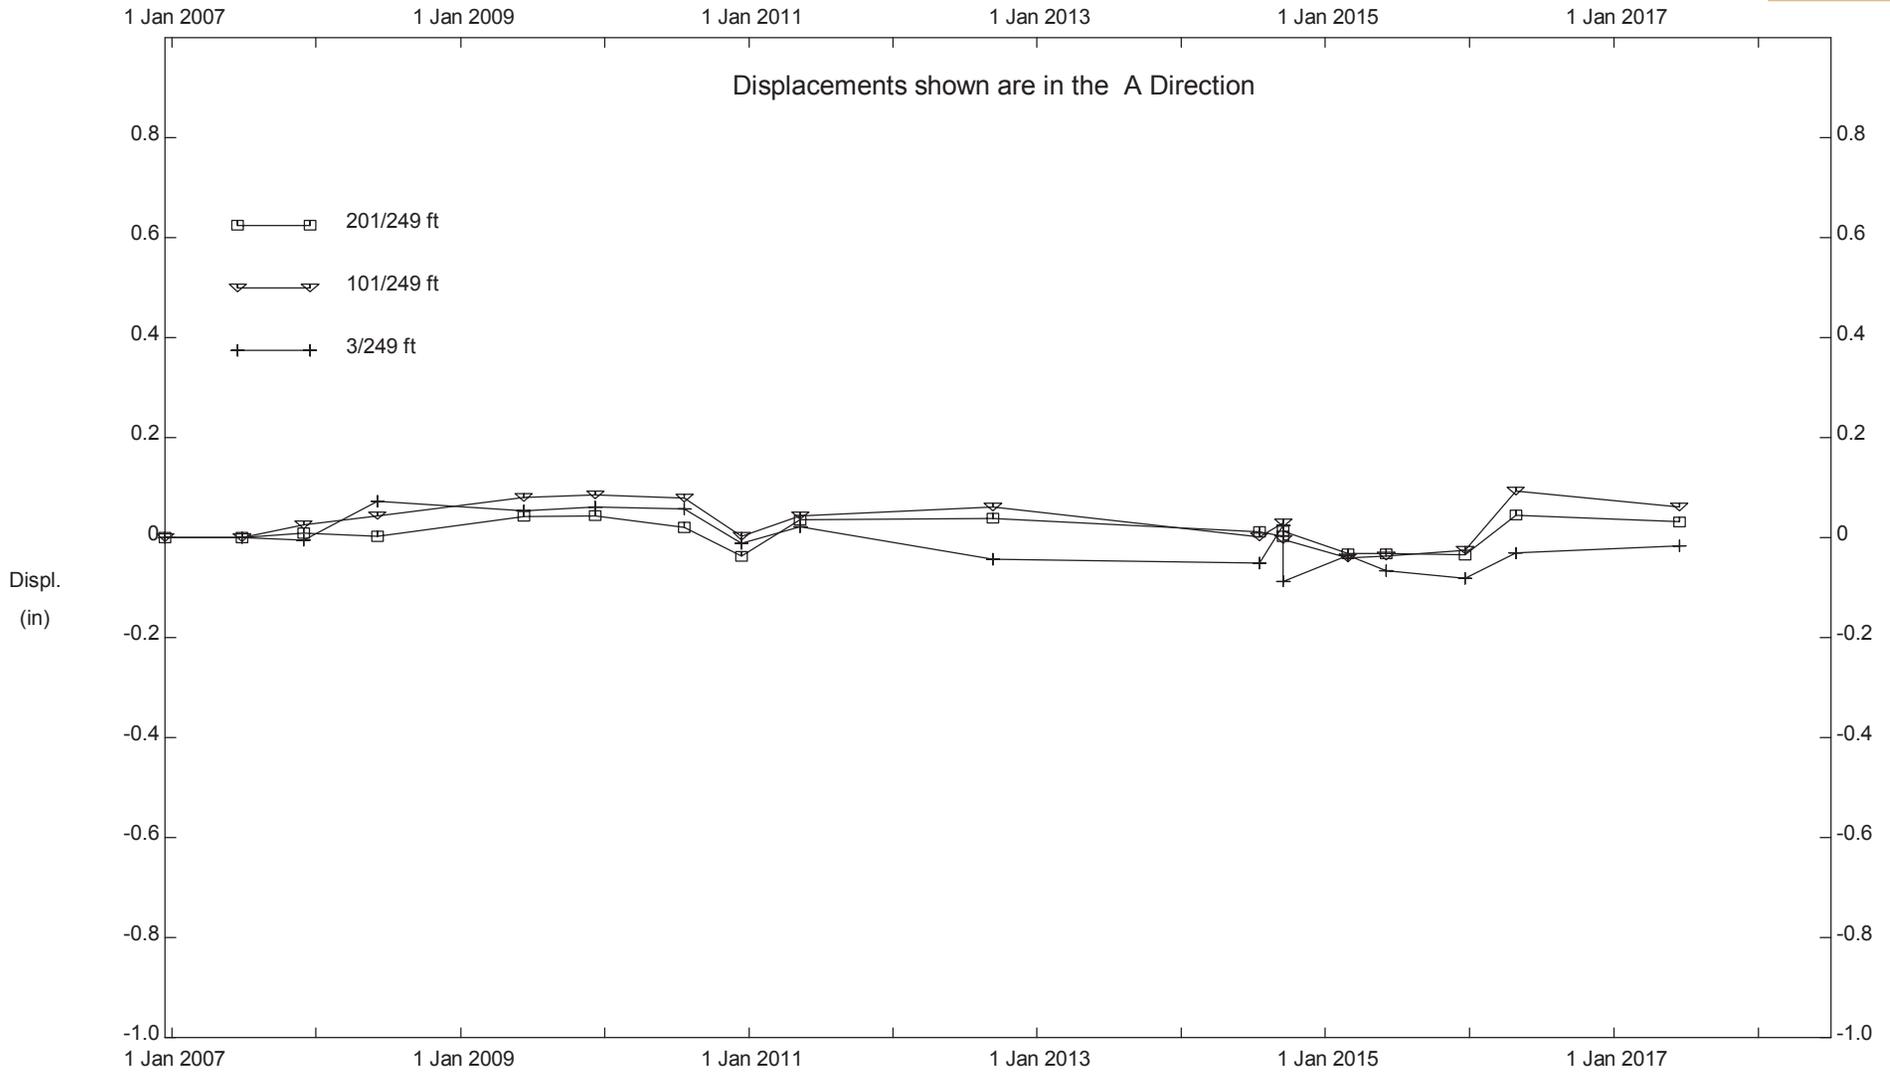
PLATE D18-3

BIG ROCK MESA, Inclinometer SP-16A

CENTRAL REGION

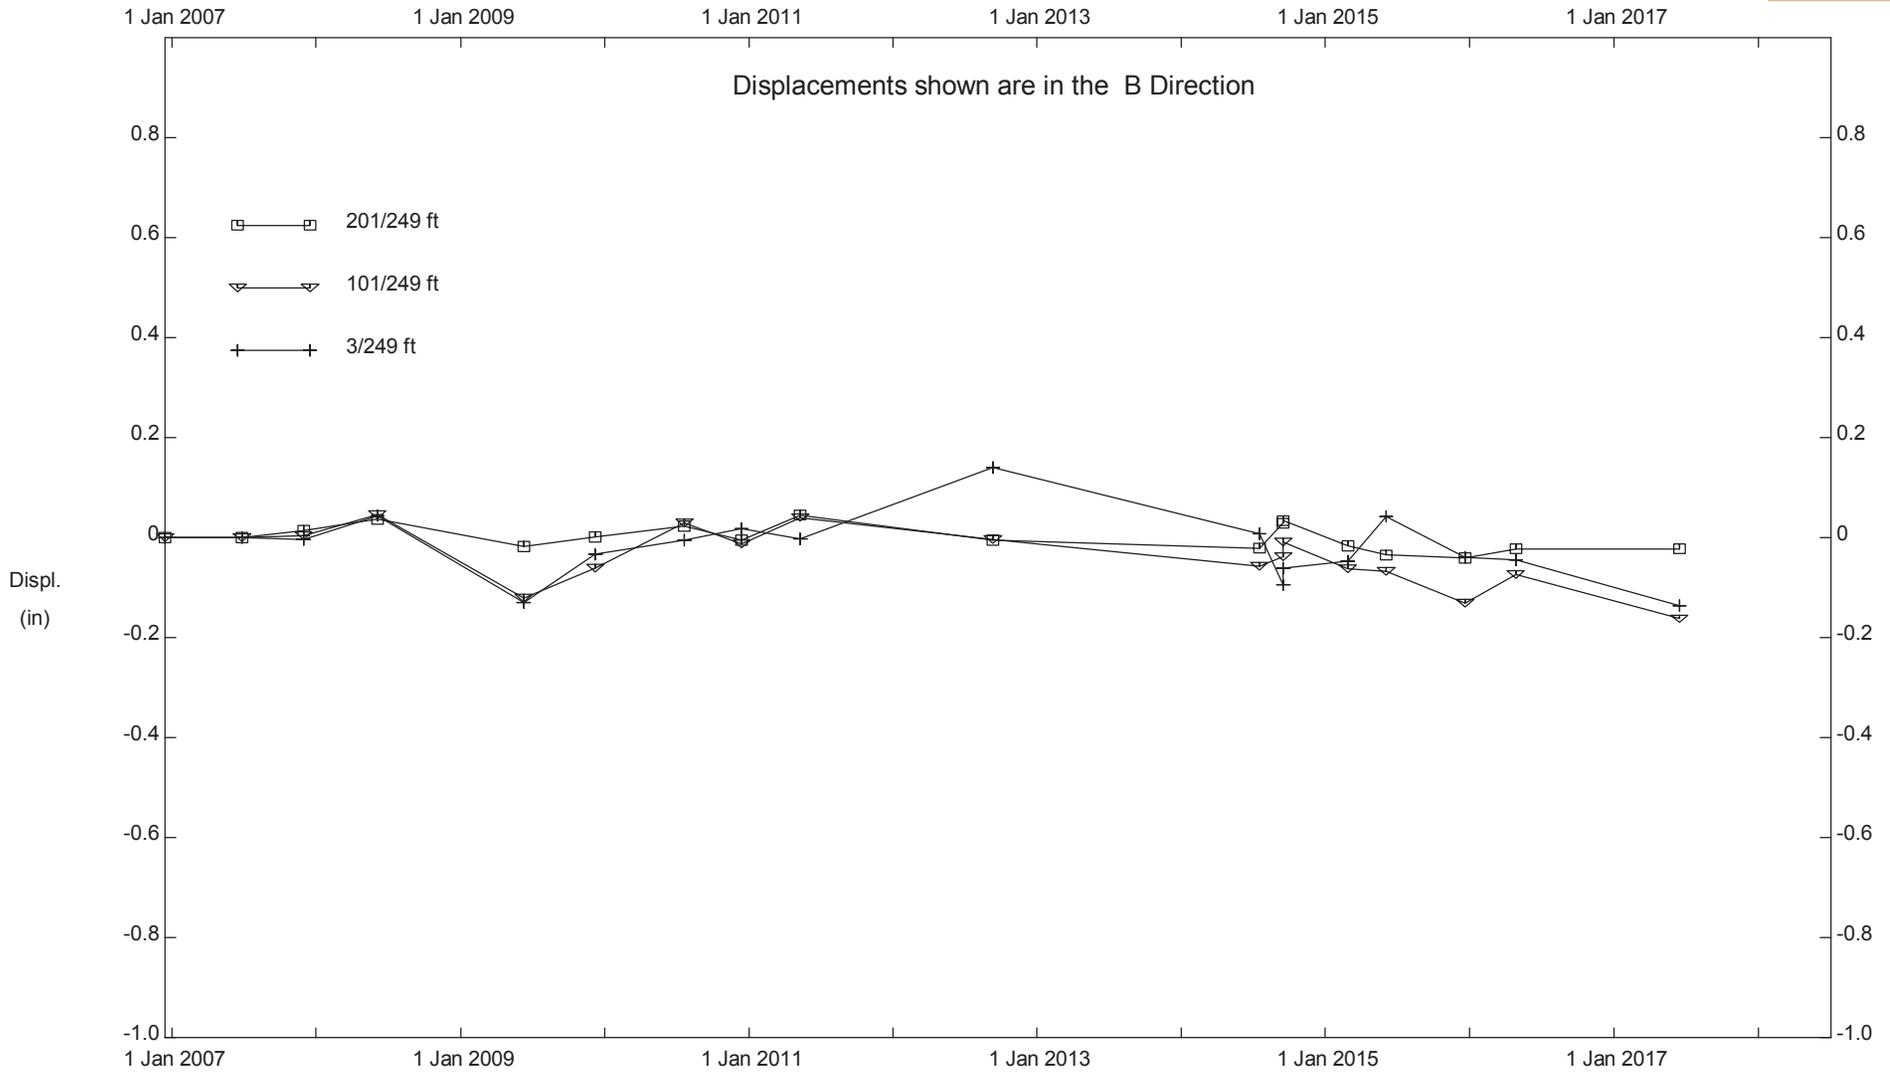
PLATE D18-4

BIG ROCK MESA, Inclinometer SP-16A

CENTRAL REGION

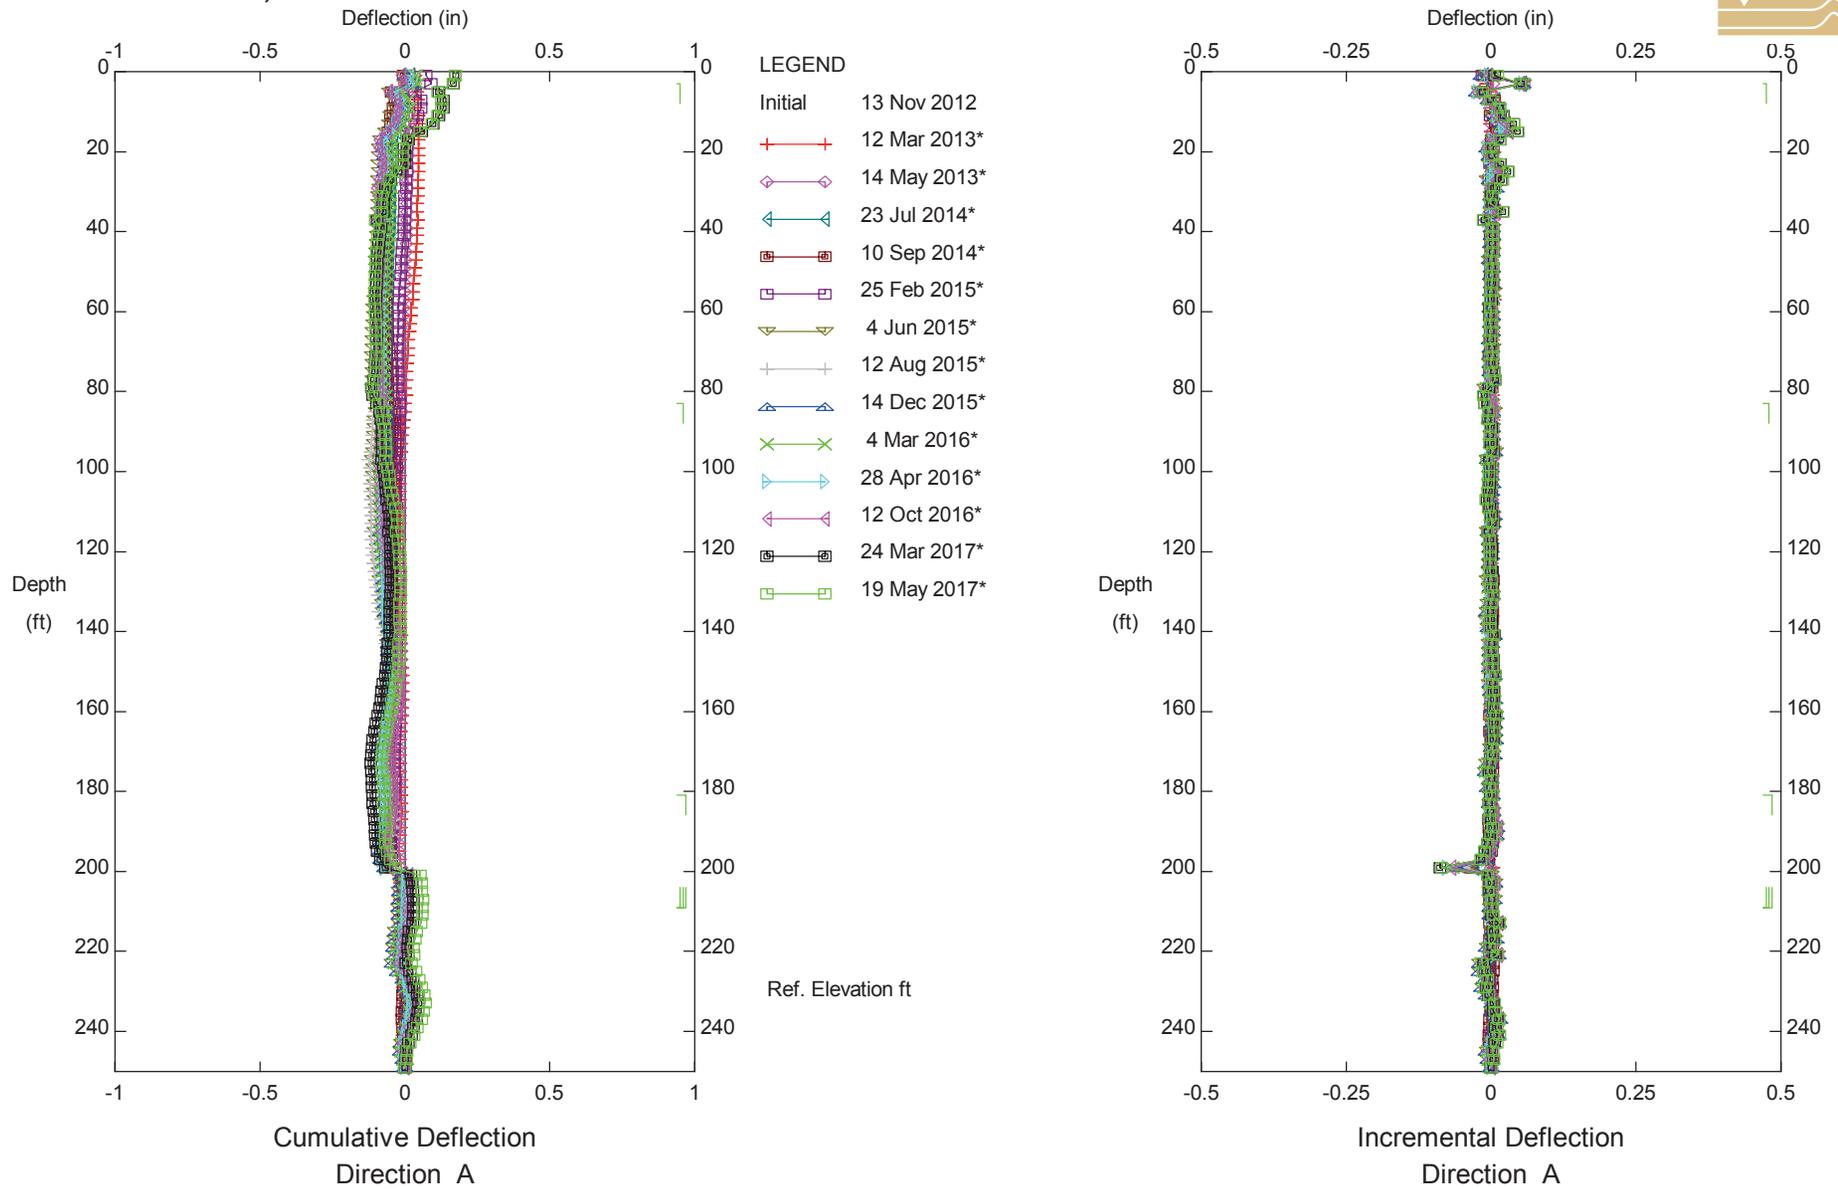
BRM, Inclinometer SP-17B

Sets marked * include zero shift and/or rotation corrections.

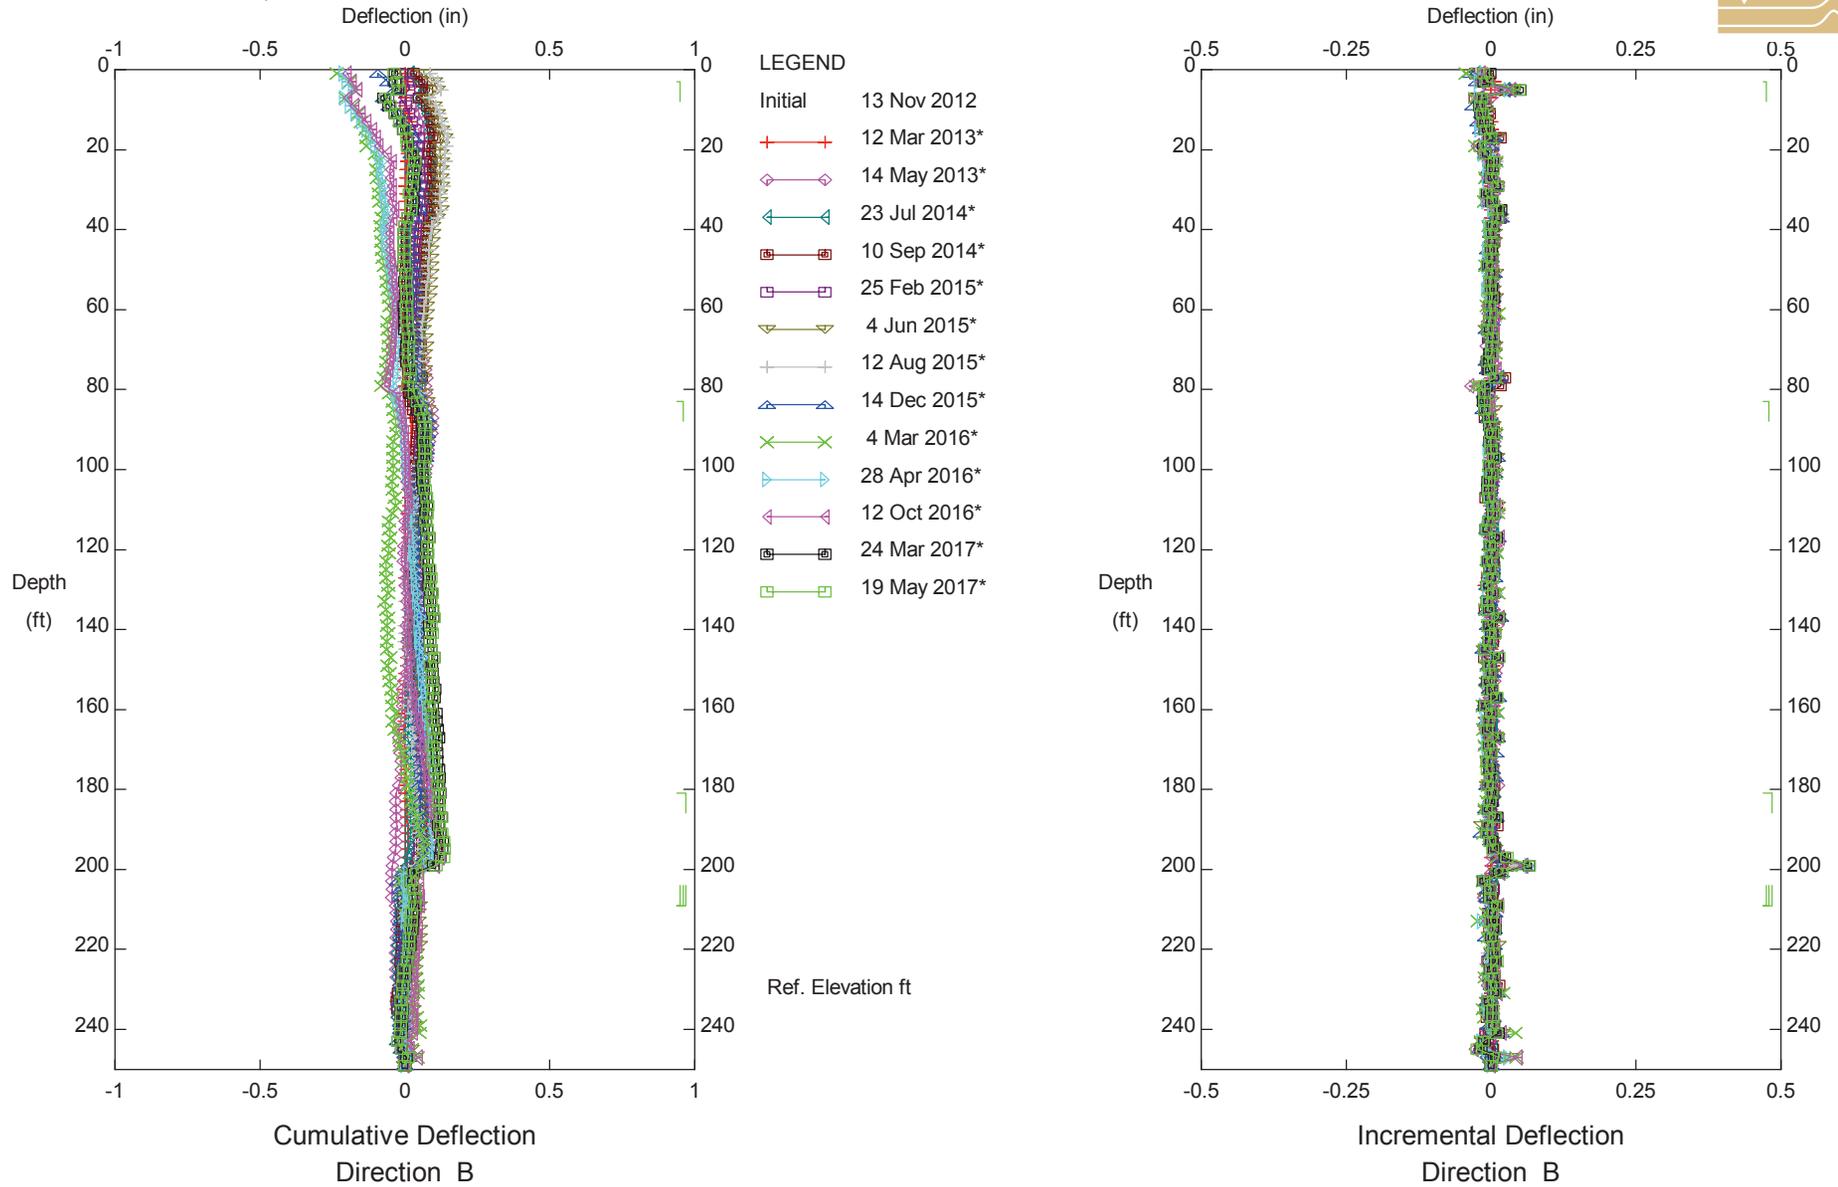
BRM, Inclinometer SP-17B

Sets marked * include zero shift and/or rotation corrections.

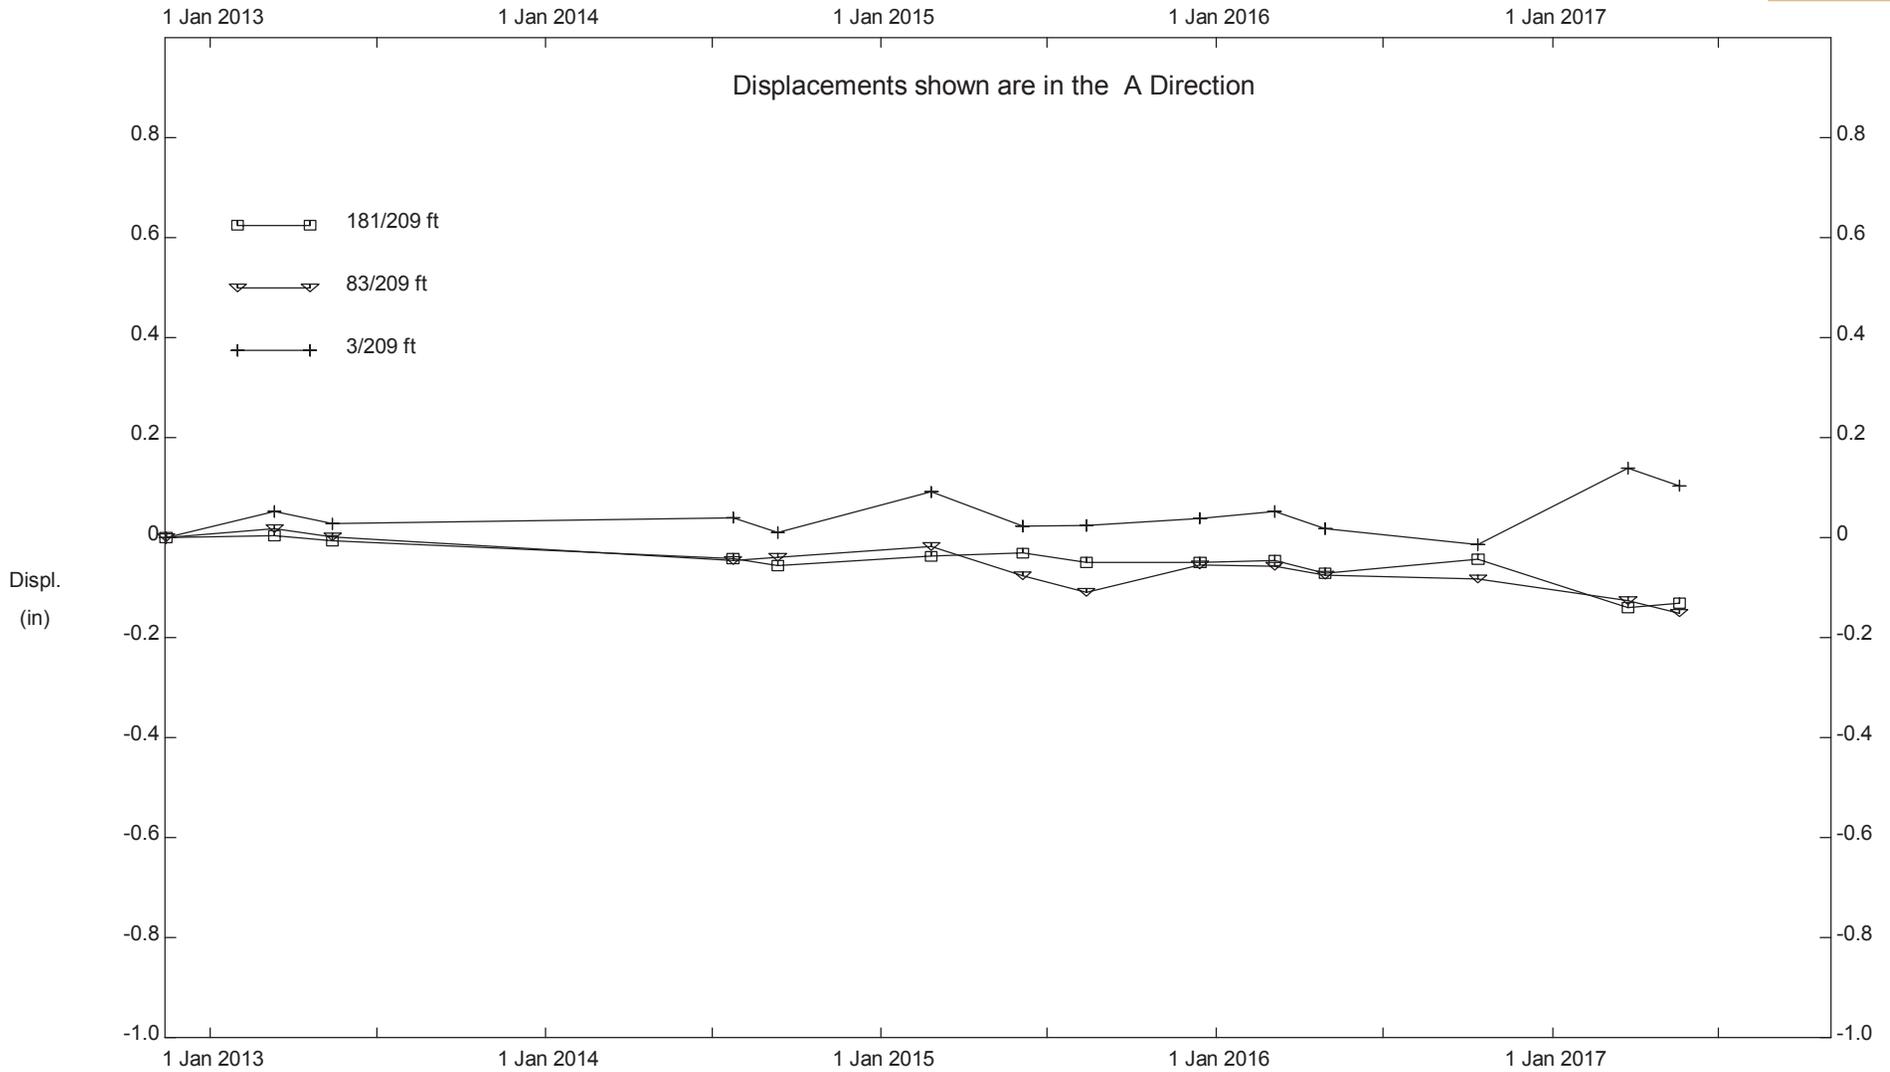
BRM, Inclinator SP-17B

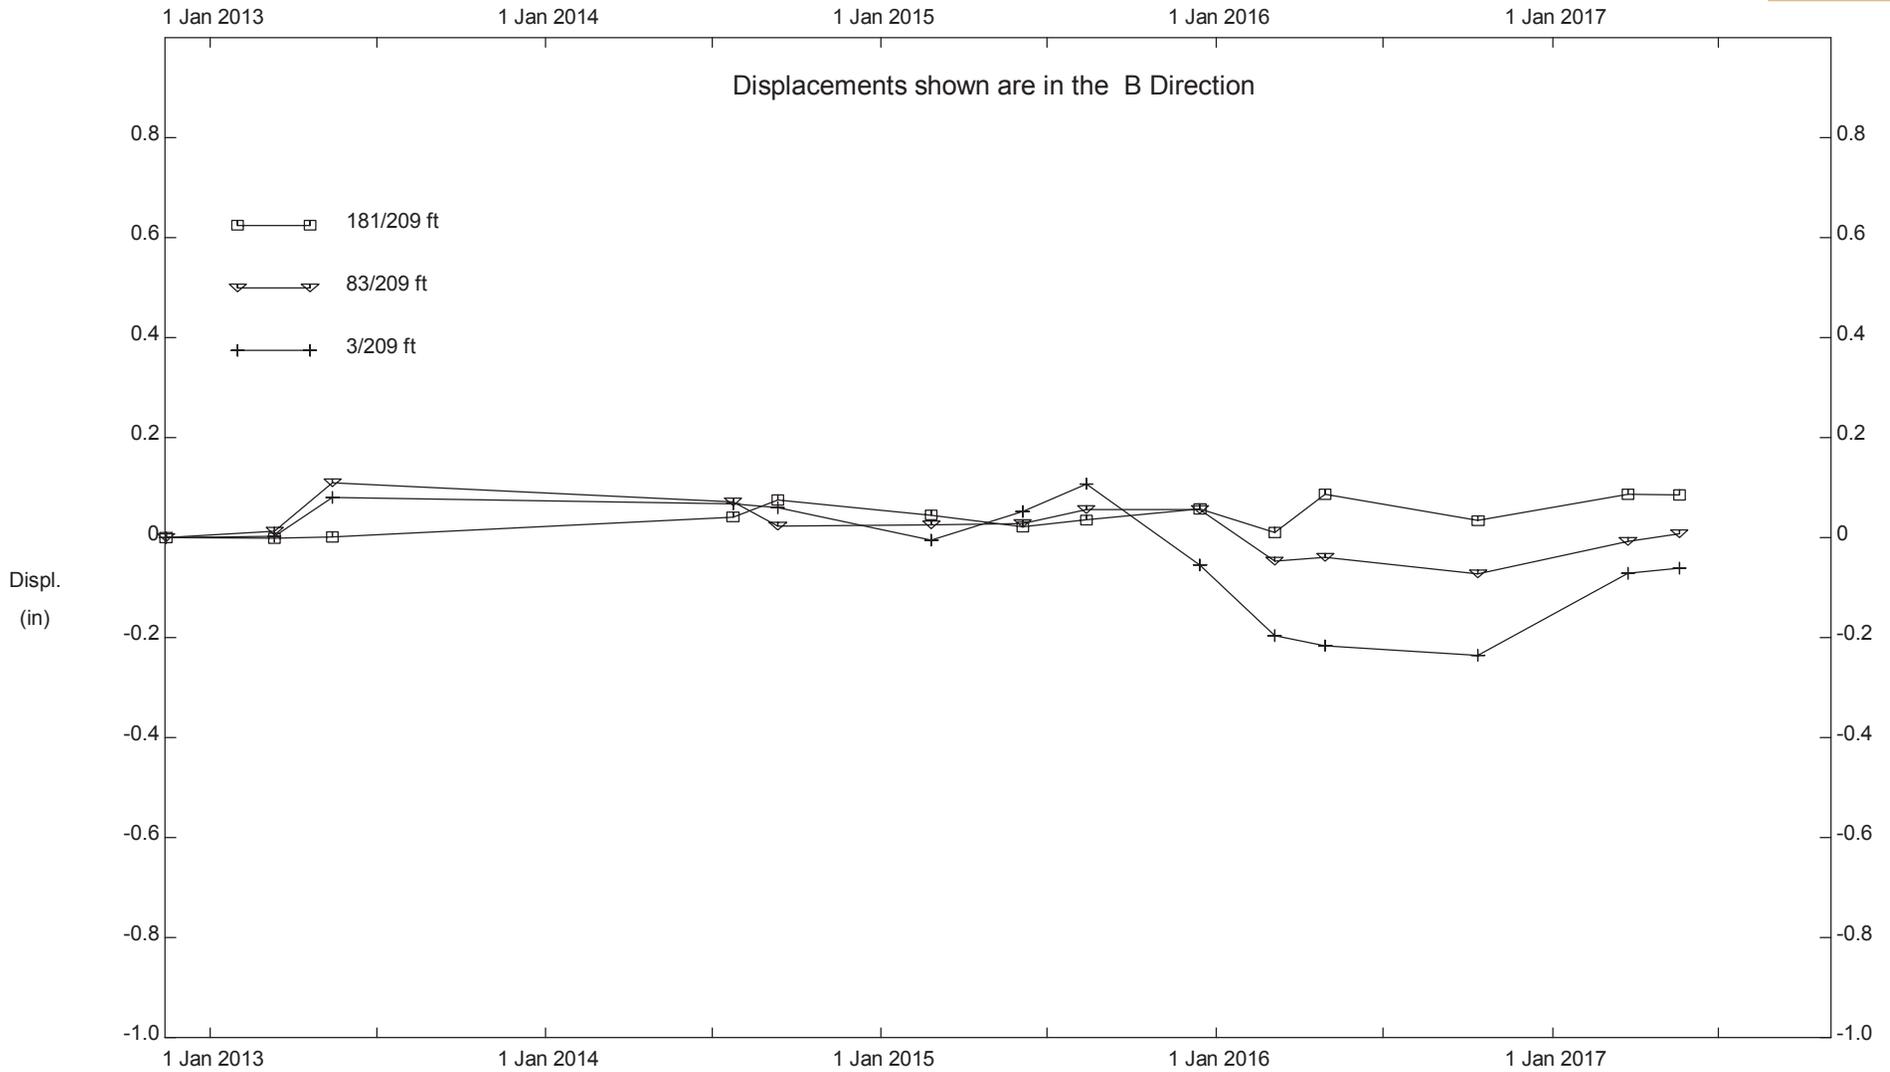
BRM, Inclinator SP-17B

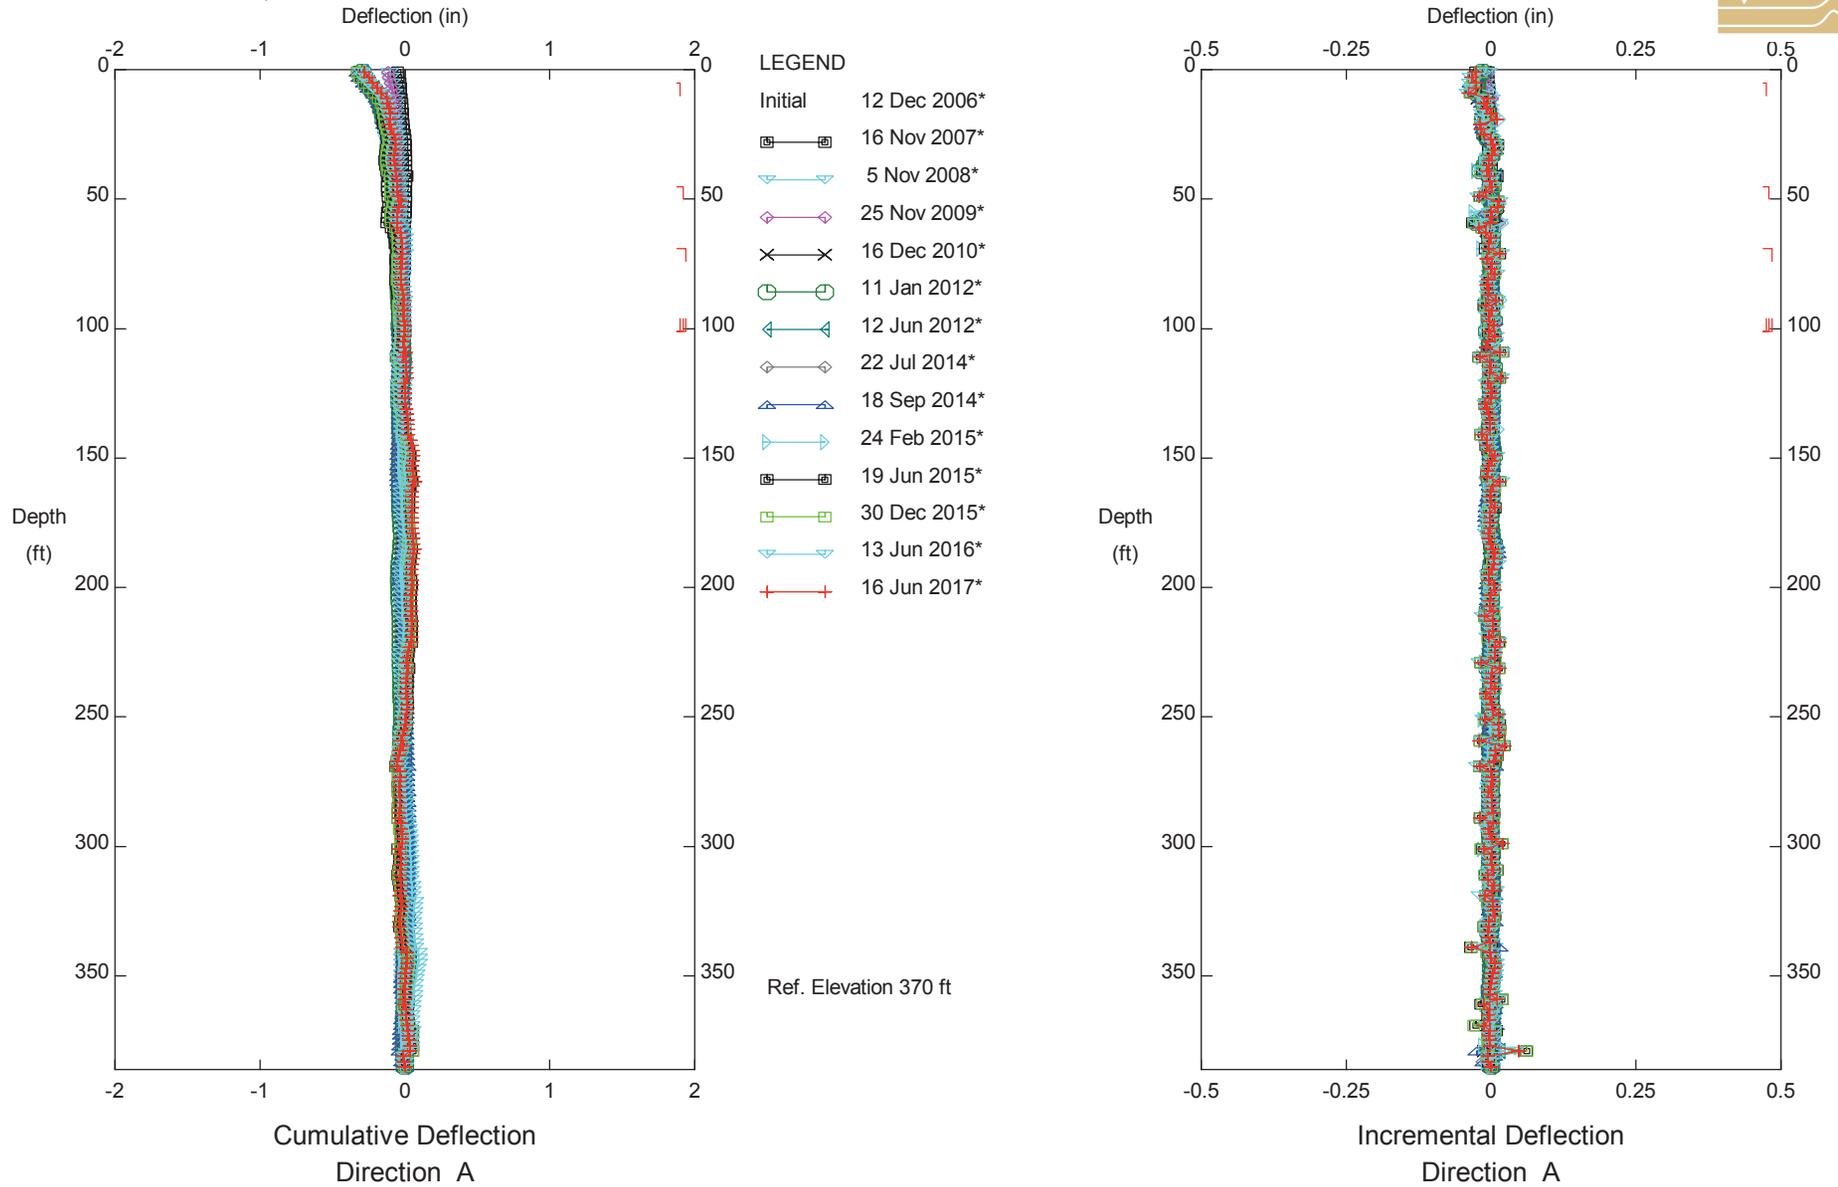
BIG ROCK MESA, Inclinometer SP-24
 CENTRAL REGION

Sets marked * include zero shift and/or rotation corrections.
