**ANNUAL REPORT
JULY 2016 THROUGH JUNE 2017
BIG ROCK MESA LANDSLIDE
ASSESSMENT DISTRICT
City of Malibu, California**

March 2018
Fugro Project No. 04.62160606
Document No. 04.62160606-PR-004(Rev.00)

**Annual Report of Maintenance and Monitoring, July 2016 through June 2017,
Big Rock Mesa Landslide Assessment District, City of Malibu, California**

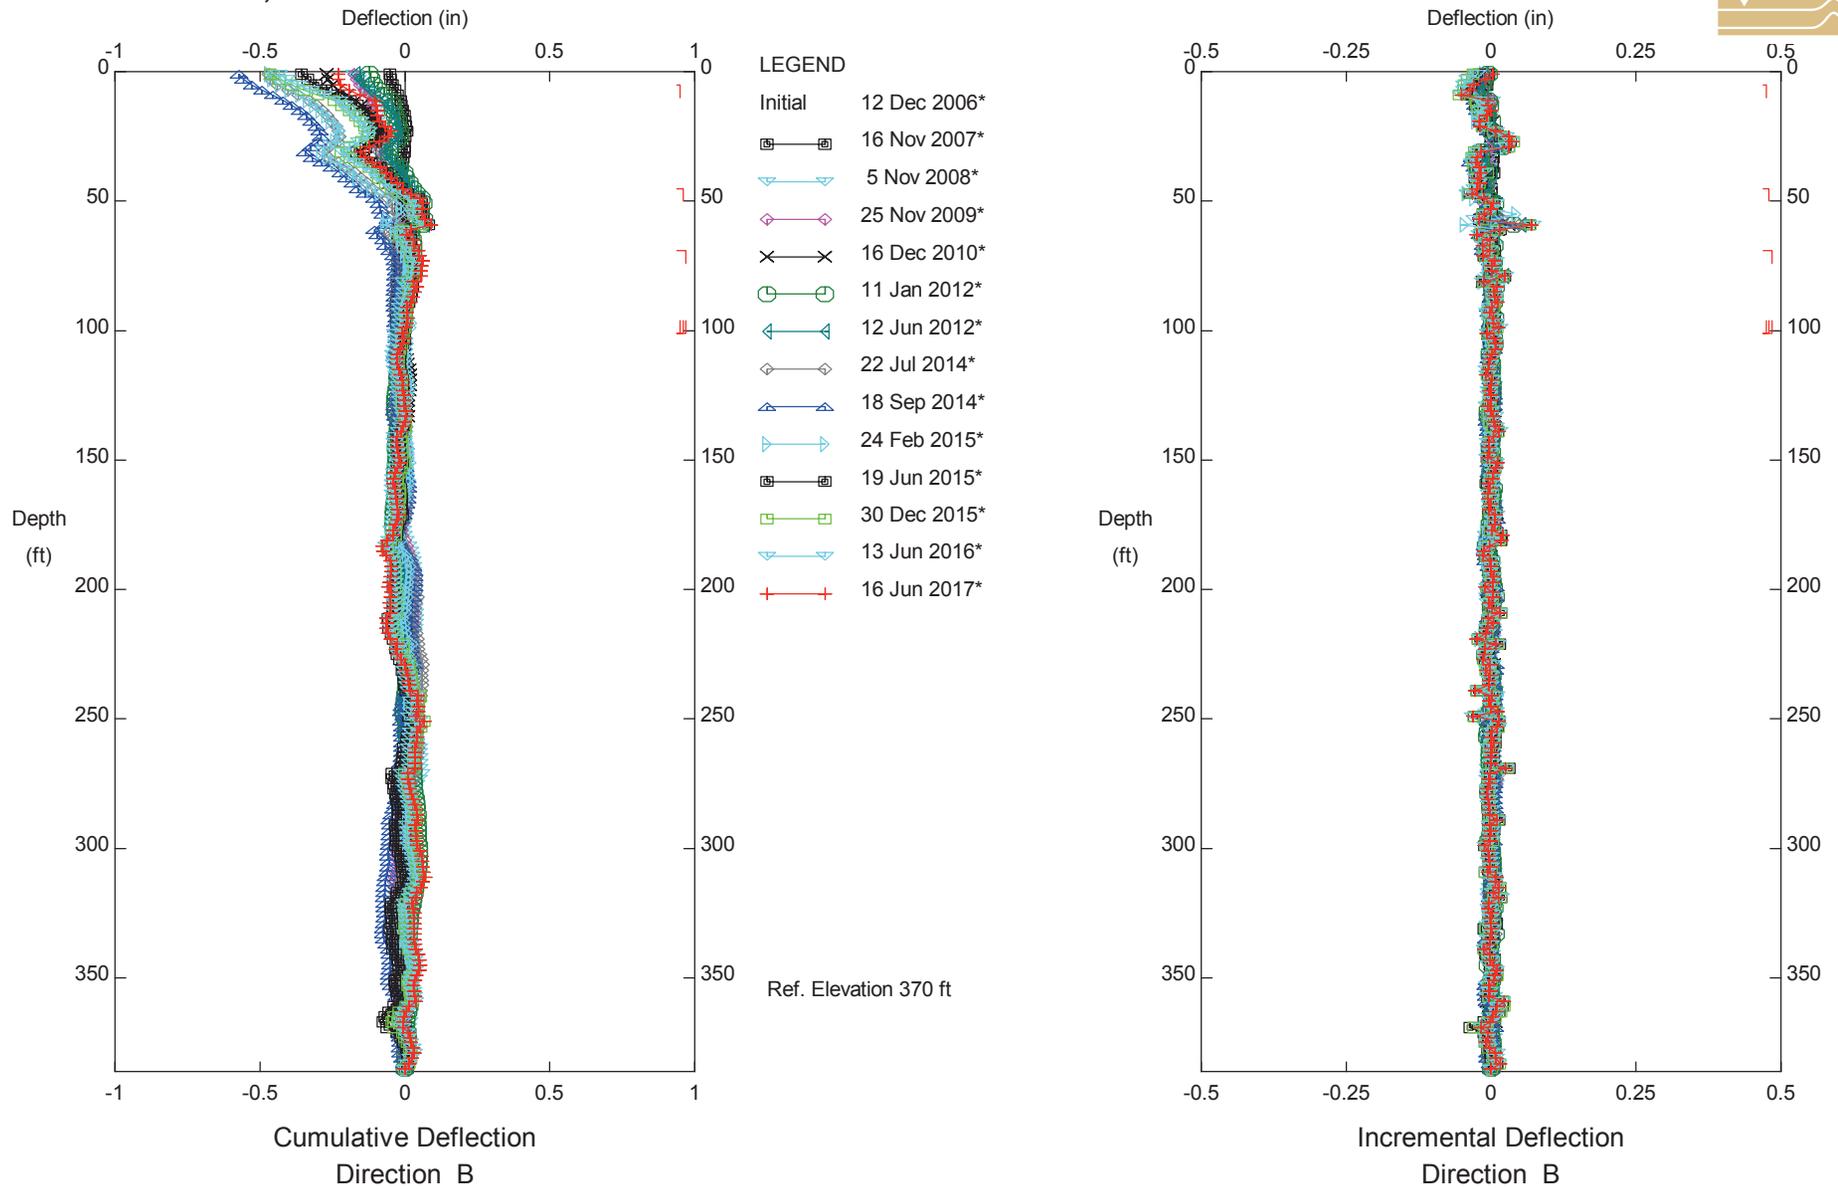
BIG ROCK MESA, Inclinometer SP-24
 CENTRAL REGION

Sets marked * include zero shift and/or rotation corrections.

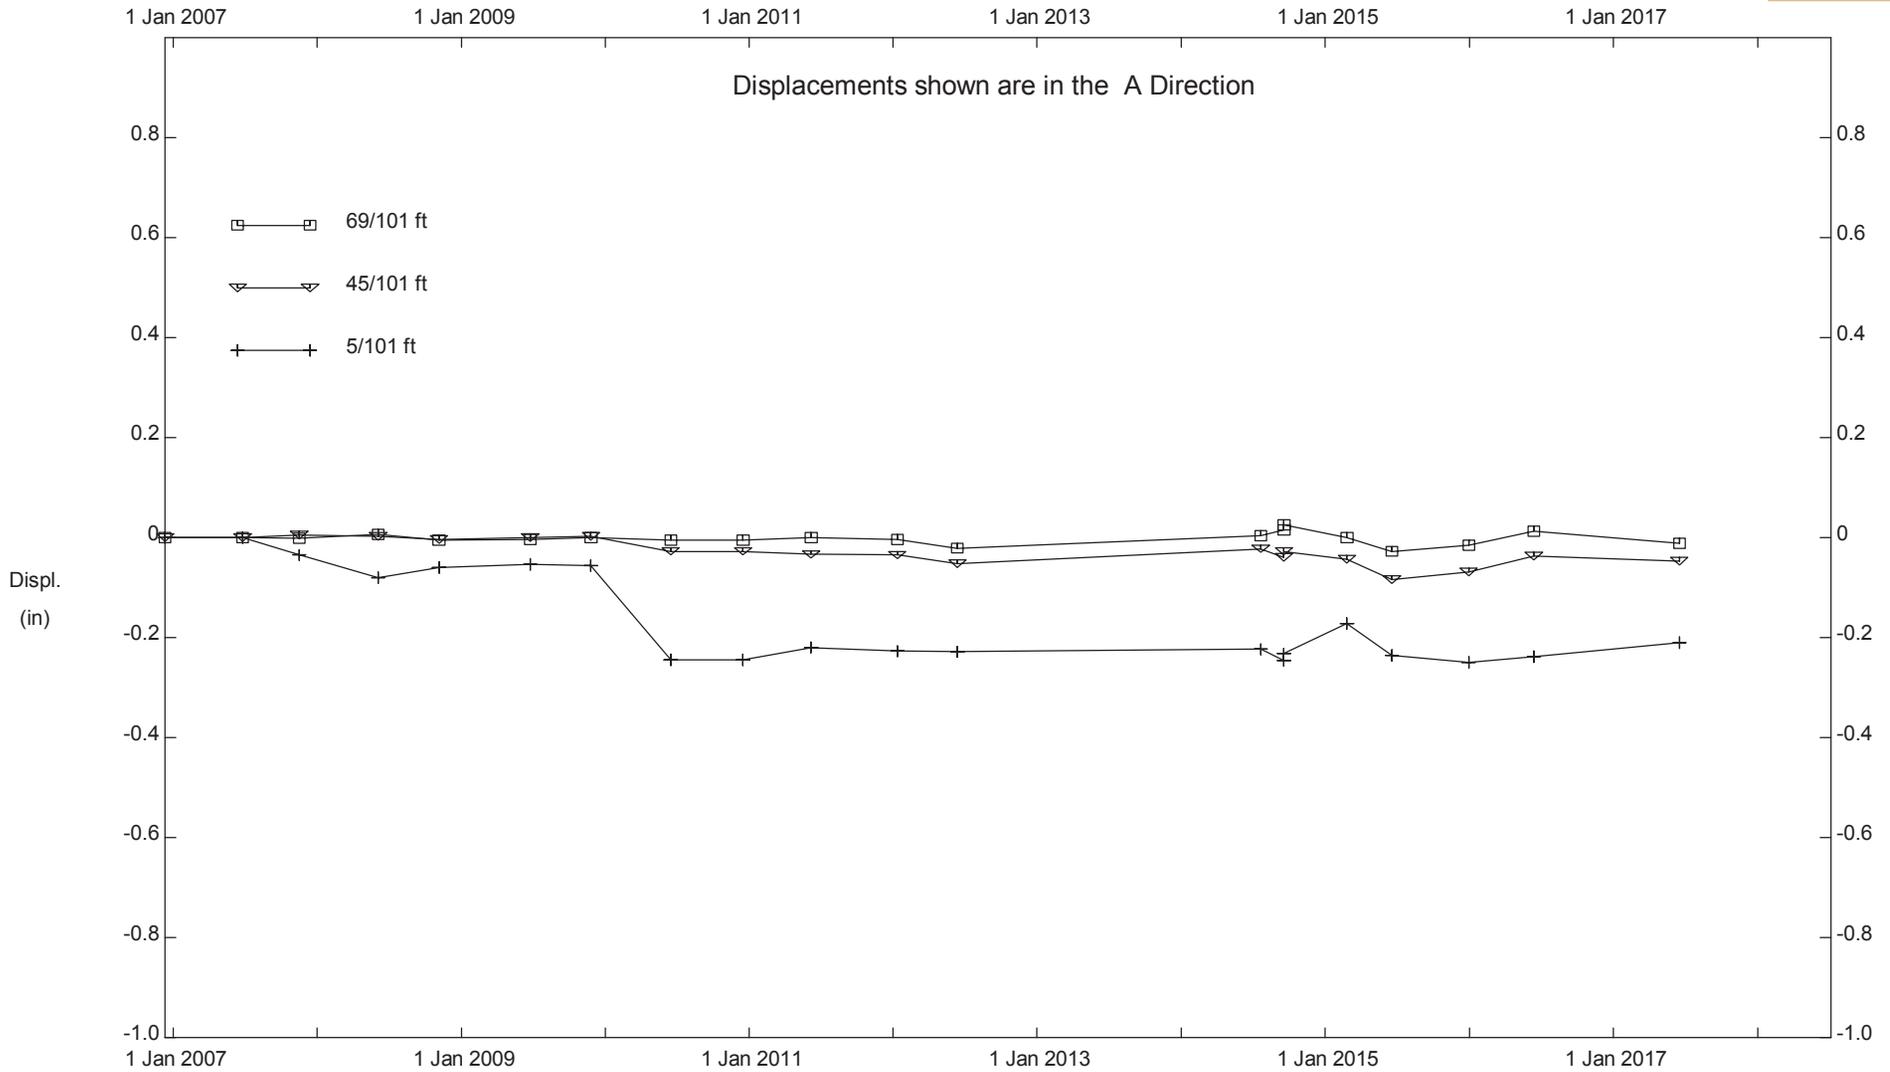
PLATE D20-3

BIG ROCK MESA, Inclinator SP-24

CENTRAL REGION

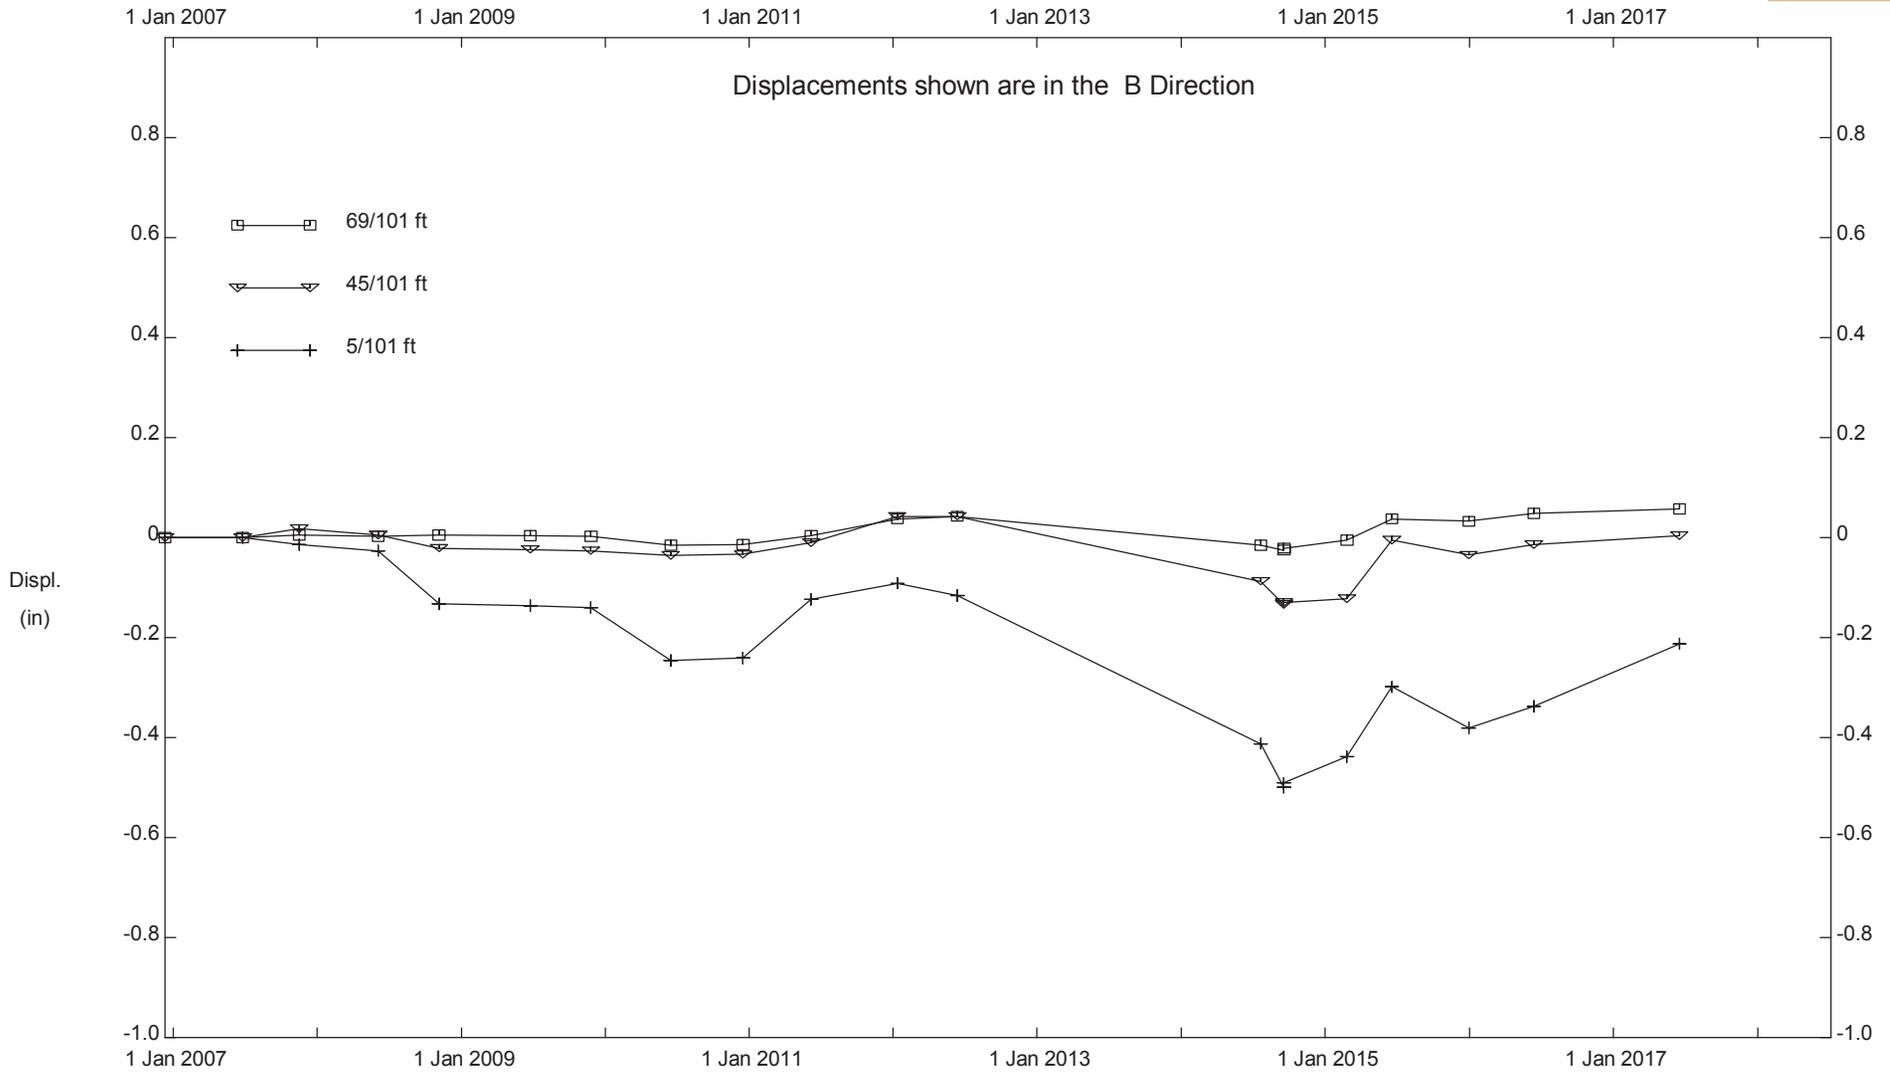
PLATE D20-4

BIG ROCK MESA, Inclinometer SP-24

CENTRAL REGION

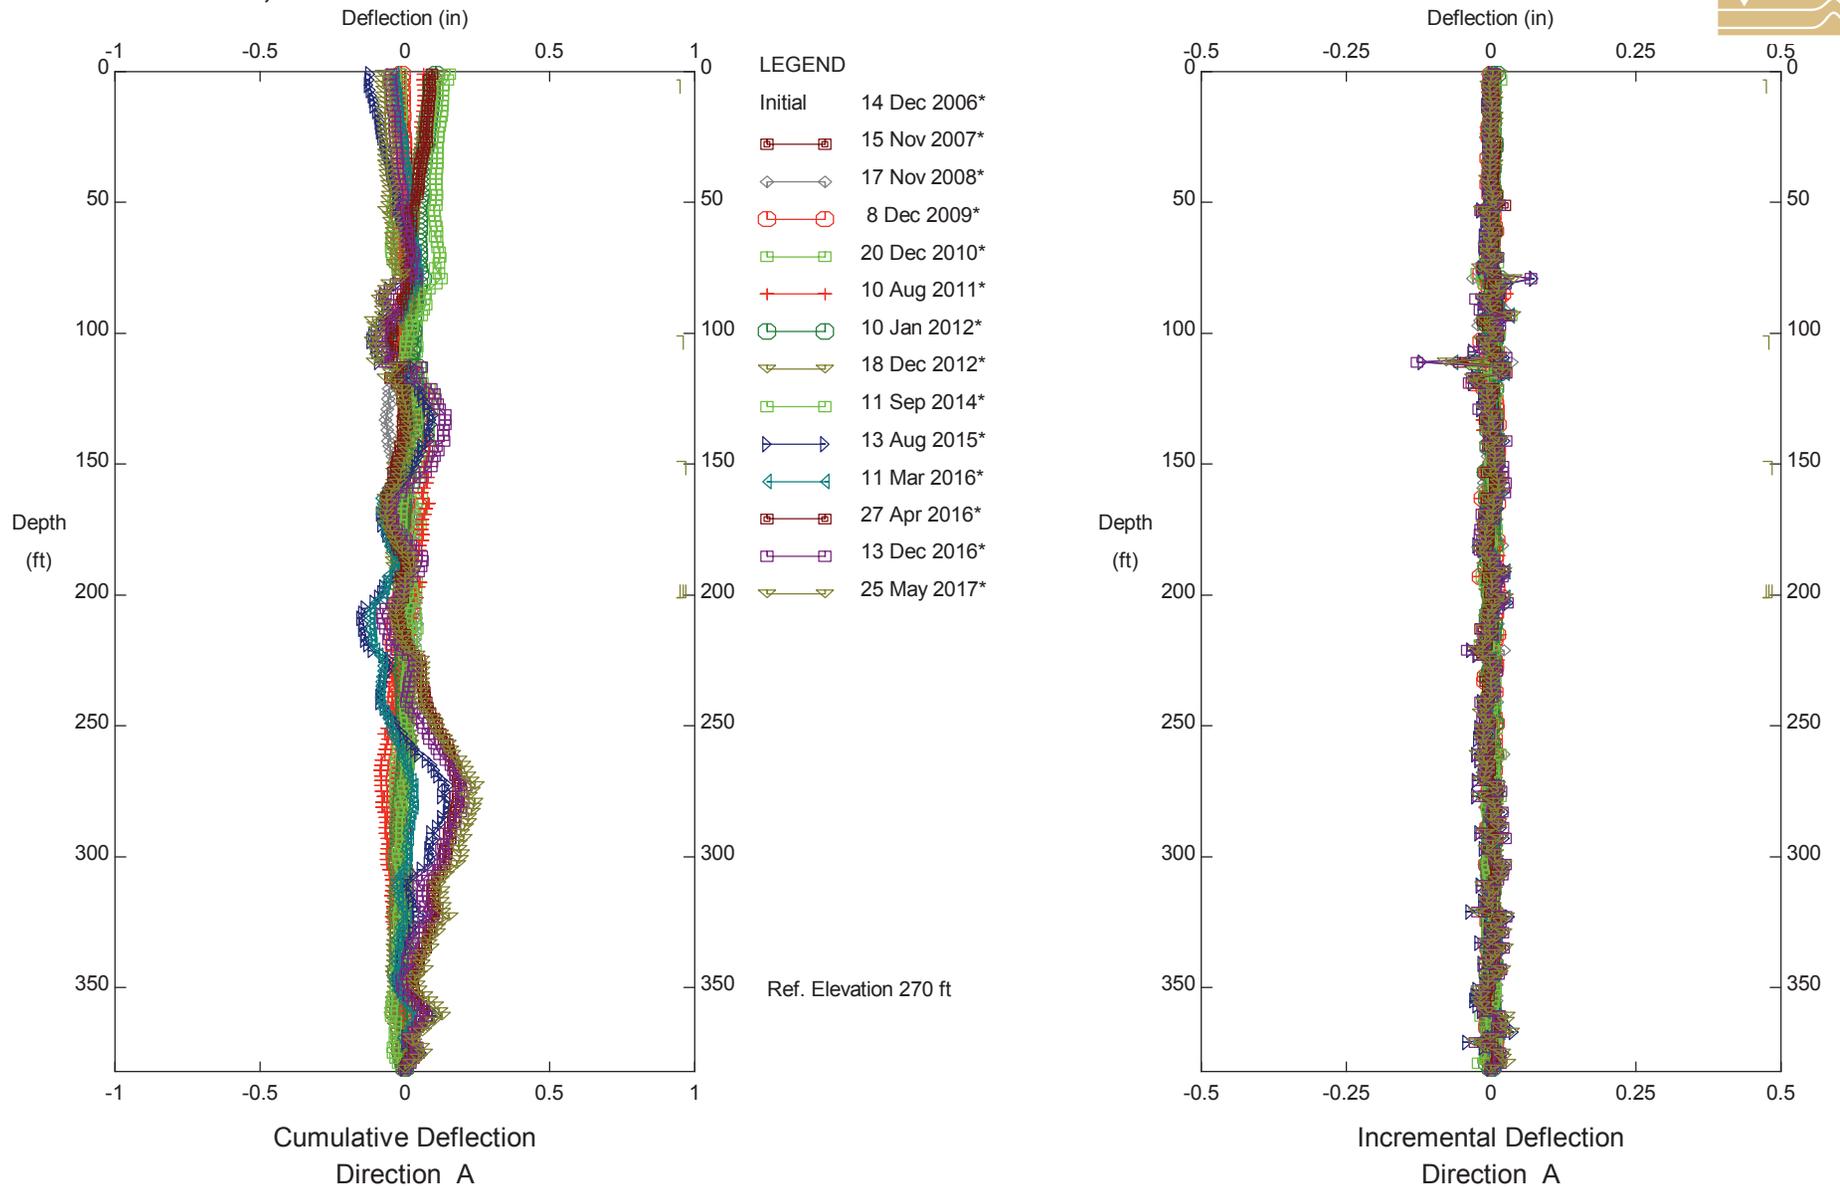
BIG ROCK MESA, Inclinometer SP-34
 CENTRAL REGION

Sets marked * include zero shift and/or rotation corrections.

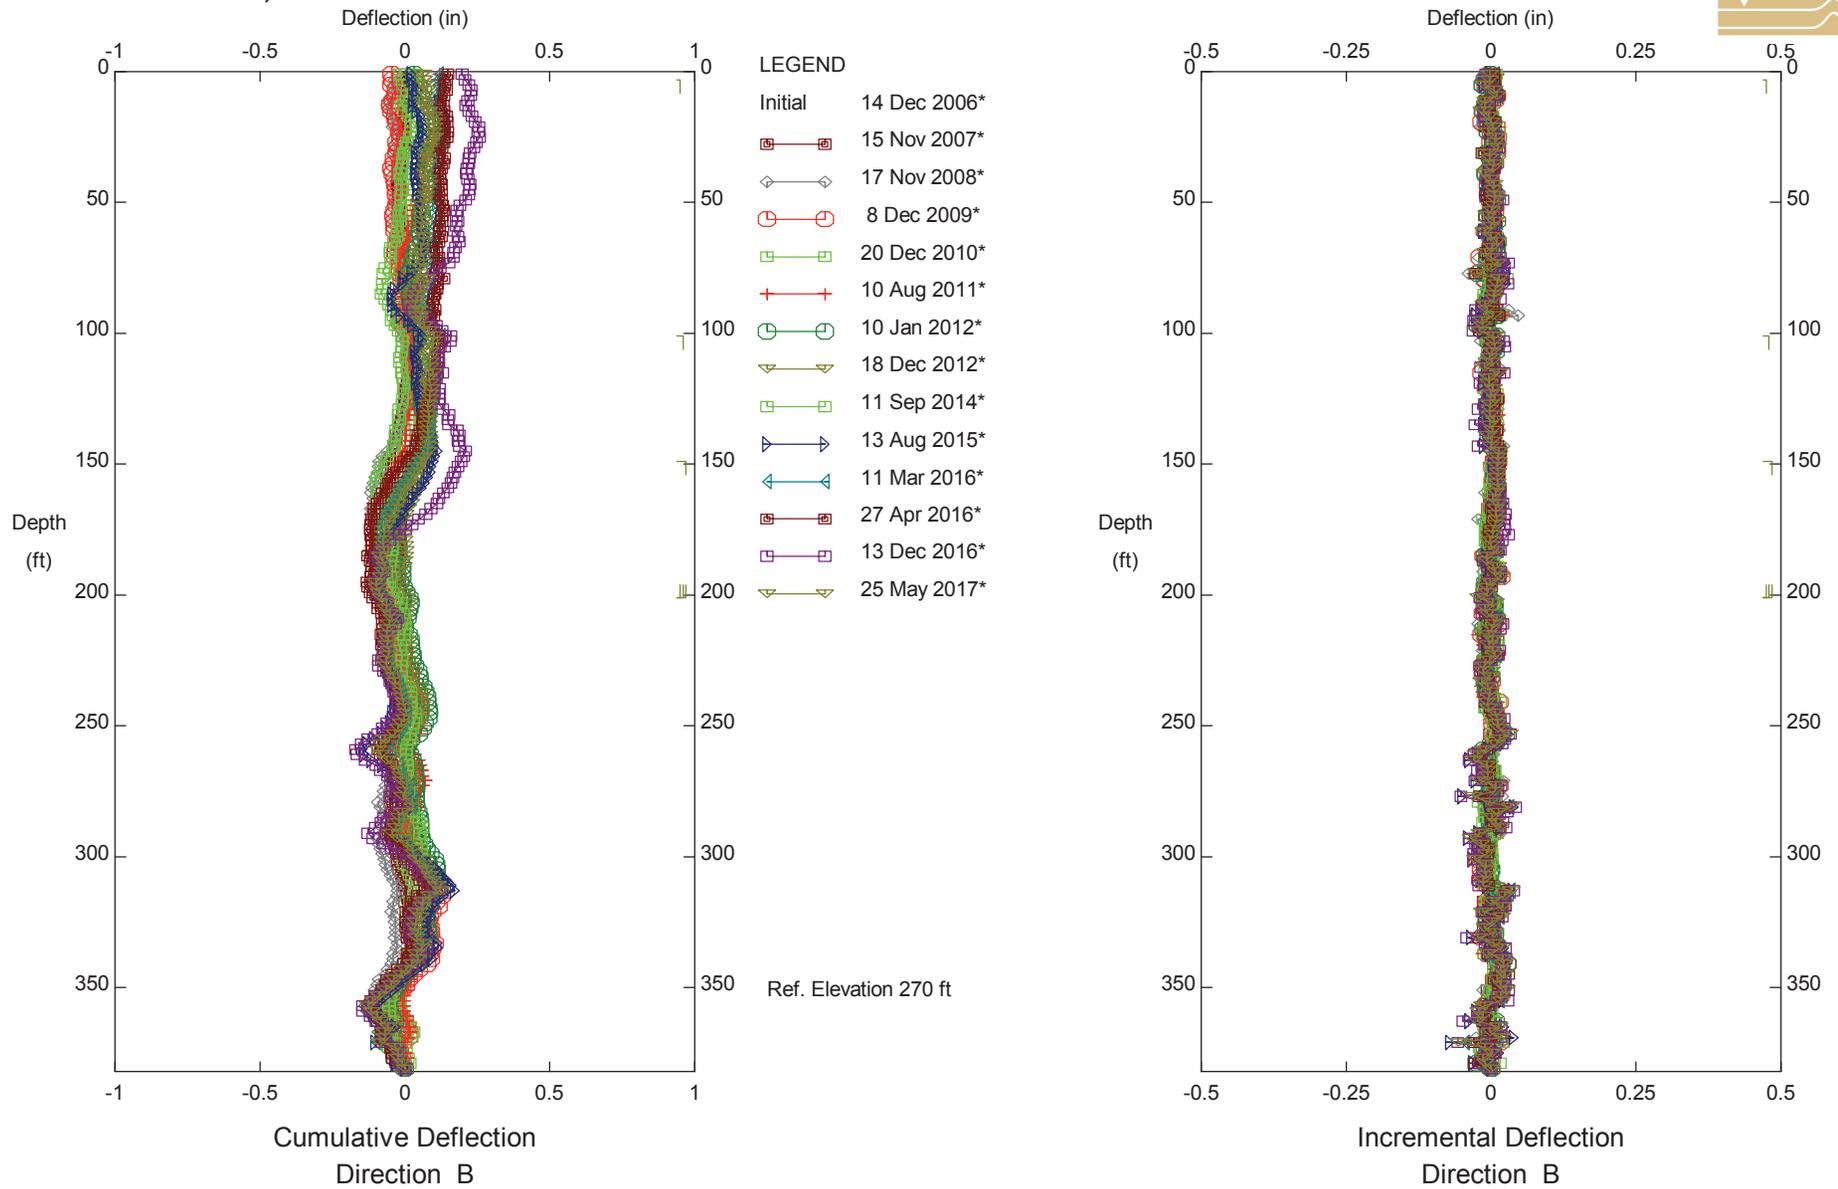
BIG ROCK MESA, Inclinometer SP-34
 CENTRAL REGION

Sets marked * include zero shift and/or rotation corrections.

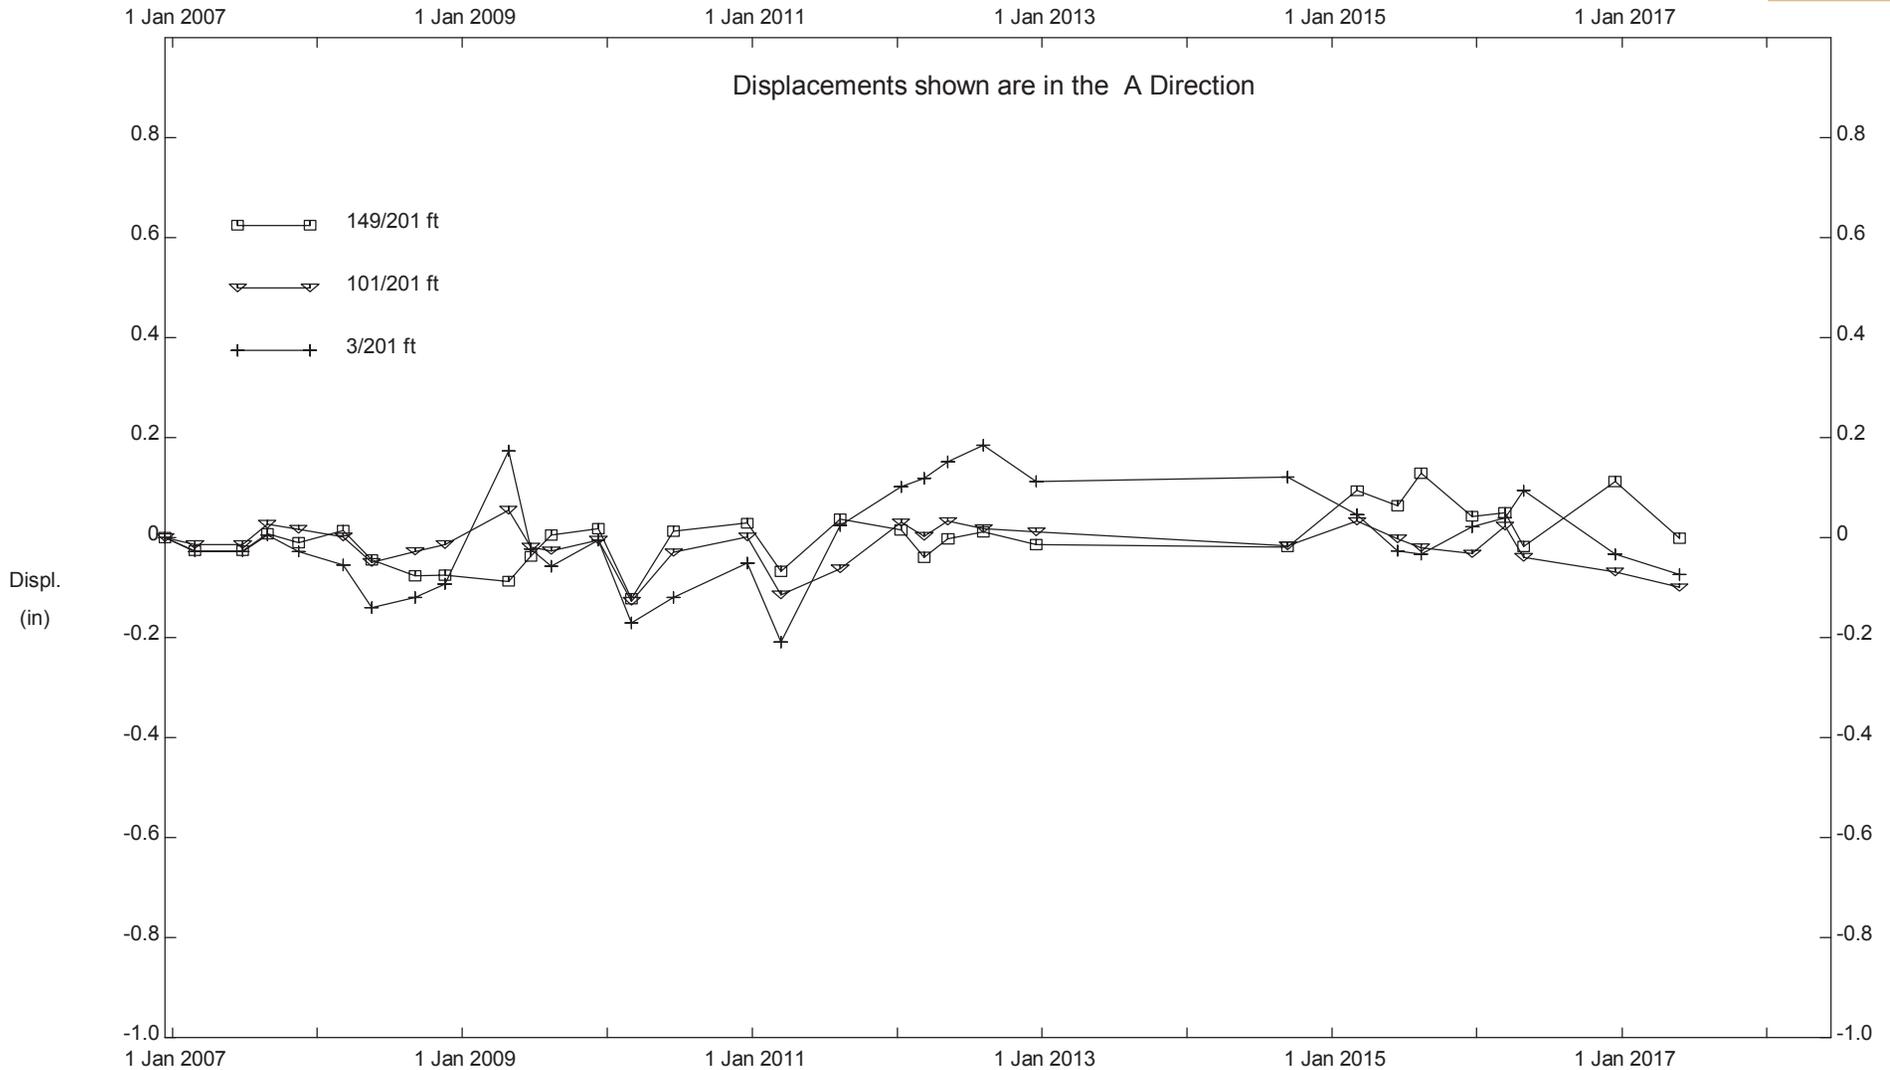
PLATE D21-3

BIG ROCK MESA, Inclinometer SP-34

CENTRAL REGION

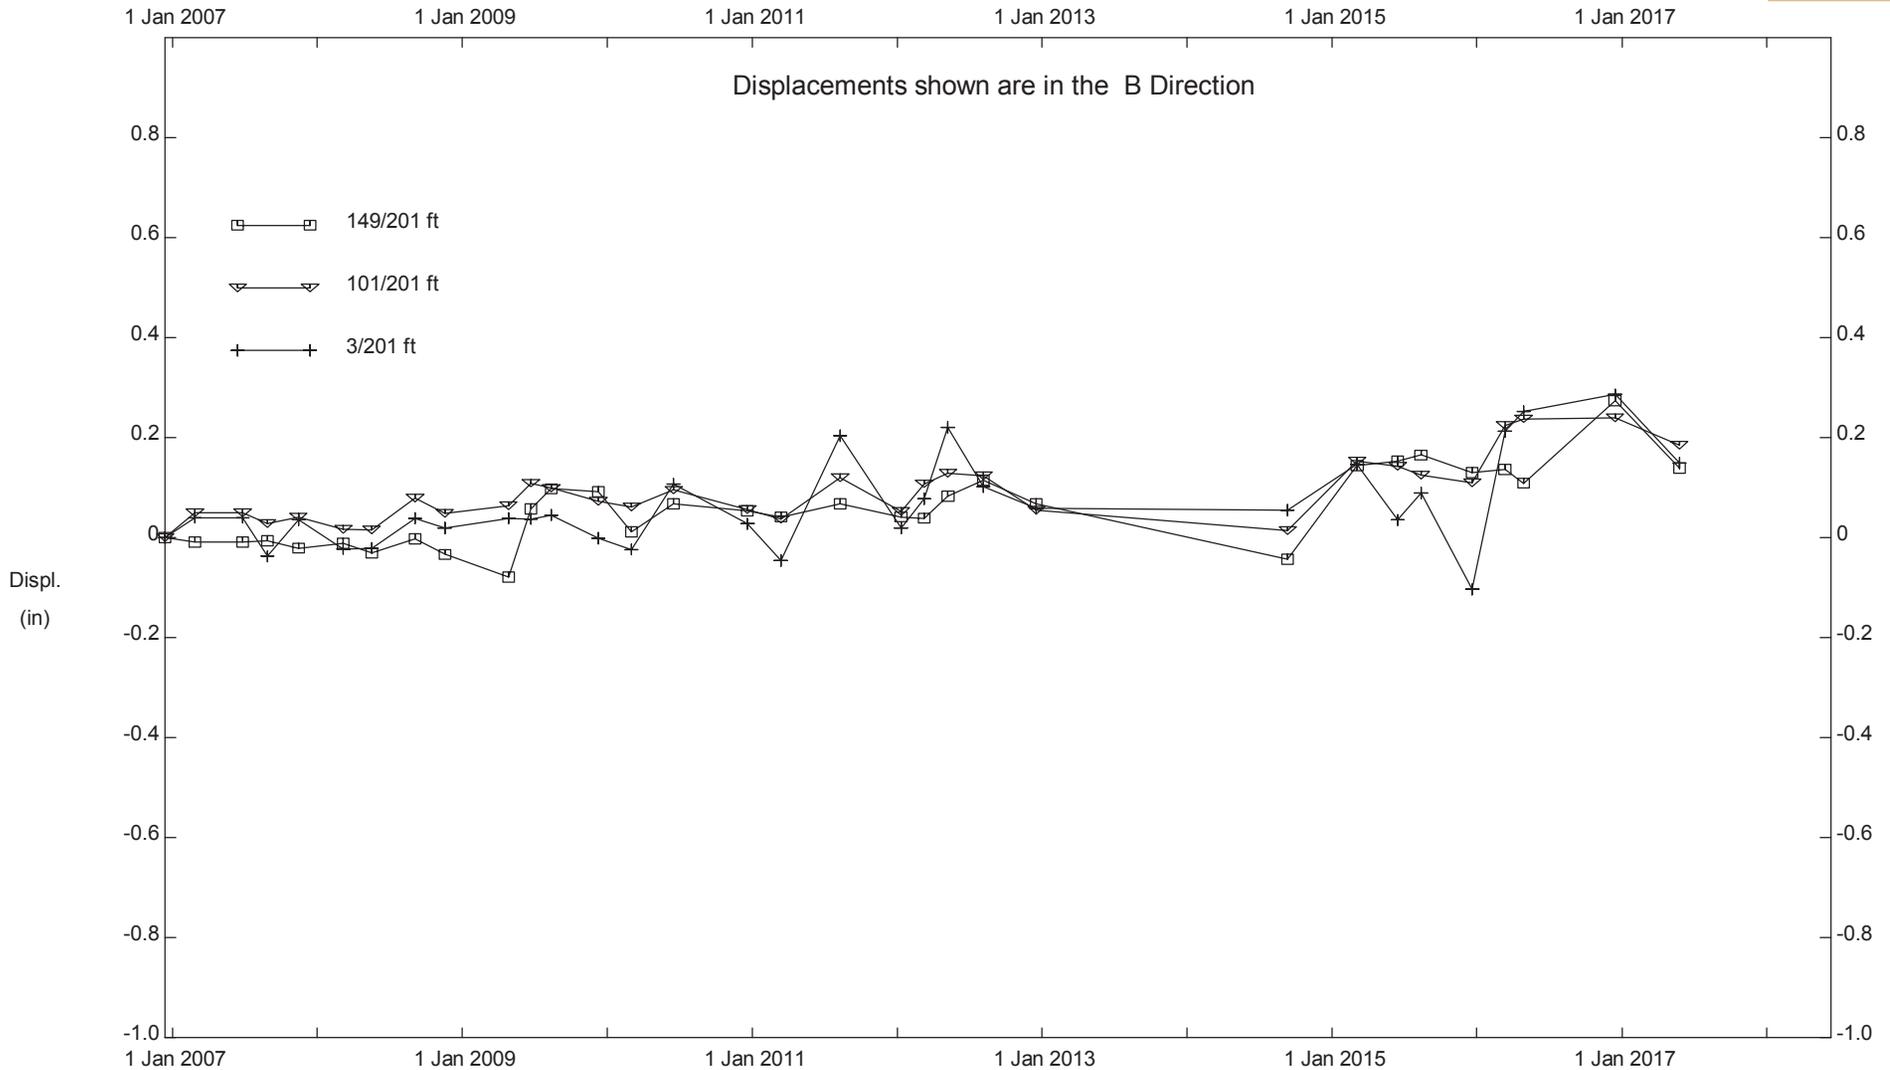
PLATE D21-4

BIG ROCK MESA, Inclinometer SP-34

CENTRAL REGION

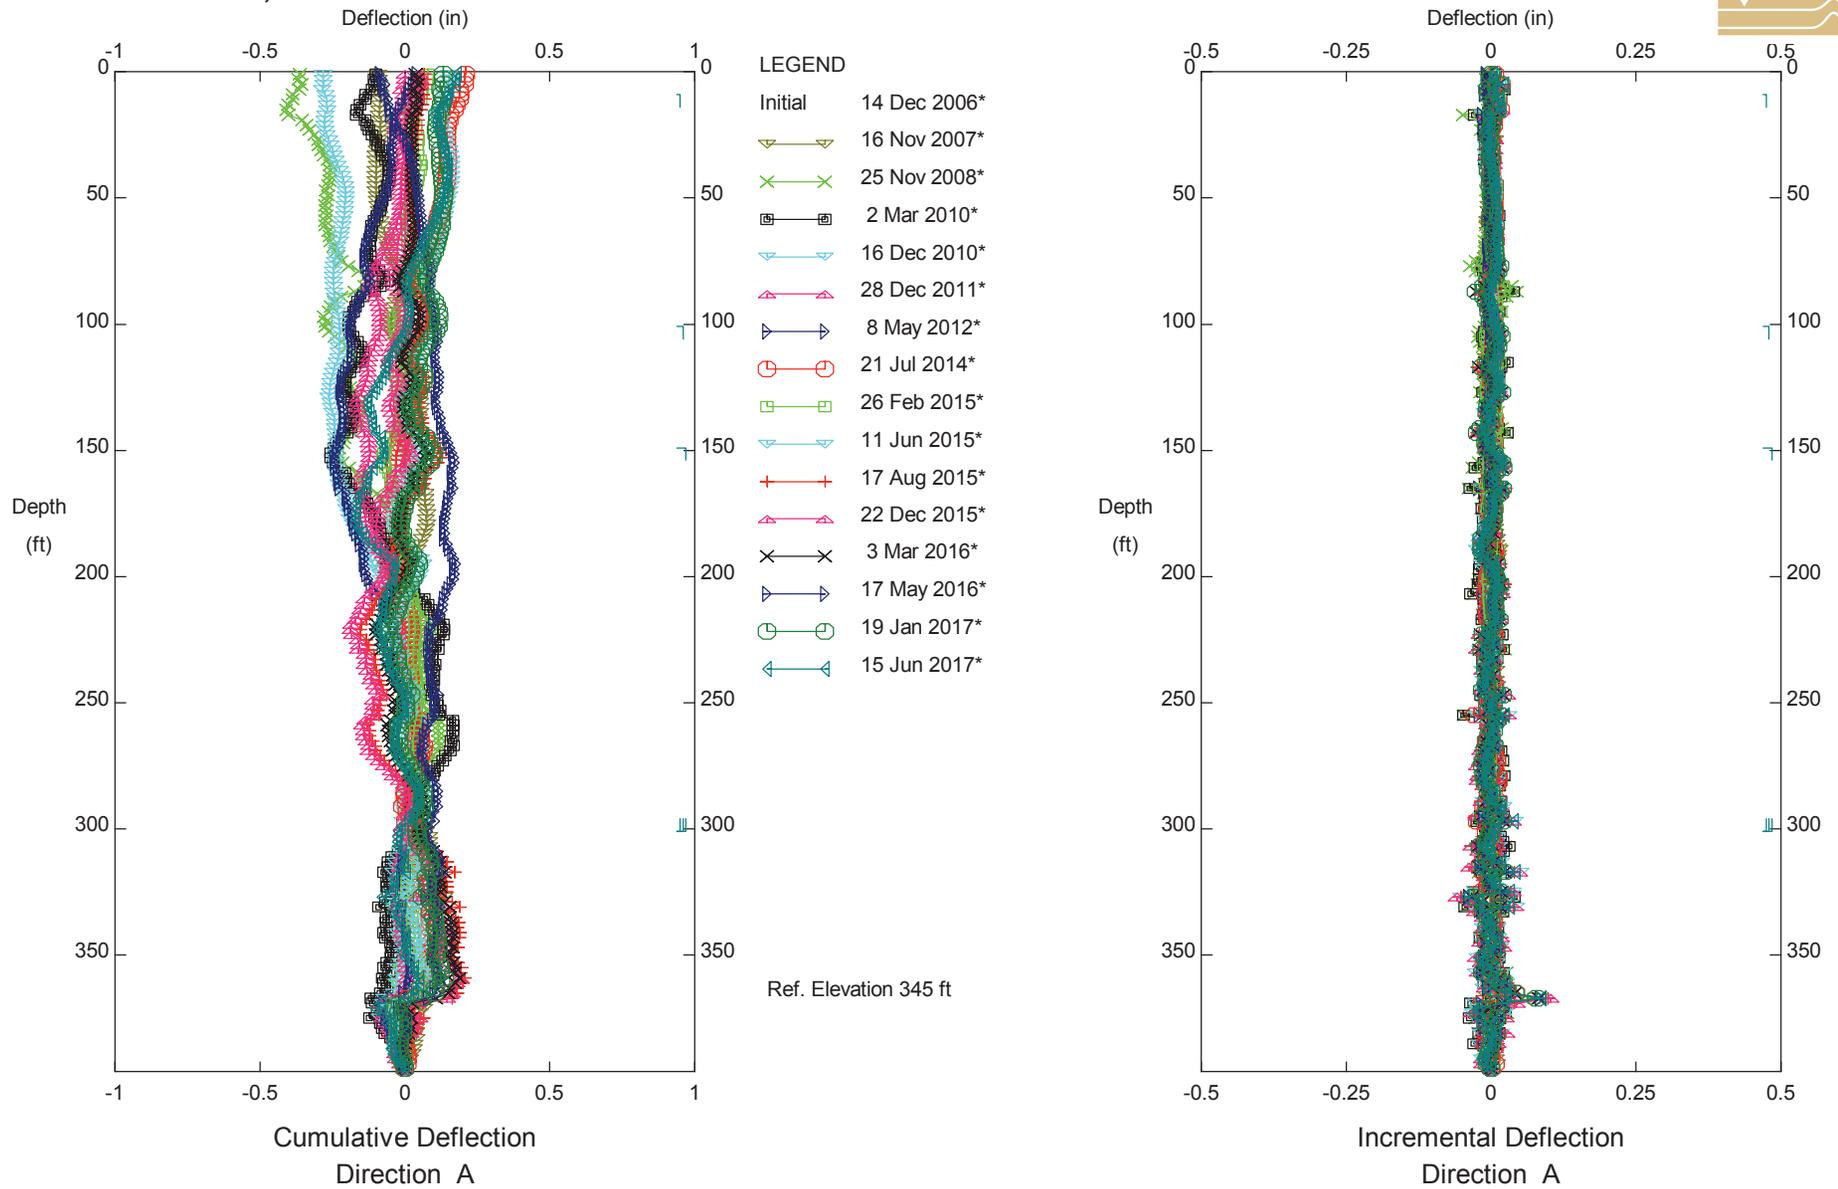
BIG ROCK MESA, Inclinometer SP-35
 CENTRAL REGION

Sets marked * include zero shift and/or rotation corrections.

Groundwater levels in SP-35 have declined steadily since February 2016 when the pump saver at BYA-4 was replaced and the well returned to operation. The June 2017 reading, the last during the 2016-2017 monitoring period, was 4.48 feet higher than the average value for the period of record.

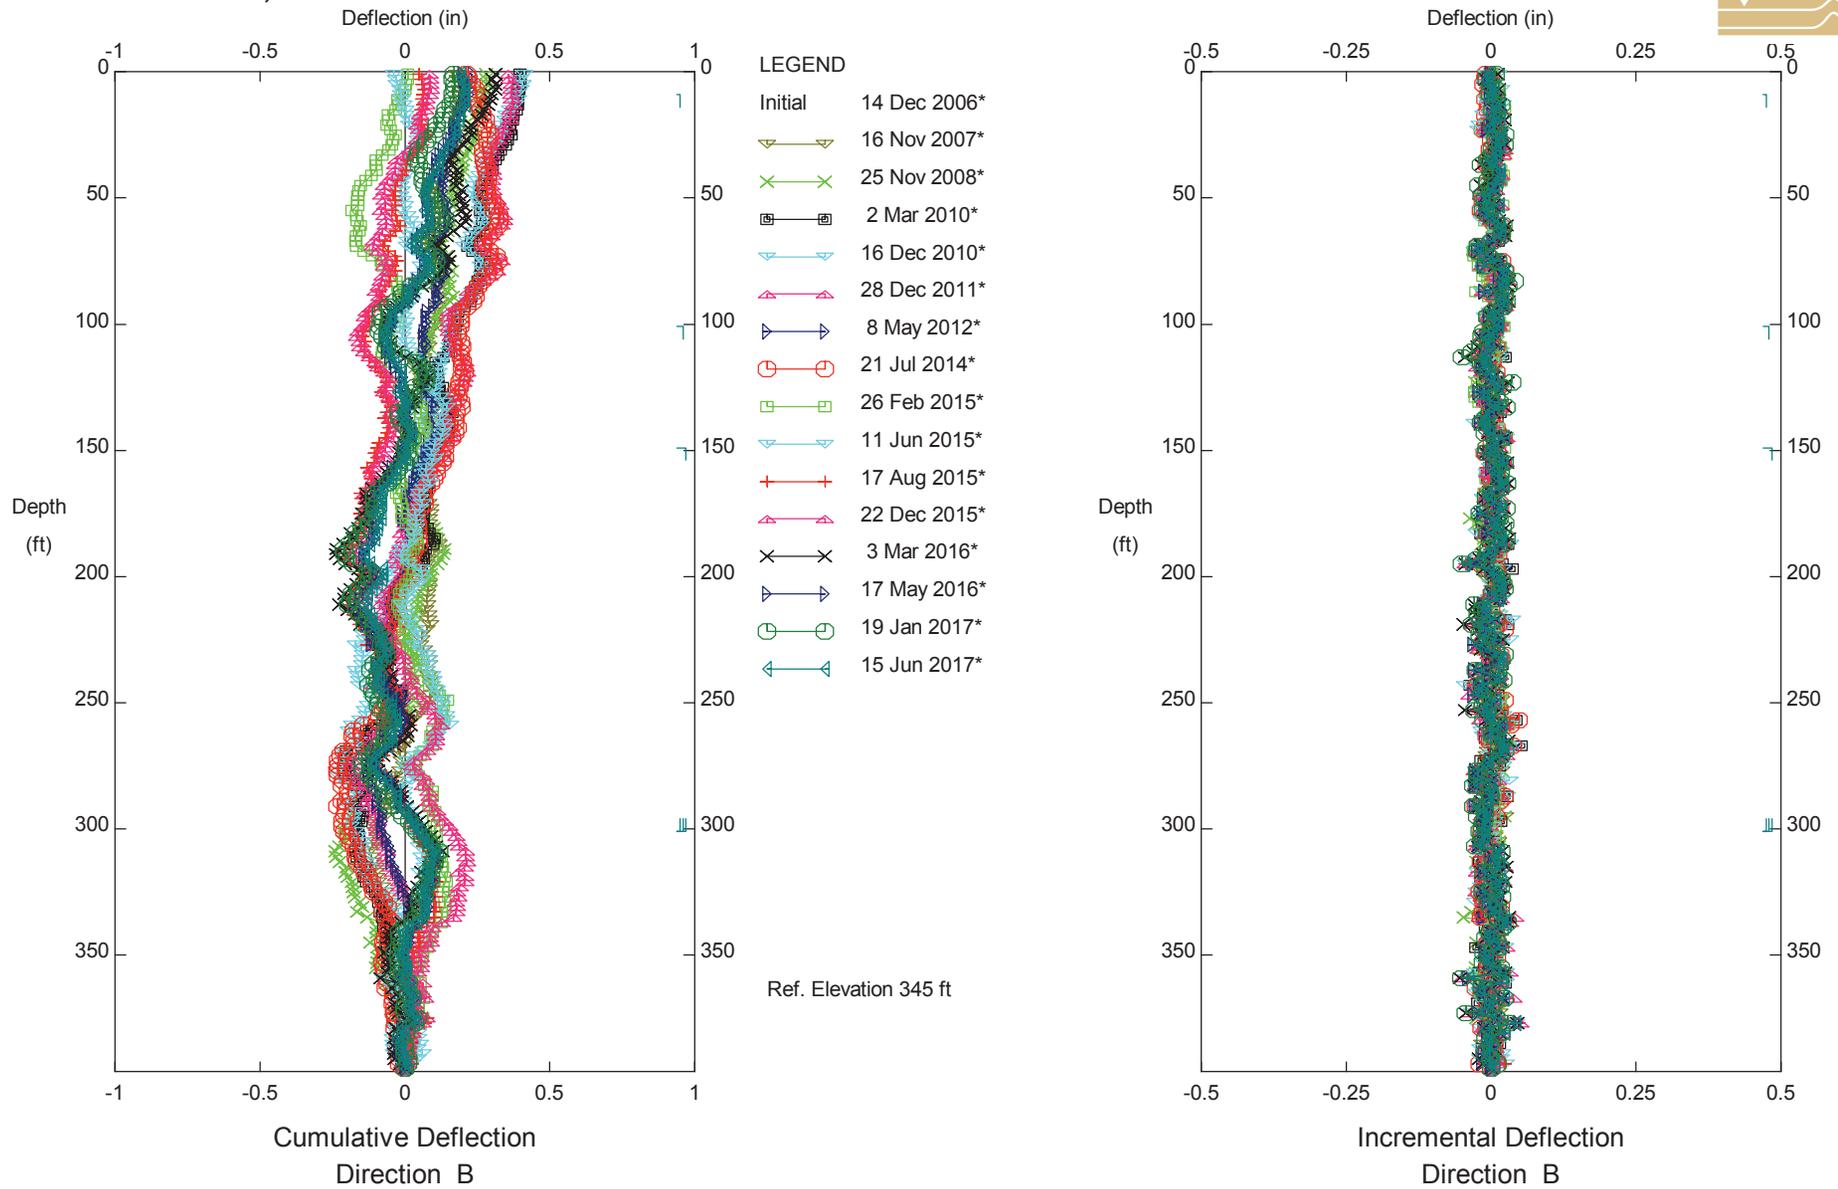
BIG ROCK MESA, Inclinometer SP-35
 CENTRAL REGION

Sets marked * include zero shift and/or rotation corrections.

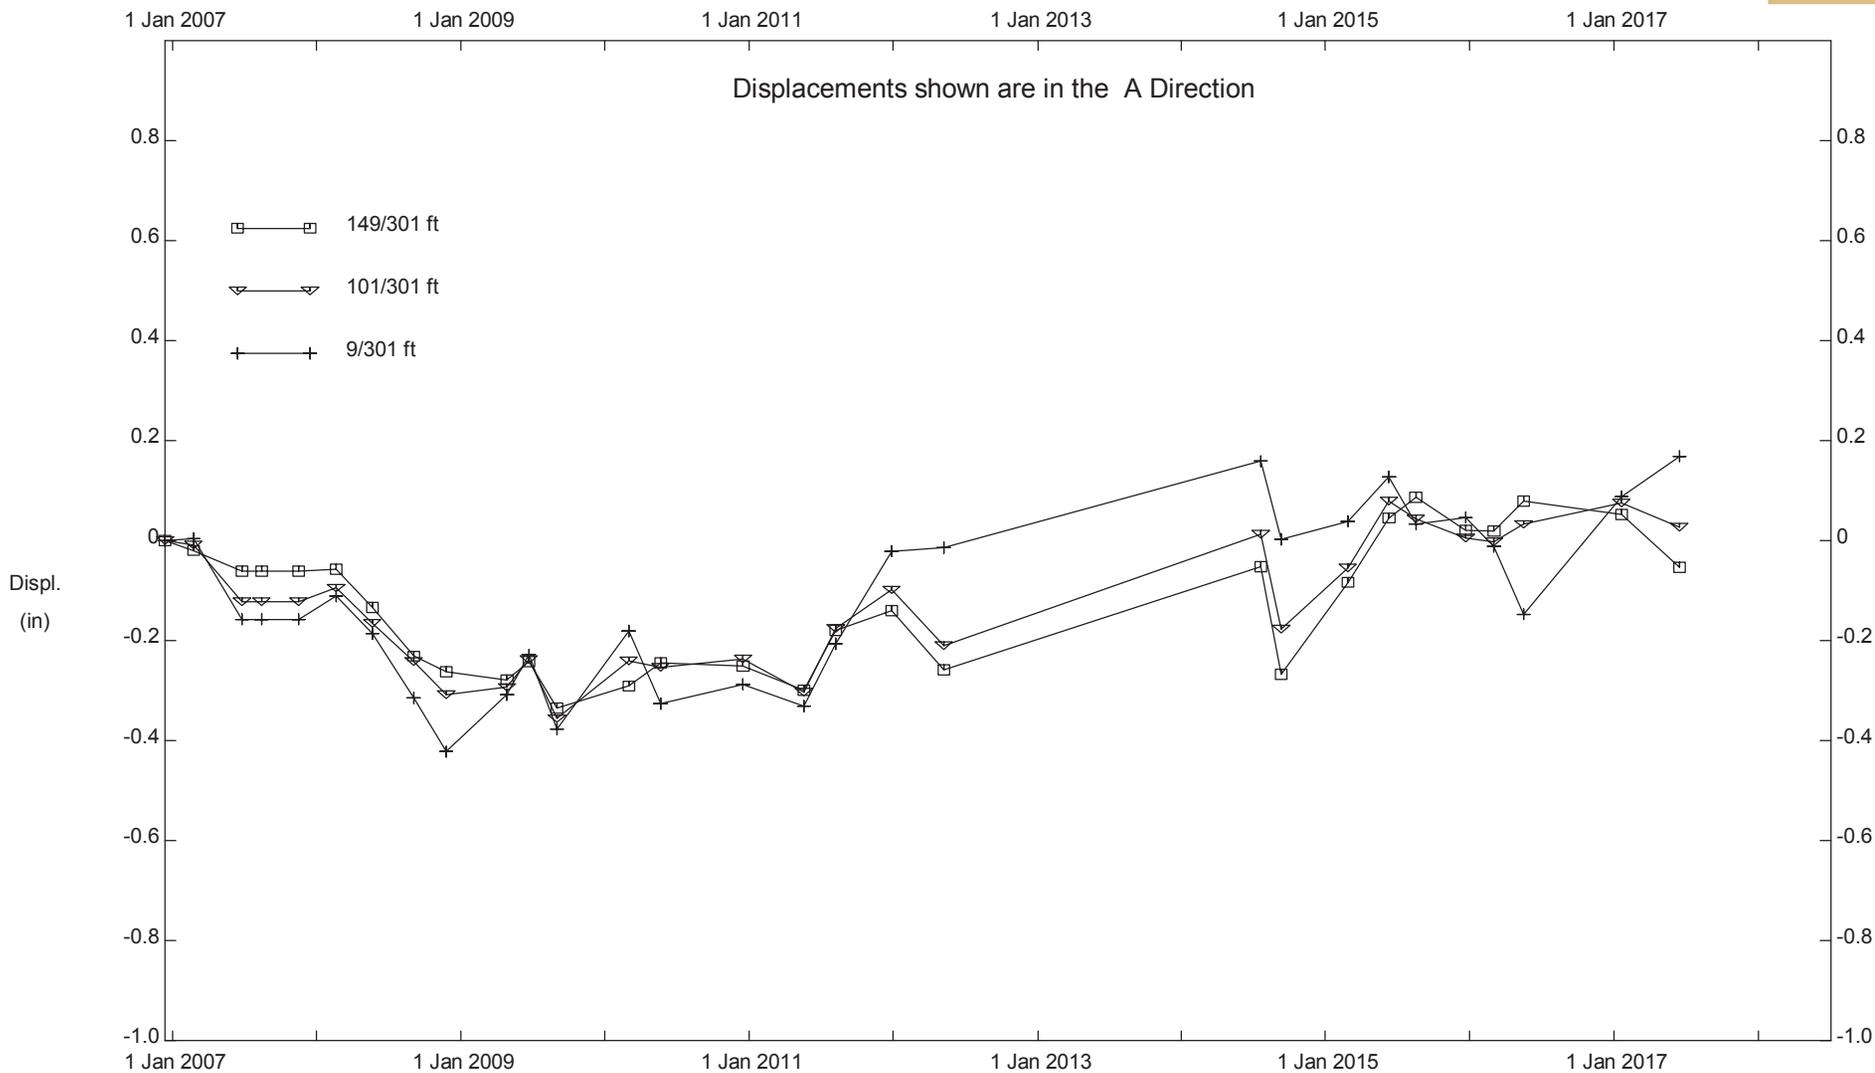
PLATE D22-3

BIG ROCK MESA, Inclinometer SP-35

CENTRAL REGION
