**ANNUAL REPORT
JULY 2016 THROUGH JUNE 2017
BIG ROCK MESA LANDSLIDE
ASSESSMENT DISTRICT
City of Malibu, California**

March 2018
Fugro Project No. 04.62160606
Document No. 04.62160606-PR-004(Rev.00)

**Annual Report of Maintenance and Monitoring, July 2016 through June 2017,
Big Rock Mesa Landslide Assessment District, City of Malibu, California**

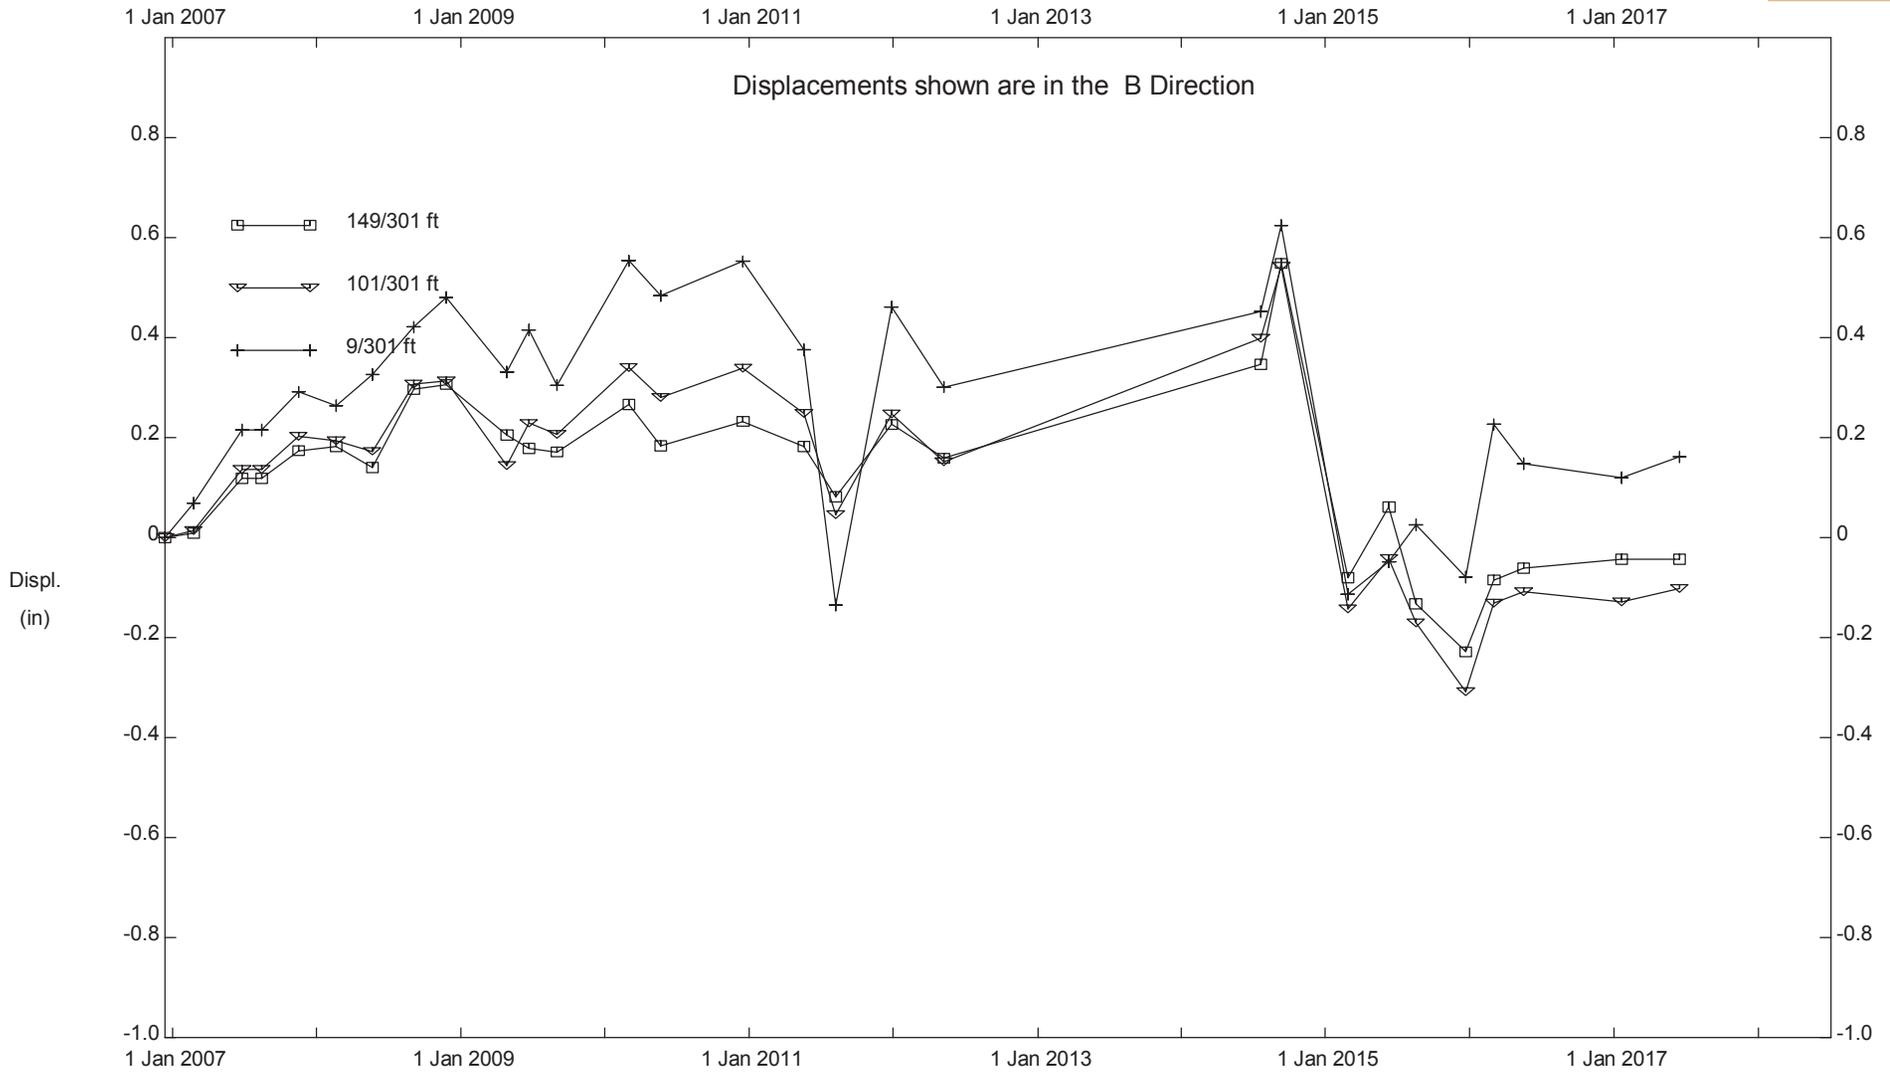
BIG ROCK MESA, Inclinometer SP-35

CENTRAL REGION

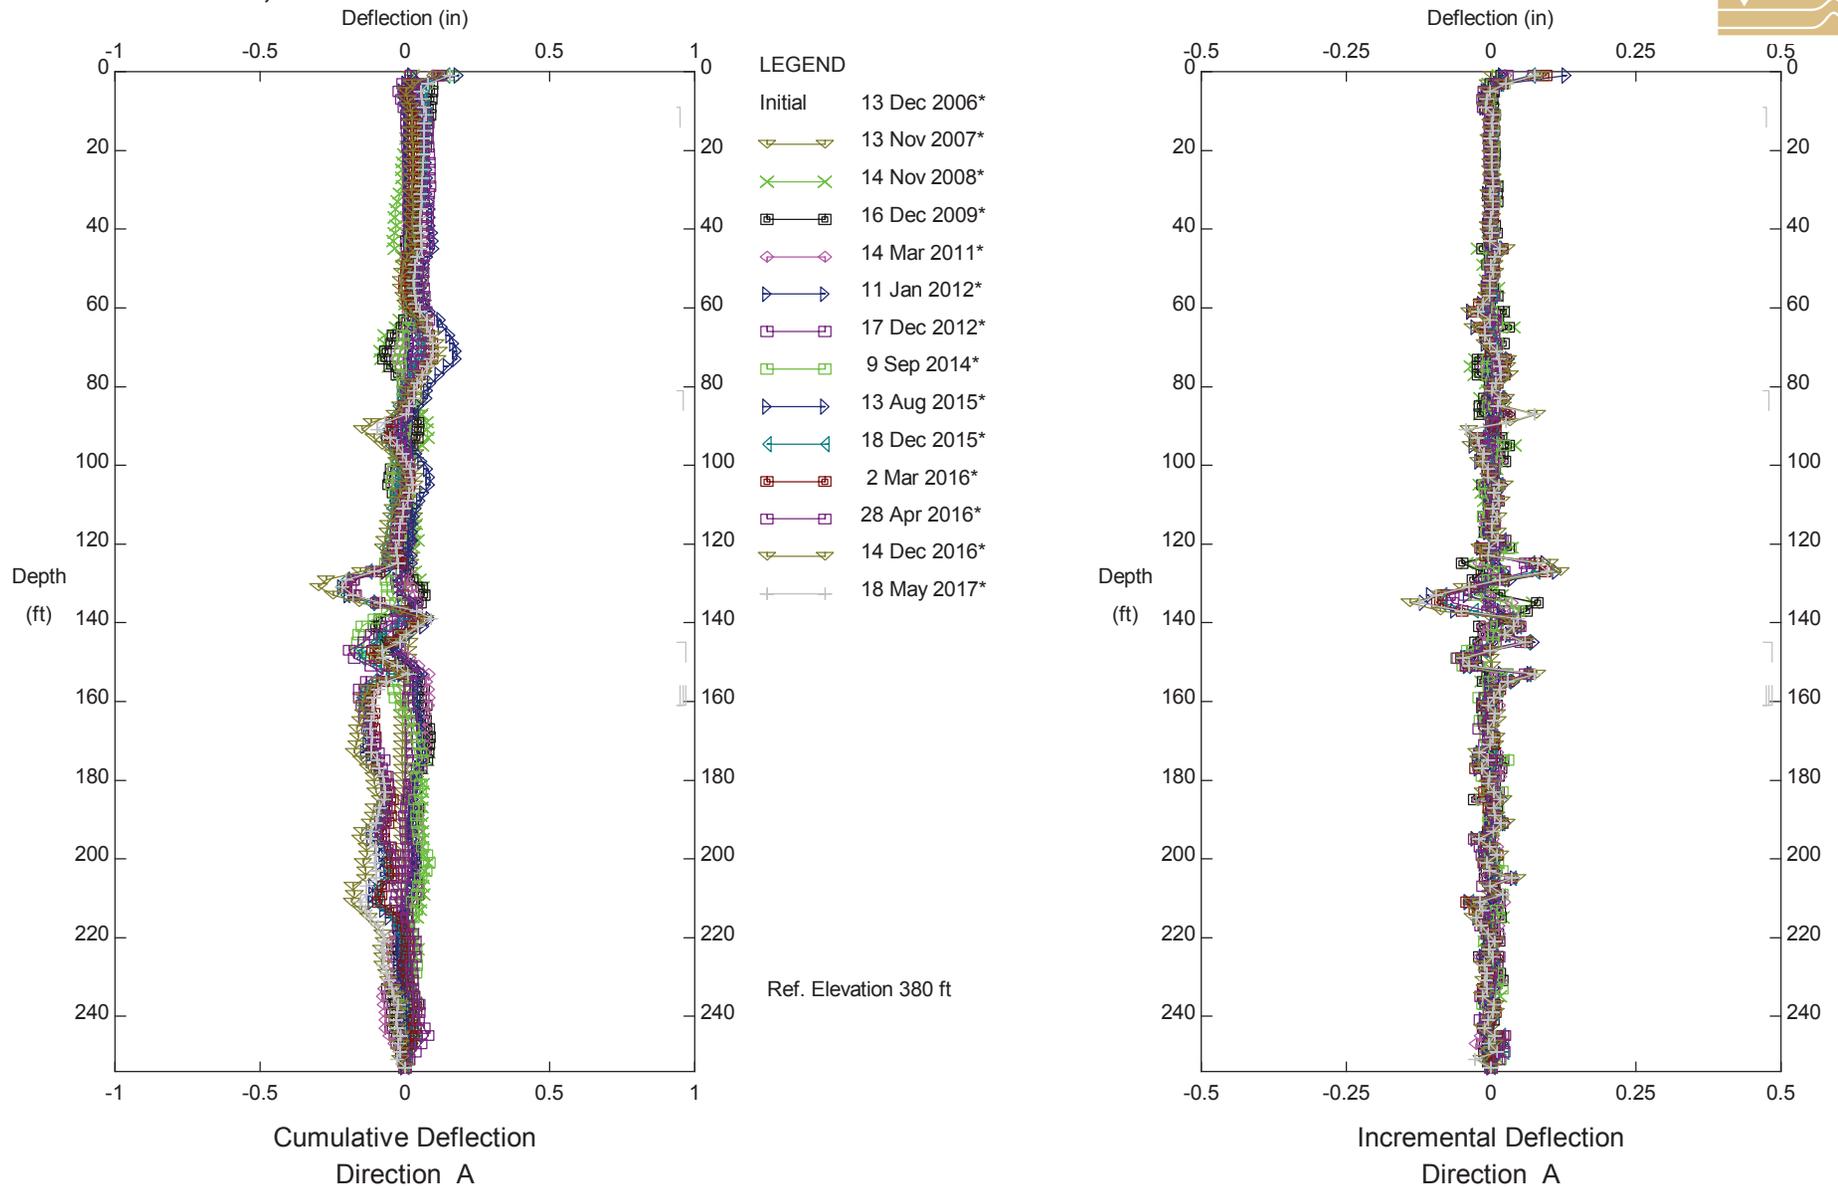
BIG ROCK MESA, Inclinometer SP-36
 CENTRAL REGION

Sets marked * include zero shift and/or rotation corrections.

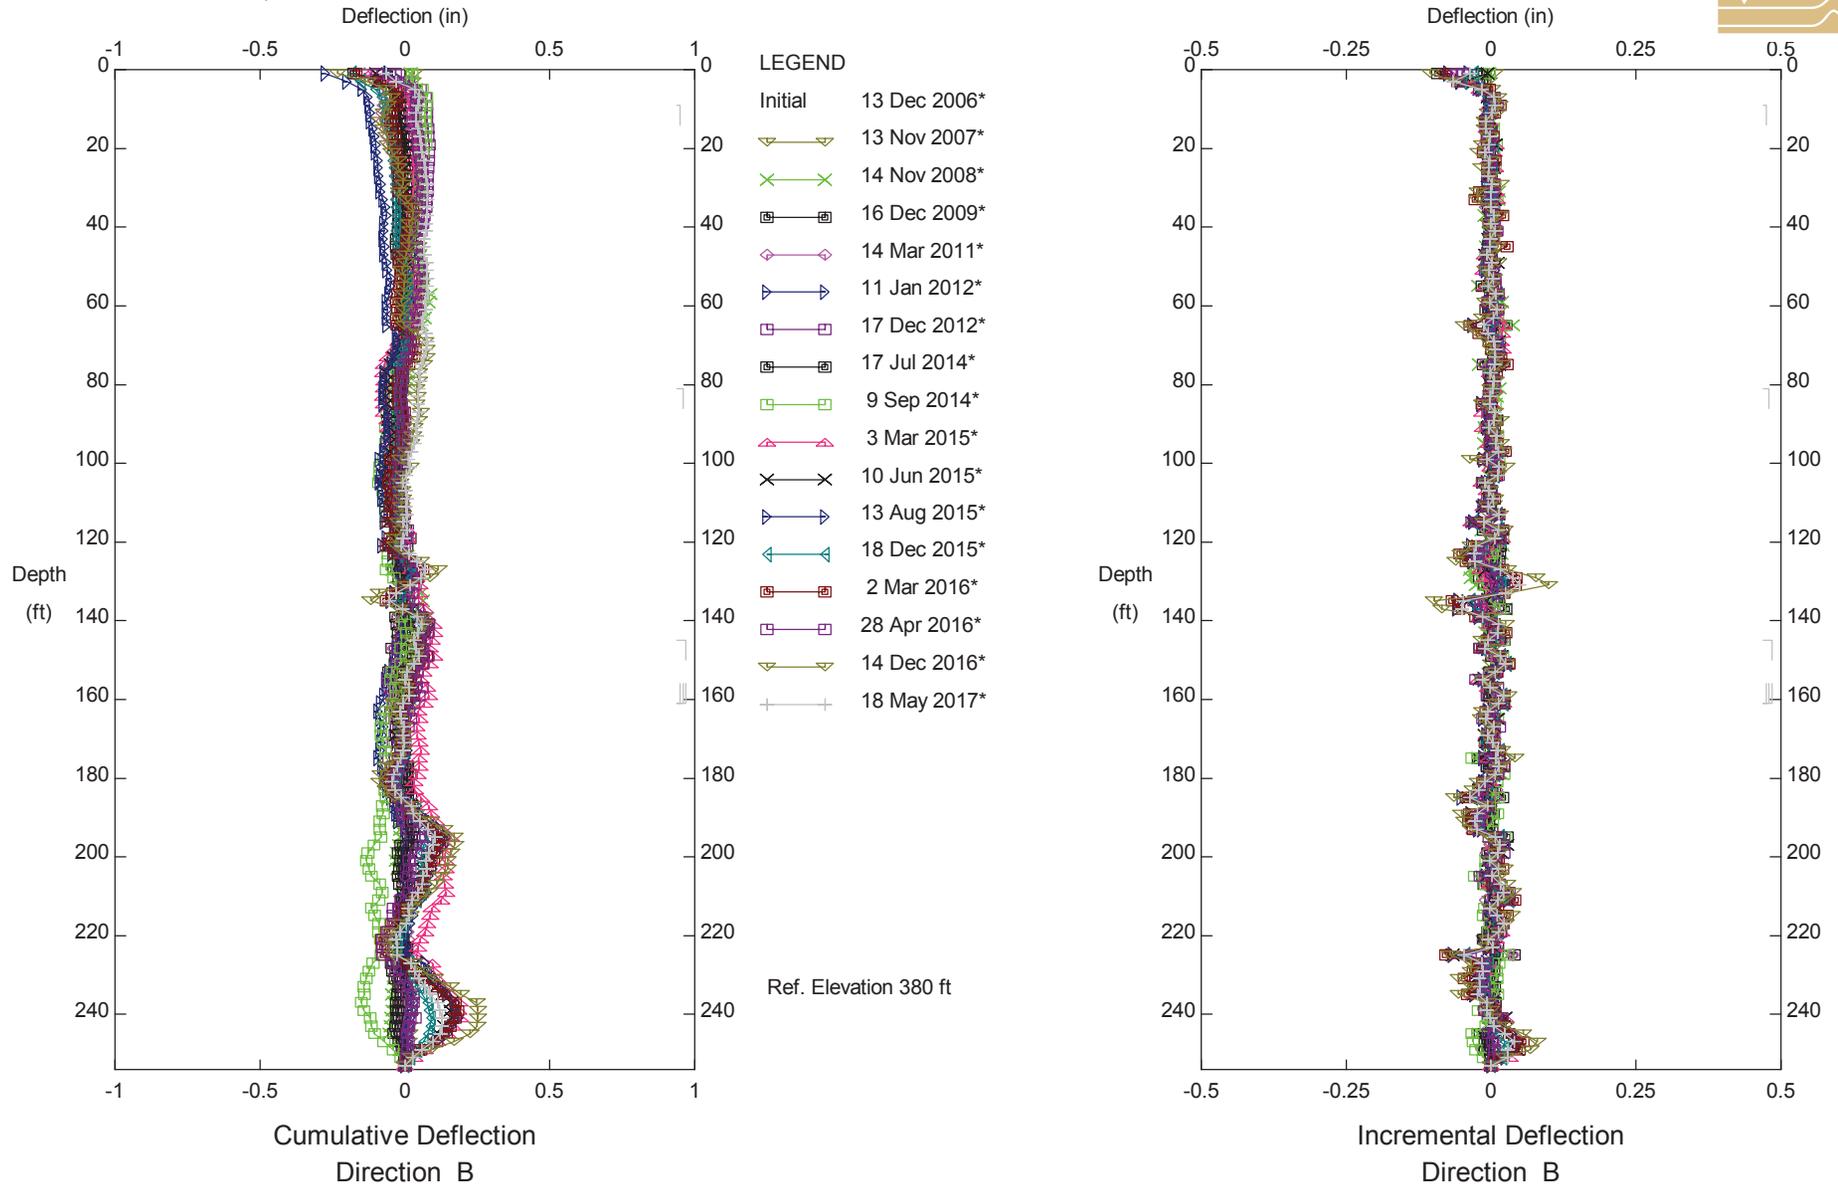
BIG ROCK MESA, Inclinometer SP-36
 CENTRAL REGION

Sets marked * include zero shift and/or rotation corrections.

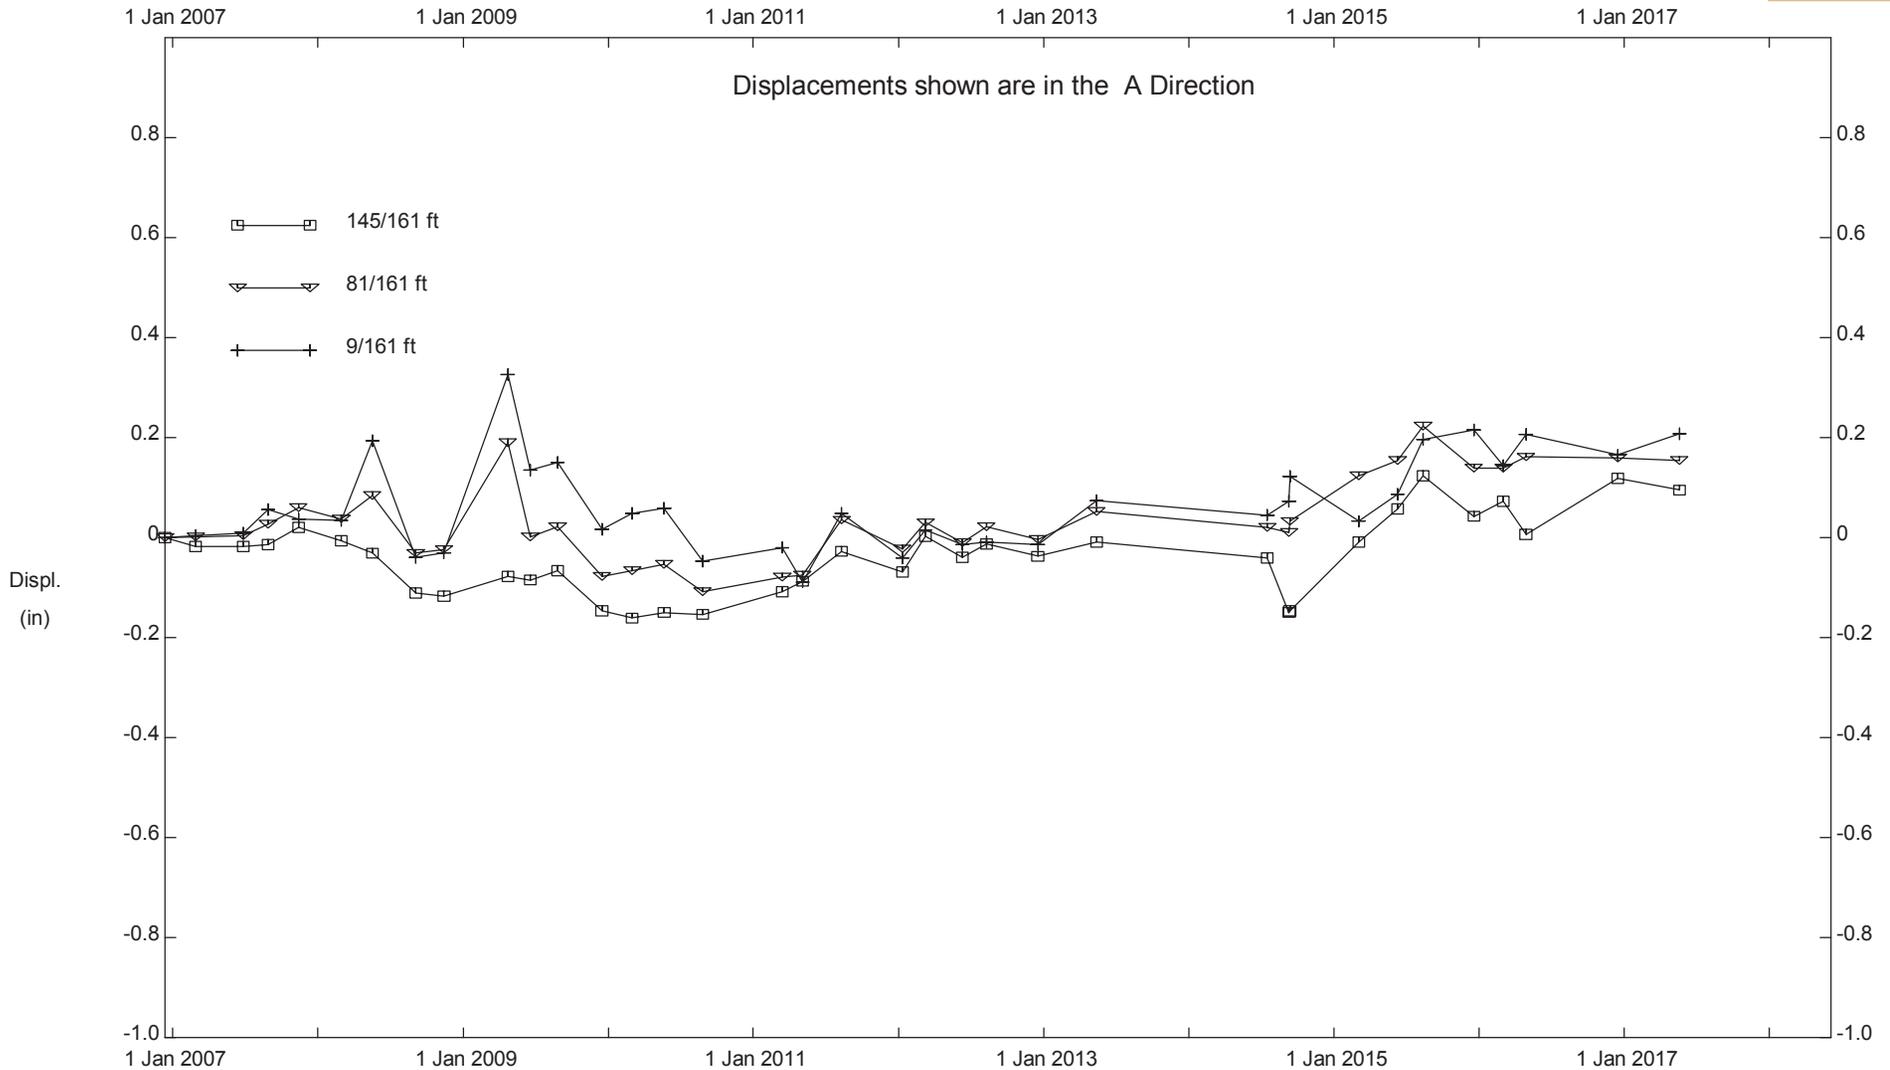
PLATE D23-3

BIG ROCK MESA, Inclinator SP-36

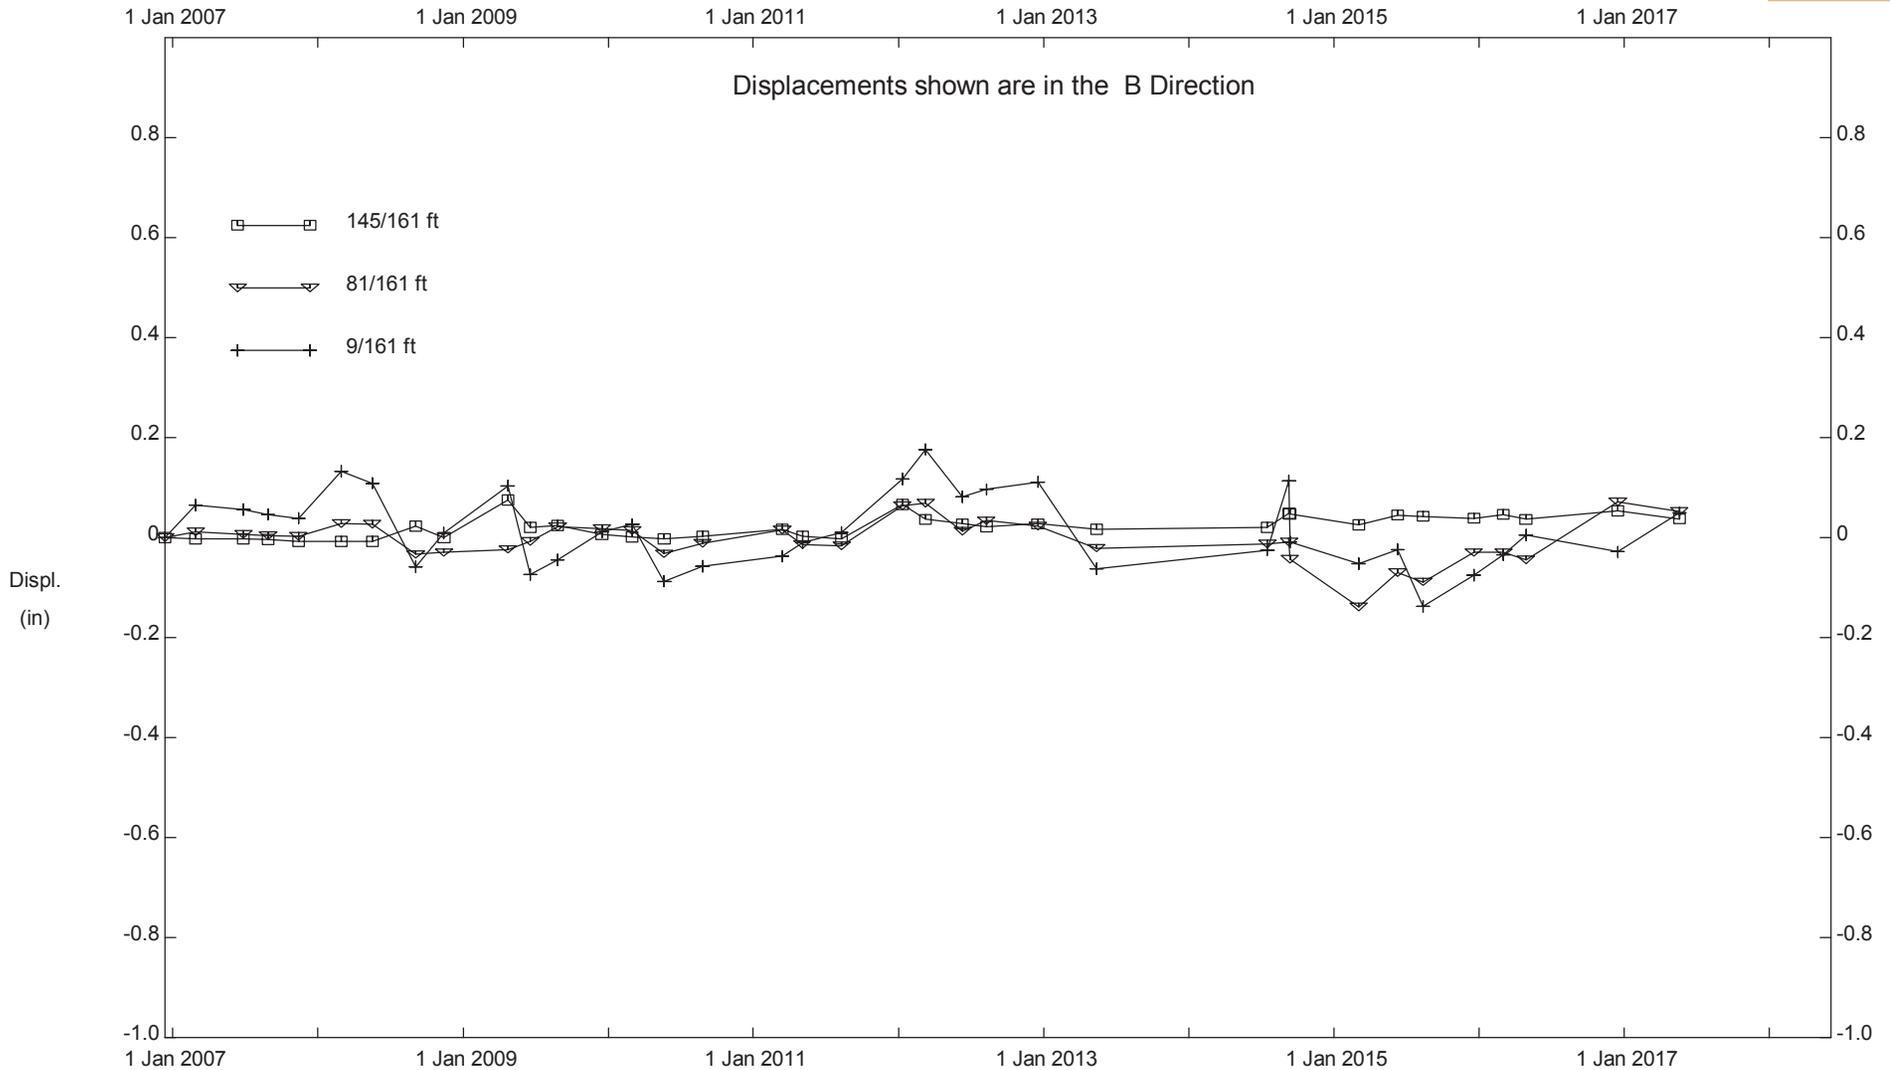
PLATE D23-4

BIG ROCK MESA, Inclinometer SP-36

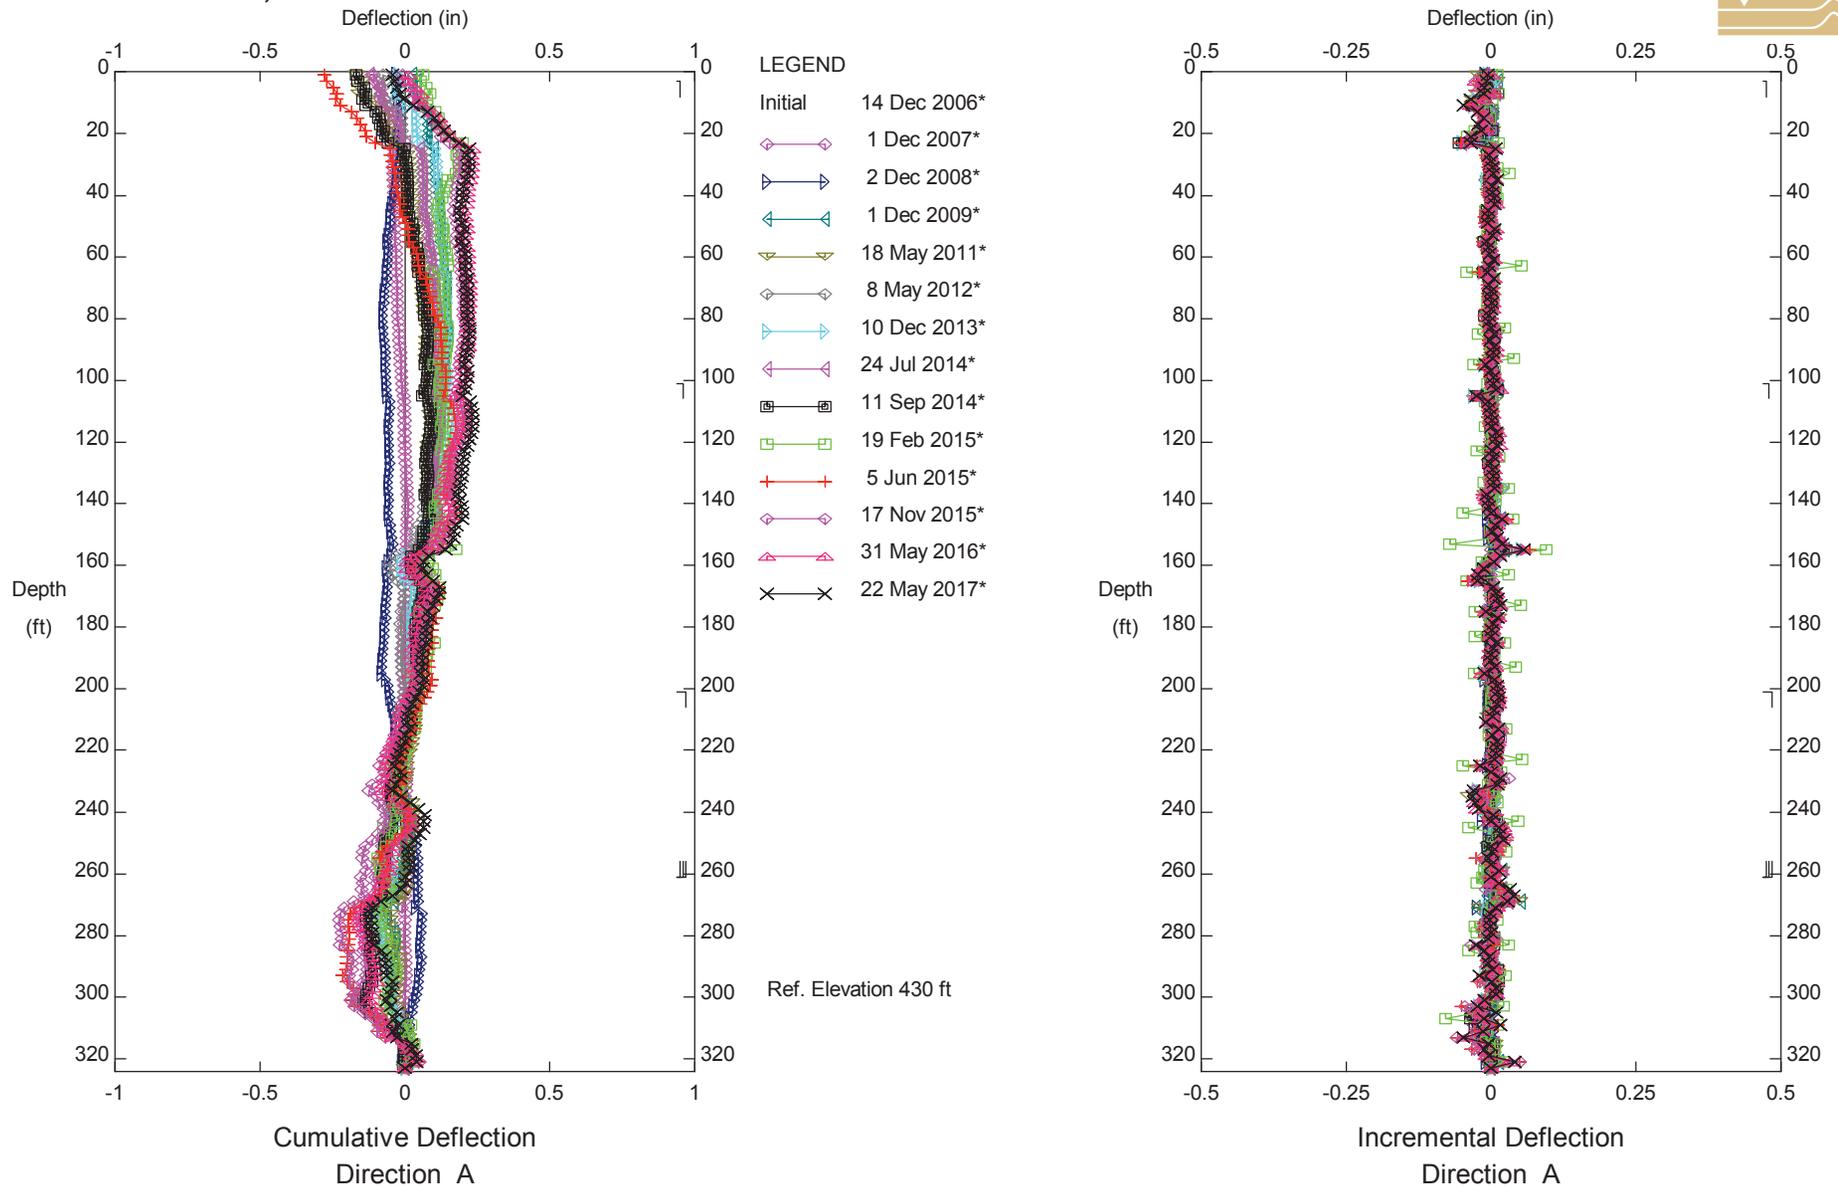
BIG ROCK MESA, Inclinometer SP-20
 WESTERN REGION

Sets marked * include zero shift and/or rotation corrections.

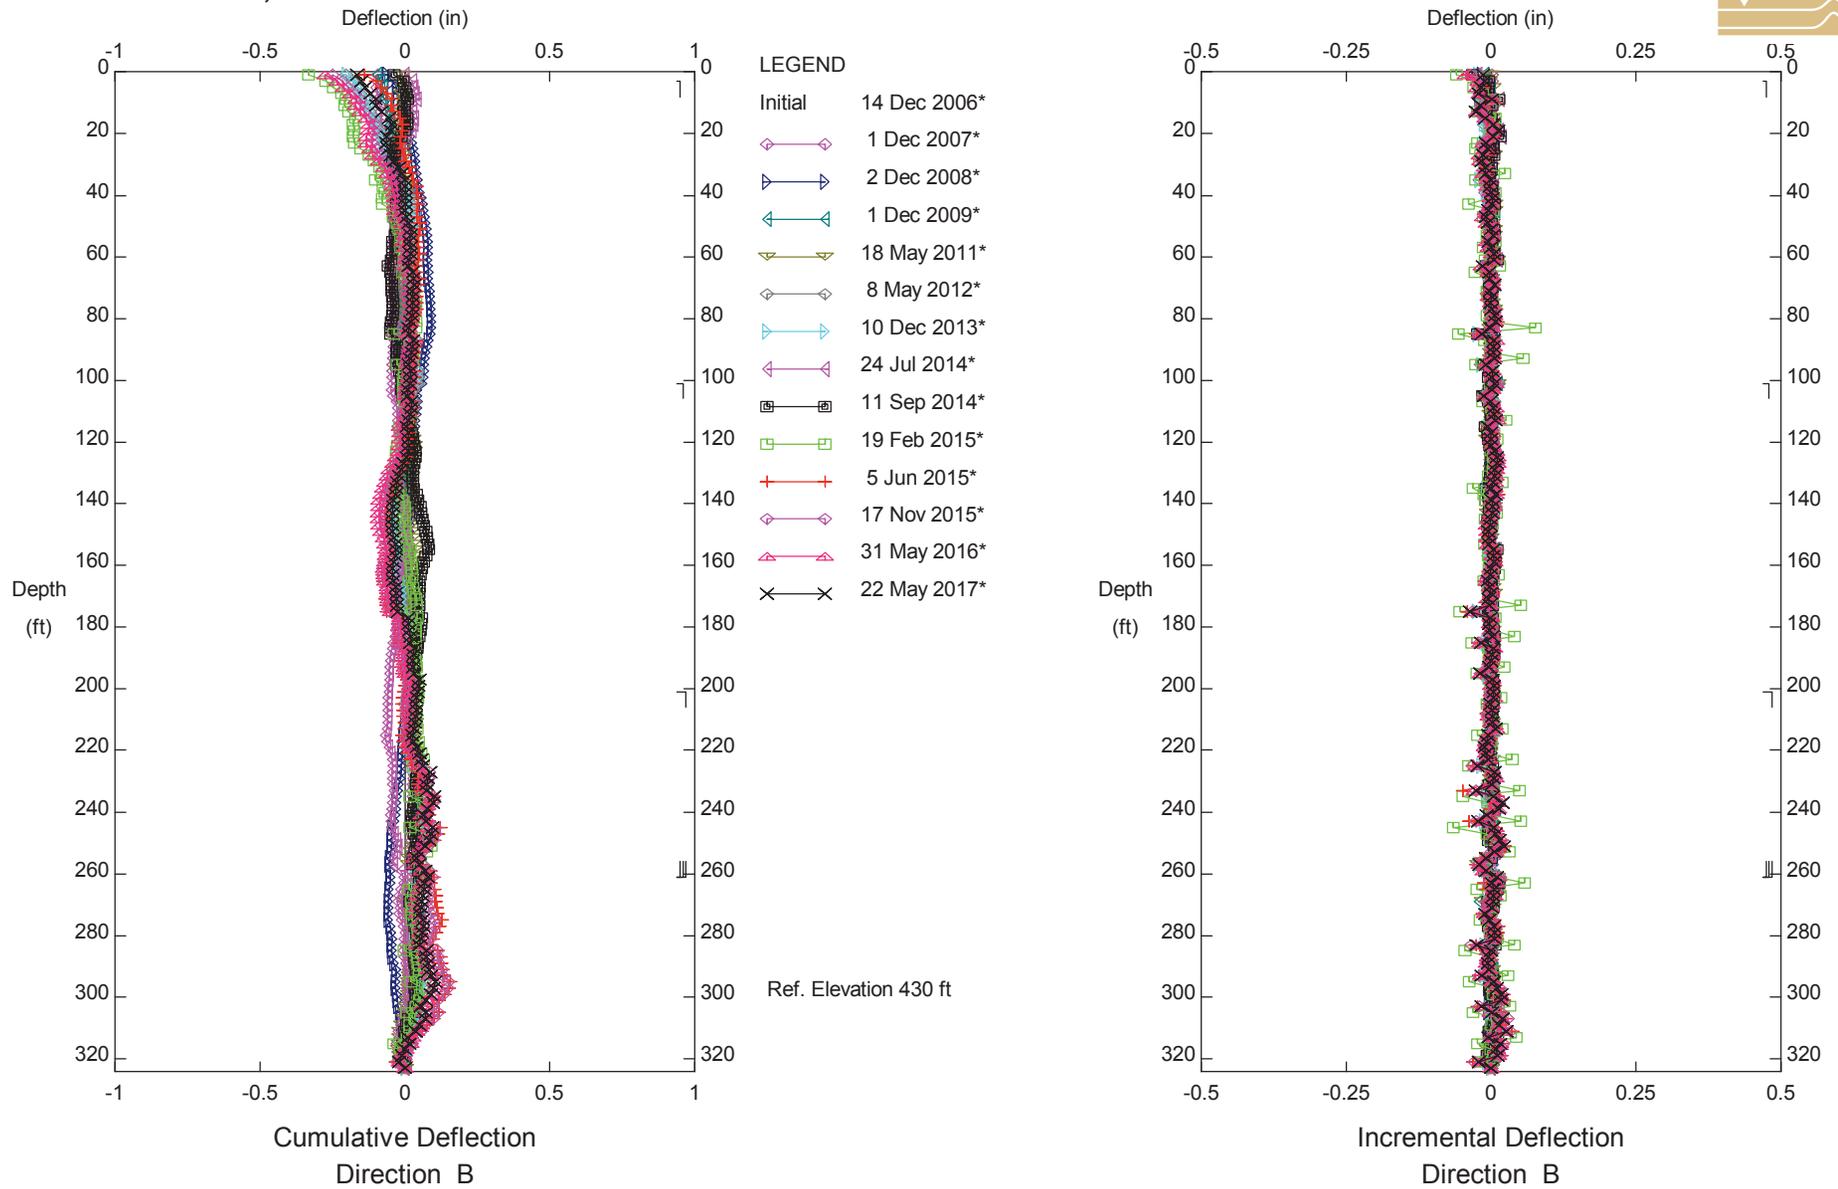
BIG ROCK MESA, Inclinometer SP-20
 WESTERN REGION

Sets marked * include zero shift and/or rotation corrections.

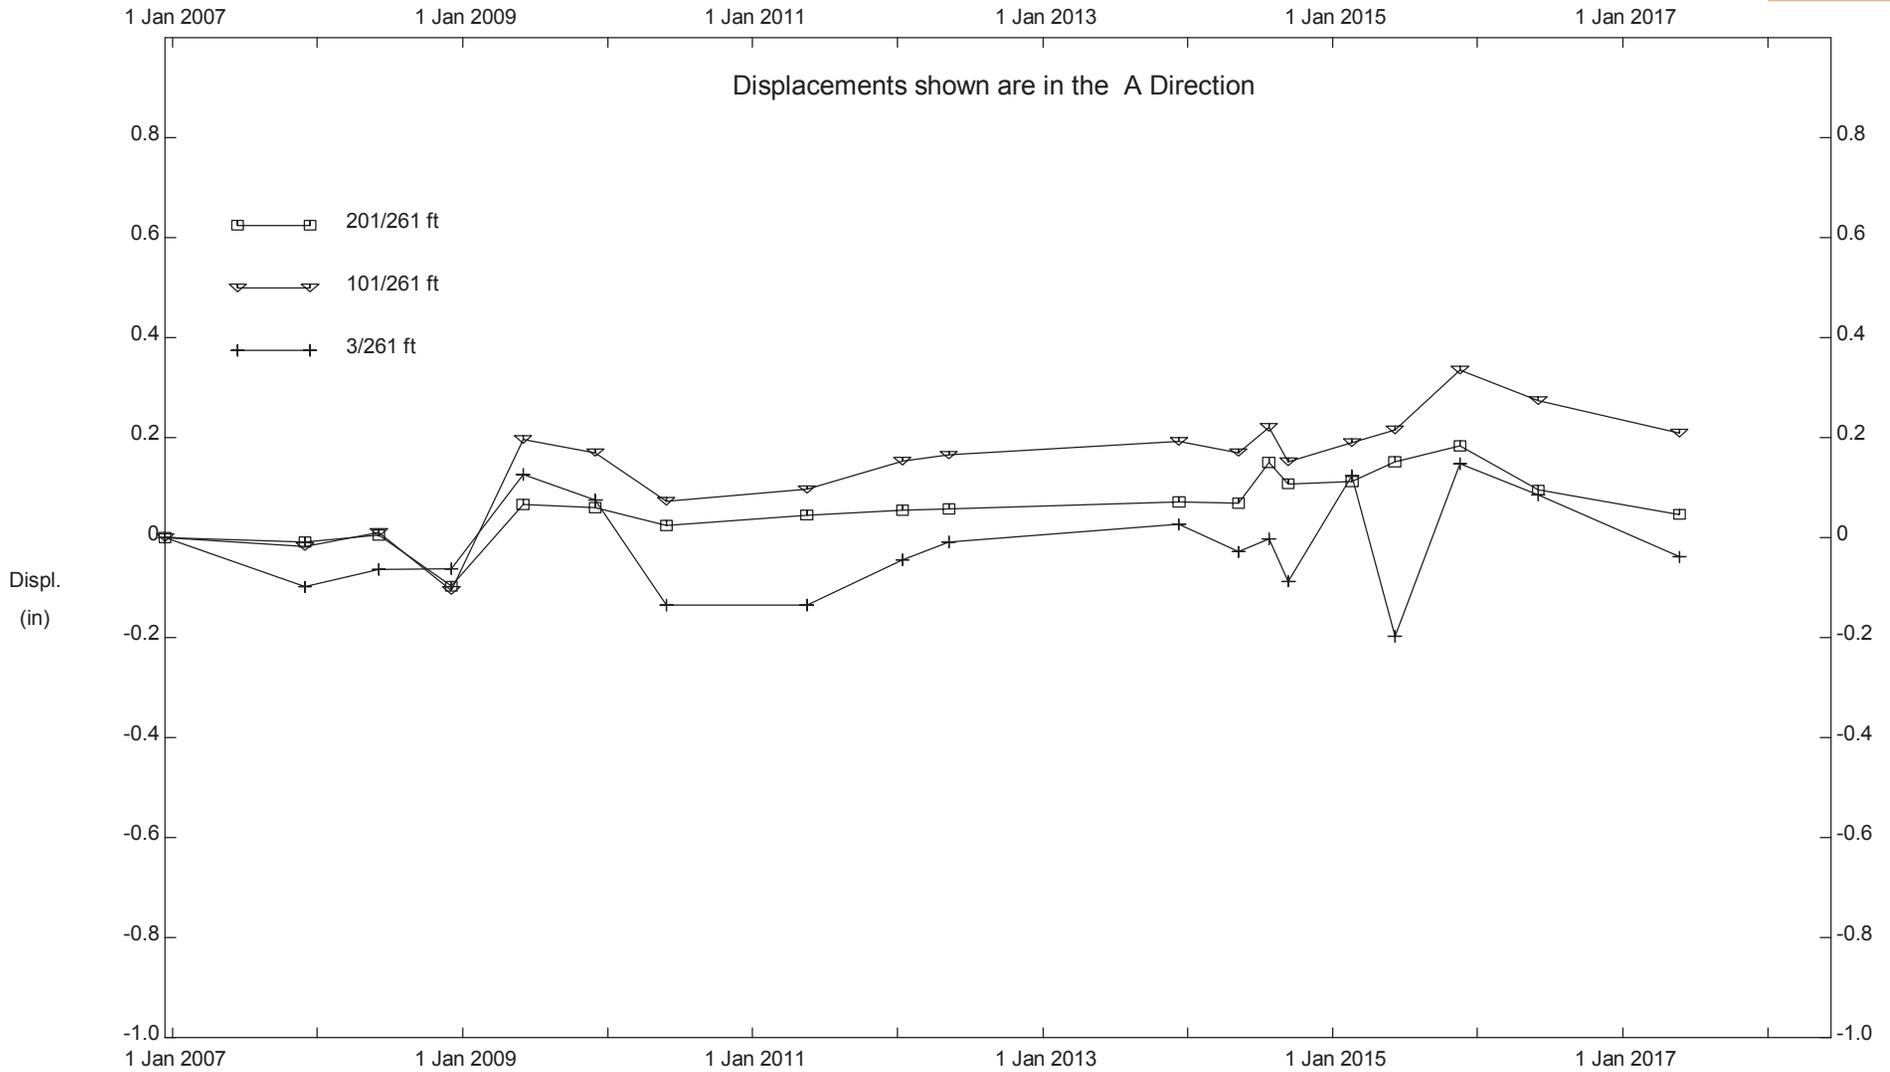
PLATE D24-3

BIG ROCK MESA, Inclinometer SP-20

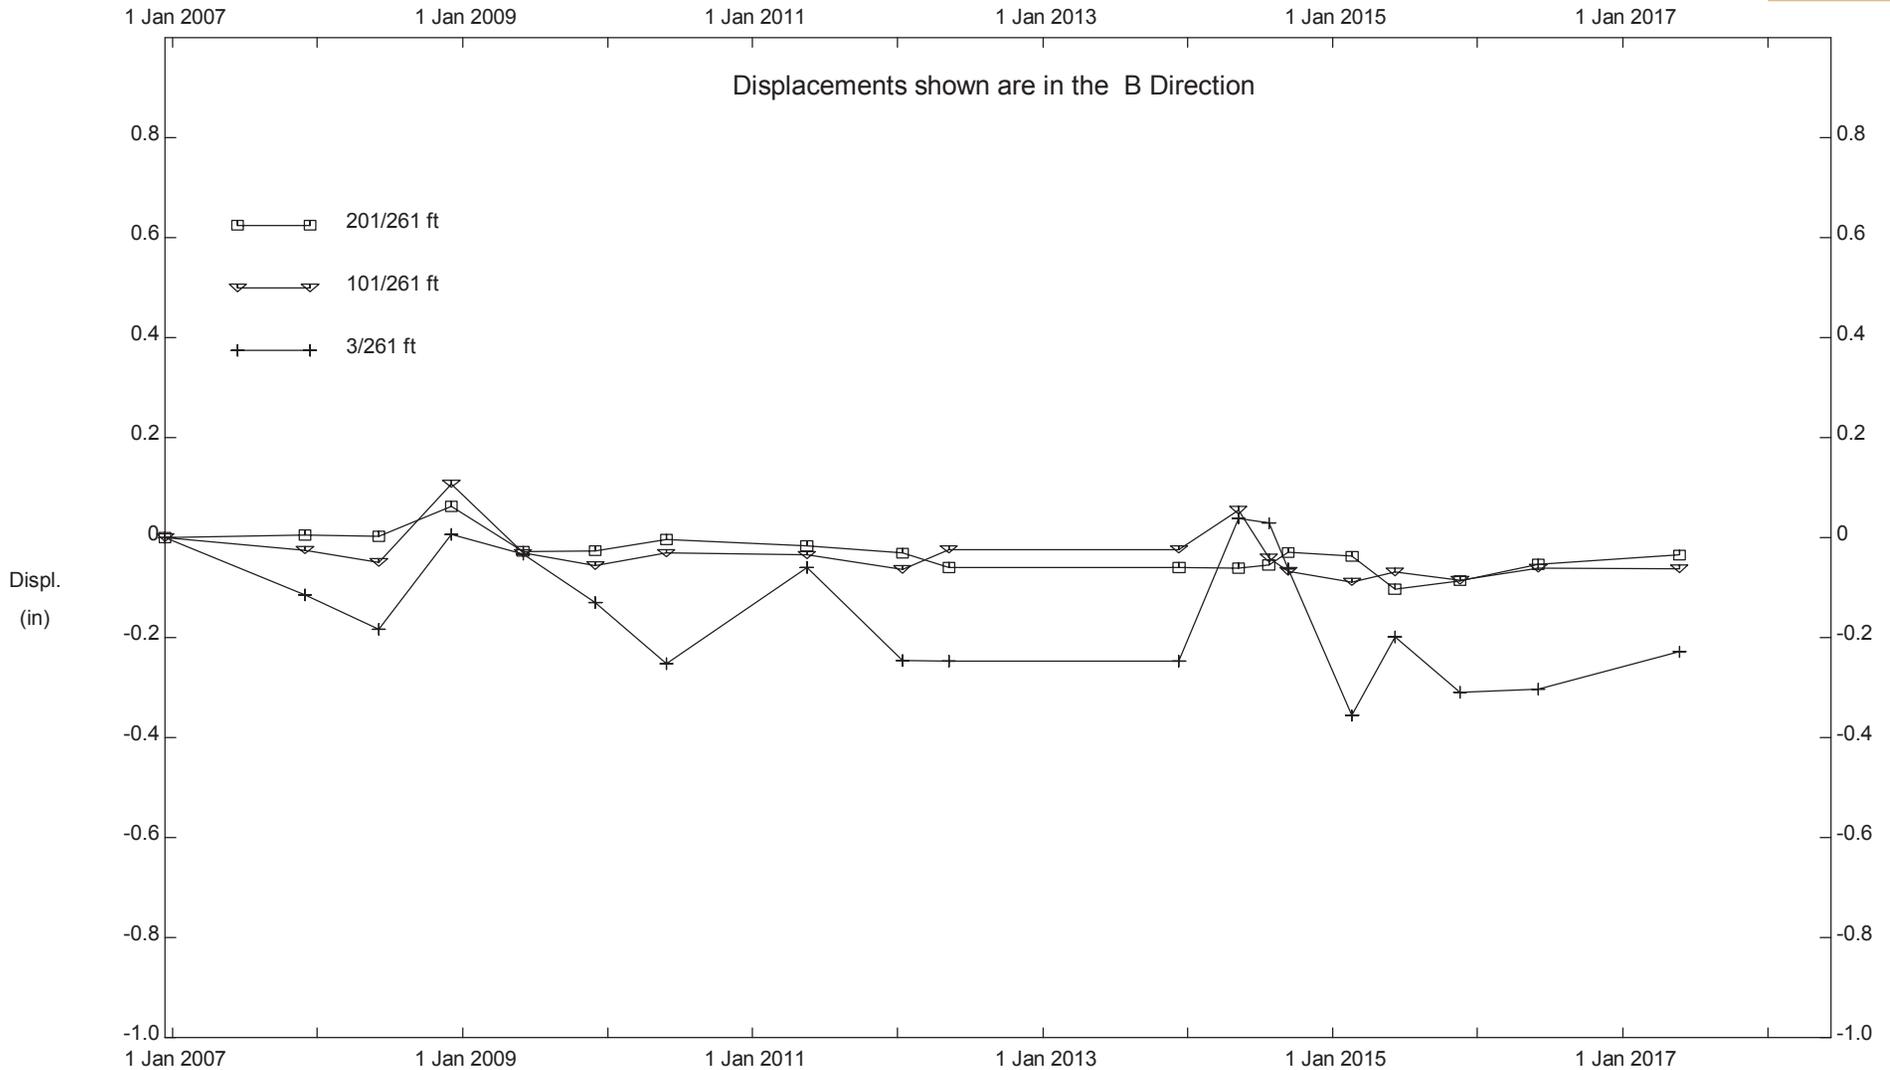
PLATE D24-4

BIG ROCK MESA, Inclinometer SP-20

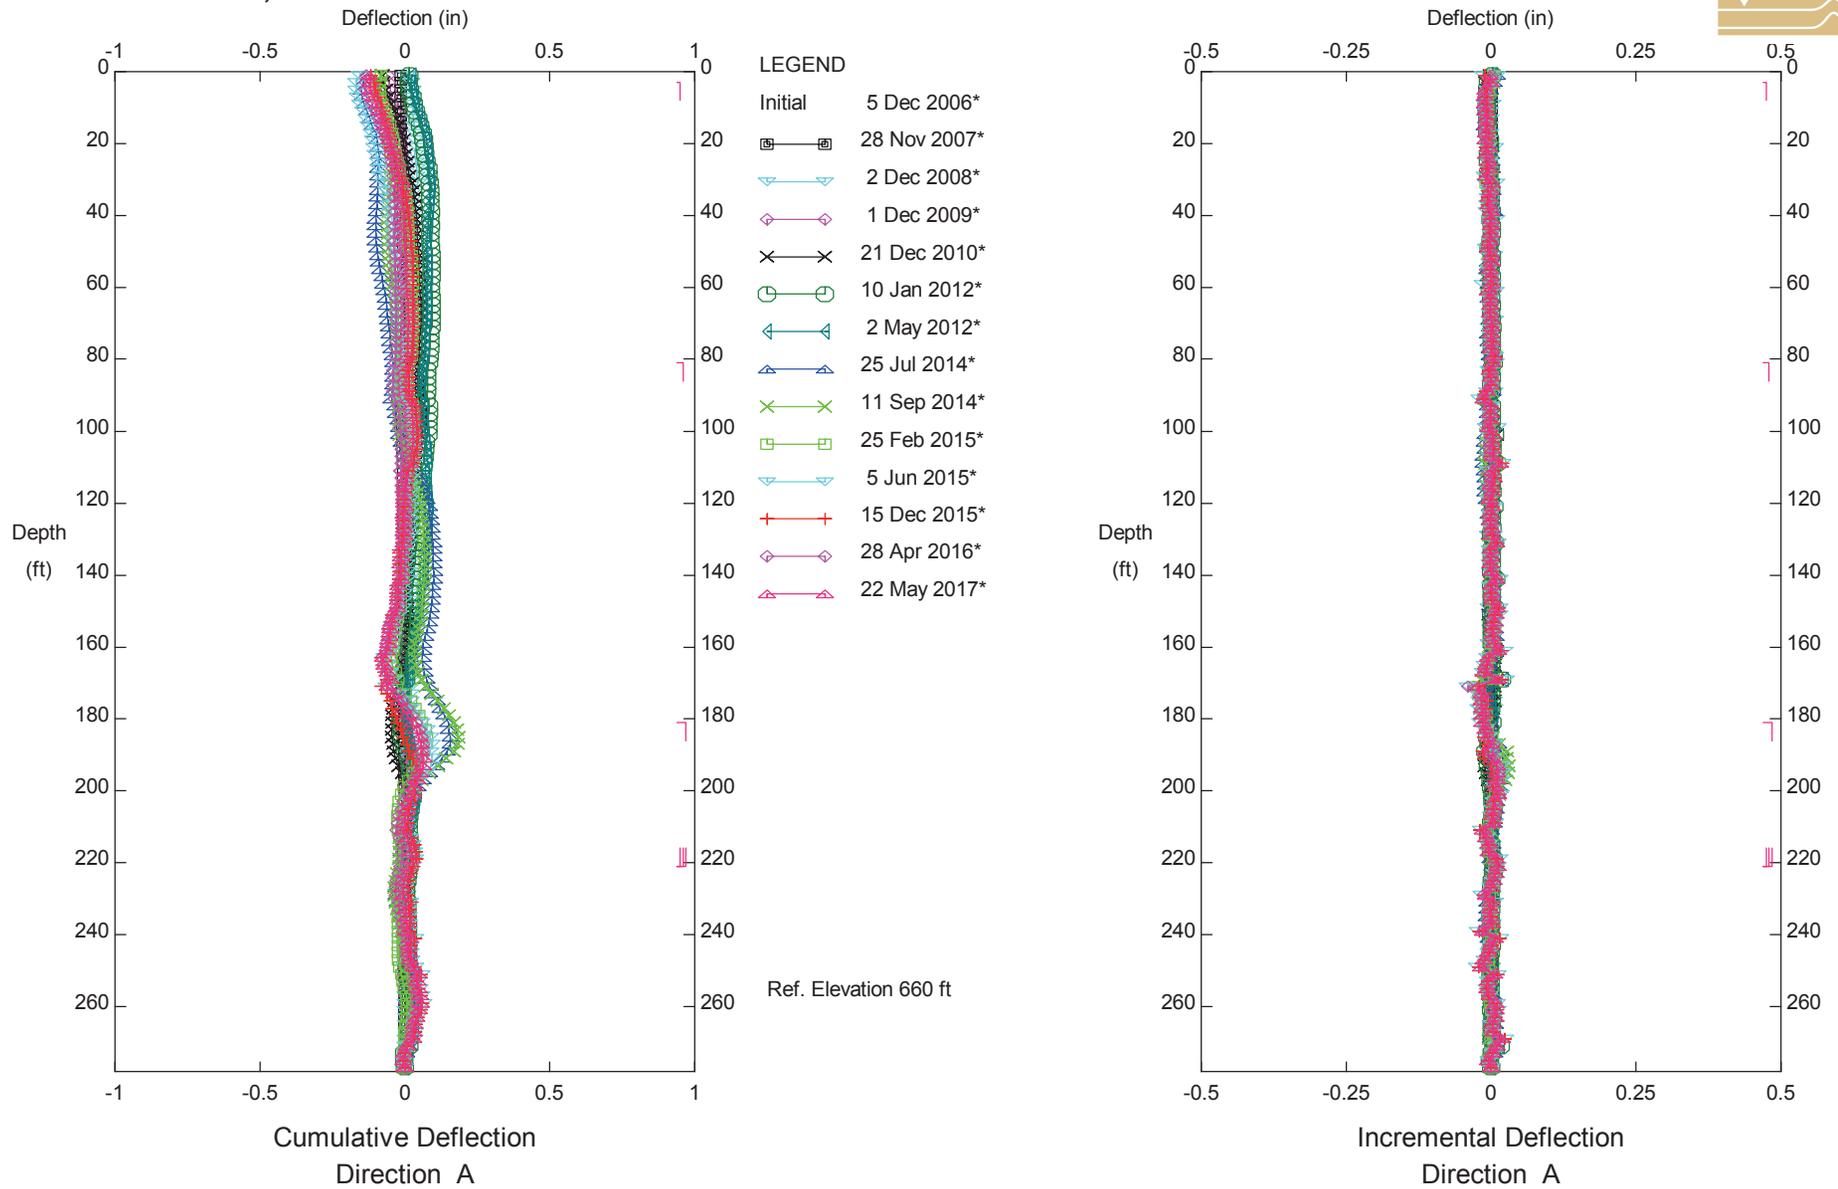
BIG ROCK MESA, Inclinometer SP-21
 WESTERN REGION

Sets marked * include zero shift and/or rotation corrections.
