**ANNUAL REPORT
JULY 2016 THROUGH JUNE 2017
BIG ROCK MESA LANDSLIDE
ASSESSMENT DISTRICT
City of Malibu, California**

March 2018
Fugro Project No. 04.62160606
Document No. 04.62160606-PR-004(Rev.00)

**Annual Report of Maintenance and Monitoring, July 2016 through June 2017,
Big Rock Mesa Landslide Assessment District, City of Malibu, California**

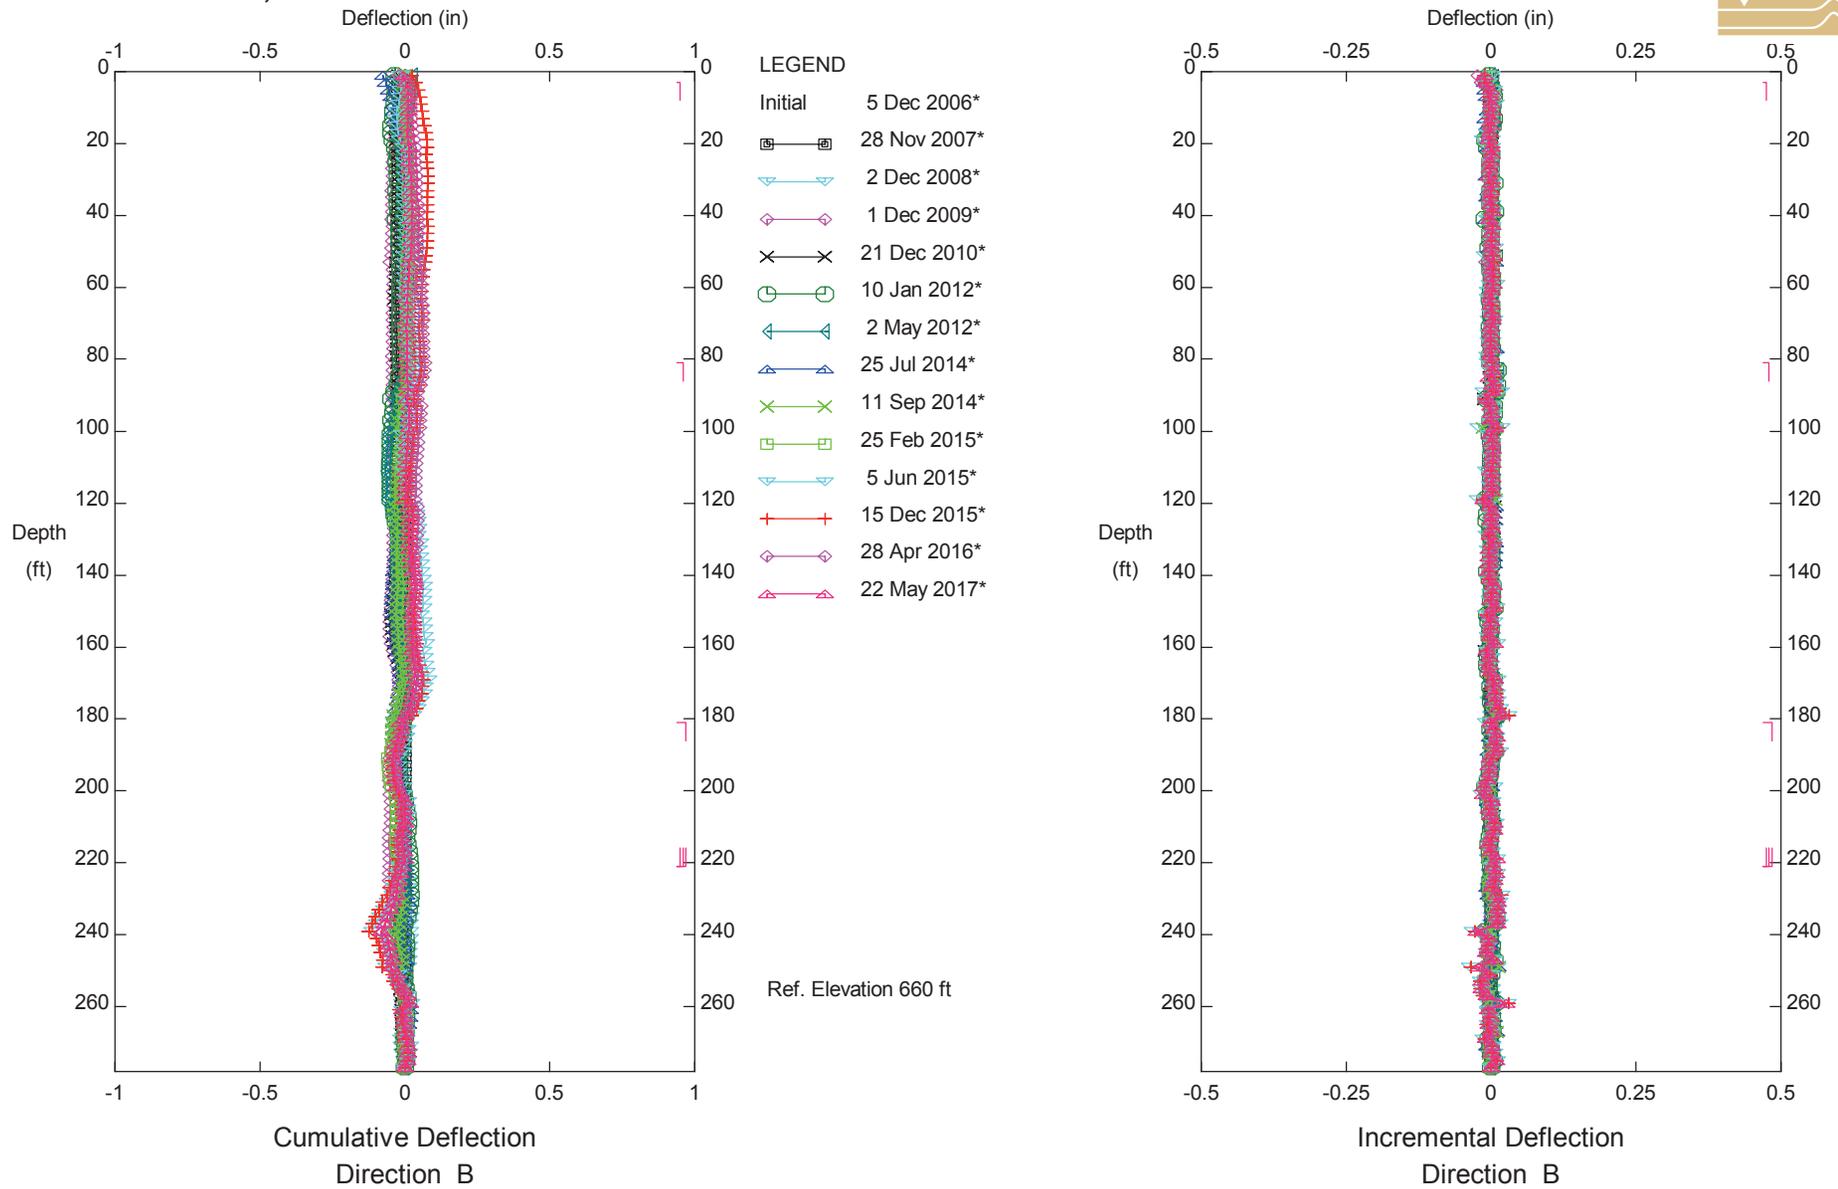
BIG ROCK MESA, Inclinator SP-21
 WESTERN REGION

Sets marked * include zero shift and/or rotation corrections.

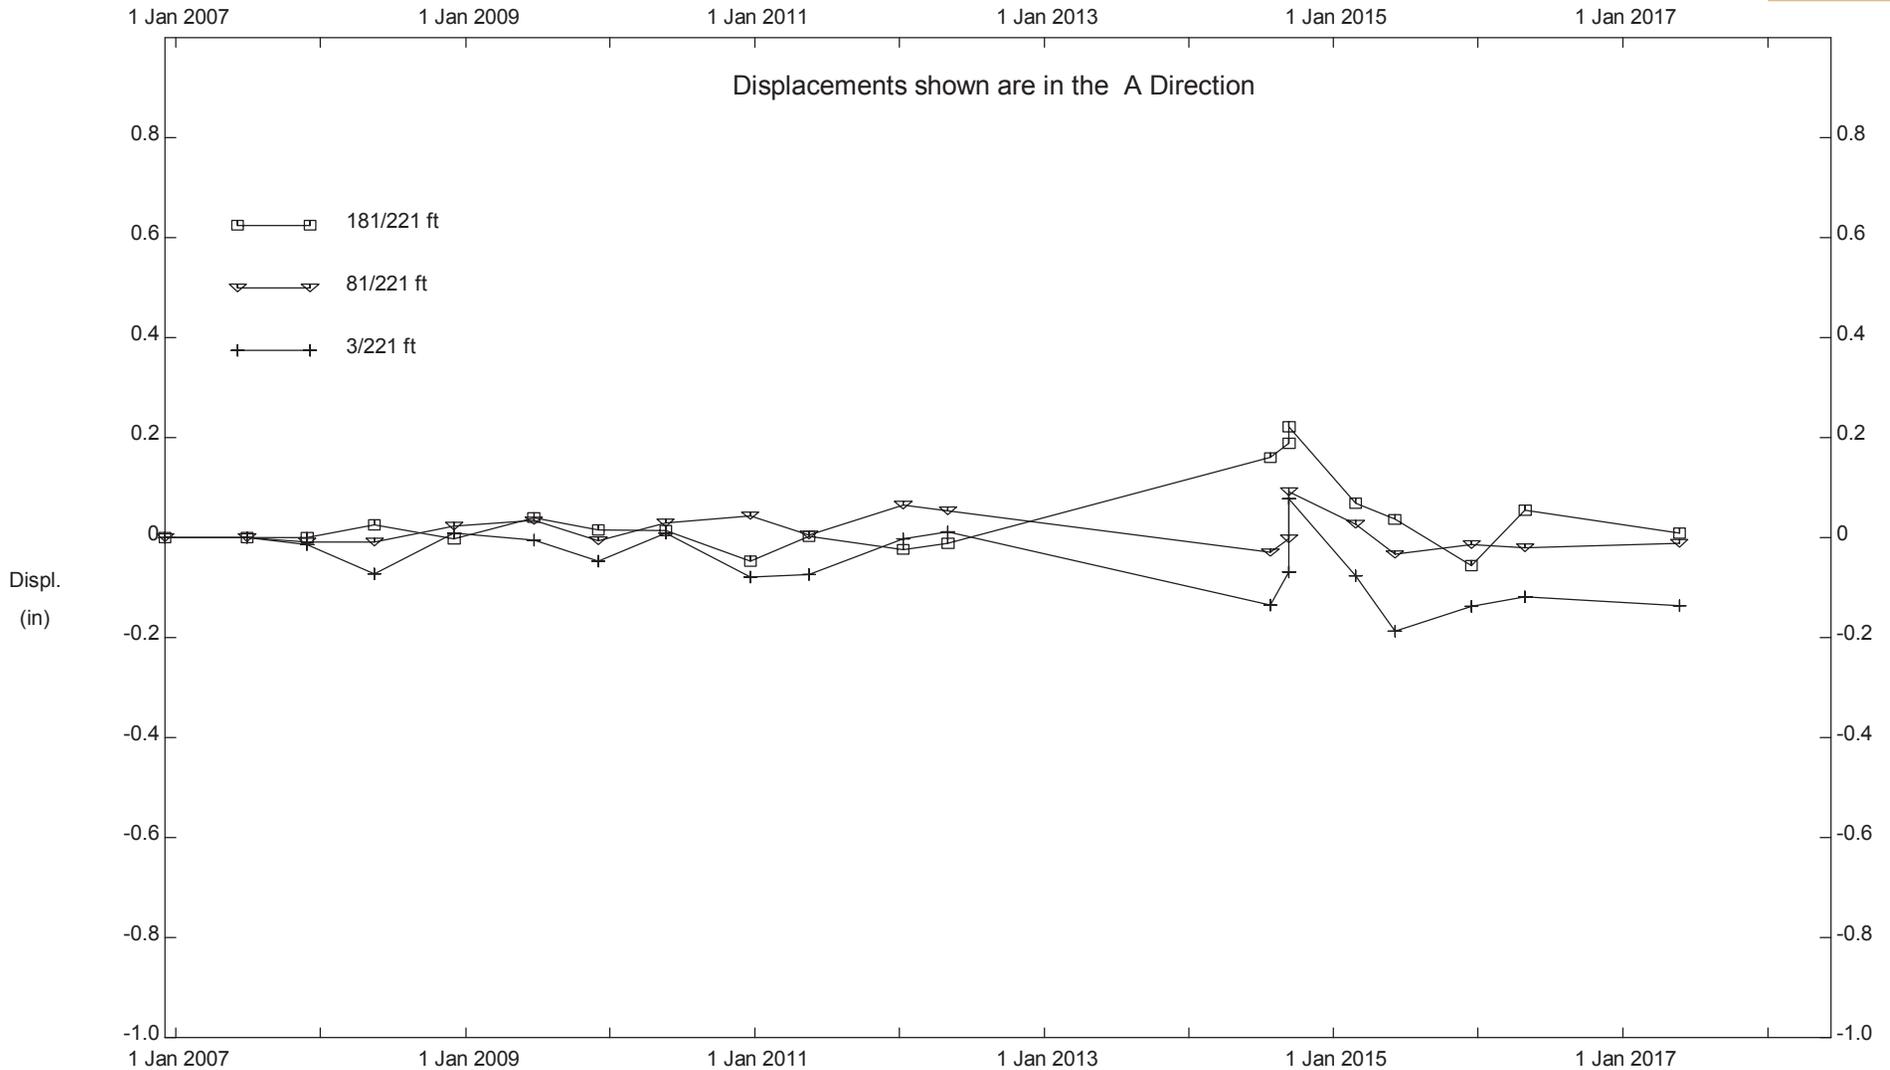
PLATE D25-3

BIG ROCK MESA, Inclinometer SP-21

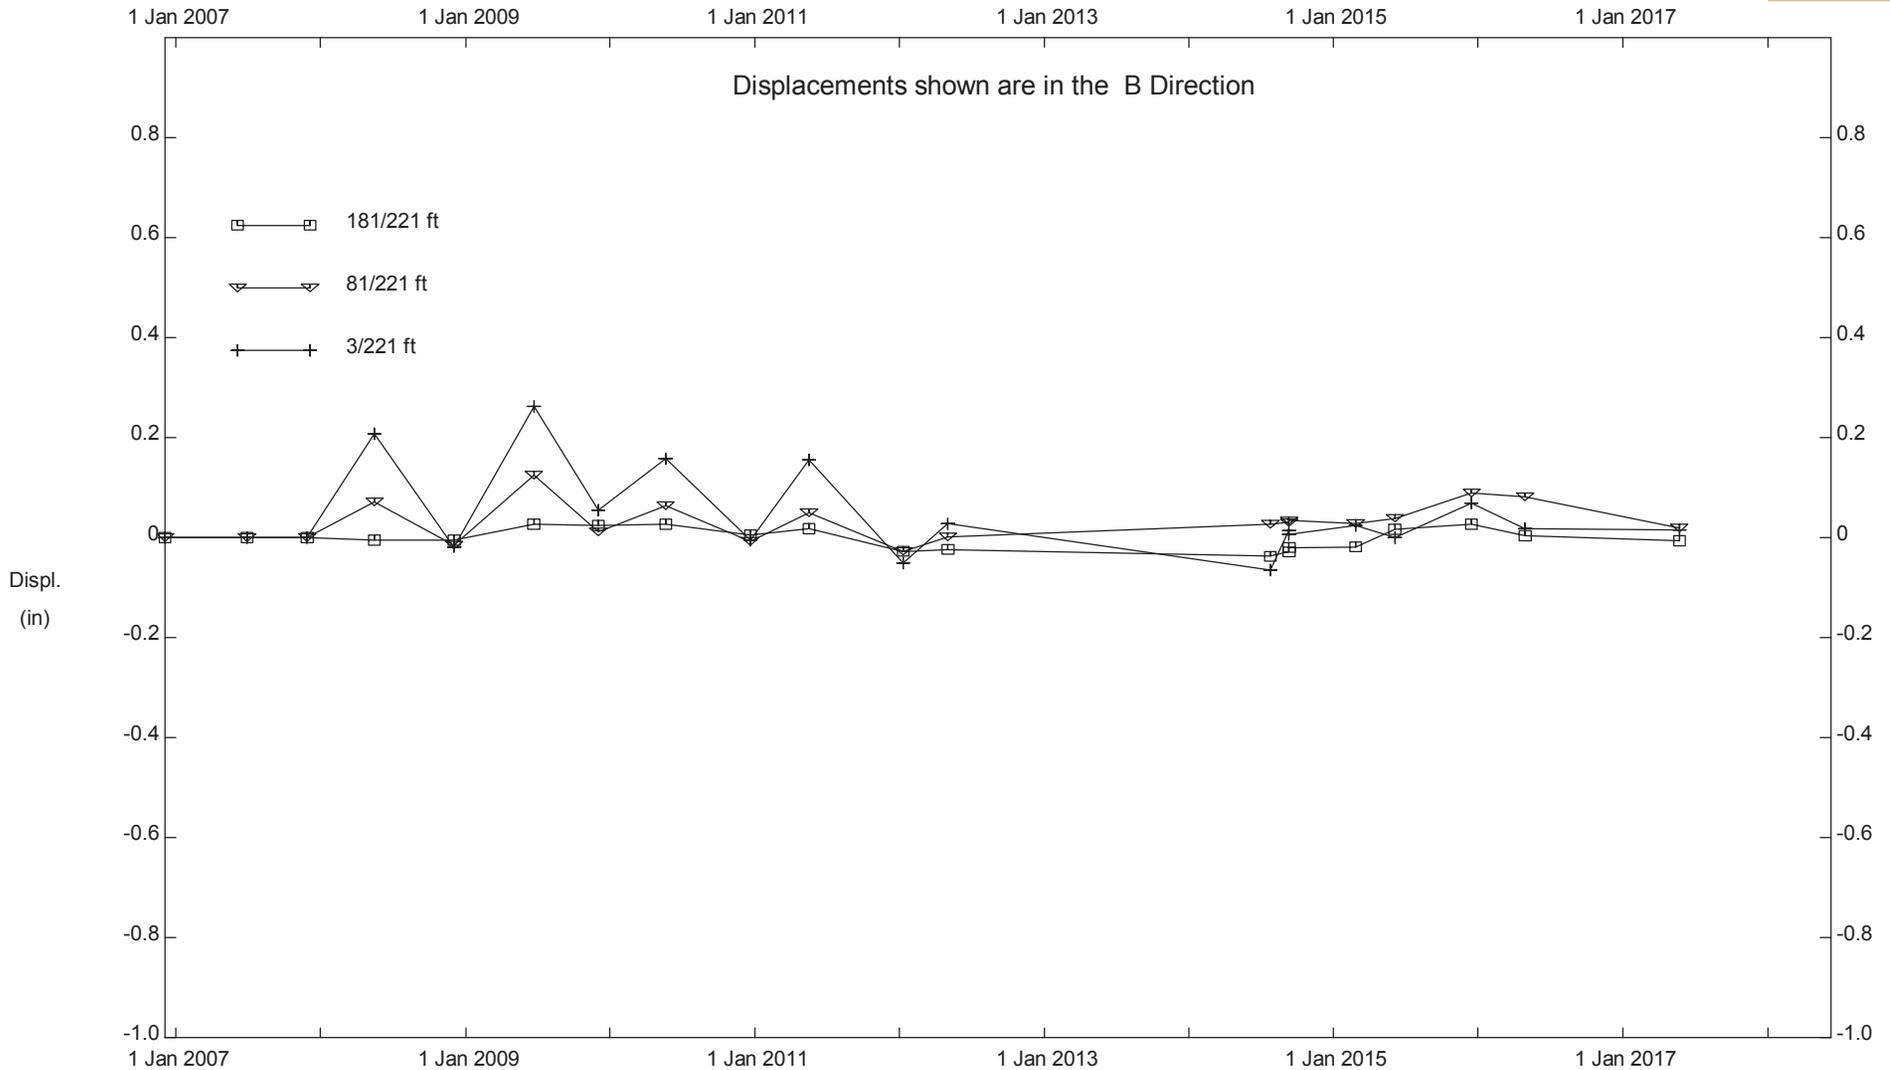
PLATE D25-4

BIG ROCK MESA, Inclinometer SP-21

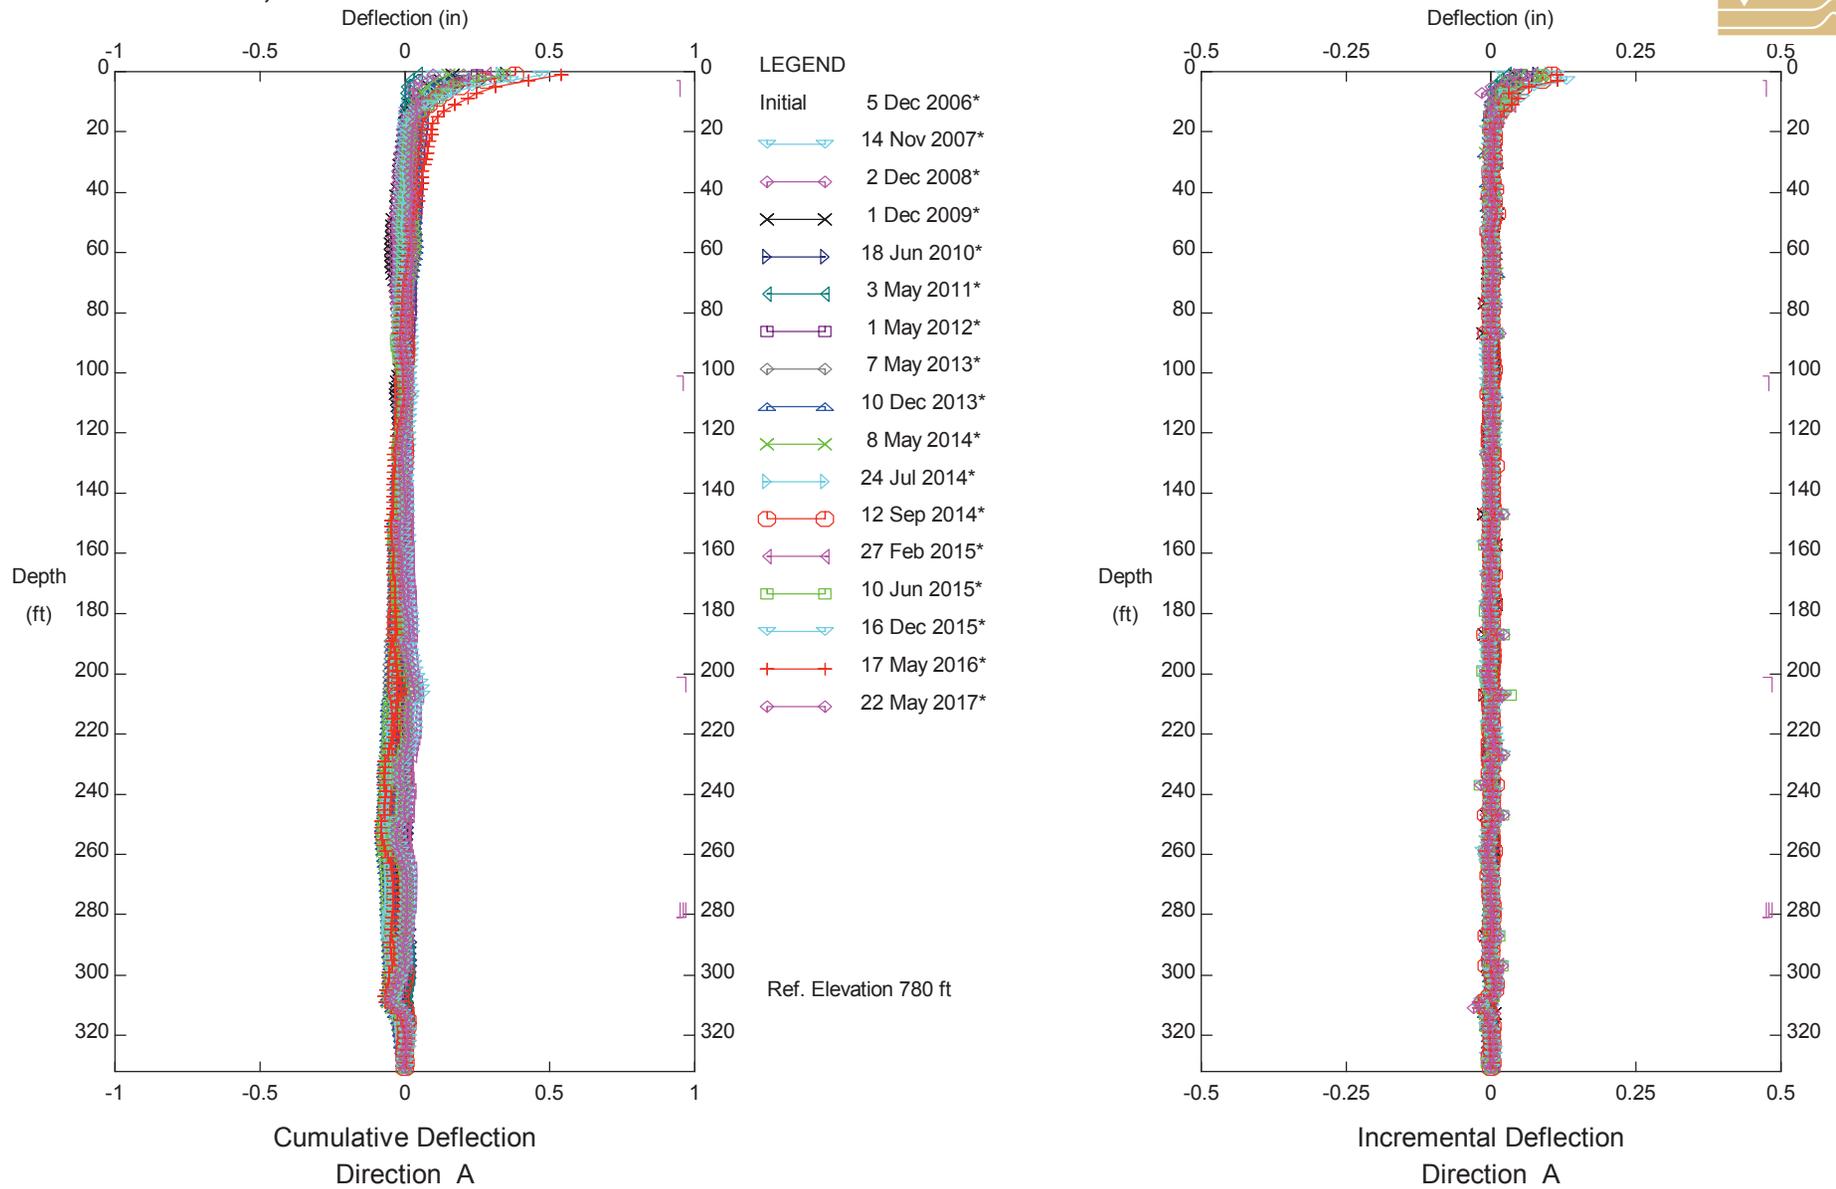
BIG ROCK MESA, Inclinometer SP-22
 WESTERN REGION

Sets marked * include zero shift and/or rotation corrections.

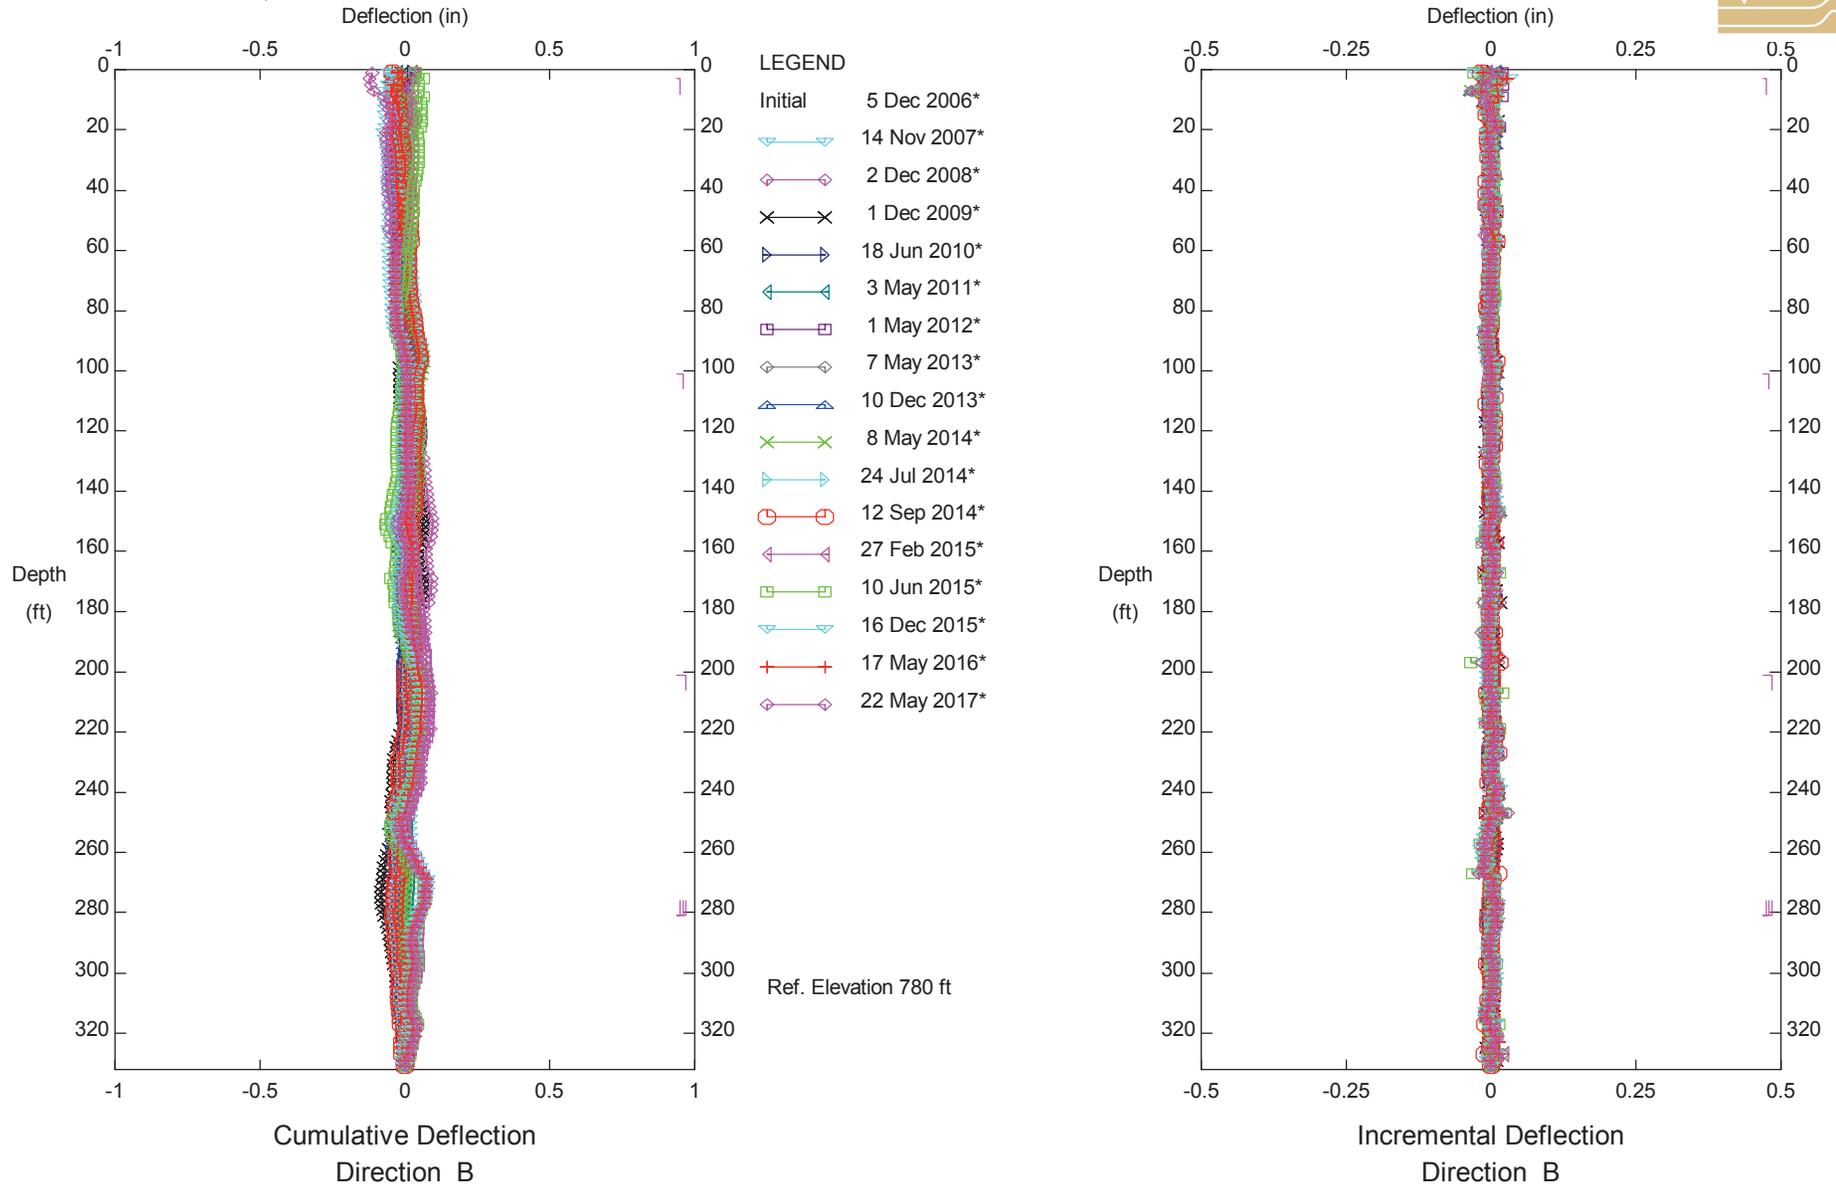
BIG ROCK MESA, Inclinometer SP-22
 WESTERN REGION

Sets marked * include zero shift and/or rotation corrections.

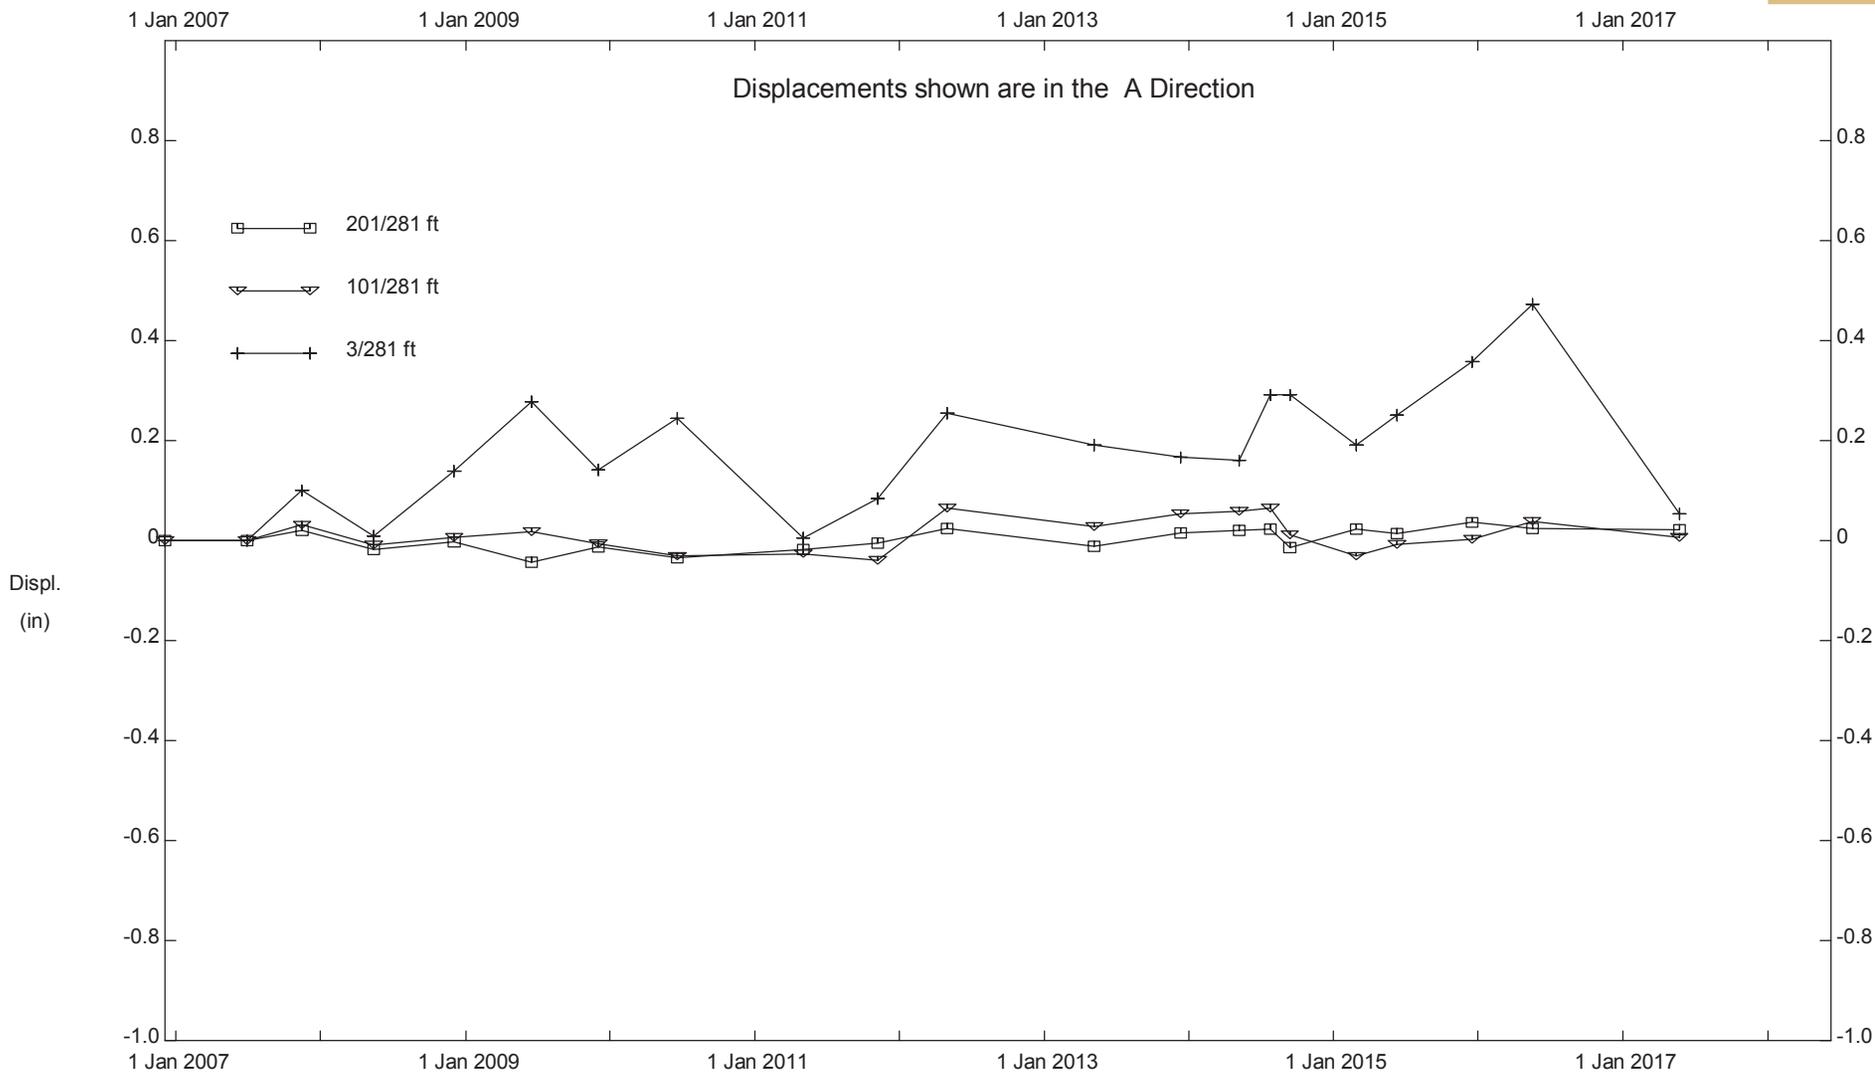
PLATE D26-3

BIG ROCK MESA, Inclinometer SP-22

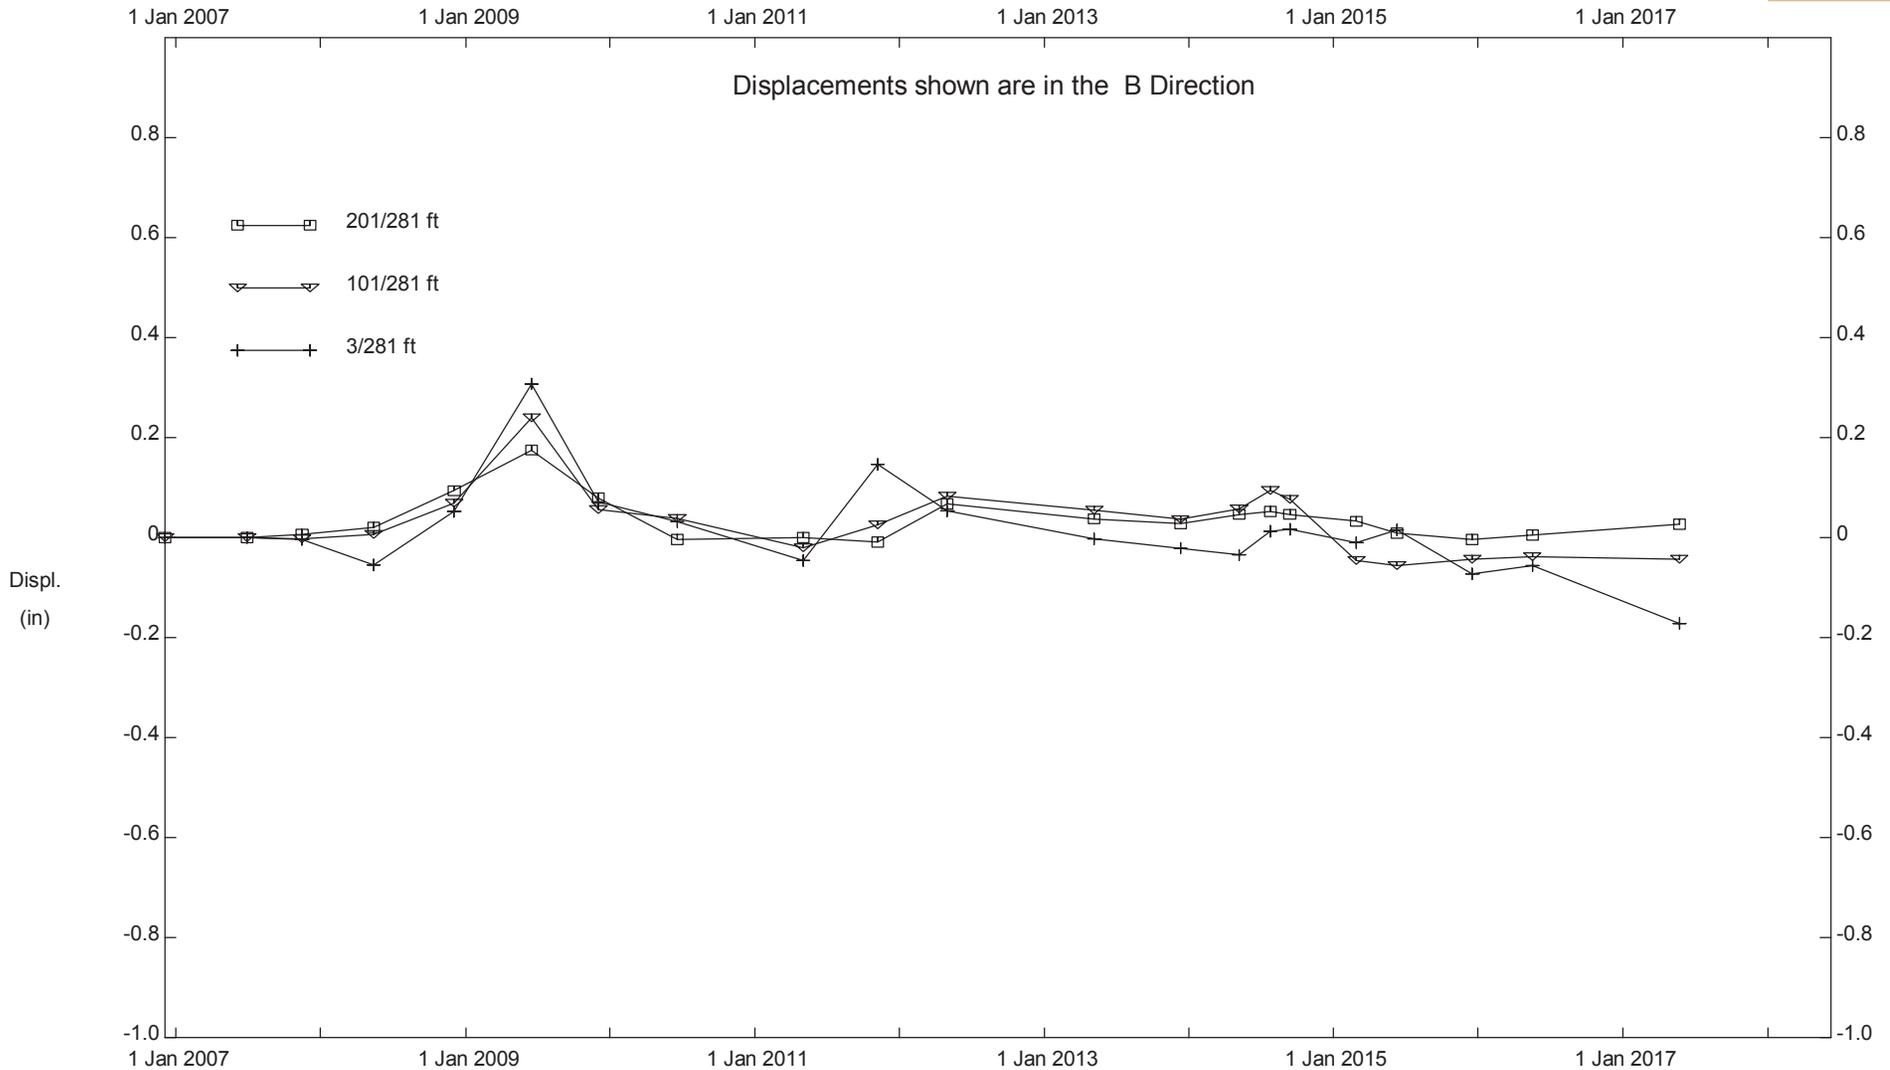
PLATE D26-4

BIG ROCK MESA, Inclinometer SP-22

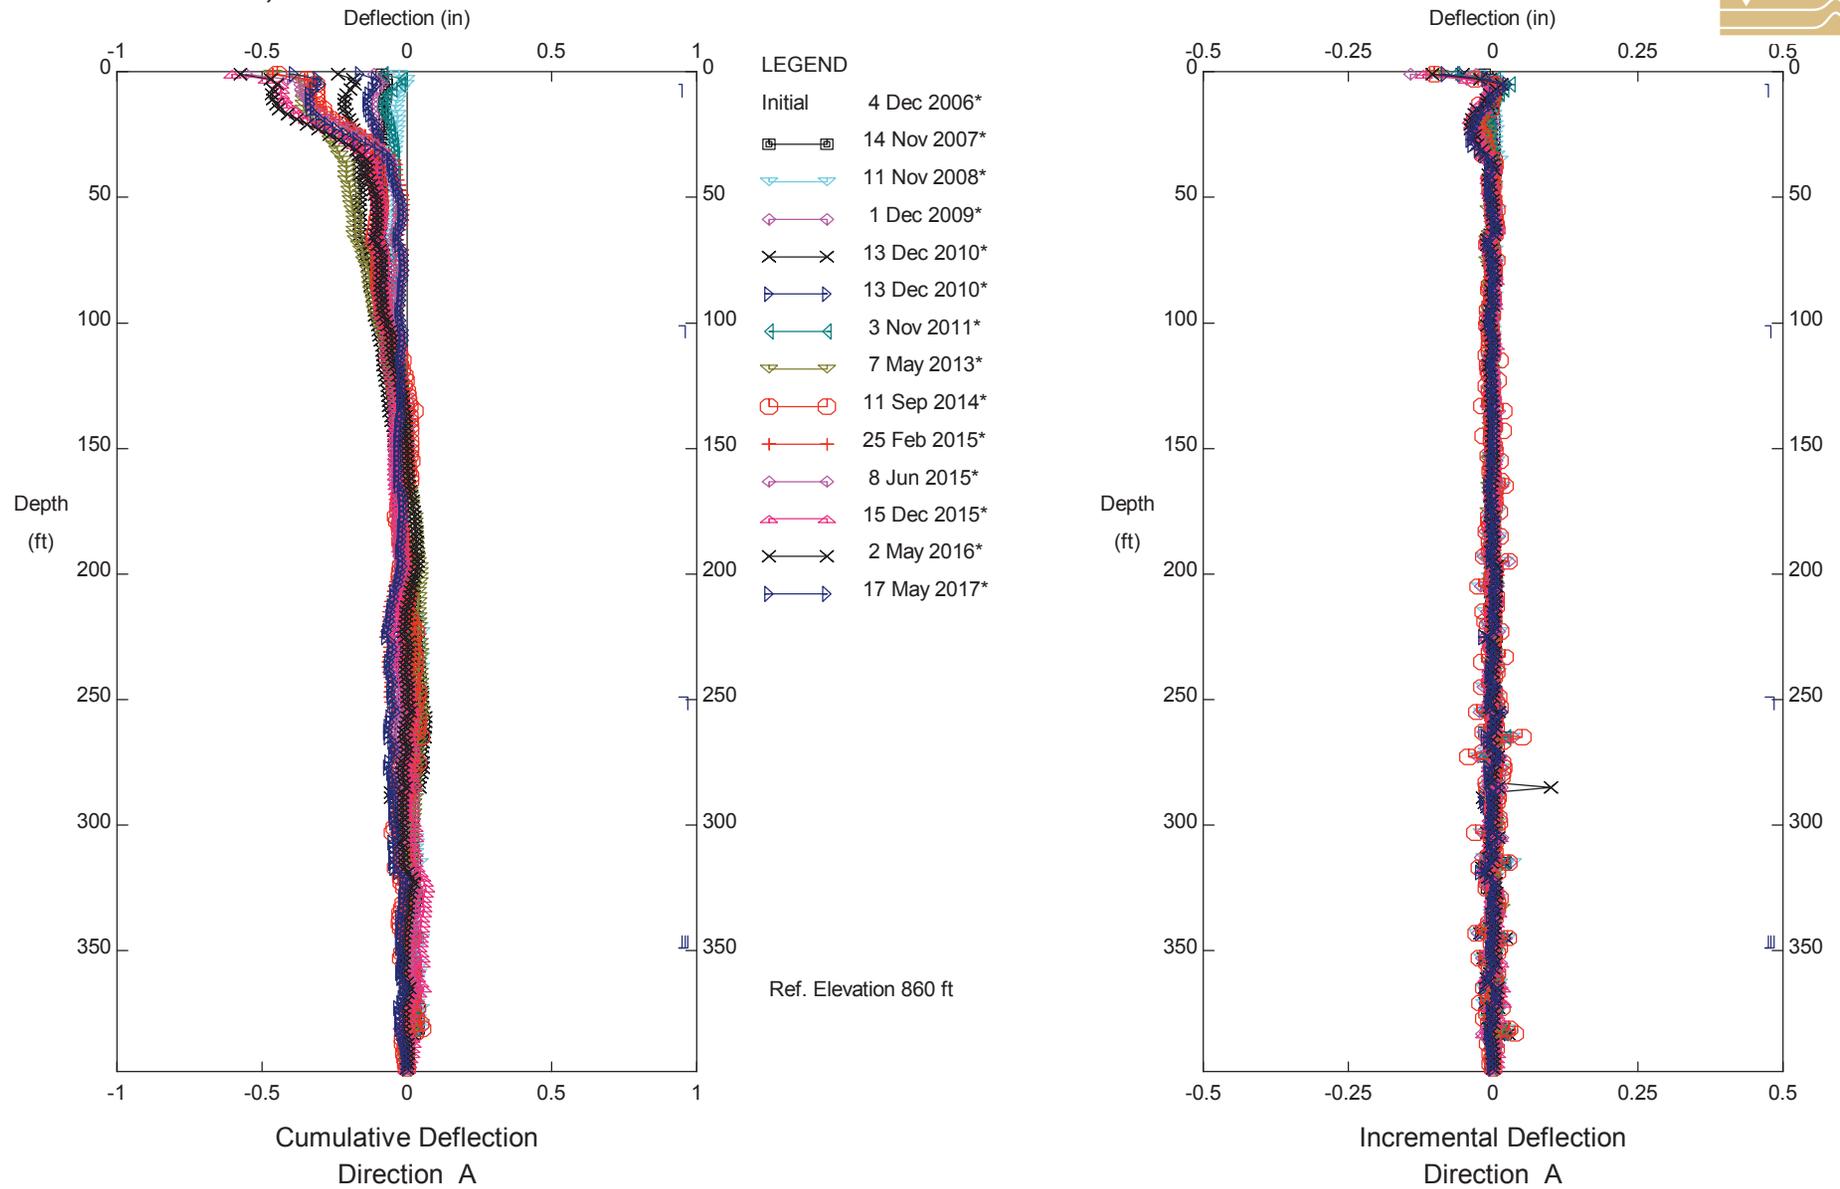
BIG ROCK MESA, Inclinometer SP-23
 WESTERN REGION

Sets marked * include zero shift and/or rotation corrections.

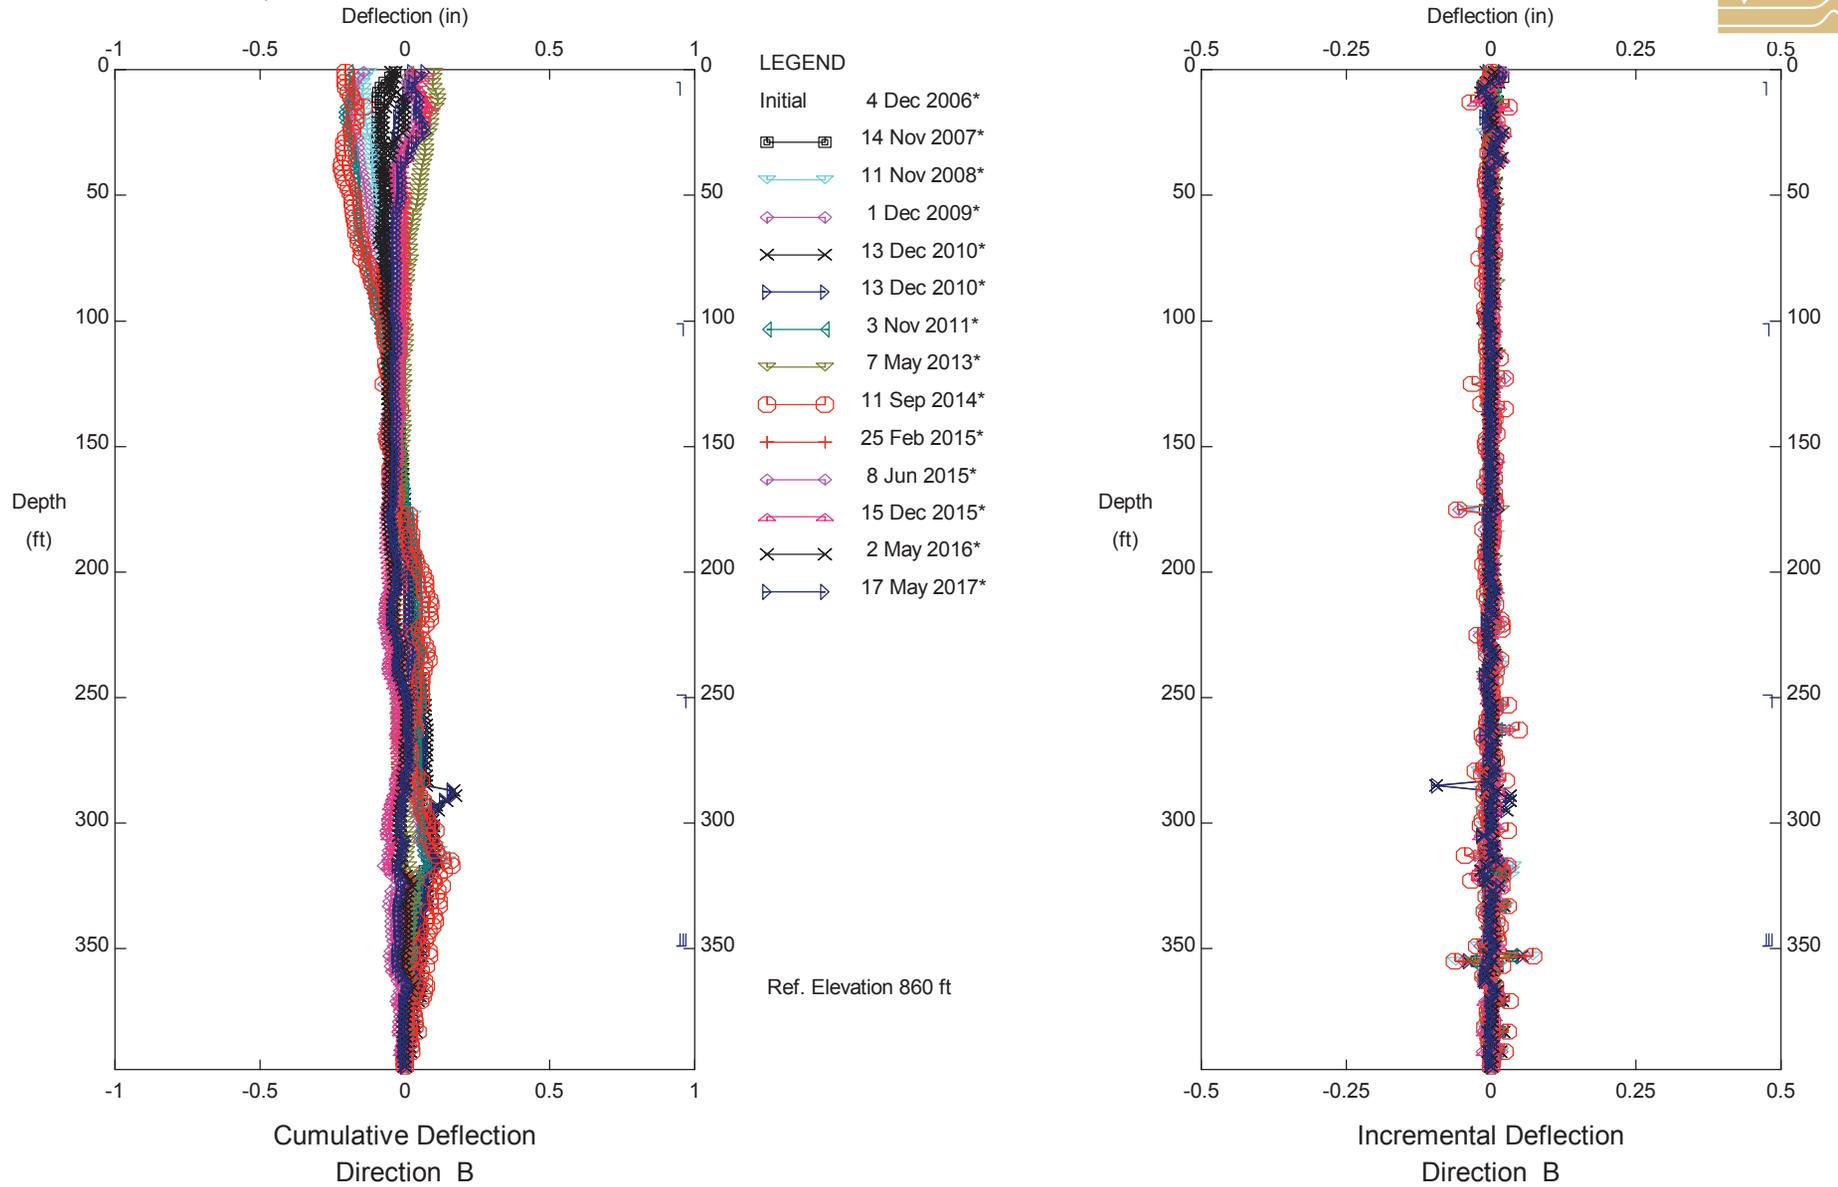
**BIG ROCK MESA, Inclinometer SP-23
 WESTERN REGION**

Sets marked * include zero shift and/or rotation corrections.

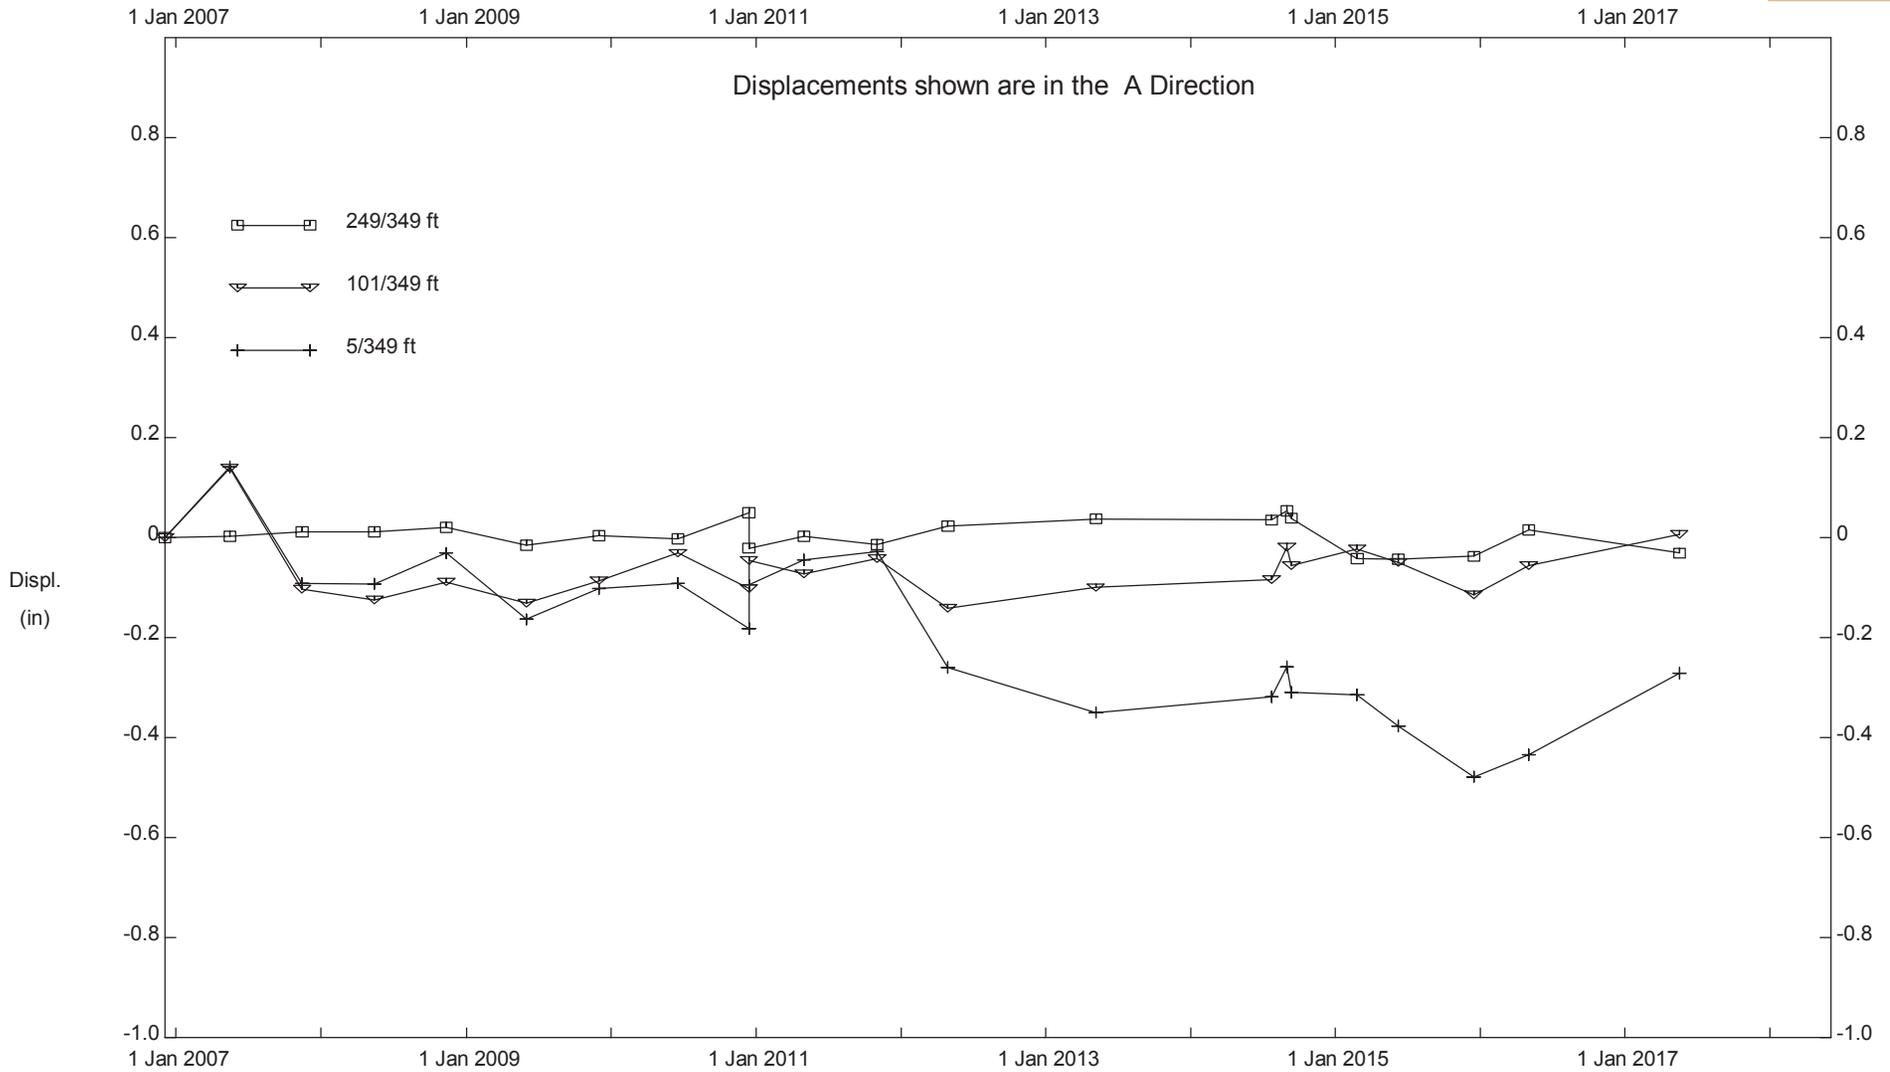
PLATE D27-3

BIG ROCK MESA, Inclinometer SP-23

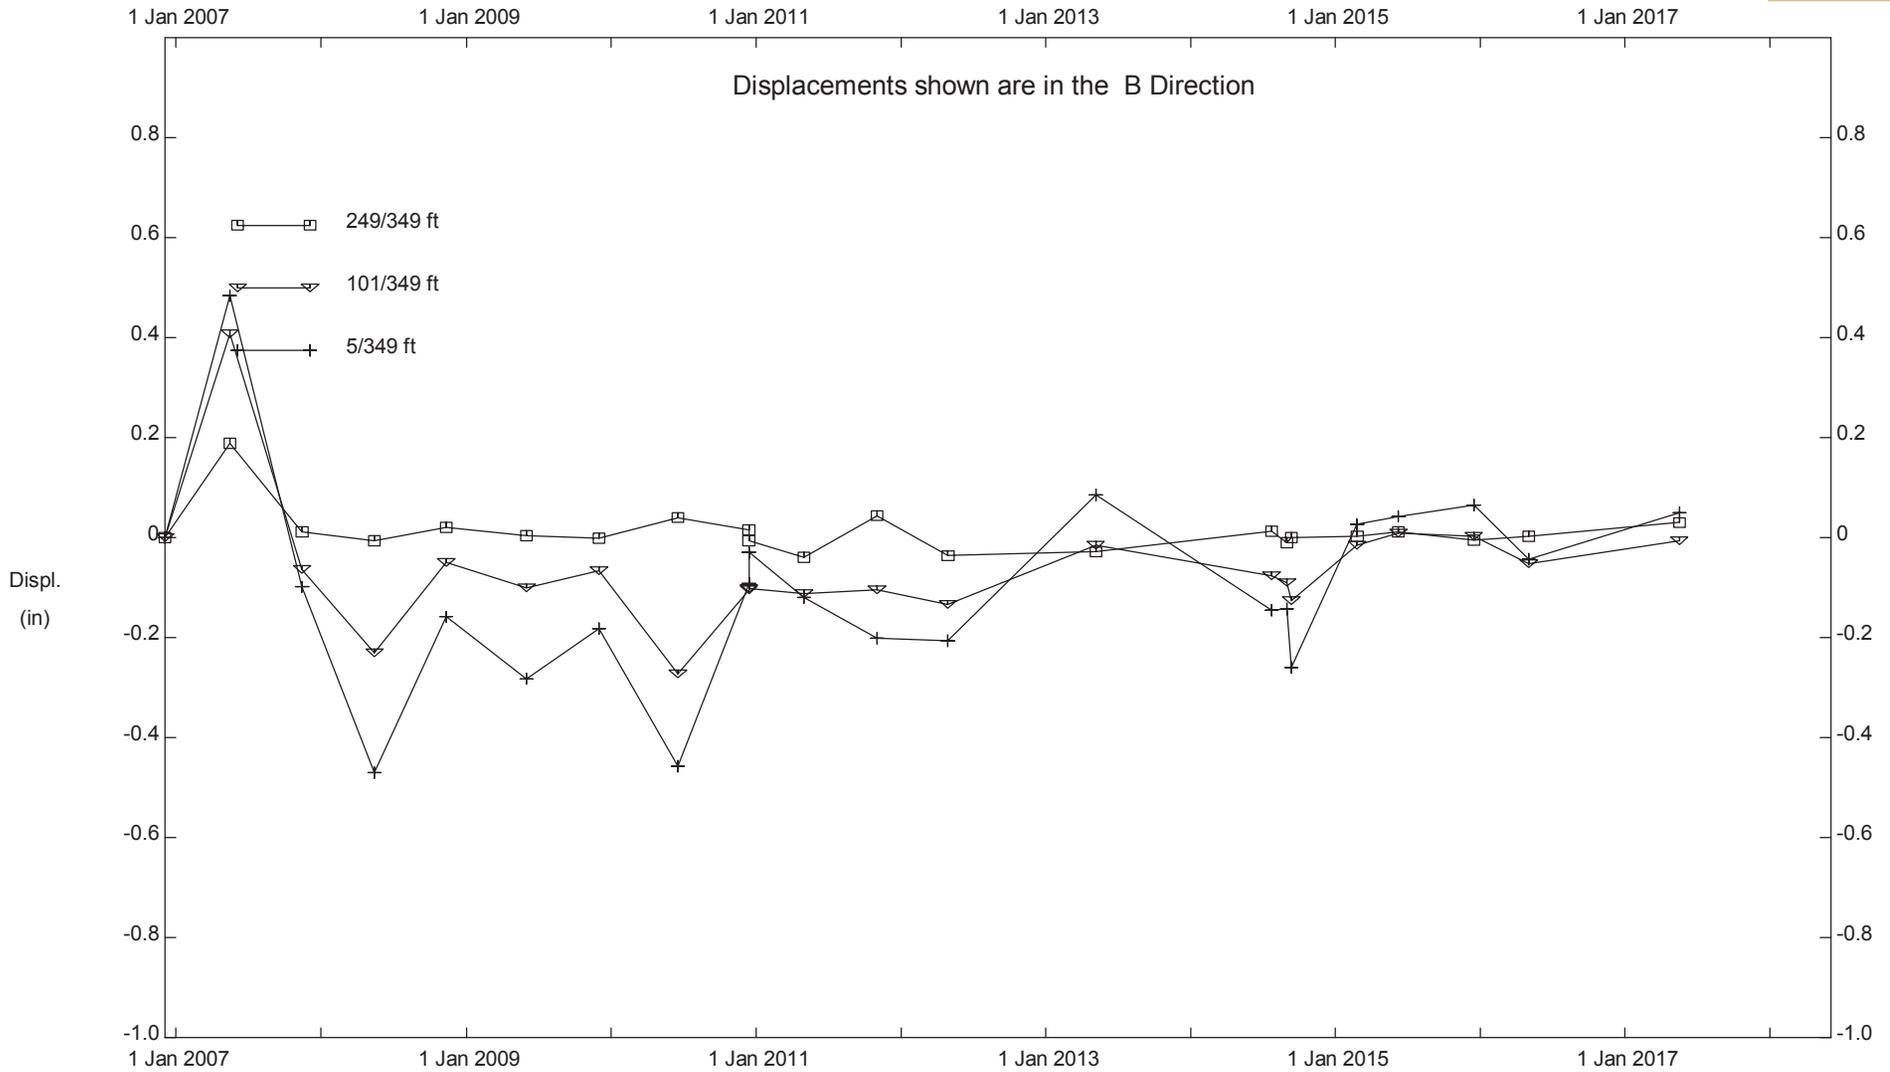
PLATE D27-4

BIG ROCK MESA, Inclinometer SP-23
