**ANNUAL REPORT
JULY 2016 THROUGH JUNE 2017
BIG ROCK MESA LANDSLIDE
ASSESSMENT DISTRICT
City of Malibu, California**

March 2018
Fugro Project No. 04.62160606
Document No. 04.62160606-PR-004(Rev.00)

**Annual Report of Maintenance and Monitoring, July 2016 through June 2017,
Big Rock Mesa Landslide Assessment District, City of Malibu, California**

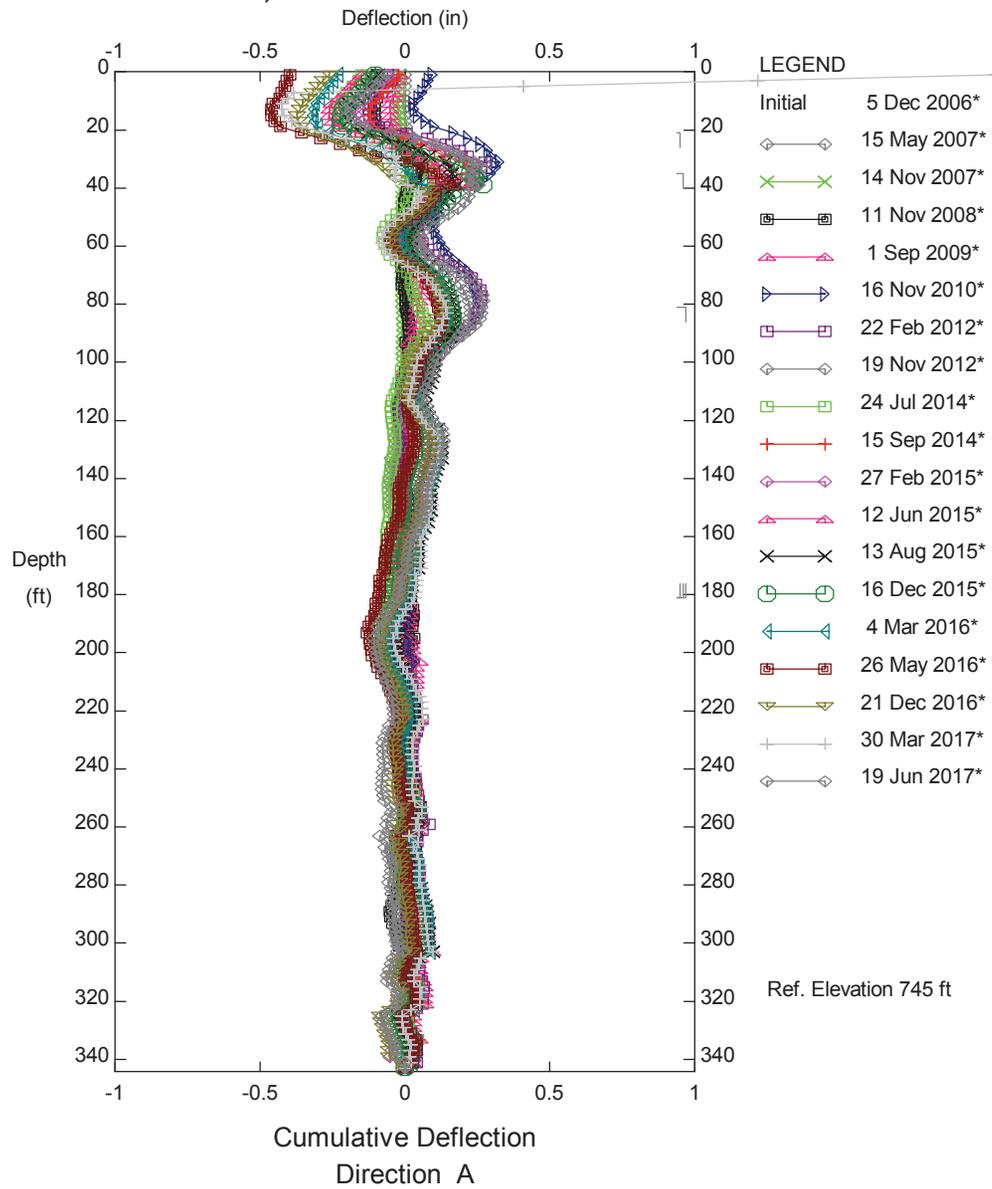
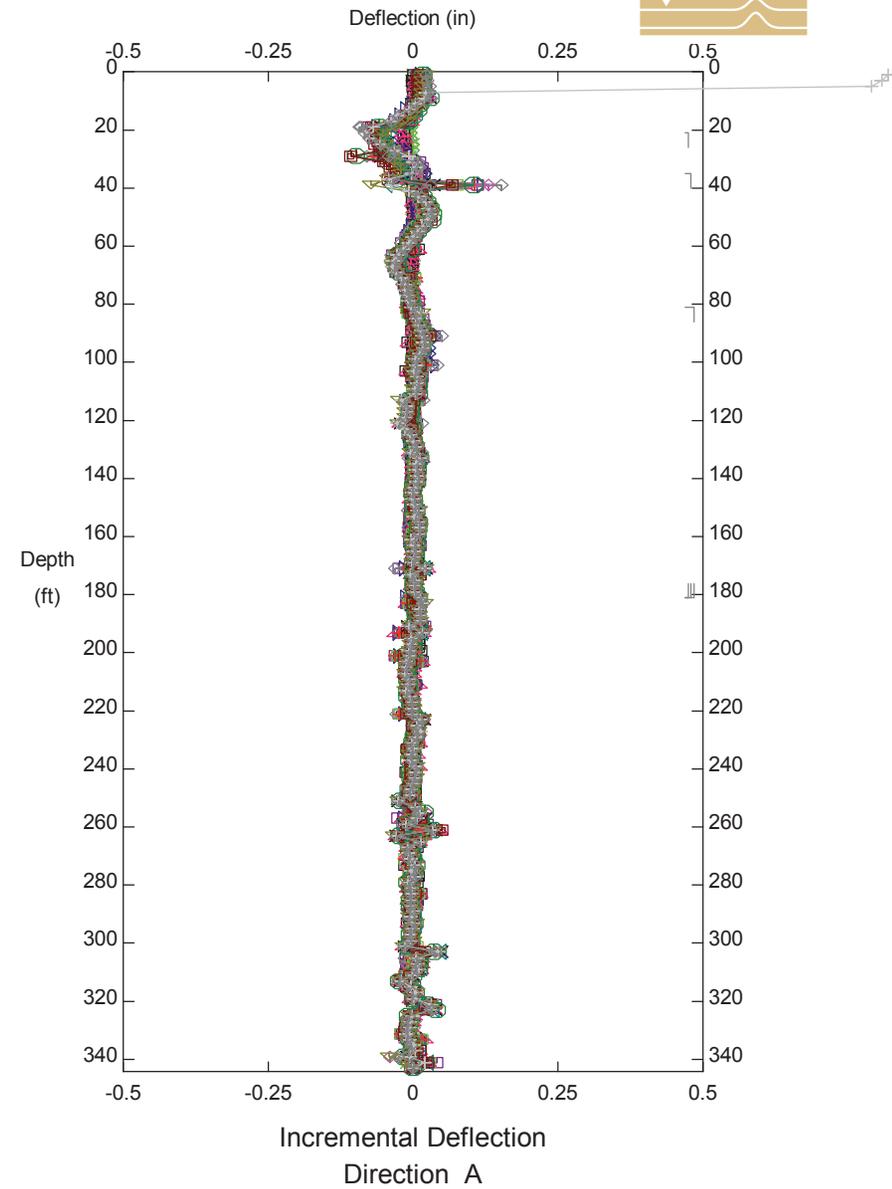
BIG ROCK MESA, Inclinator SP-26
 HEADSCARP REGION

Sets marked * include zero shift and/or rotation corrections.

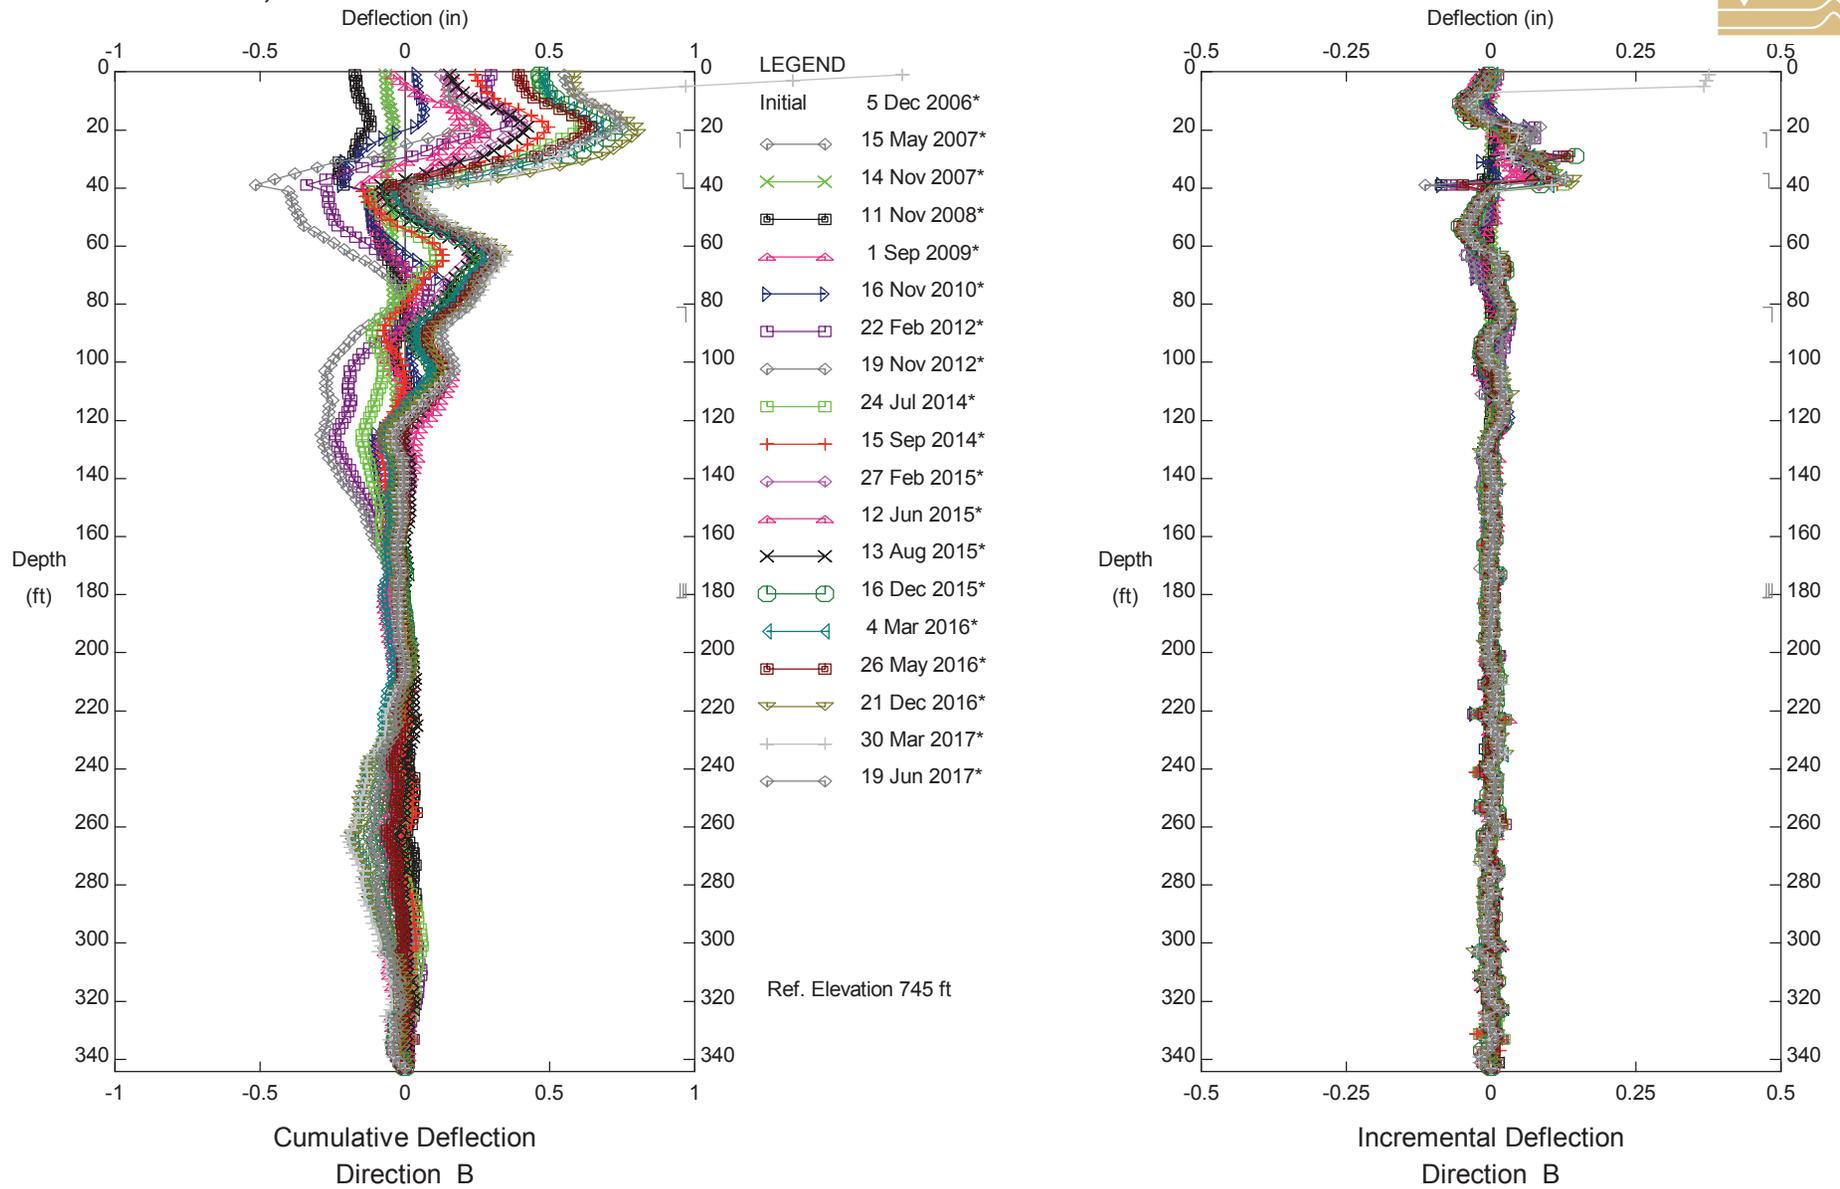
BIG ROCK MESA, Inclinometer SP-26
 HEADSCARP REGION

Sets marked * include zero shift and/or rotation corrections.

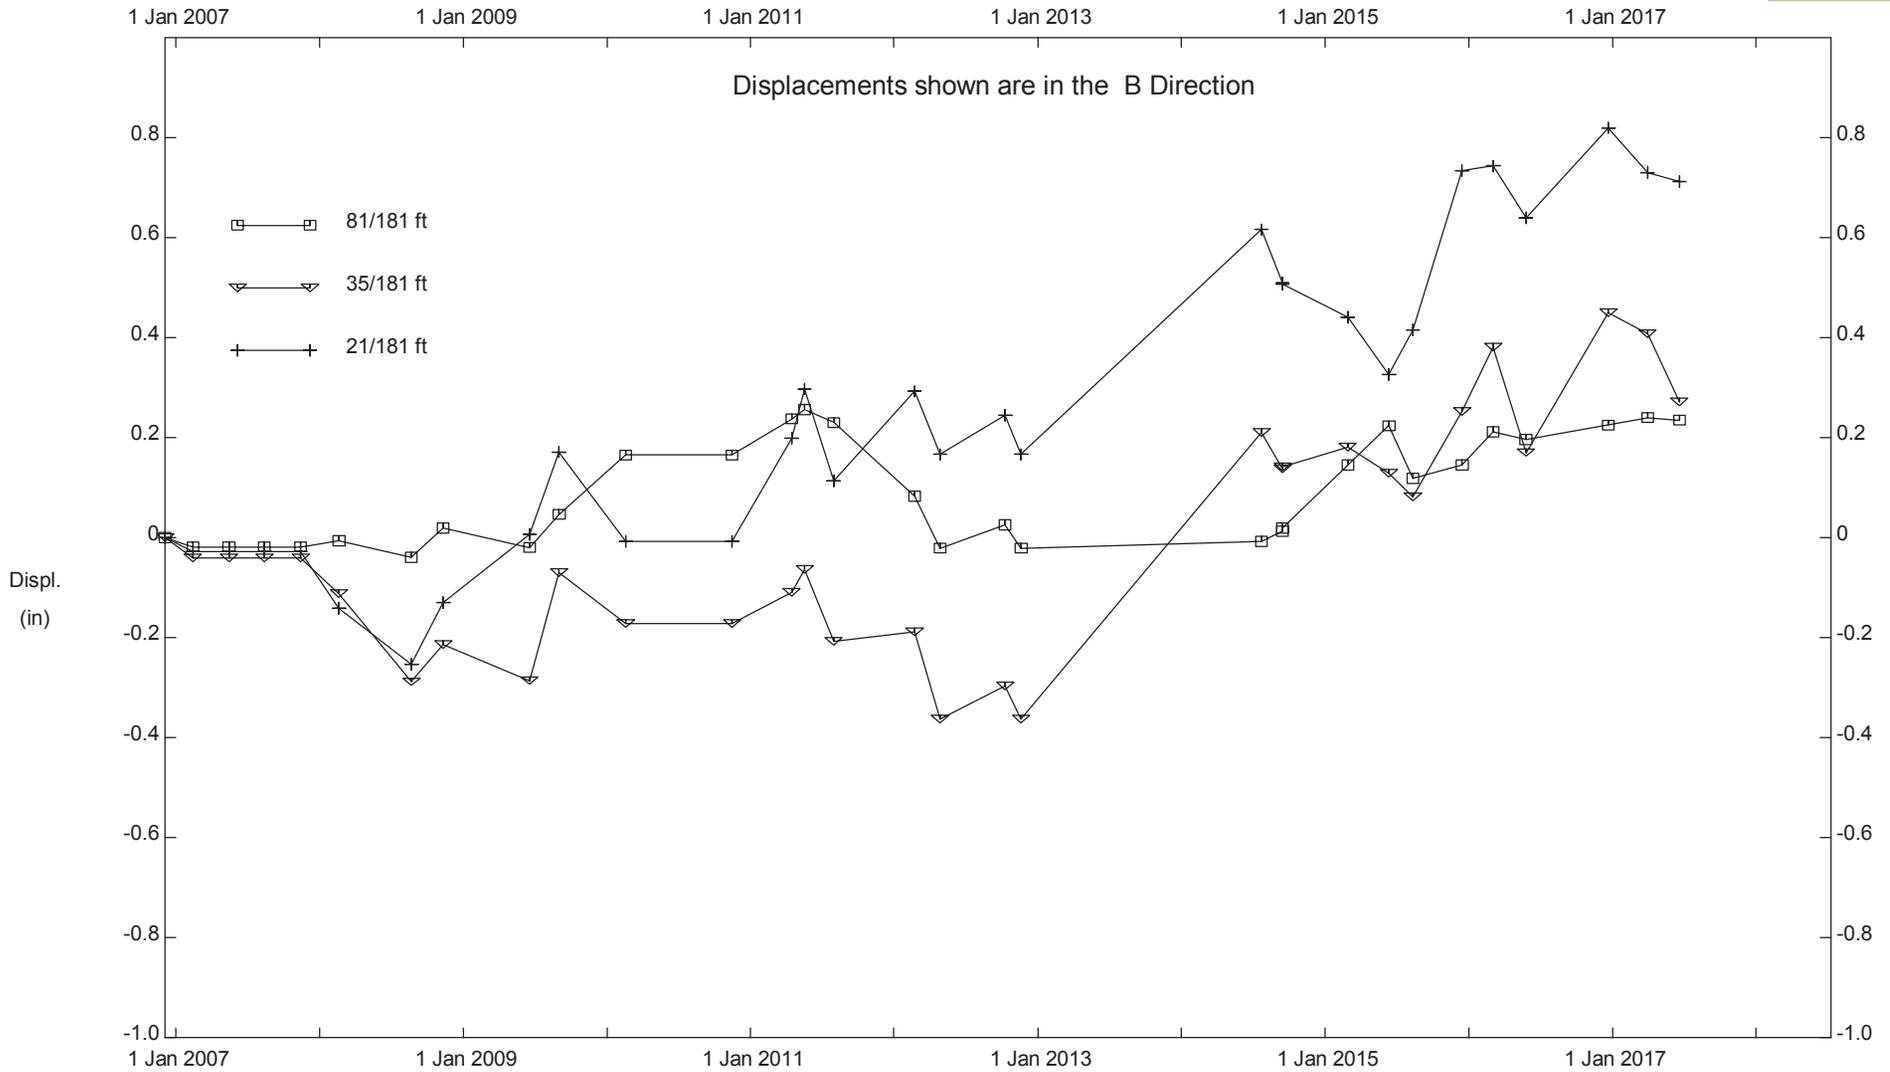
BIG ROCK MESA, Inclinometer SP-26
