**ANNUAL REPORT
JULY 2018 THROUGH JUNE 2019
BIG ROCK MESA LANDSLIDE
ASSESSMENT DISTRICT
City of Malibu, California**

November 2019
Fugro Project No. 04.62160606
Document No. 04.62160606-PR-006(Rev.00)

Annual Report of Maintenance and Monitoring, July 2018 through June 2019, Big Rock Mesa Landslide Assessment District, City of Malibu, California

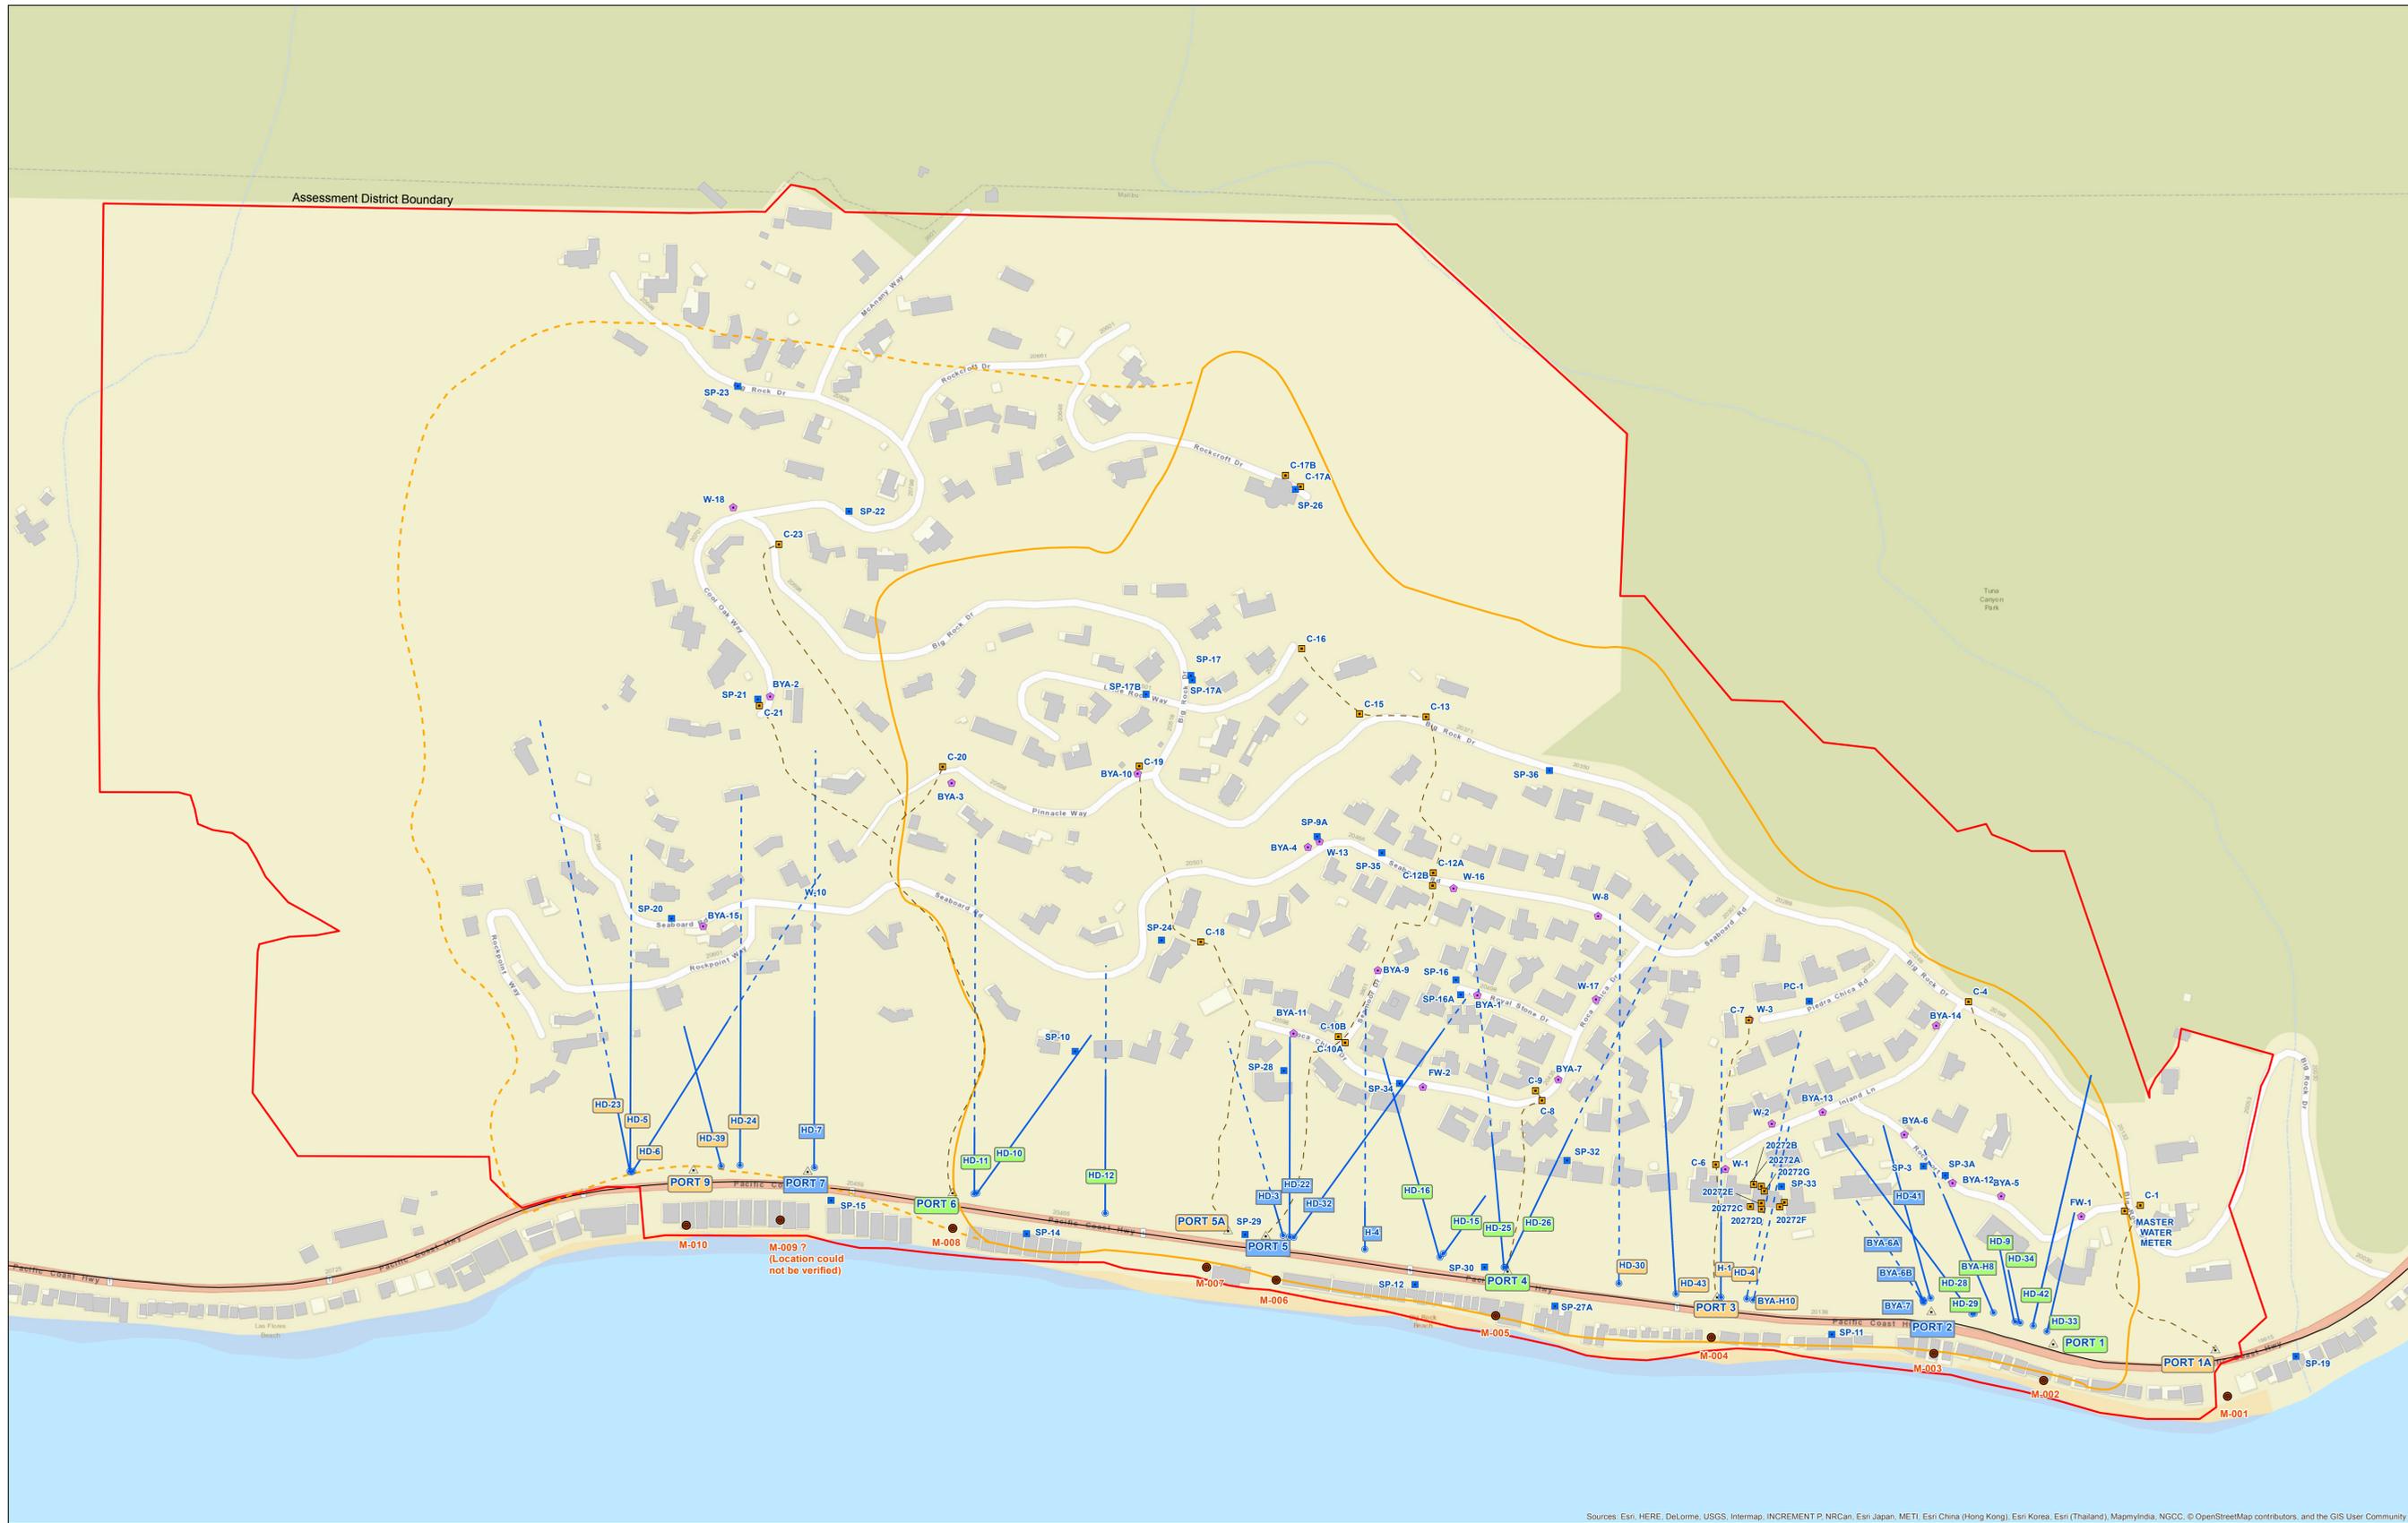
DEWATERING FACILITIES MAP

- Standpipe
- Dewatering Well (In Service)
- Hydrauger (In Service) Color Referenced to Inferred Storm Drain Outfall
- Storm Drain Outfall
- Catch Basin
- Discharge Point
- Hydrauger
- Approximate Limits of Primary Land Movement
- Western Extension Boundary
- Big Rock Mesa Landslide Assessment District Boundary
- Storm Drain
- Trees/Bush
- Streams
- Building

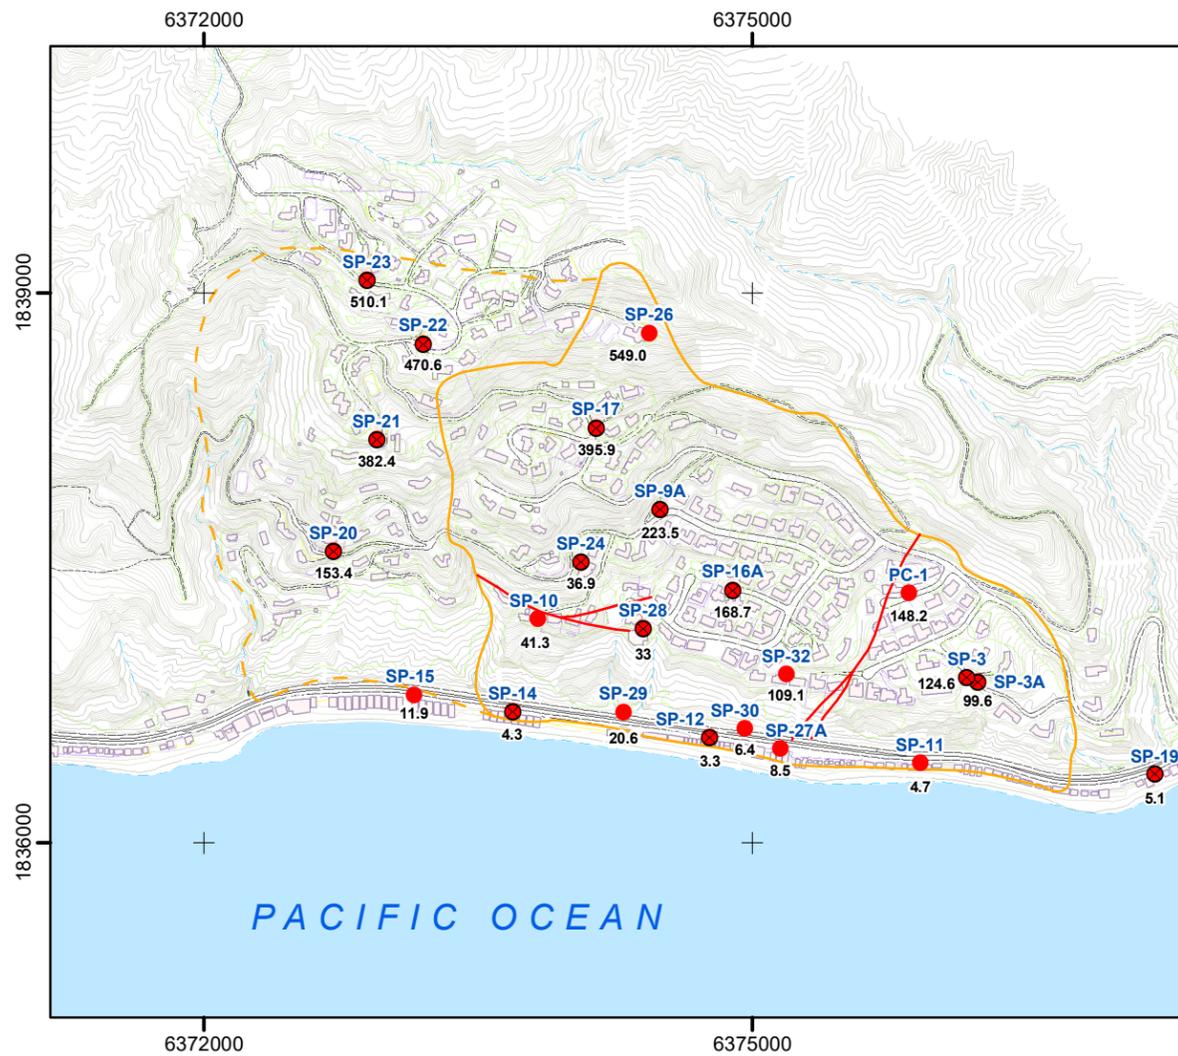
Groundwater Elevation (May 8, 1995)

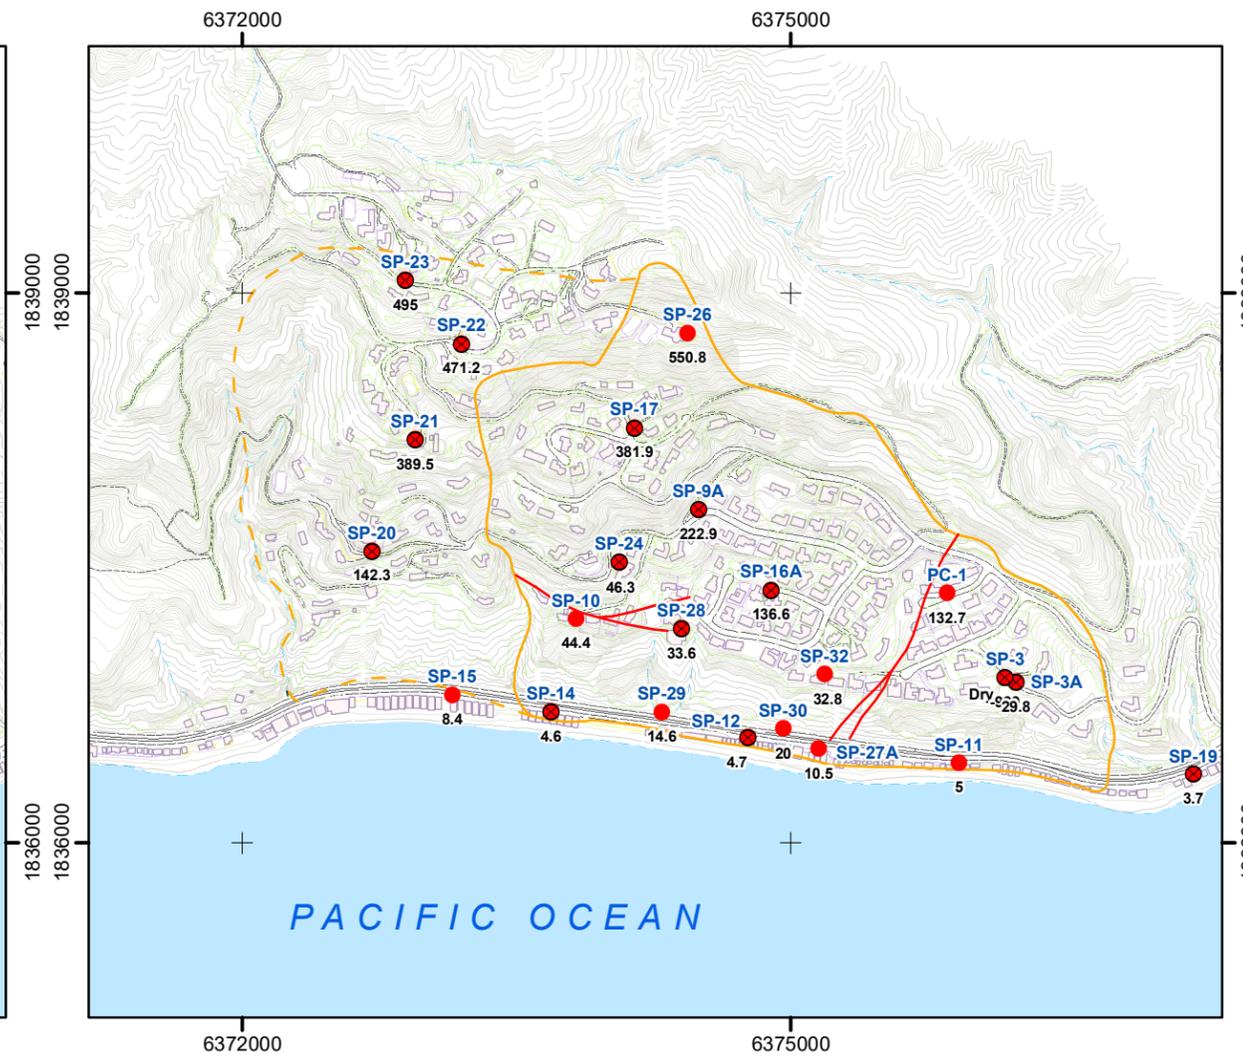
Groundwater Elevation (May 20, 2019)

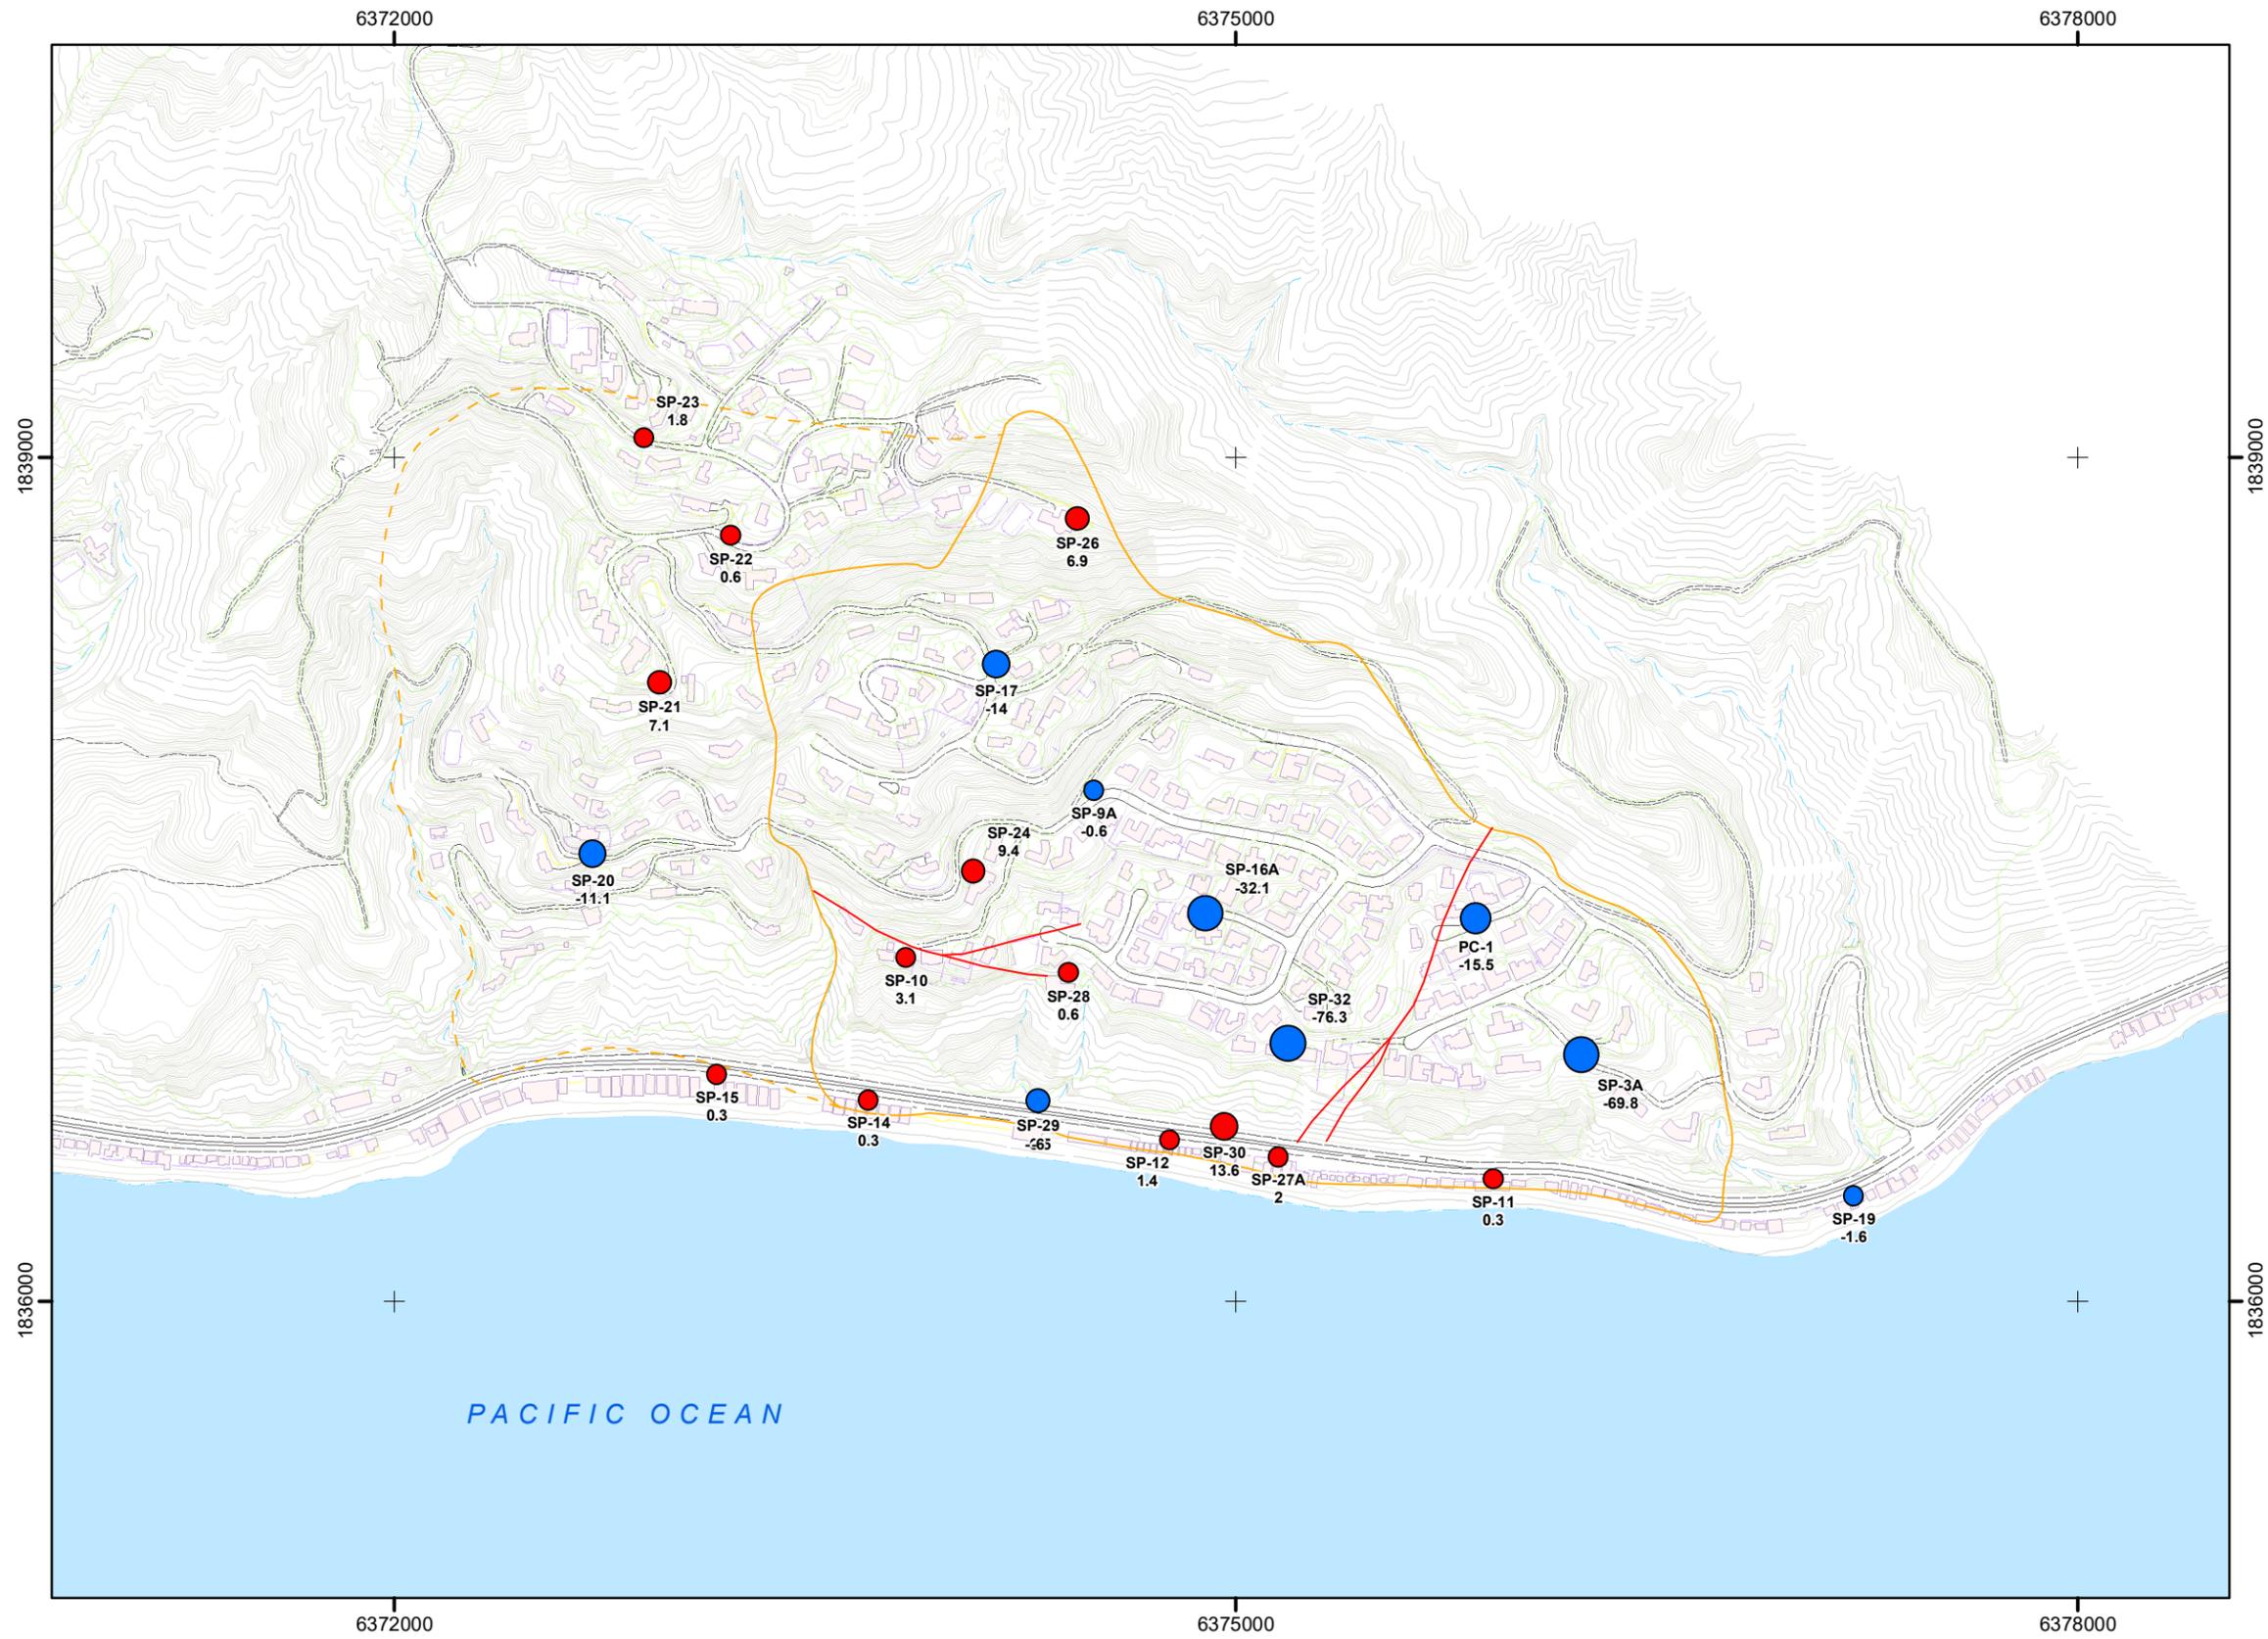
**CHANGE IN GROUNDWATER
ELEVATION MAY 1995 TO MAY 2019**
Big Rock Mesa Landslide
Assessment District
Malibu, California

SP-16
-3.1
Instrument Label and Ground Water Elevation Change in feet

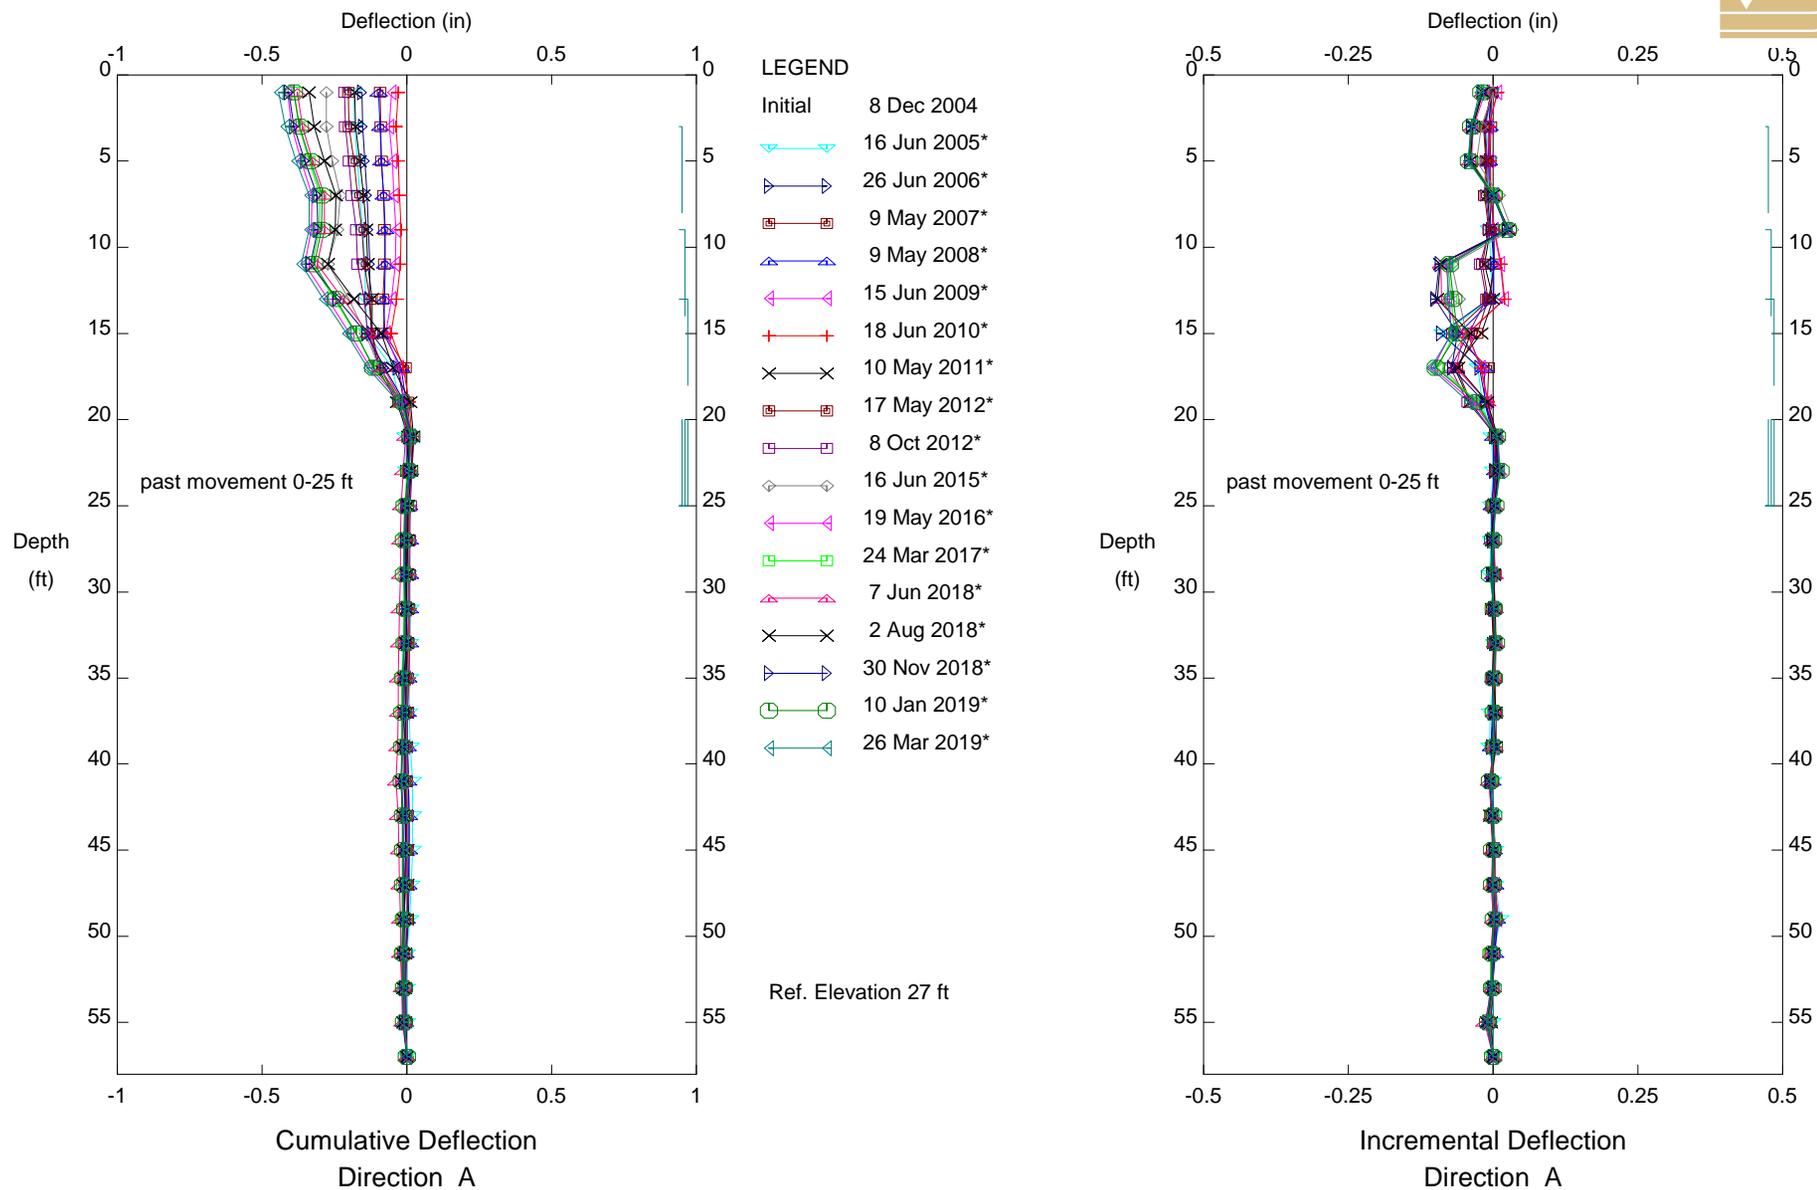
**BIG ROCK MESA, Inclinometer SP-11
 PCH REGION**

Sets marked * include zero shift and/or rotation corrections.

Several inclinometers show some inconsistent changes (typically <0.1 to 0.2 inch), but the potential movement magnitude and orientation is not clear and is not within the reliable accuracy of the instrument. Some of the irregular shapes observed in the deep inclinometers can be attributed to depth position and rotation errors caused by cable length changes, local curvatures within the casings, and significant deviation from vertical during initial installation, which is common to deep inclinometers.

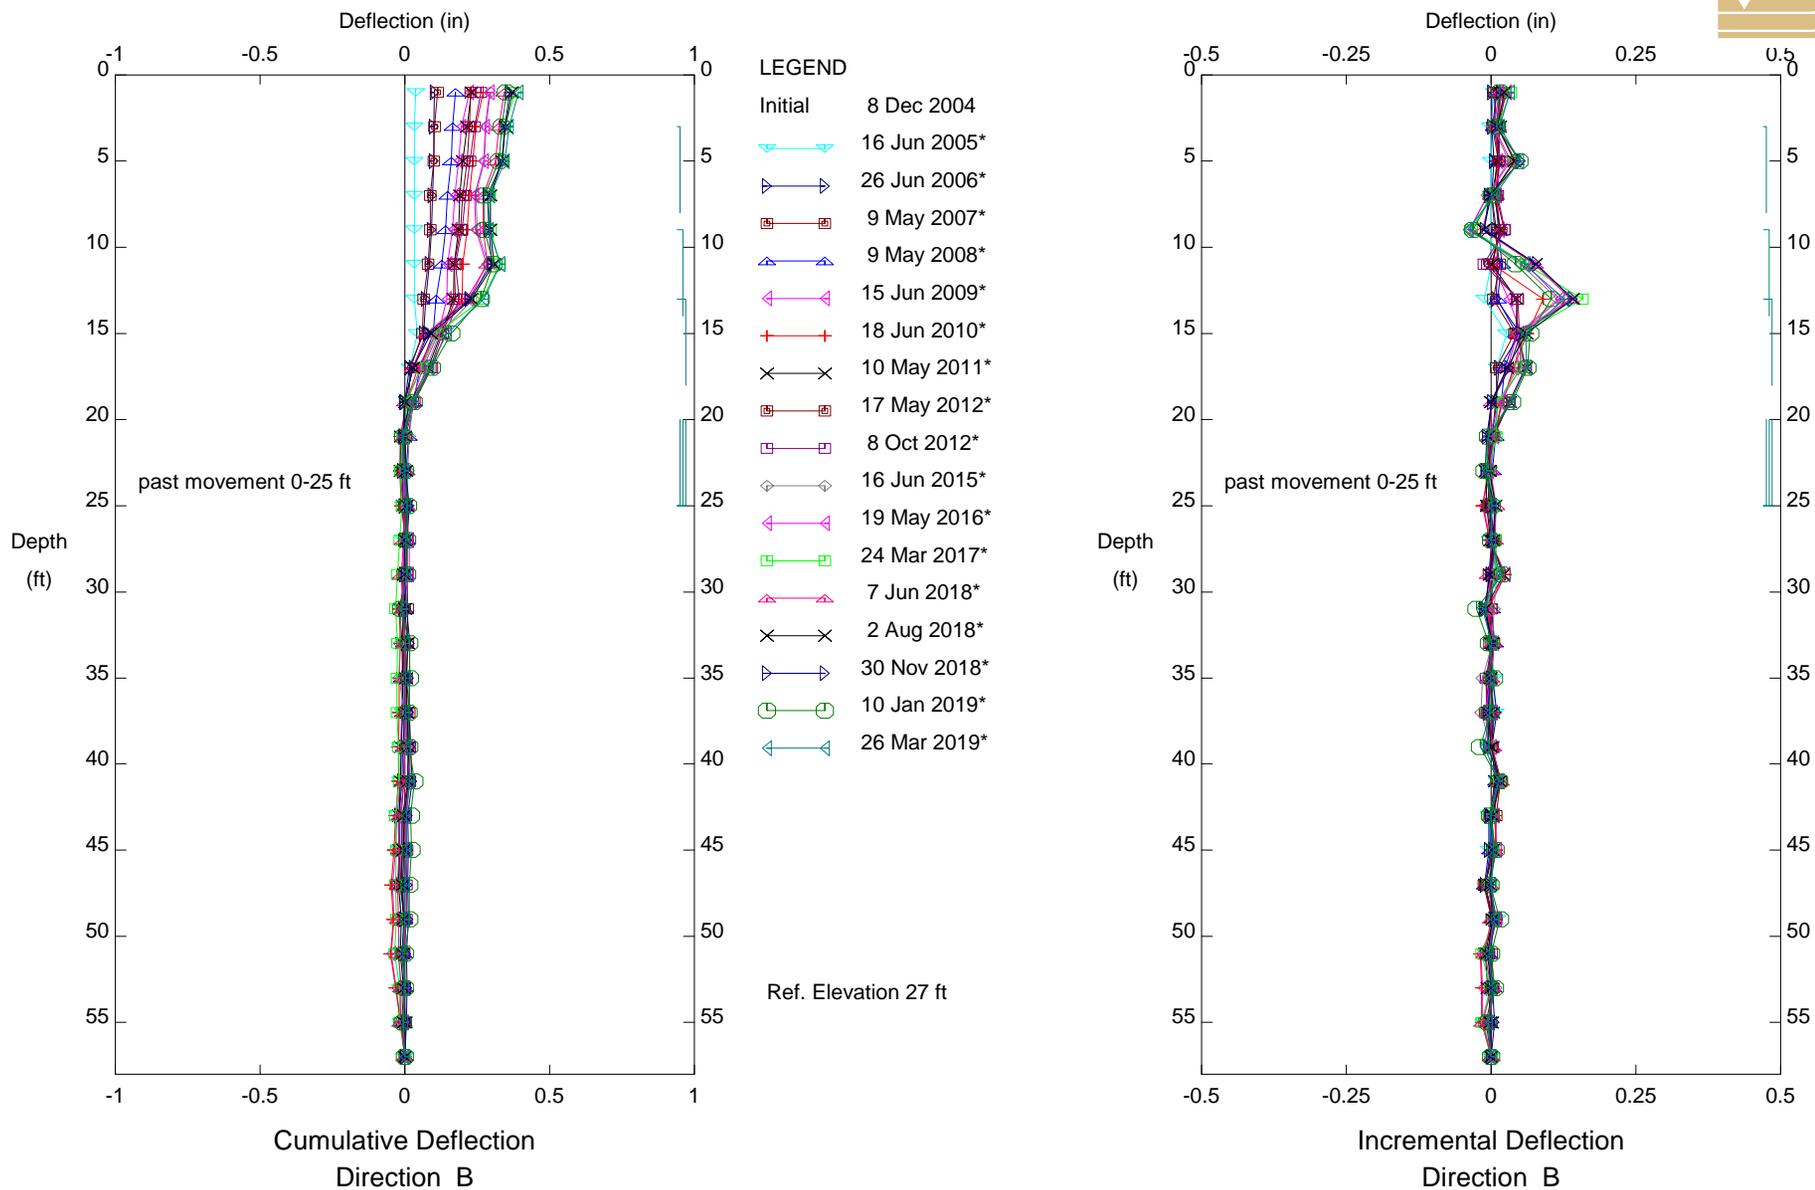
**BIG ROCK MESA, Inclinometer SP-11
 PCH REGION**

Sets marked * include zero shift and/or rotation corrections.

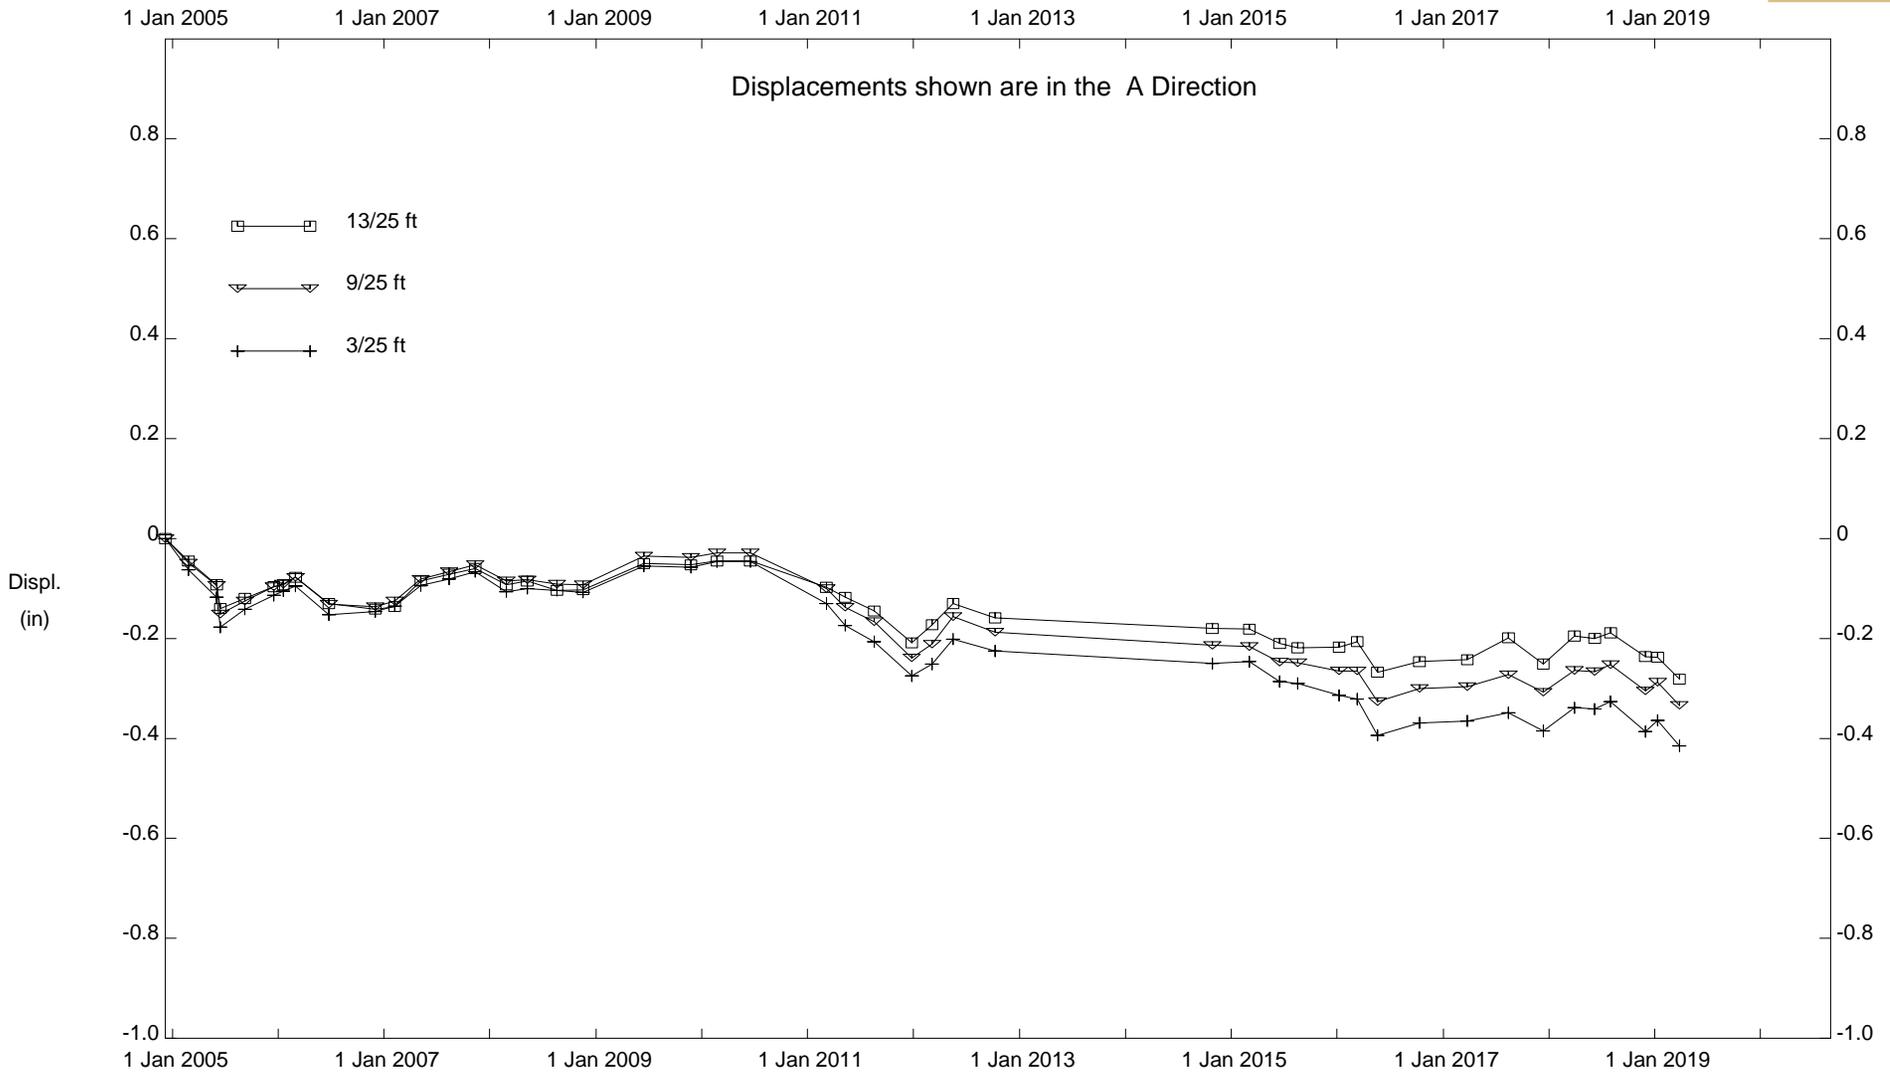
BIG ROCK MESA, Inclinator SP-11

PCH REGION

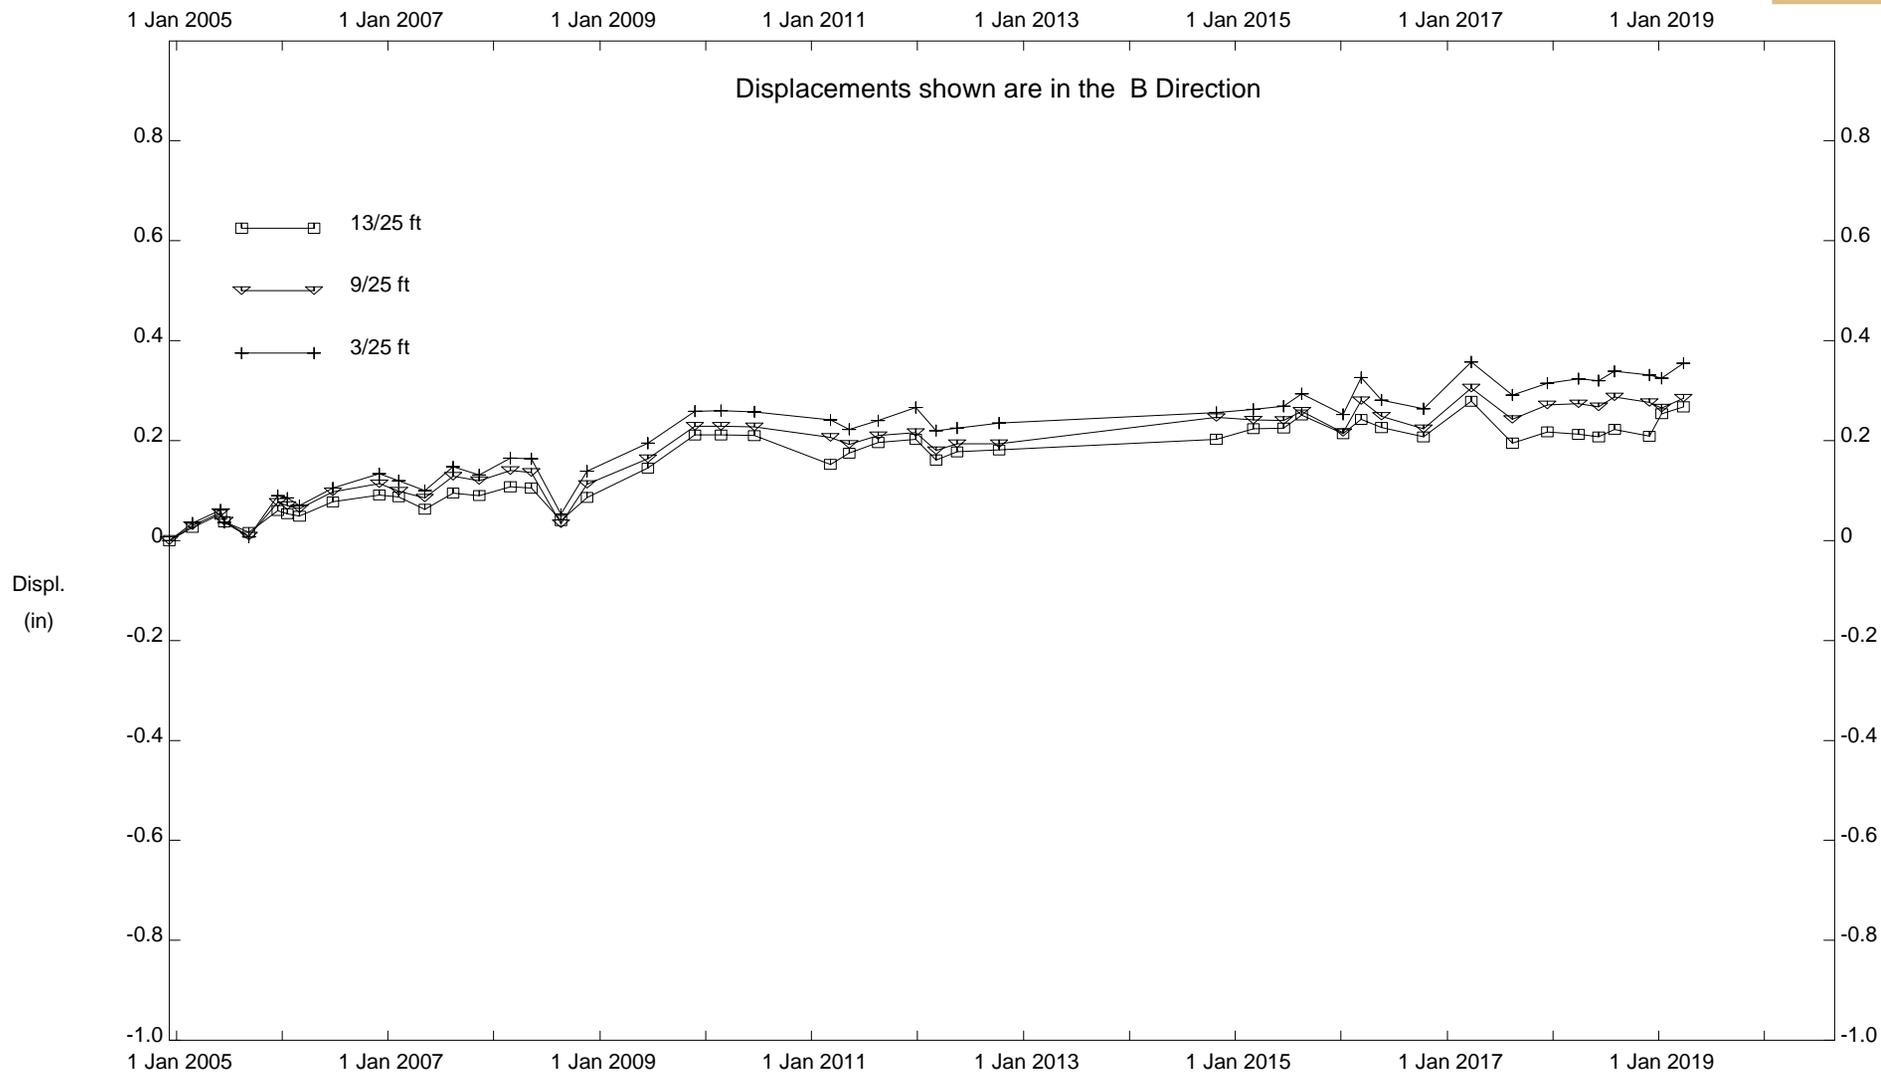
BIG ROCK MESA, Inclinator SP-11

PCH REGION

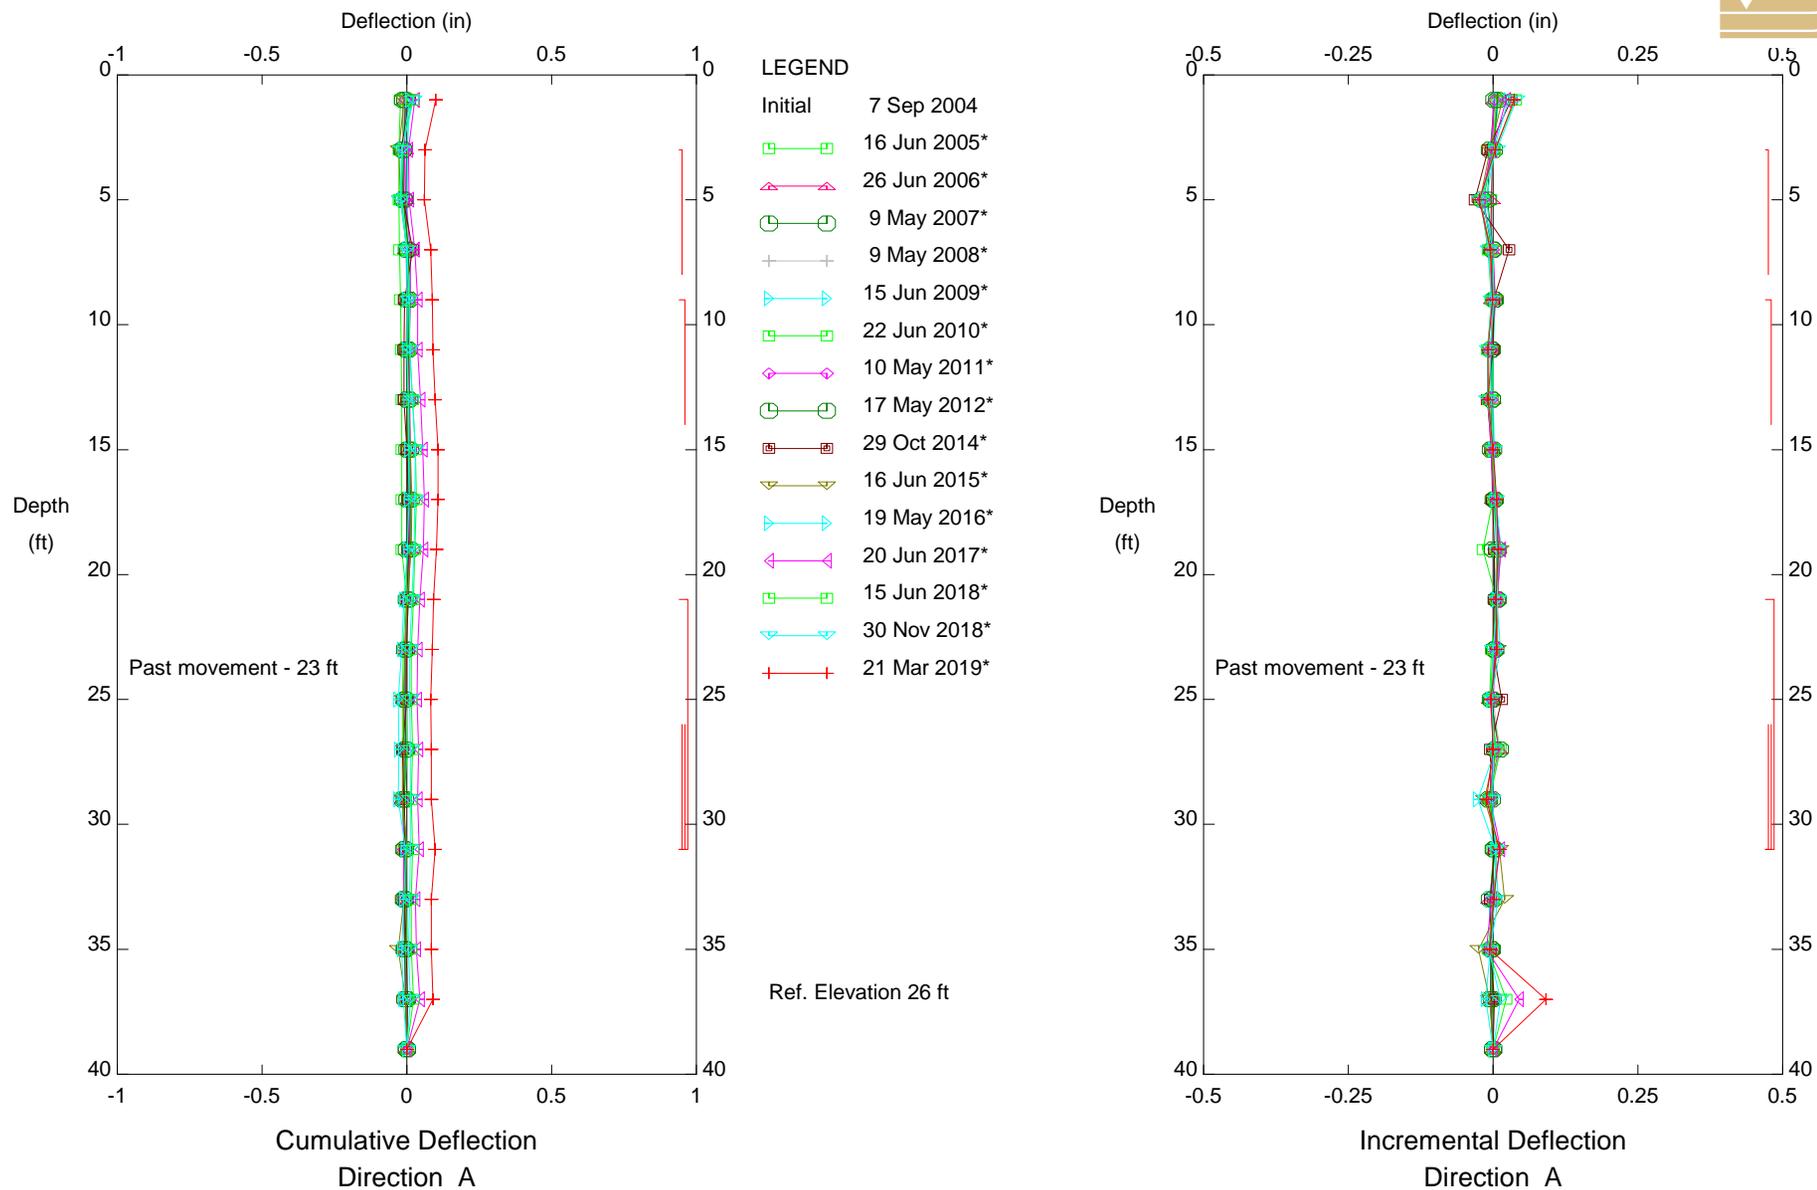
**BIG ROCK MESA, Inclinometer SP-12
 PCH REGION**

Sets marked * include zero shift and/or rotation corrections.

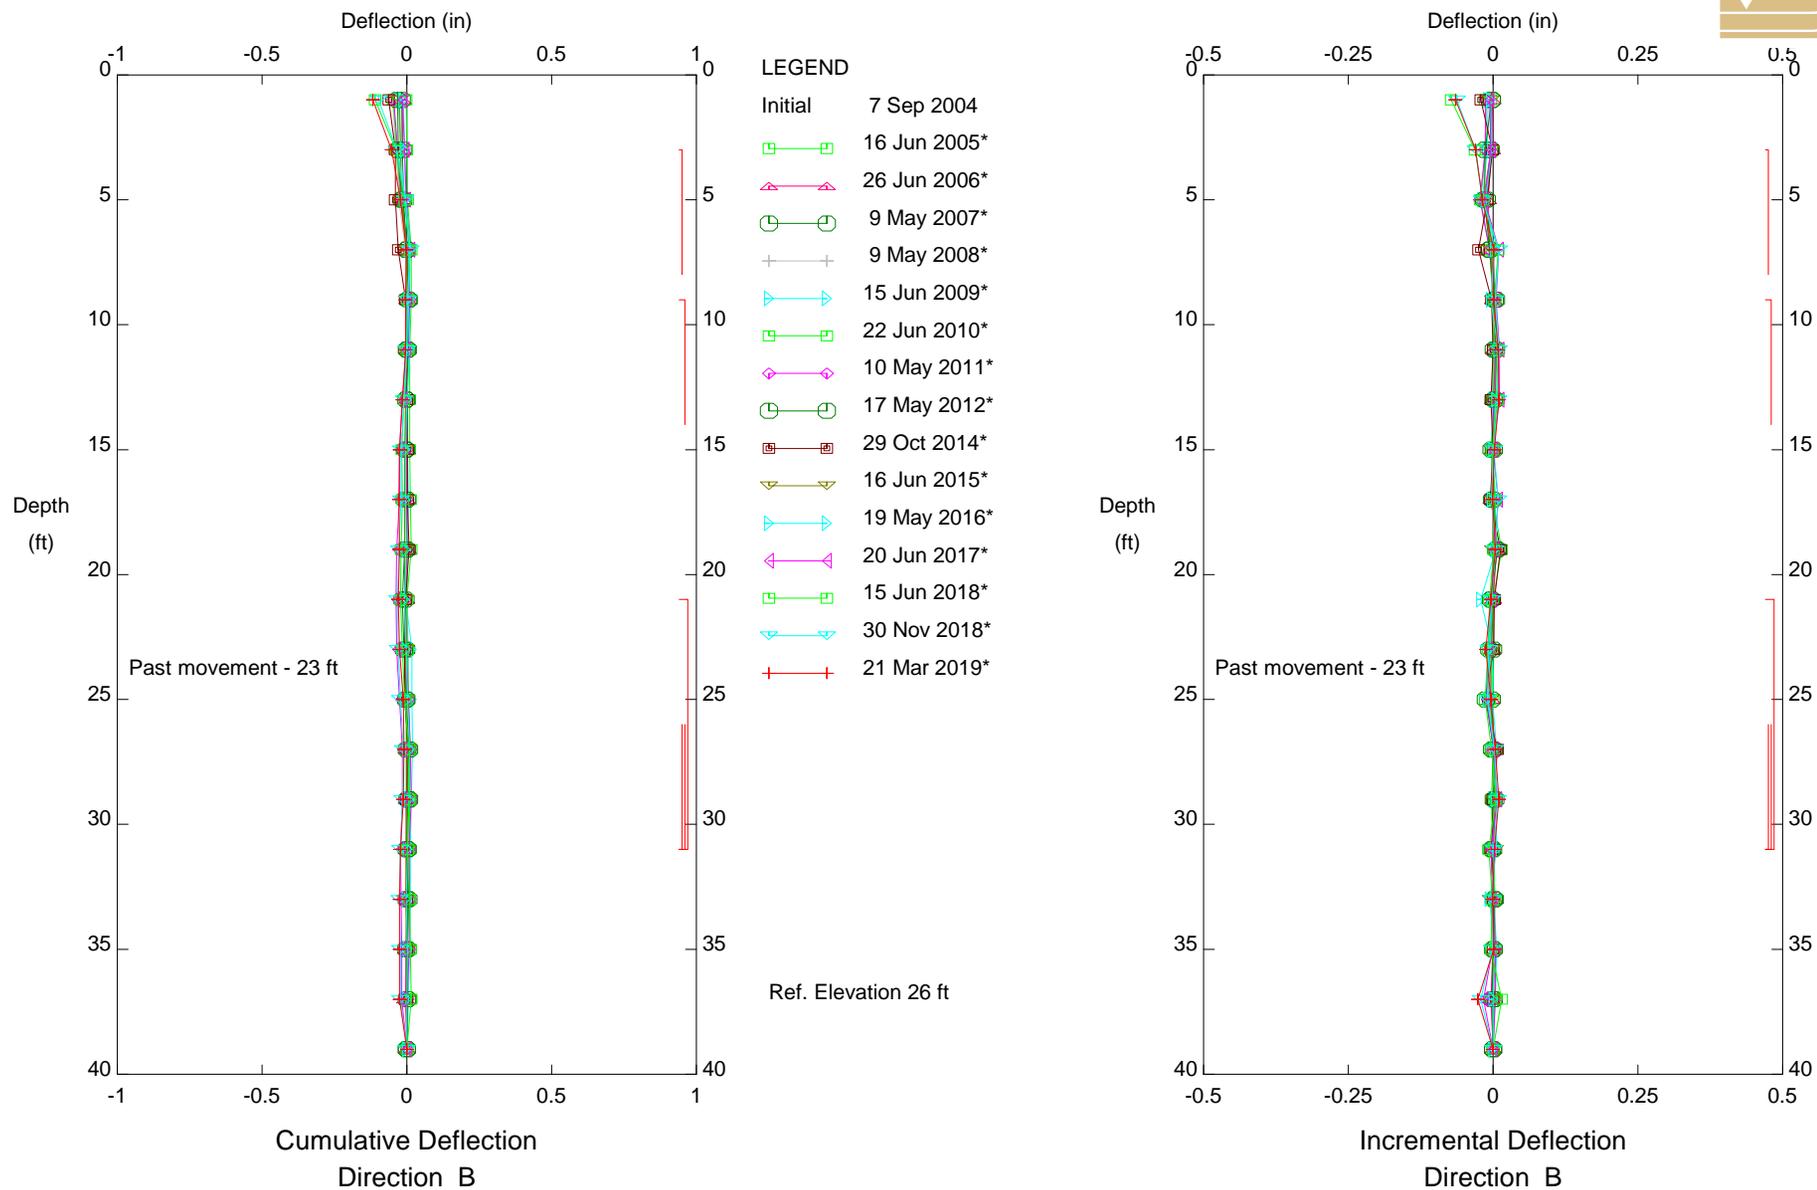
**BIG ROCK MESA, Inclinometer SP-12
 PCH REGION**

Sets marked * include zero shift and/or rotation corrections.
