**ANNUAL REPORT
JULY 2018 THROUGH JUNE 2019
BIG ROCK MESA LANDSLIDE
ASSESSMENT DISTRICT
City of Malibu, California**

November 2019
Fugro Project No. 04.62160606
Document No. 04.62160606-PR-006(Rev.00)

Annual Report of Maintenance and Monitoring, July 2018 through June 2019, Big Rock Mesa Landslide Assessment District, City of Malibu, California

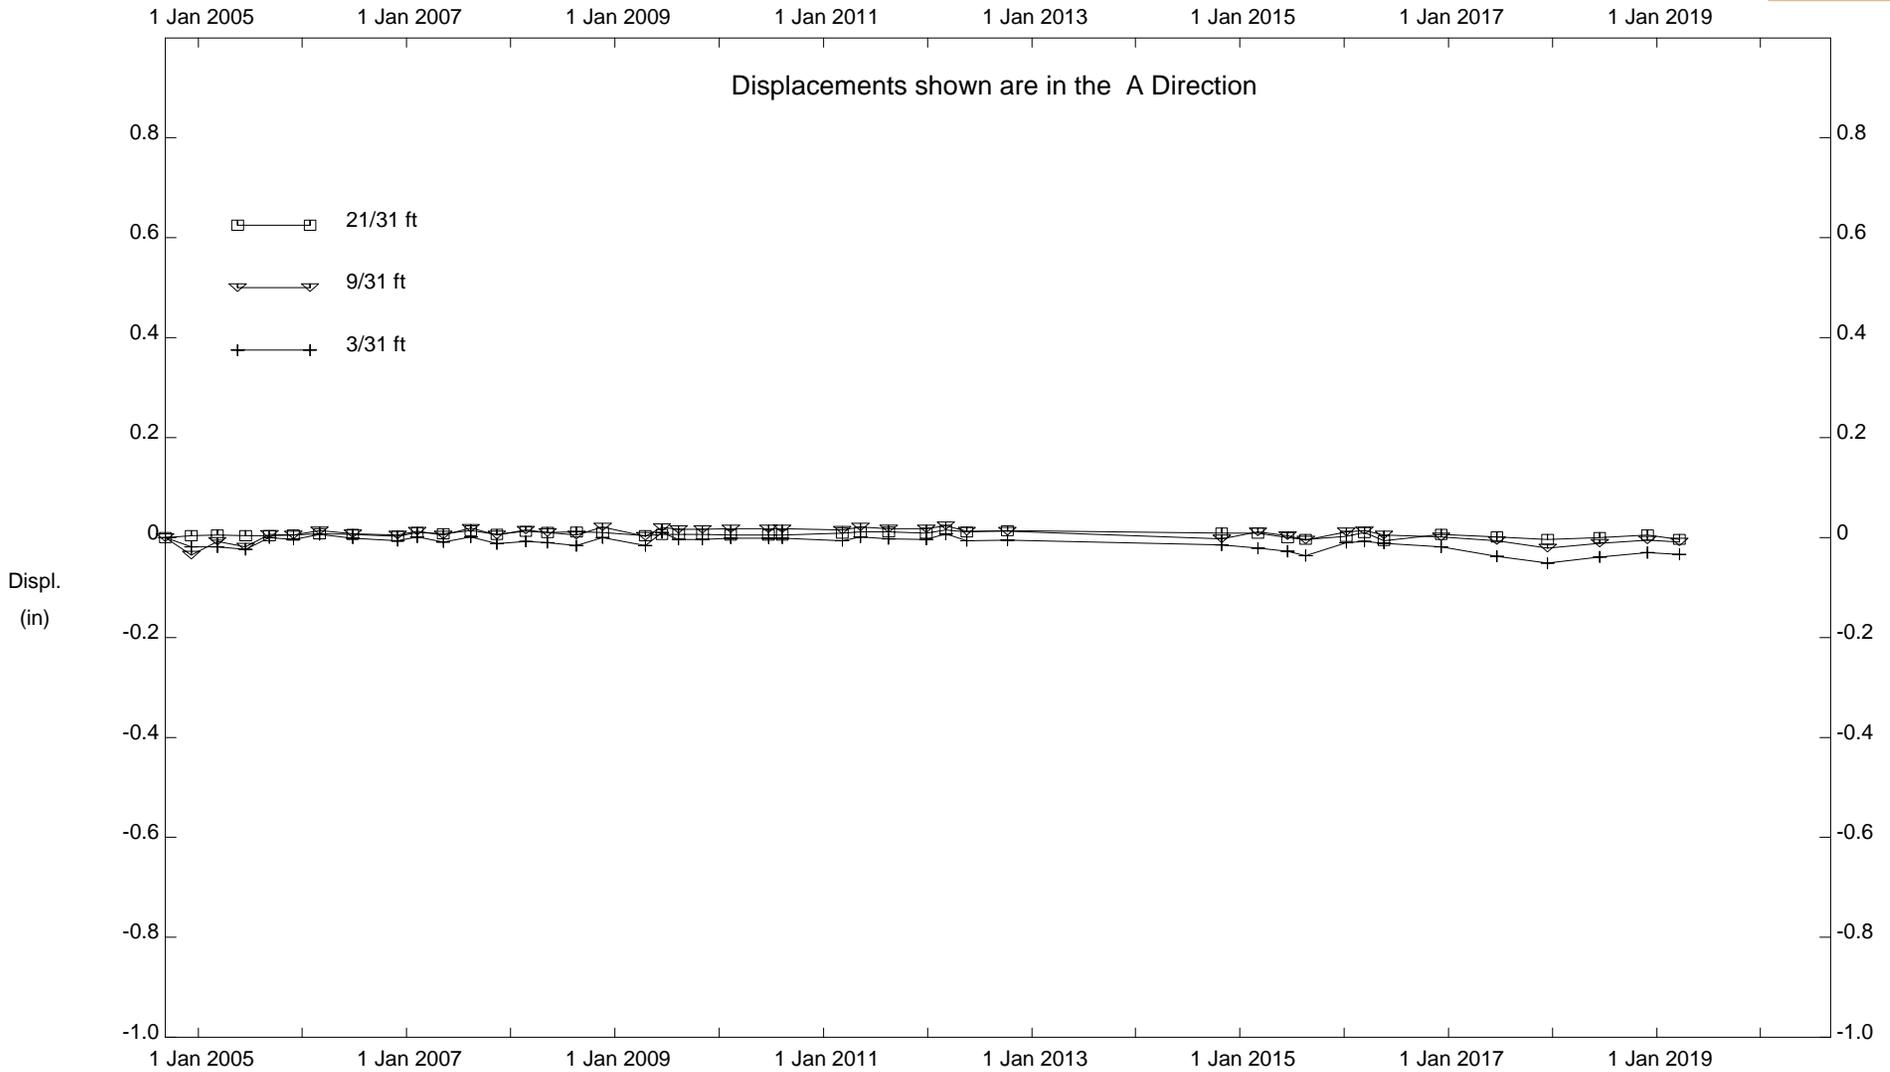
BIG ROCK MESA, Inclinator SP-12

PCH REGION

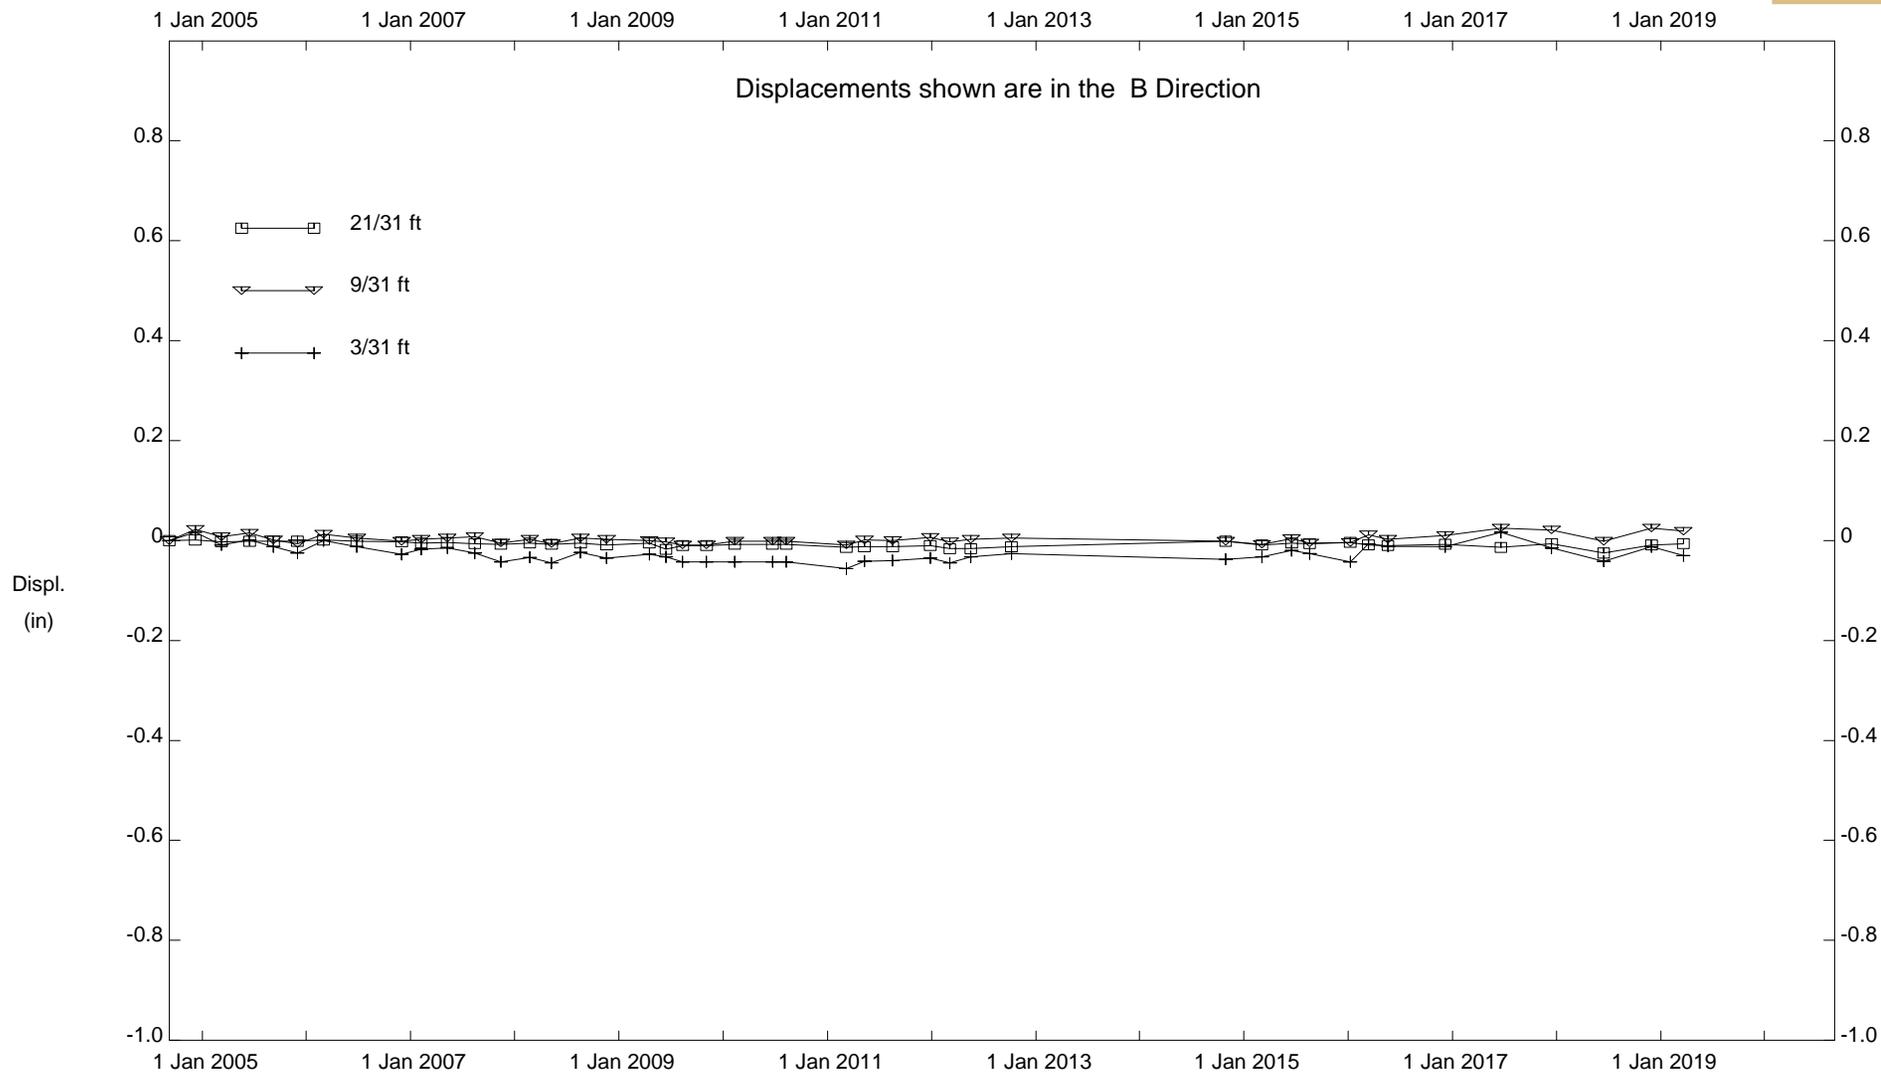
BIG ROCK MESA, Inclinator SP-12

PCH REGION

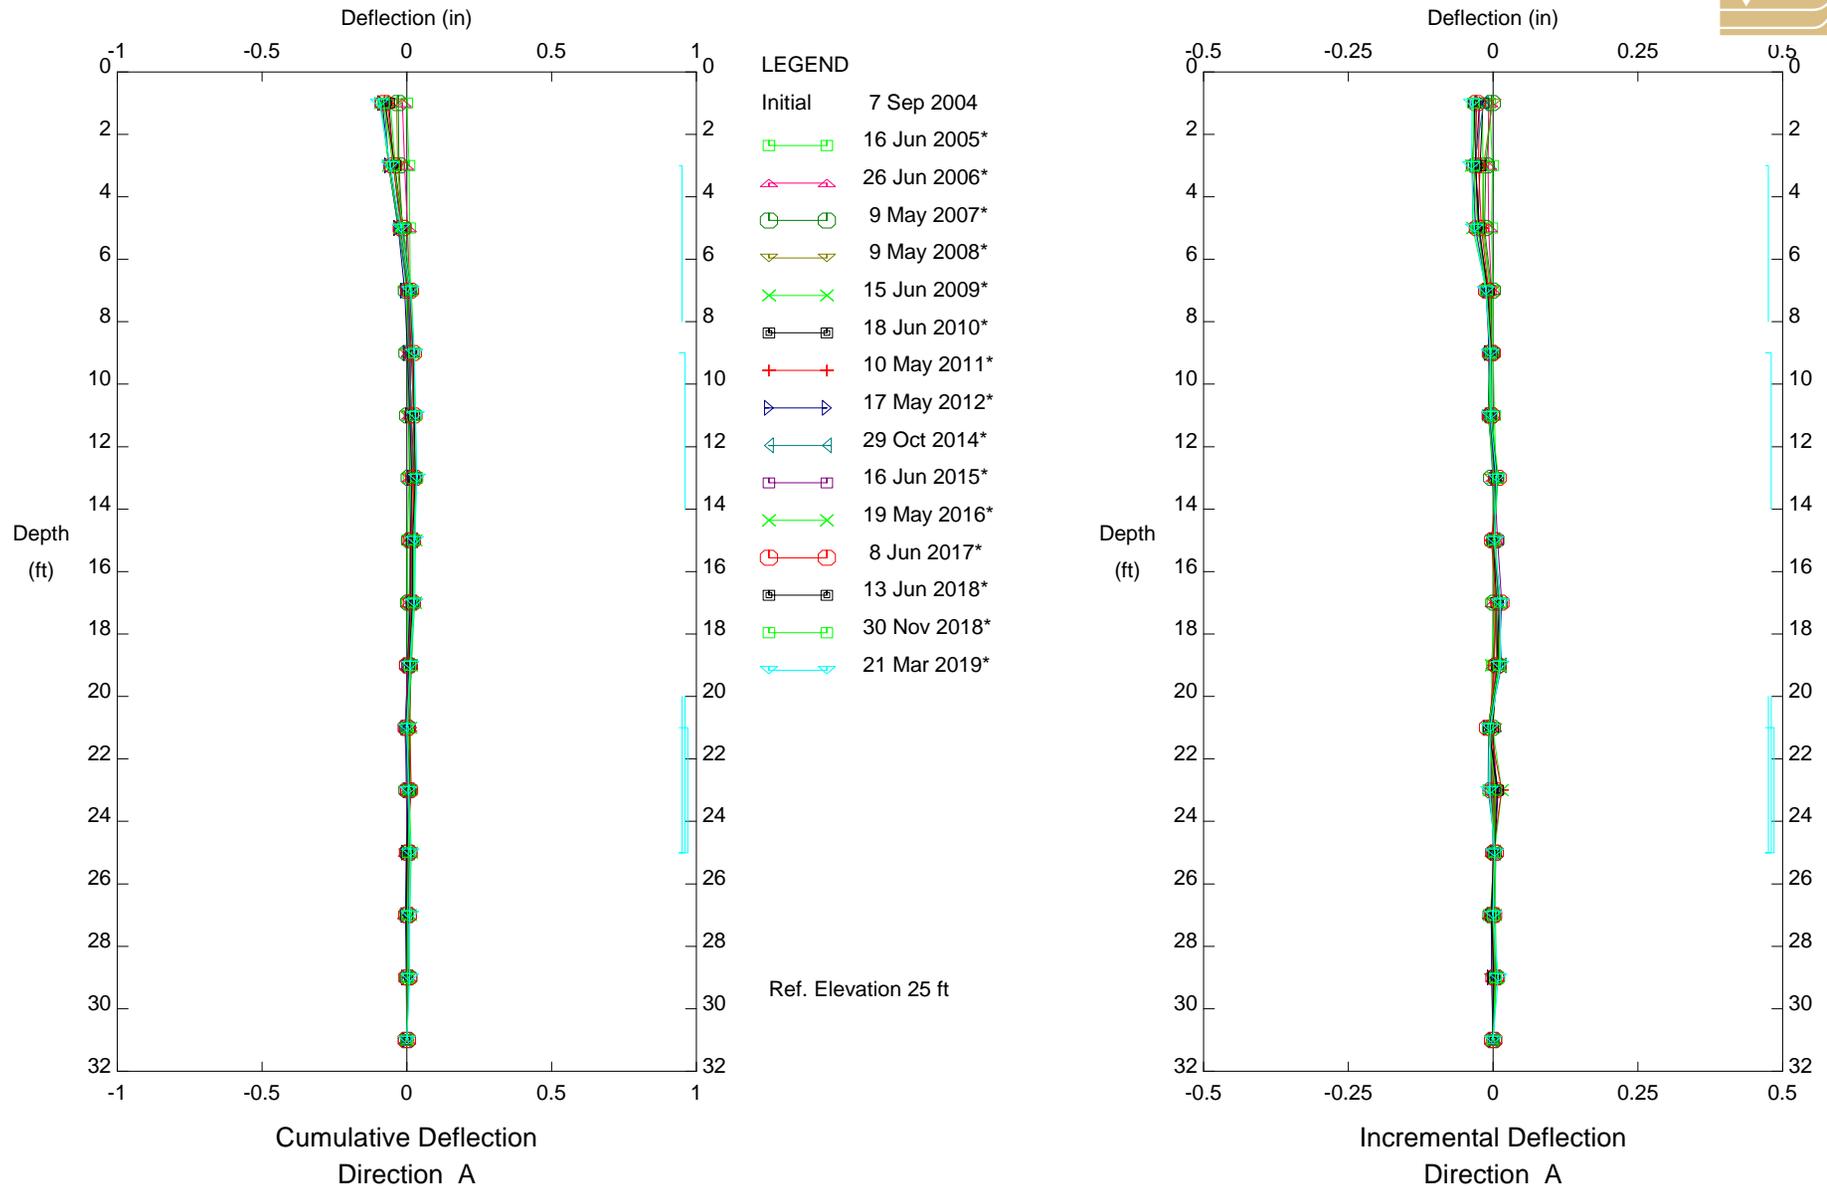
**BIG ROCK MESA, Inclinometer SP-14
 PCH REGION**

Sets marked * include zero shift and/or rotation corrections.

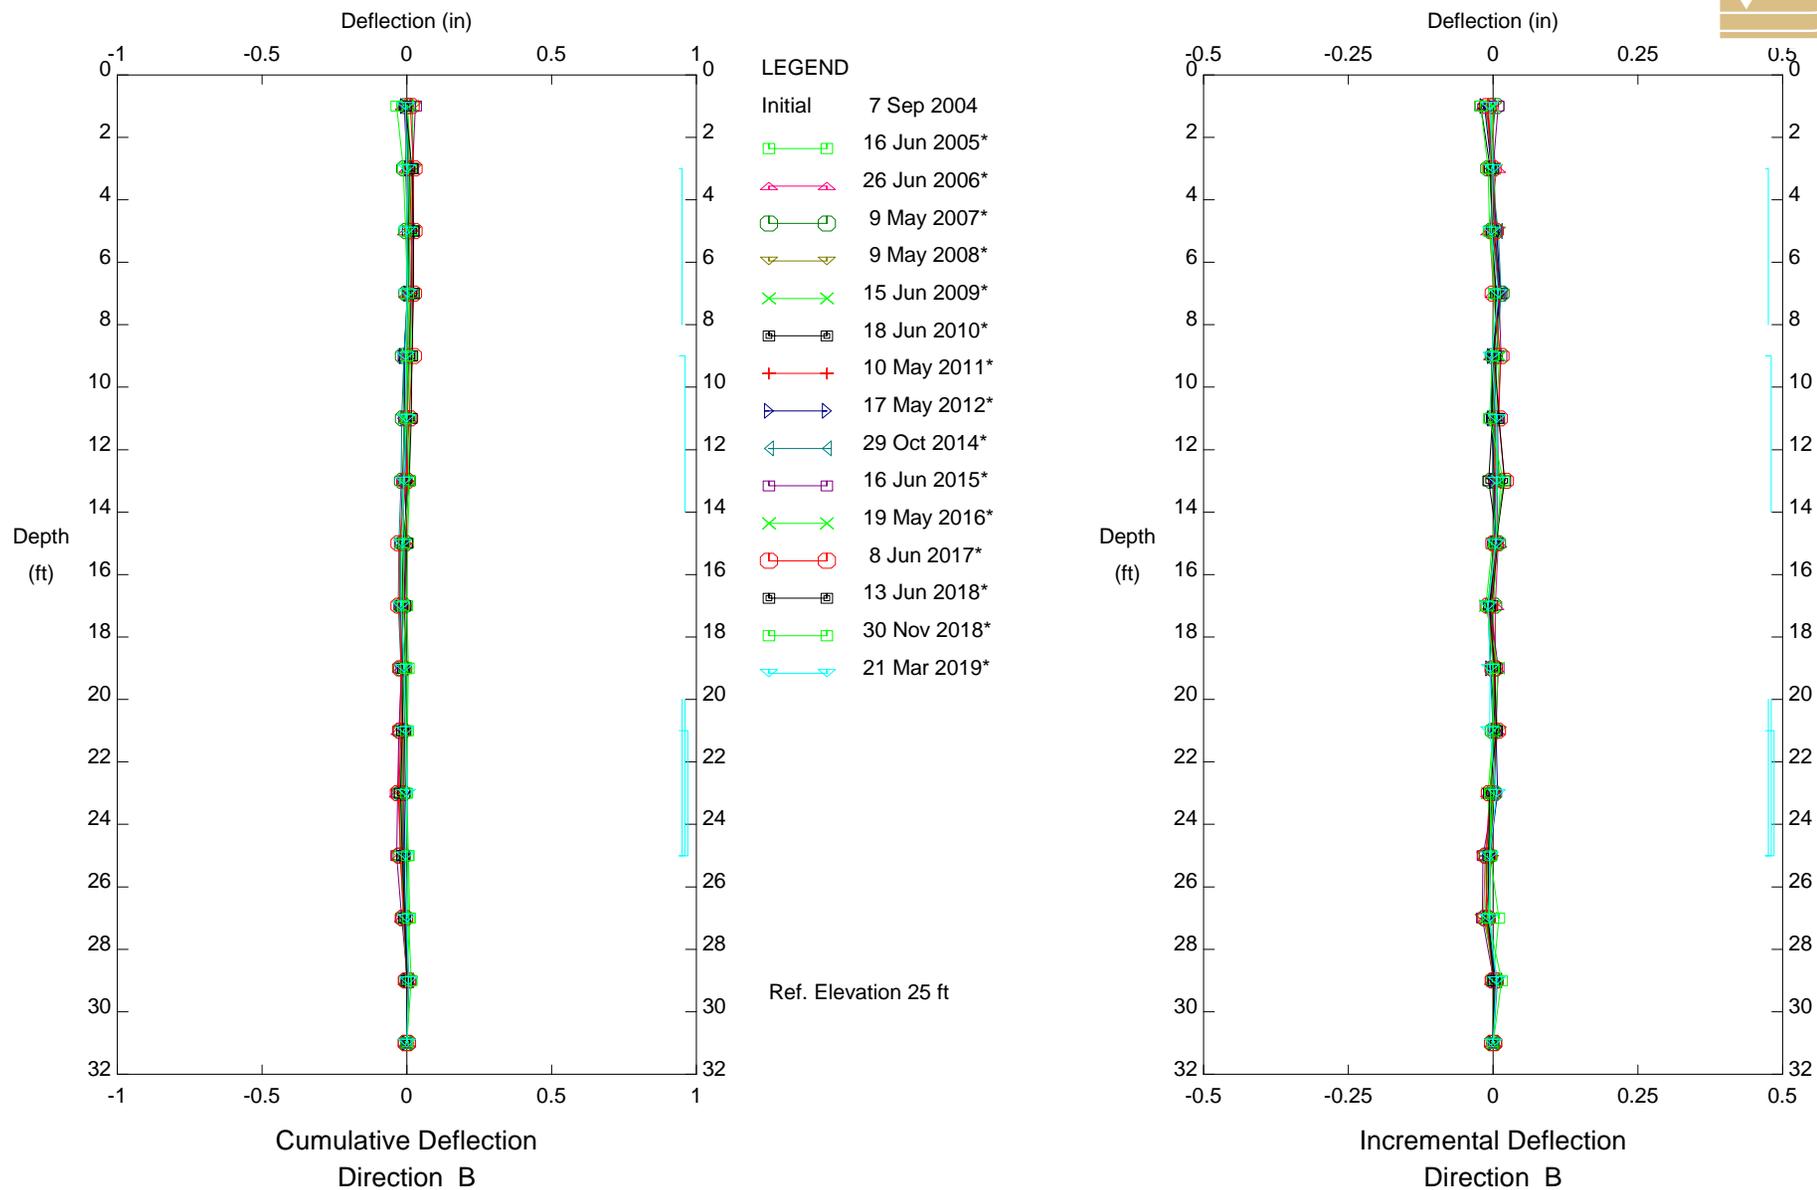
**BIG ROCK MESA, Inclinometer SP-14
 PCH REGION**

Sets marked * include zero shift and/or rotation corrections.

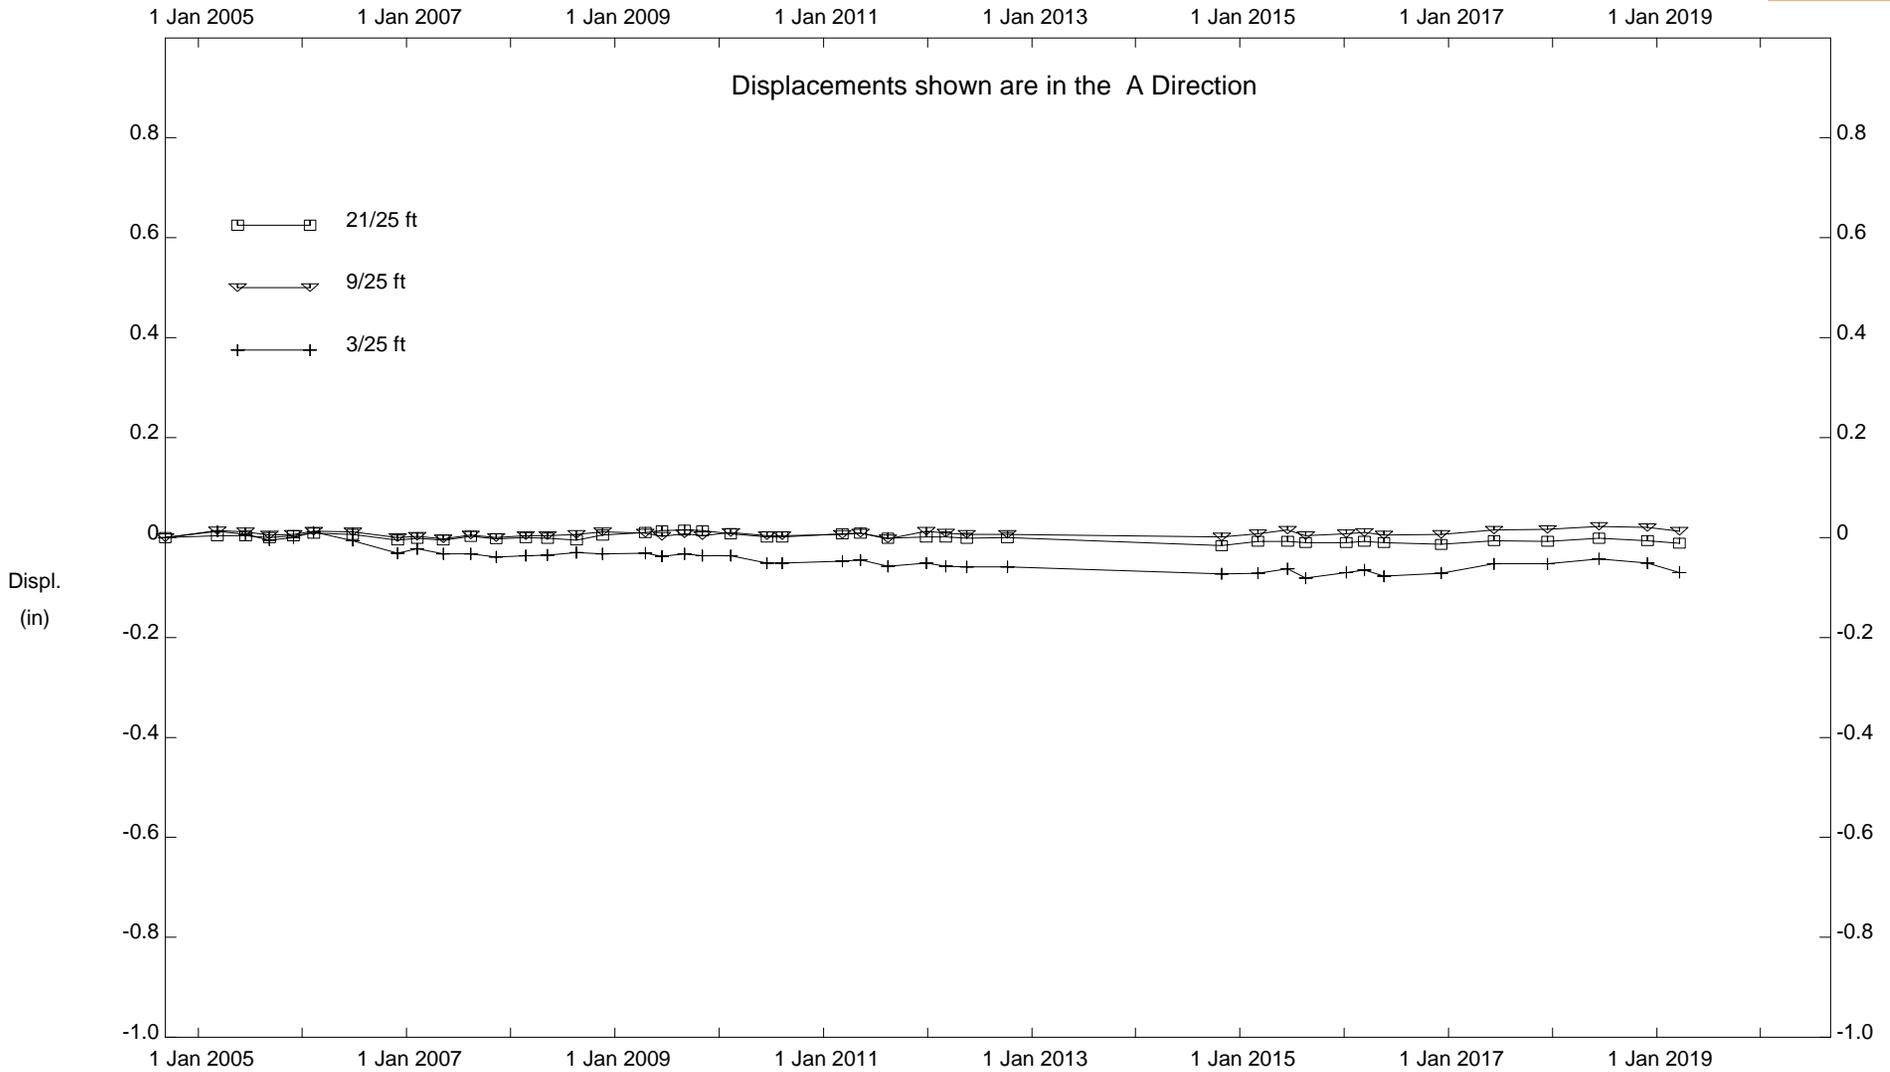
BIG ROCK MESA, Inclinator SP-14

PCH REGION

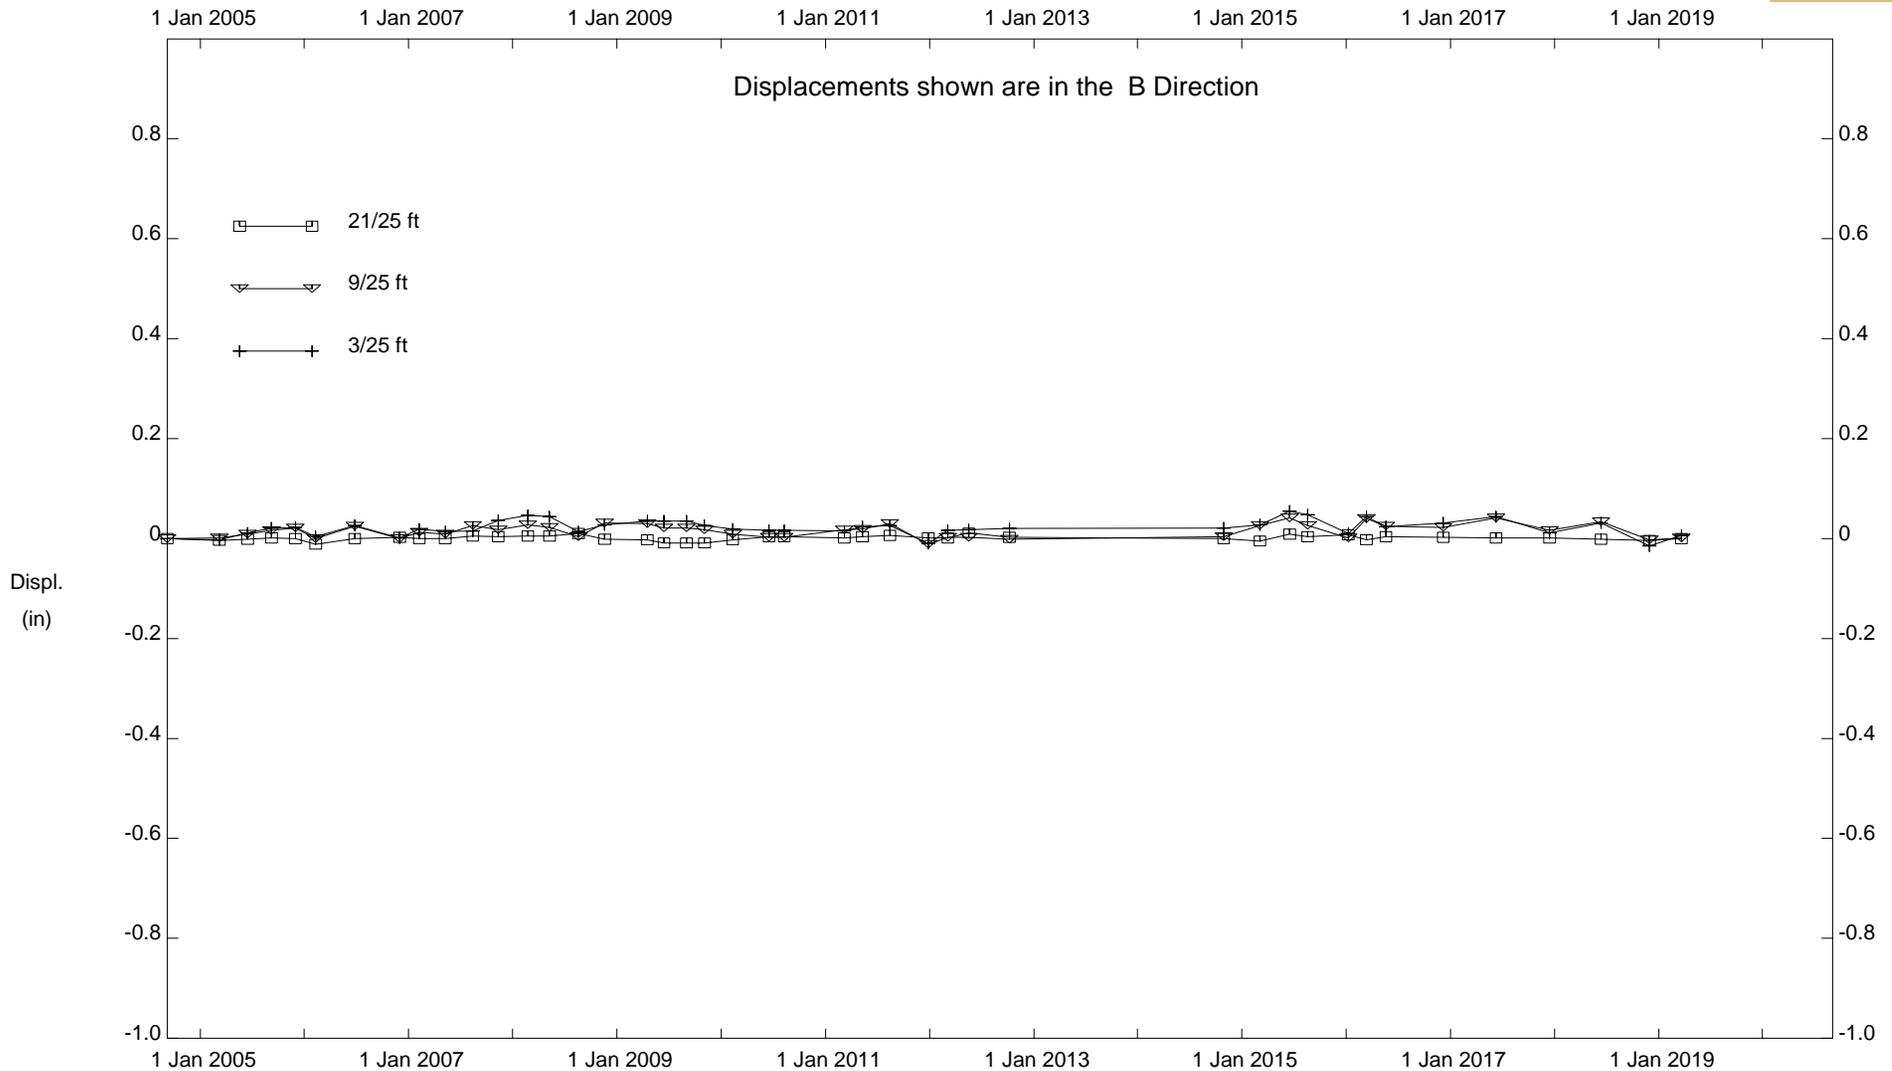
BIG ROCK MESA, Inclinometer SP-14

PCH REGION

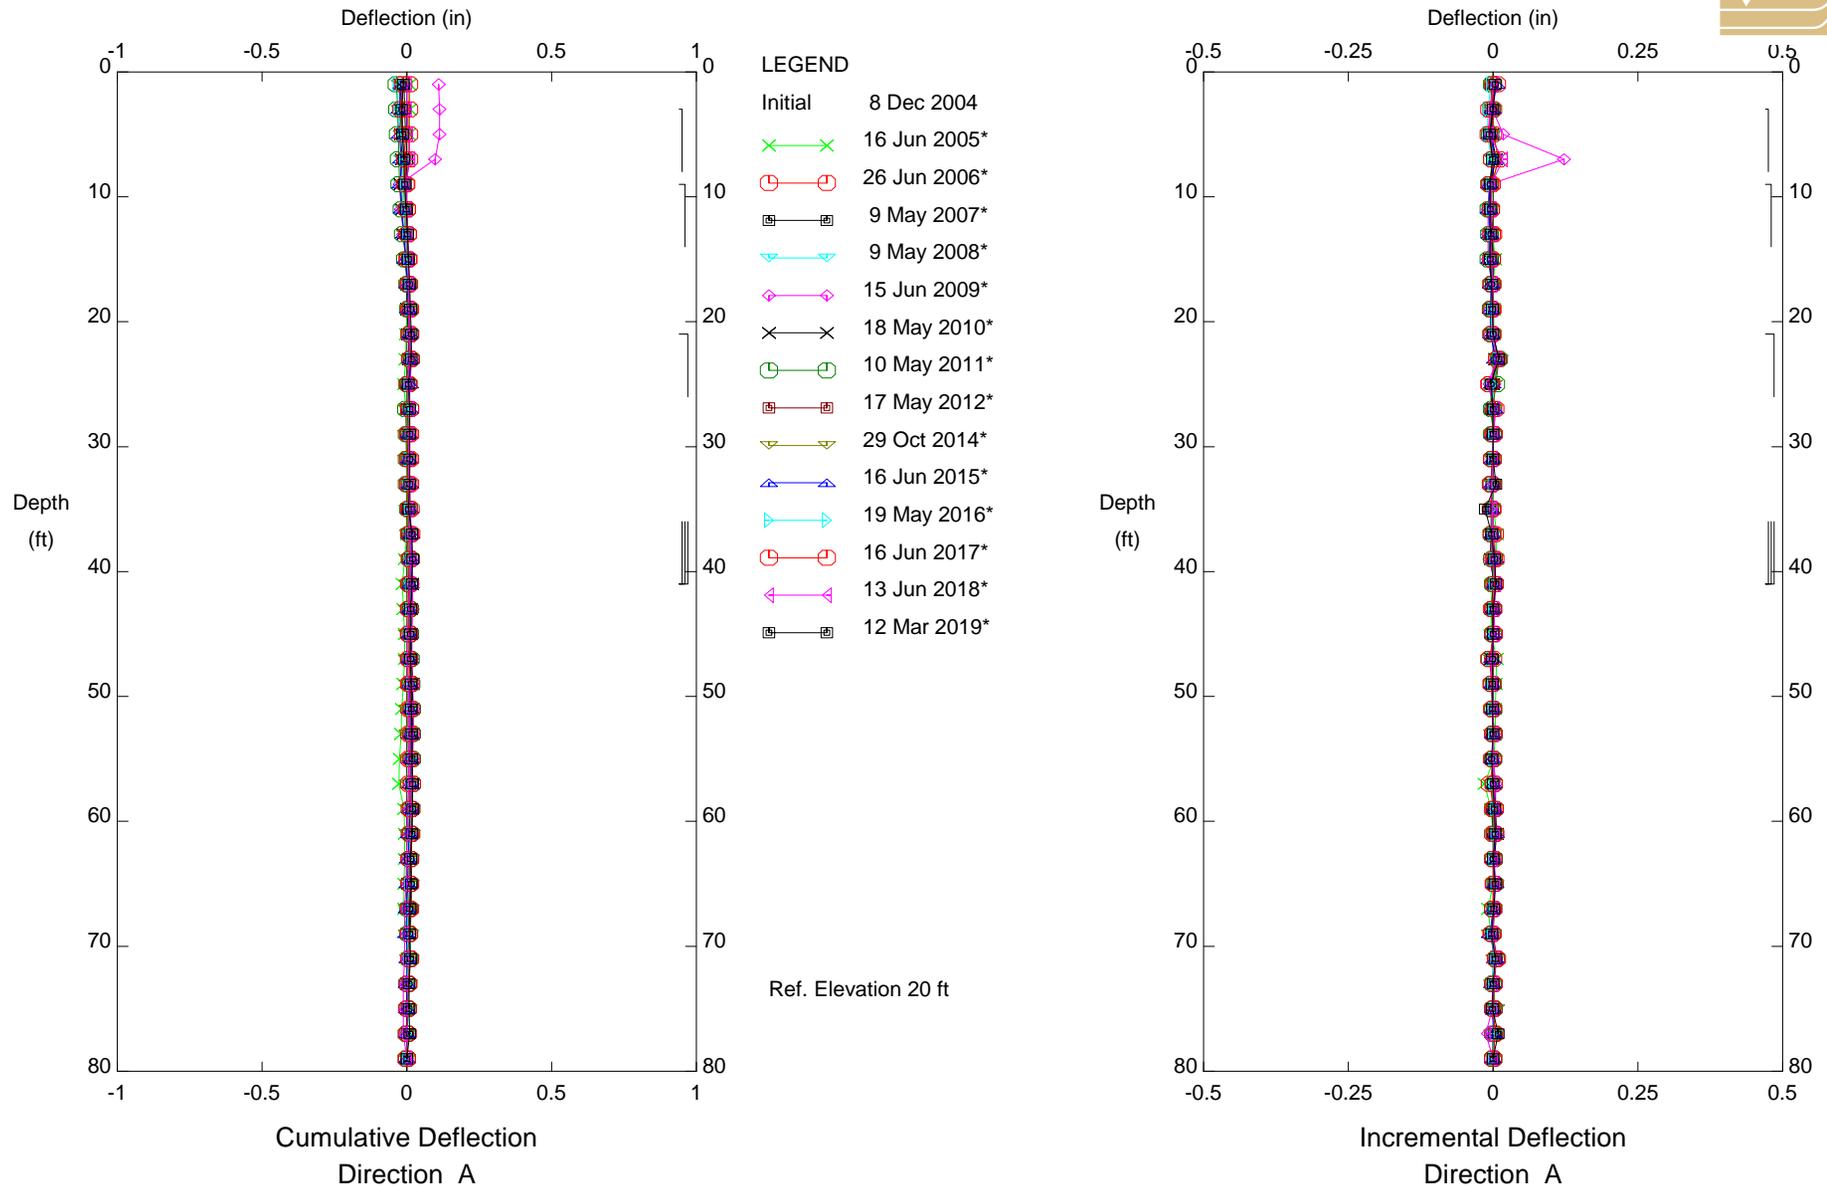
**BIG ROCK MESA, Inclinometer SP-15
 PCH REGION**

Sets marked * include zero shift and/or rotation corrections.

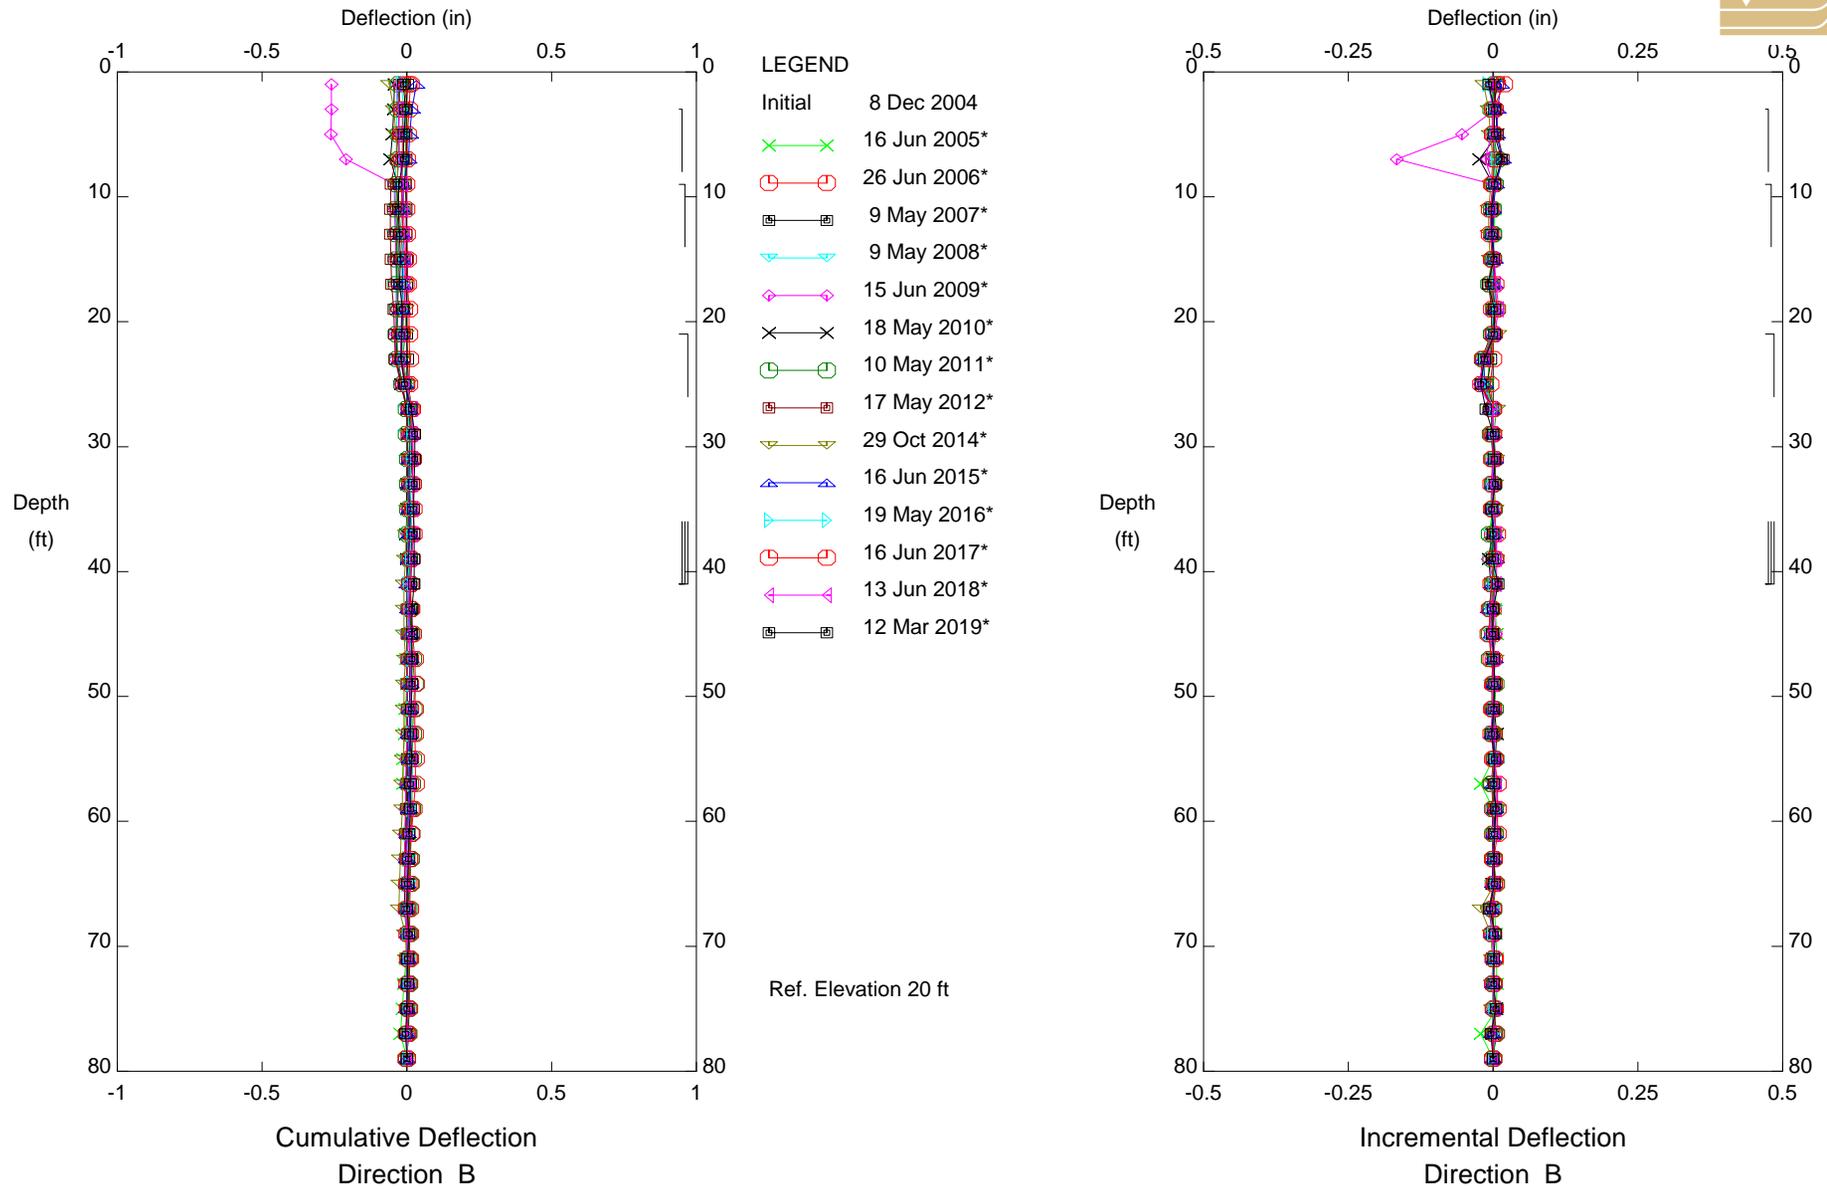
**BIG ROCK MESA, Inclinometer SP-15
 PCH REGION**

Sets marked * include zero shift and/or rotation corrections.

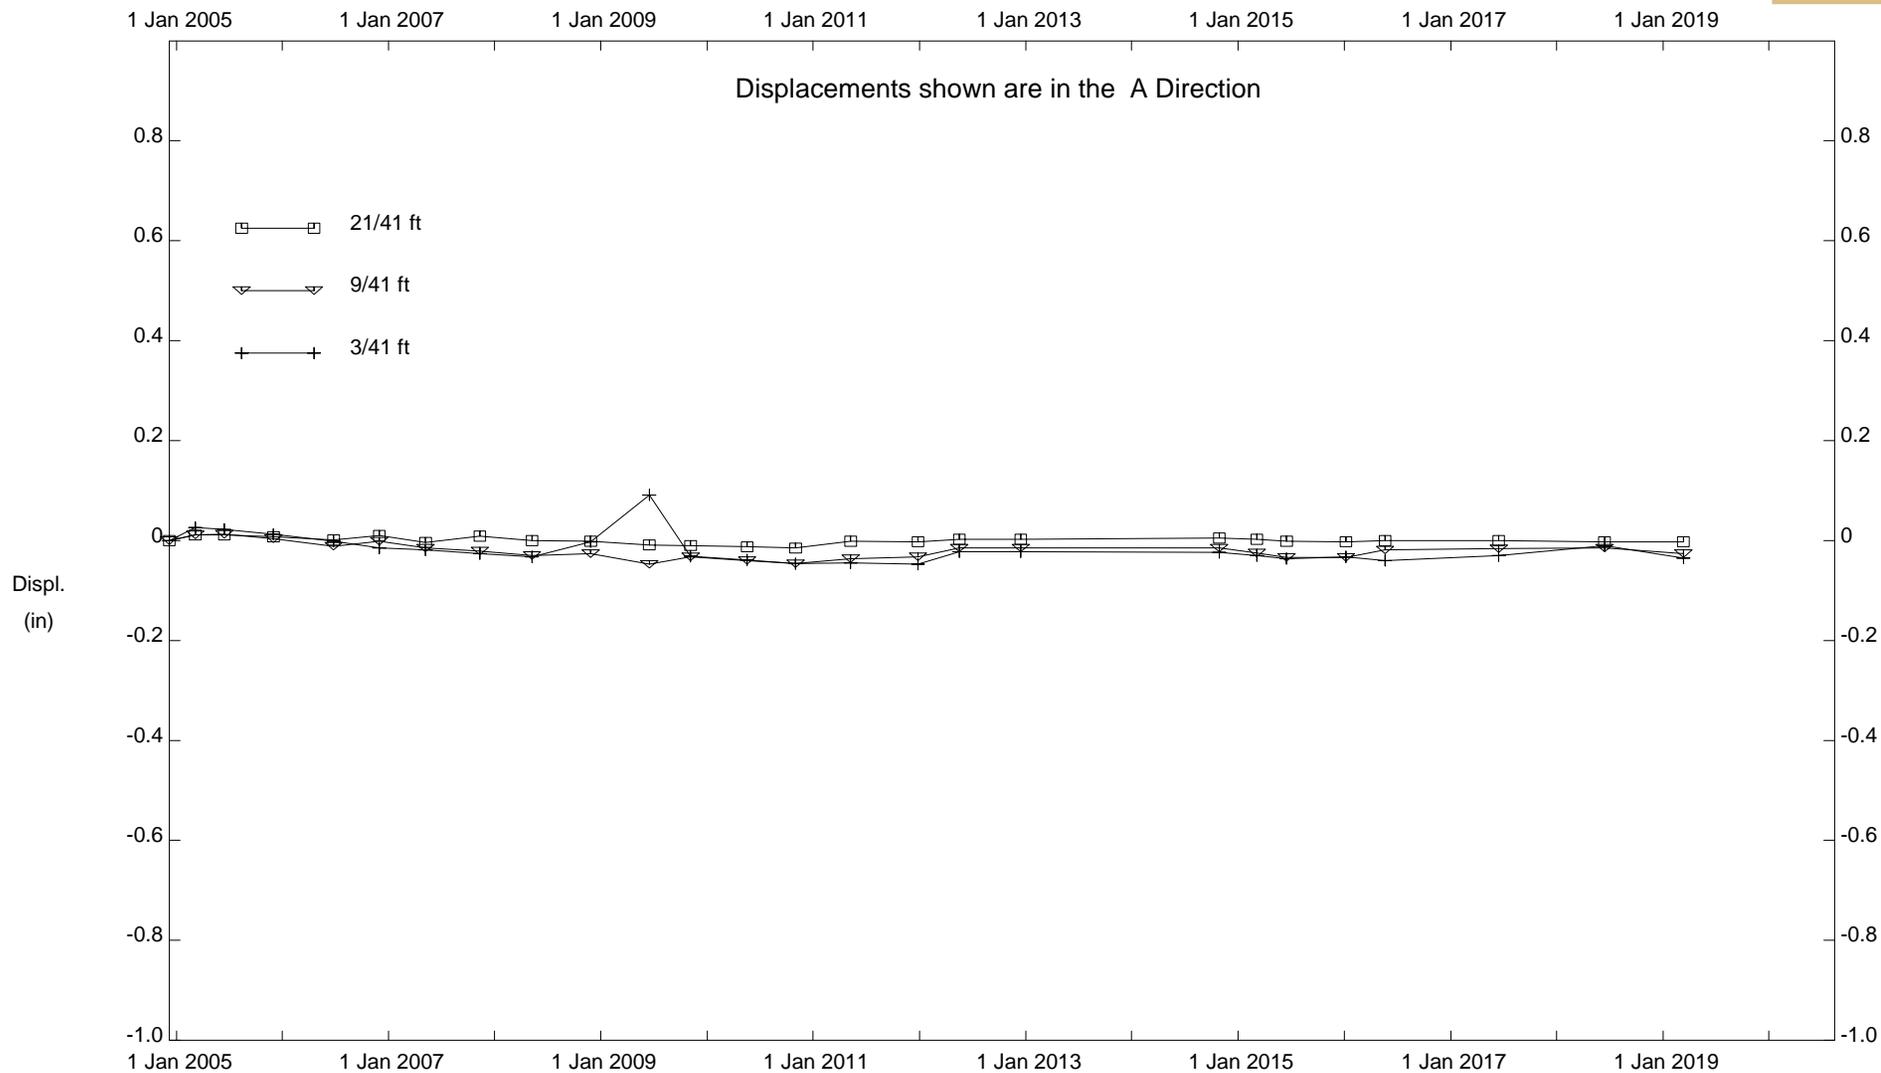
BIG ROCK MESA, Inclinator SP-15

PCH REGION

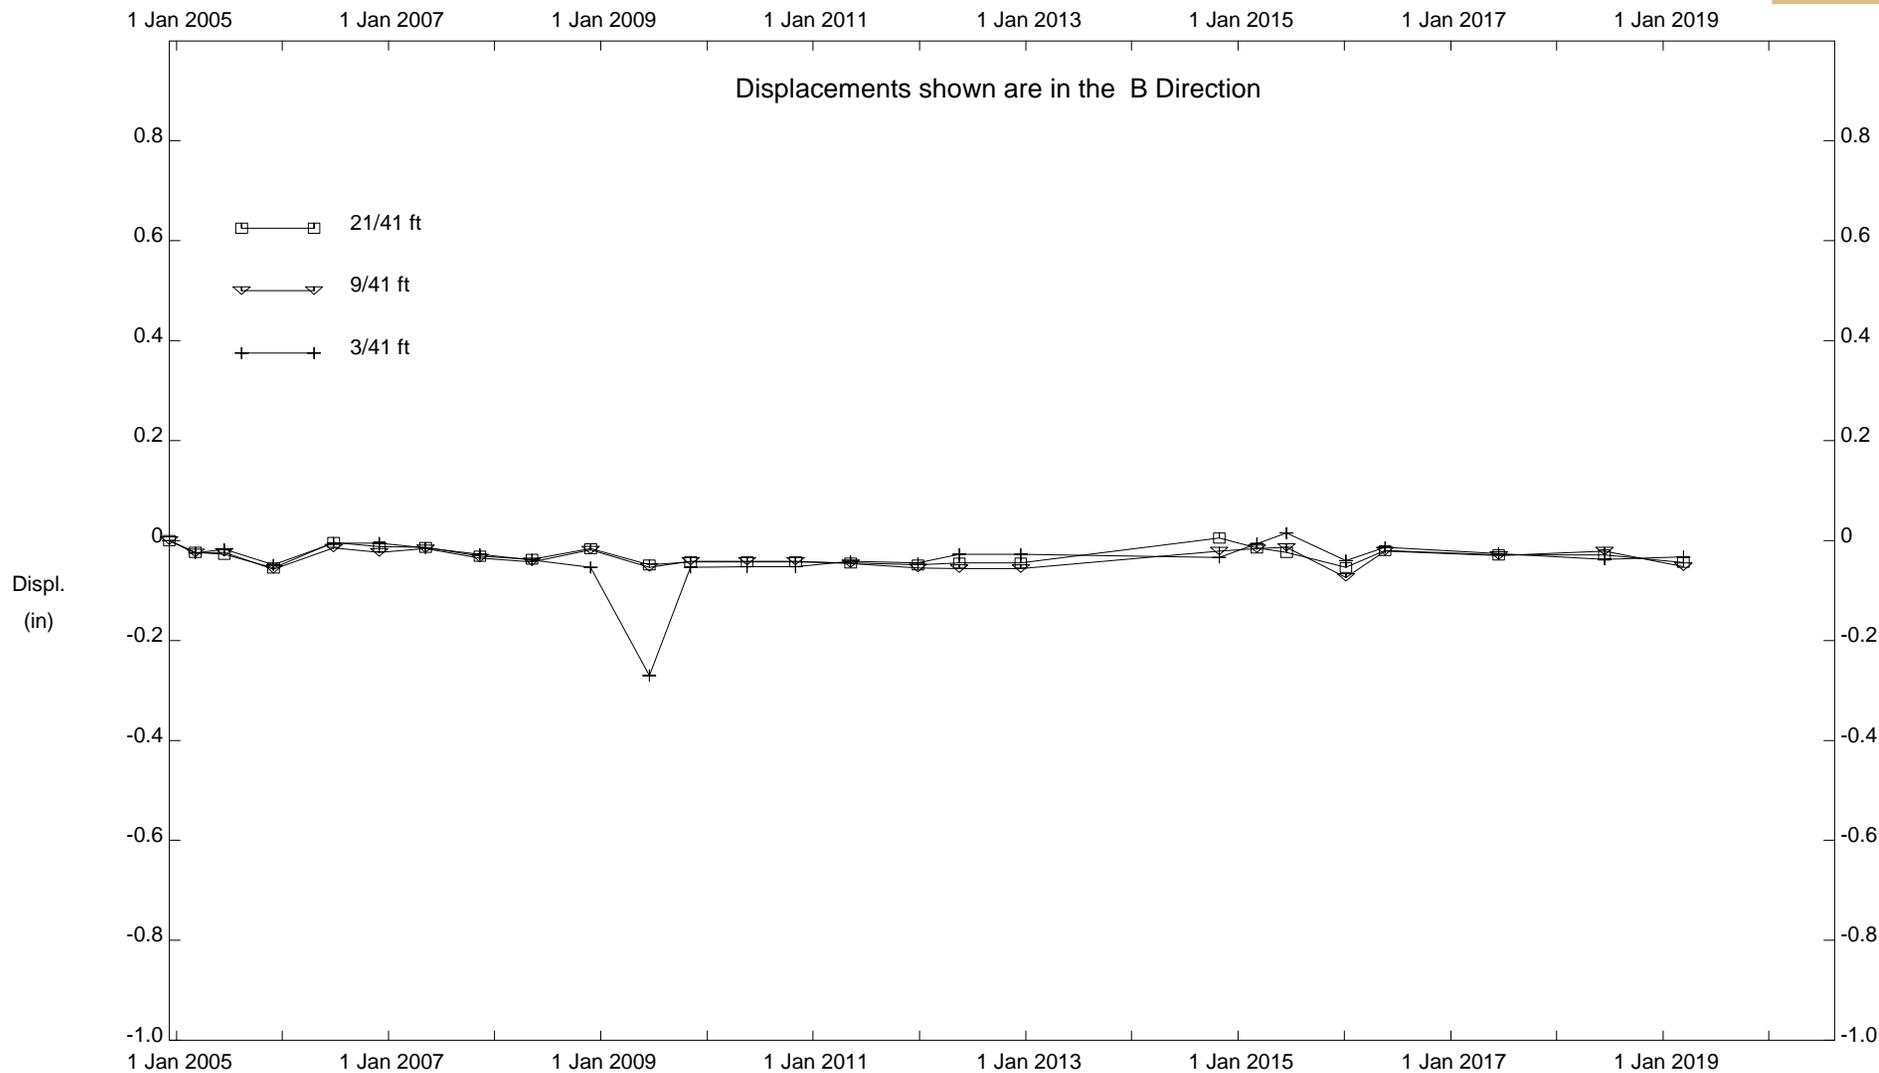
BIG ROCK MESA, Inclinator SP-15

PCH REGION
