**ANNUAL REPORT
JULY 2018 THROUGH JUNE 2019
BIG ROCK MESA LANDSLIDE
ASSESSMENT DISTRICT
City of Malibu, California**

November 2019
Fugro Project No. 04.62160606
Document No. 04.62160606-PR-006(Rev.00)

Annual Report of Maintenance and Monitoring, July 2018 through June 2019, Big Rock Mesa Landslide Assessment District, City of Malibu, California

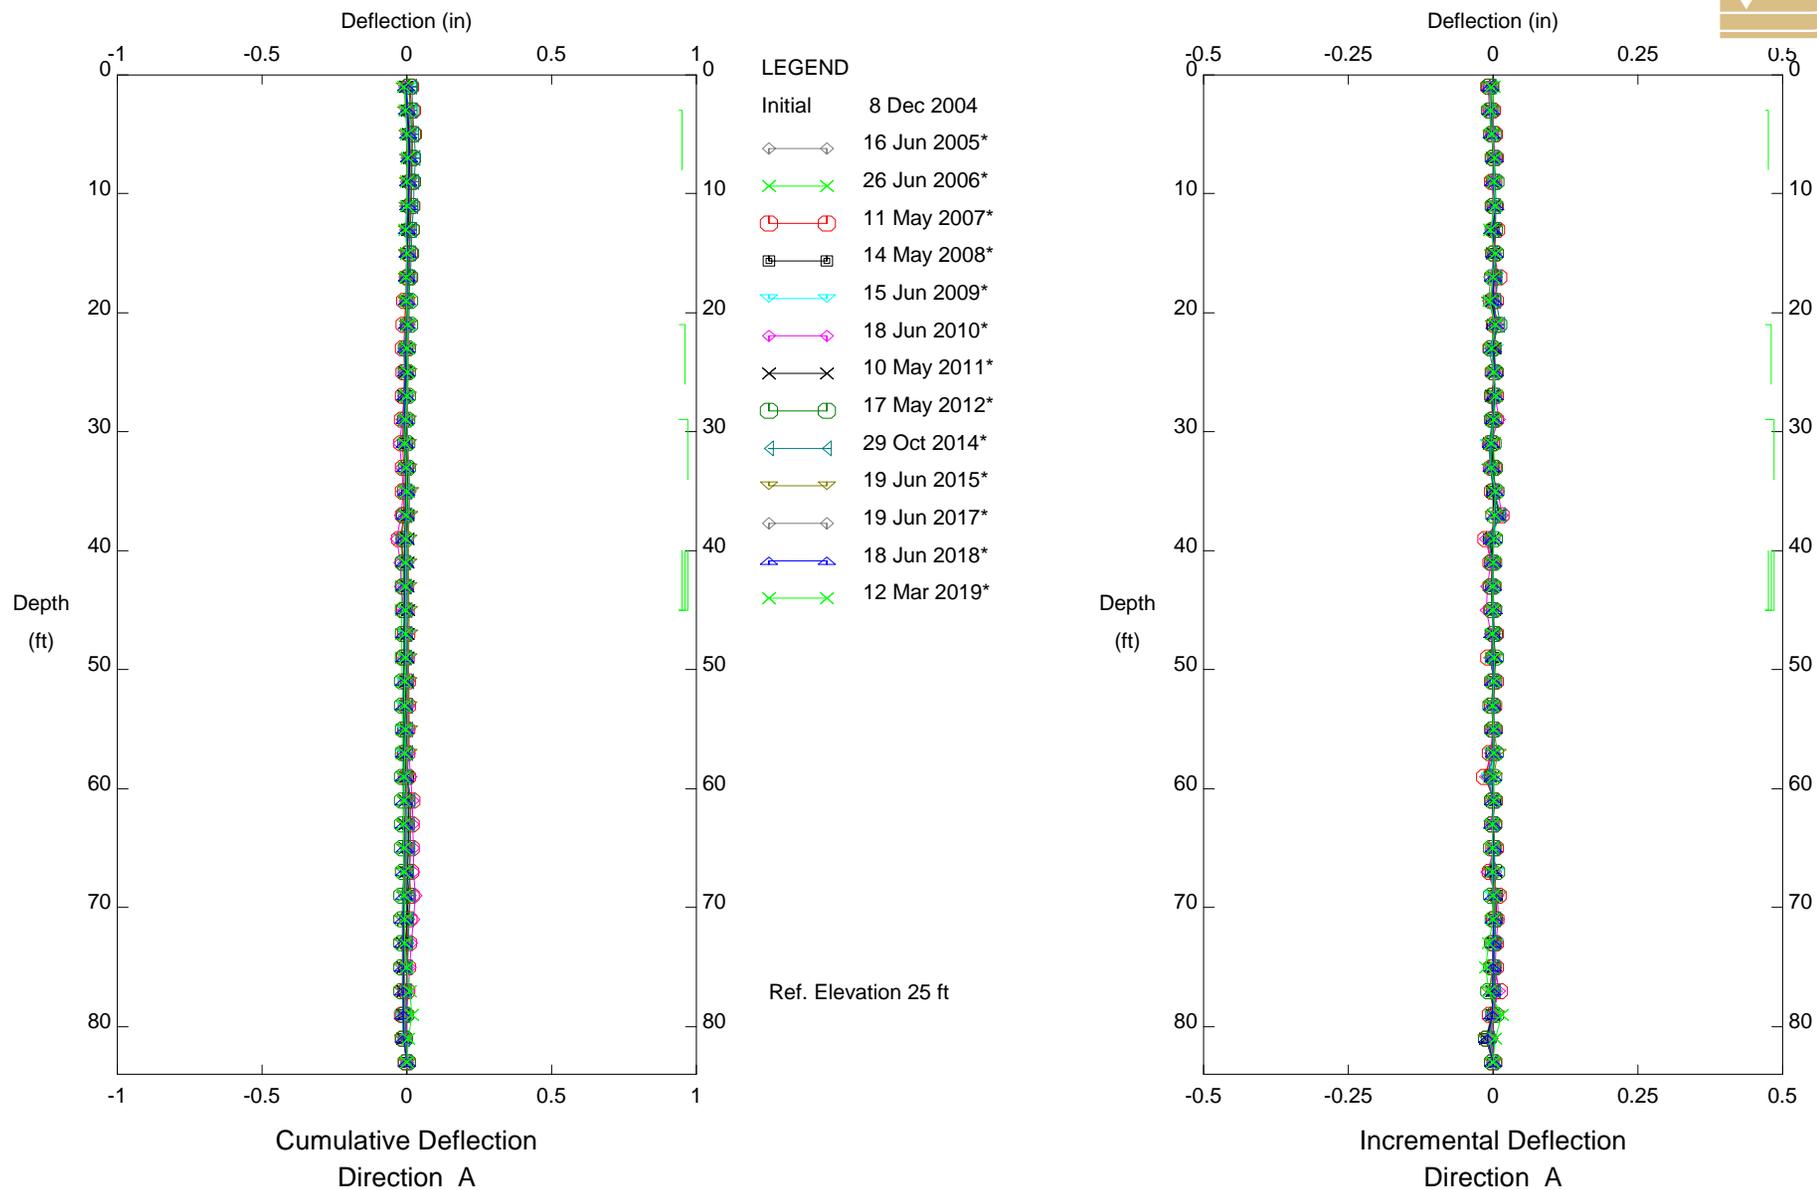
PLATE D6-1

**BIG ROCK MESA, Inclinometer SP-19
 PCH REGION**

Sets marked * include zero shift and/or rotation corrections.

While taking standpipe measurements on March 6, 2019, Fugro observed that the casing and vault for SP-19 was filled with water. In addition, we noticed that a nearby storm drain manhole had been dislodged. It is possible that storm water from recent rainfall exceeded the capacity of the nearby storm drain and filled the standpipe and vault with water. The abnormal reading taken in February 2019 is also assumed to be a result of water entering the casing from the surface. As a result, the February and March 2019 readings were not included in the average groundwater elevation as a result. Water level readings taken after March 2019 were consistent with readings prior to February.

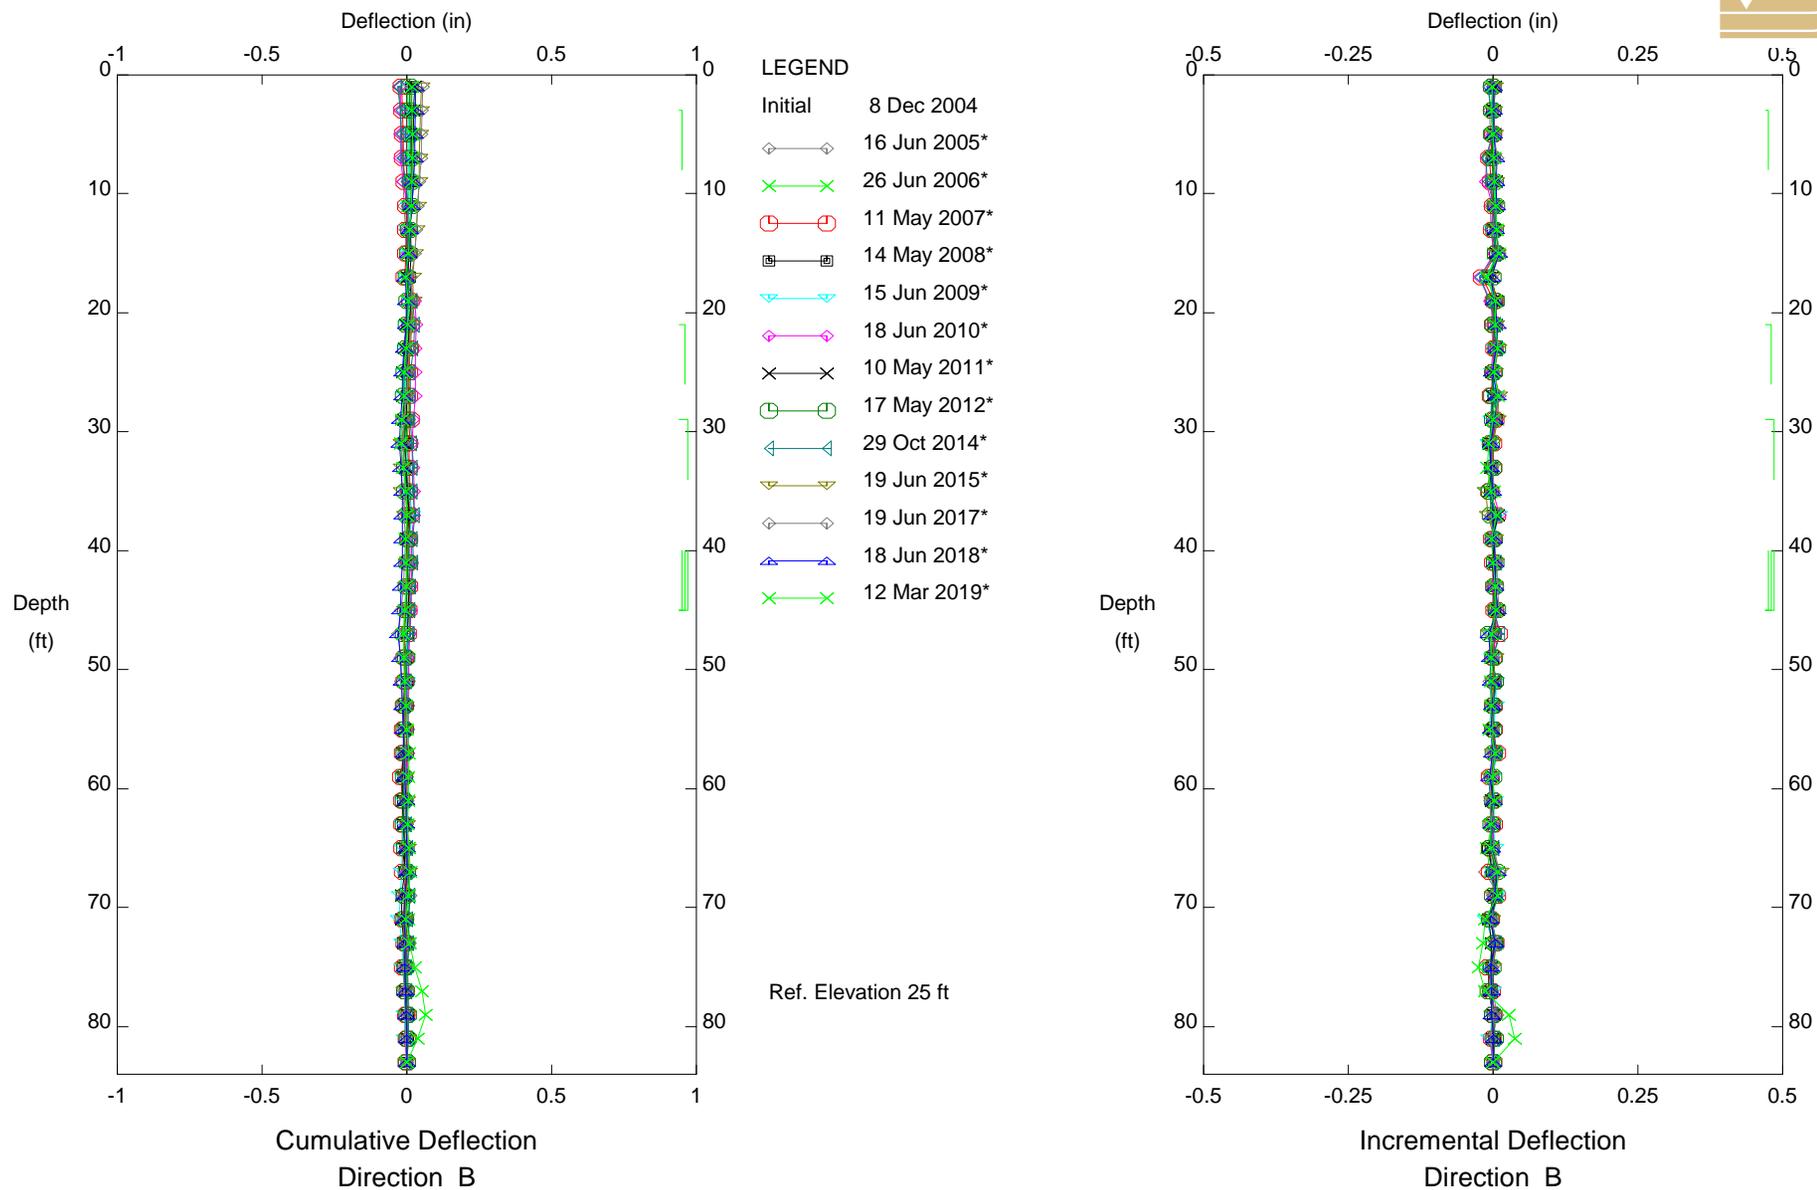
**BIG ROCK MESA, Inclinometer SP-19
 PCH REGION**

Sets marked * include zero shift and/or rotation corrections.

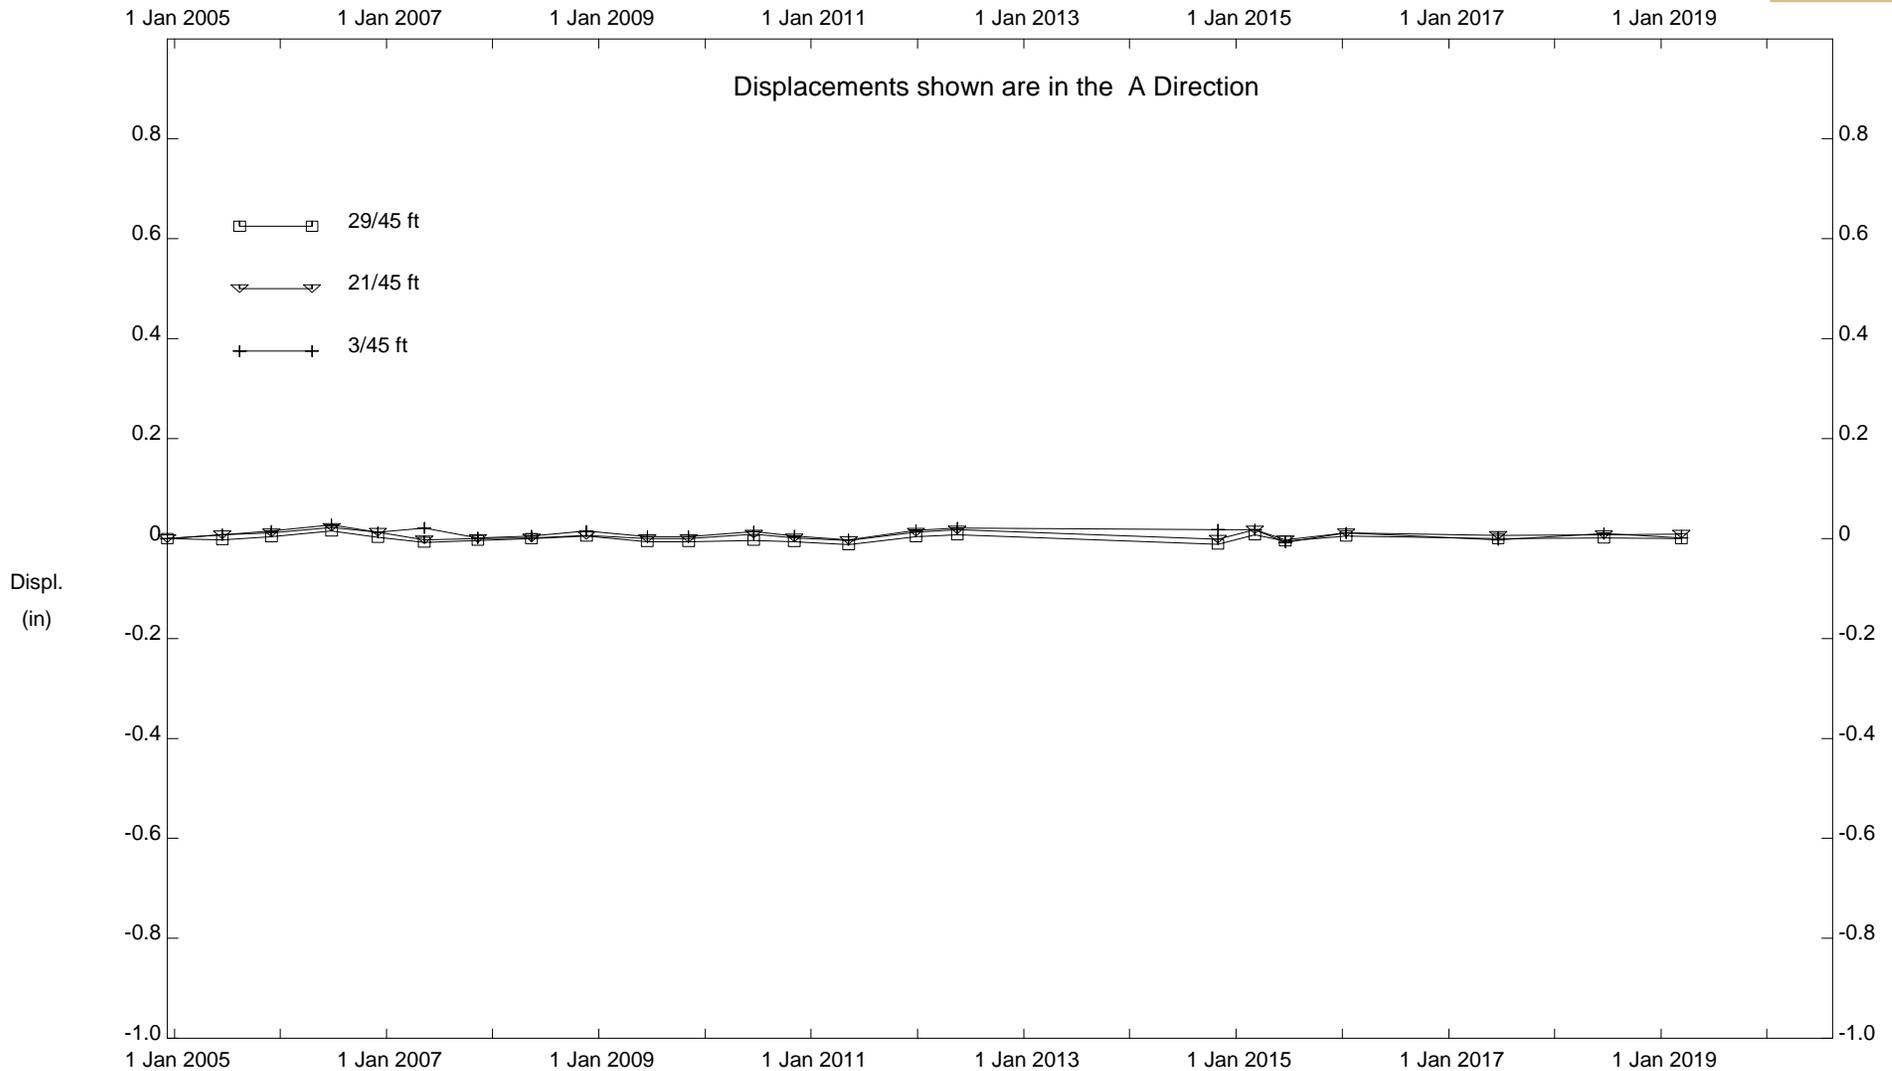
BIG ROCK MESA, Inclinometer SP-19

PCH REGION

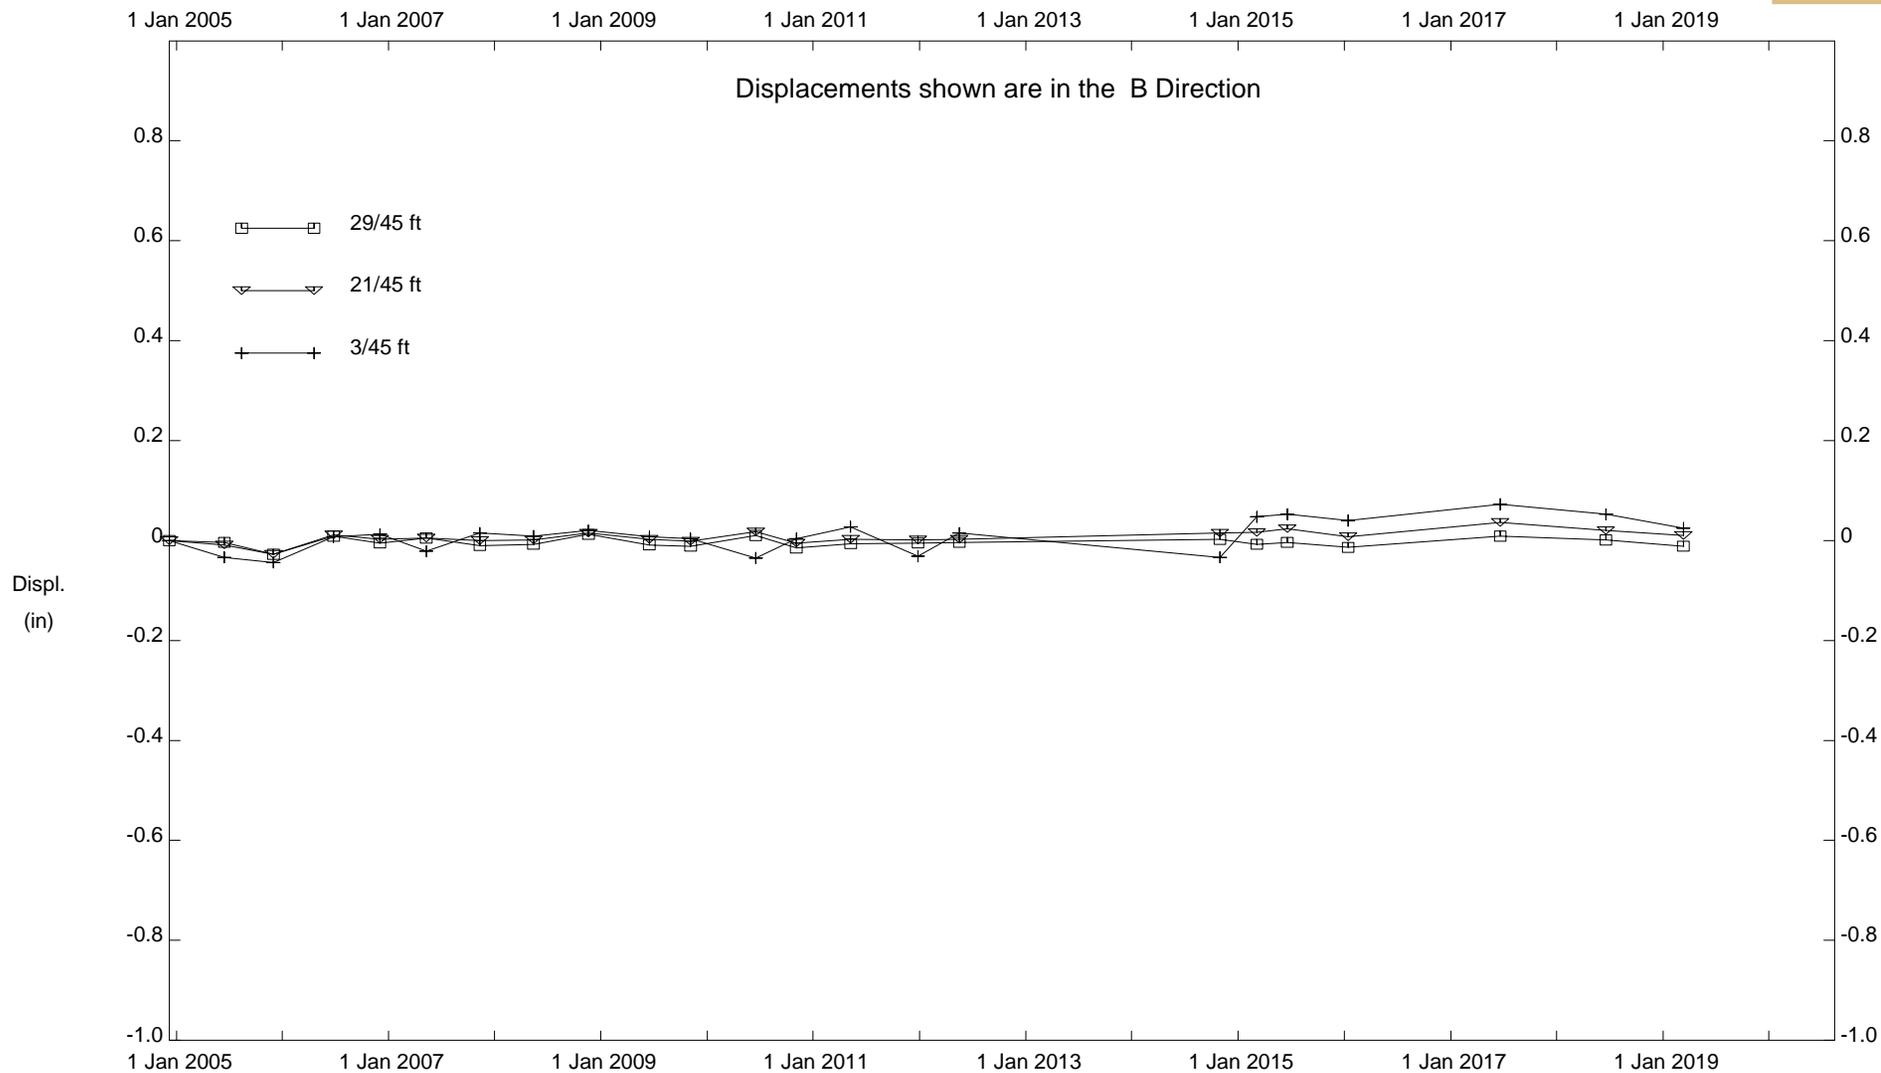
BIG ROCK MESA, Inclinator SP-19

PCH REGION

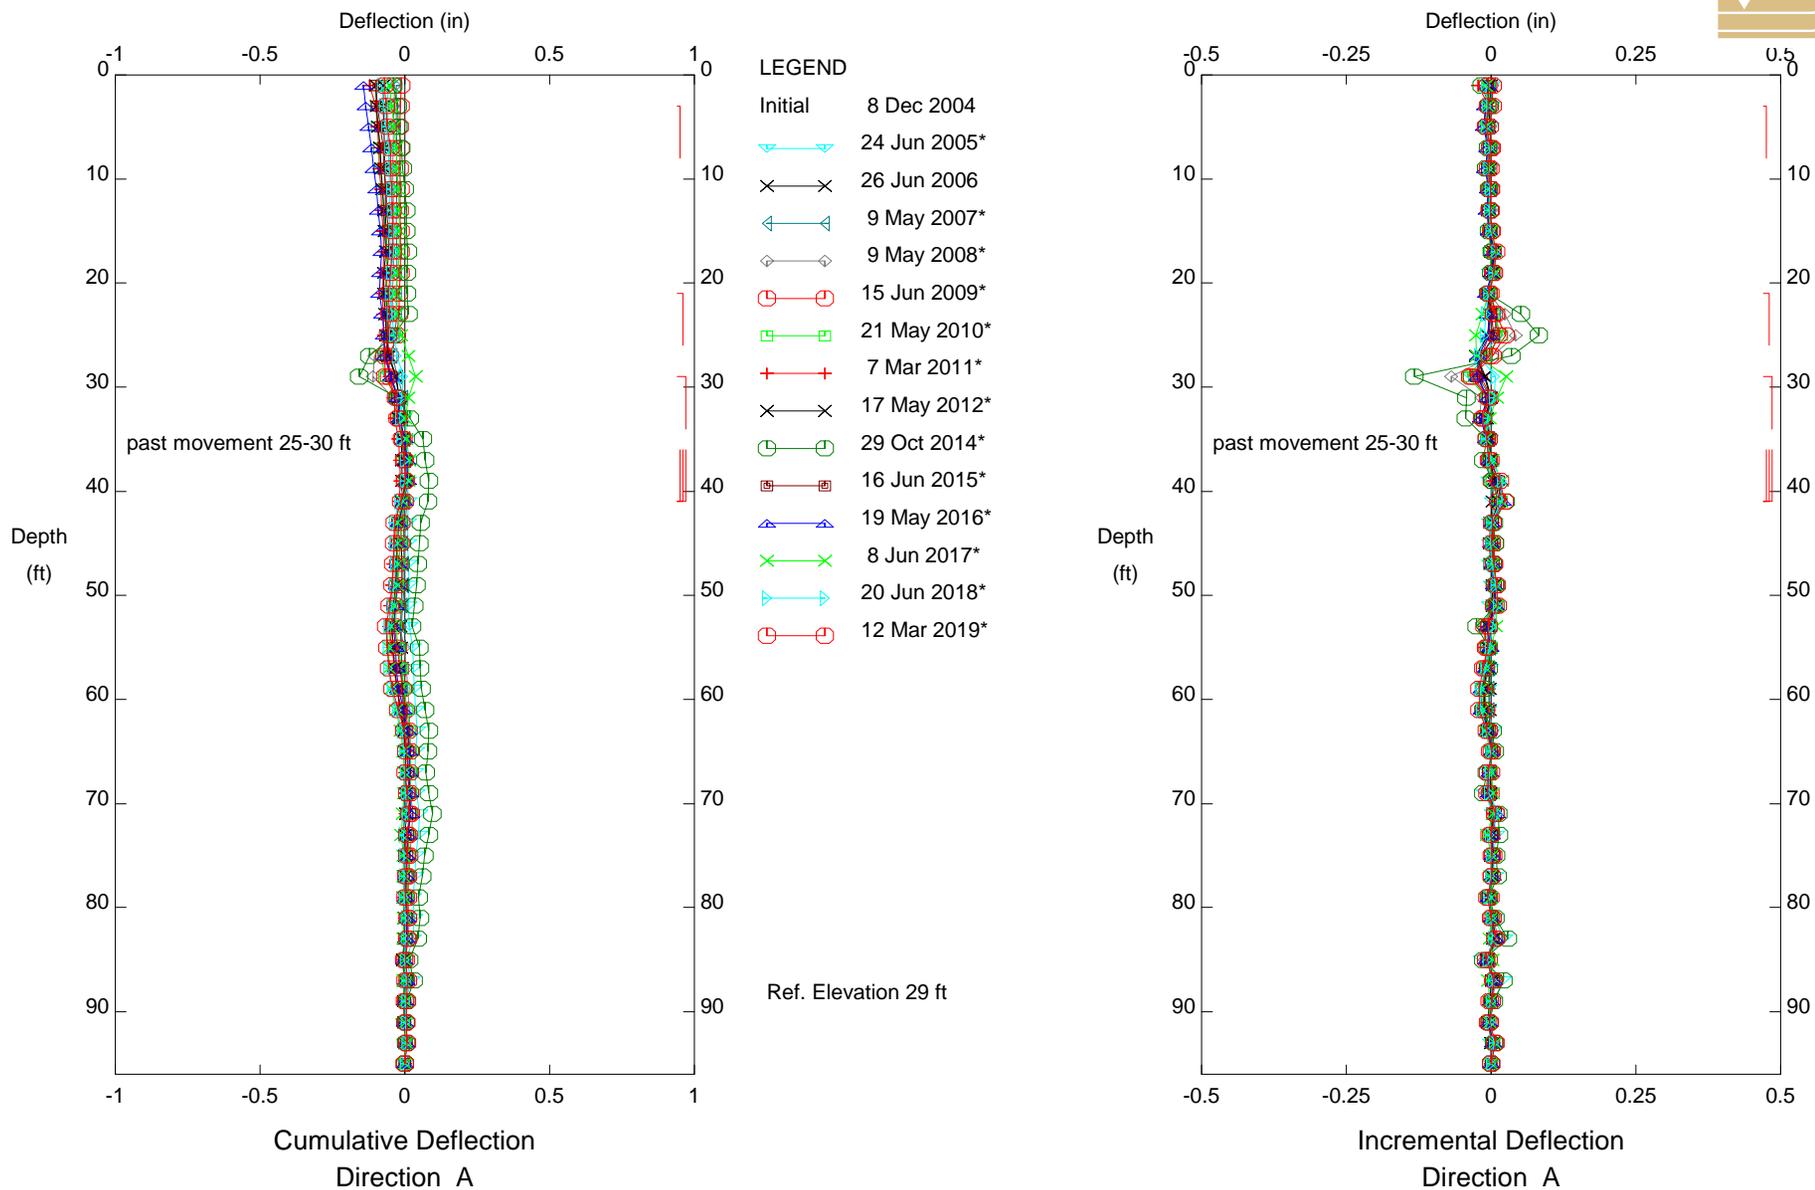
**BIG ROCK MESA, Inclinometer SP-27A
 PCH REGION**

Sets marked * include zero shift and/or rotation corrections.

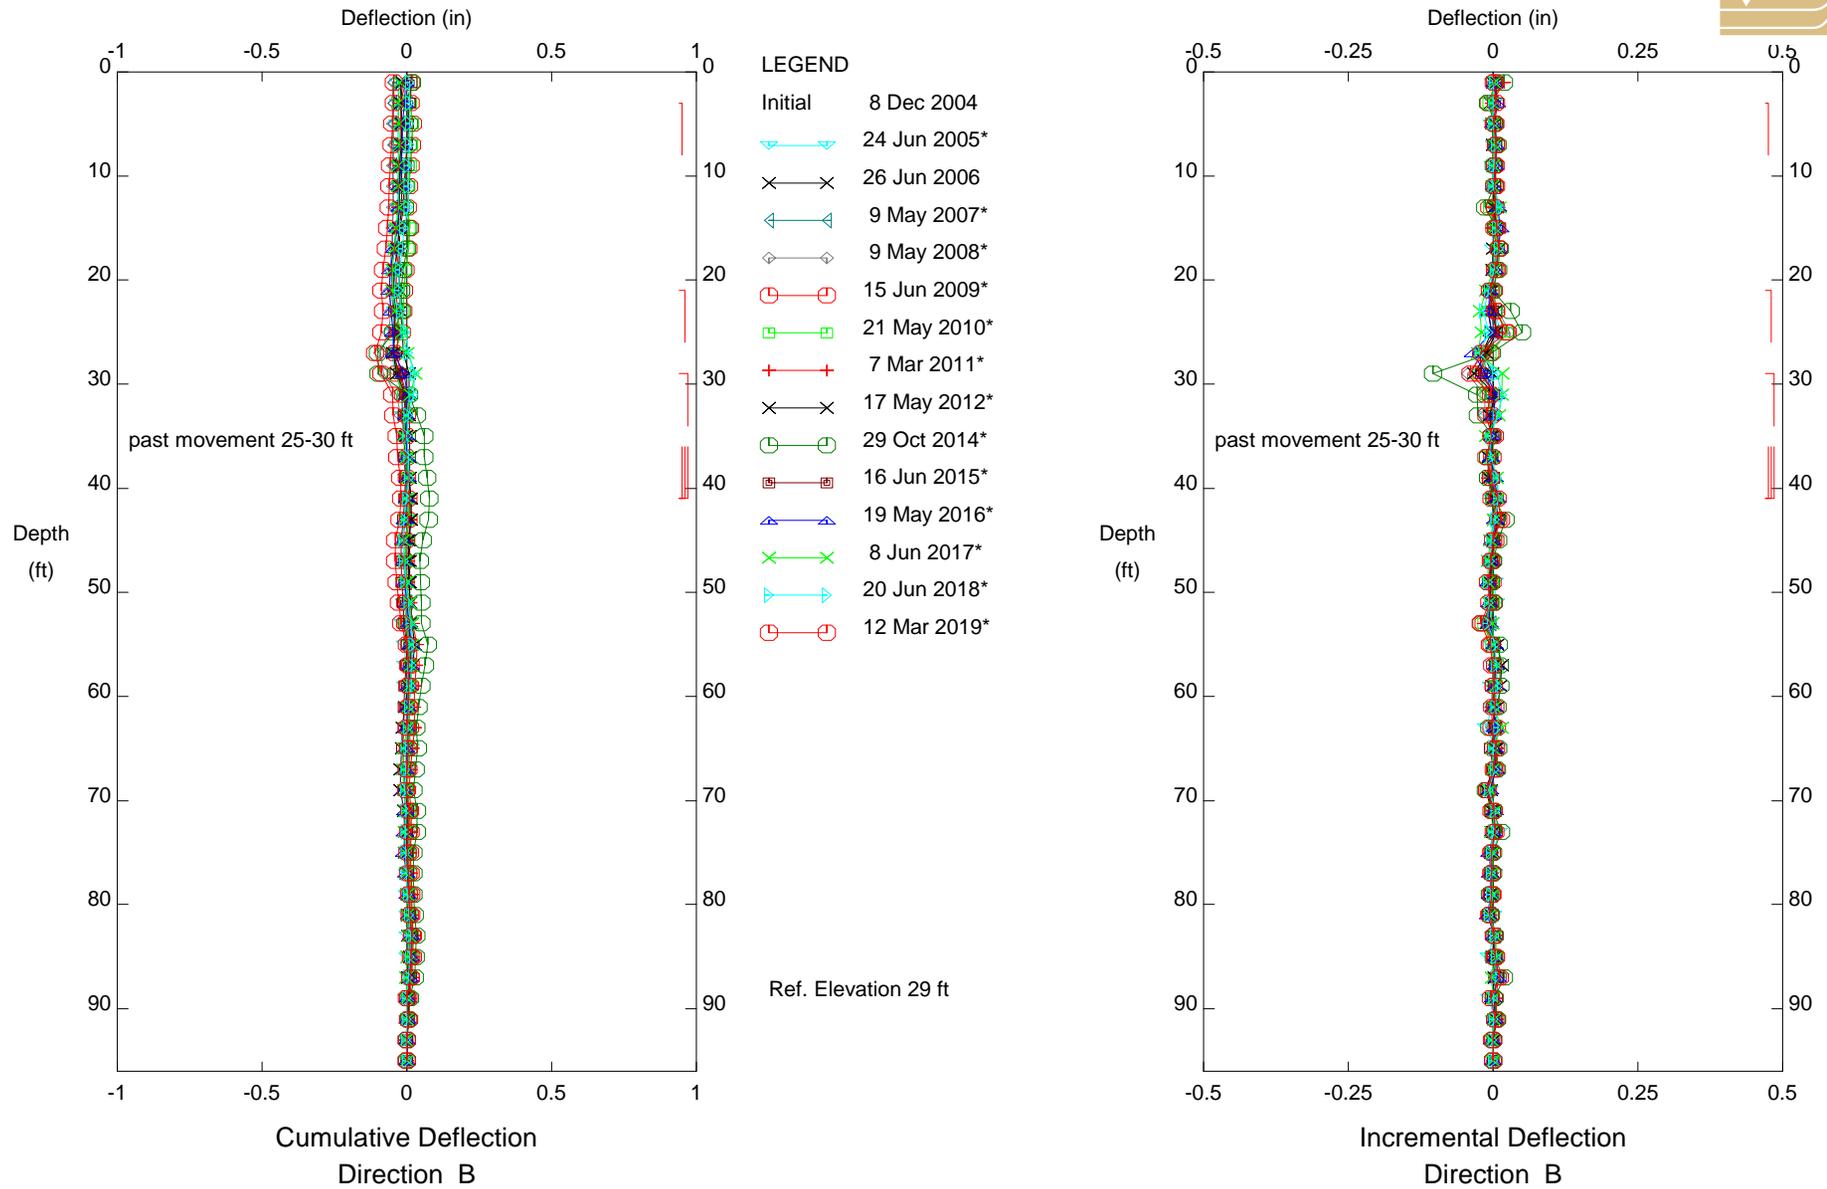
**BIG ROCK MESA, Inclinometer SP-27A
 PCH REGION**

Sets marked * include zero shift and/or rotation corrections.

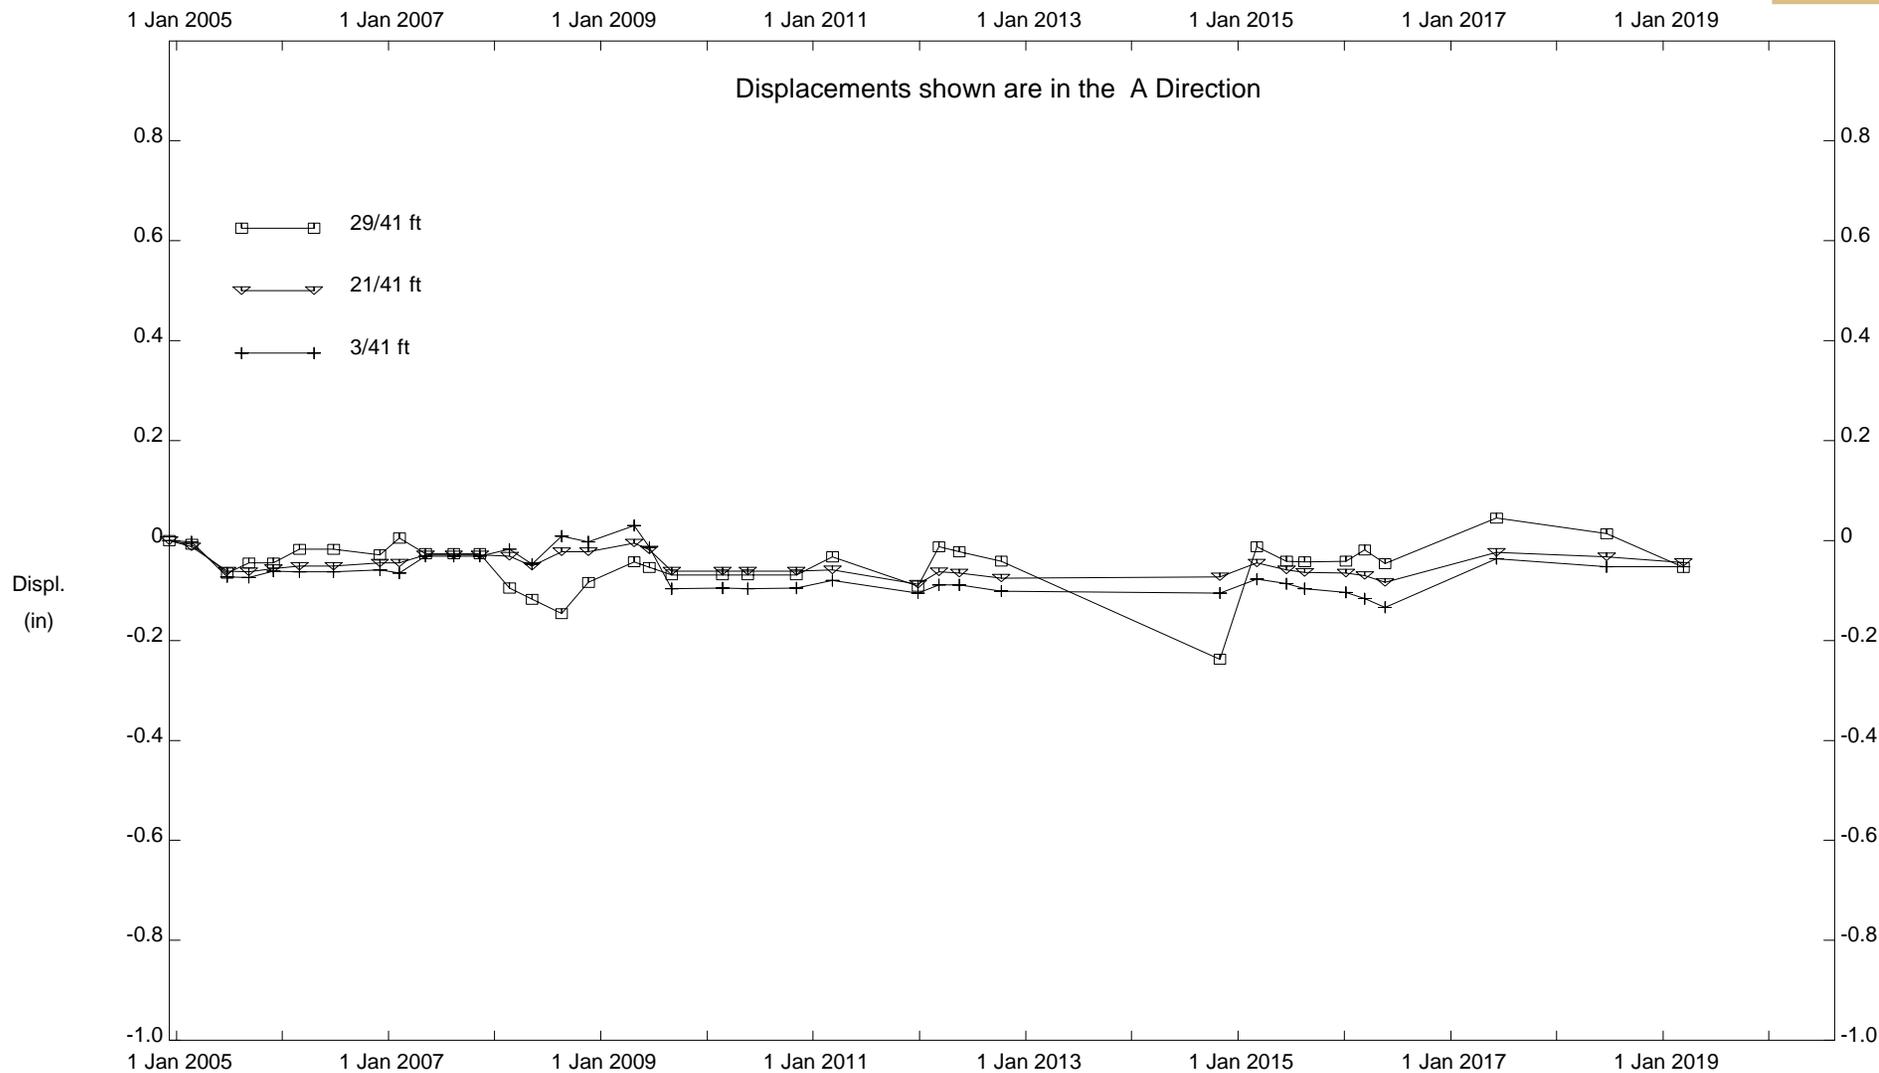
BIG ROCK MESA, Inclinometer SP-27A

PCH REGION

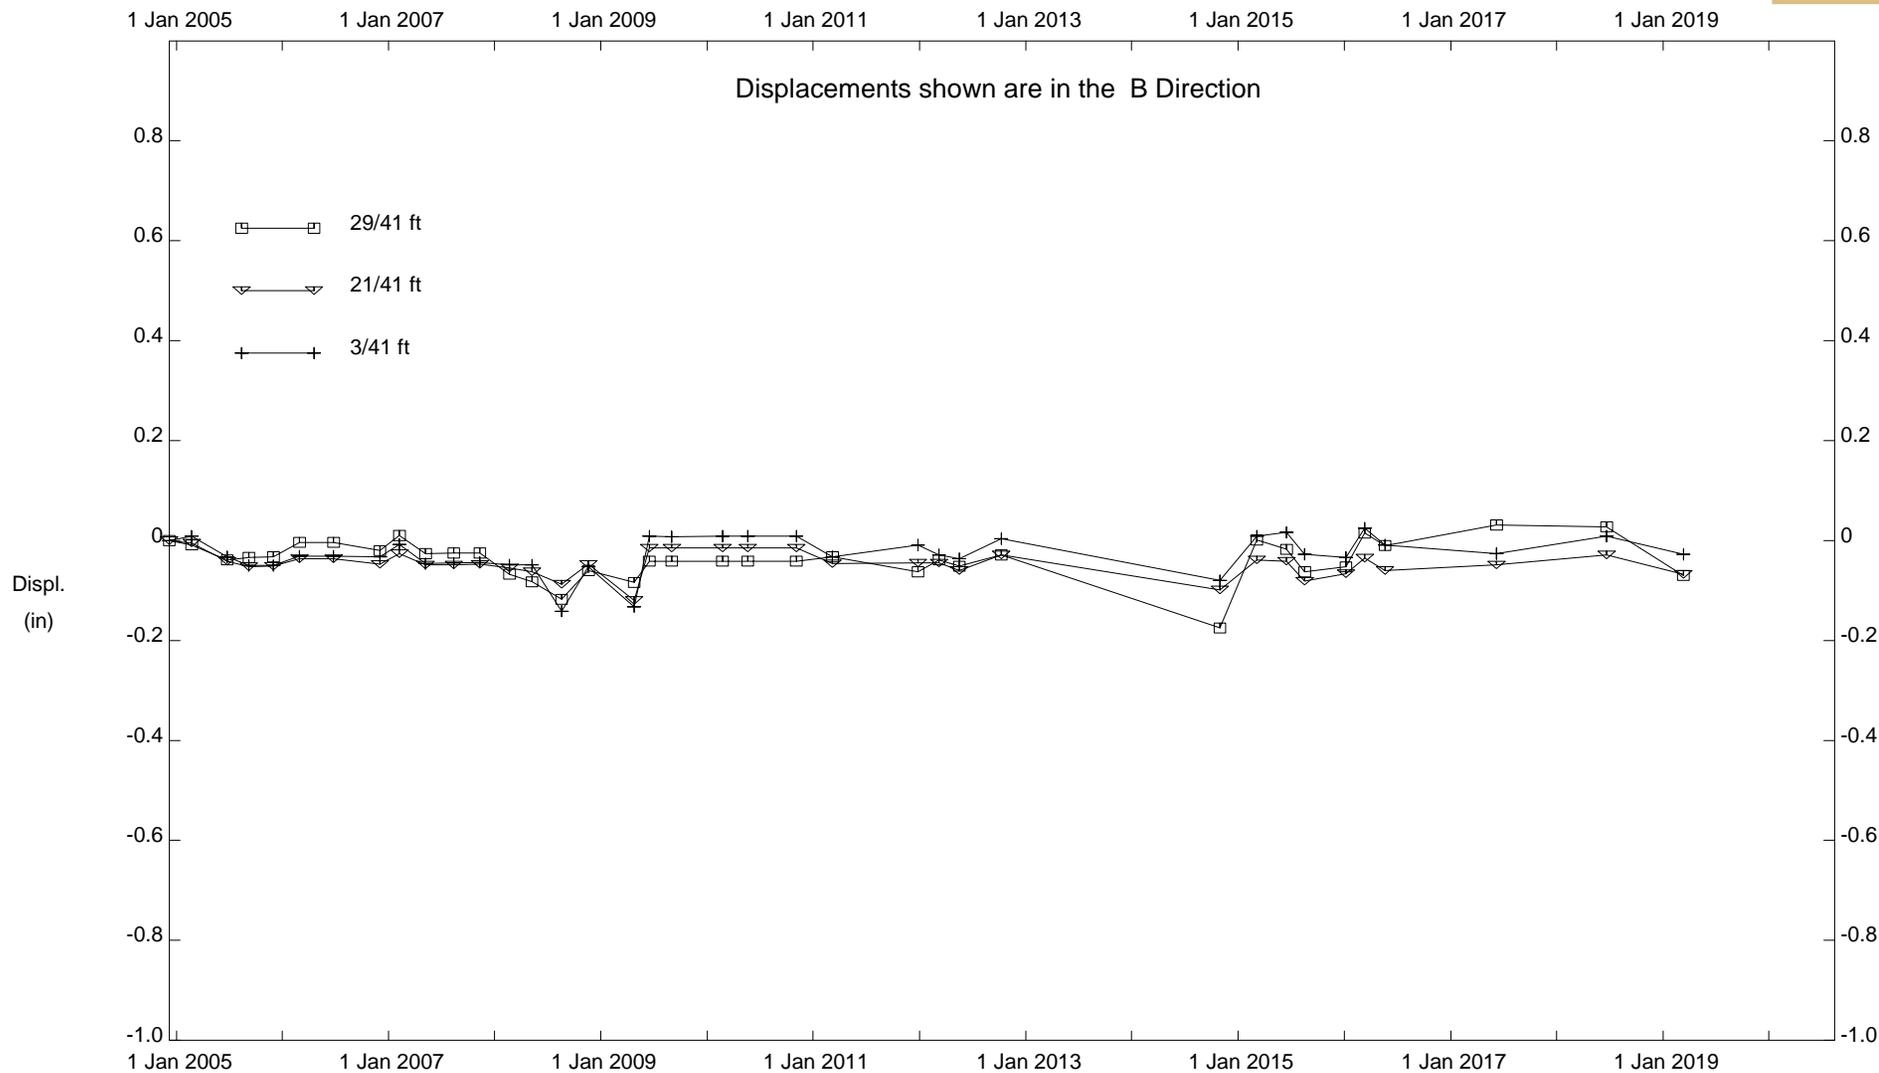
BIG ROCK MESA, Inclinator SP-27A

PCH REGION

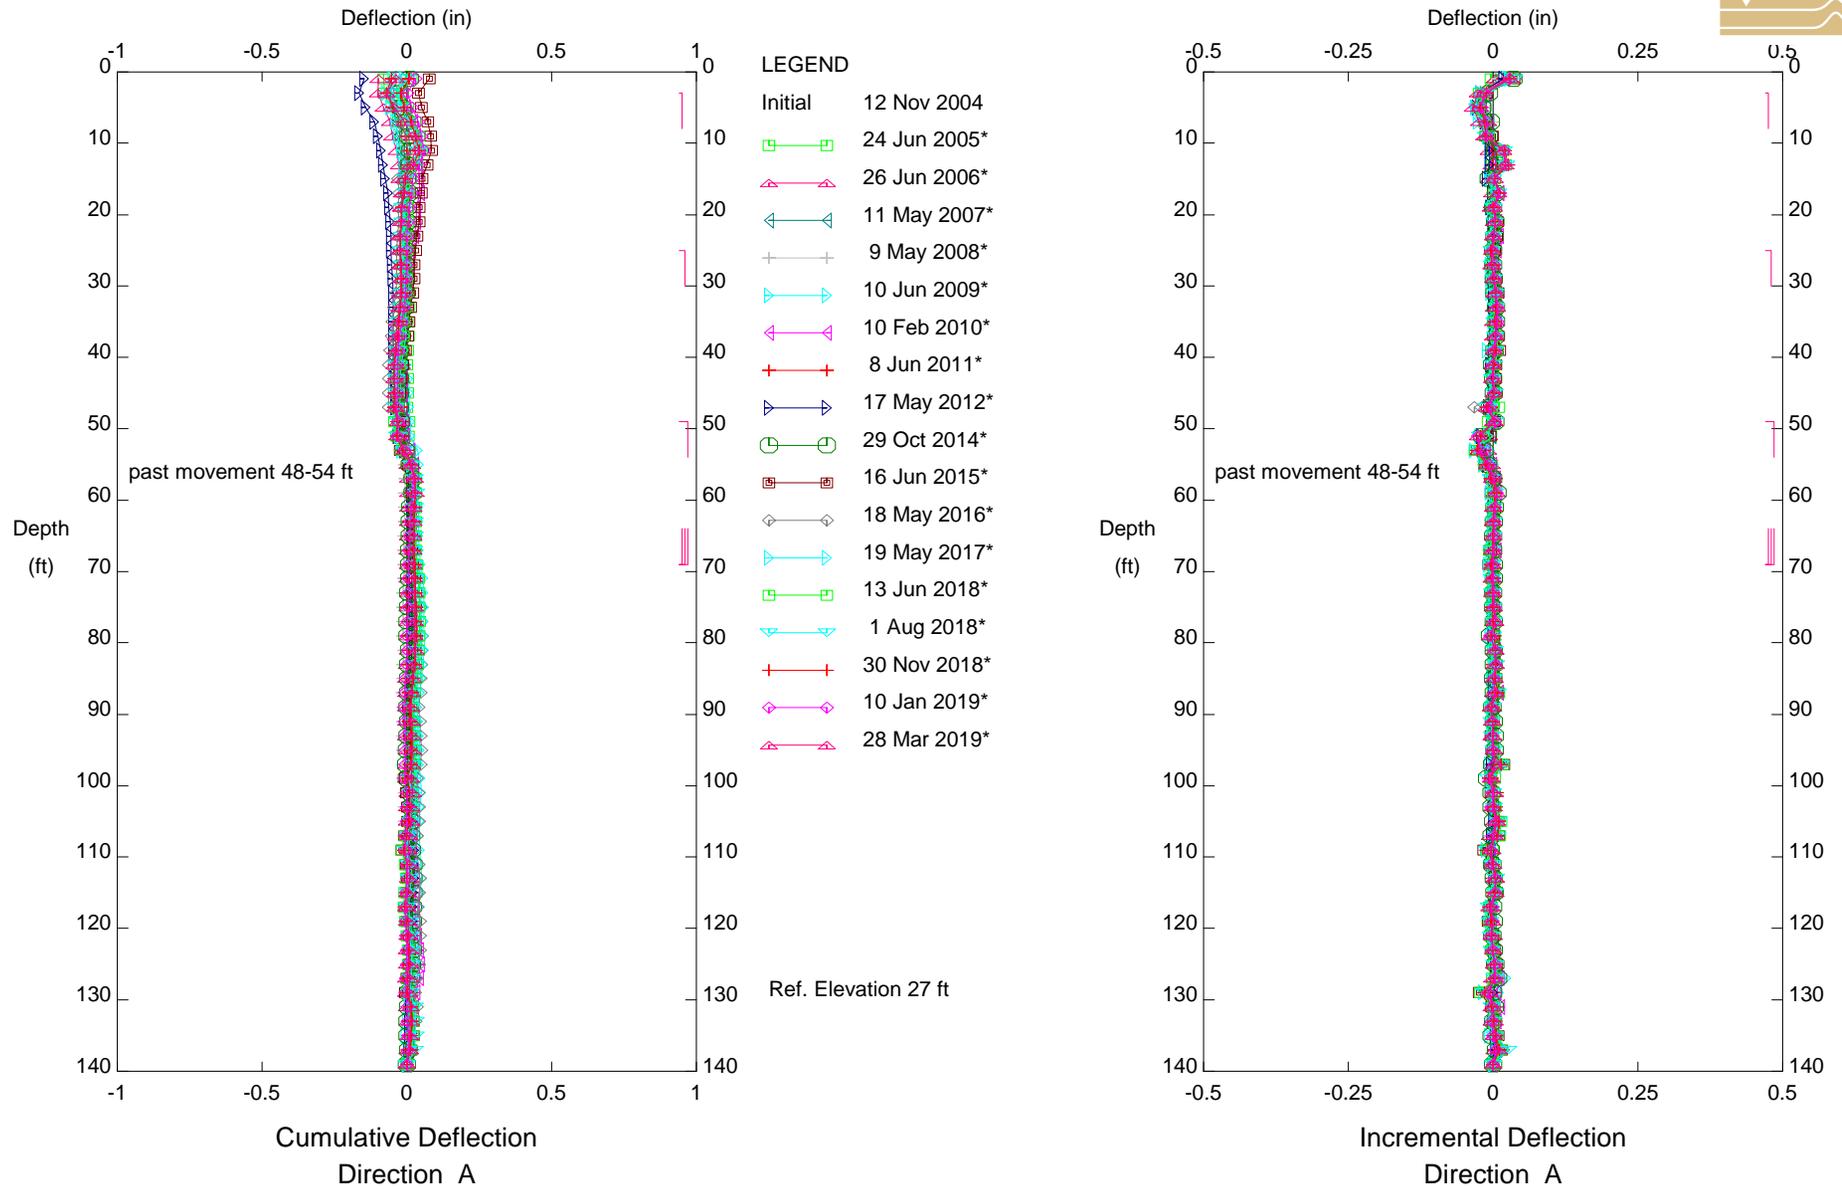
**BIG ROCK MESA, Inclinometer SP-29
 PCH REGION**

Sets marked * include zero shift and/or rotation corrections.

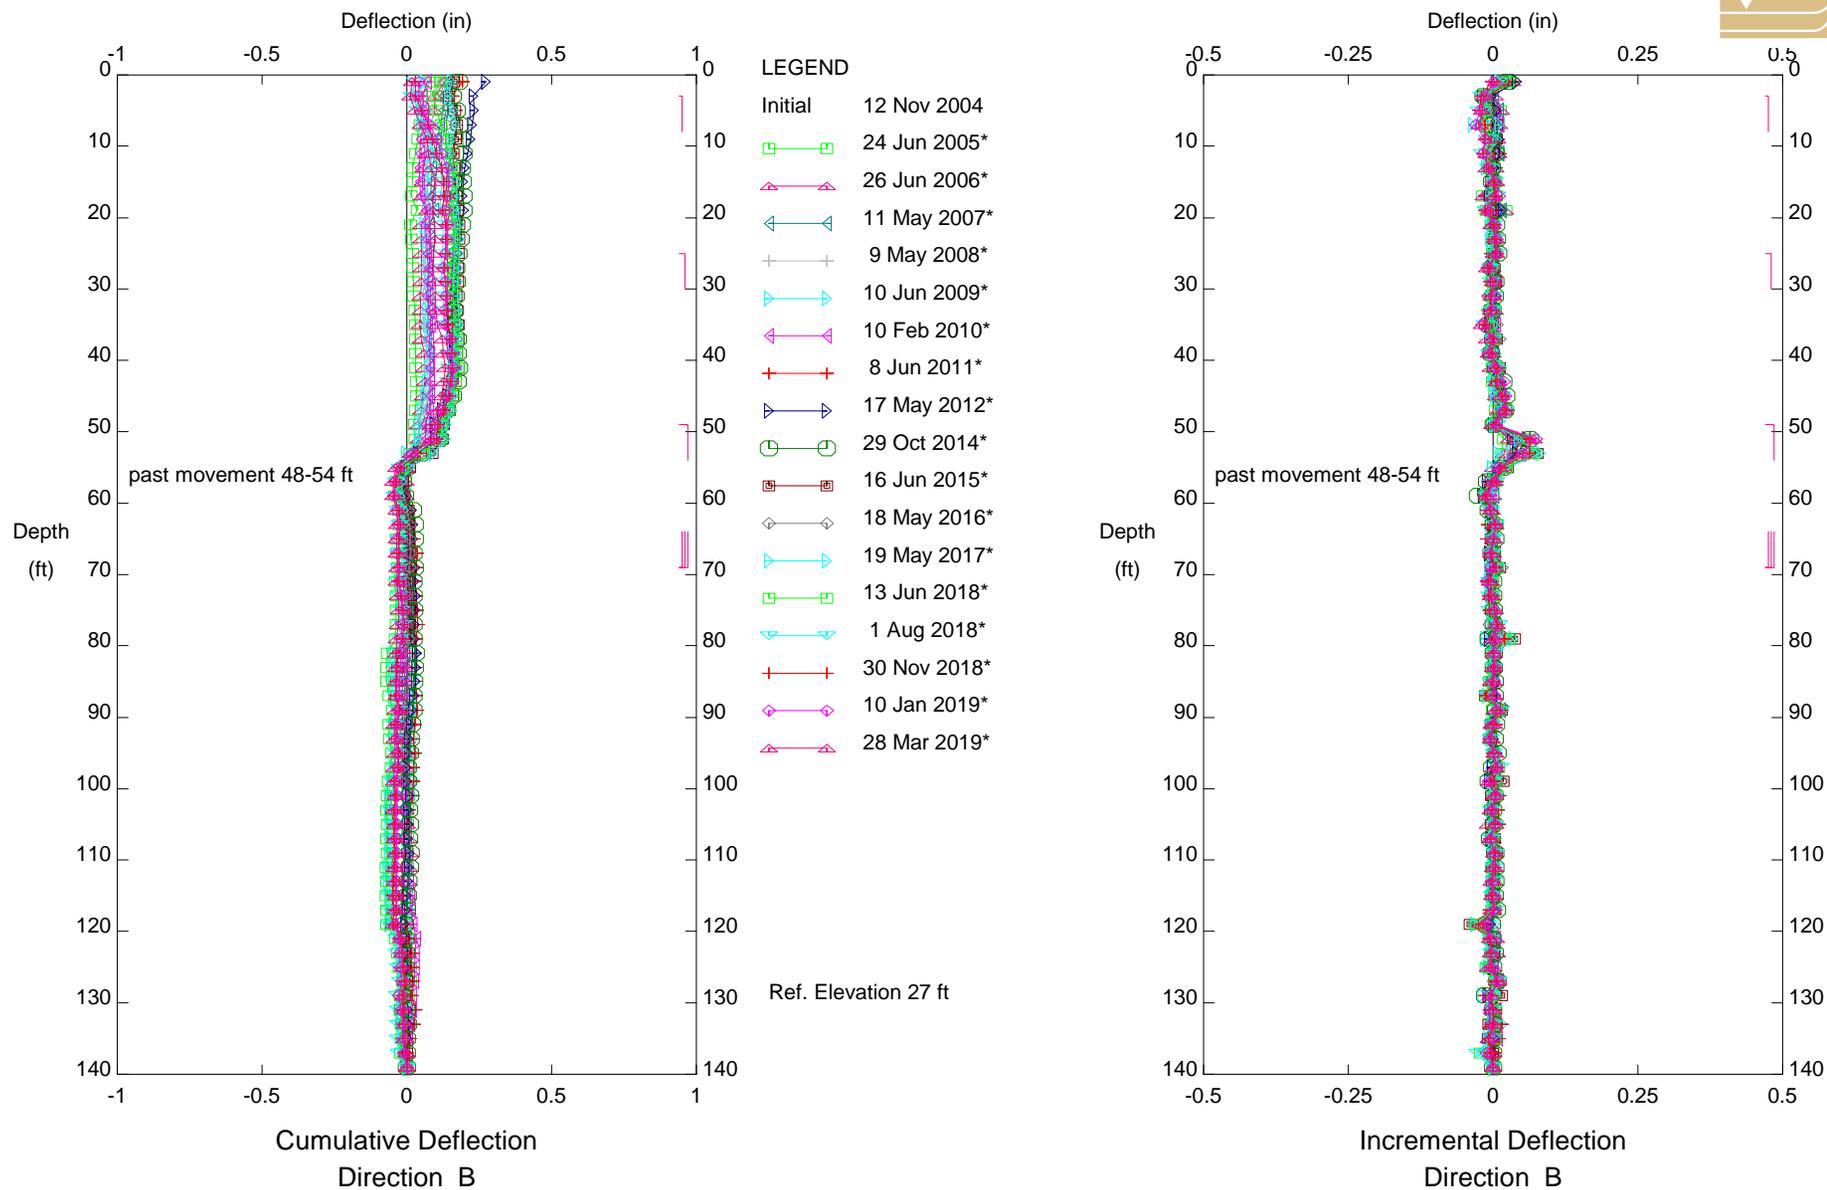
**BIG ROCK MESA, Inclinator SP-29
 PCH REGION**

Sets marked * include zero shift and/or rotation corrections.
