**ANNUAL REPORT
JULY 2018 THROUGH JUNE 2019
BIG ROCK MESA LANDSLIDE
ASSESSMENT DISTRICT
City of Malibu, California**

November 2019
Fugro Project No. 04.62160606
Document No. 04.62160606-PR-006(Rev.00)

Annual Report of Maintenance and Monitoring, July 2018 through June 2019, Big Rock Mesa Landslide Assessment District, City of Malibu, California

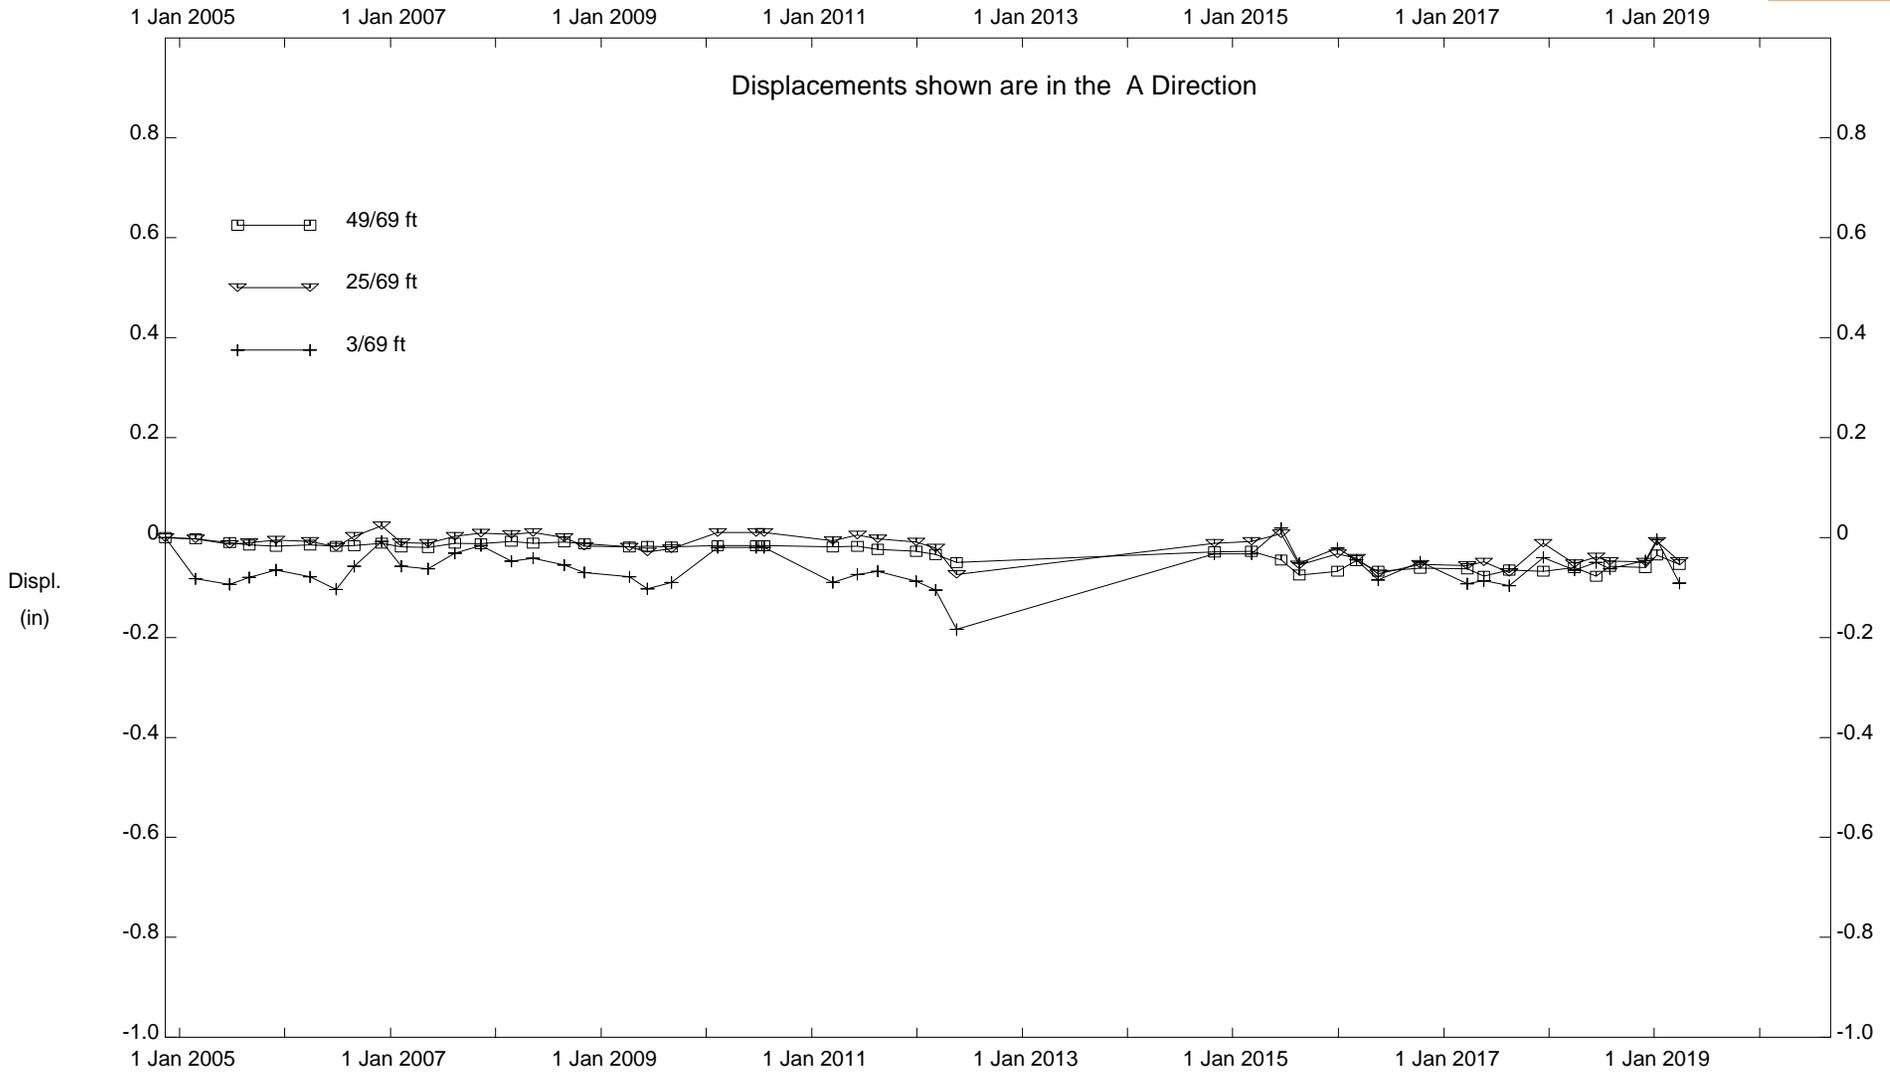
BIG ROCK MESA, Inclinometer SP-29

PCH REGION

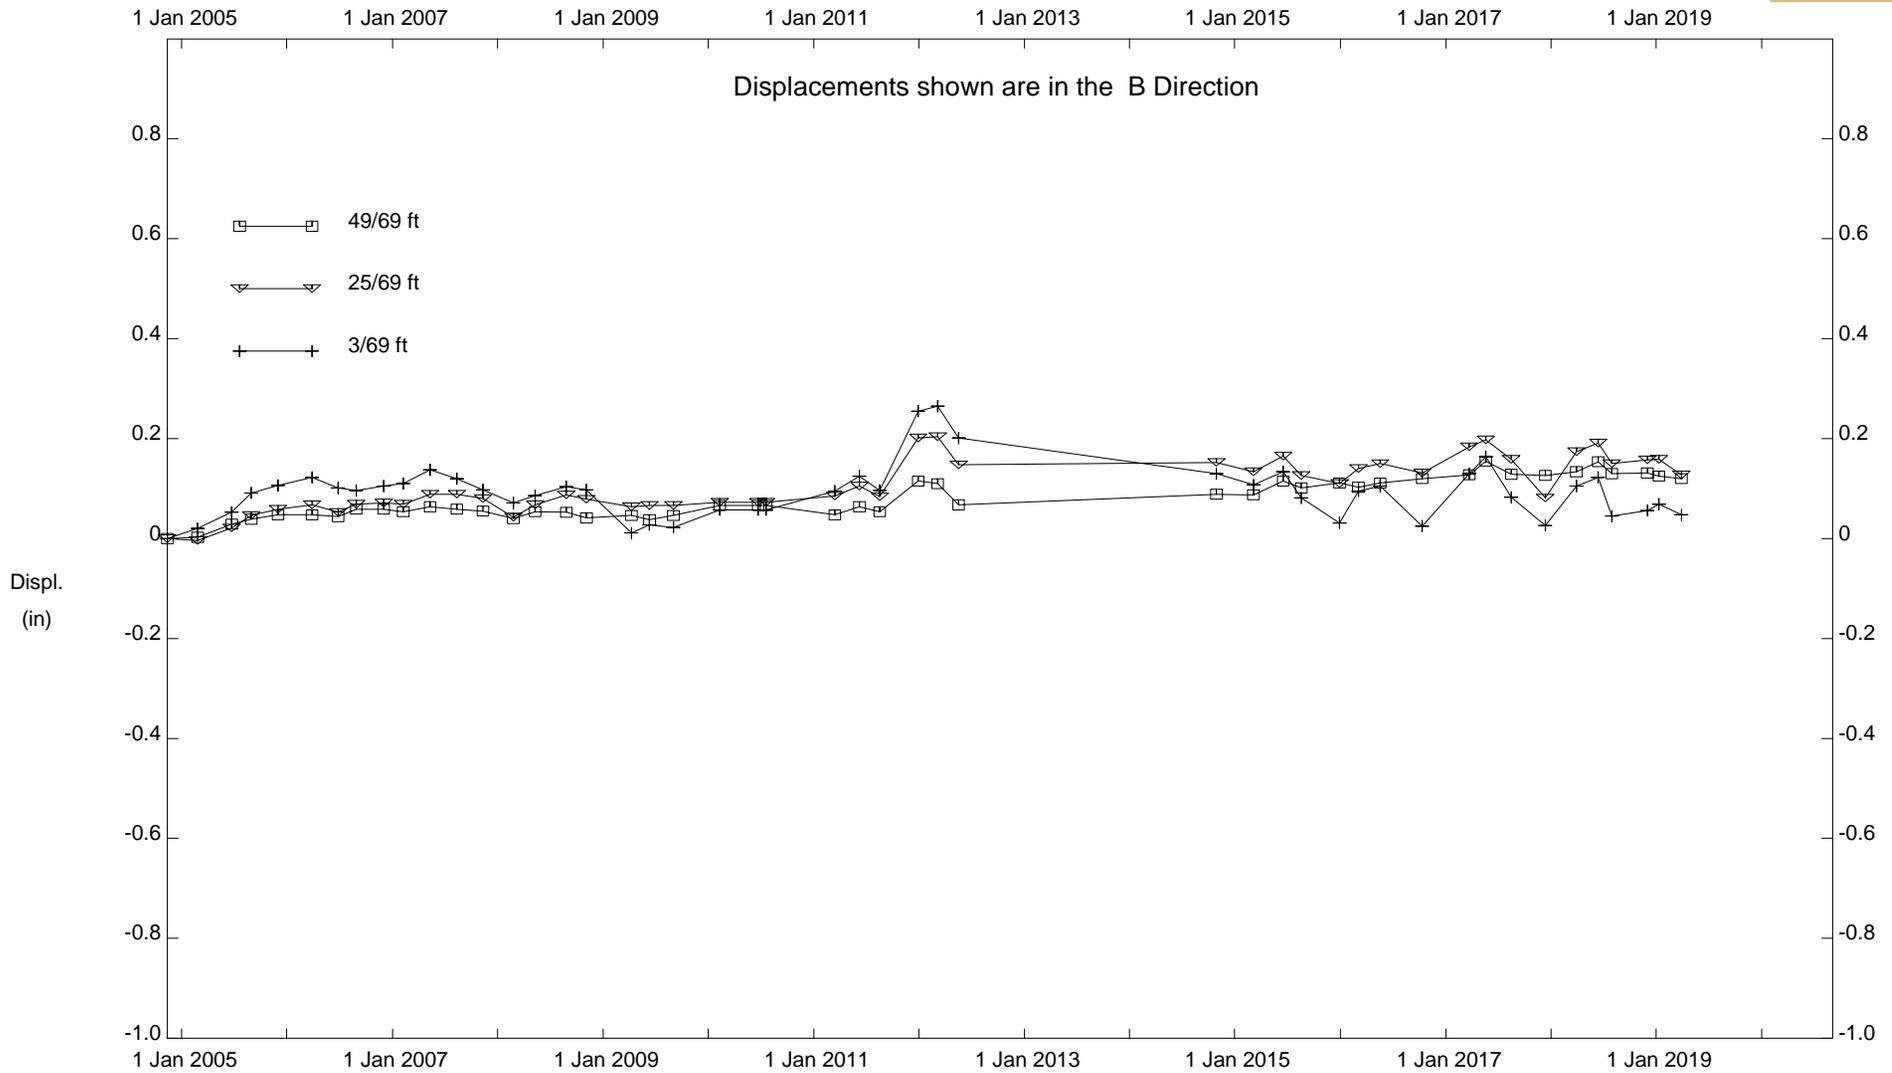
BIG ROCK MESA, Inclinometer SP-29

PCH REGION

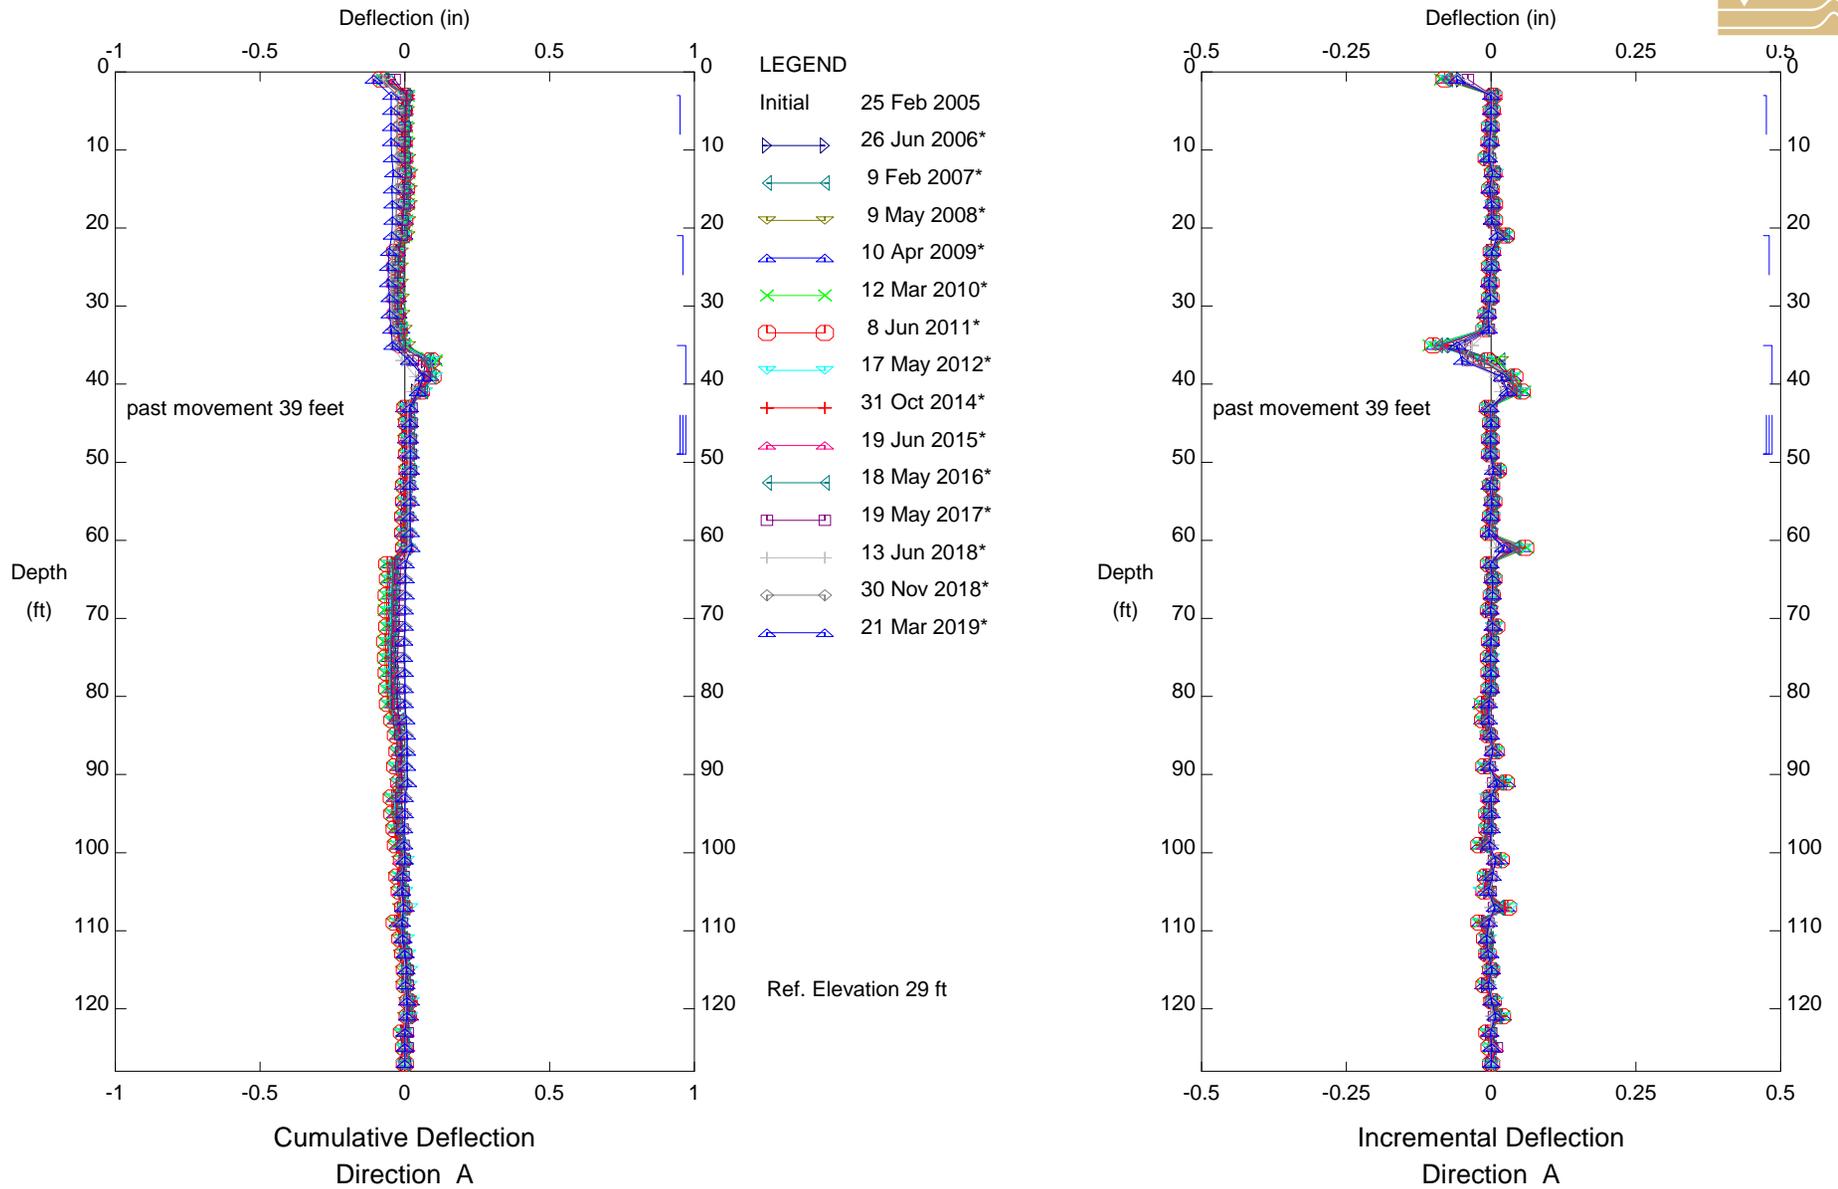
**BIG ROCK MESA, Inclinometer SP-30
 PCH REGION**

Sets marked * include zero shift and/or rotation corrections.

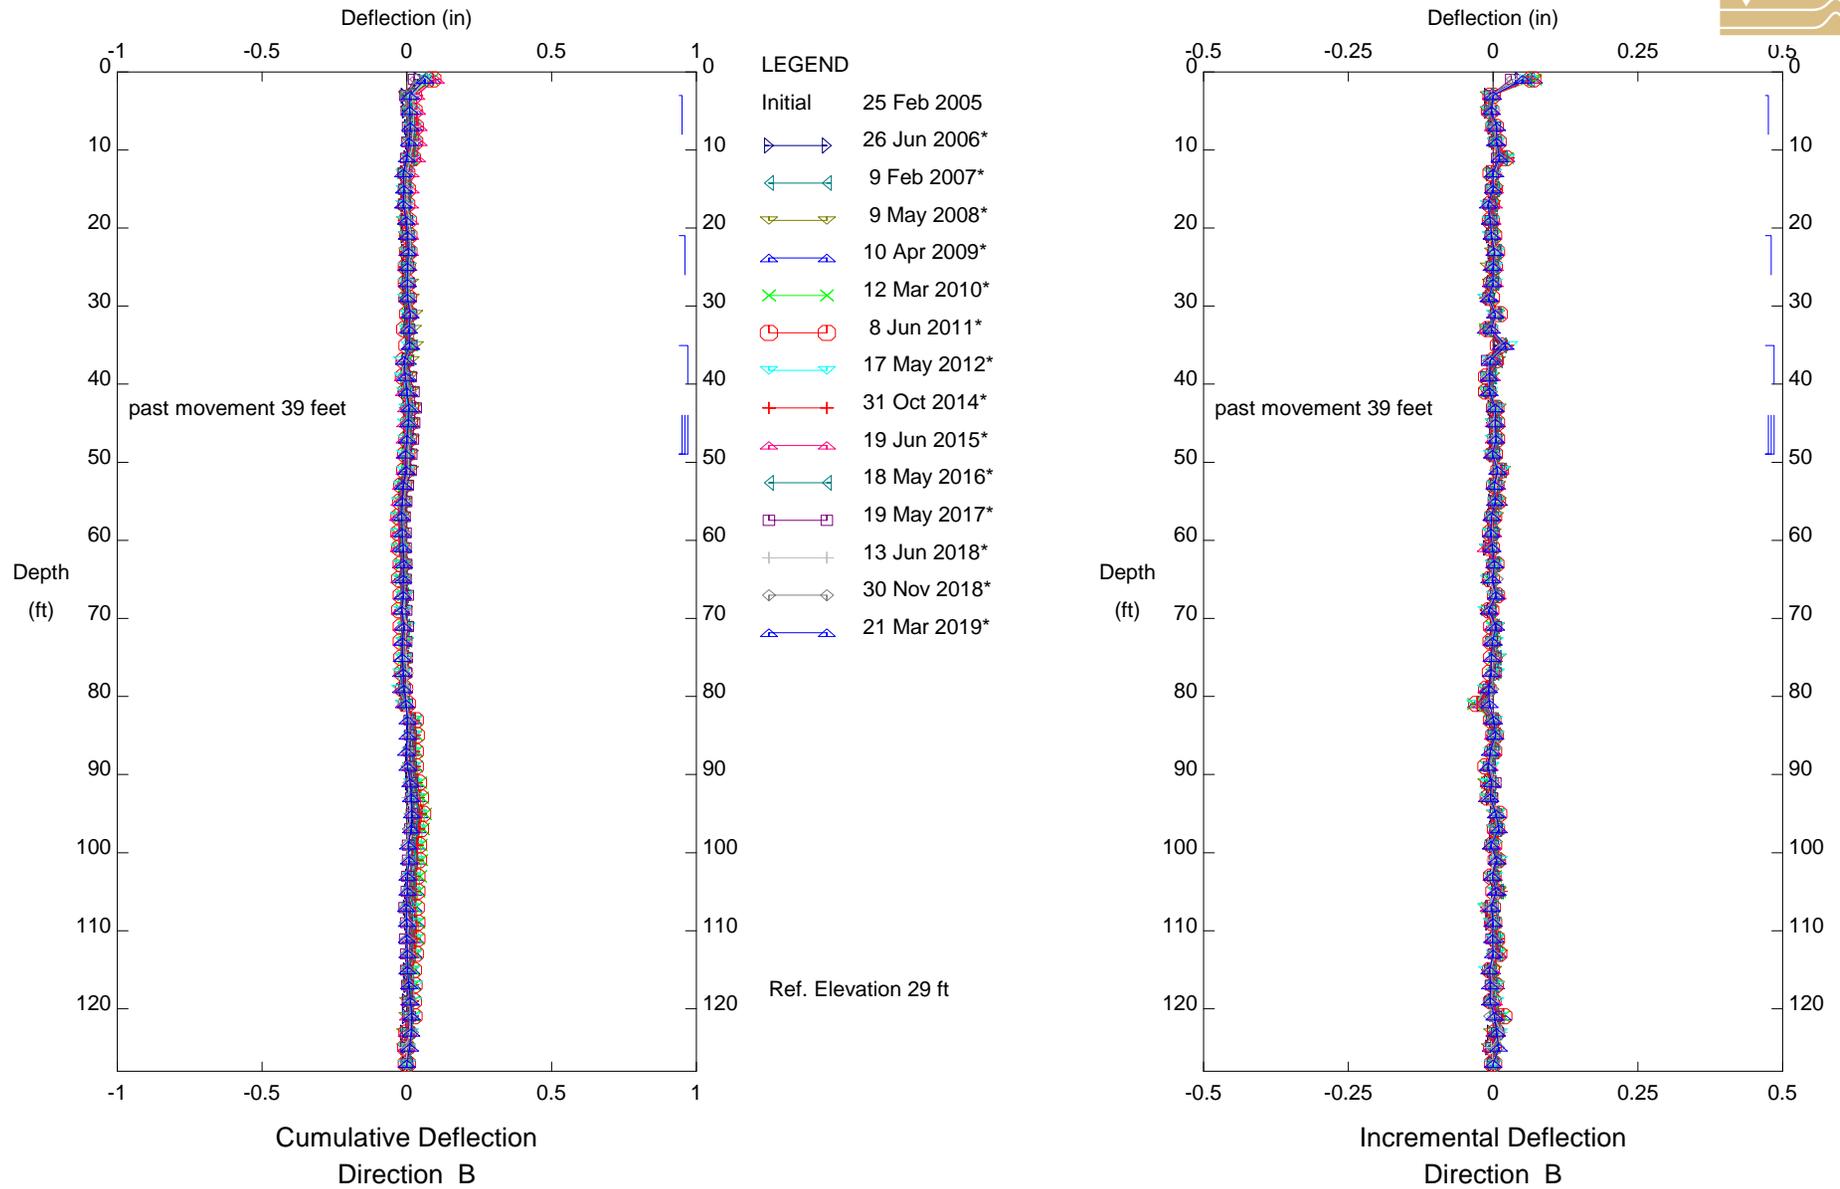
**BIG ROCK MESA, Inclinometer SP-30
 PCH REGION**

Sets marked * include zero shift and/or rotation corrections.

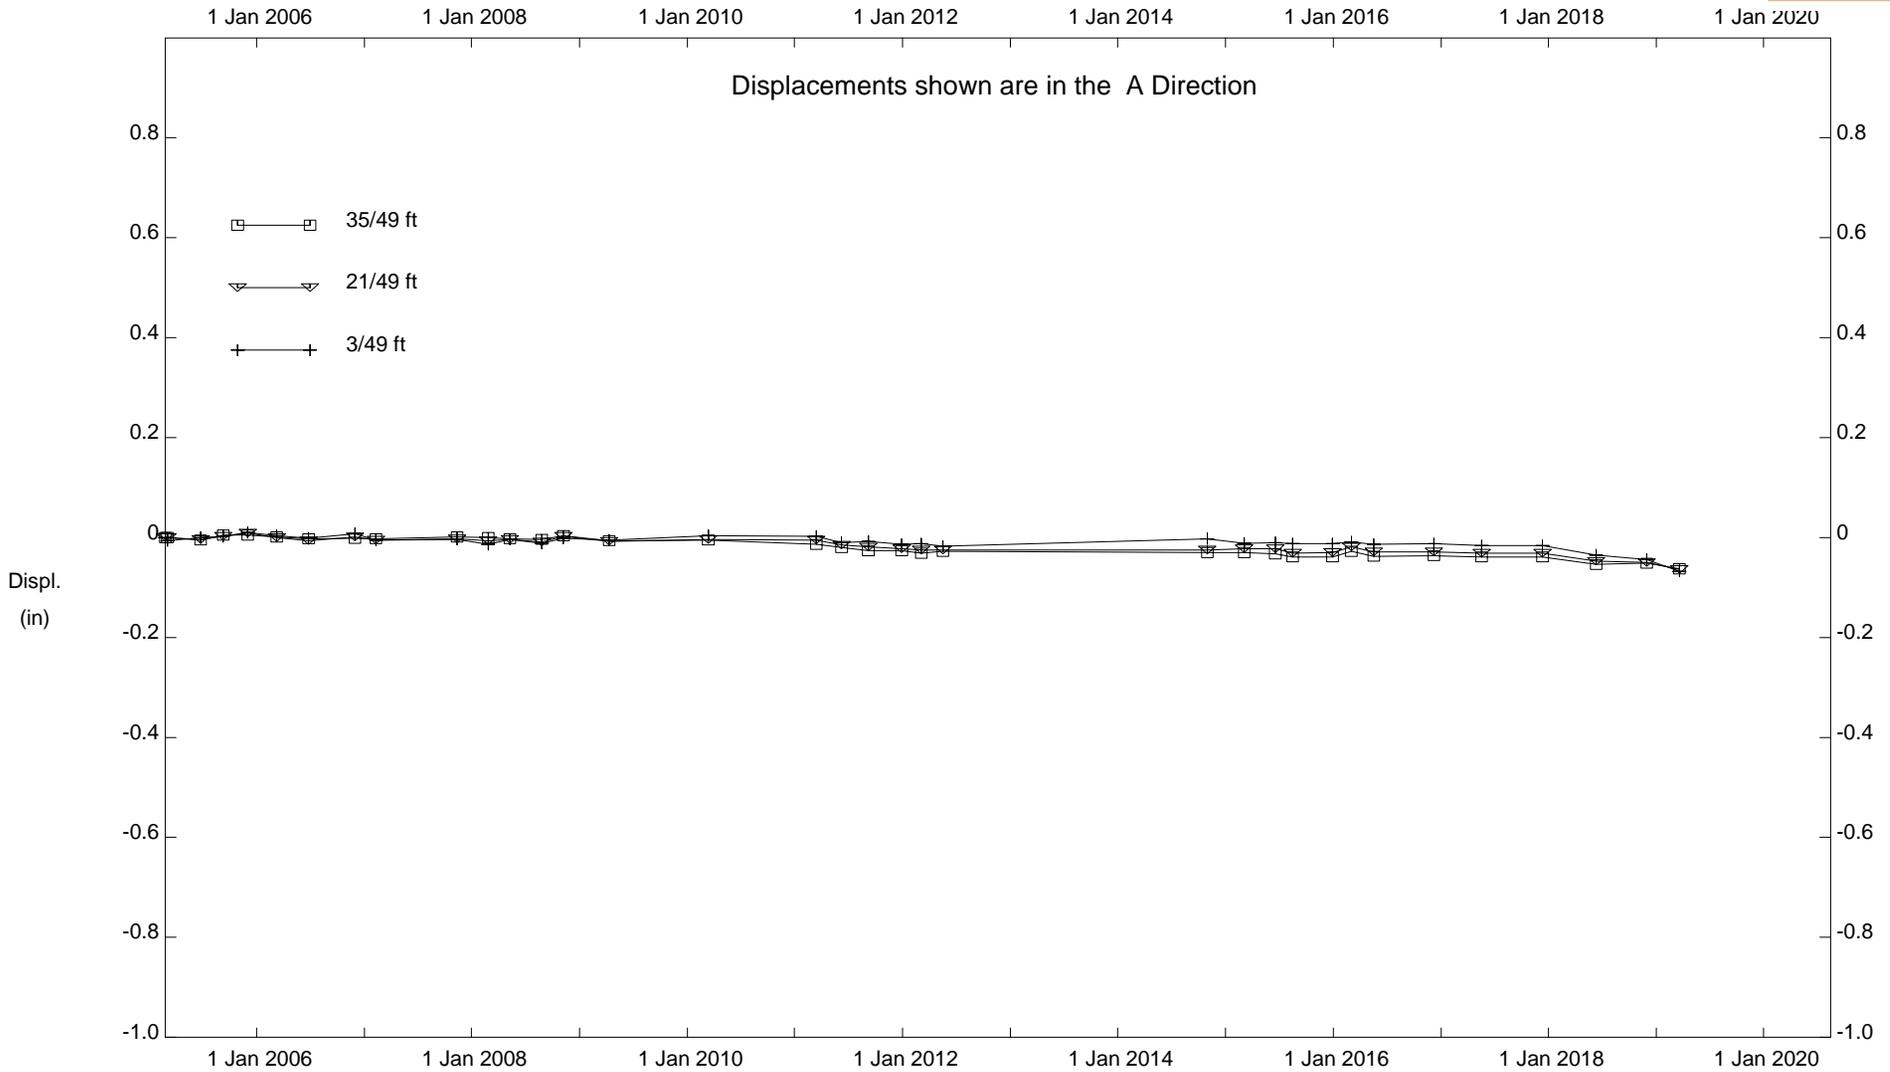
BIG ROCK MESA, Inclinator SP-30

PCH REGION

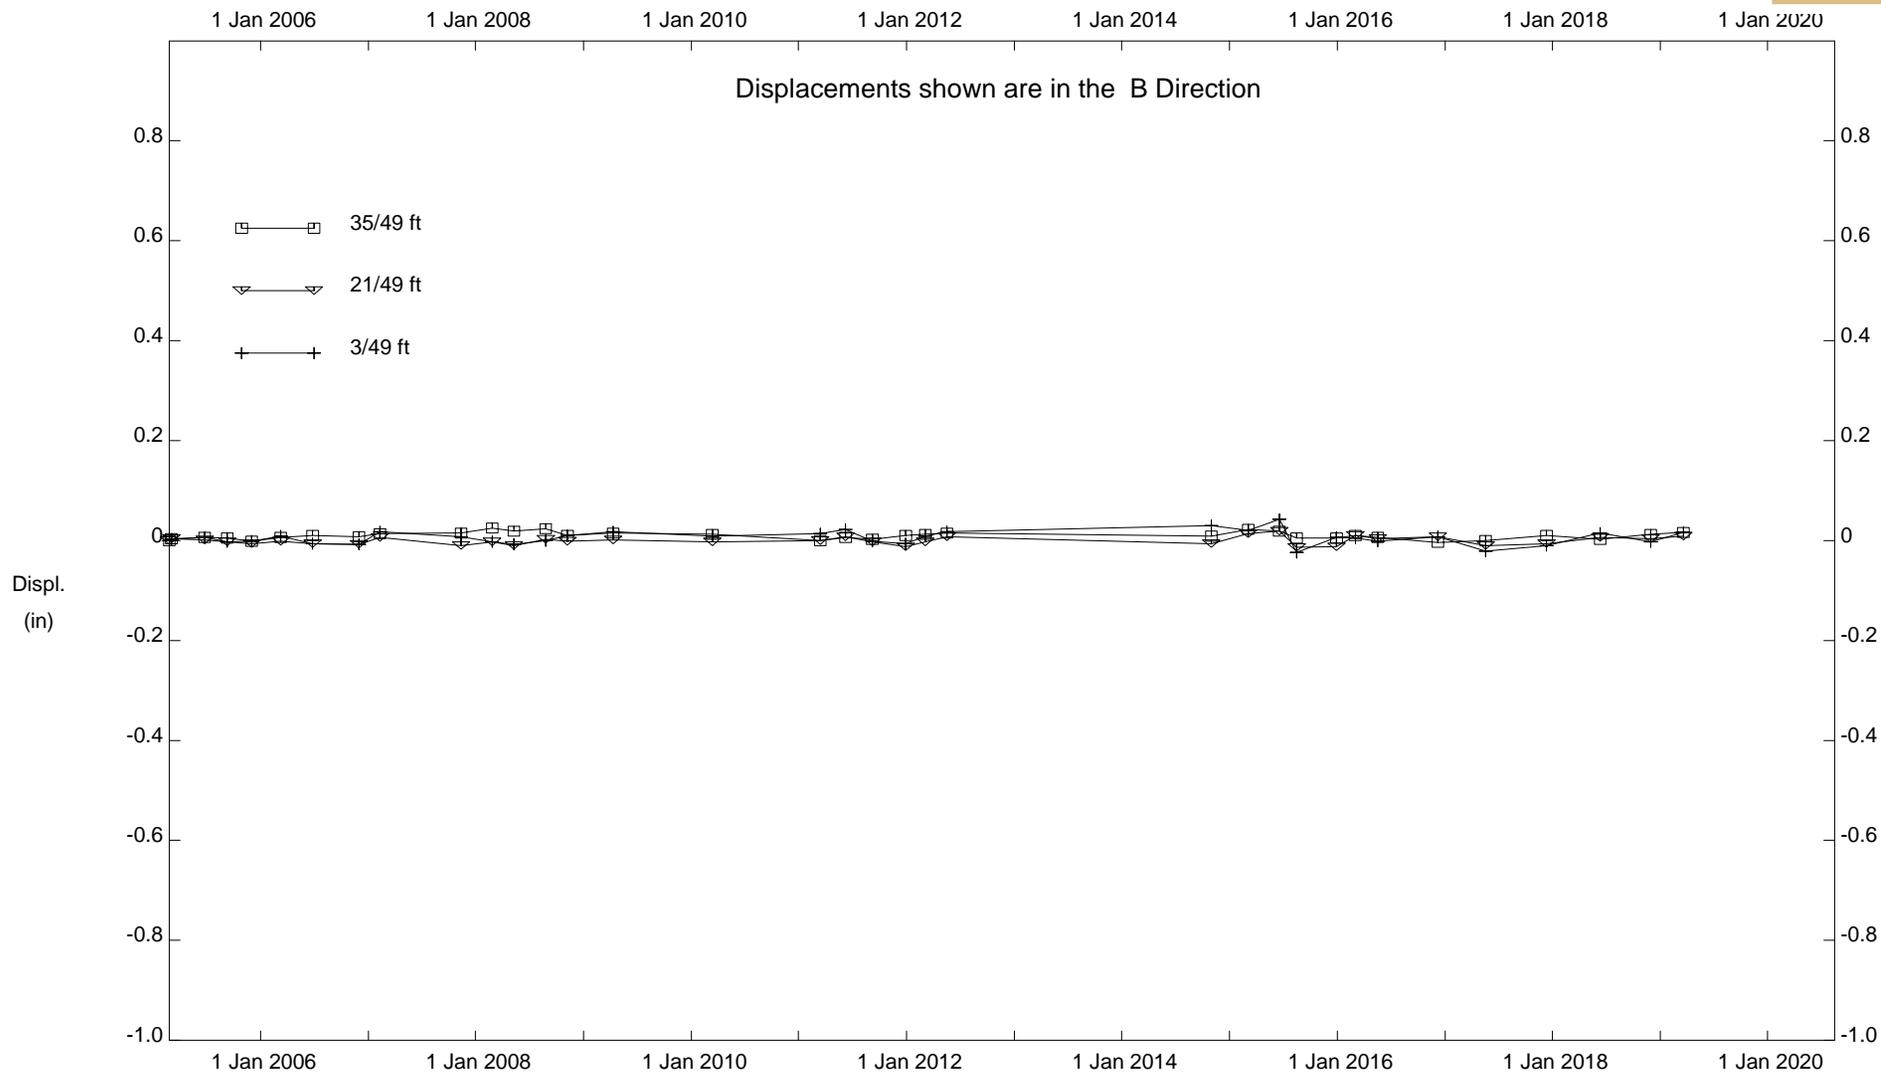
BIG ROCK MESA, Inclinometer SP-30

PCH REGION

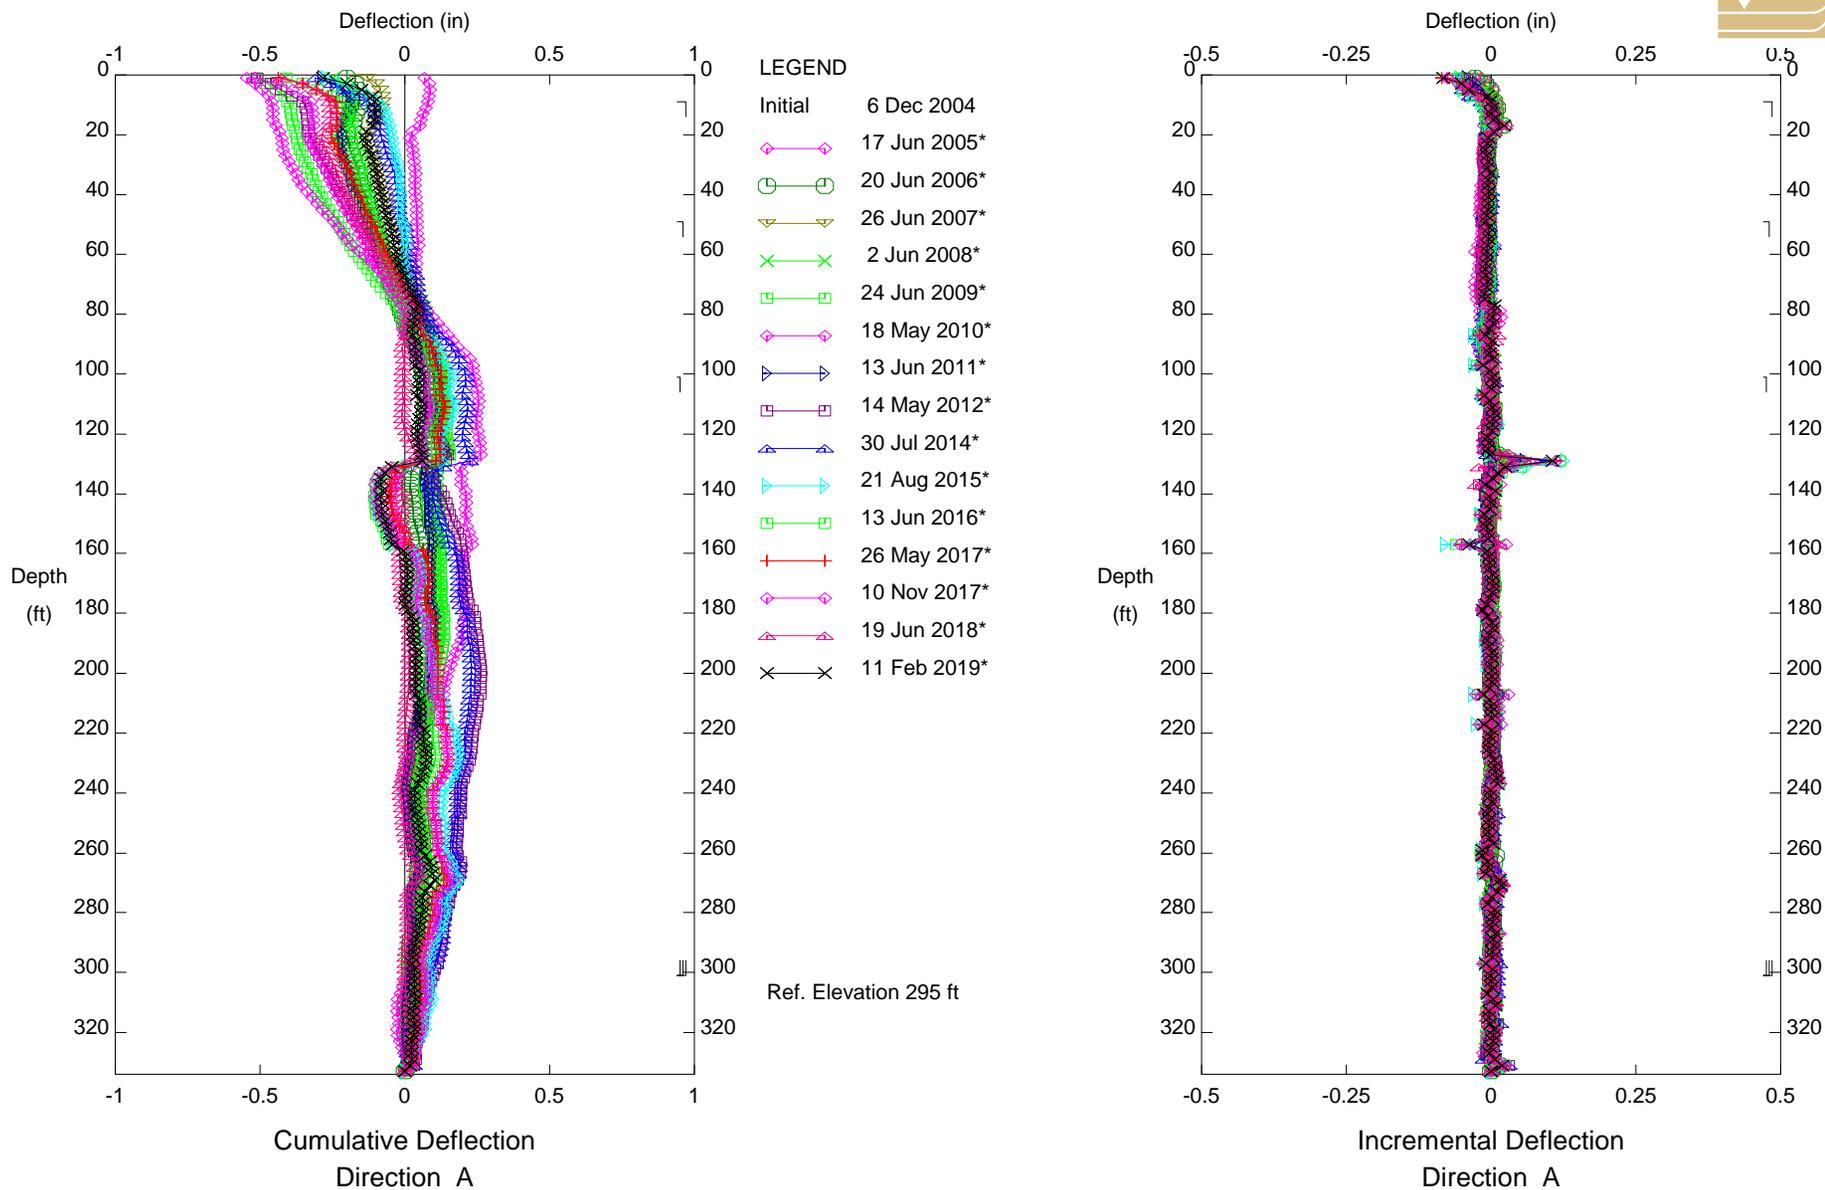
**BIG ROCK MESA, Inclinometer SP-10
 BLUFF REGION**

Sets marked * include zero shift and/or rotation corrections.

The Bluff Region extends along the top of the slope immediately north of the PCH Region, where intense ground cracking was observed during the 1983 landslide. The inclinometers in that area are deep and show evidence of depth position and rotation errors, associated with cable stretch, casing curvature, and casing deviation from vertical. No quantifiable offsets within the inclinometers of the Bluff Region were measured during this monitoring period.

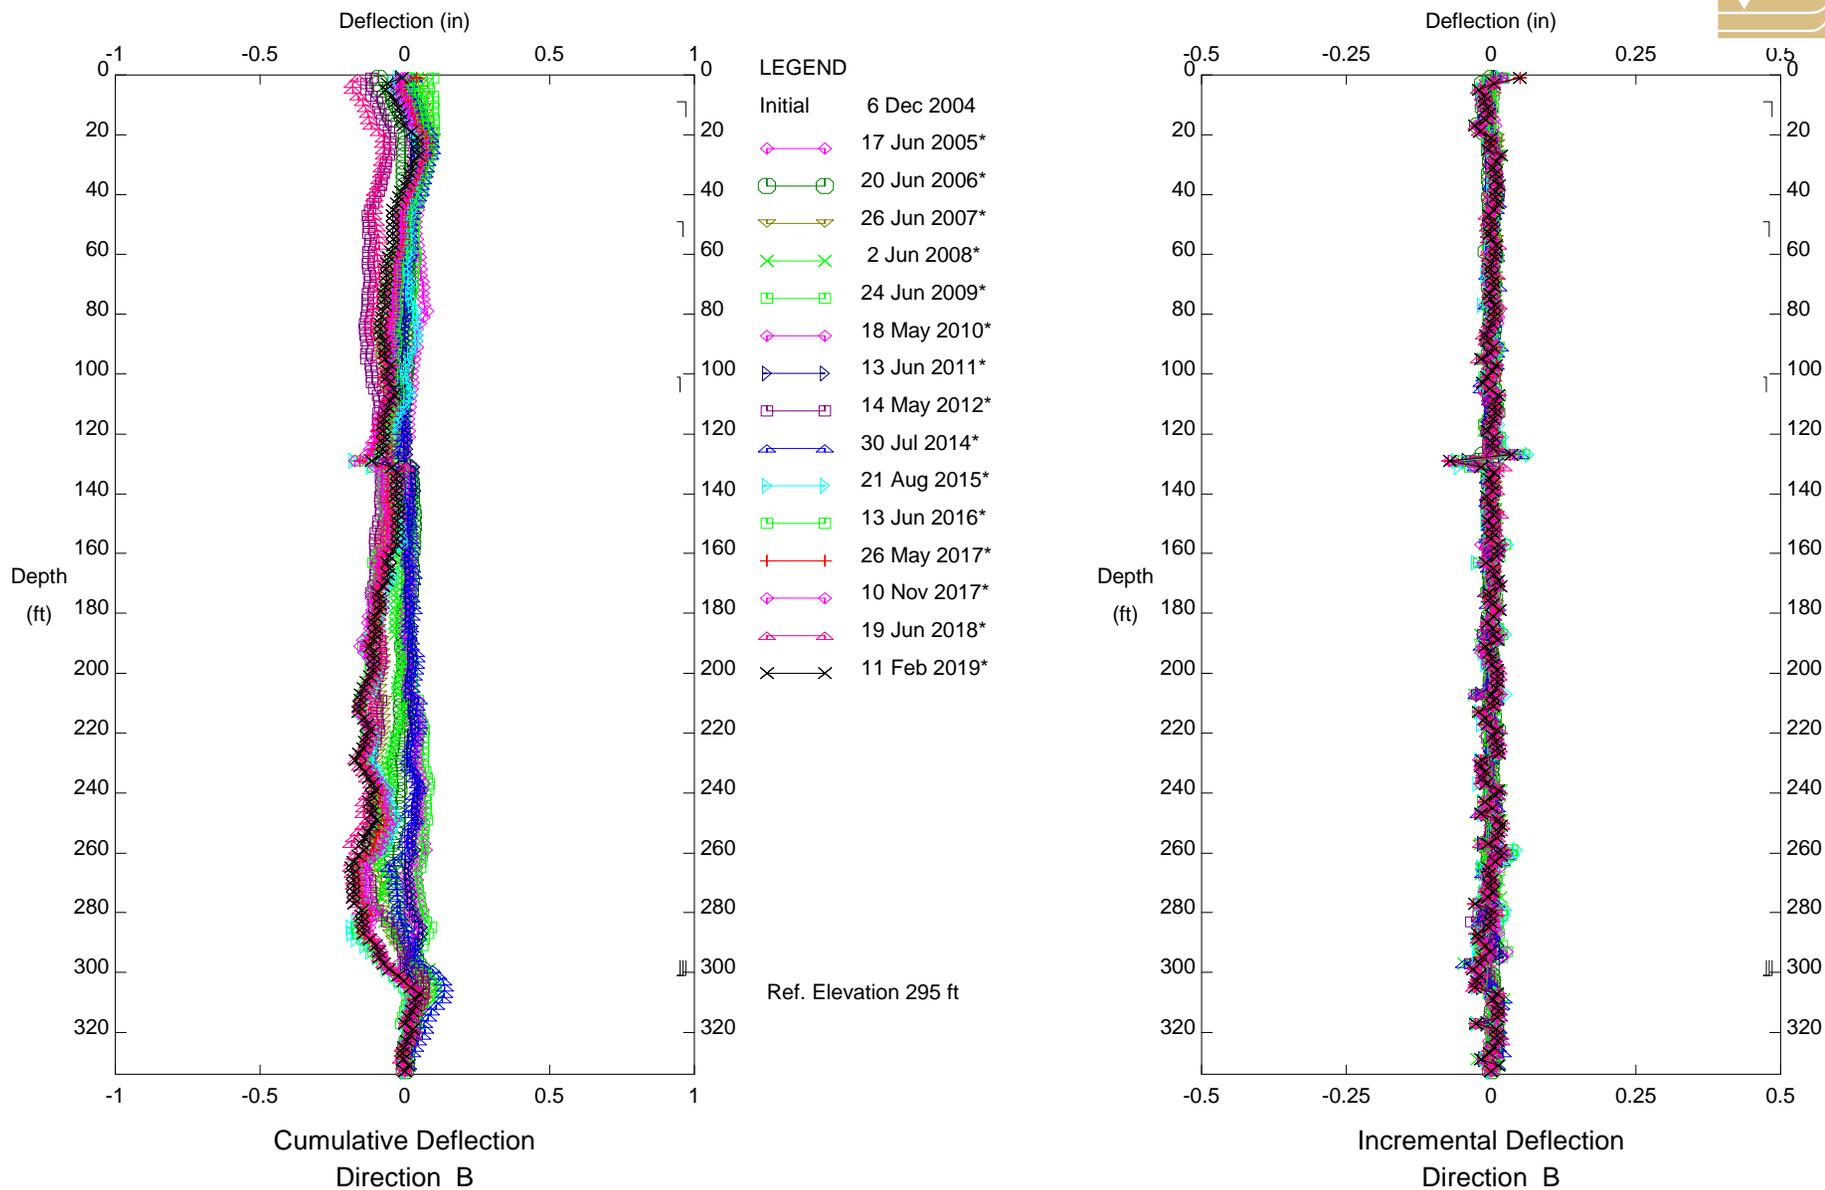
**BIG ROCK MESA, Inclinometer SP-10
 BLUFF REGION**

Sets marked * include zero shift and/or rotation corrections.

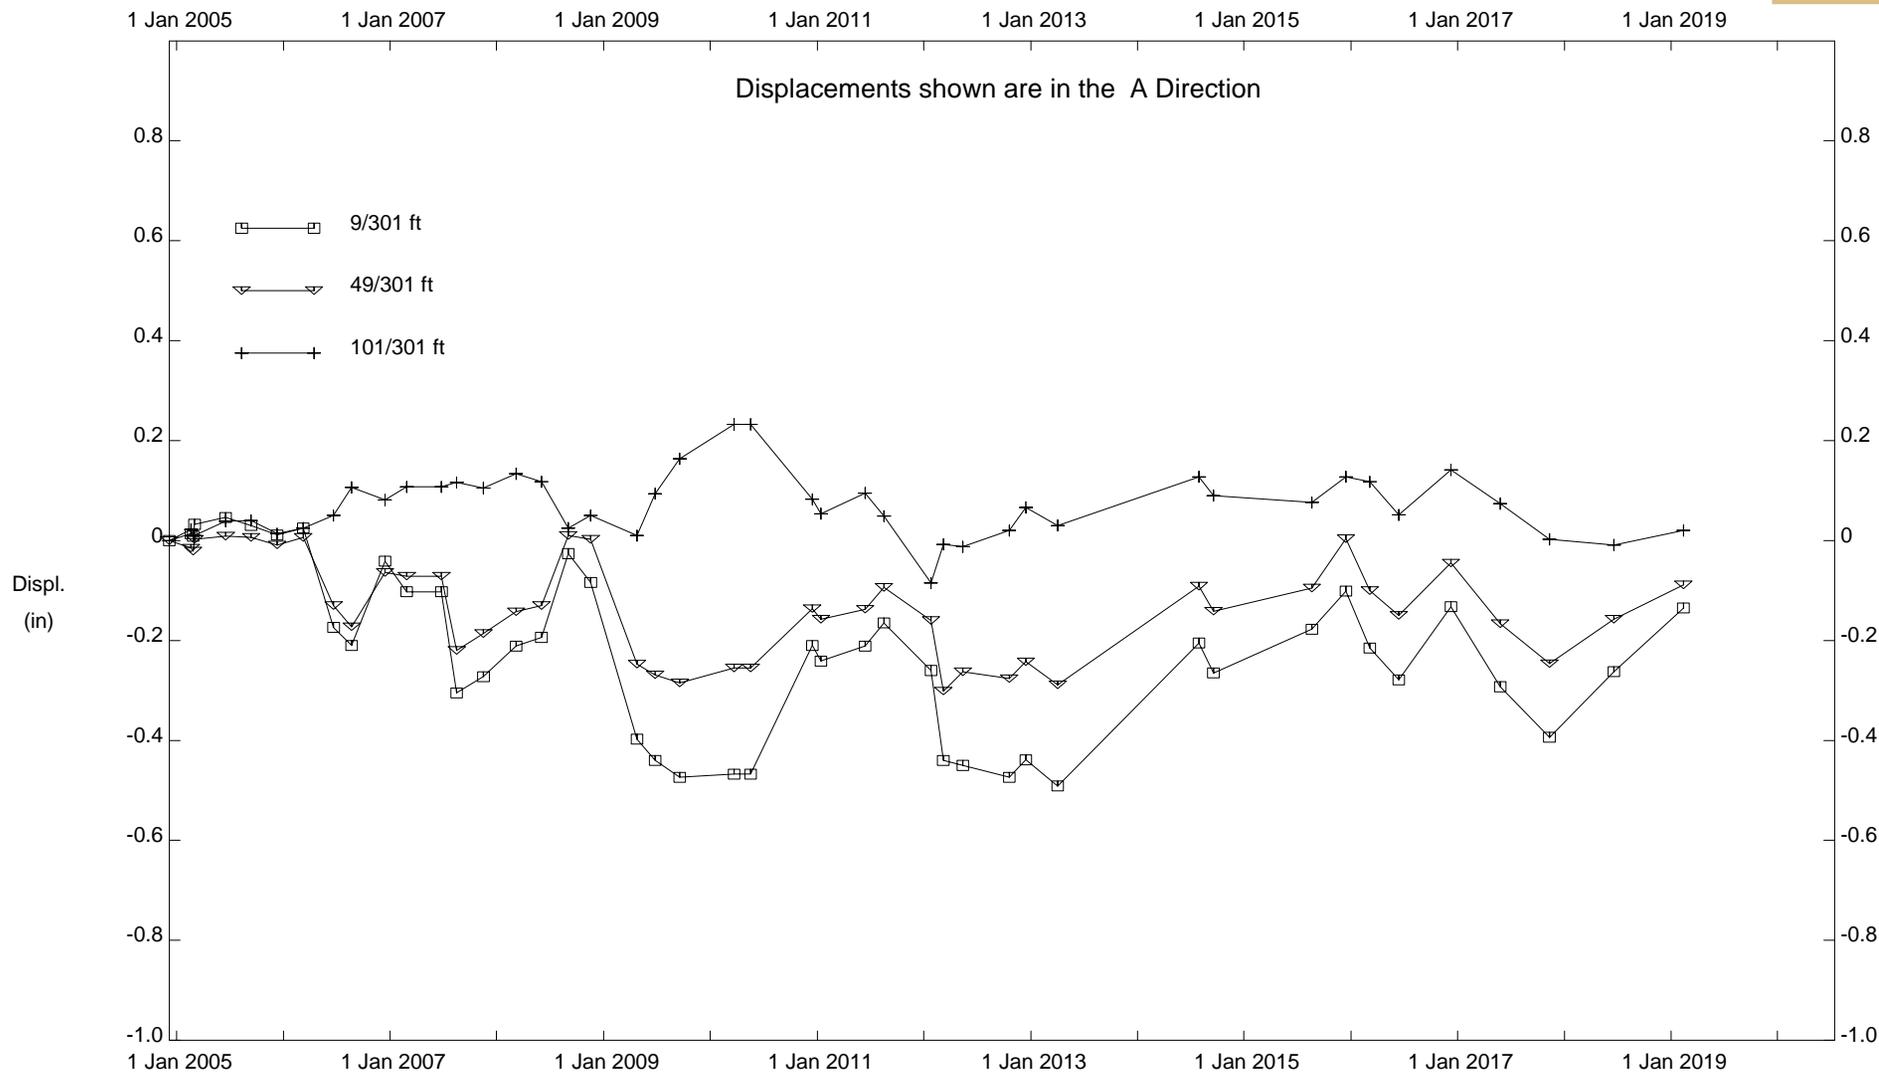
BIG ROCK MESA, Inclinometer SP-10

BLUFF REGION

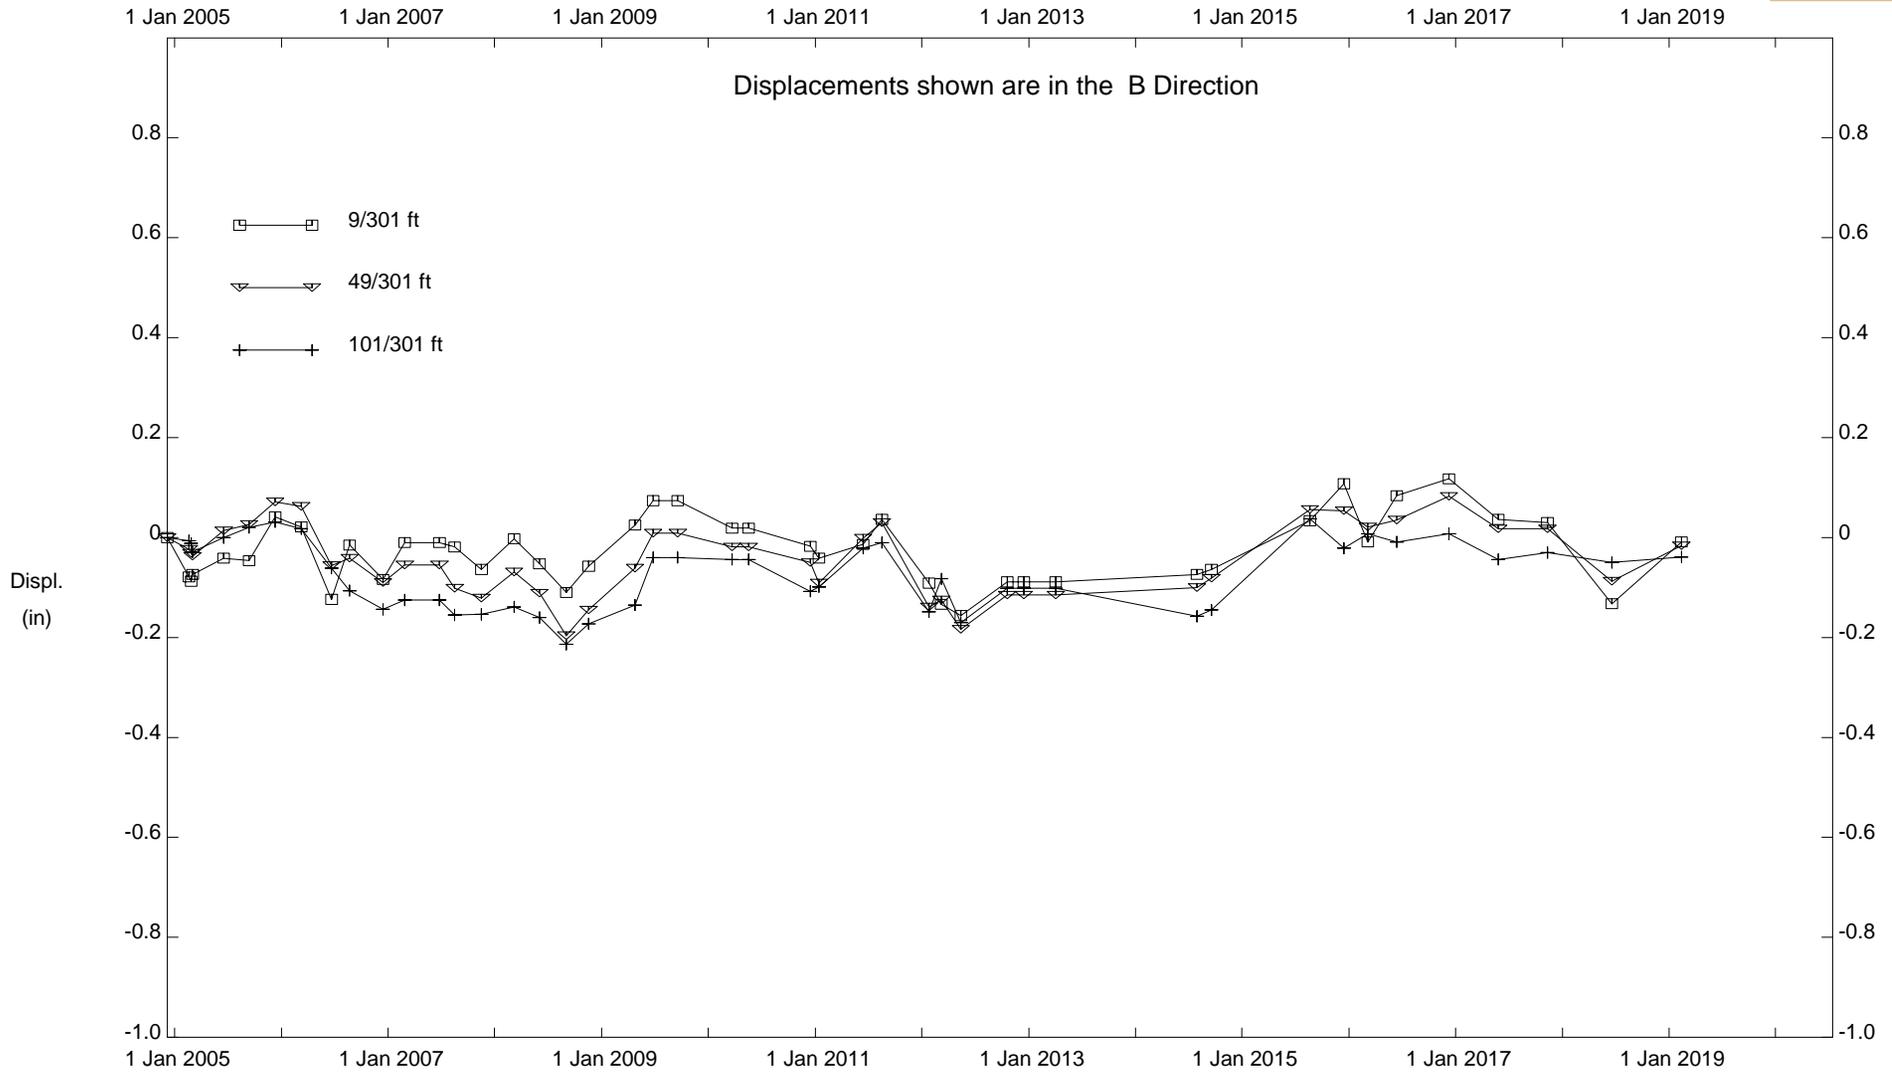
BIG ROCK MESA, Inclinometer SP-10

BLUFF REGION
