**ANNUAL REPORT
JULY 2018 THROUGH JUNE 2019
BIG ROCK MESA LANDSLIDE
ASSESSMENT DISTRICT
City of Malibu, California**

November 2019
Fugro Project No. 04.62160606
Document No. 04.62160606-PR-006(Rev.00)

Annual Report of Maintenance and Monitoring, July 2018 through June 2019, Big Rock Mesa Landslide Assessment District, City of Malibu, California

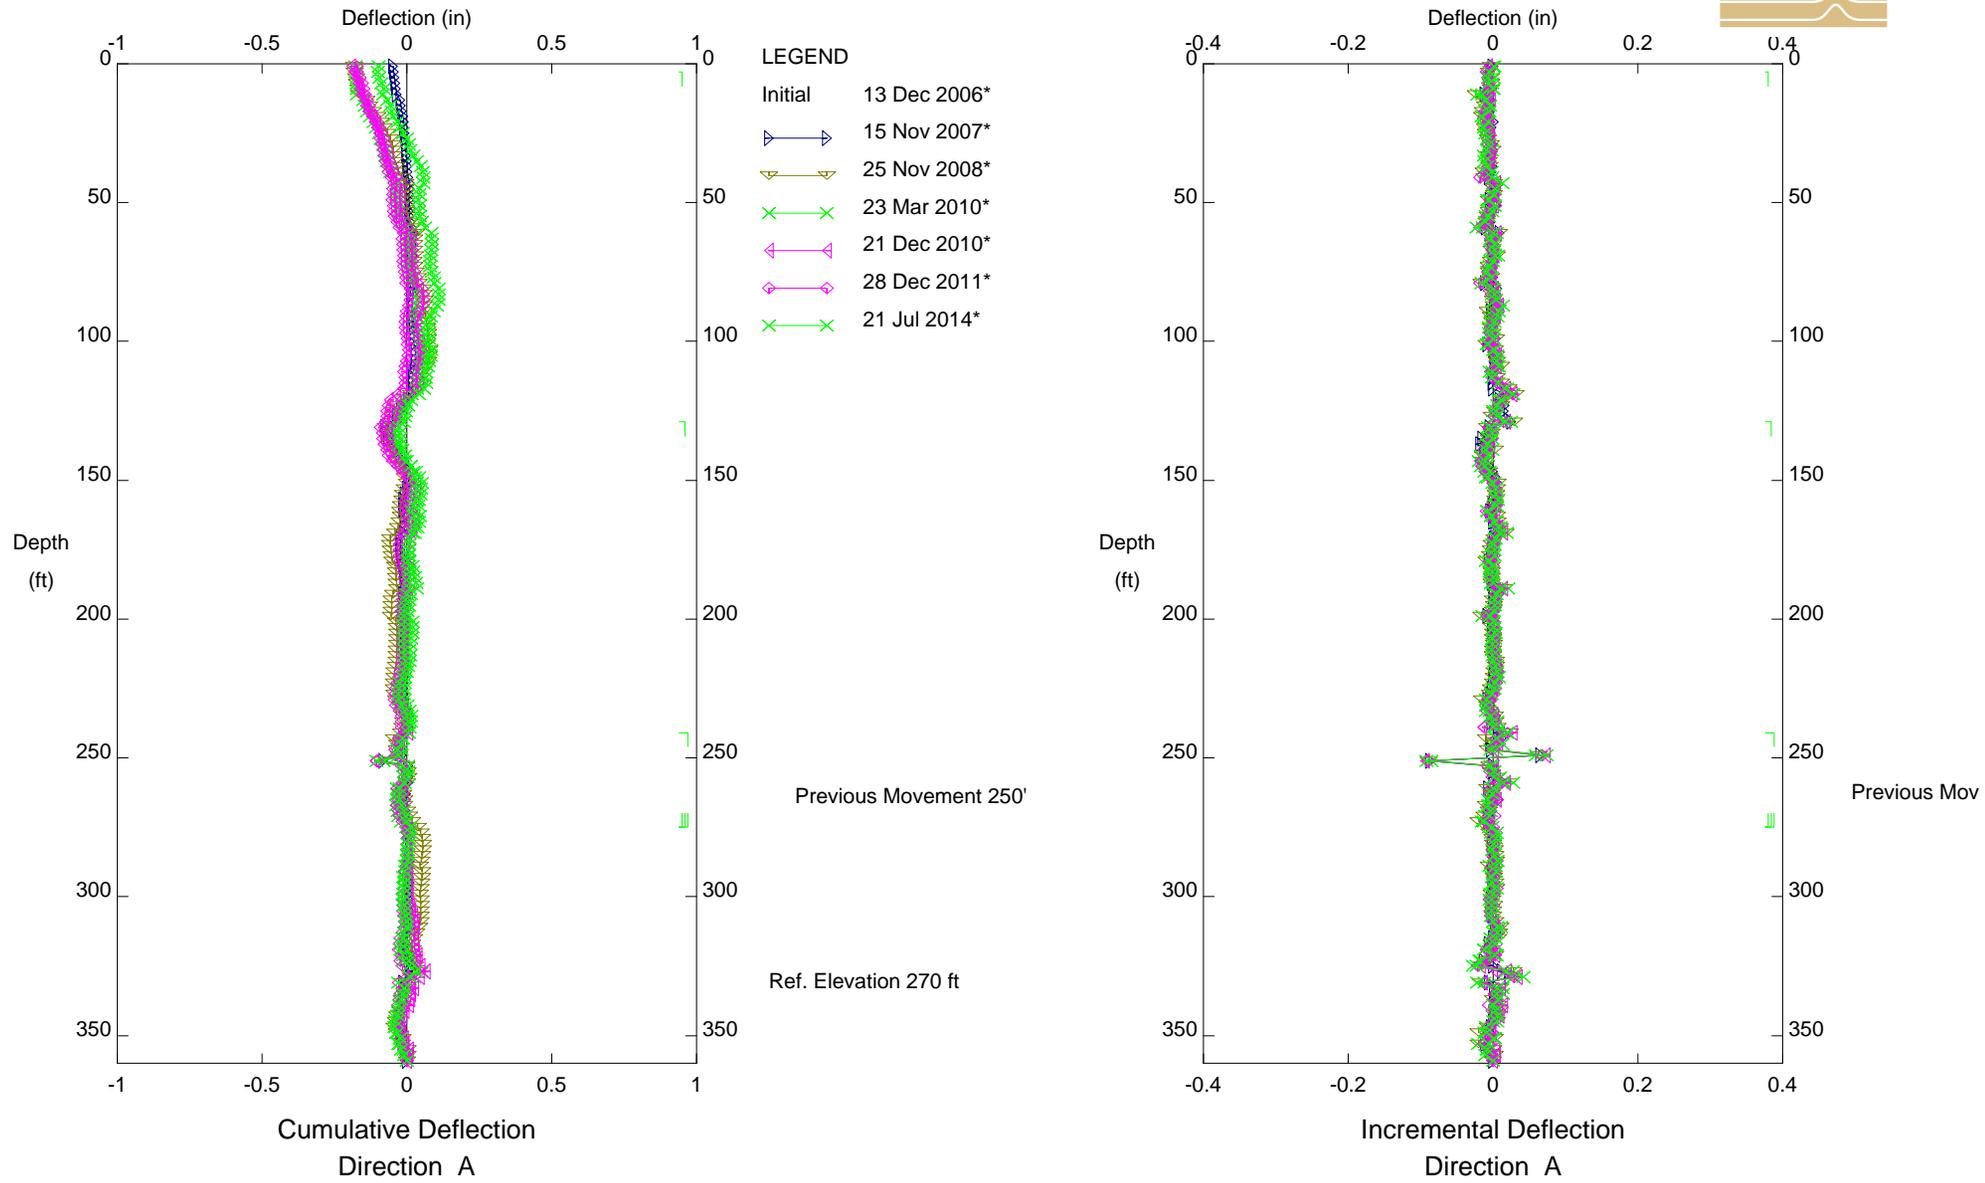
**BIG ROCK MESA, Inclinometer SP-28
 BLUFF REGION**

Sets marked * include zero shift and/or rotation corrections.

The Bluff Region extends along the top of the slope immediately north of the PCH Region, where intense ground cracking was observed during the 1983 landslide. The inclinometers in that area are deep and show evidence of depth position and rotation errors, associated with cable stretch, casing curvature, and casing deviation from vertical. No quantifiable offsets within the inclinometers of the Bluff Region were measured during this monitoring period.

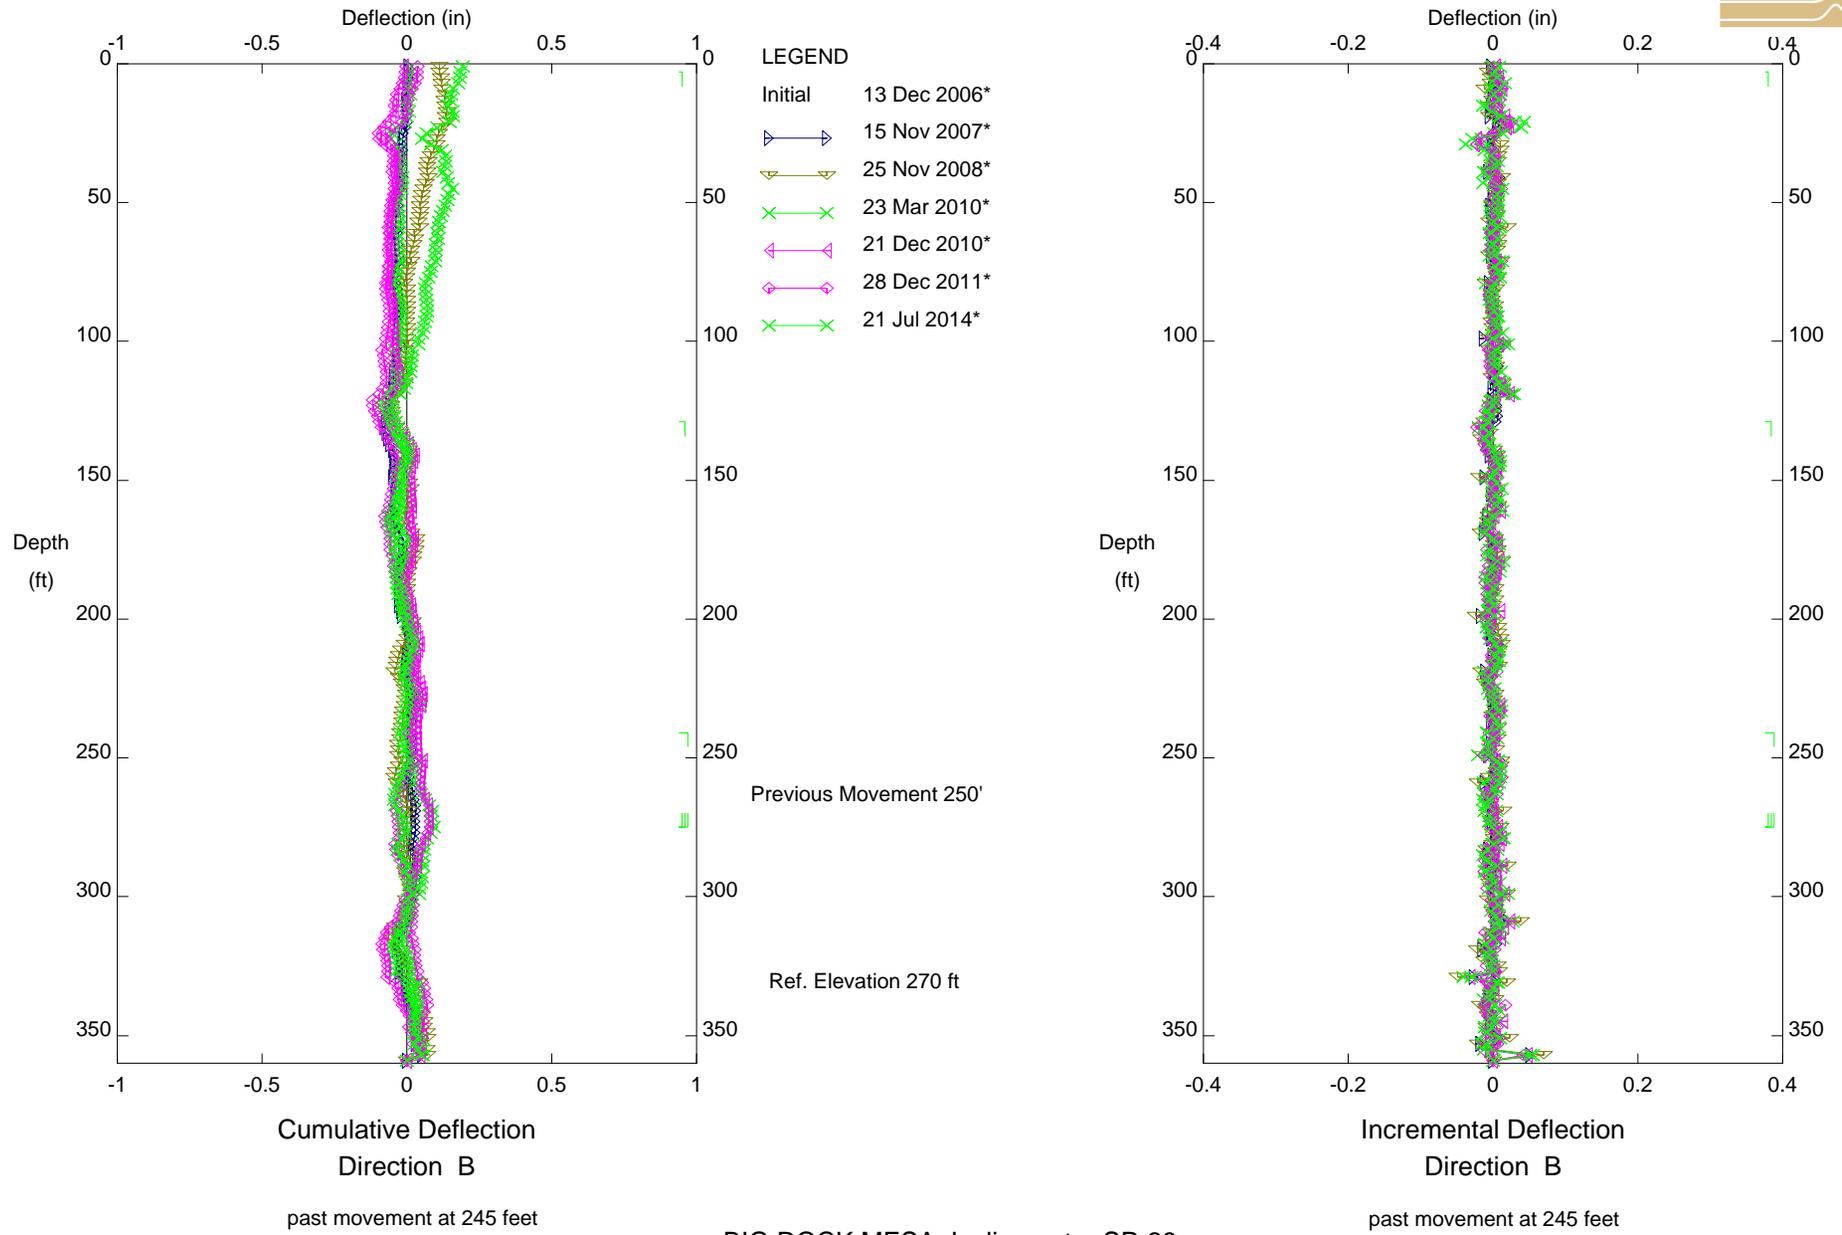
**BIG ROCK MESA, Inclinometer SP-28
 BLUFF REGION**

Sets marked * include zero shift and/or rotation corrections.

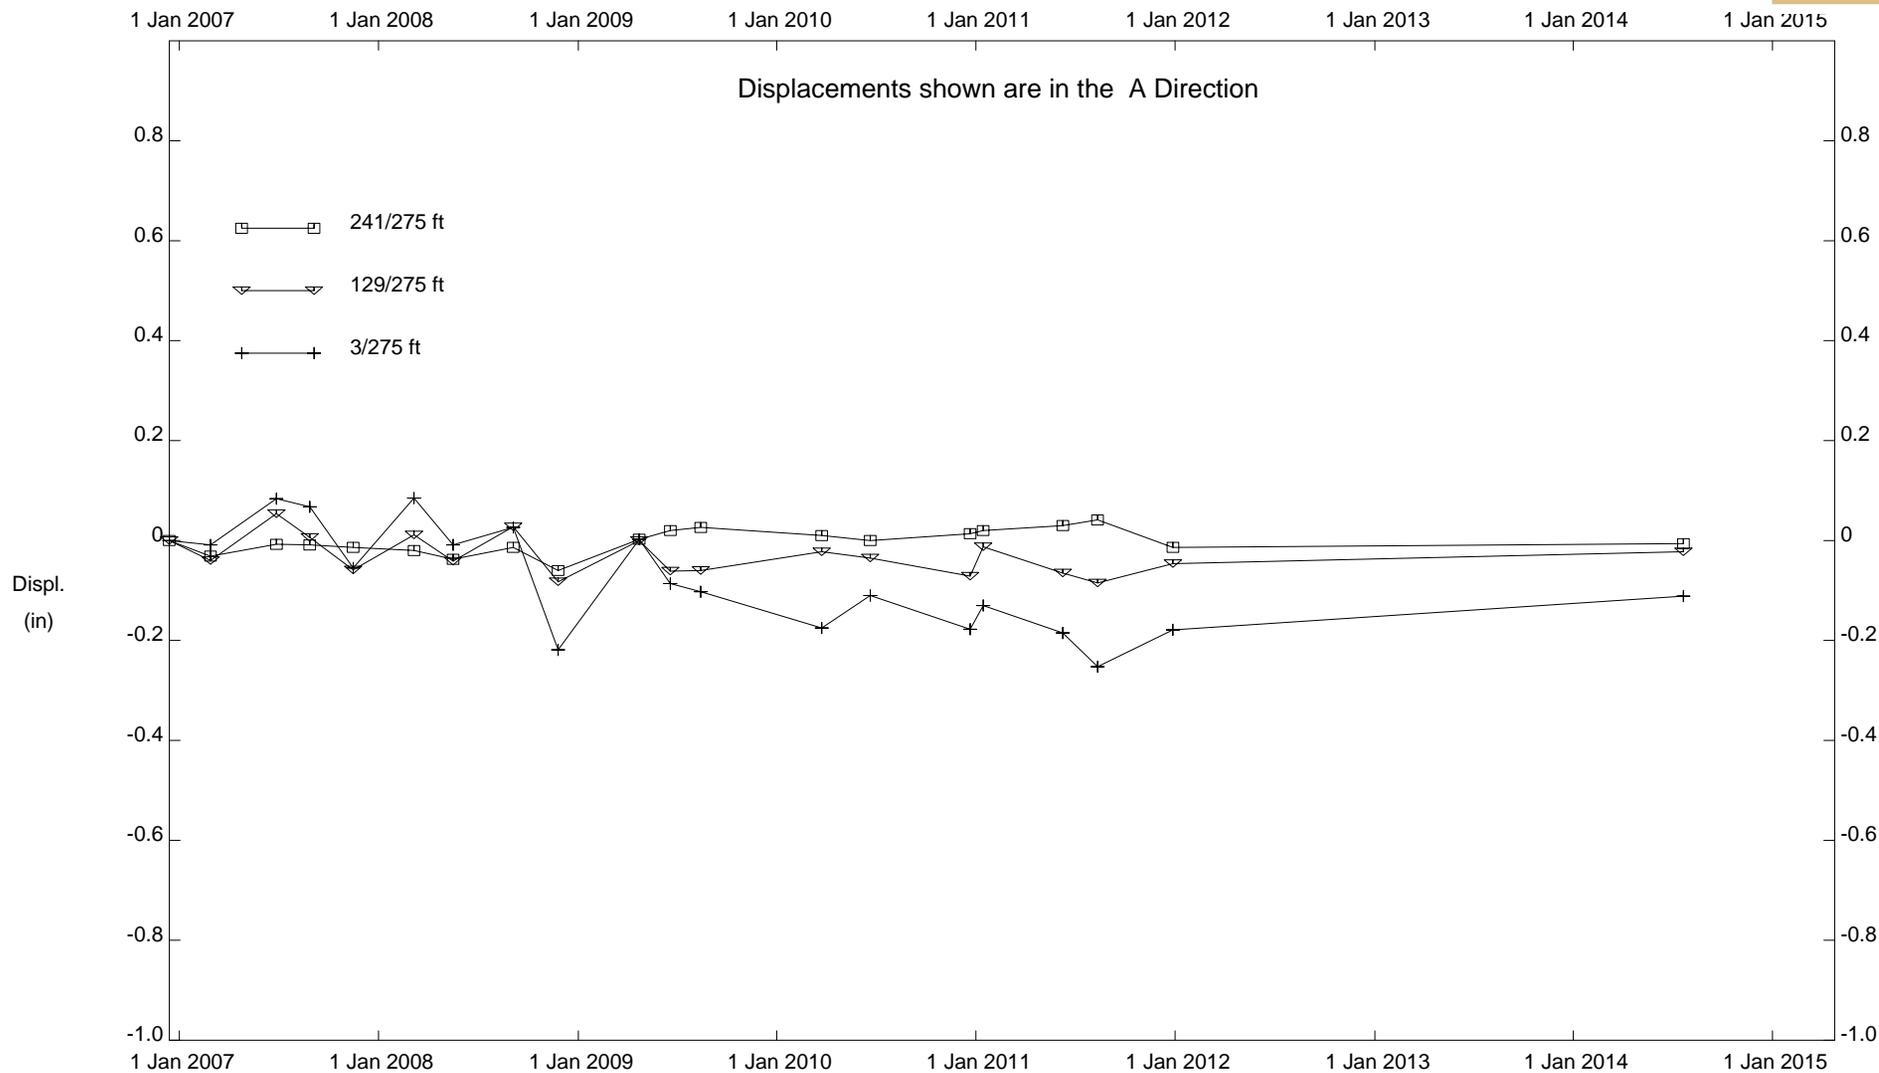
BIG ROCK MESA, Inclinometer SP-28

BLUFF REGION

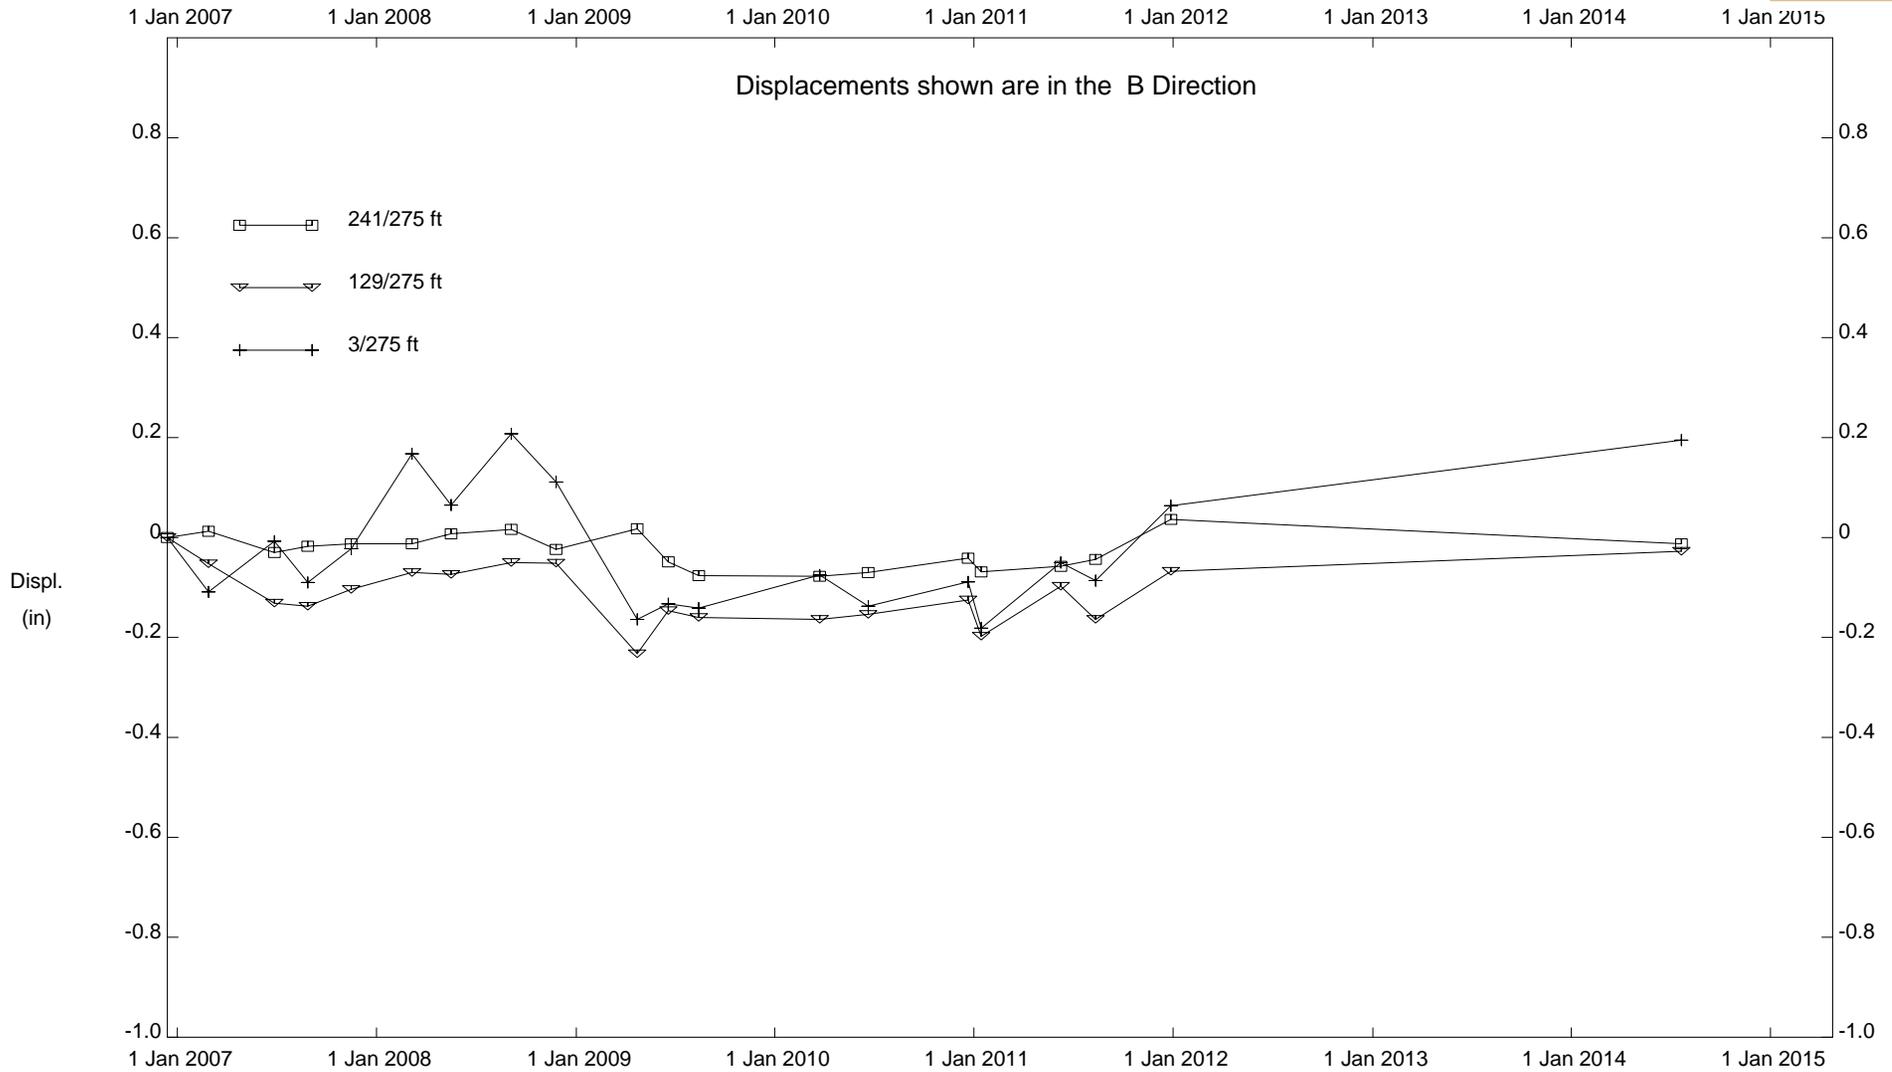
BIG ROCK MESA, Inclinometer SP-28

BLUFF REGION

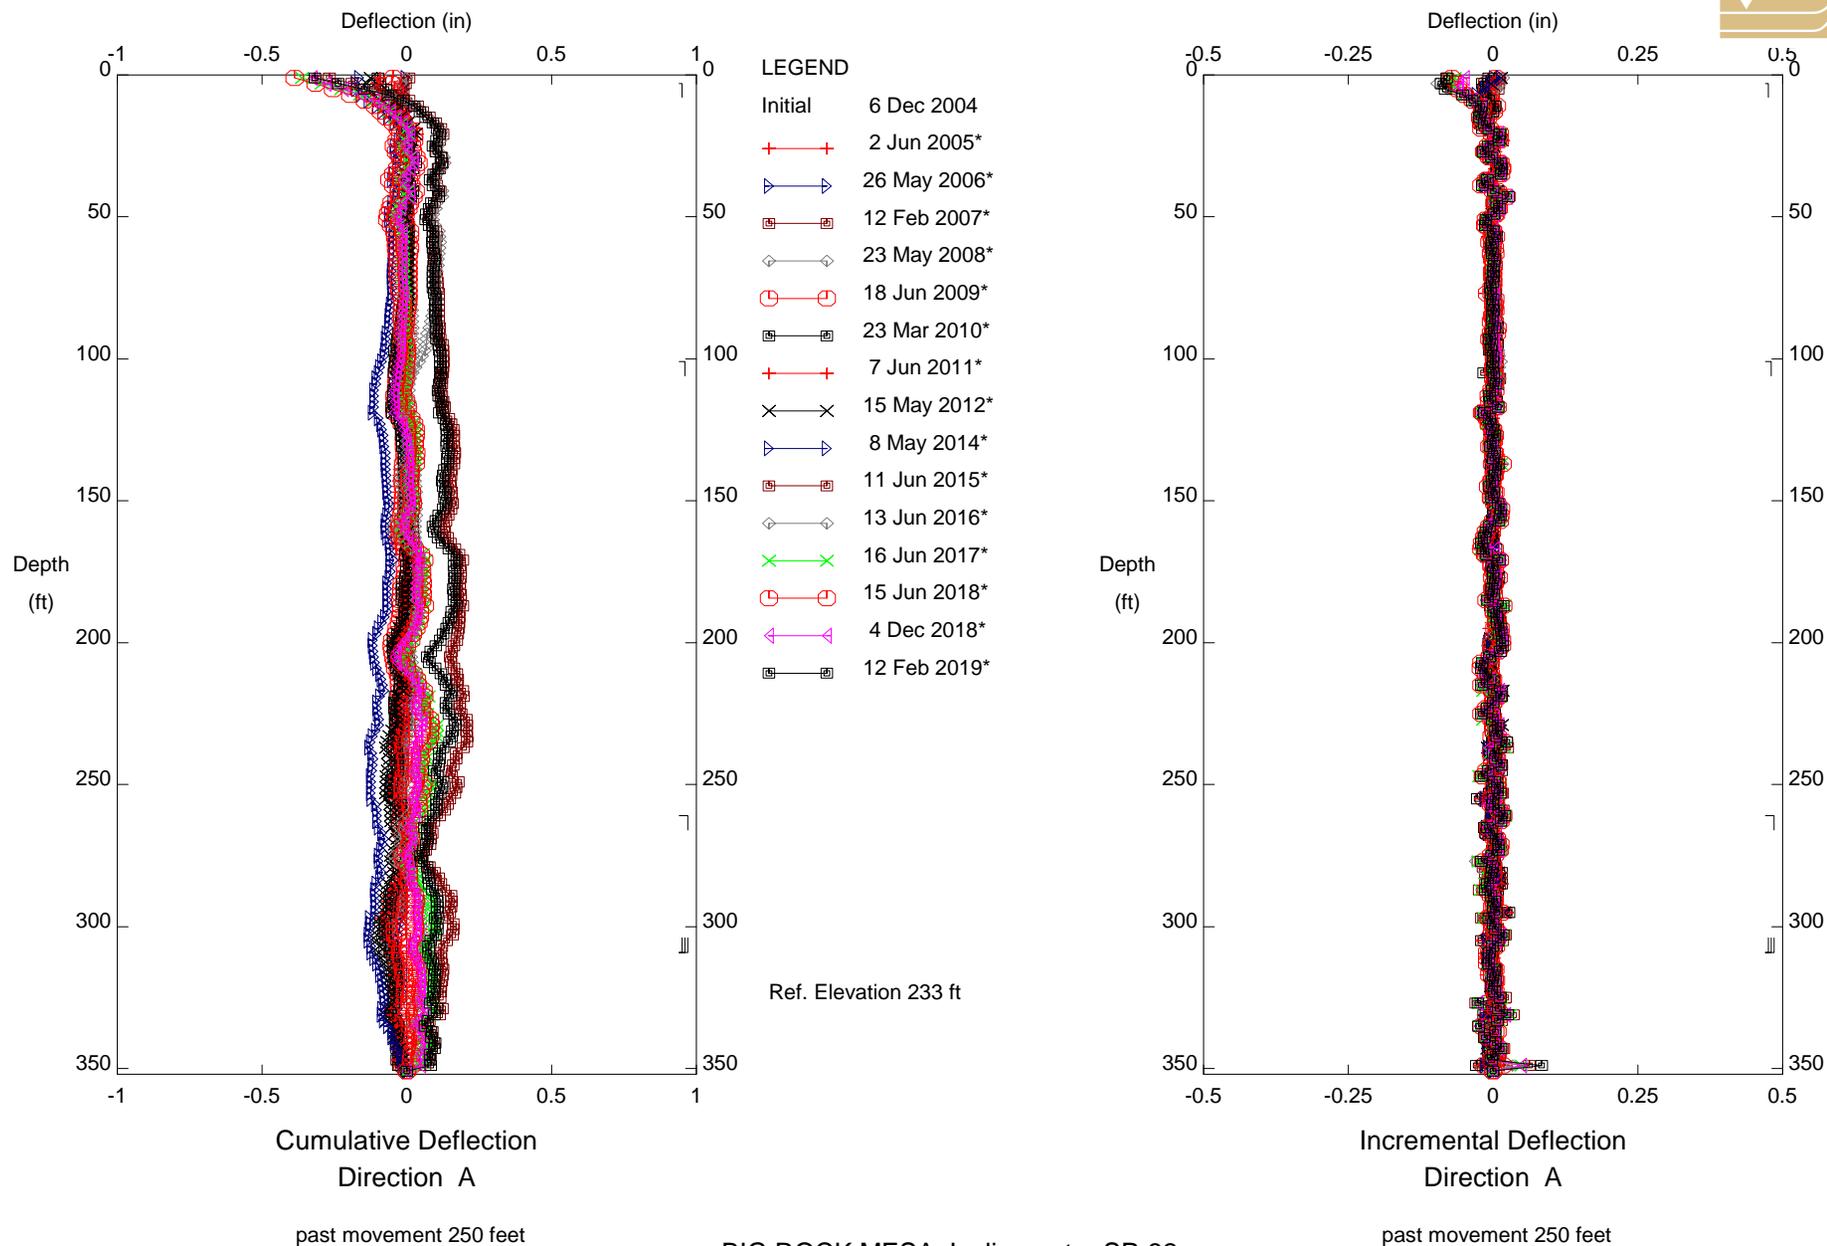
**BIG ROCK MESA, Inclinometer SP-32
 BLUFF REGION**

Sets marked * include zero shift and/or rotation corrections.

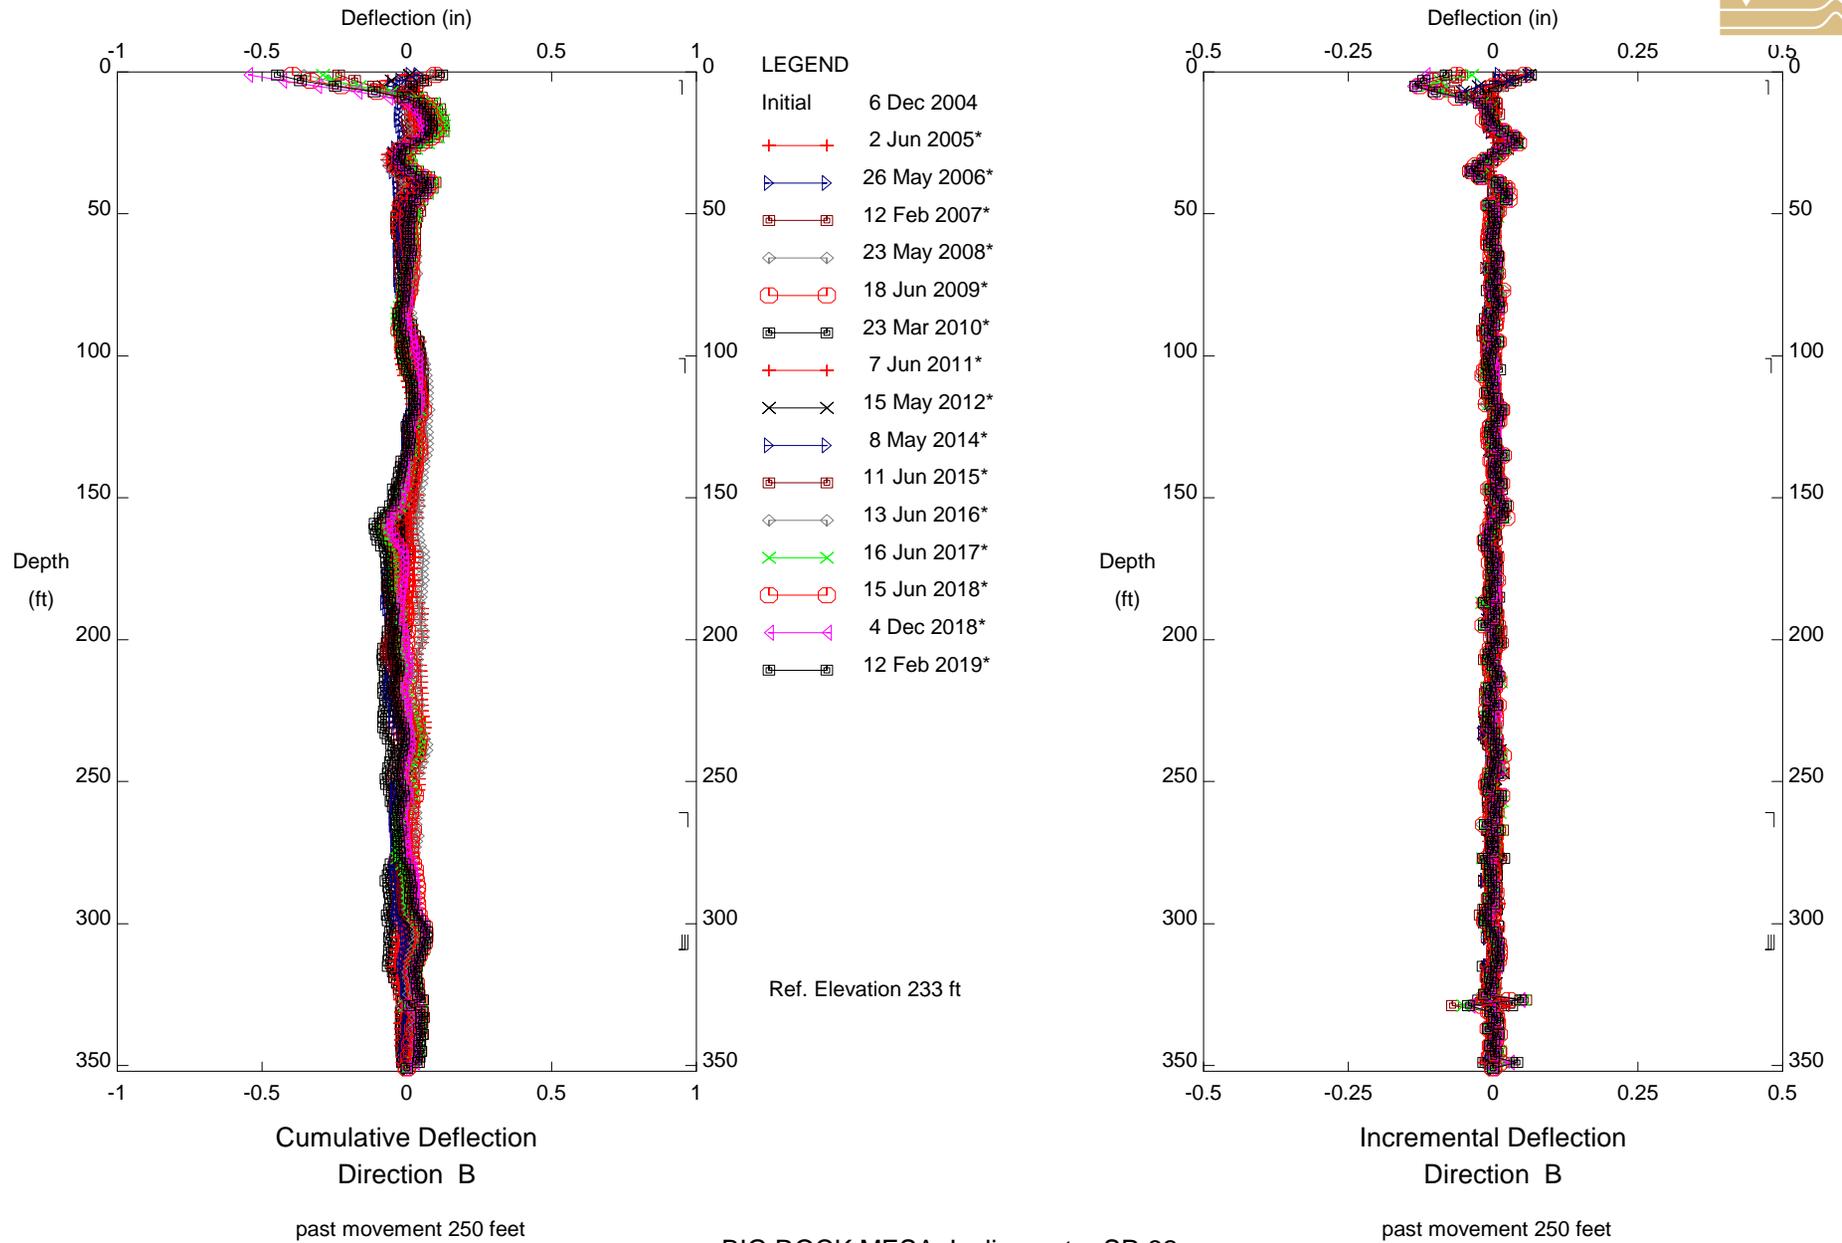
**BIG ROCK MESA, Inclinator SP-32
 BLUFF REGION**

Sets marked * include zero shift and/or rotation corrections.

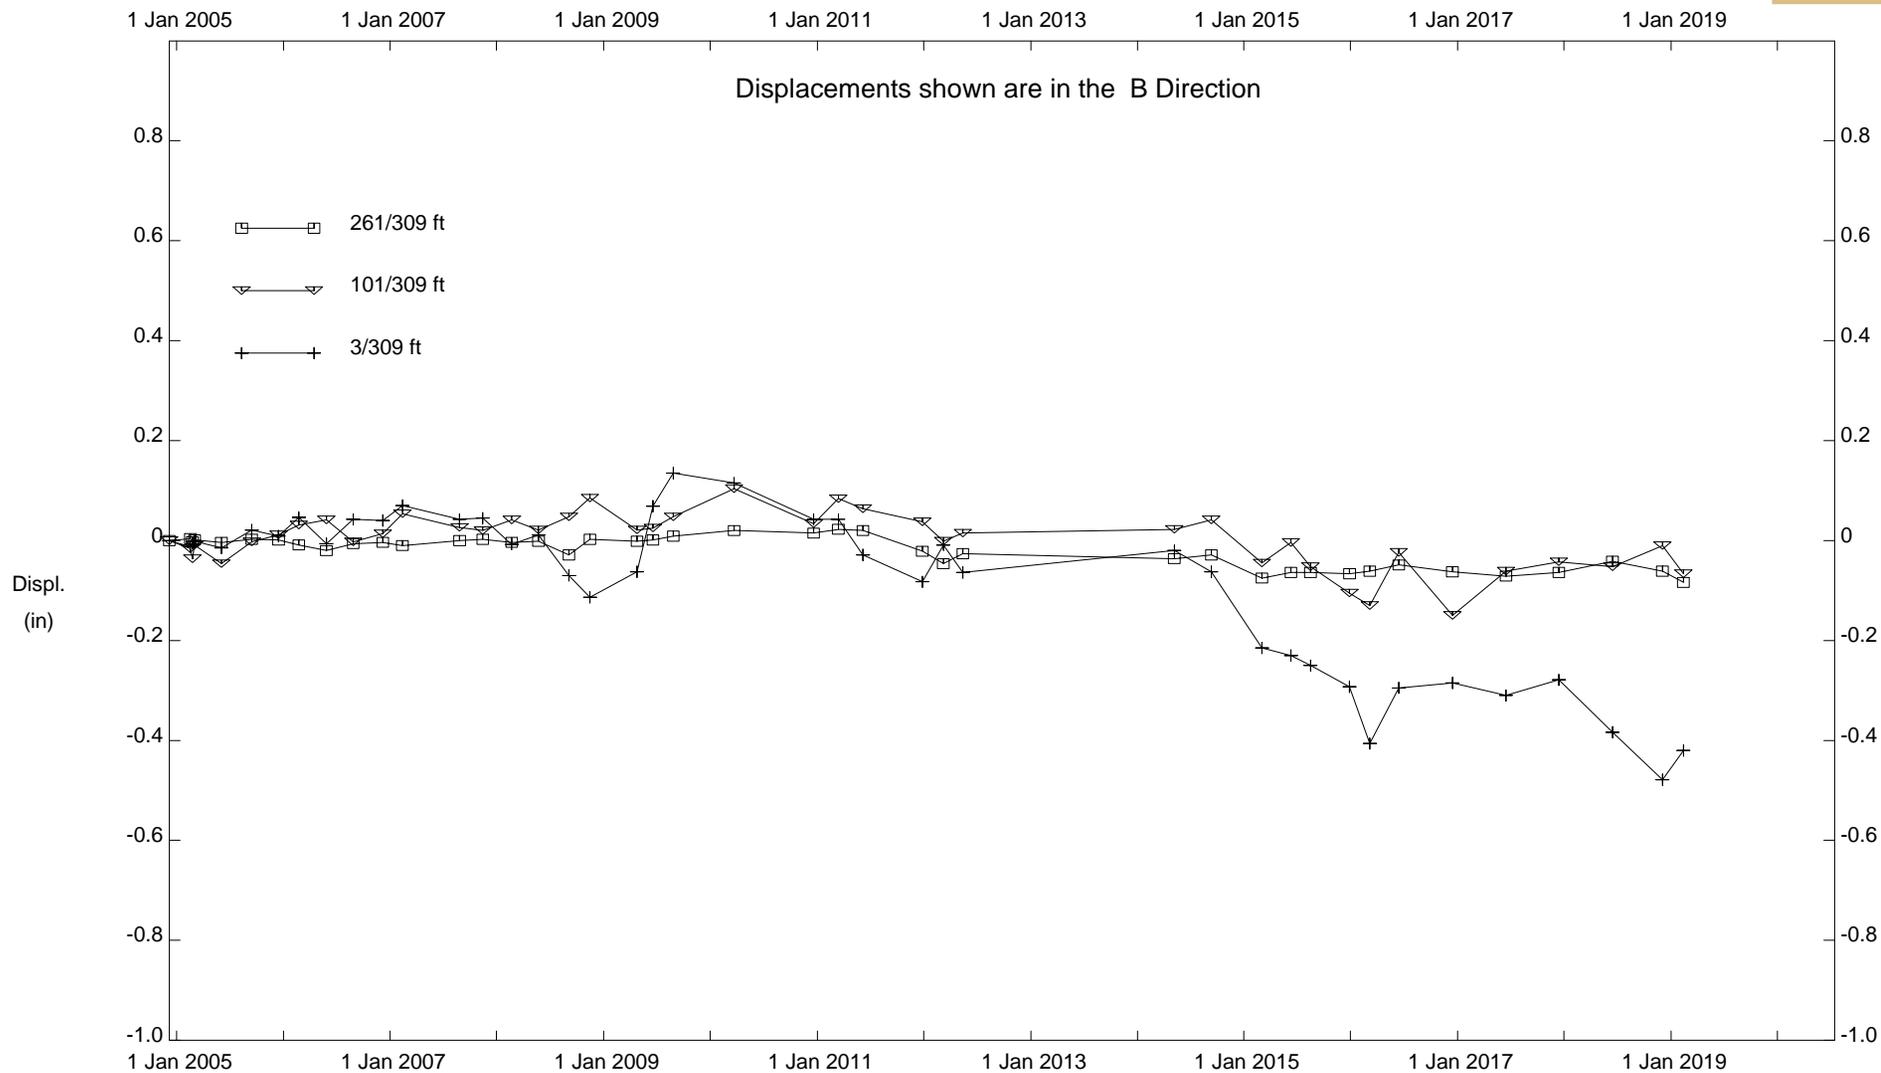
BIG ROCK MESA, Inclinometer SP-32

BLUFF REGION

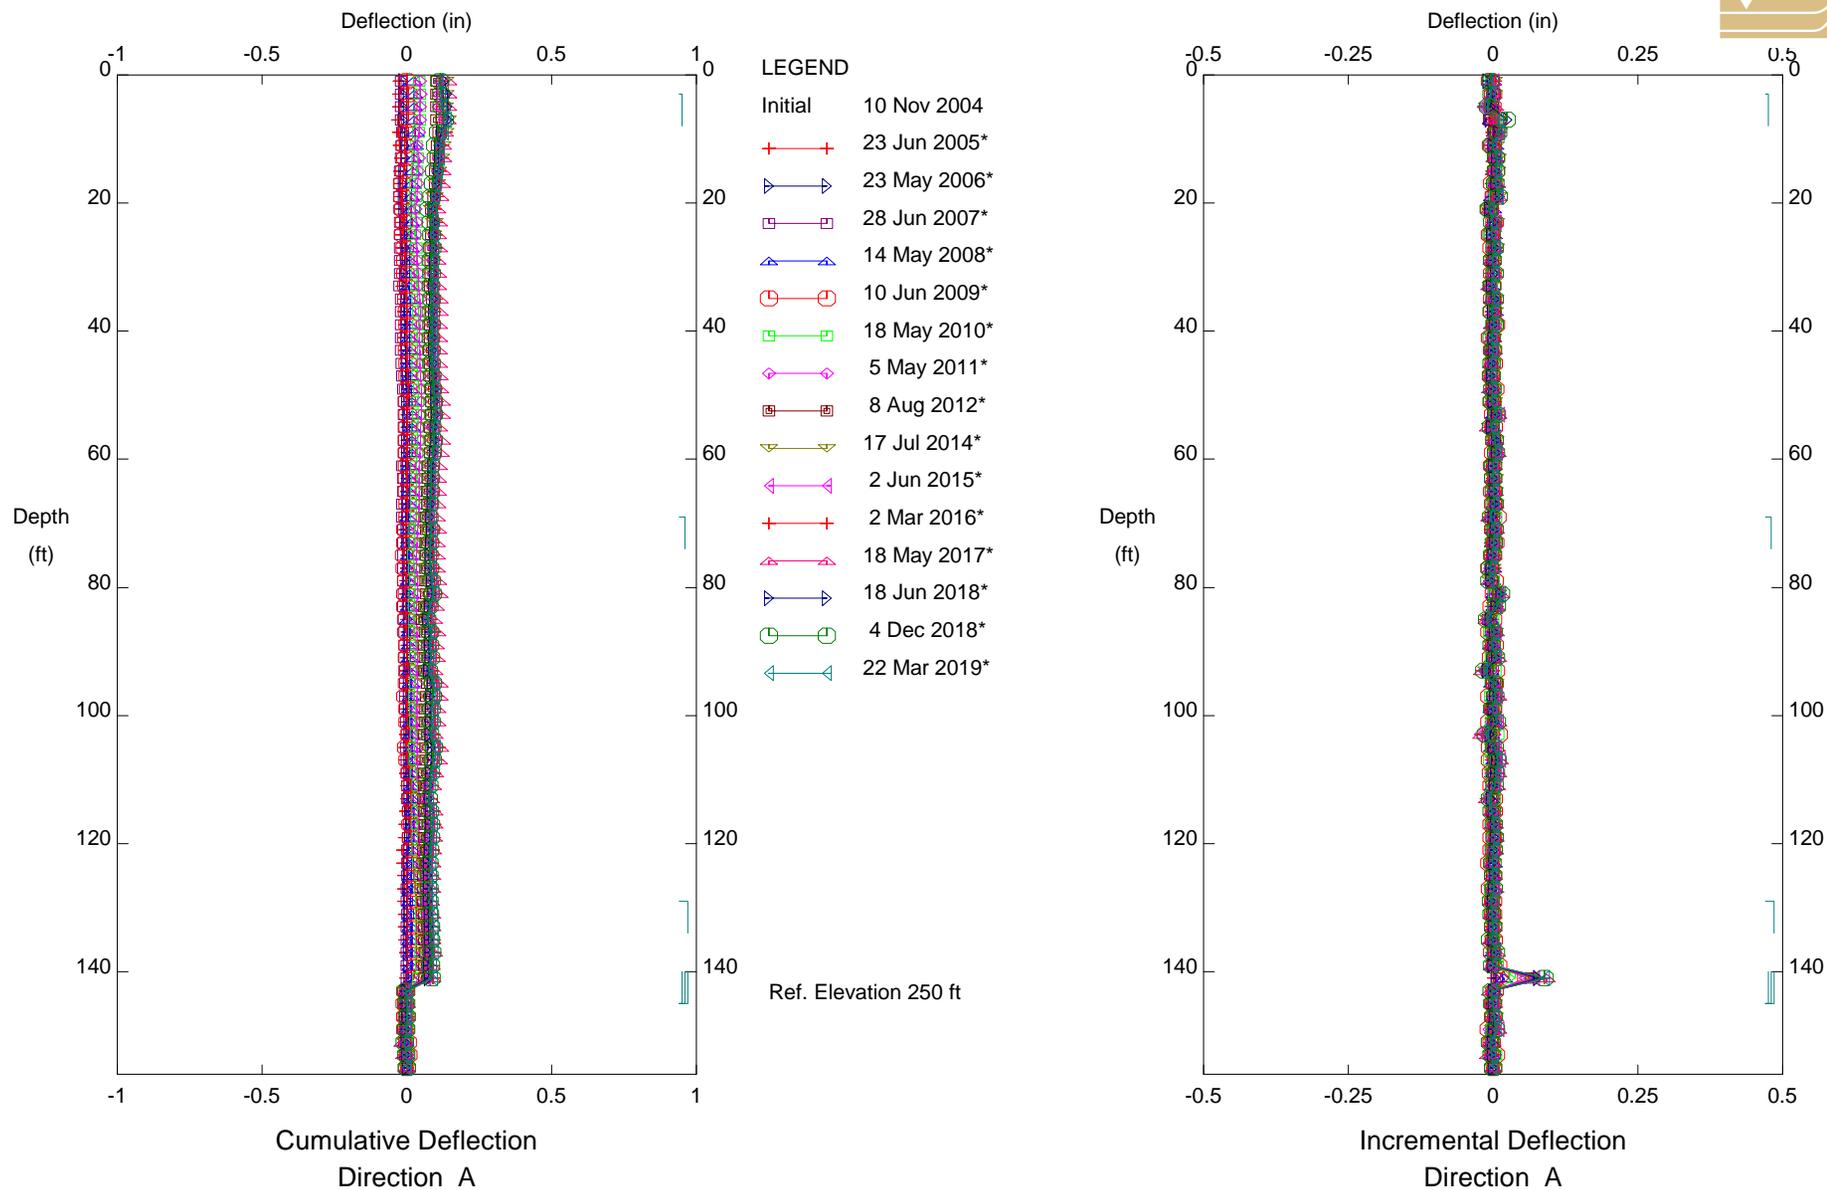
**BIG ROCK MESA, Inclinator PC-1
 EASTERN REGION**

Sets marked * include zero shift and/or rotation corrections.

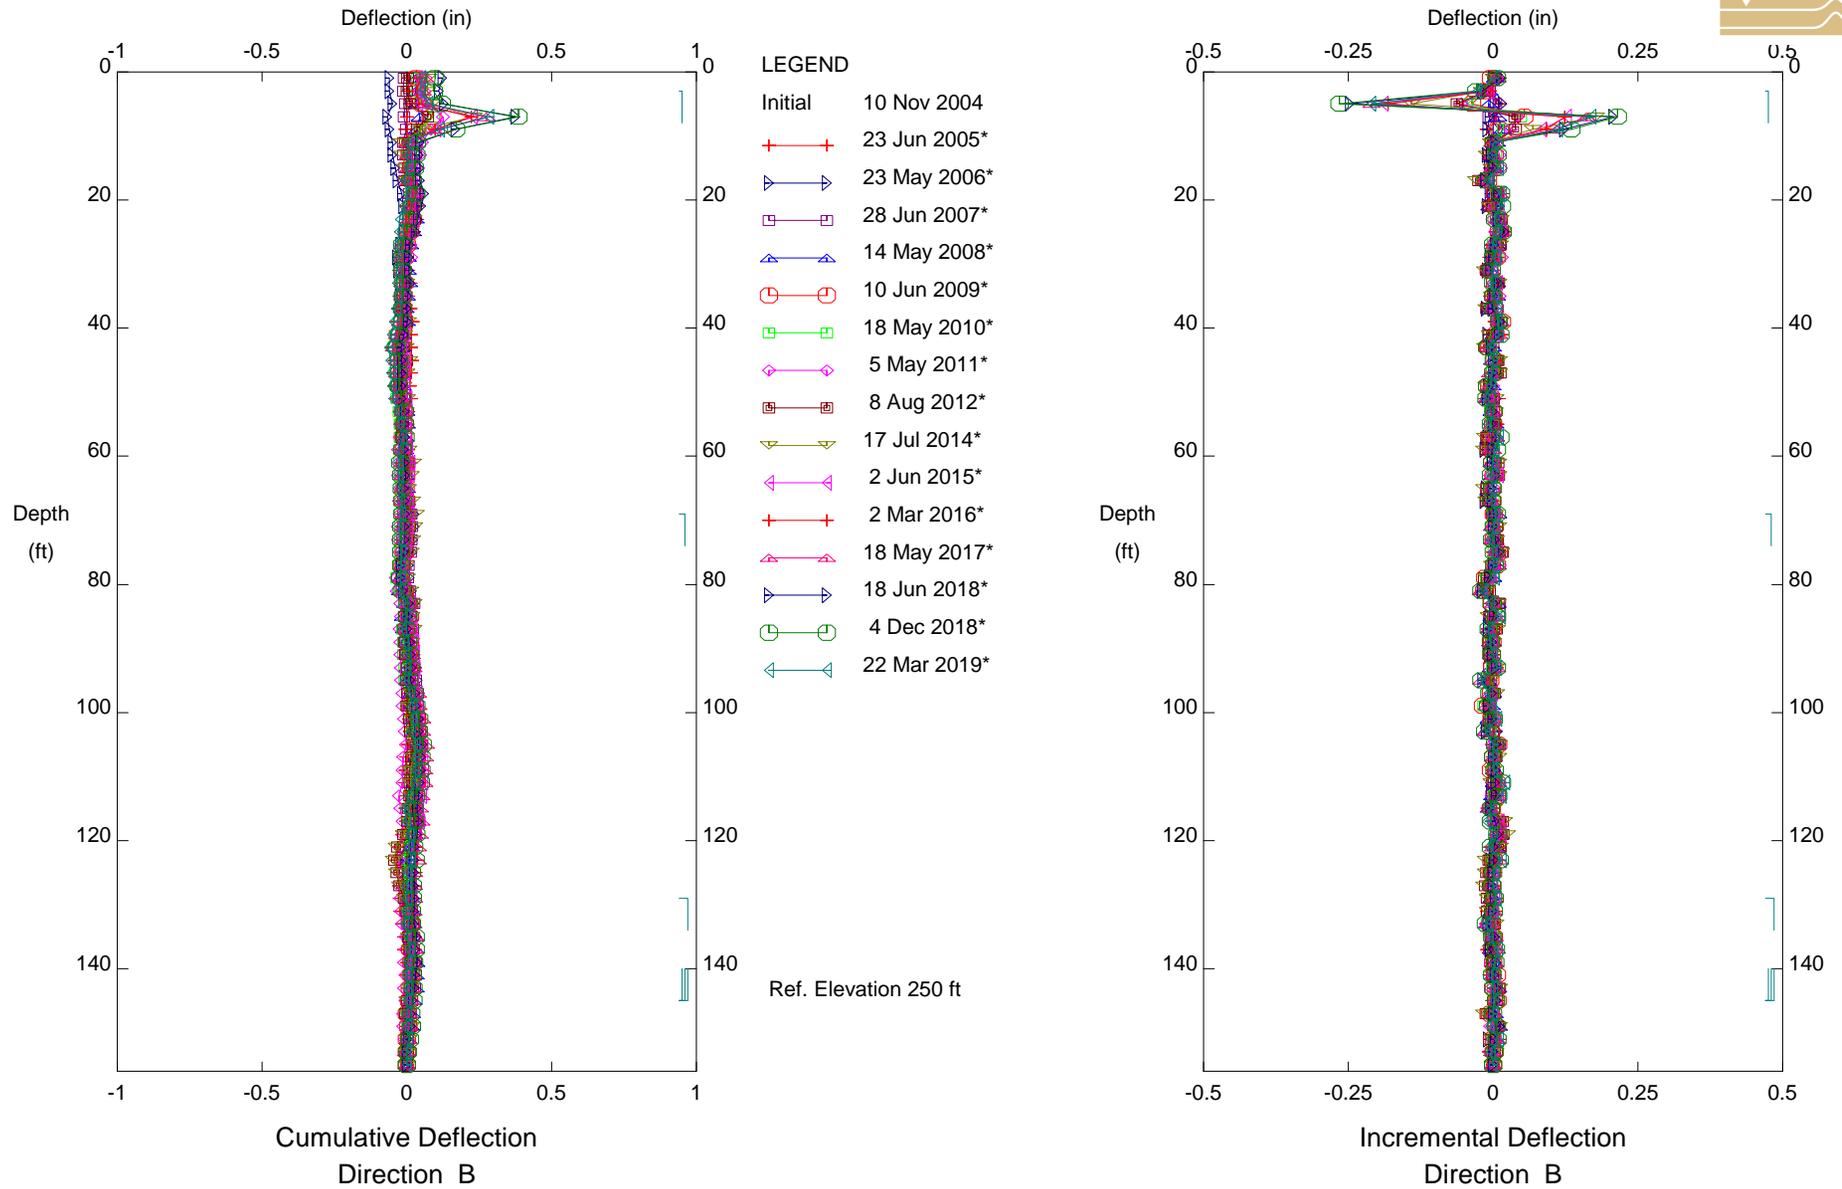
**BIG ROCK MESA, Inclinometer PC-1
 EASTERN REGION**

Sets marked * include zero shift and/or rotation corrections.

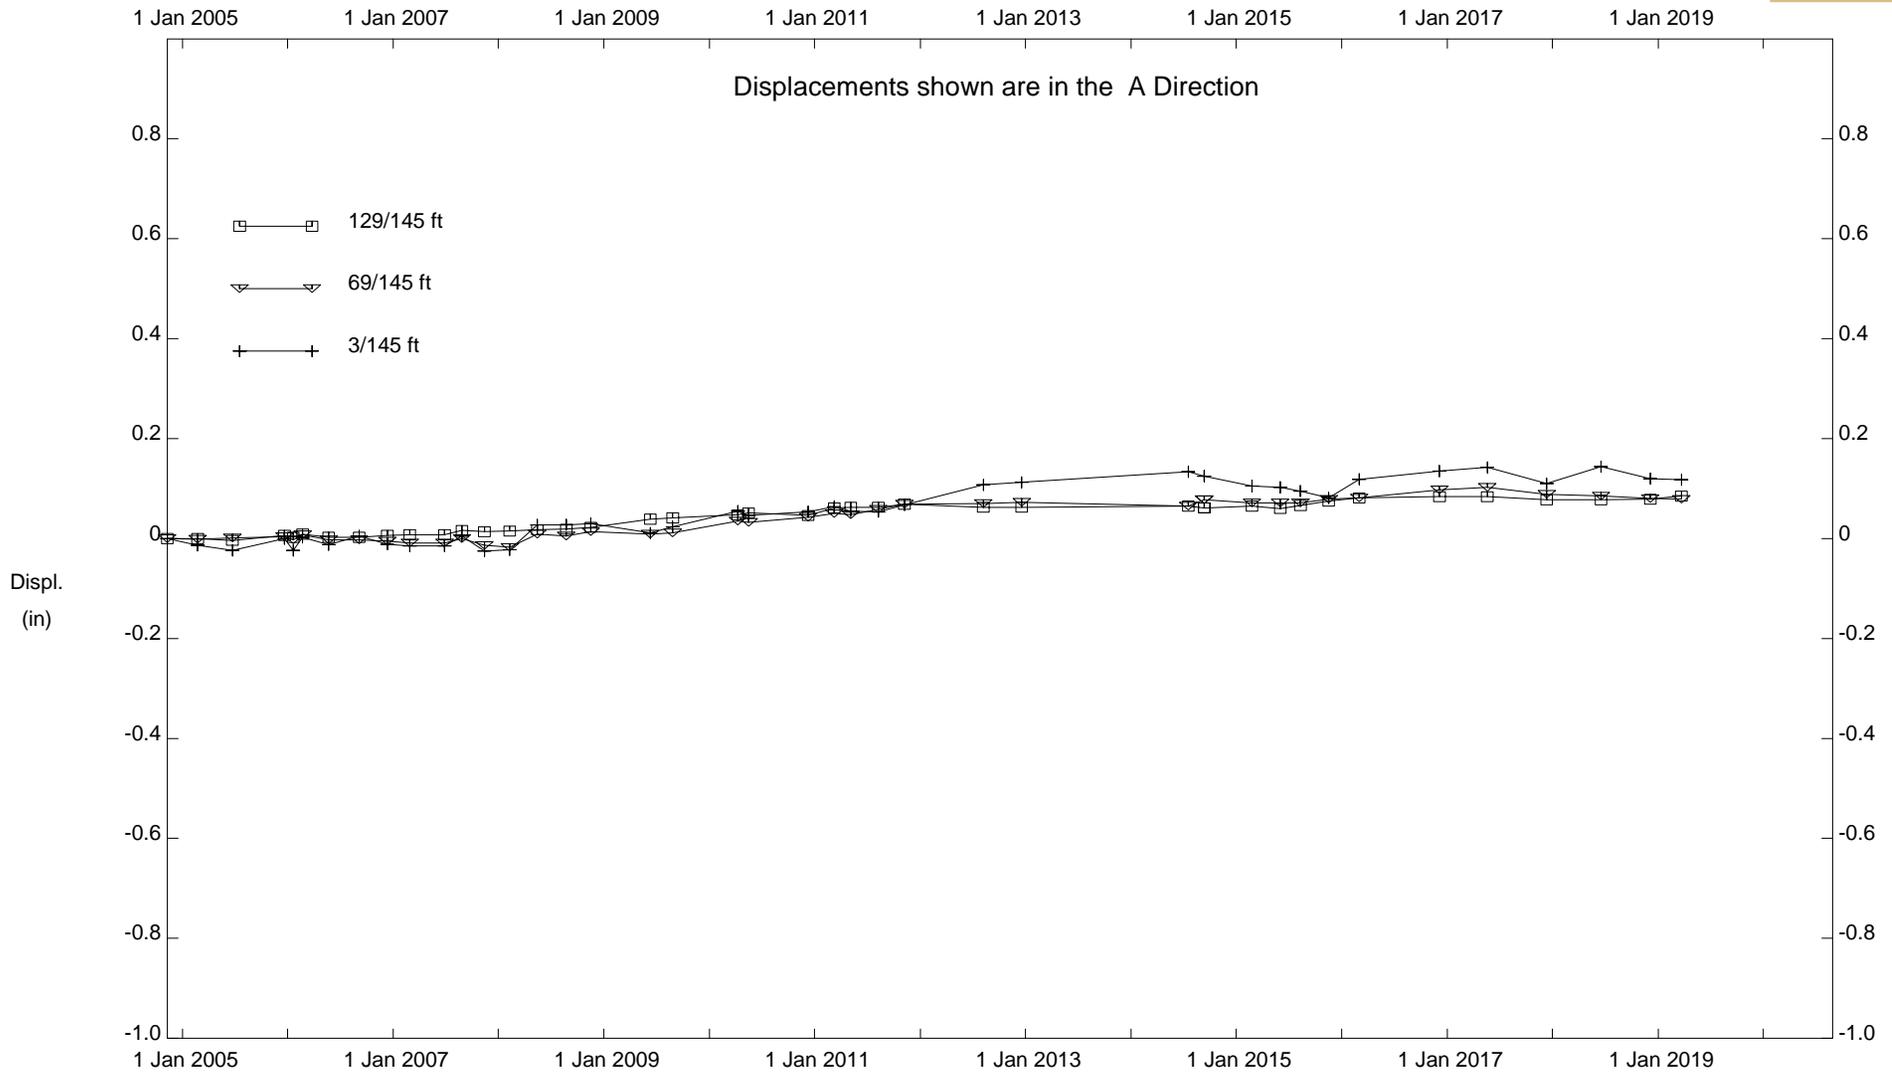
BIG ROCK MESA, Inclinometer PC-1

EASTERN REGION
