**ANNUAL REPORT
JULY 2018 THROUGH JUNE 2019
BIG ROCK MESA LANDSLIDE
ASSESSMENT DISTRICT
City of Malibu, California**

November 2019
Fugro Project No. 04.62160606
Document No. 04.62160606-PR-006(Rev.00)

Annual Report of Maintenance and Monitoring, July 2018 through June 2019, Big Rock Mesa Landslide Assessment District, City of Malibu, California

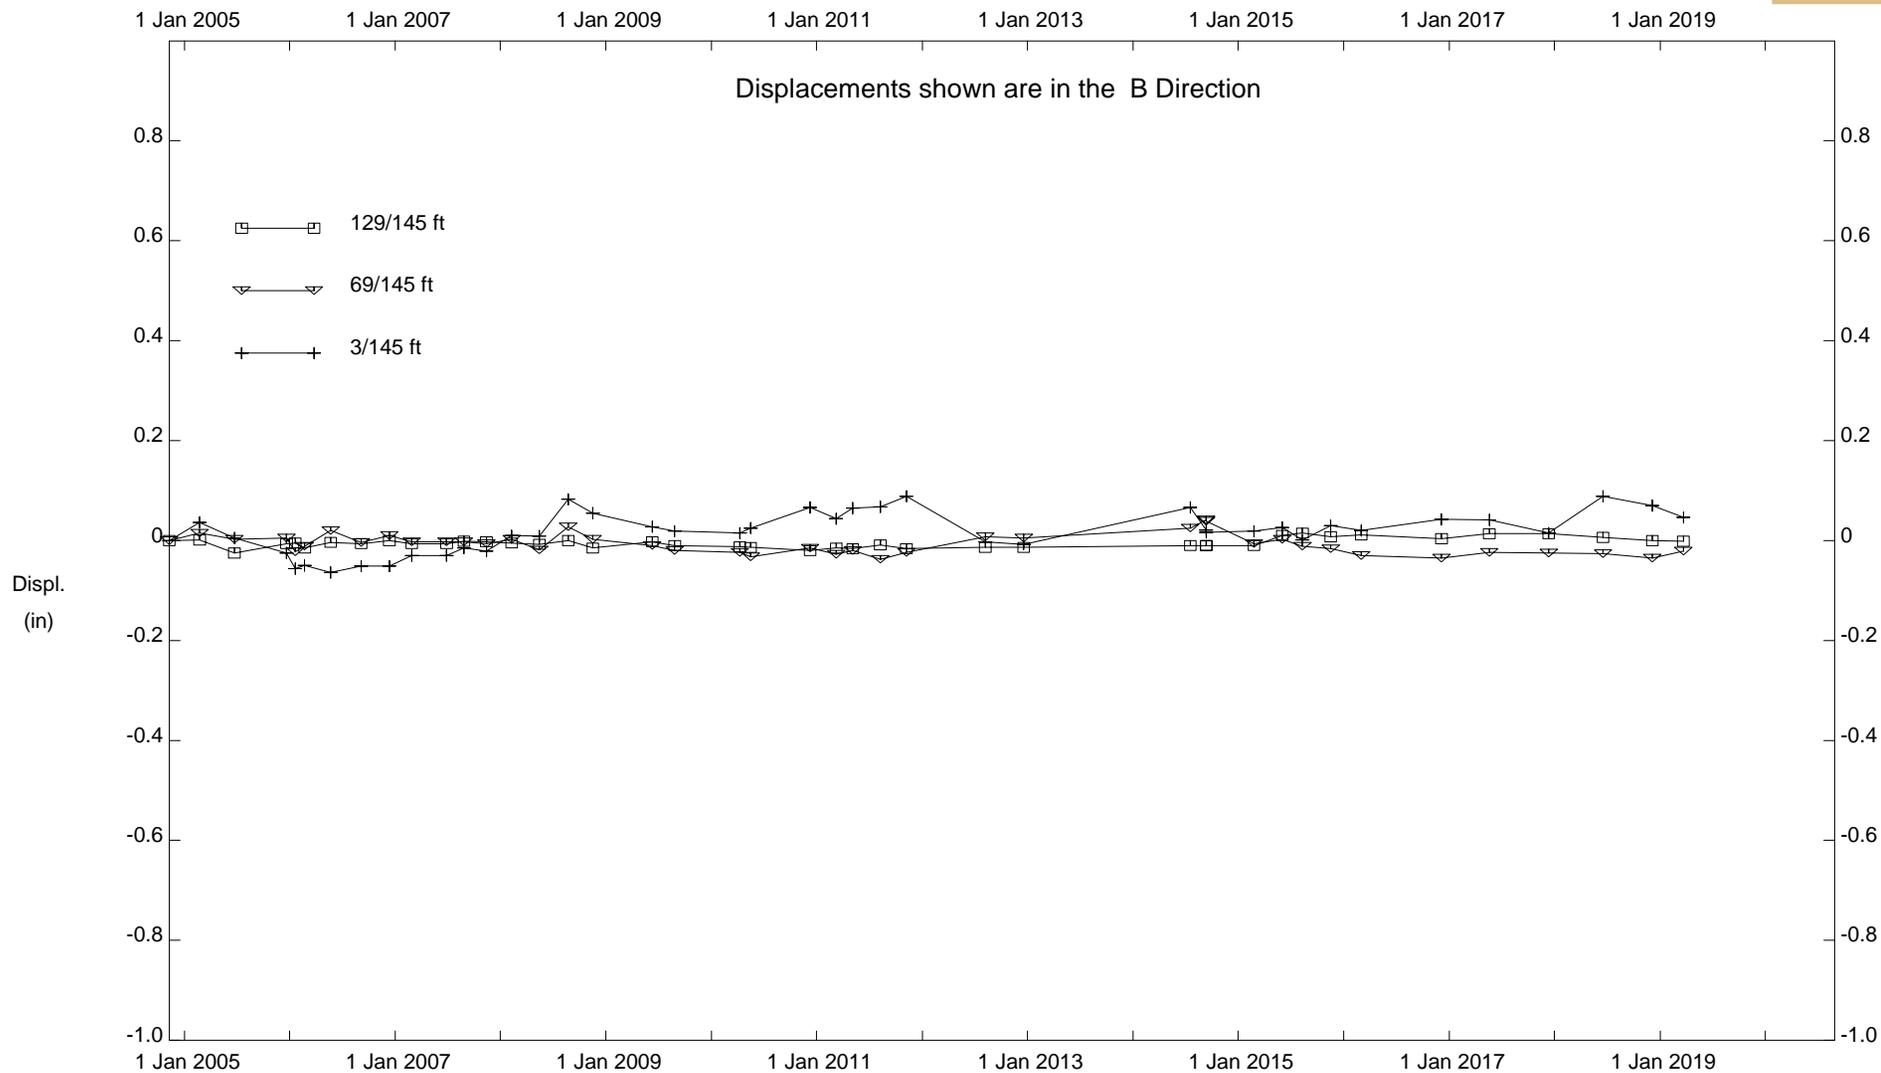
BIG ROCK MESA, Inclinometer PC-1

EASTERN REGION

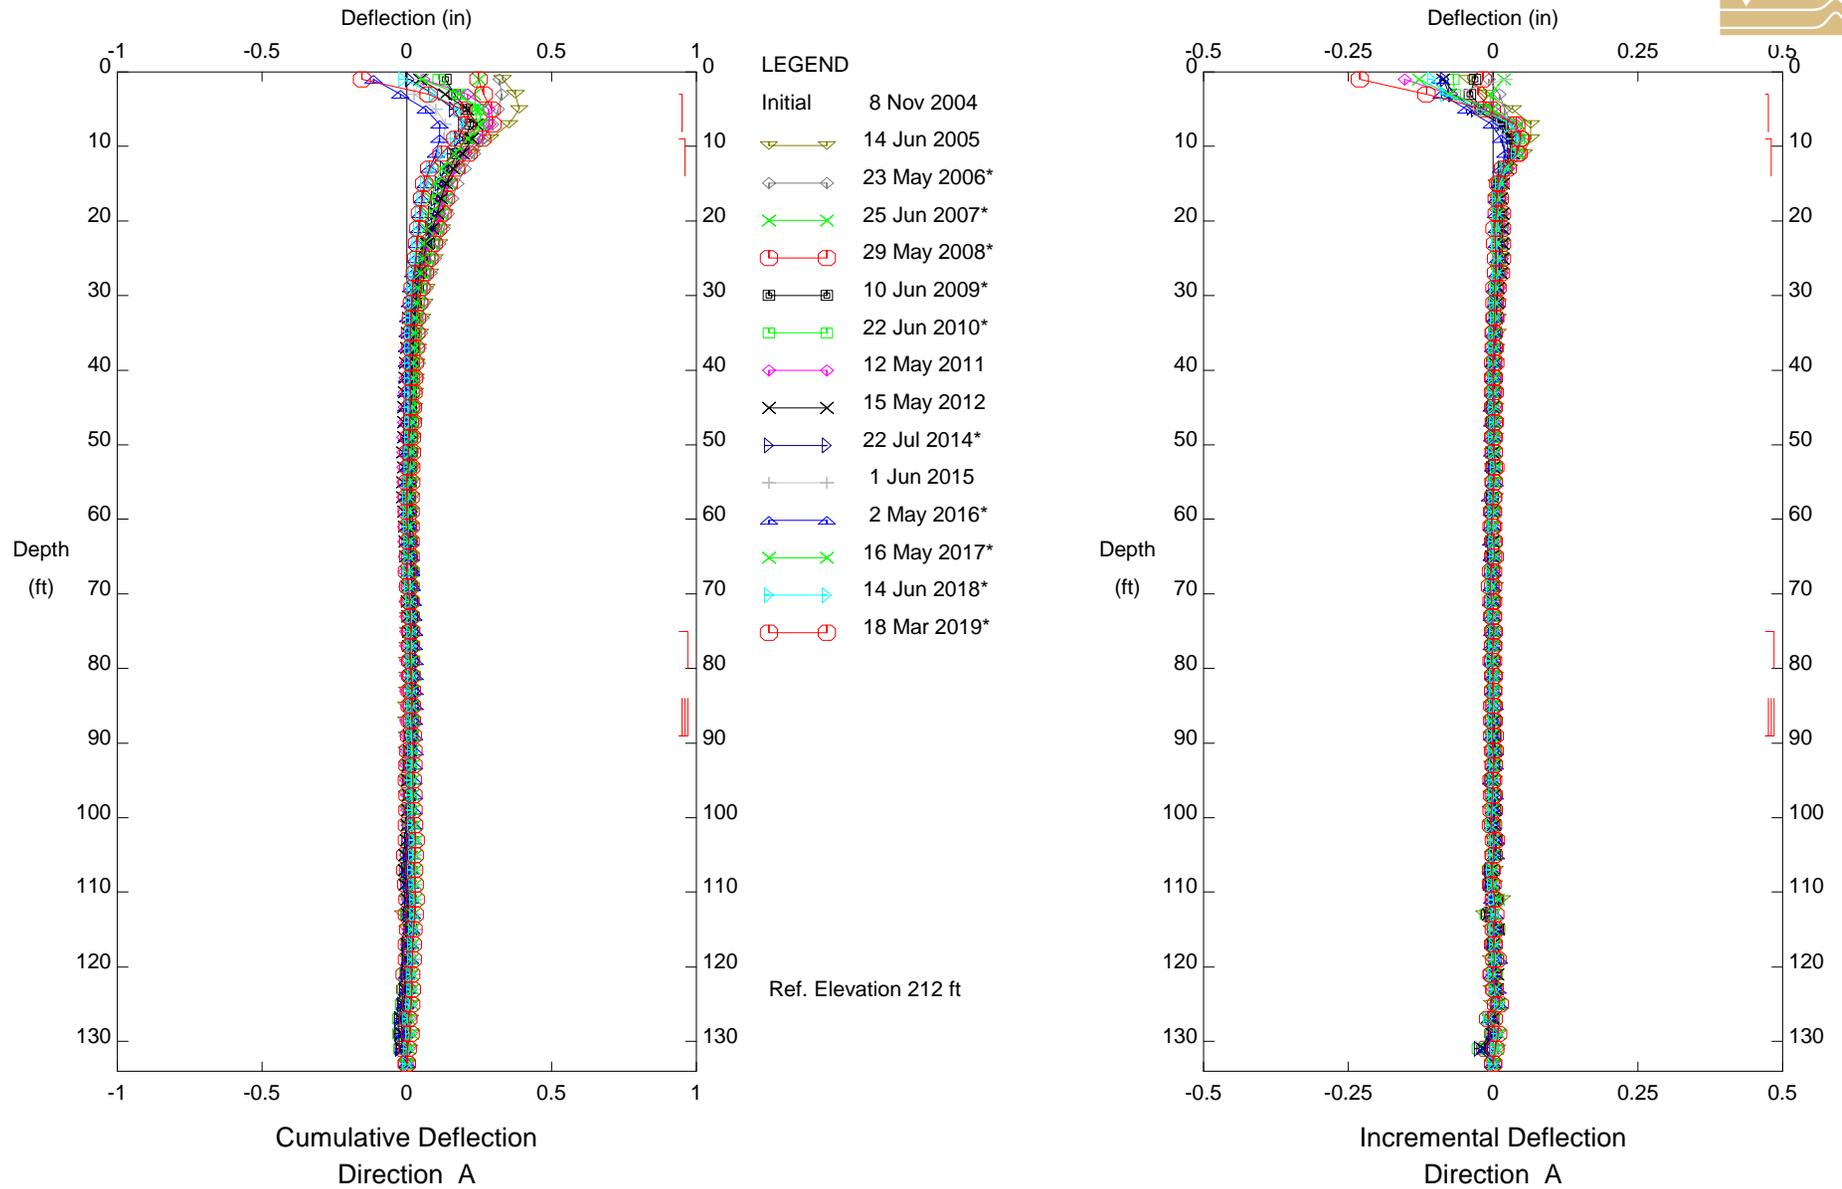
**BIG ROCK MESA, Incliner SP-3
 EASTERN REGION**

Sets marked * include zero shift and/or rotation corrections.

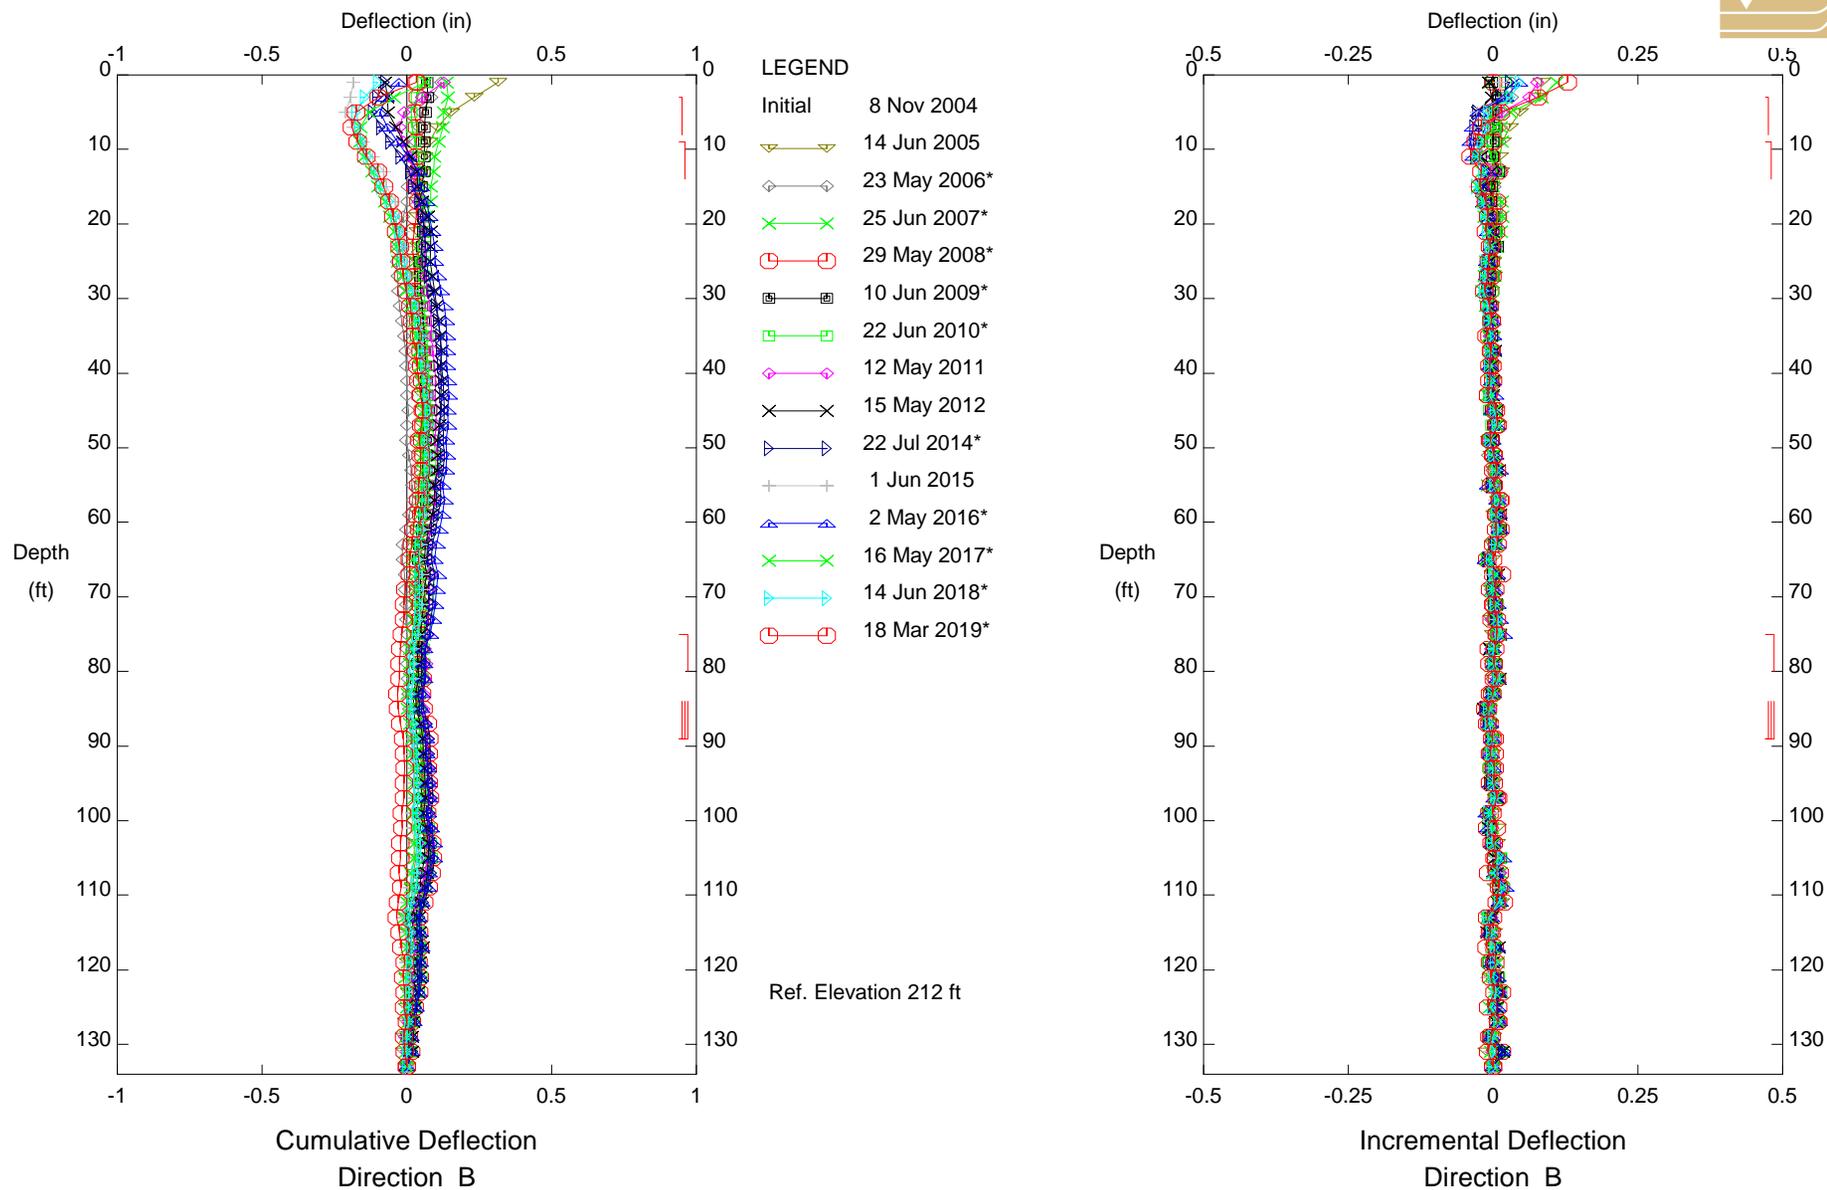
**BIG ROCK MESA, Inclinometer SP-3
 EASTERN REGION**

Sets marked * include zero shift and/or rotation corrections.

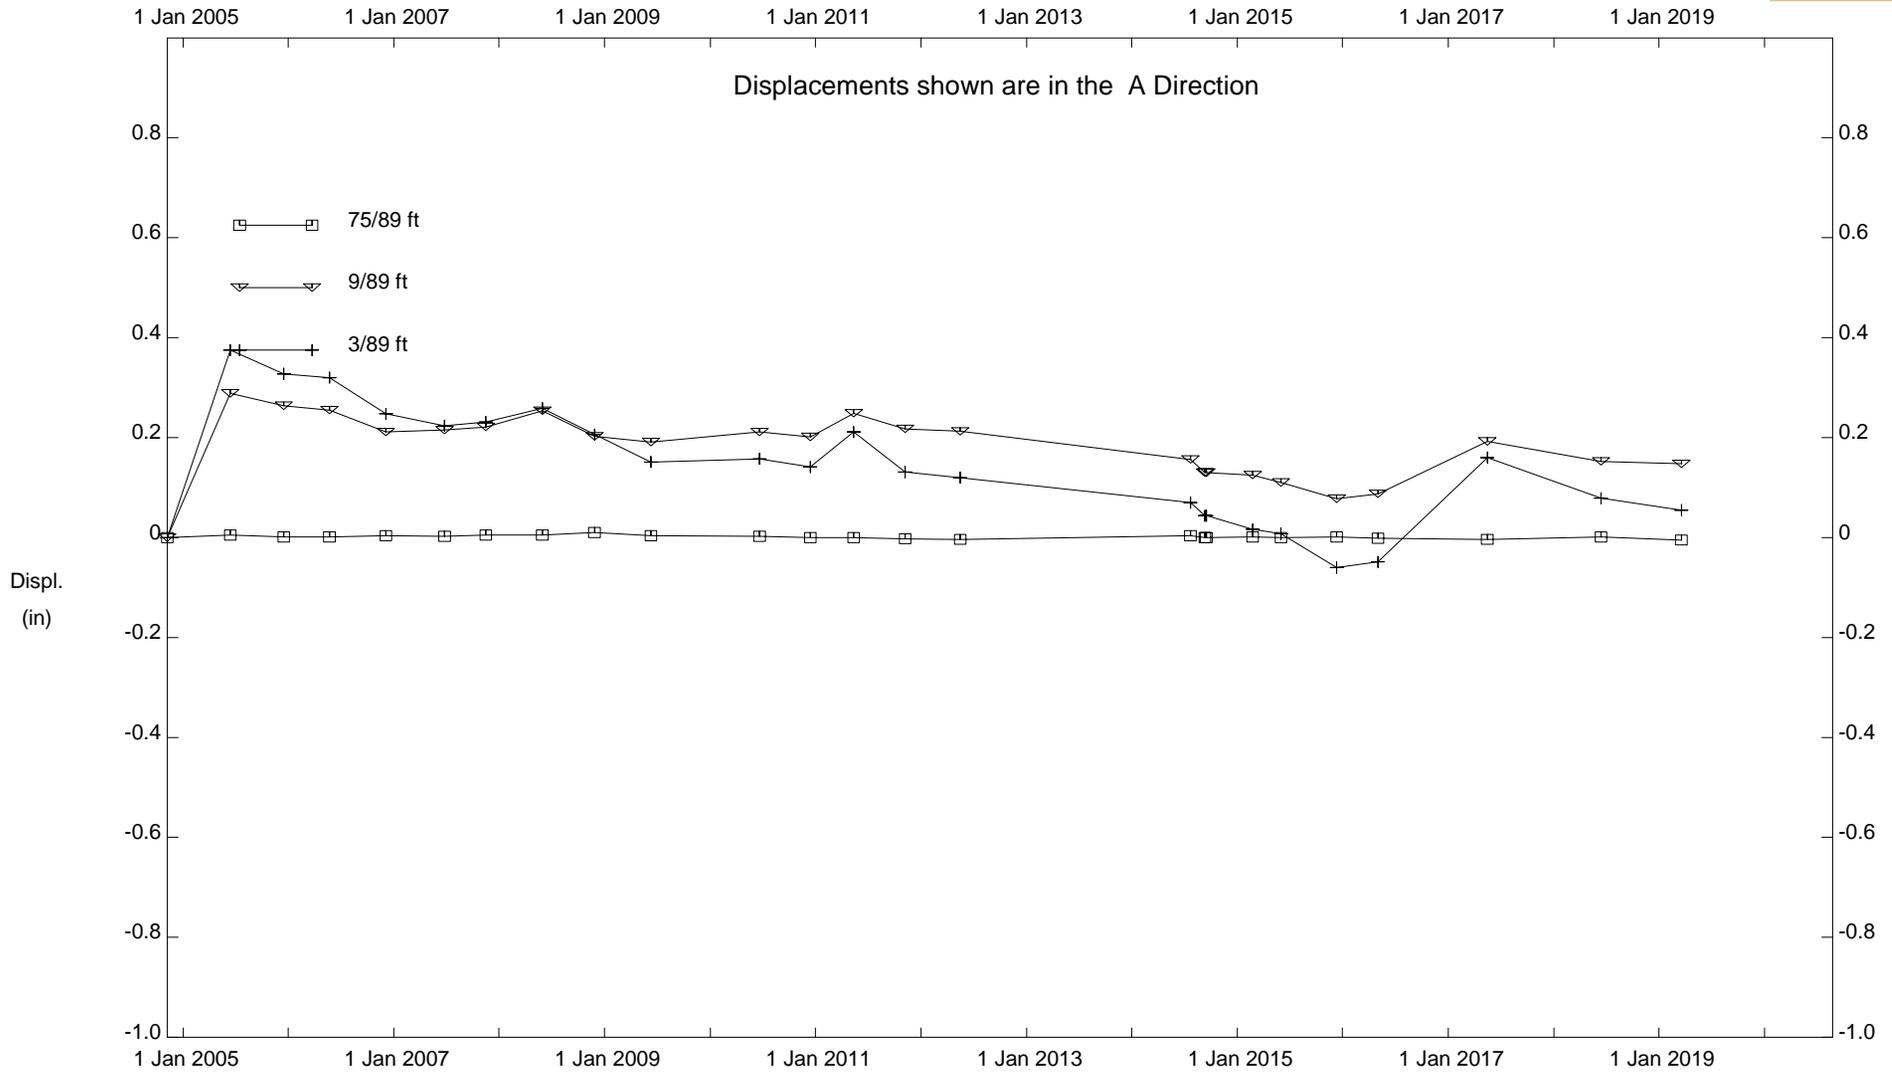
BIG ROCK MESA, Inclinator SP-3

EASTERN REGION

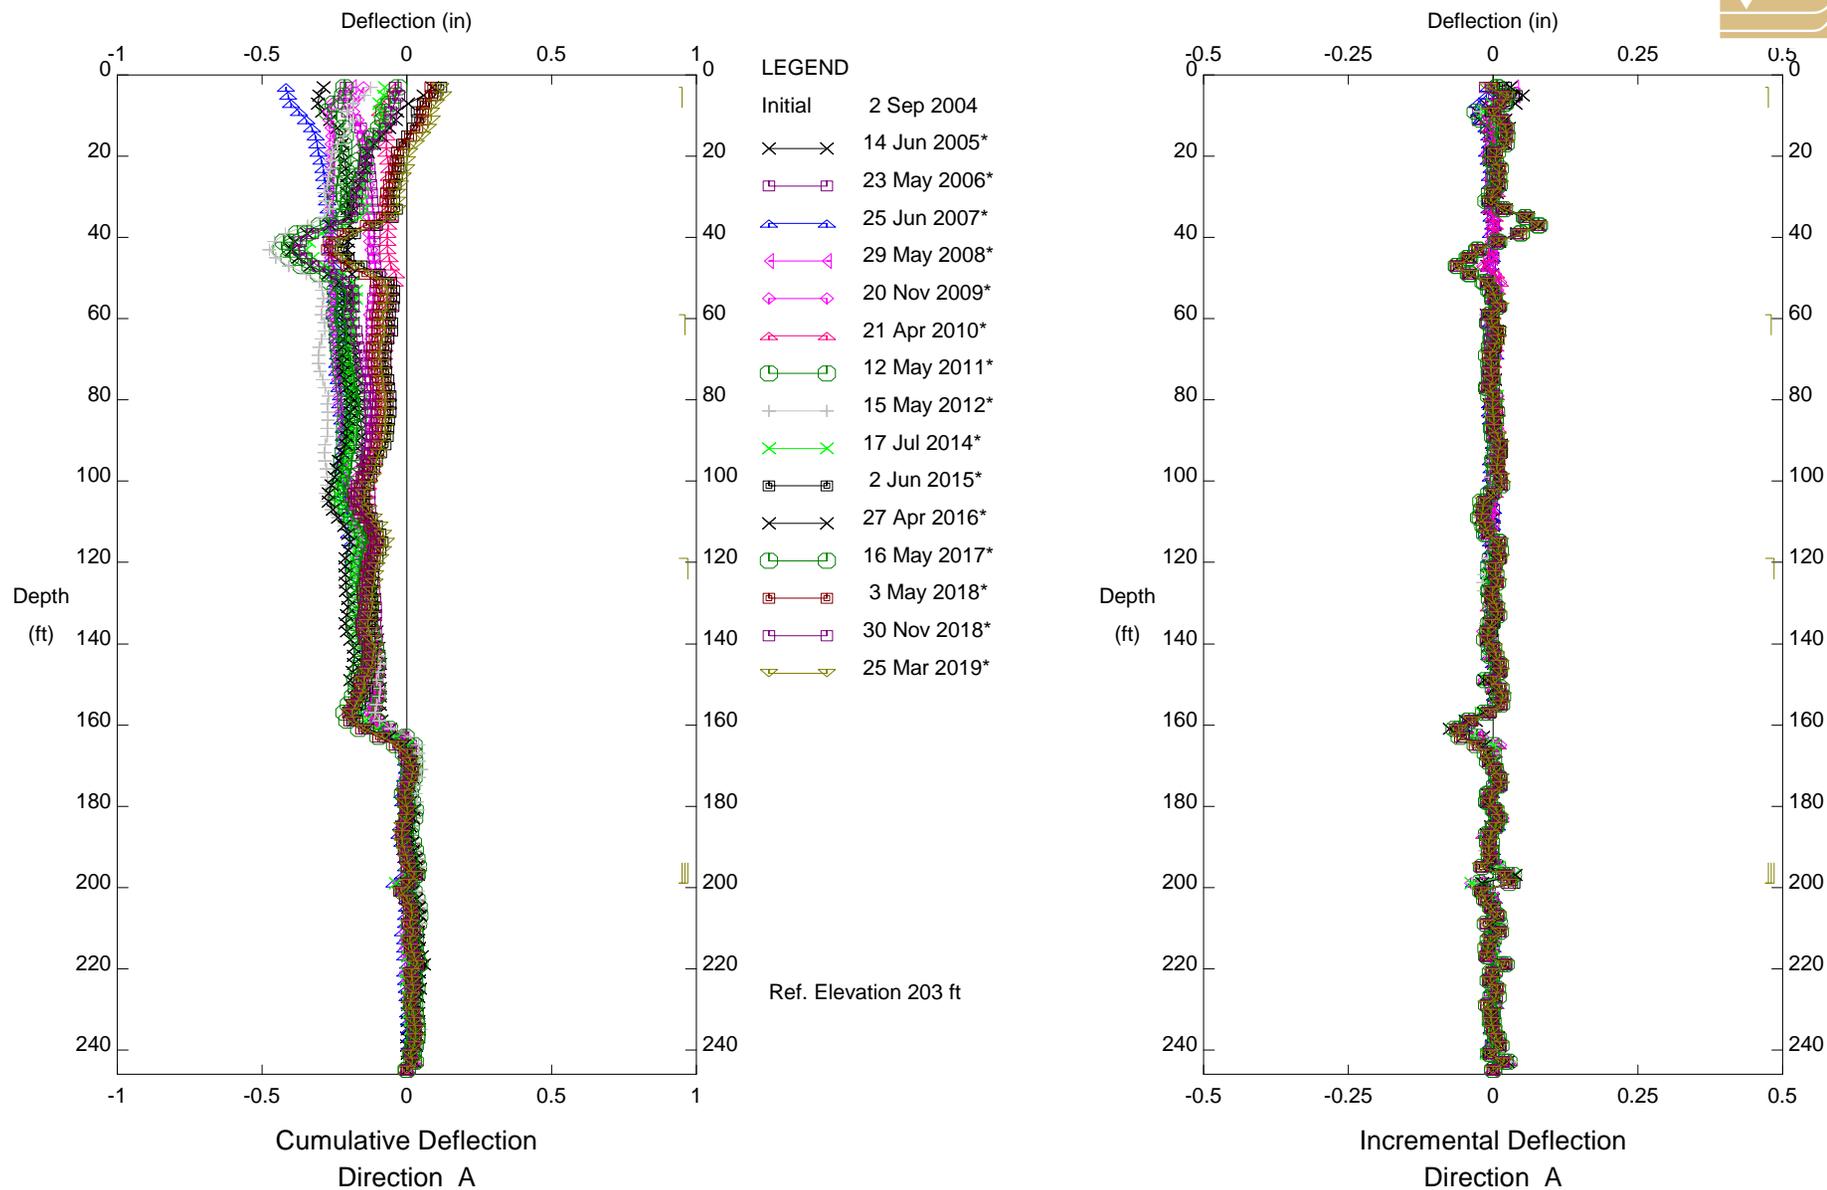
**BIG ROCK MESA, Inclinometer SP-3A
 EASTERN REGION**

Sets marked * include zero shift and/or rotation corrections.

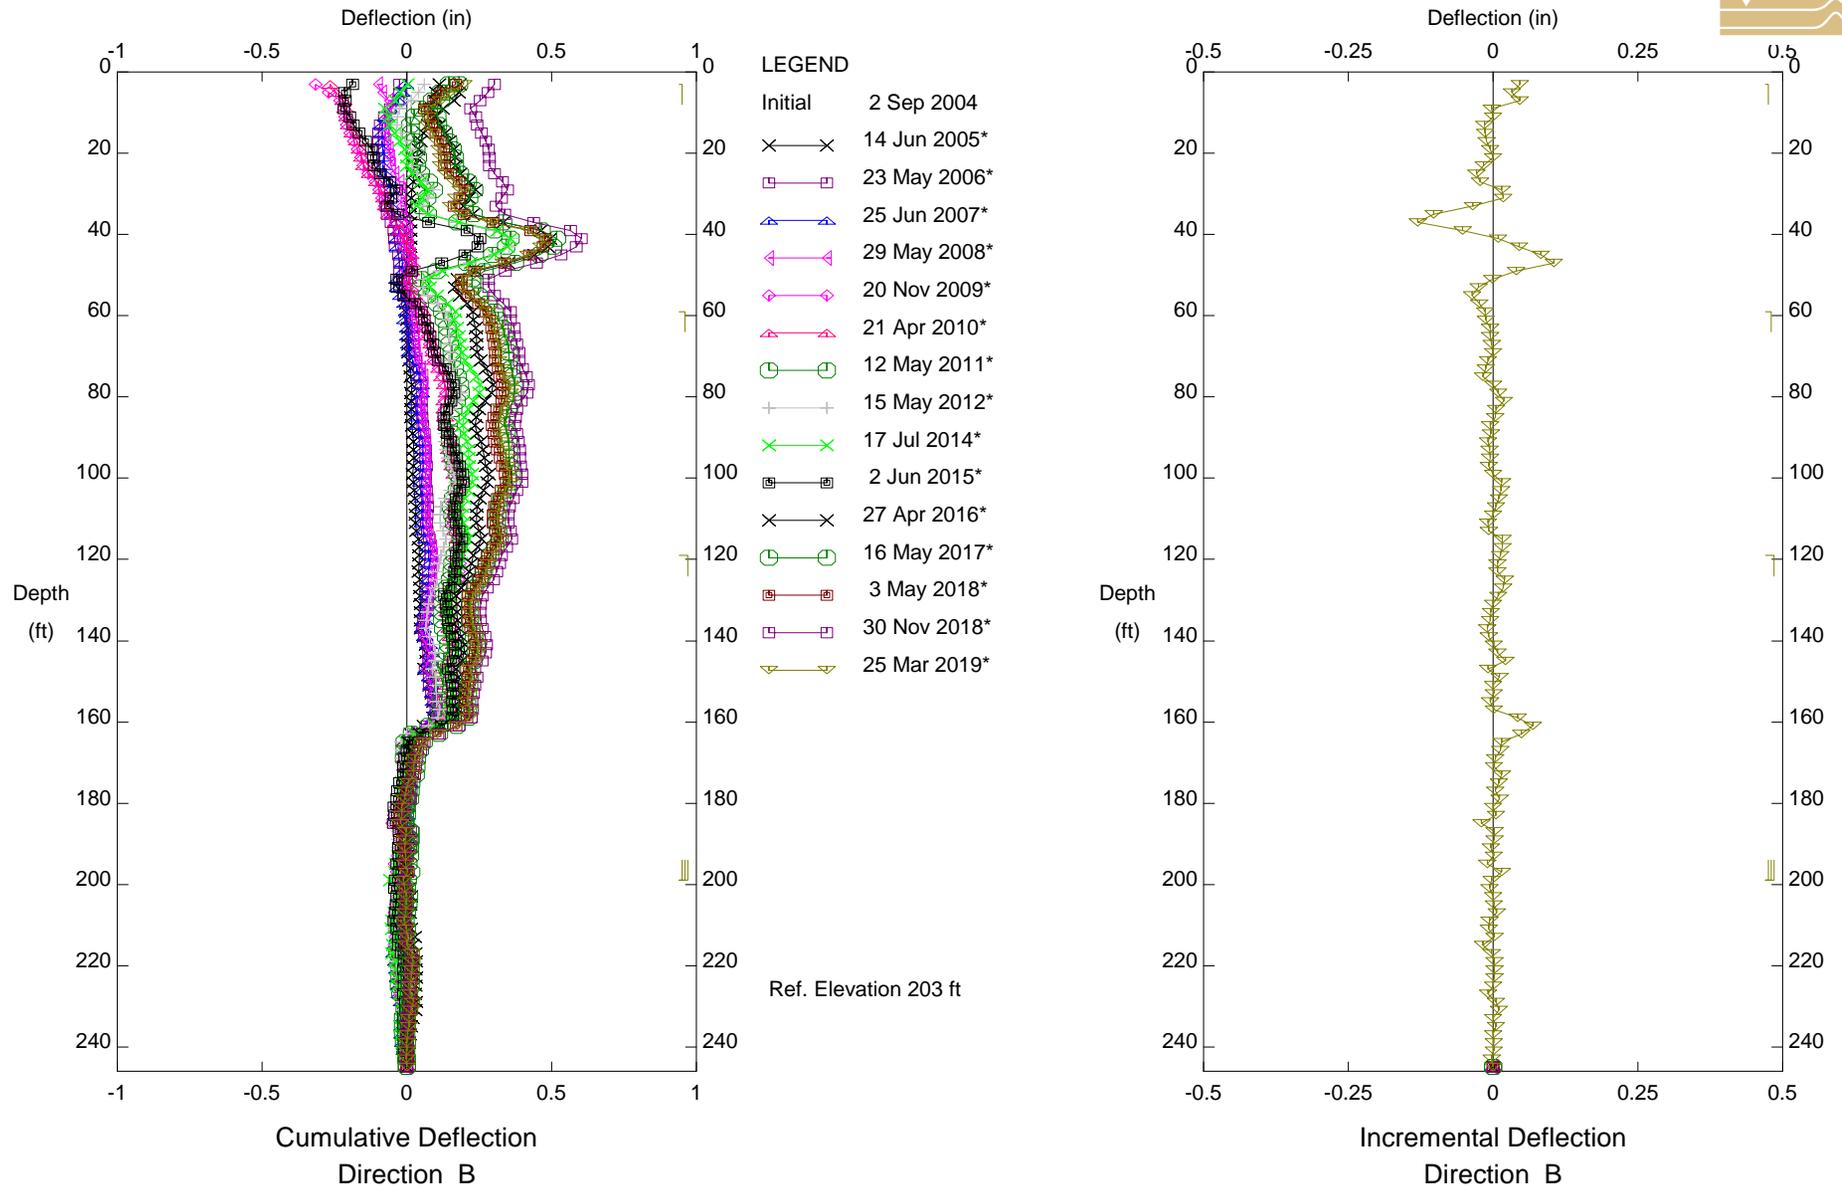
**BIG ROCK MESA, Inclinometer SP-3A
 EASTERN REGION**

Sets marked * include zero shift and/or rotation corrections.

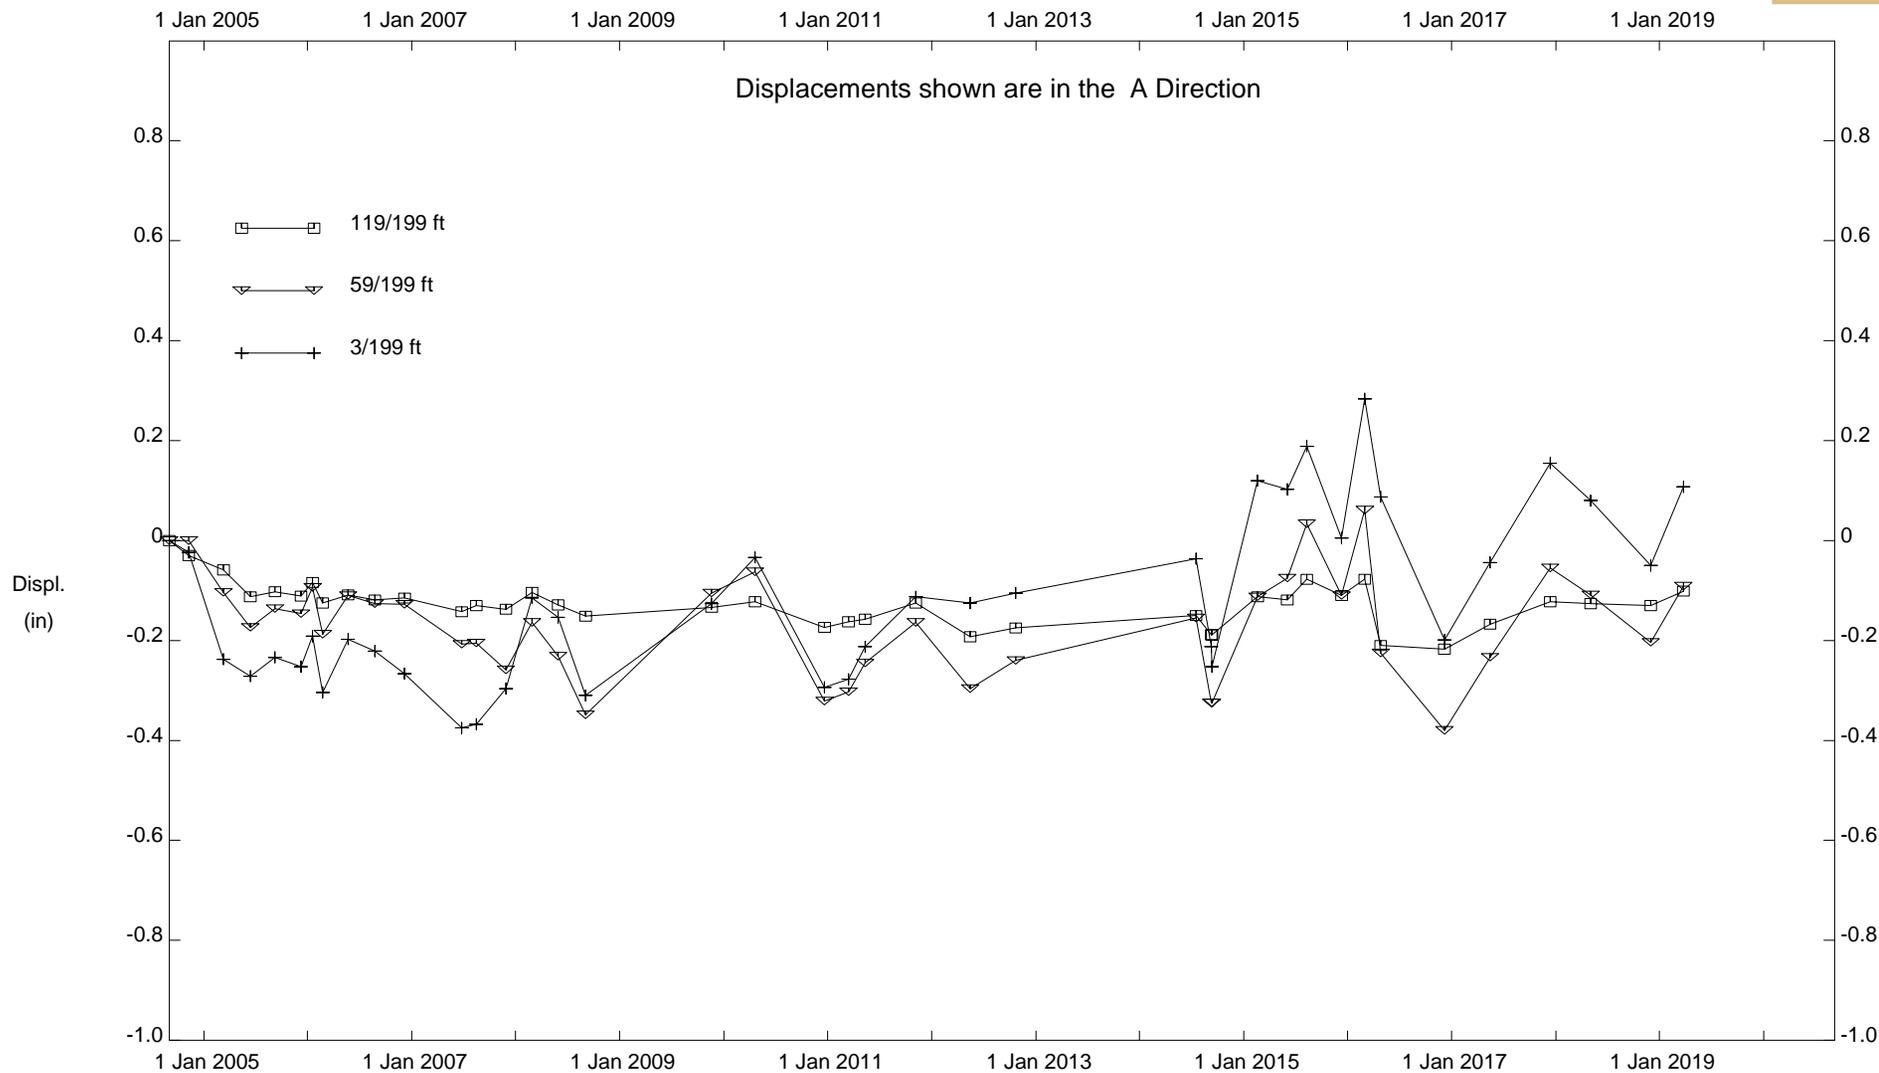
BIG ROCK MESA, Inclinometer SP-3A

EASTERN REGION

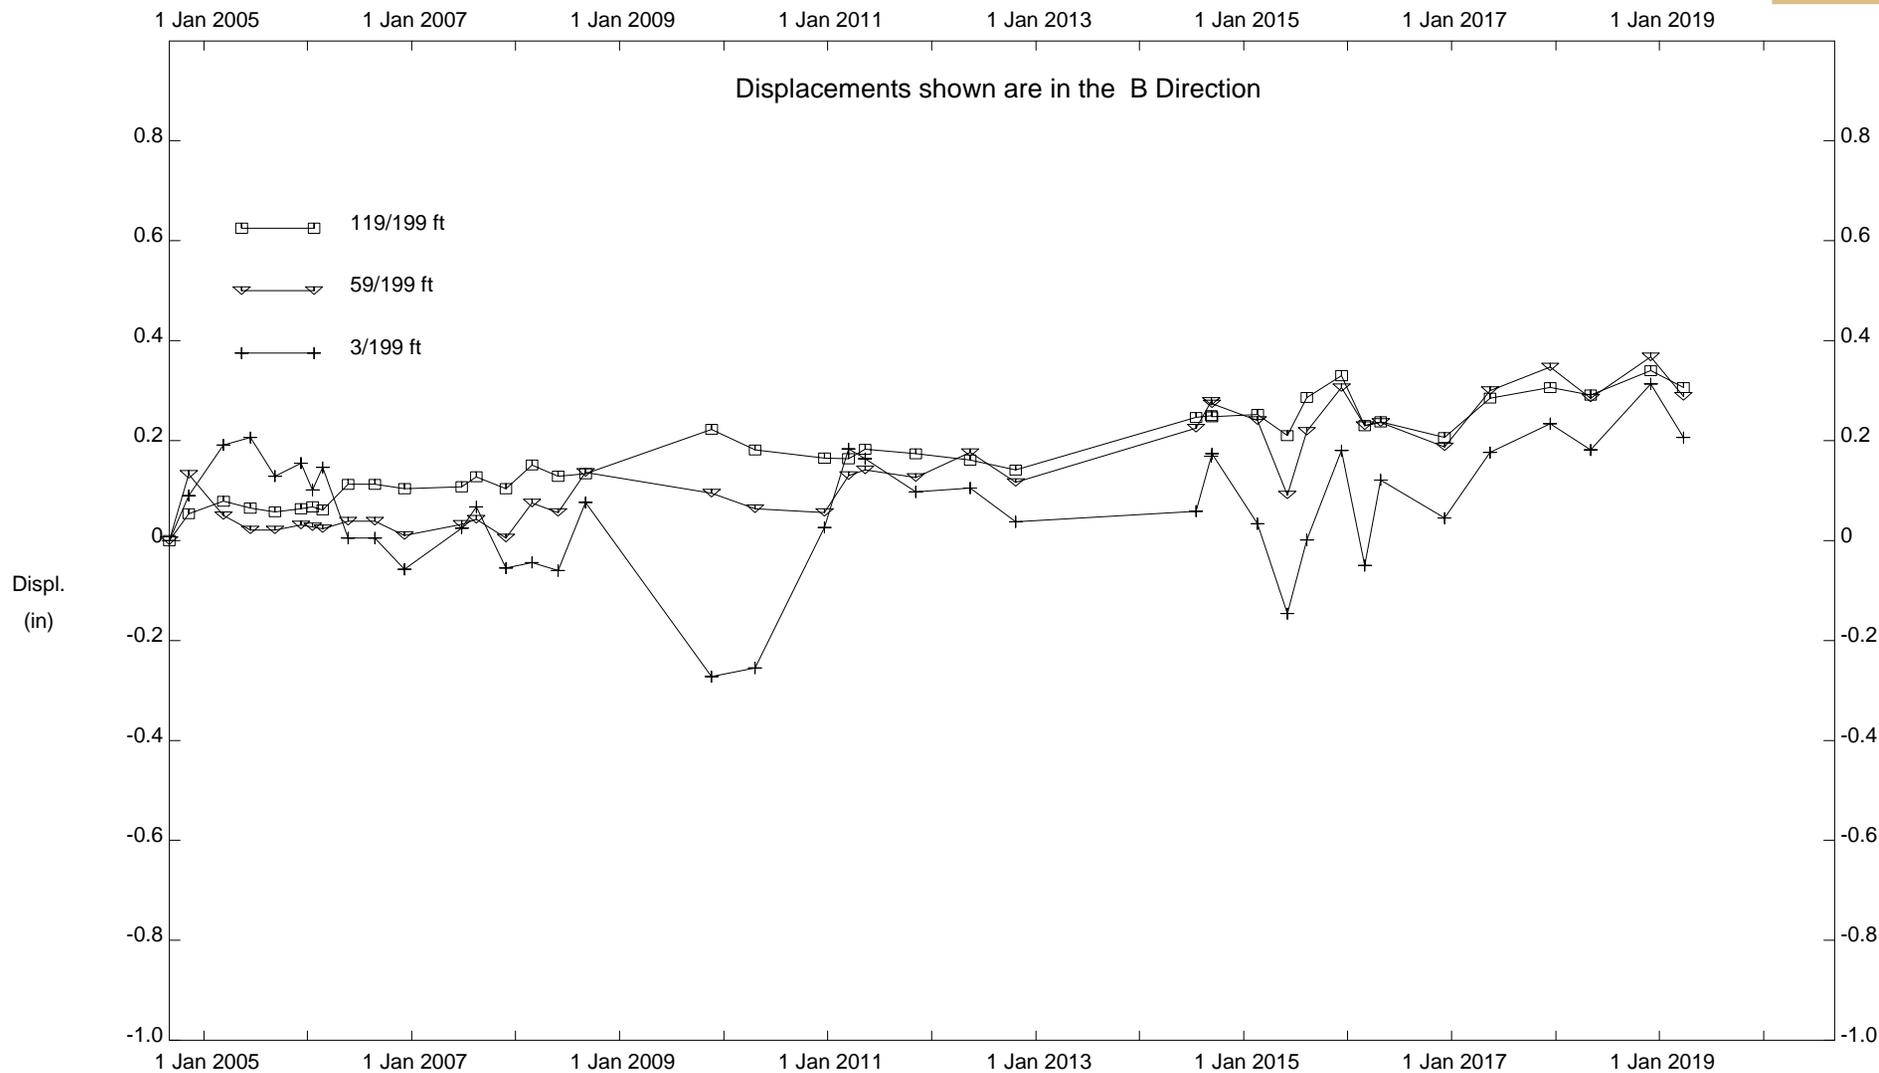
BIG ROCK MESA, Inclinometer SP-3A

EASTERN REGION

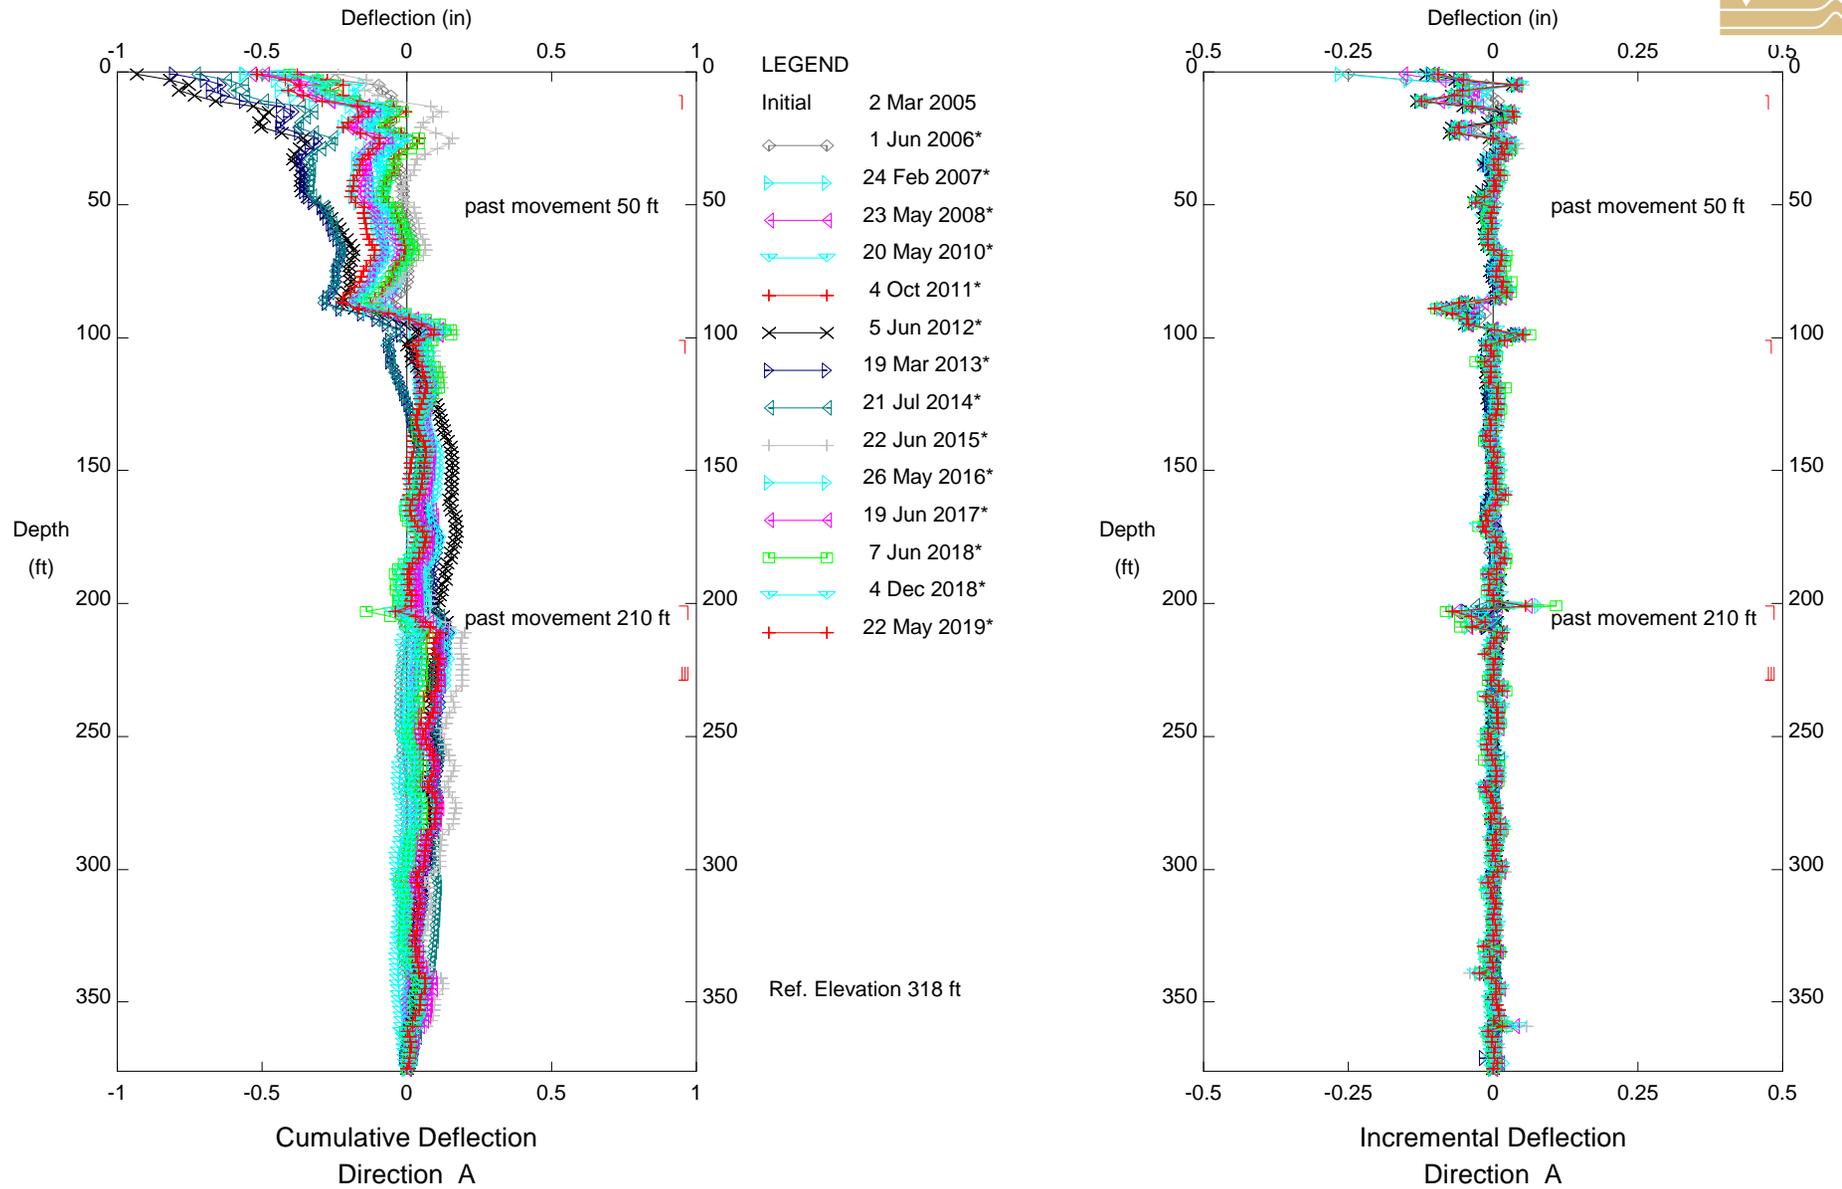
**BIG ROCK MESA, Inclinometer SP-33
 EASTERN REGION**

Sets marked * include zero shift and/or rotation corrections.

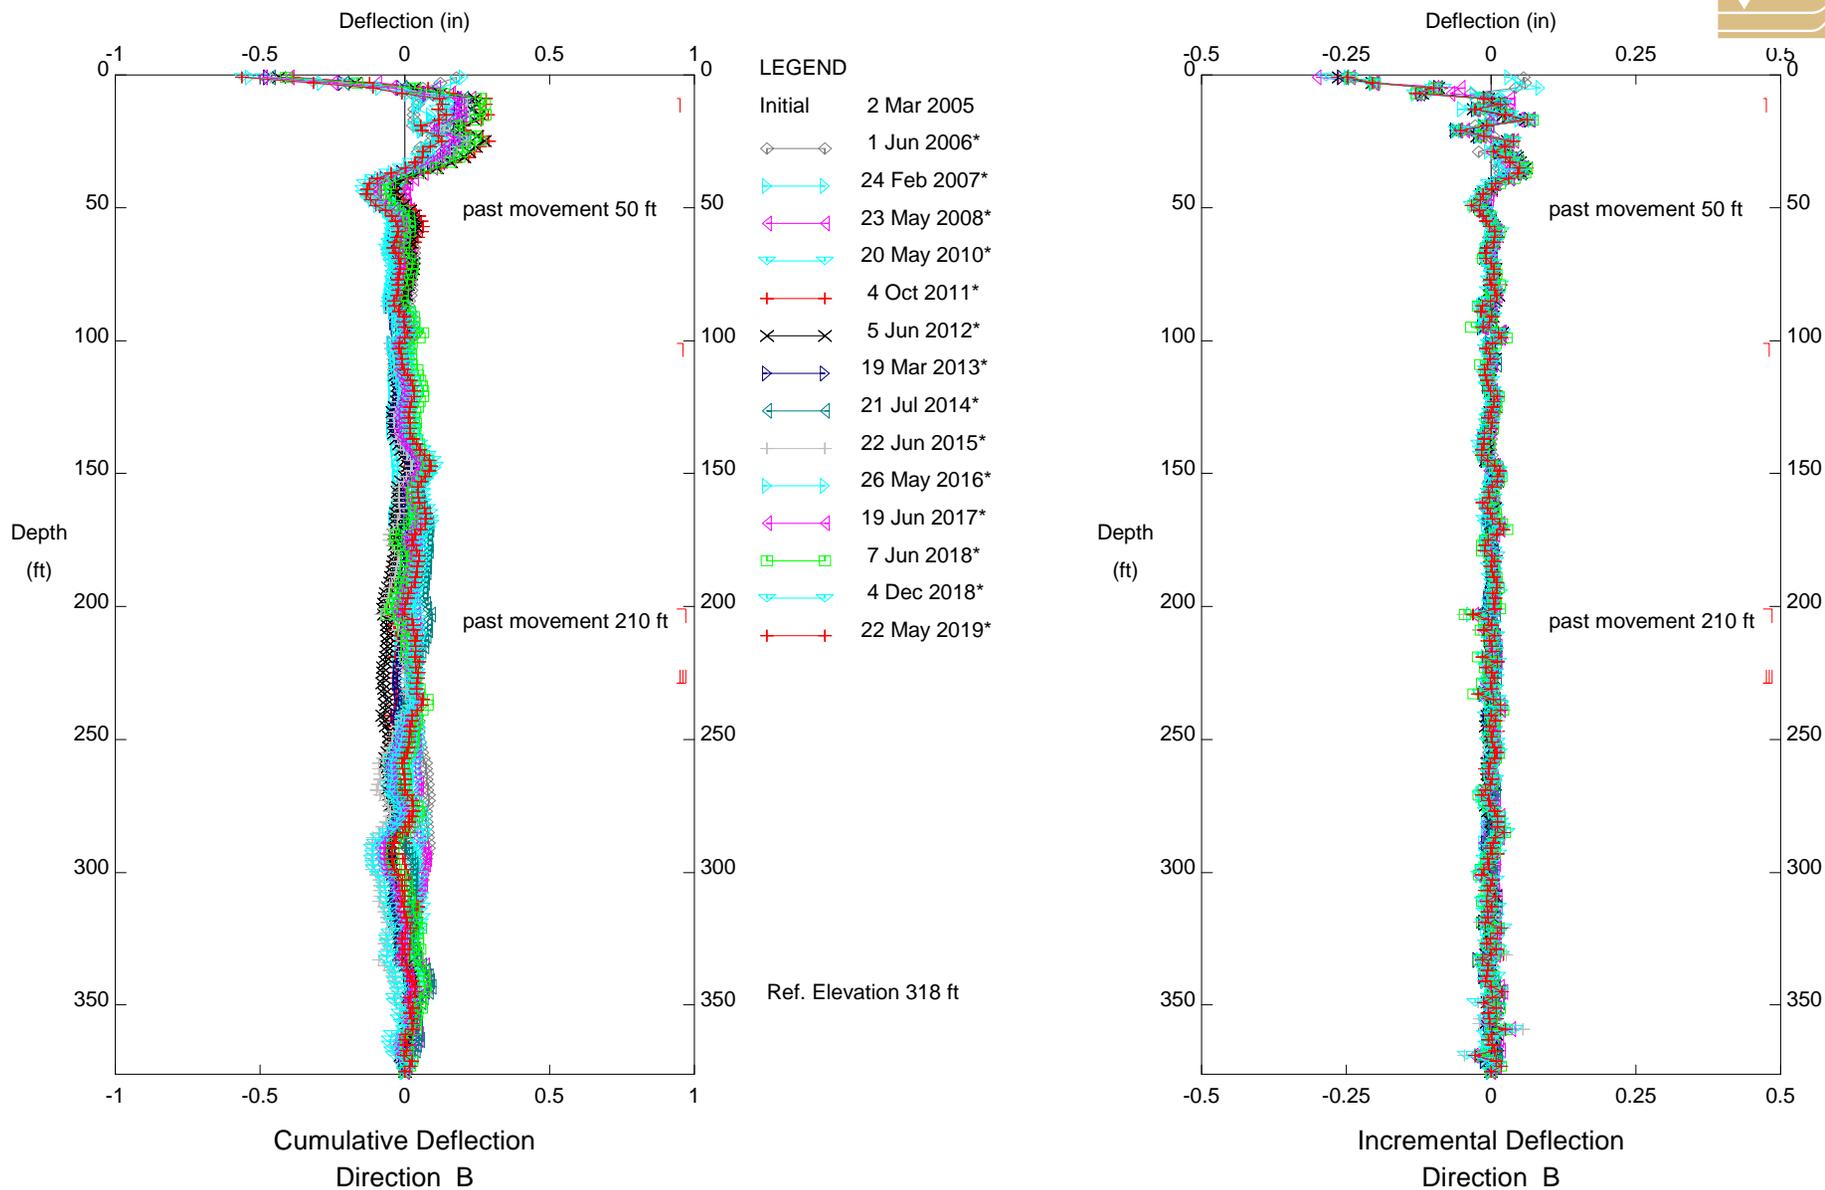
**BIG ROCK MESA, Inclinator SP-33
 EASTERN REGION**

Sets marked * include zero shift and/or rotation corrections.
