**ANNUAL REPORT
JULY 2018 THROUGH JUNE 2019
BIG ROCK MESA LANDSLIDE
ASSESSMENT DISTRICT
City of Malibu, California**

November 2019
Fugro Project No. 04.62160606
Document No. 04.62160606-PR-006(Rev.00)

Annual Report of Maintenance and Monitoring, July 2018 through June 2019, Big Rock Mesa Landslide Assessment District, City of Malibu, California

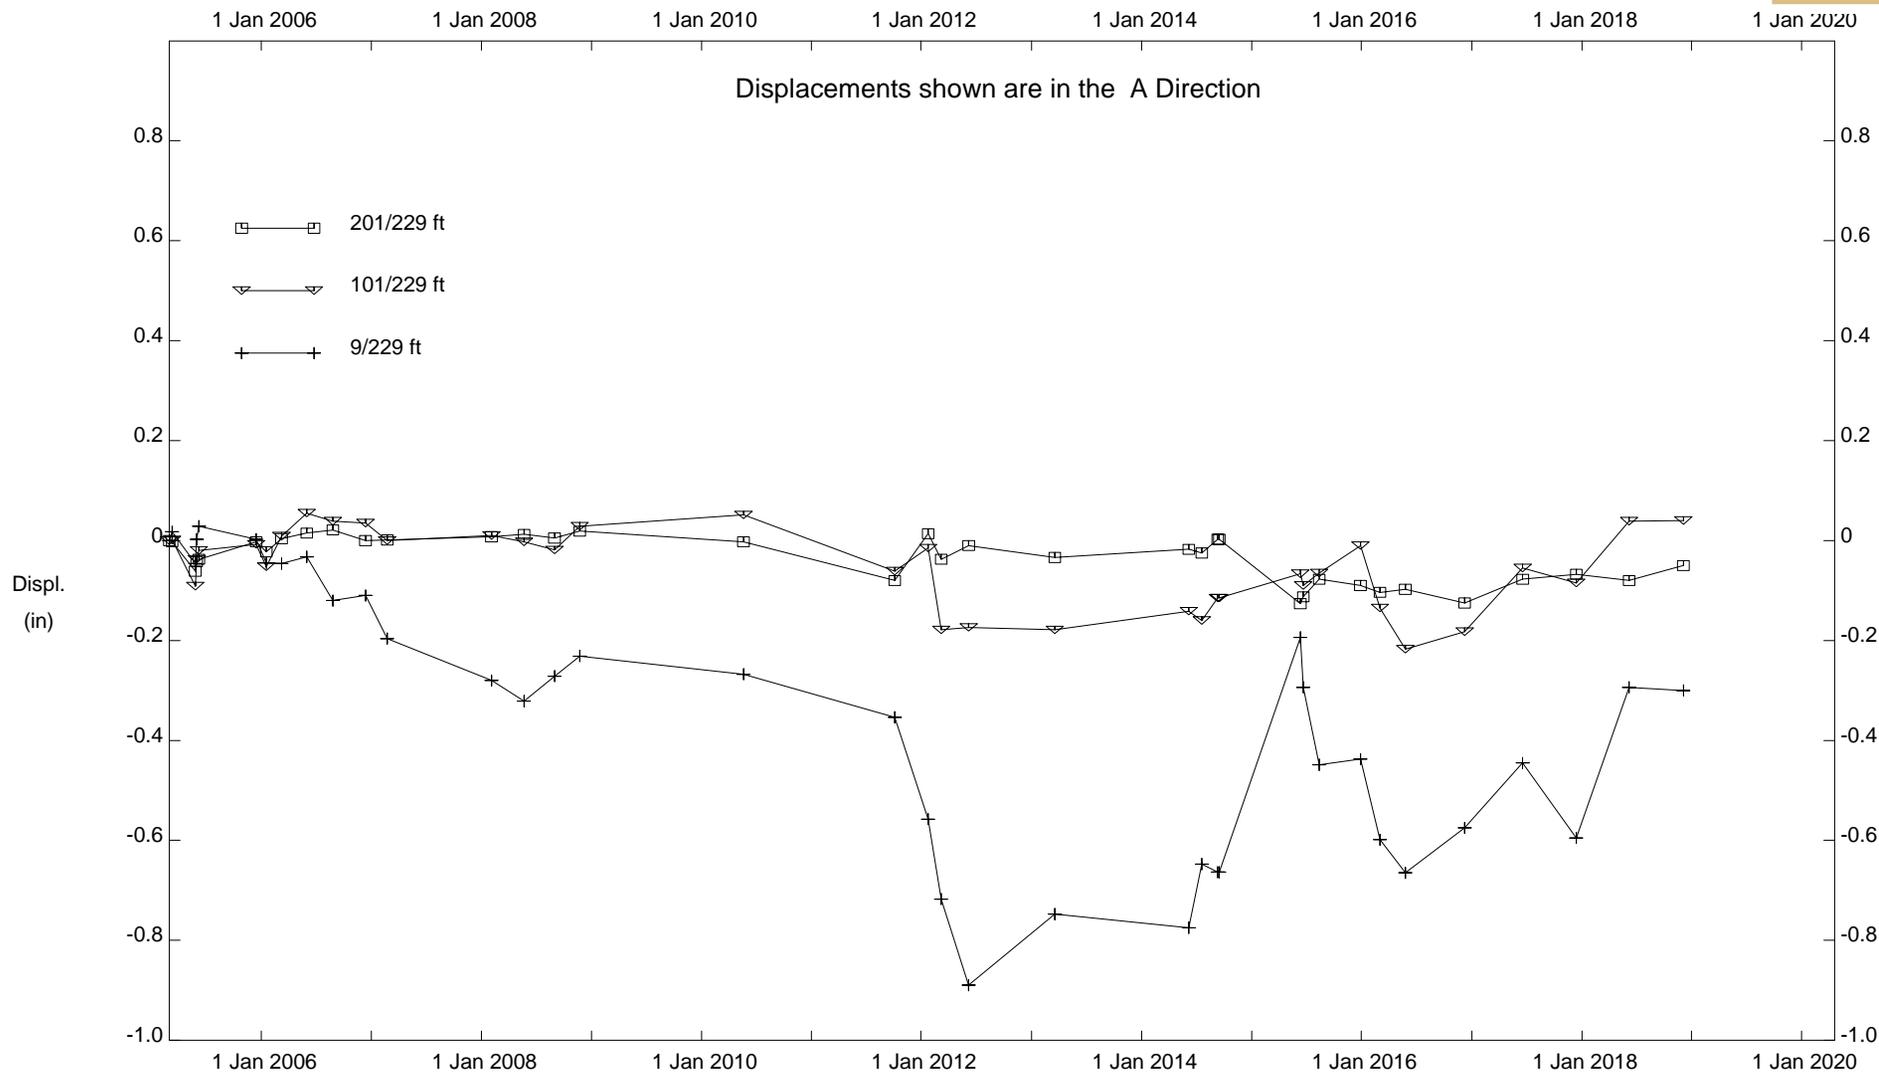
BIG ROCK MESA, Inclinometer SP-33

EASTERN REGION

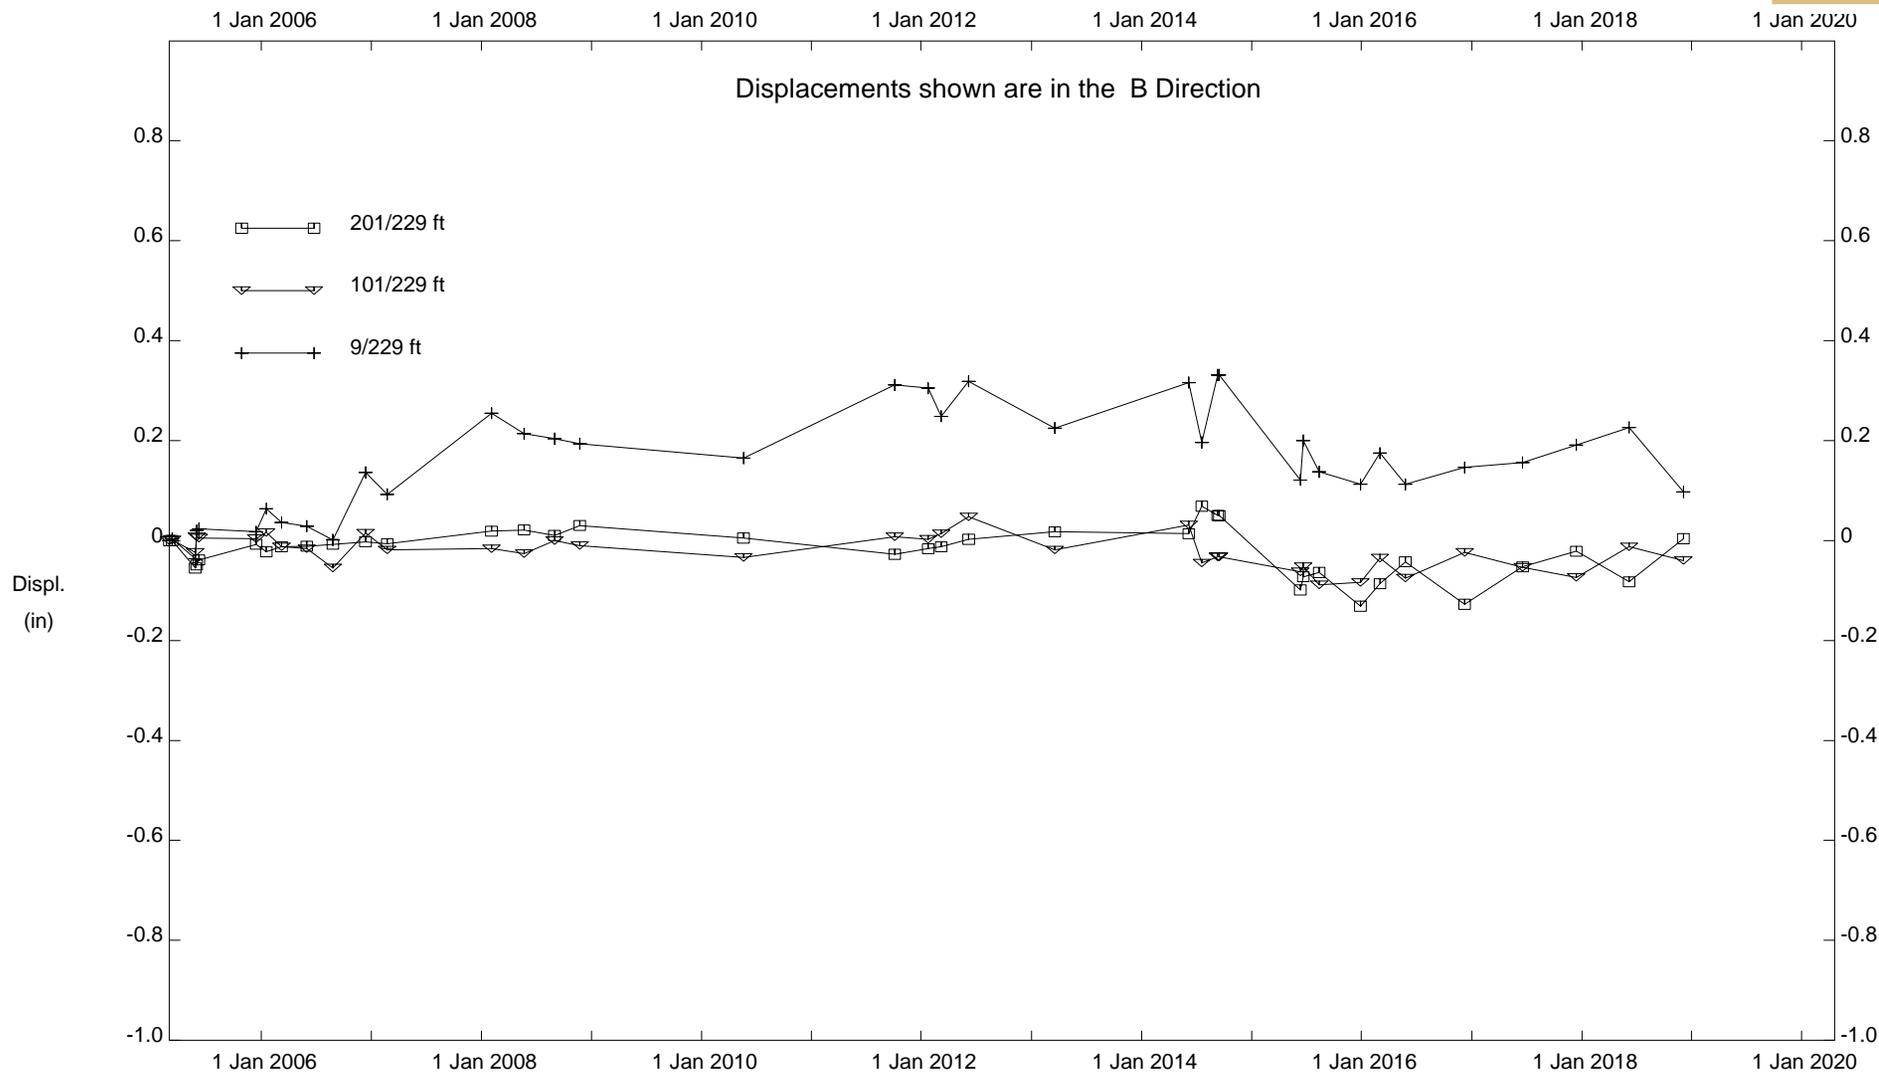
BIG ROCK MESA, Inclinometer SP-33

EASTERN REGION

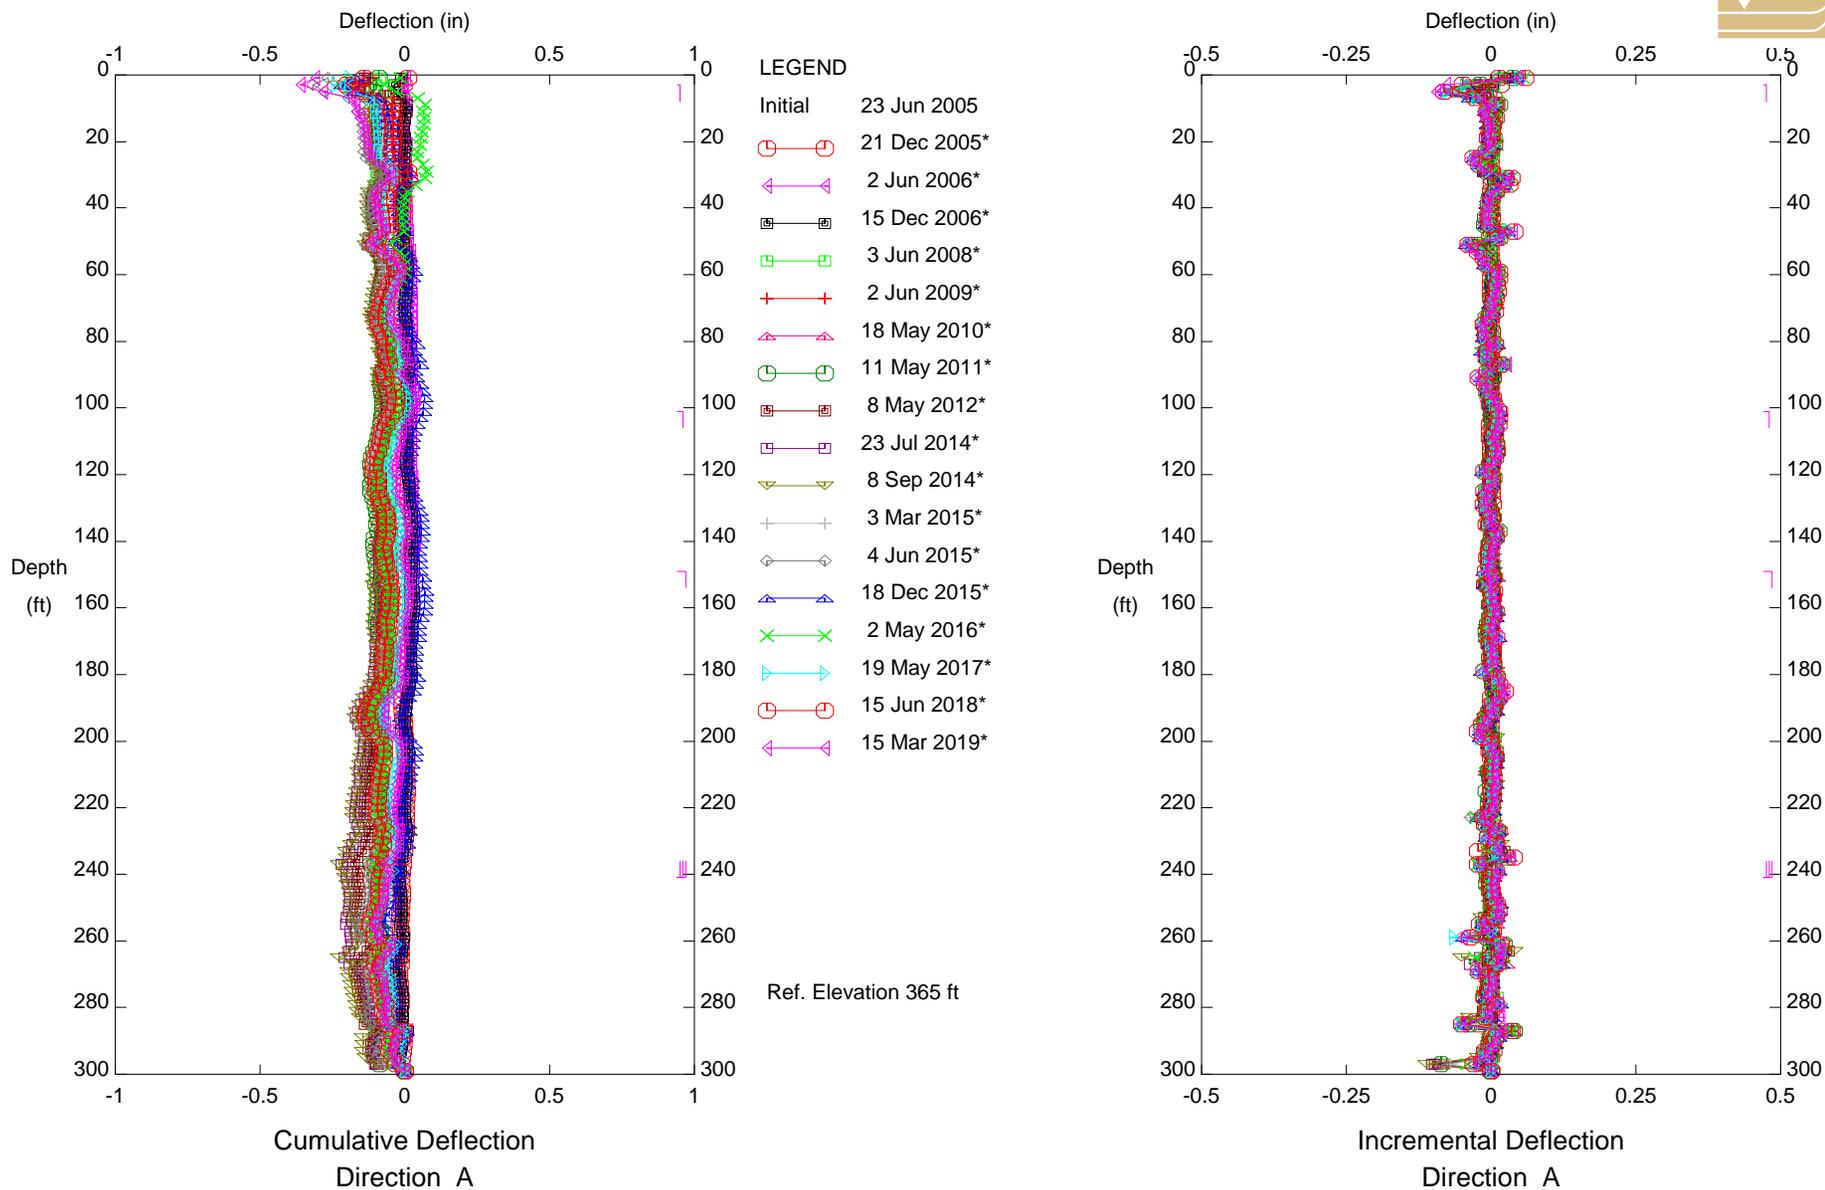
**BIG ROCK MESA, Inclinometer SP-9A
 CENTRAL REGION**

Sets marked * include zero shift and/or rotation corrections.

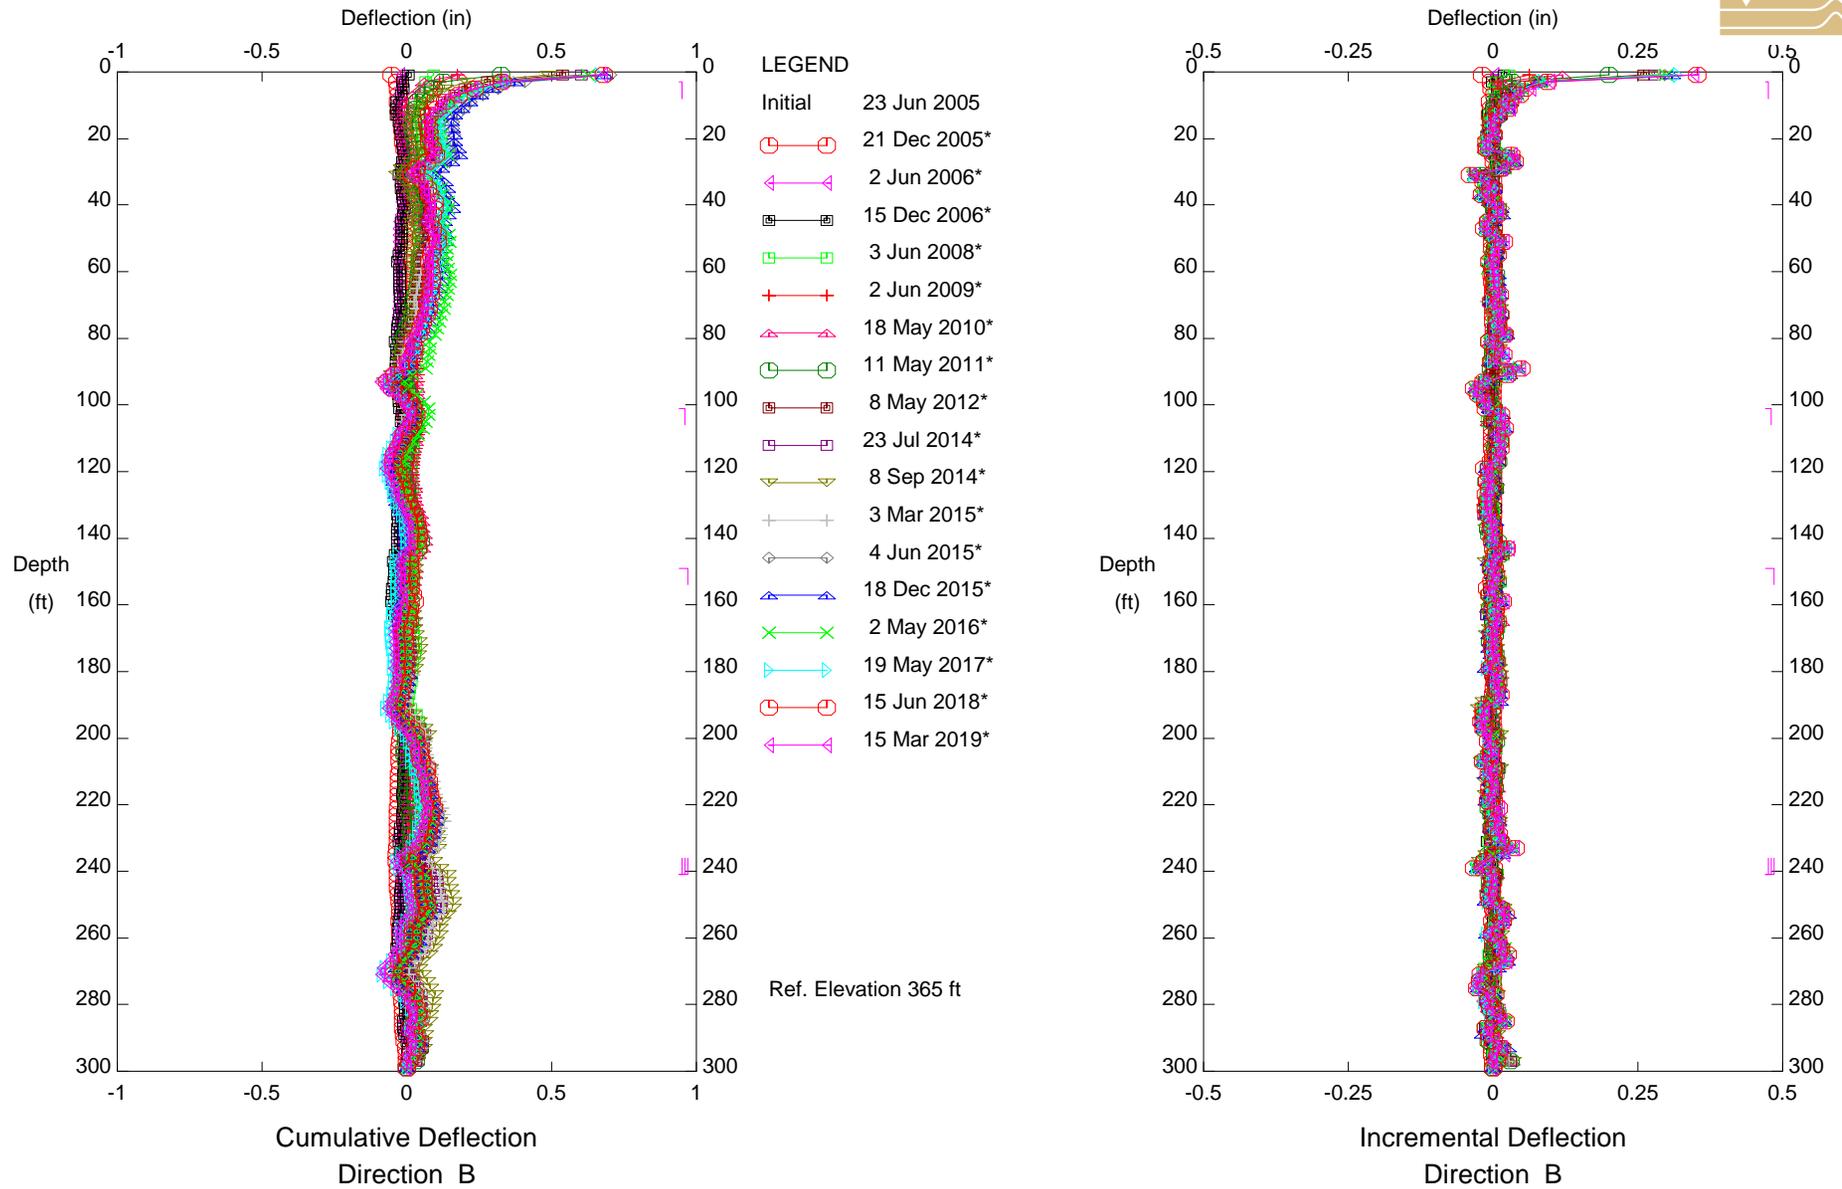
**BIG ROCK MESA, Incliner SP-9A
 CENTRAL REGION**

Sets marked * include zero shift and/or rotation corrections.

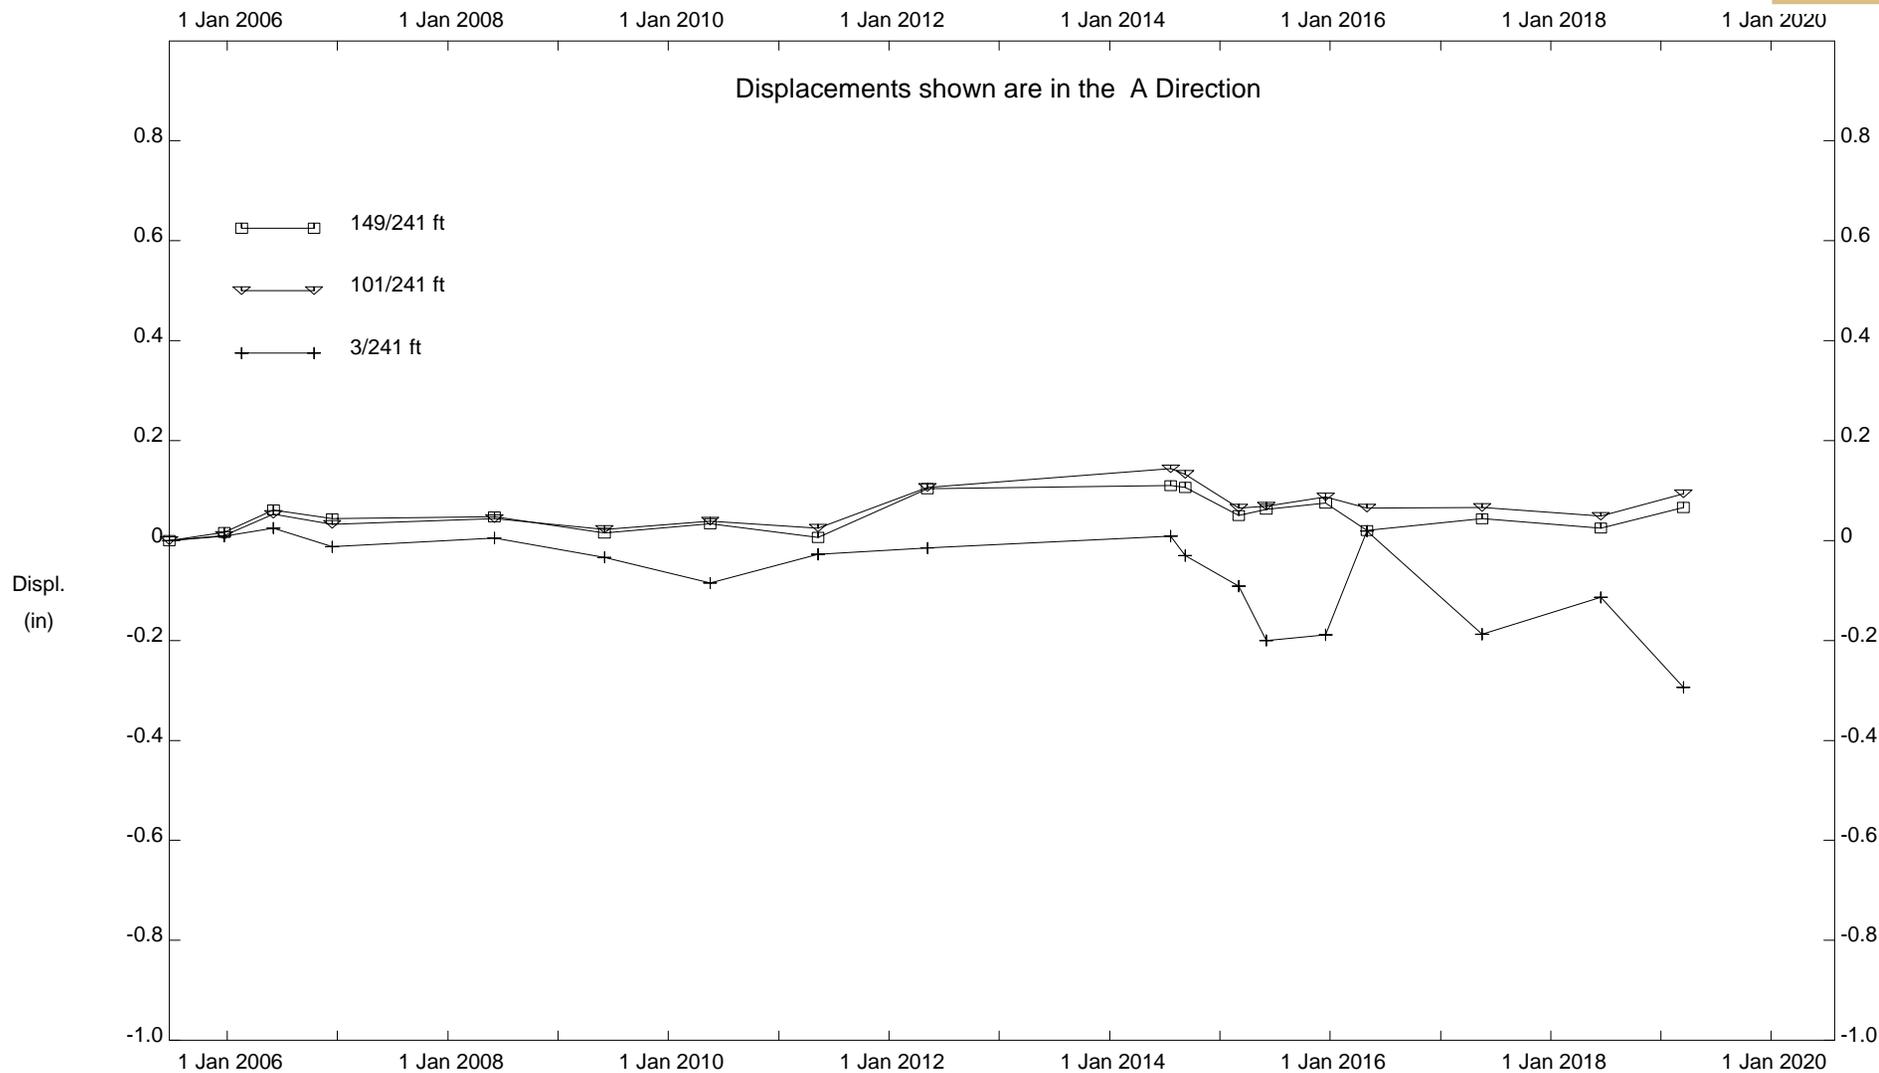
BIG ROCK MESA, Inclinometer SP-9A

CENTRAL REGION

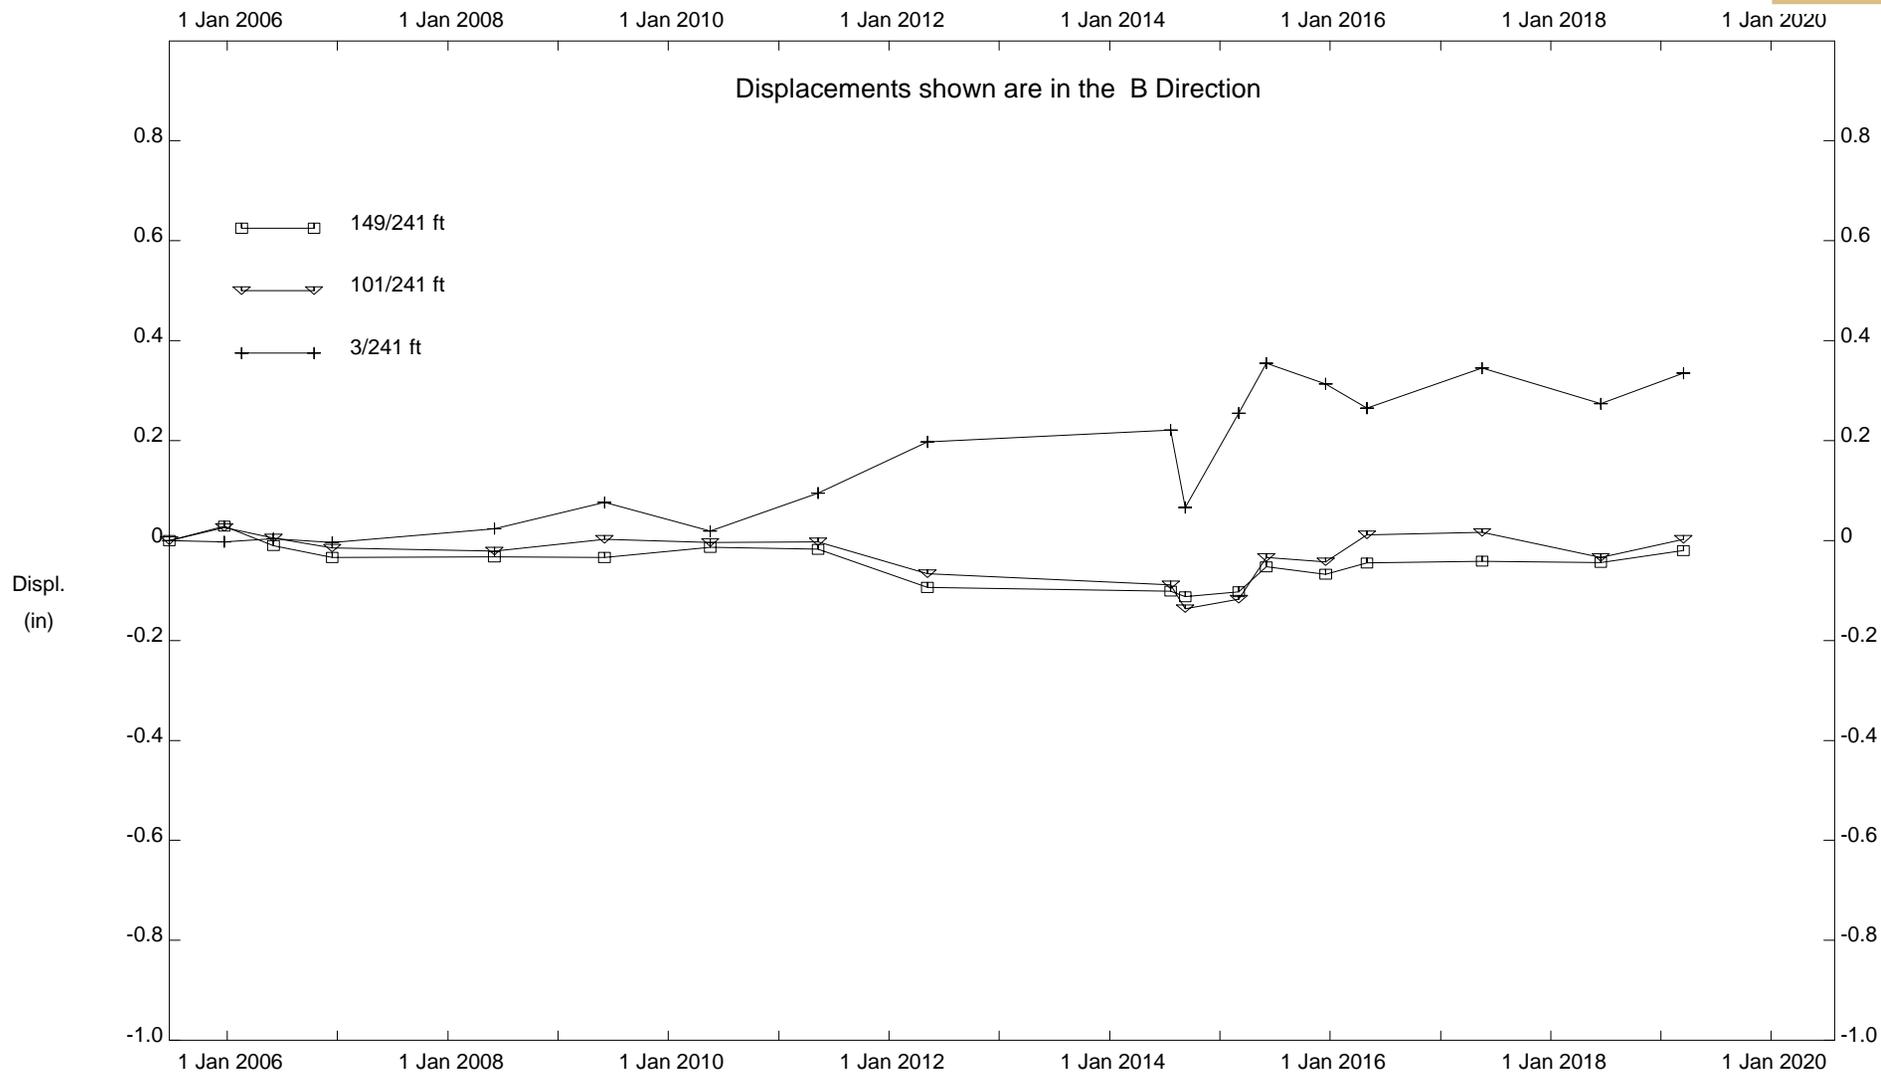
BIG ROCK MESA, Inclinometer SP-9A

CENTRAL REGION

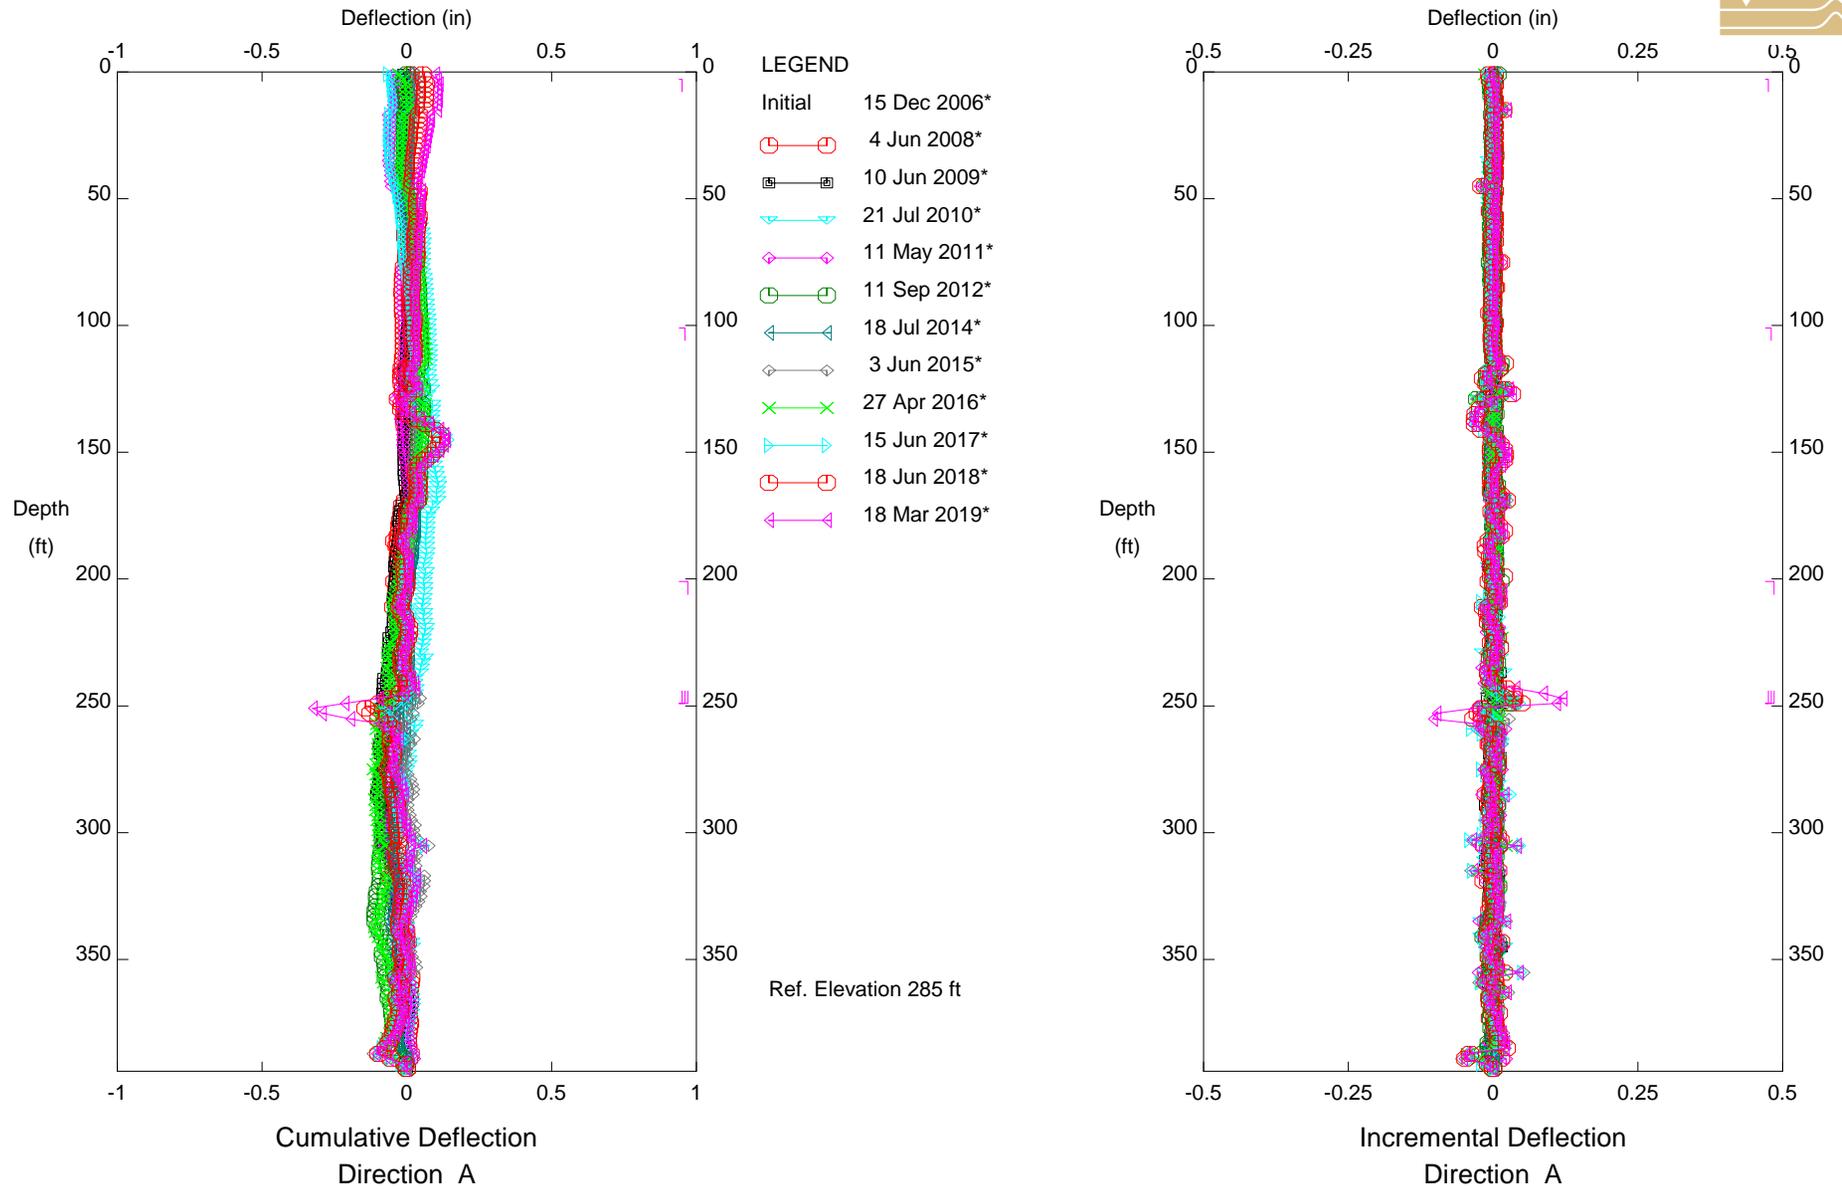
**BIG ROCK MESA, Inclinometer SP-16A
 CENTRAL REGION**

Sets marked * include zero shift and/or rotation corrections.

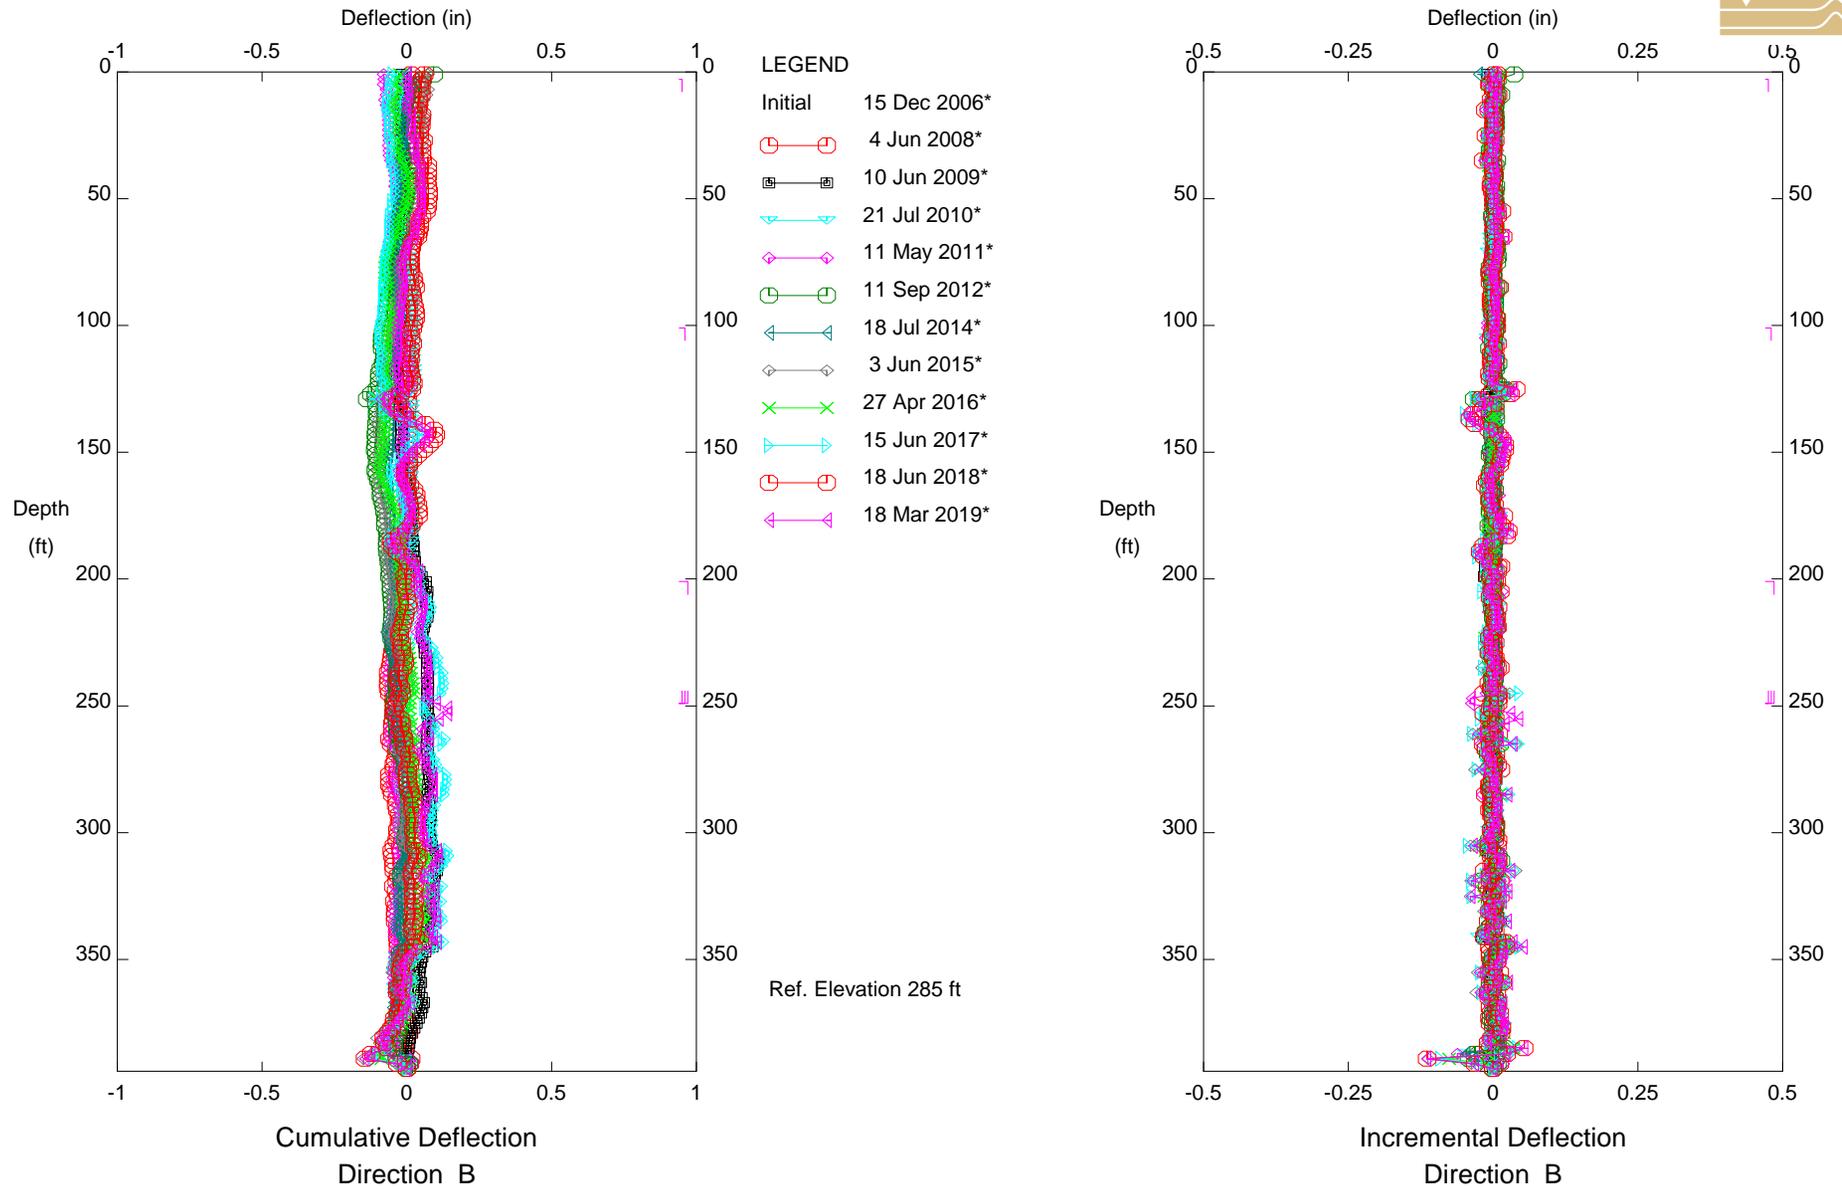
**BIG ROCK MESA, Inclinometer SP-16A
 CENTRAL REGION**

Sets marked * include zero shift and/or rotation corrections.

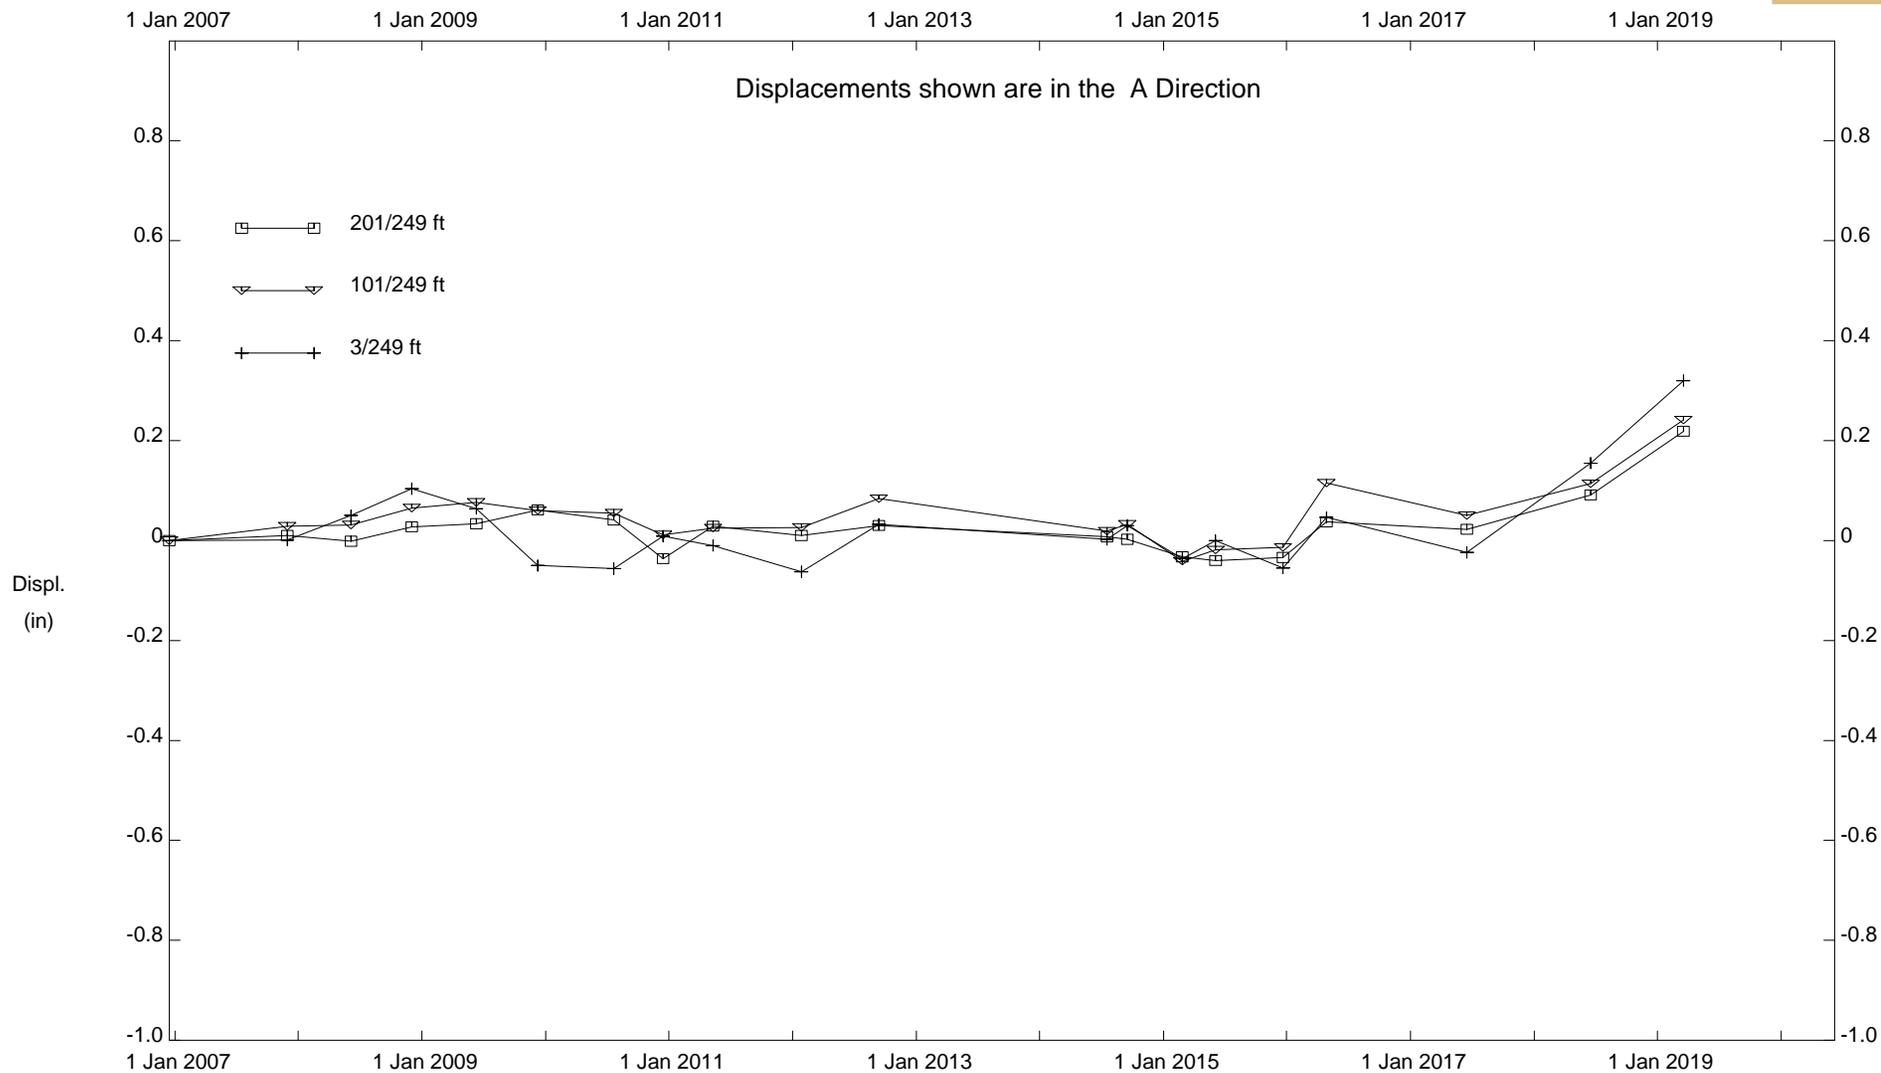
BIG ROCK MESA, Inclinometer SP-16A

CENTRAL REGION

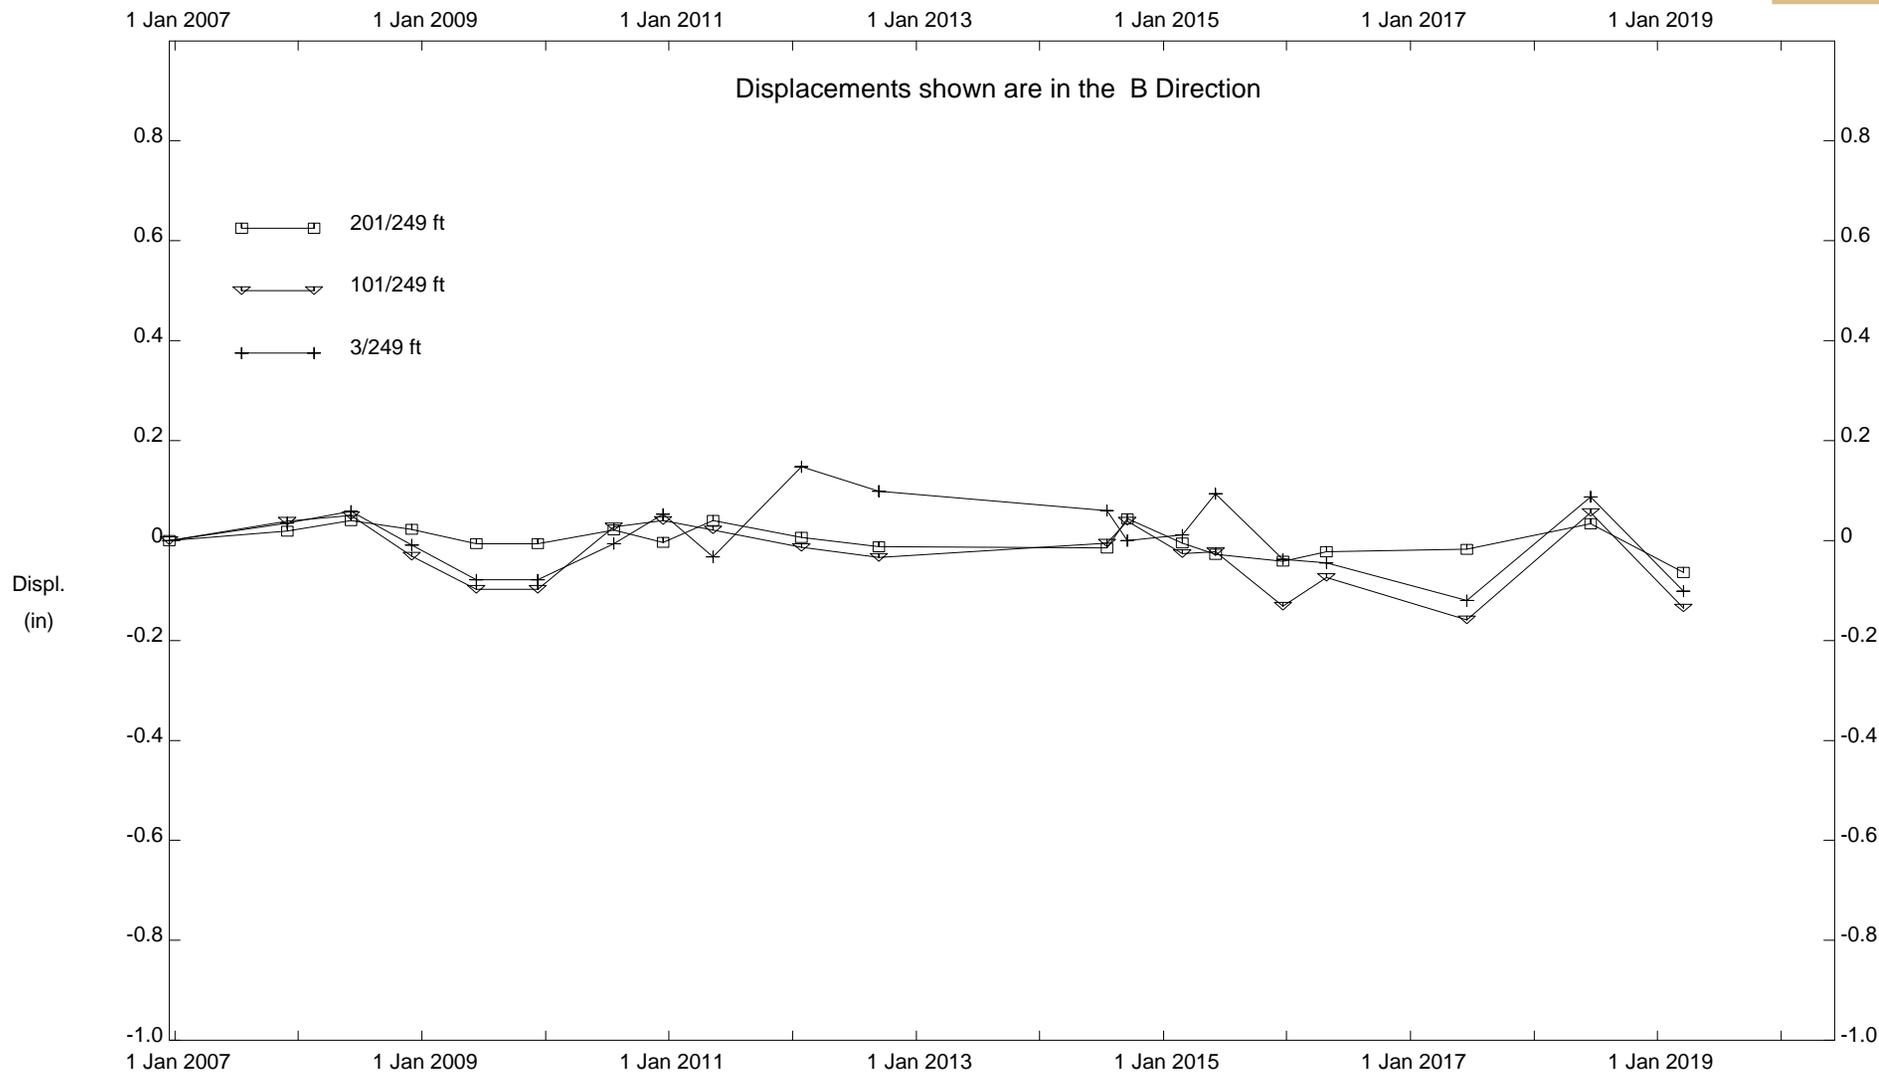
BIG ROCK MESA, Inclinometer SP-16A

CENTRAL REGION

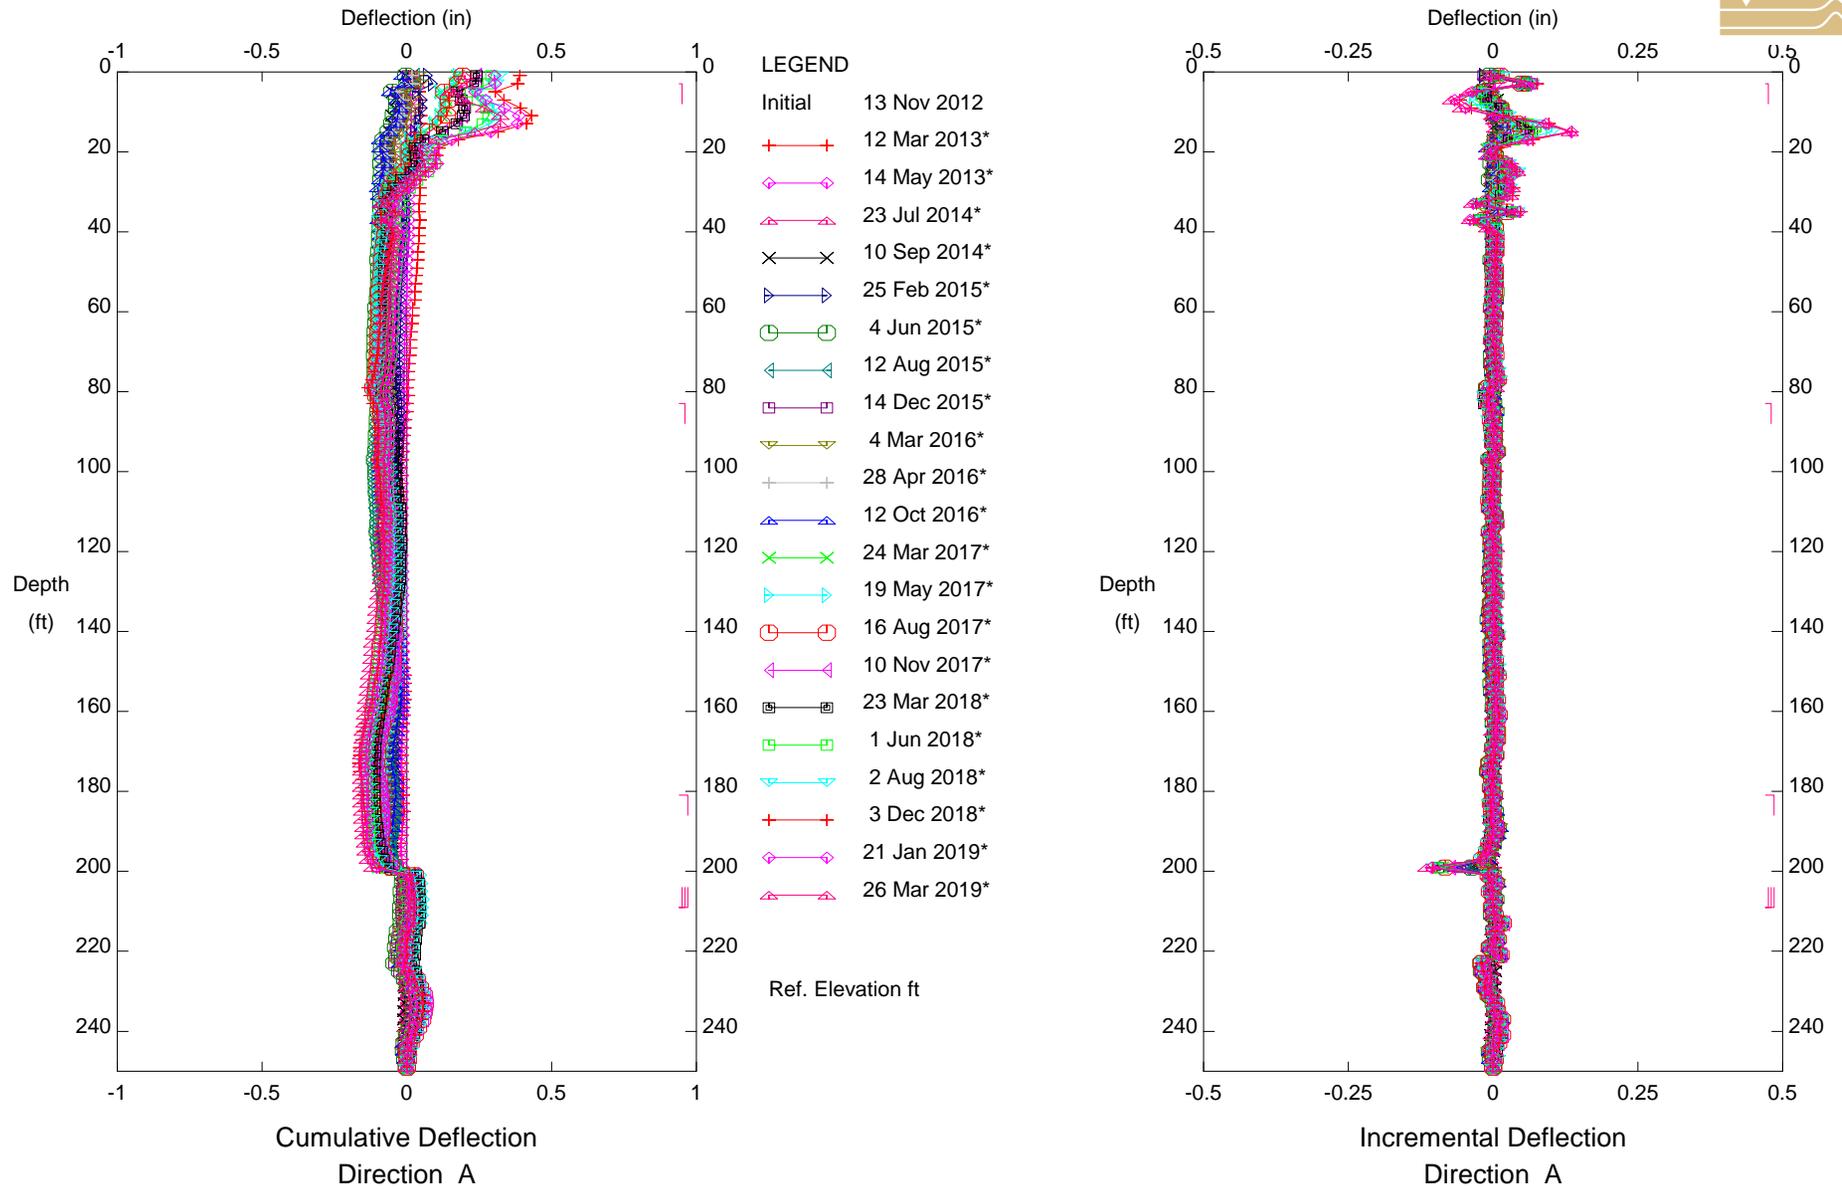
BRM, Inclinometer SP-17B

Sets marked * include zero shift and/or rotation corrections.
