**ANNUAL REPORT
JULY 2018 THROUGH JUNE 2019
BIG ROCK MESA LANDSLIDE
ASSESSMENT DISTRICT
City of Malibu, California**

November 2019
Fugro Project No. 04.62160606
Document No. 04.62160606-PR-006(Rev.00)

Annual Report of Maintenance and Monitoring, July 2018 through June 2019, Big Rock Mesa Landslide Assessment District, City of Malibu, California

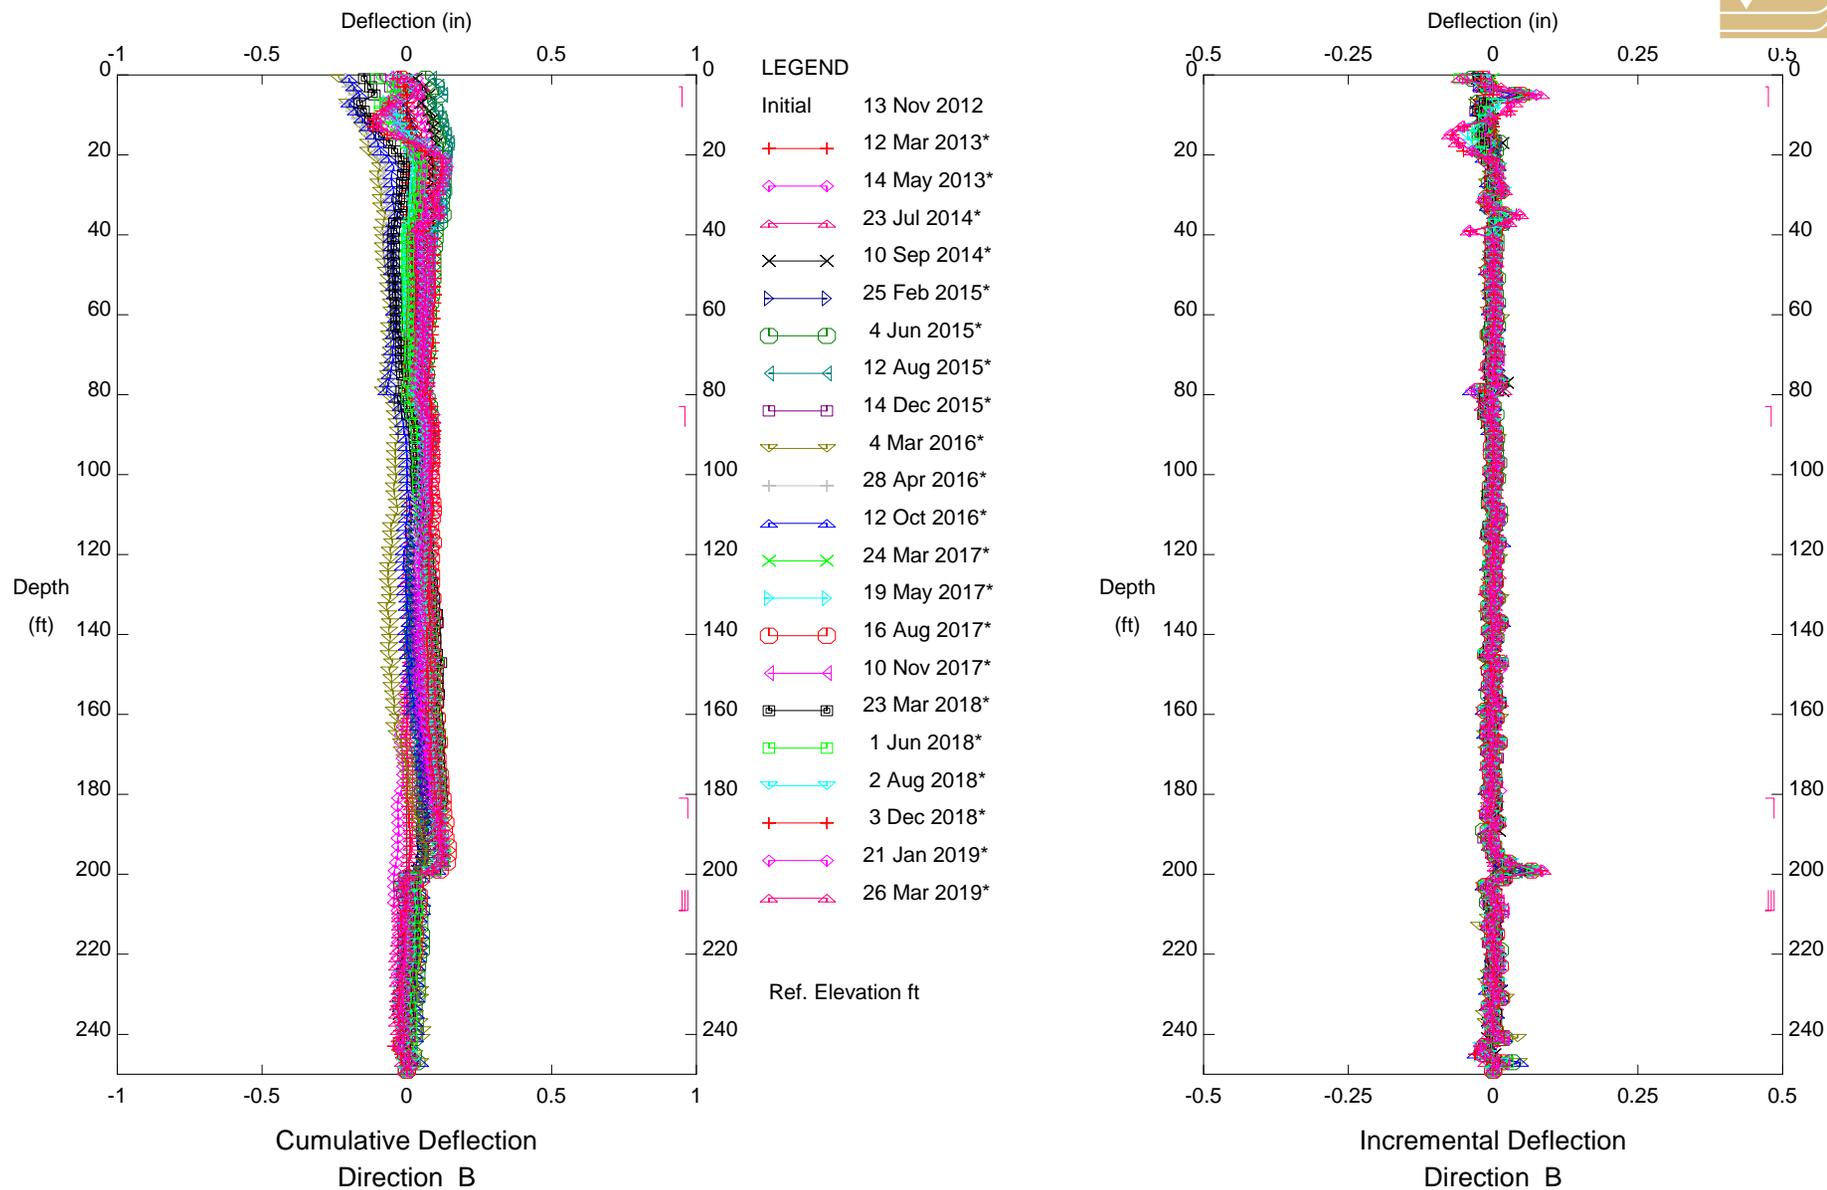
BRM, Inclinator SP-17B

Sets marked * include zero shift and/or rotation corrections.

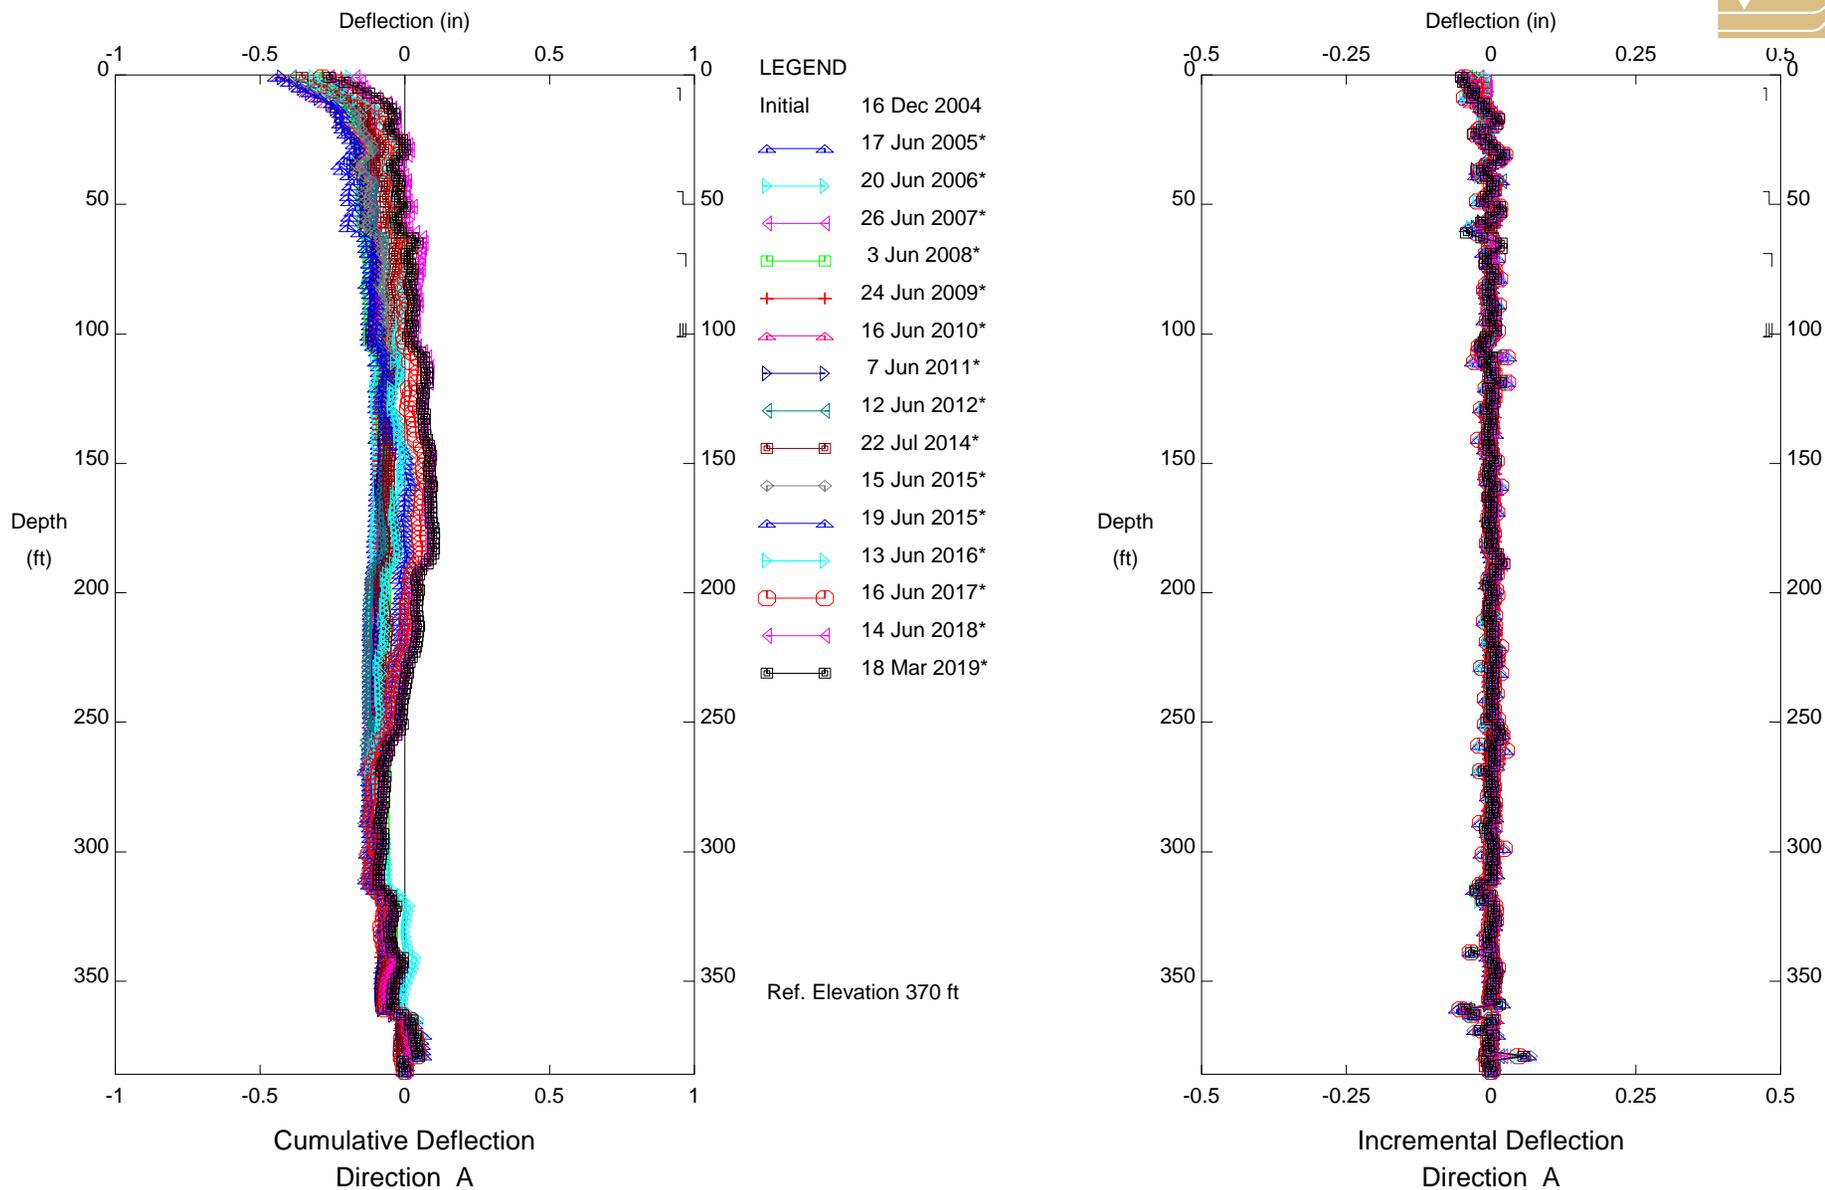
**BIG ROCK MESA, Inclinometer SP-24
 CENTRAL REGION**

Sets marked * include zero shift and/or rotation corrections.

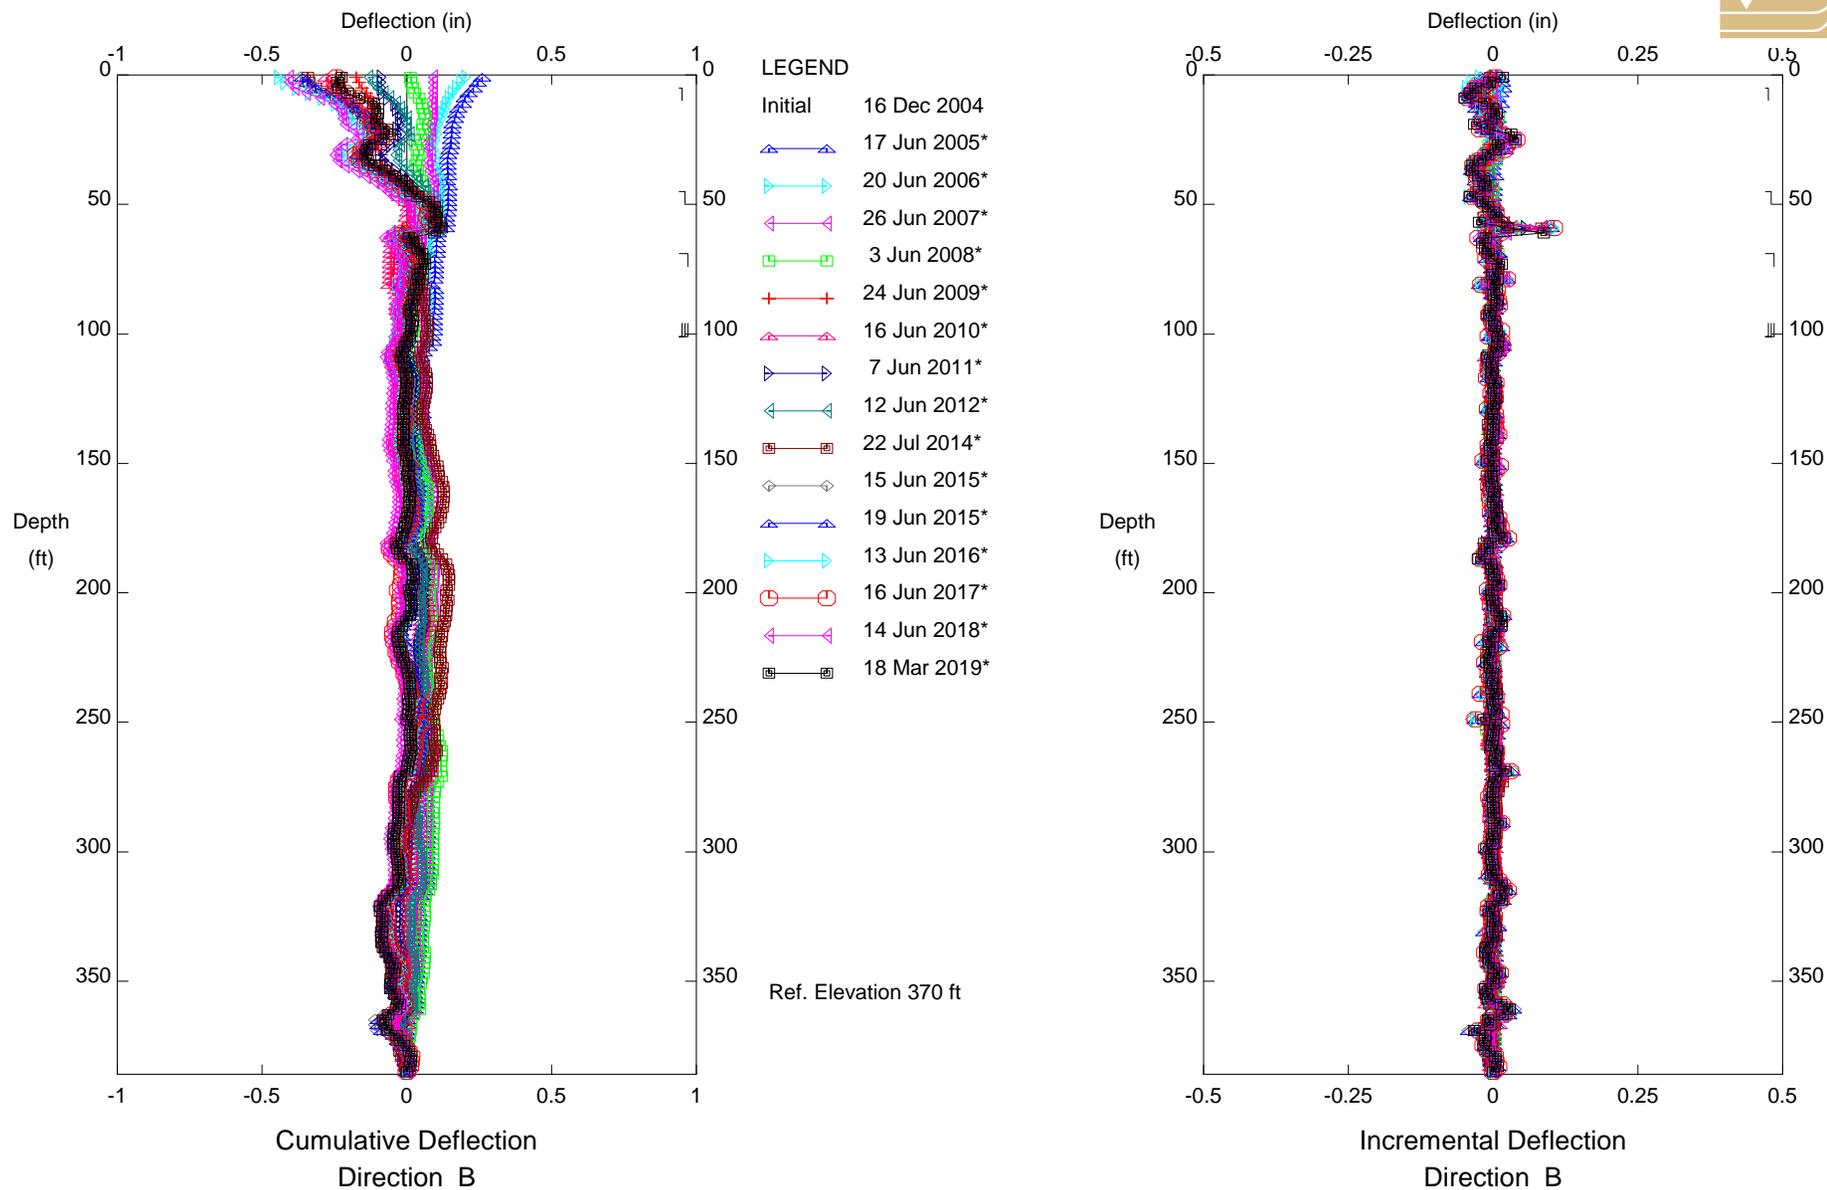
**BIG ROCK MESA, Inclinometer SP-24
 CENTRAL REGION**

Sets marked * include zero shift and/or rotation corrections.

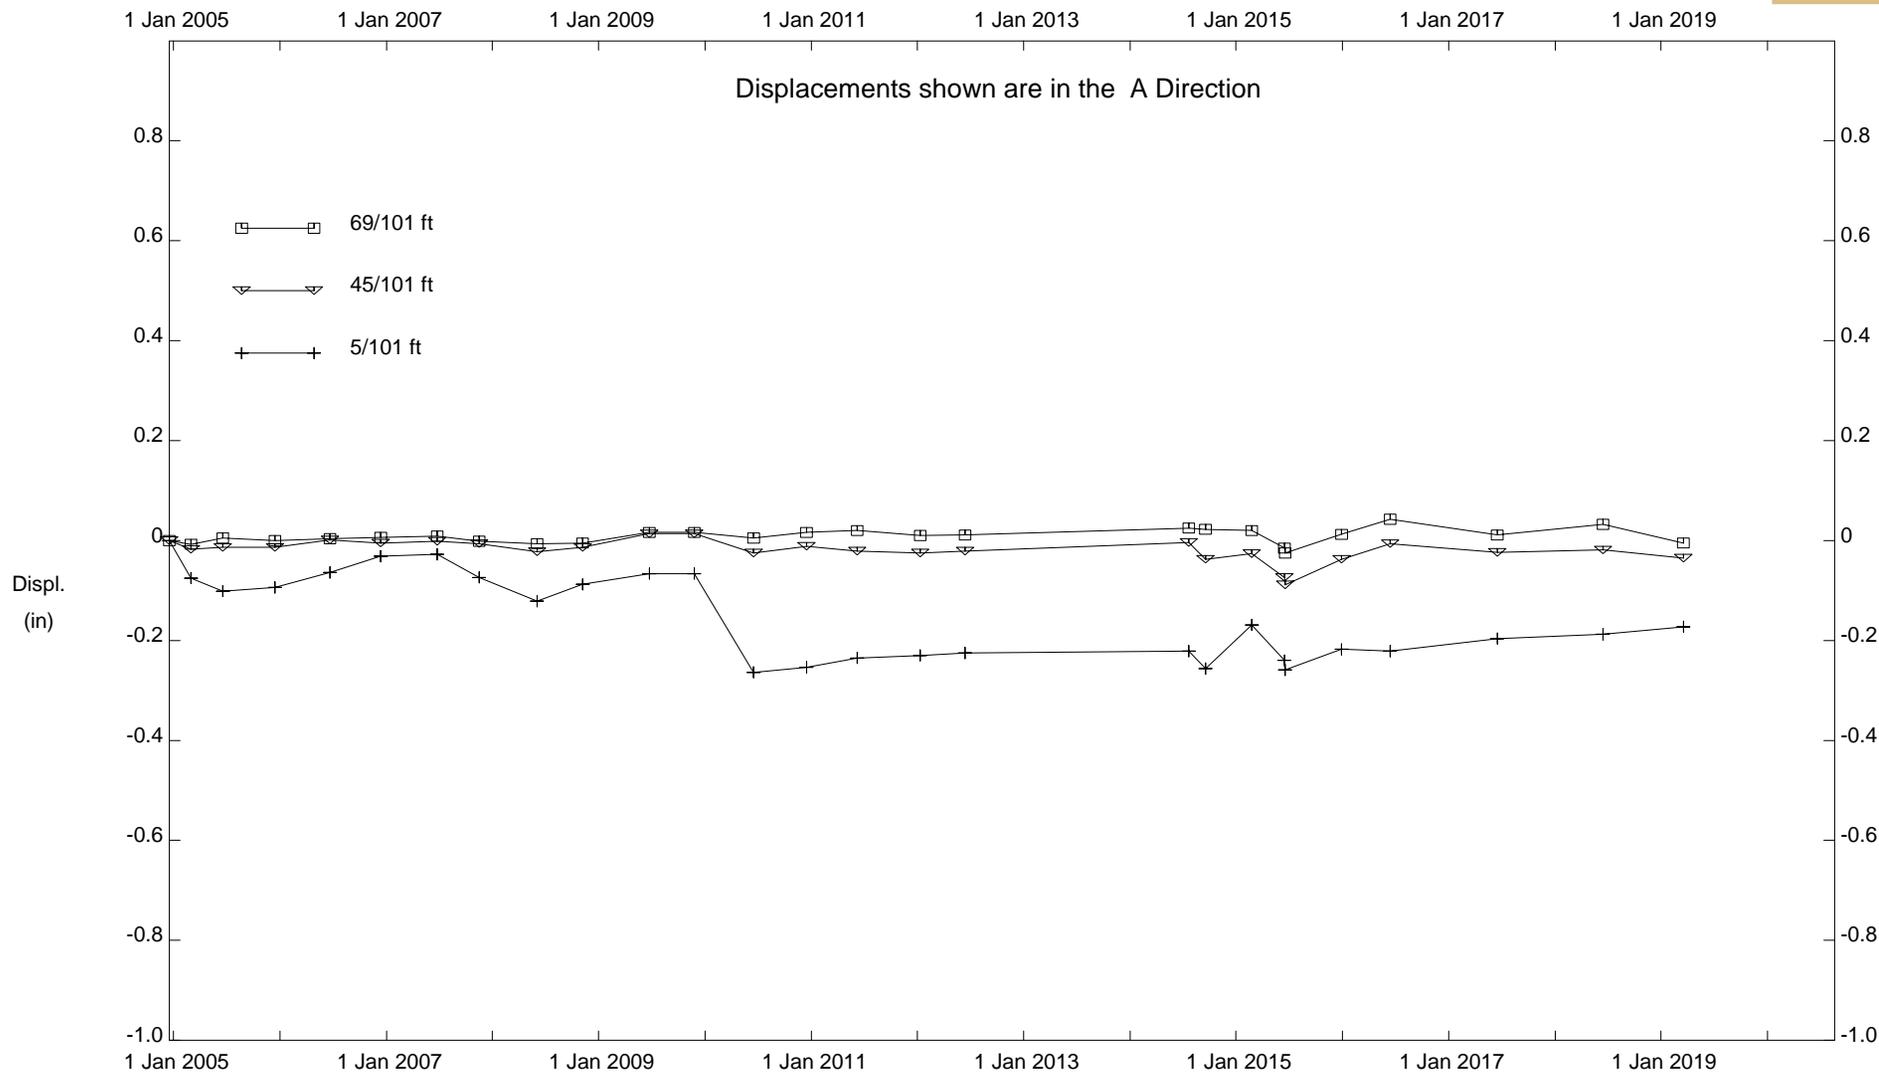
BIG ROCK MESA, Inclinometer SP-24

CENTRAL REGION

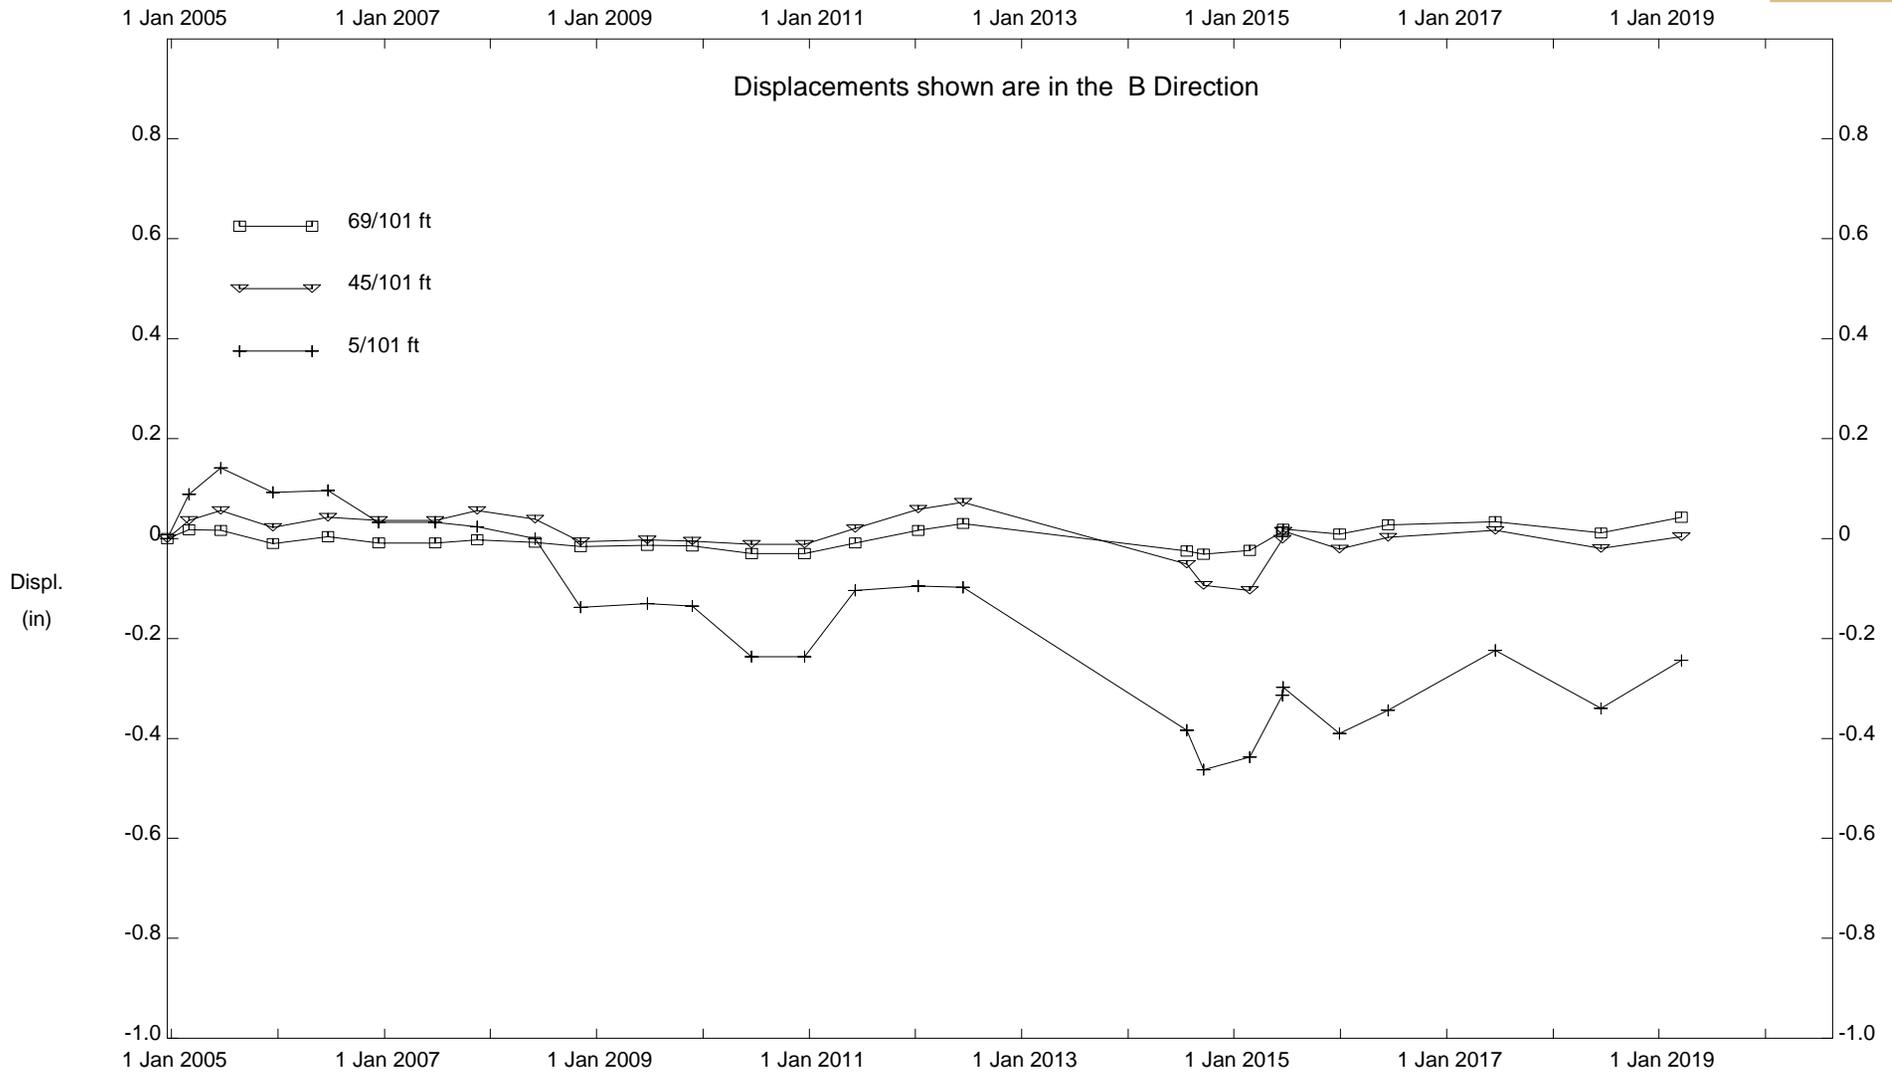
BIG ROCK MESA, Inclinometer SP-24

CENTRAL REGION

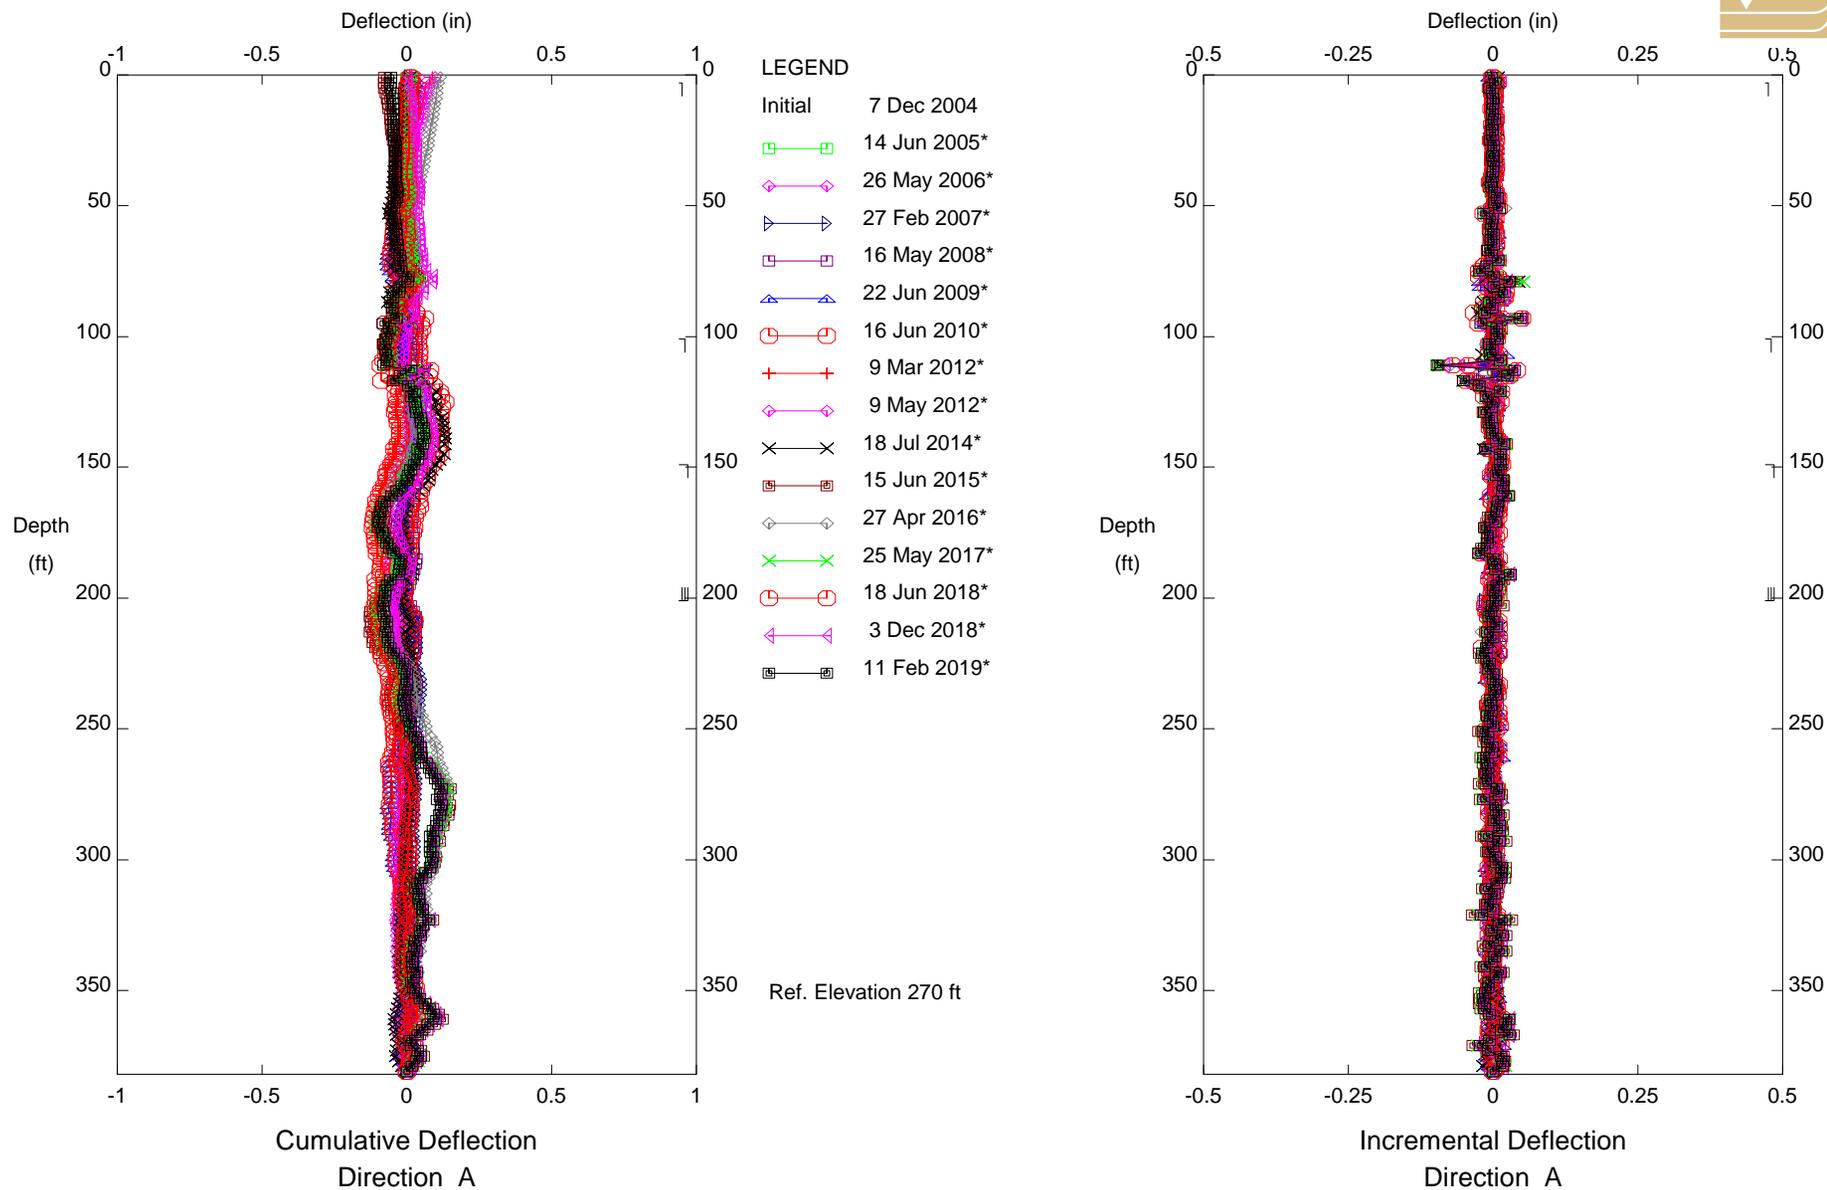
**BIG ROCK MESA, Inclinerometer SP-34
 CENTRAL REGION**

Sets marked * include zero shift and/or rotation corrections.

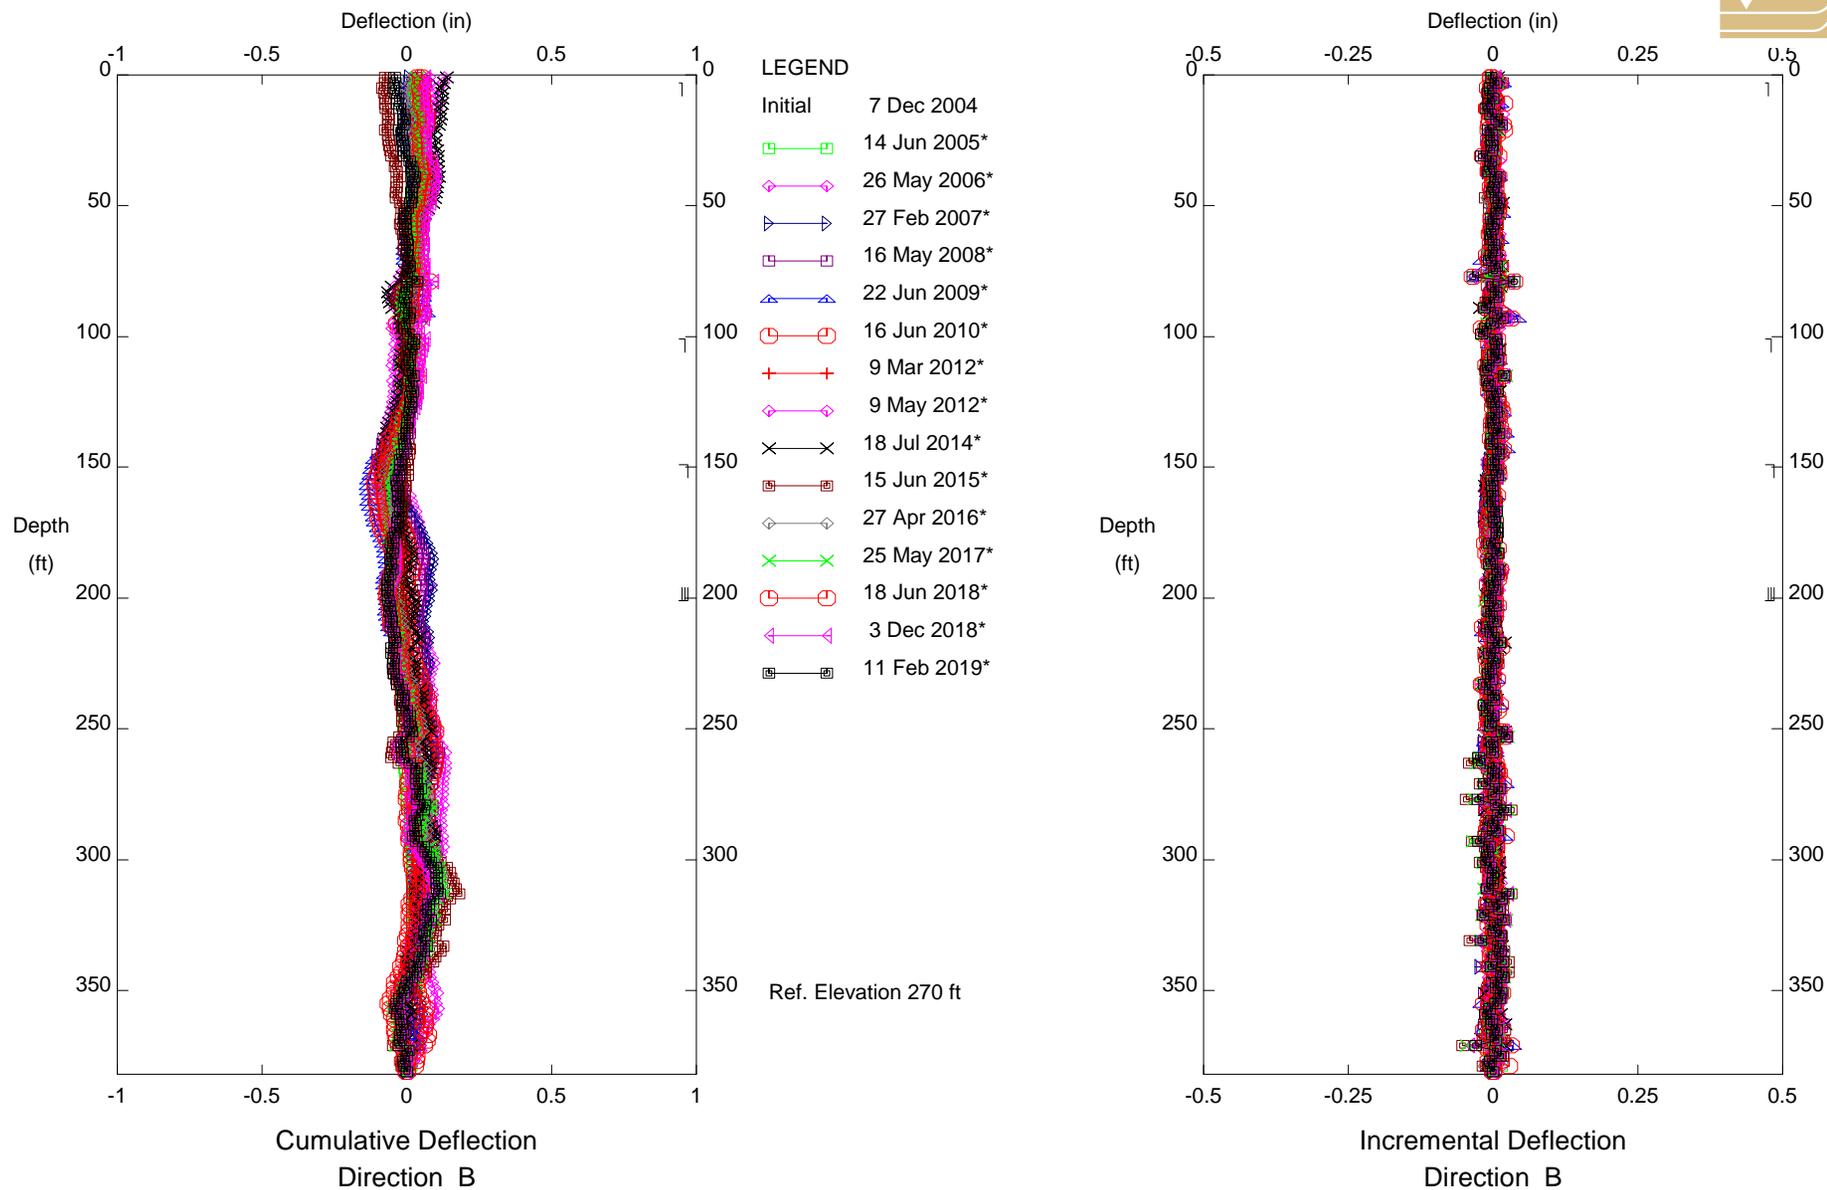
**BIG ROCK MESA, Inclinometer SP-34
 CENTRAL REGION**

Sets marked * include zero shift and/or rotation corrections.

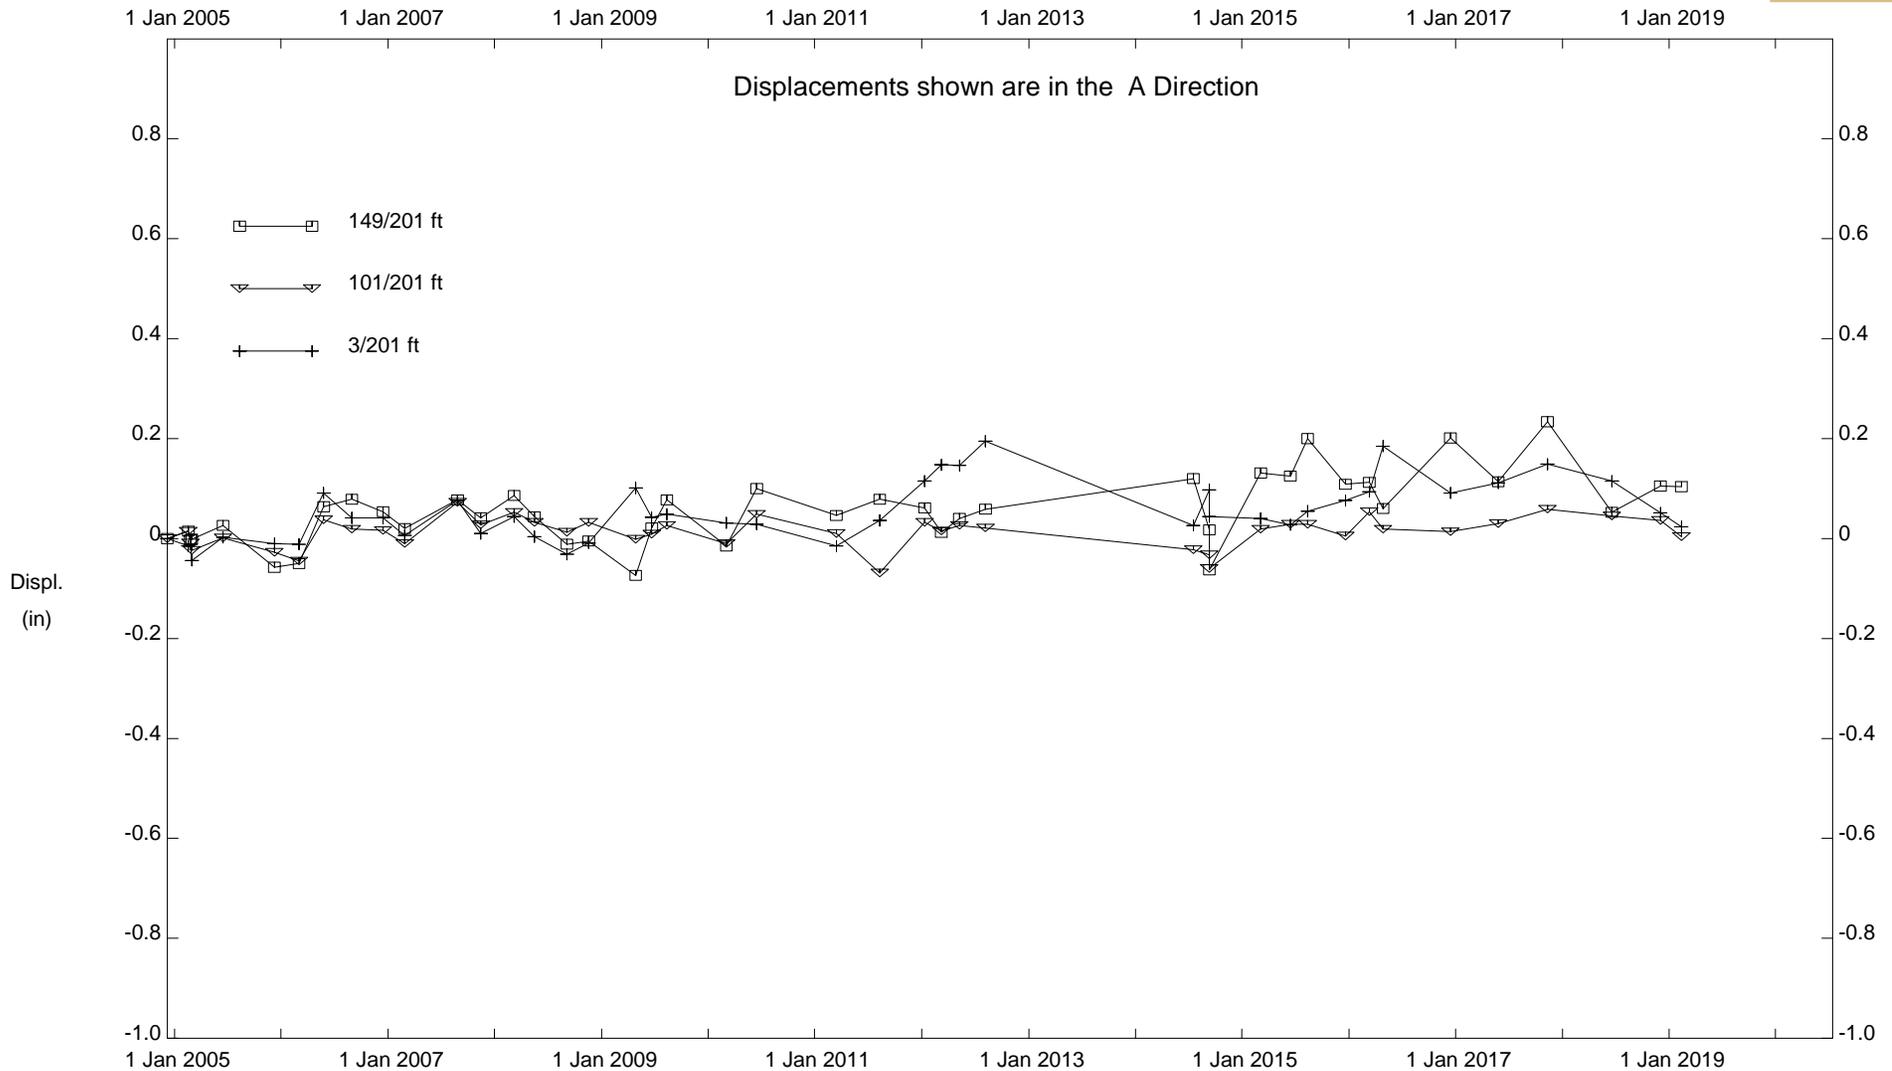
BIG ROCK MESA, Inclinometer SP-34

CENTRAL REGION

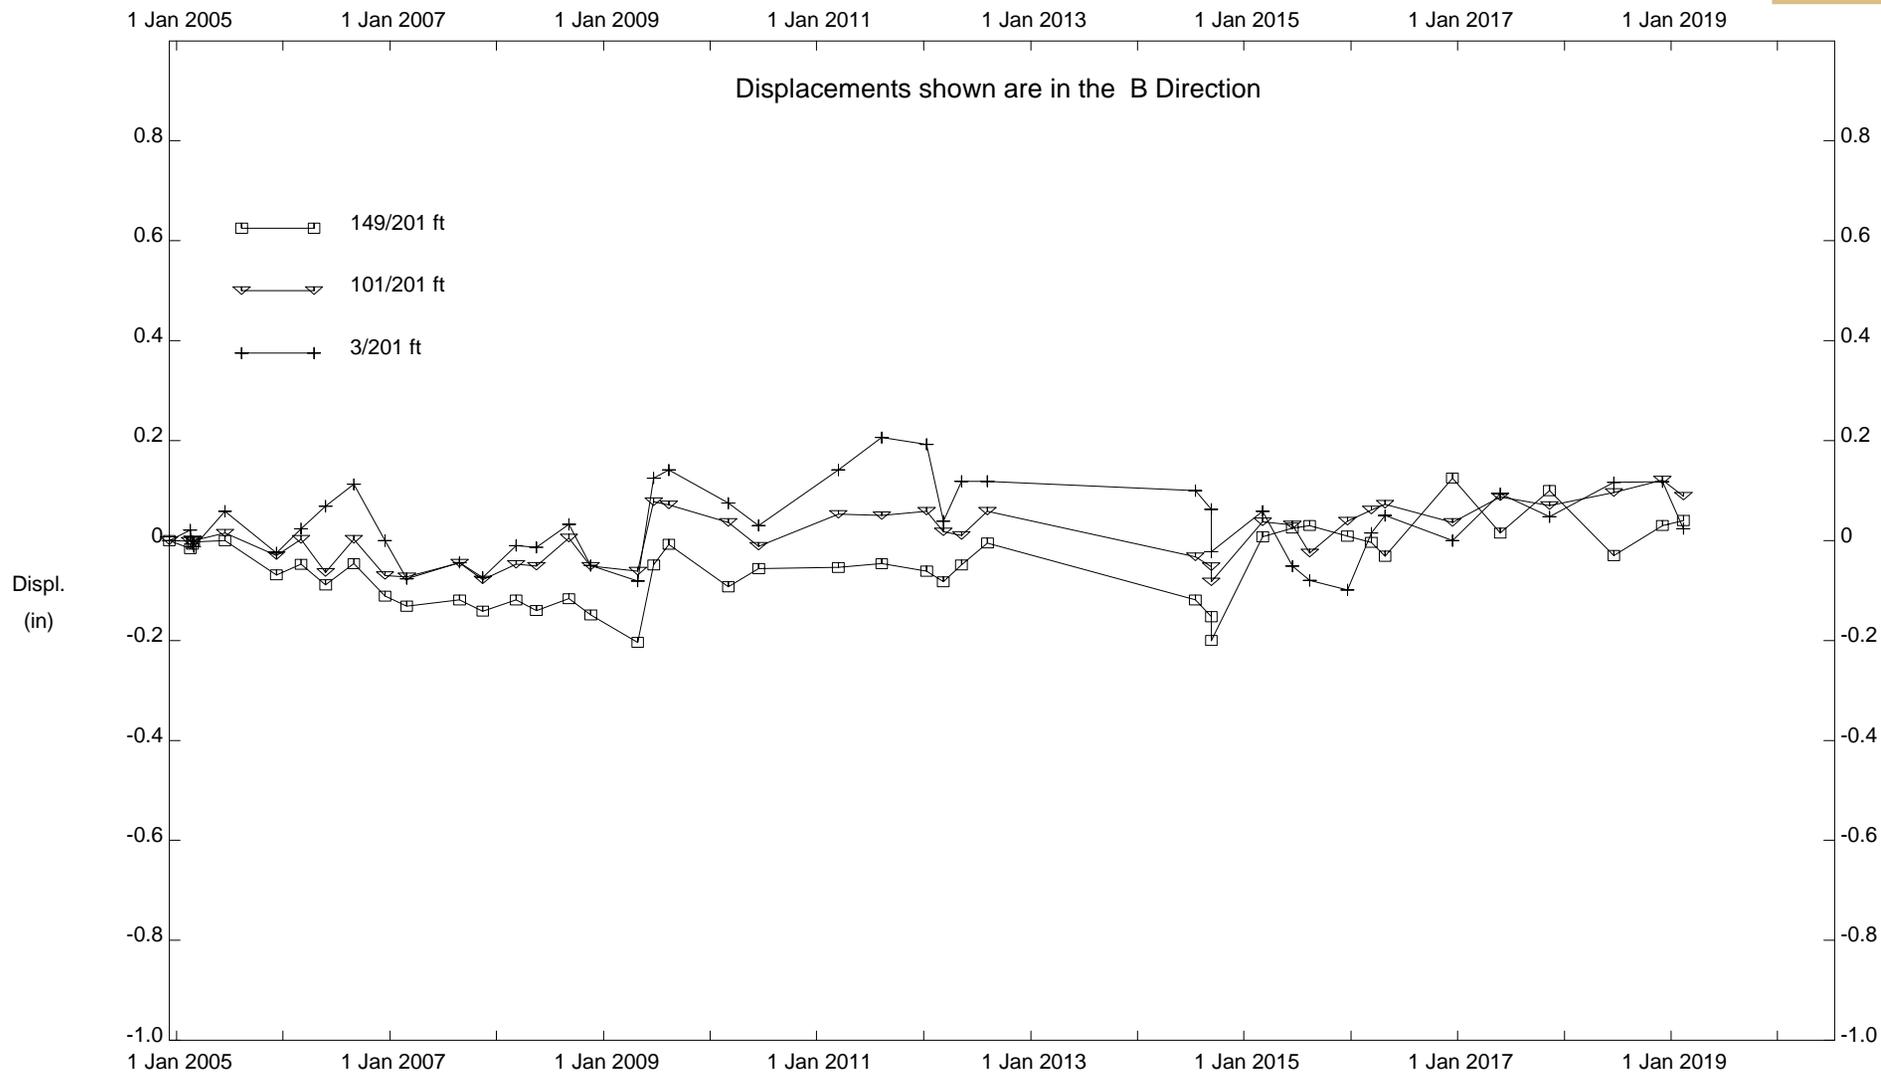
BIG ROCK MESA, Inclinometer SP-34

CENTRAL REGION

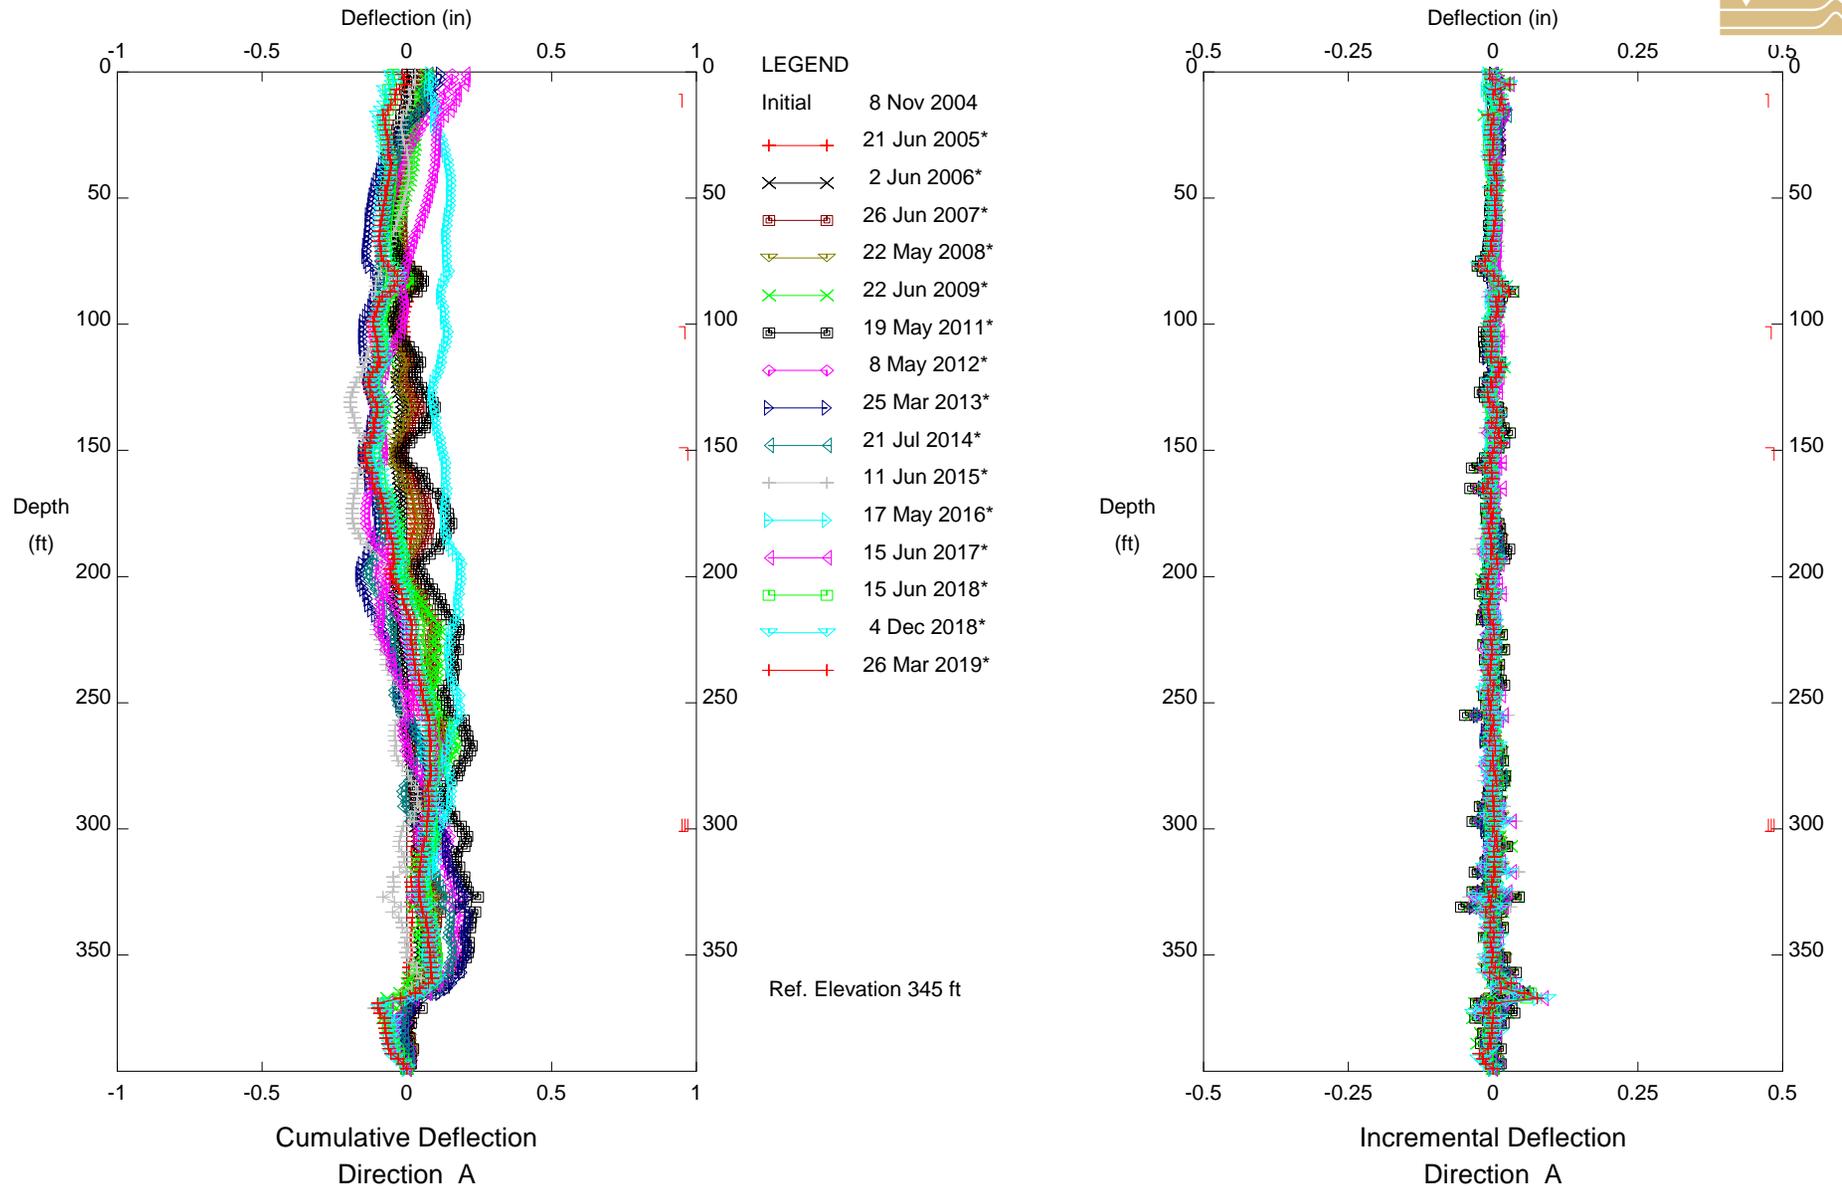
**BIG ROCK MESA, Inclinometer SP-35
 CENTRAL REGION**

Sets marked * include zero shift and/or rotation corrections.
