**ANNUAL REPORT
JULY 2018 THROUGH JUNE 2019
BIG ROCK MESA LANDSLIDE
ASSESSMENT DISTRICT
City of Malibu, California**

November 2019
Fugro Project No. 04.62160606
Document No. 04.62160606-PR-006(Rev.00)

Annual Report of Maintenance and Monitoring, July 2018 through June 2019, Big Rock Mesa Landslide Assessment District, City of Malibu, California

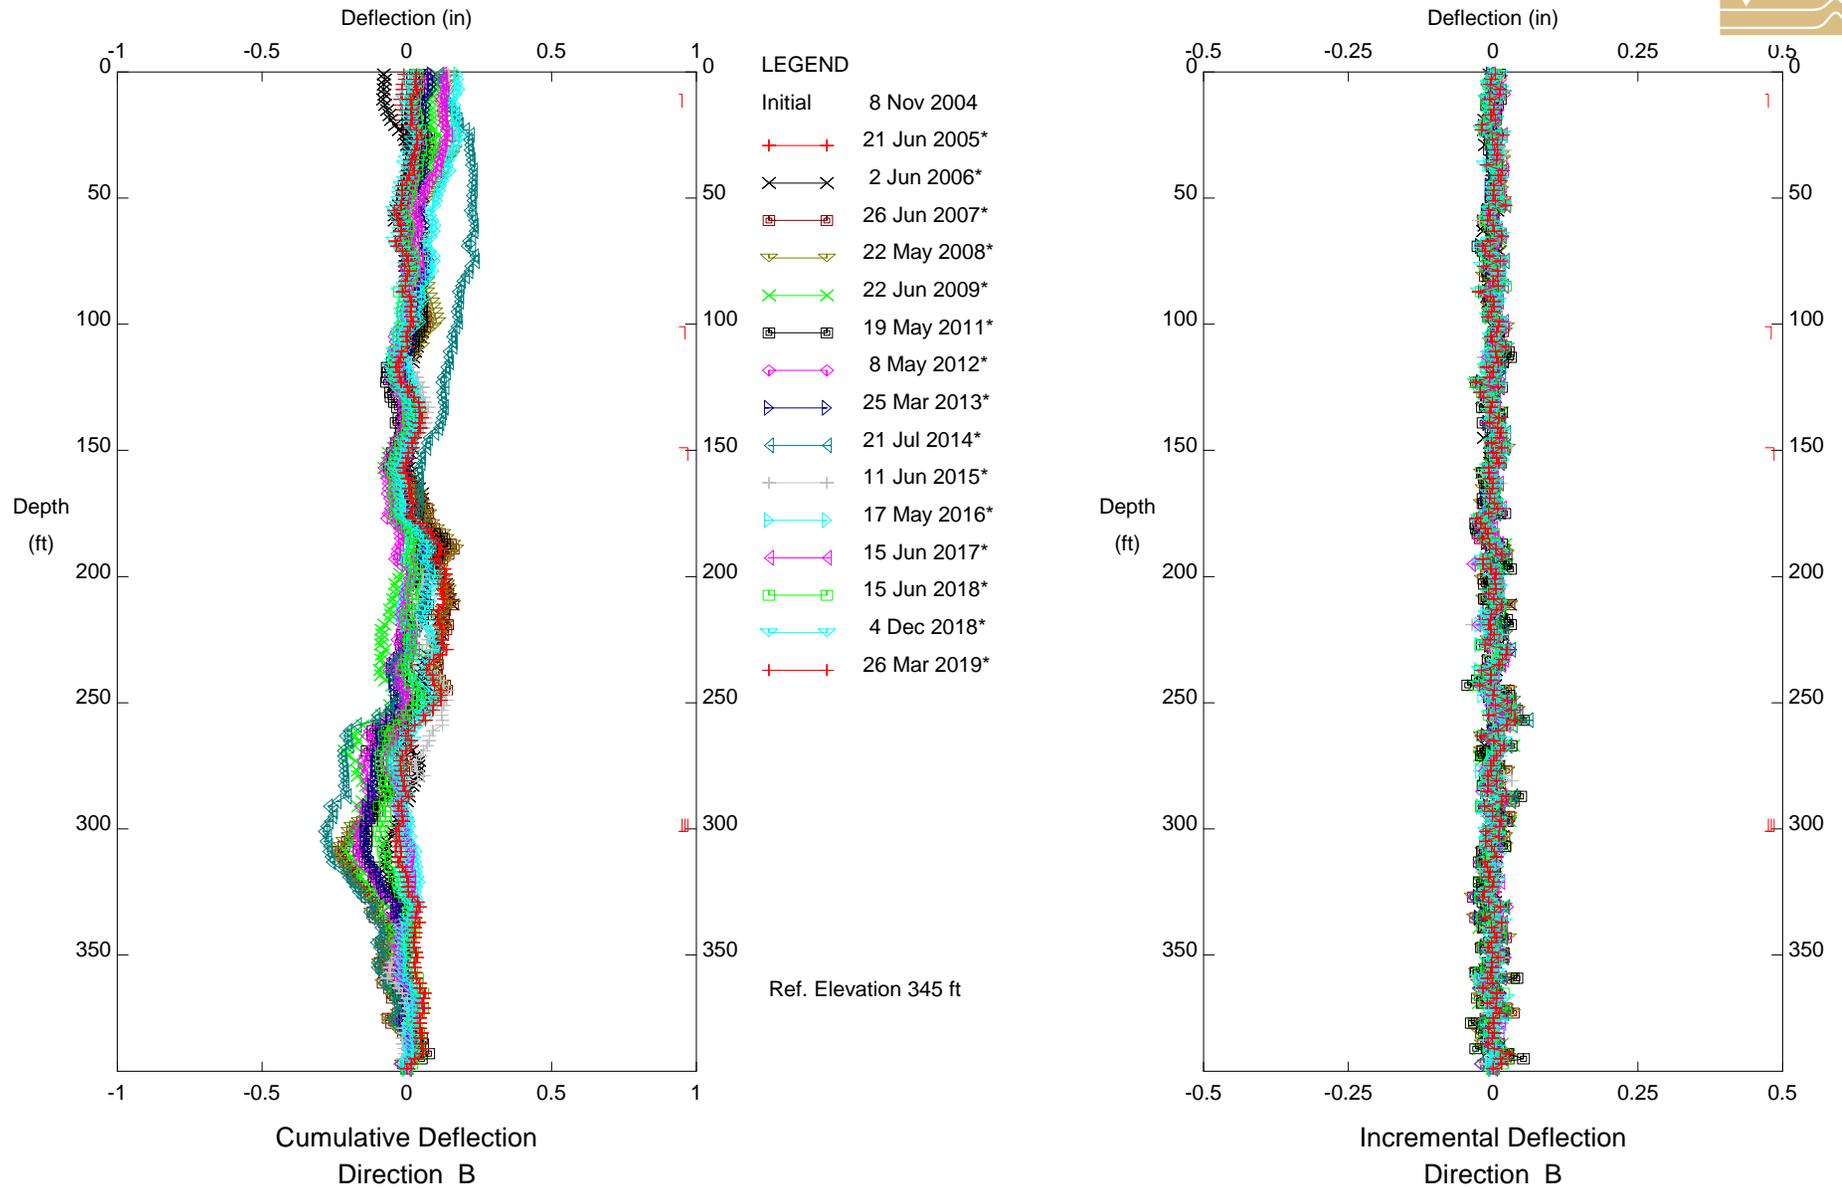
**BIG ROCK MESA, Inclinometer SP-35
 CENTRAL REGION**

Sets marked * include zero shift and/or rotation corrections.

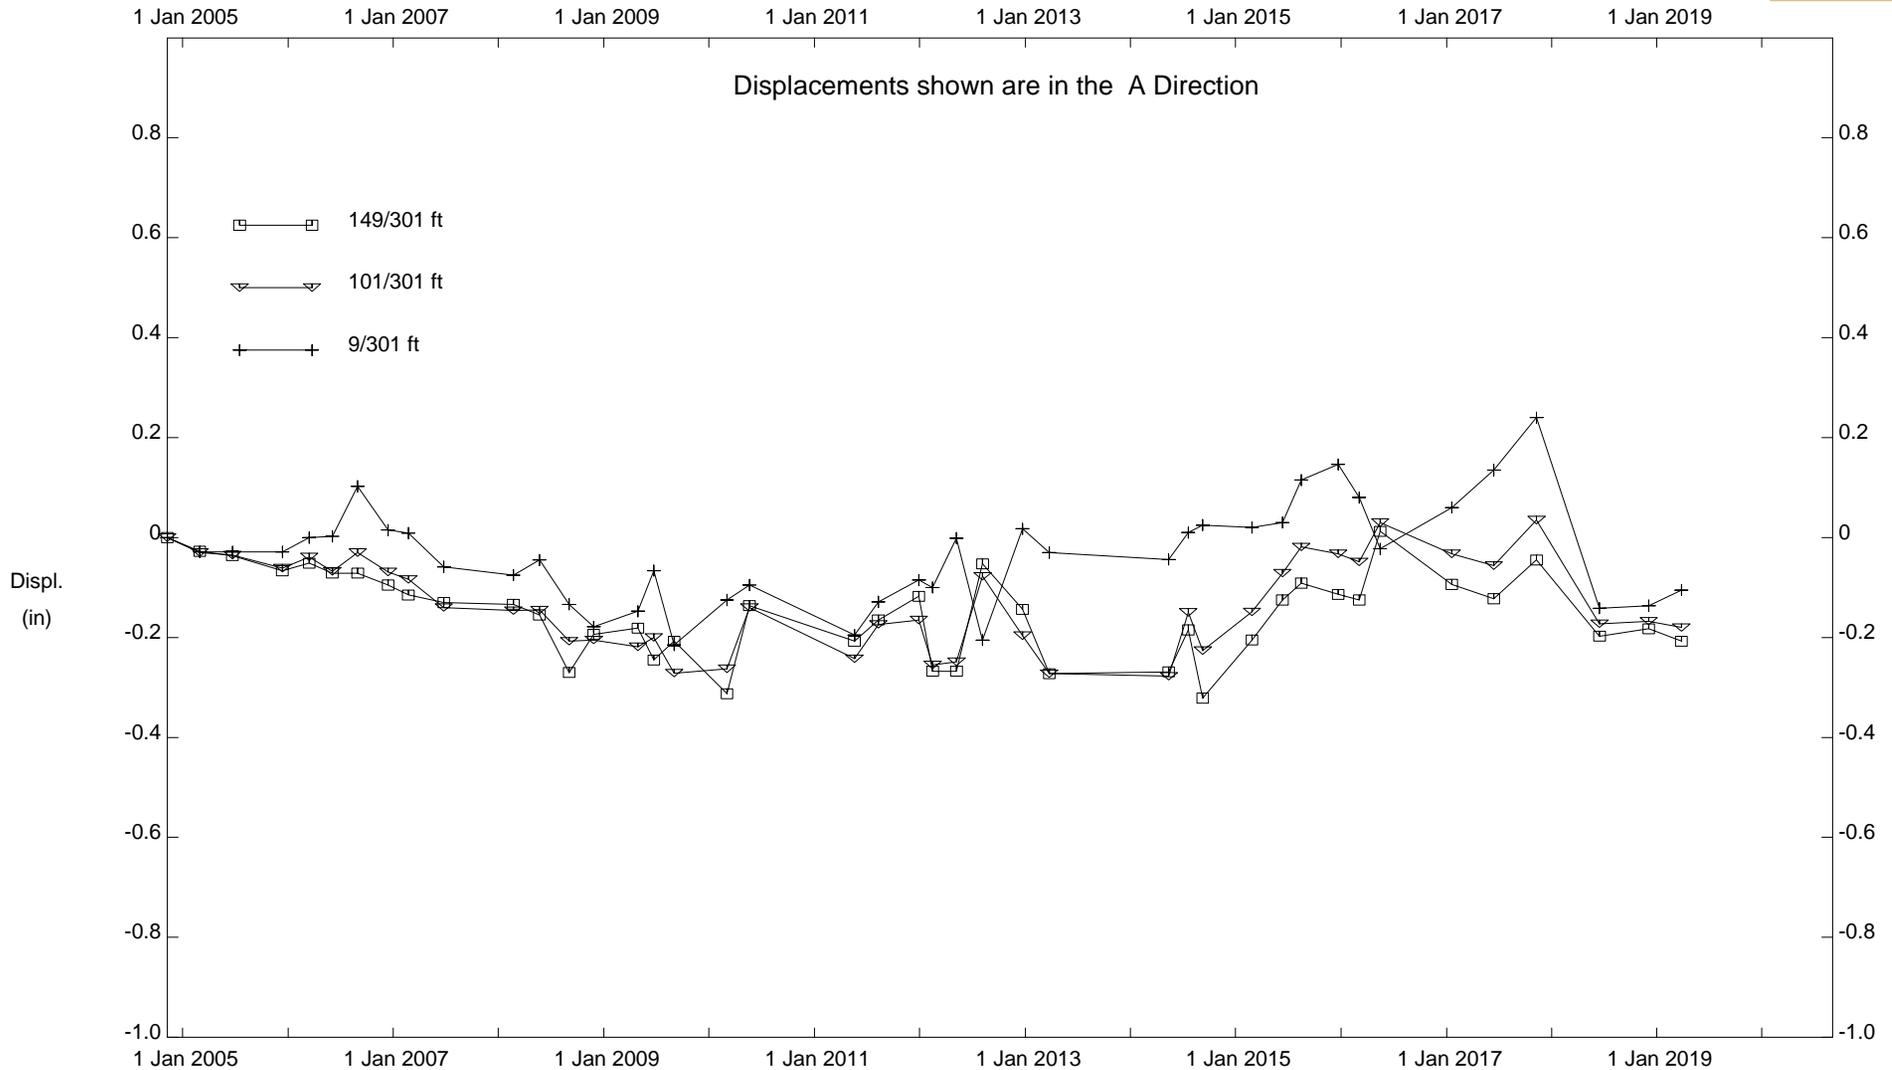
BIG ROCK MESA, Inclinometer SP-35

CENTRAL REGION

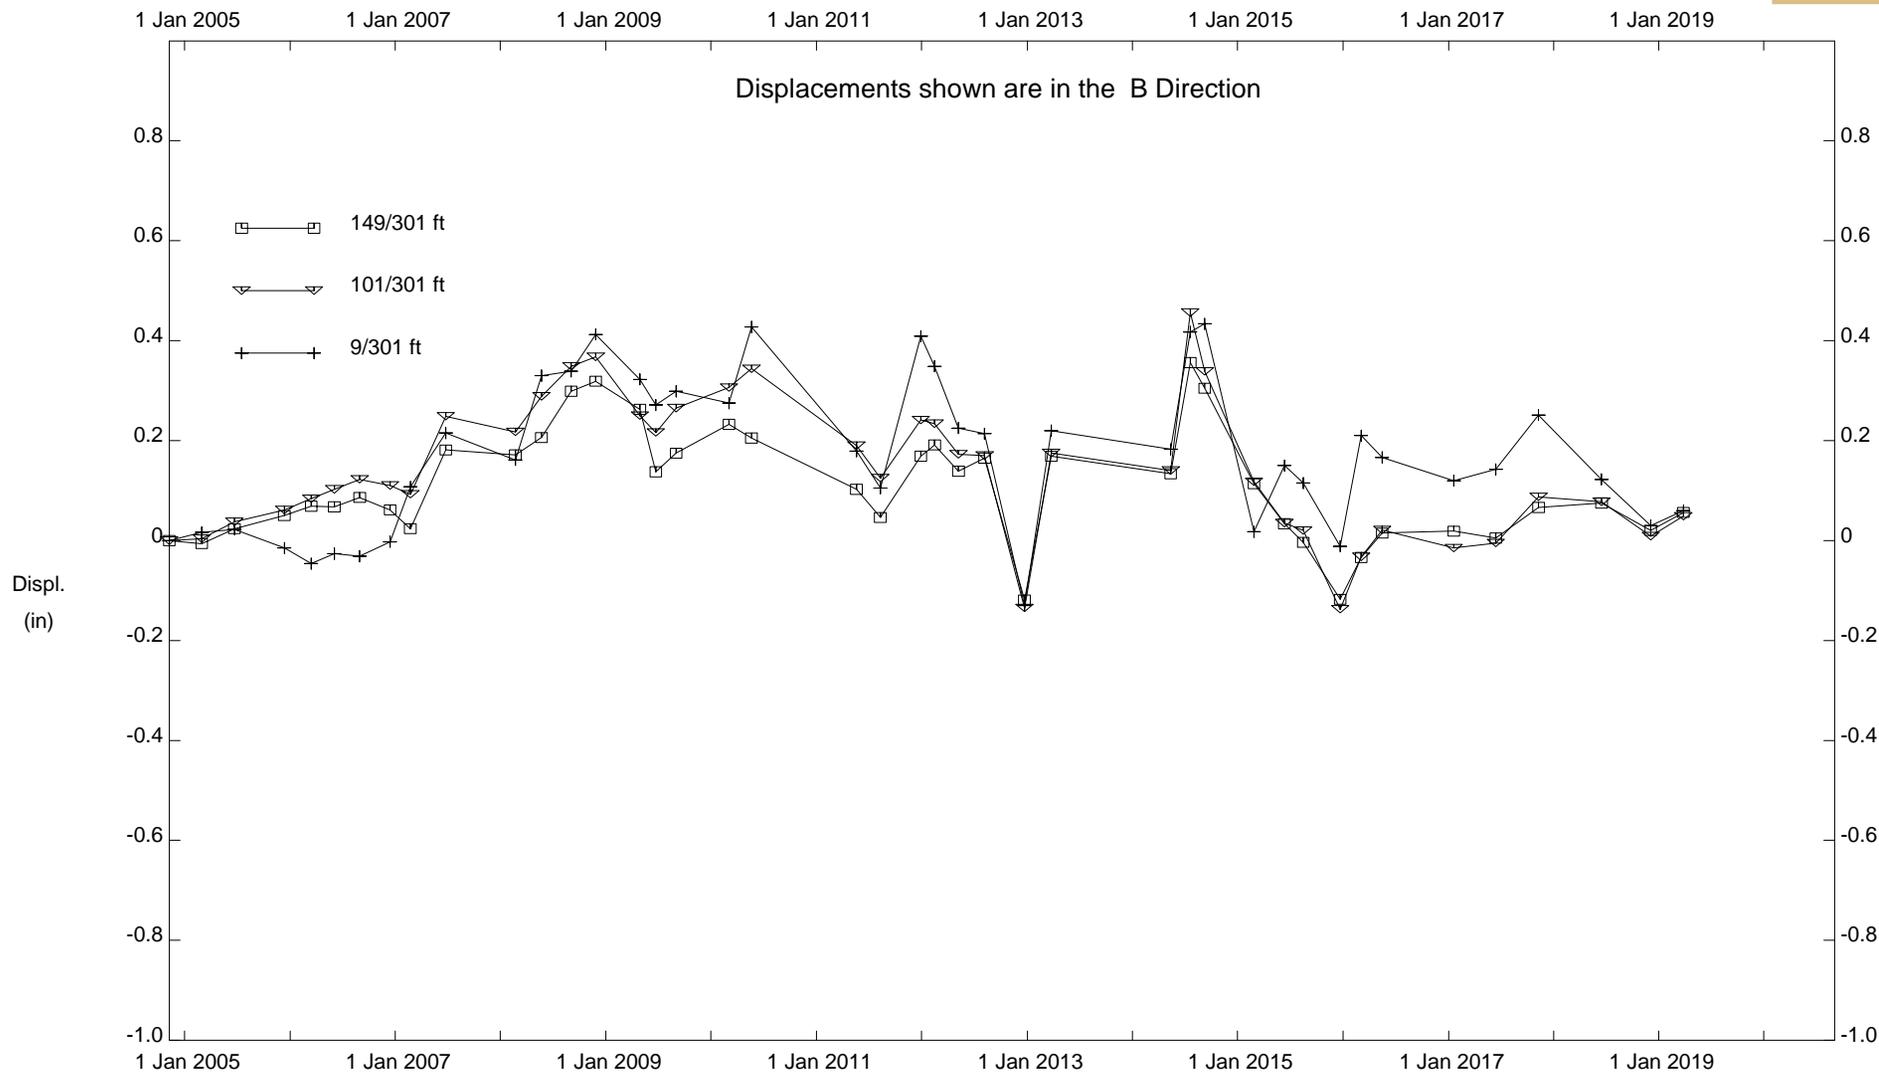
BIG ROCK MESA, Inclinometer SP-35

CENTRAL REGION

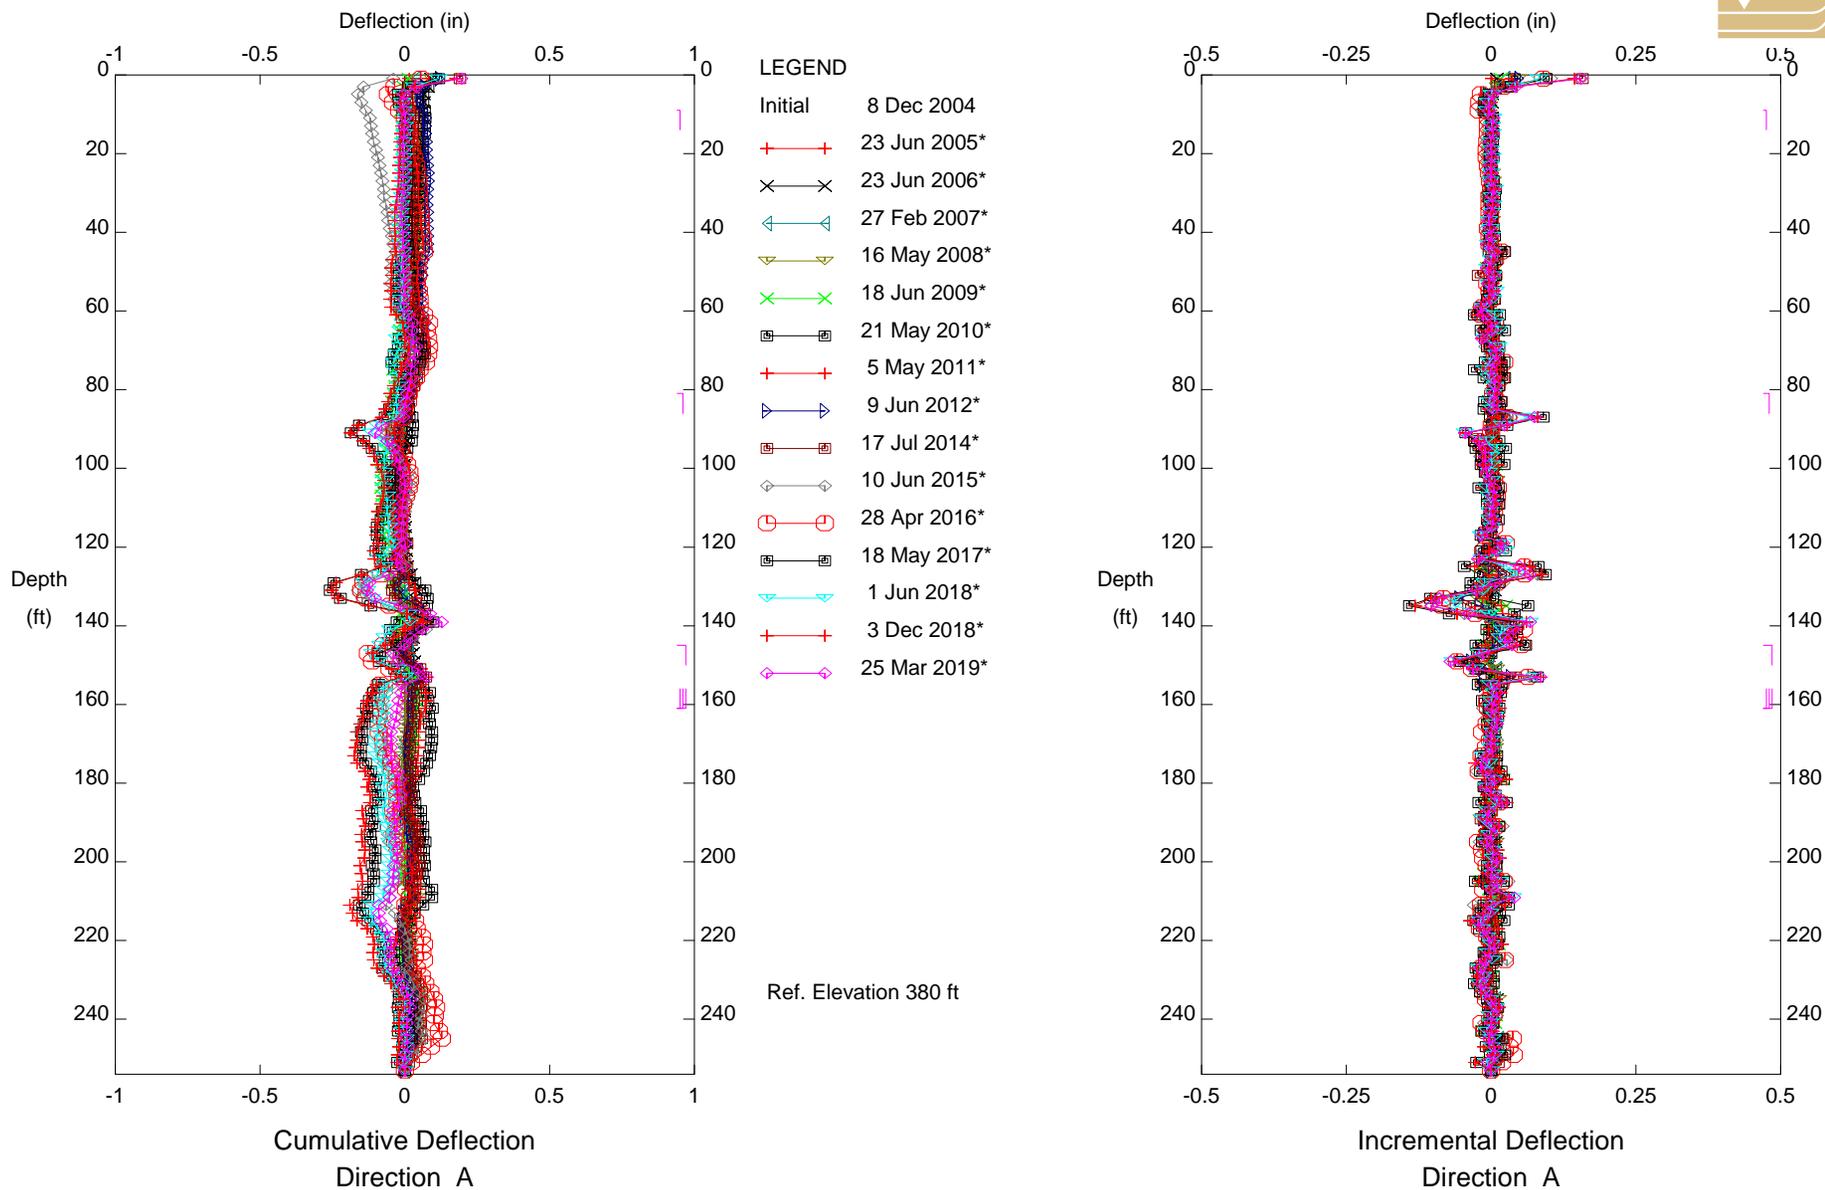
**BIG ROCK MESA, Inclinometer SP-36
 CENTRAL REGION**

Sets marked * include zero shift and/or rotation corrections.

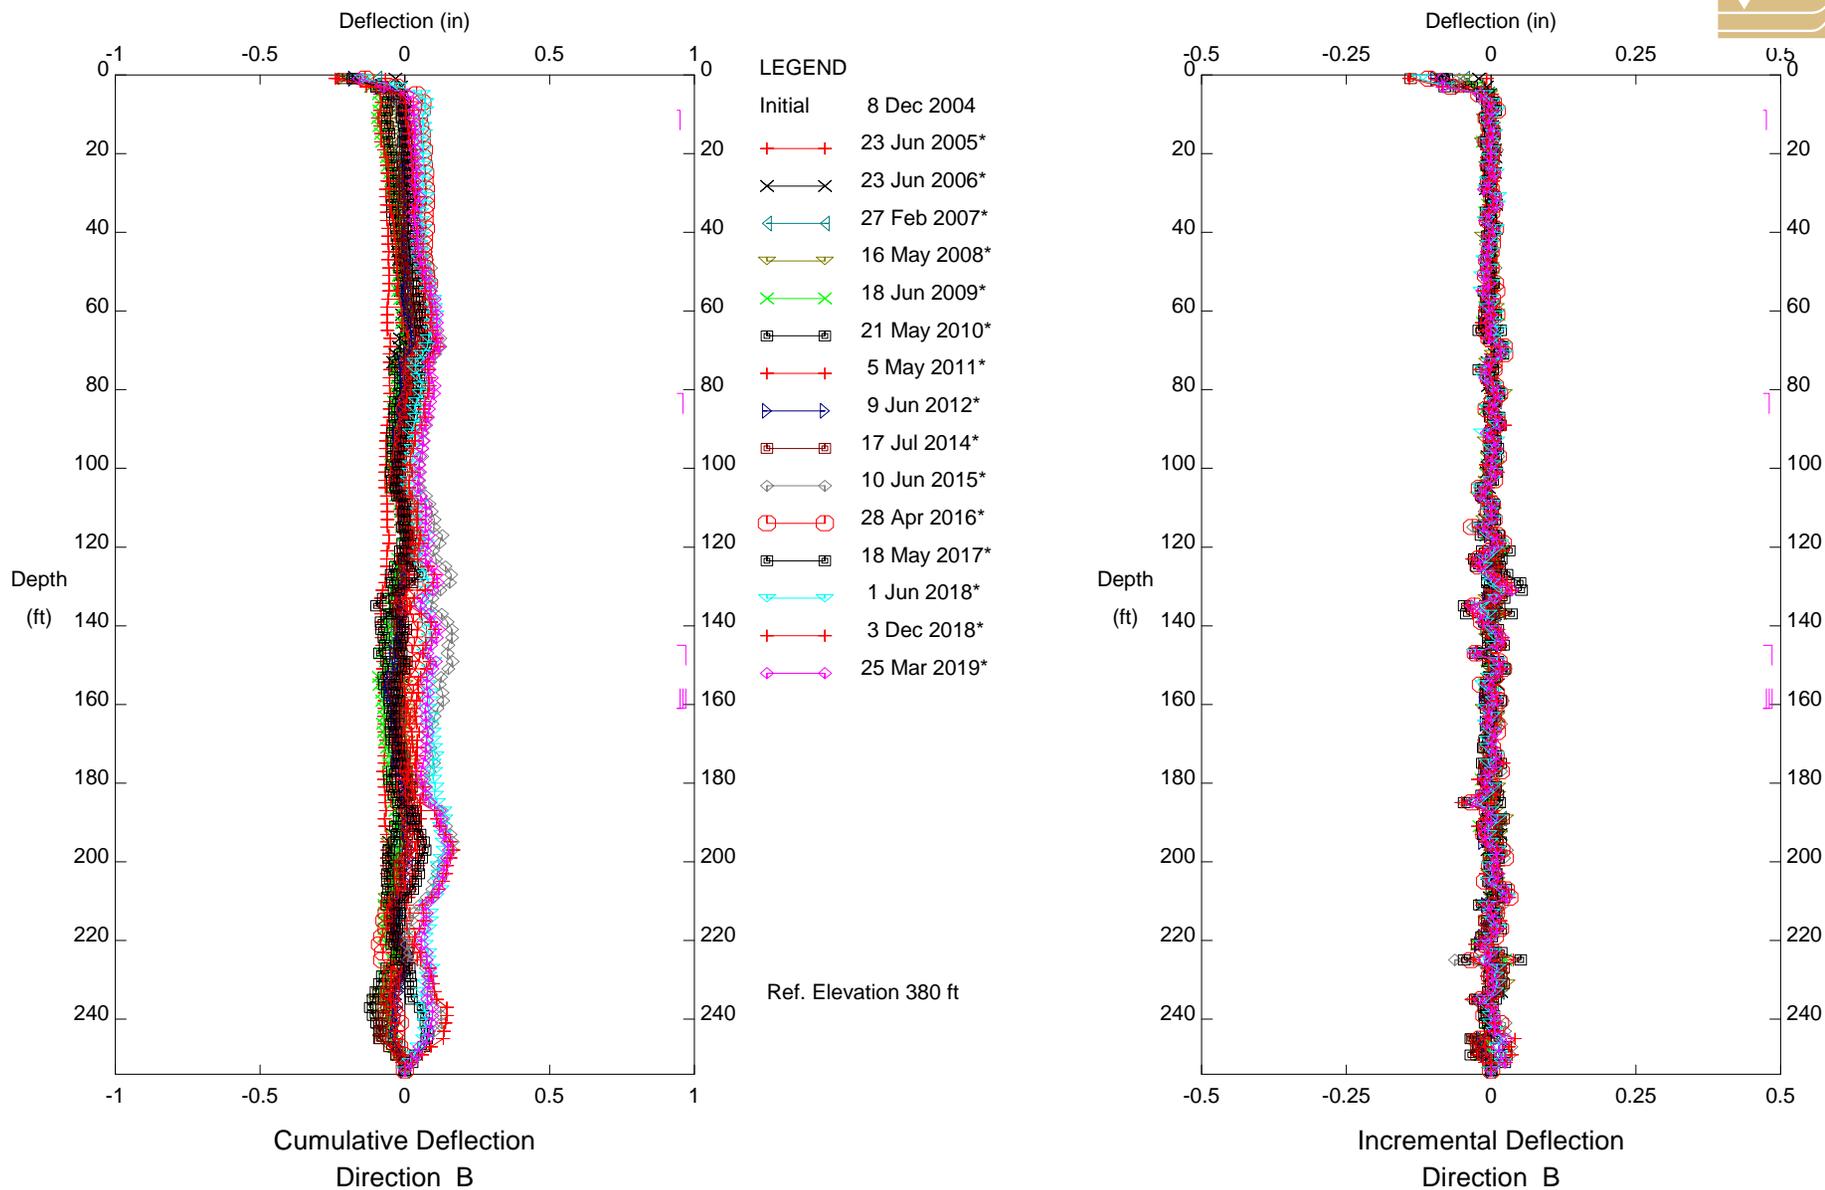
**BIG ROCK MESA, Inclinerometer SP-36
 CENTRAL REGION**

Sets marked * include zero shift and/or rotation corrections.

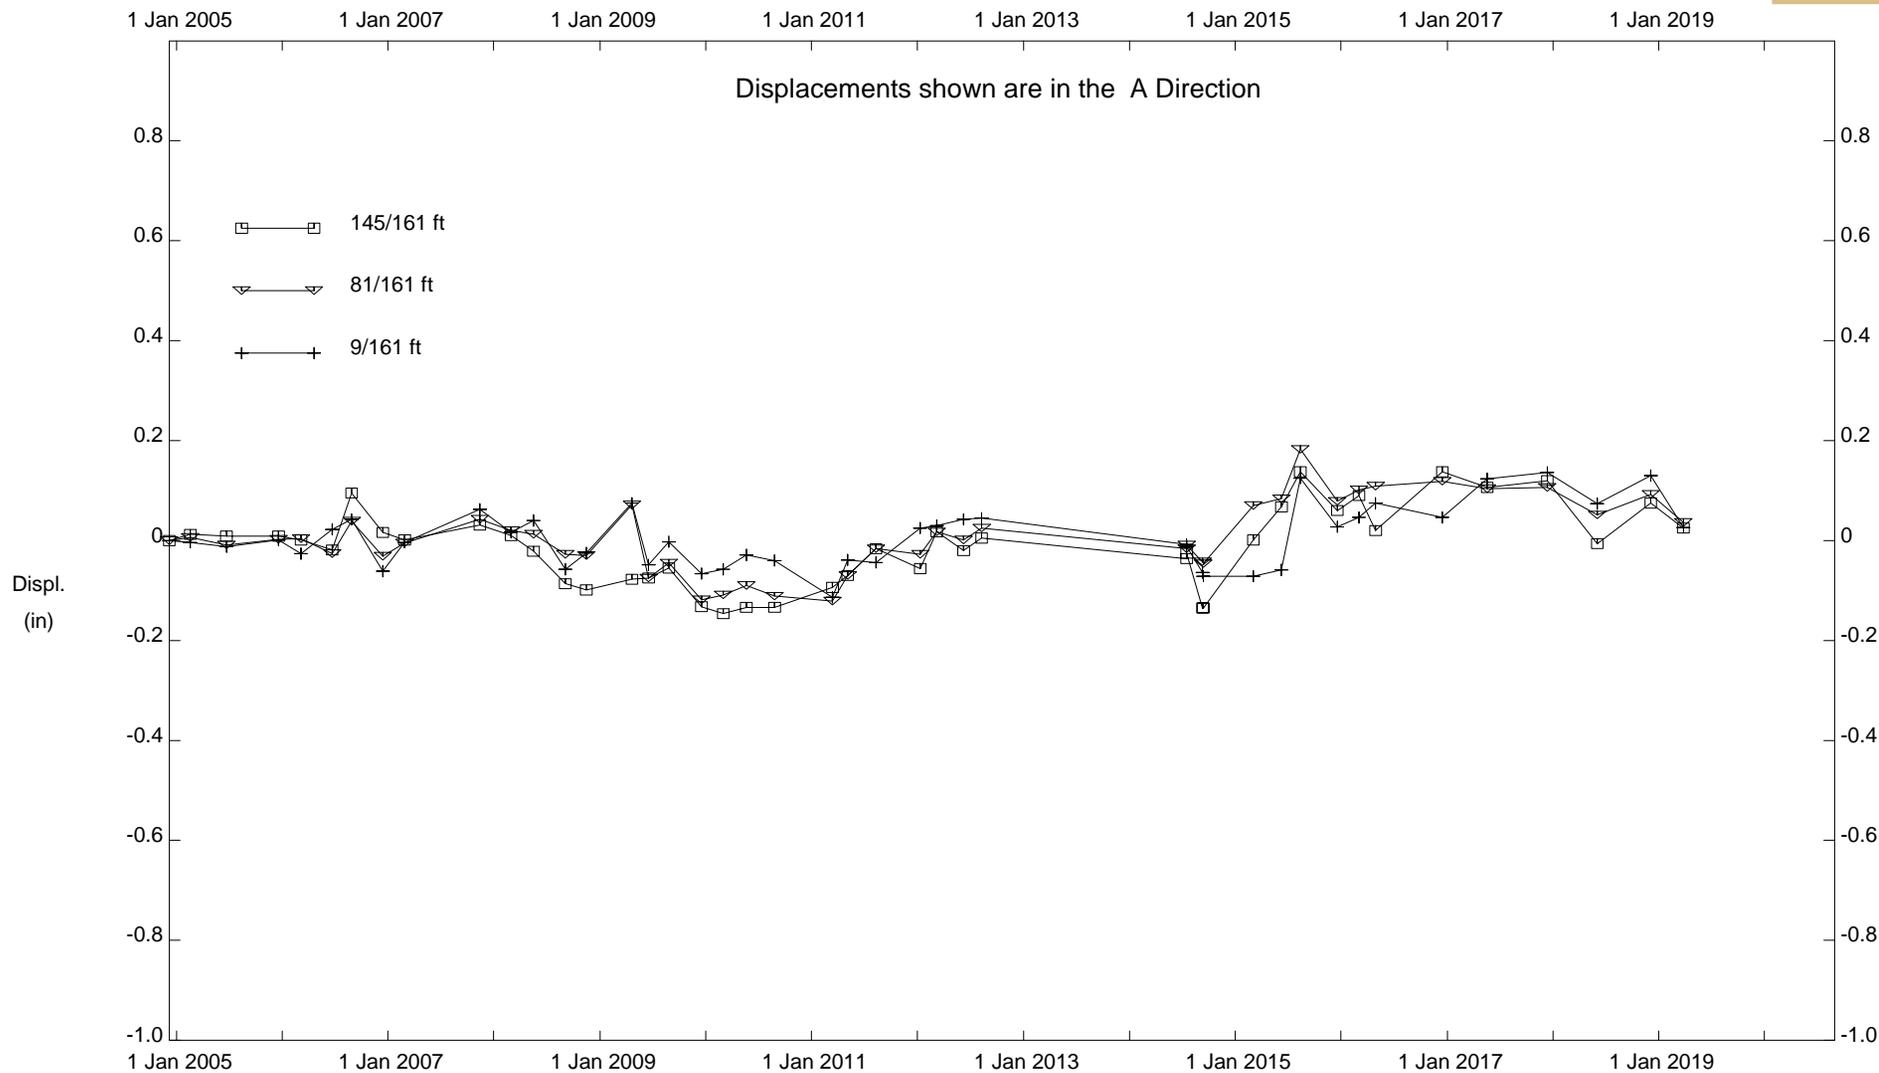
BIG ROCK MESA, Inclinometer SP-36

CENTRAL REGION

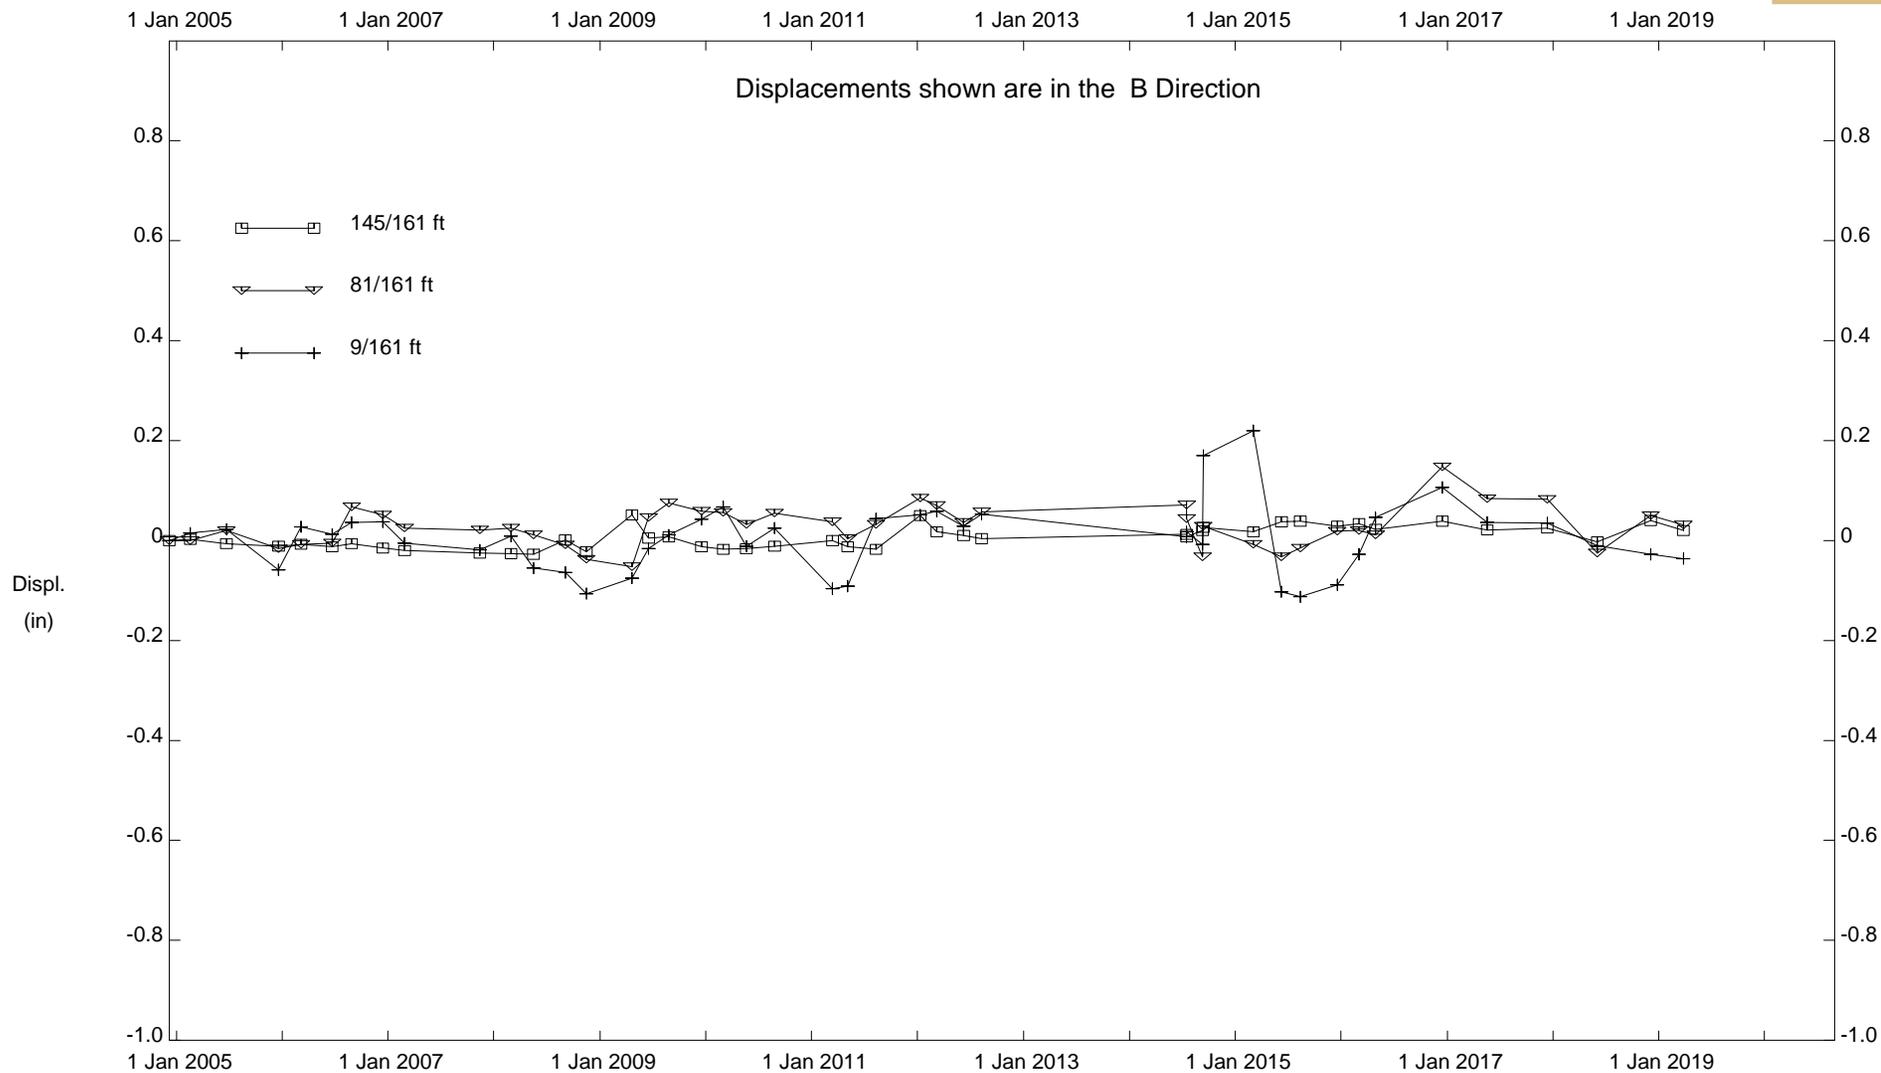
BIG ROCK MESA, Inclinometer SP-36

CENTRAL REGION

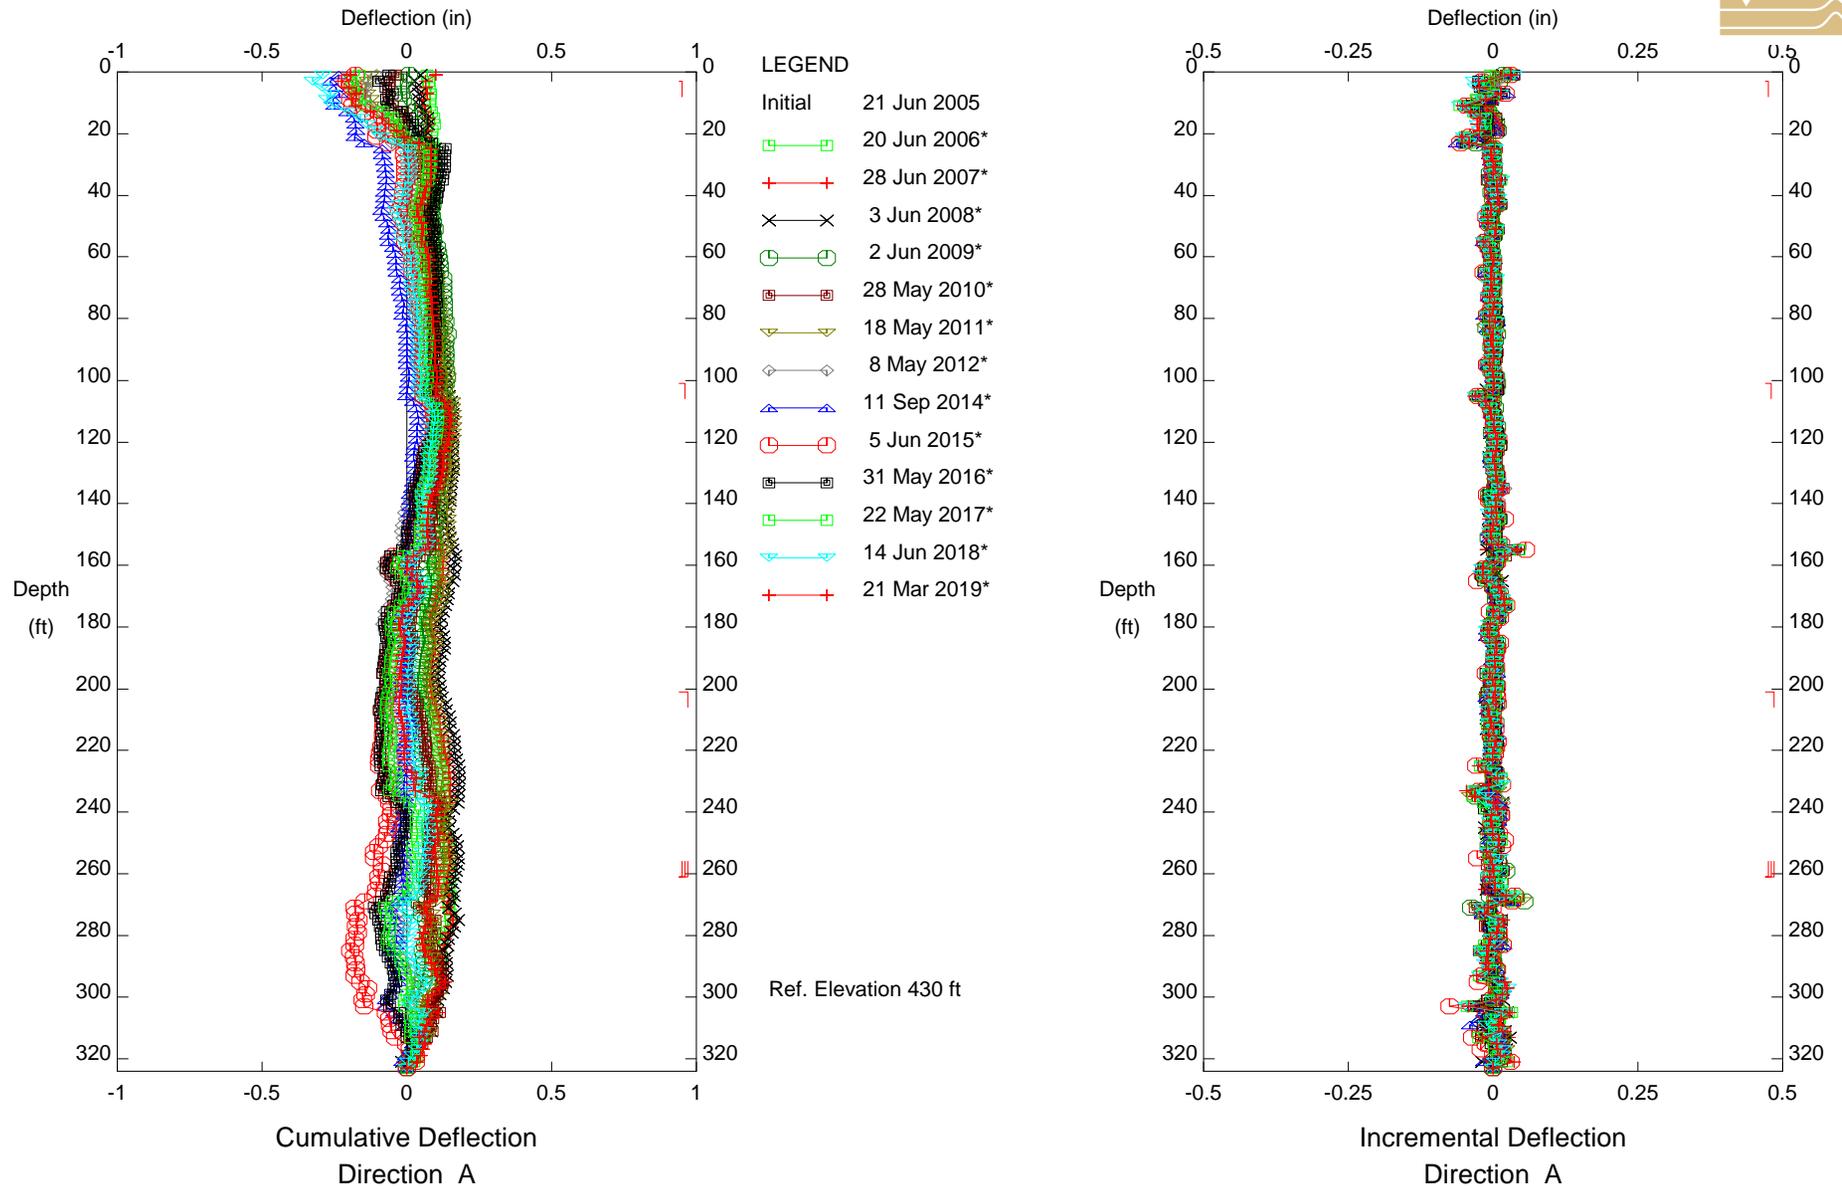
**BIG ROCK MESA, Inclinometer SP-20
 WESTERN REGION**

Sets marked * include zero shift and/or rotation corrections.

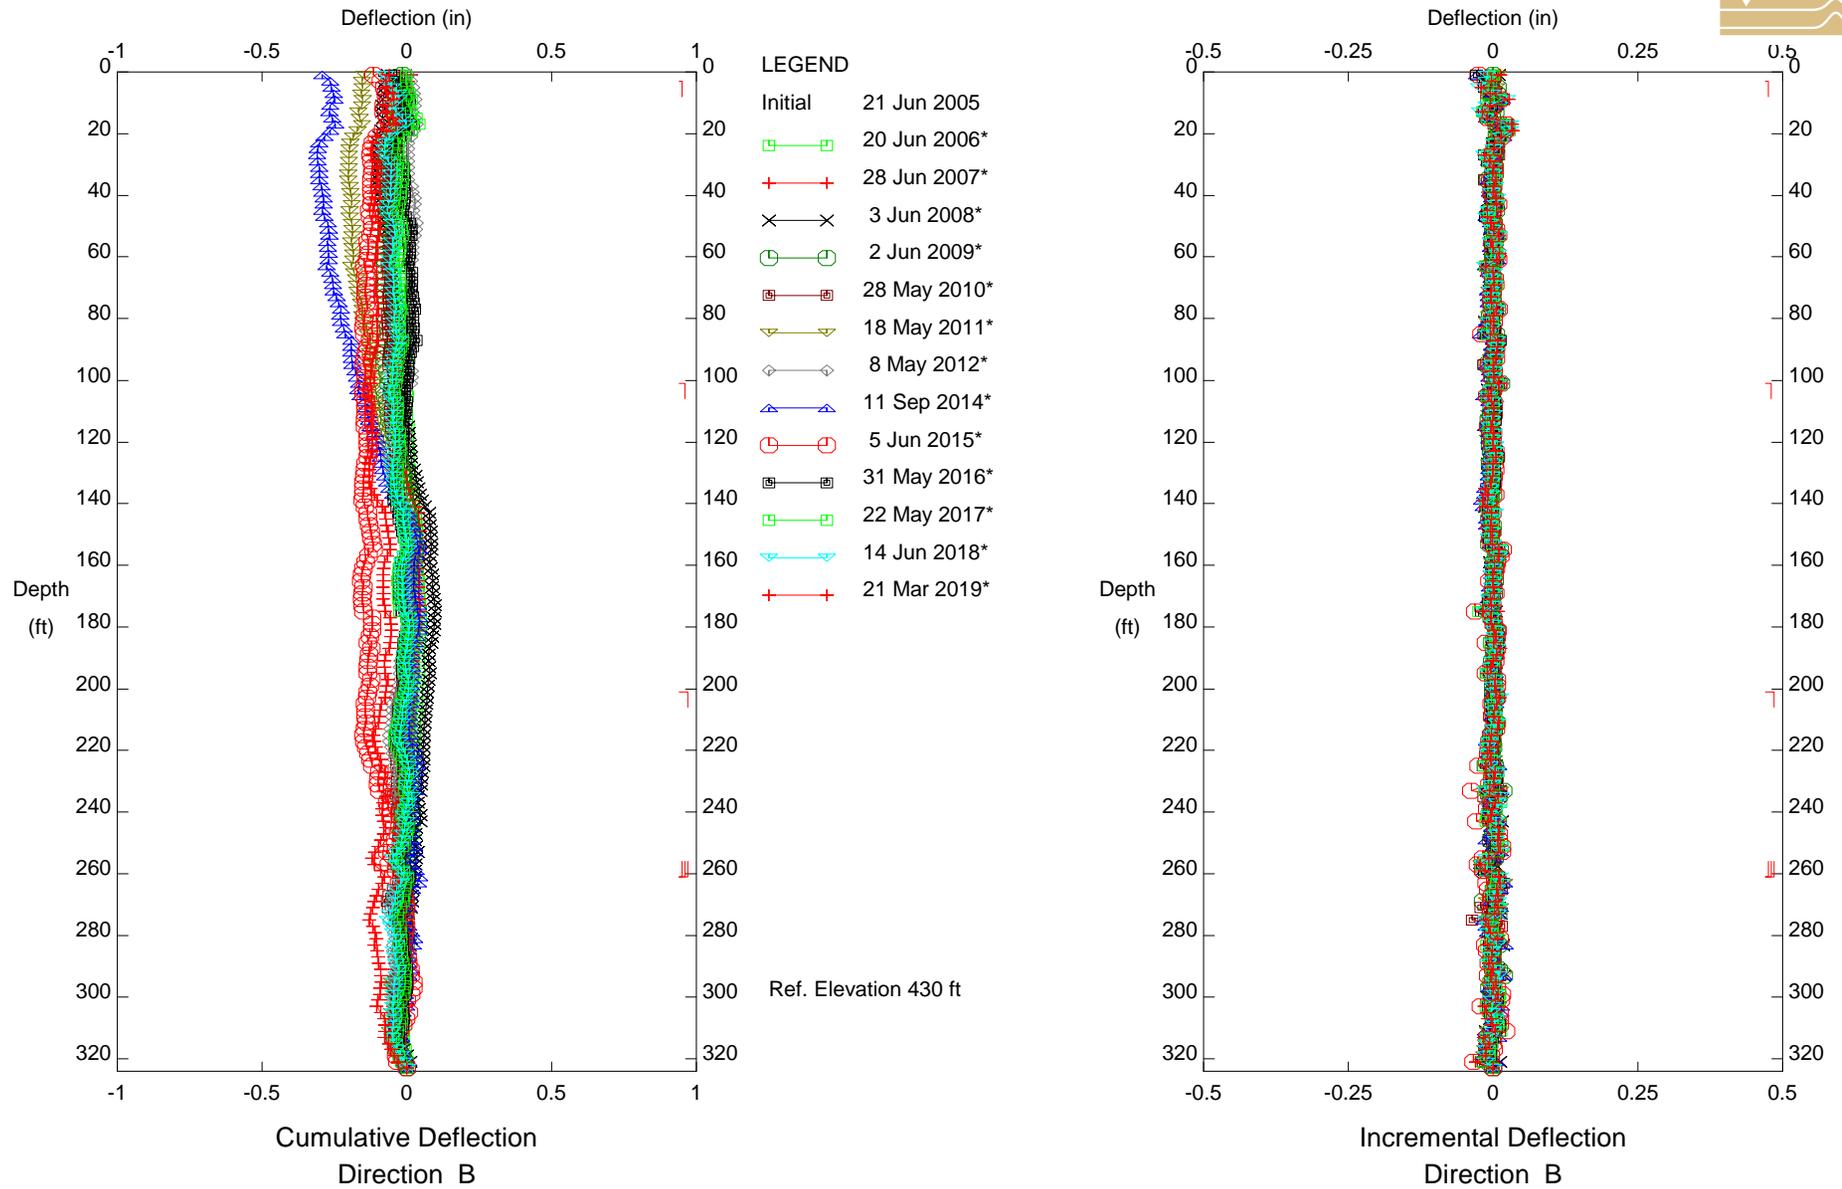
**BIG ROCK MESA, Inclinometer SP-20
 WESTERN REGION**

Sets marked * include zero shift and/or rotation corrections.

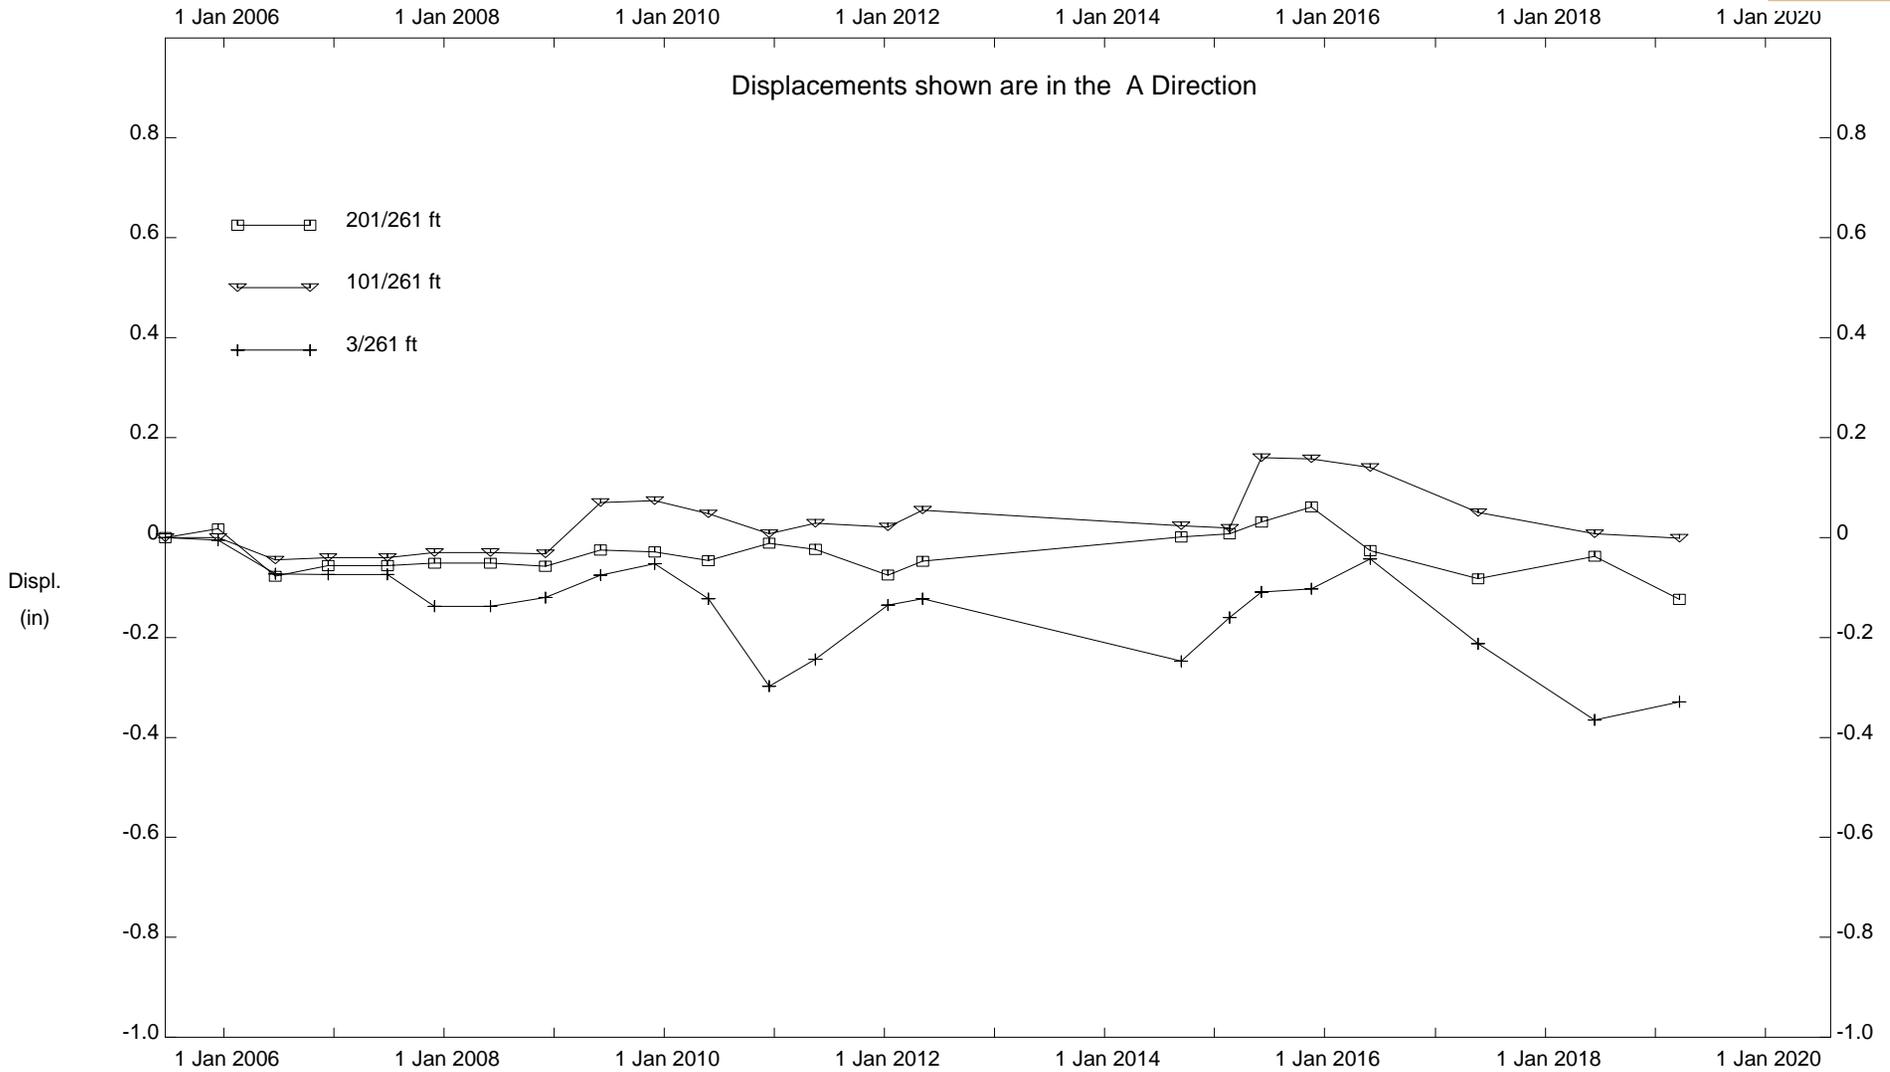
BIG ROCK MESA, Inclinator SP-20

WESTERN REGION

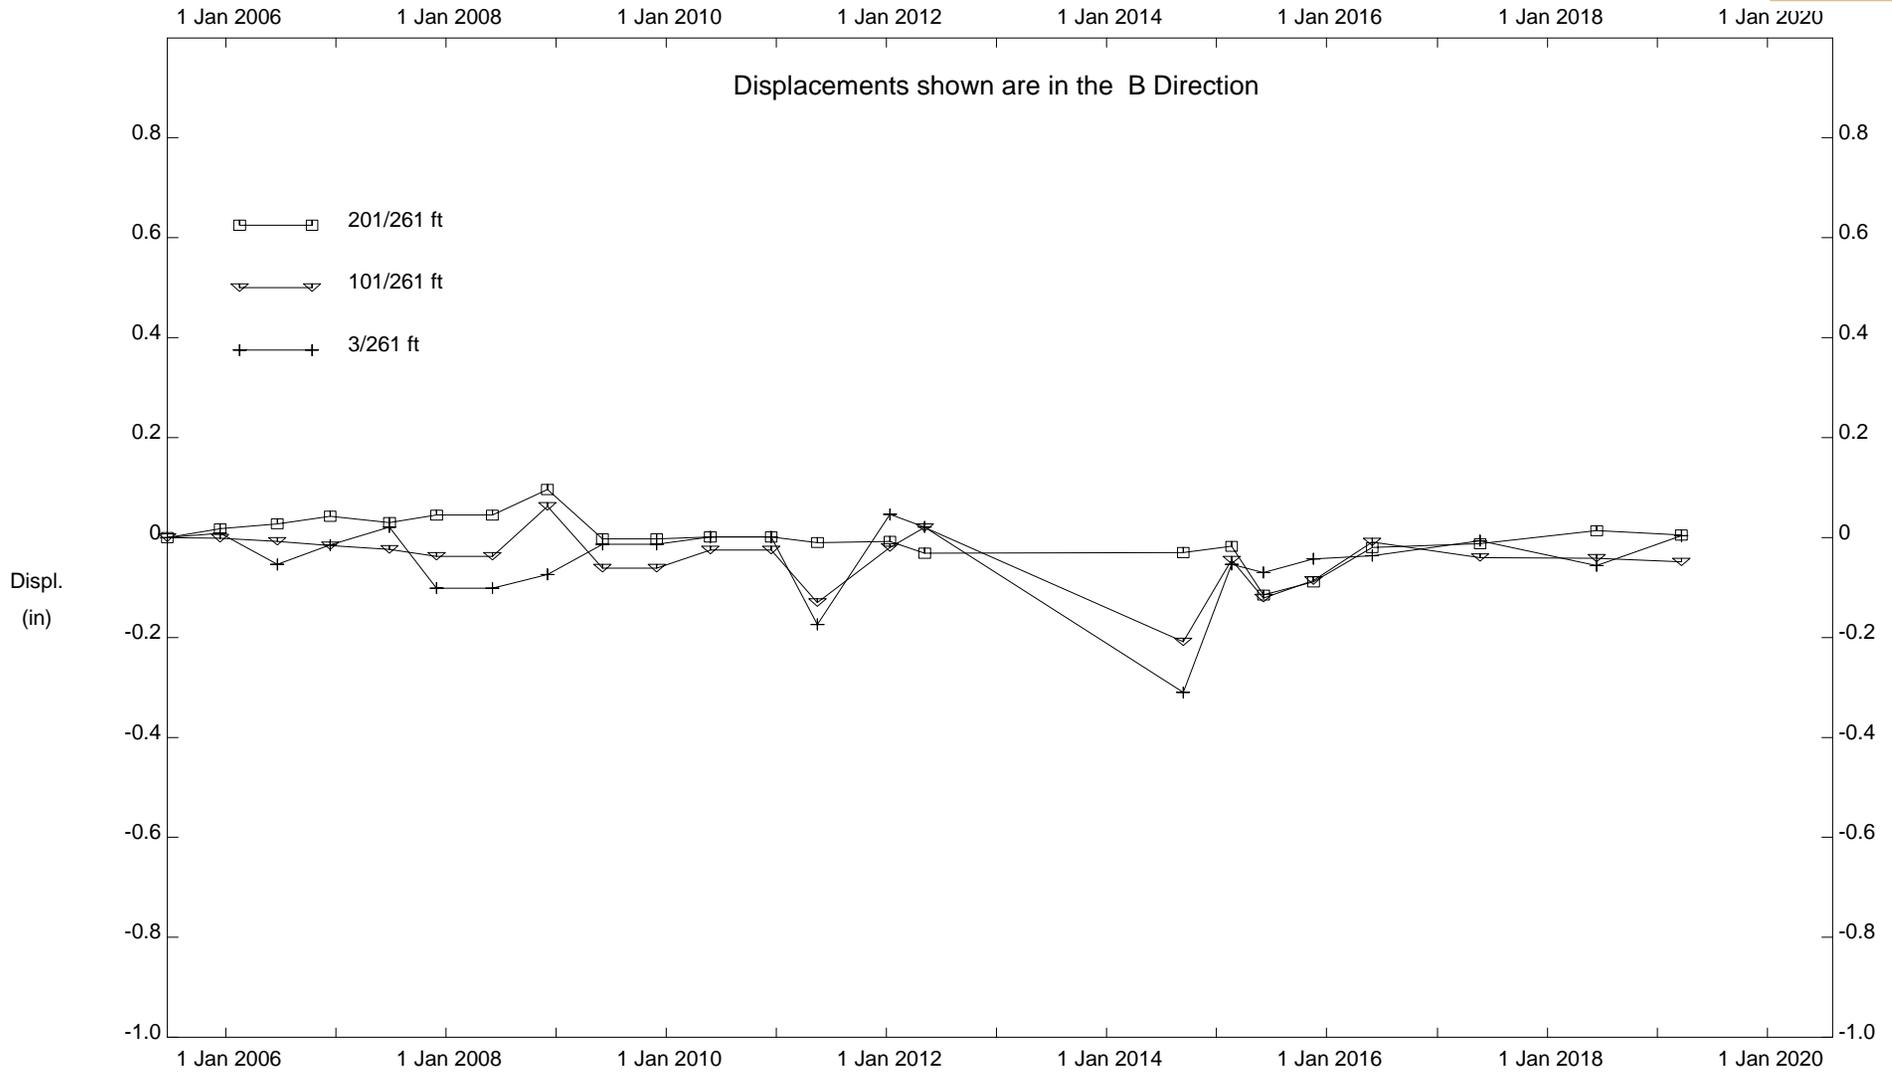
BIG ROCK MESA, Inclinator SP-20

WESTERN REGION
