**ANNUAL REPORT
JULY 2018 THROUGH JUNE 2019
BIG ROCK MESA LANDSLIDE
ASSESSMENT DISTRICT
City of Malibu, California**

November 2019
Fugro Project No. 04.62160606
Document No. 04.62160606-PR-006(Rev.00)

Annual Report of Maintenance and Monitoring, July 2018 through June 2019, Big Rock Mesa Landslide Assessment District, City of Malibu, California

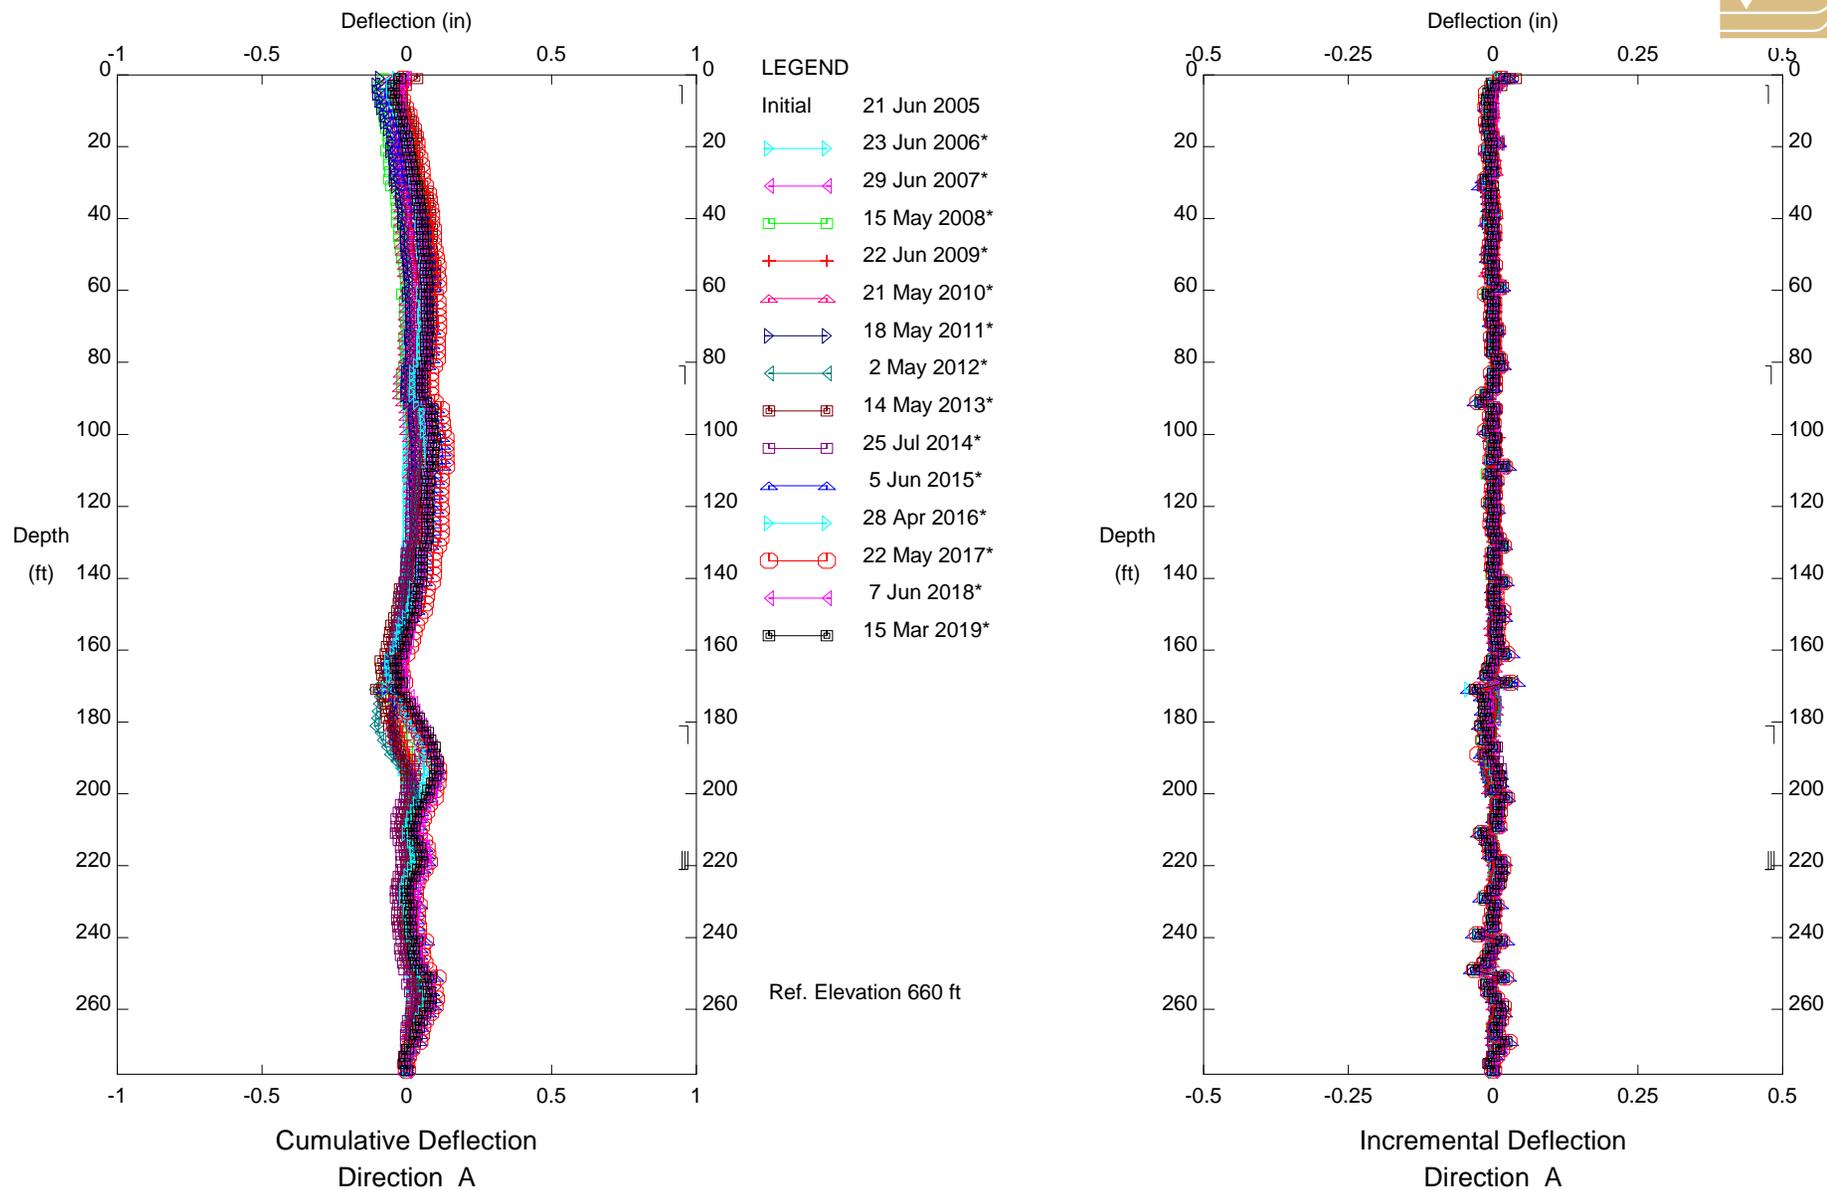
**BIG ROCK MESA, Inclinometer SP-21
 WESTERN REGION**

Sets marked * include zero shift and/or rotation corrections.

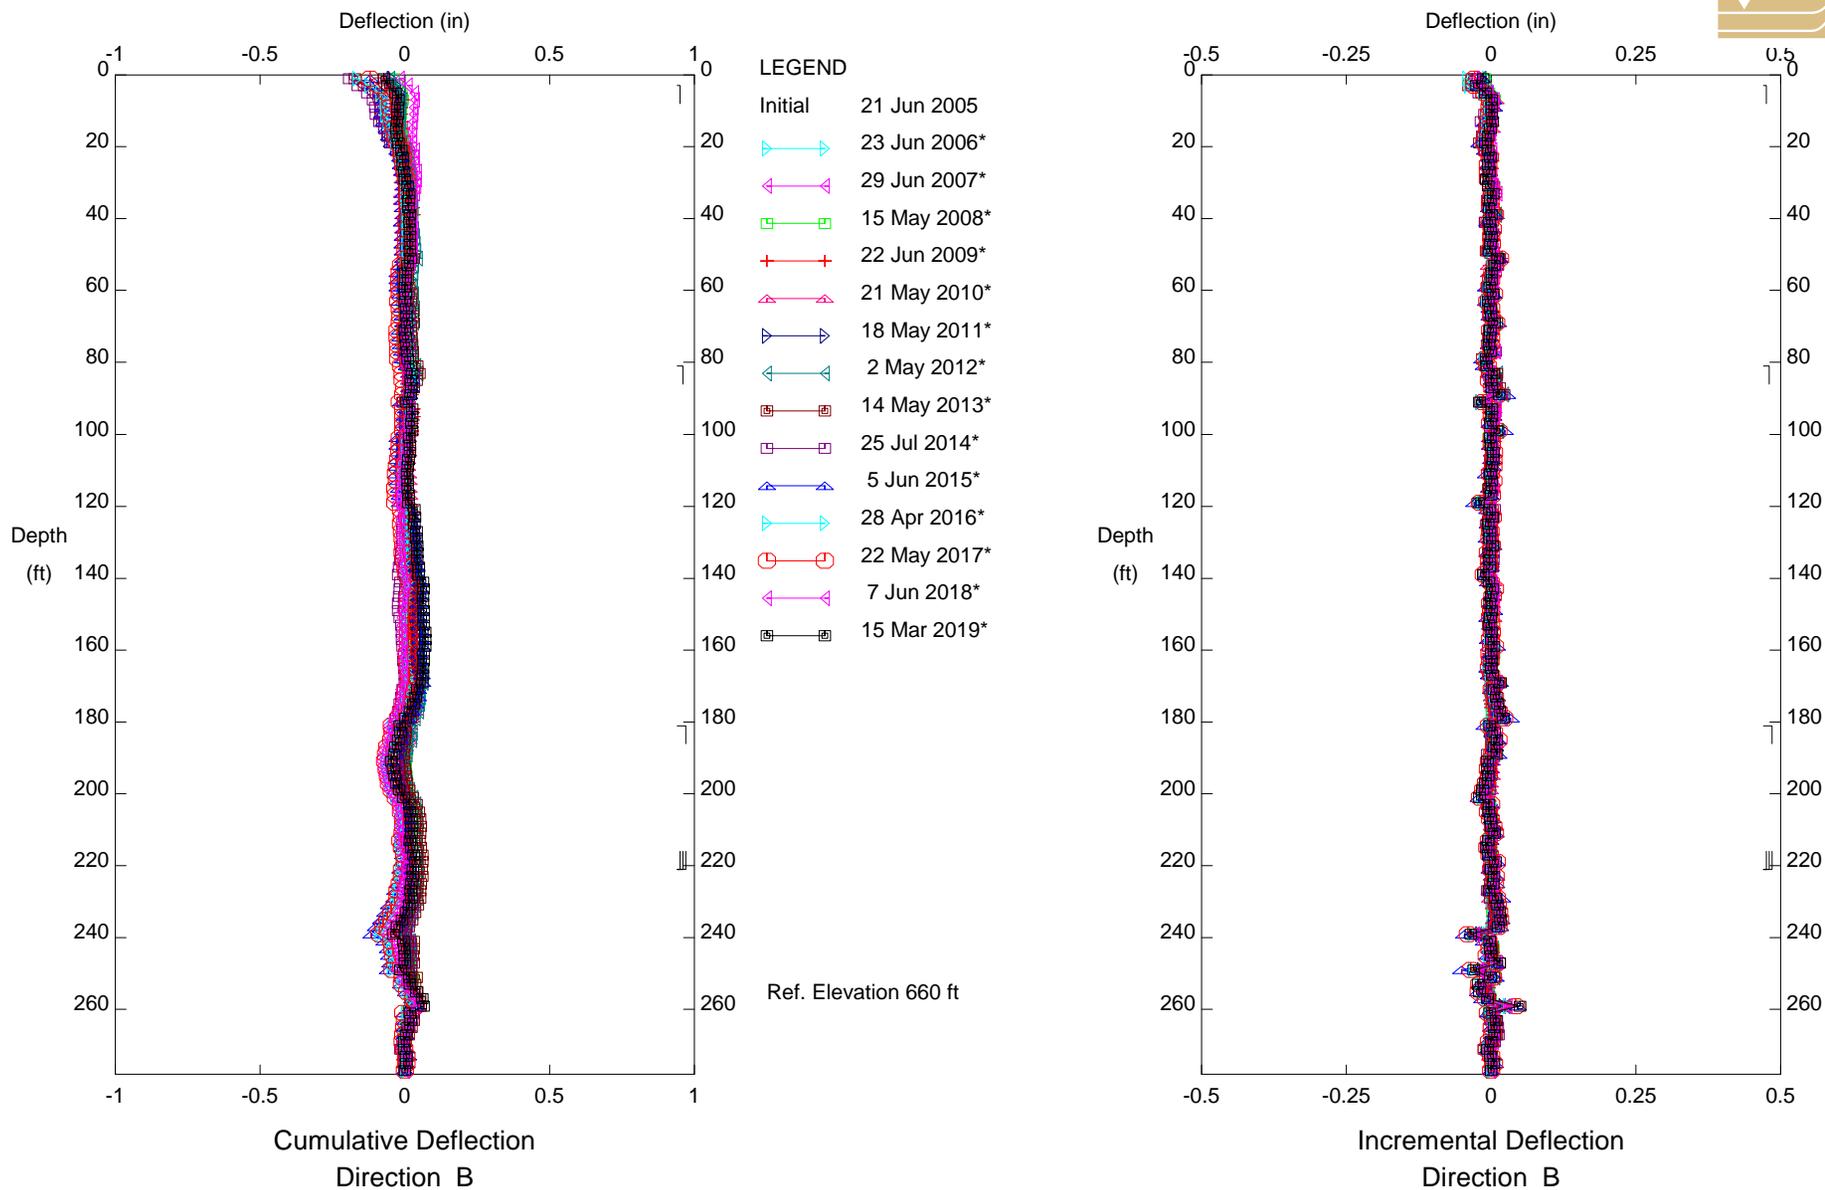
**BIG ROCK MESA, Inclinometer SP-21
 WESTERN REGION**

Sets marked * include zero shift and/or rotation corrections.

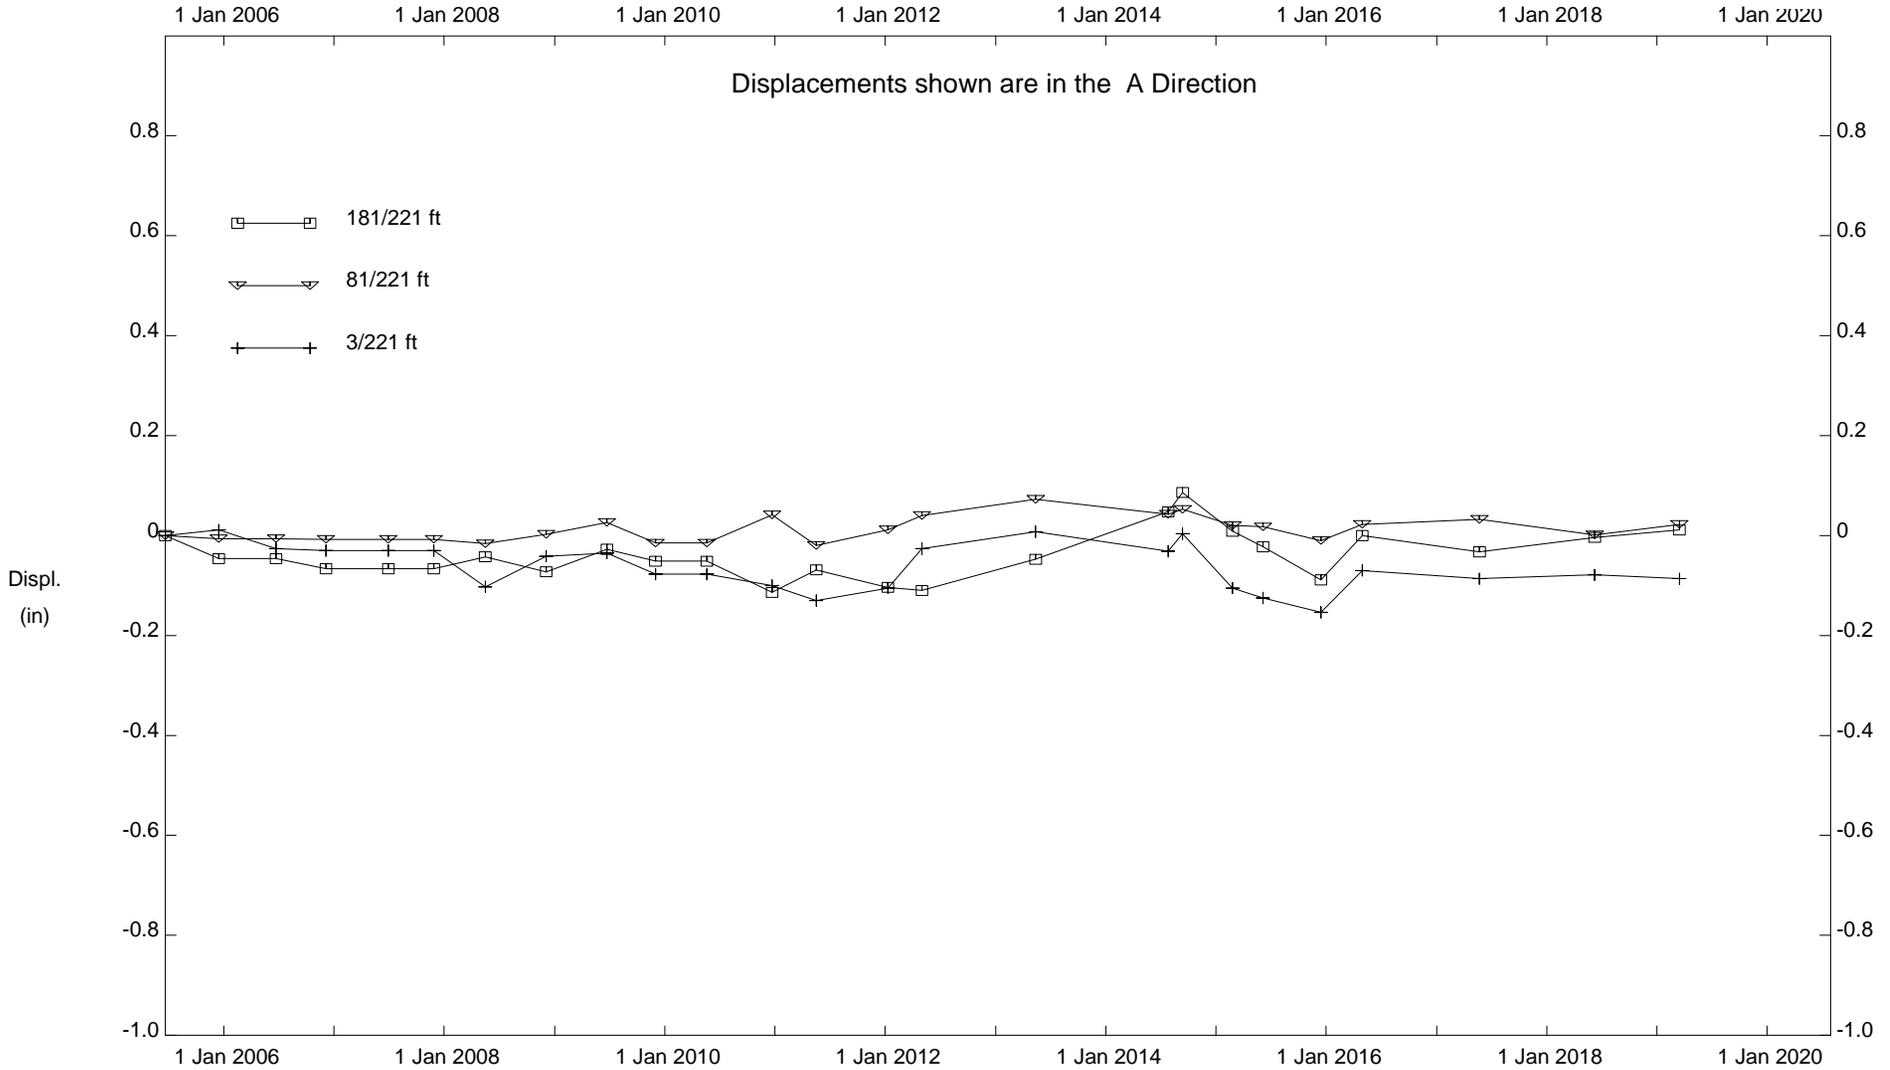
BIG ROCK MESA, Inclinometer SP-21

WESTERN REGION

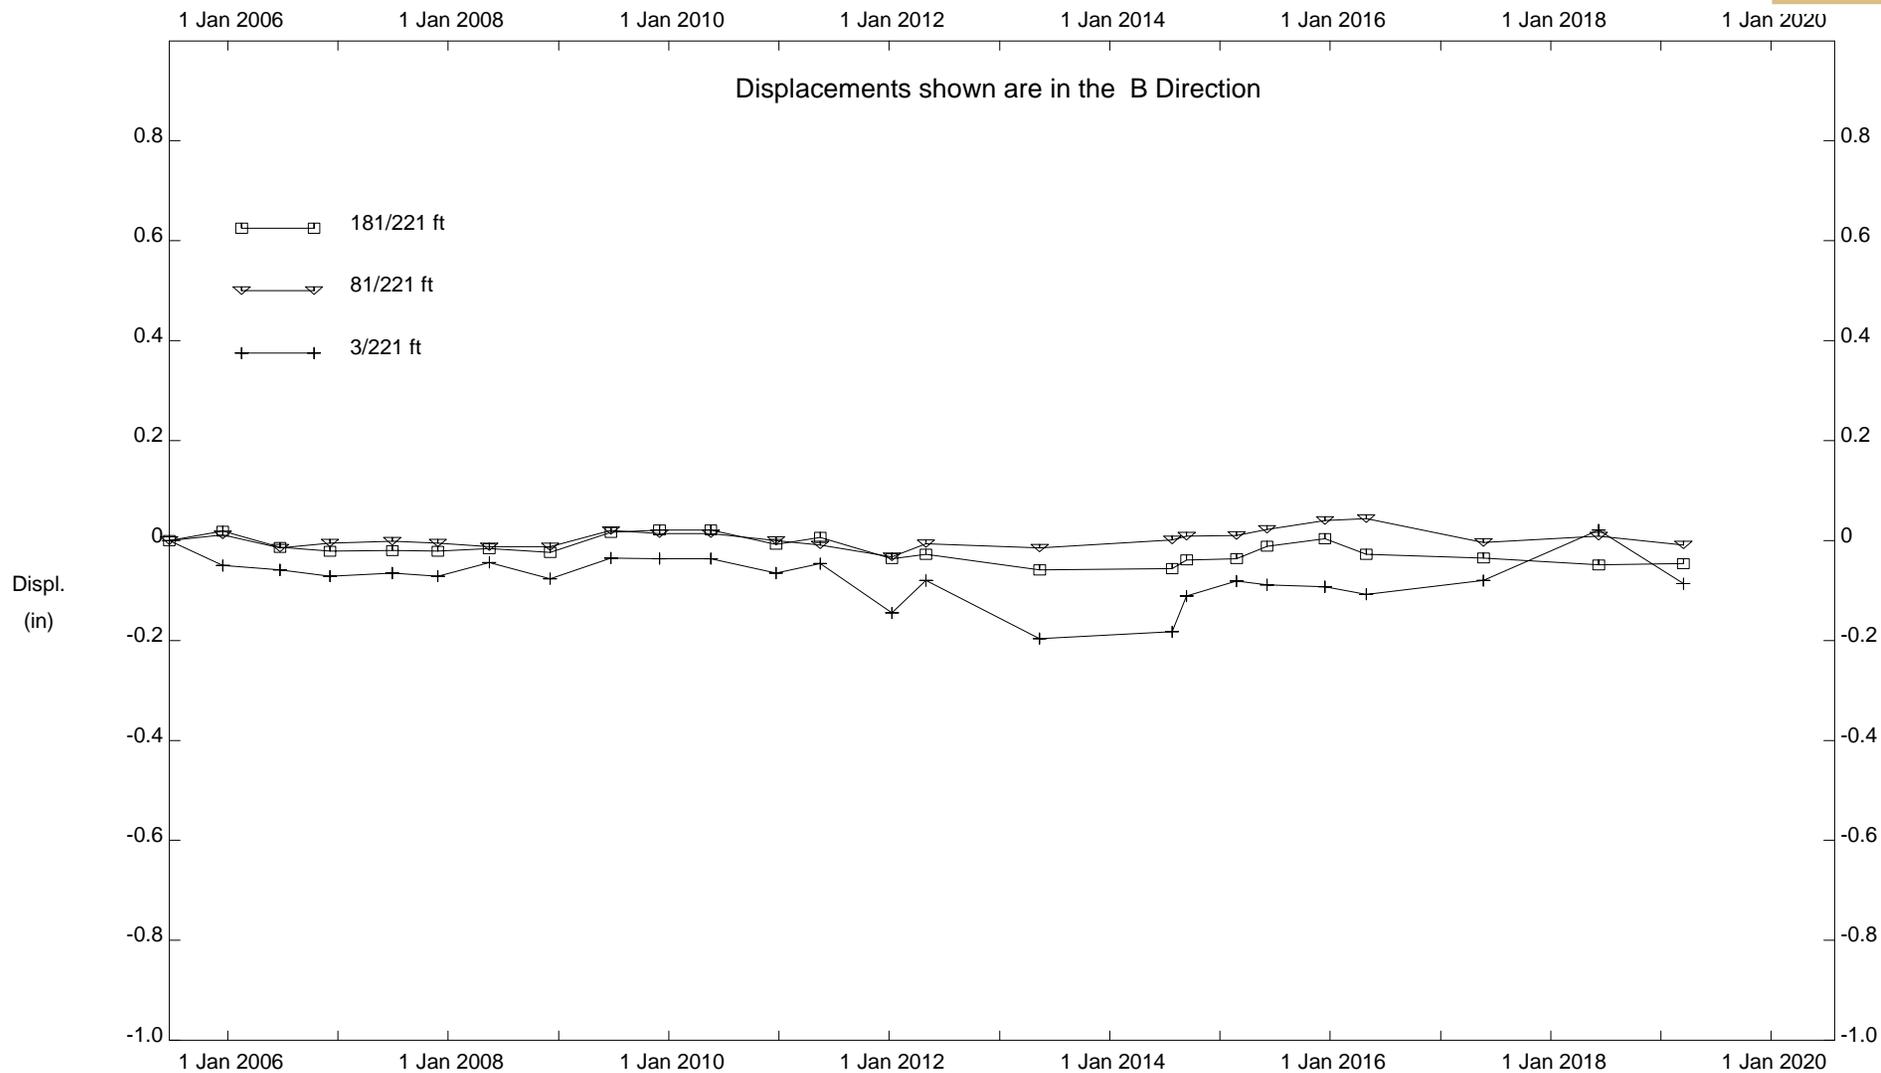
BIG ROCK MESA, Inclinometer SP-21

WESTERN REGION

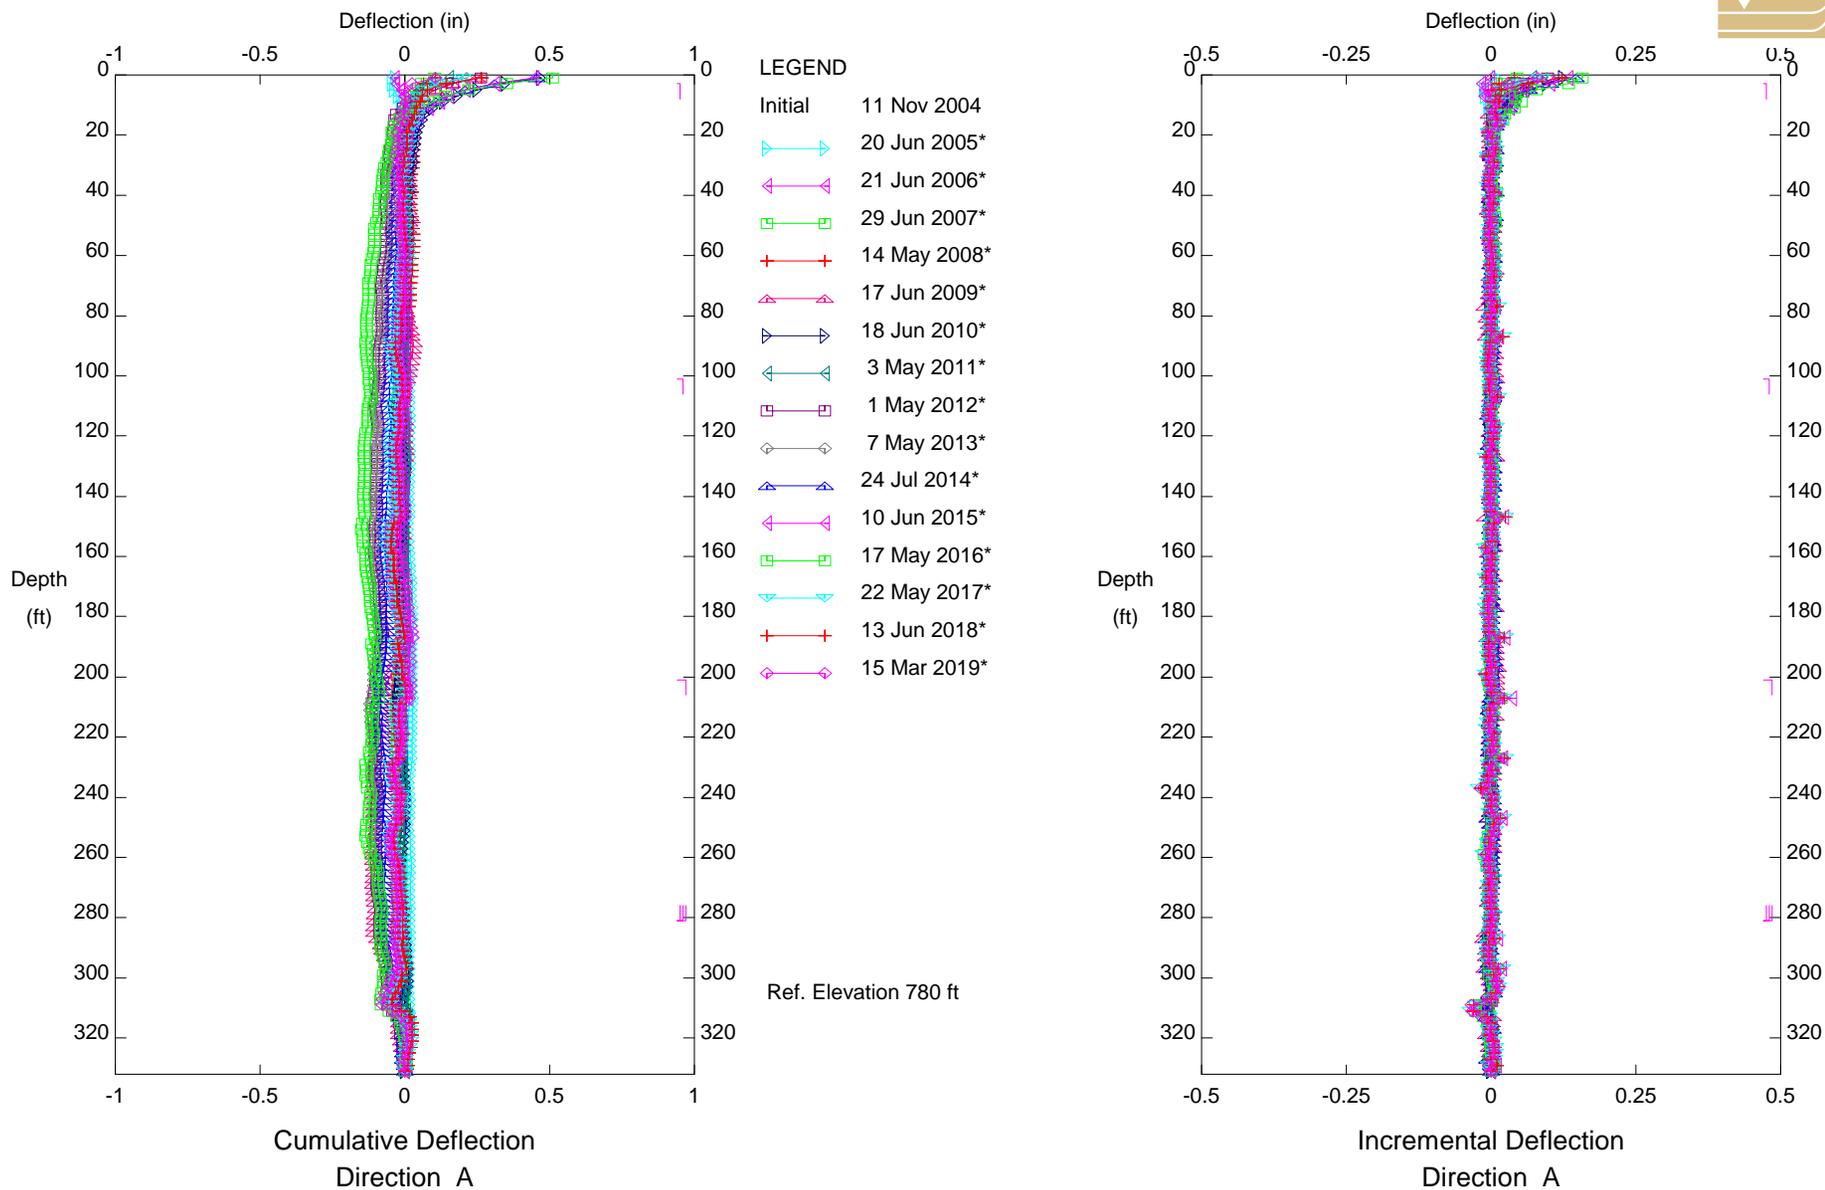
**BIG ROCK MESA, Inclinometer SP-22
 WESTERN REGION**

Sets marked * include zero shift and/or rotation corrections.

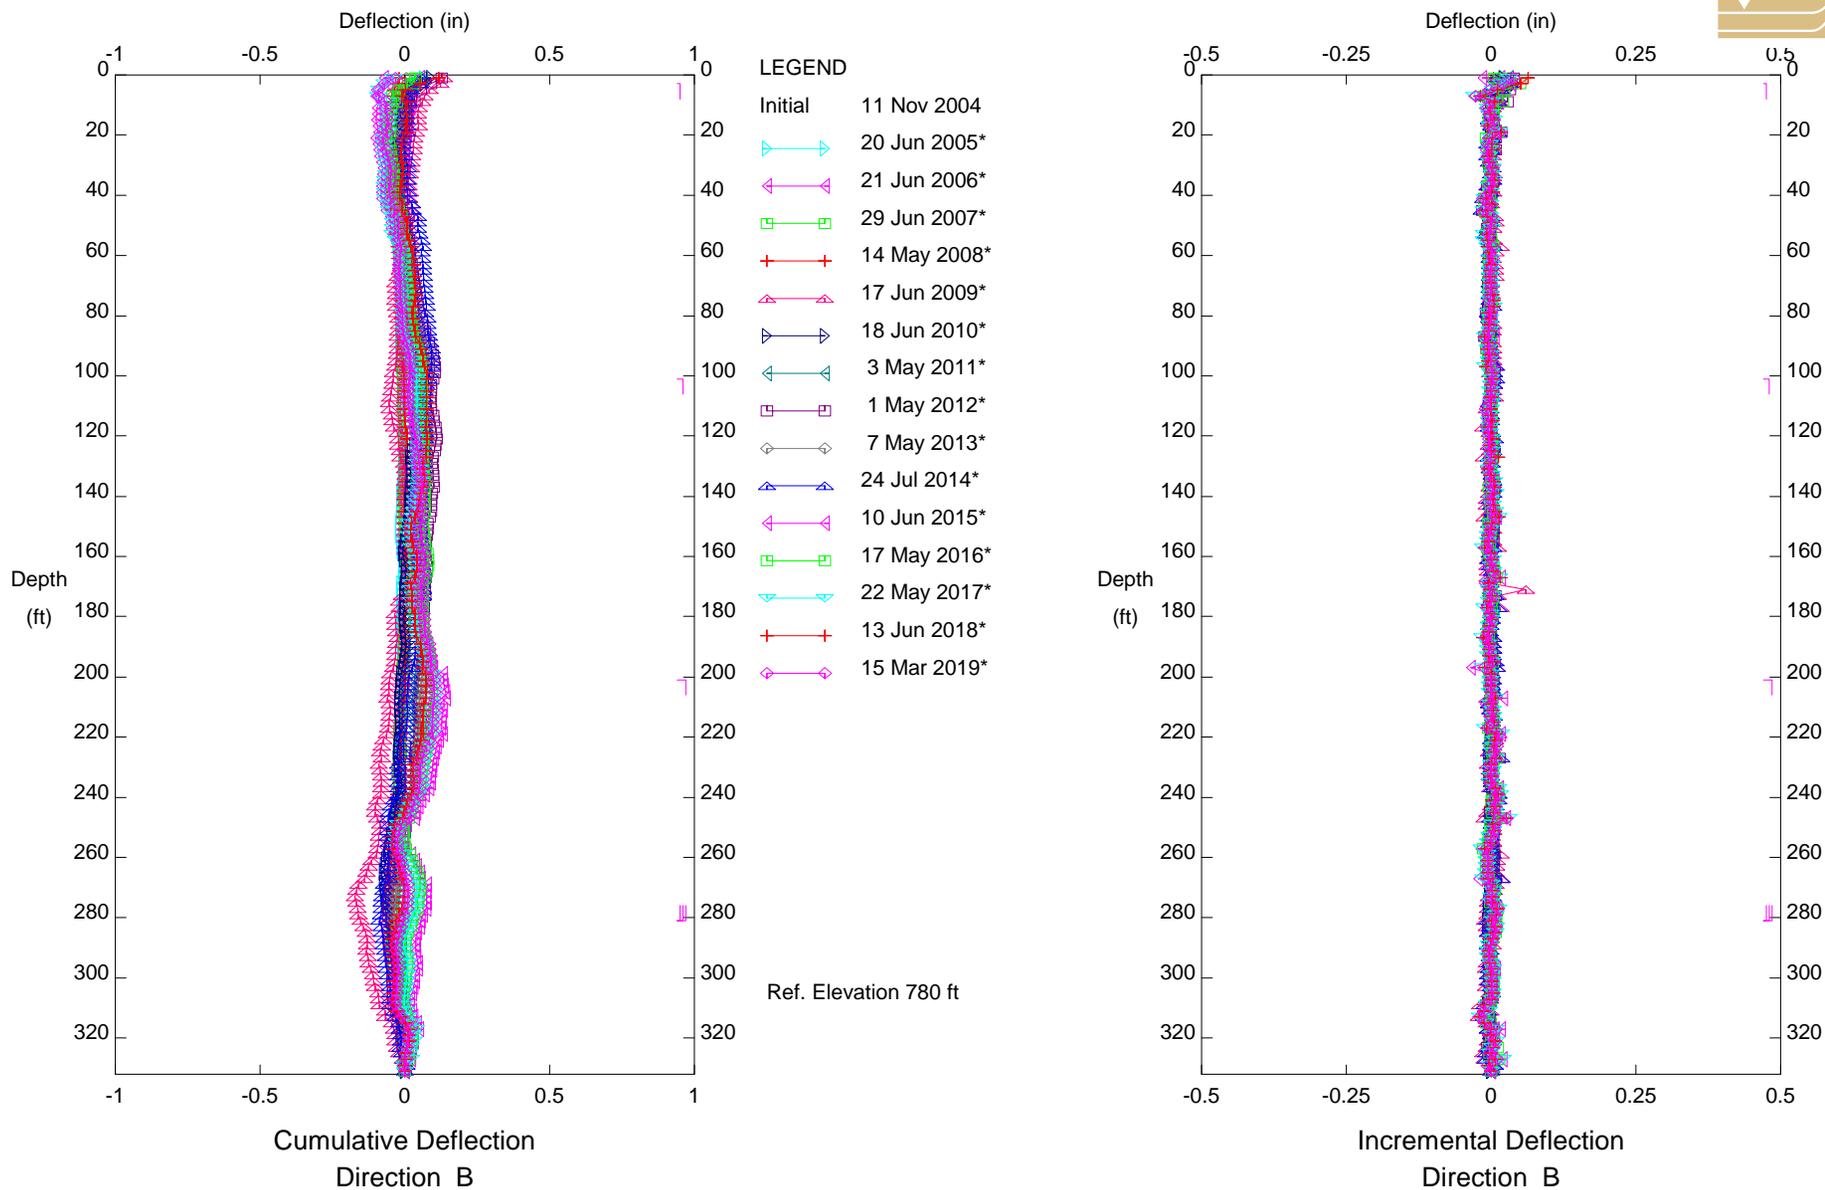
**BIG ROCK MESA, Inclinator SP-22
 WESTERN REGION**

Sets marked * include zero shift and/or rotation corrections.

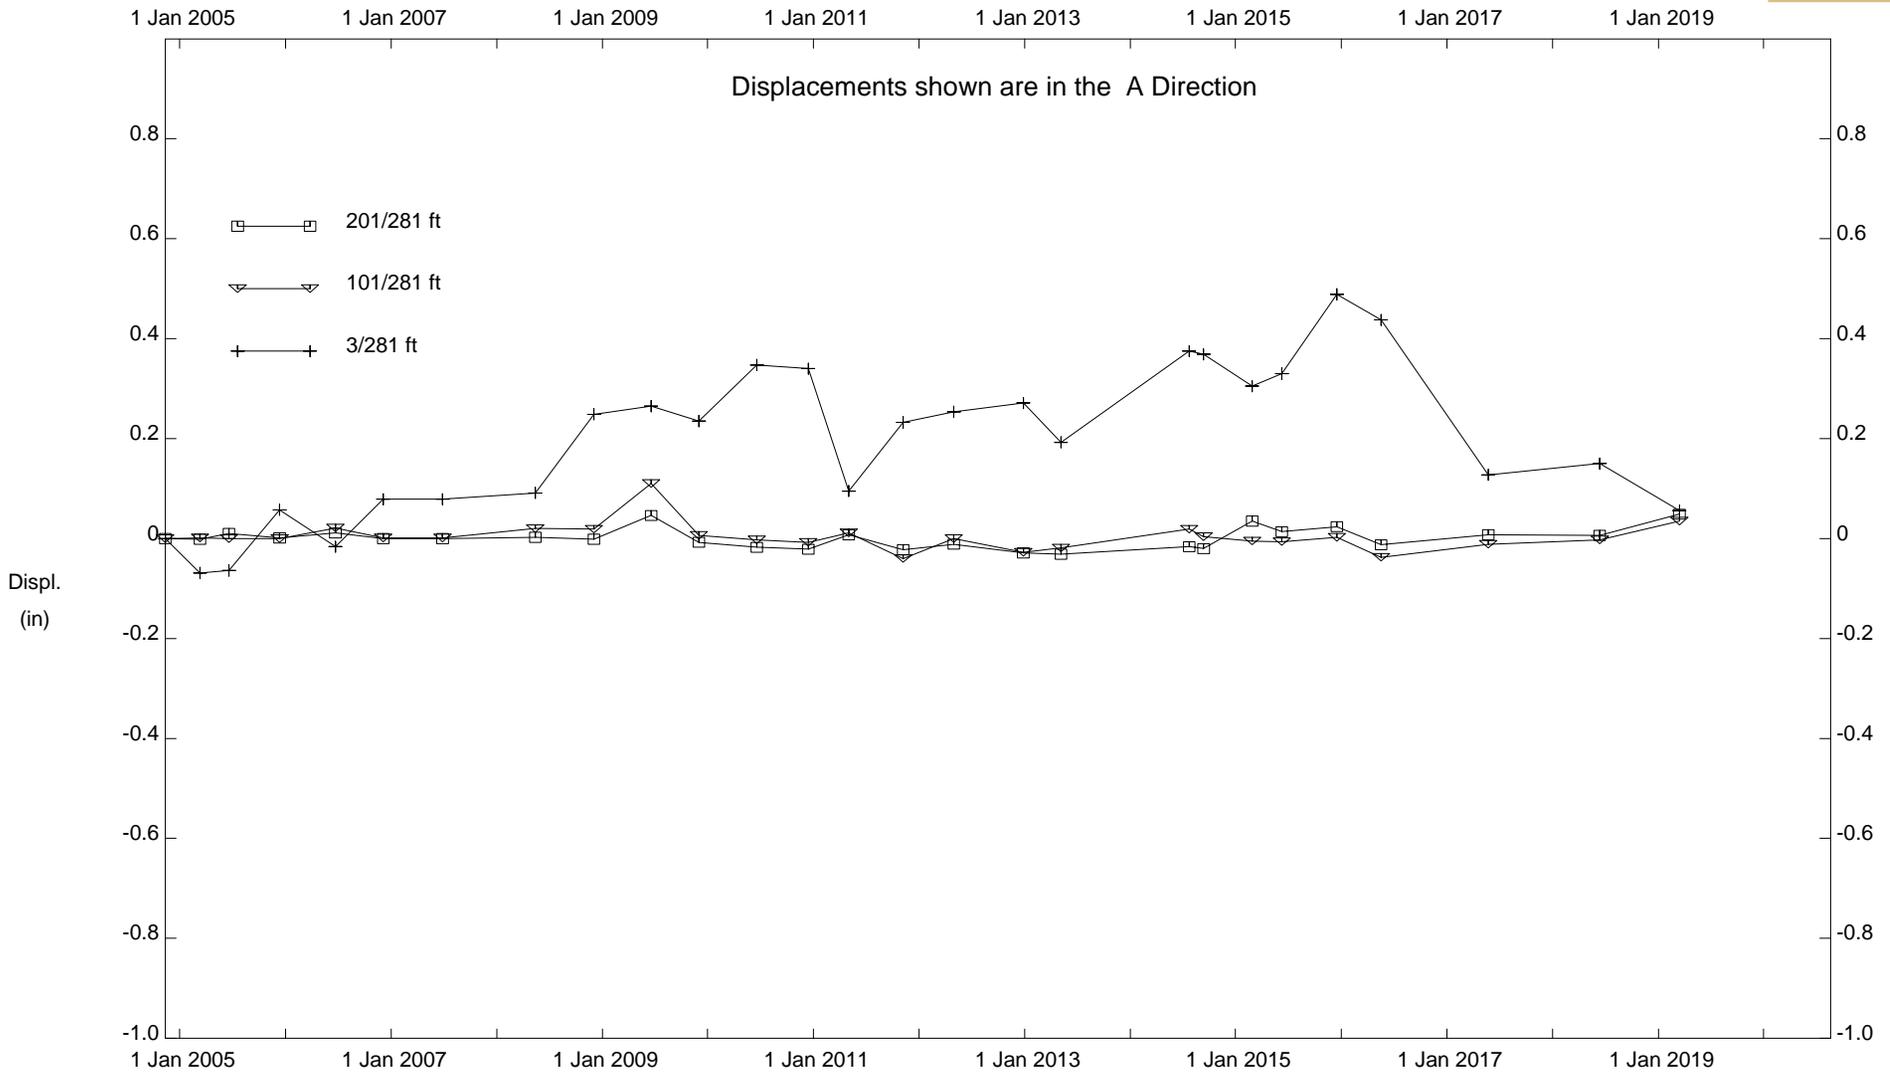
BIG ROCK MESA, Inclinometer SP-22

WESTERN REGION

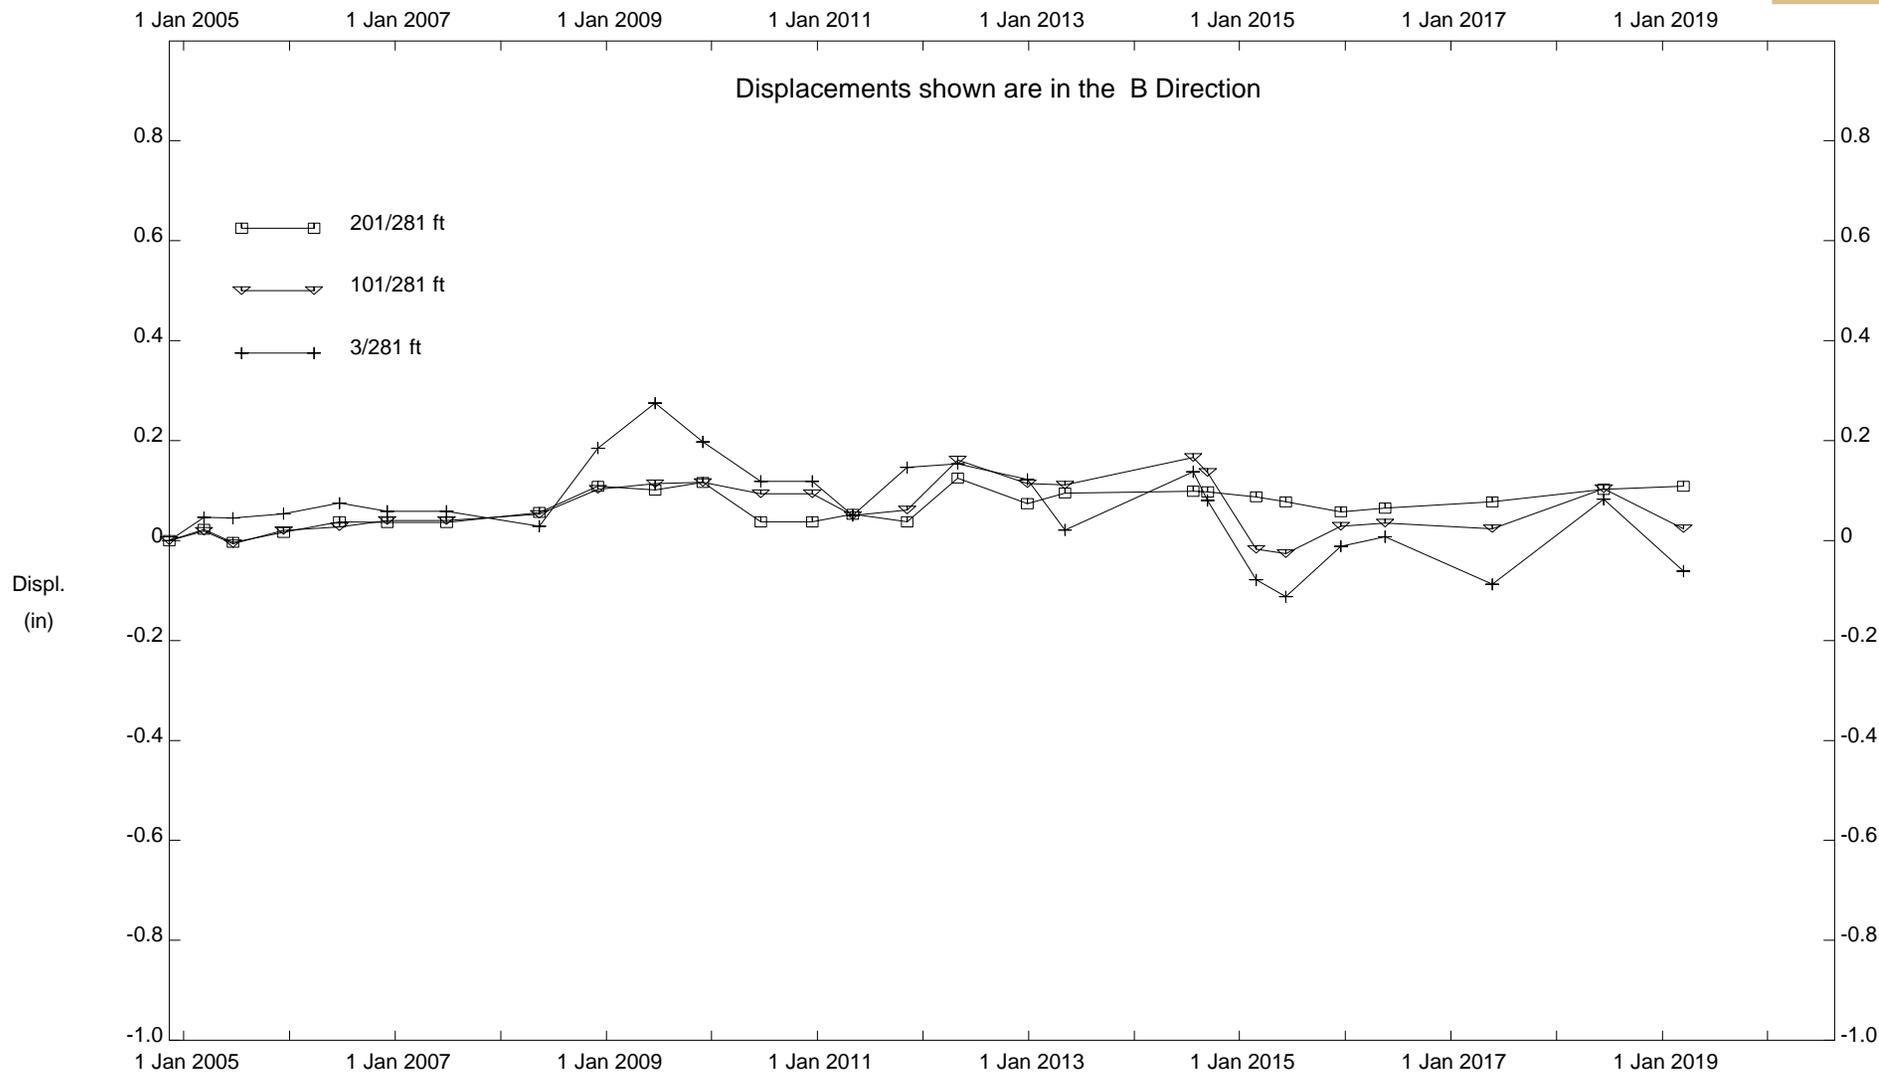
BIG ROCK MESA, Inclinometer SP-22

WESTERN REGION

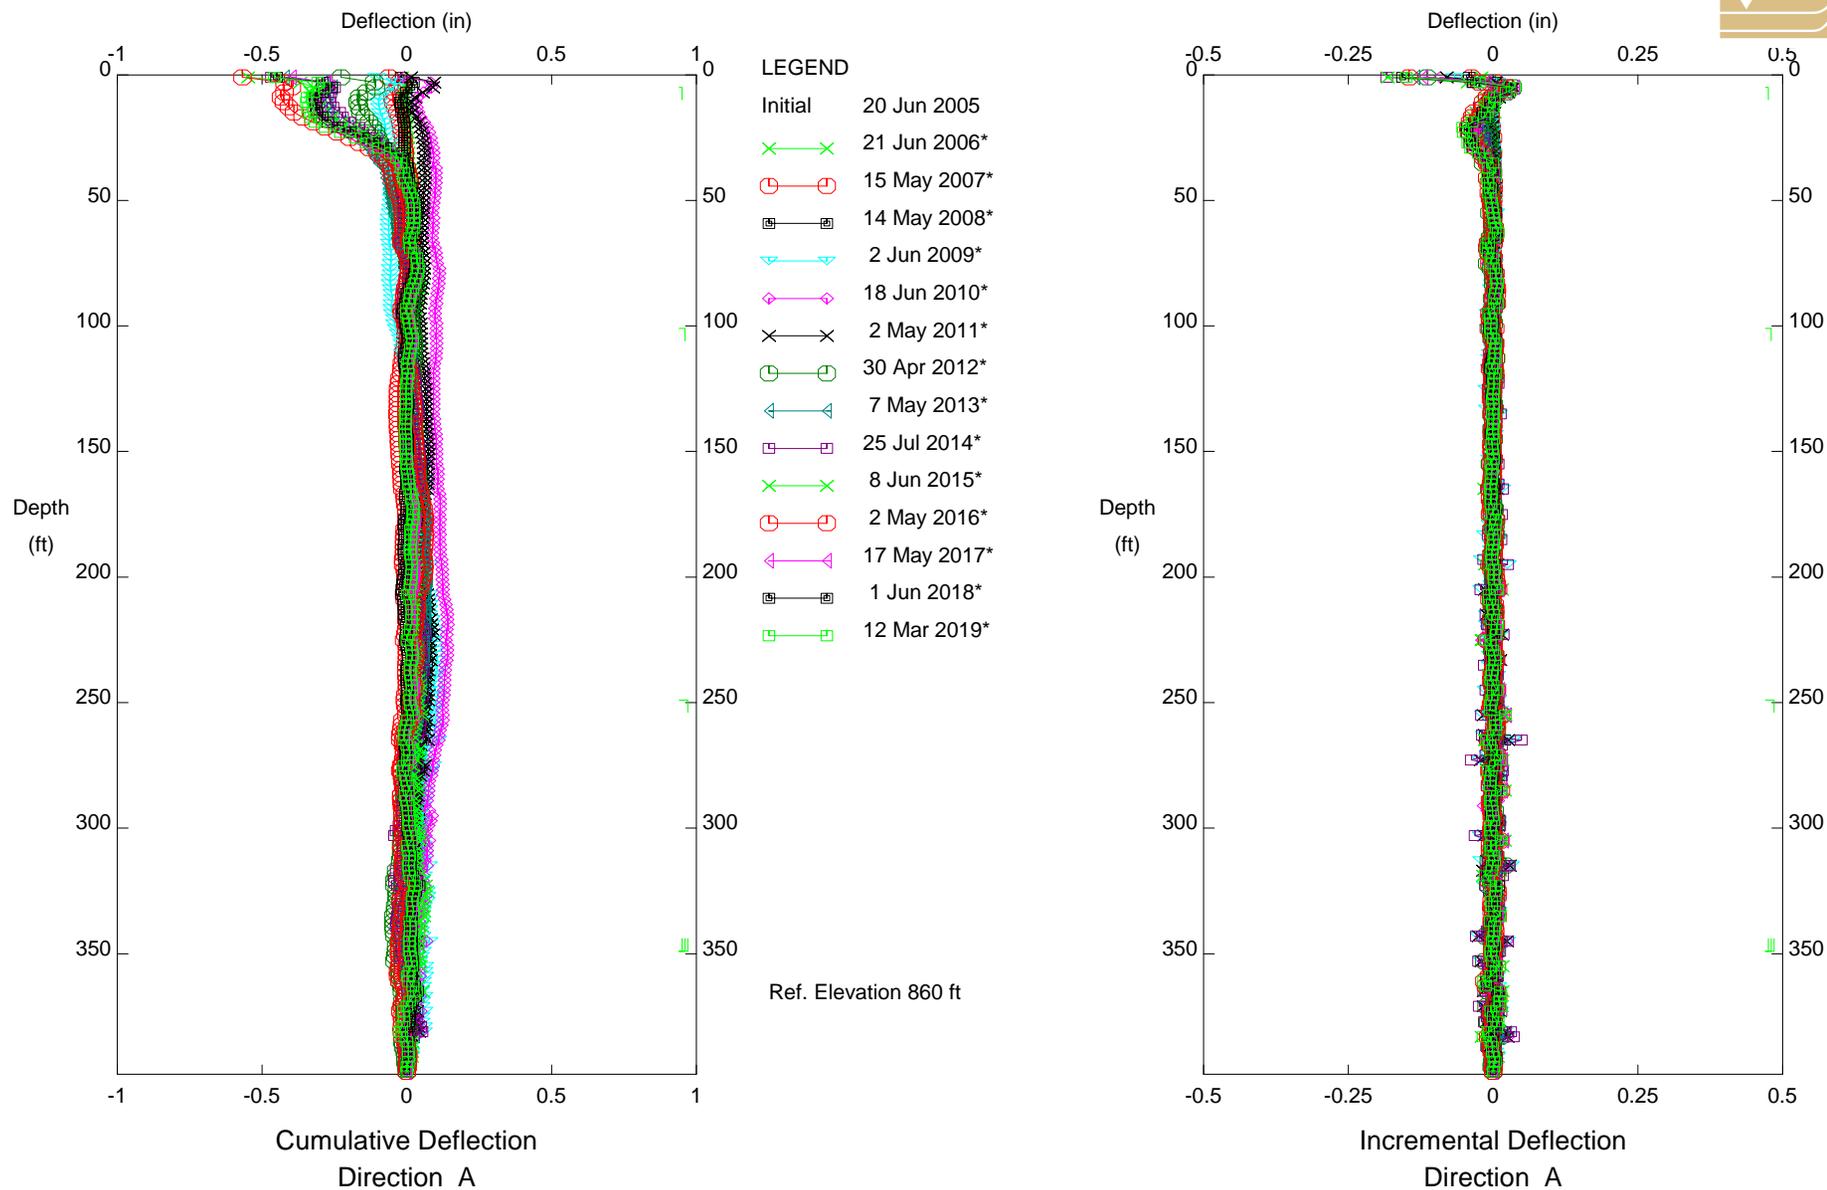
**BIG ROCK MESA, Inclinometer SP-23
 WESTERN REGION**

Sets marked * include zero shift and/or rotation corrections.

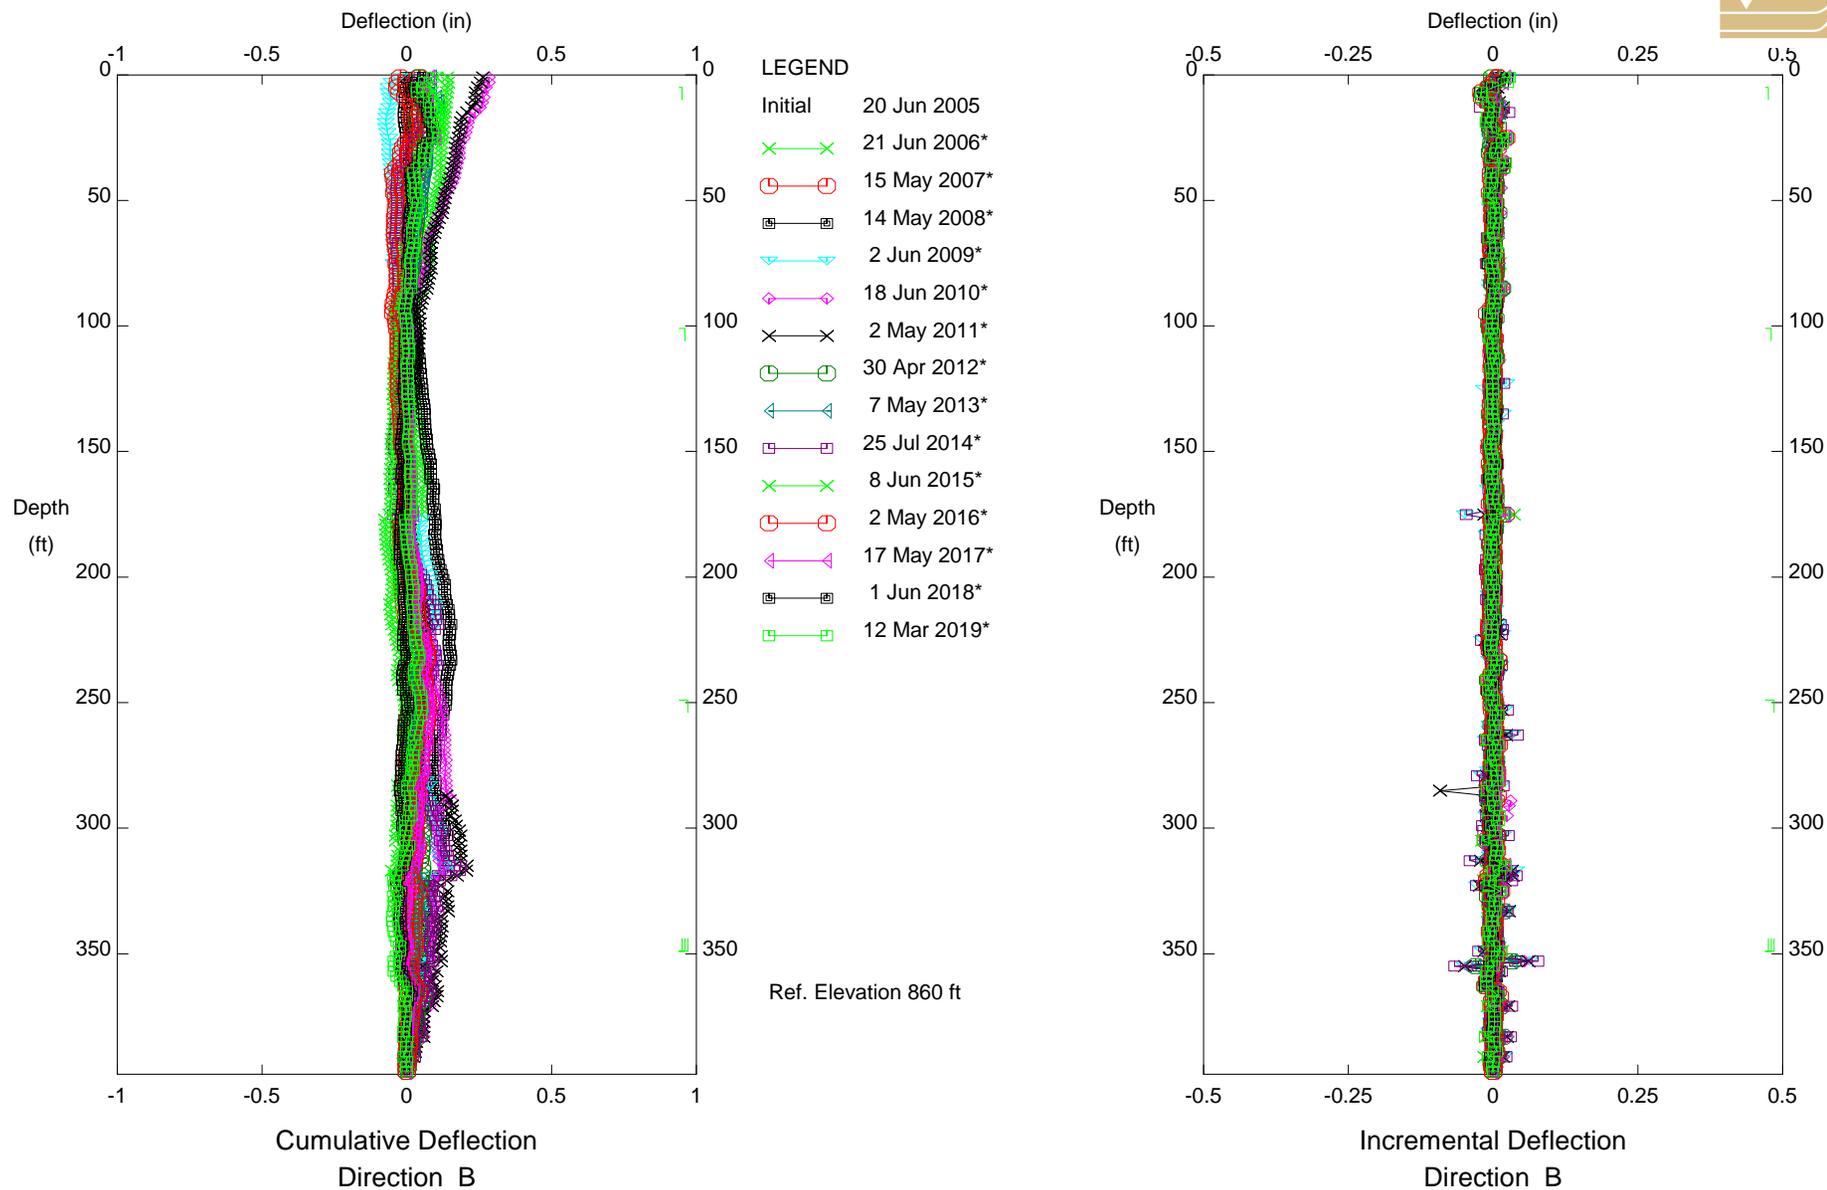
PLATE D27-2

**BIG ROCK MESA, Inclinometer SP-23
 WESTERN REGION**

Sets marked * include zero shift and/or rotation corrections.
