**ANNUAL REPORT
JULY 2018 THROUGH JUNE 2019
BIG ROCK MESA LANDSLIDE
ASSESSMENT DISTRICT
City of Malibu, California**

November 2019
Fugro Project No. 04.62160606
Document No. 04.62160606-PR-006(Rev.00)

Annual Report of Maintenance and Monitoring, July 2018 through June 2019, Big Rock Mesa Landslide Assessment District, City of Malibu, California

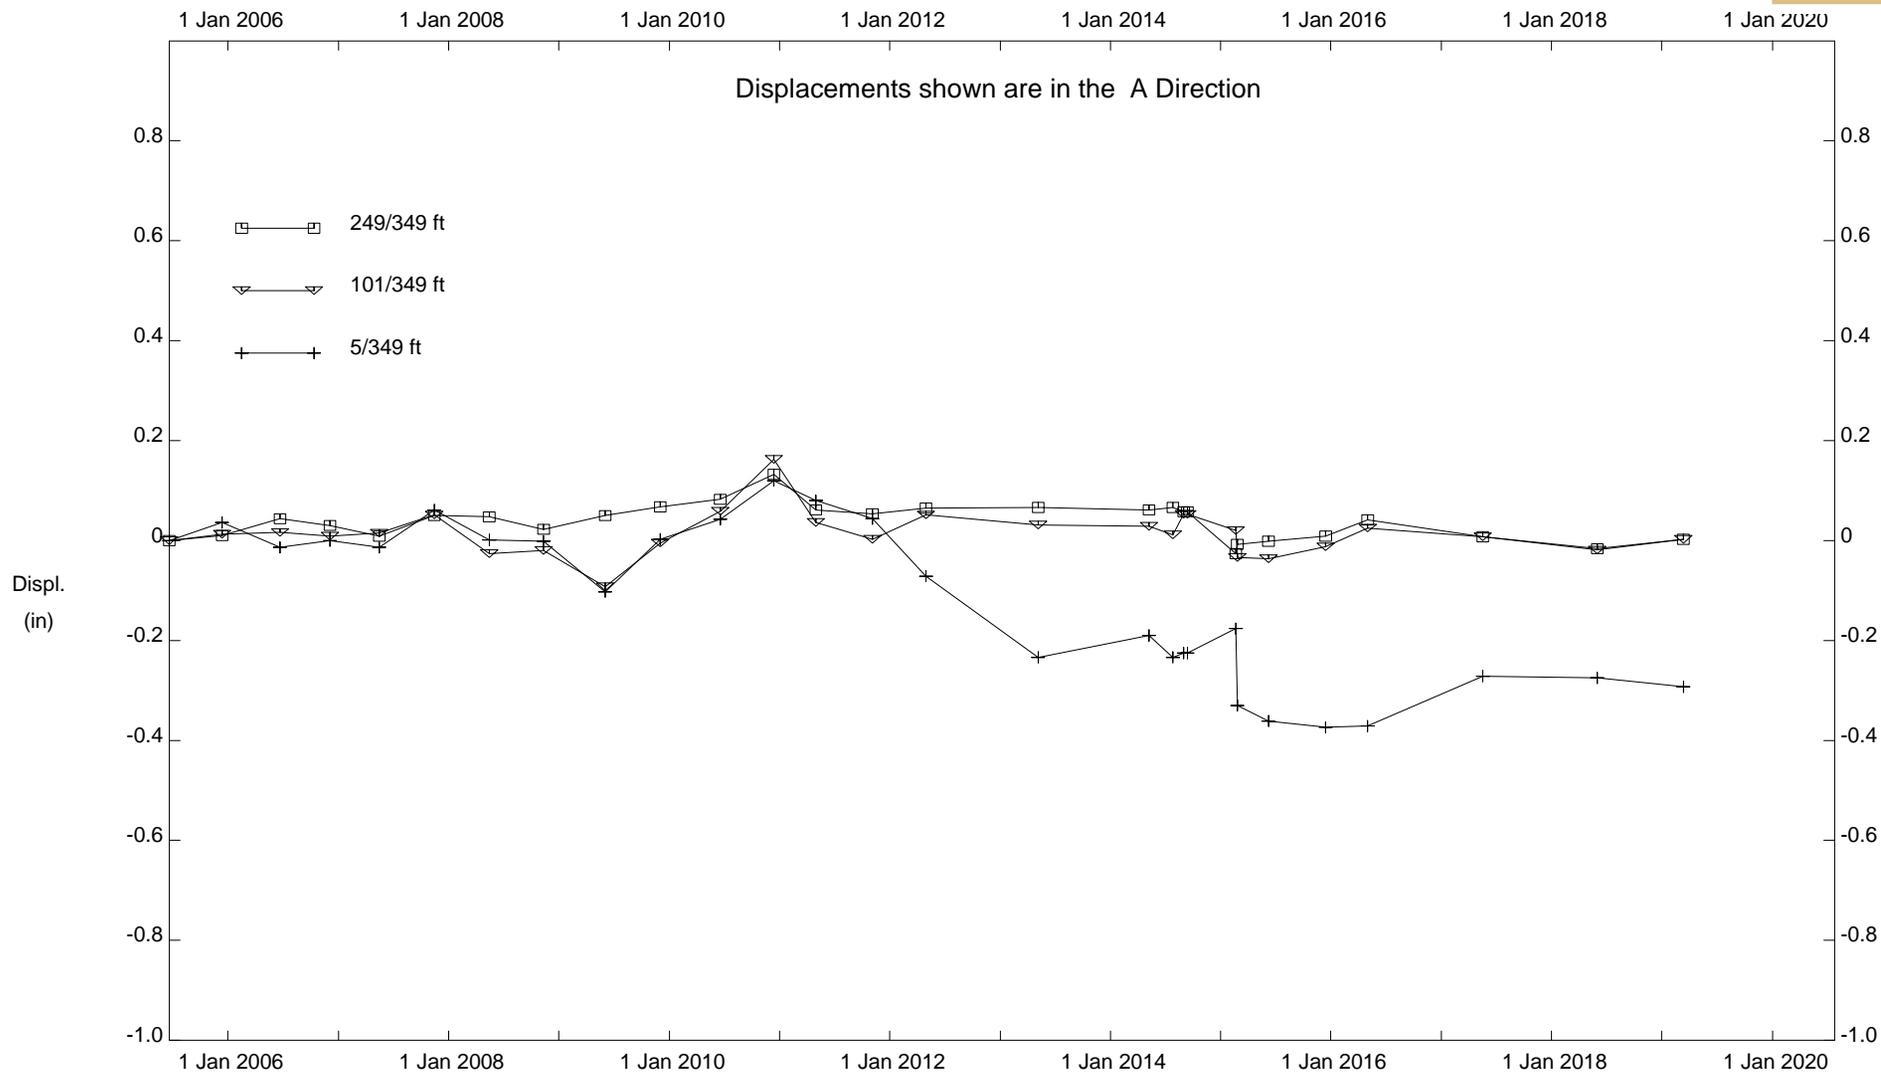
BIG ROCK MESA, Inclinometer SP-23

WESTERN REGION

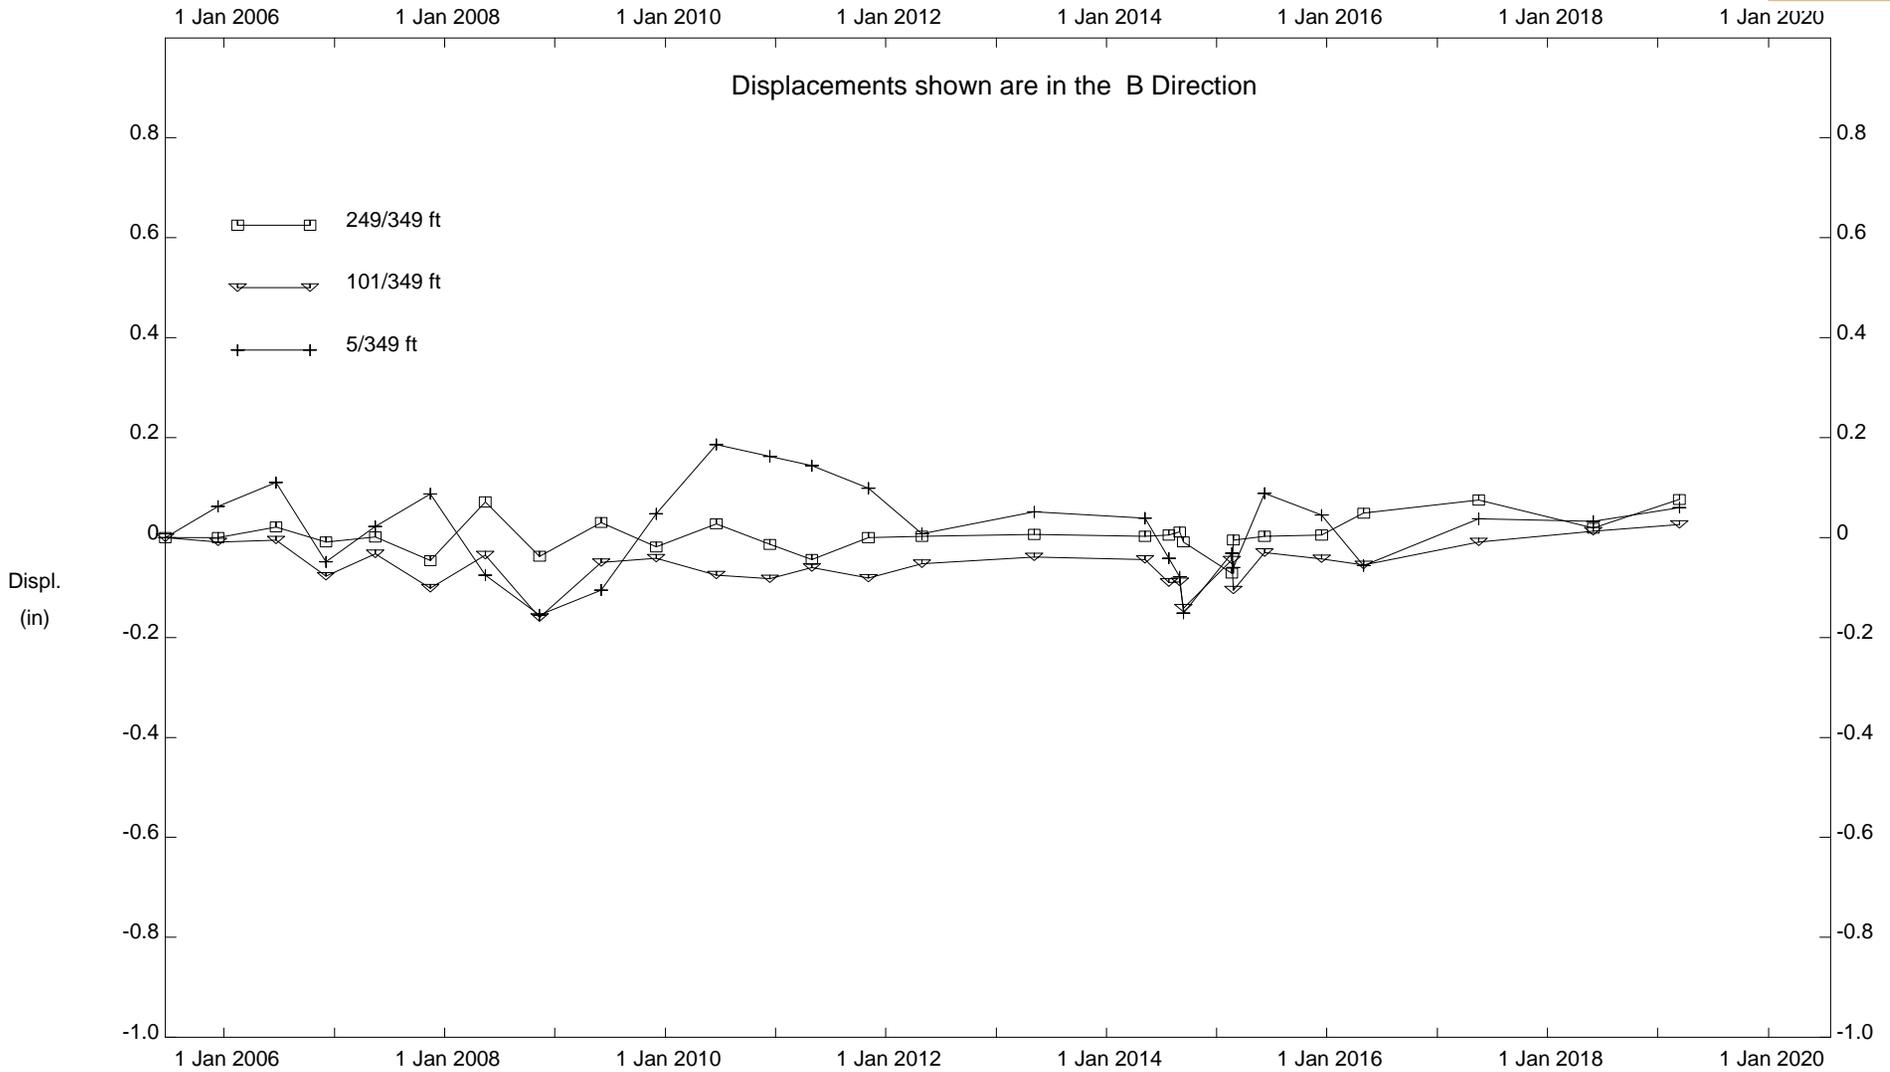
BIG ROCK MESA, Inclinometer SP-23

WESTERN REGION

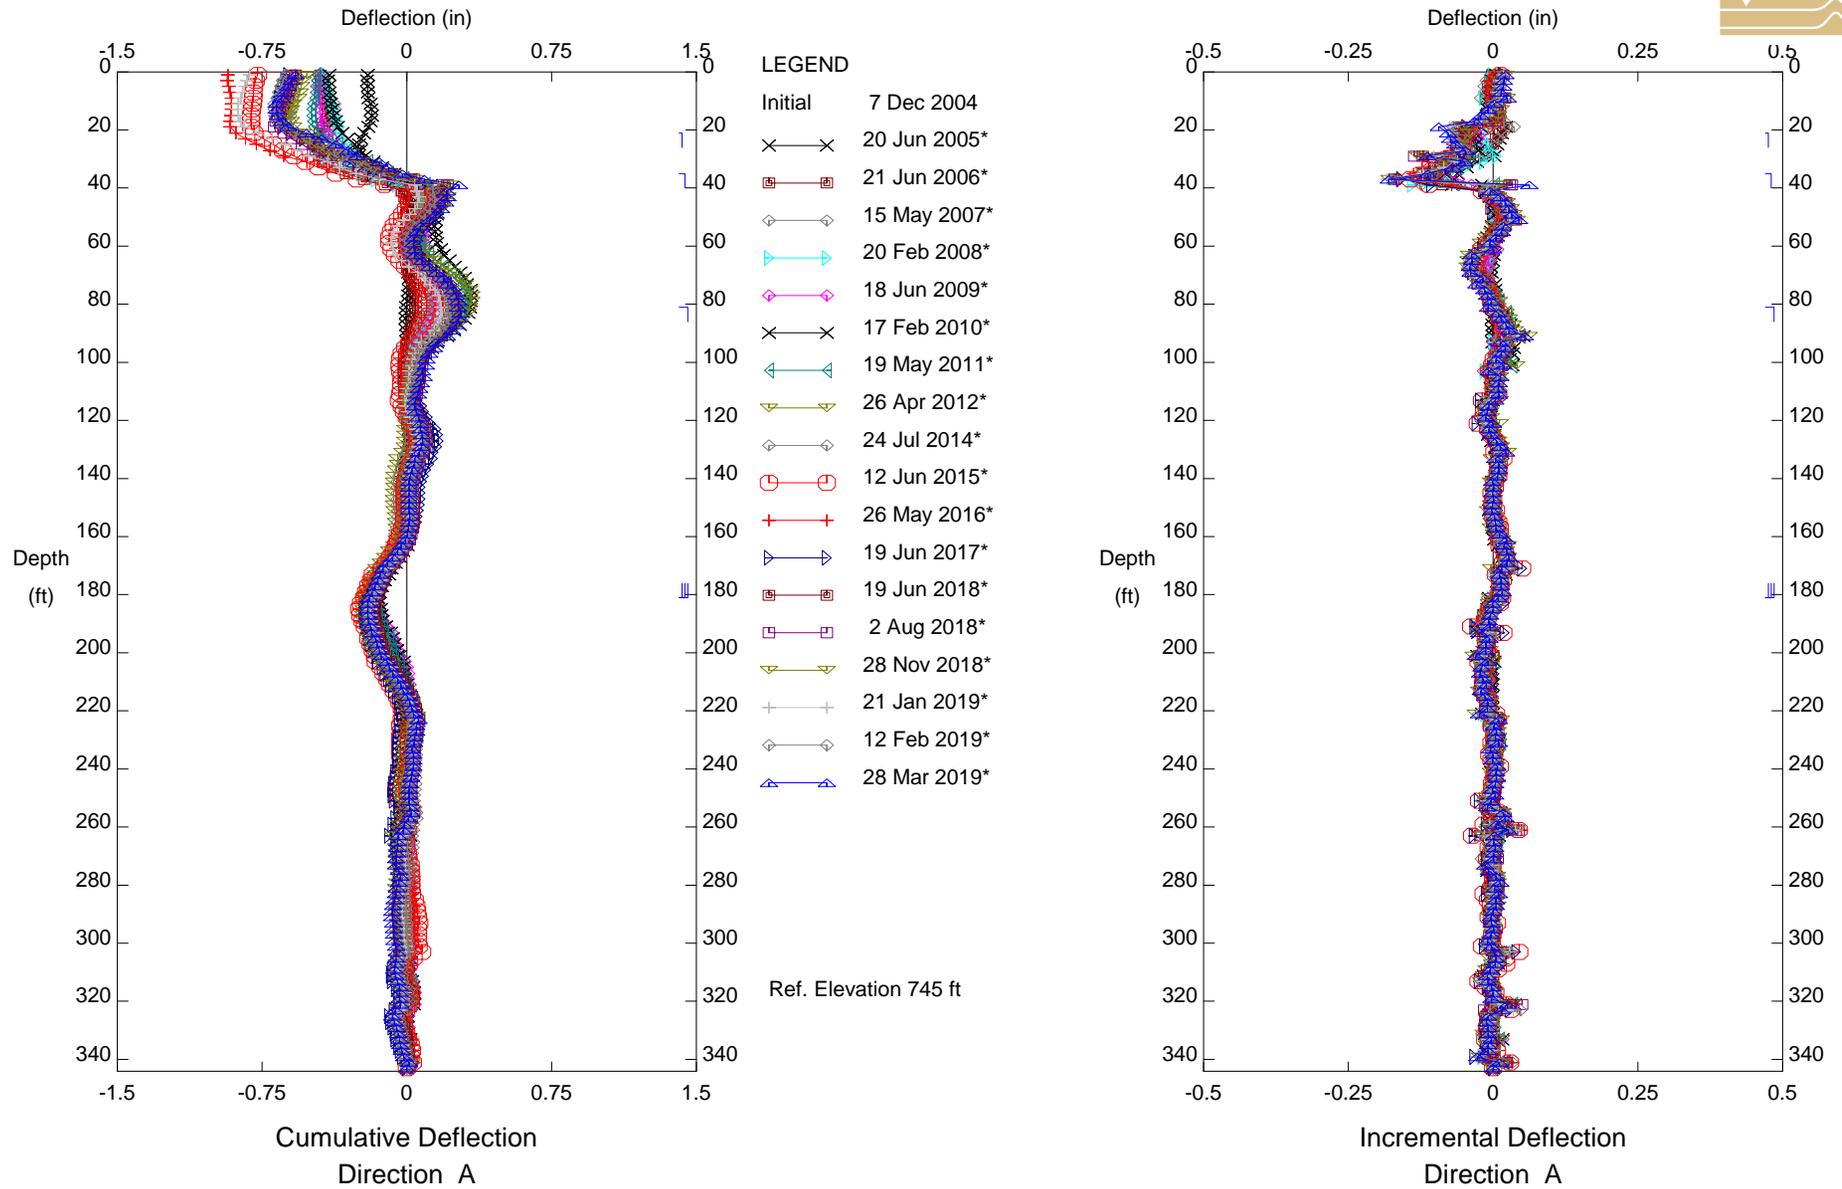
**BIG ROCK MESA, Inclinometer SP-26
 HEADSCARP REGION**

Sets marked * include zero shift and/or rotation corrections.

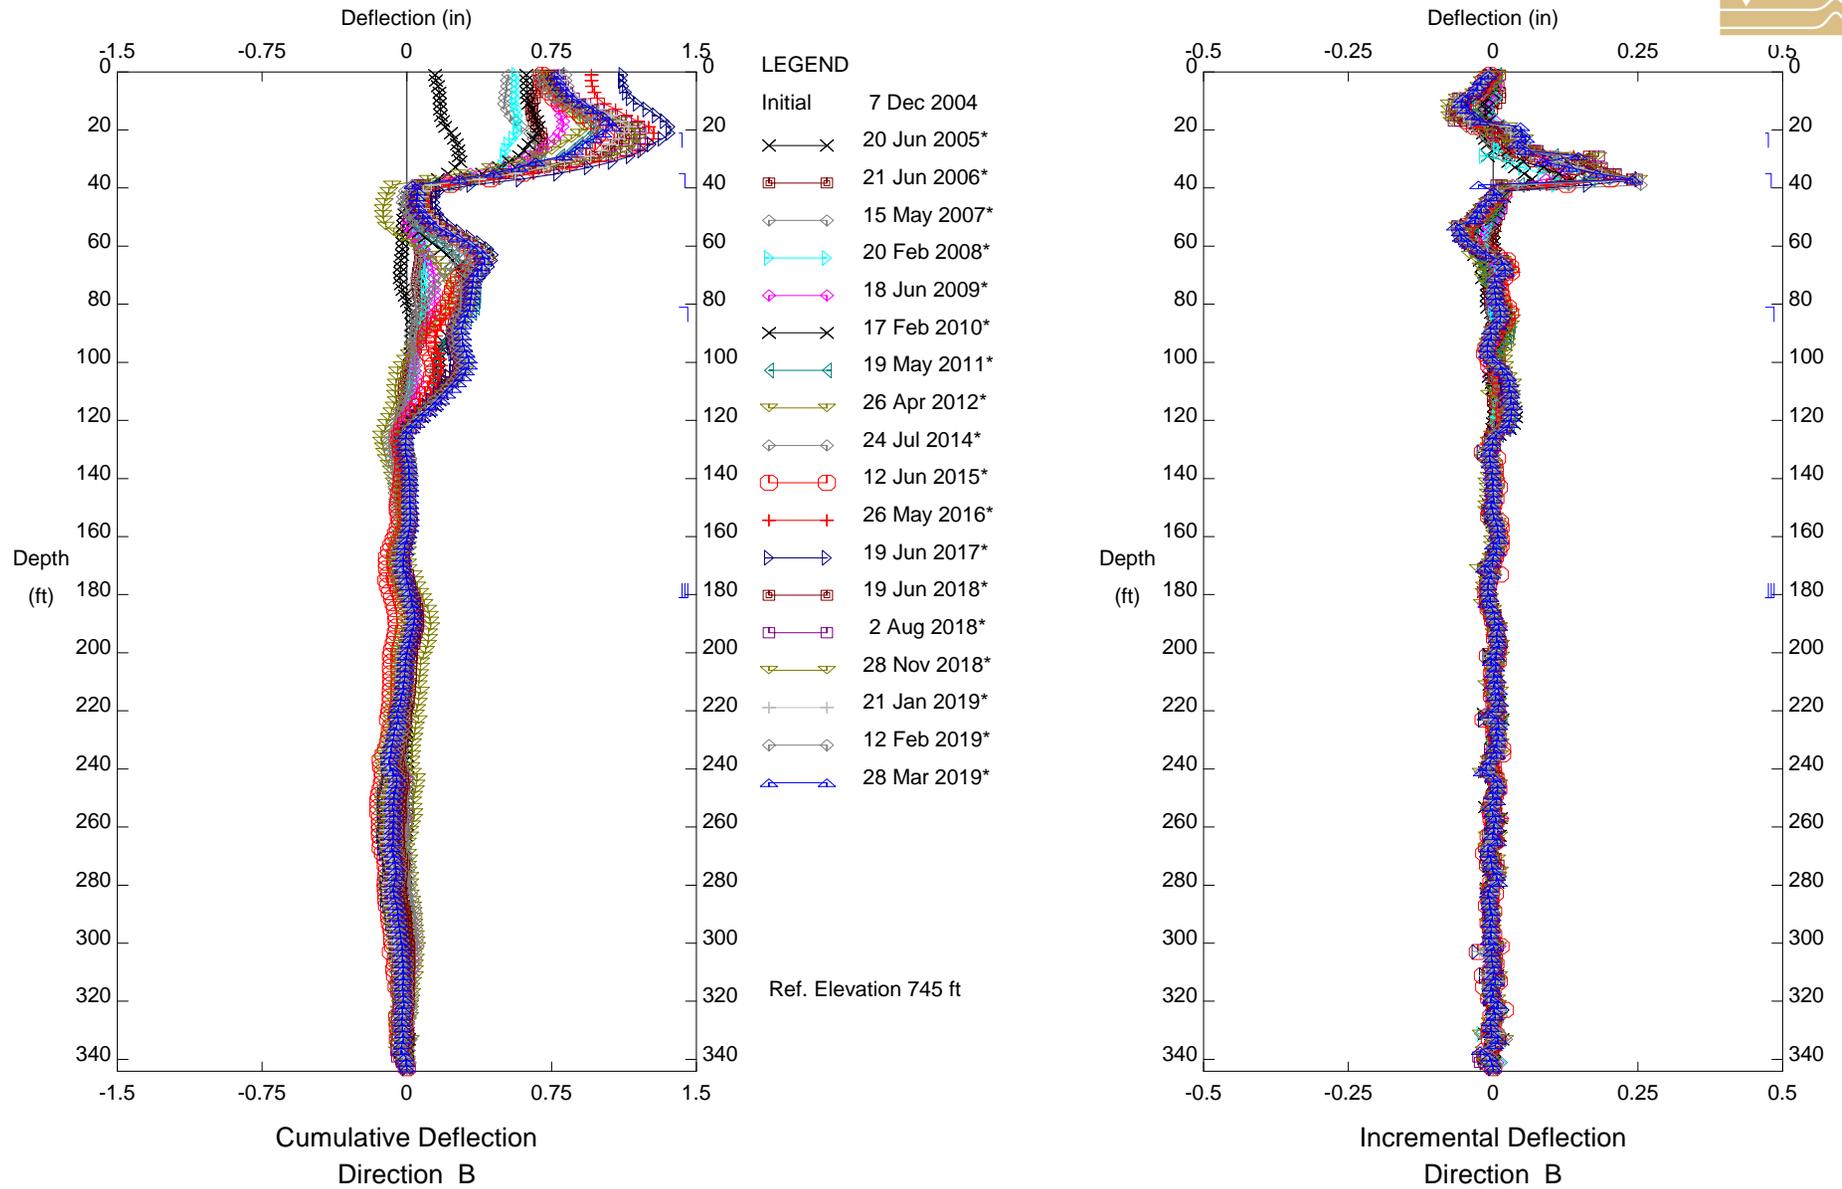
**BIG ROCK MESA, Inclinometer SP-26
 HEADSCARP REGION**

Sets marked * include zero shift and/or rotation corrections.

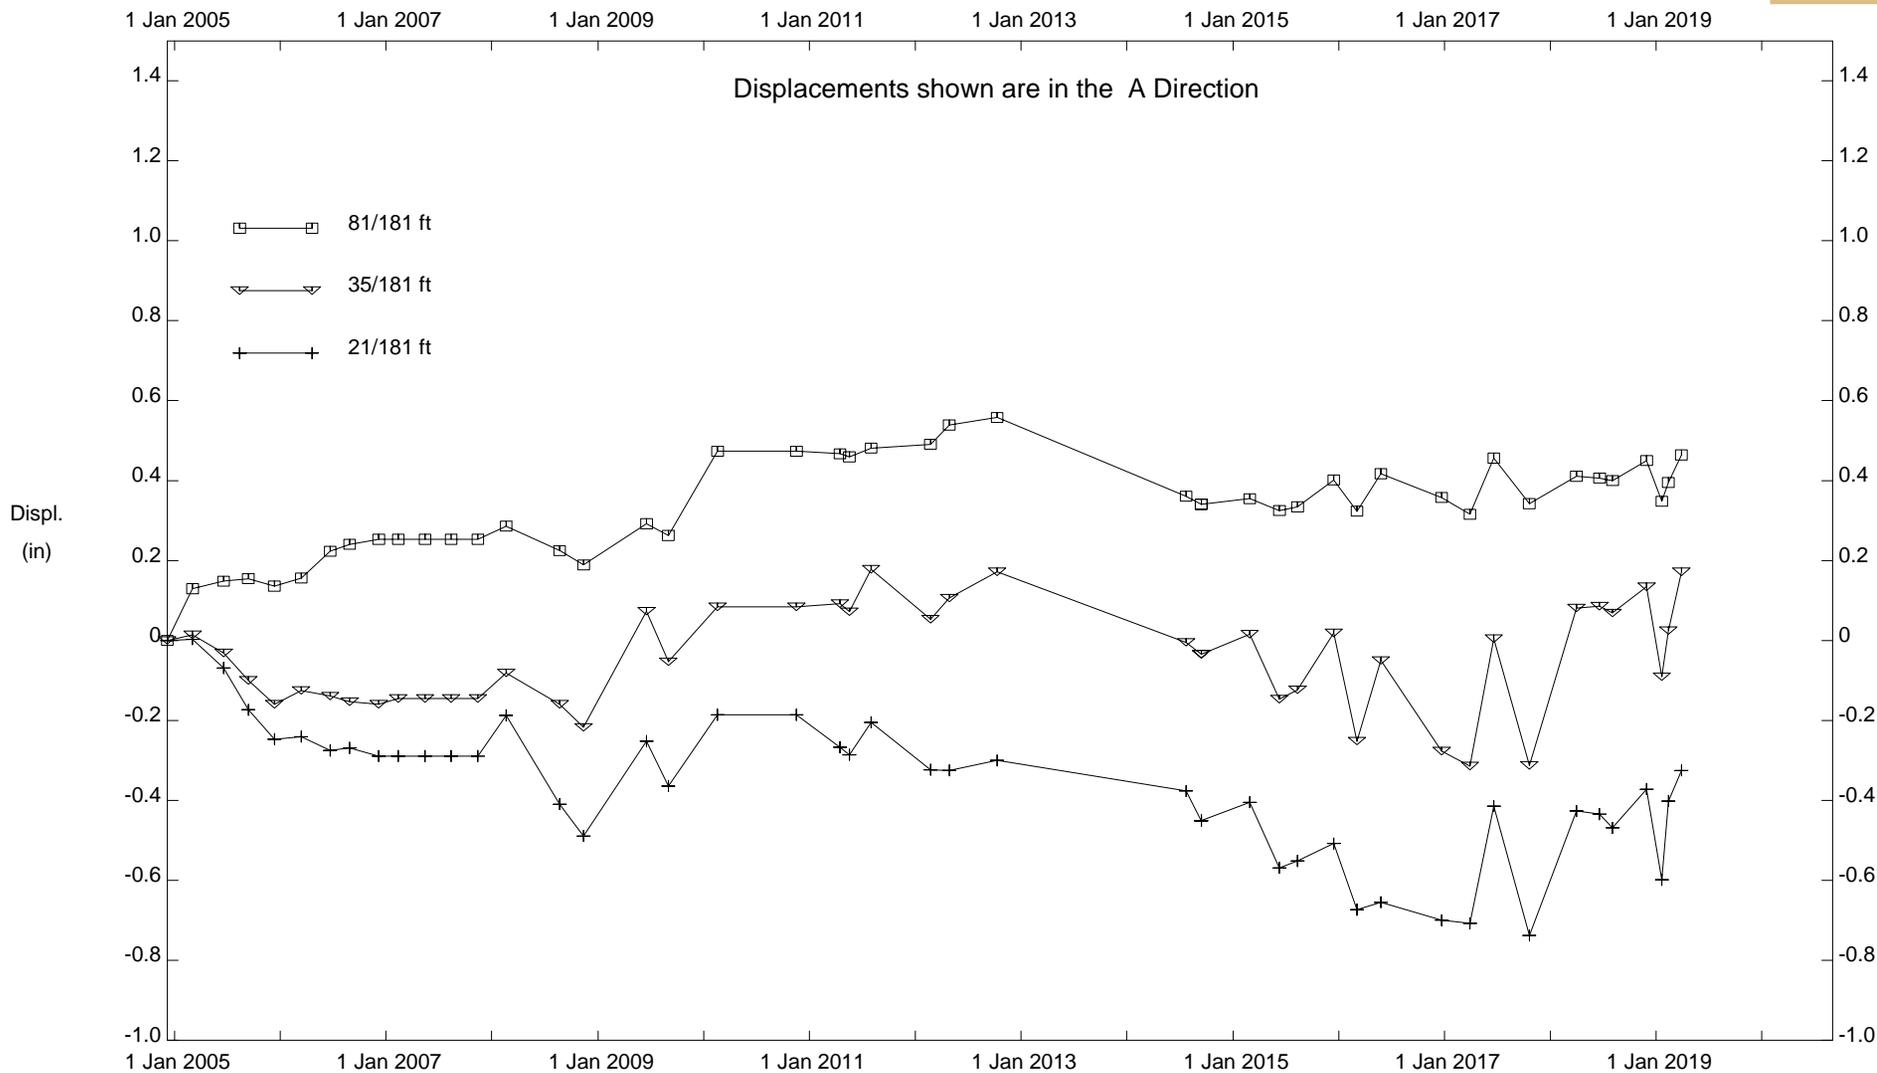
BIG ROCK MESA, Inclinometer SP-26

HEADSCARP REGION

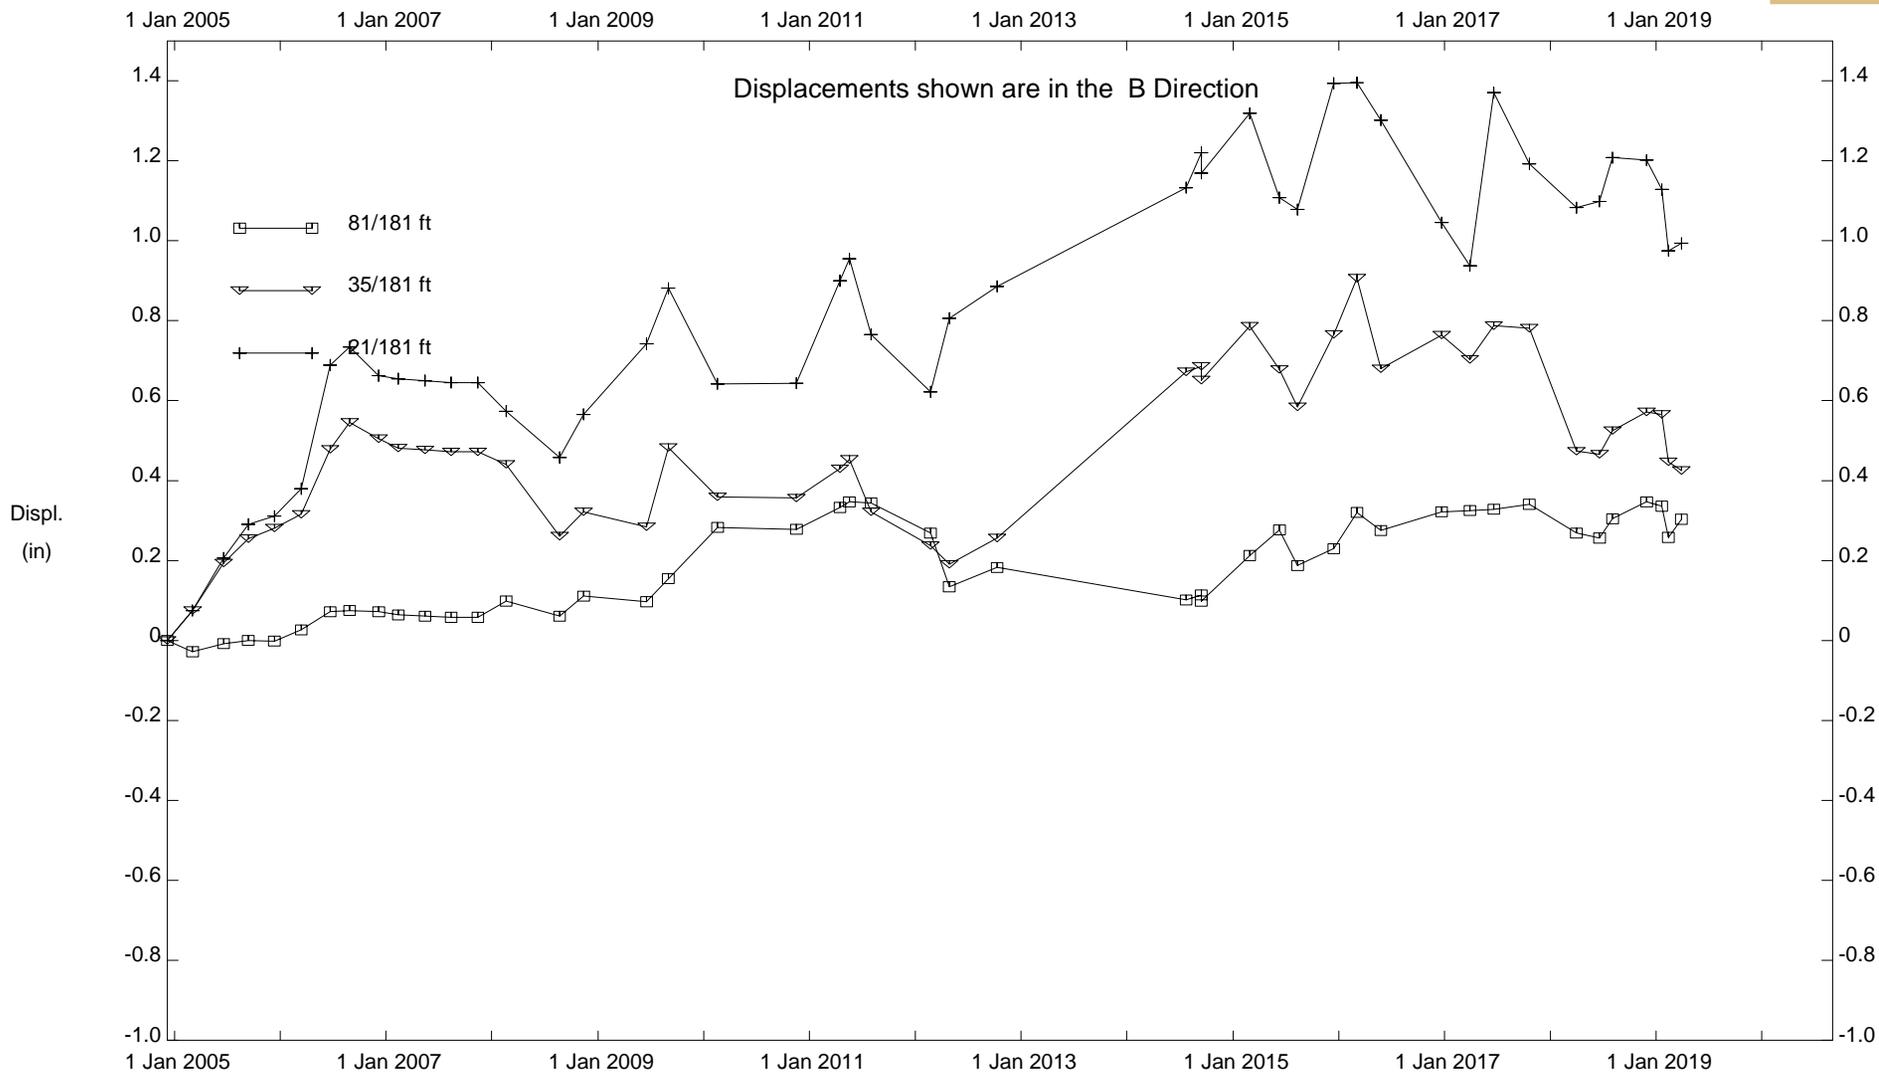
BIG ROCK MESA, Inclinometer SP-26

HEADSCARP REGION
