**ANNUAL REPORT
JULY 2019 THROUGH JUNE 2020
BIG ROCK MESA LANDSLIDE
ASSESSMENT DISTRICT
City of Malibu, California**

Fugro Project No. 04.62160606

Document No. 04.62160606-PR-007(Rev.00)

**Annual Report of Maintenance and Monitoring, July 2019 through June 2020,
Big Rock Mesa Landslide Assessment District, City of Malibu, California**

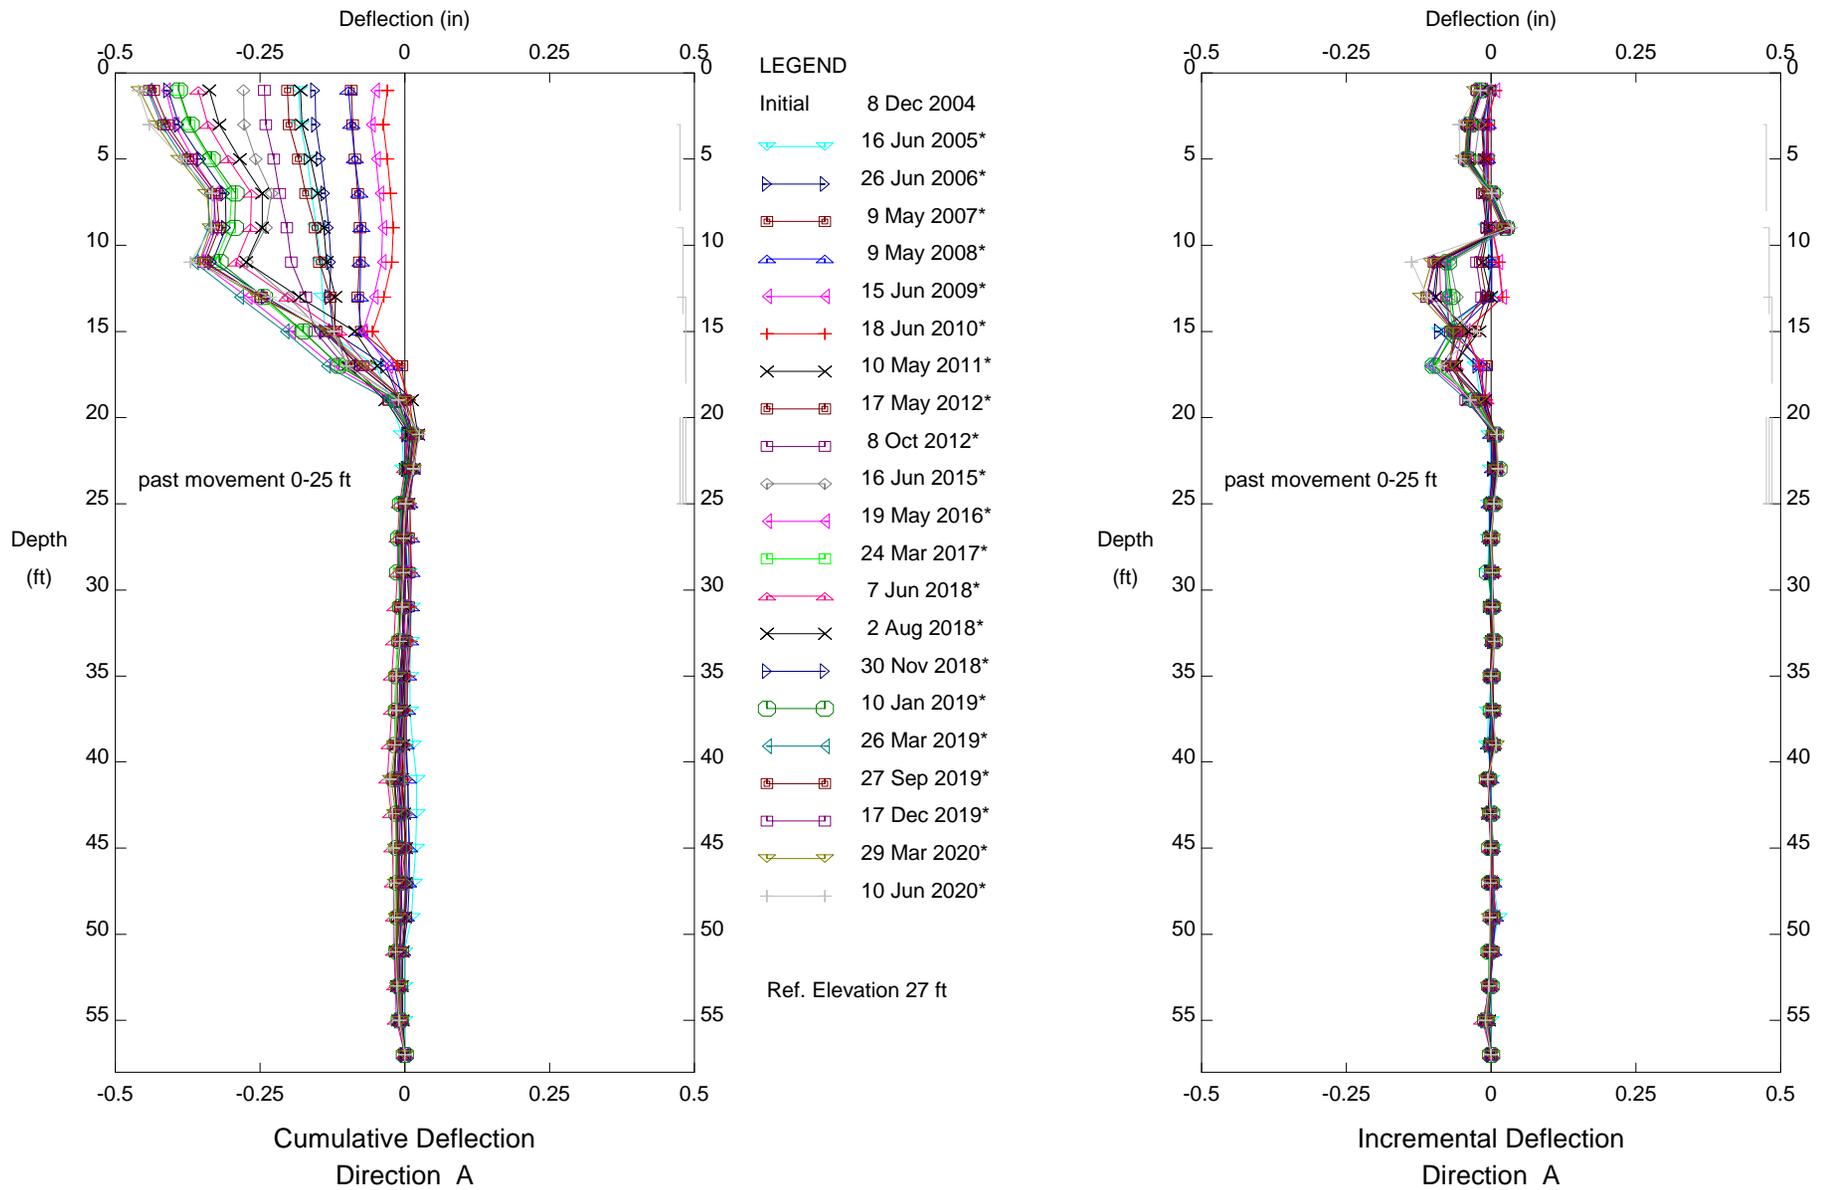
BIG ROCK MESA, Inclinometer SP-11
PCH REGION

Sets marked * include zero shift and/or rotation corrections.

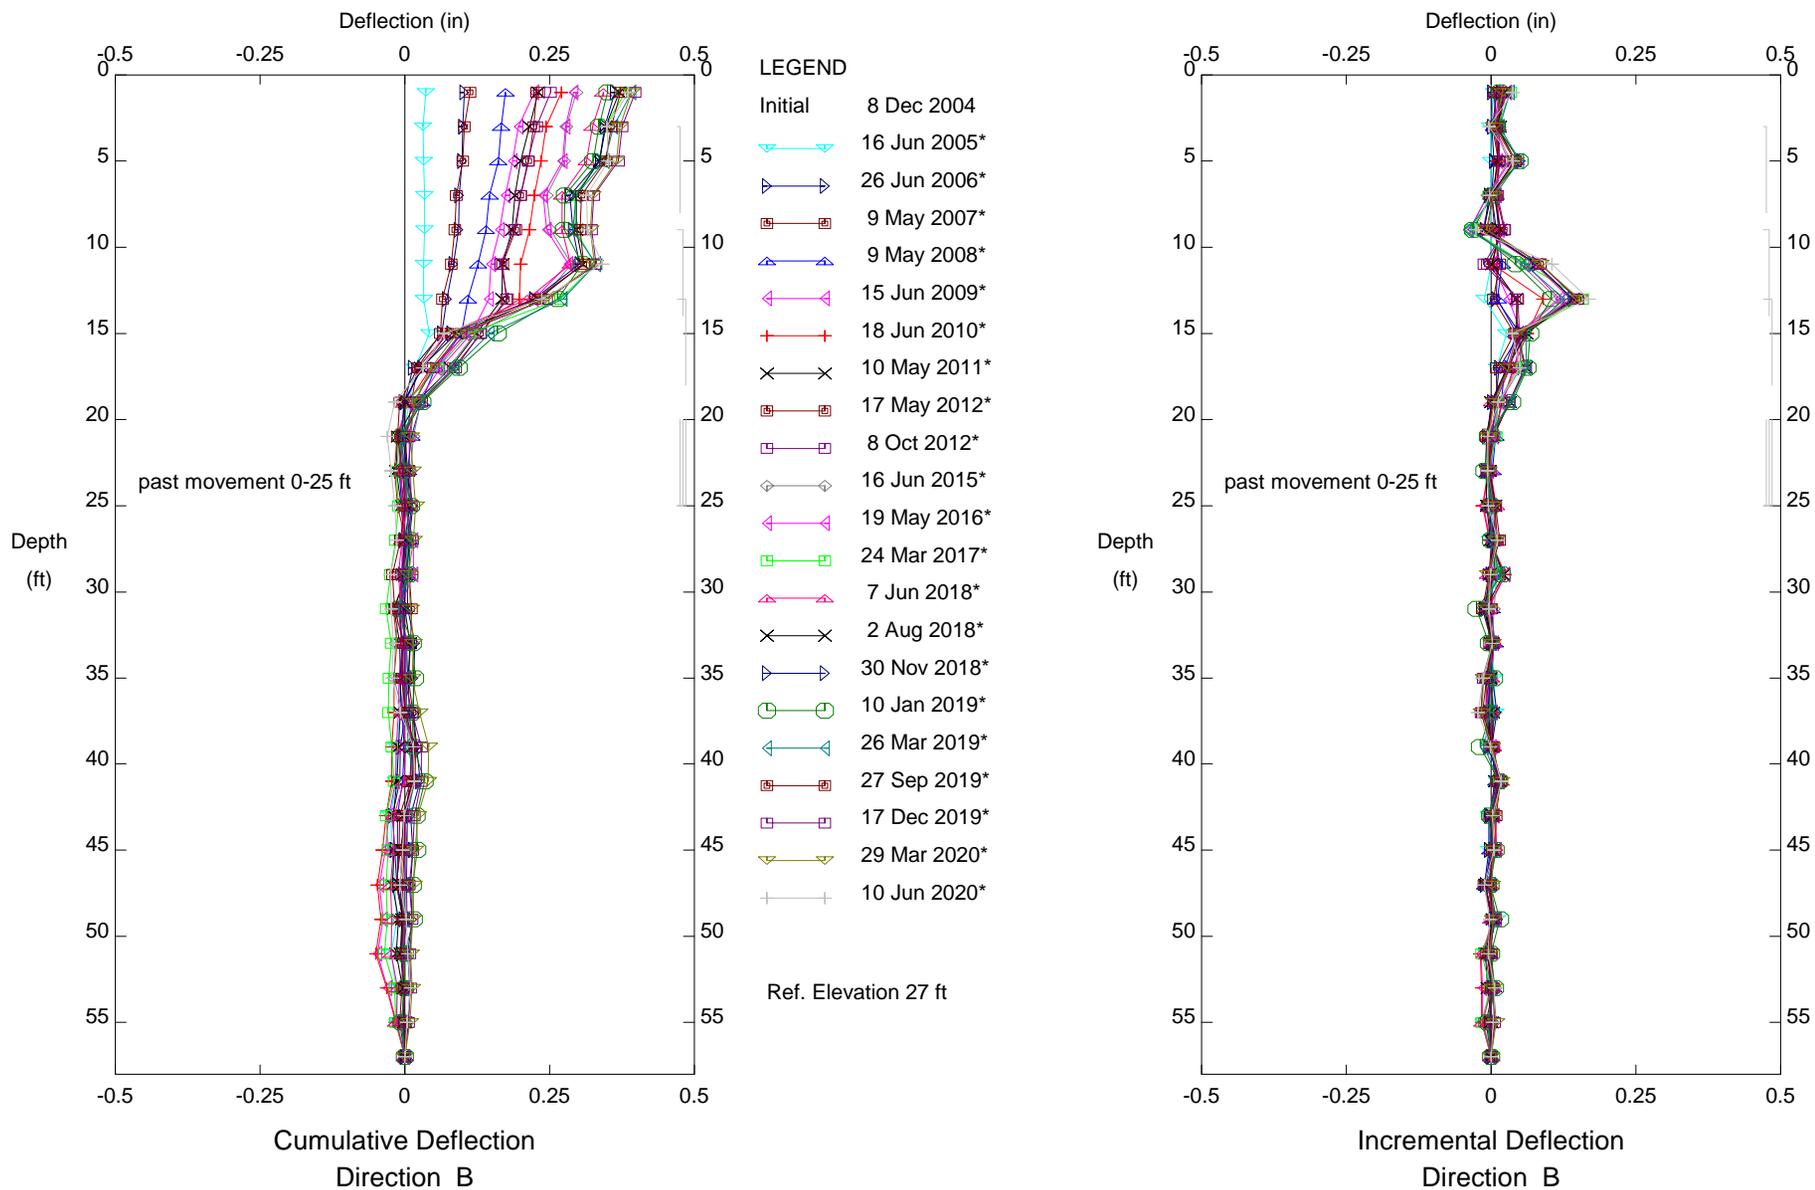
BIG ROCK MESA, Inclinator SP-11
PCH REGION

Sets marked * include zero shift and/or rotation corrections.

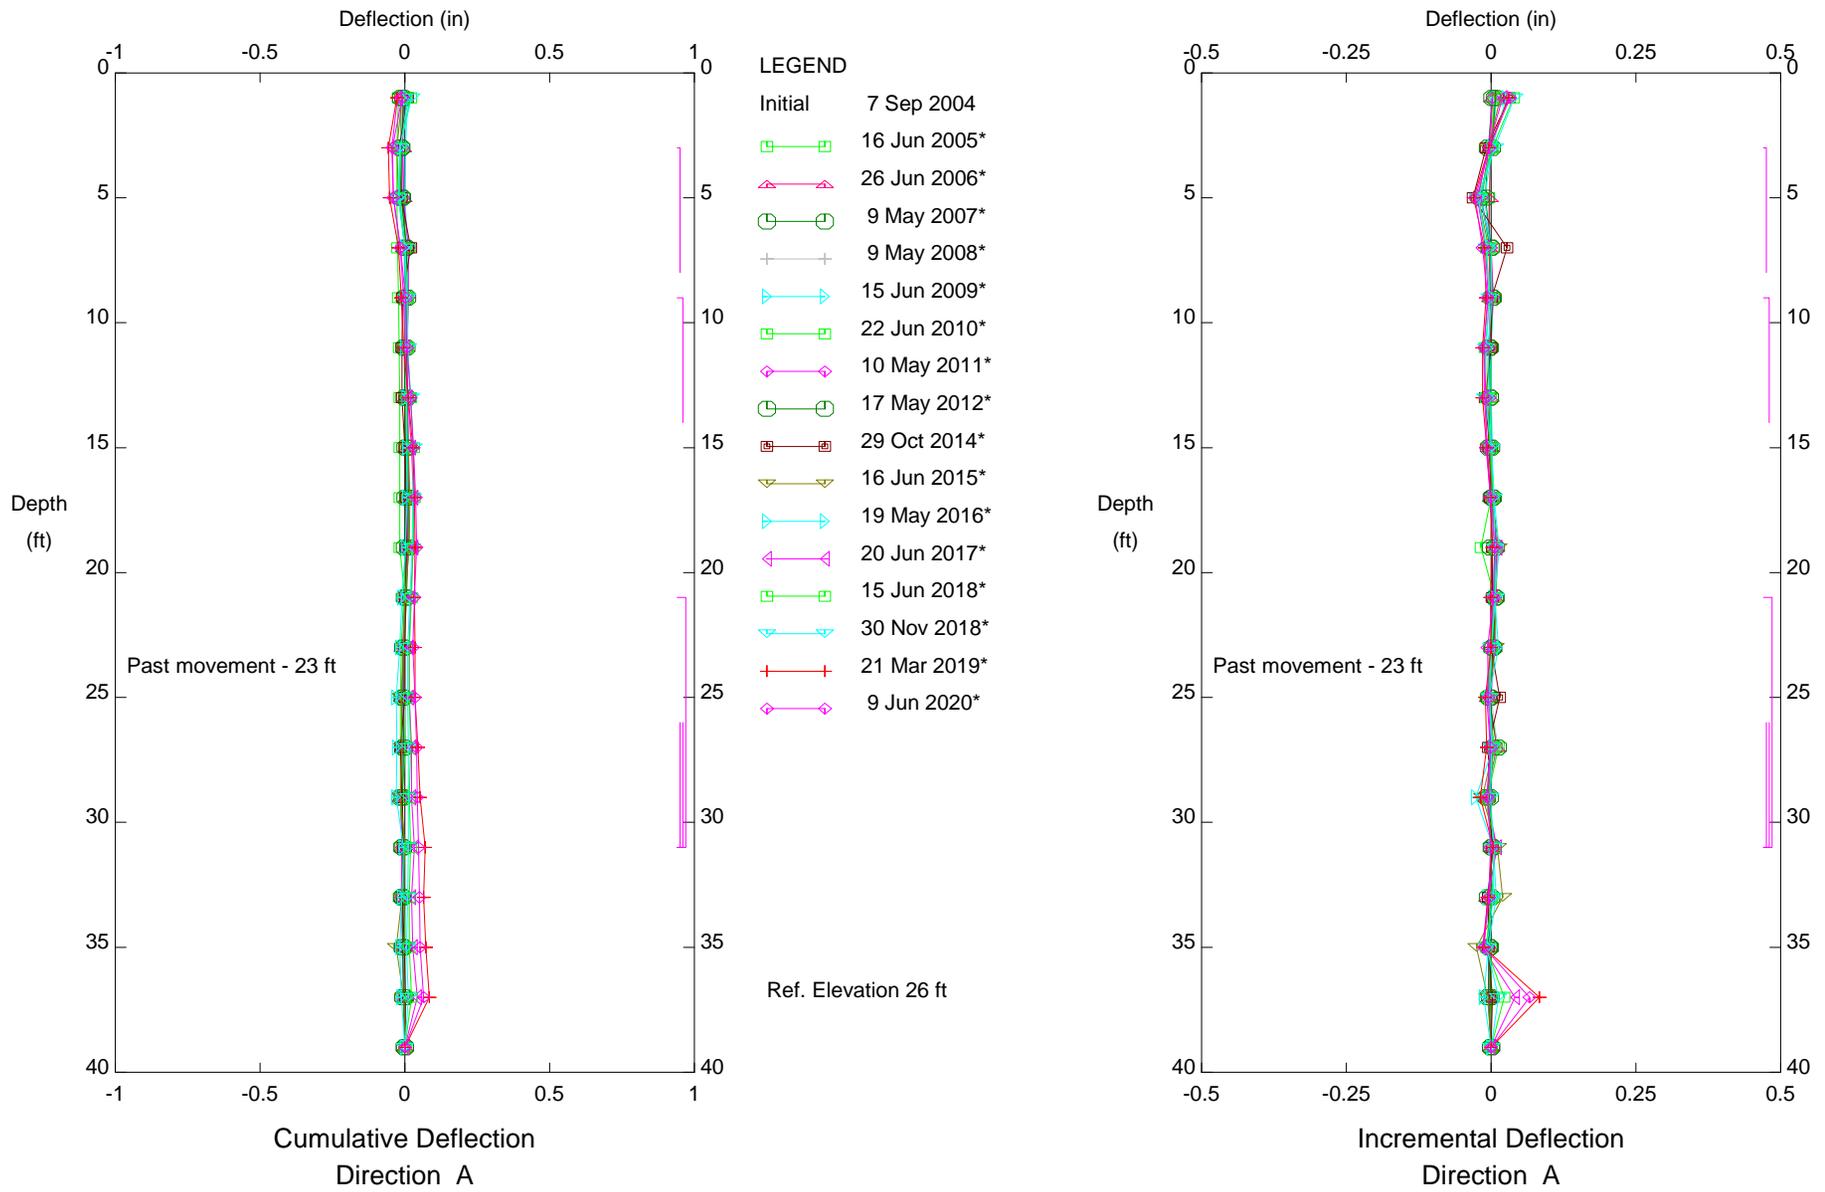
BIG ROCK MESA, Inclinator SP-12
PCH REGION

Sets marked * include zero shift and/or rotation corrections.

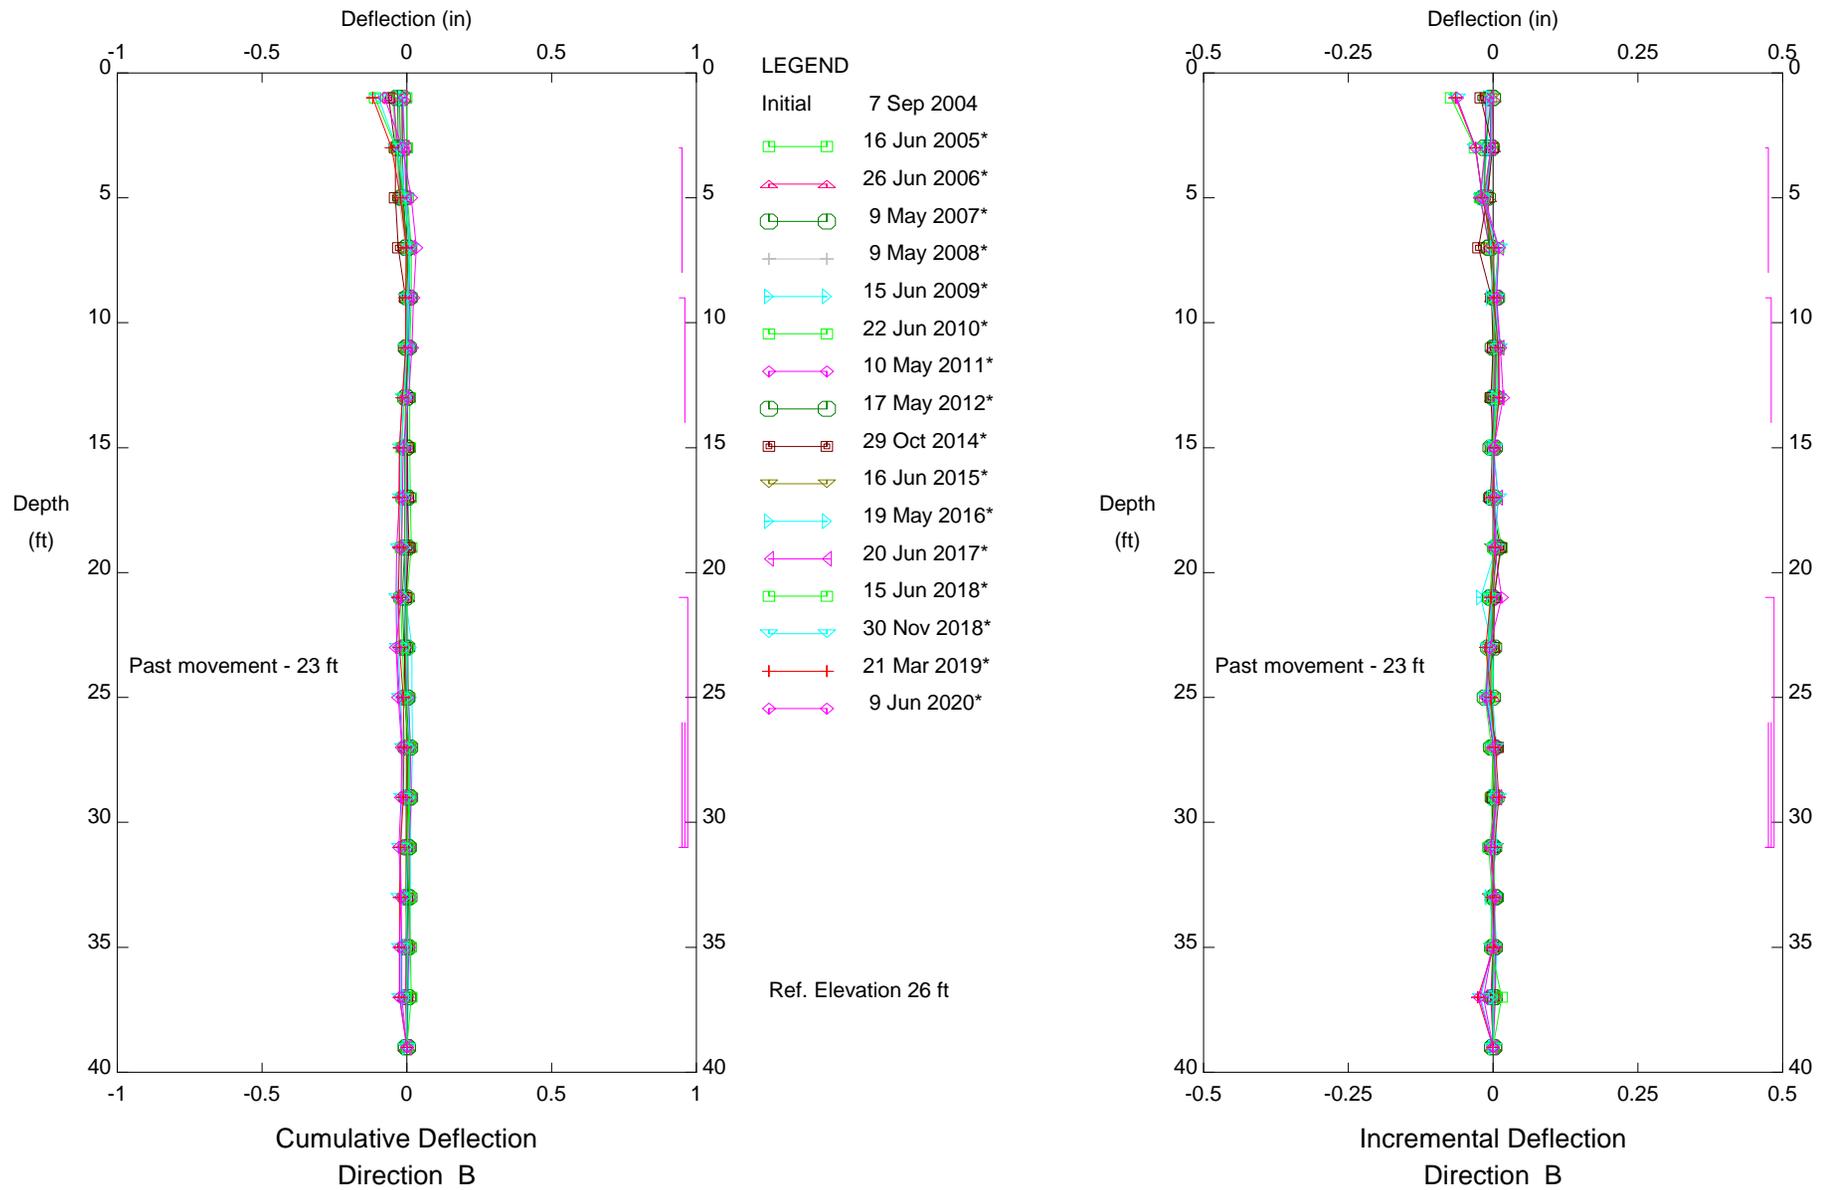
BIG ROCK MESA, Inclinometer SP-12
PCH REGION

Sets marked * include zero shift and/or rotation corrections.

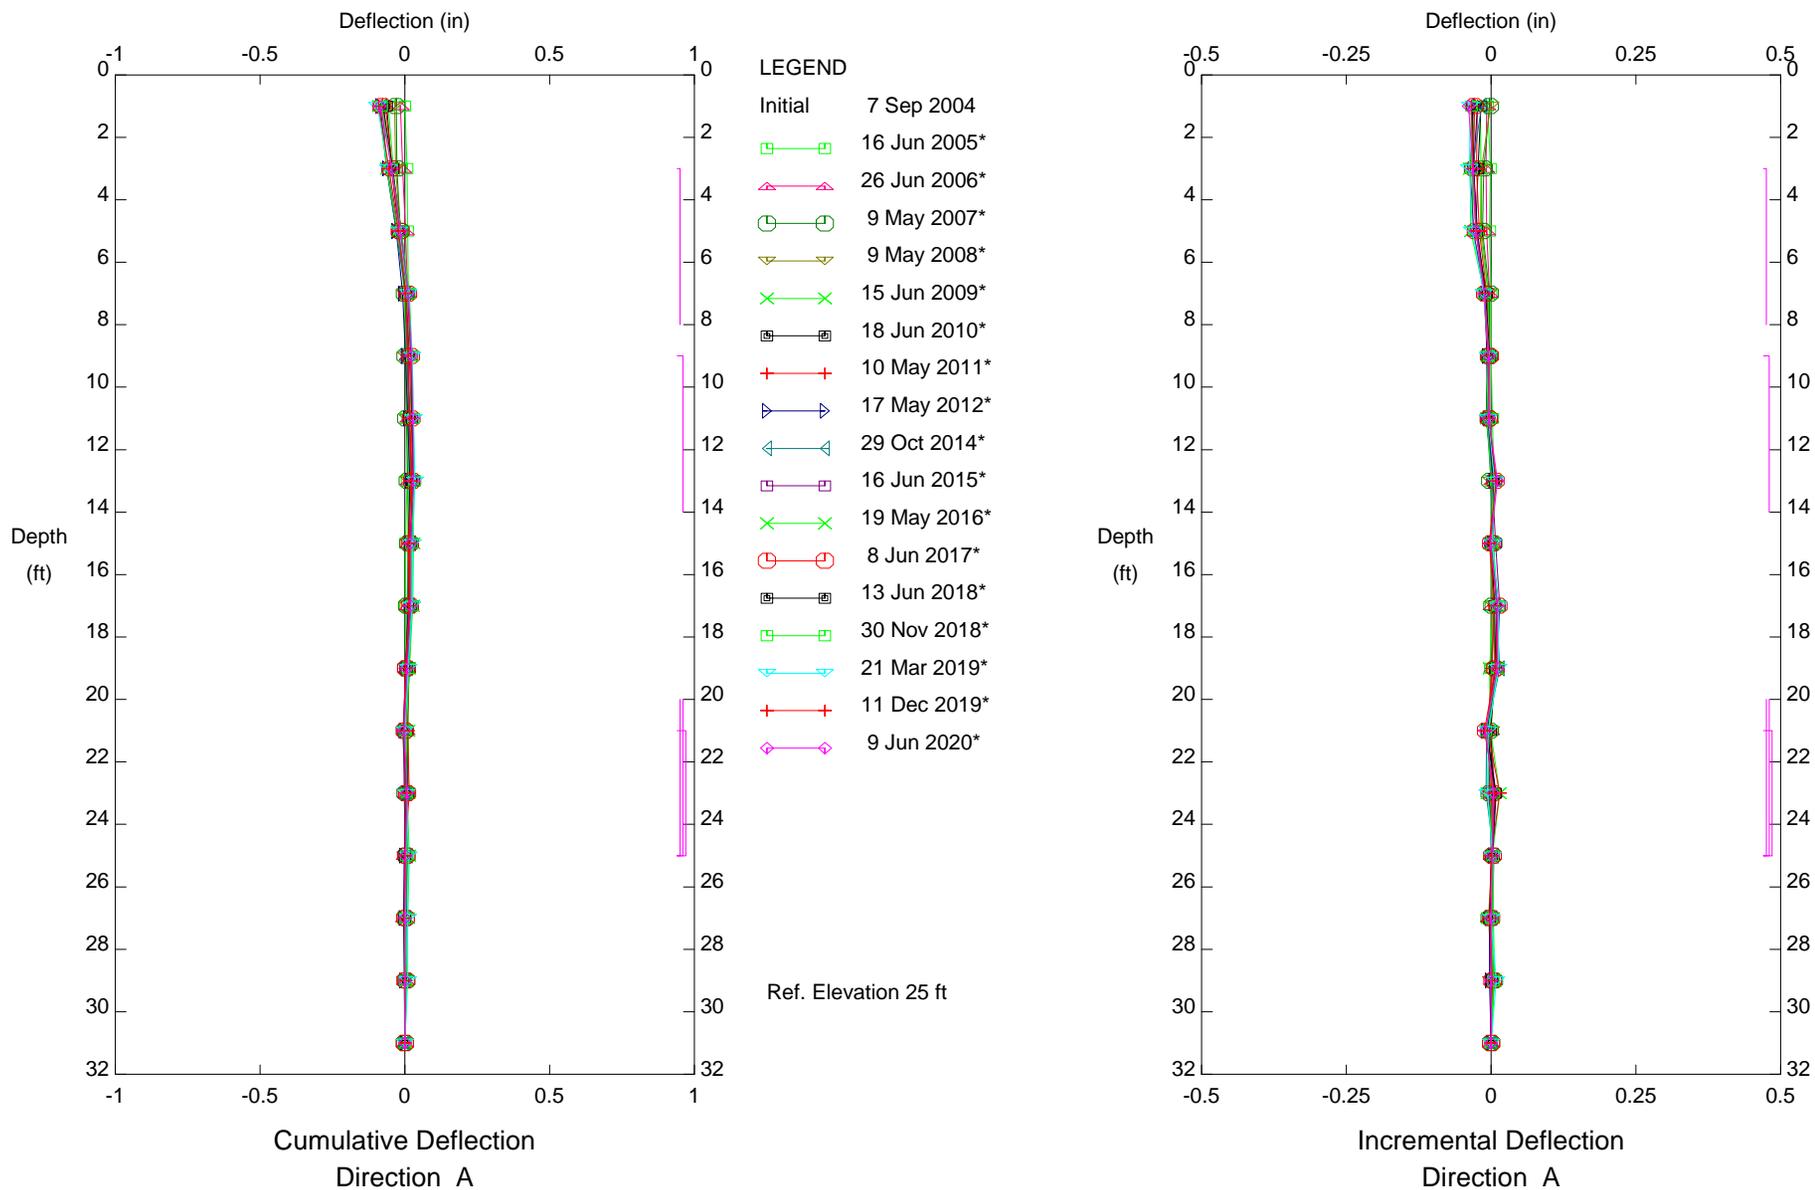
BIG ROCK MESA, Inclinometer SP-14
PCH REGION

Sets marked * include zero shift and/or rotation corrections.

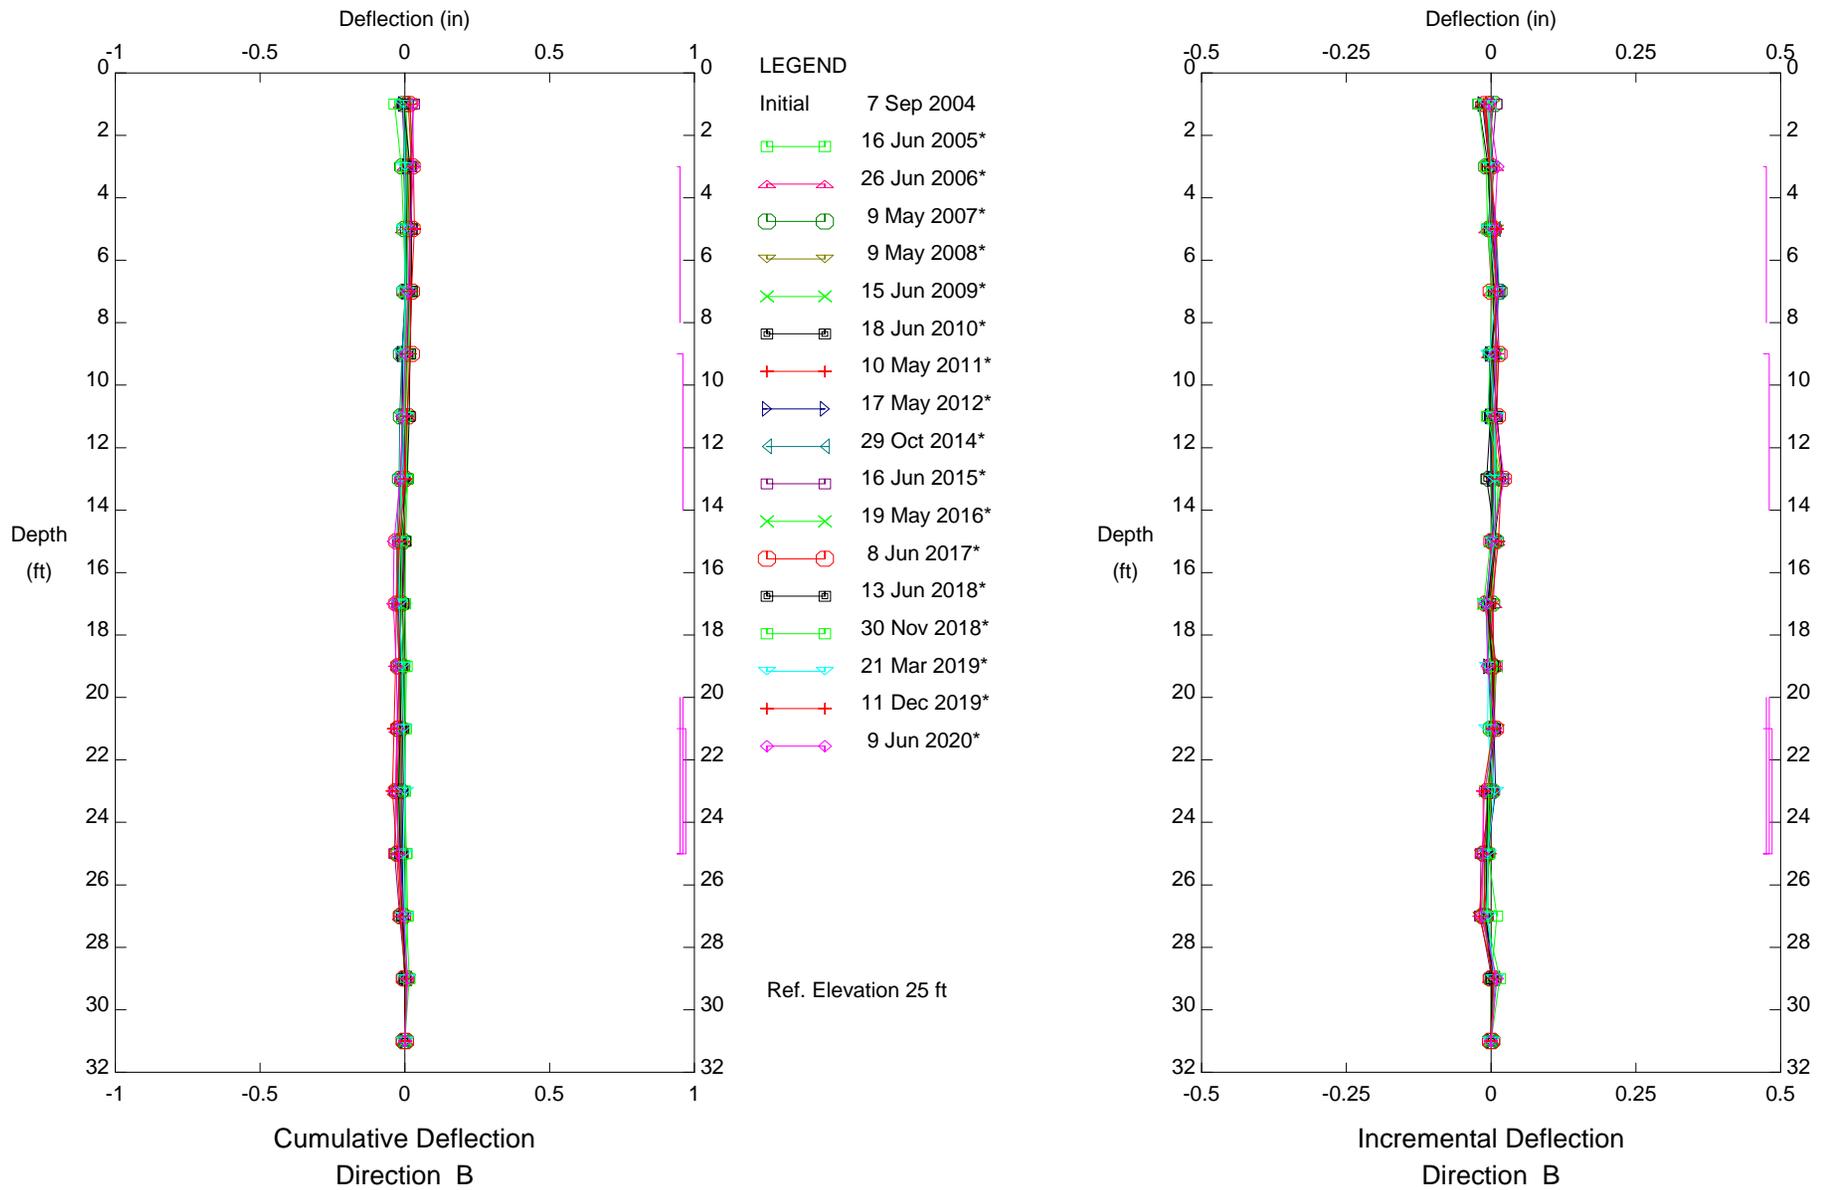
BIG ROCK MESA, Inclinometer SP-14
PCH REGION

Sets marked * include zero shift and/or rotation corrections.

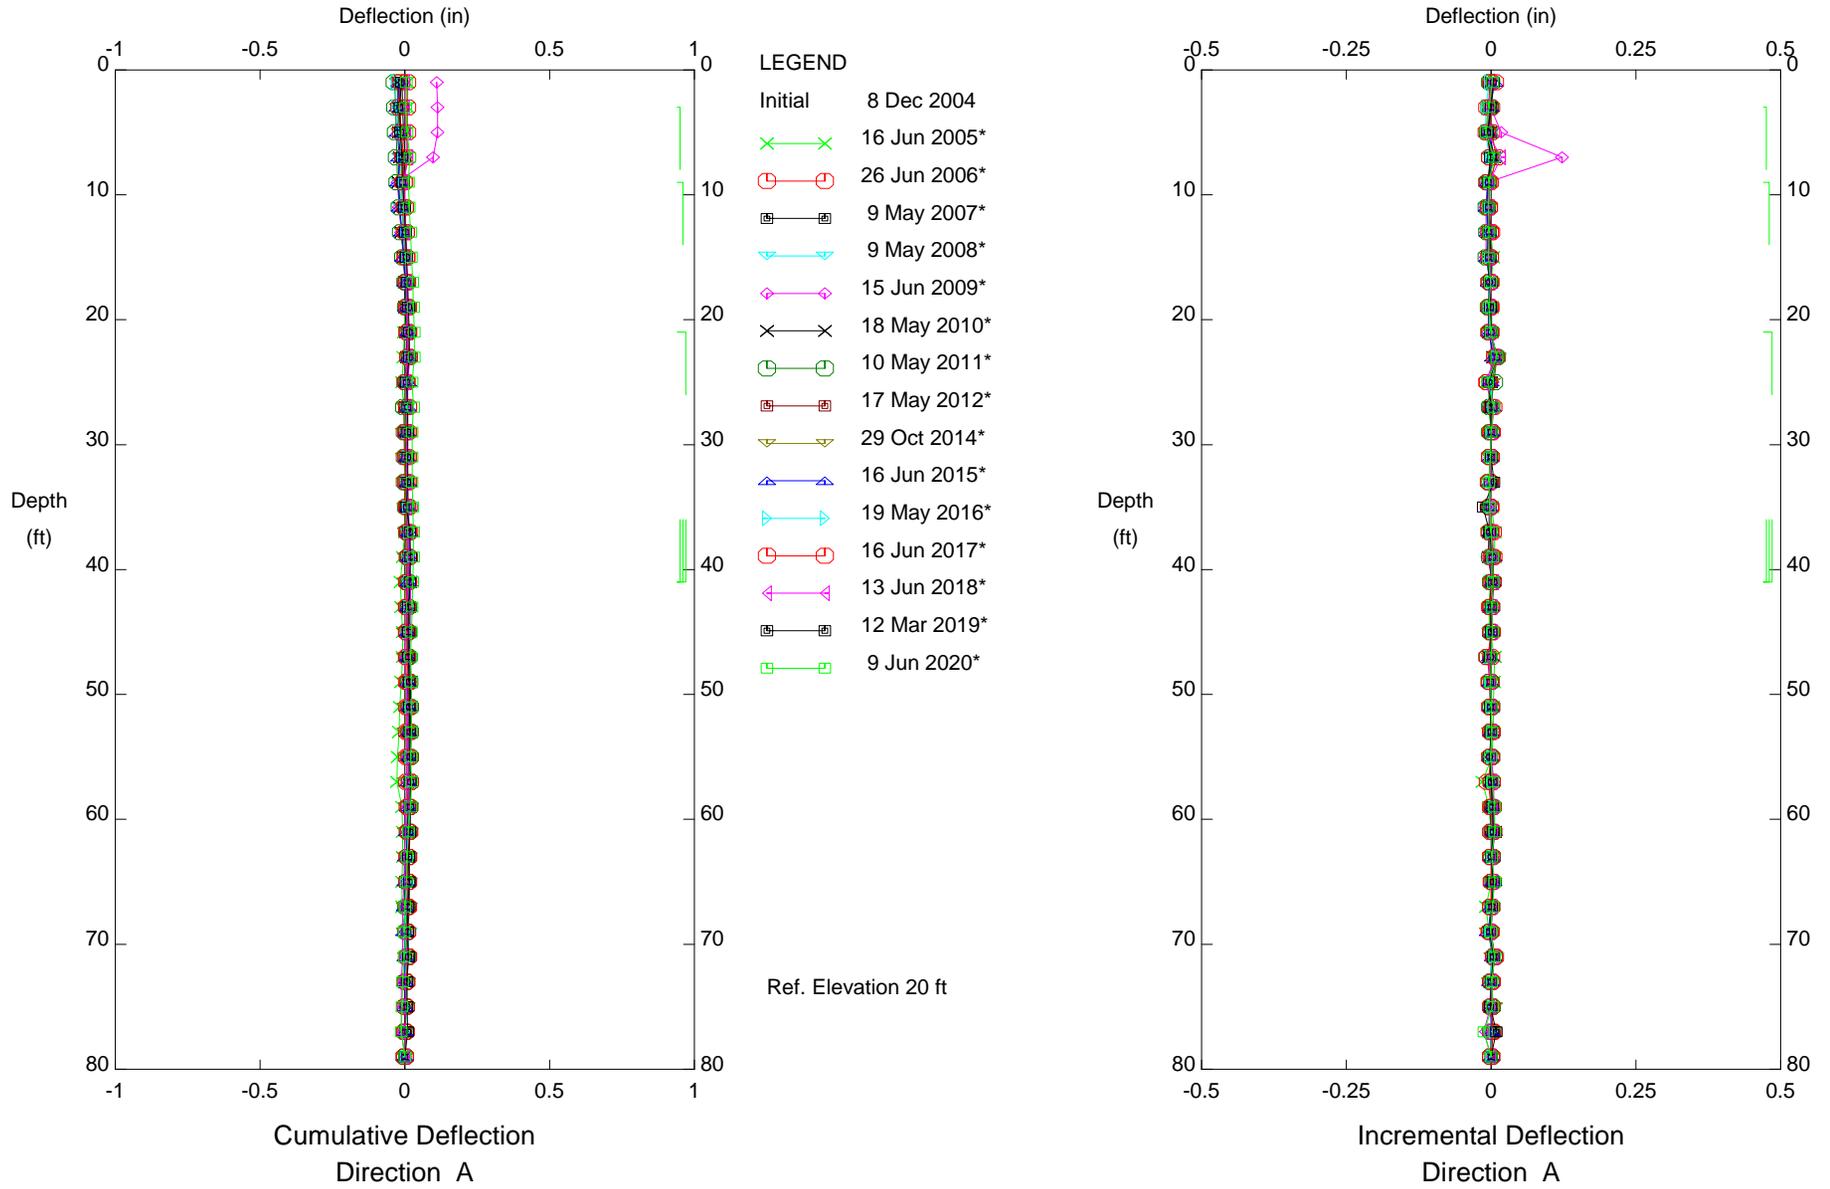
BIG ROCK MESA, Inclinator SP-15
PCH REGION

Sets marked * include zero shift and/or rotation corrections.

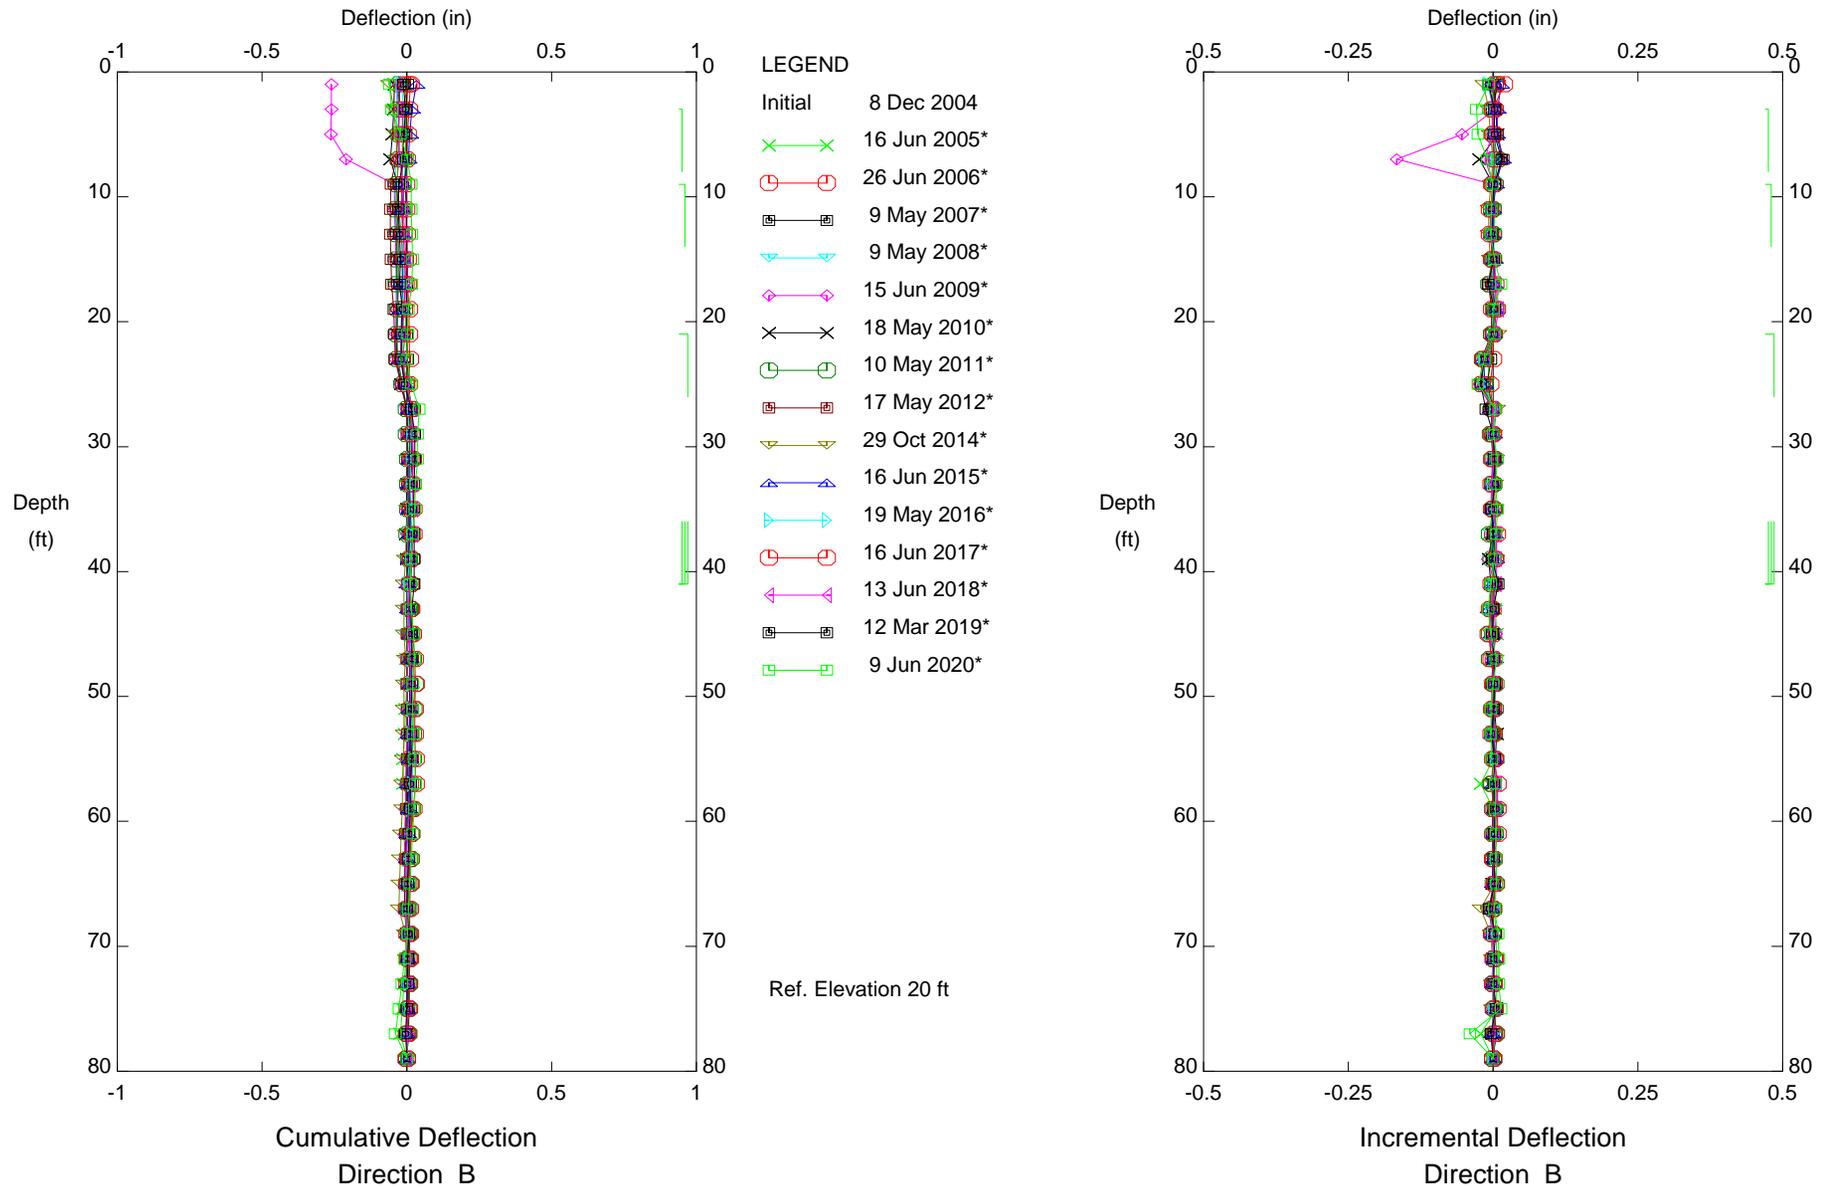
BIG ROCK MESA, Inclinometer SP-15
PCH REGION

Sets marked * include zero shift and/or rotation corrections.

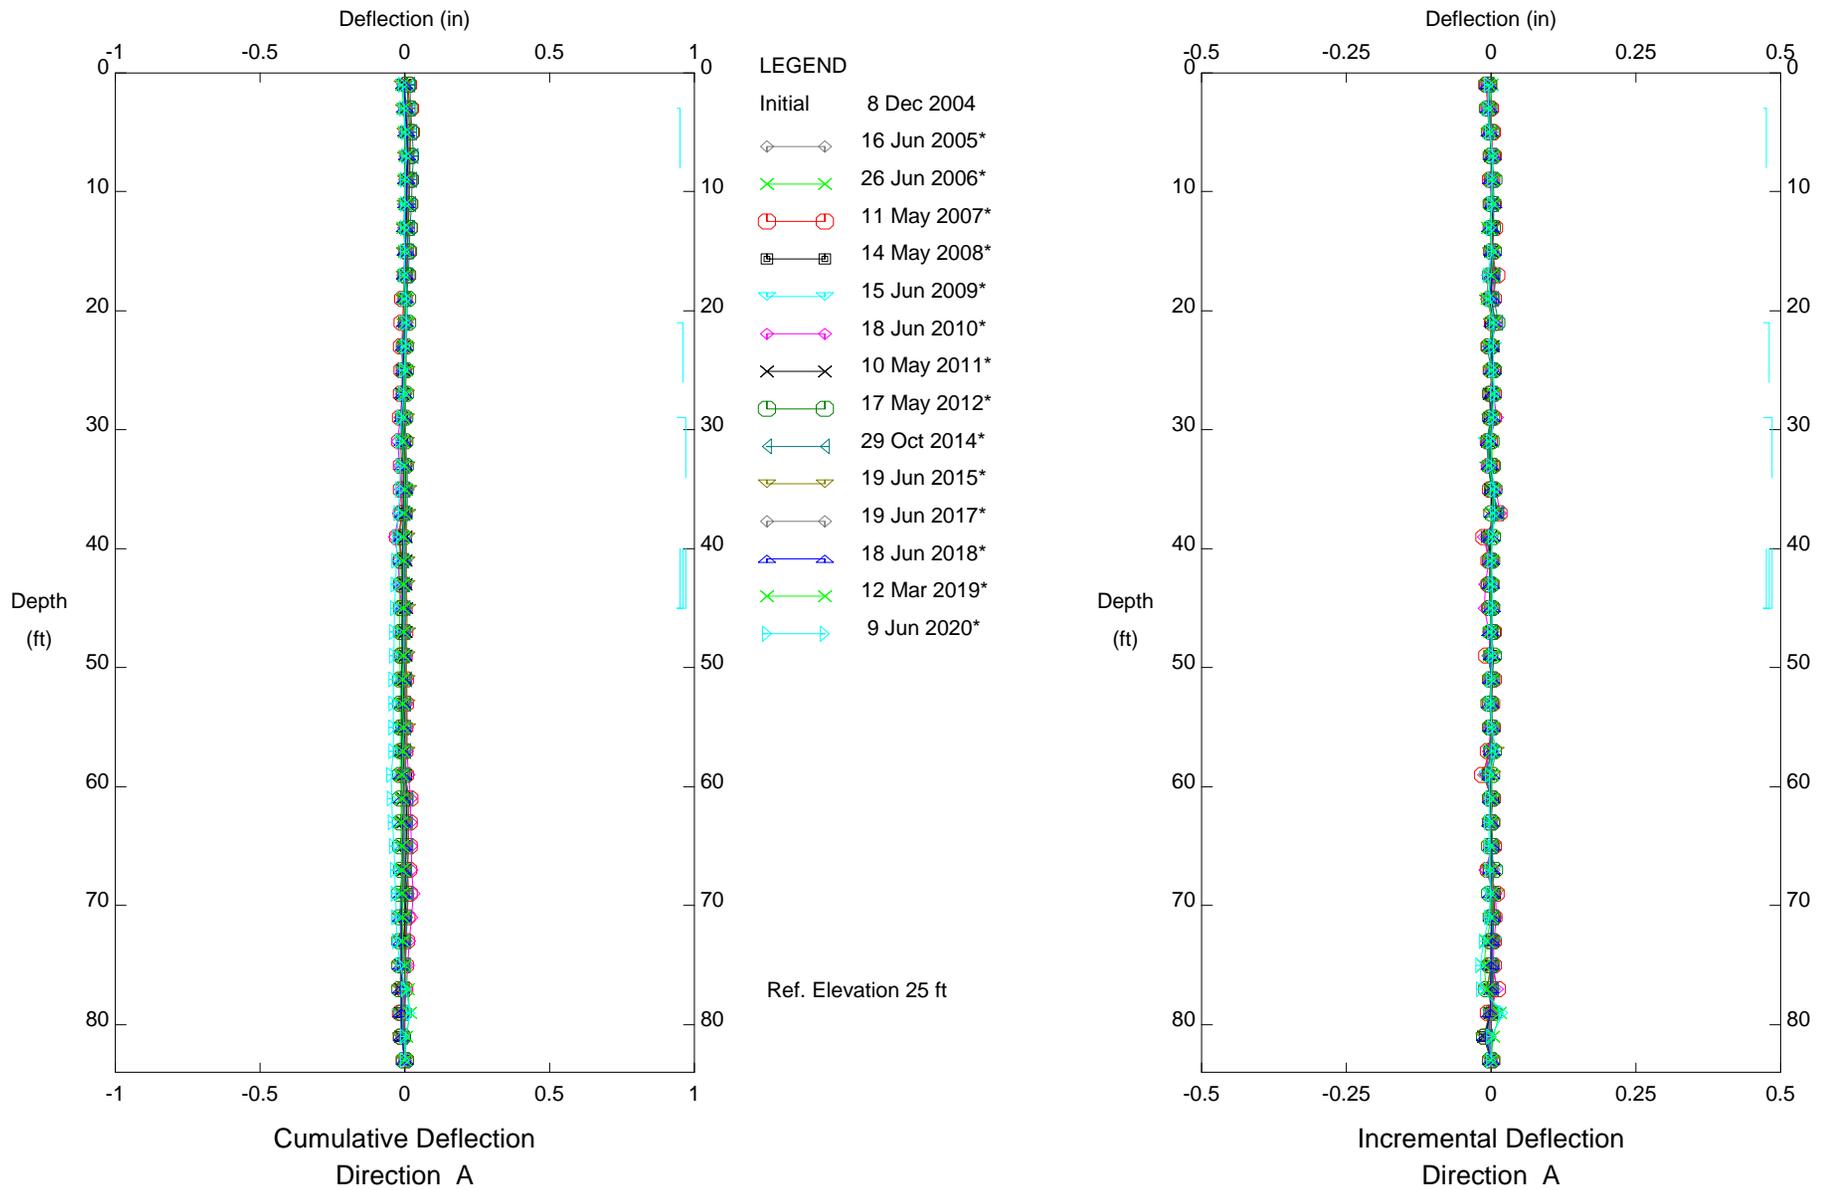
BIG ROCK MESA, Inclinometer SP-19
PCH REGION

Sets marked * include zero shift and/or rotation corrections.

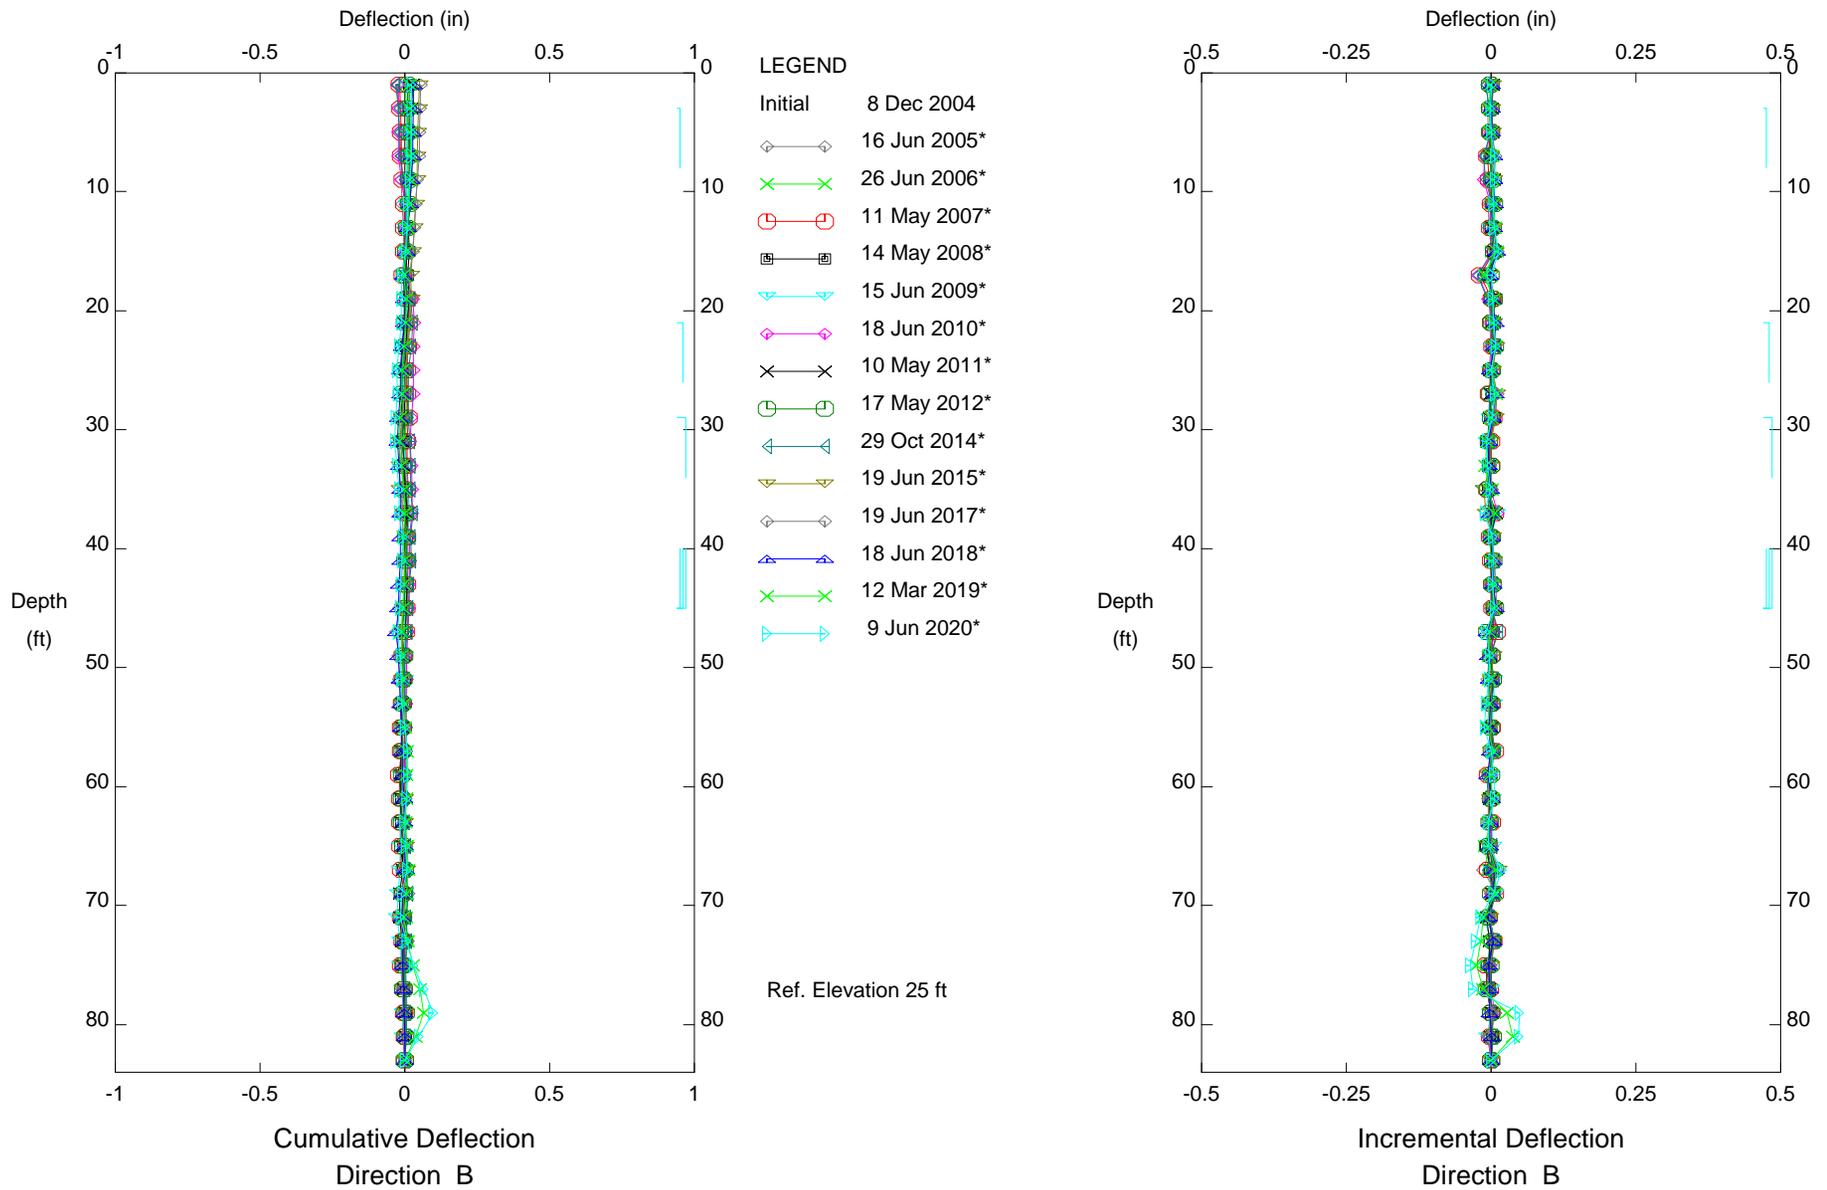
BIG ROCK MESA, Inclinometer SP-19
PCH REGION

Sets marked * include zero shift and/or rotation corrections.
