**ANNUAL REPORT
JULY 2019 THROUGH JUNE 2020
BIG ROCK MESA LANDSLIDE
ASSESSMENT DISTRICT
City of Malibu, California**

Fugro Project No. 04.62160606

Document No. 04.62160606-PR-007(Rev.00)

**Annual Report of Maintenance and Monitoring, July 2019 through June 2020,
Big Rock Mesa Landslide Assessment District, City of Malibu, California**

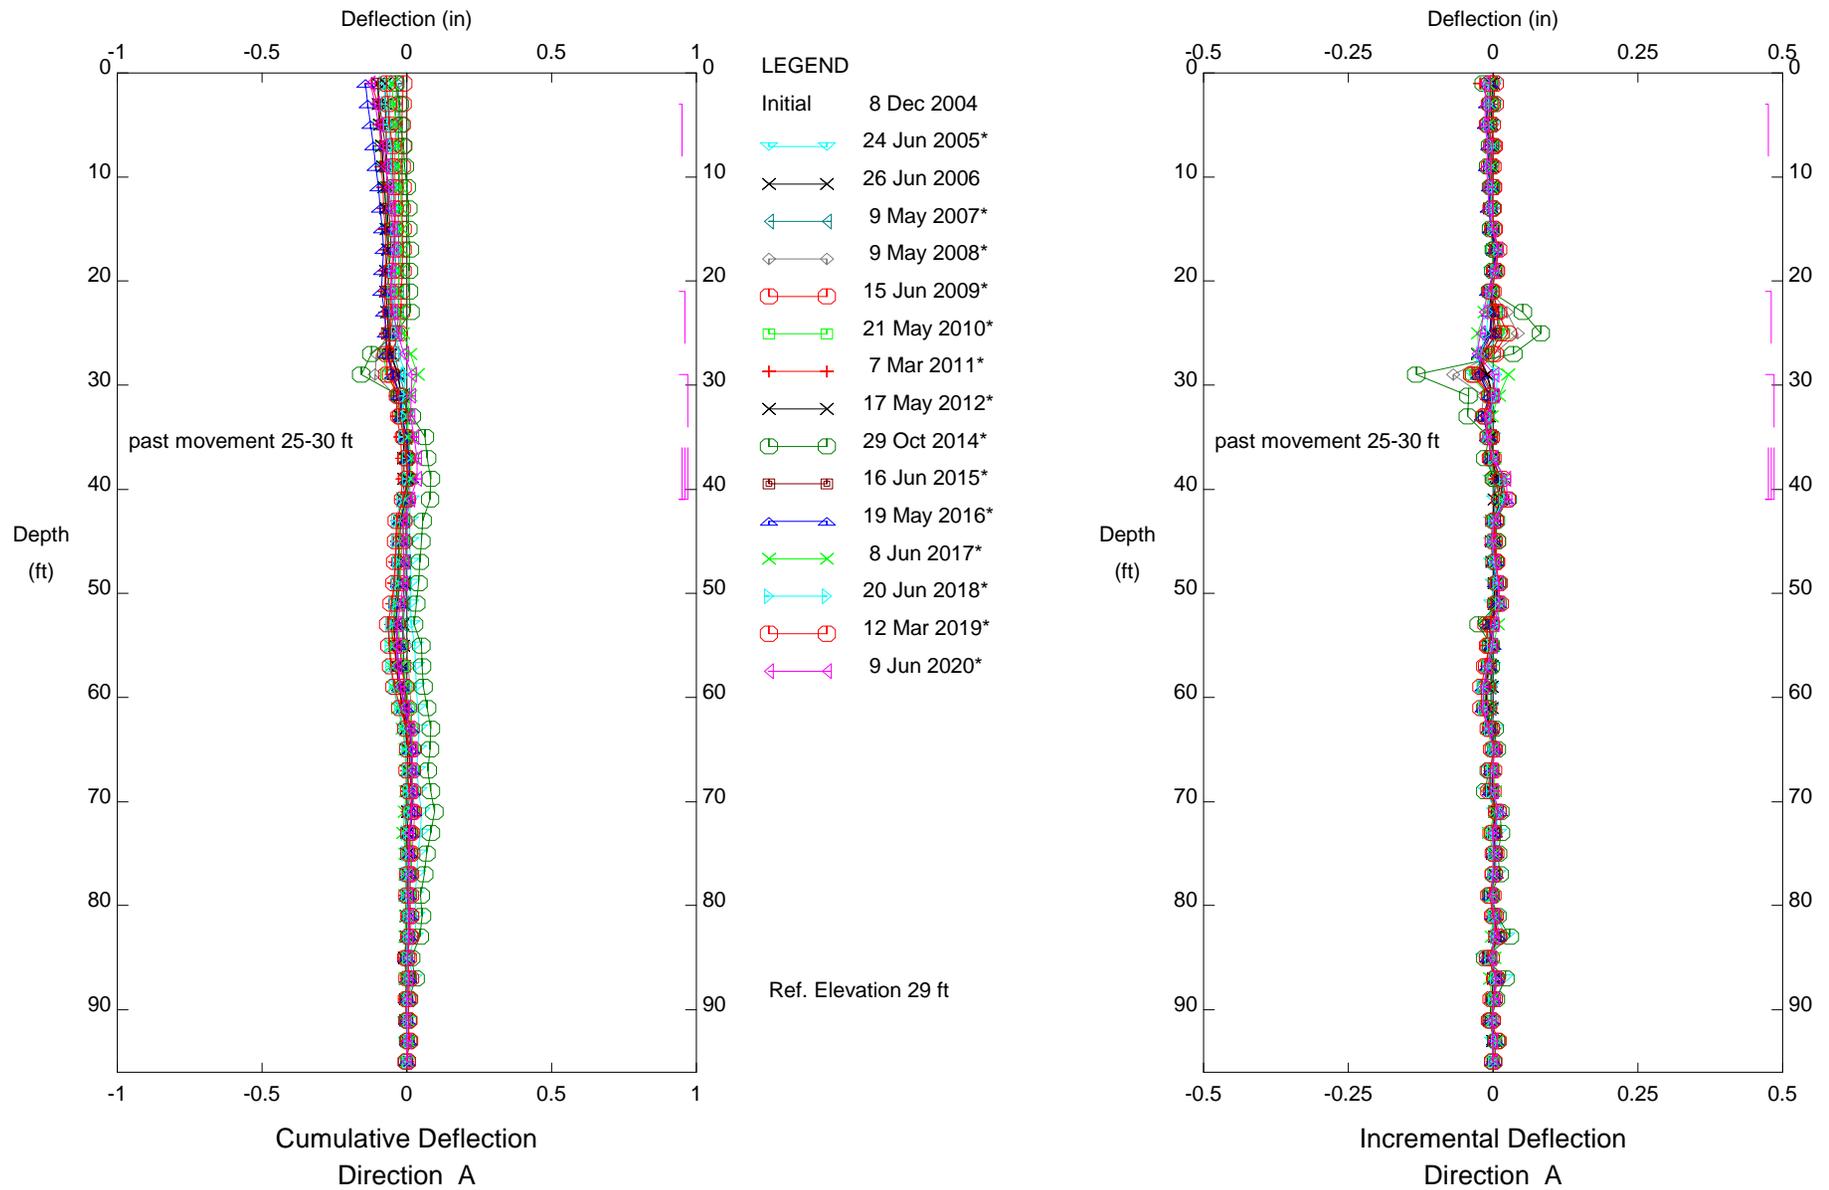
BIG ROCK MESA, Inclinometer SP-27A
PCH REGION

Sets marked * include zero shift and/or rotation corrections.

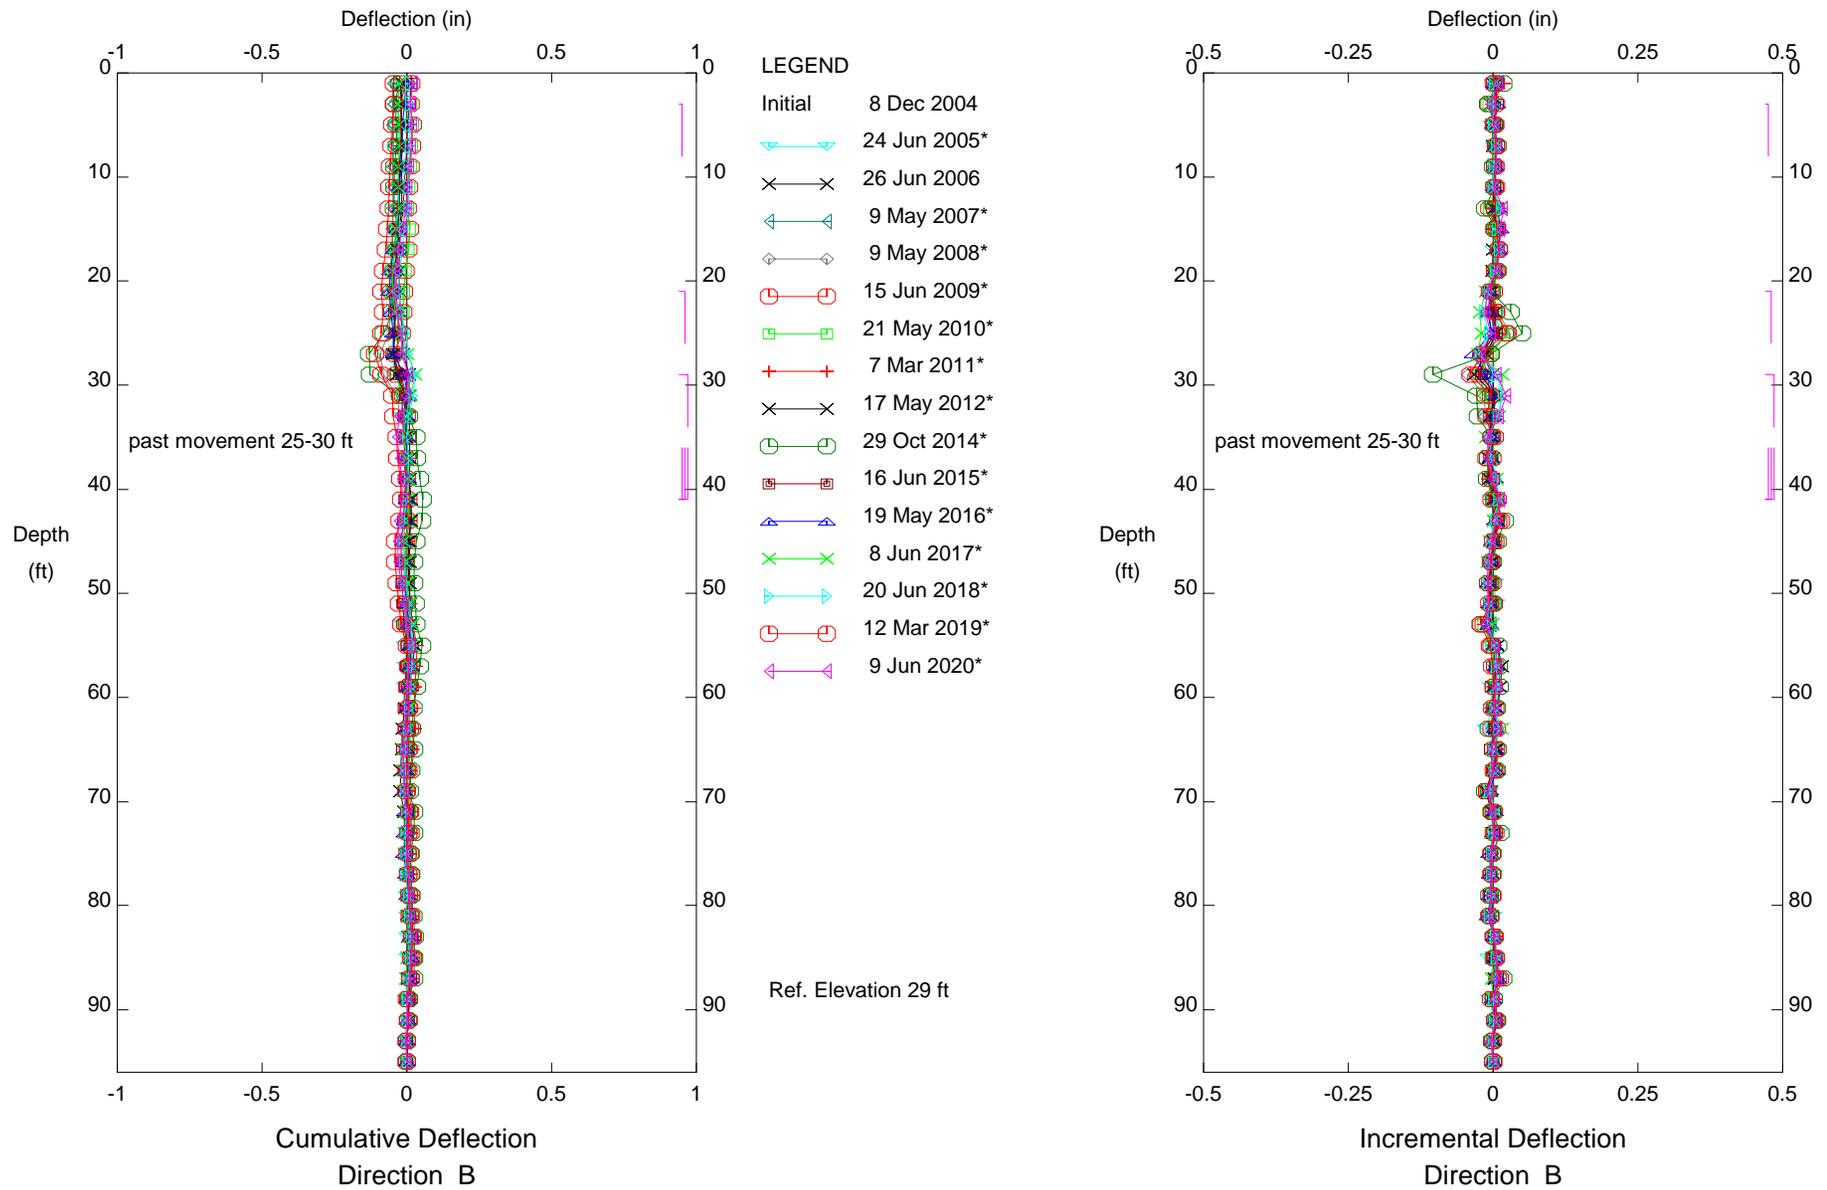
BIG ROCK MESA, Inclinometer SP-27A
PCH REGION

Sets marked * include zero shift and/or rotation corrections.

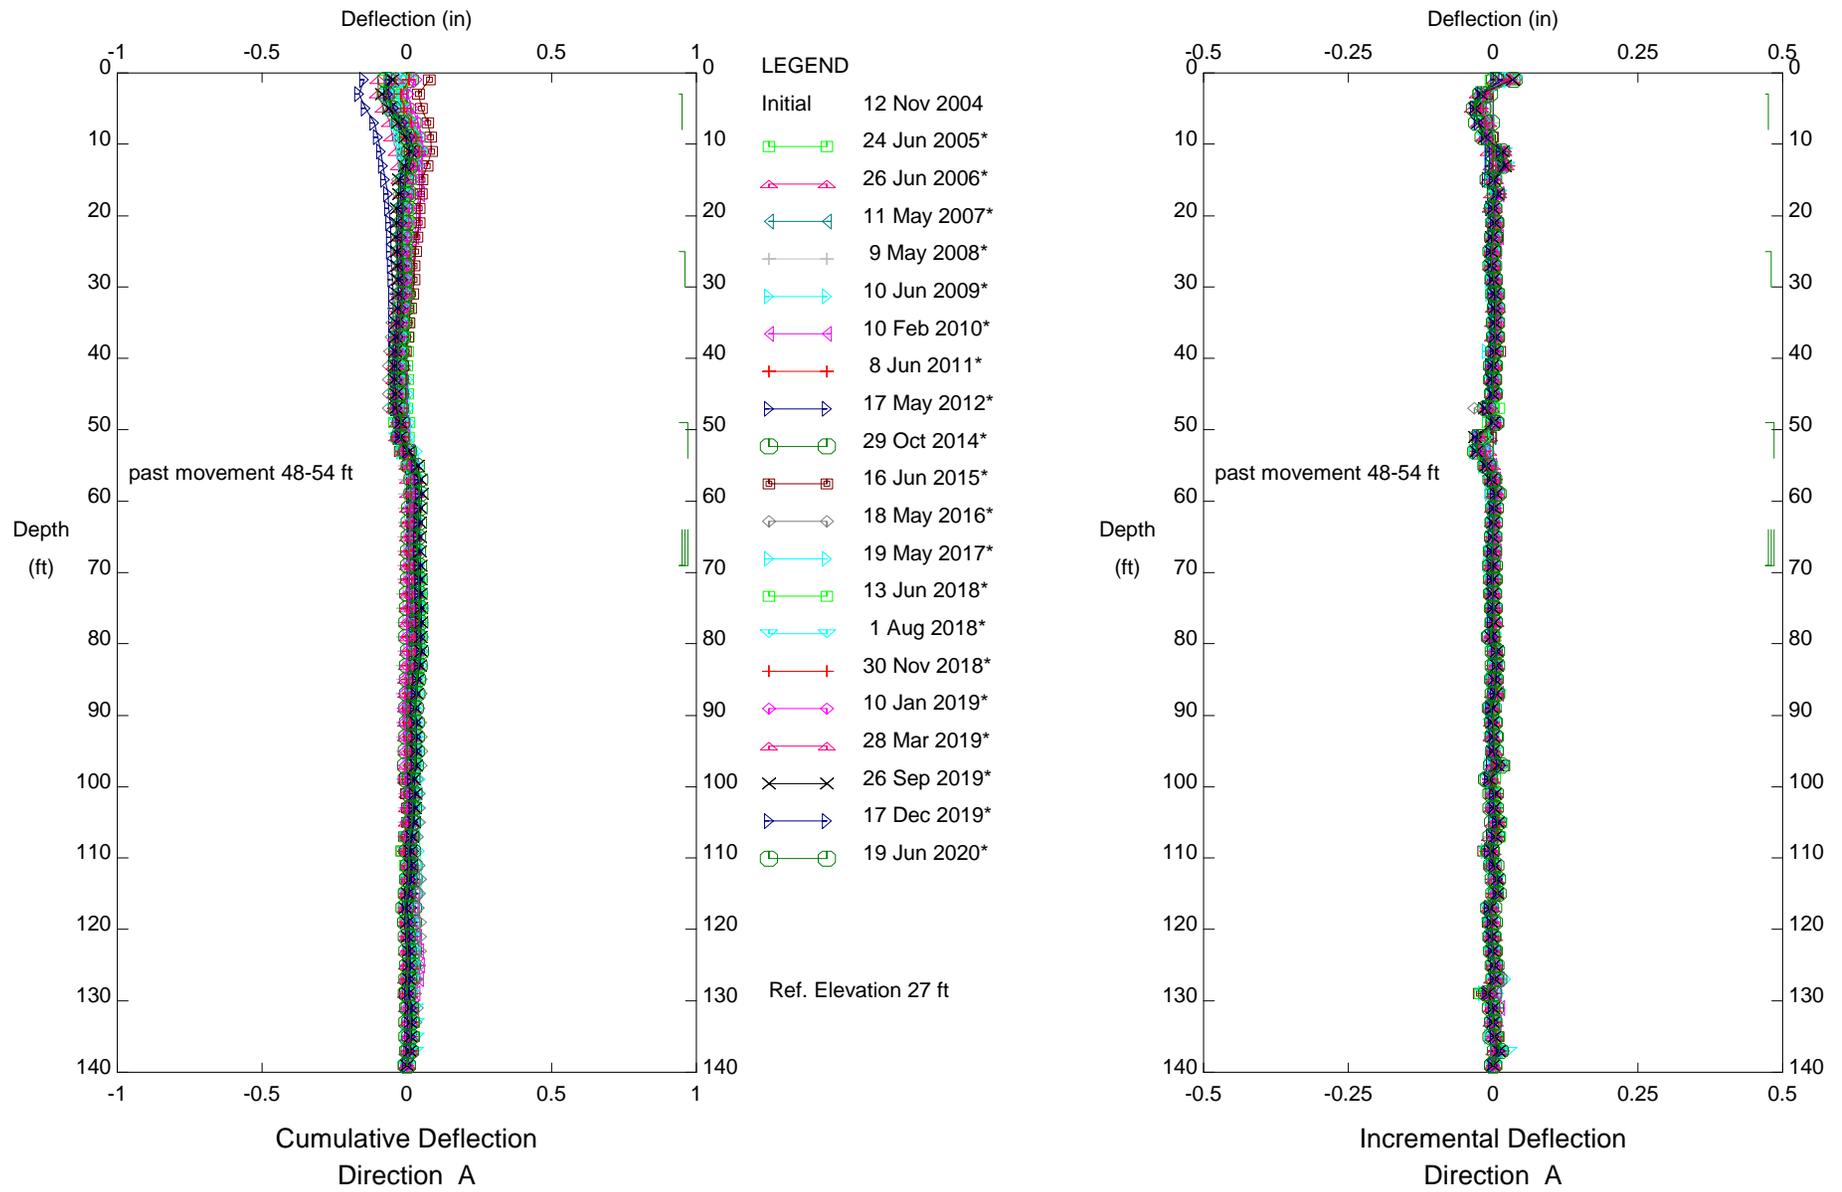
BIG ROCK MESA, Inclinometer SP-29
 PCH REGION

Sets marked * include zero shift and/or rotation corrections.

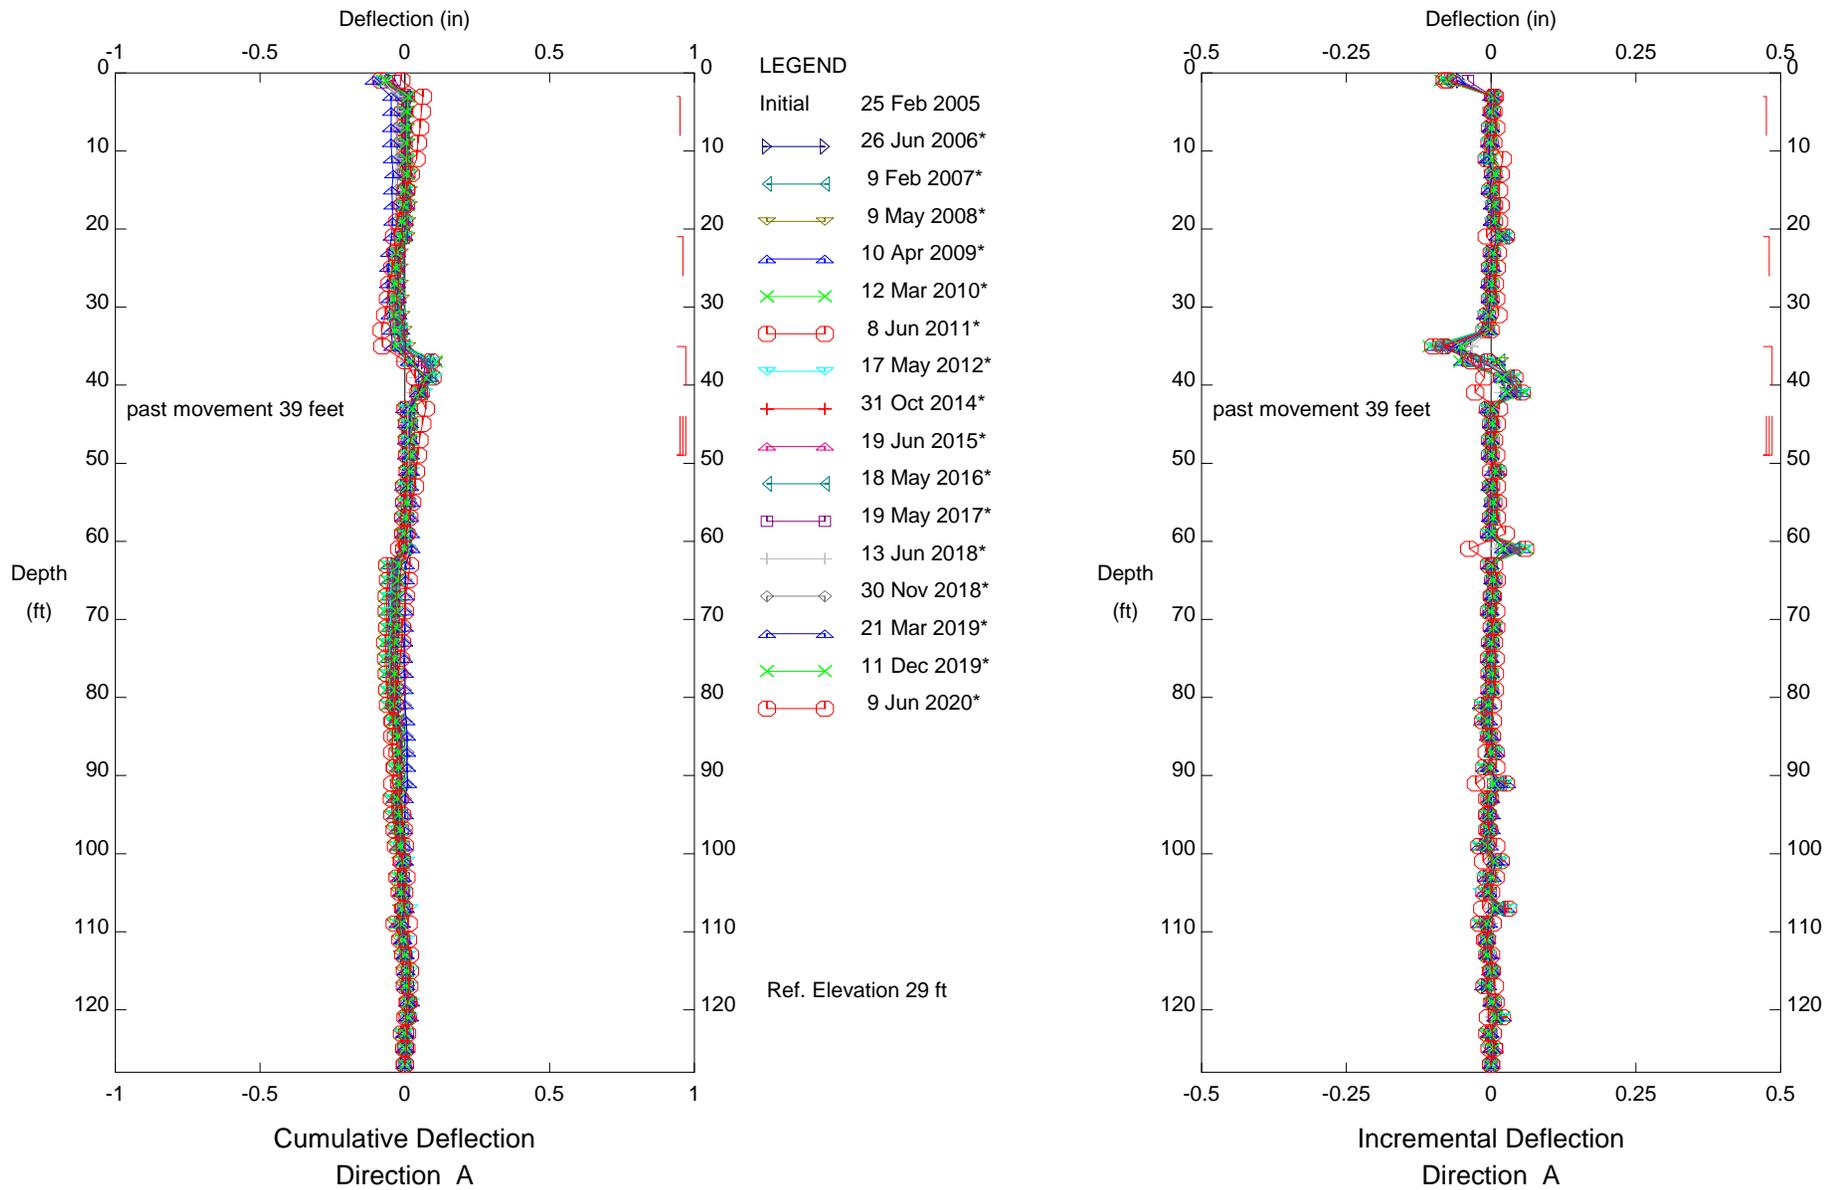
BIG ROCK MESA, Inclinometer SP-30
PCH REGION

Sets marked * include zero shift and/or rotation corrections.

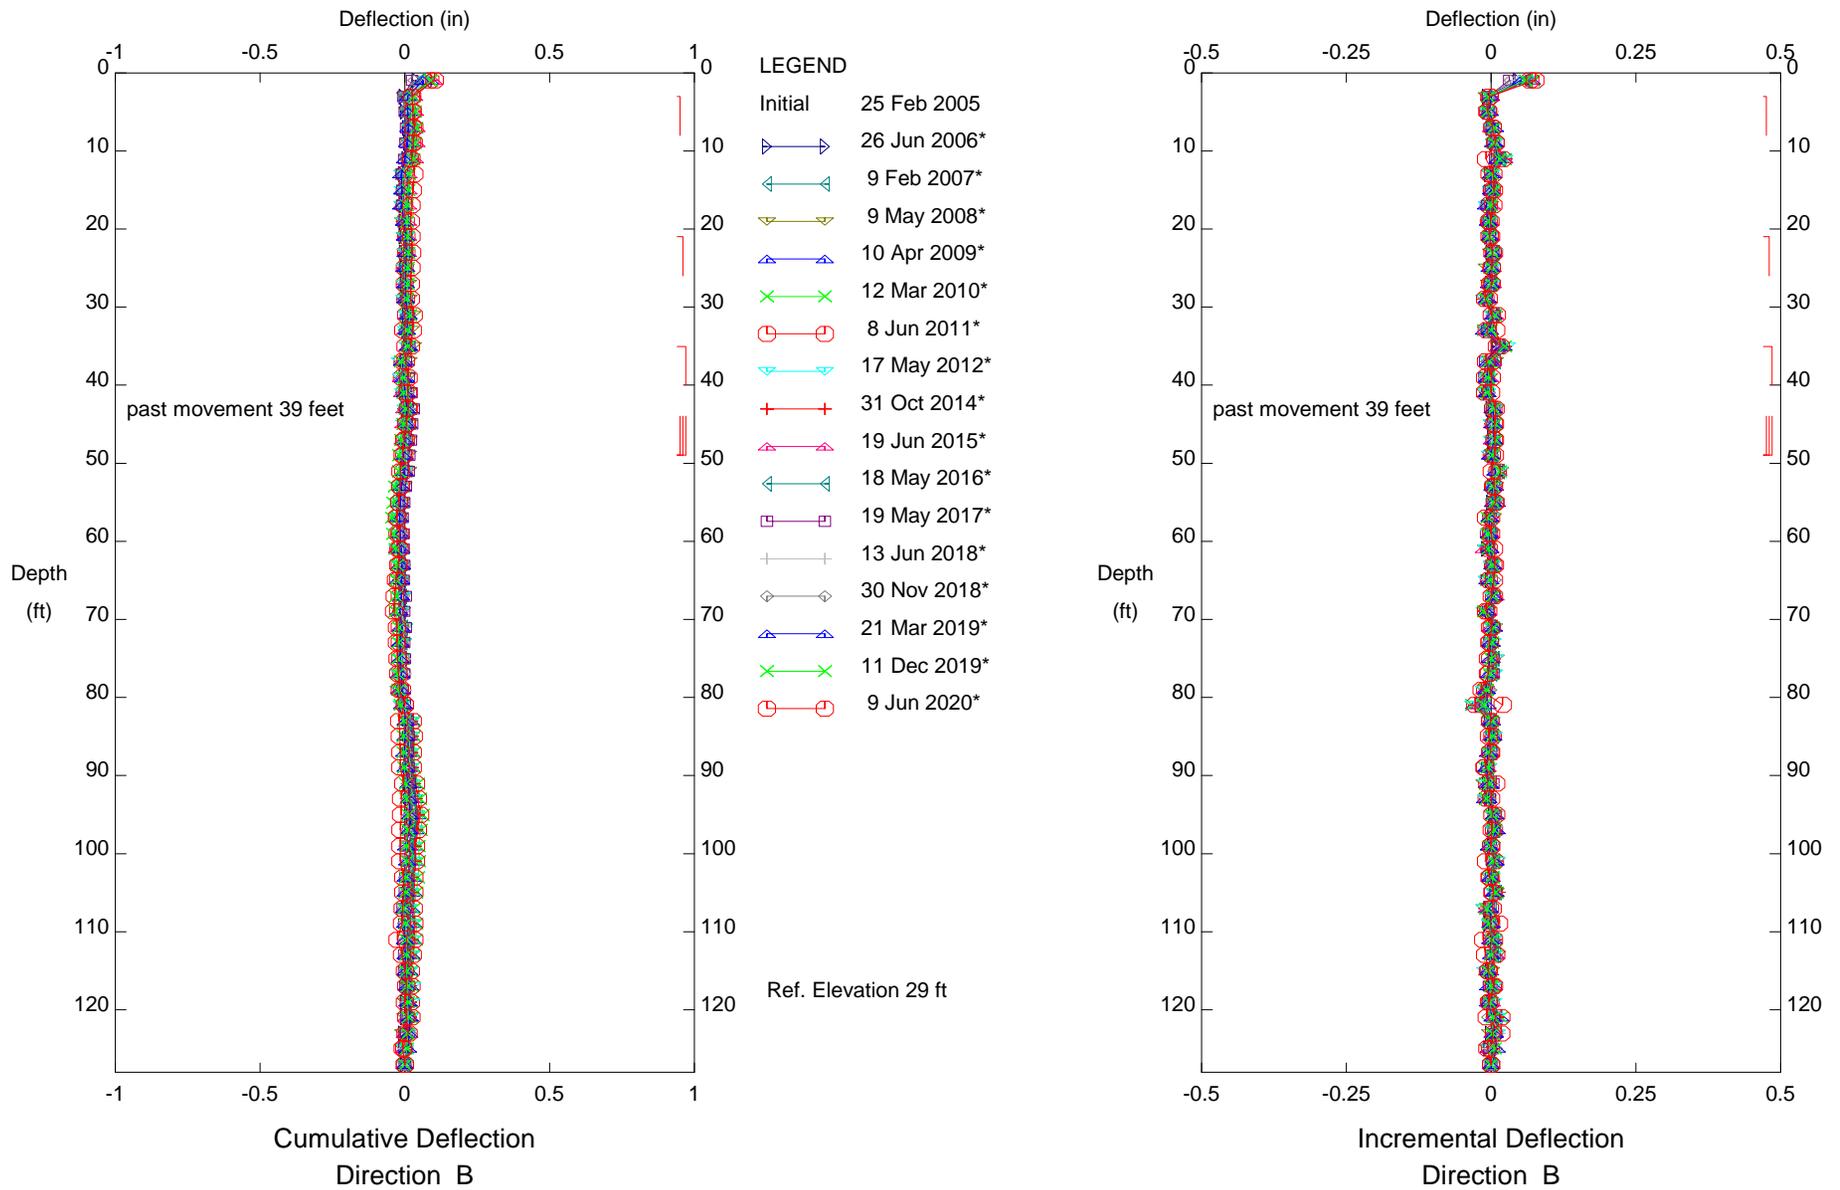
BIG ROCK MESA, Inclinometer SP-30
PCH REGION

Sets marked * include zero shift and/or rotation corrections.

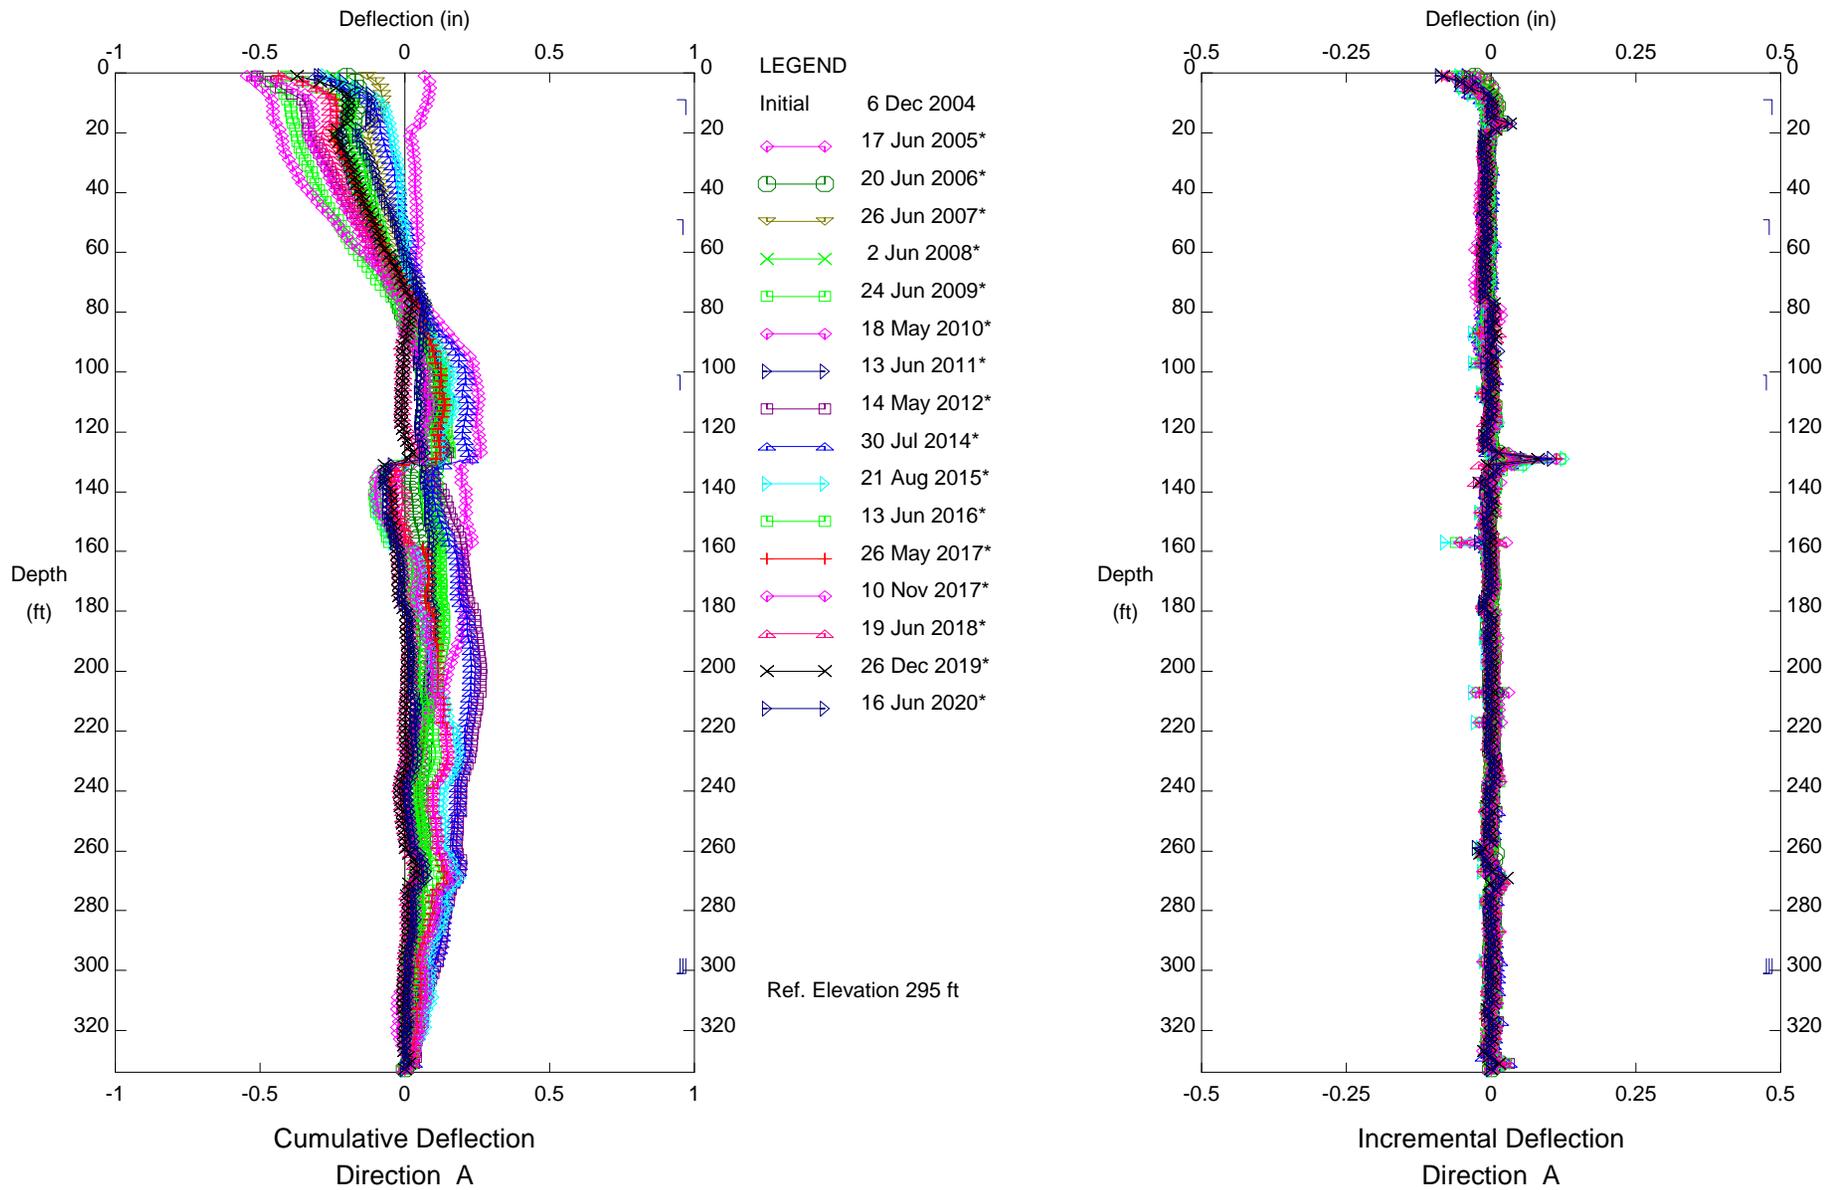
BIG ROCK MESA, Inclinometer SP-10
BLUFF REGION

Sets marked * include zero shift and/or rotation corrections.

The Bluff Region extends along the top of the slope immediately north of the PCH Region, where intense ground cracking was observed during the 1983 landslide. The inclinometers in that area are deep and show evidence of depth position and rotation errors, associated with cable stretch, casing curvature, and casing deviation from vertical. SP-32 displayed movement less than 0.1 inches between a depth of approximately 260 to 300 feet. No other quantifiable offsets within the inclinometers of the Bluff Region were measured during this monitoring period.

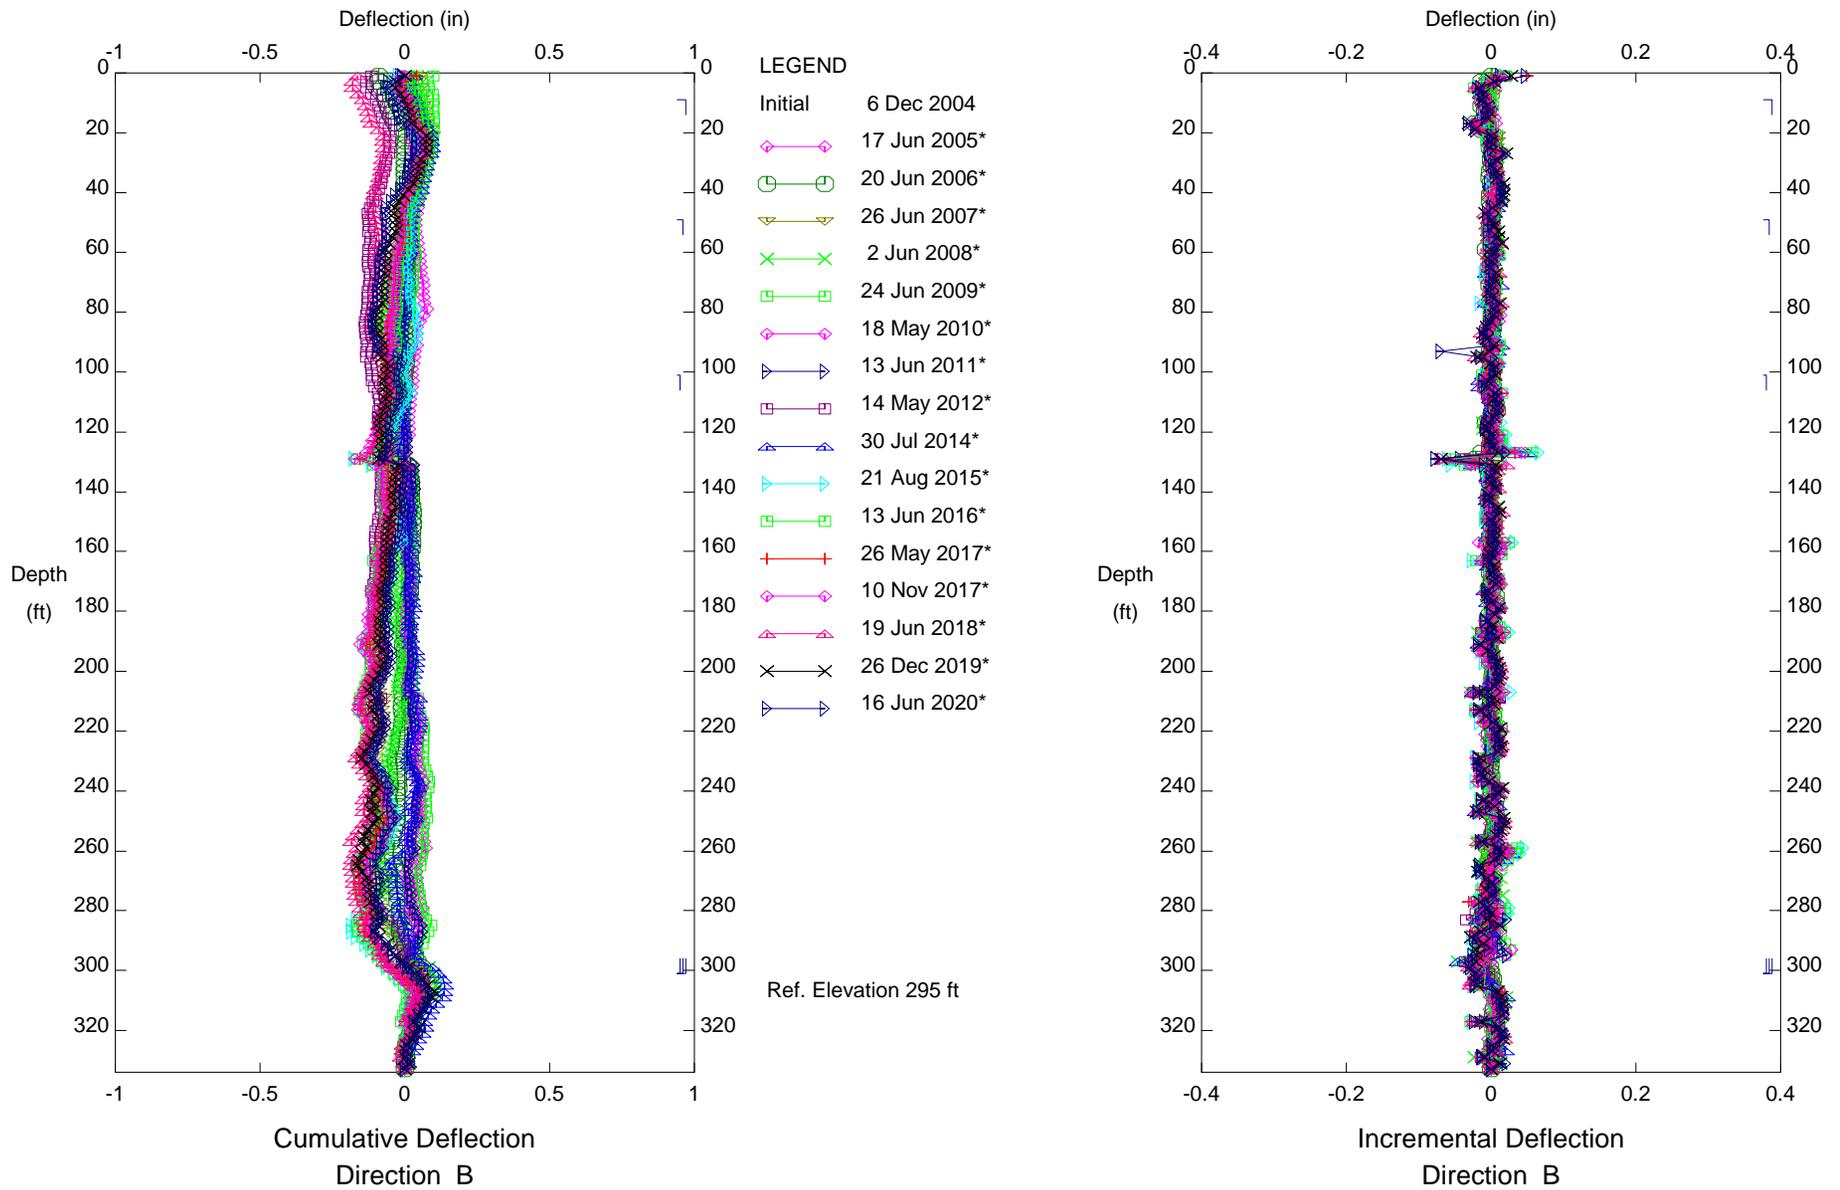
BIG ROCK MESA, Inclinometer SP-10
BLUFF REGION

Sets marked * include zero shift and/or rotation corrections.

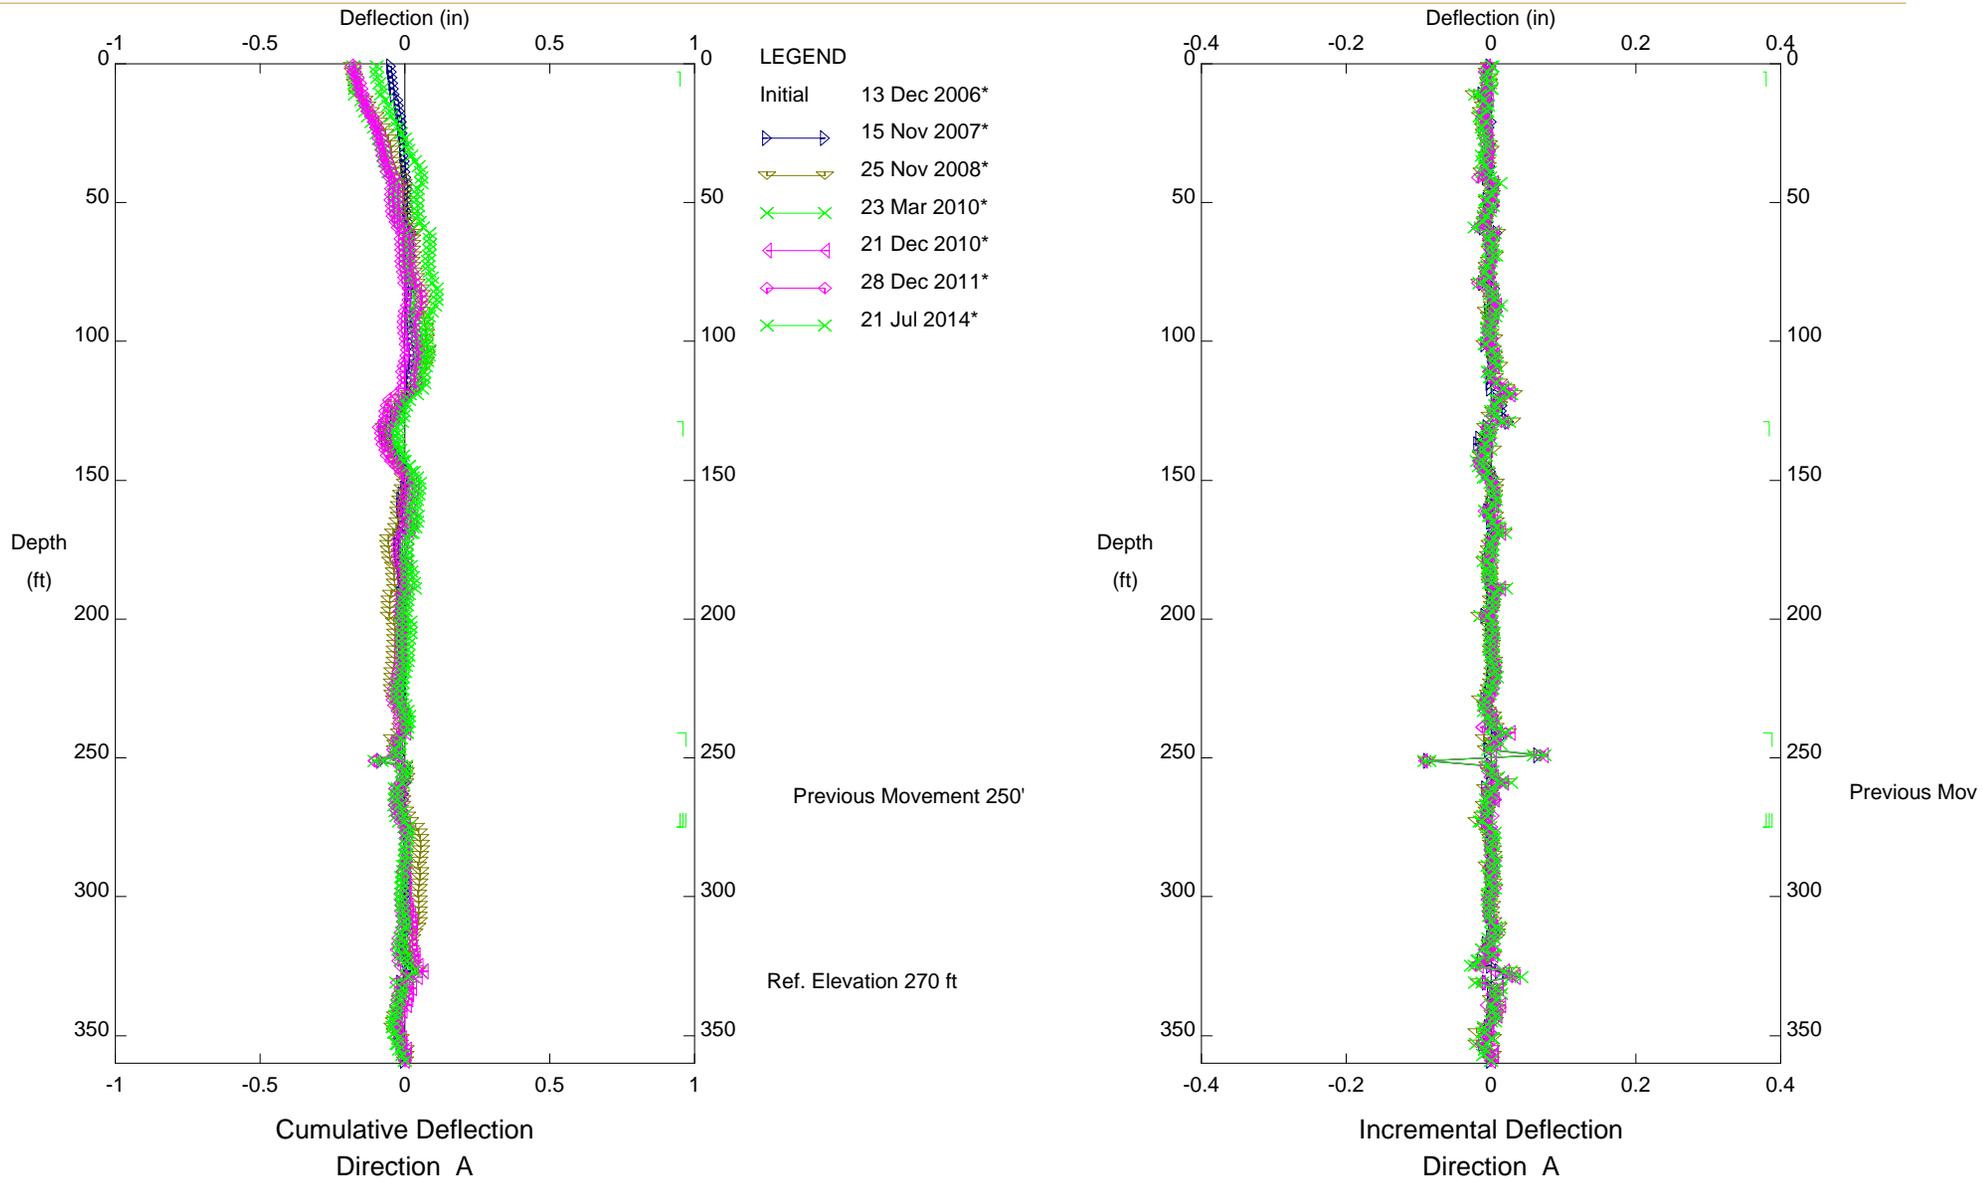
**BIG ROCK MESA, Inclinometer SP-28
BLUFF REGION**

Cumulative Deflection
Direction A

Incremental Deflection
Direction A

past movement at 245 feet

Sets marked * include zero shift and/or rotation corrections.

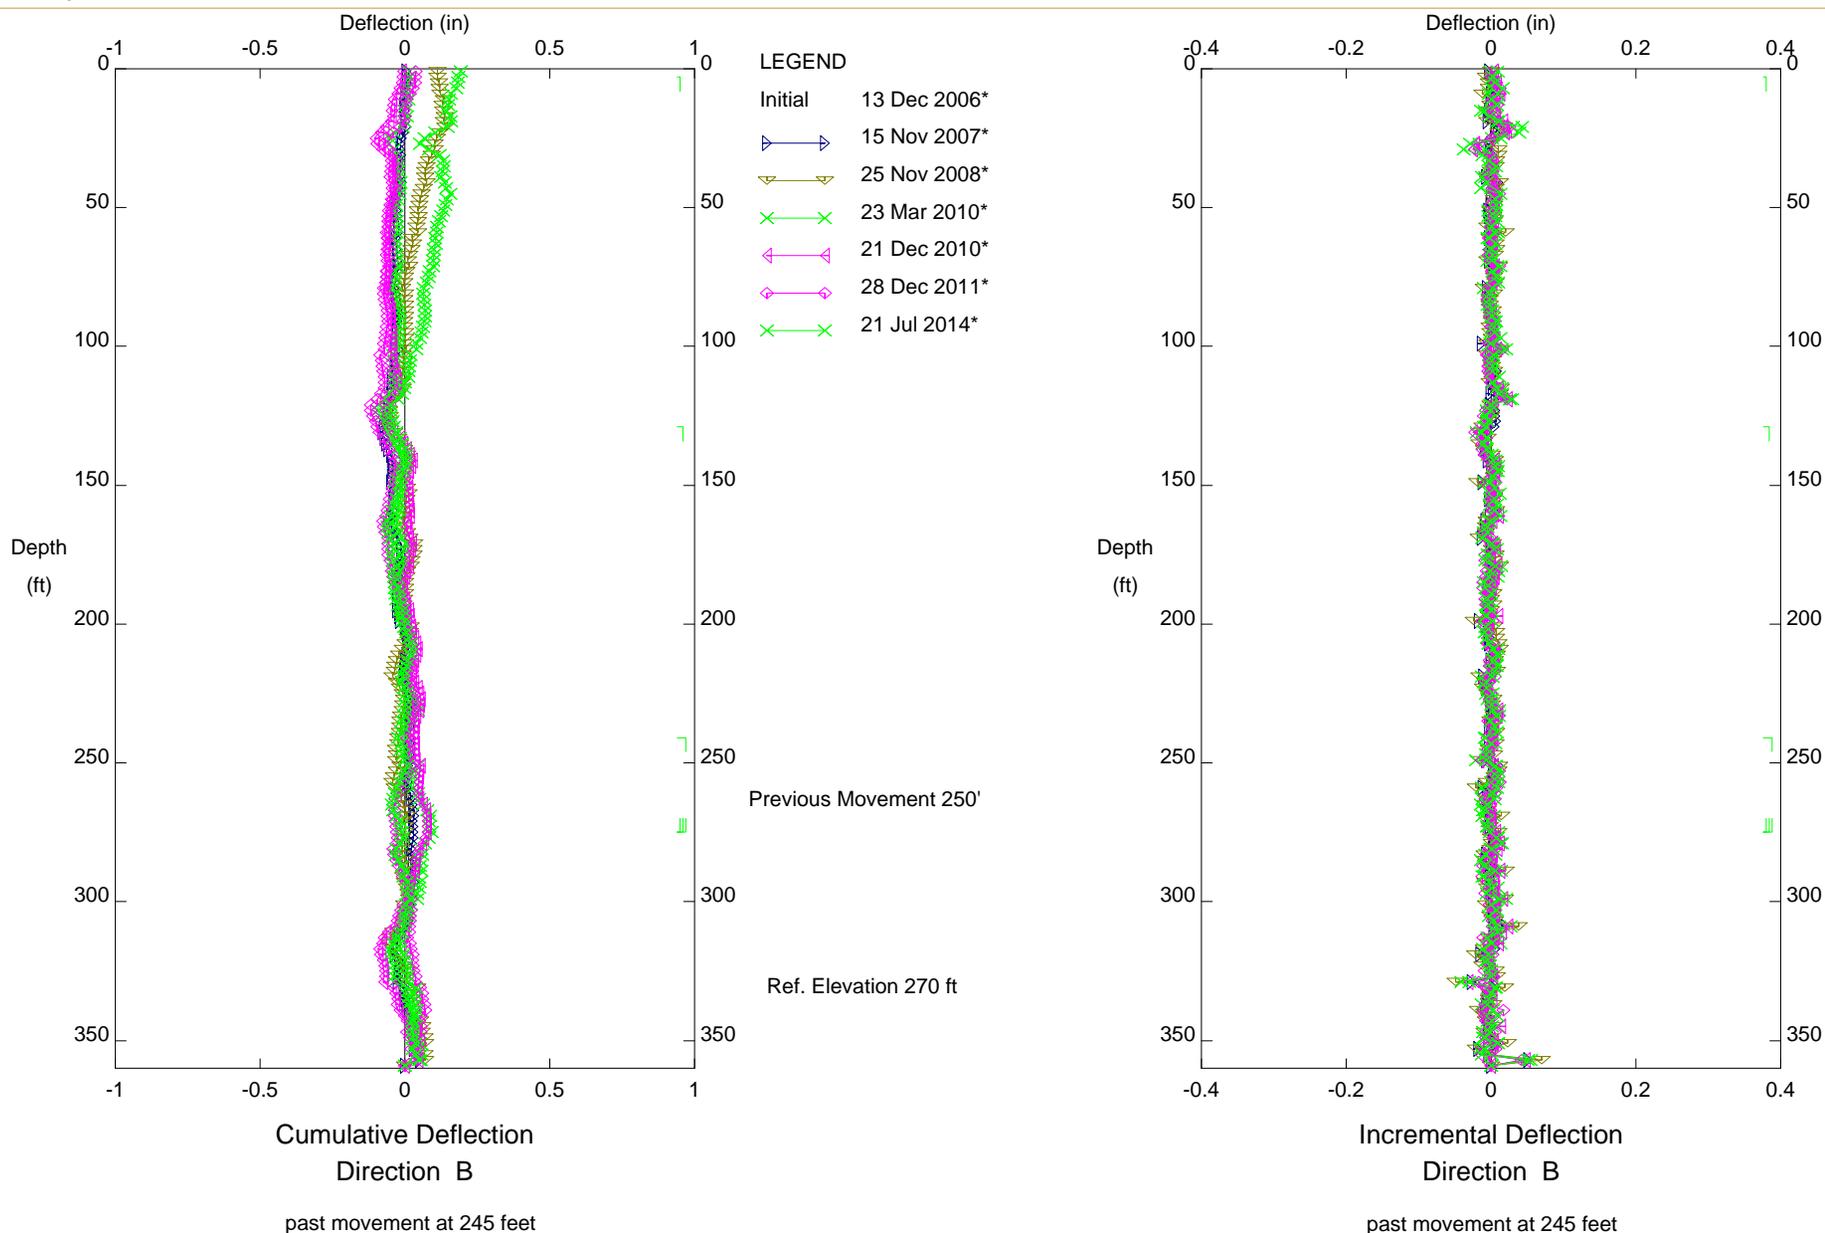
BIG ROCK MESA, Inclinometer SP-28
BLUFF REGION

Sets marked * include zero shift and/or rotation corrections.

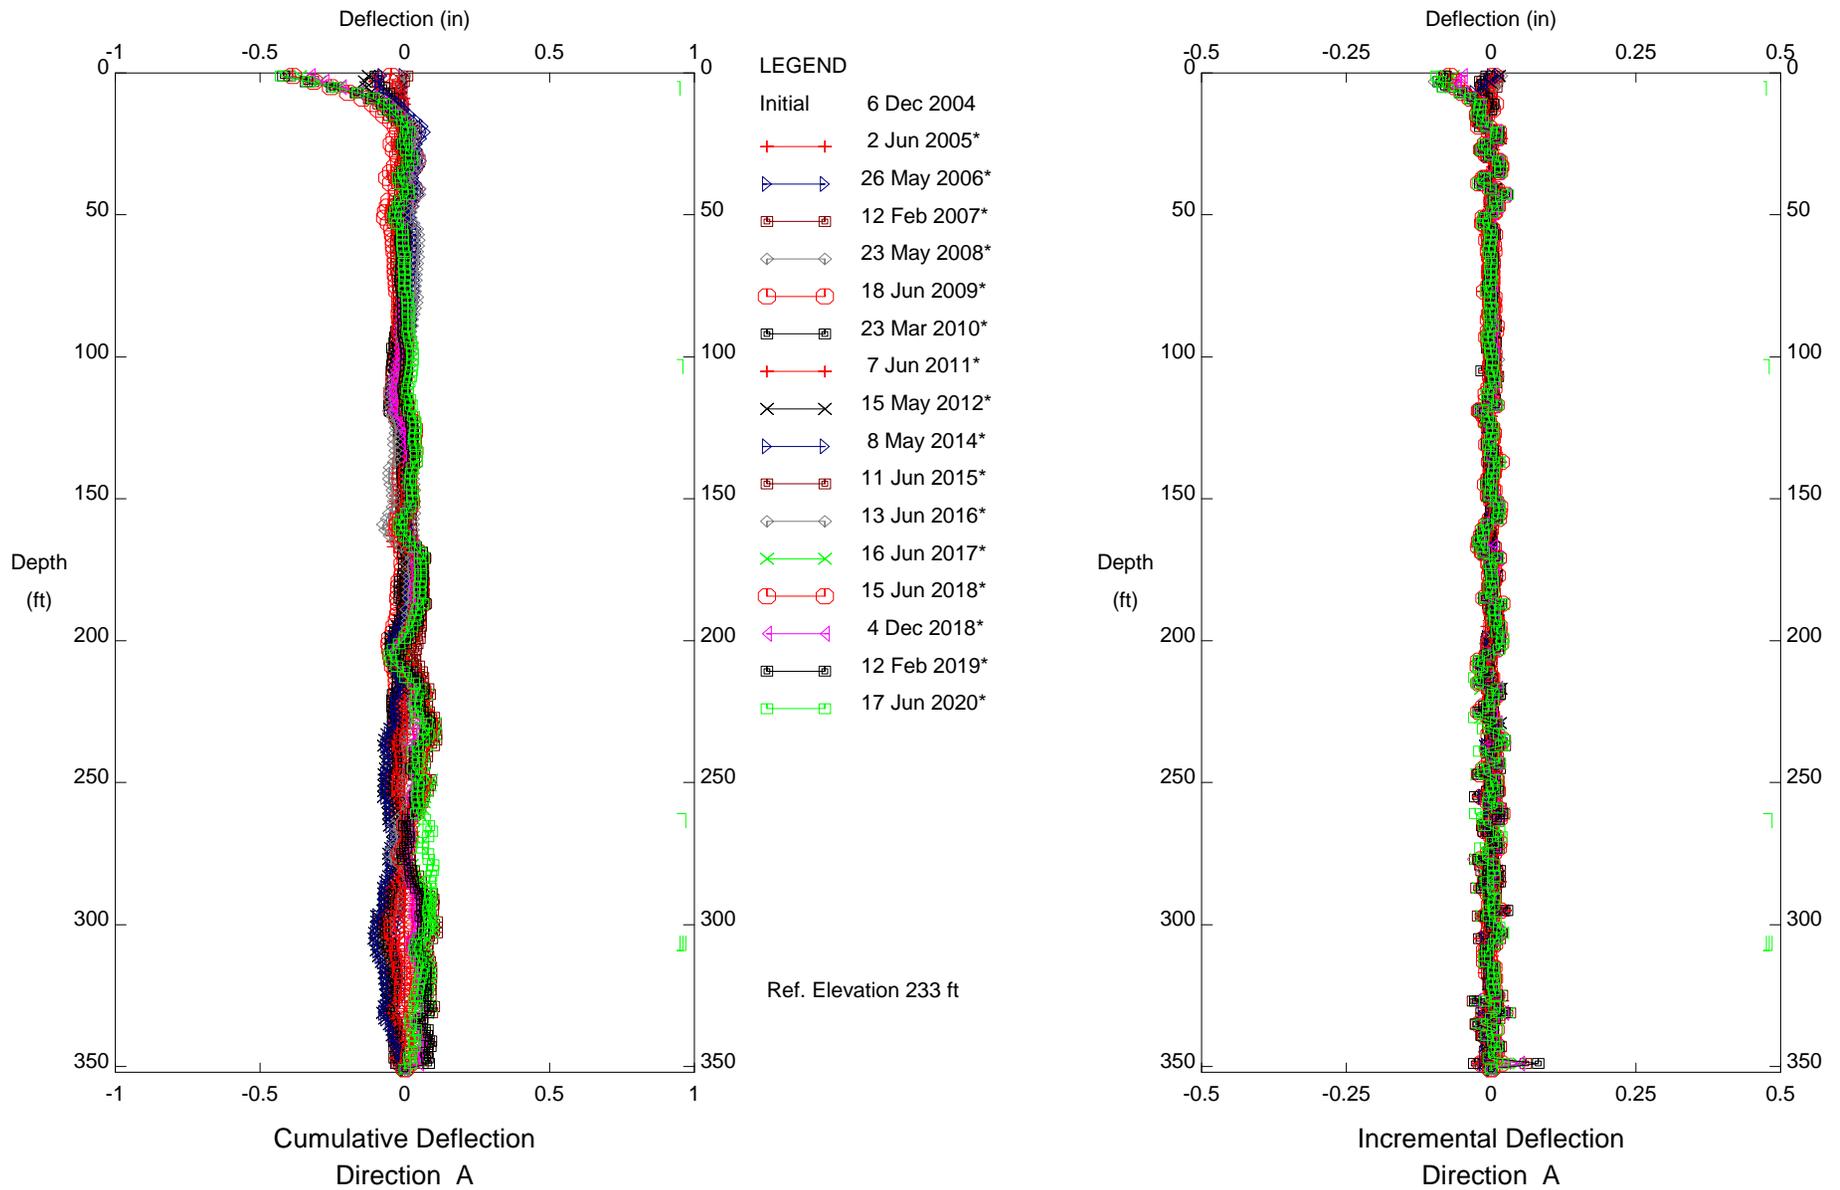
BIG ROCK MESA, Inclinometer SP-32
BLUFF REGION

Sets marked * include zero shift and/or rotation corrections.

past movement 250 feet
