**ANNUAL REPORT
JULY 2019 THROUGH JUNE 2020
BIG ROCK MESA LANDSLIDE
ASSESSMENT DISTRICT
City of Malibu, California**

Fugro Project No. 04.62160606

Document No. 04.62160606-PR-007(Rev.00)

**Annual Report of Maintenance and Monitoring, July 2019 through June 2020,
Big Rock Mesa Landslide Assessment District, City of Malibu, California**

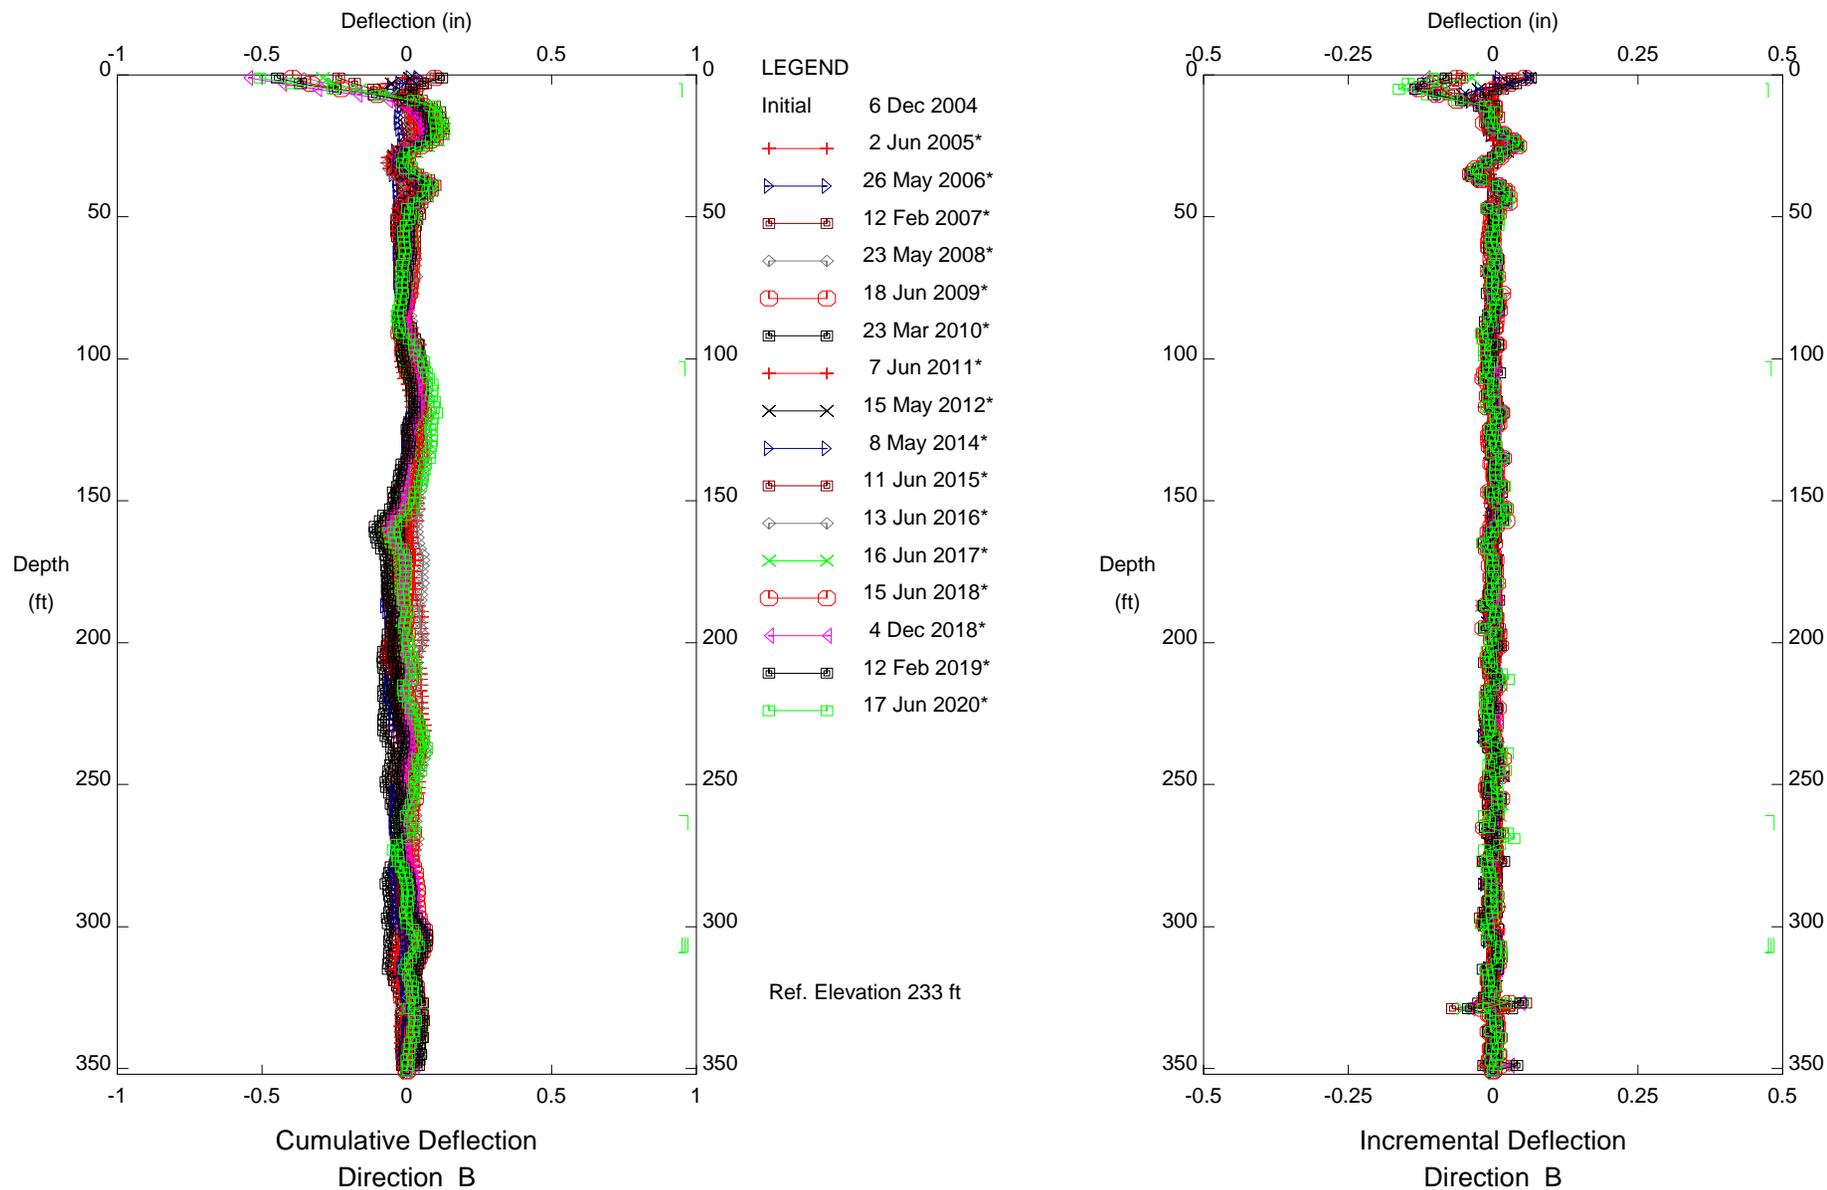
BIG ROCK MESA, Inclinometer SP-32
BLUFF REGION

Sets marked * include zero shift and/or rotation corrections.

past movement 250 feet

The Bluff Region extends along the top of the slope immediately north of the PCH Region, where intense ground cracking was observed during the 1983 landslide. The inclinometers in that area are deep and show evidence of depth position and rotation errors, associated with cable stretch, casing curvature, and casing deviation from vertical. SP-32 displayed movement less than 0.1 inches between a depth of approximately 260 to 300 feet. No other quantifiable offsets within the inclinometers of the Bluff Region were measured during this monitoring period.

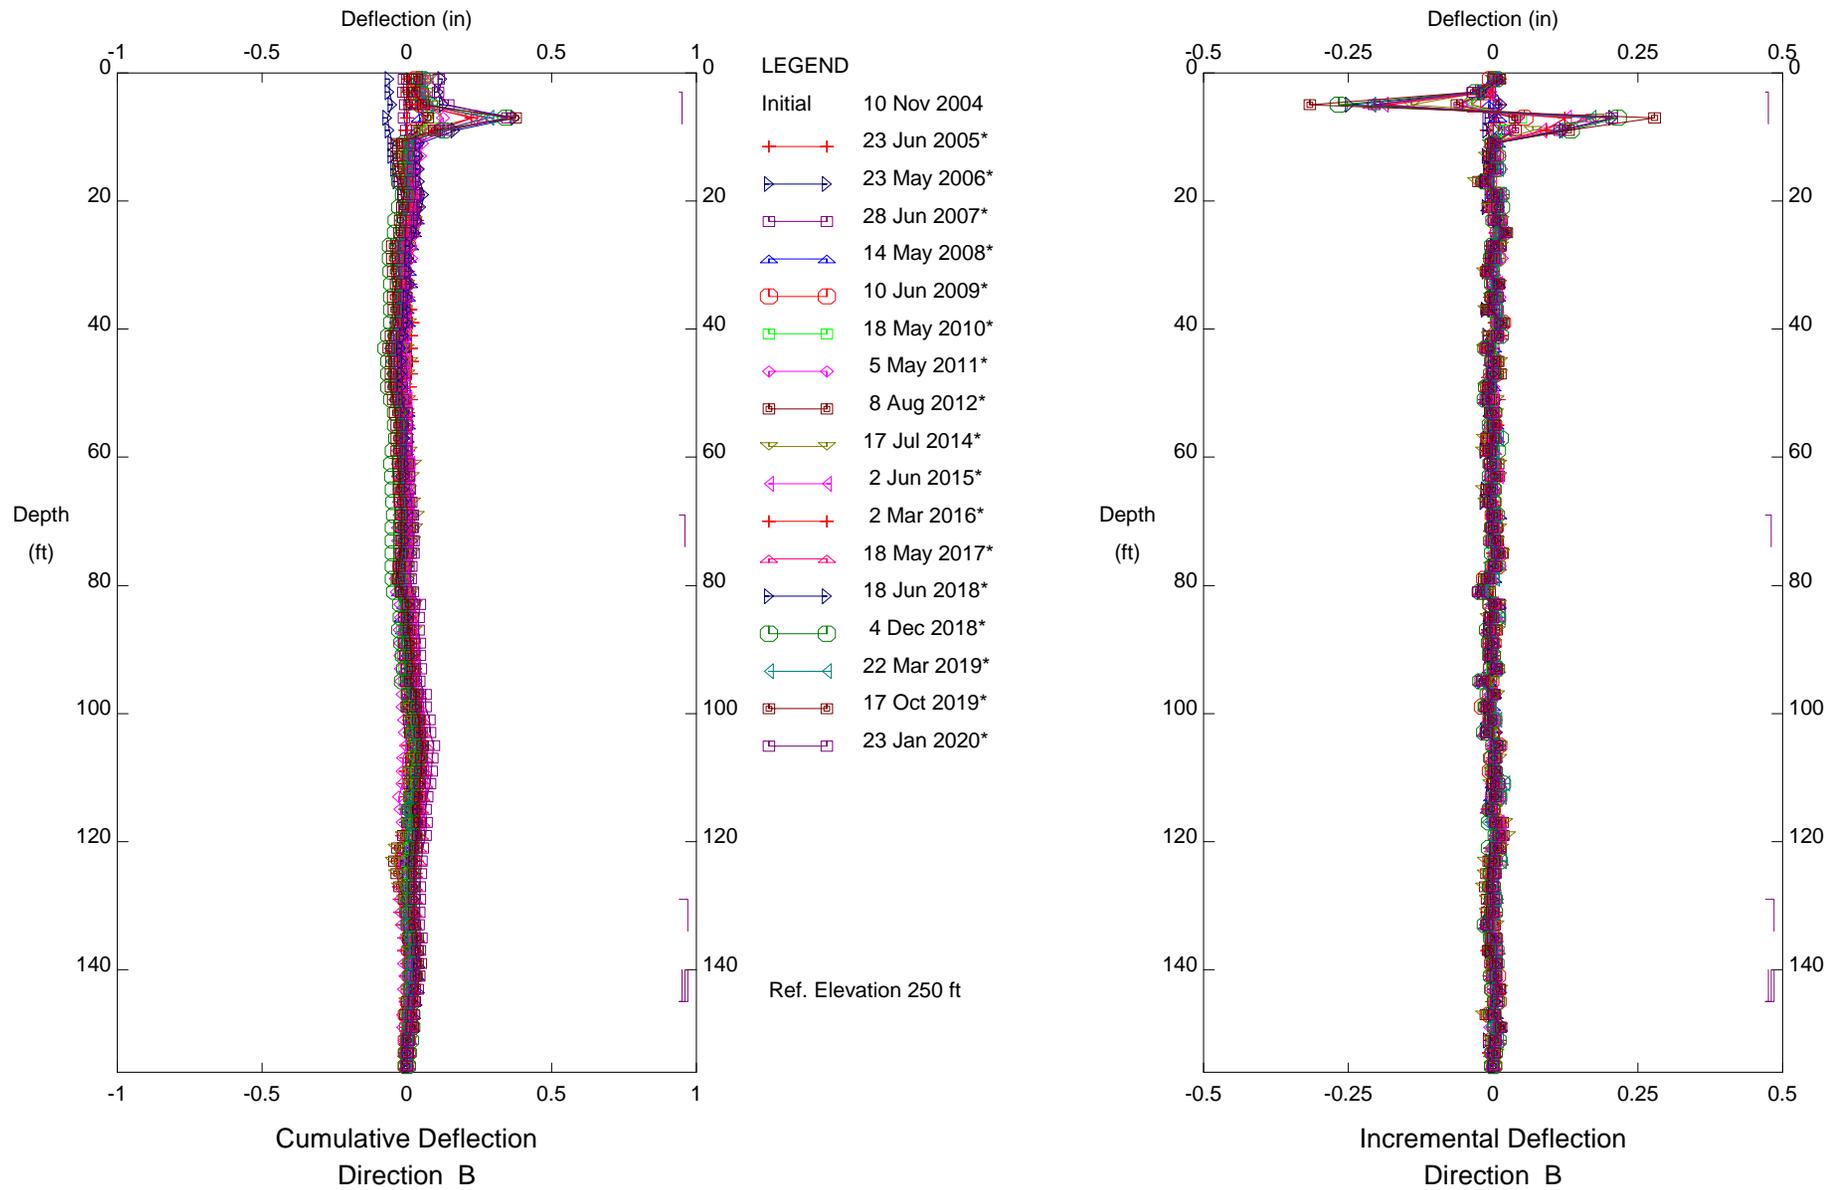
BIG ROCK MESA, Inclinometer PC-1
EASTERN REGION

Sets marked * include zero shift and/or rotation corrections.

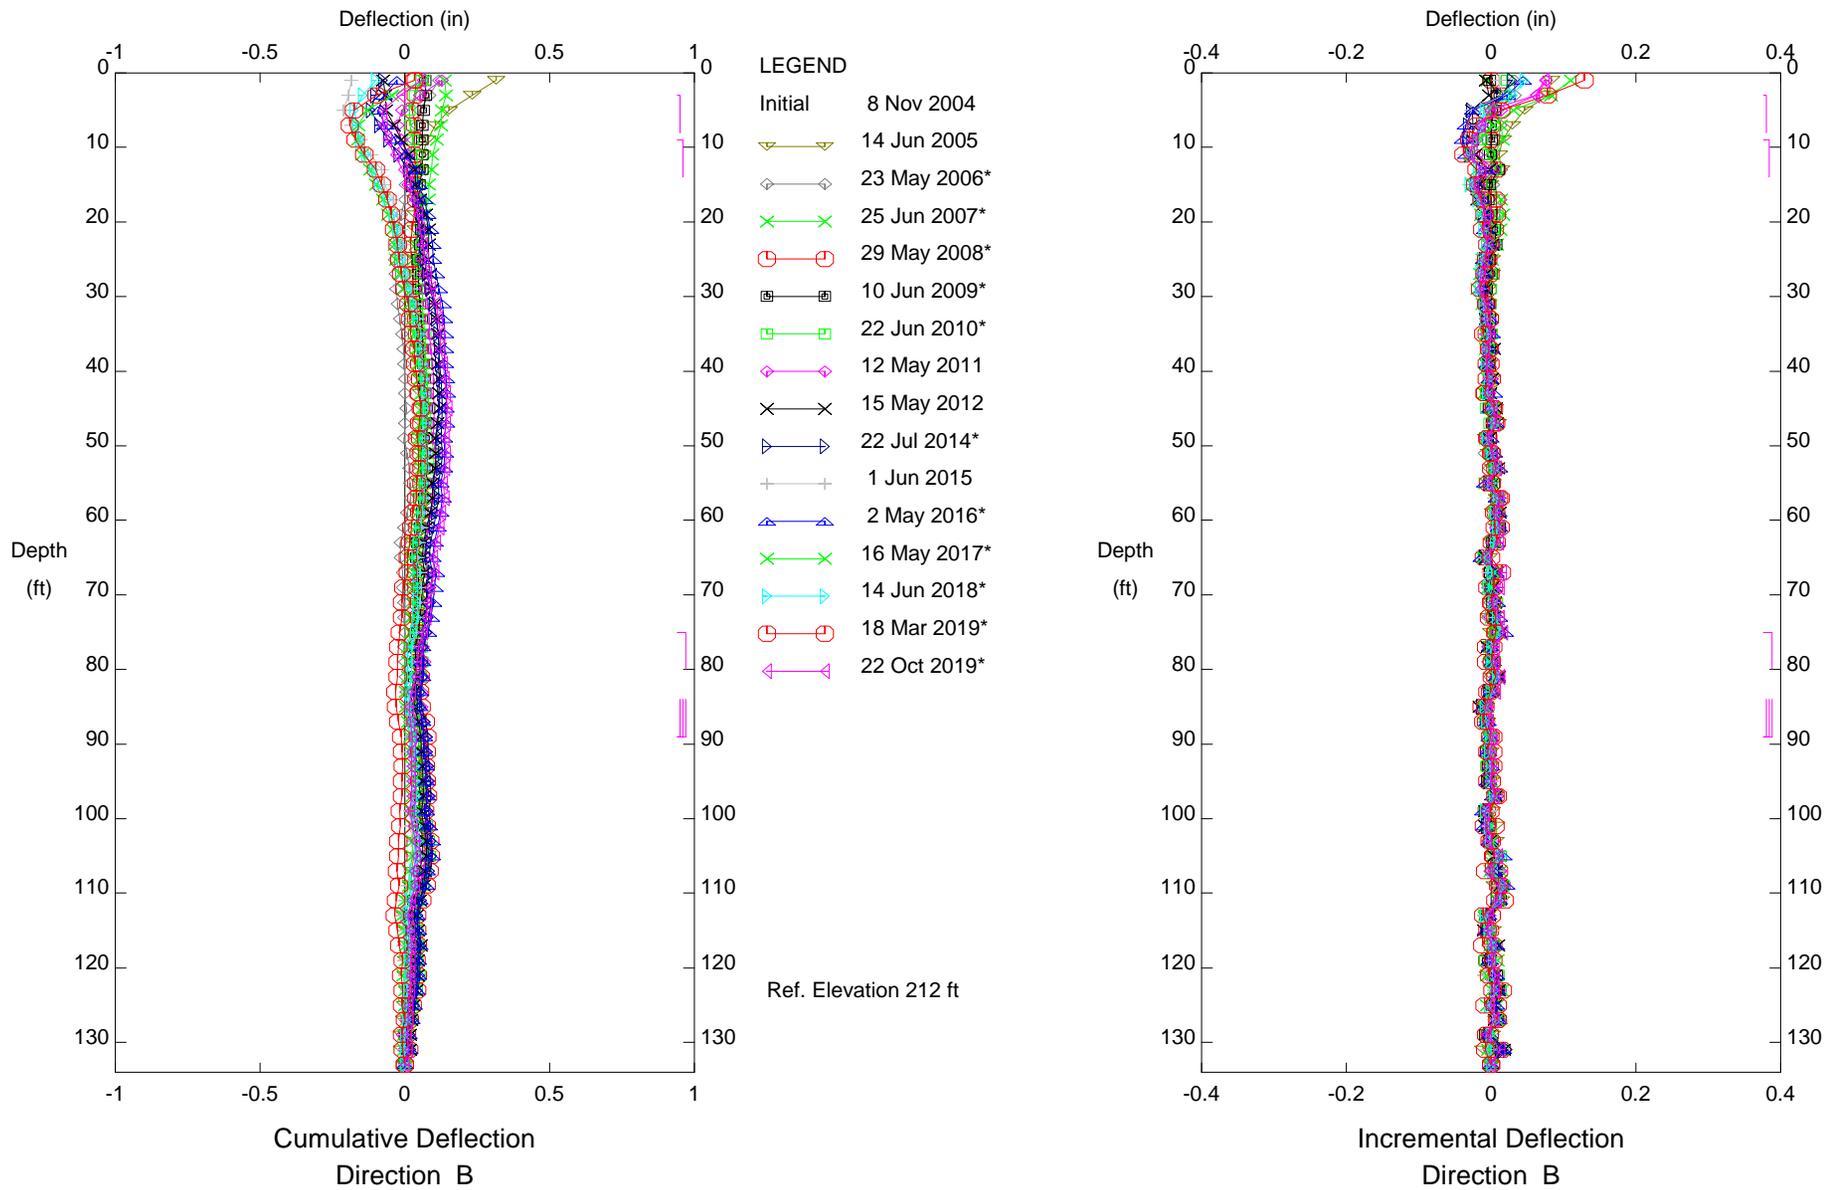
BIG ROCK MESA, Inclinometer SP-3
EASTERN REGION

Sets marked * include zero shift and/or rotation corrections.

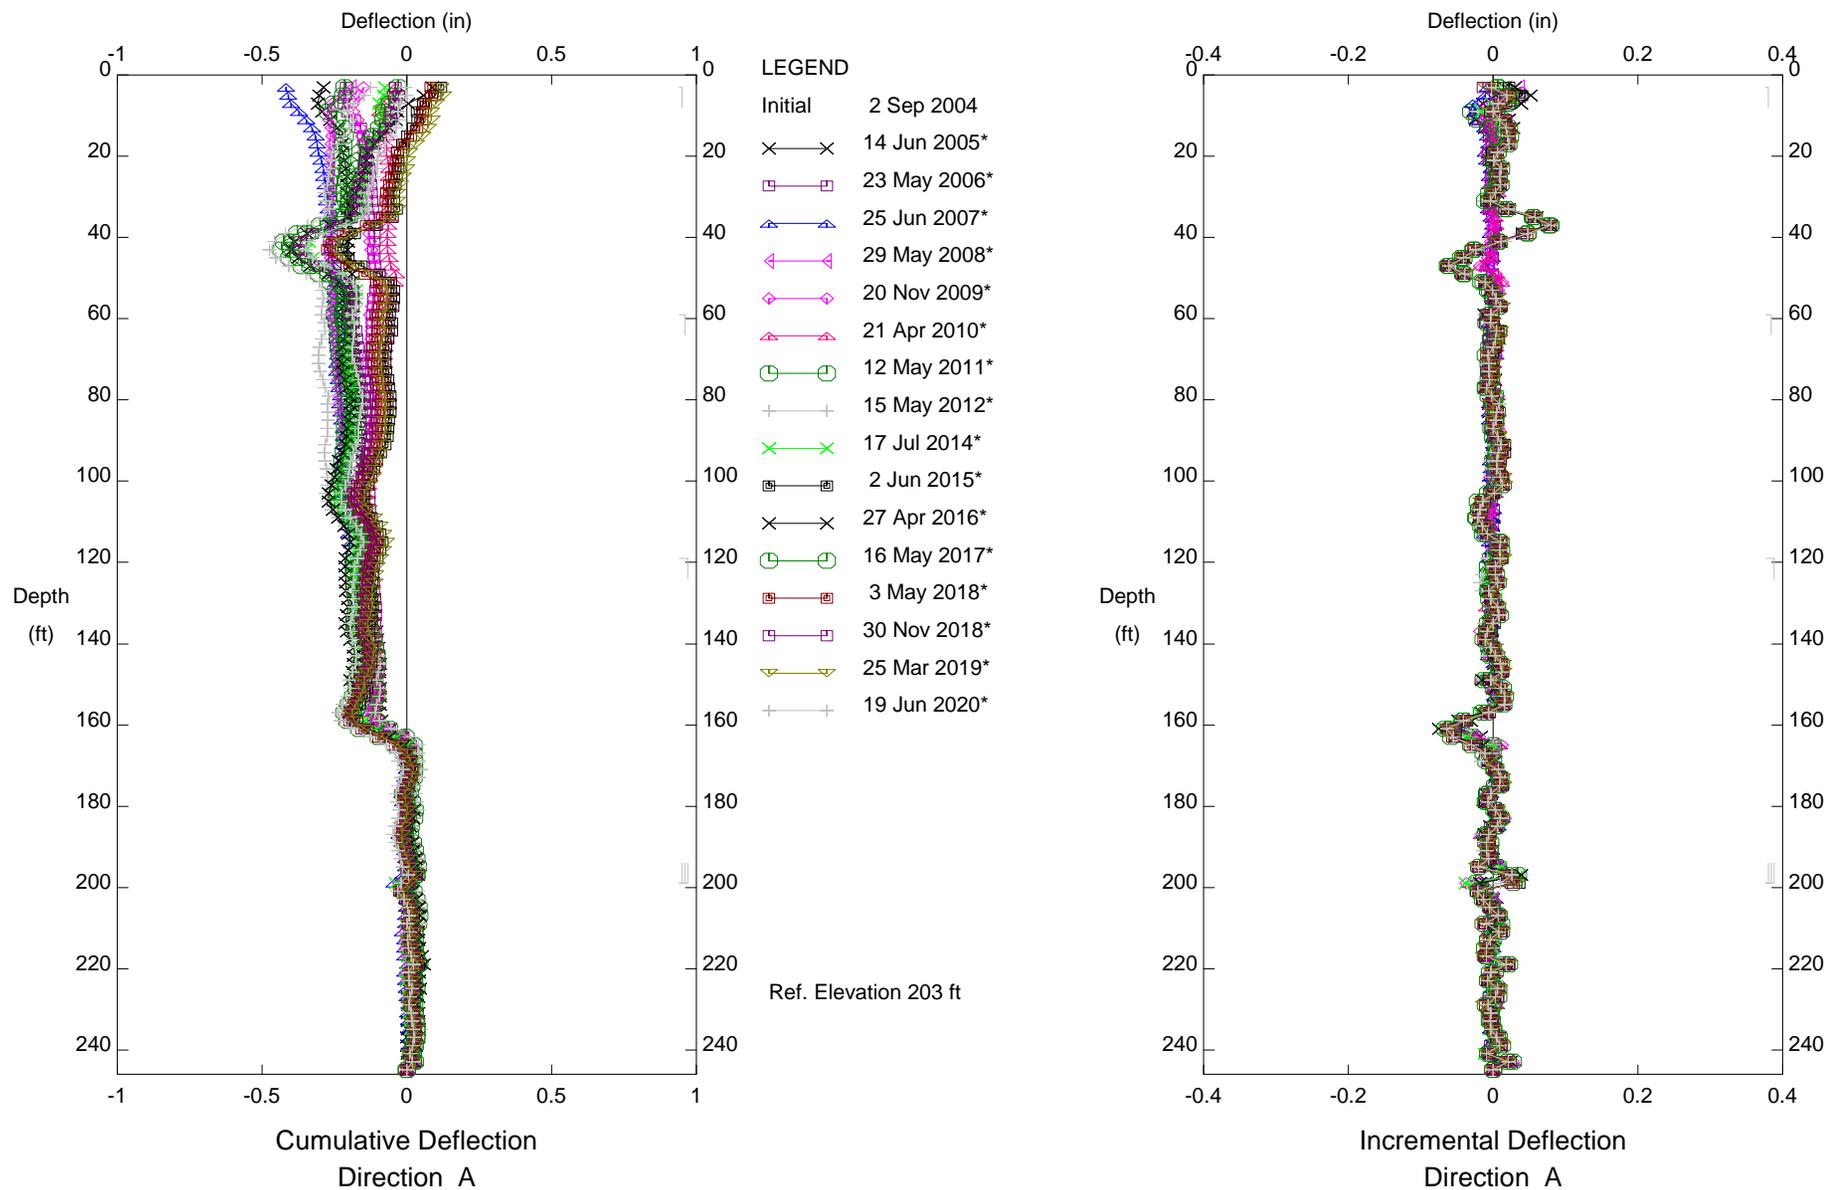
BIG ROCK MESA, Inclinator SP-3A
EASTERN REGION

Sets marked * include zero shift and/or rotation corrections.

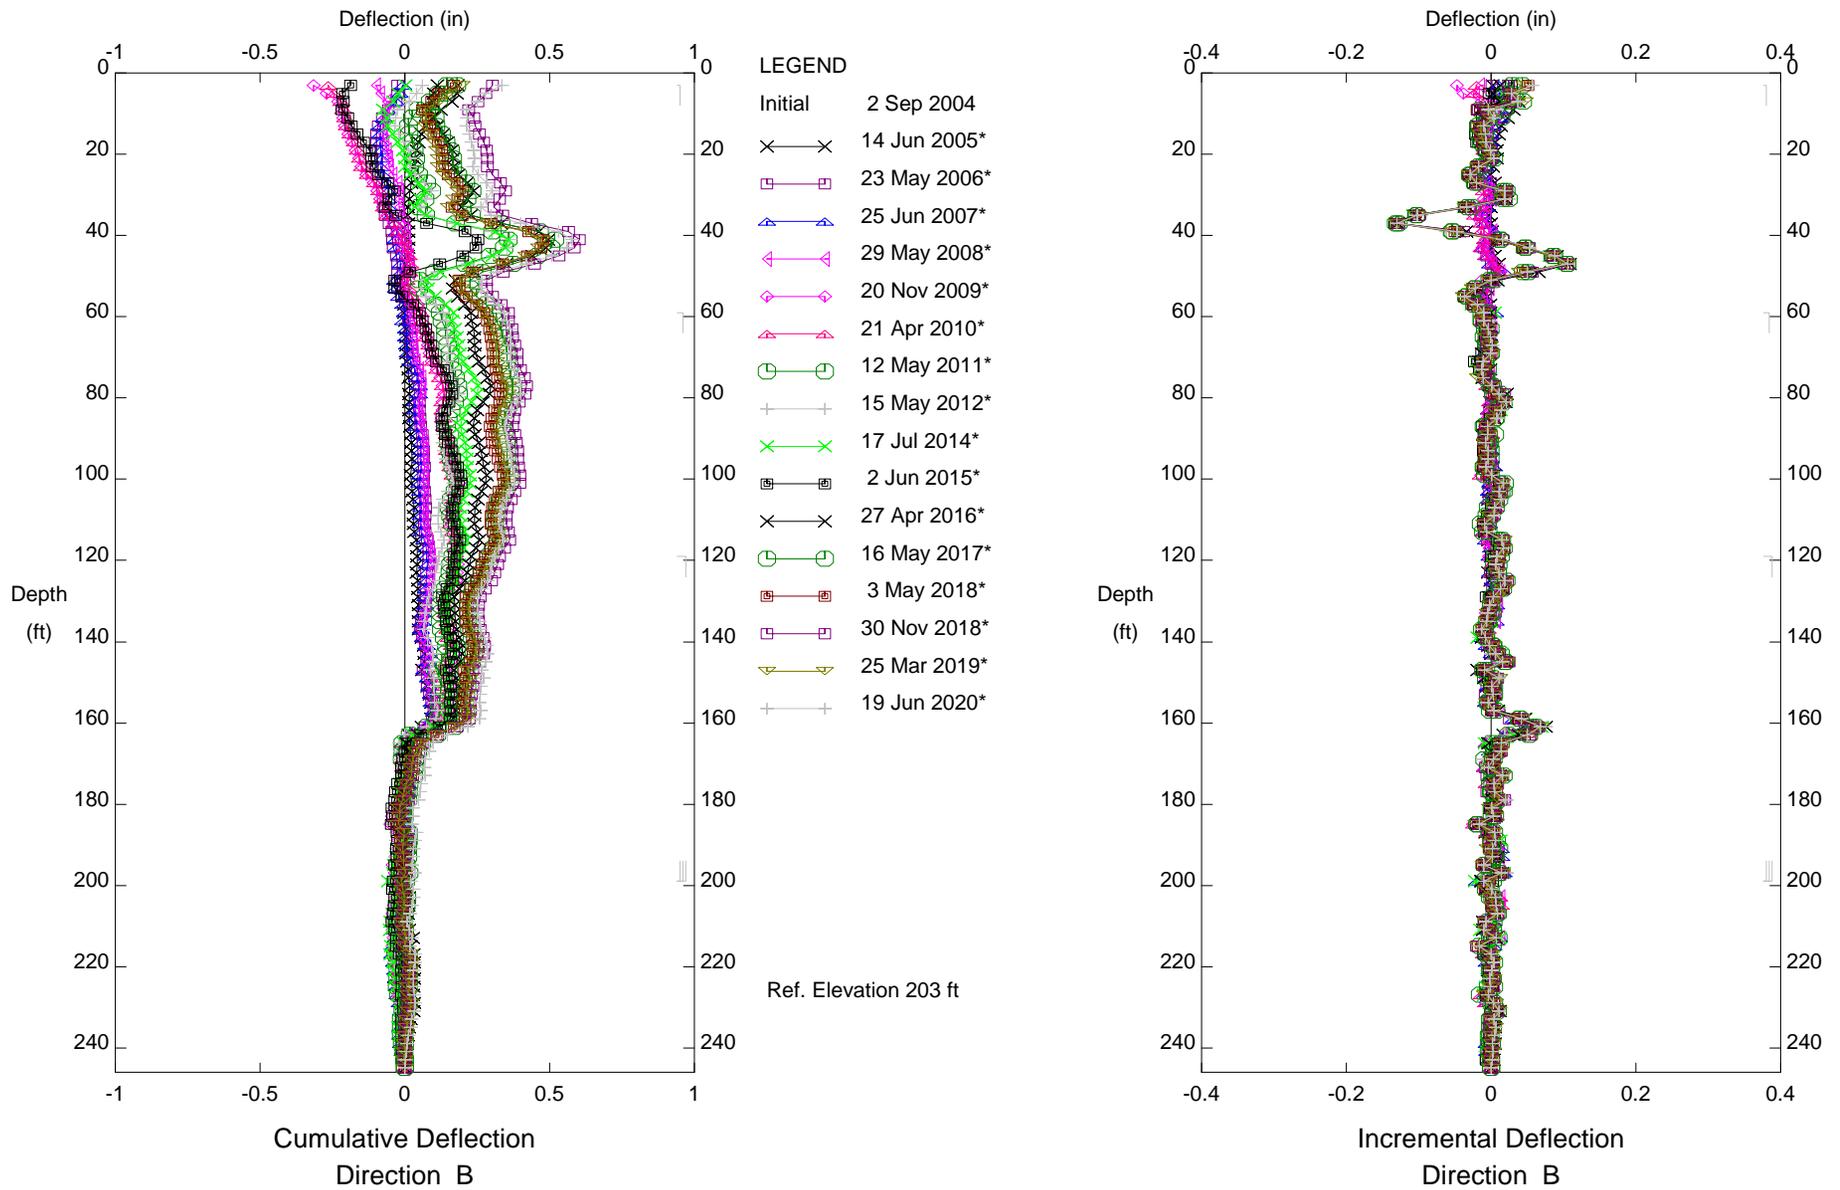
BIG ROCK MESA, Inclinometer SP-3A
EASTERN REGION

Sets marked * include zero shift and/or rotation corrections.

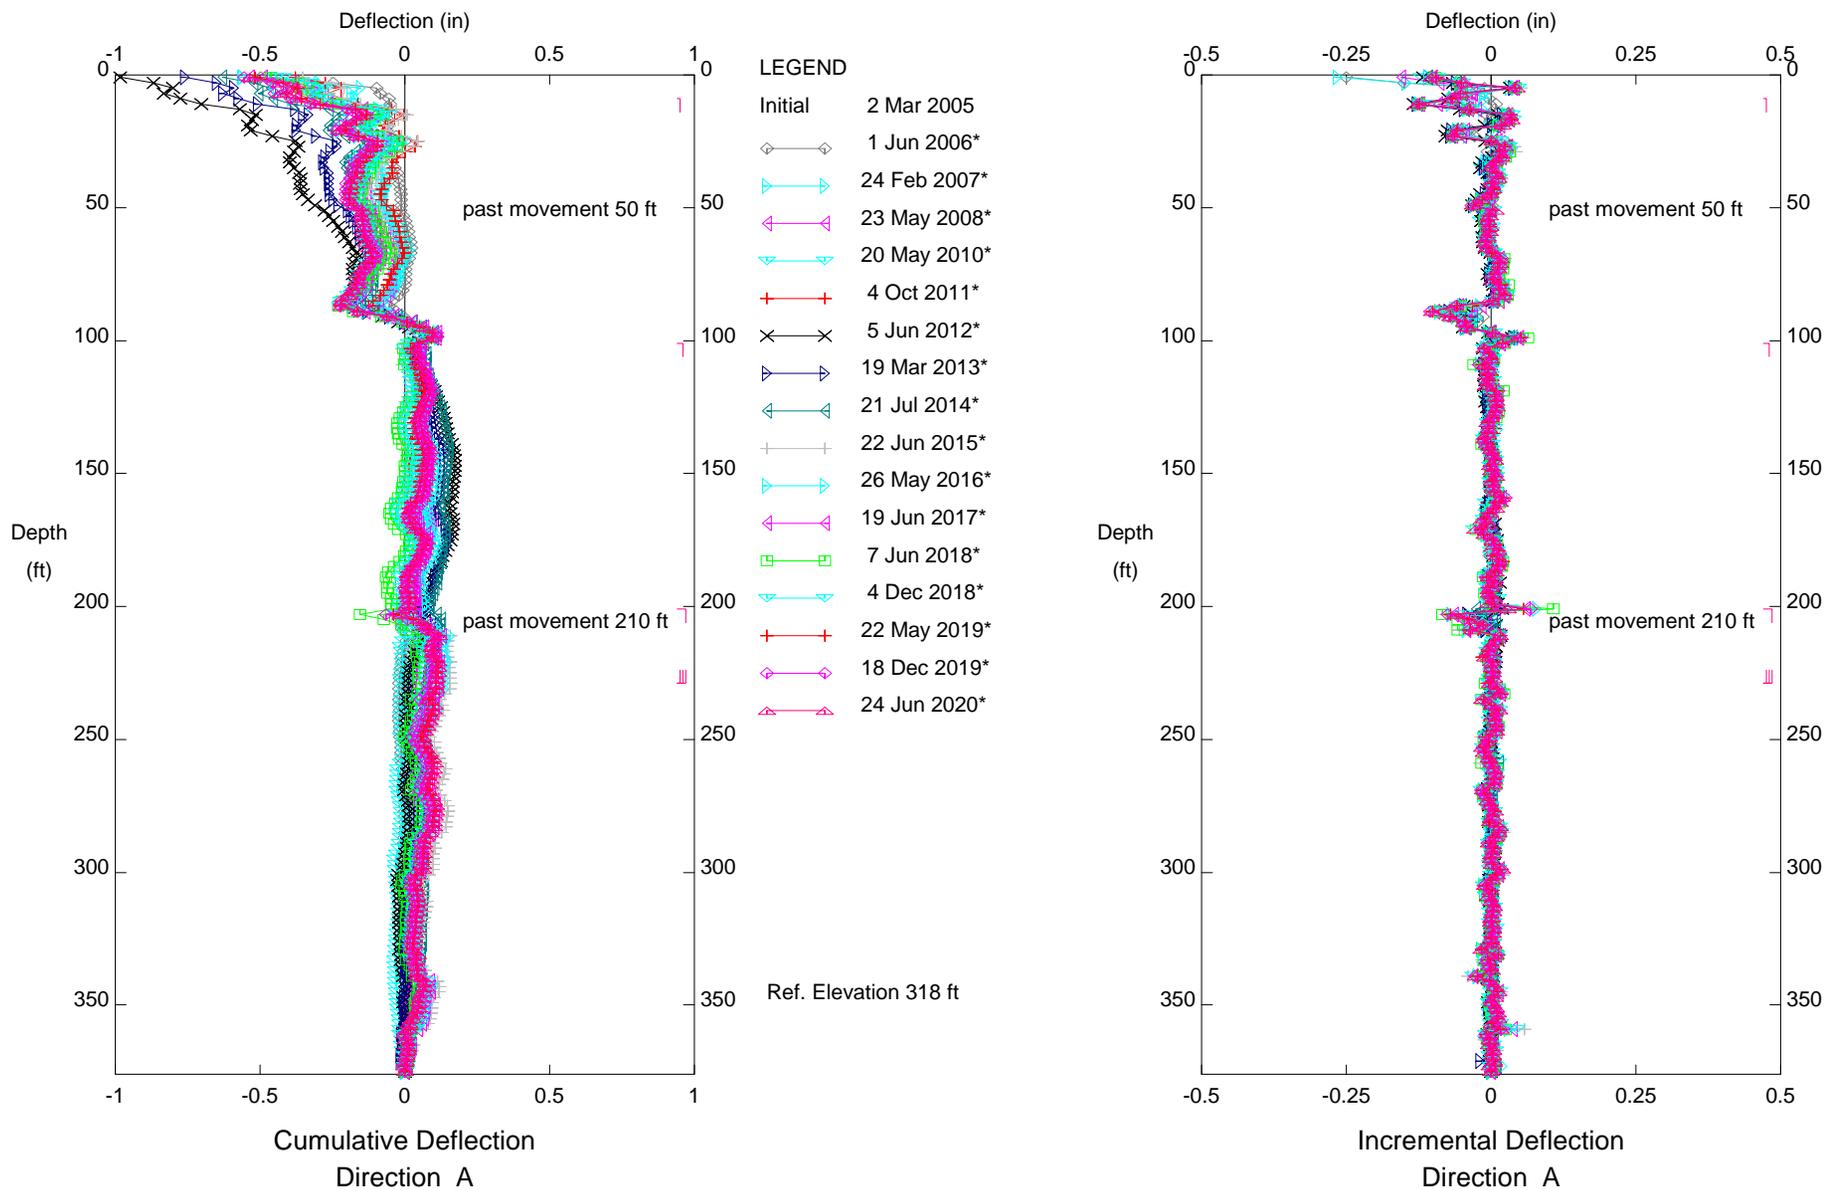
BIG ROCK MESA, Inclinometer SP-33
EASTERN REGION

Sets marked * include zero shift and/or rotation corrections.

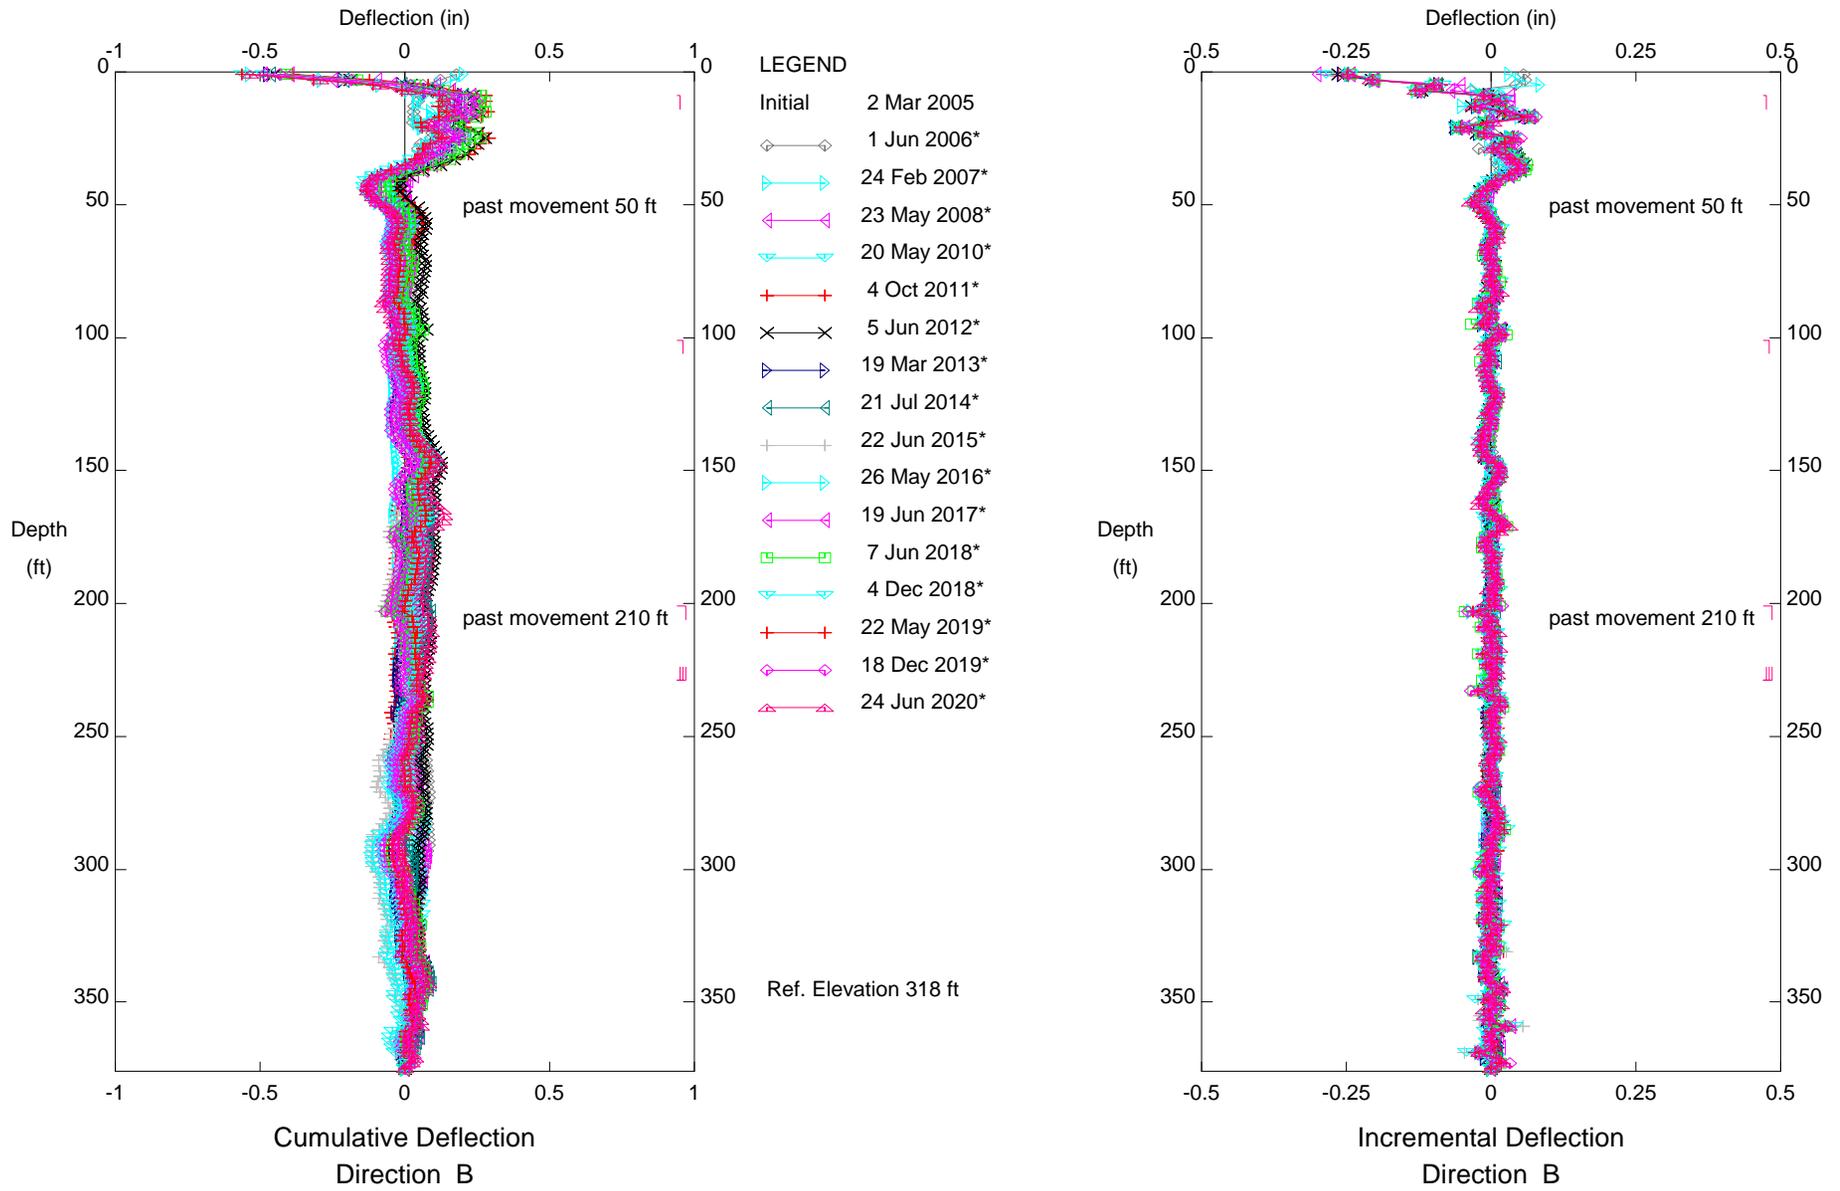
BIG ROCK MESA, Inclinometer SP-33
EASTERN REGION

Sets marked * include zero shift and/or rotation corrections.

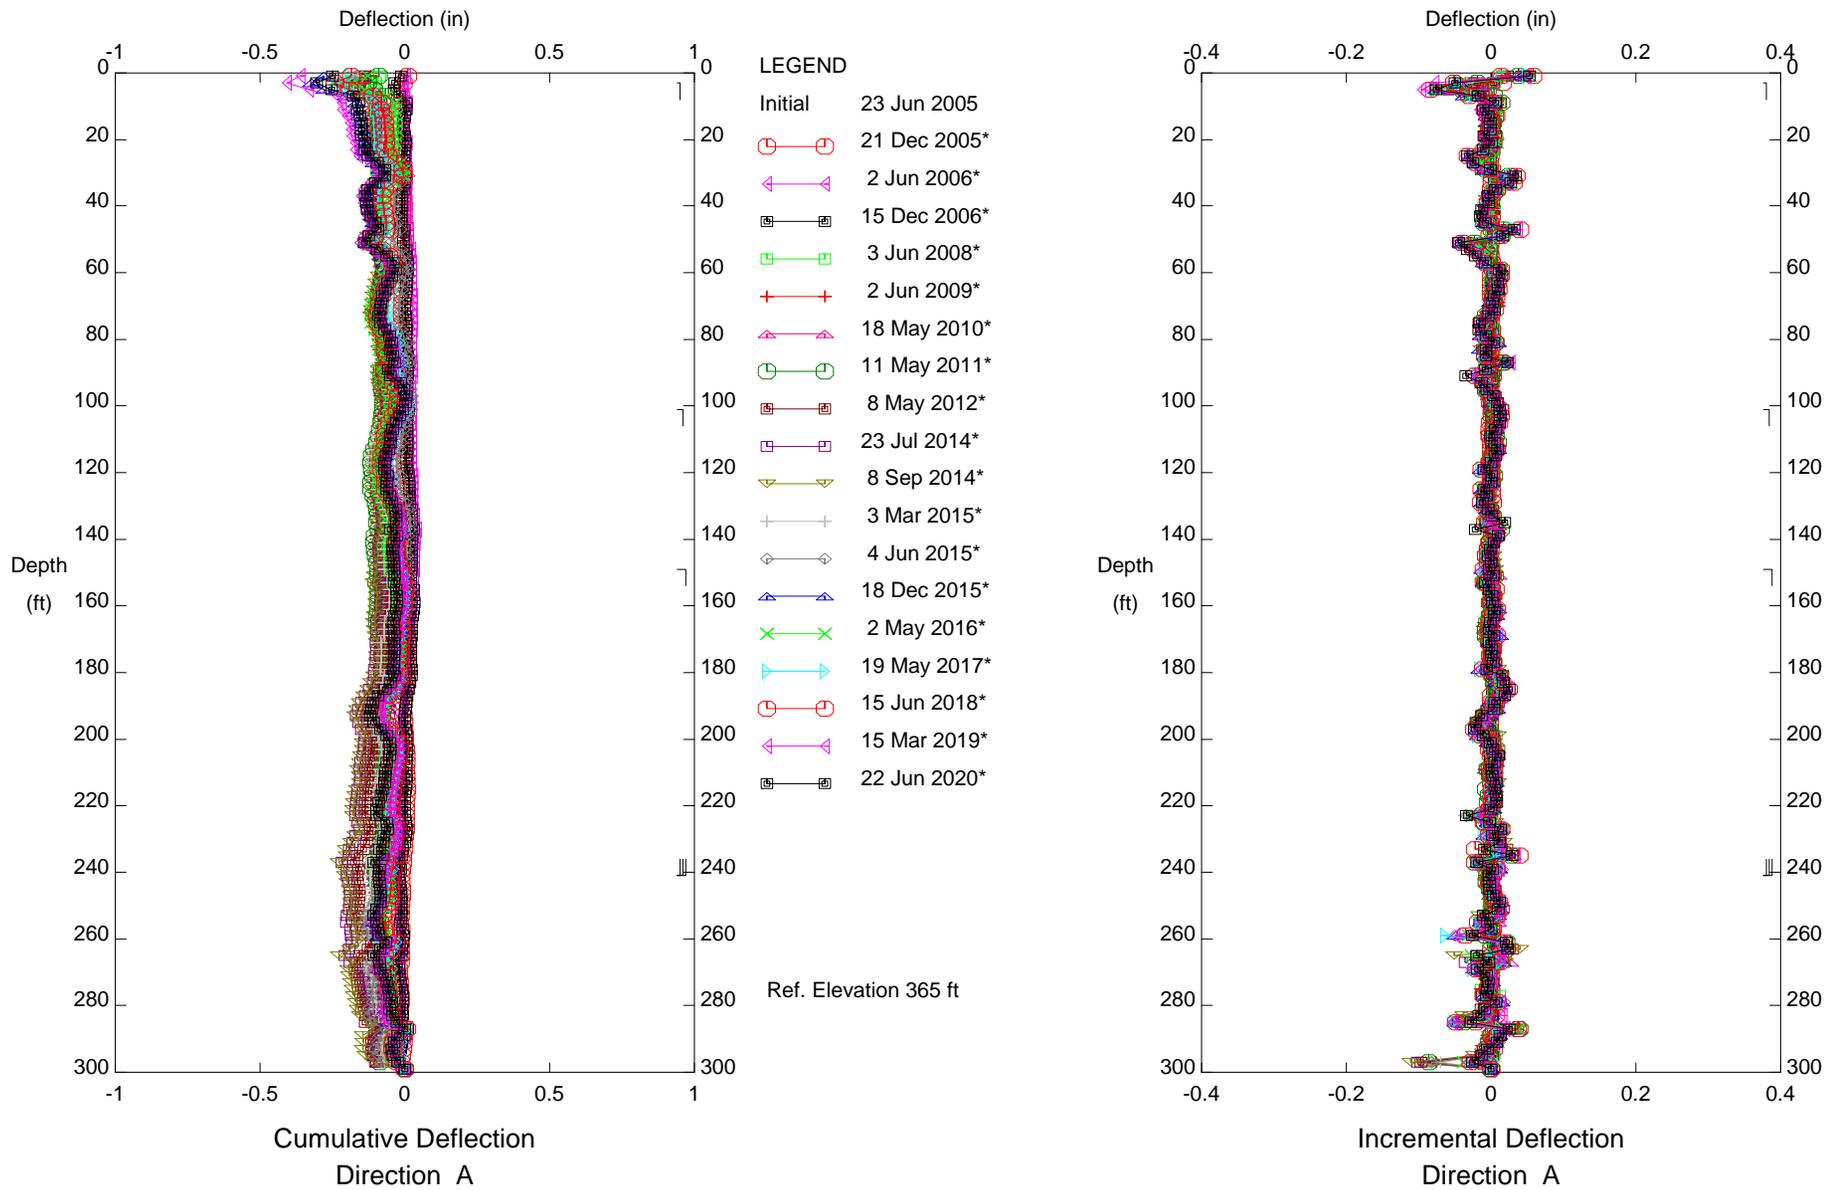
BIG ROCK MESA, Inclinometer SP-9A
CENTRAL REGION

Sets marked * include zero shift and/or rotation corrections.

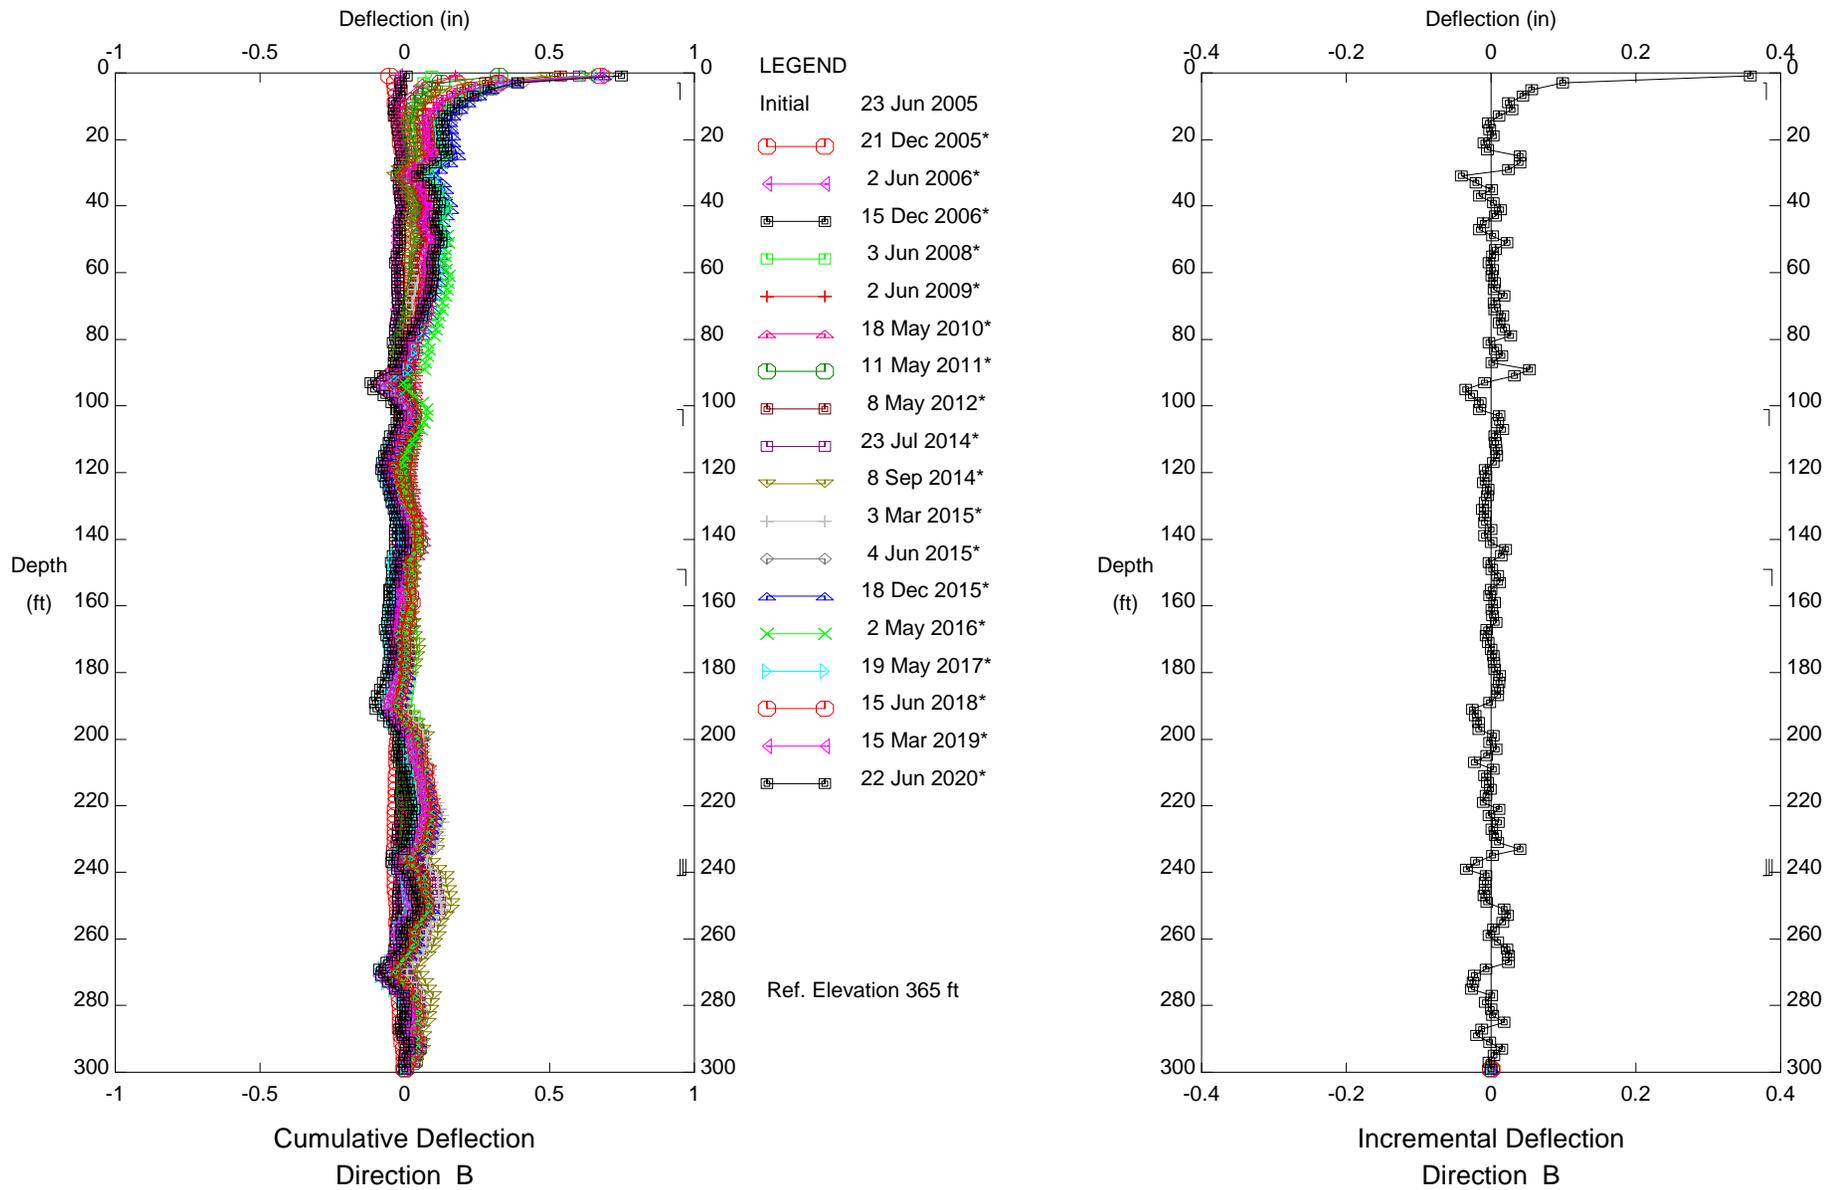
BIG ROCK MESA, Inclinometer SP-9A
CENTRAL REGION

Sets marked * include zero shift and/or rotation corrections.

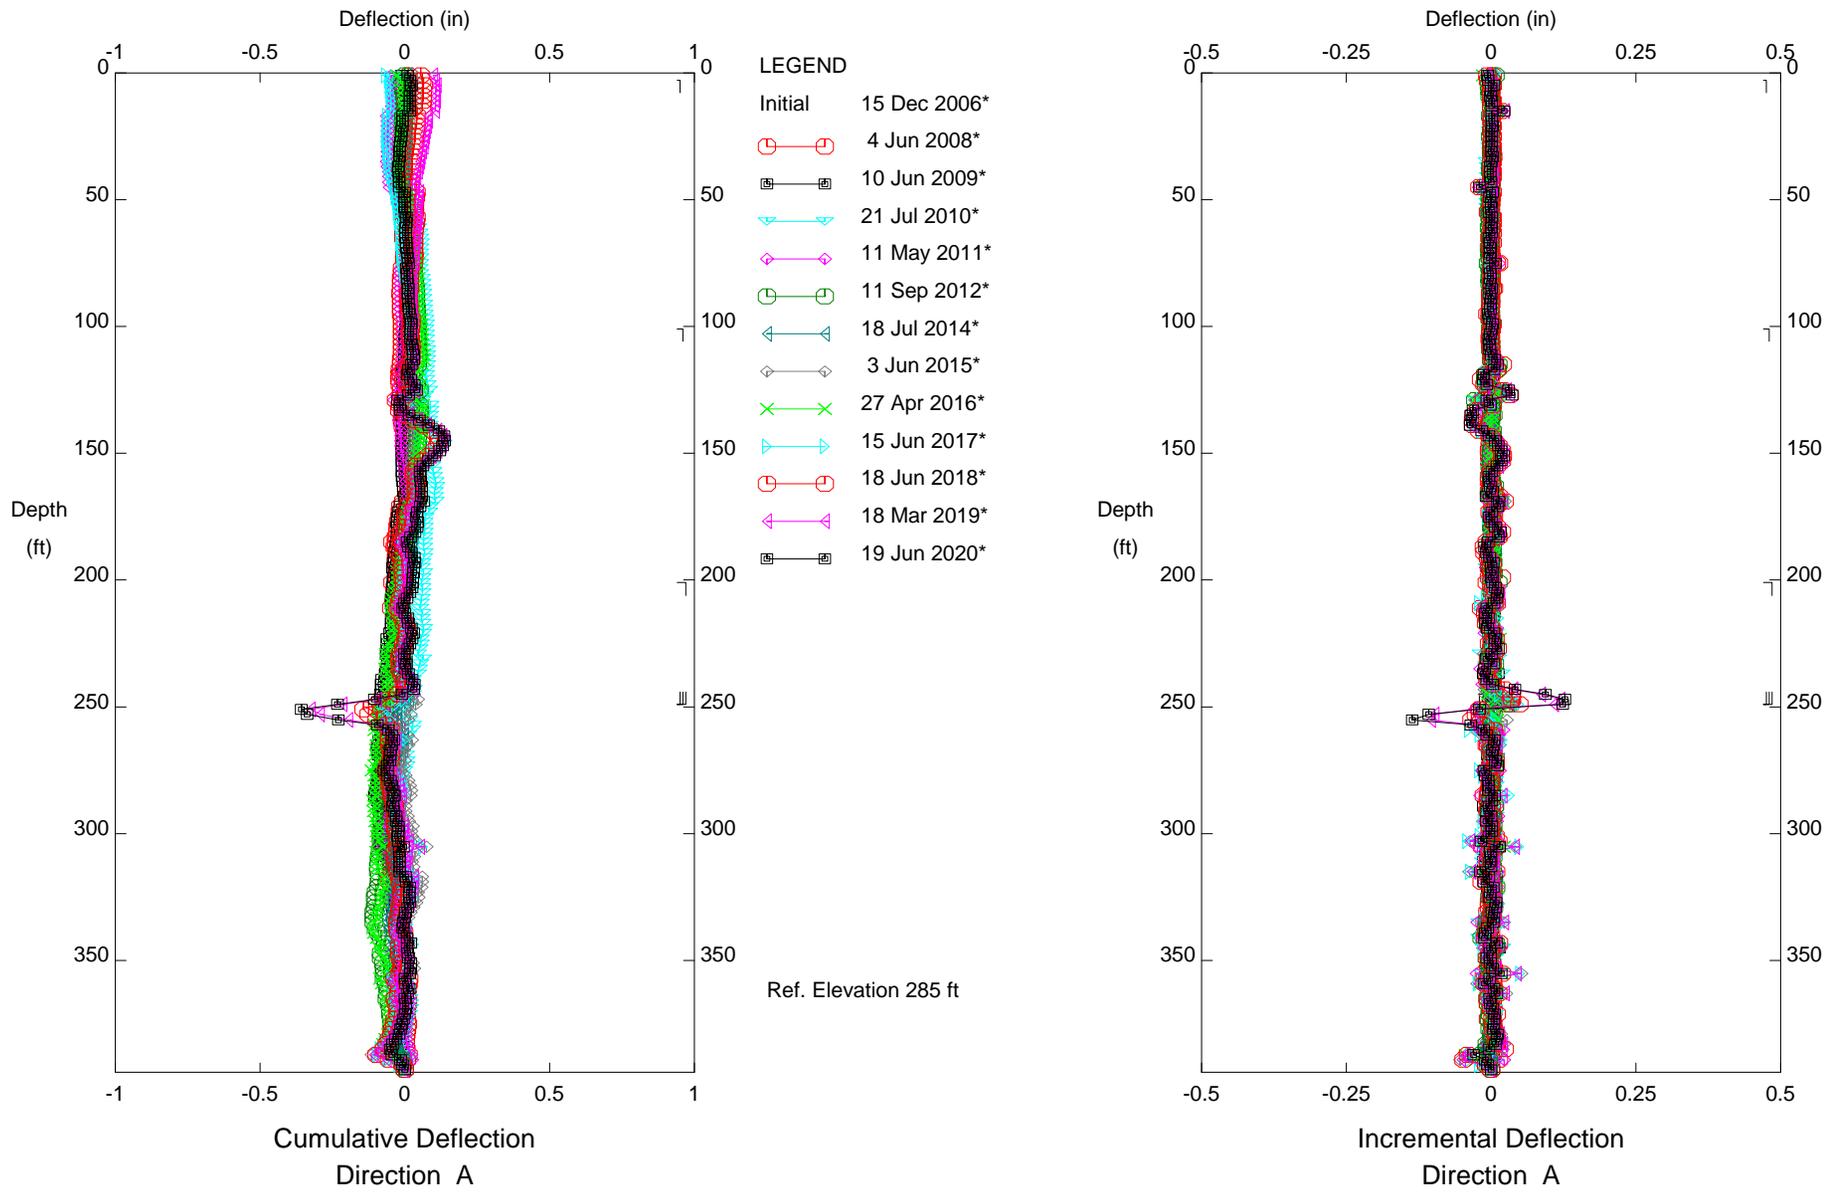
BIG ROCK MESA, Inclinometer SP-16A
CENTRAL REGION

Sets marked * include zero shift and/or rotation corrections.
