**ANNUAL REPORT
JULY 2019 THROUGH JUNE 2020
BIG ROCK MESA LANDSLIDE
ASSESSMENT DISTRICT
City of Malibu, California**

Fugro Project No. 04.62160606

Document No. 04.62160606-PR-007(Rev.00)

**Annual Report of Maintenance and Monitoring, July 2019 through June 2020,
Big Rock Mesa Landslide Assessment District, City of Malibu, California**

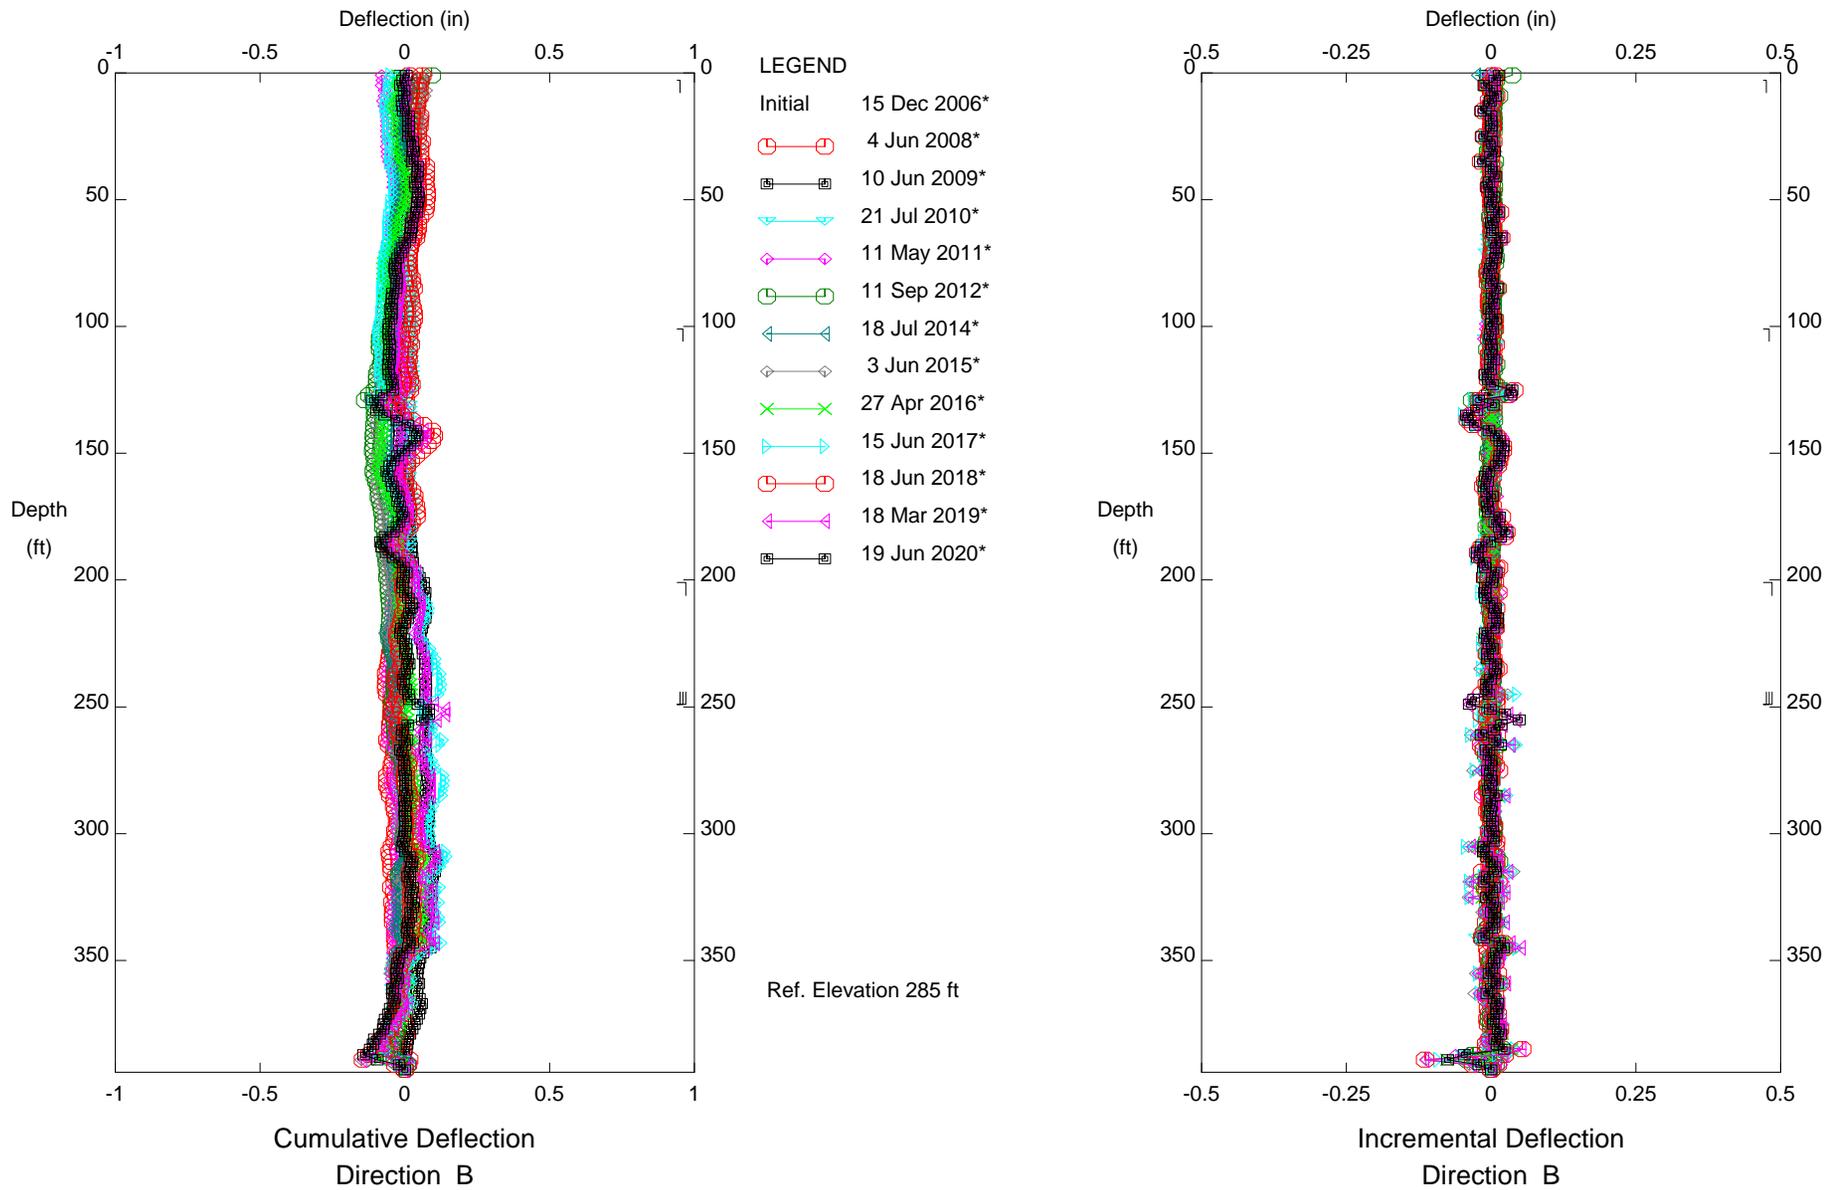
BIG ROCK MESA, Inclinometer SP-16A
CENTRAL REGION

Sets marked * include zero shift and/or rotation corrections.

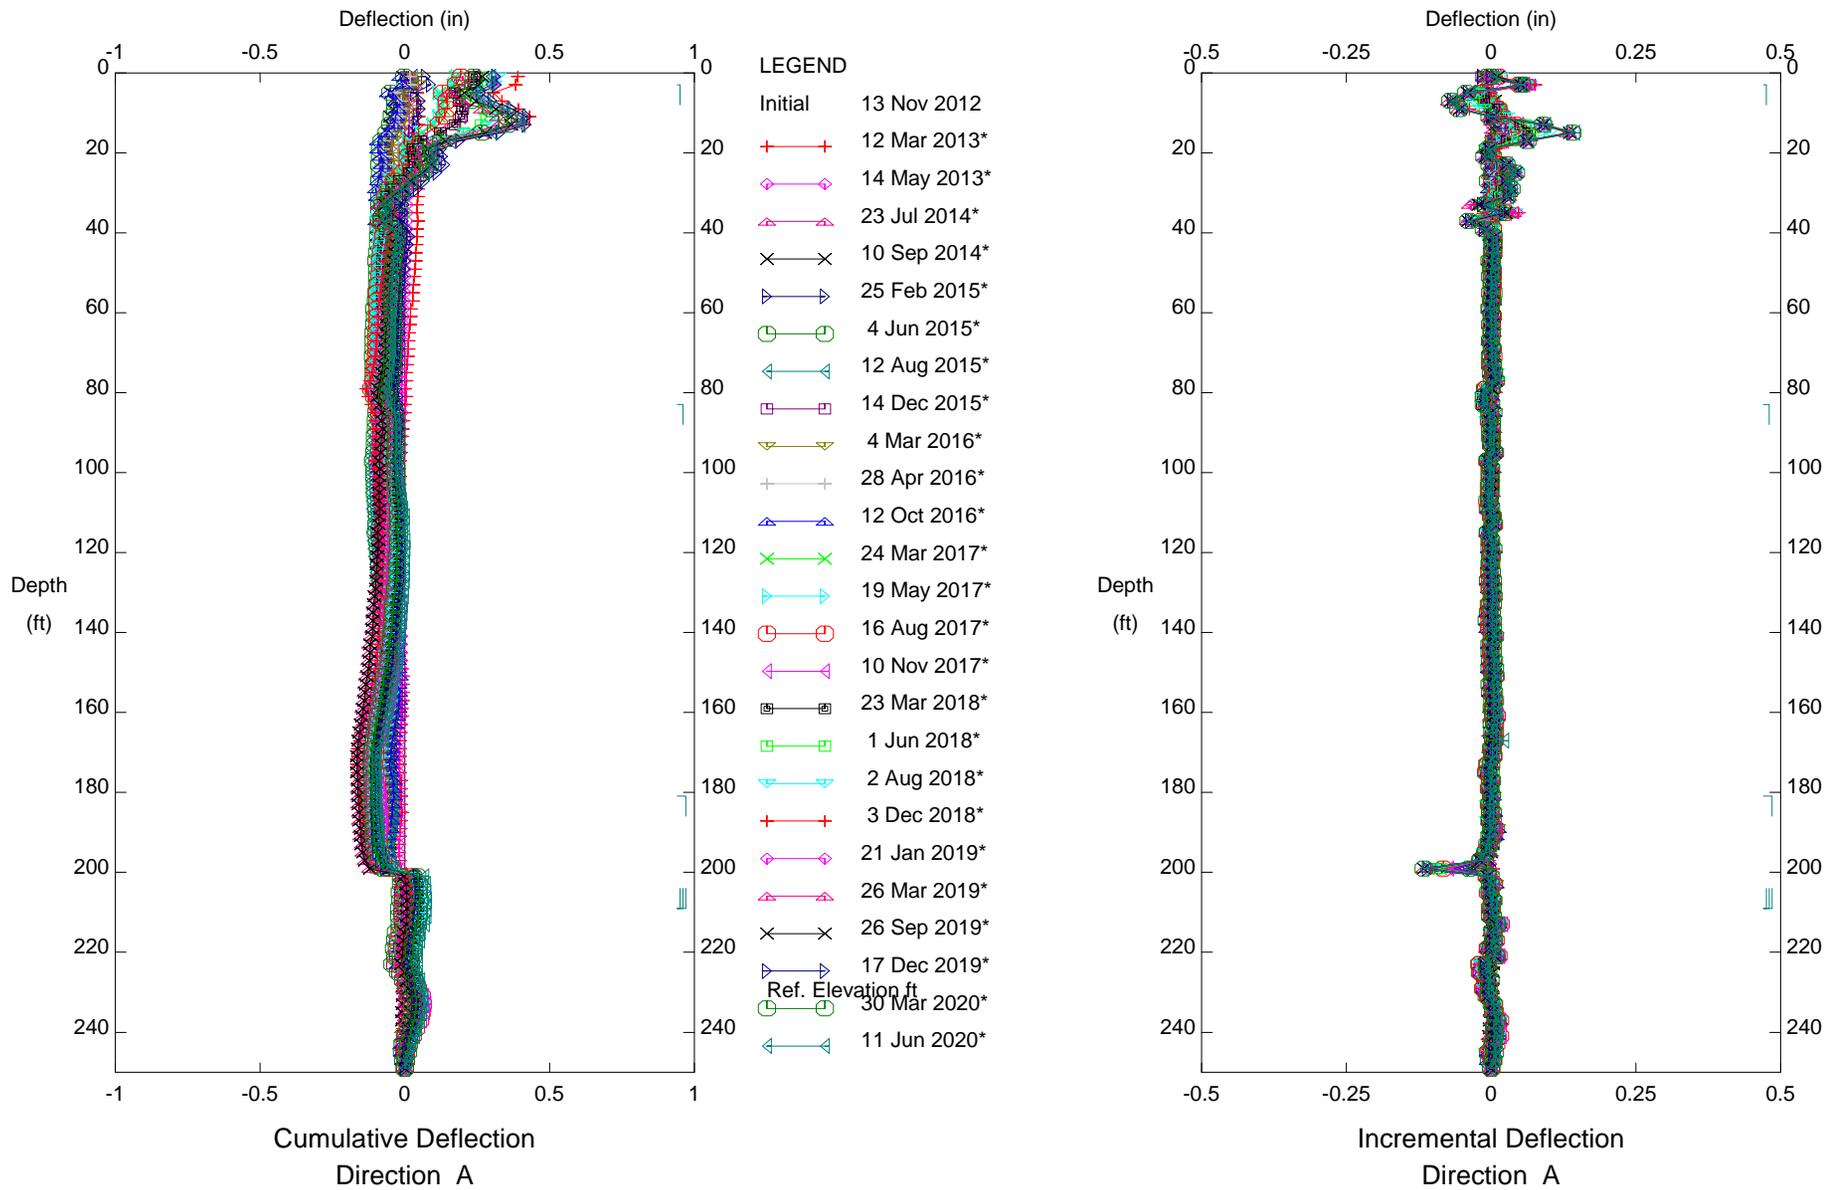
BRM, Inclinometer SP-17B

Sets marked * include zero shift and/or rotation corrections.

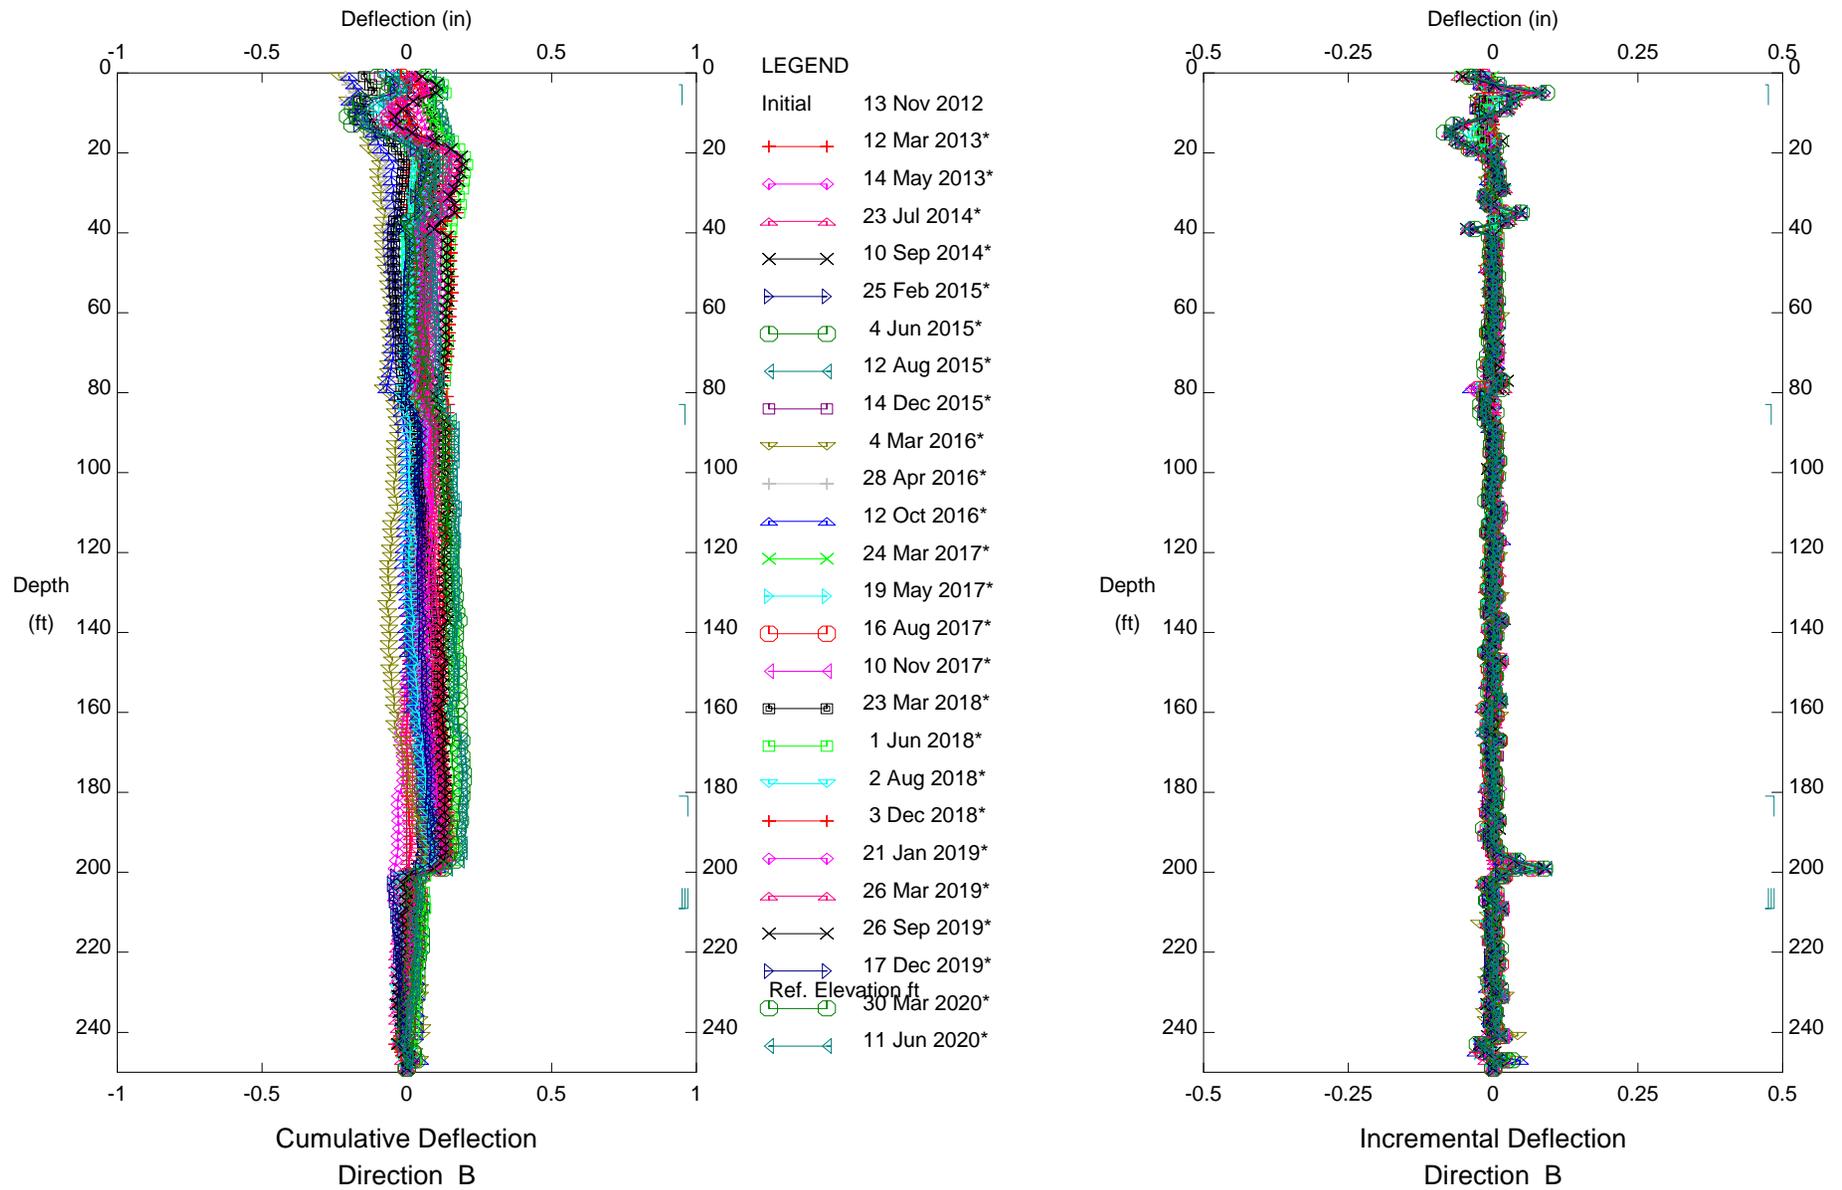
BRM, Inclinator SP-17B

Sets marked * include zero shift and/or rotation corrections.

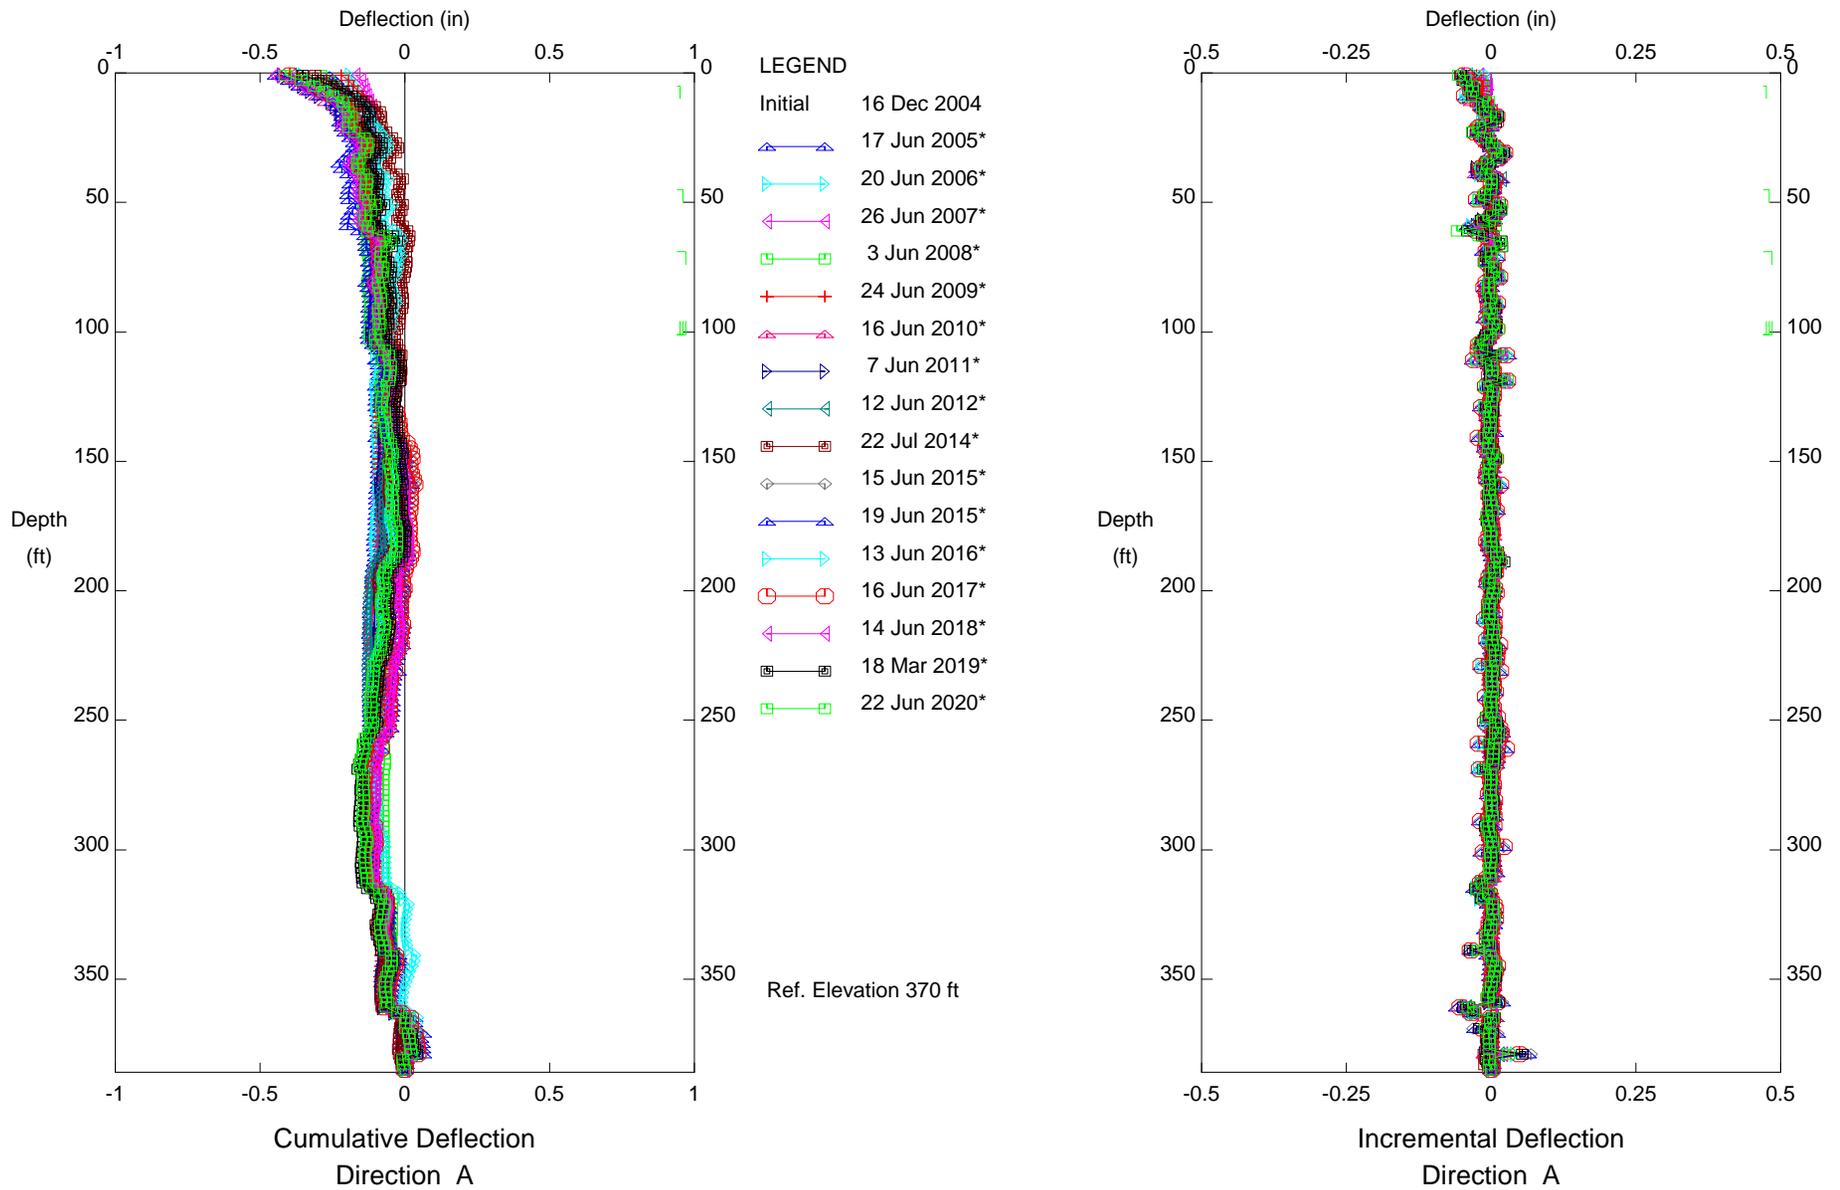
BIG ROCK MESA, Inclinometer SP-24
CENTRAL REGION

Sets marked * include zero shift and/or rotation corrections.

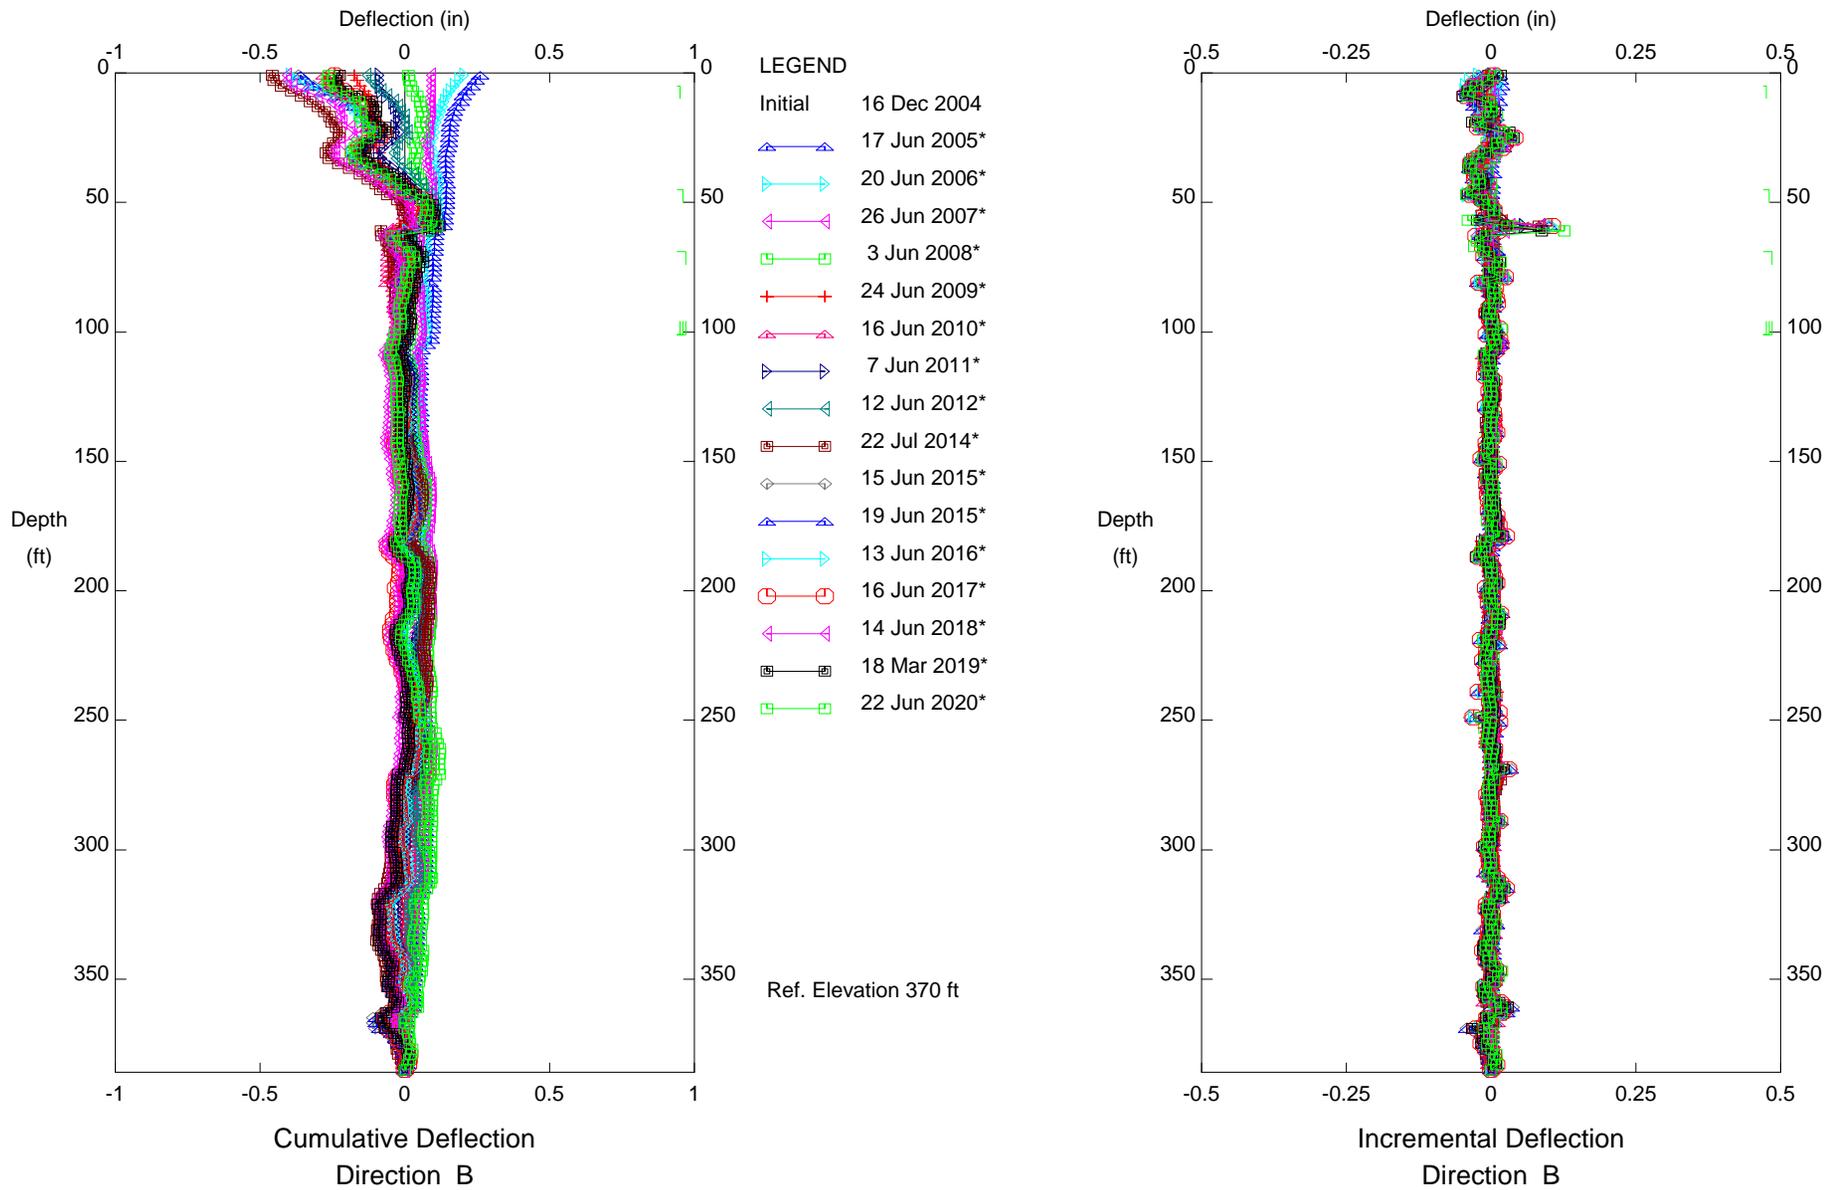
BIG ROCK MESA, Inclinometer SP-24
CENTRAL REGION

Sets marked * include zero shift and/or rotation corrections.

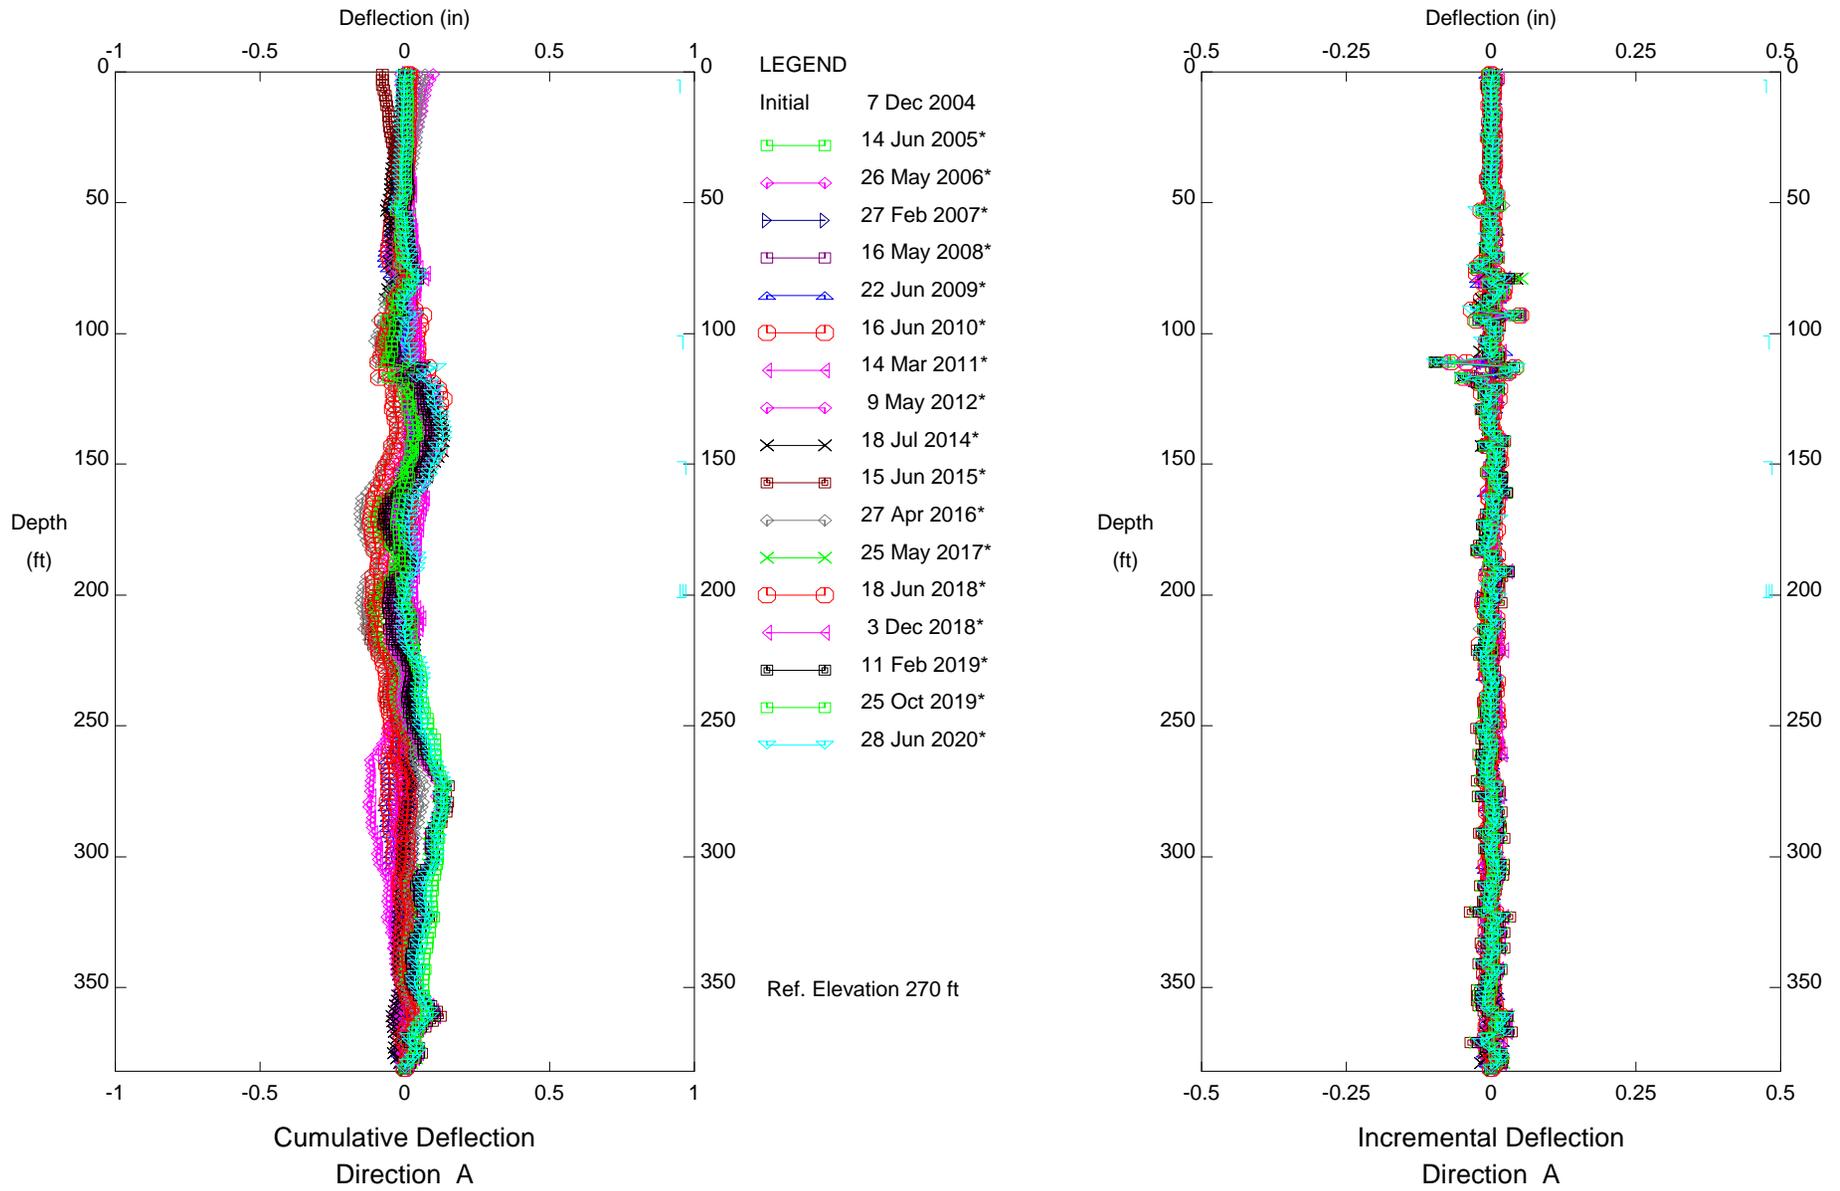
BIG ROCK MESA, Inclinometer SP-34
CENTRAL REGION

Sets marked * include zero shift and/or rotation corrections.

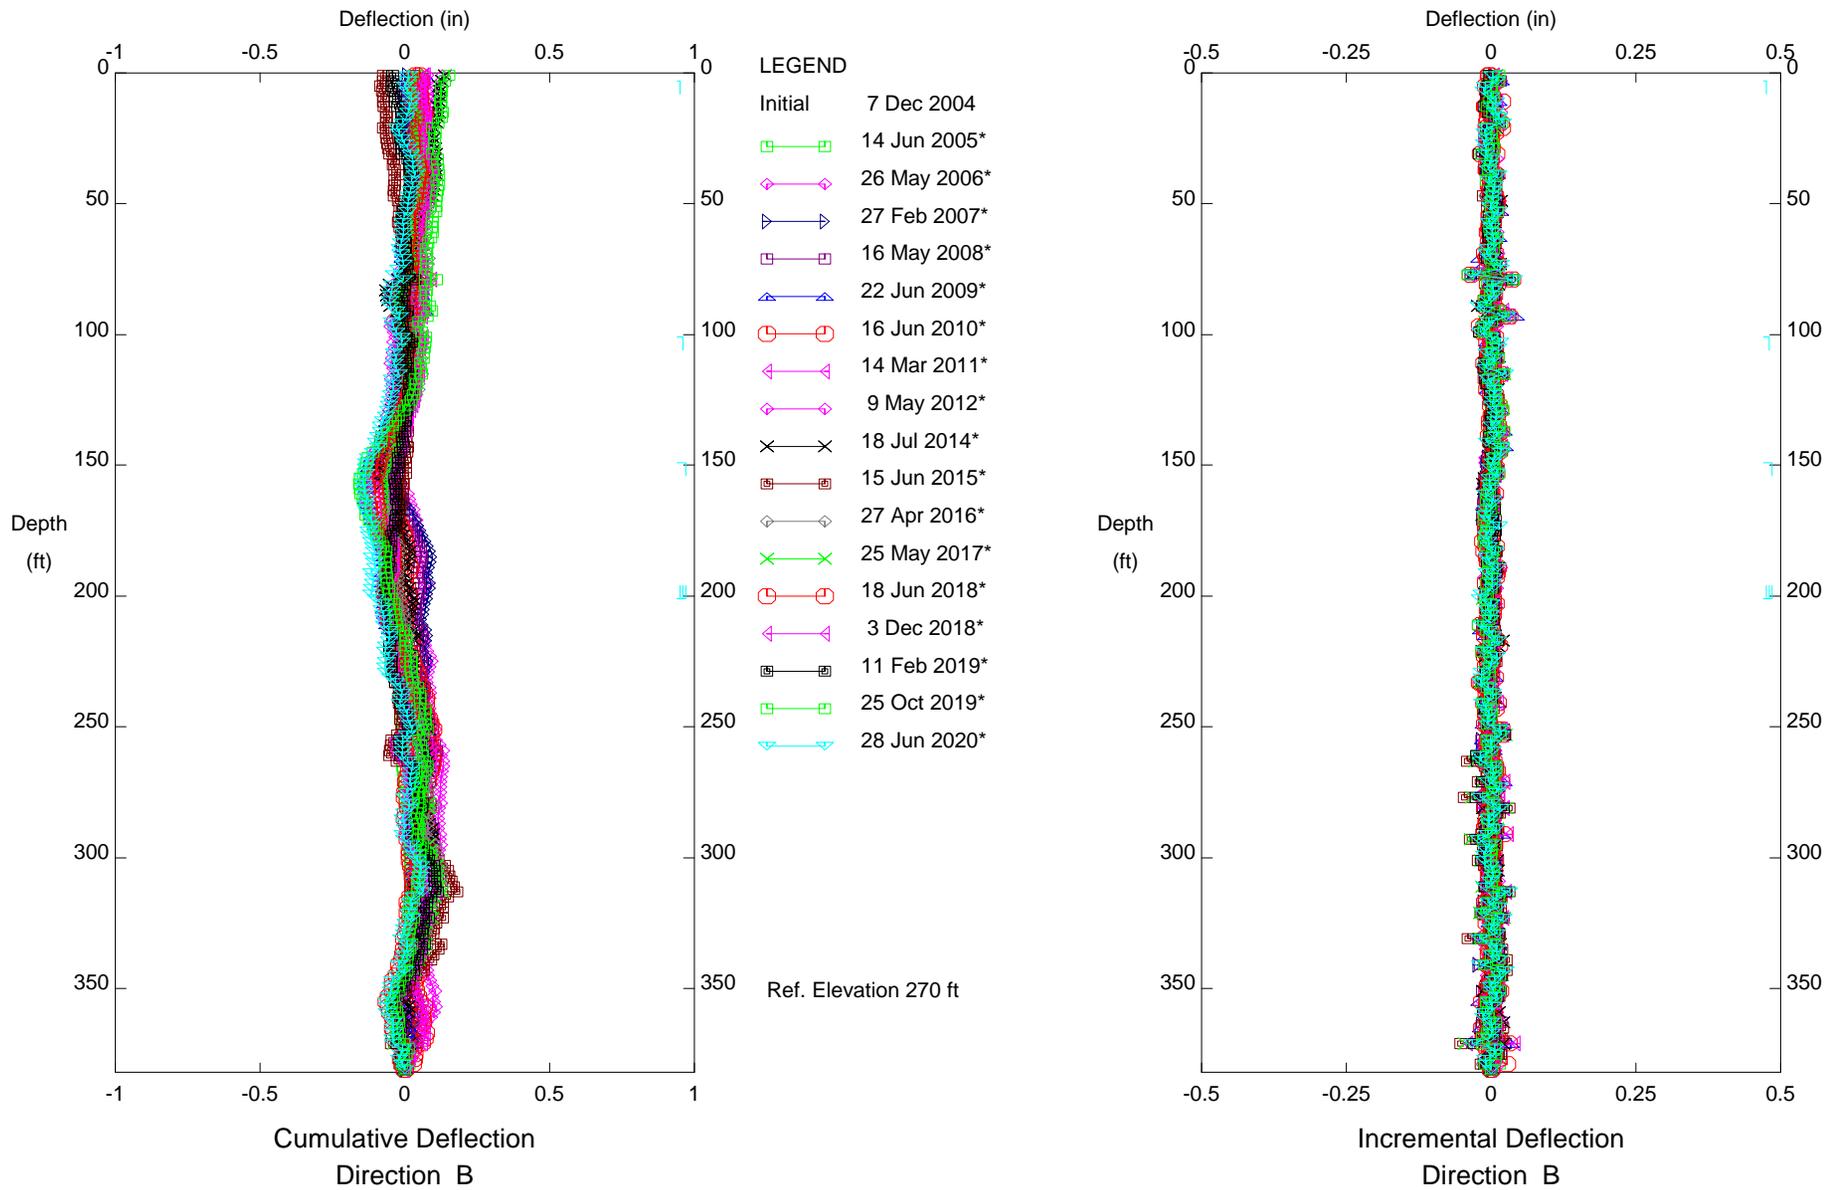
BIG ROCK MESA, Inclinometer SP-34
CENTRAL REGION

Sets marked * include zero shift and/or rotation corrections.

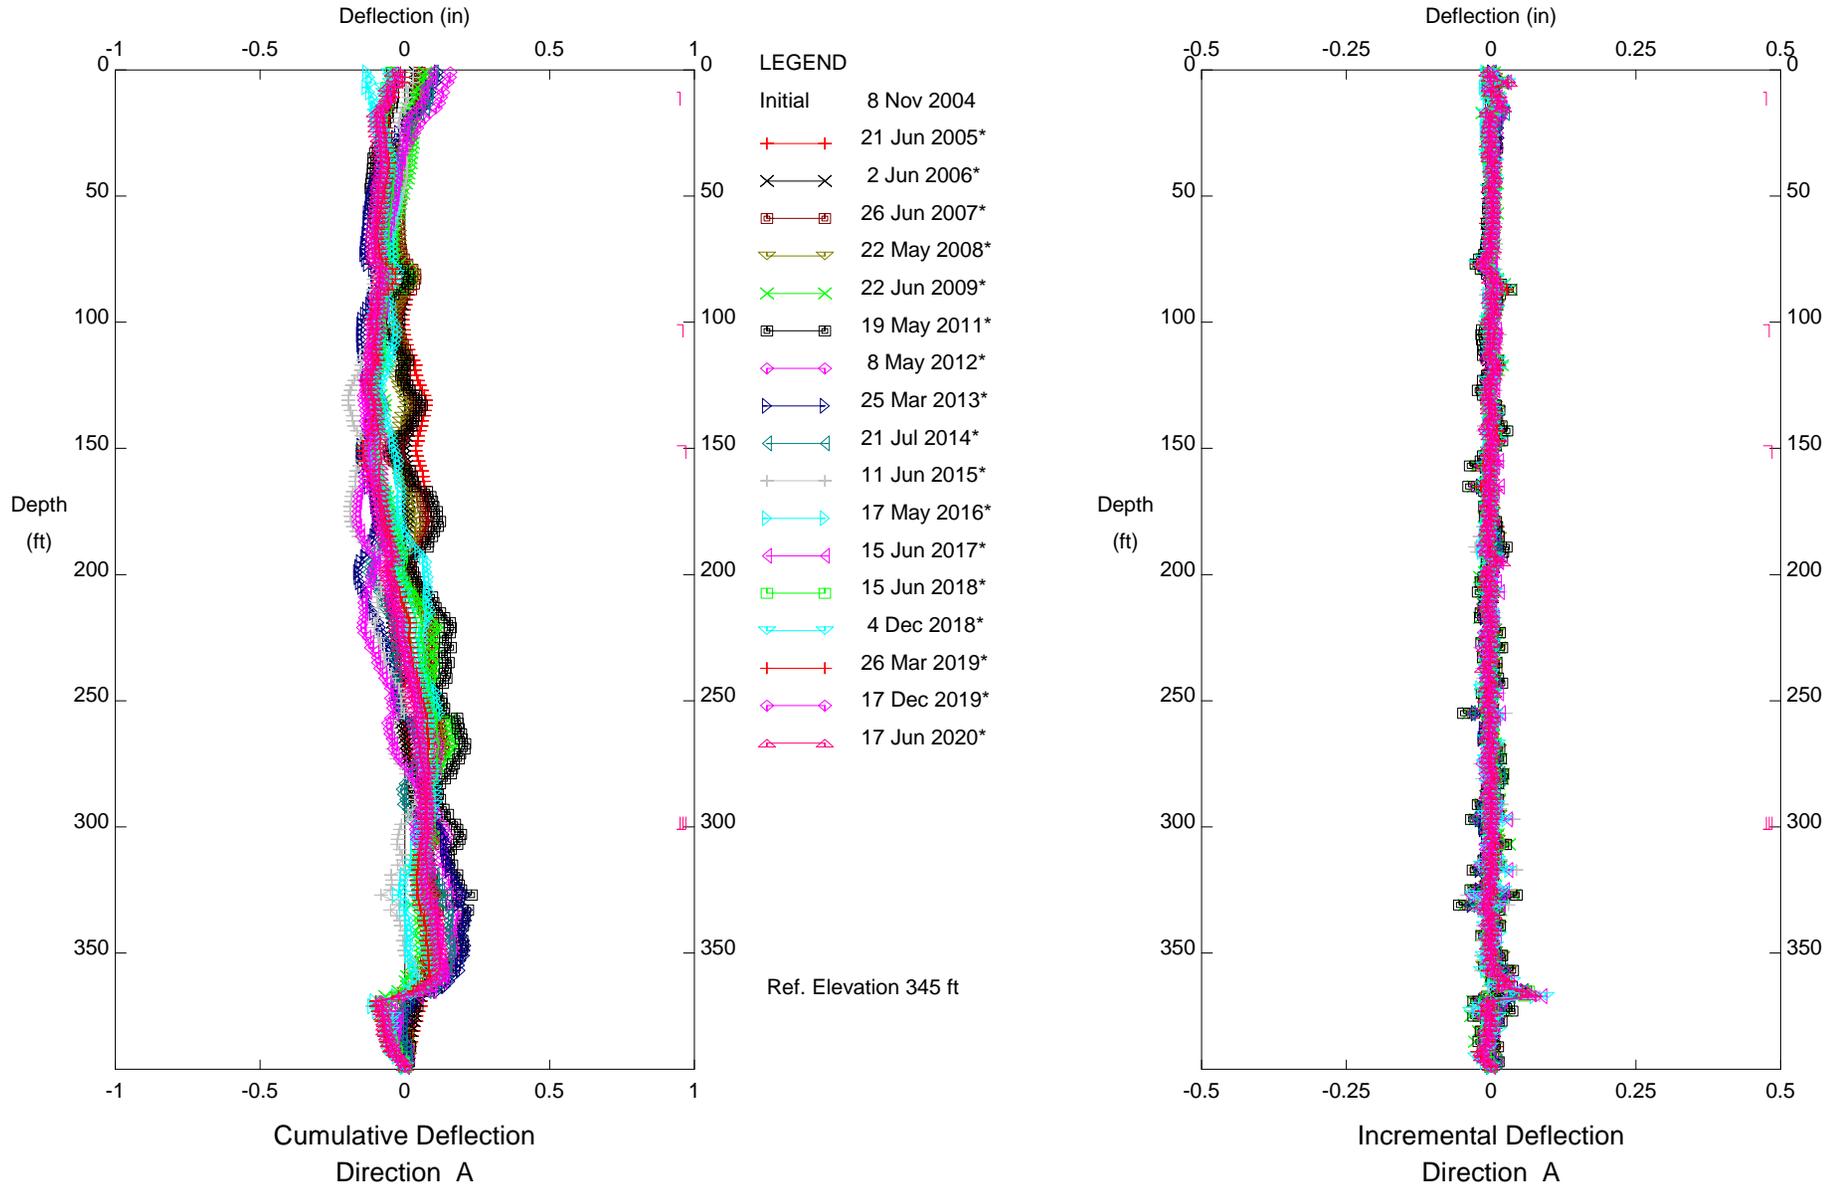
BIG ROCK MESA, Inclinometer SP-35
CENTRAL REGION

Sets marked * include zero shift and/or rotation corrections.

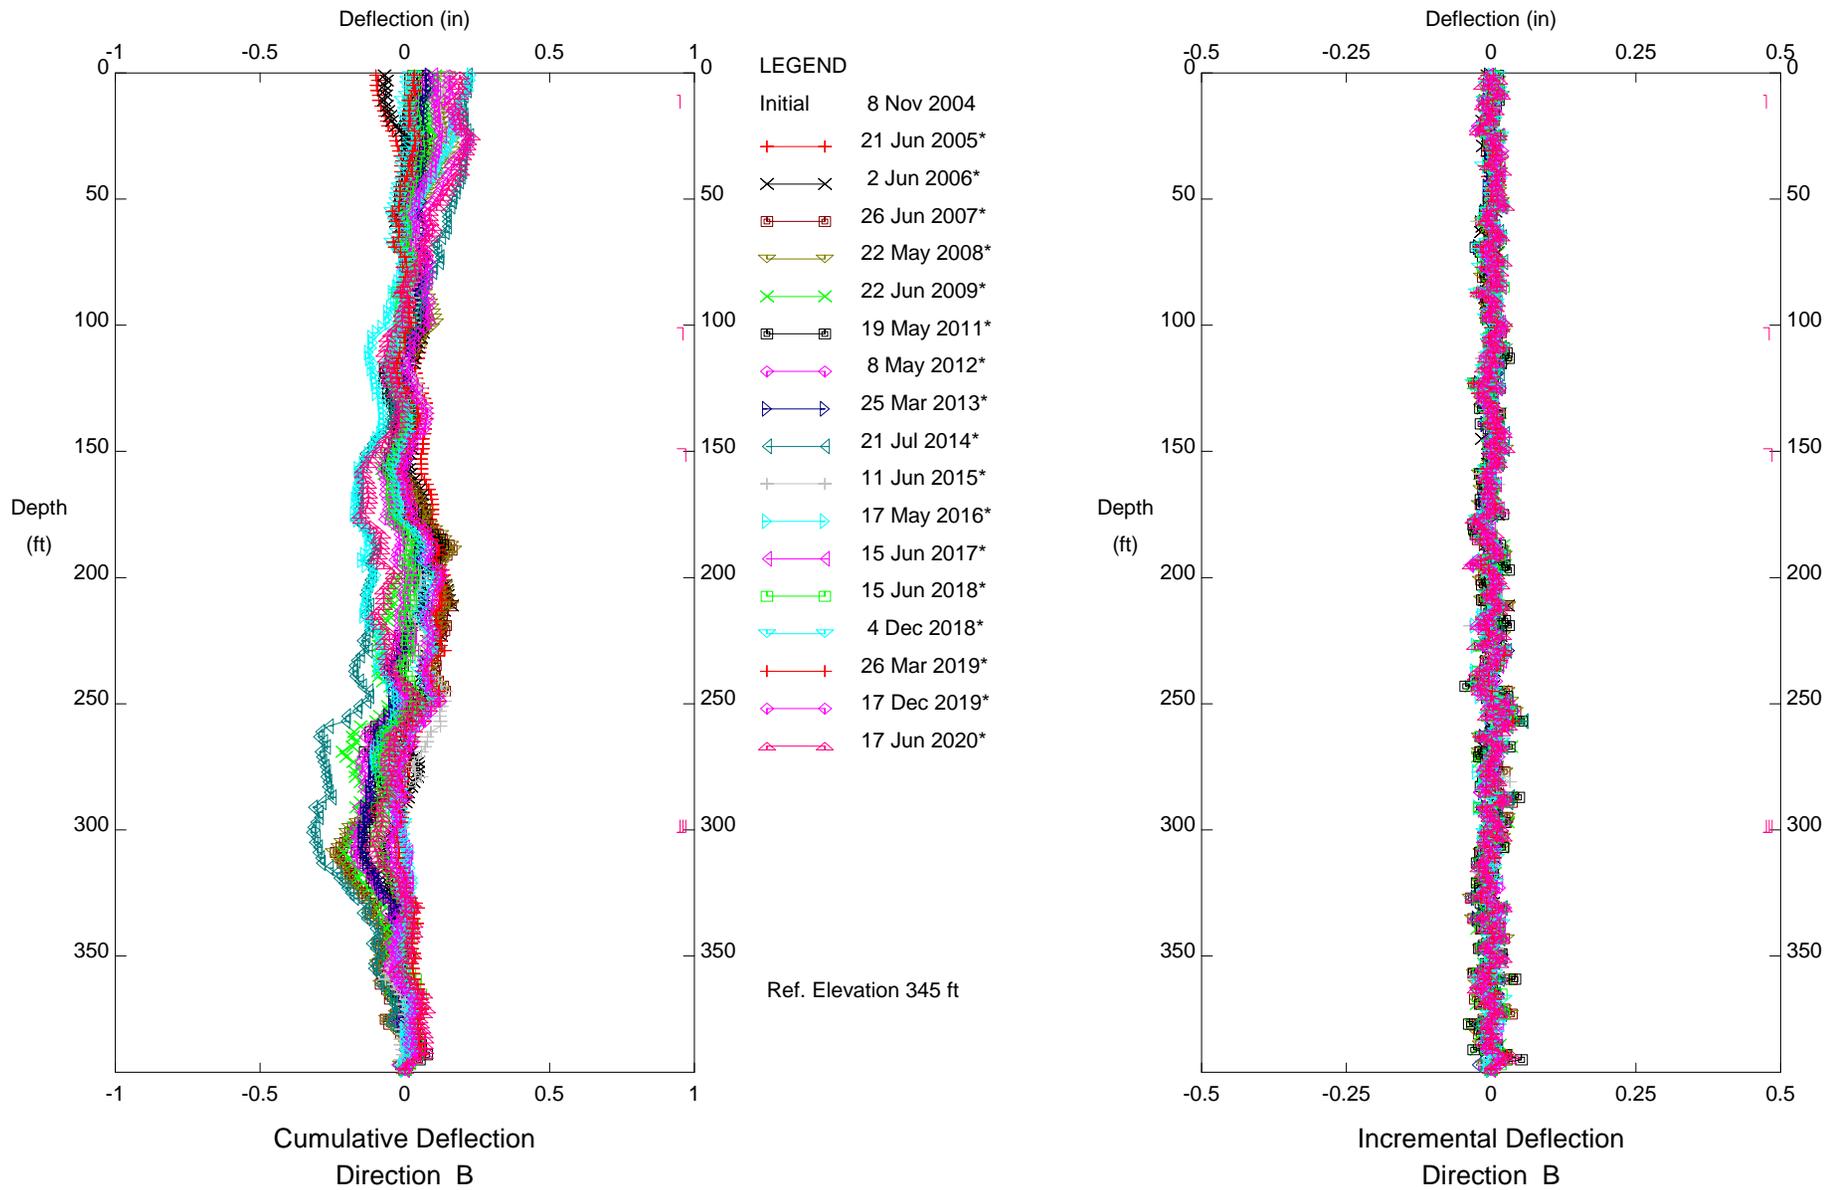
BIG ROCK MESA, Inclinometer SP-35
CENTRAL REGION

Sets marked * include zero shift and/or rotation corrections.

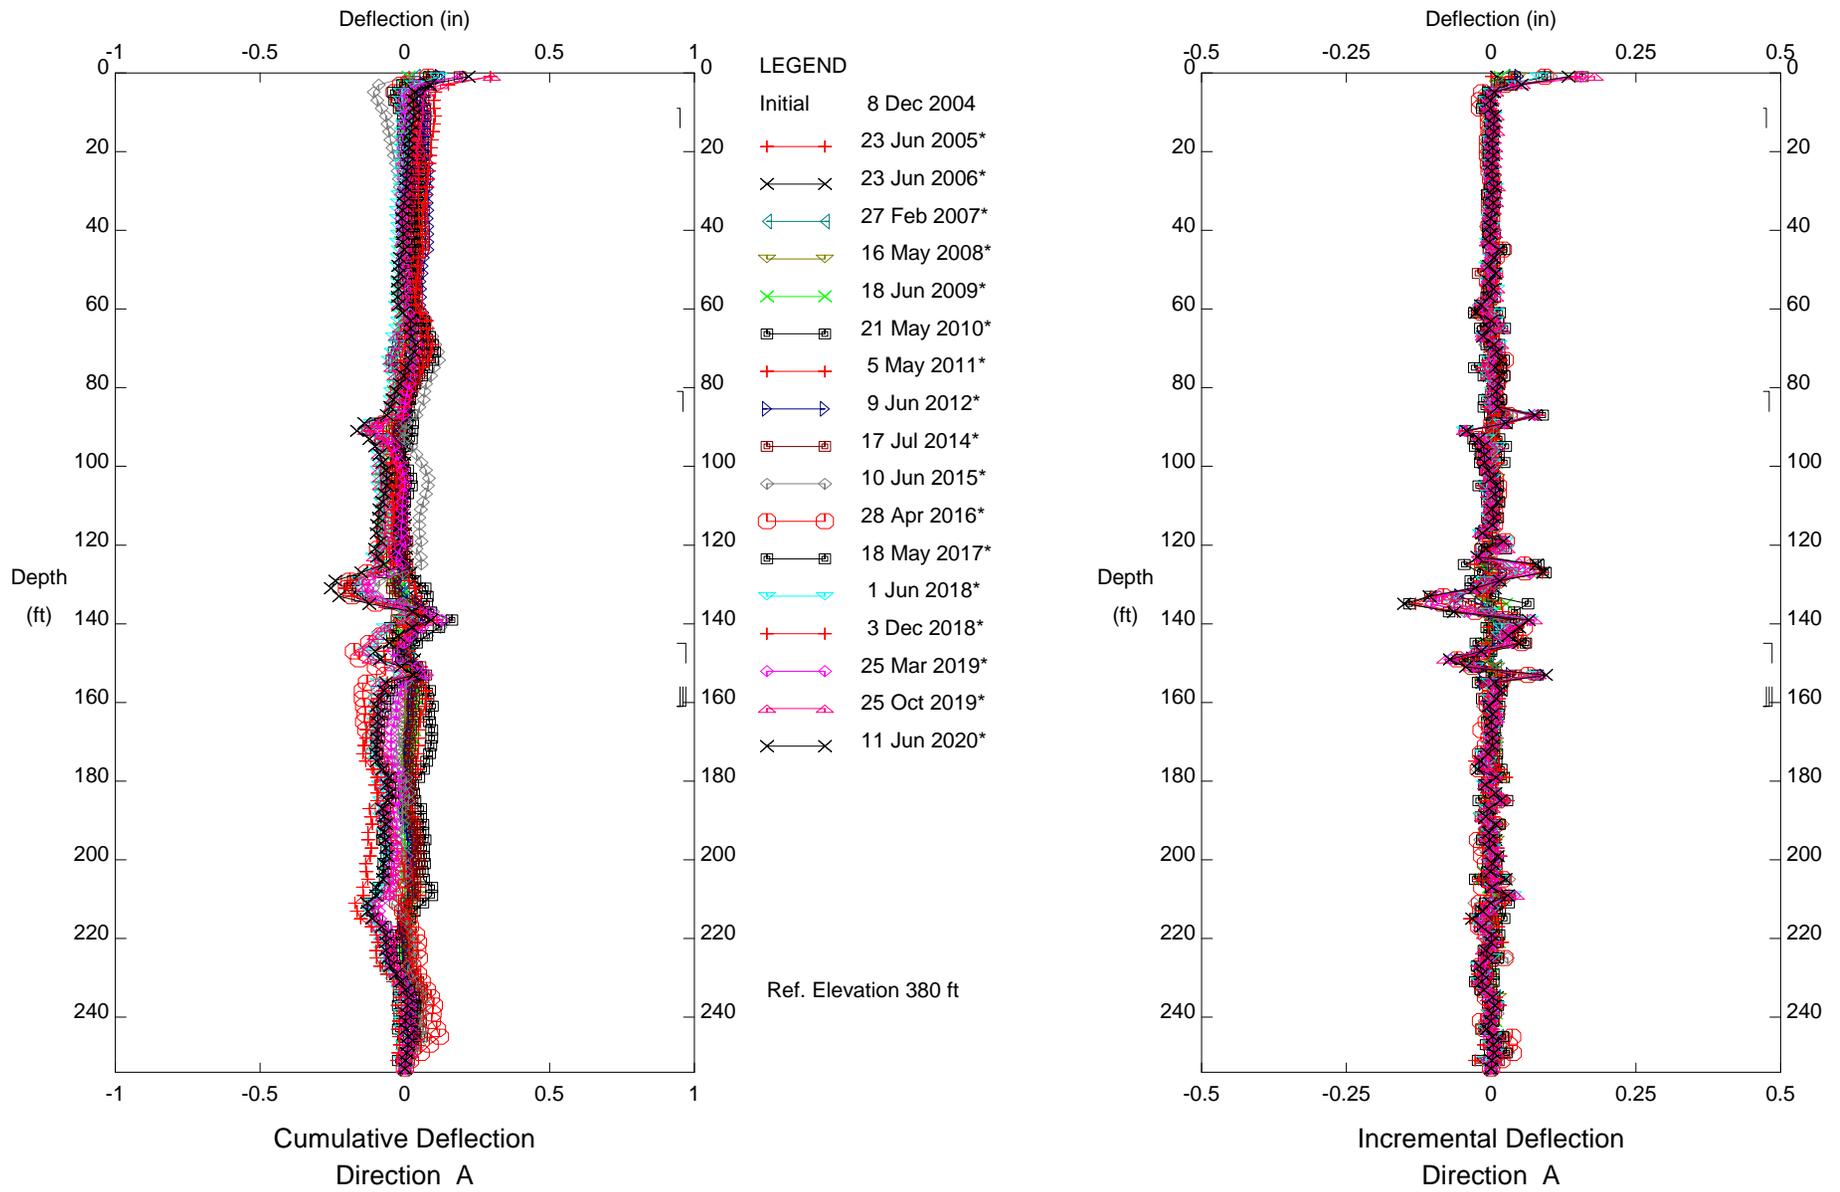
BIG ROCK MESA, Inclinometer SP-36
CENTRAL REGION

Sets marked * include zero shift and/or rotation corrections.
