**ANNUAL REPORT
JULY 2019 THROUGH JUNE 2020
BIG ROCK MESA LANDSLIDE
ASSESSMENT DISTRICT
City of Malibu, California**

Fugro Project No. 04.62160606

Document No. 04.62160606-PR-007(Rev.00)

**Annual Report of Maintenance and Monitoring, July 2019 through June 2020,
Big Rock Mesa Landslide Assessment District, City of Malibu, California**

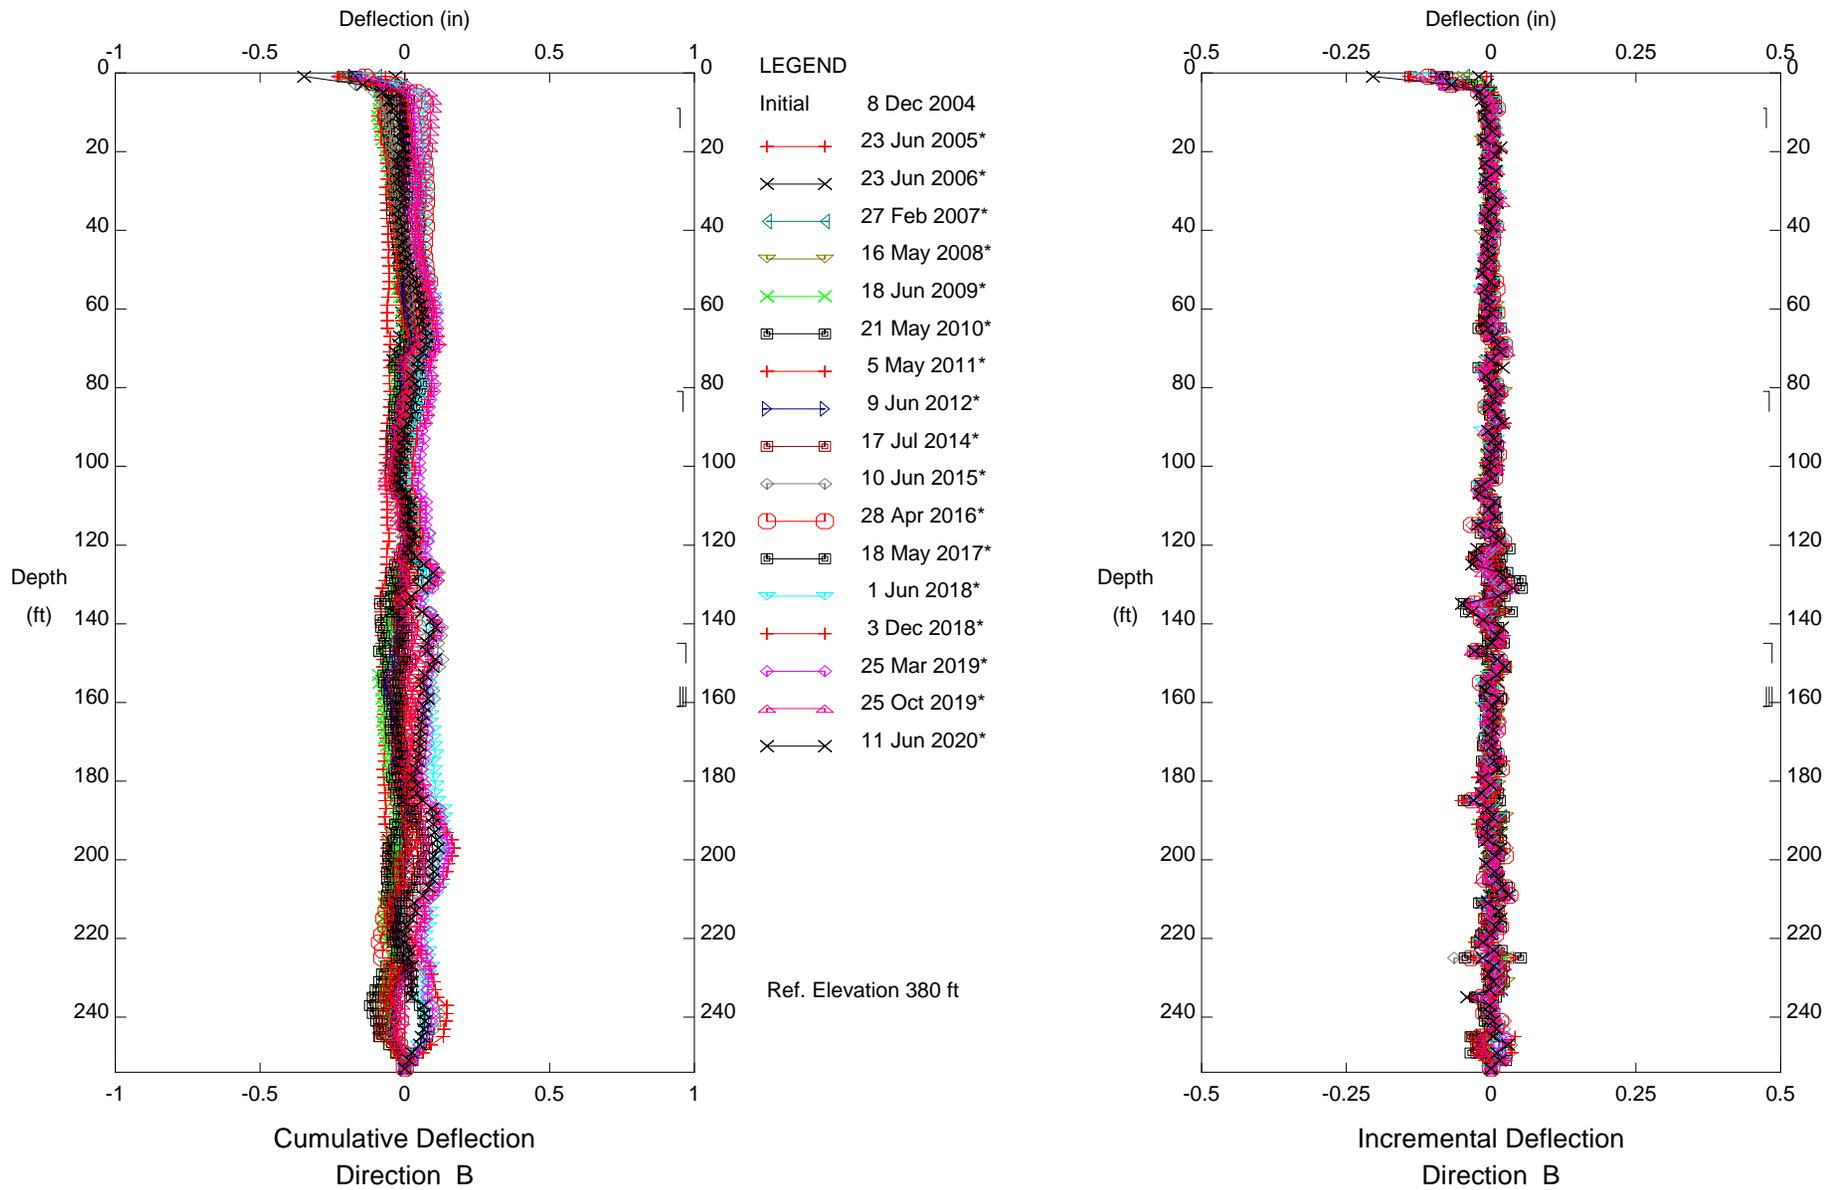
BIG ROCK MESA, Incliner SP-36
CENTRAL REGION

Sets marked * include zero shift and/or rotation corrections.

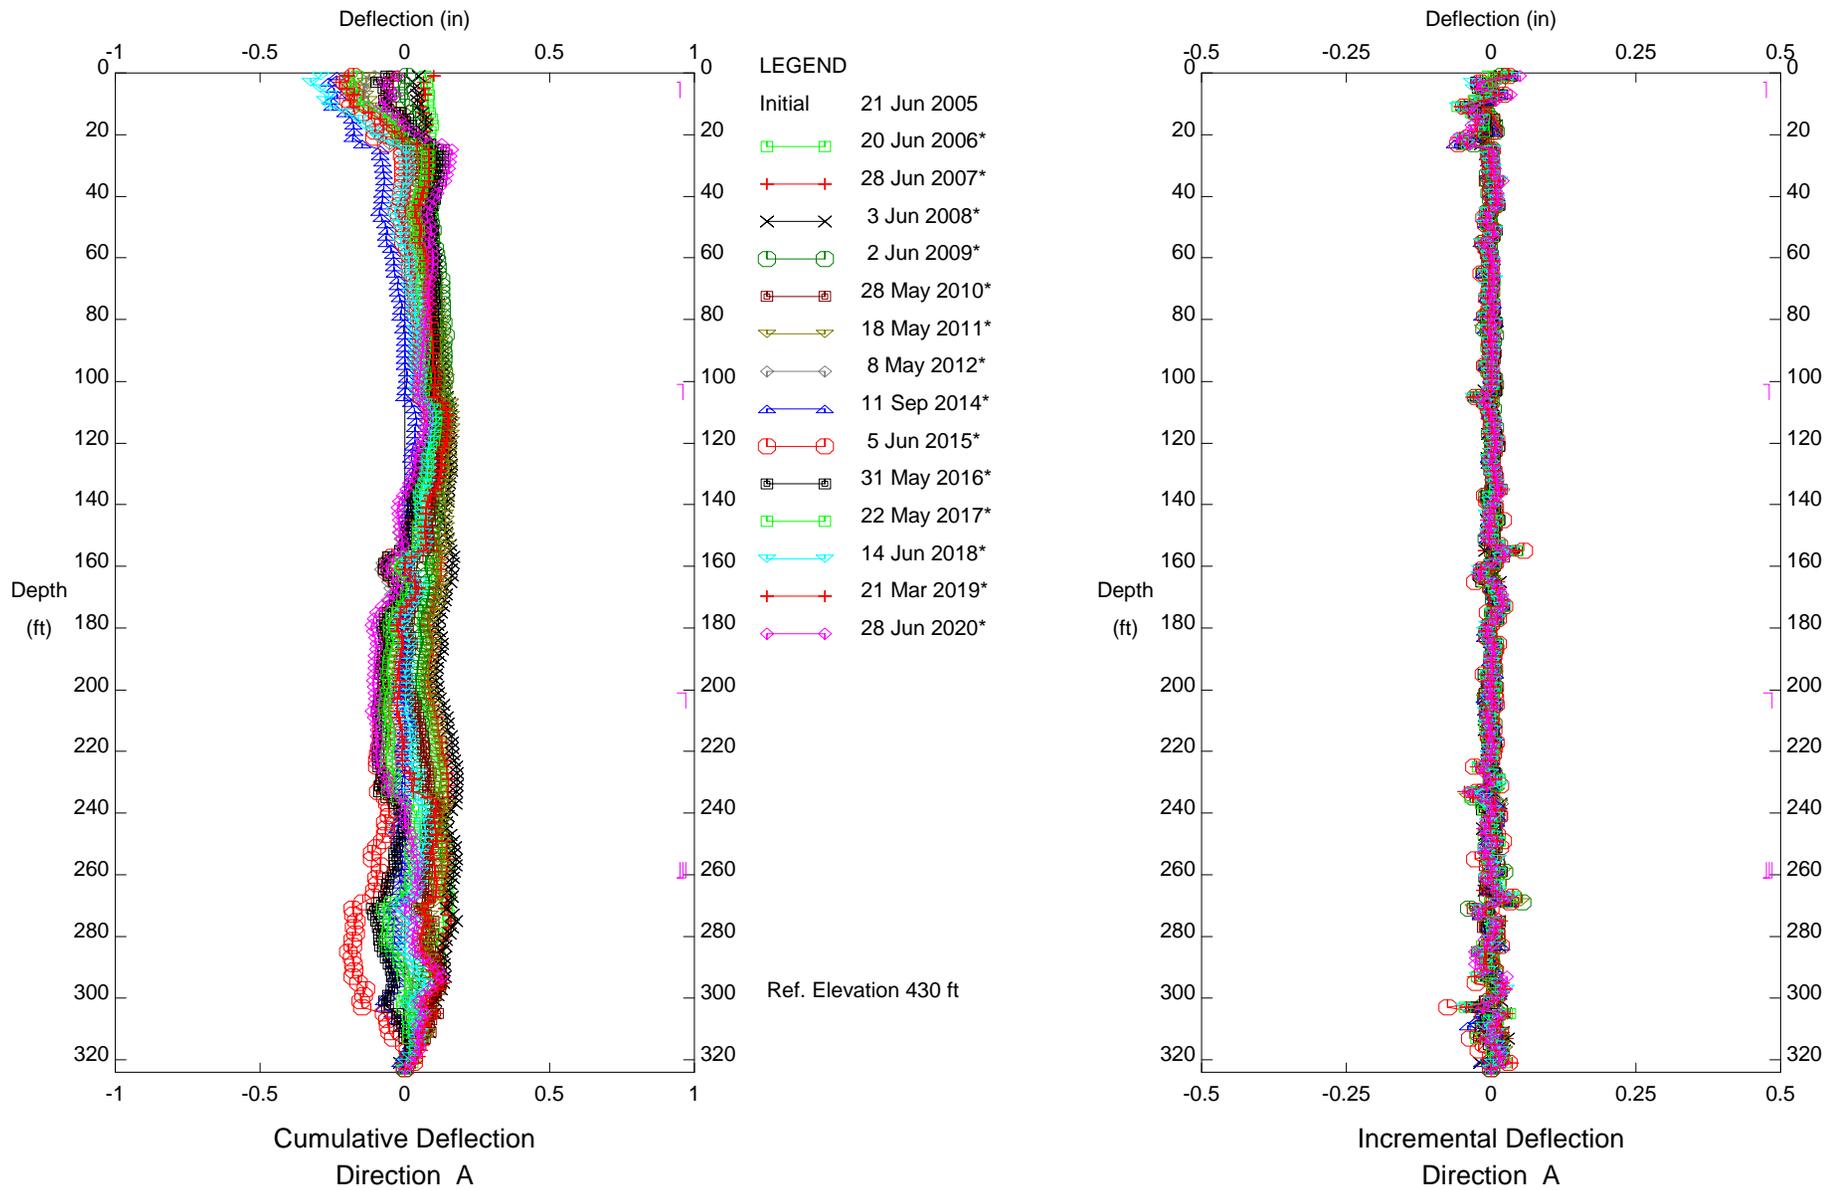
BIG ROCK MESA, Inclinometer SP-20
WESTERN REGION

Sets marked * include zero shift and/or rotation corrections.

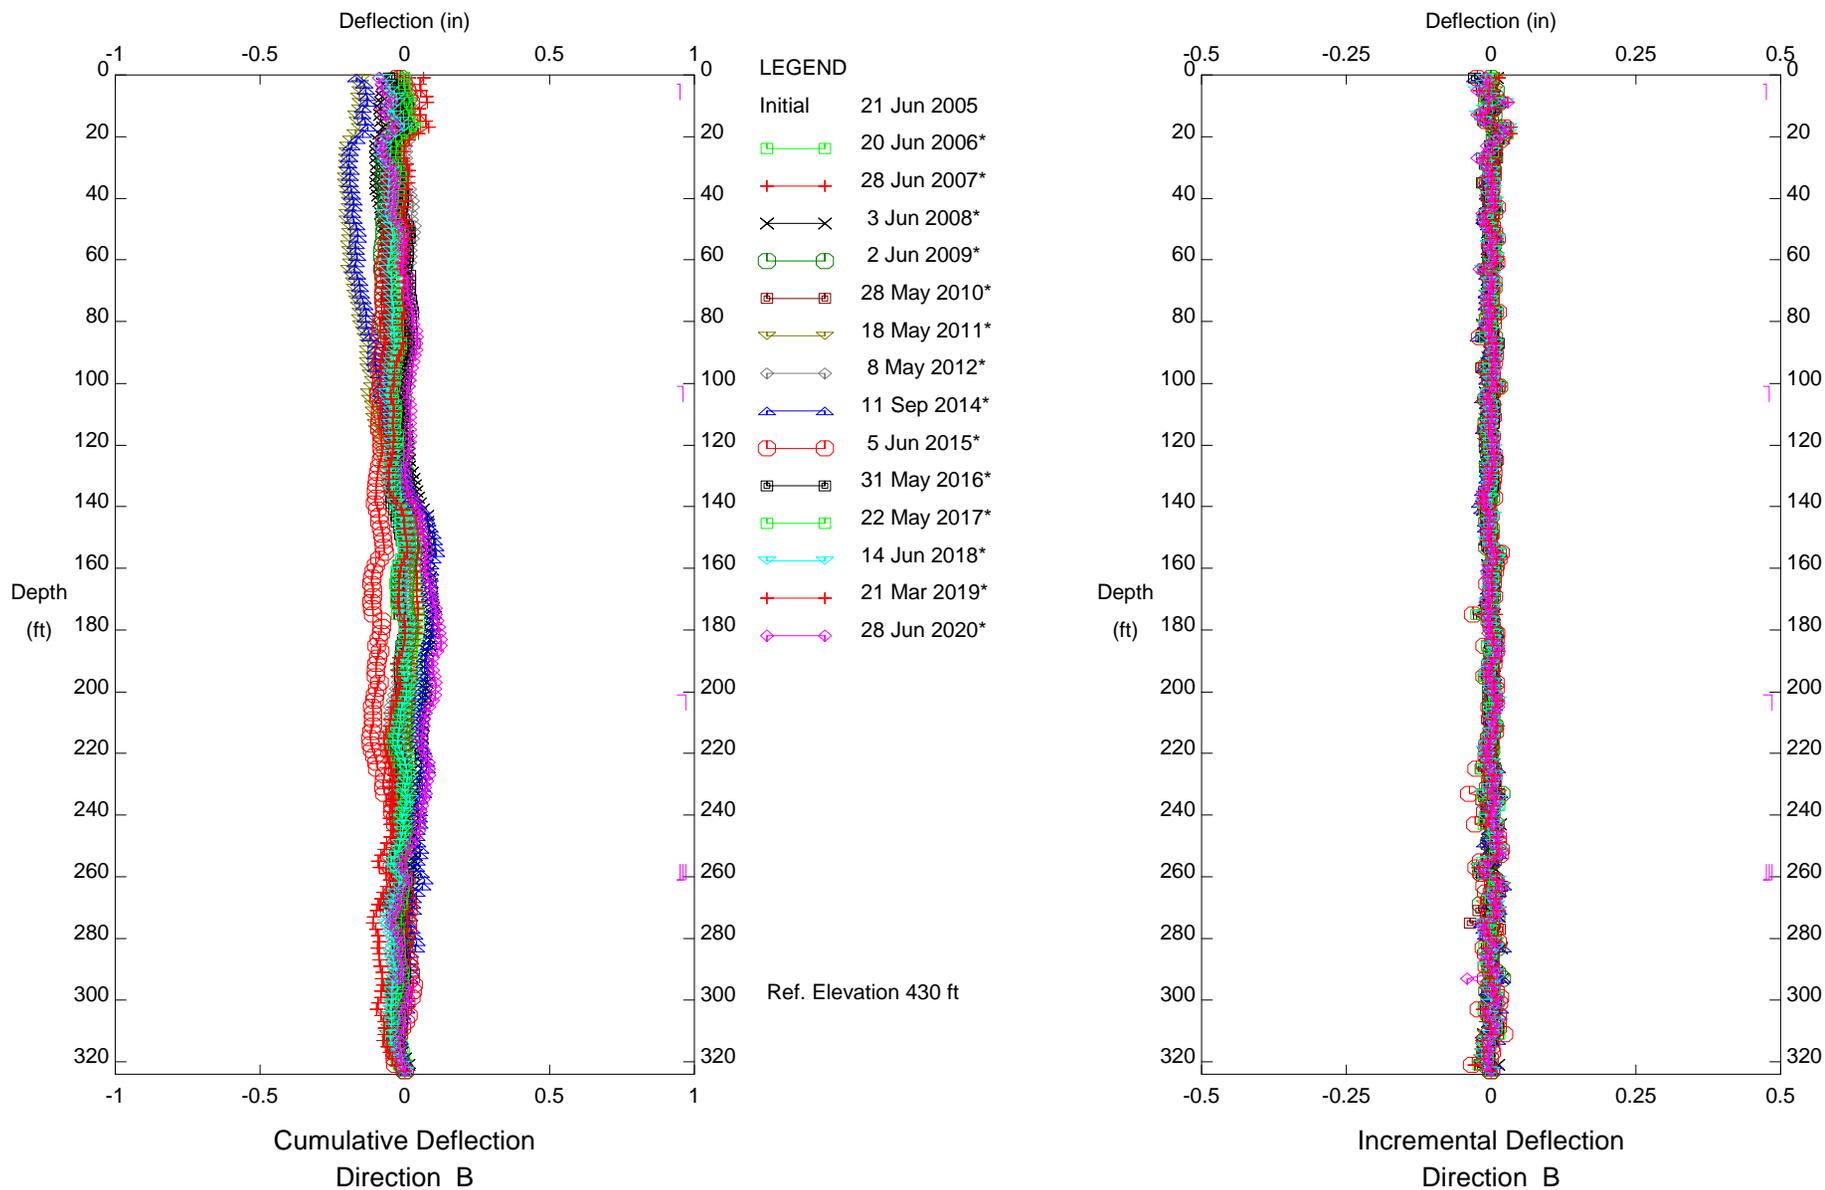
BIG ROCK MESA, Inclinometer SP-20
WESTERN REGION

Sets marked * include zero shift and/or rotation corrections.

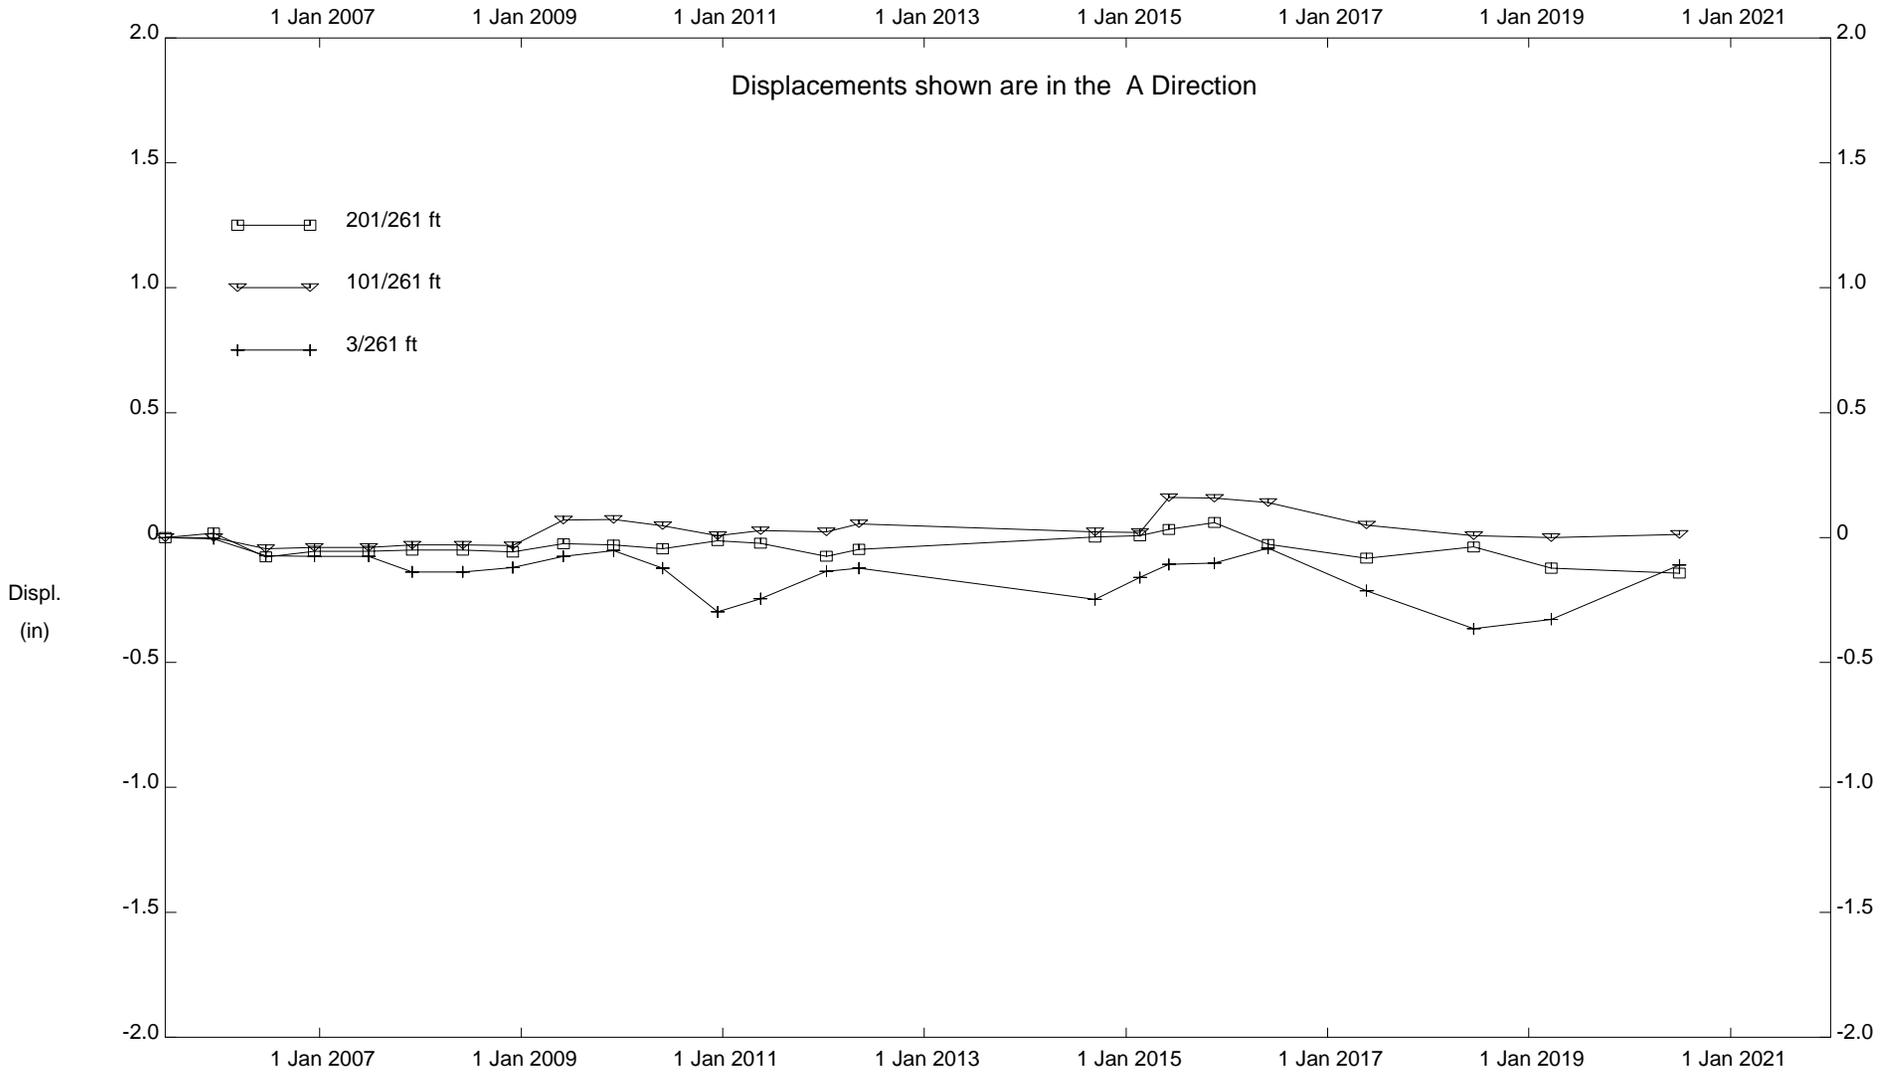
BIG ROCK MESA, Inclinator SP-20

WESTERN REGION

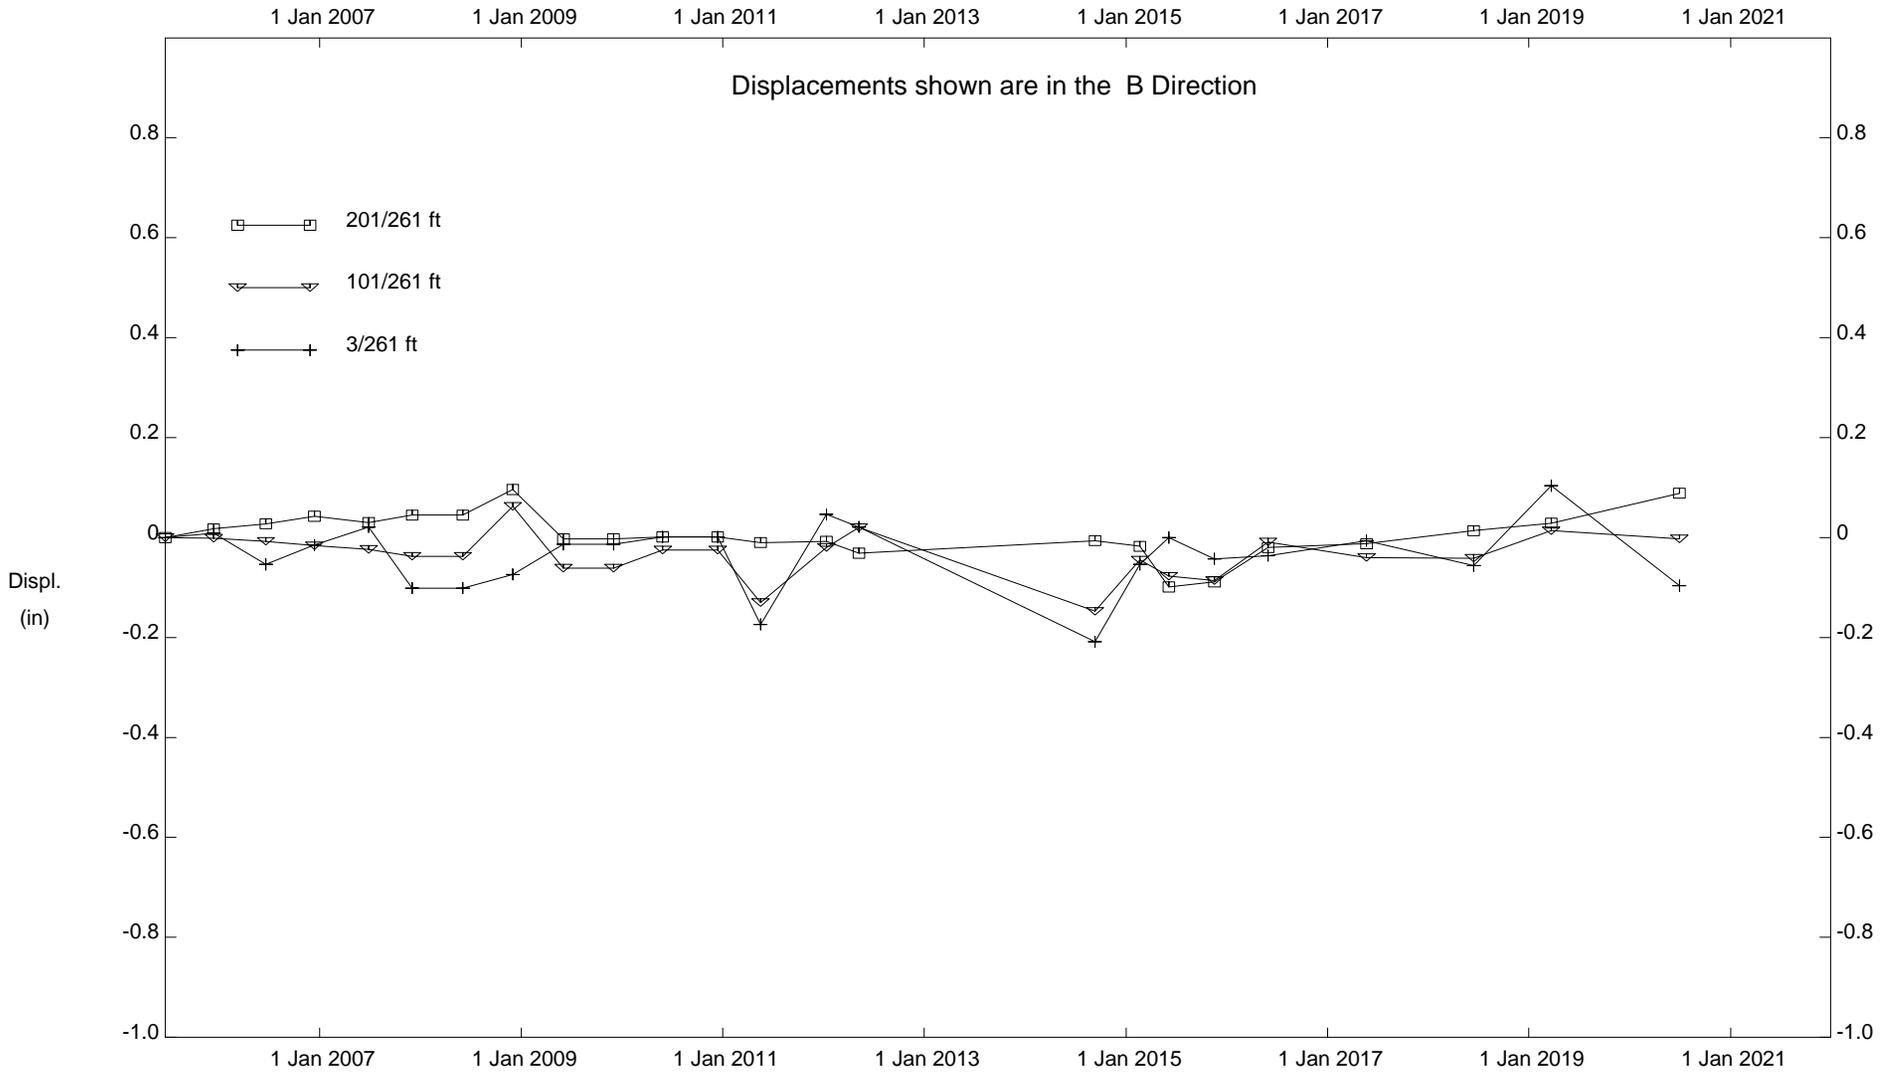
BIG ROCK MESA, Inclinometer SP-20

WESTERN REGION

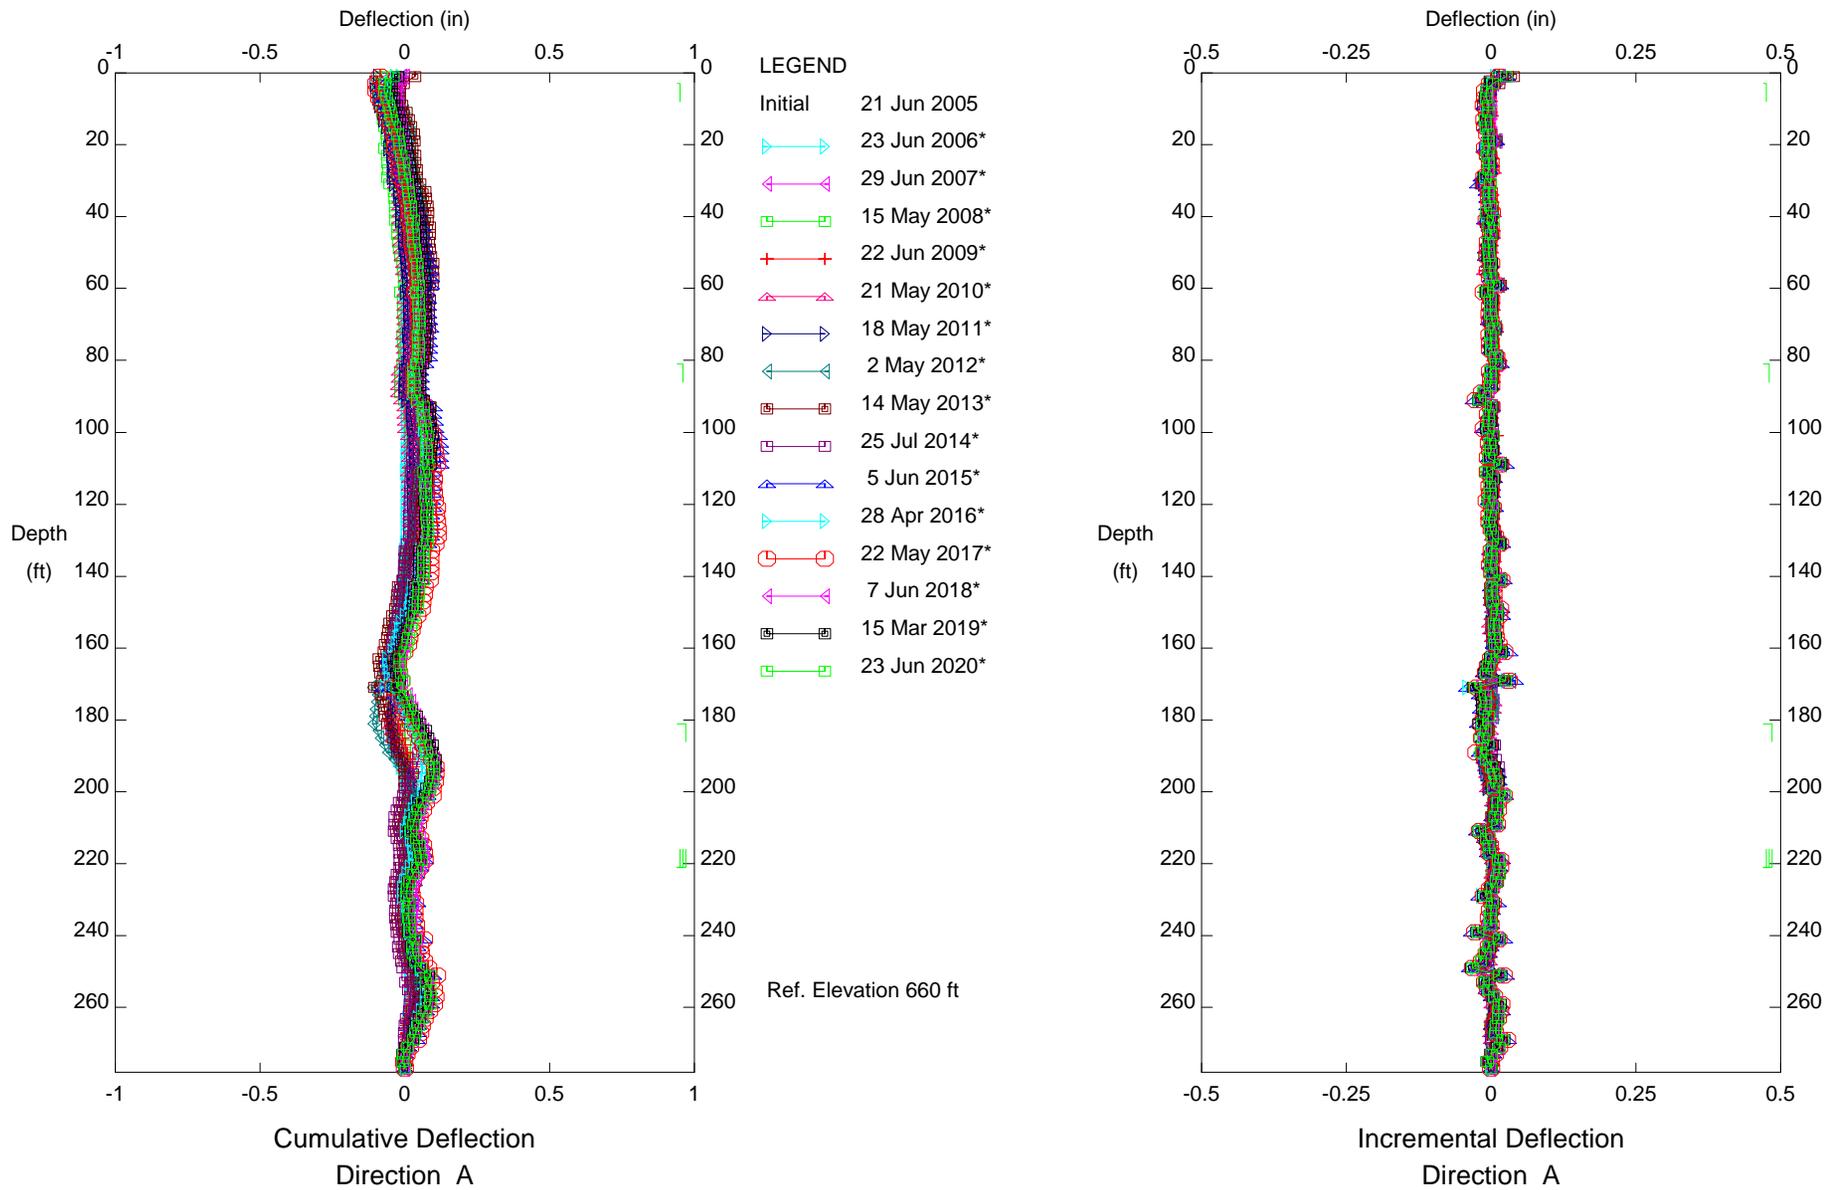
BIG ROCK MESA, Inclinometer SP-21
WESTERN REGION

Sets marked * include zero shift and/or rotation corrections.

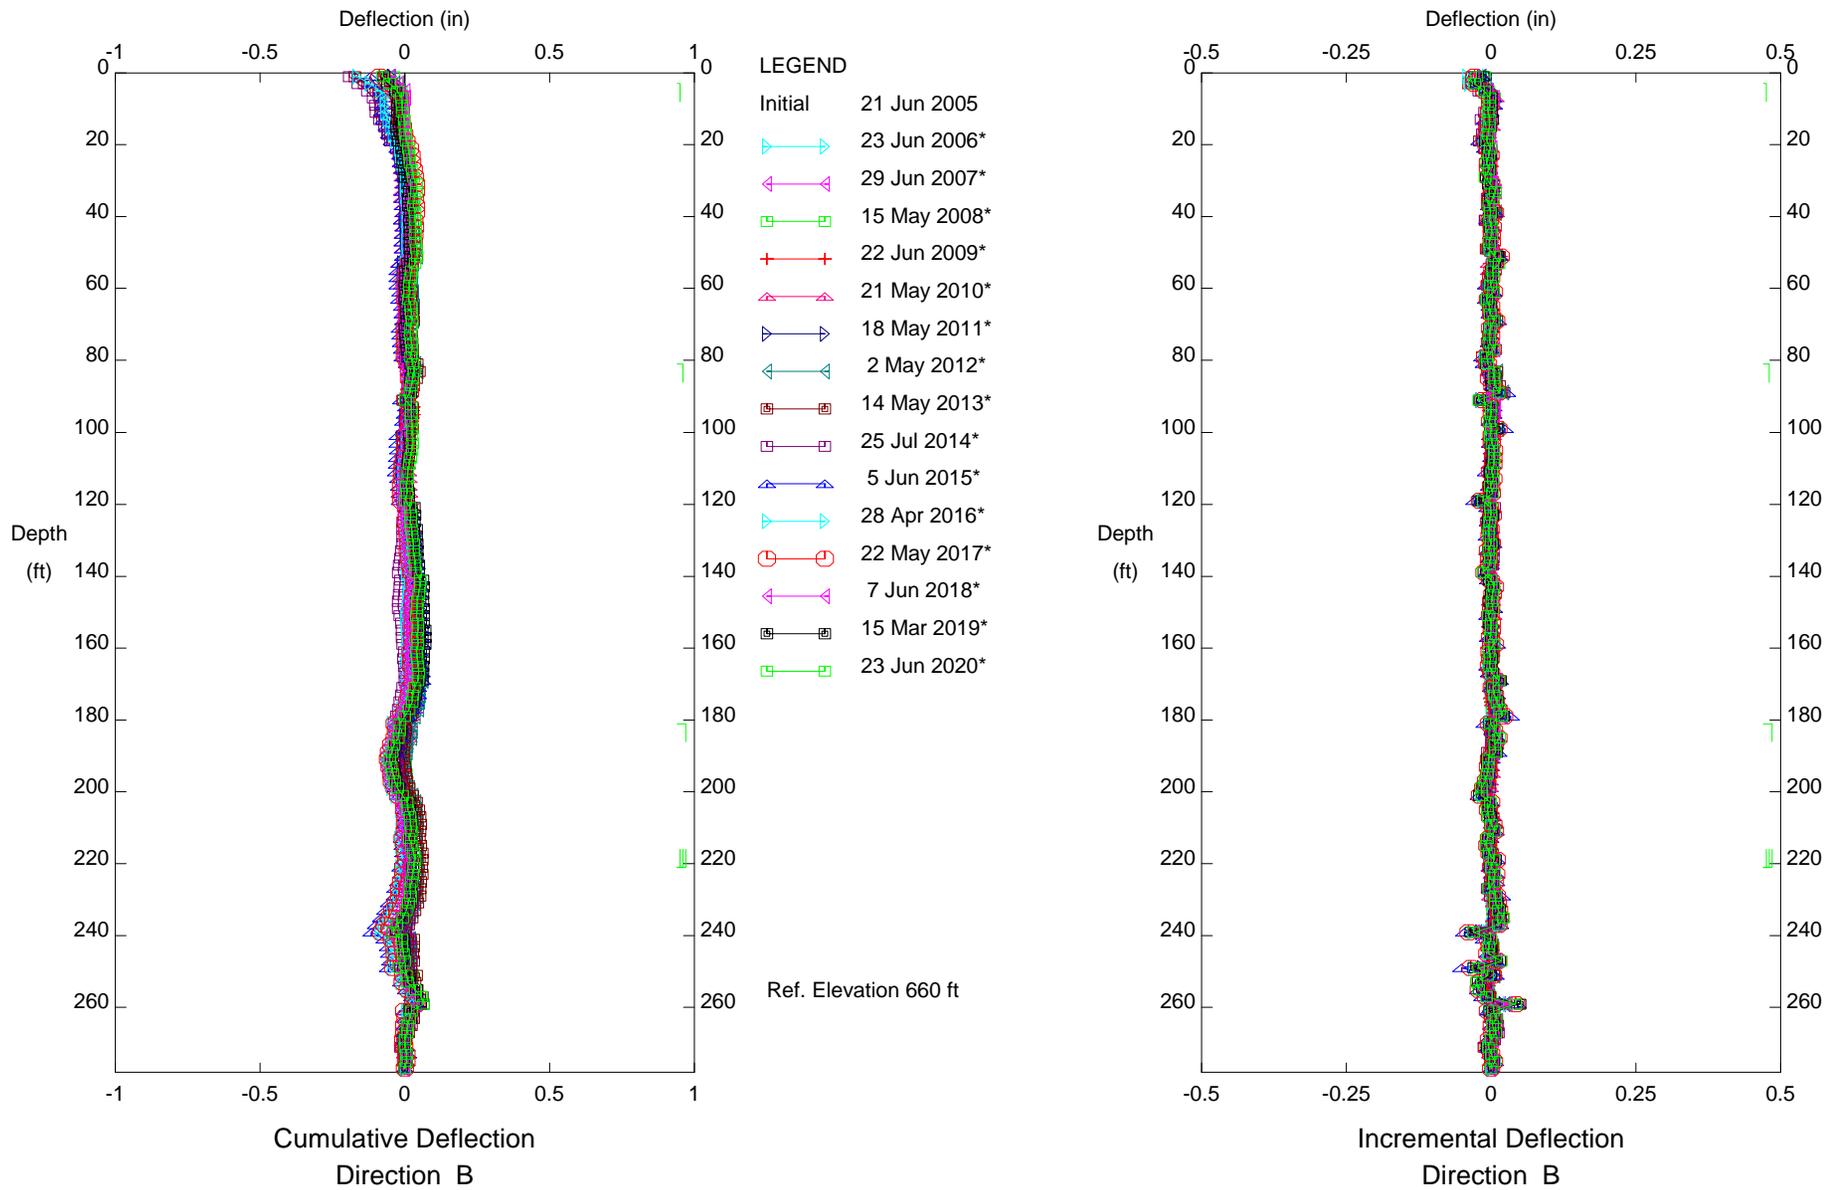
BIG ROCK MESA, Inclinometer SP-21
WESTERN REGION

Sets marked * include zero shift and/or rotation corrections.

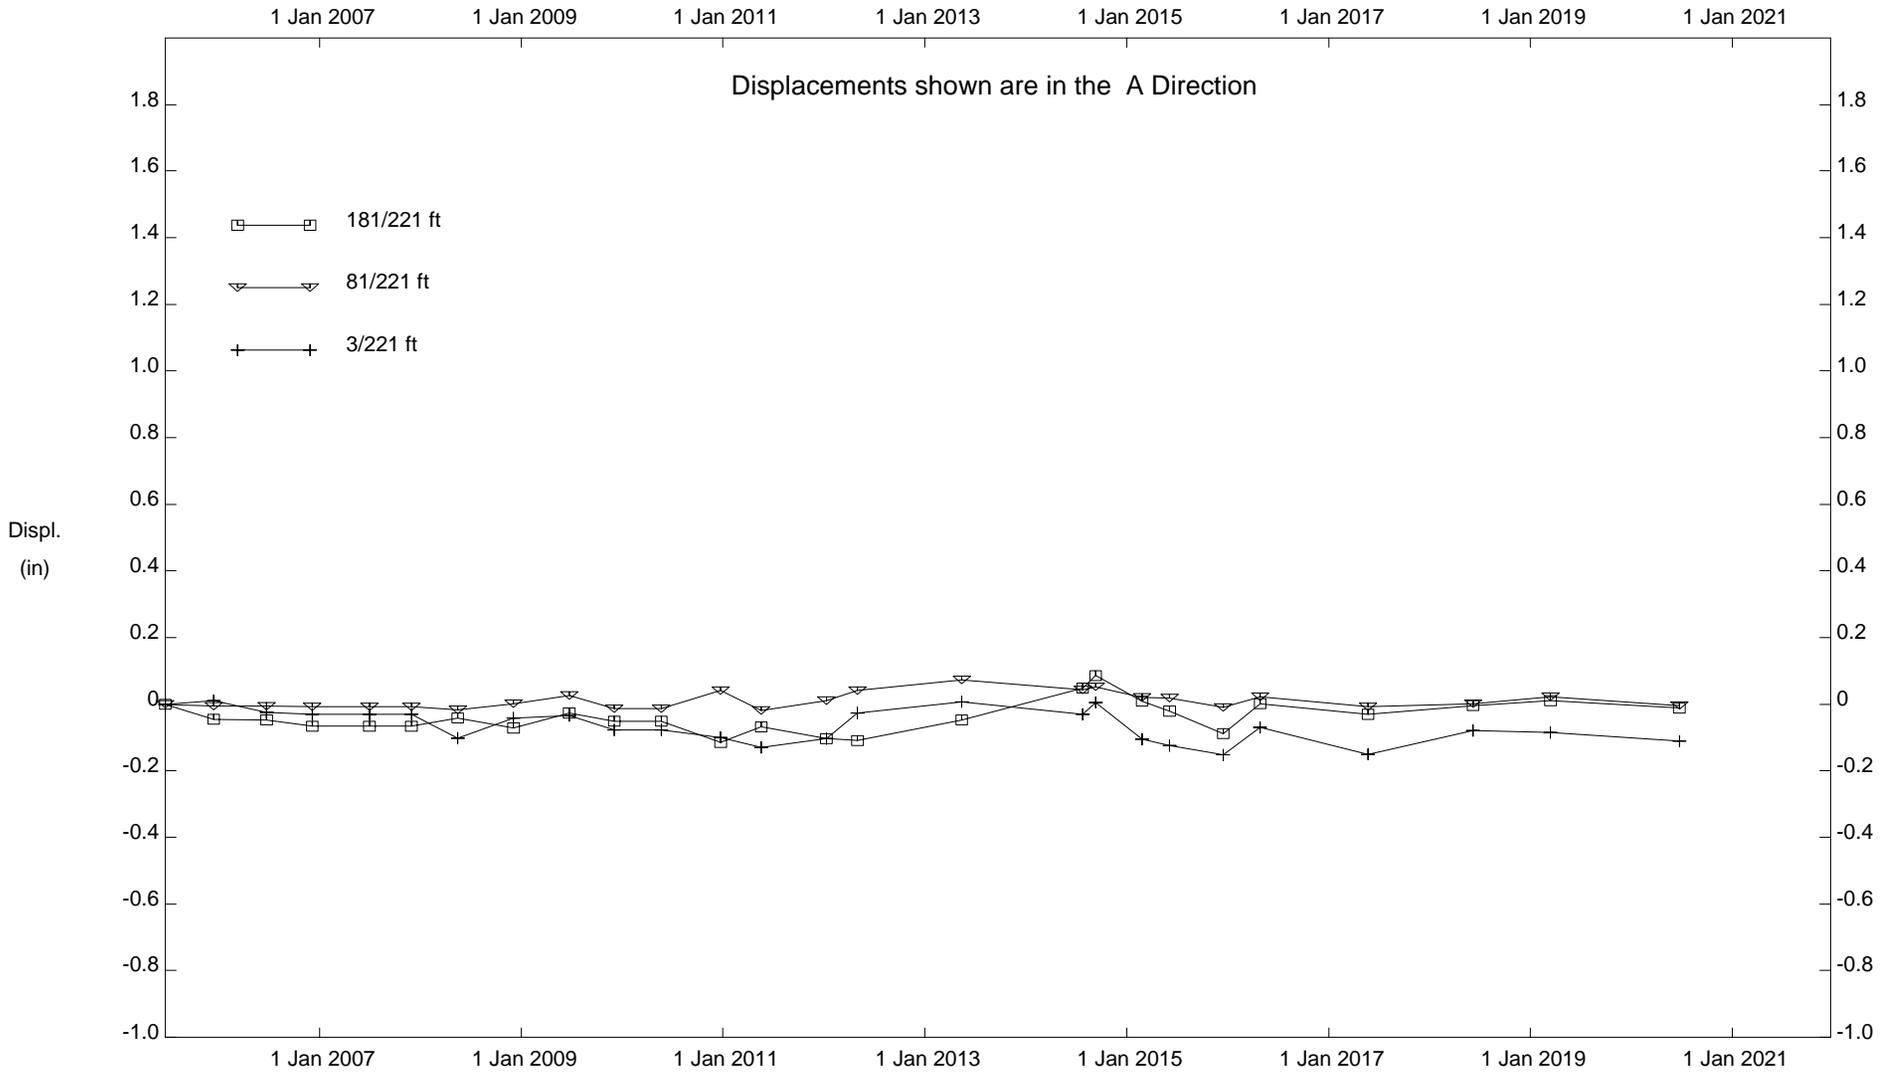
BIG ROCK MESA, Incliner SP-21

WESTERN REGION

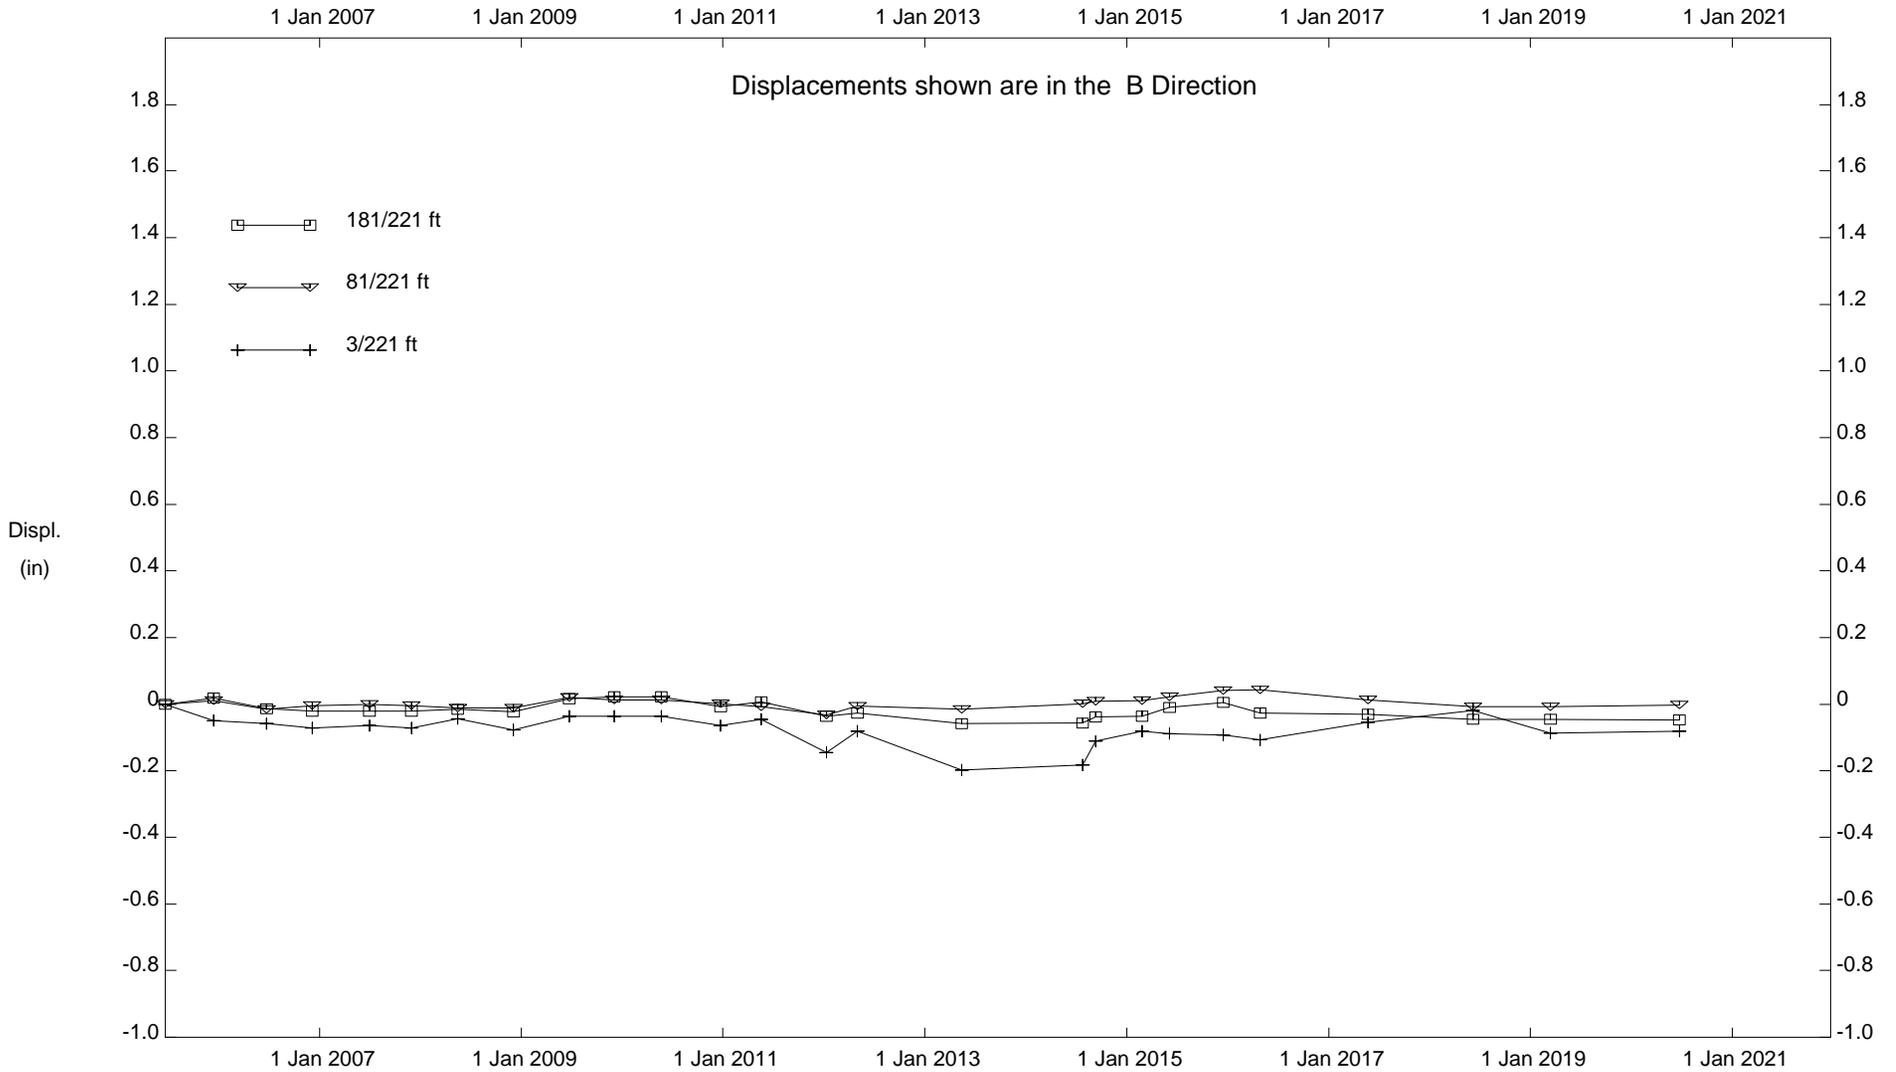
BIG ROCK MESA, Inclinometer SP-21

WESTERN REGION

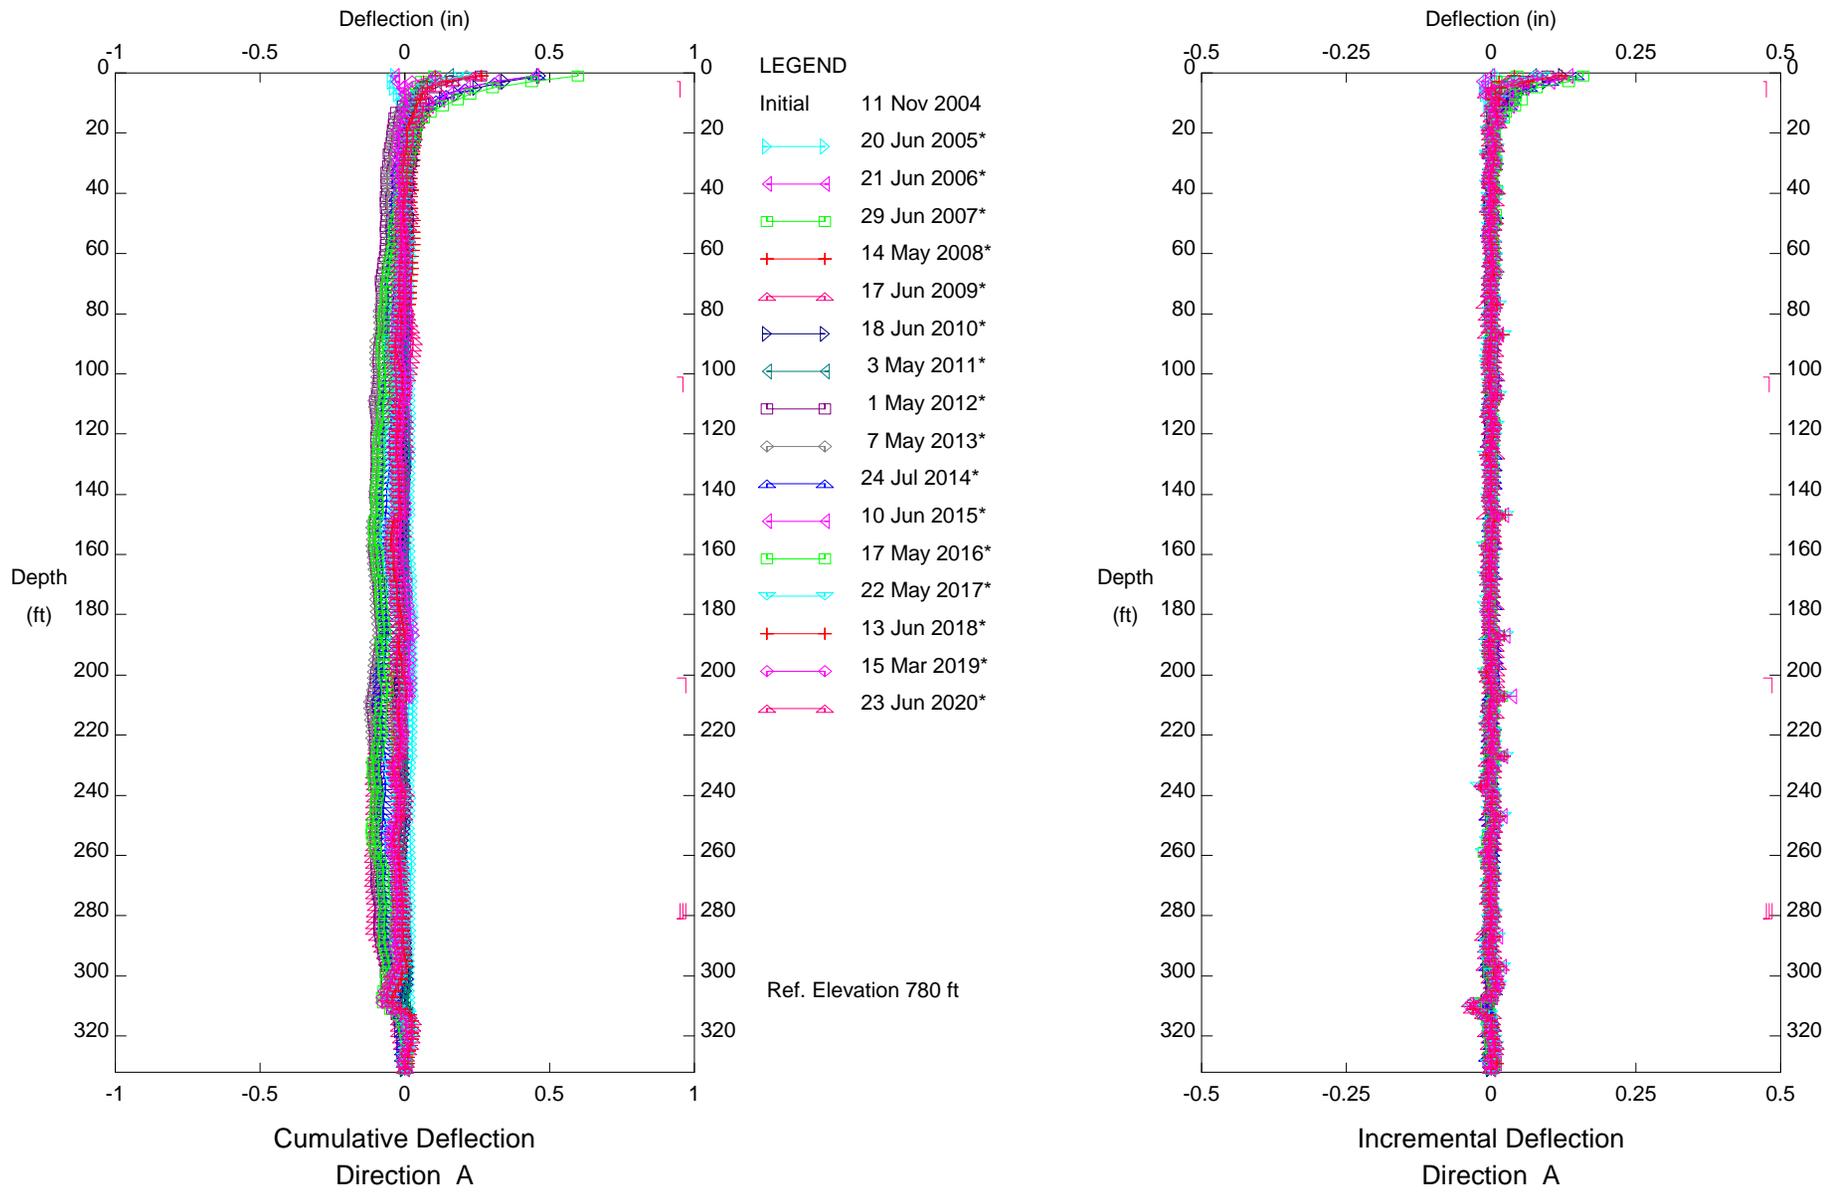
BIG ROCK MESA, Inclinator SP-22
WESTERN REGION

Sets marked * include zero shift and/or rotation corrections.
