**ANNUAL REPORT
JULY 2019 THROUGH JUNE 2020
BIG ROCK MESA LANDSLIDE
ASSESSMENT DISTRICT
City of Malibu, California**

Fugro Project No. 04.62160606

Document No. 04.62160606-PR-007(Rev.00)

**Annual Report of Maintenance and Monitoring, July 2019 through June 2020,
Big Rock Mesa Landslide Assessment District, City of Malibu, California**

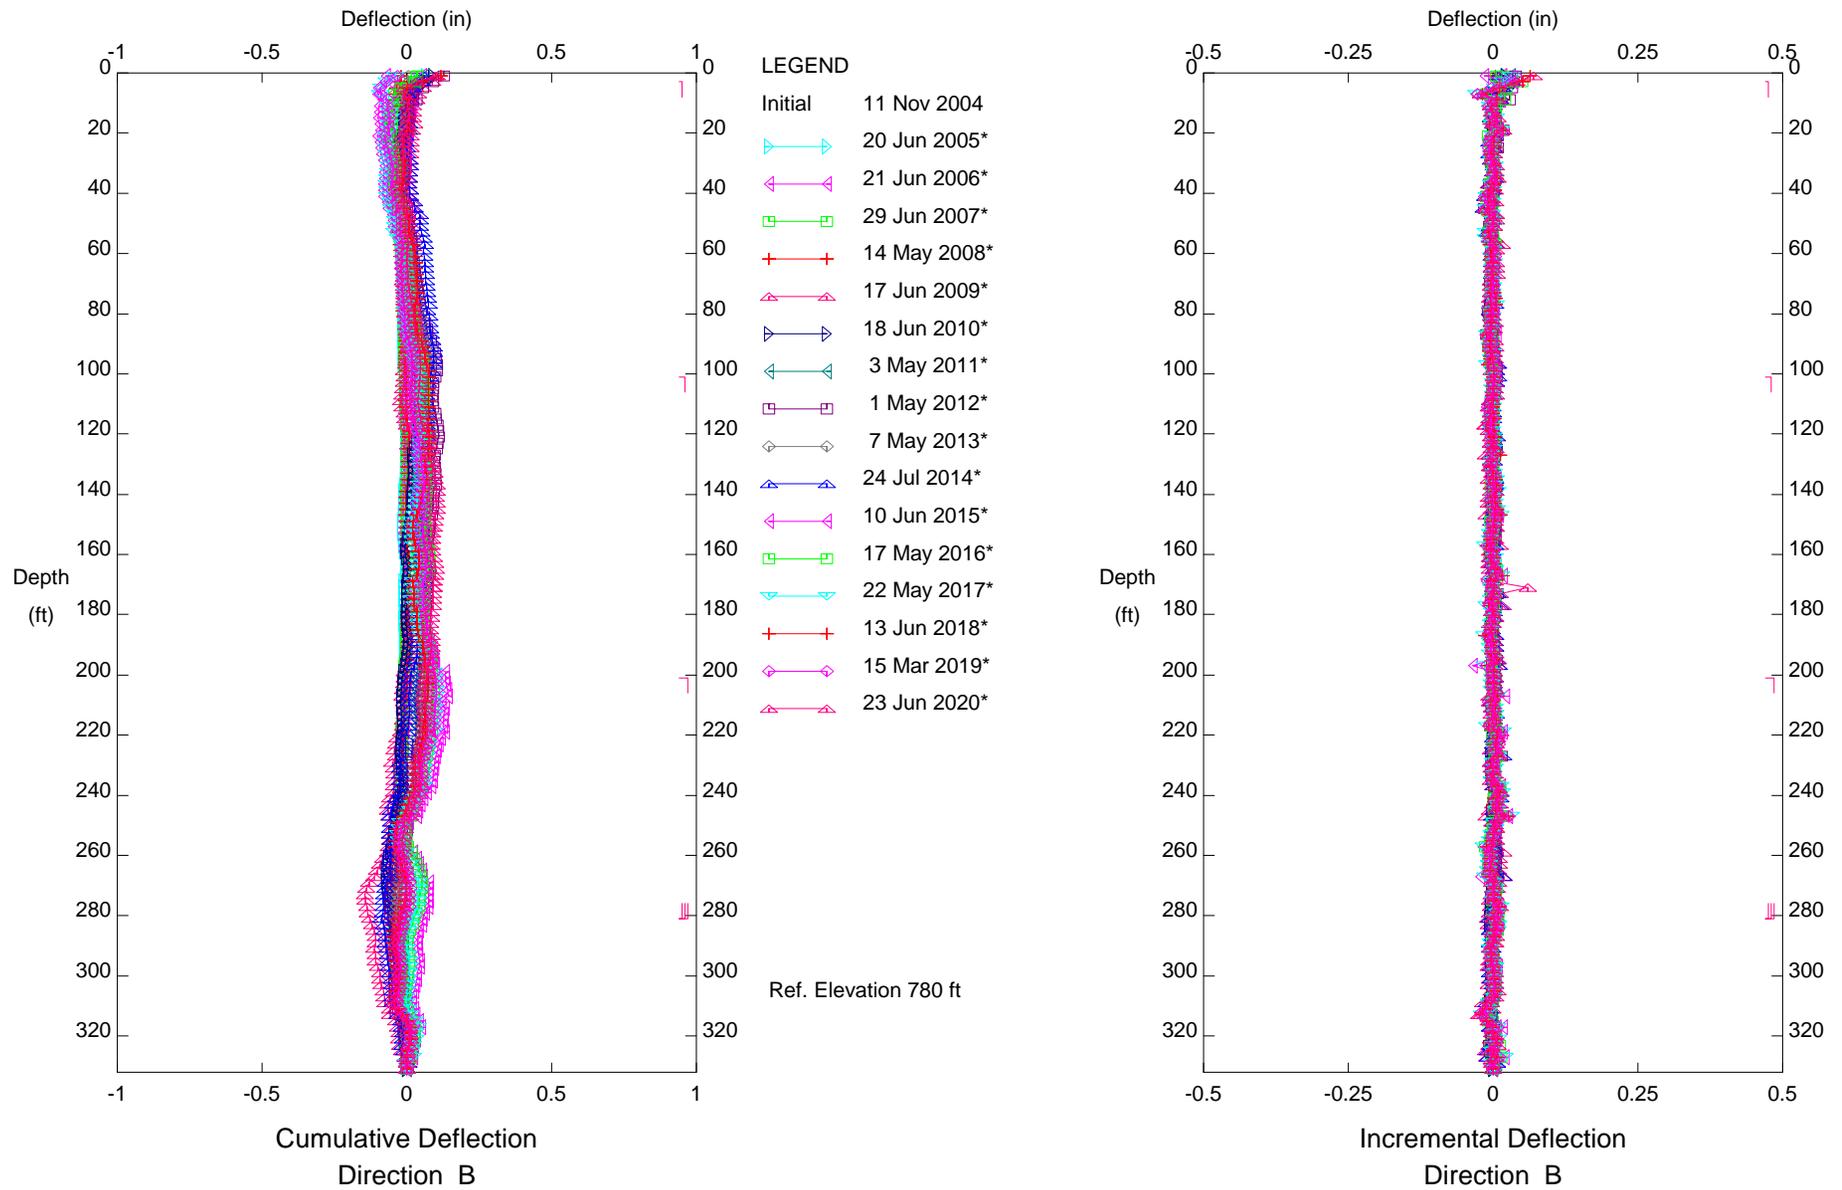
BIG ROCK MESA, Inclinator SP-22
WESTERN REGION

Sets marked * include zero shift and/or rotation corrections.

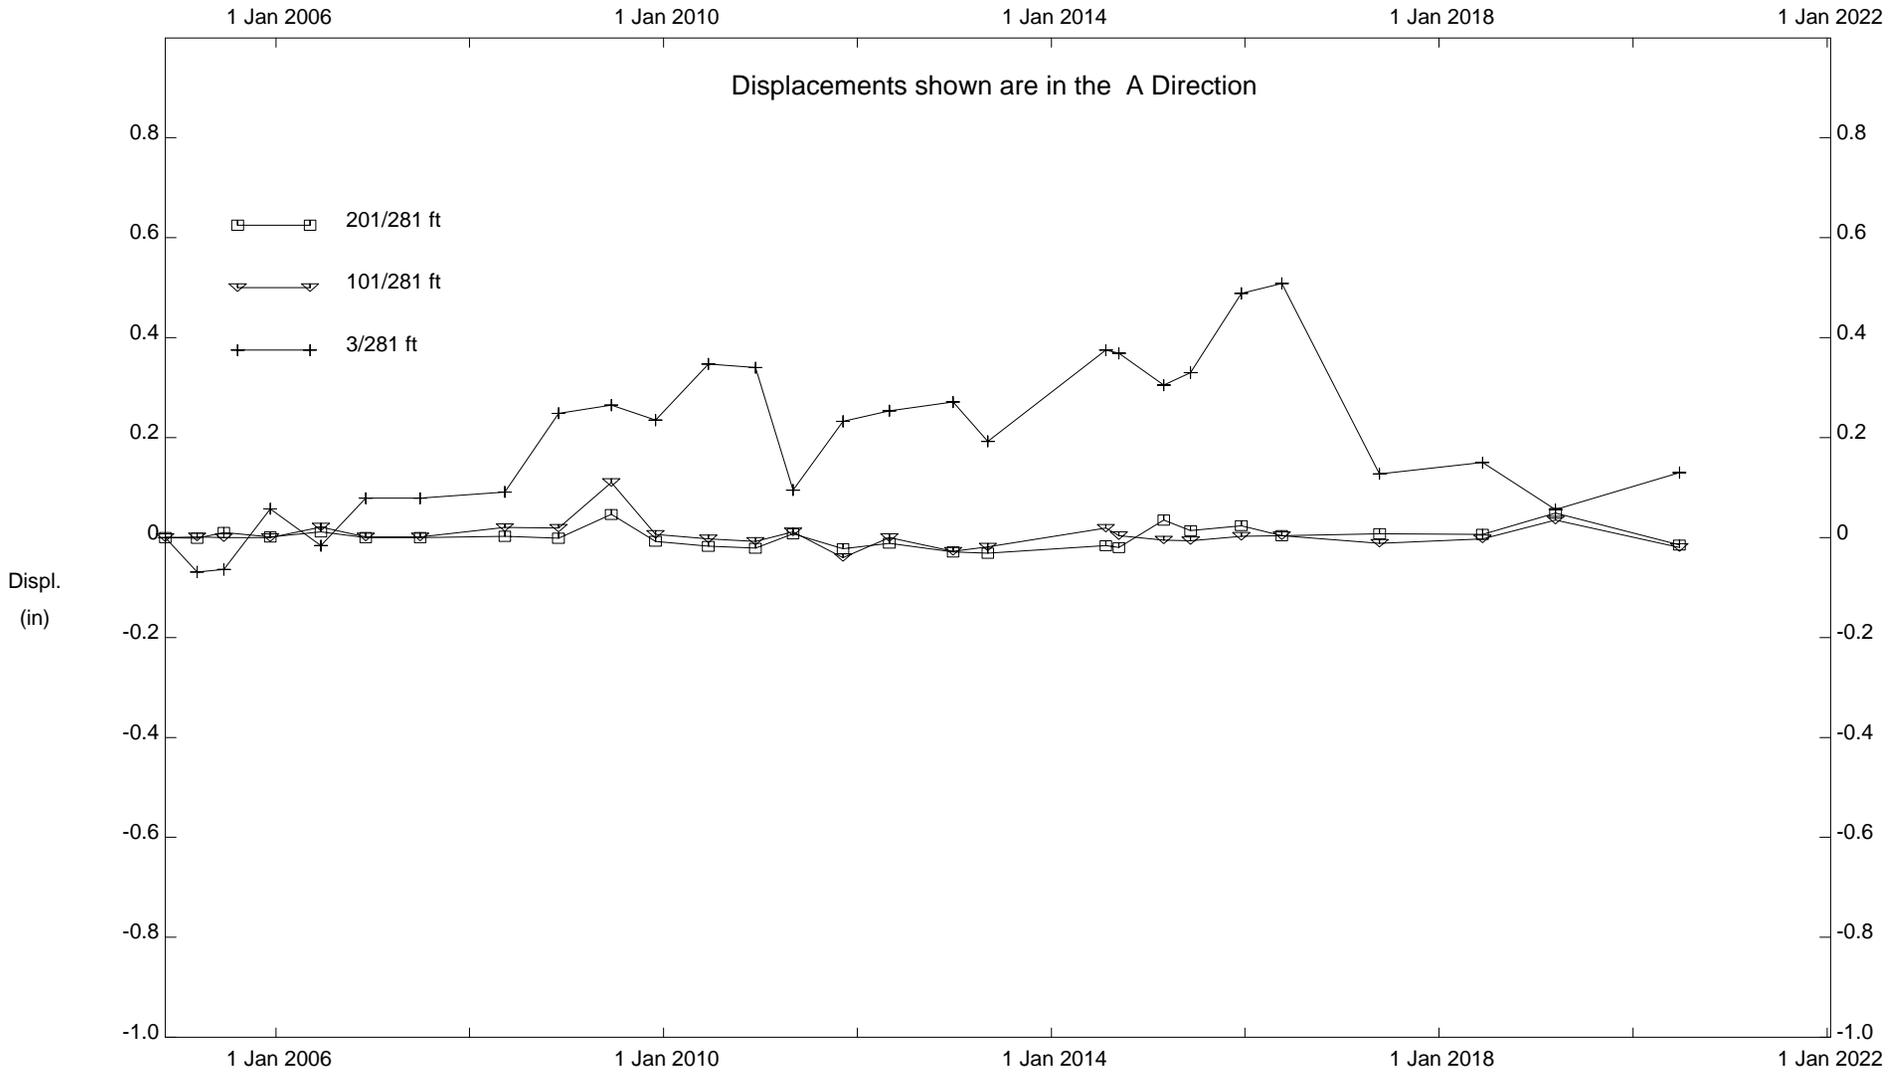
BIG ROCK MESA, Inclinator SP-22

WESTERN REGION

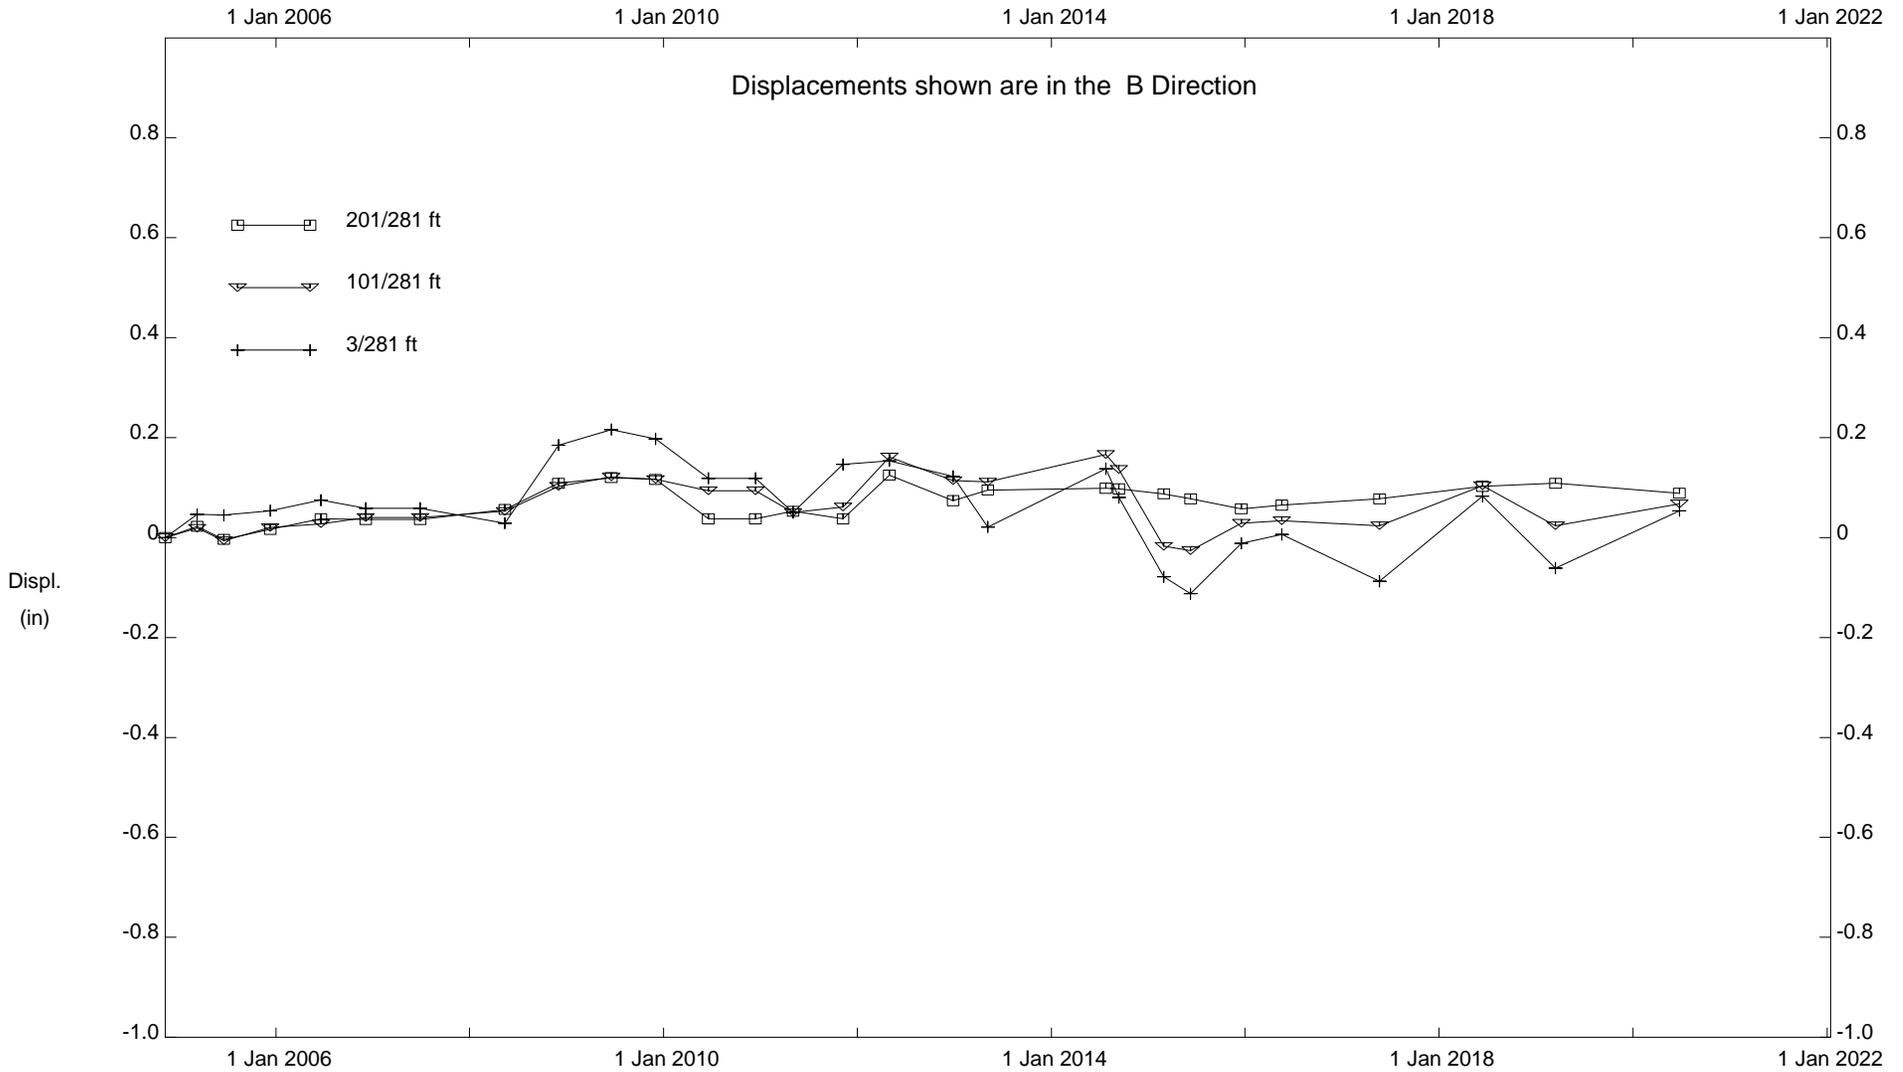
BIG ROCK MESA, Inclinometer SP-22

WESTERN REGION

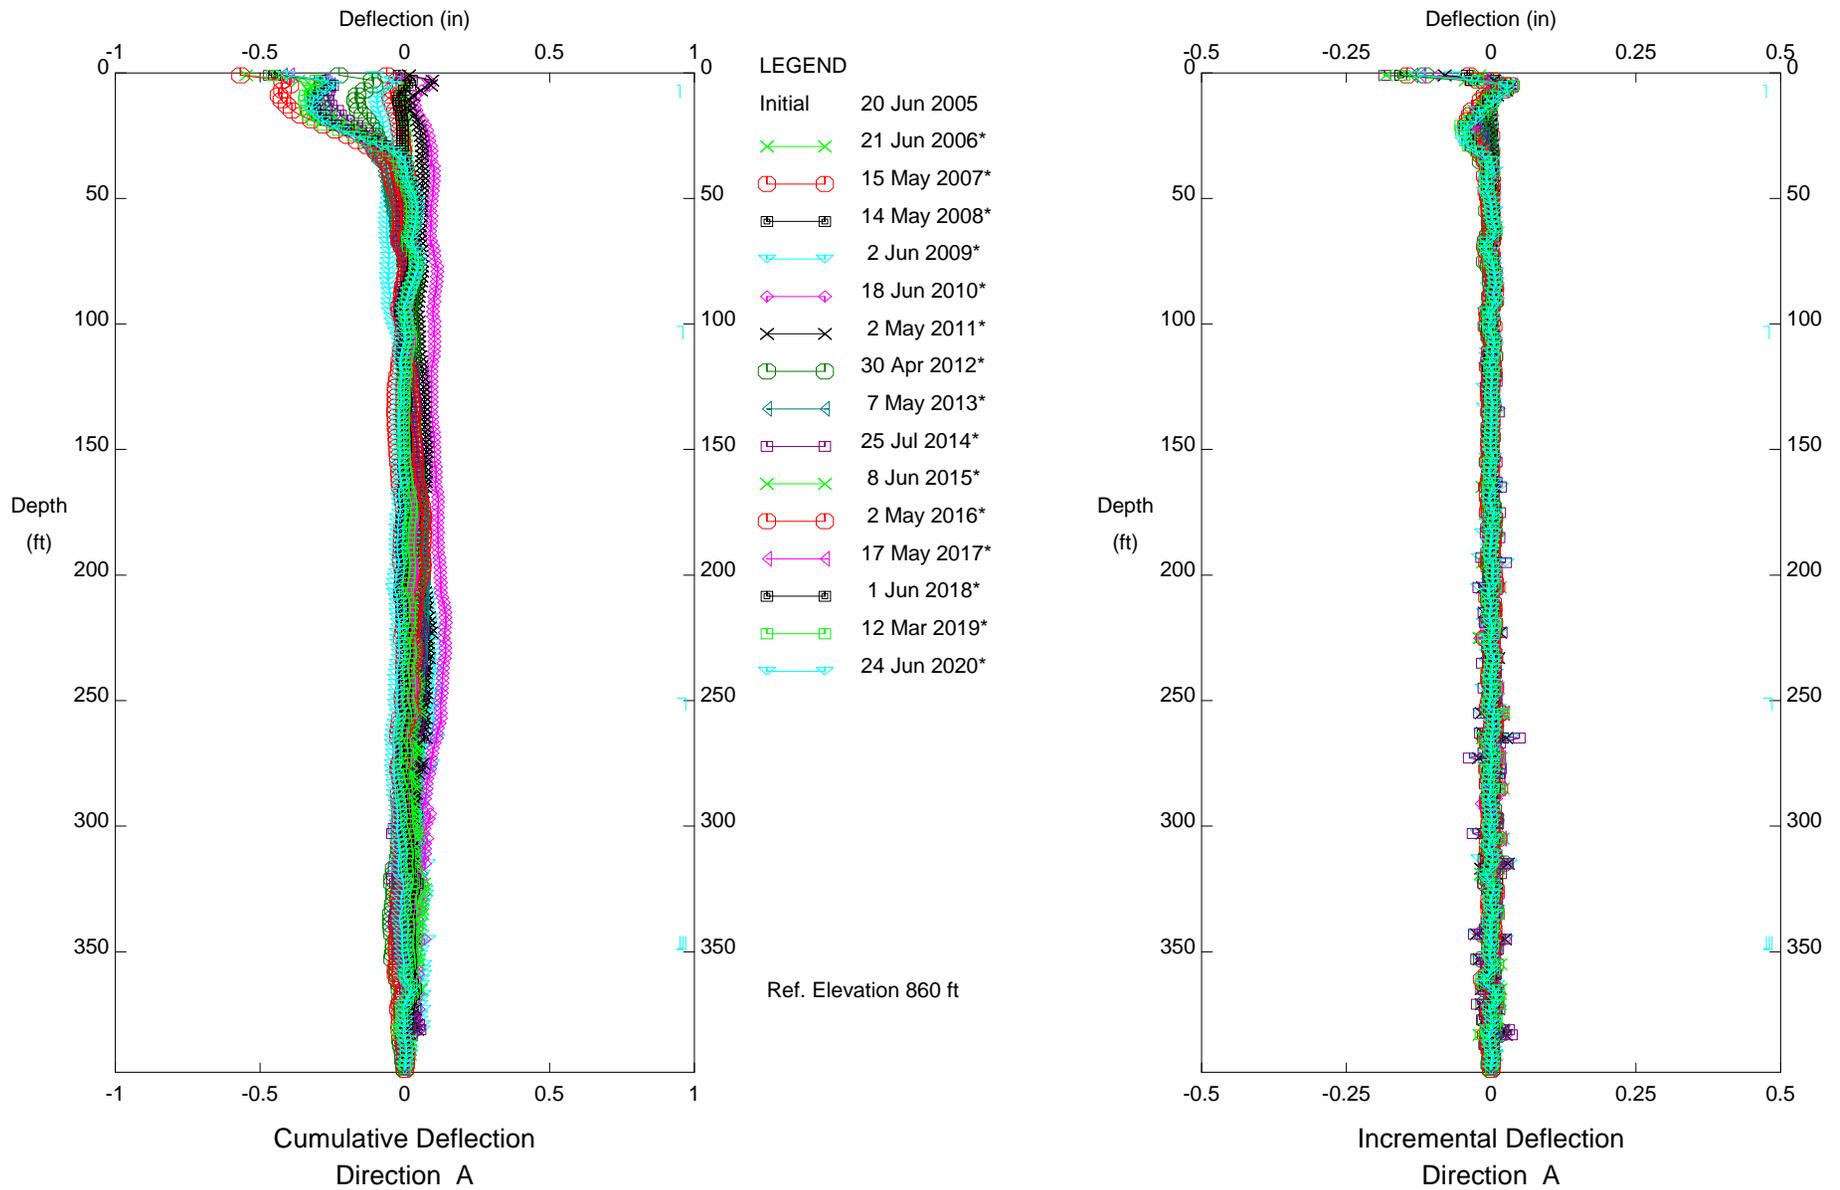
BIG ROCK MESA, Inclinometer SP-23
WESTERN REGION

Sets marked * include zero shift and/or rotation corrections.

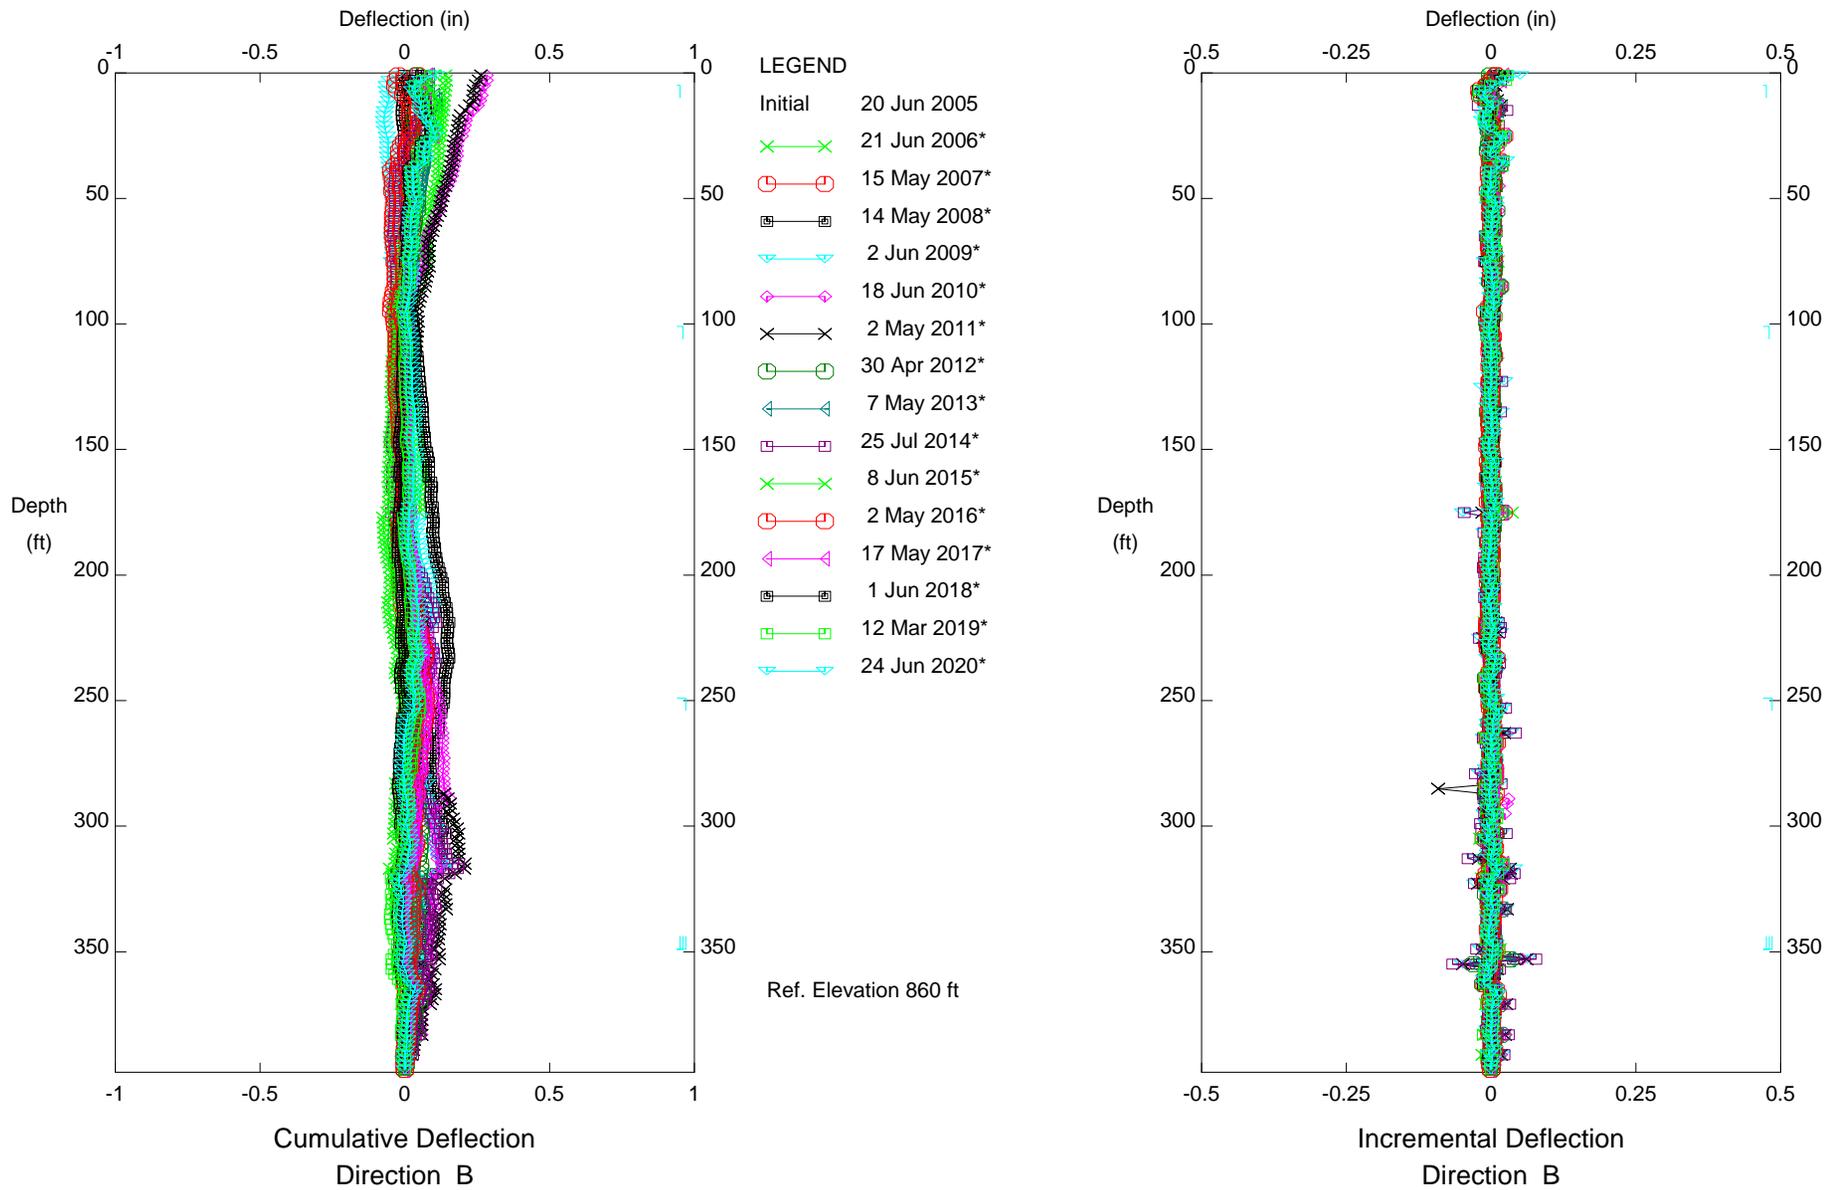
BIG ROCK MESA, Inclinometer SP-23
WESTERN REGION

Sets marked * include zero shift and/or rotation corrections.

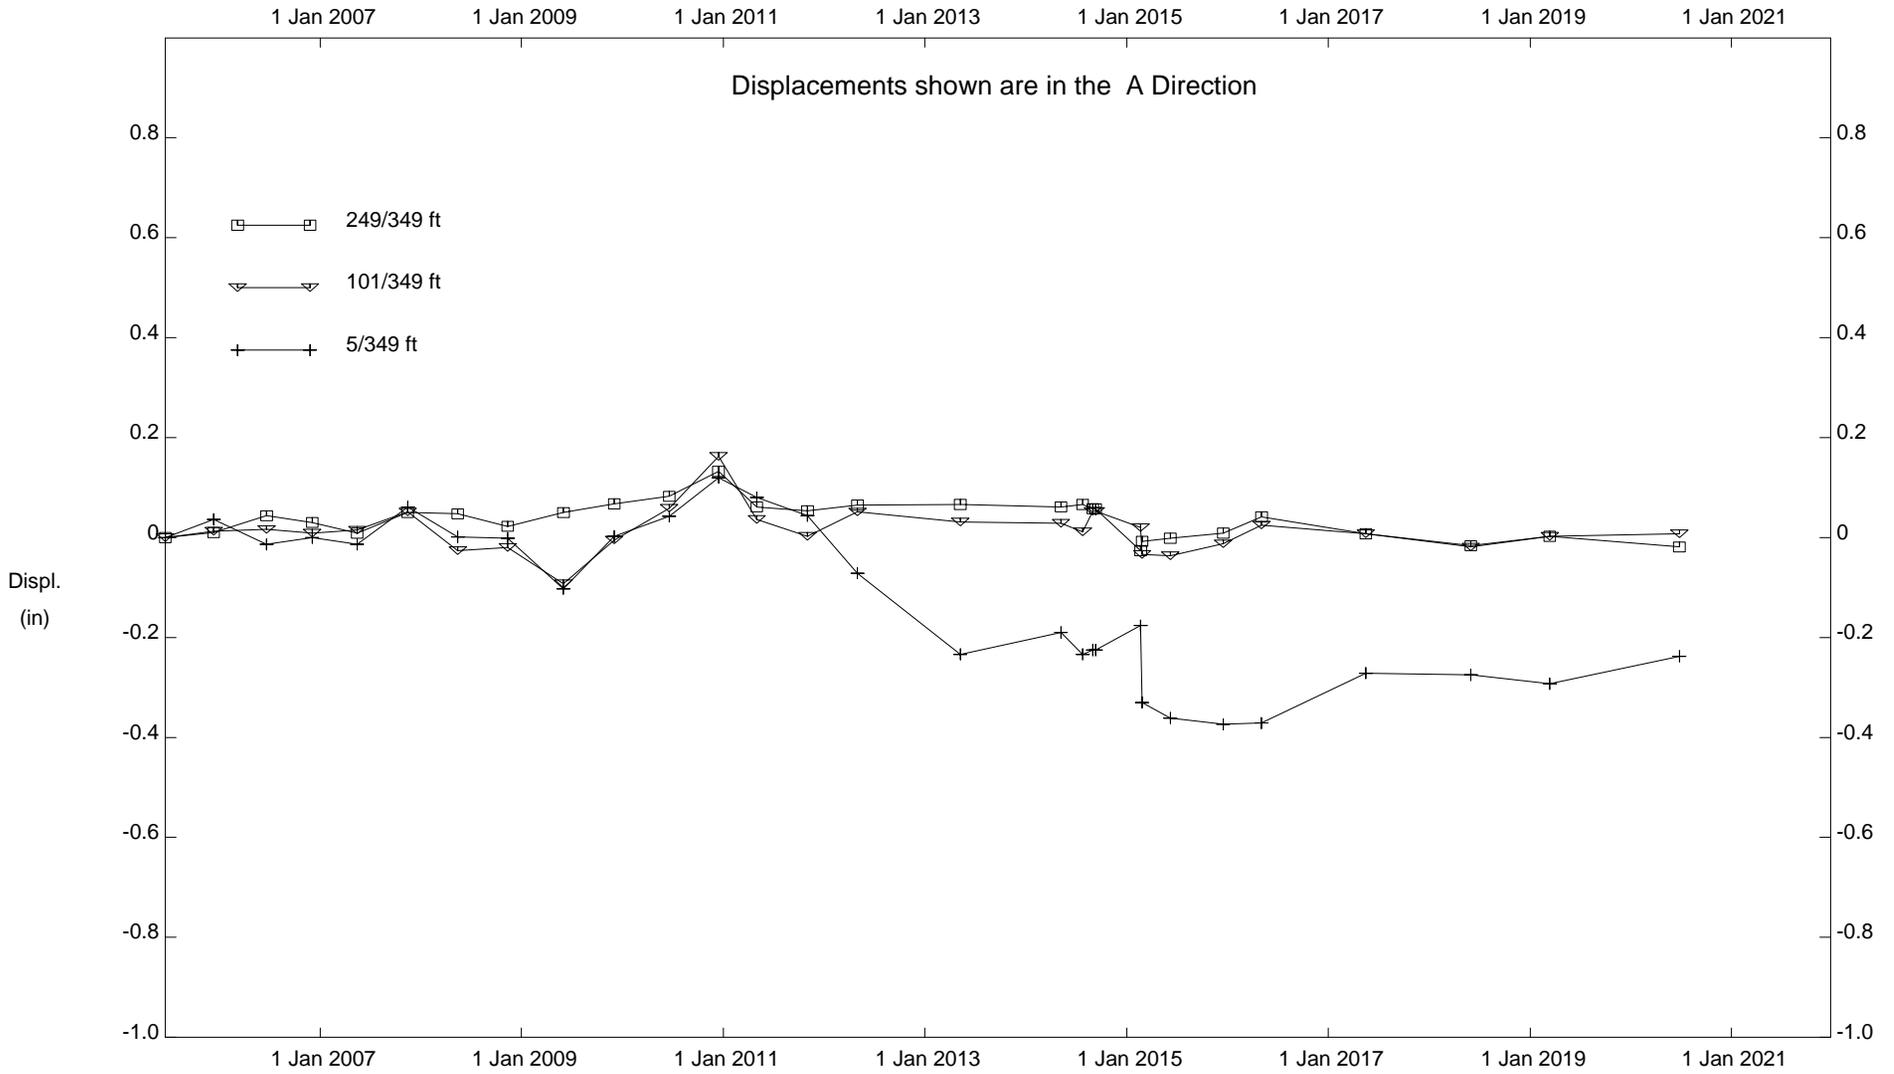
BIG ROCK MESA, Inclinometer SP-23

WESTERN REGION

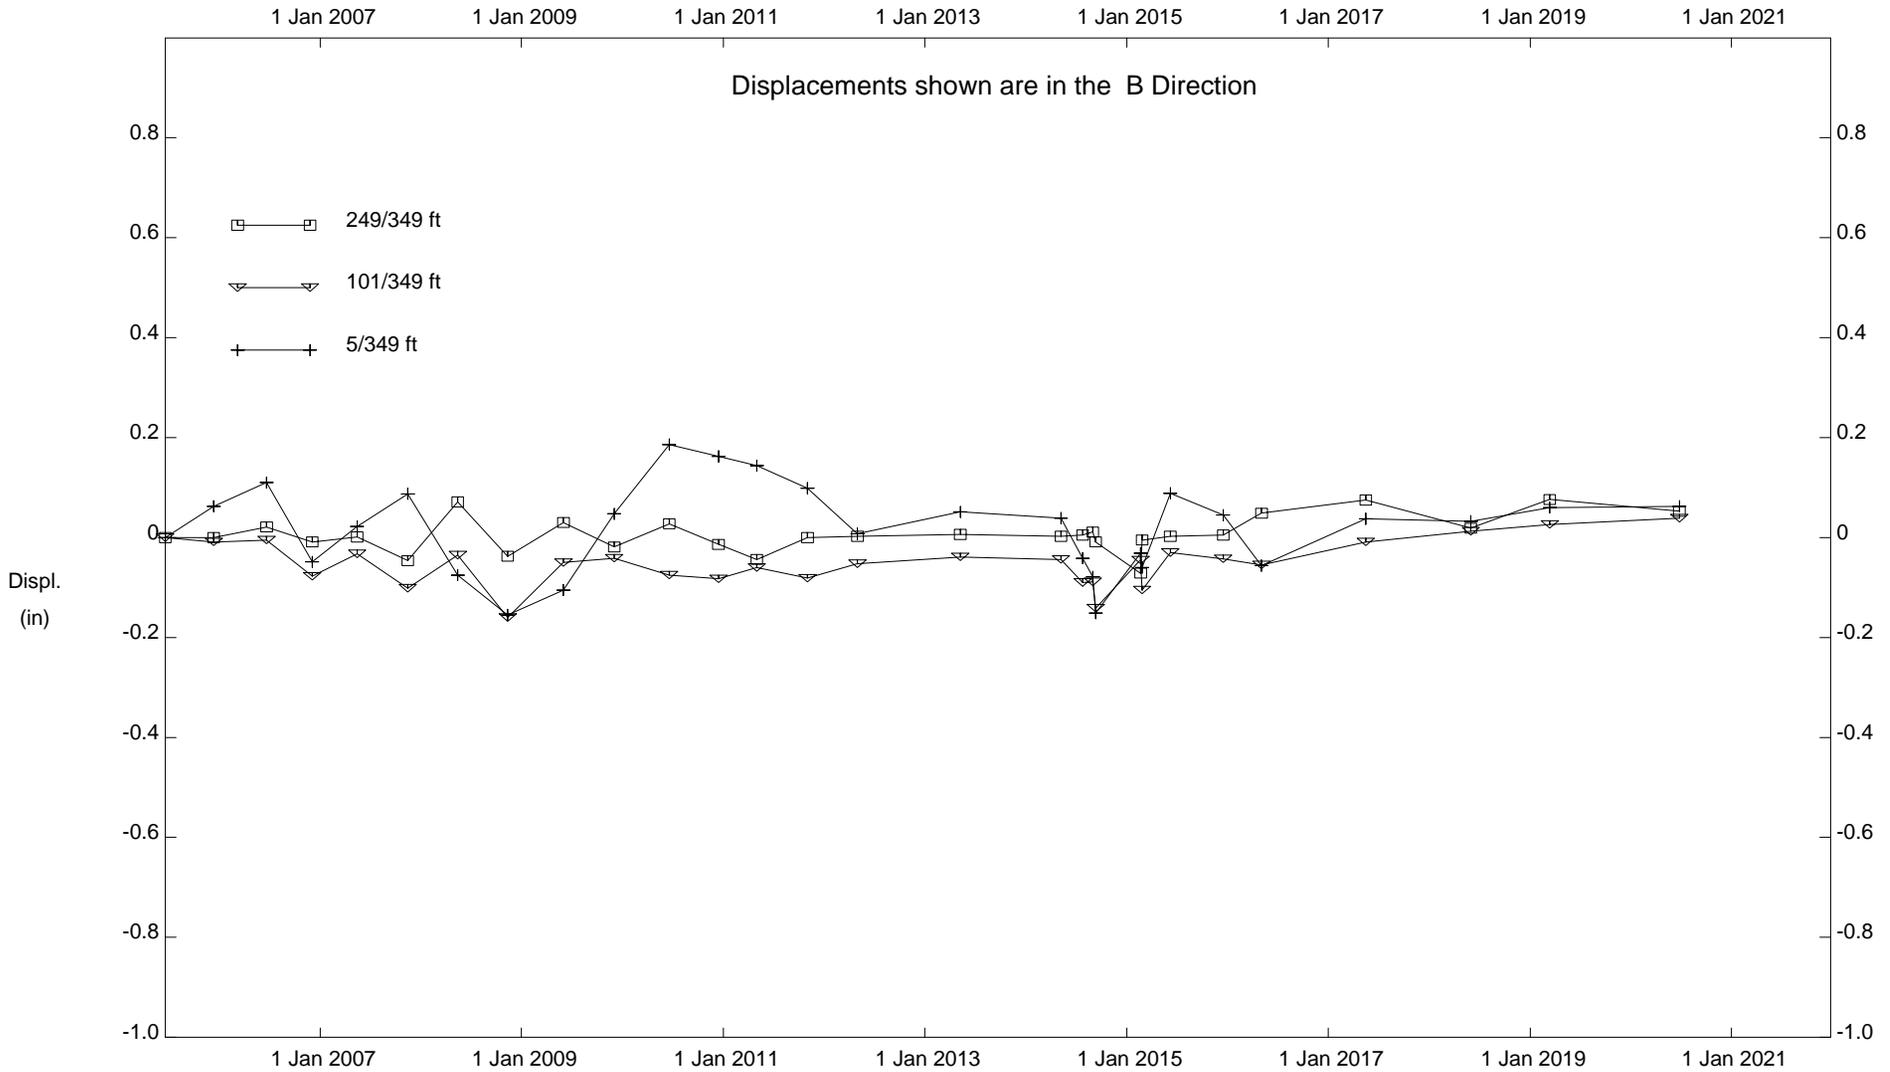
BIG ROCK MESA, Inclinator SP-23

WESTERN REGION

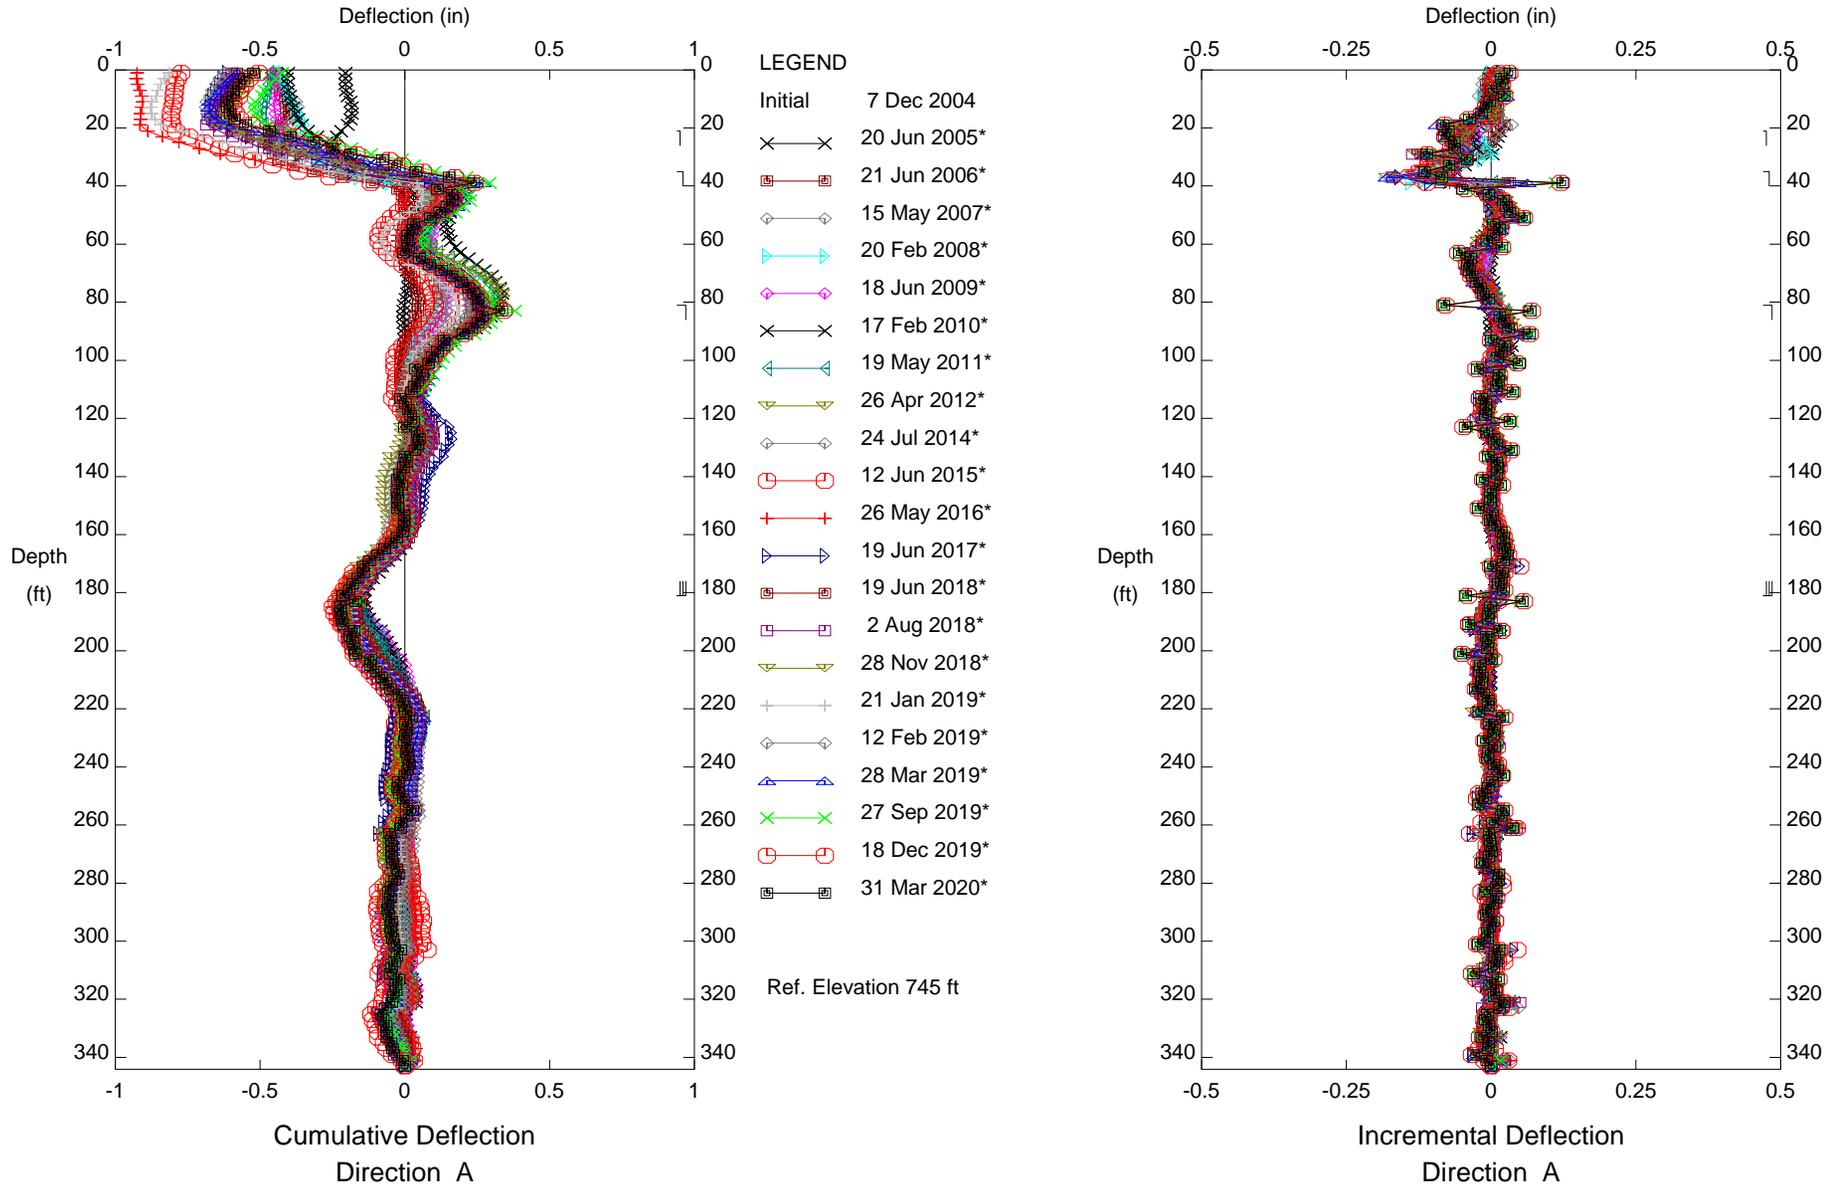
BIG ROCK MESA, Inclinator SP-26
HEADSCARP REGION

Sets marked * include zero shift and/or rotation corrections.

The Bluff Region extends along the top of the slope immediately north of the PCH Region, where intense ground cracking was observed during the 1983 landslide. The inclinometers in that area are deep and show evidence of depth position and rotation errors, associated with cable stretch, casing curvature, and casing deviation from vertical. SP-32 displayed movement less than 0.1 inches between a depth of approximately 260 to 300 feet. No other quantifiable offsets within the inclinometers of the Bluff Region were measured during this monitoring period.

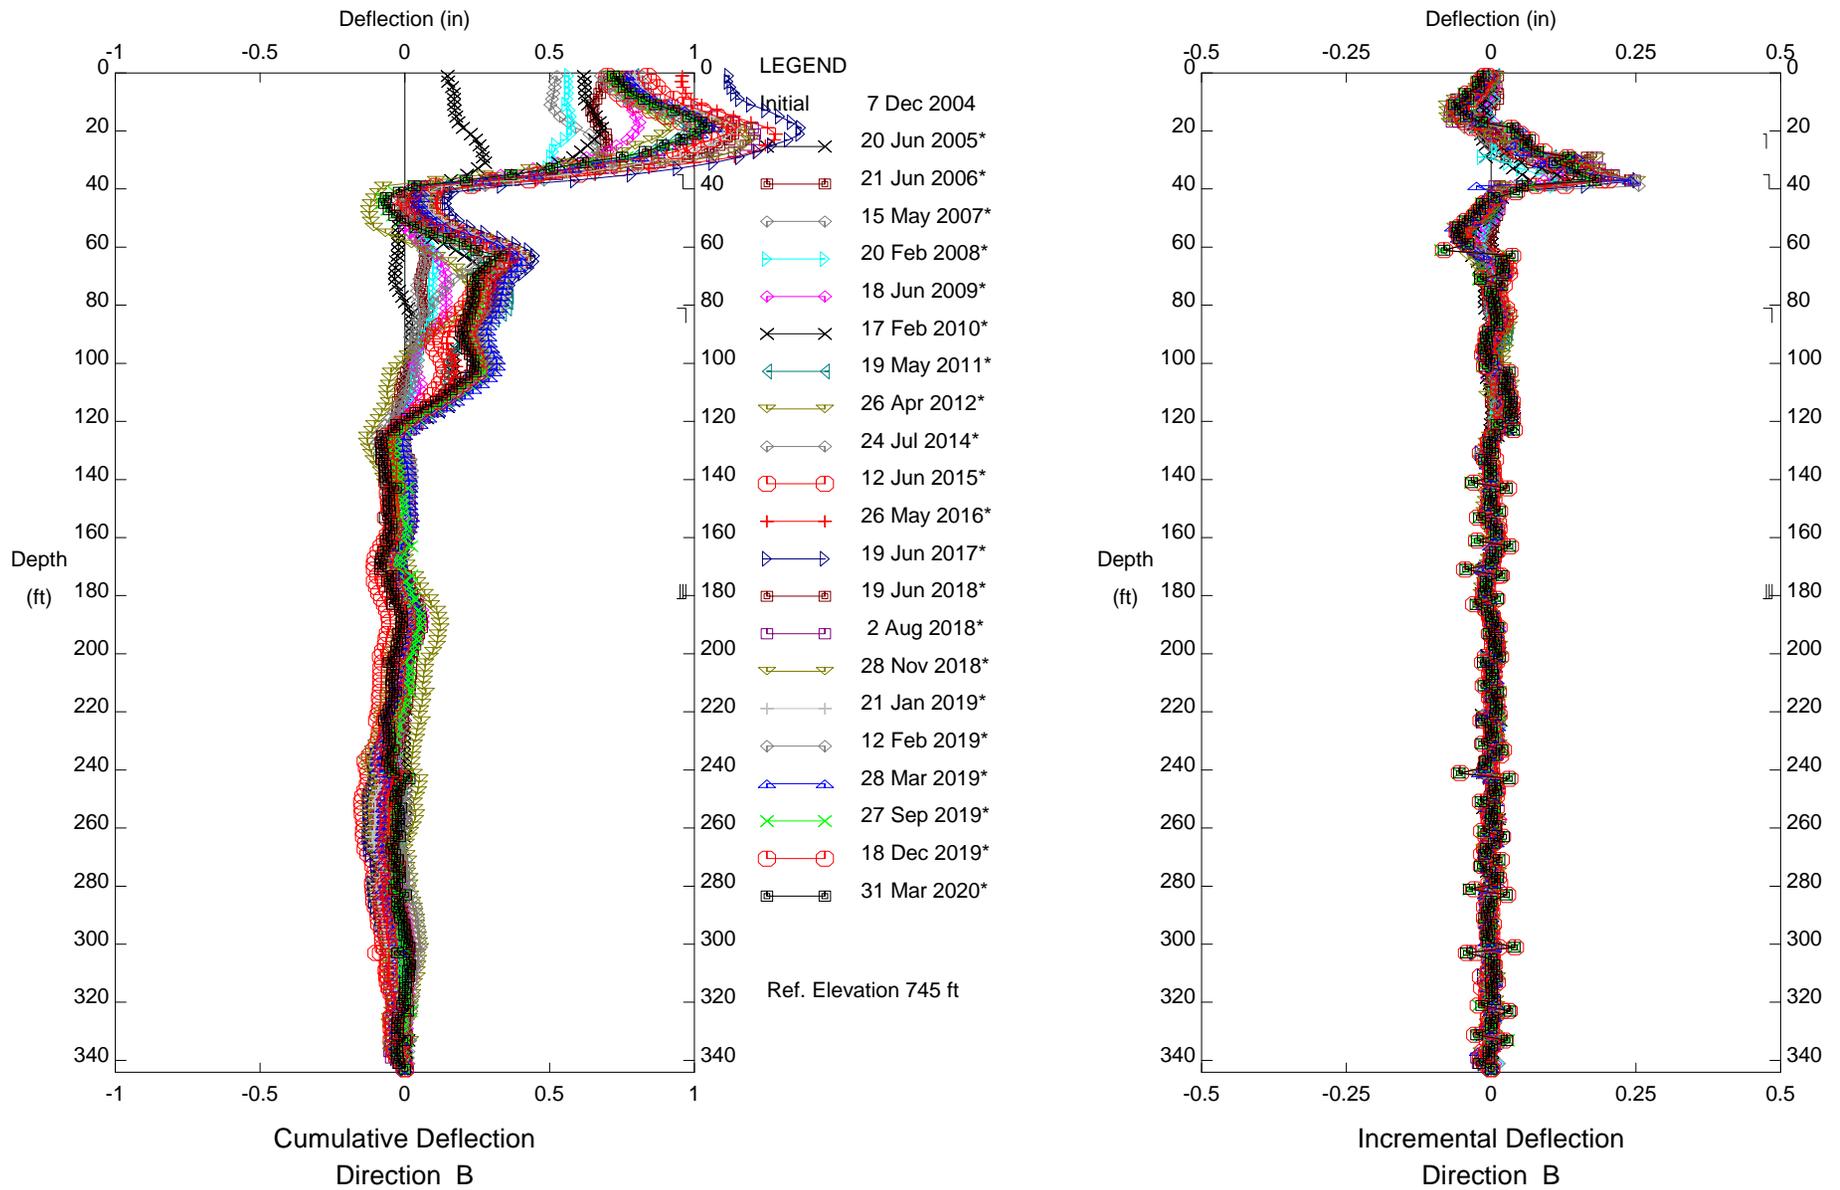
BIG ROCK MESA, Inclinometer SP-26
HEADSCARP REGION

Sets marked * include zero shift and/or rotation corrections.

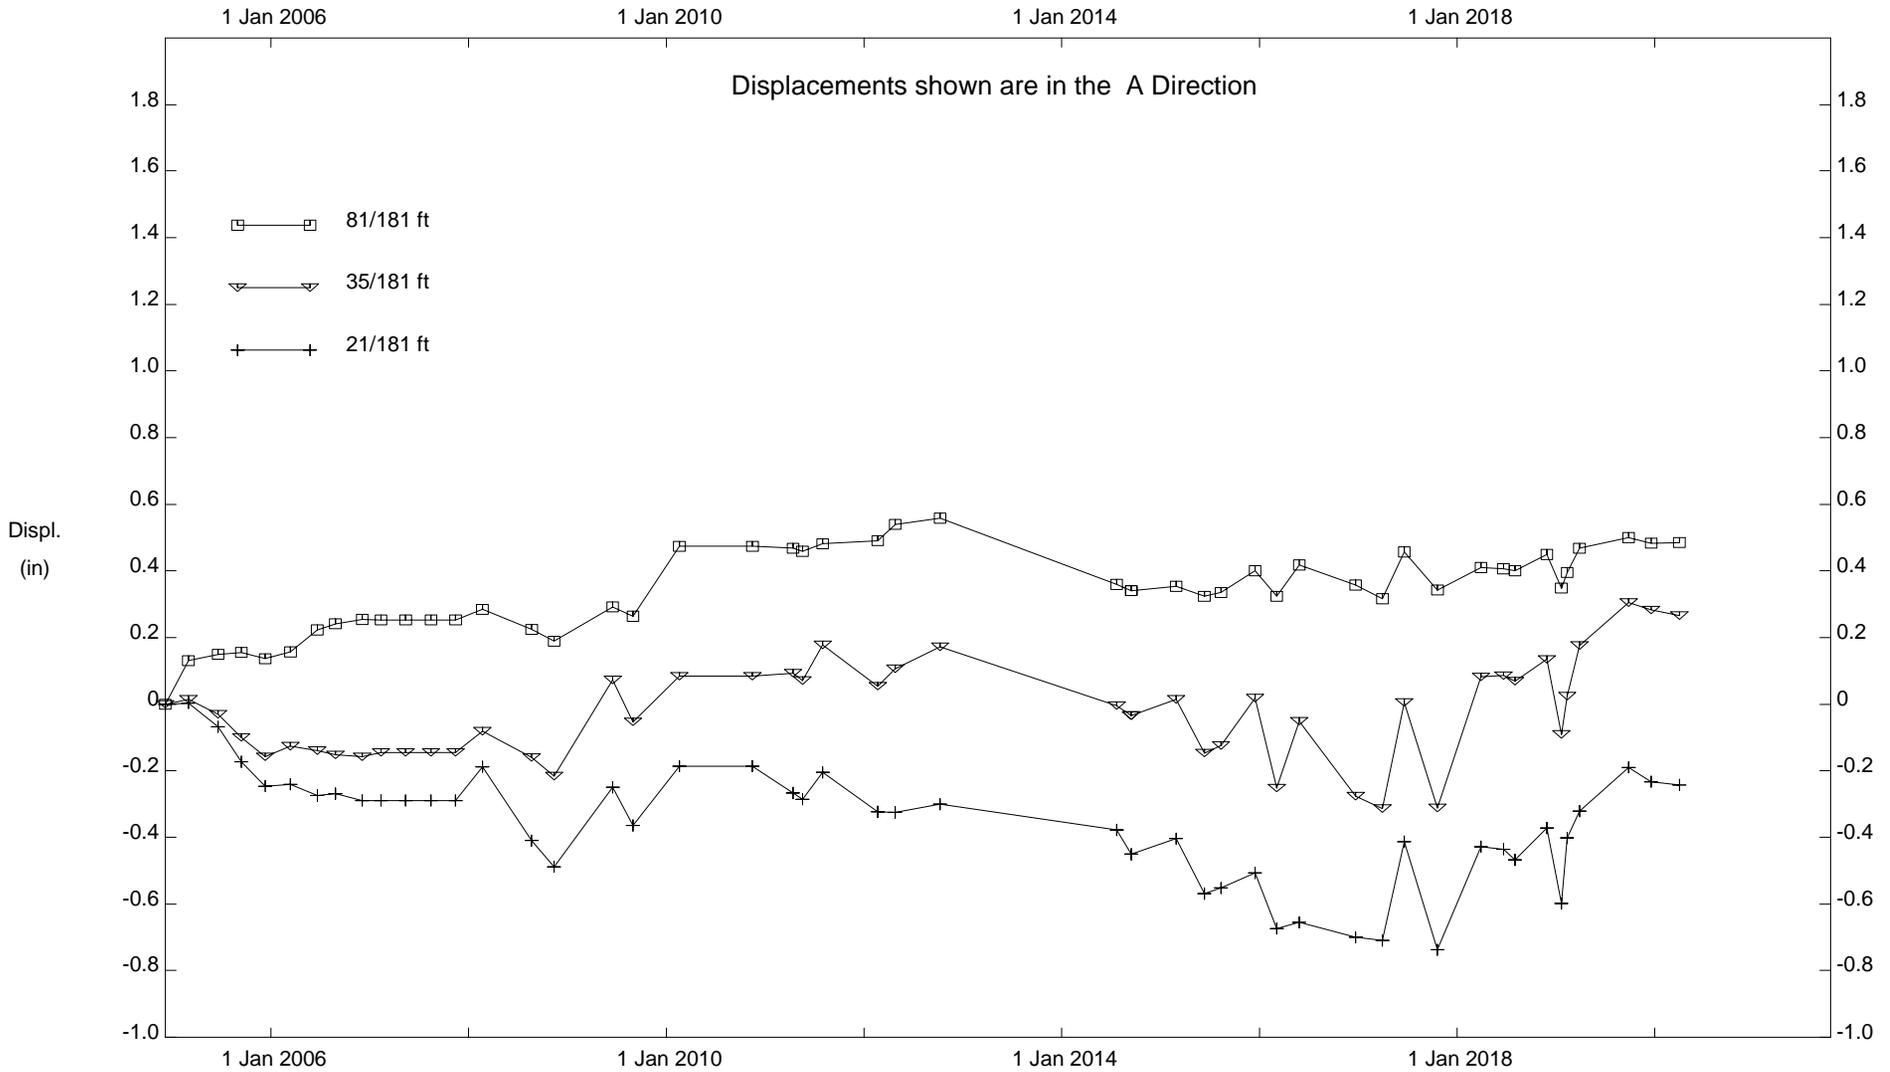
BIG ROCK MESA, Inclinator SP-26

HEADSCARP REGION
