**ANNUAL REPORT
JULY 2019 THROUGH JUNE 2020
BIG ROCK MESA LANDSLIDE
ASSESSMENT DISTRICT
City of Malibu, California**

Fugro Project No. 04.62160606

Document No. 04.62160606-PR-007(Rev.00)

**Annual Report of Maintenance and Monitoring, July 2019 through June 2020,
Big Rock Mesa Landslide Assessment District, City of Malibu, California**

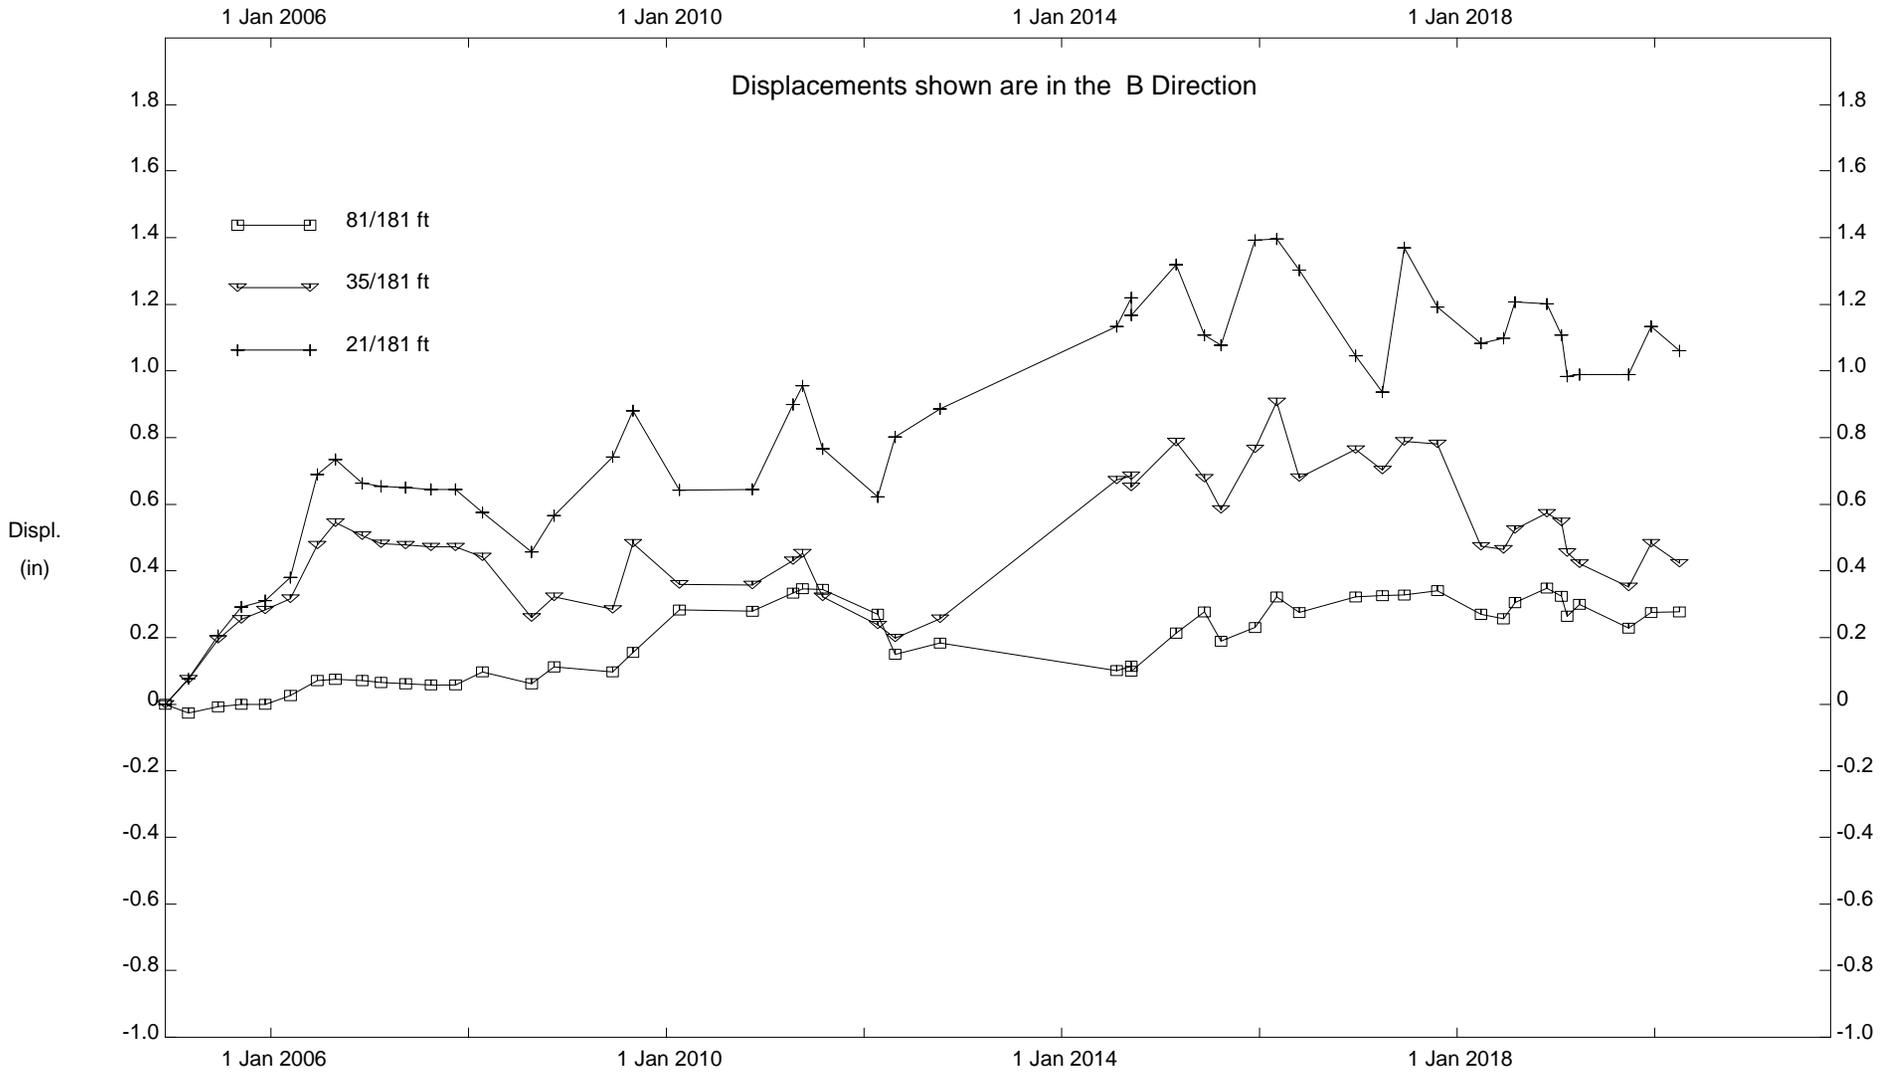
BIG ROCK MESA, Inclinometer SP-26

HEADSCARP REGION
